June 9, 2014

**Subject: Spring 2014 Cap Inspection
Keith Middle School
New Bedford, Massachusetts**

SITE PHOTOGRAPHS
April 2014 Cap Inspection
Keith Middle School
New Bedford, Massachusetts

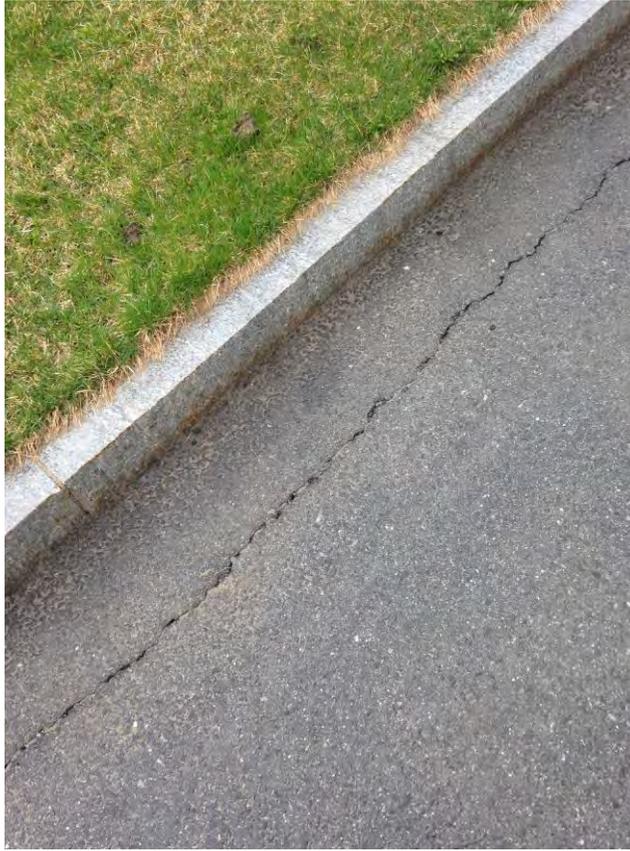
Two cracks were observed in the southern parking lot, which are greater than ¼ - inch. These cracks require repair prior to the next scheduled inspection. Several curbed areas along the exterior of the middle school had small tufts grass penetrating through the concrete and asphalt. This issue has been monitored and treated following previous inspection reports, and the results have been positive. Although these cracks through which vegetation is penetrating were not greater than ¼-inch, they do pose potential future problems as weathering could increase crack

All asphalt areas look in good condition except for two cracks greater than ¼ - inch in the southern parking lot, please view Photographs 1 and 2. A minor crack less than ¼-inch was observed on the eastern “driveway” in the previous visit, but appears to be OK. Small tufts of grass were observed penetrating up through the curbed sidewalk in various areas but are less than a ¼-inch and deemed acceptable, see Photograph 3 These areas should be addressed to prevent potential cap issues in the future.

1) Crack in the asphalt greater than ¼-inch, located in the southern parking lot

- Animal burrows were observed on the western and northern slopes. Reportedly, six gophers were captured during 2013, but the burrows need to be filled in.
- Potentially deep-rooted vegetation was observed on the western and southern slopes and should be cut down.
- Two cracks larger than ¼ of an inch were observed in the southern parking lot, and should be repaired.

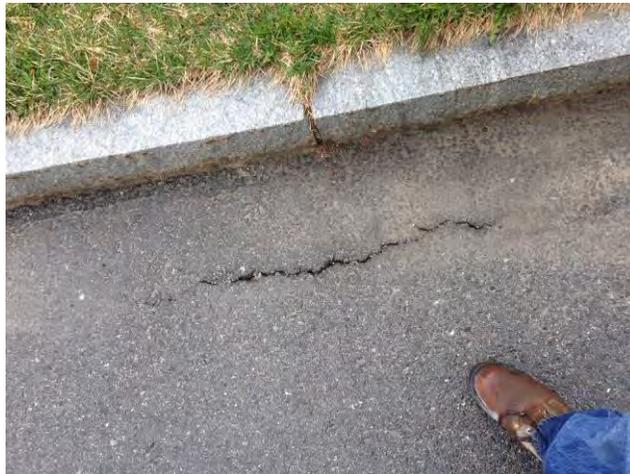
2) Crack in the asphalt greater than ¼-inch, located in the southern parking lot

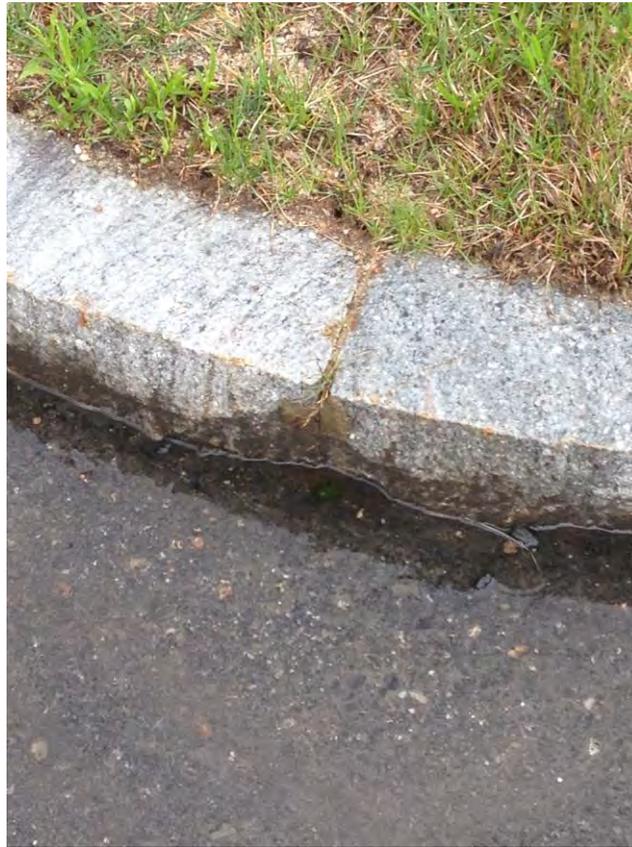
- Vegetation was observed penetrating pavement surfaces, particularly in the areas adjacent to curbs and catch basins. Although the cracking/gaps in these areas are minor, potential expansion could occur if this situation is left untreated. These areas should continue to be monitored.

3) Tufts of grass protruding through the curb.

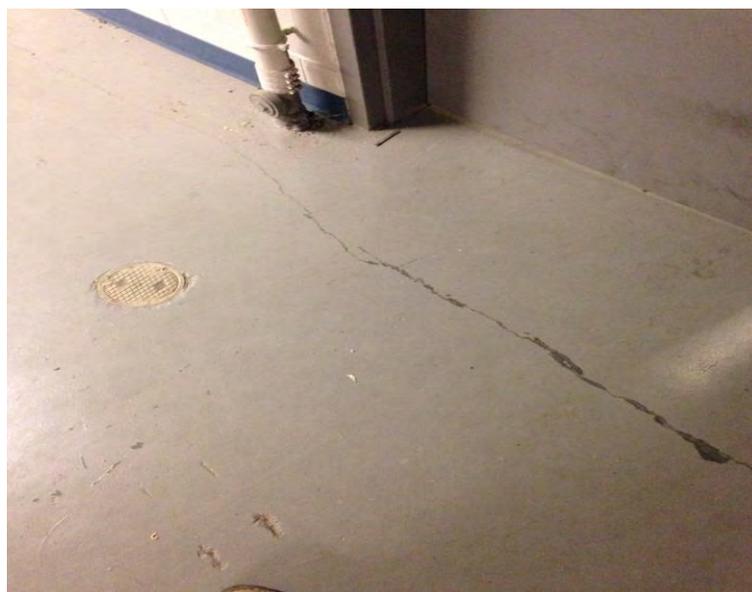
. Four cracks in the boiler room floor are less than ¼-inch wide and have not increased in size, see Photograph 4. Three minor cracks in storage room 44 are also less than ¼-inch wide and have not increased in size, see Photograph 5. A small crack was observed in the electric closet, and in the tile covering the concrete along the southern hallway (please see Photograph 6). The majority of interior concrete floors are covered with tiles or other type of flooring material. Based on visual inspection and conversations with current employees, there are no breaches or other significant damage or deterioration of the interior surficial flooring materials or, where visible, concrete floors. No construction was occurring within the building at the time of the inspection.

4) Cracks in boiler room

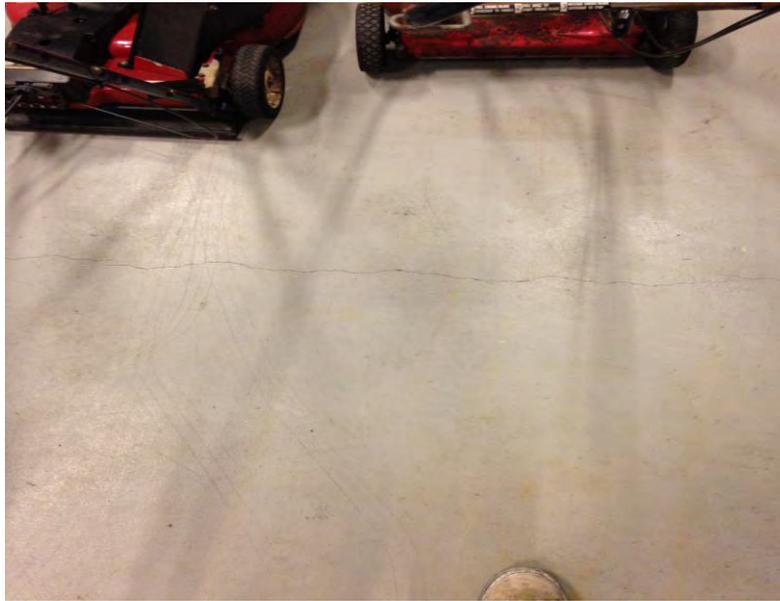
5) Cracks in gym storage room

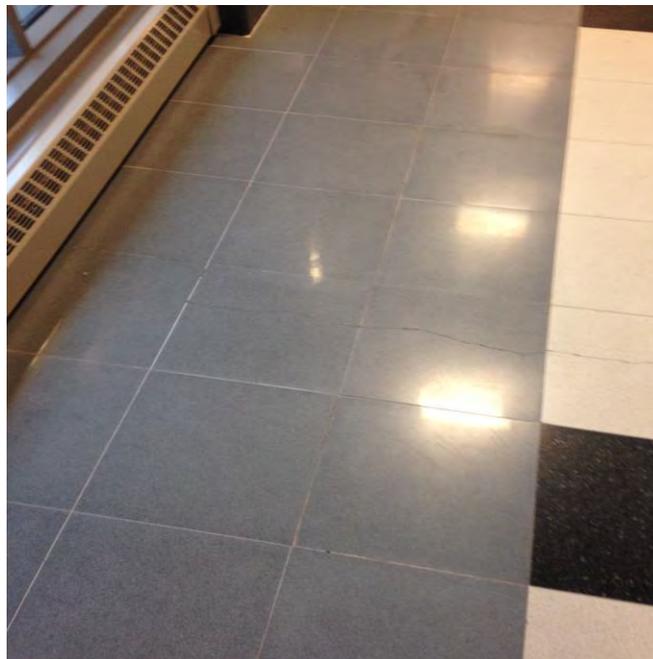
6) Crack along the southern hallway

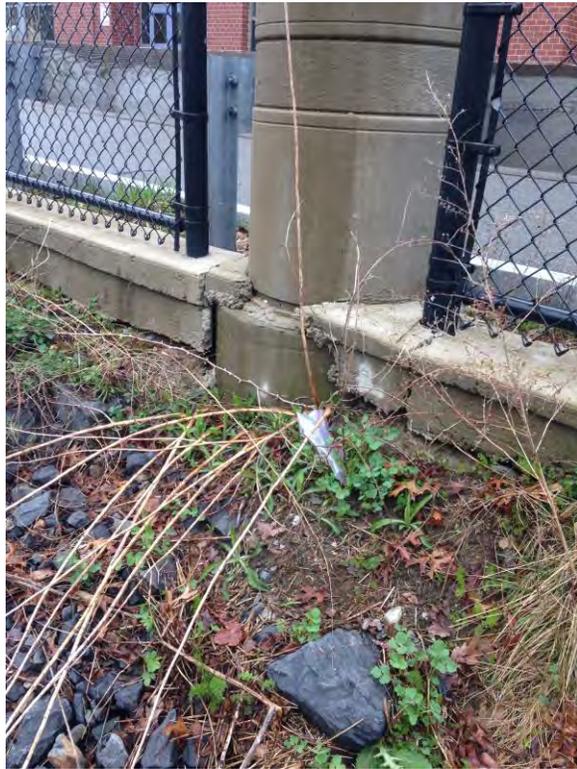
- The cap slope is sloughing in an area adjacent to the wetland west of the school, and is undermining the concrete fence support. A crack was observed in the concrete fence support.

- Sloughing riprap is undermining the concrete fence support at the top of the slope, and filling the outlet of the storm water drainage culvert on the west side of the Site. Areas of soil erosion were observed along the upper slope, as well as a crack in the concrete fence support. The area appears relatively stable at this time, but the condition is likely due to an increase in slope steepness. The crack in the concrete fence support is not identified as a cap integrity issue, nor is the riprap accumulating in the culvert outlet, but these issues should be addressed to maintain the integrity of the fence and the function of the culvert.

The structural integrity of this fence may be compromised if the sloughing and erosion continues, see Photograph 7. The cap soils beneath the riprap may also become exposed and susceptible to erosion. The area appears stable at the moment, but the condition is likely due to an increase in steepness beyond the cap design slope. The extent of erosion seems similar to the conditions observed during several previous inspections.

7) Undermining of concrete structure for fence west of school.

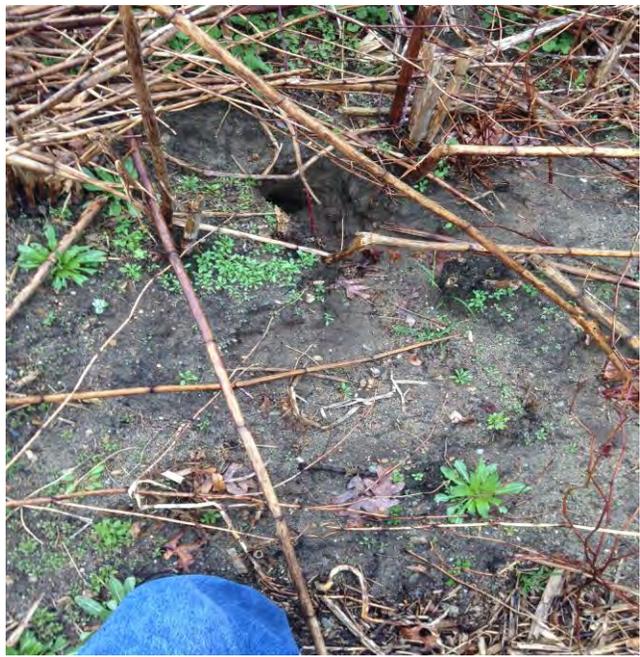
- Several small holes were observed along the western and northern edges of the cap, which may have been burrowed by small animals. As previously stated in this report, six gophers were previously removed, but the holes should be filled prior to the next cap inspection report.

- 1) Animal burrow holes were observed on the slopes to the north and west of the school, see Photographs 8 & 9. Currently these borrow do not look active, TRC will monitor these areas for increased animal activity, i.e., resumed use of borrows and increased quantity of borrows. .
- 2) Potentially deep rooted vegetation was observed on the slope to the south and west of the school and should be cut down, see Photograph 10

8) Animals burrows in the western slope.

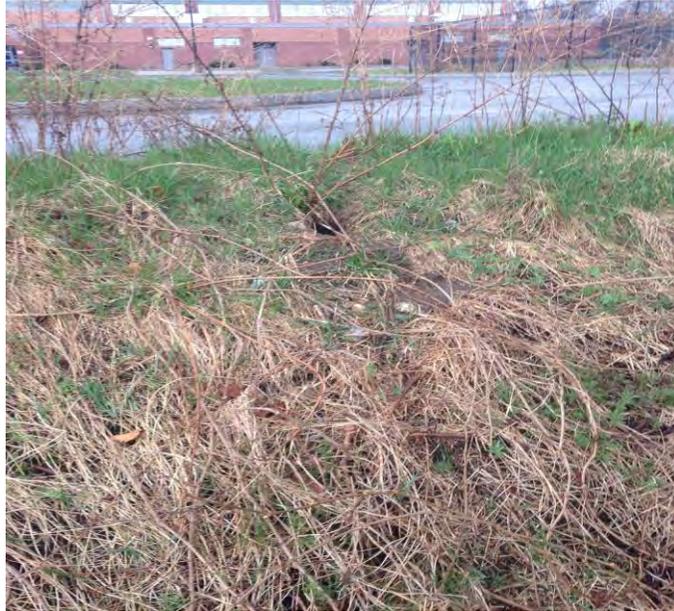
9) Animals burrows in the northern slope.

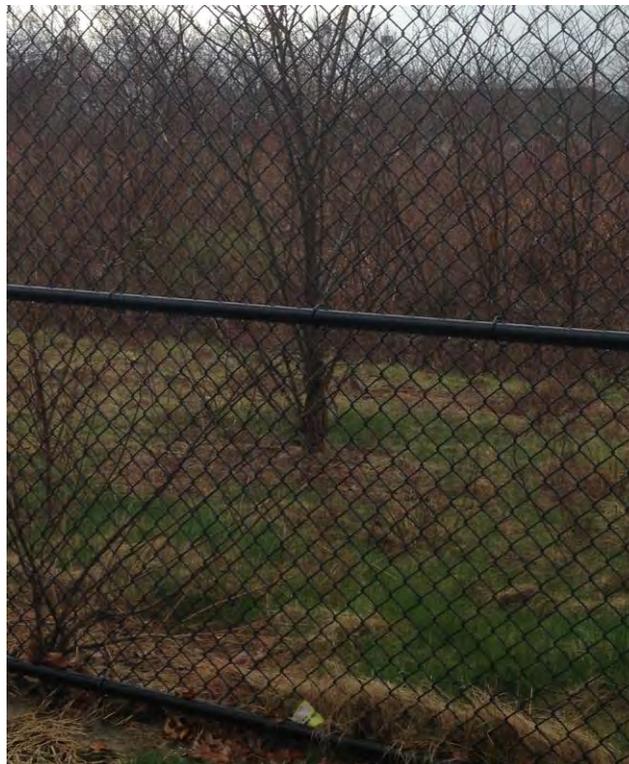
- Potentially deep-rooted vegetation observed on the slopes south and west of the school and should be cut down.

10) Potentially deep-rooted at southern slope of cap.

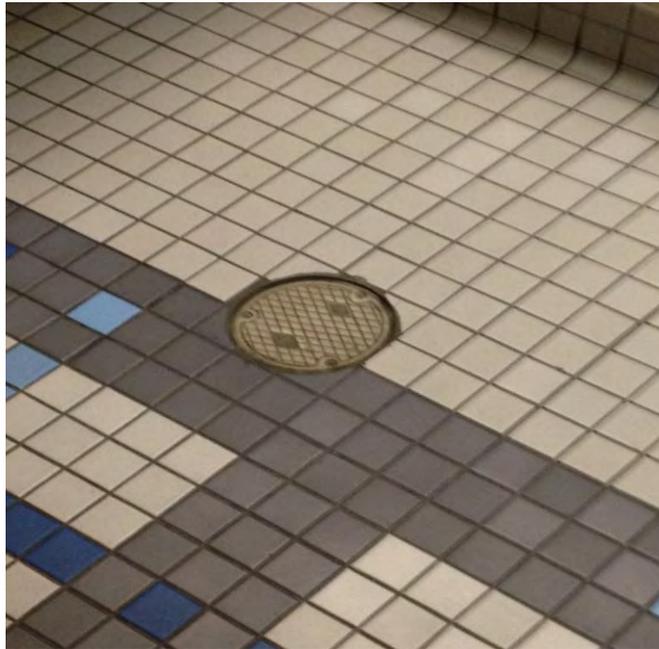
- Two clean-out drains located in the bathroom near room 148 and the school store appeared to be deteriorating, though no cracks greater than ¼-inch were observed at this time, please view photos 11 and 12. These areas should be monitored and/or repaired to prevent future deterioration.

11) Deteriorating clean out drain in bathroom near room 148.

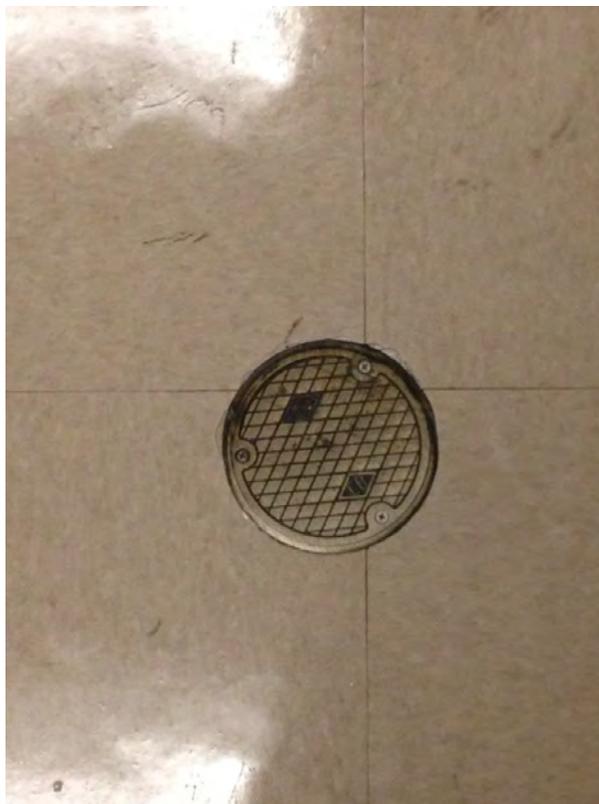
12) Deteriorating clean out drain in school store.

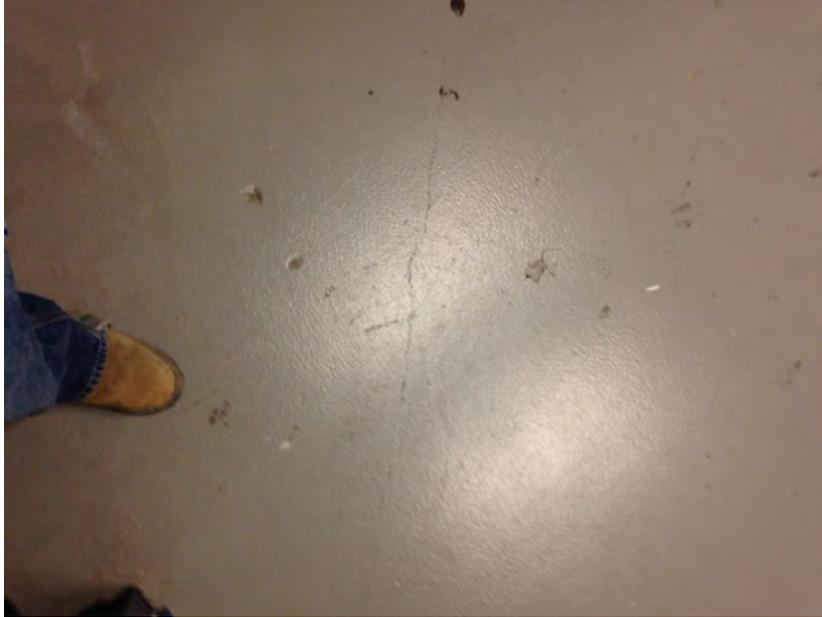
Based on TRC's inspection, the concrete floor within the footprint of the building is currently acting to prevent exposure to the impacted fill beneath. Four minor cracks were previously noted in the boiler room floor and still do not present a cap integrity issue at this time. Three very minor cracks were also observed in storage room 44, and also do not require repairs at this time. A hair line crack was observed in the electric closet, please view picture 13. Each of the eight cracks noted above appears in a general east-to-west orientation.

13) Hairline crack in electric closet
