January 24, 2014

**Subject: Fall 2013 Cap Inspection  
Keith Middle School  
New Bedford, Massachusetts**

# **Figure 1**

## **Site Map**

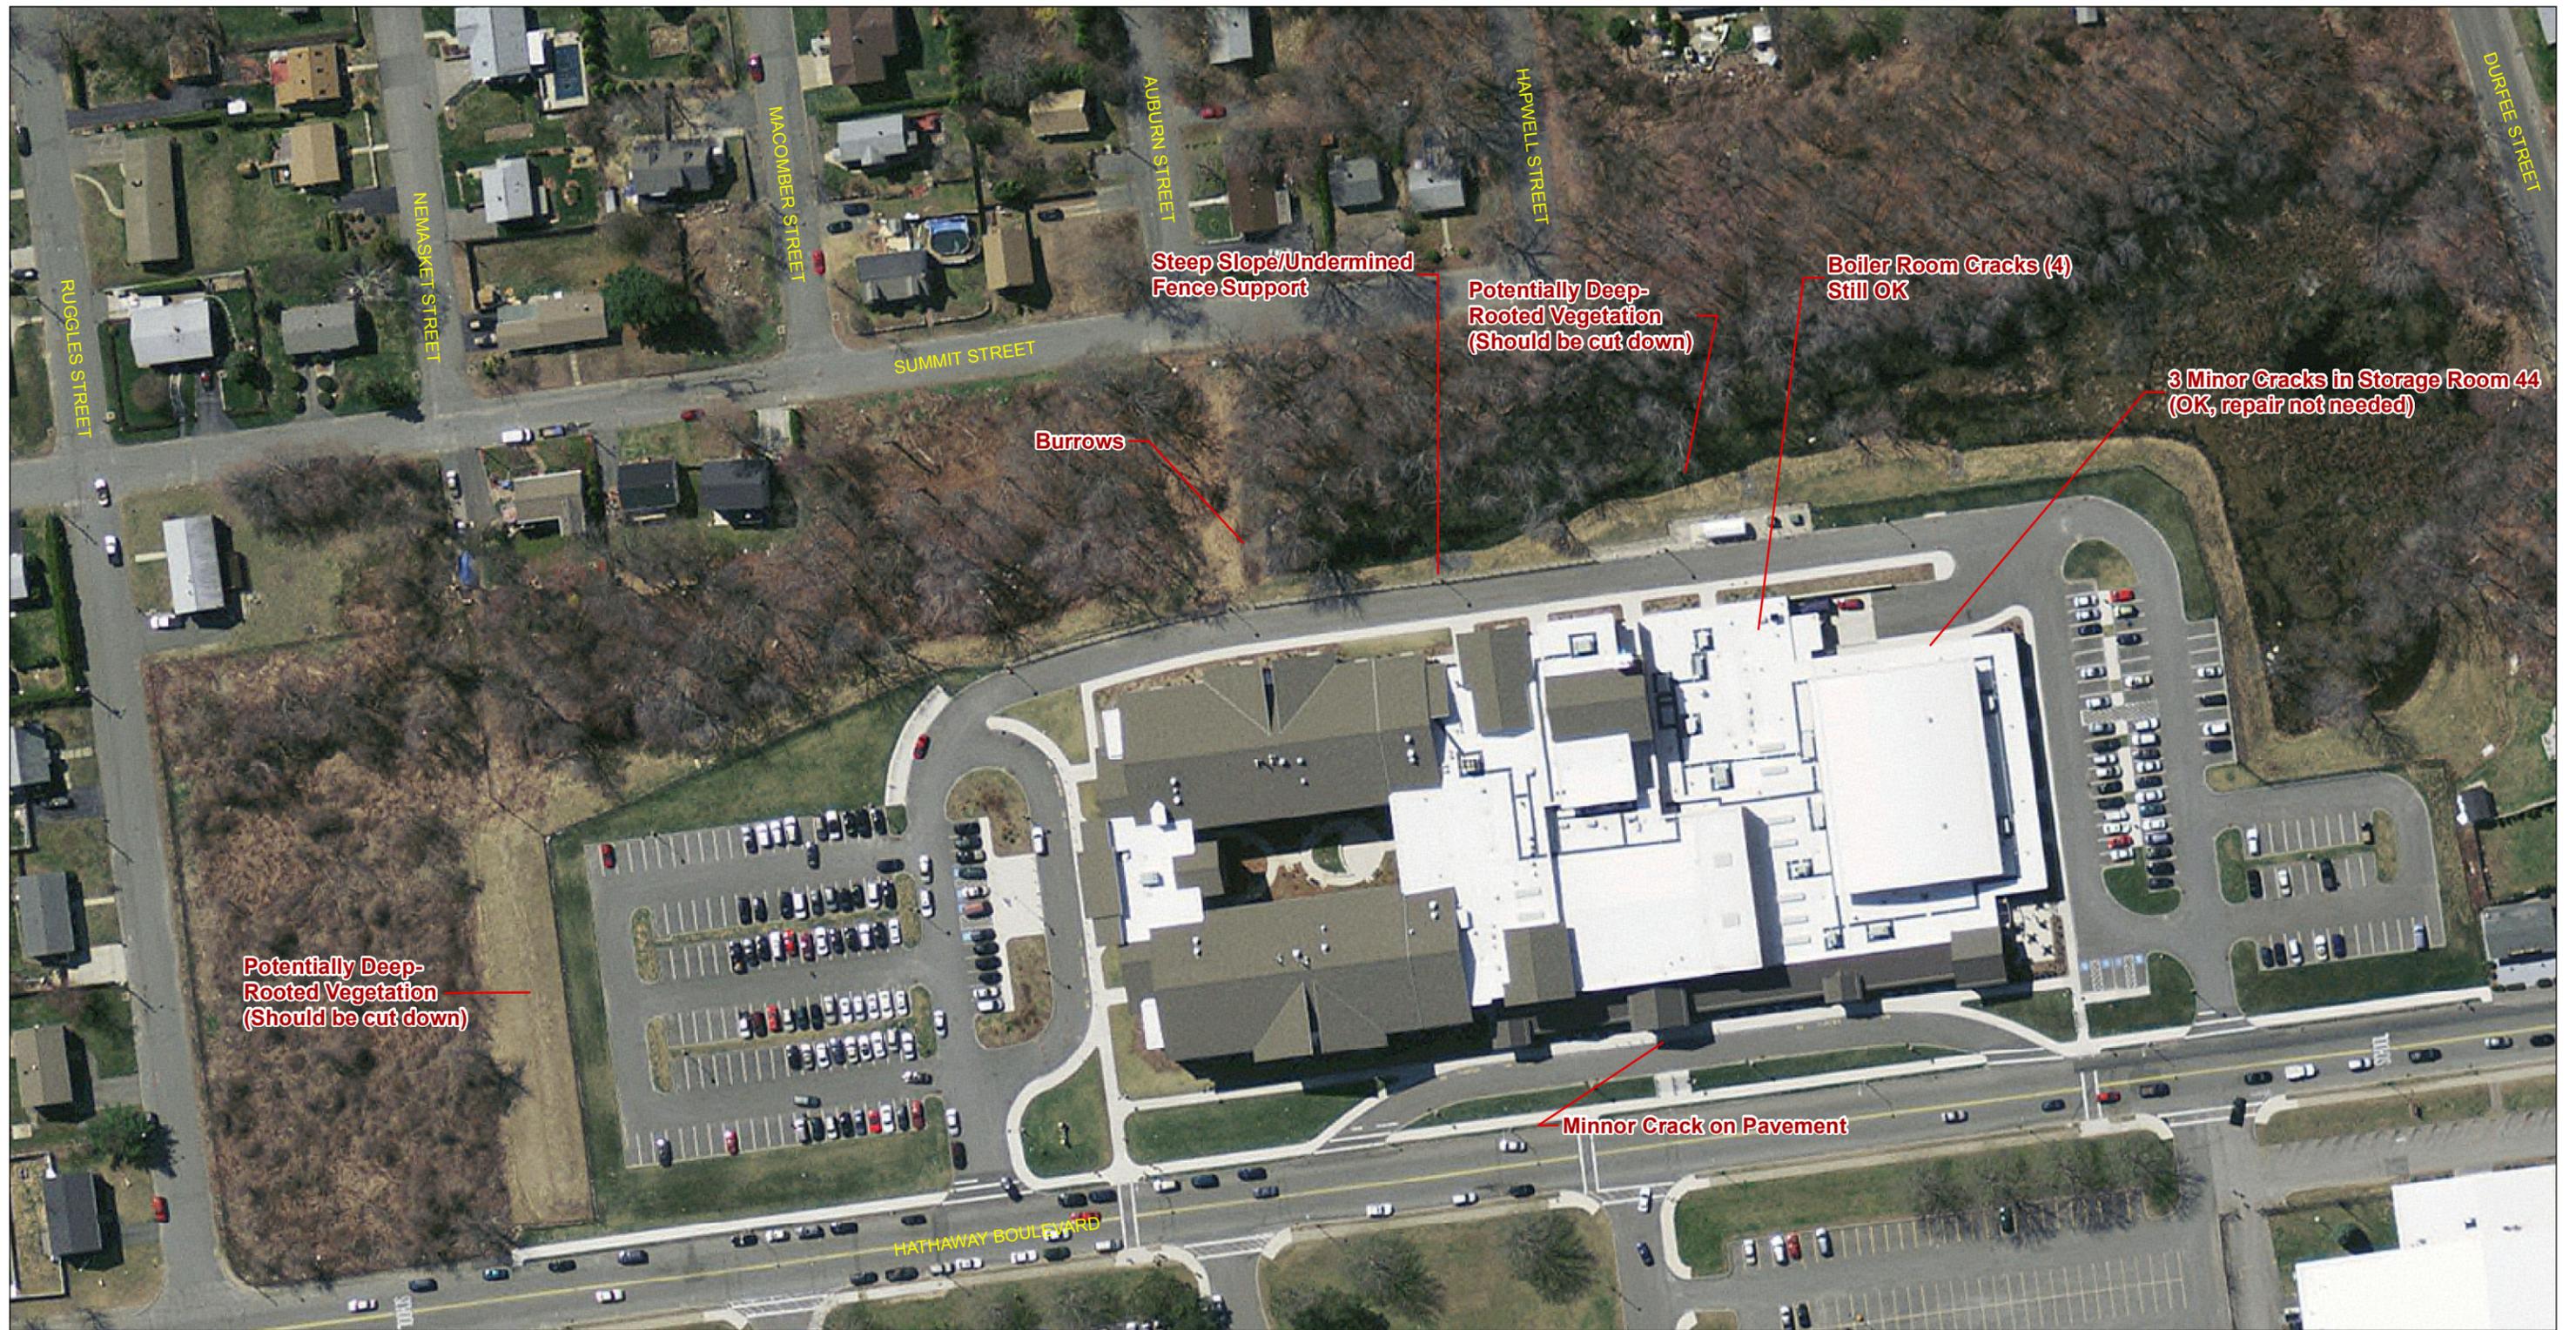
Potentially Deep-Rooted Vegetation (Should be cut down)

Burrows

Steep Slope/Undermined Fence Support

Boiler Room Cracks (4) Still OK

3 Minor Cracks in Storage Room 44 (OK, repair not needed)

Minor Crack on Pavement

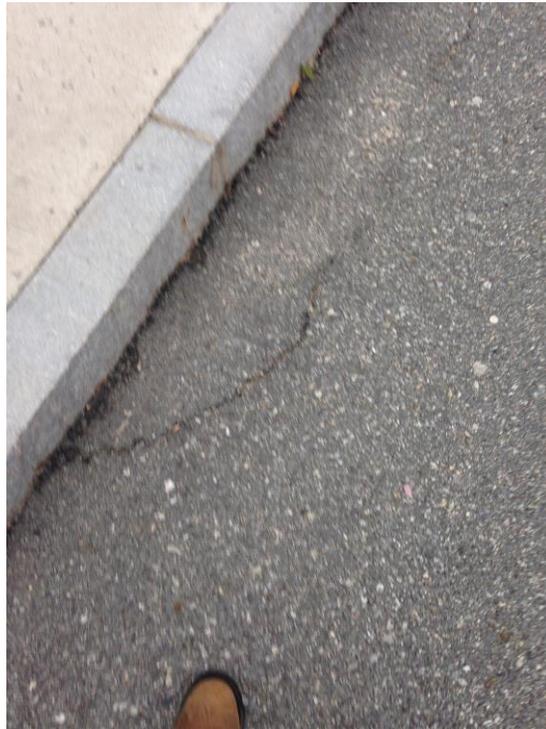
All asphalt crack repairs appear in very good condition. A minor crack less than 1/4-inch was observed on the eastern “driveway” but appears to be OK. Small tufts of grass were observed penetrating up through the curbed sidewalk in various areas but are less than a 1/4-inch and deemed acceptable, see Photographs 1 and 2. These areas should be addressed to prevent potential cap issues in the future.

- 1) Small crack observed on asphalt.**

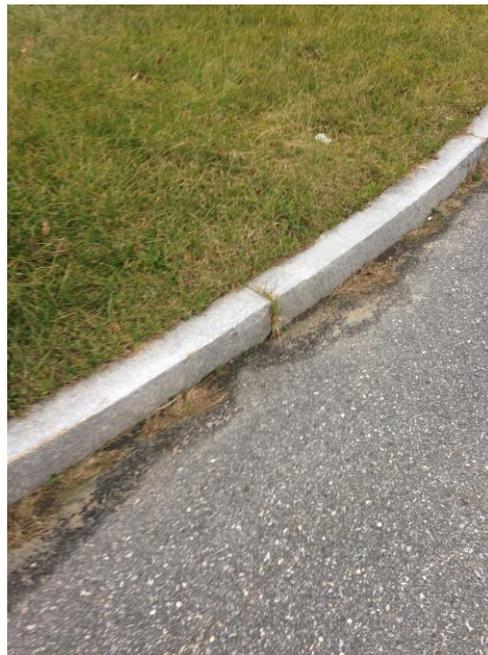
- Vegetation was observed penetrating pavement surfaces, particularly in the areas adjacent to curbs and catch basins. Although the cracking/gaps in these areas are minor, potential expansion could occur if this situation is left untreated.
- Areas of caulking between the building walls and exterior walkways are continuing to deteriorate. These areas will likely need to be repaired in the future.
- The cap slope is sloughing in an area adjacent to the wetland west of the school, and is undermining the concrete fence support. A crack was observed in the concrete fence support.
- A minor crack was observed in the eastern driveway pavement. Although less than ¼-inch at this time, this area should continue to be monitored and/or repaired to prevent potential further deterioration.

- 2) Tufts of grass protruding through the curb.**

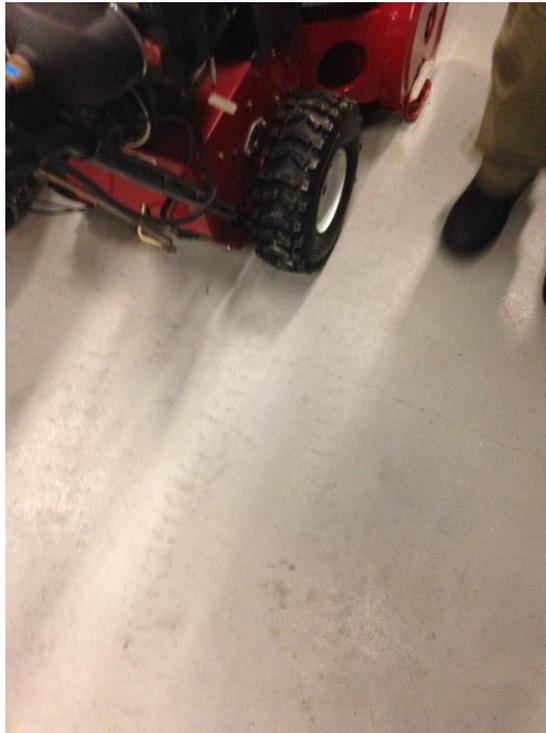
A crack greater than 1/4-inch wide that have been observed previously in the Women’s Locker room has been fixed. Four cracks in the boiler room floor are less than 1/4-inch wide and have not increased in size. Three minor cracks in storage room 44 are also less than 1/4-inch wide and have not increased in size, see Photograph 3. Another small crack was observed in the tile of the Art room but is less than 1/4 inch wide, see photograph 4. The majority of interior concrete floors are covered with tiles or other type of flooring material. Based on visual inspection and conversations with current employees, there are no breaches or other significant damage or deterioration of the interior surficial flooring materials or, where visible, concrete floors. No construction was occurring within the building at the time of the inspection.

**3) Minor crack storage room 44**

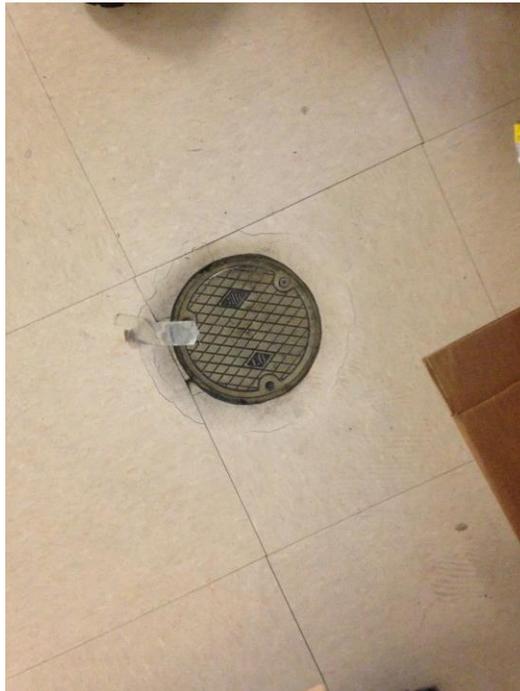
**4) Minor crack in tile in Art Room.**

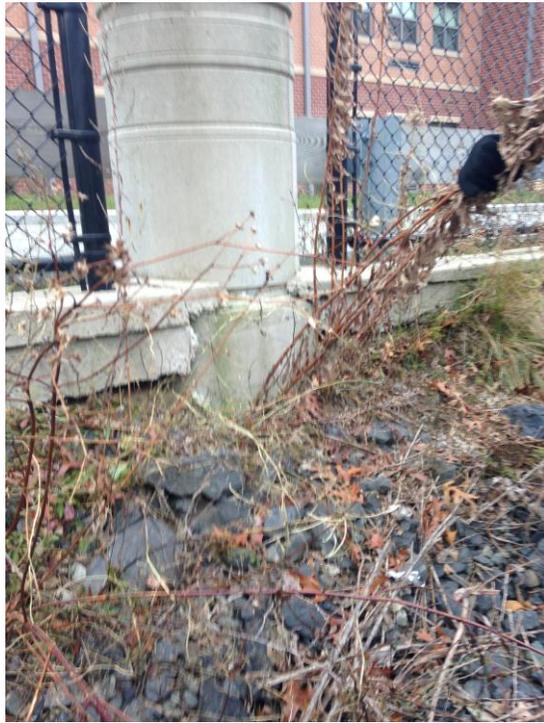
- Several small holes were observed along the western edge of the cap, which may have been borrowed by small animals.
- Sloughing riprap is undermining the concrete fence support at the top of the slope, and filling the outlet of the storm water drainage culvert on the west side of the Site. Areas of soil erosion were observed along the upper slope, as well as a crack in the concrete fence support. The area appears relatively stable at this time, but the condition is likely due to an increase in steepness. The crack in the concrete fence support is not identified as a cap integrity issue, nor is the riprap accumulating in the culvert outlet, but these issues should be addressed to maintain the integrity of the fence and the function of the culvert.

Landscaping was inspected by Rishabh Iyer and Ray Holberger from the City of New Bedford to observe unacceptable conditions. Several animal borrows were observed along the west and southwest slopes. Deep rooted vegetation was observed on the western slope. Sloughing and erosion under the fence to the west of the school appears to be stable and the extent of erosion similar to conditions observed during past inspections.

The structural integrity of this fence may be compromised if the sloughing and erosion continues, see Photograph 5. The cap soils beneath the riprap may also become exposed and susceptible to erosion. The area appears stable at the moment, but the condition is likely due to an increase in steepness beyond the cap design slope. The extent of erosion seems similar to the conditions observed during several previous inspections. See inspection report letters dated May 23, 2013, January 24, 2013, May 4, 2012 and August 31, 2011

**5) Undermining of concrete structure for fence west of school.**

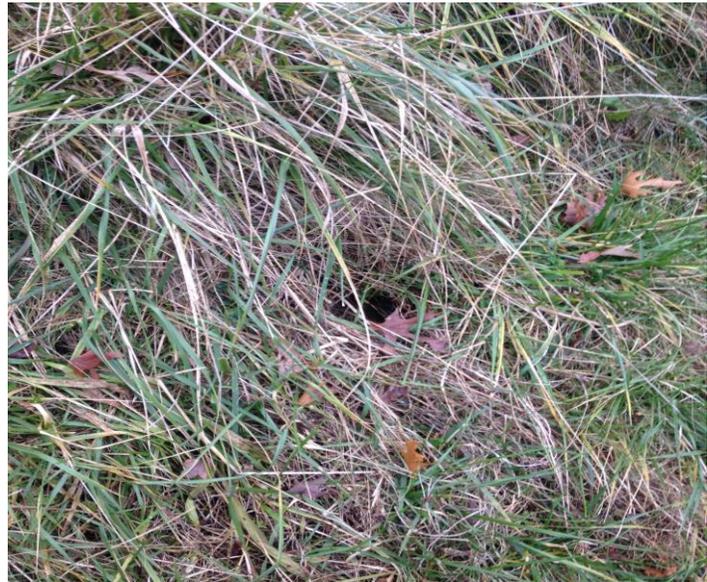
- 1) Animal burrow holes were observed on the slopes to the west of the school, see Photographs 6 & 7. Talked with Gary Gomes, plant engineer, he had stated that they were able to catch 5 gophers since last visit, current borrows may not be occupied. Potentially deep rooted vegetation was observed on the slope to the south and west of the school and should be cut down, see Photographs 8 and 9.
- 2) Potentially deep rooted vegetation was observed by riprap at the base of the slope to the west of the school, see Photograph 10

**6) Animal burrows at west slope of cap.**

Deep-rooted vegetation had not been cut down. Borrows need to be filled in.

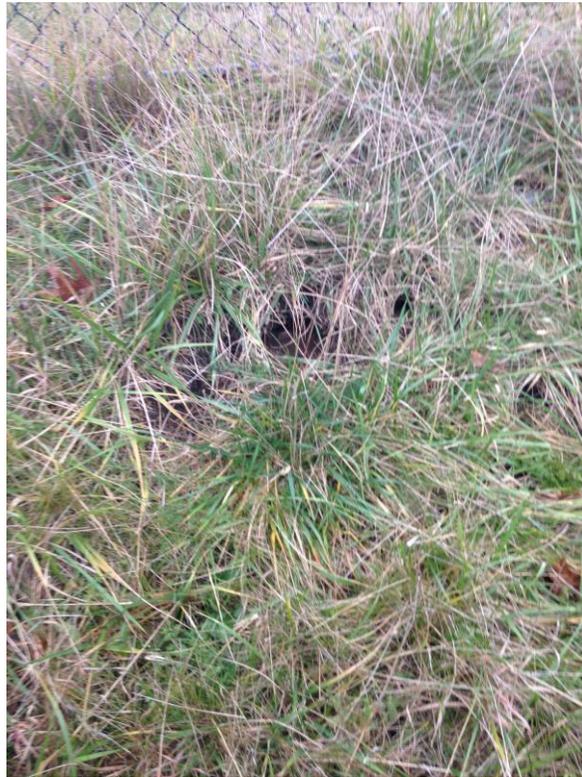
**7) Animal burrows along land bridge to the west of the school.**

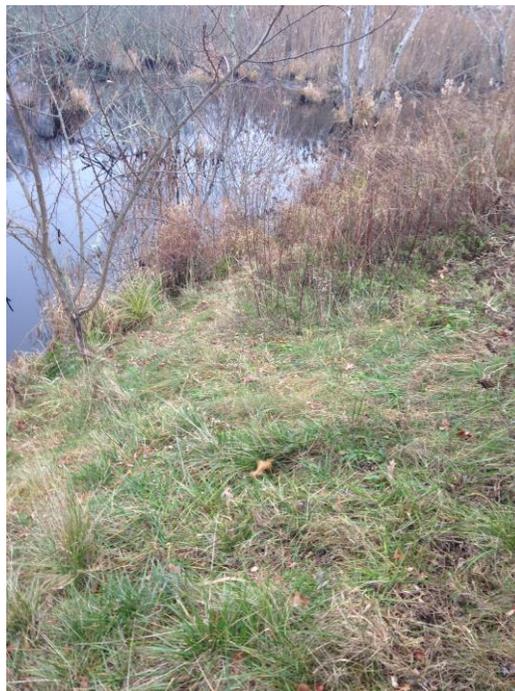
**8) Deep rooted vegetation at western slope of cap.**

- Potentially deep-rooted vegetation observed on the slopes south and west of the school and should be cut down.

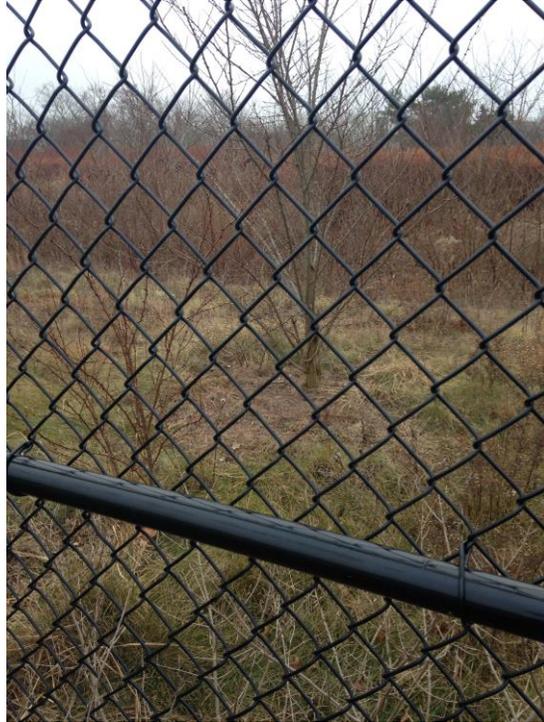
**9) Potentially deep-rooted at southern slope of cape.**

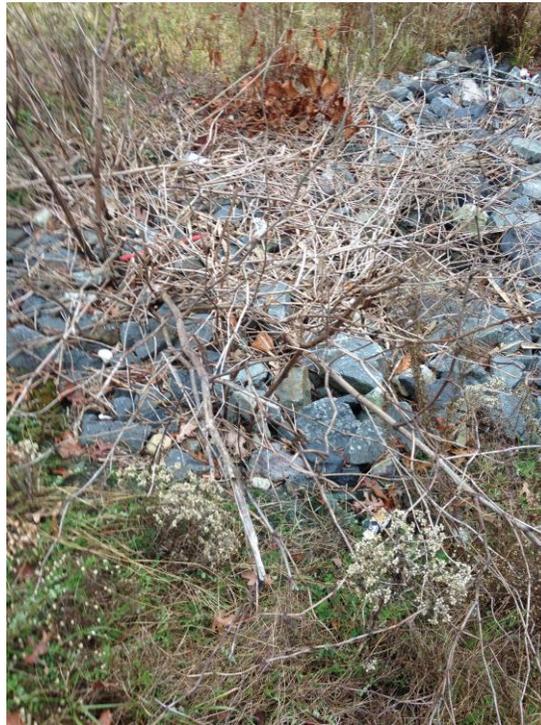
**10) Potentially deep-rooted vegetation at western slope of cap by rip rap.**
