**RE: Response Letter
Certificate of Compliance – Parallel Products (SE49-0771)
100 Duchaine Blvd. – New Bedford, Massachusetts**

We have enclosed a response letter and revised As-Built Plan in response to the comment letter prepared by Nitsch Engineering dated May 17, 2019 in regard to their site inspection that was performed at the property referenced above.

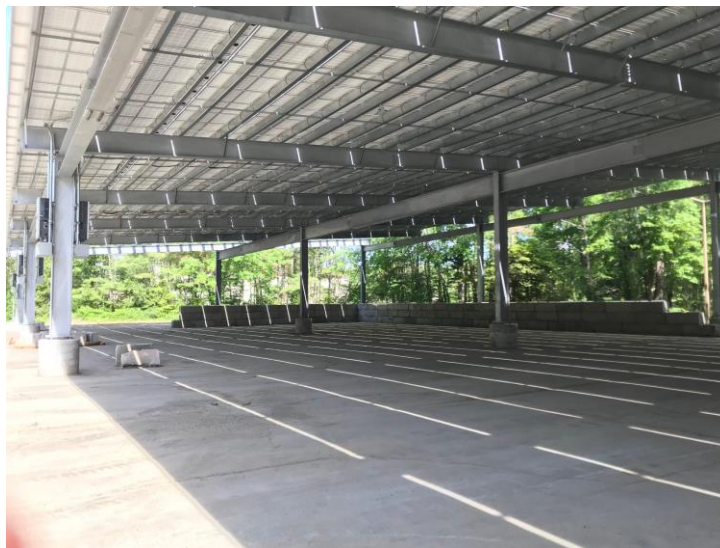
Comment #1:

The area beneath the solar panels contains a significant amount of stockpiled glass that is mixed with sediment. Some of the sediment has been tracked onto the pavement in the parking area located underneath the solar panels. This pavement drains towards the access driveway and rain garden. The pavement needs to be swept regularly to limit the amount of sediment that is transported down the driveway and towards the raingarden.

The stockpiled glass has been completely removed and the parking area has been swept of debris.

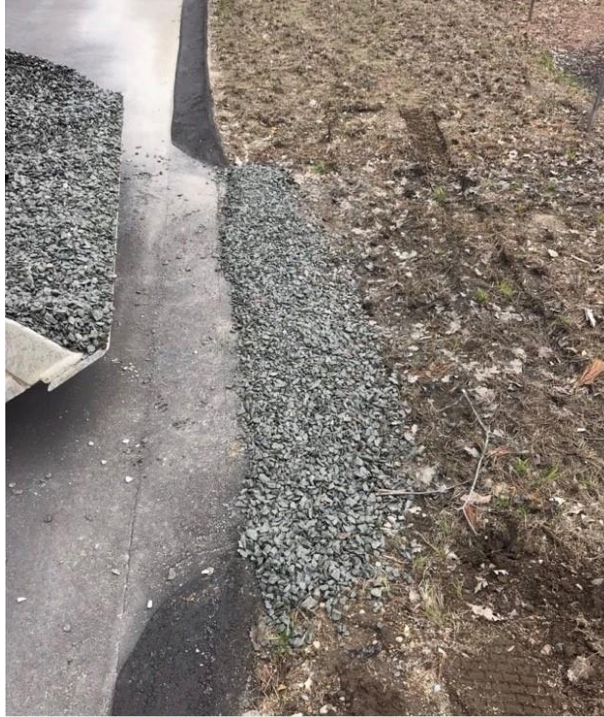
Comment #2:

The stone located at the inlet to the raingarden appears too small and was placed above the elevation of the inlet from the access driveway. It appears to be restricting water from flowing into the raingarden from the access driveway. We observed sediment along the edge of the access driveway where water appears to have settled.

The stone diaphragm has been removed and replaced with larger stone, and the elevation of the inlet itself has been lowered to allow for the proper flow of runoff into the rain garden.

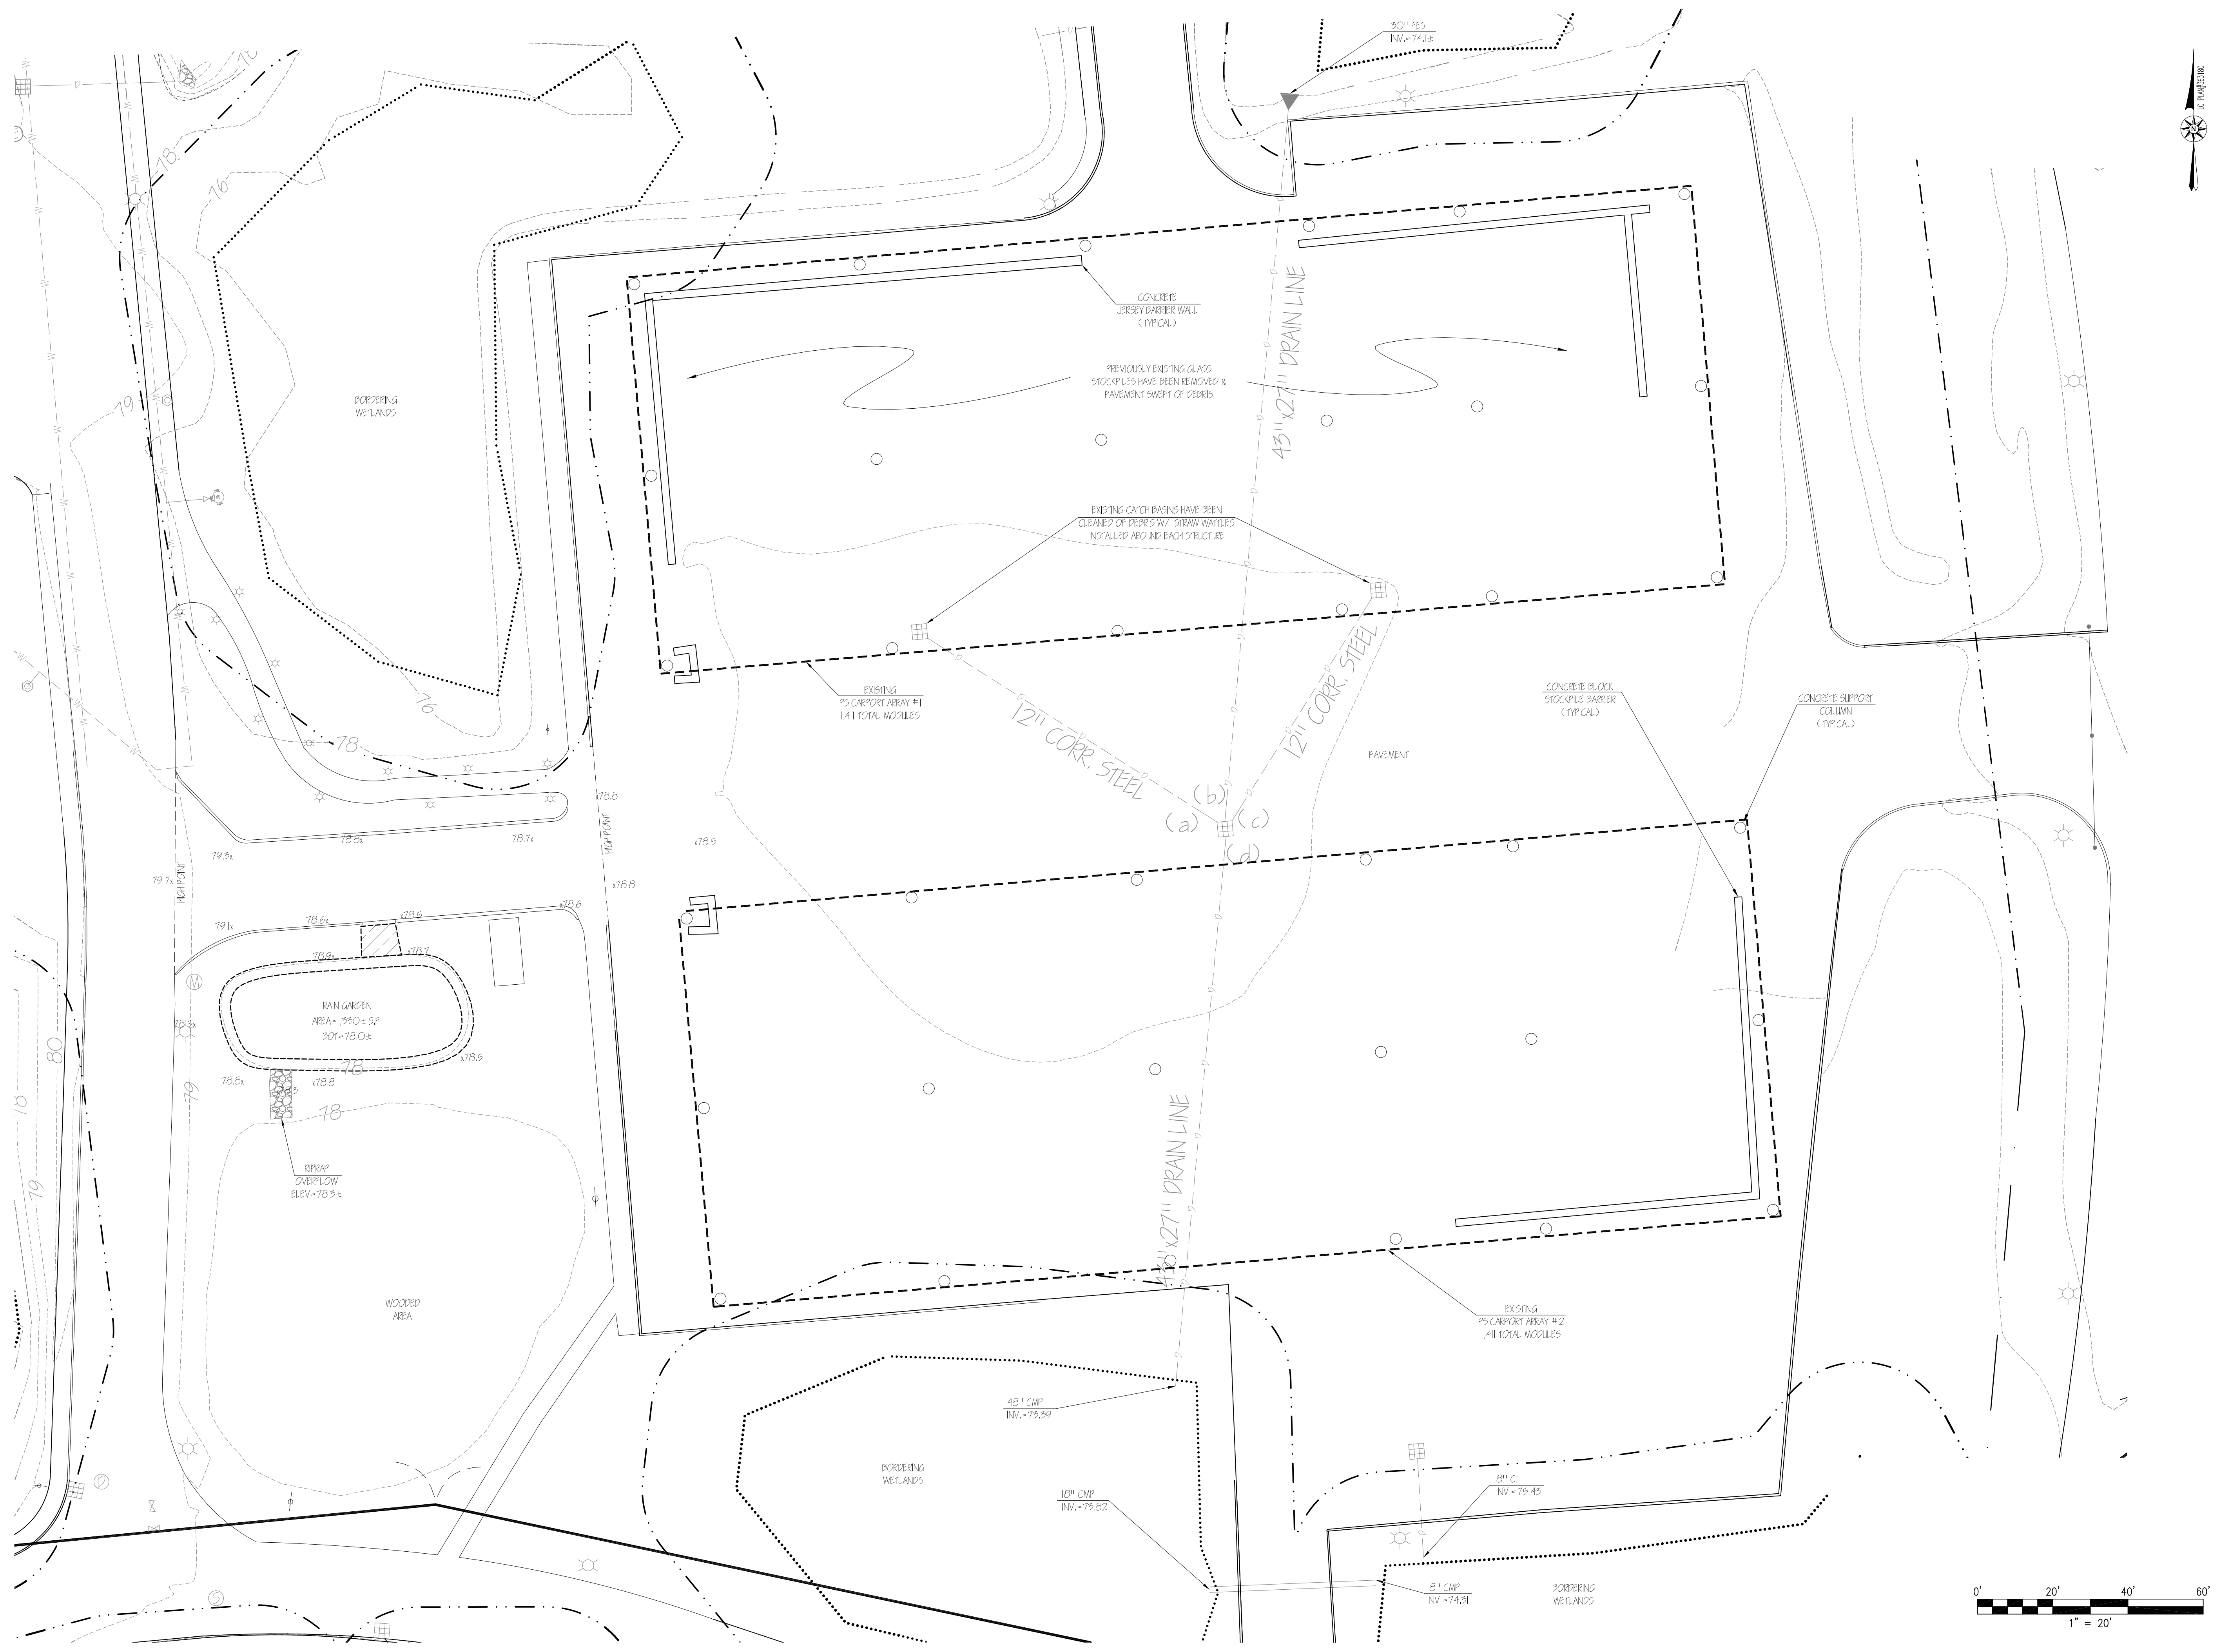
AS-BUILT PLAN
 100 DUCHAINE BOULEVARD
 ASSESSORS MAP 134 LOT 5
 NEW BEDFORD, MASSACHUSETTS
 PREPARED FOR:
 PARALLEL PRODUCTS OF NEW ENGLAND
 401 INDUSTRY ROAD
 LOUISVILLE, KY 40208

It is unclear whether the access driveway was graded properly. The as-built plan does not show grades along the driveway. Our recollection is the driveway was supposed to be super-elevated to direct water towards the raingarden. There is sediment located along the edge of the access driveway opposite the raingarden. If the driveway were super-elevated, sediment would not collect on the opposite side of the access driveway.

The rip-rap overflow appears to have been set too high. There are no elevations shown on the as-built plan regarding the grading of the raingarden or the overflow.

The calculations submitted support the approved design. However, the as-built plan does not include elevations so we cannot compare the calculations with the as-built plan.

The inlet to the rain garden has been re-graded to allow for proper flow, and additional spot grades have been added to the as-built plan. (See Attached As-Built Plan)

The rip-rap overflow was installed 6” too high and has been lowered to the design elevation. Additional spot grades have been added to the plan. (See Attached)

Spot grades have been added to the plan to show current existing conditions of the access driveway and rain garden. (See Attached)
