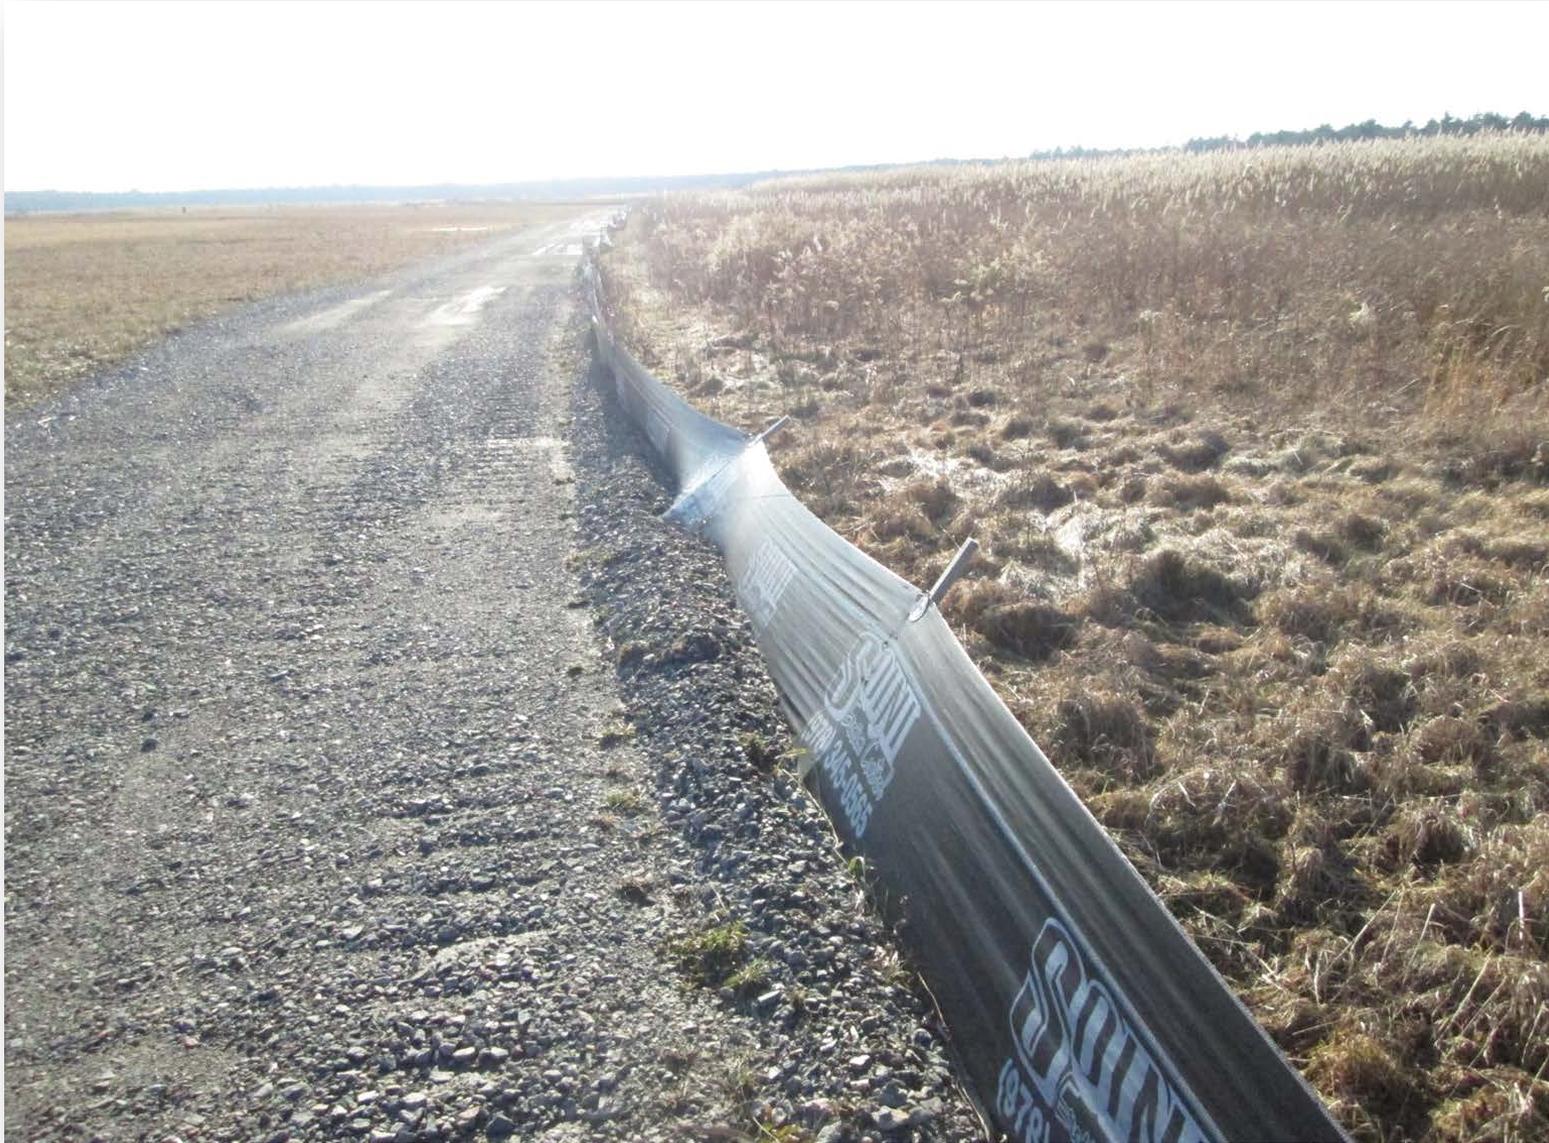
Representative view of silt fence along RSA access road after snow and ice melted and water ponding in the road had dissipated.

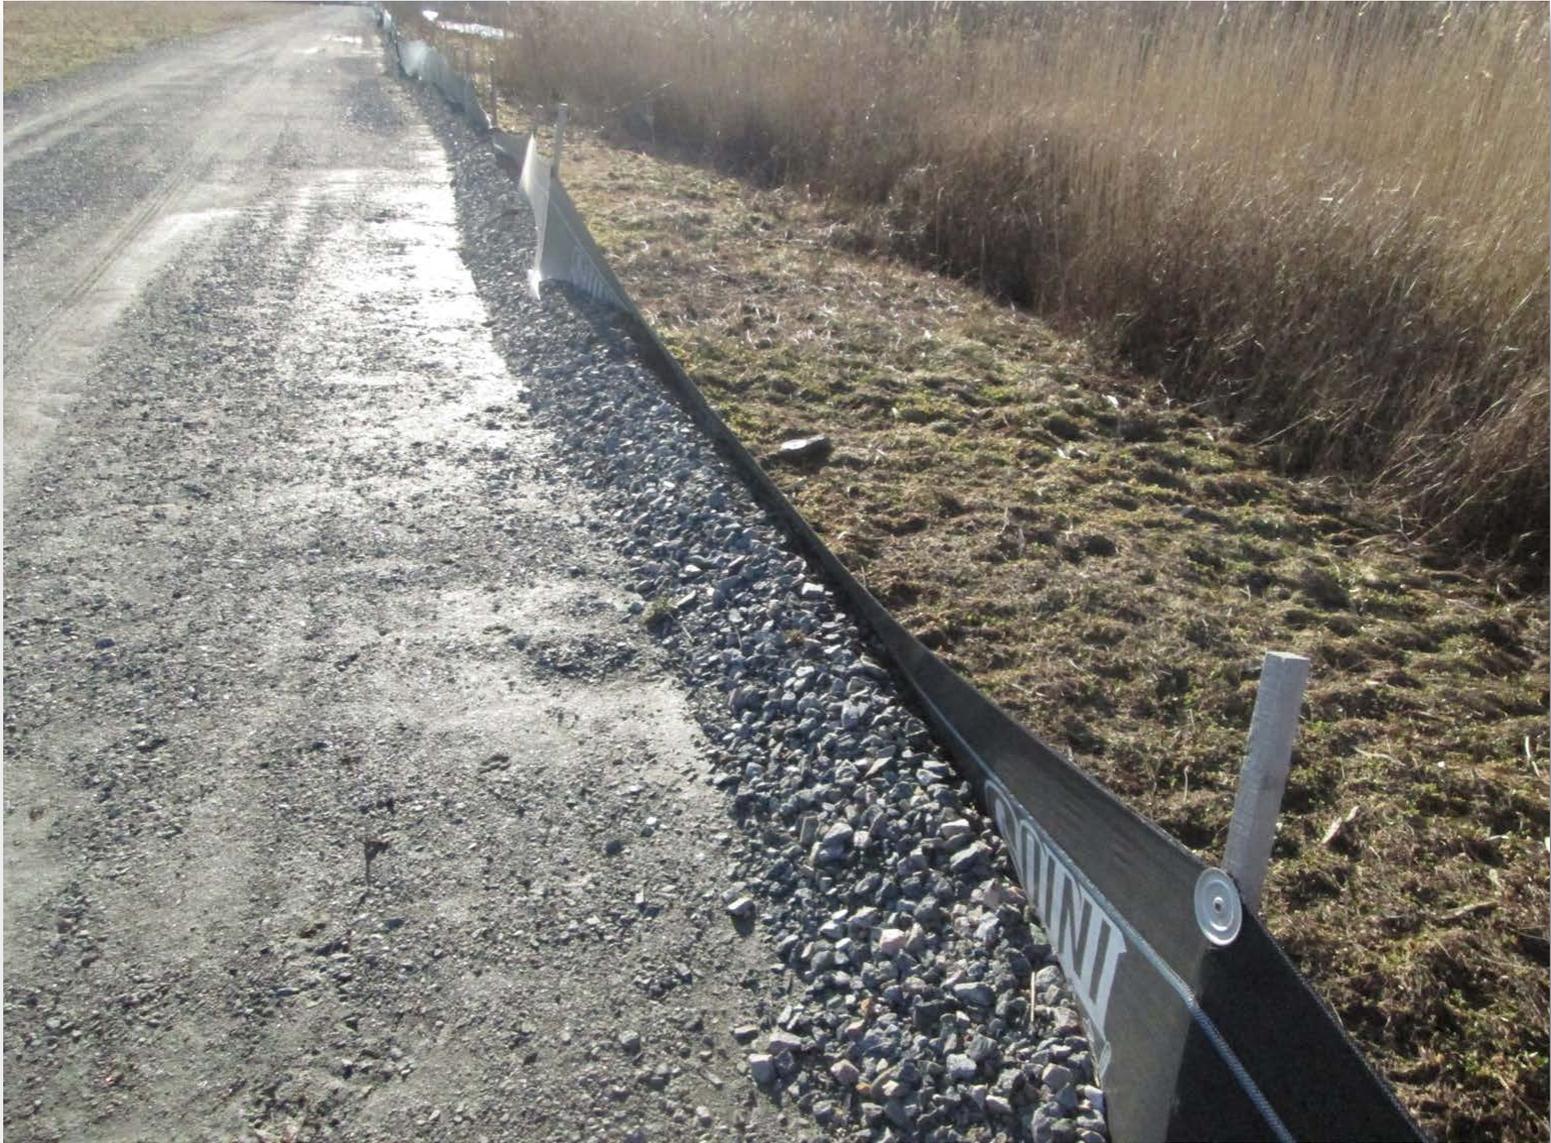
View of silt fence along RSA road where gravel has collected and pushed up against fencing during freeze and thaw cycles. Gravel appears to be having the positive effect of functioning as a temporary berm that can be used to sort out fines from any runoff. Silt fence is holding up thus far in this location.

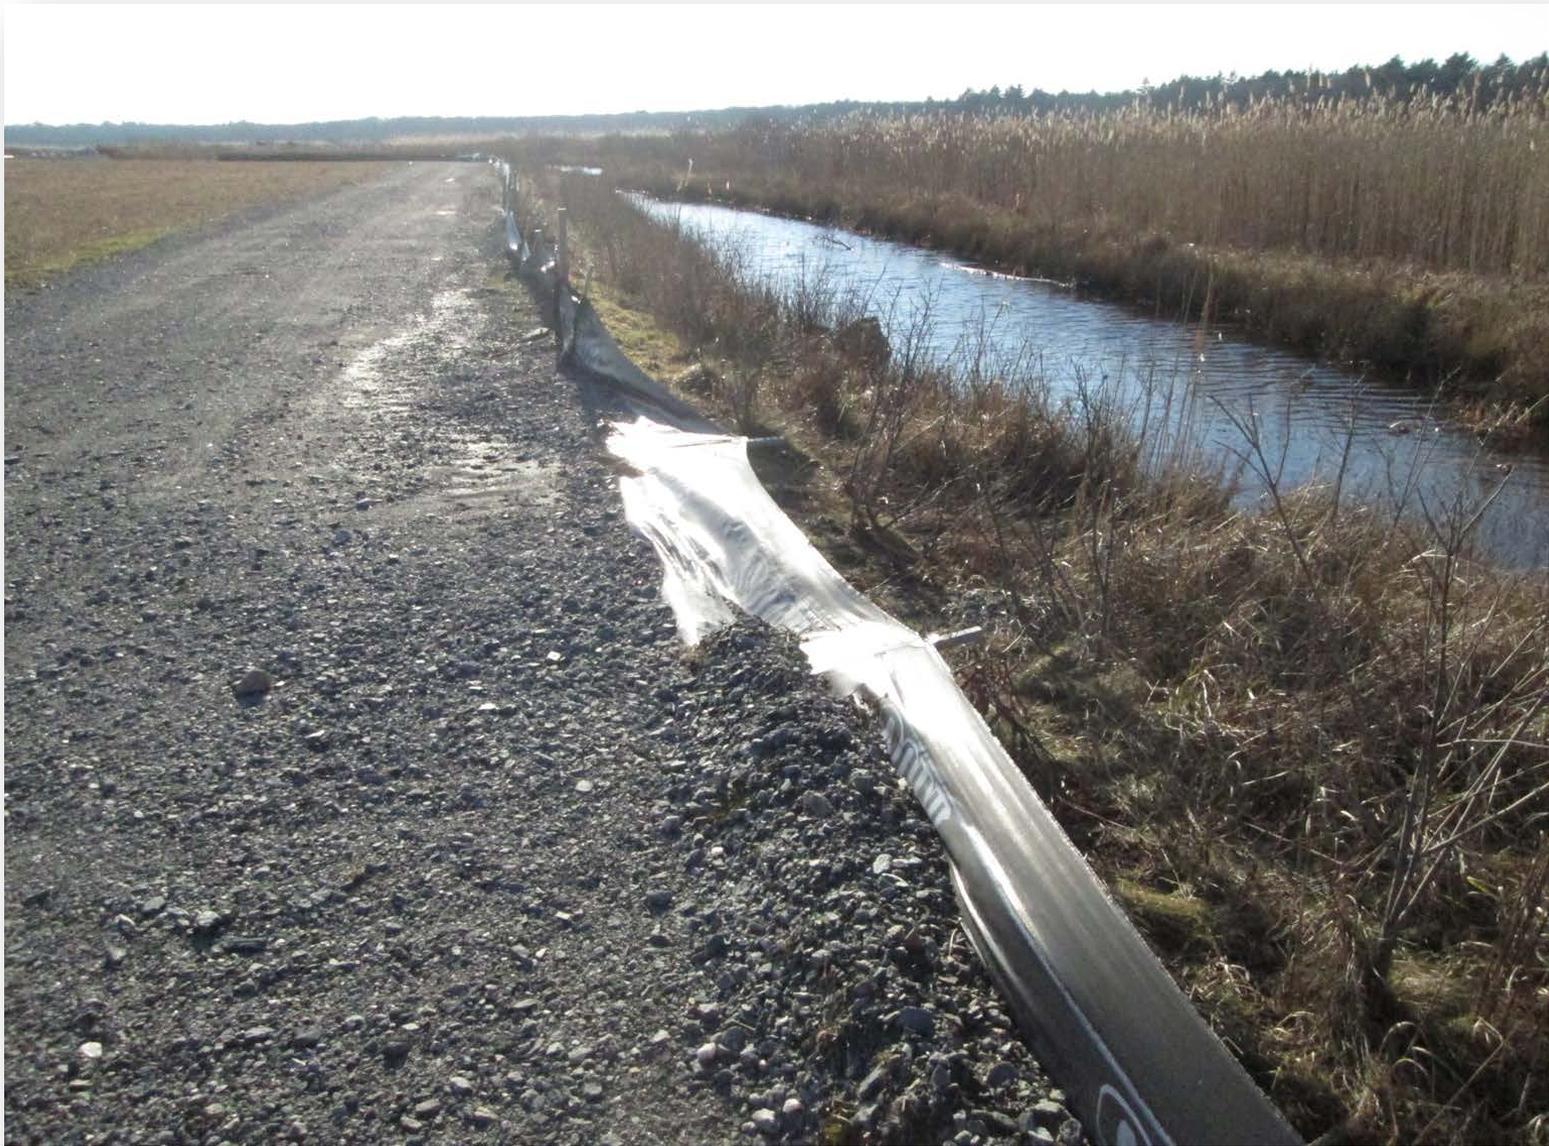
Typical view of silt fence over wash area where a small amount of gravel had passed through the collapsed fencing (see next slide). Fencing collapsed in response to ice and snow build-up. Will advise Airport to repair this stretch of silt fence.

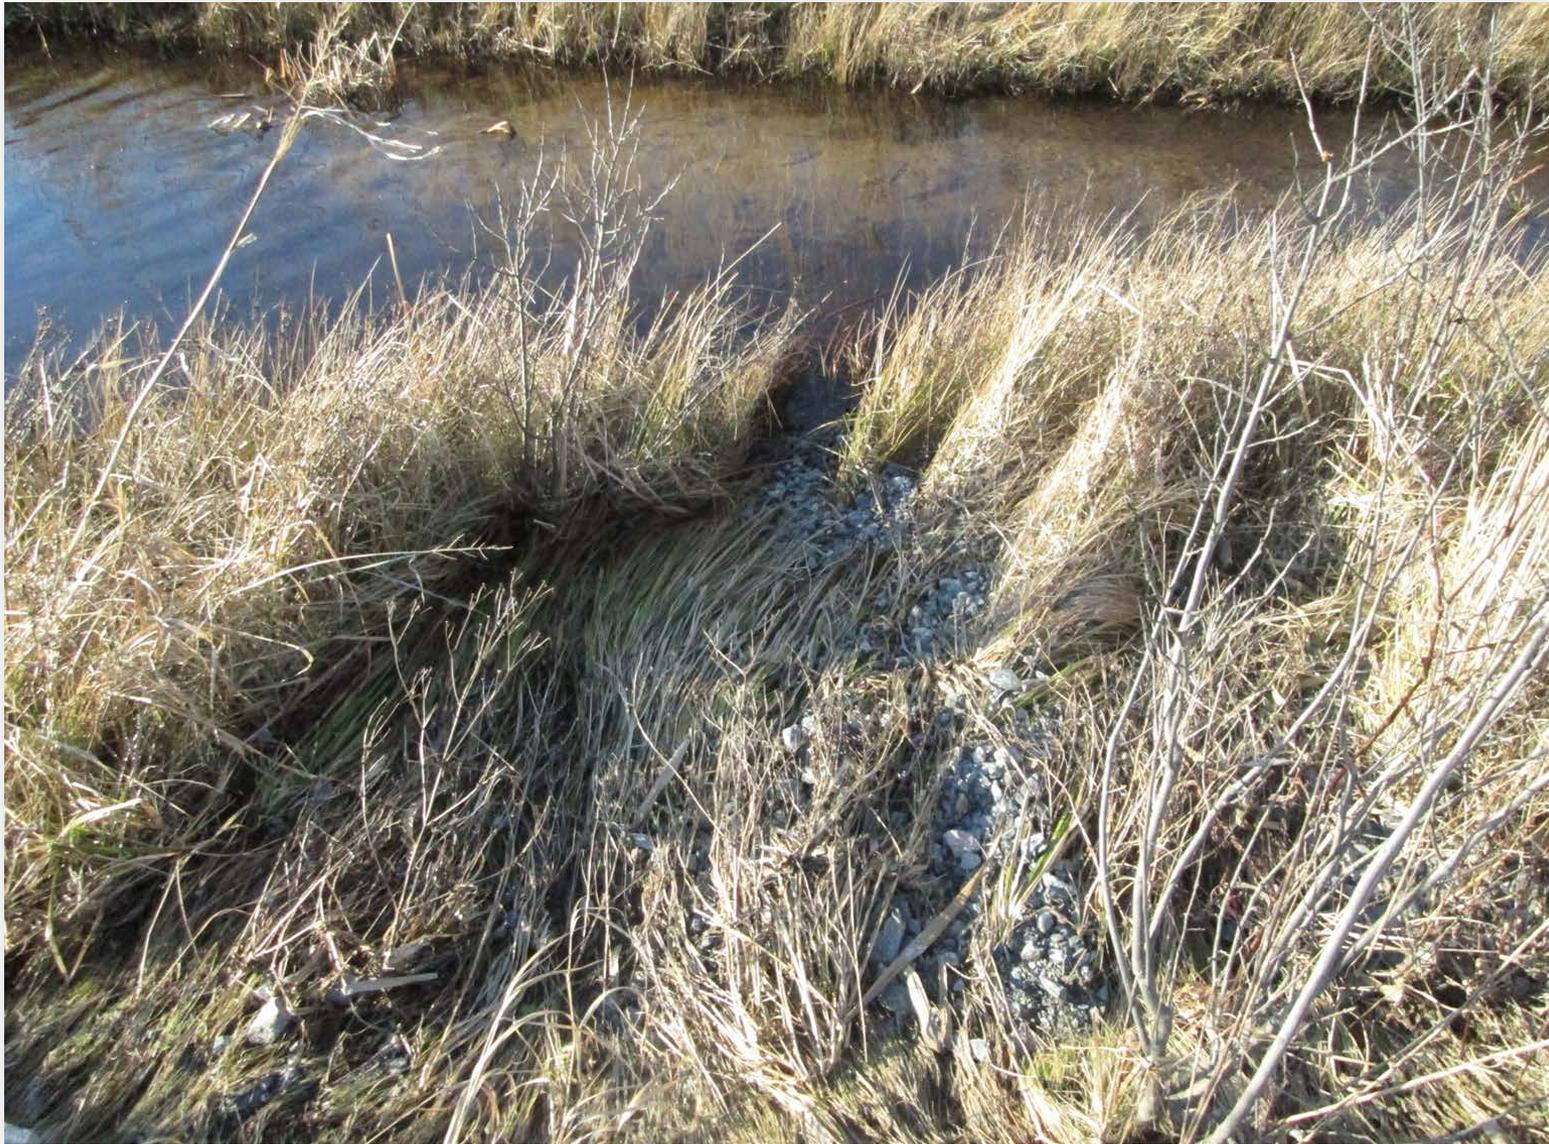
View of gravel flow from silt fence overflow area (very small amount). No gravel has been deposited into the West Ditch. The gravel can be removed by hand.

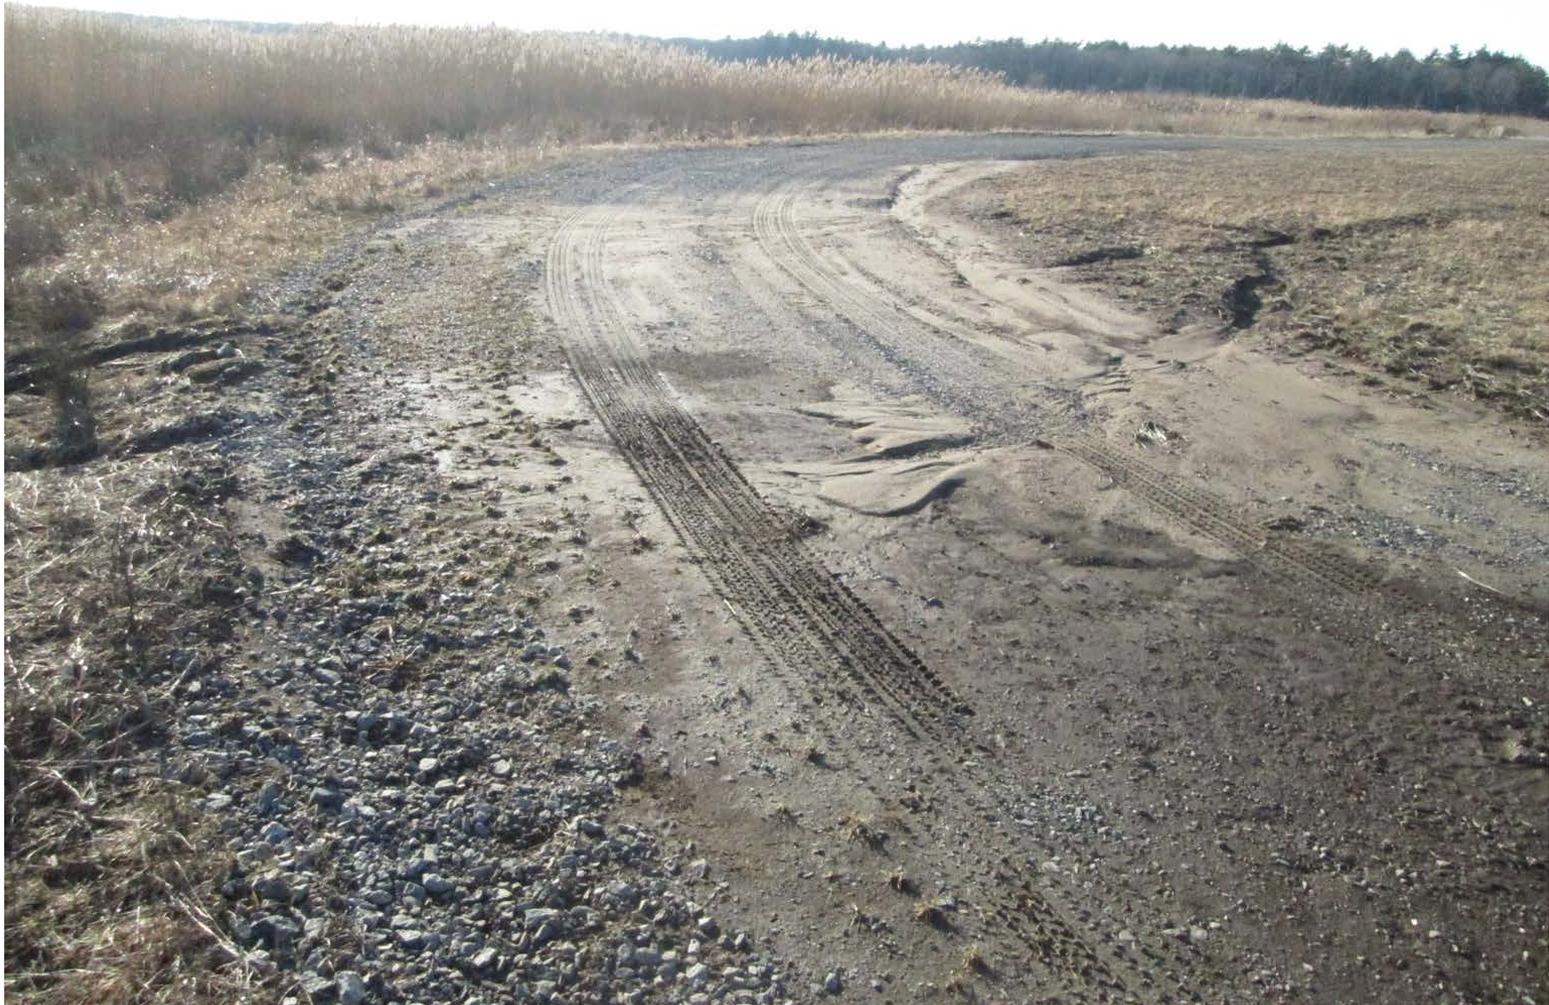
View of sediment building up on RSA access road at the intersection of the West Ditch and East Ditch. Some gullies developing in grassed area from surface runoff. This area of the access road and RSA requires some additional stabilization work. Epsilon will advise Airport accordingly.
