**New Bedford Regional Airport  
Runway Safety Improvements Project – Phase 4  
Reconstruct, Mark, and Groove Runway 5-23  
MassDEP File No. SE049-0635**

**ENVIRONMENTAL MONITOR INSPECTION FORM**

Environmental Monitor: **Amanda Atwell**      Date/ Time of Inspections: **4/14/14 (9am to 11am), 4/24/14 (10am-4pm), and 5/1/14 (9:30am-4pm)**

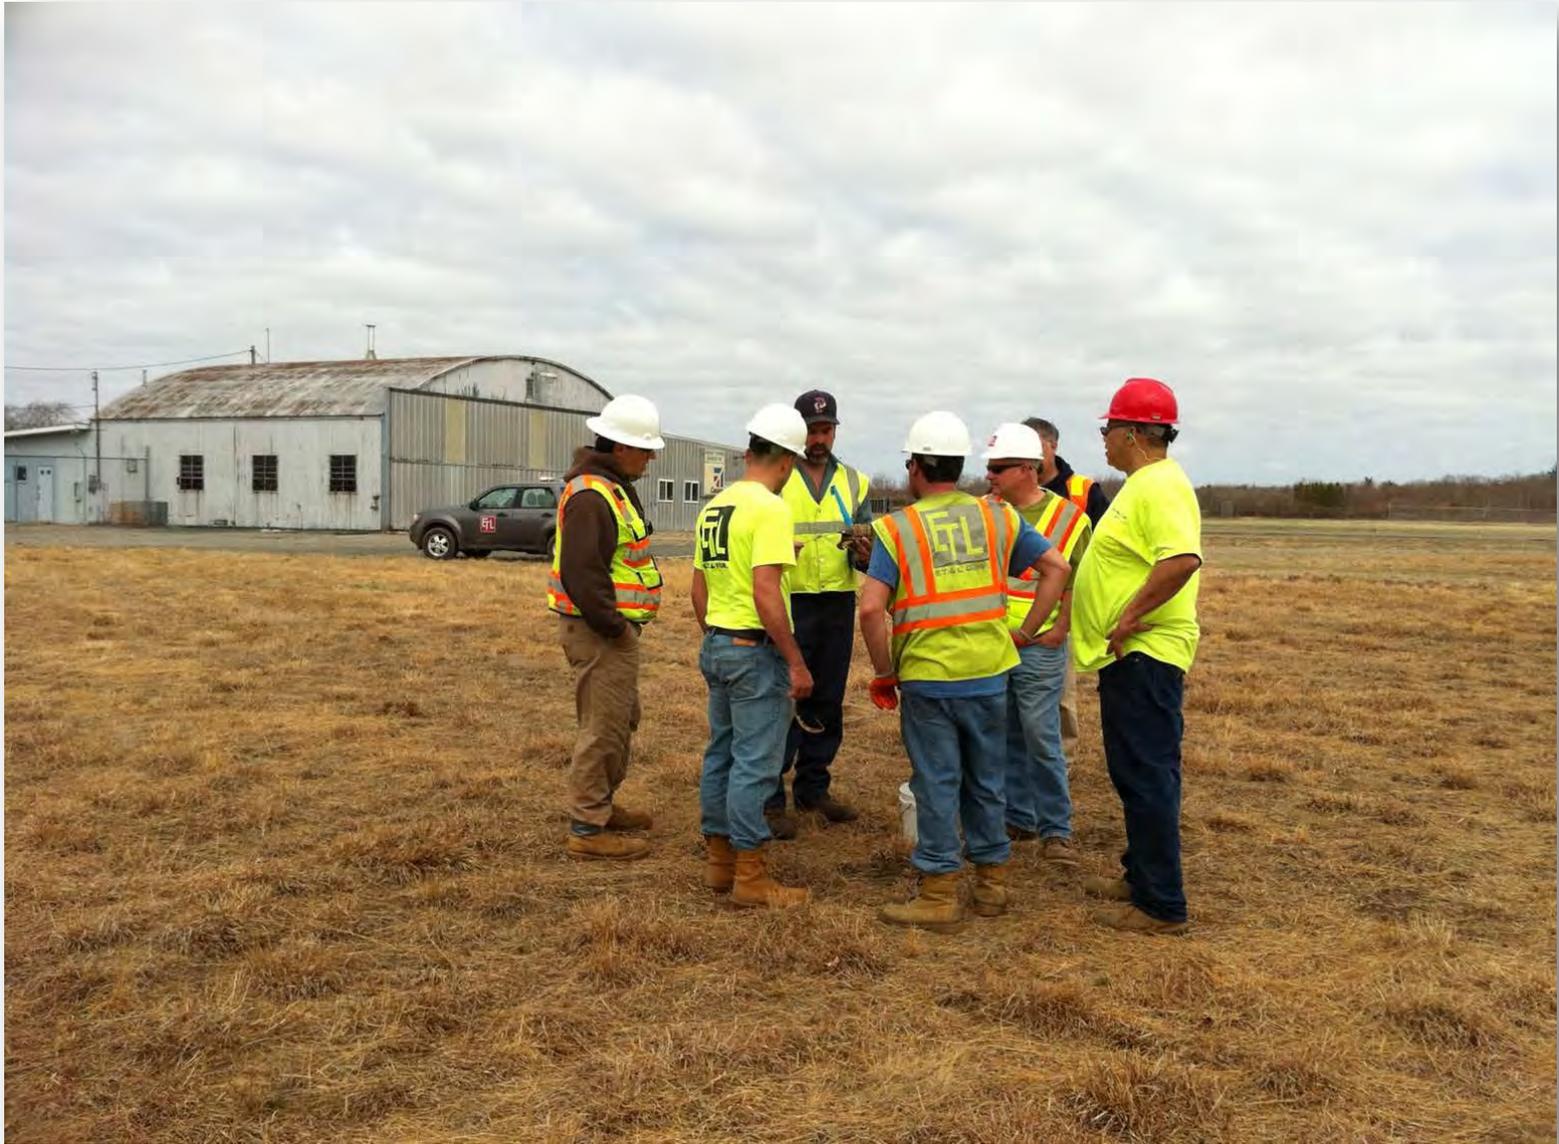
April 14, 2014 mobilization. Scott Smyers of Oxbow giving the Contractor training on eastern box turtle. Note turtle in hand.

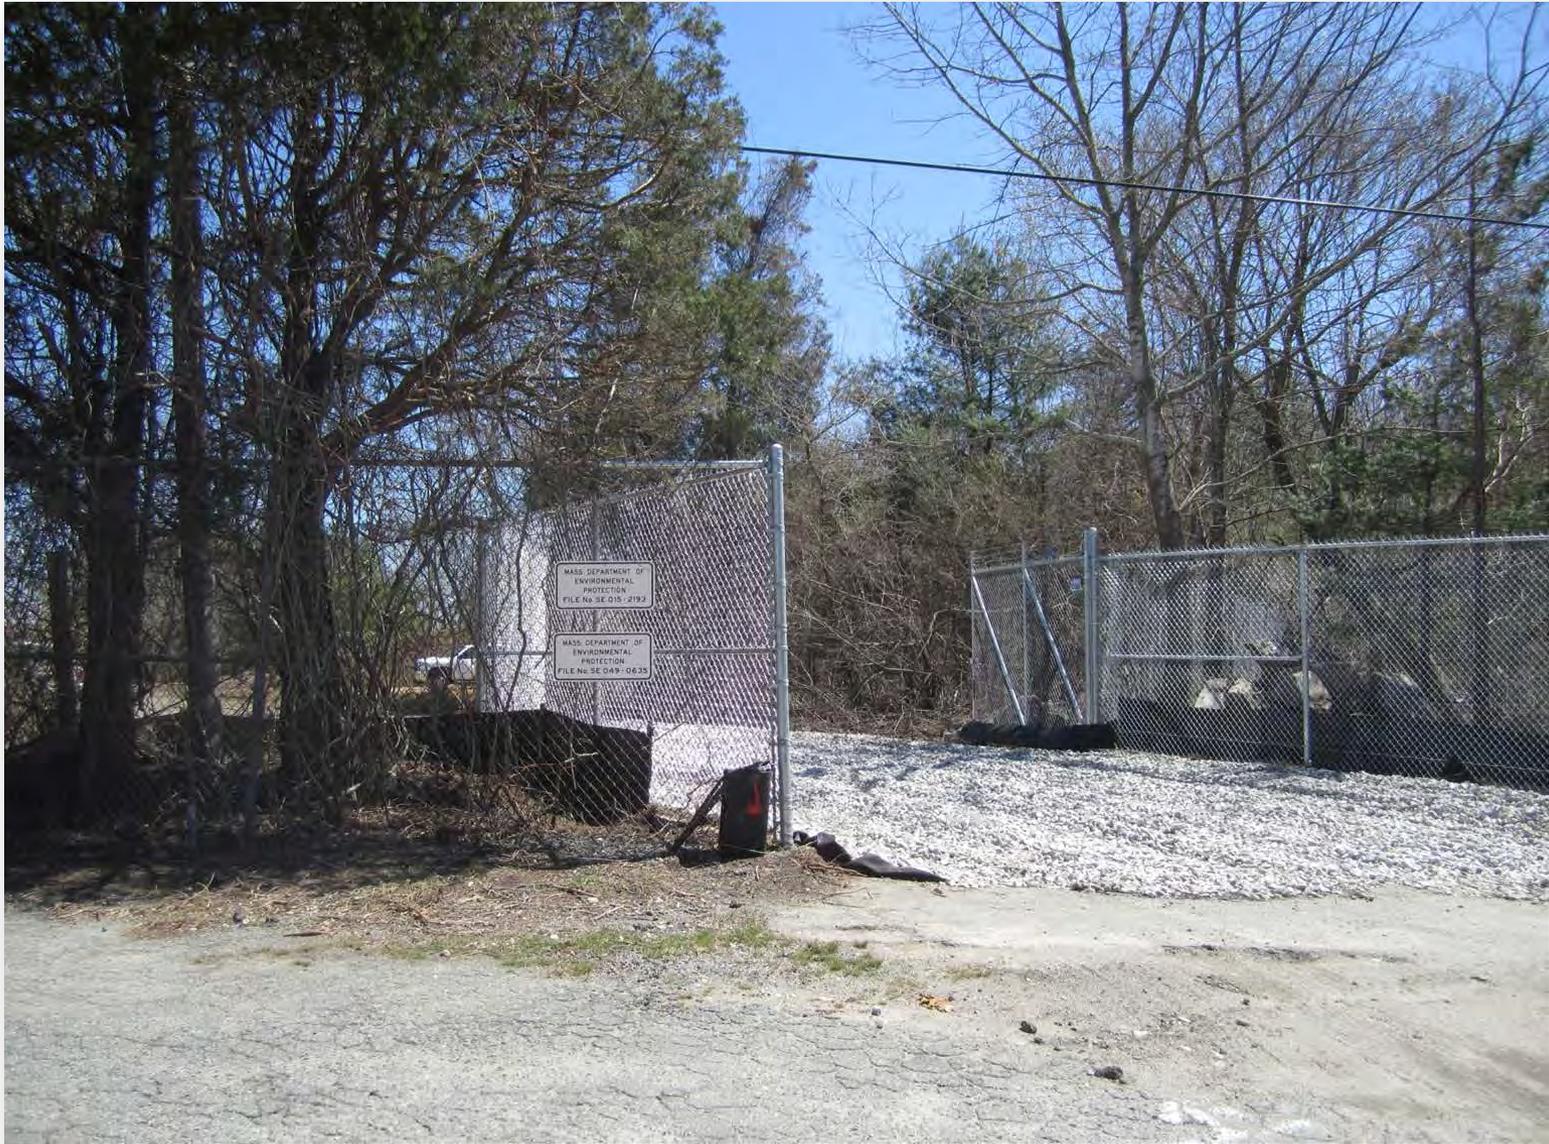
MassDEP permits are posted at each construction entrance. View of stone tracking pad.

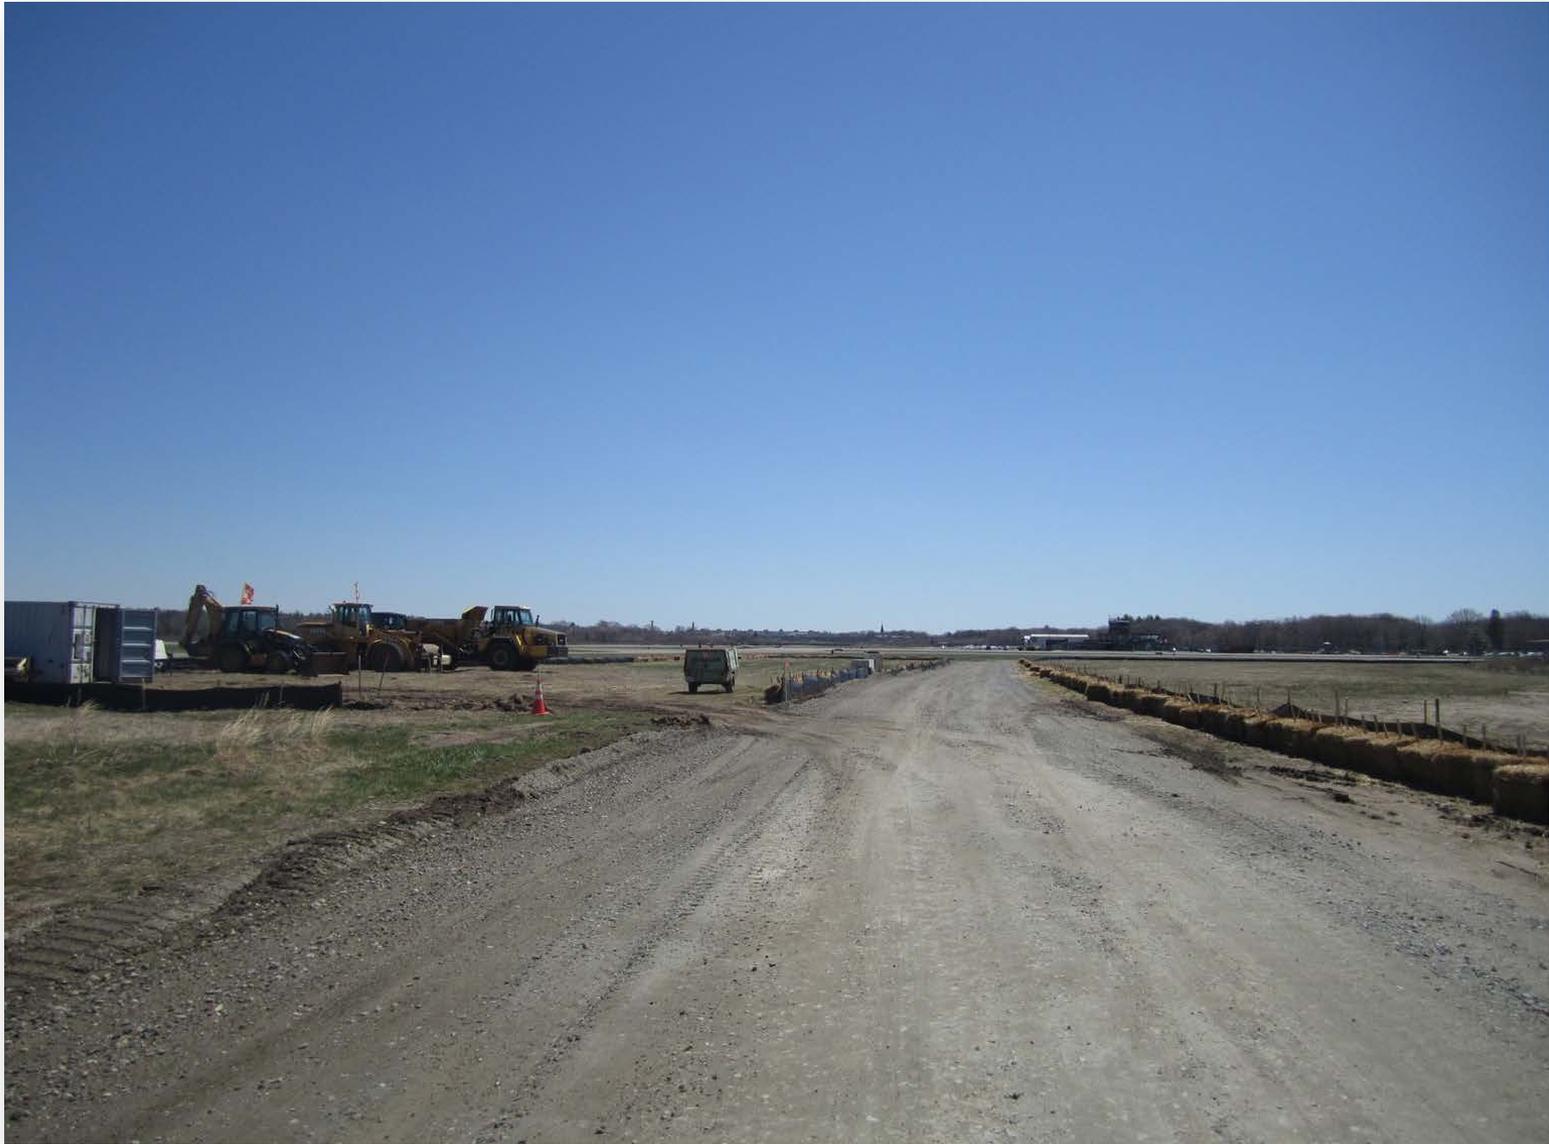
Typical view of fully installed silt fence/hay bale erosion controls and turtle barriers.

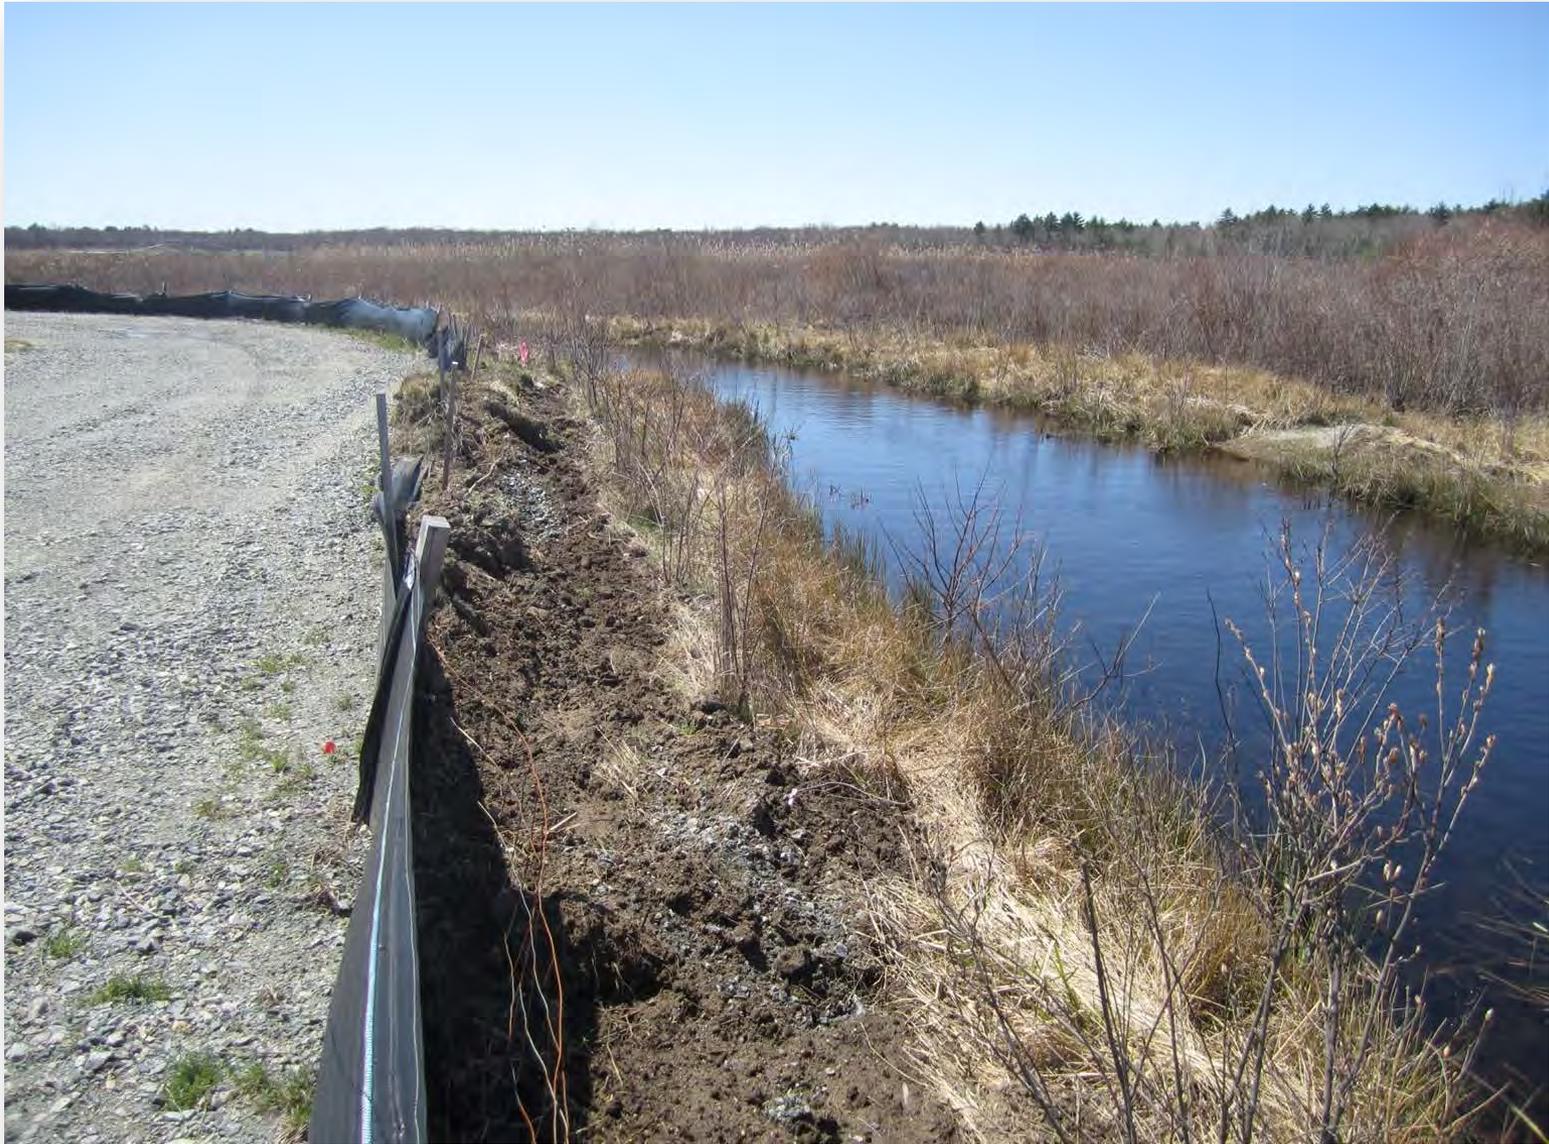
View of west ditch bank that was inadvertently disturbed down gradient of preexisting Phase 2 controls in order to install Phase 4 silt fence. See subsequent photos and proposed restoration plan prepared by the ET&L's Wetlands Specialist.

Describe any corrective action required at this time: The Contractor's WS should provide Epsilon with a revised restoration and monitoring plan as noted above.

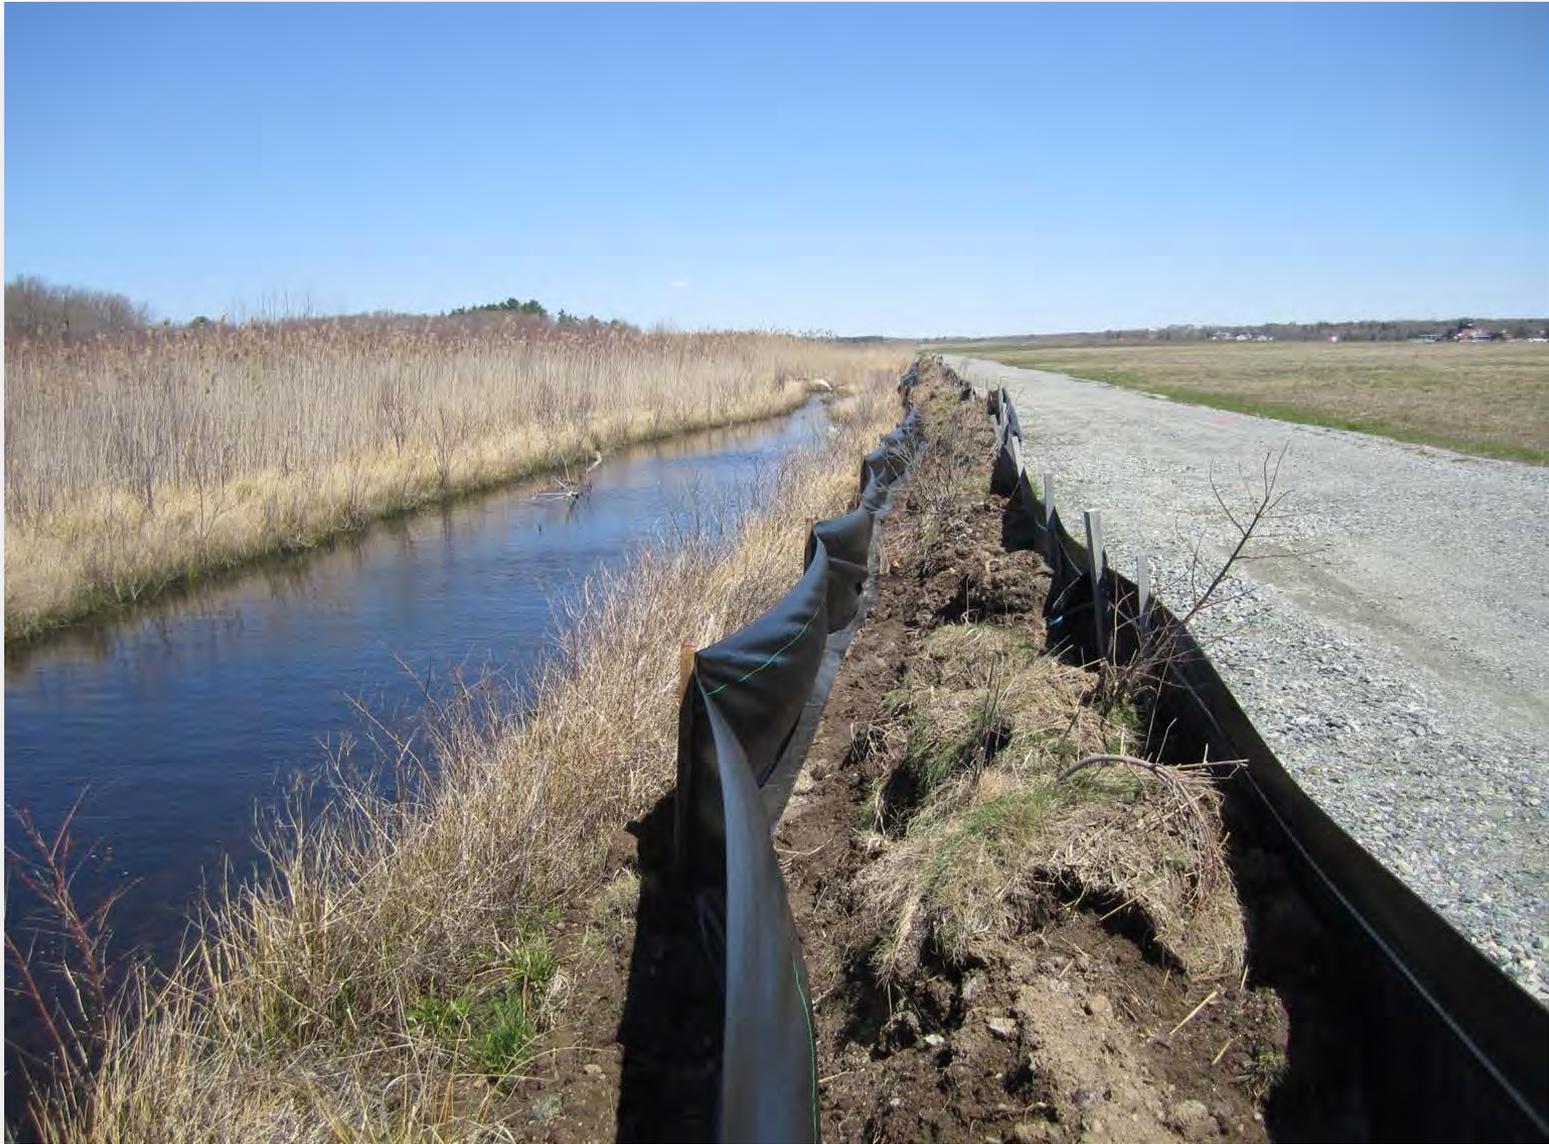
View of west ditch bank that was inadvertently disturbed by ET&L in order to install new silt fence. See subsequent photos and proposed restoration plan prepared by the ET&L's Wetlands Specialist.

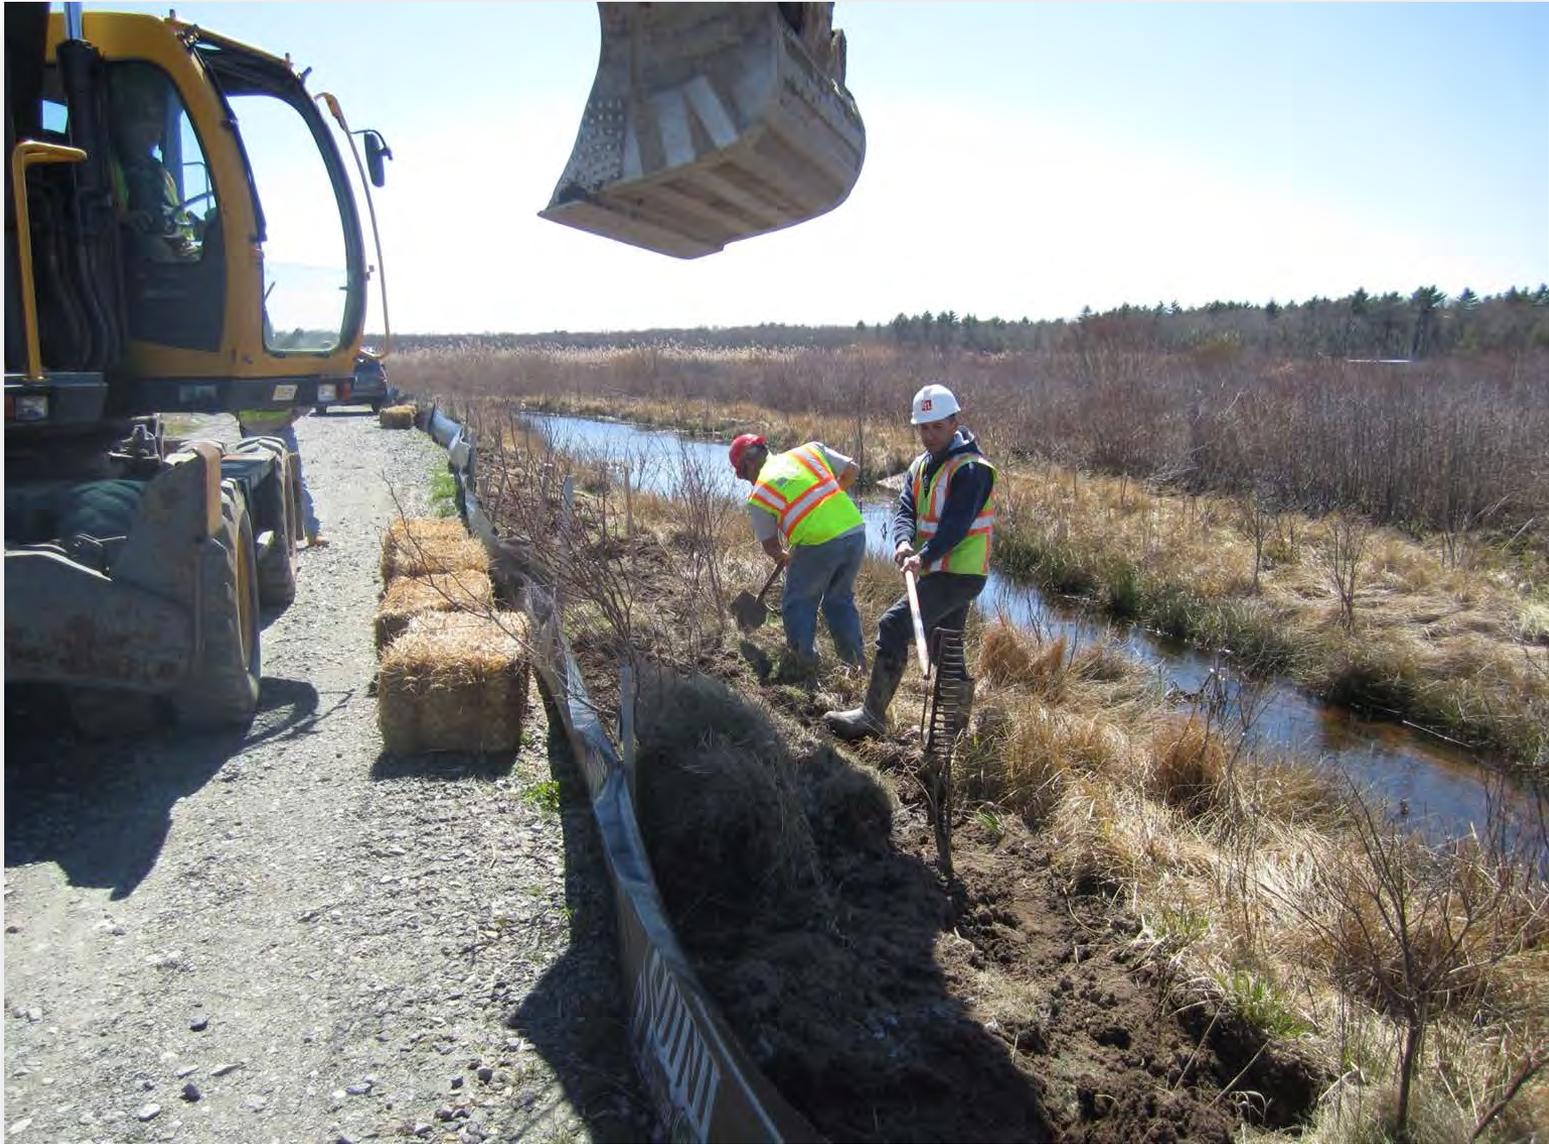
View of Contractor replacing shrubs and temporarily restoring disturbed area along West Ditch.

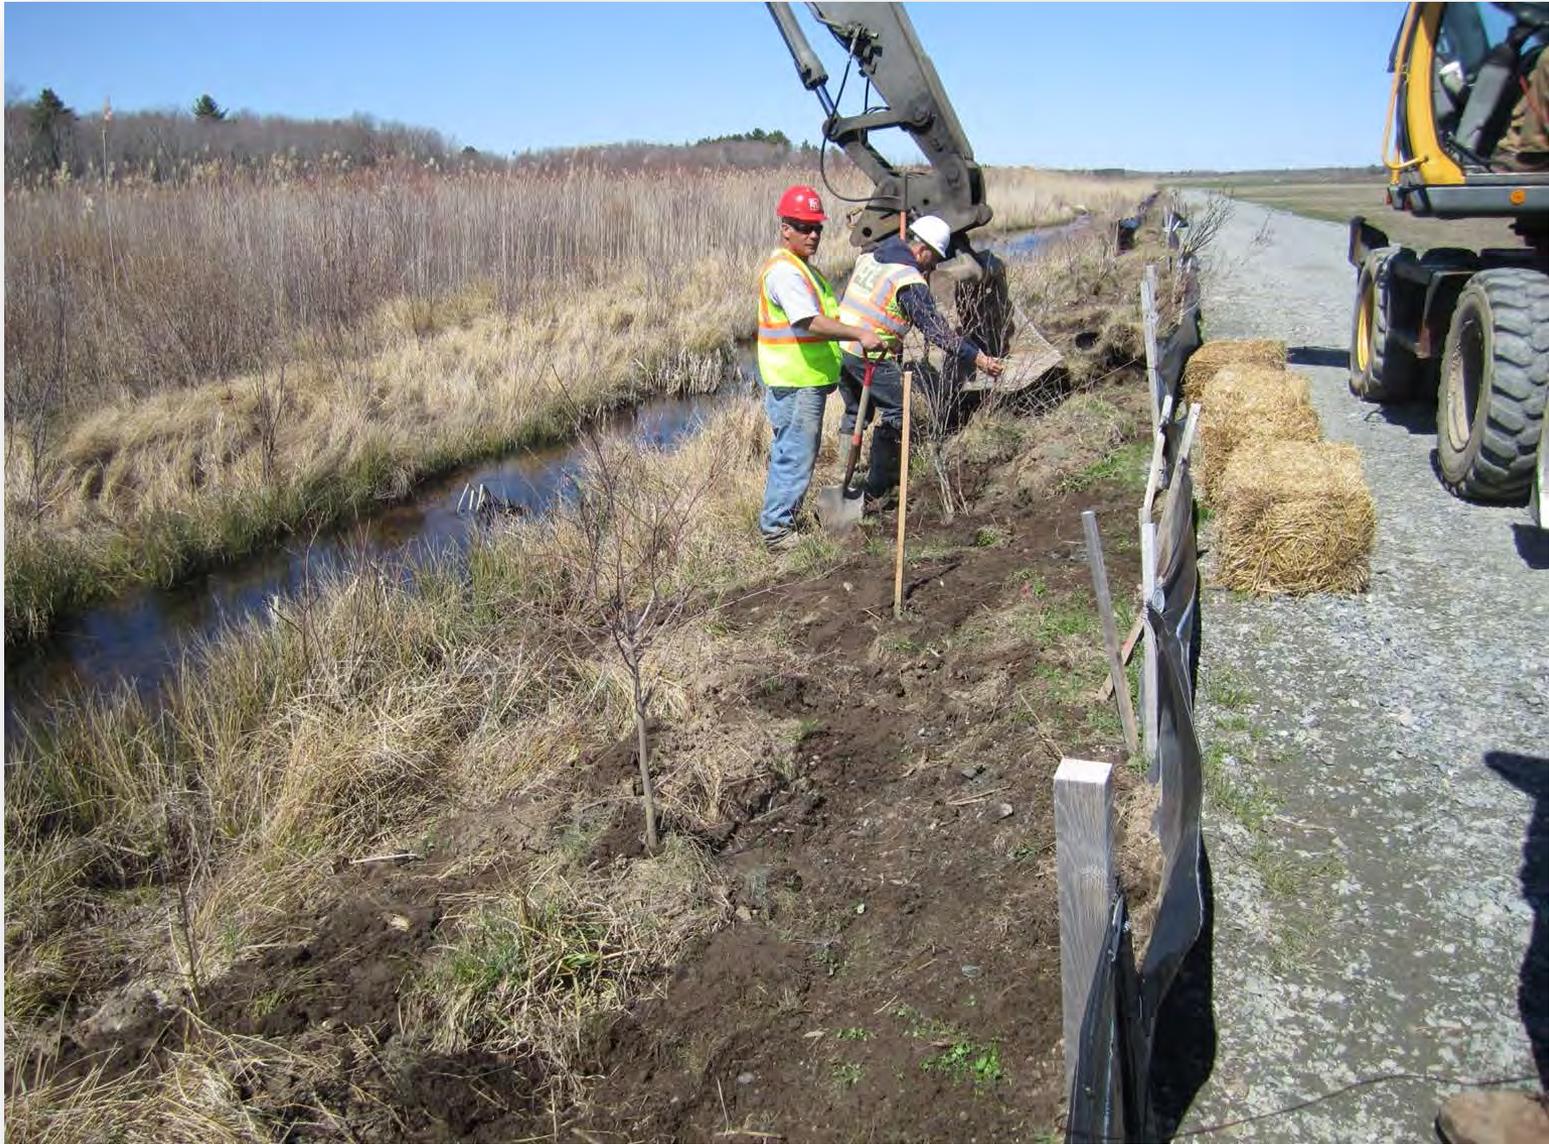
View of Contractor replacing shrubs and temporarily restoring disturbed area. Starting to place straw to protect soil.

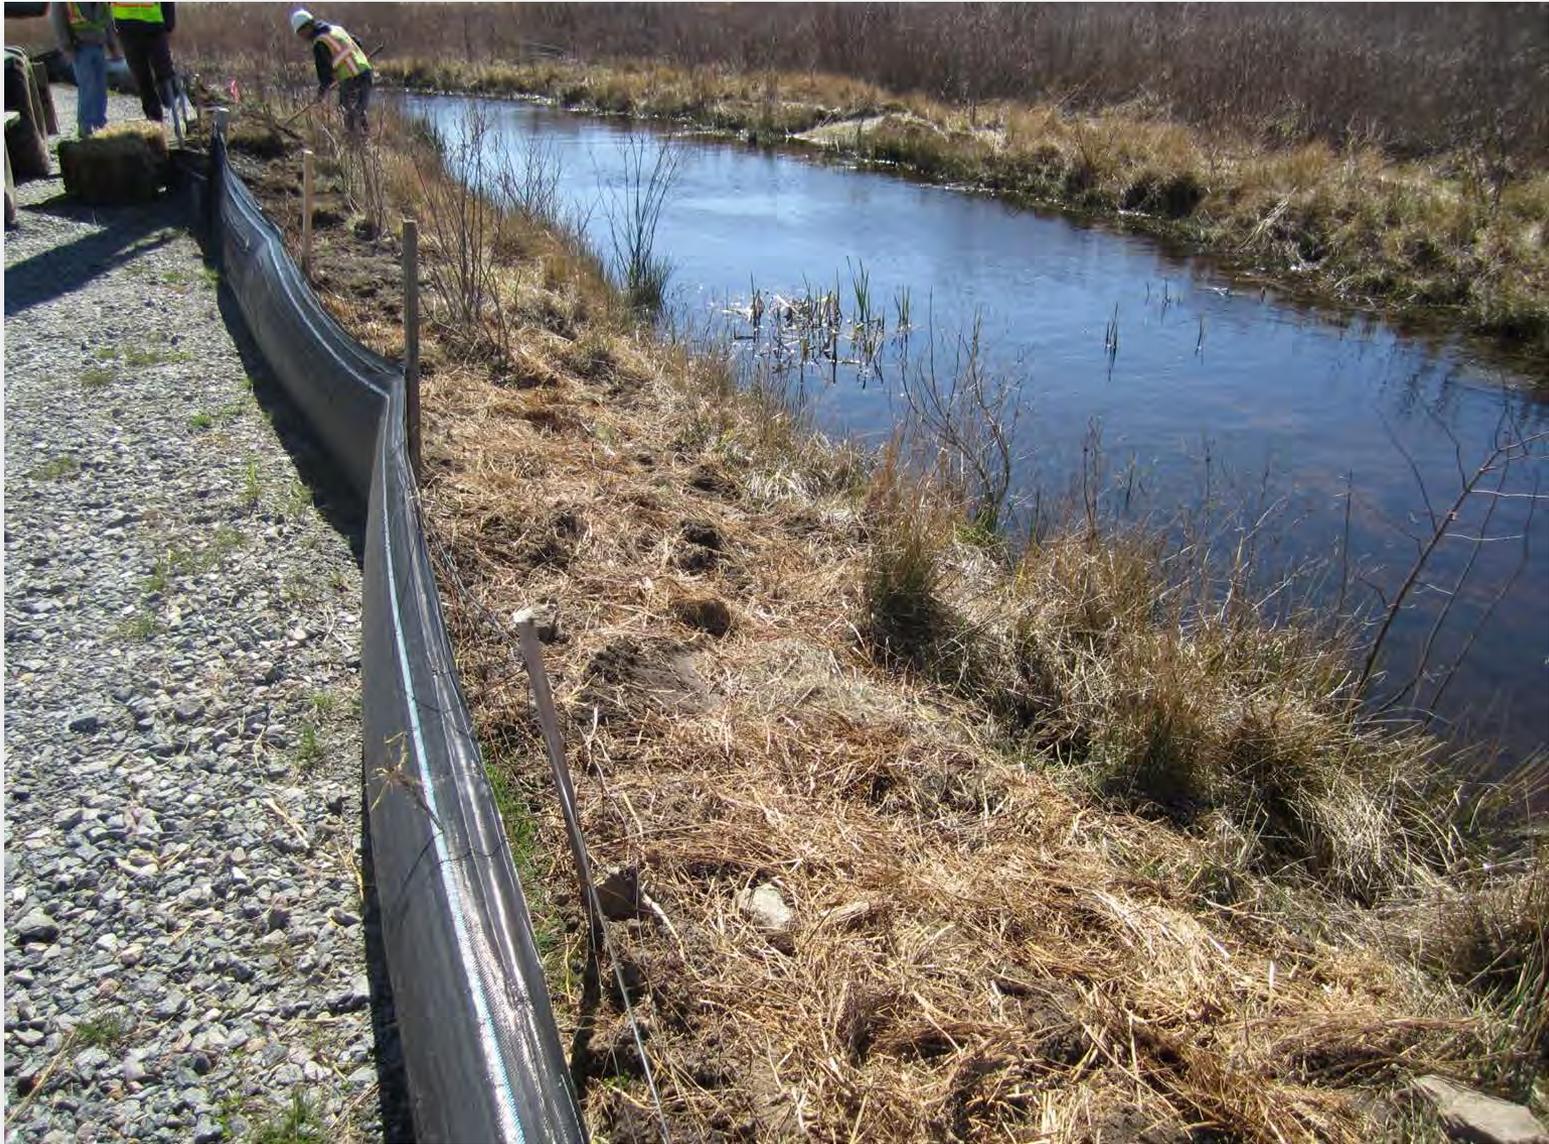
View of Contractor replacing shrubs and temporarily restoring disturbed area. Starting to place straw to protect soil.

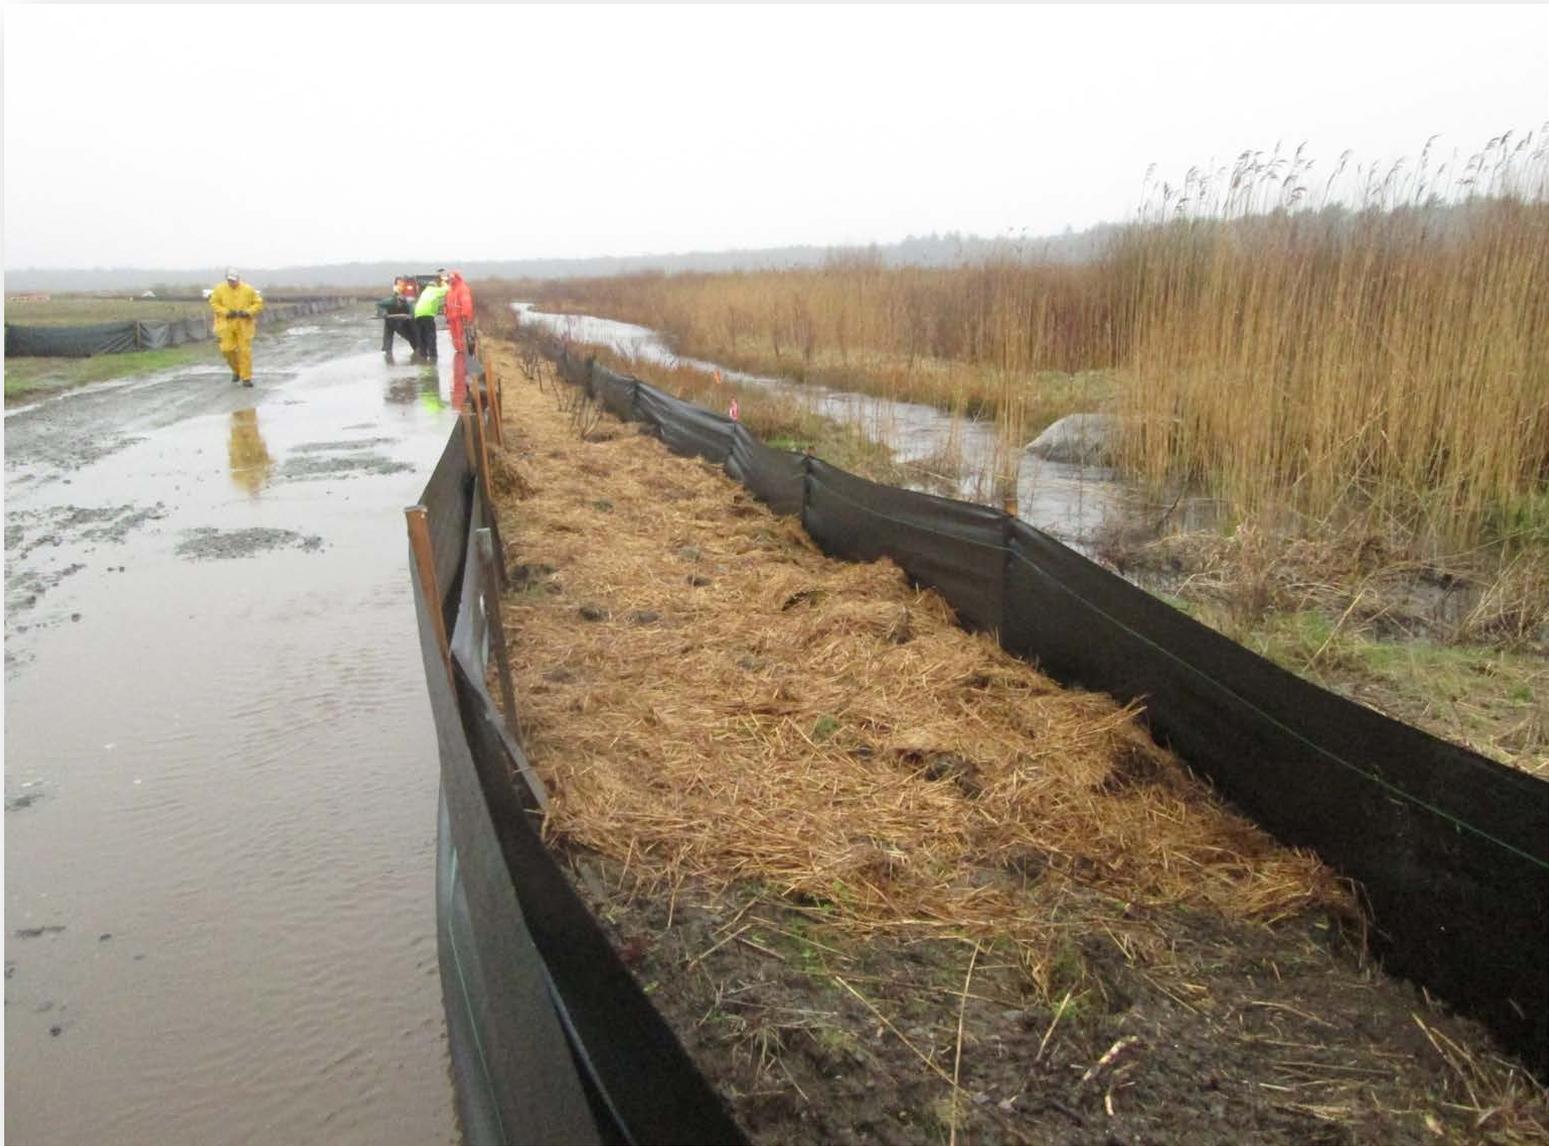
View of RSA 5 end post rain event. Contractors are actively installing silt fence immediately adjacent to existing silt fence.

no yes If yes, describe: Hay bales need to be installed per the specifications adjacent to the silt fence. New silt fence adjacent to the abandoned Phase 2 silt fence needs to be properly tailed. Relocate silt fence from toe of slope of wetland at Runway 5 end. The WS was informed of these requirements at the time of inspection by Epsilon. The WS should also implement the recommended erosion control measures in its most recent WS report.

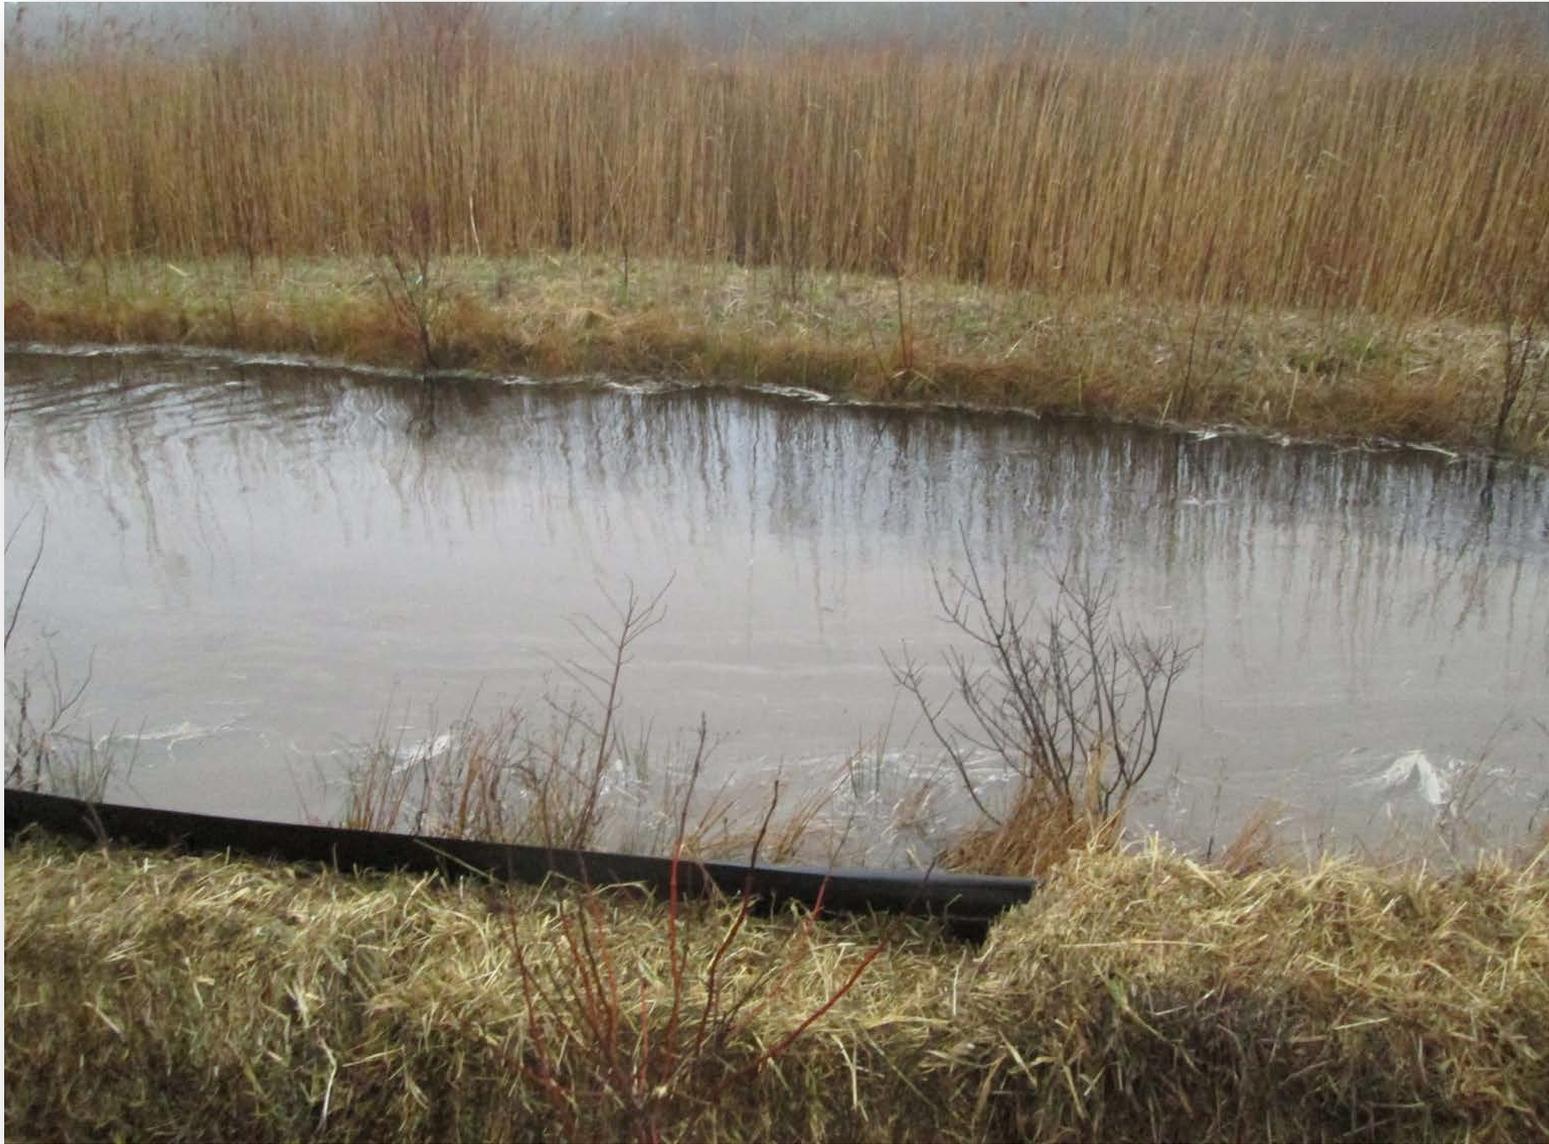
On 5/1/14 Epsilon visited the Runway 5 end RSA after approximately 1.4 inches of rain fell within a 24 hr. period. Much of the site was inundated from the heavy precipitation and two areas were observed where the abandoned Phase 2 silt fence failed and a breach occurred. Epsilon observed the Contractor installing silt fence immediately adjacent to Phase 2 abandoned silt fence. The WS was onsite and was actively trying to contain the site, including adding additional silt fence south of the gravel access road to break up the water flow. Turbid water (very fine sediment) was observed flowing into the West Ditch and the wetland located between the Runway 5 end and the West Ditch. During a follow up site visit after rains dissipated turbid water conditions were no longer present in the West Ditch (the water clarified relatively quickly as the rain event died down and water levels dropped). Sarah Porter of the New Bedford Conservation Commission conducted a site inspection with Epsilon and the WS in the afternoon. One other area, located at the northern bend of the West Ditch was observed and the WS was notified. Once water was controlled the contractor raked eroded areas and spread hay to protect the ground surface. Epsilon recommends that at the appropriate time the silt fence placed along the toe of slope (between Runway 5 end pavement and the west ditch) be relocated or installed at the top of slope to prevent sedimentation into the wetland in the future. We will coordinate this recommendation with the RE and WS.

View of west ditch in morning (approximately 9:45am) in location of silt fence breach. See WS report for more photos of this area.

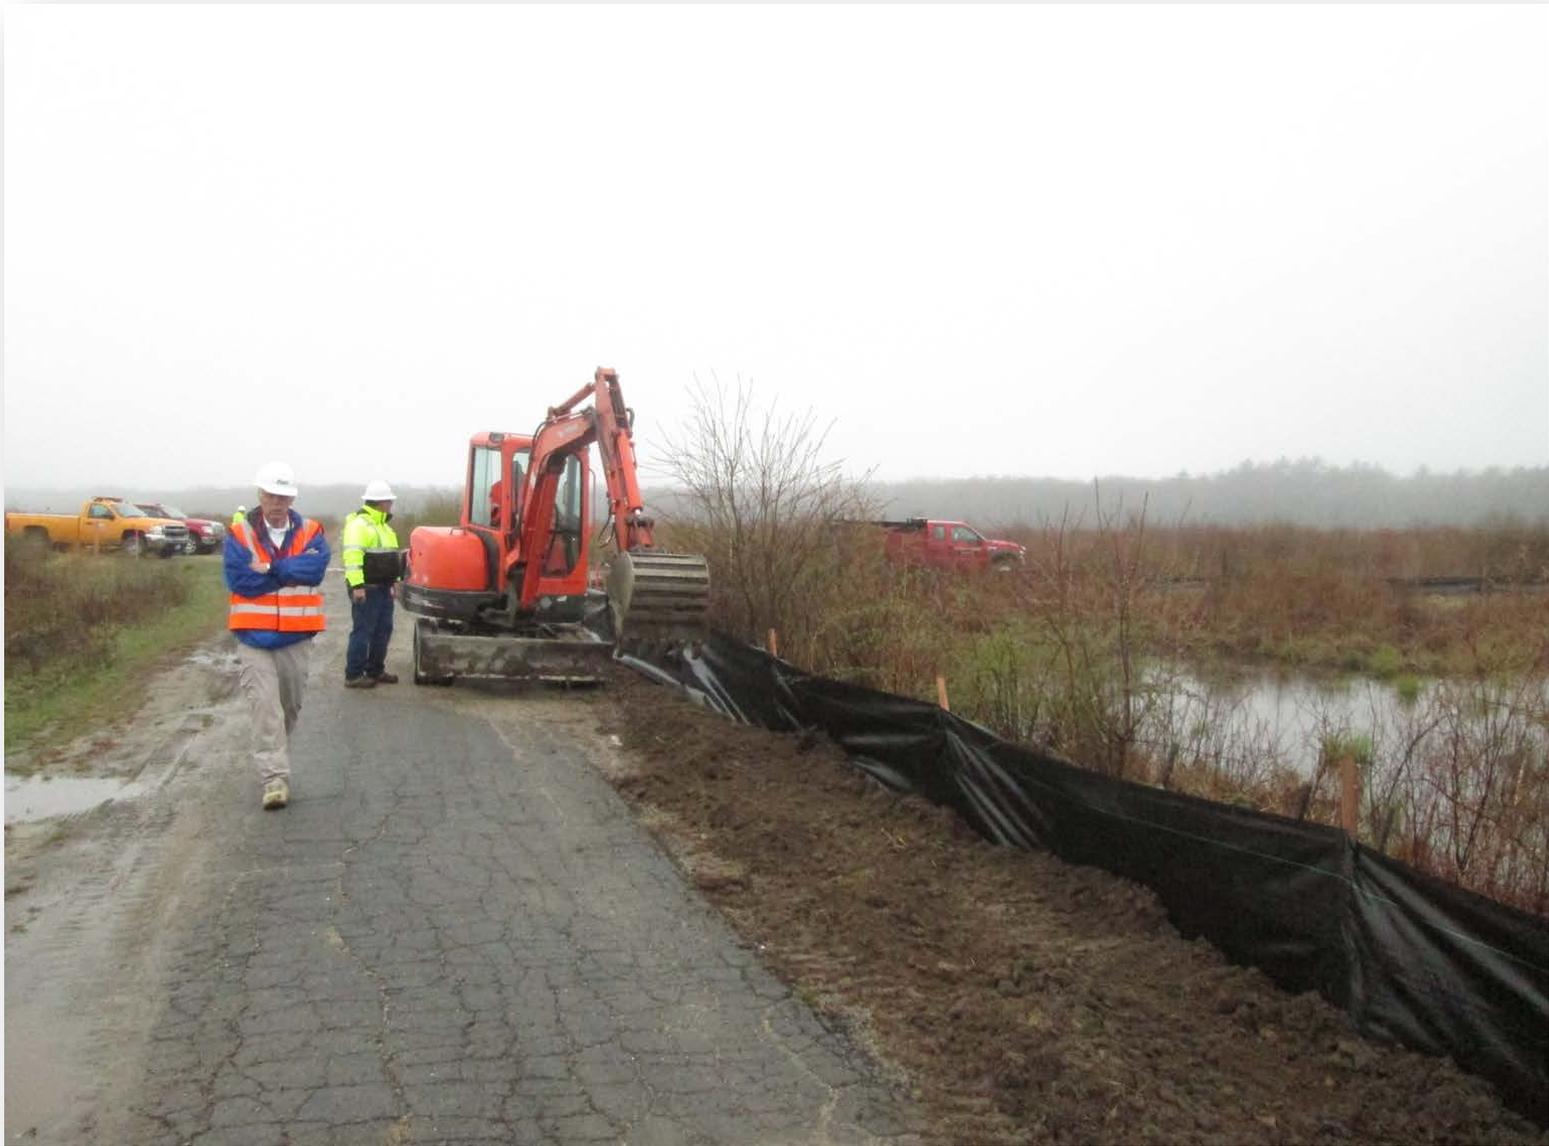
View of actively installing silt fence along ILS road, beyond the Runway 5 end RSA.

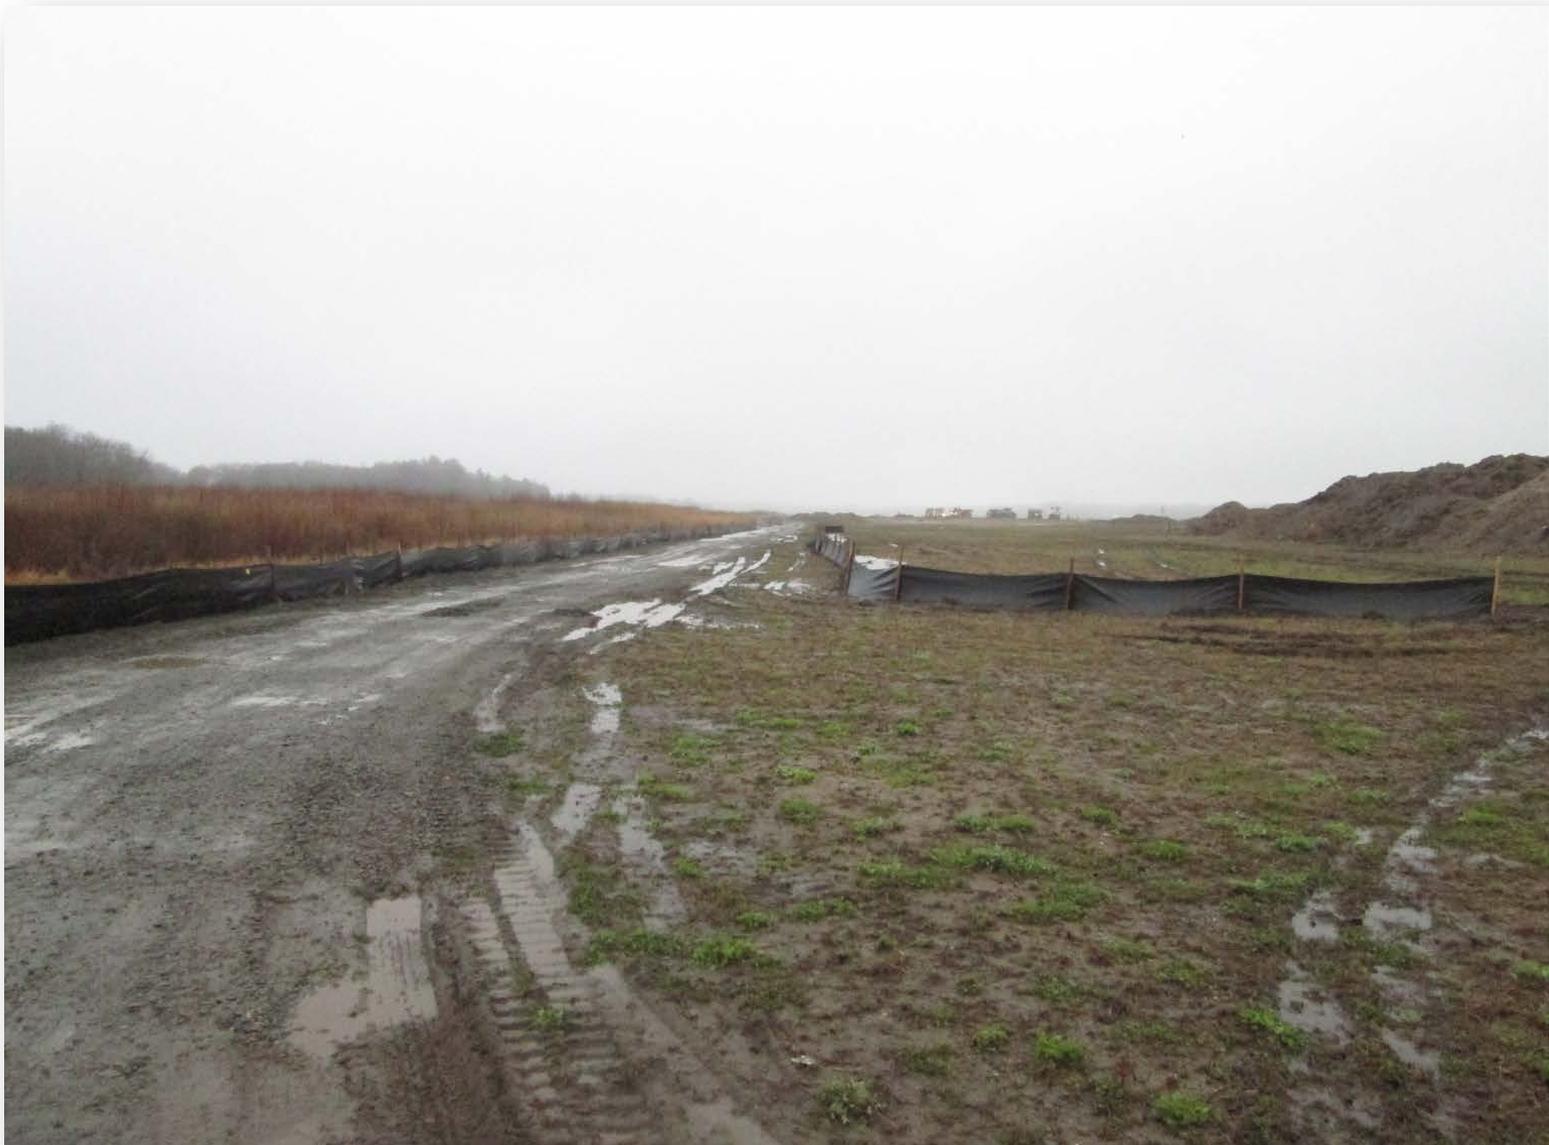
View of RSA 5 end from western point (curve of access road). The Contractor installed half moon erosion control on the RSA side of gravel road.
