**New Bedford Regional Airport  
Runway Safety Improvements Project – Phase 4  
Reconstruct, Mark, and Groove Runway 5-23  
MassDEP File No. SE049-0635**

**ENVIRONMENTAL MONITOR INSPECTION FORM**

Environmental Monitor: **Amanda Atwell**      Date/ Time of Inspections: **4/14/14 (9am to 11am), 4/24/14 (10am-4pm), and 5/1/14 (9:30am-4pm)**

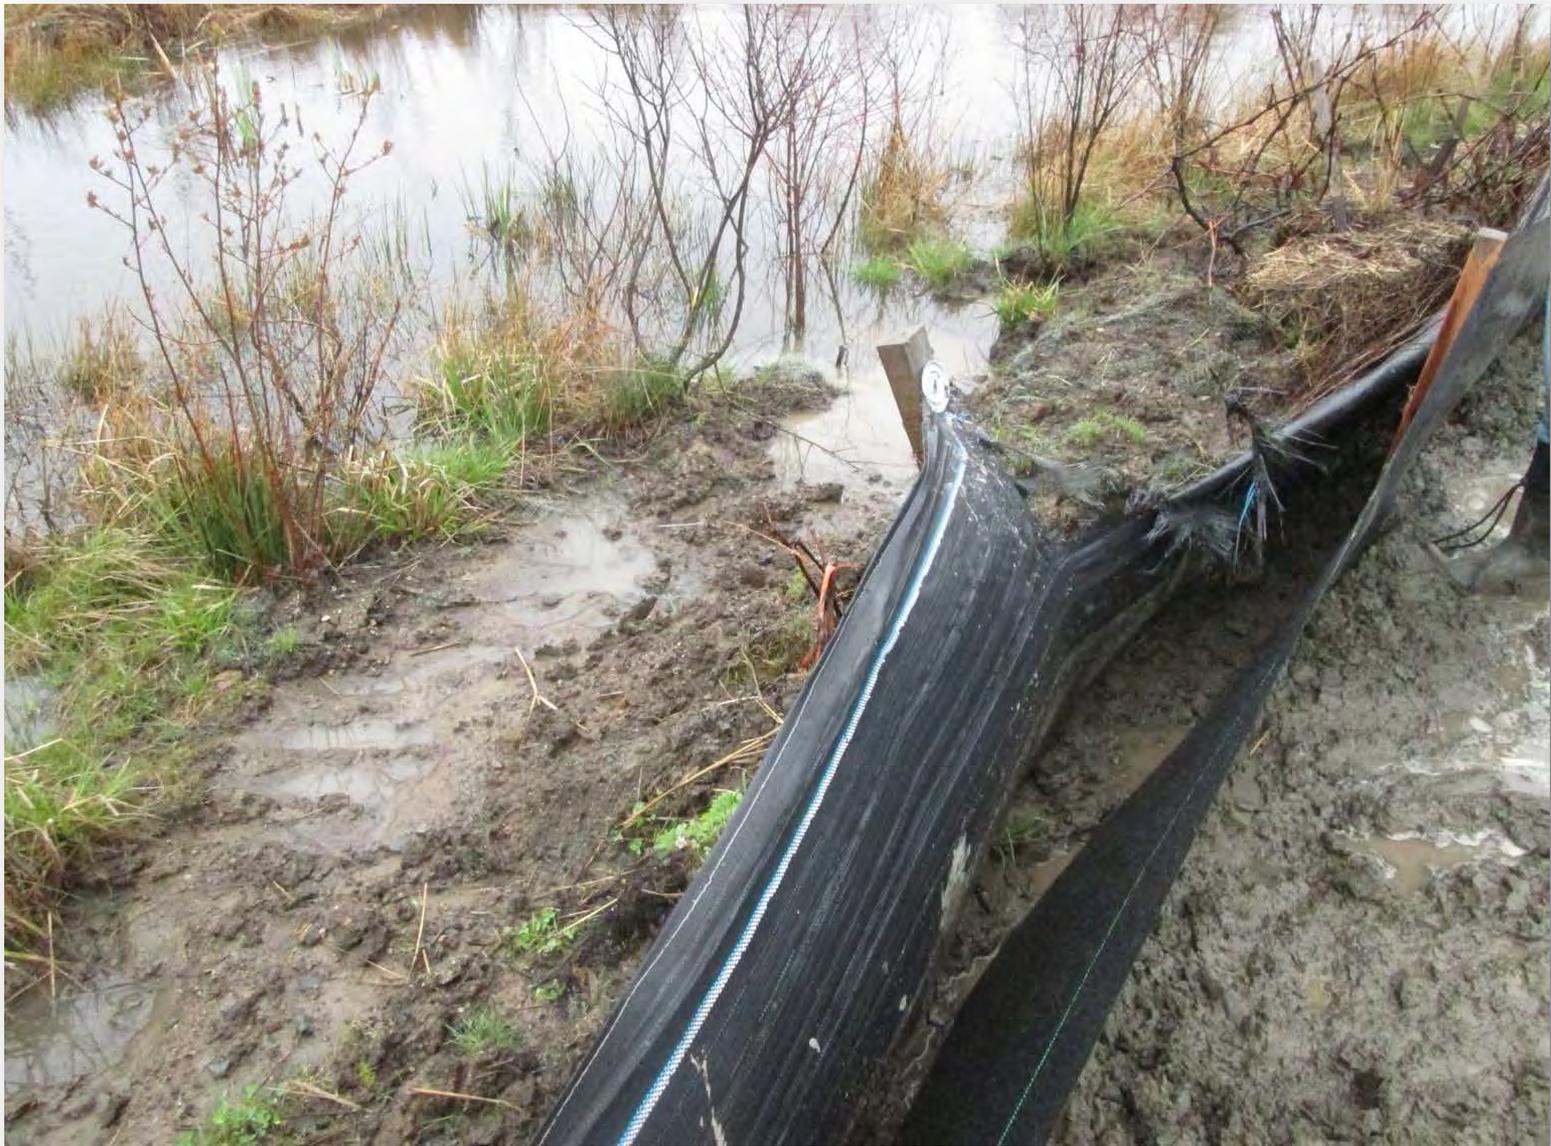
View of west ditch breach at corner of RSA (western edge). The Contractor placed hay to protect soil surface and will include this area in restoration plan.

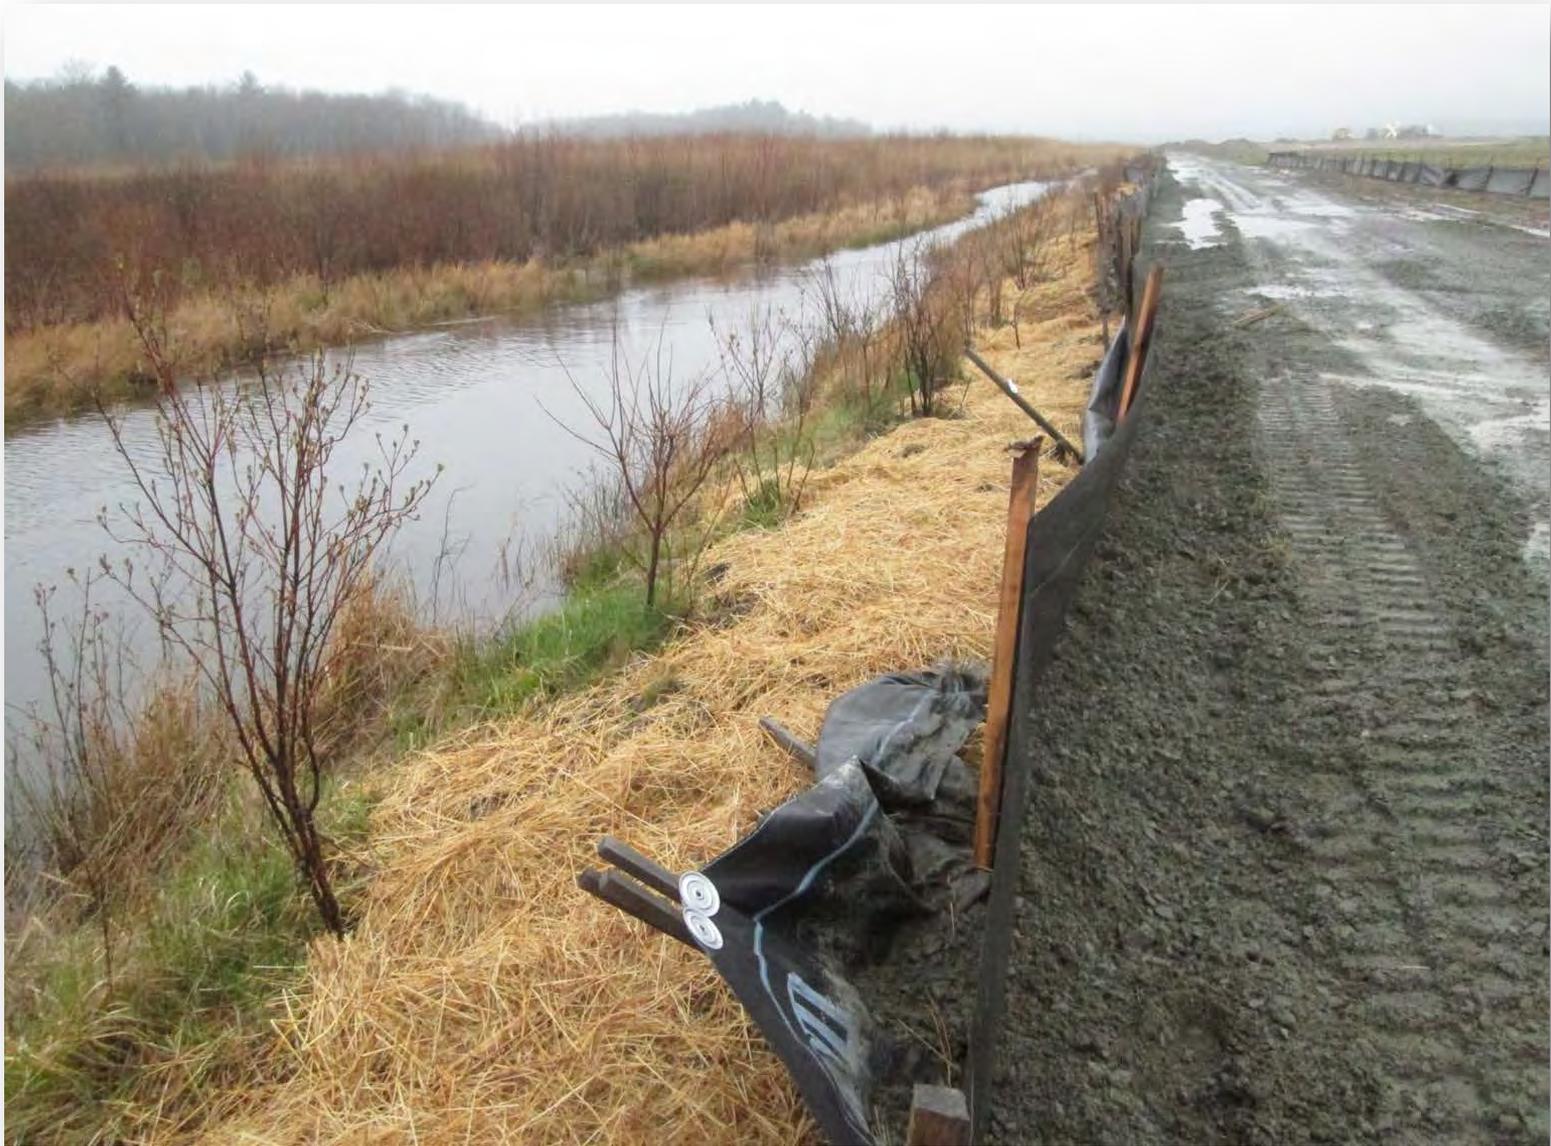
View of protected bank along a portion of the disturbed west ditch area at approximately 2pm.

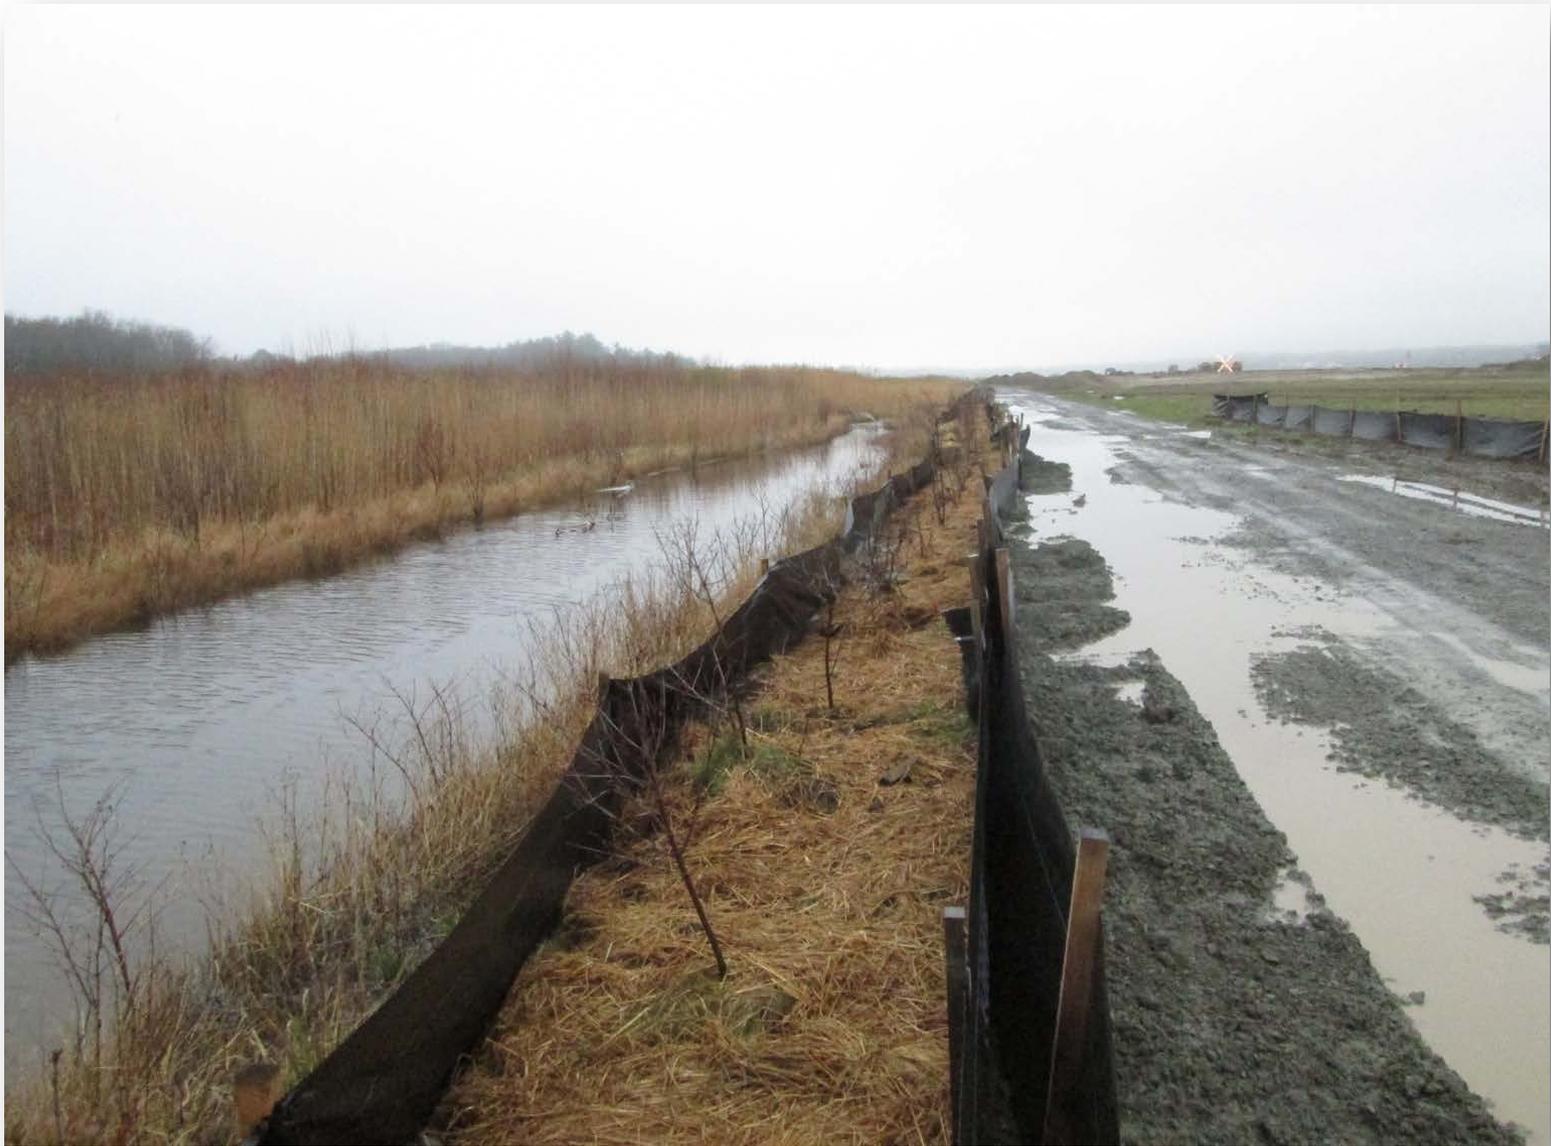
View of protected bank along a portion of the disturbed west ditch area at approximately 2pm.

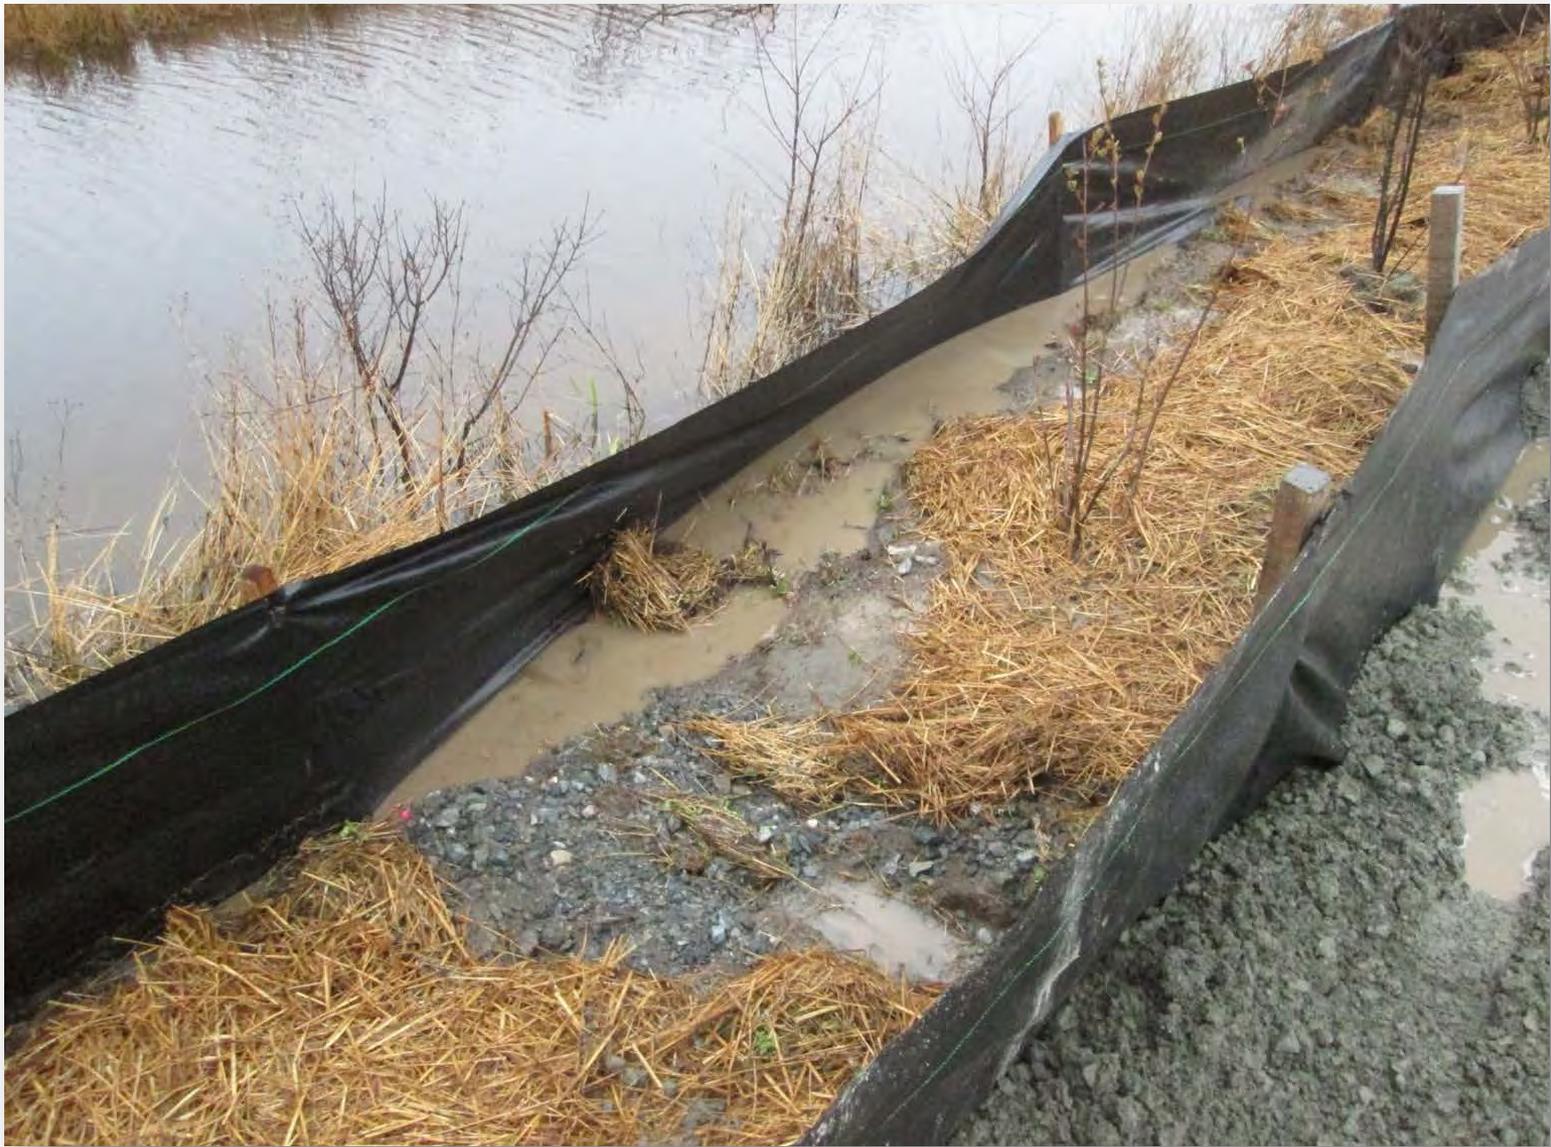
View of breach number three along west ditch.

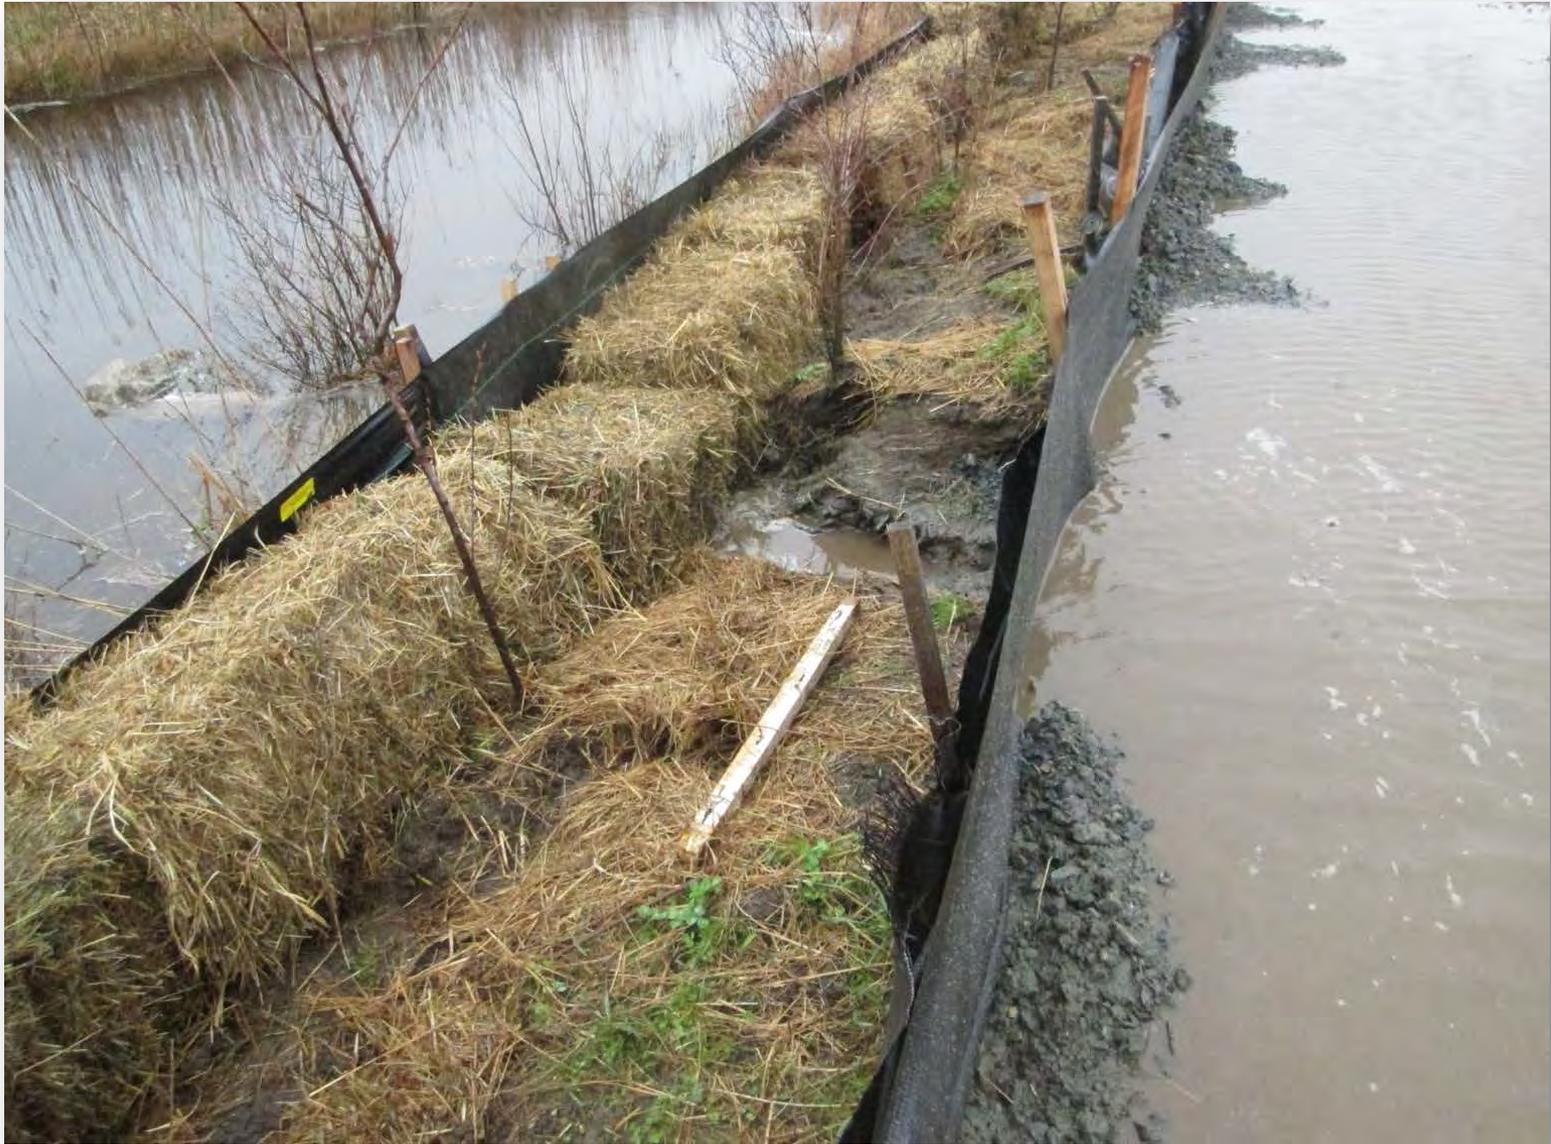
View of first breach during very intense rainfall event, once water dissipated. The previous erosion control had a hole in it.

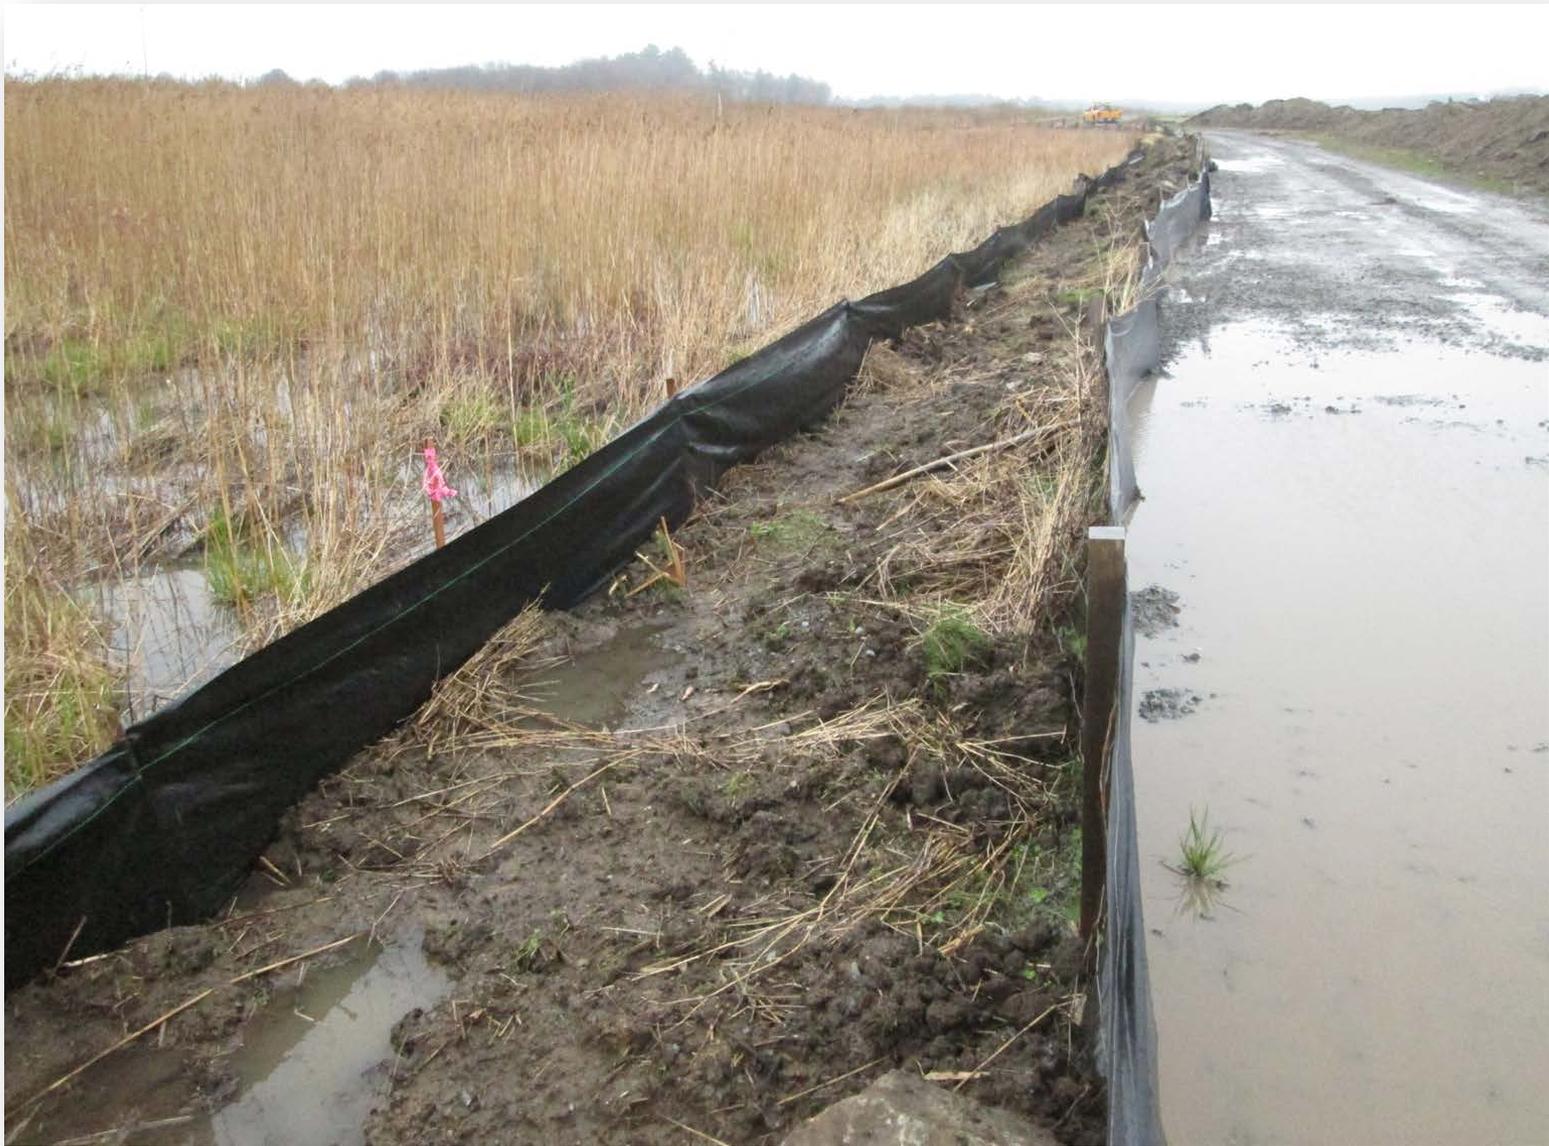
View of silt fence installed at toe of slope near Runway 5 end.

no yes If yes, describe: Hay bales need to be installed per the specifications adjacent to the silt fence. New silt fence adjacent to the abandoned Phase 2 silt fence needs to be properly tailed. Relocate silt fence from toe of slope of wetland at Runway 5 end. The WS was informed of these requirements at the time of inspection by Epsilon. The WS should also implement the recommended erosion control measures in its most recent WS report.

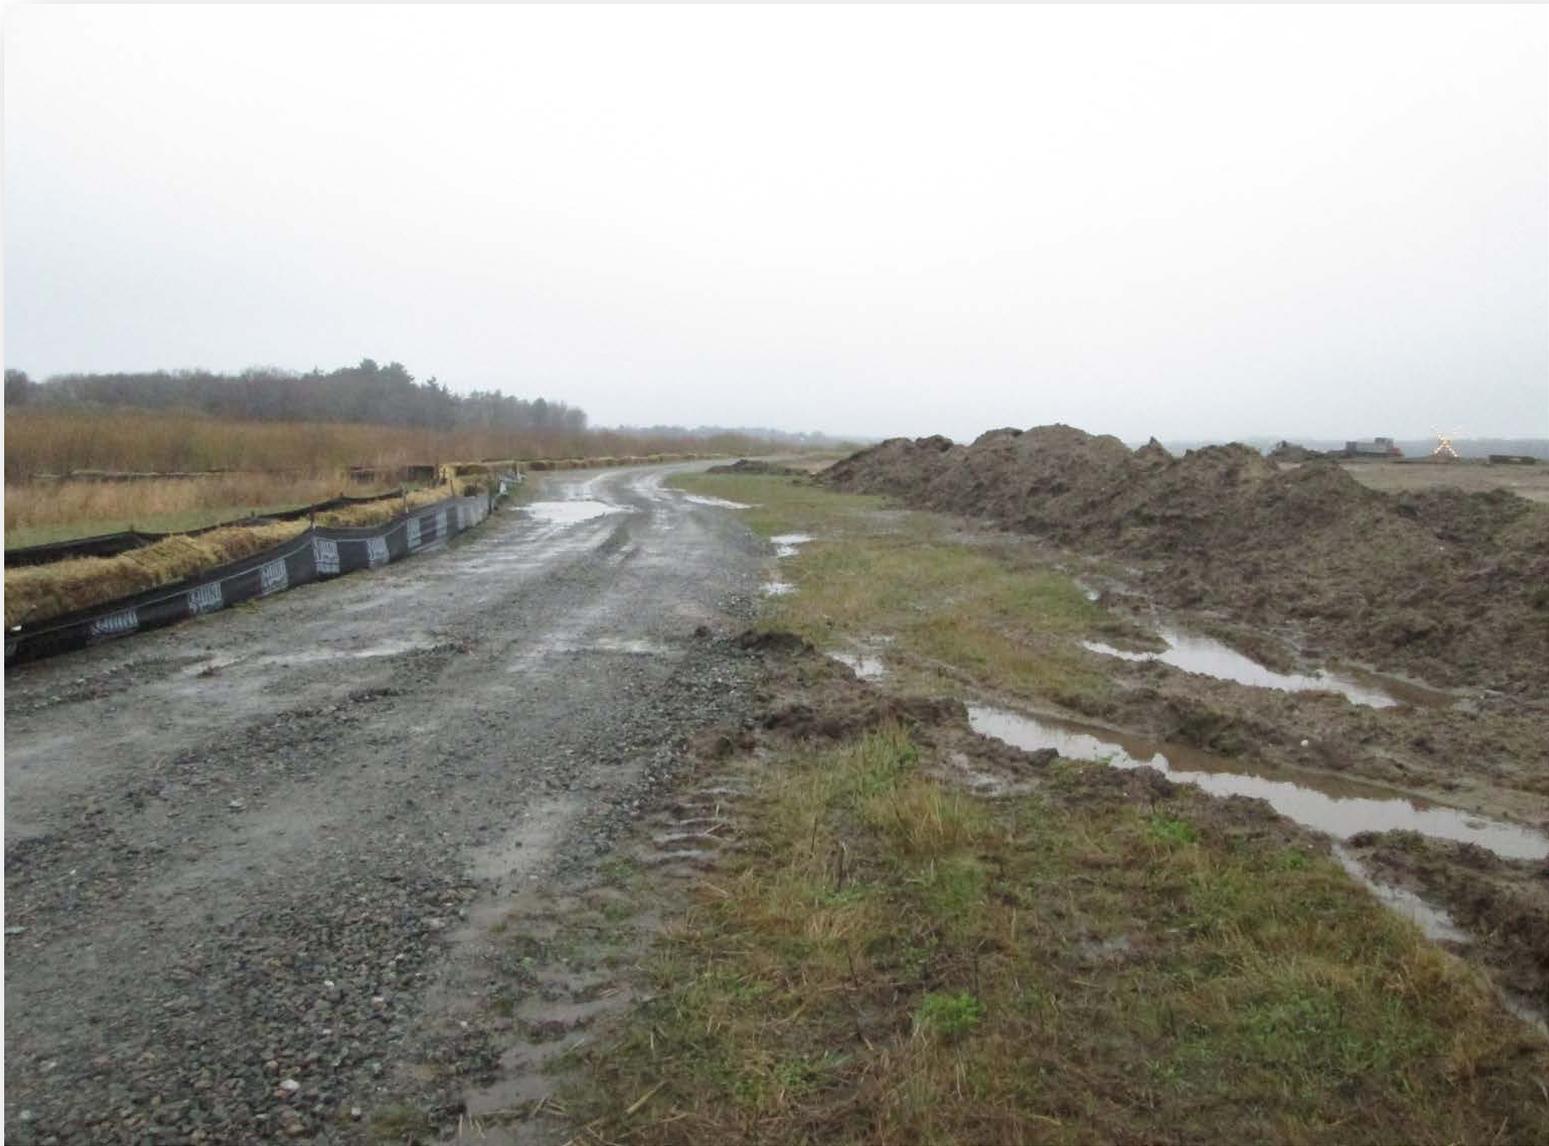
View of sediment stockpile. The WS and contractor have been instructed to ensure that this area is beyond the BVW 100-ft buffer zone.

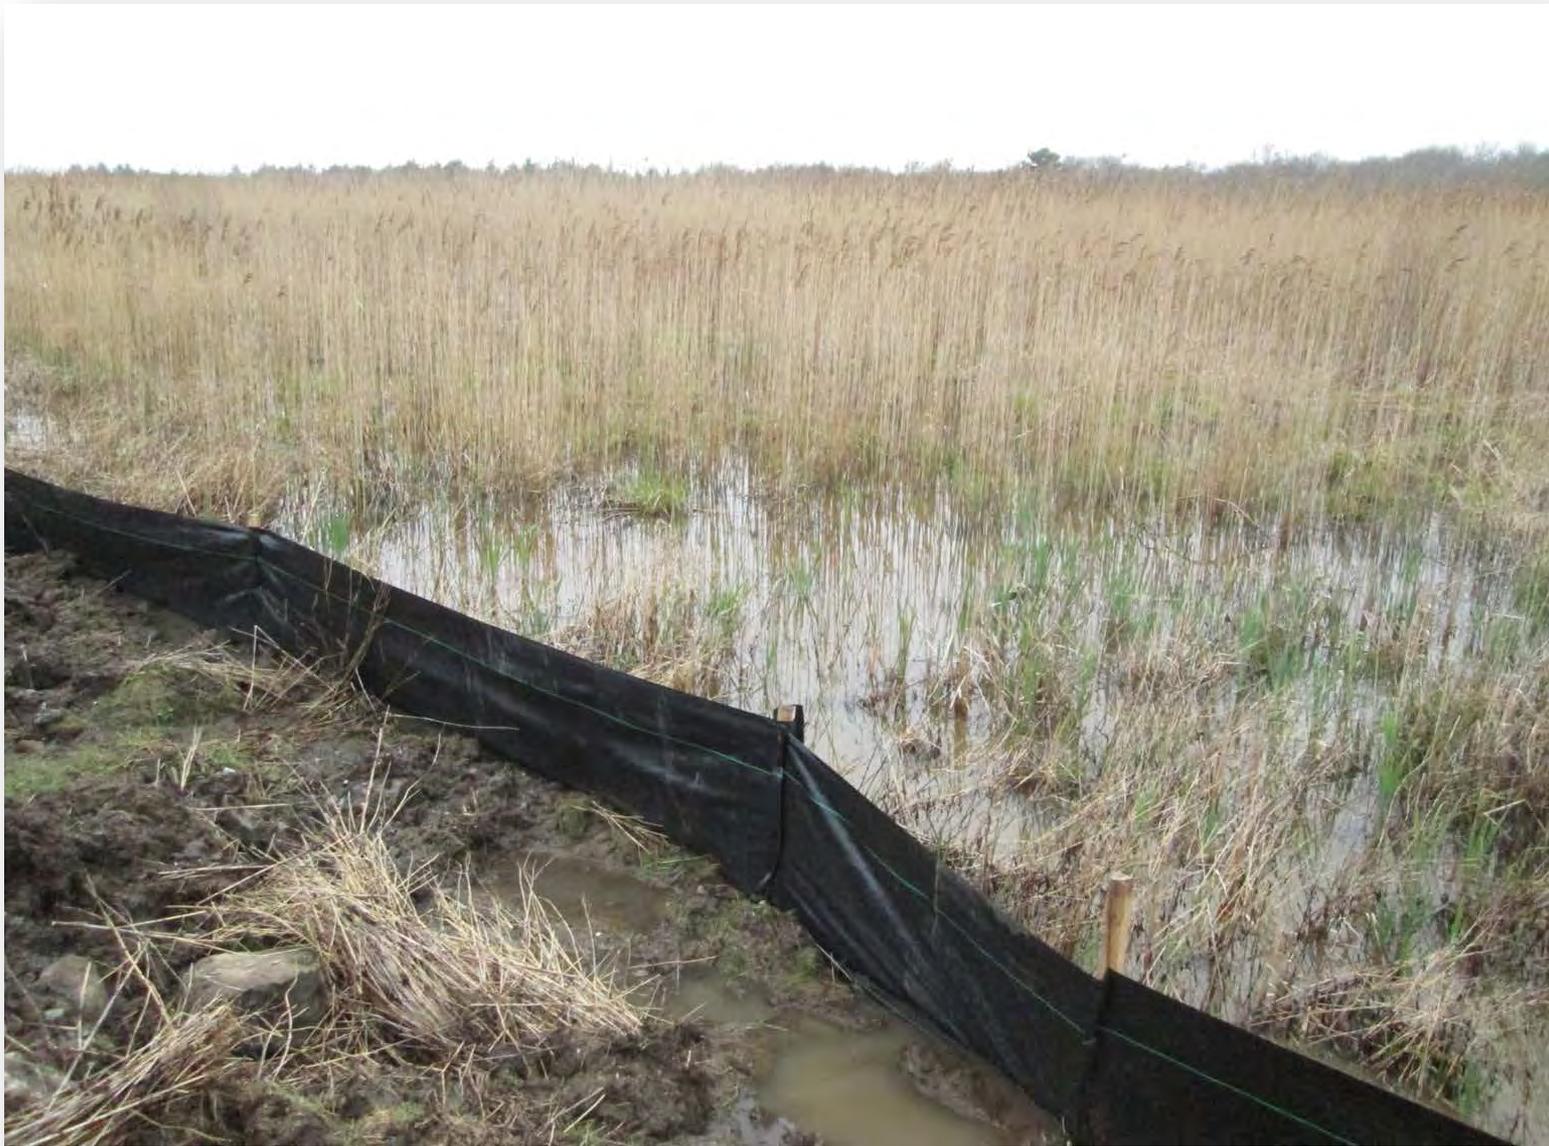
View of silt fence installed at toe of slope near Runway 5 end.

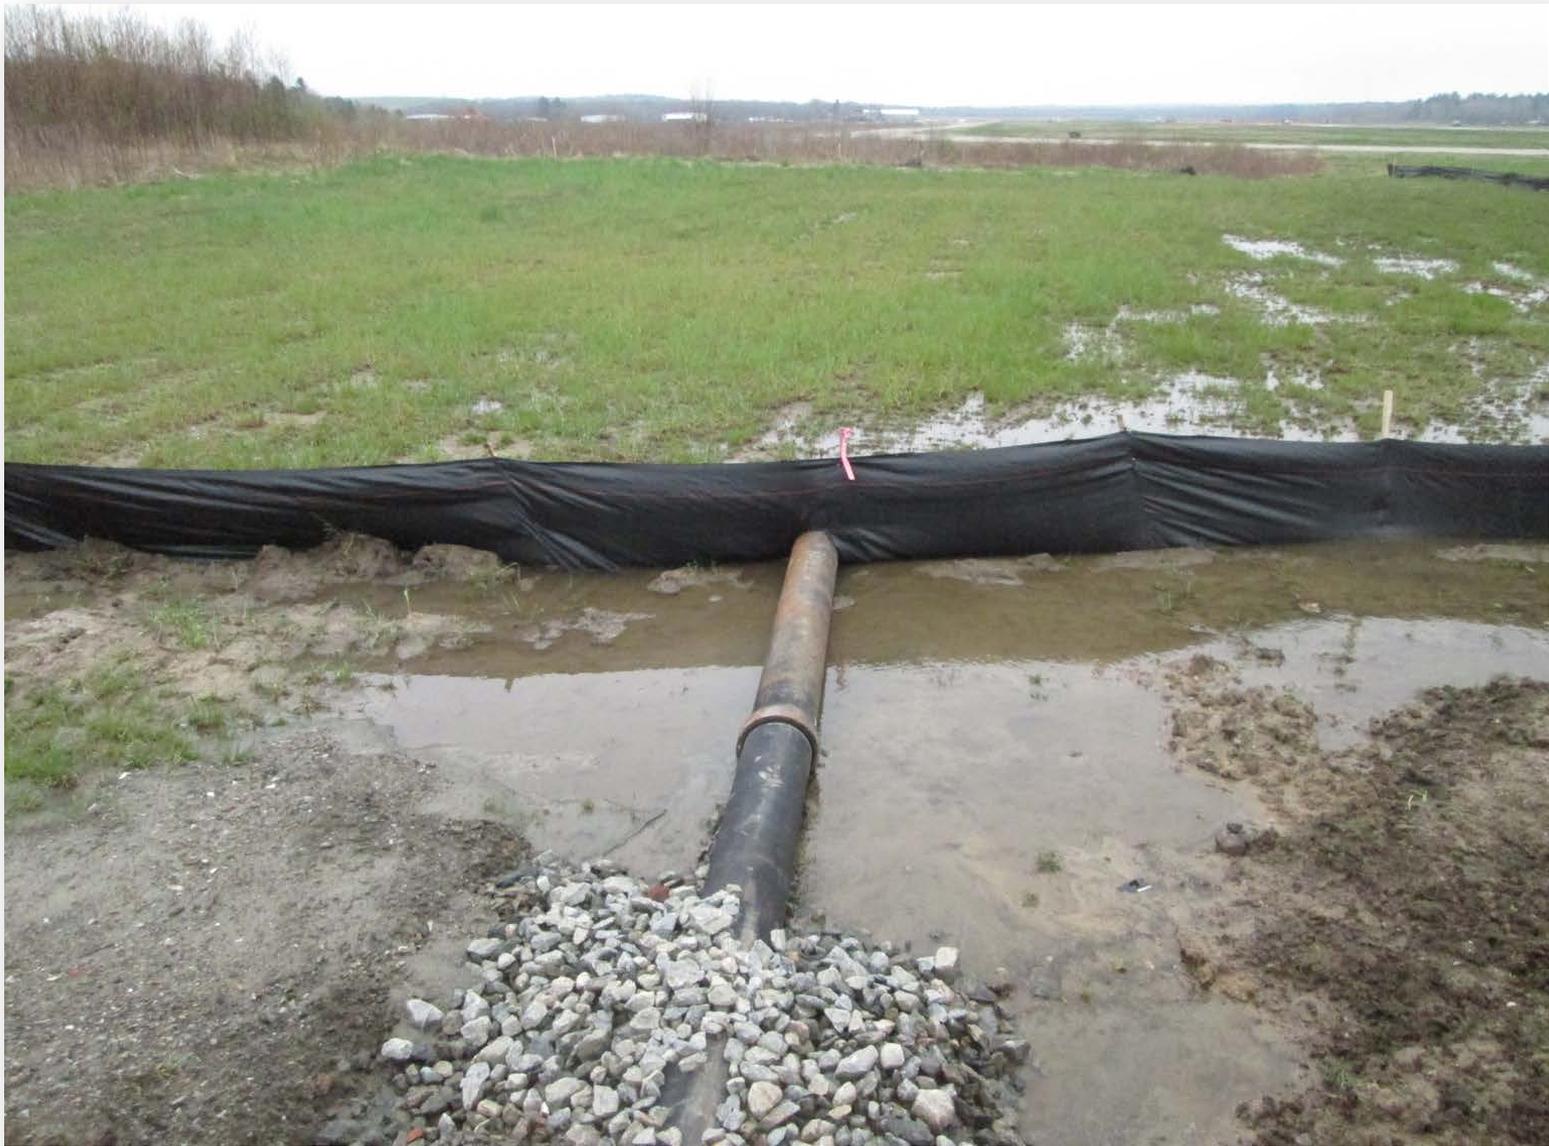
View of temporary culvert in upland area where ponding occurred under the temporary access road at Runway 23 end.

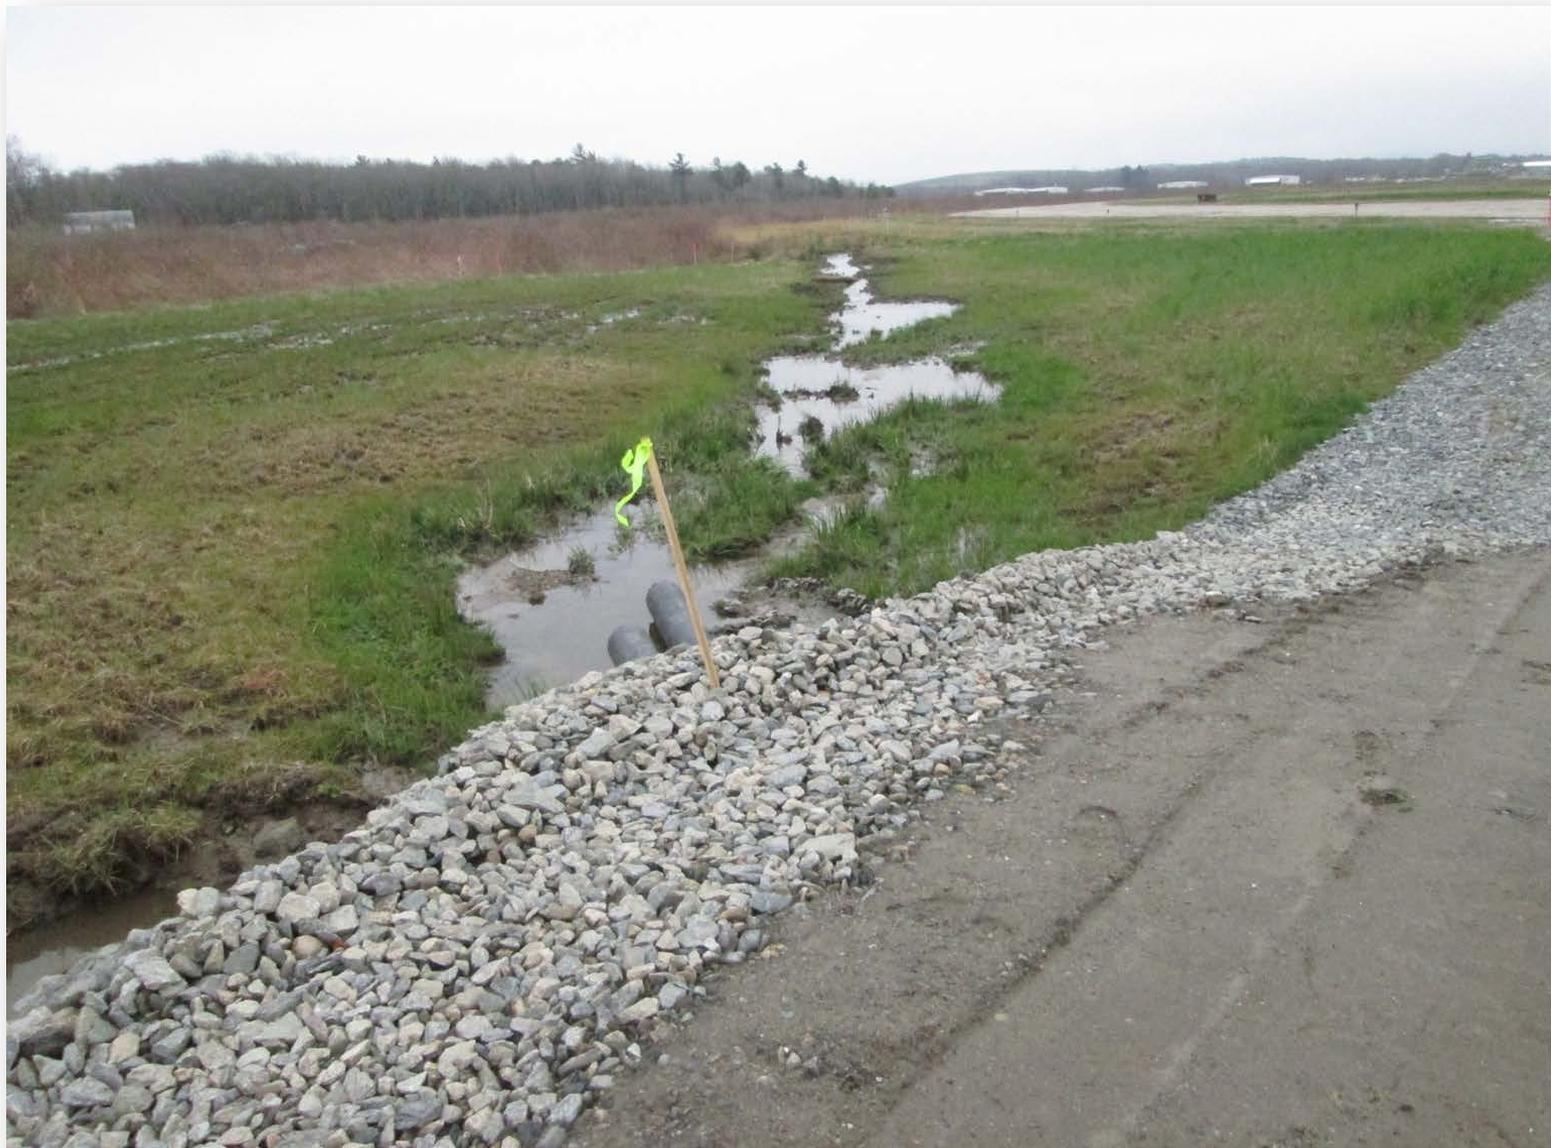
View of culvert under gravel access road in uplands at Runway 23 end.
