**New Bedford Regional Airport
Runway Safety Improvements Project – Phase 4
Reconstruct, Mark, and Groove Runway 5-23
MassDEP File No. SE049-0635**

ENVIRONMENTAL MONITOR INSPECTION FORM

Environmental Monitor: **Amanda Atwell** Date/ Time of Inspections: **5/8/14 (10am to 5pm), 5/15/14 (10am-3pm)**

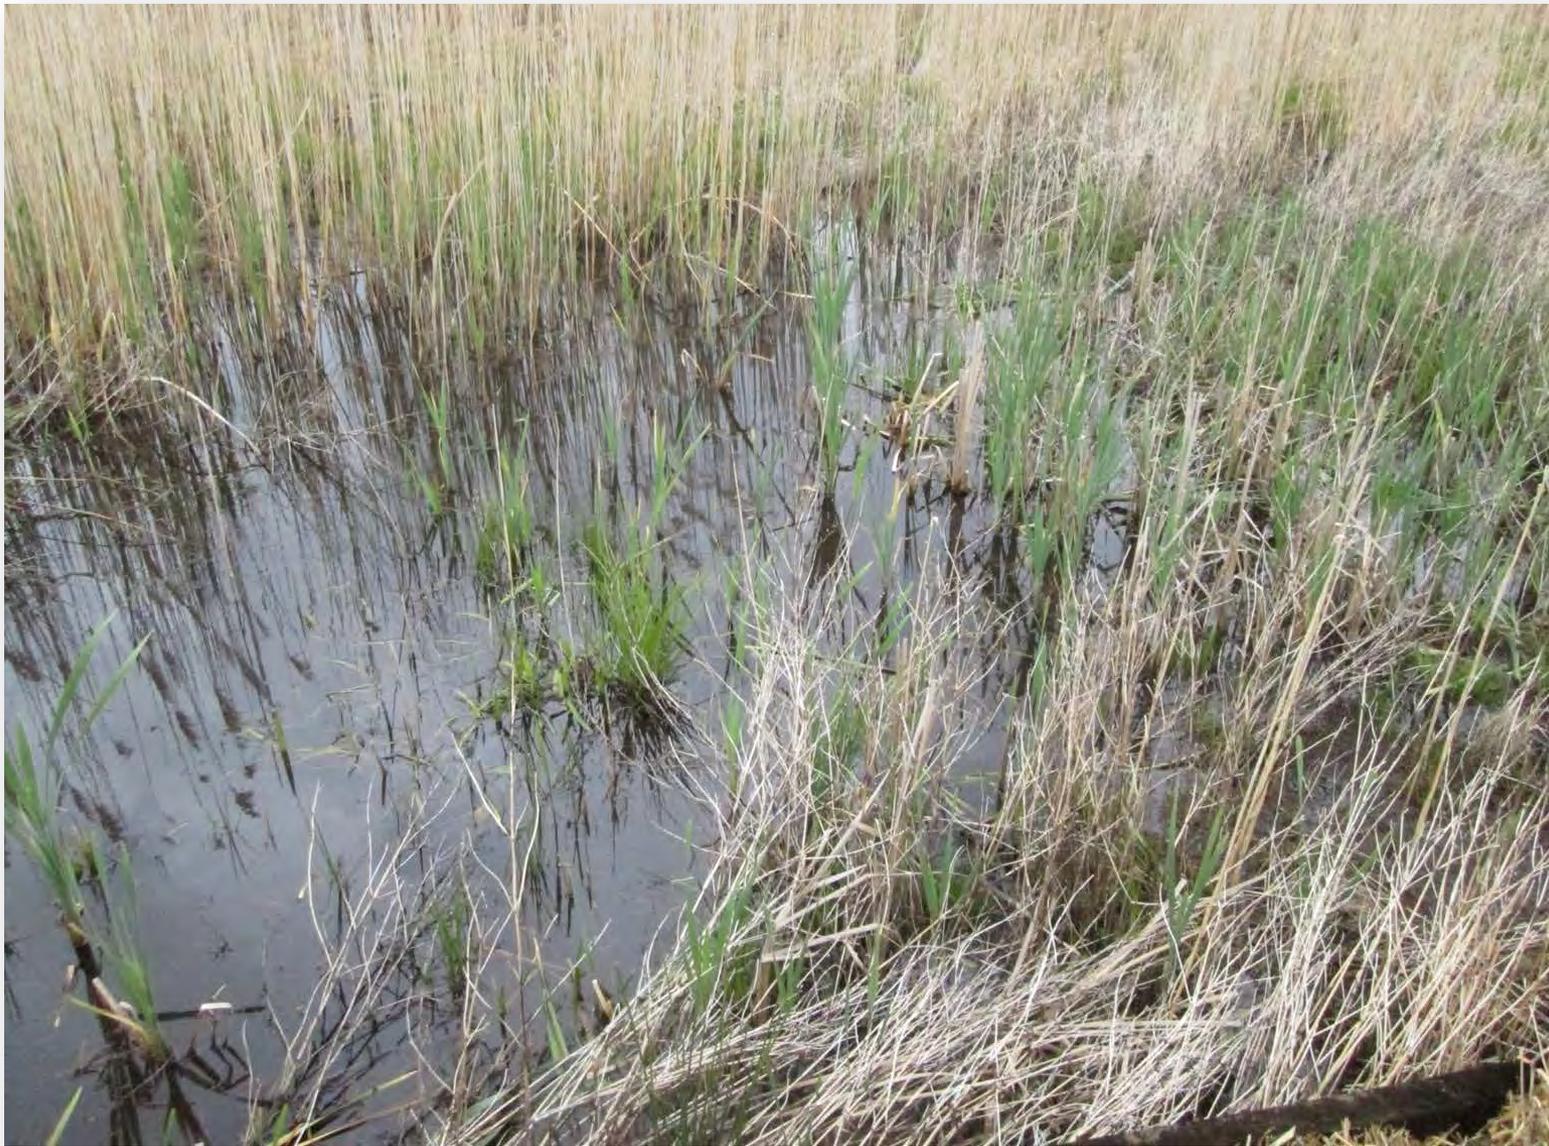
View of wetland area by Runway 5 end where silt fence was installed at toe of slope. Previous May 1 photos showed sedimentation in the water column. No appreciable sediment was observed one week later.

no yes If yes, describe: Relocate silt fence from toe of slope of wetland at Runway 5 end; Replenish emergency stockpiles of erosion controls; Close gaps in turtle barriers as directed by Oxbow.

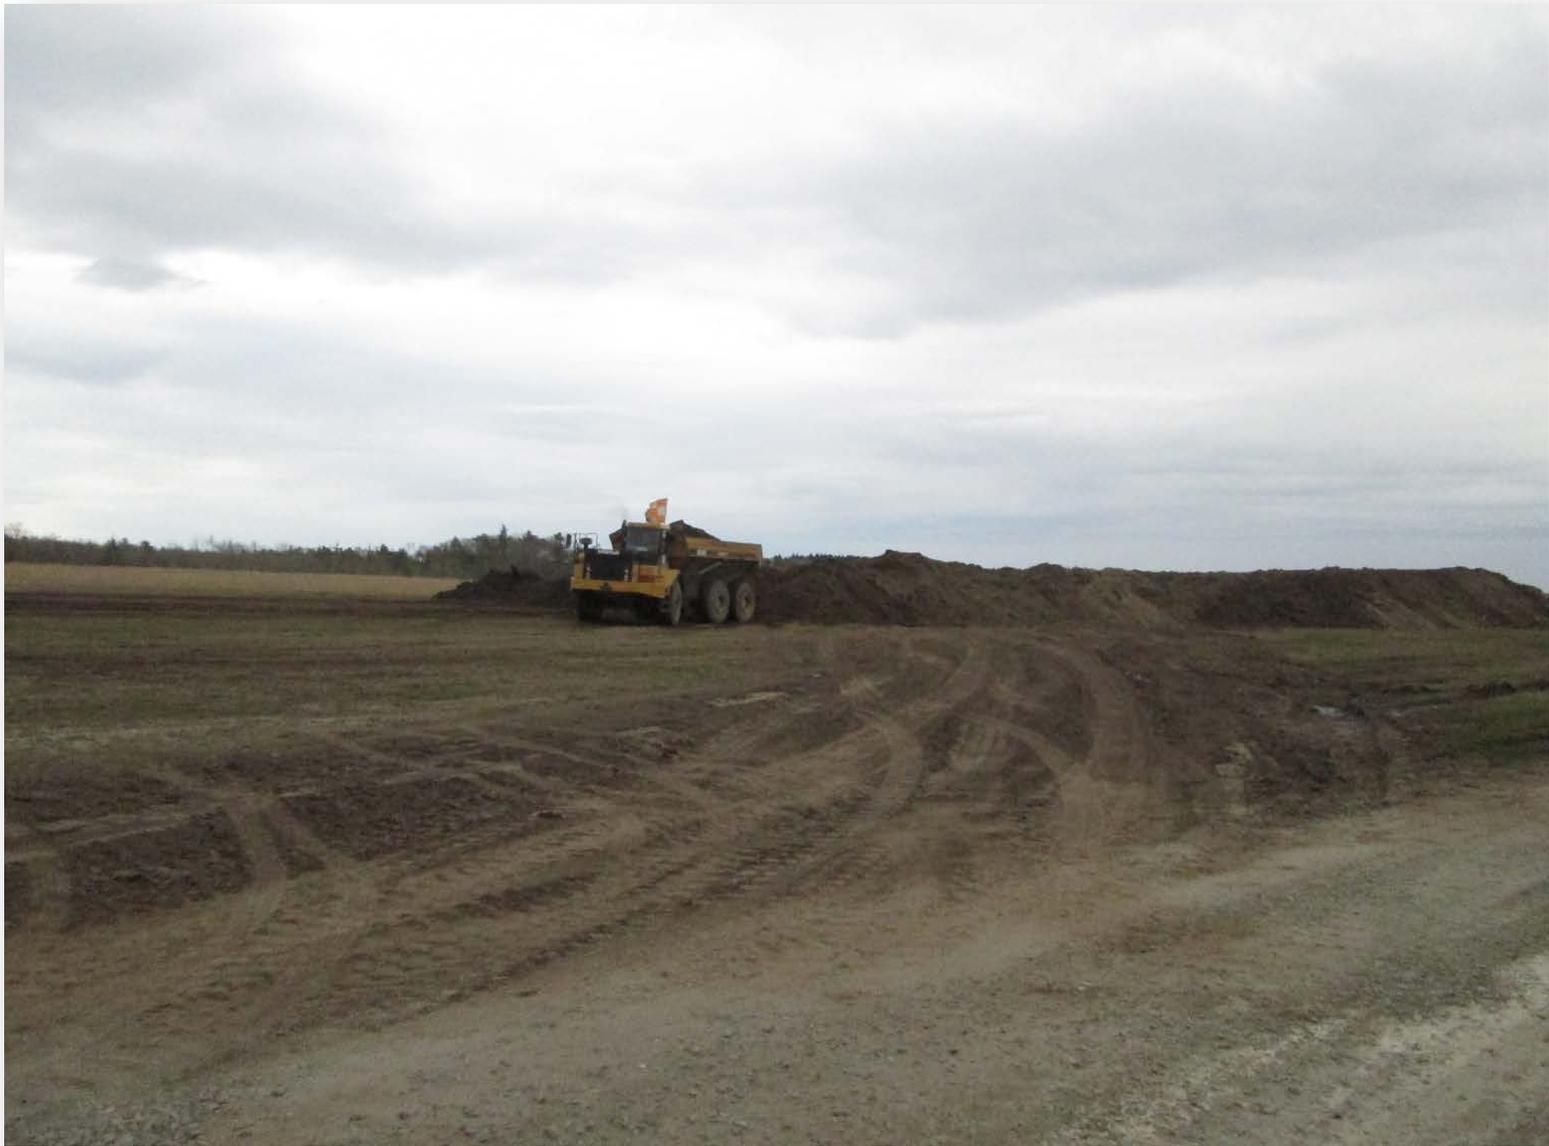
View of soil stockpile located outside the 100-ft buffer zone. This area will likely be seeded with annual rye to help stabilize.

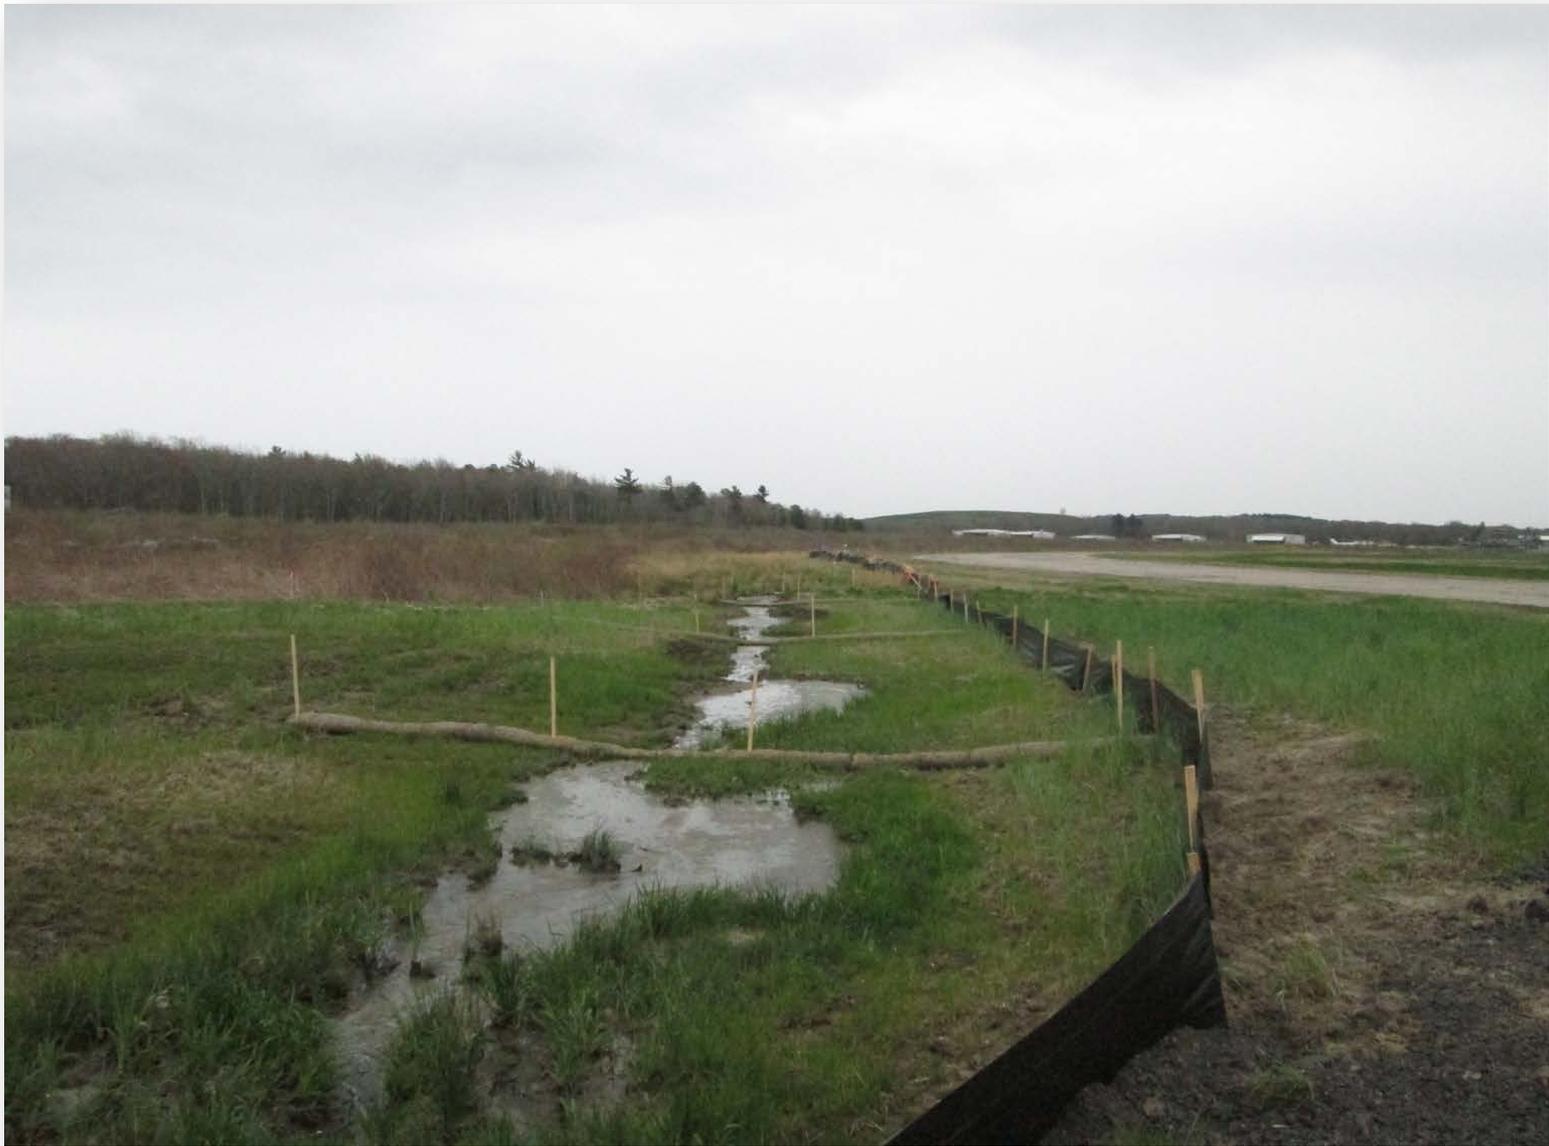
View of check dams installed in constructed storm water swale.

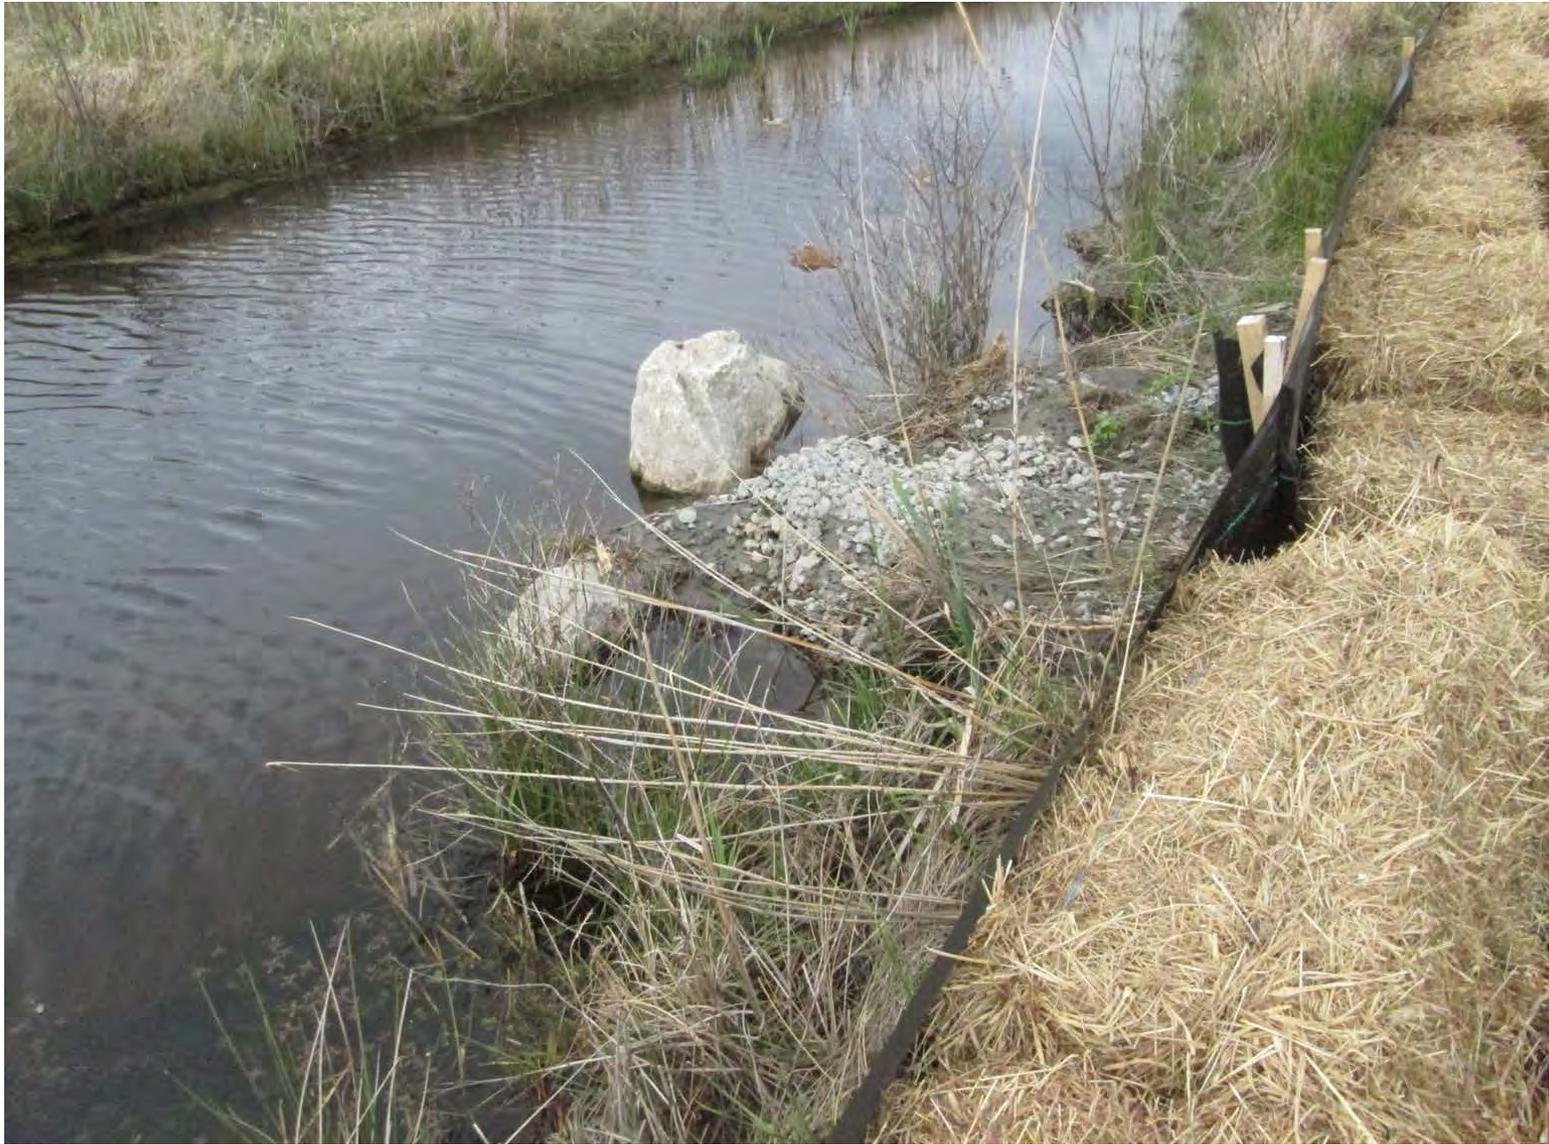
On 5/8/14 Epsilon reviewed the Runway 5 end RSA area with the IO, and the WS. Water levels in the West Ditch had substantially subsided since the previous week's inspection. Accumulated sediment was observed in three locations within the streambed of the West Ditch that was previously obscured by high water. We recommended that it be removed immediately and the WS adhered to this schedule. Based on the Friday 5/9/14 WS report, this material was removed from the West Ditch; one area yielded approximately 4 cubic feet of sediment and rock. Three other very small areas were accessed and sediment was removed from the West Ditch if noted. The EM reviewed and commented on the proposed restoration plan that was required as a result of the disturbance to the West Ditch. On Monday May 12, 2014 the EM approved the final restoration plan and this plan was forwarded to MassDEP. Epsilon flagged the shrubs that were impacted by disturbance for future reference and monitoring.

View of May 8, observed sediment and rocks within the West Ditch

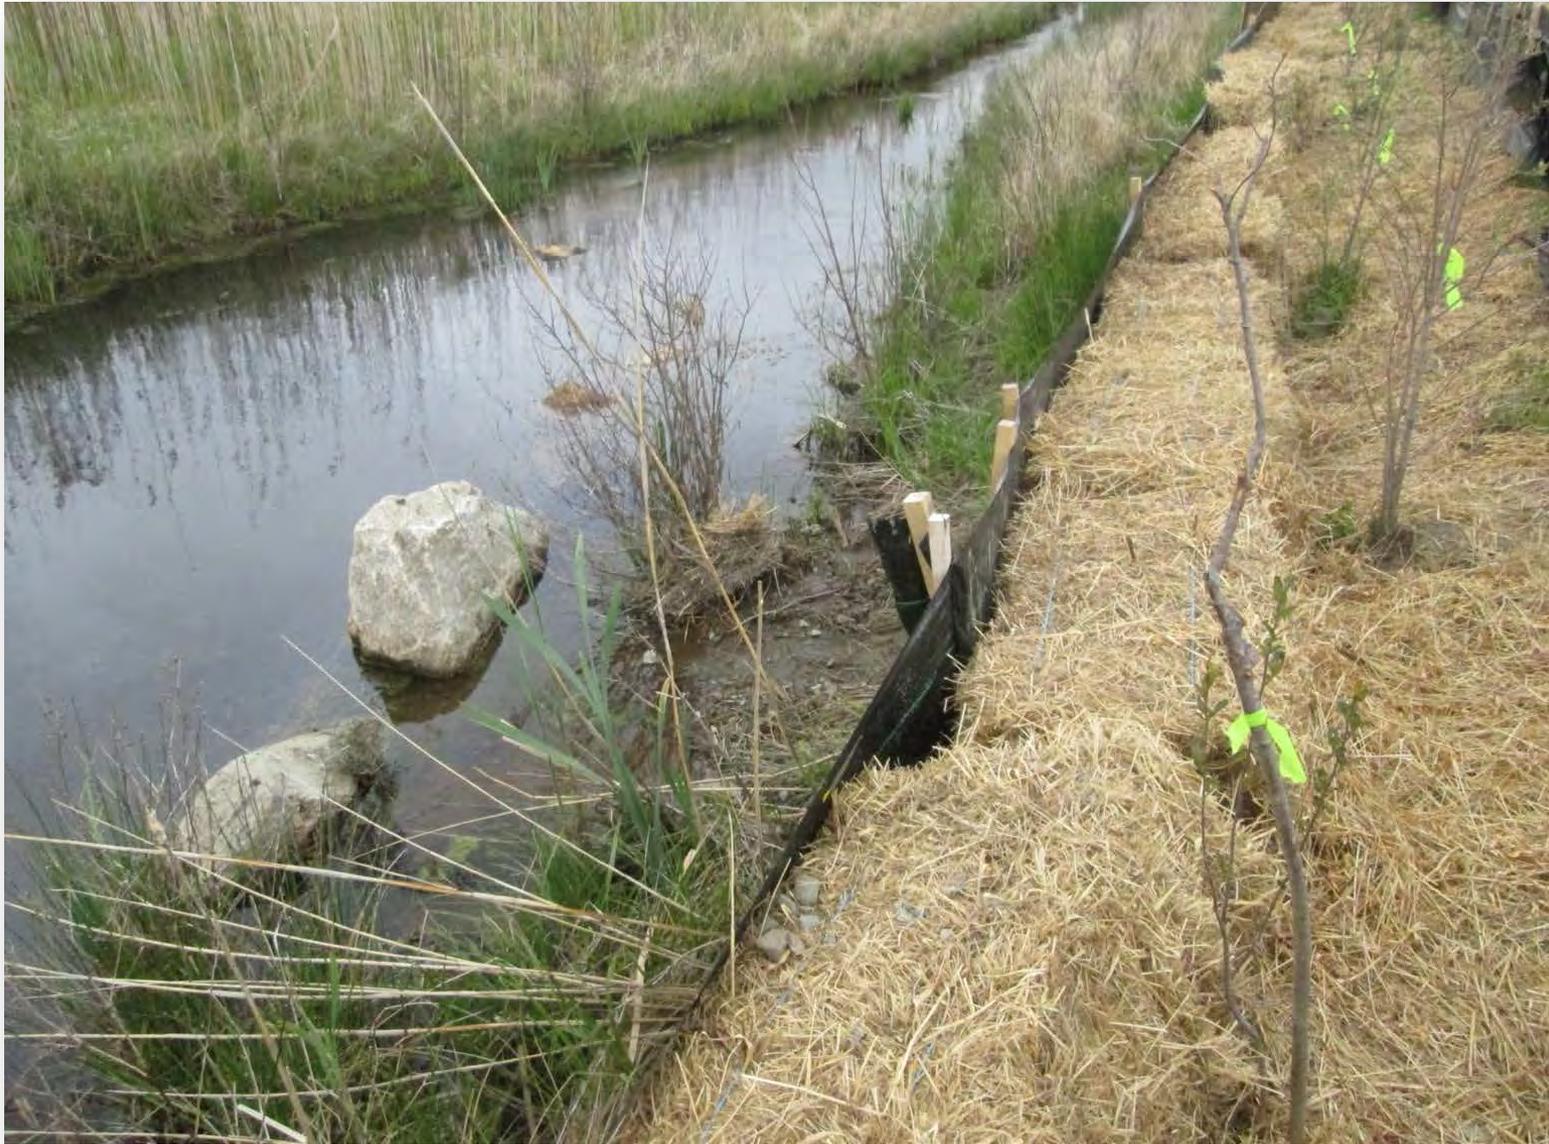
View of May 15, area where sediment and rocks were removed from West Ditch. The ground surface was reshaped and straw was placed in this area for stabilization. Approximately 4 CF of material were removed.

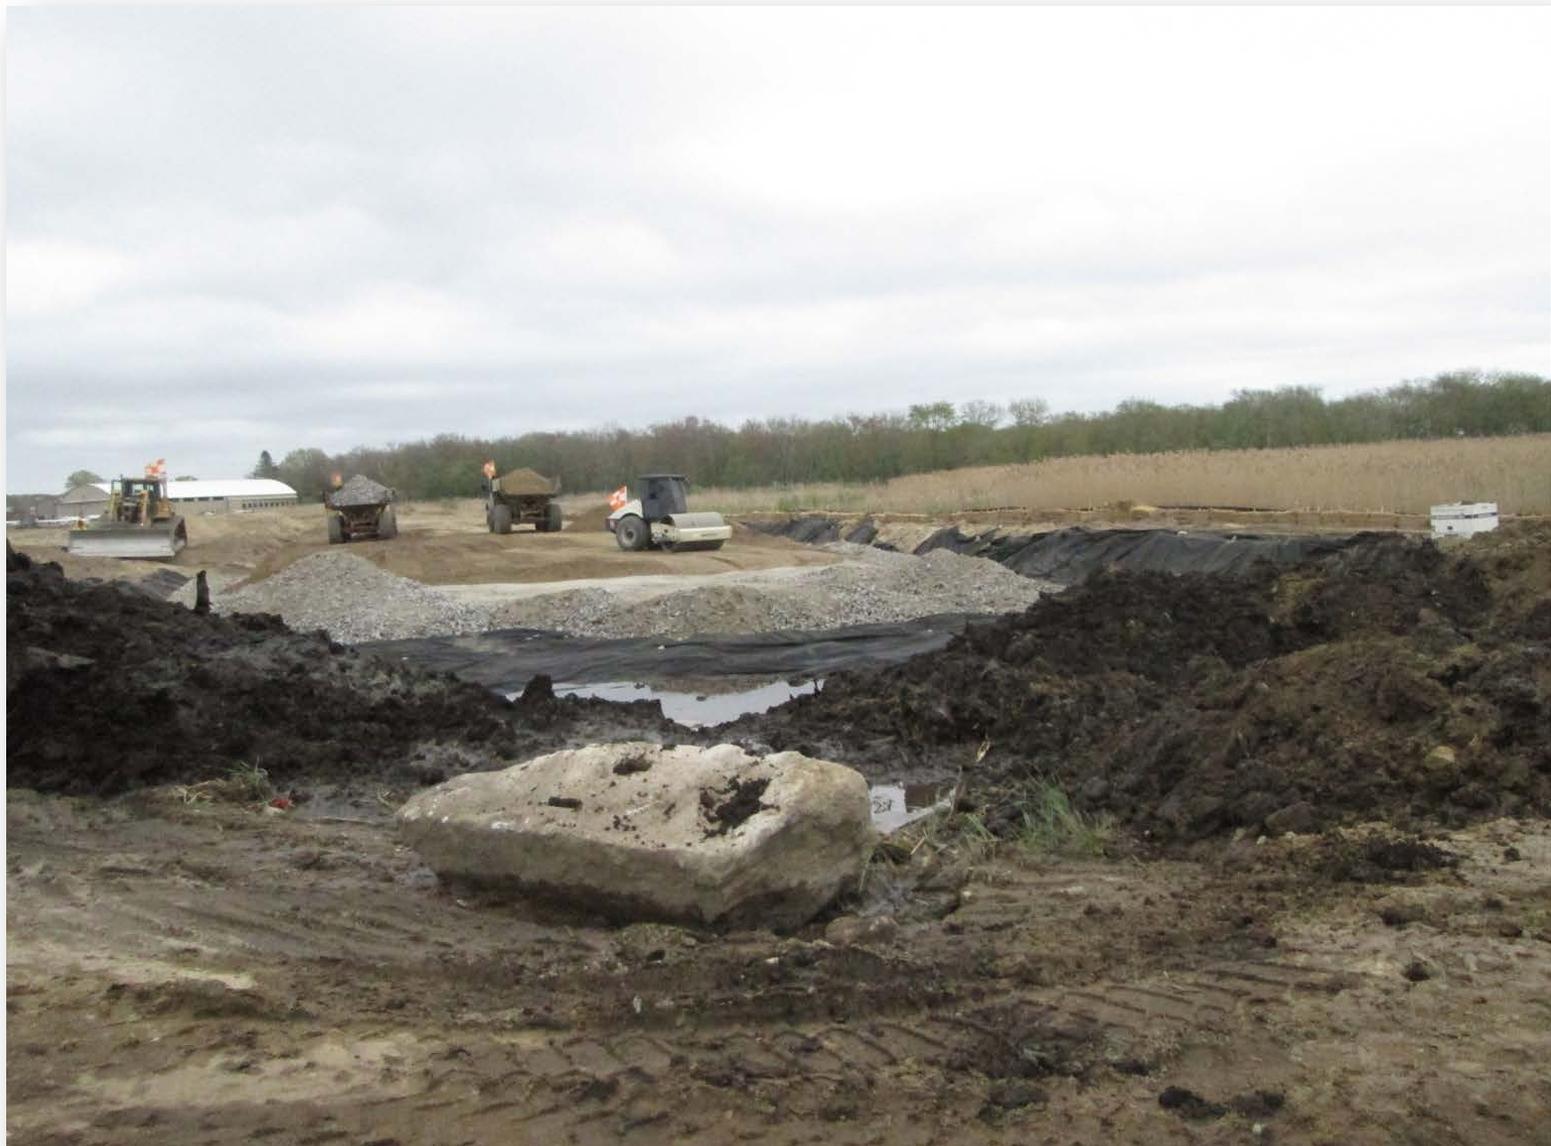
Dewatering	<input type="checkbox"/> yes <input checked="" type="checkbox"/> no <input type="checkbox"/> n/a	A small area of authorized wetland fill is located within the footprint of Taxiway A. This area was identified as “unsuitable material” during Phase 2 construction and was purposefully delayed until Phase 4 work. The underlying material was approximately 6-ft of muck with debris from the airfield overlaying mineral soil. The contractor is removing the muck layer down to the mineral layer. The dewatering trench is periodically dewatered utilizing a pump attached to a settling tank. Water from the settling tank is discharged to the exposed soil area in the middle of the Runway 5 RSA. Discharge is monitored to ensure that water does not seep into wetlands. No significant discharge has reached the hay bale/silt fence area.
Construction Equipment Storage and Refueling	<input type="checkbox"/> yes <input checked="" type="checkbox"/> no <input type="checkbox"/> n/a	Equipment storage is located within the designated lay down area. Refueling occurred outside of resource areas and buffer zones.

View of dewatering efforts and fill along the Taxiway A footprint (May 15, 2014).

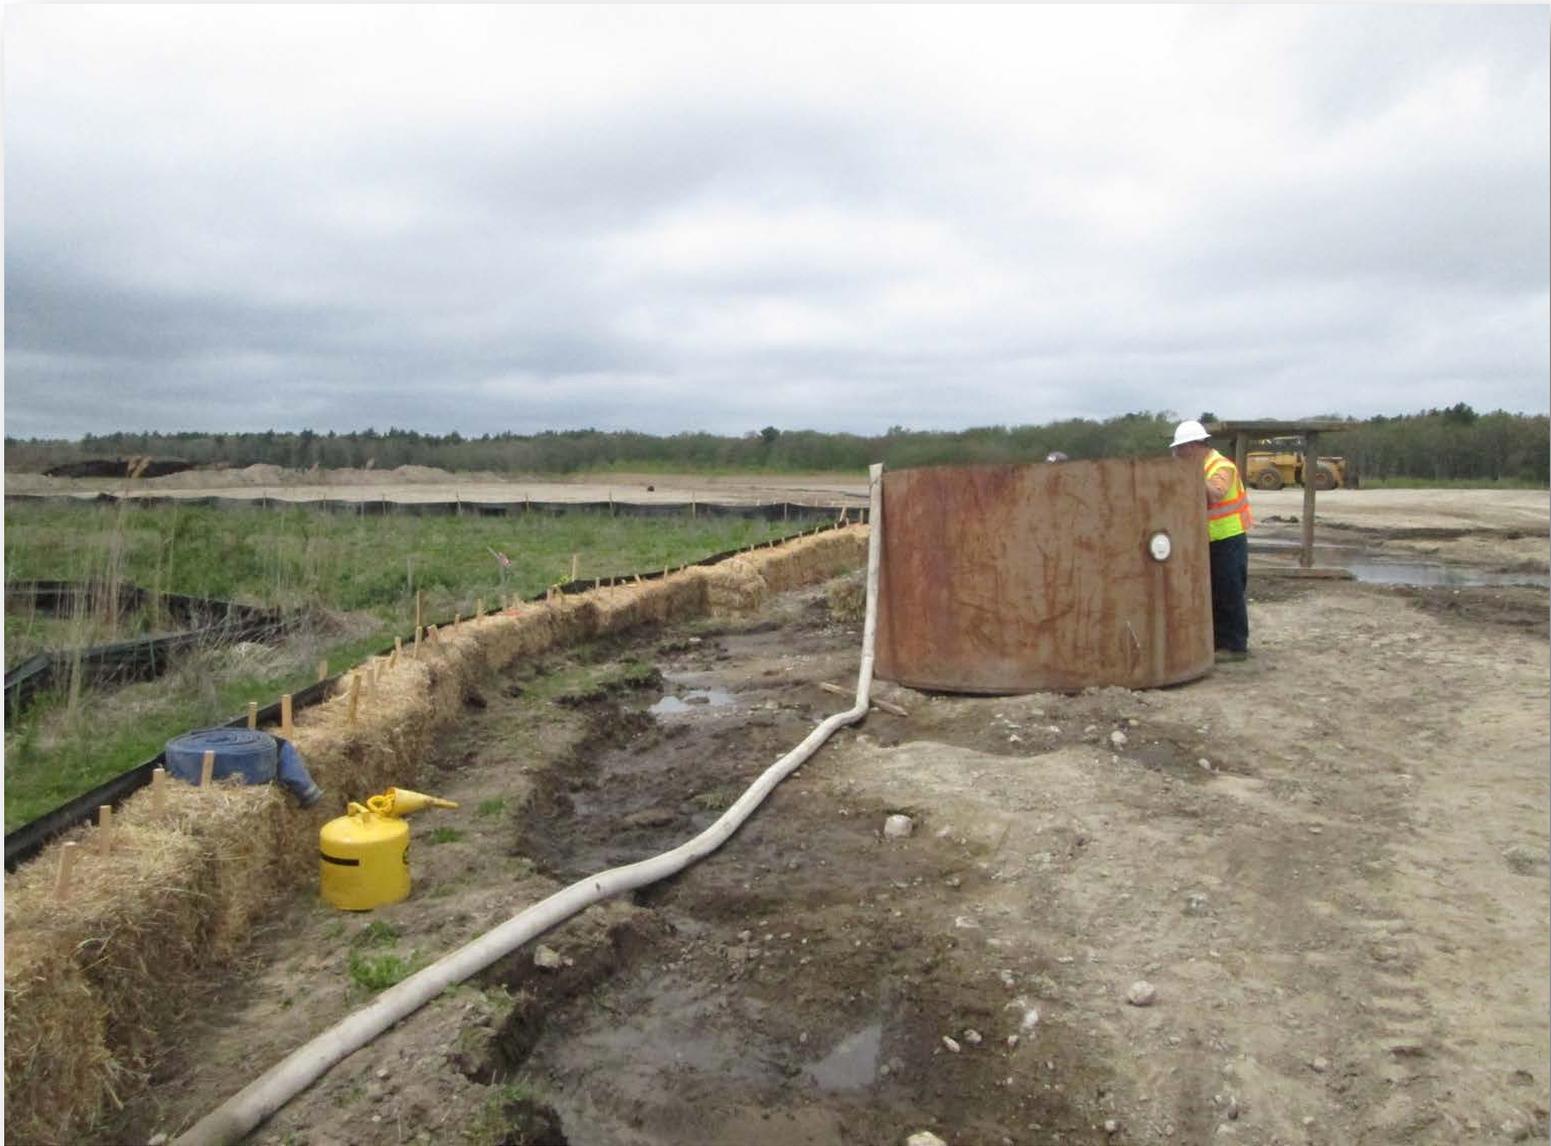
View of settling tank as part of dewatering efforts.

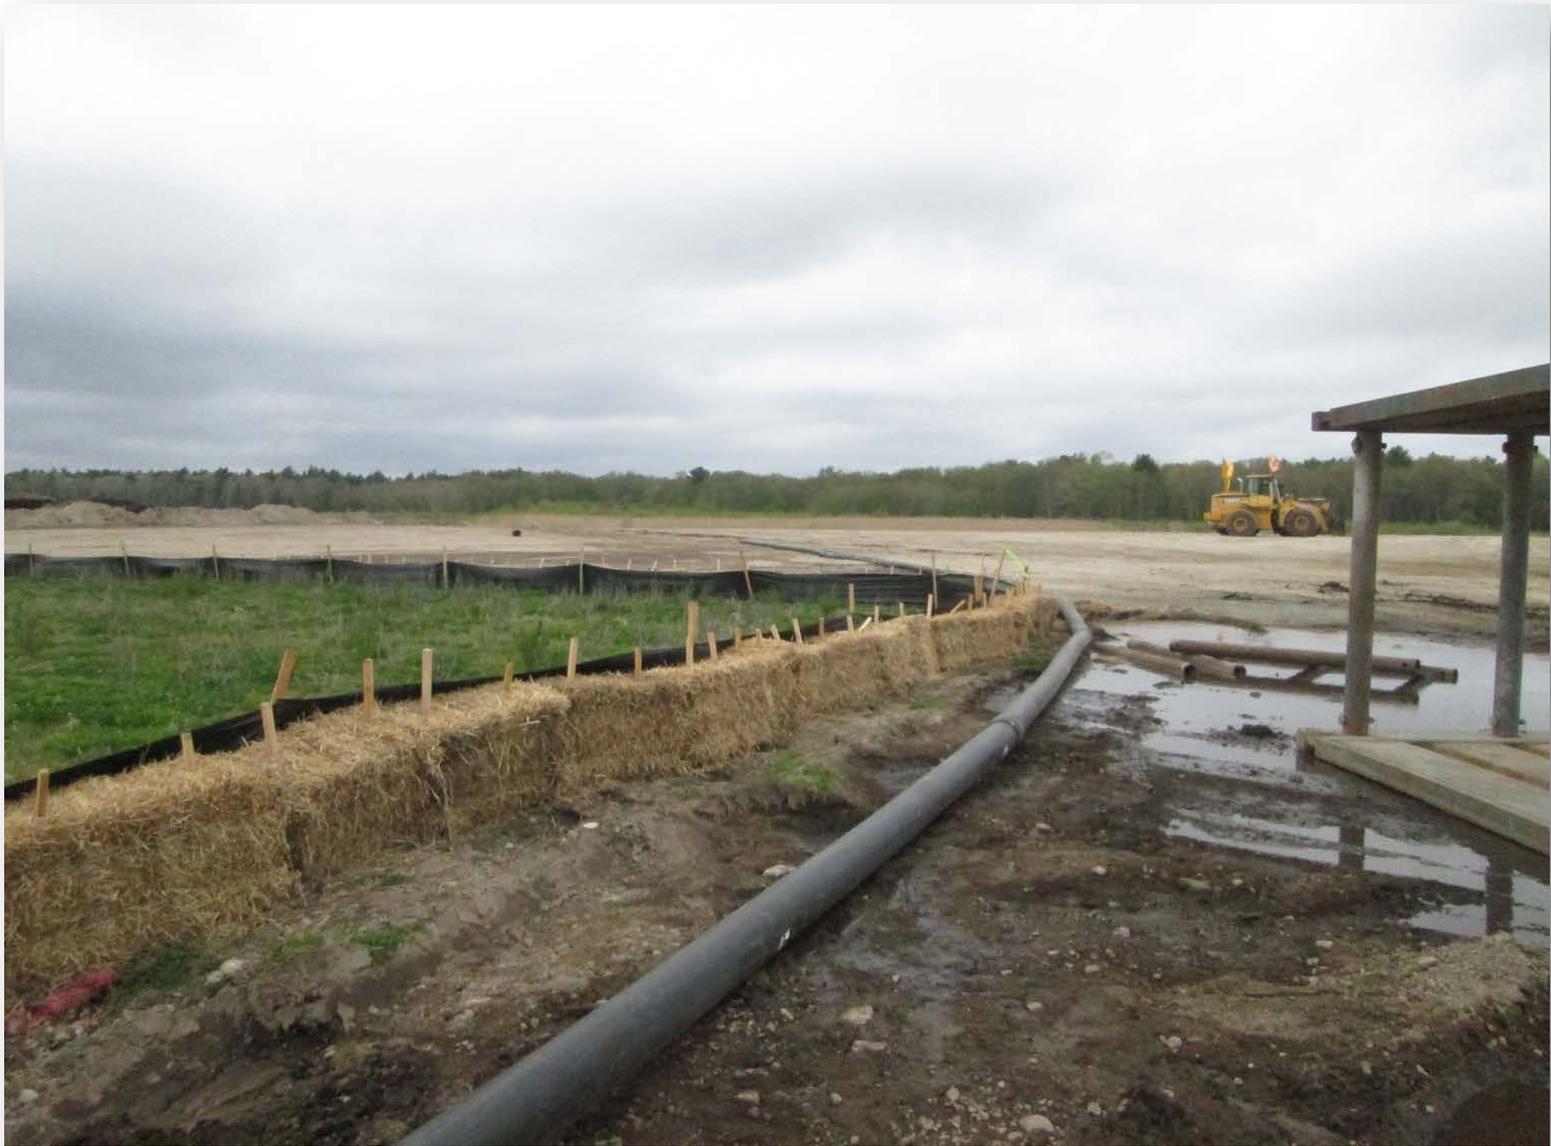
View of drainage pipe from settling tank transferring water to central part of the RSA area (Runway 5 end).

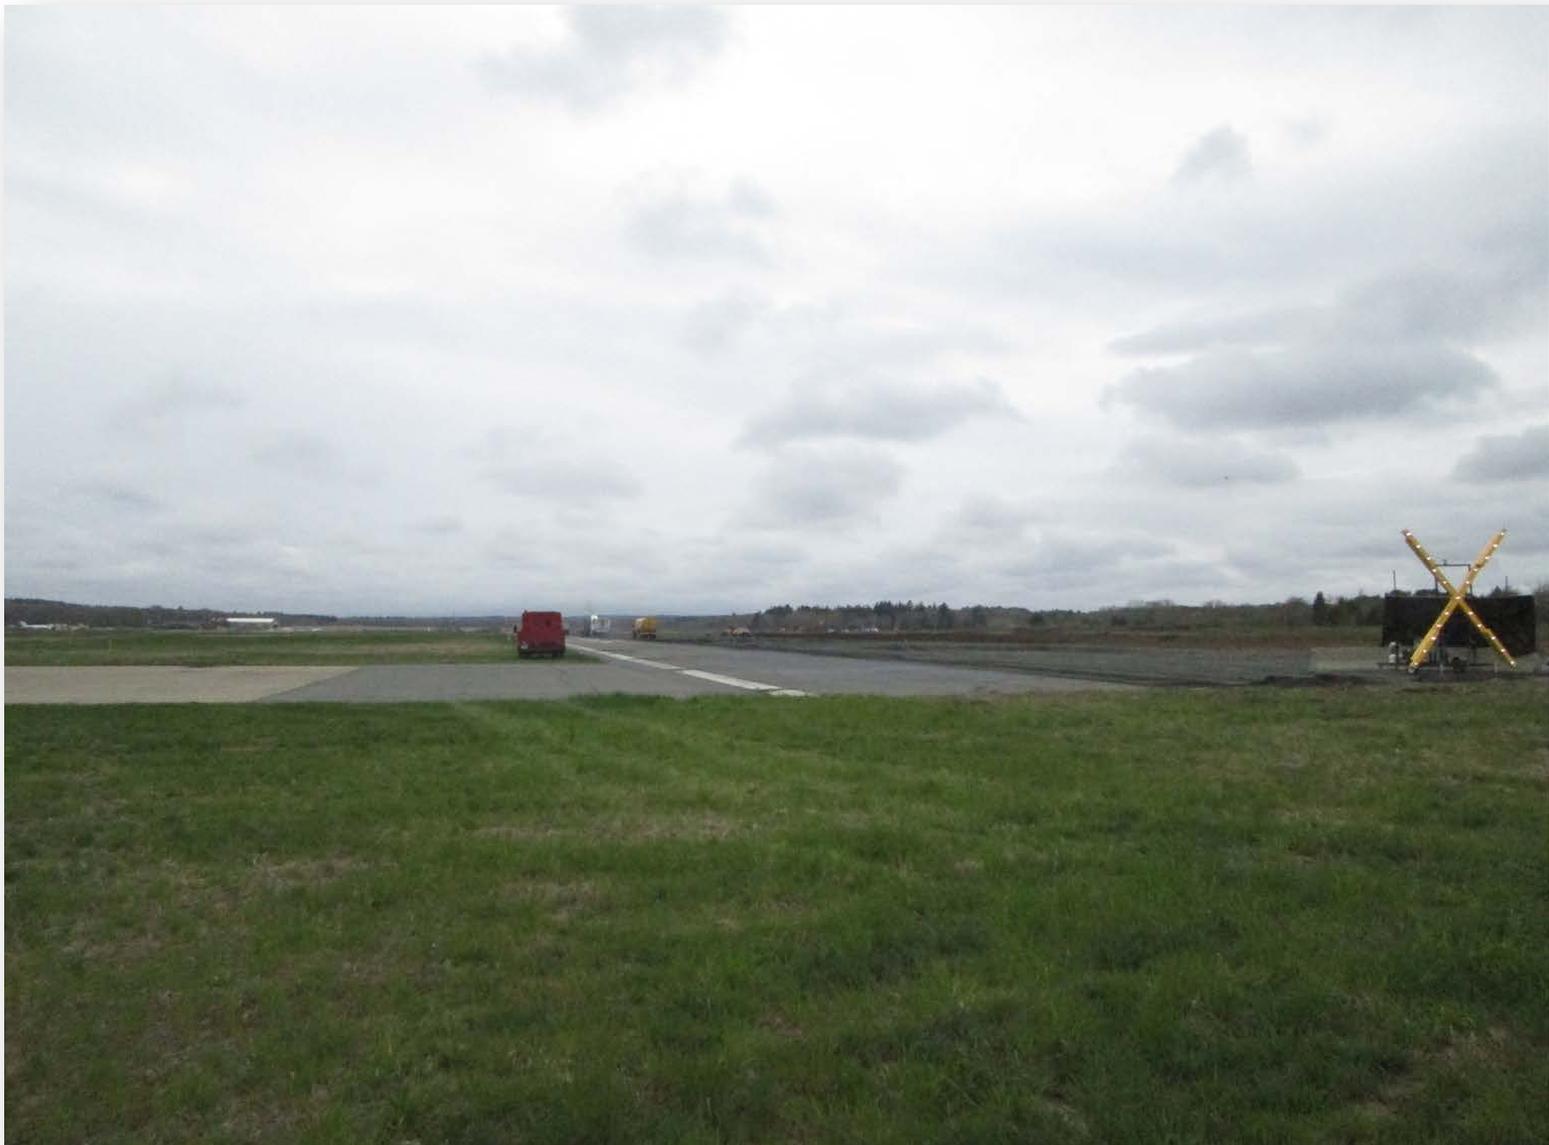
View of milling work from the Runway 23 end.

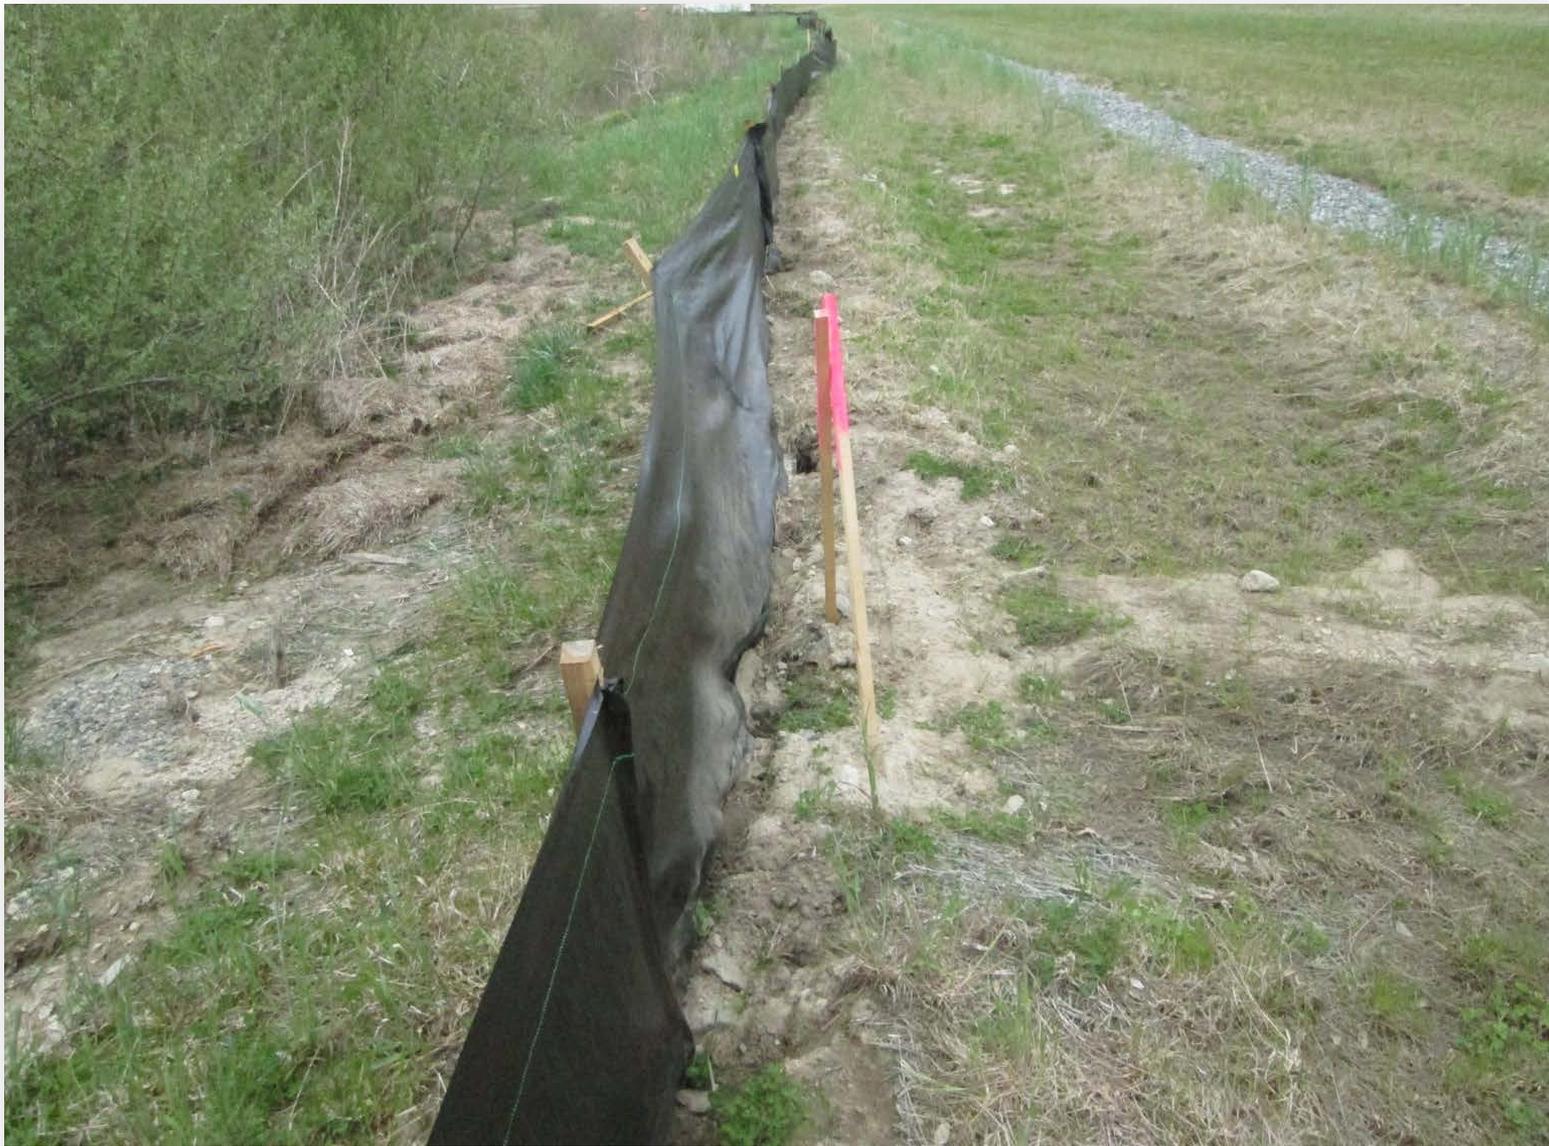
Epsilon recommended that the silt fence be relocated at the top of the slope by the wetland resource and observed an area by the RSA 23 end where the silt fence failed and needed to be mended. Further, the Turtle Ecologist recommended a change in silt fence location mentioned previously in the table above.

View of silt fence where sediment breach occurred at the northern end of the 23 RSA.

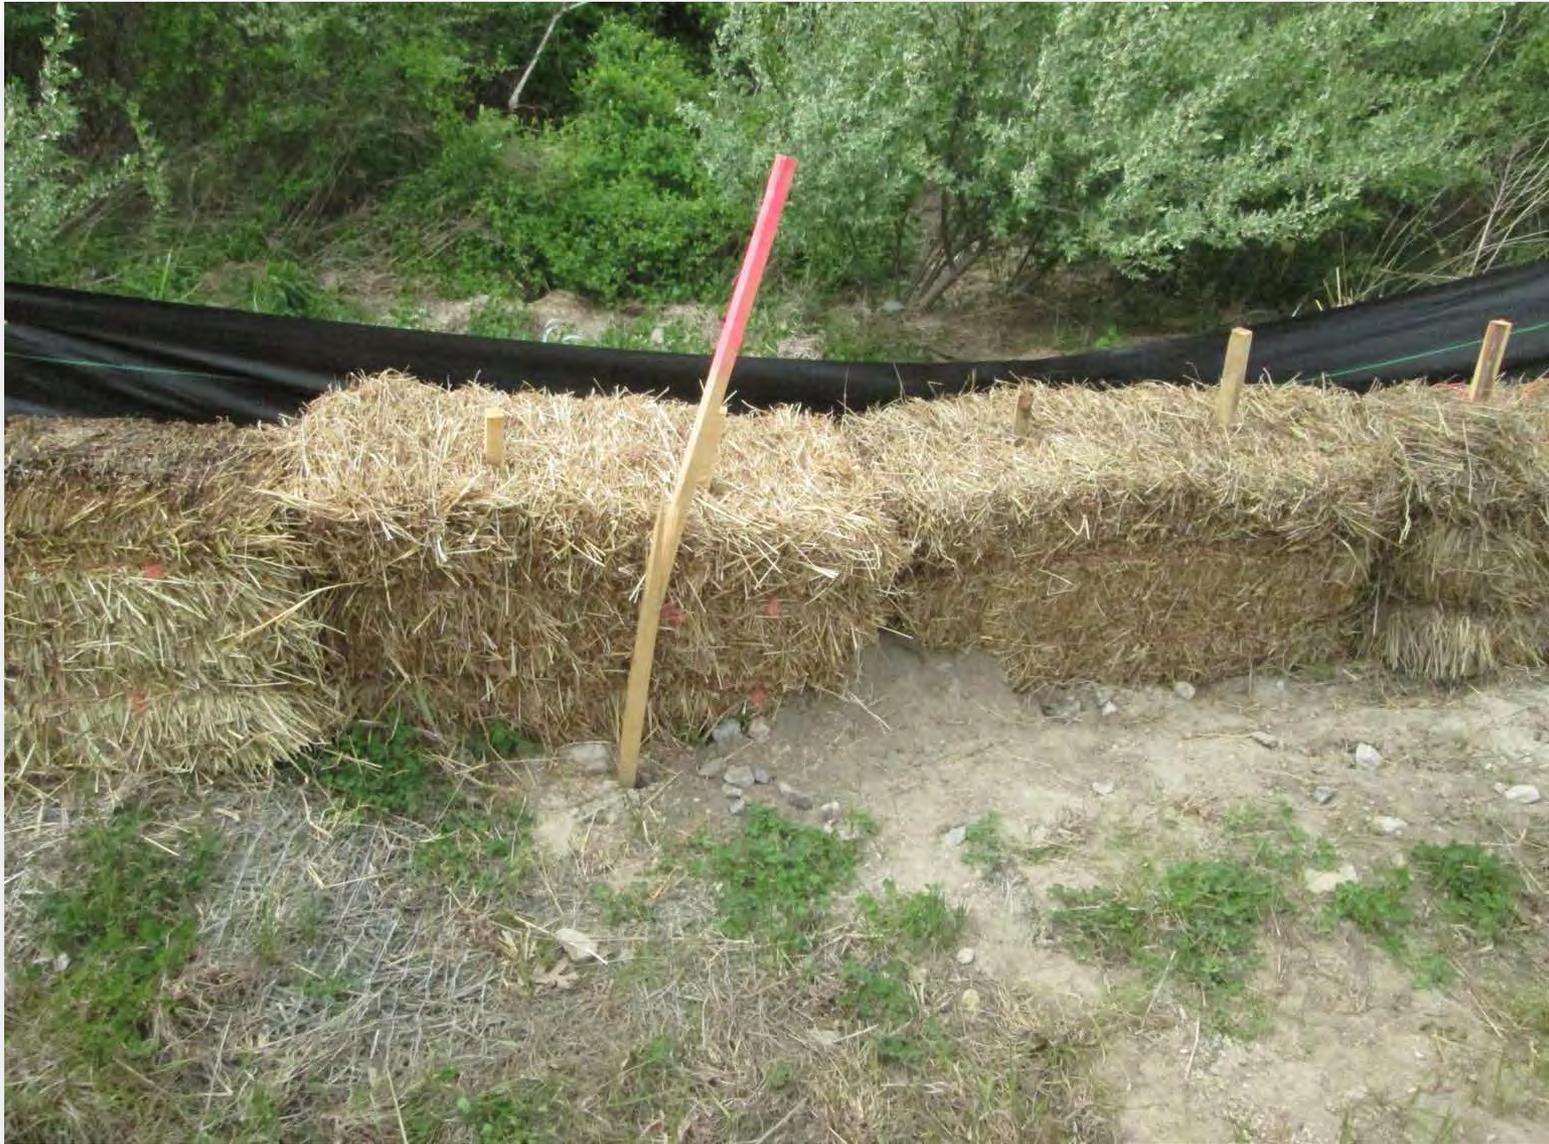
View of 23 end blow out area from May 8, view of repairs and hay bale placement as of May 15.

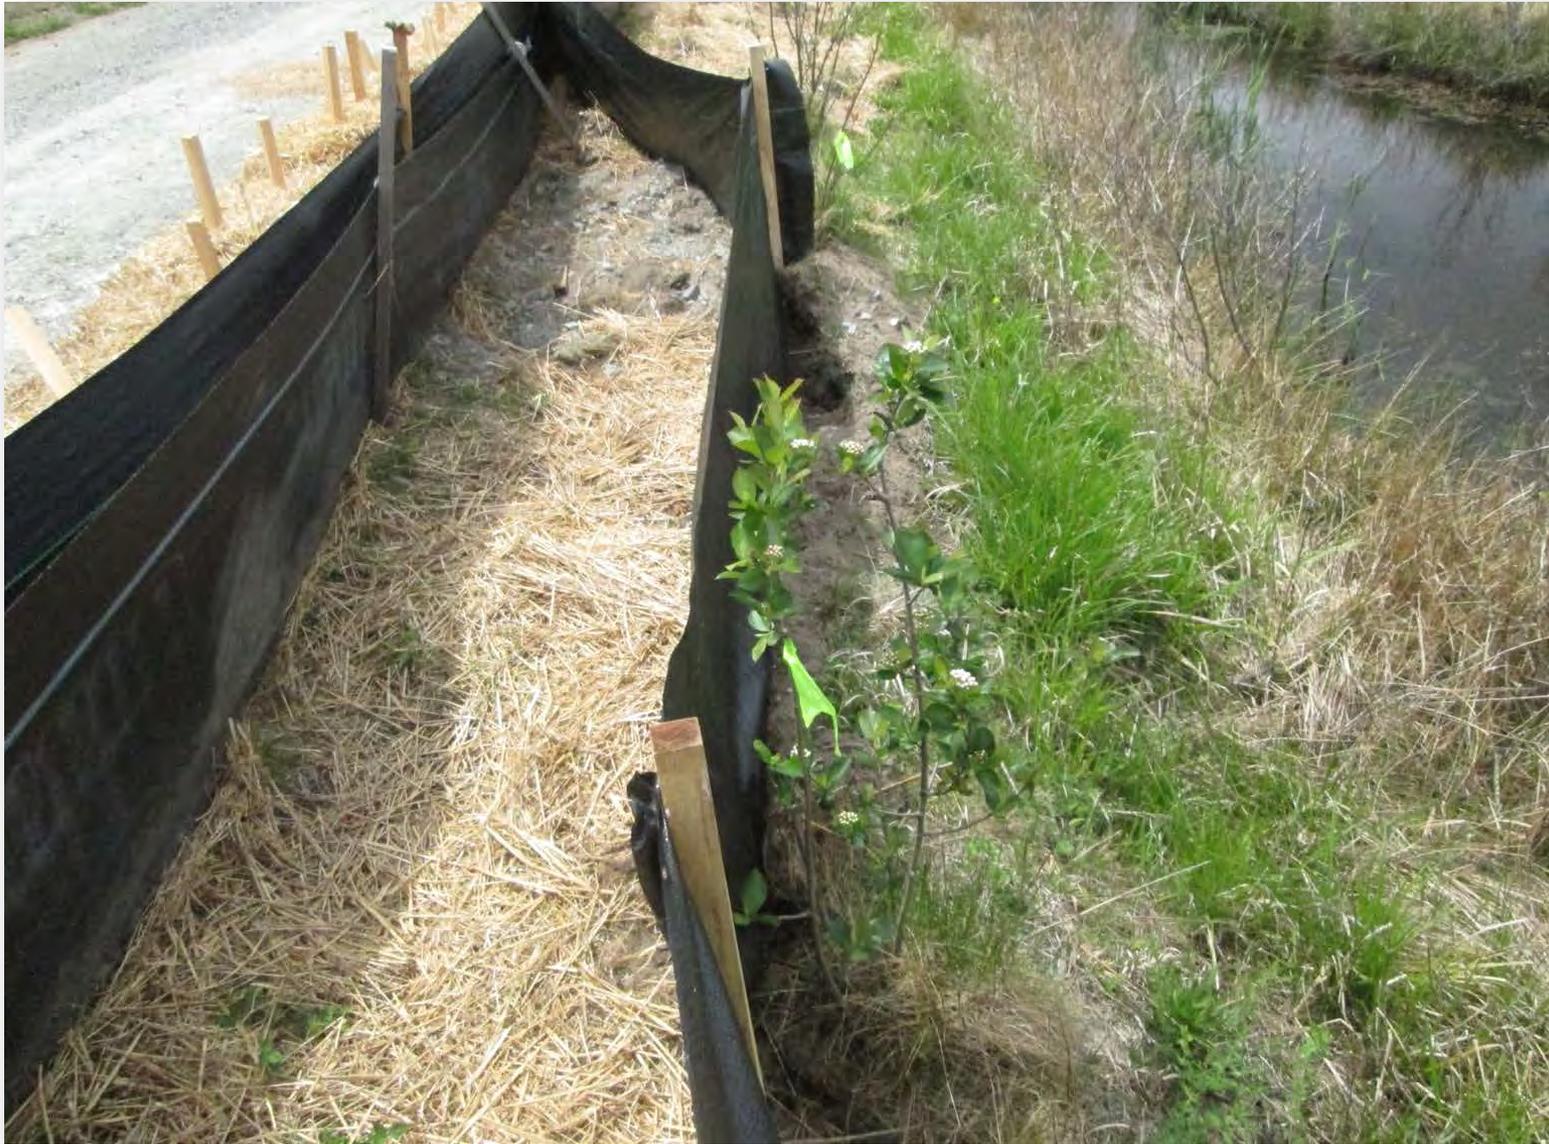
View of exposed sediment on the down gradient side of the silt fence. Recommended mulching in this area.
