**New Bedford Regional Airport
Runway Safety Improvements Project – Phase 4
Reconstruct, Mark, and Groove Runway 5-23
MassDEP File No. SE049-0635**

ENVIRONMENTAL MONITOR INSPECTION FORM

Environmental Monitor: **Amanda Atwell** Date/ Time of Inspections: **5/8/14 (10am to 5pm), 5/15/14 (10am-3pm)**

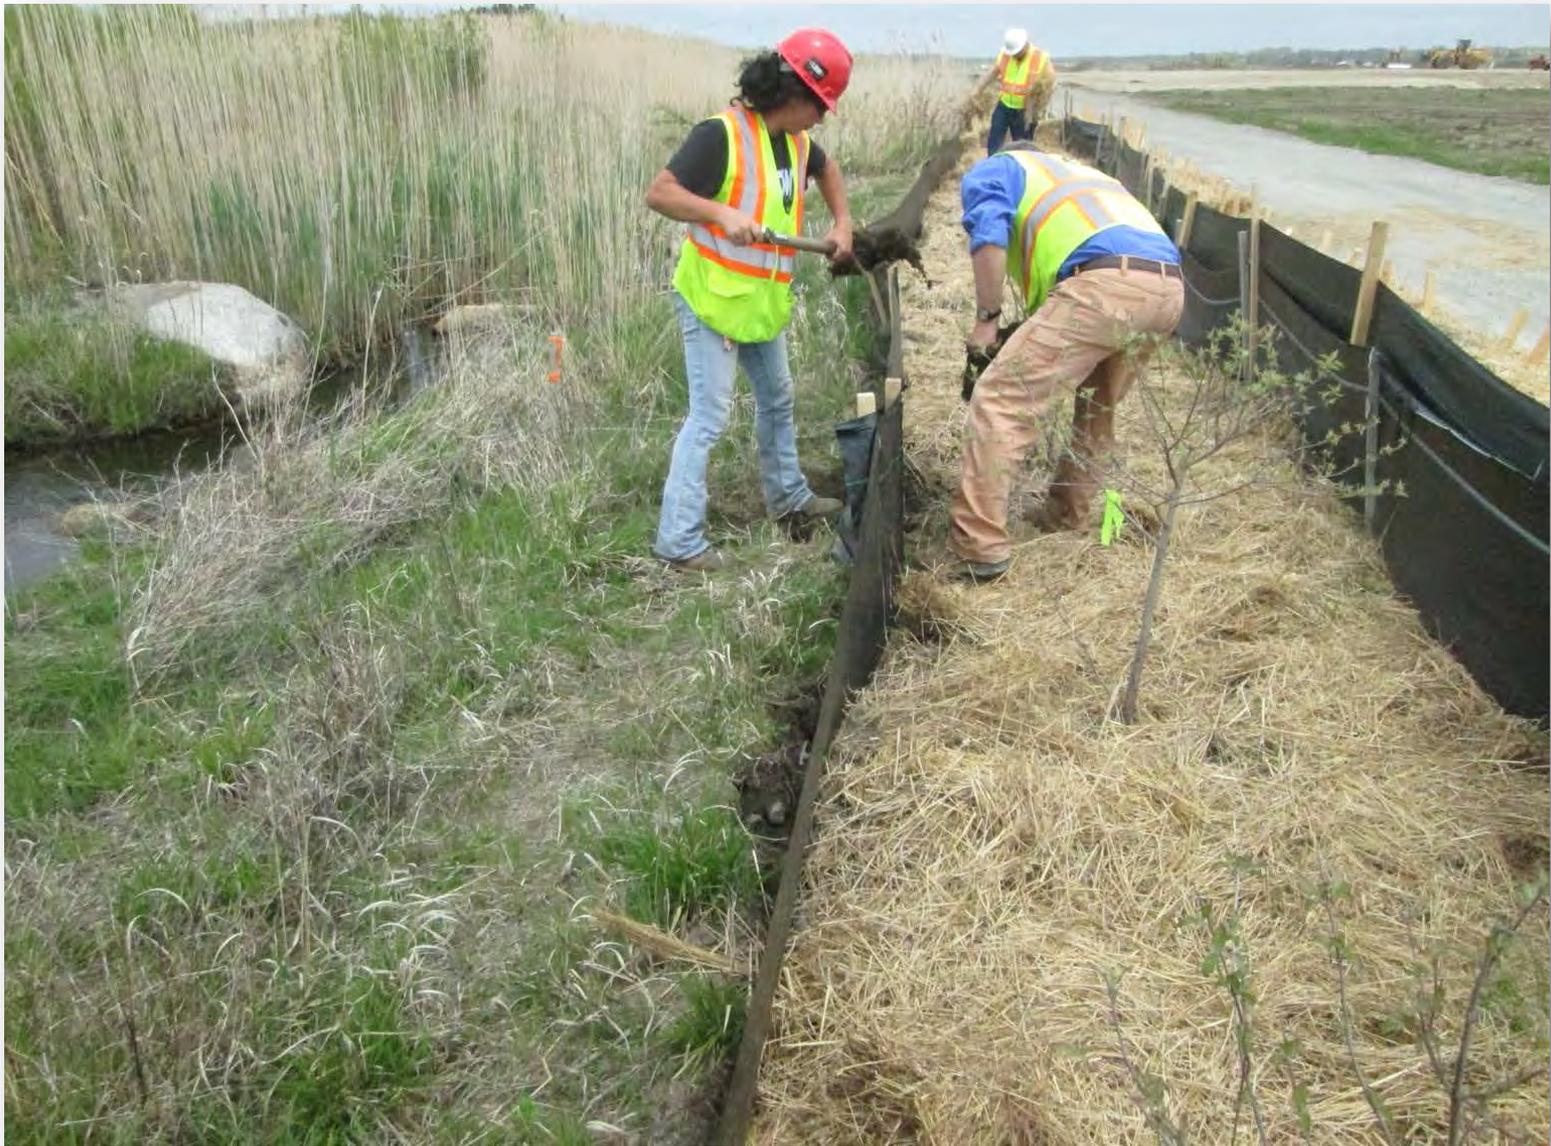
View of patching an area of silt fence that was found to not be tailed in properly. The WS and contractor immediately addressed as soon as it was documented.

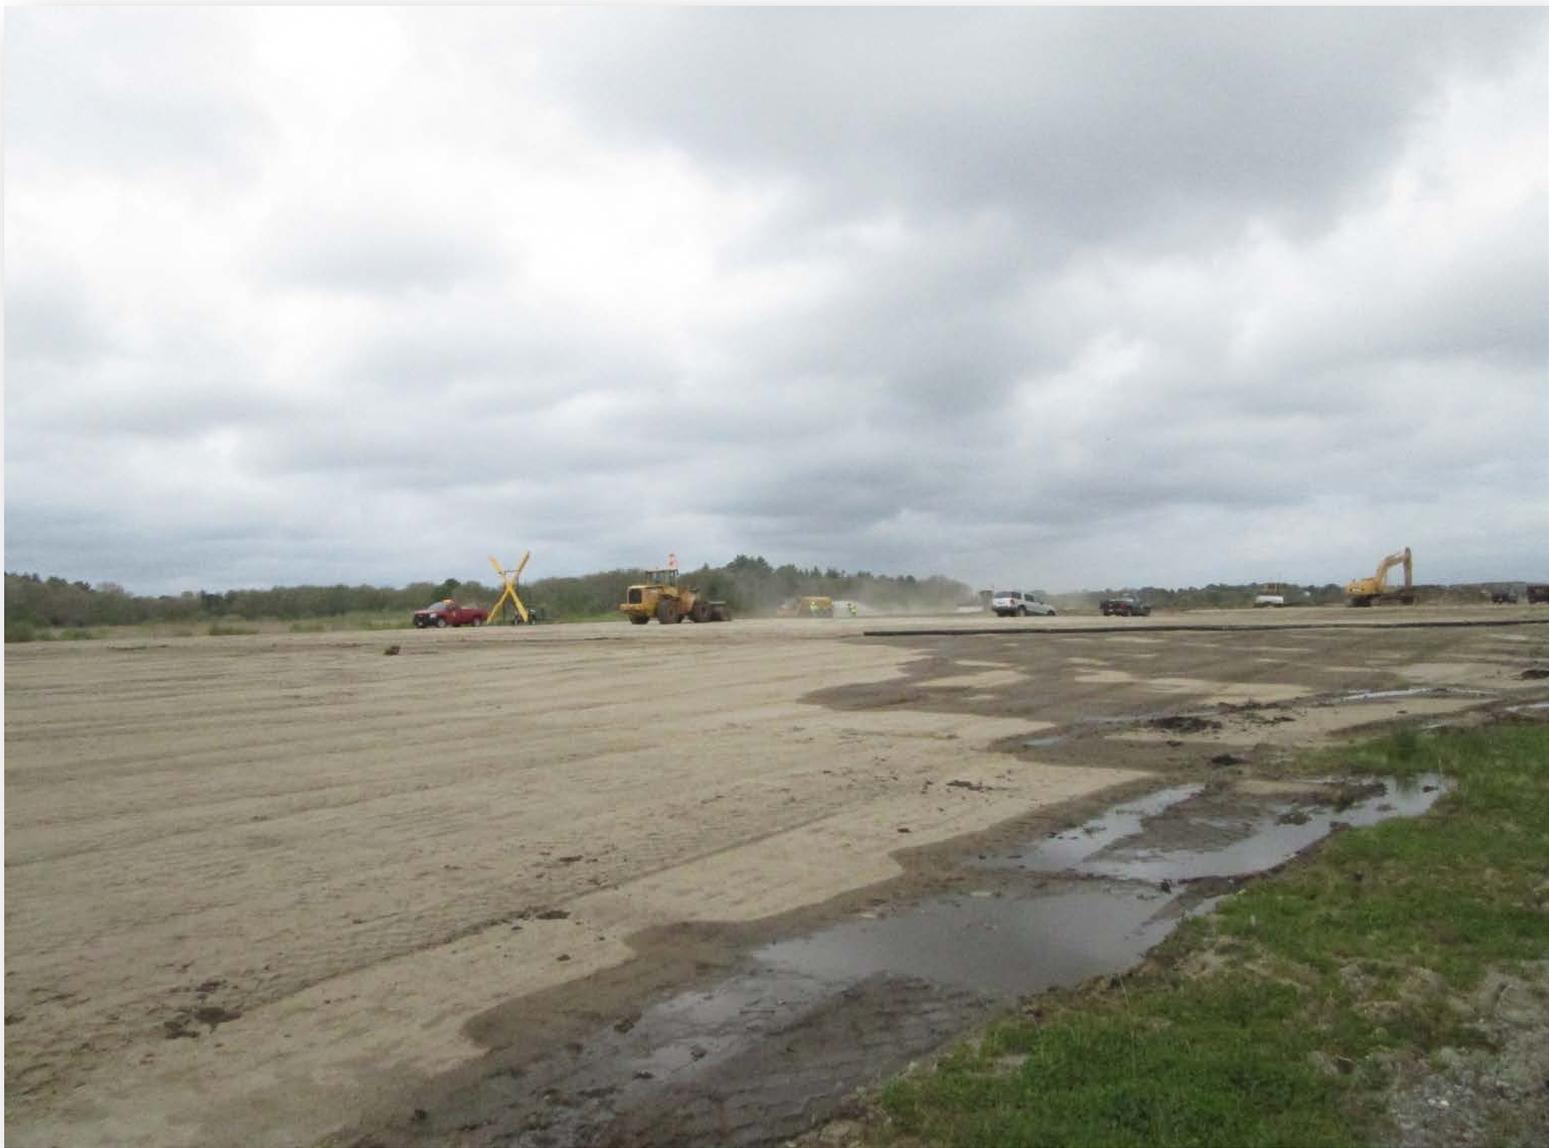
View of water truck watering exposed sediment on the runway on May 15, 2014.
