NEW BEDFORD REGIONAL AIRPORT
RUNWAY 5-23 – PHASE 4

Reconstruct, Mark and Grove

Weekly Environmental Report

WEEK 3

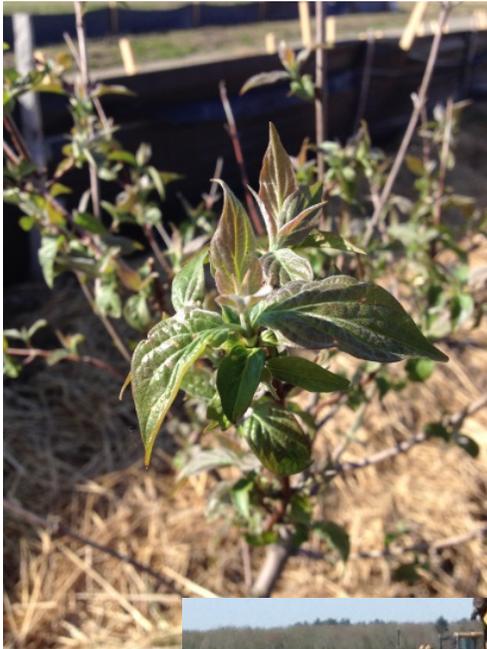
1. Shrubs along the West Ditch bank stabilization area that were affected by silt fence installation last month were thoroughly inspected. Dead shoots and broken limbs were trimmed to above the closest bud. Of the 55 affected shrubs, 53 showed good signs of growth. Two were determined to be dead, one of which was likely dead before the disturbance took place. Fourteen of the 53 shrubs showed a higher degree of stress and were just beginning to bud. The shrubs will be monitored on a regular basis until they become established.

Photo 1: Shrubs on slope adjacent to the west ditch were inspected and dead and damaged branches were removed.

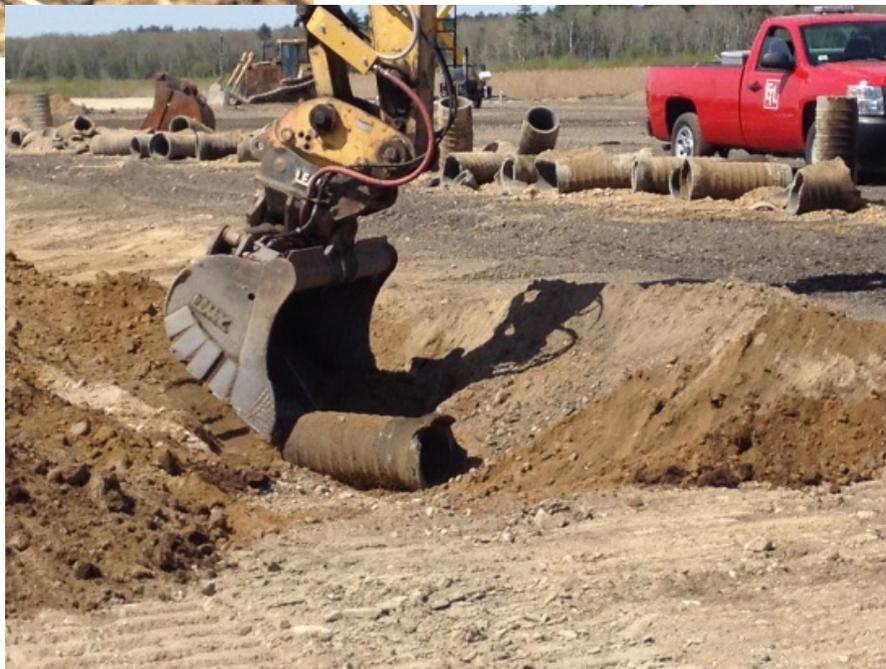
Photo 2: below – old concrete pipe drainage was removed along runway 5 through the entire week.

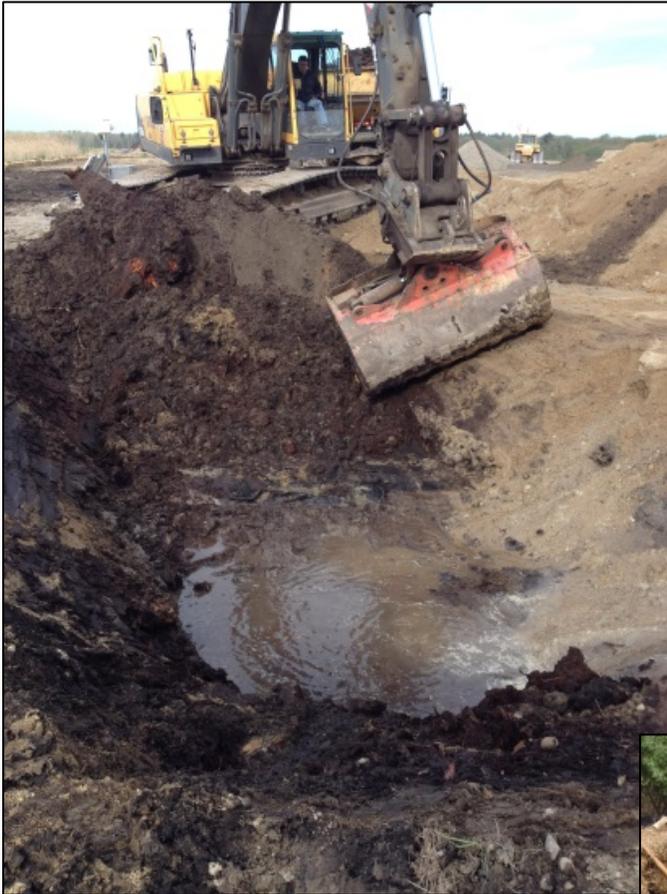
Photo 3: (left) View of excavation of unsuitable materials on new Taxiway A area of 5 End. Dewatering to a stilling basin and discharge to uplands occurred as needed.

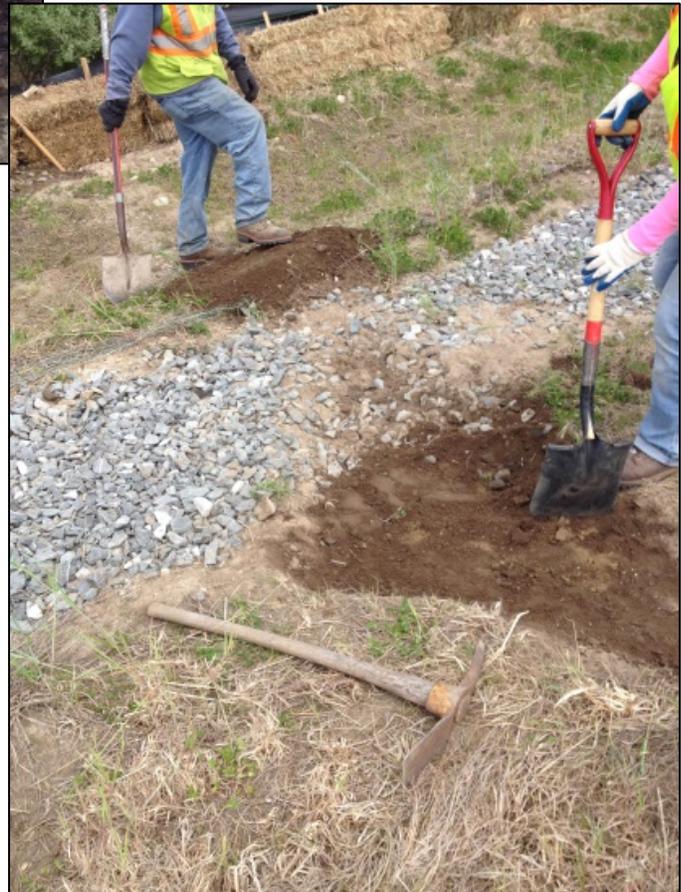
4. An issue that caused a silt fence breach identified in last week's report was addressed. An old silt fence scar across the end of Runway 23 appears to be acting as a channel for runoff, which overwhelmed the old infiltration trench. The breach in both the silt fence and the infiltration trench wall were repaired.

Photo 4 (below): View of repaired silt fence with hay bales added on 23 End RSA. This area received concentrated flow from above with velocities sufficient to bypass infiltration trench in foreground. Back berm of infiltration trench repaired by hand.

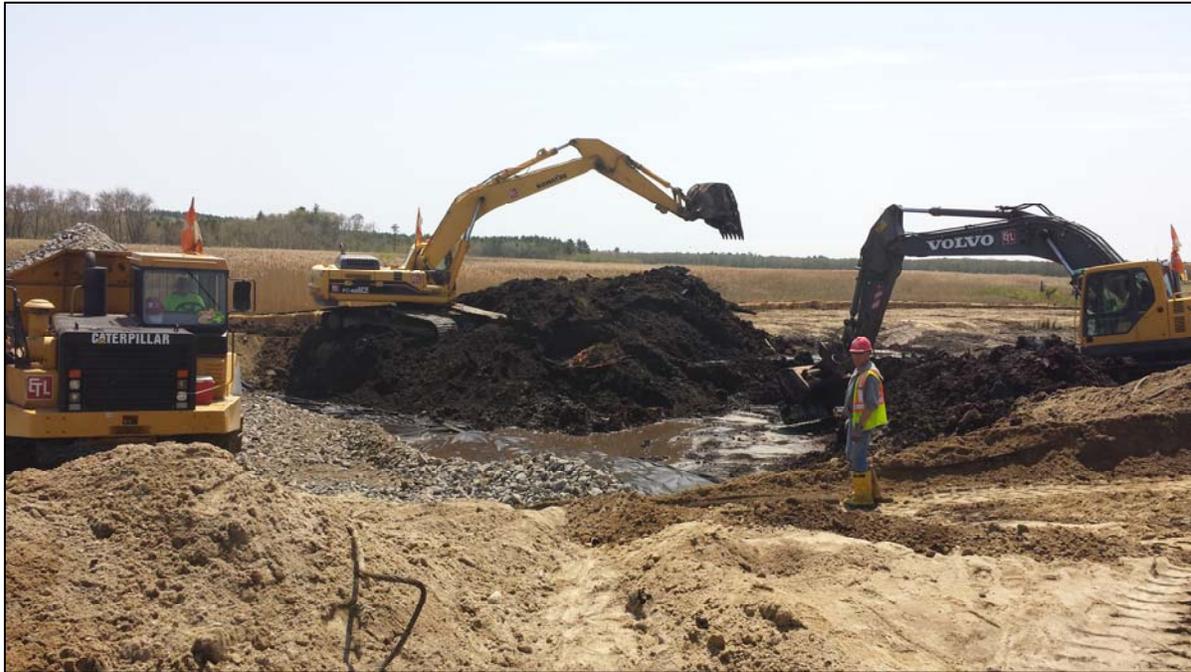
Photo 5 – View of excavation of unsuitable material. Once depth is reached, geo-textile fabric is installed and 3 feet of 6” minus stone is placed in excavation.

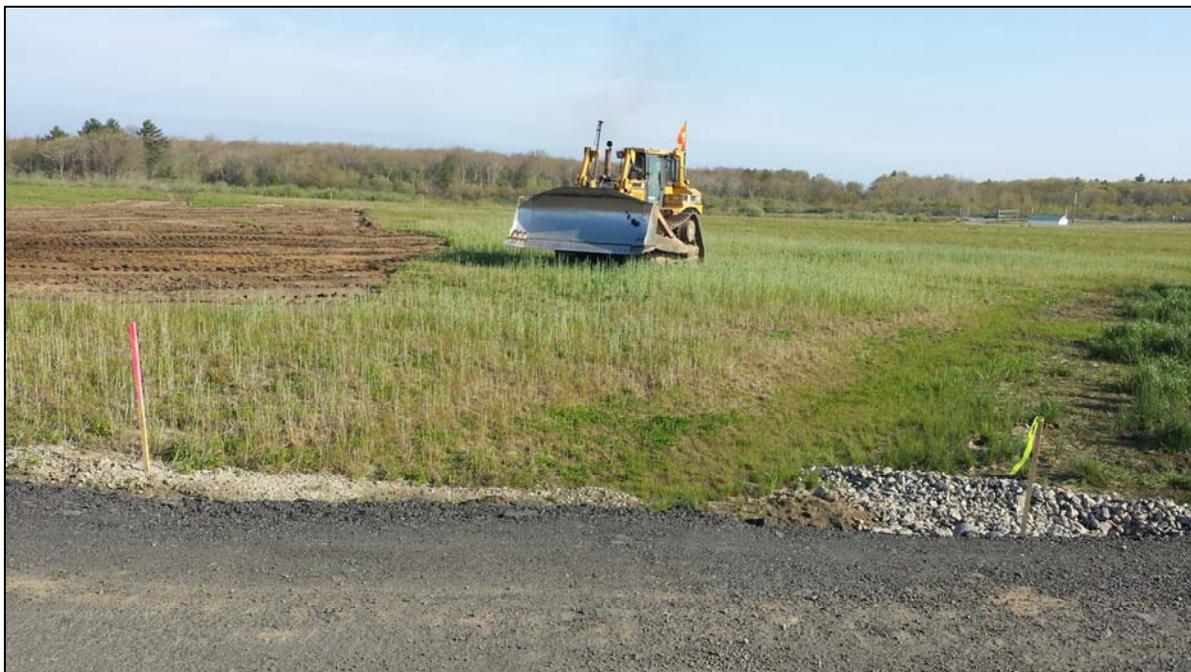
Photo 6 – Stripping loam at 23 End of runway. Infiltration swale is at right of photo.

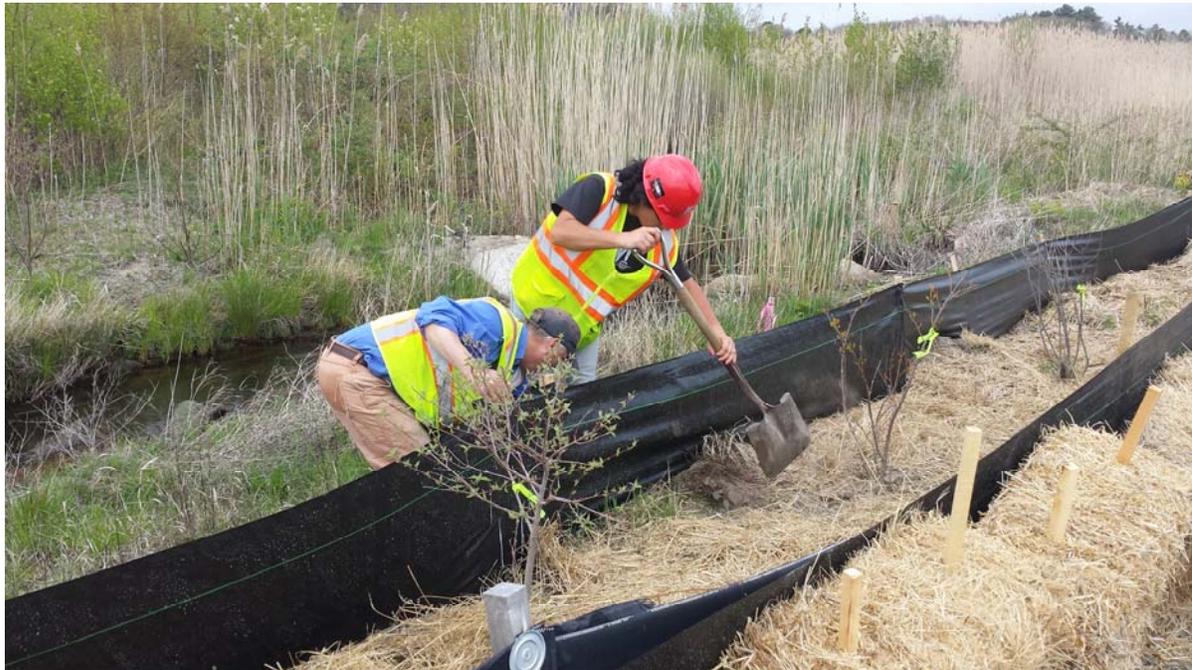
Photo 7 - During weekly site tour, GZA identified a short section of improperly toed silt fence along west ditch. No evidence of a breach at this location. Section was immediately repaired.

9. Repaired small breach in silt fence identified by GZA along access road silt fence.

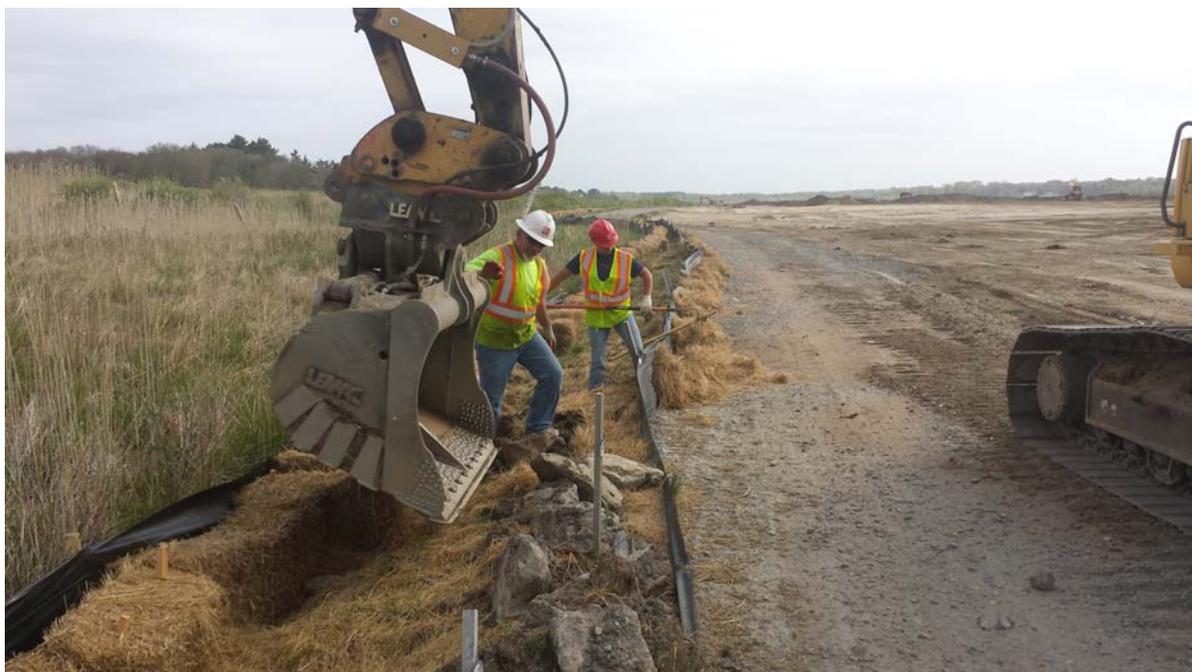
Photo 8 – Removal of rocks along access road slope

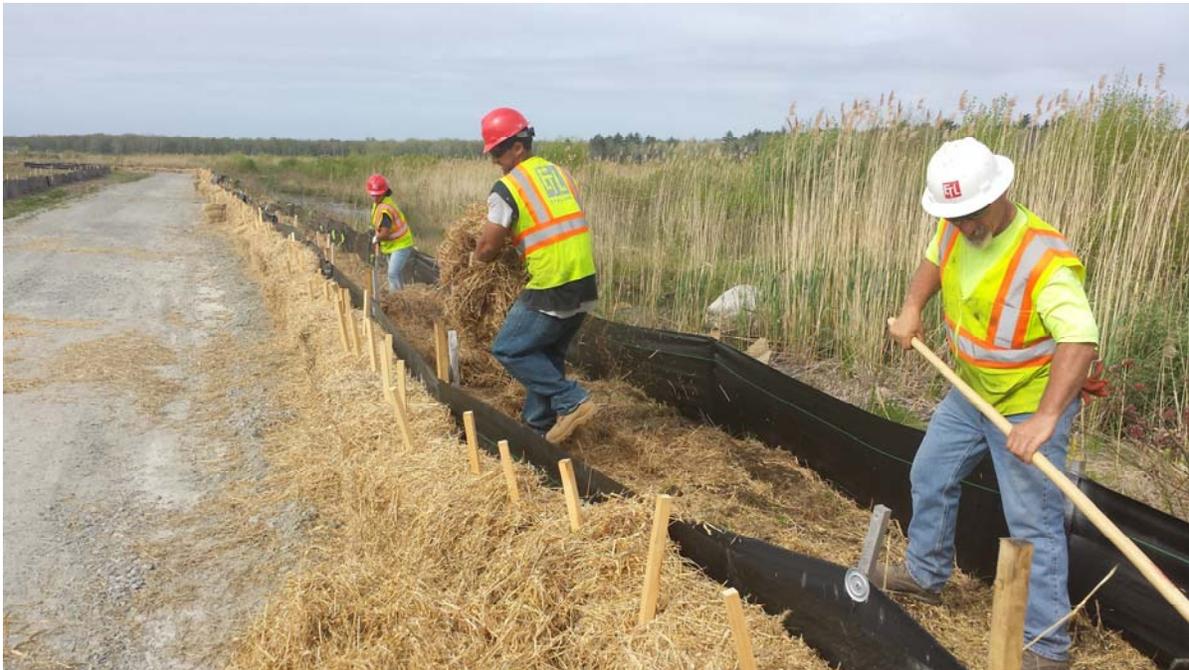
Photo 9 – Removal of existing hay mulch in preparation of seeding and smoothing.

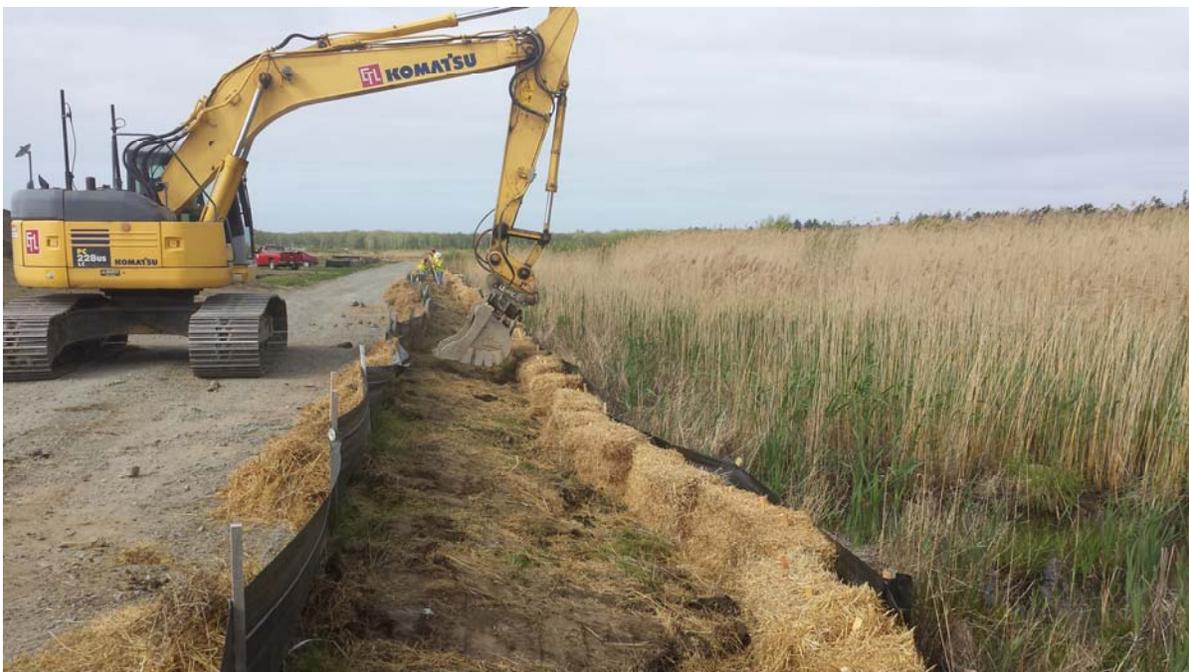
Photo 10: Smoothing of slope with flat part of bucket, used as needed with continuous monitoring.

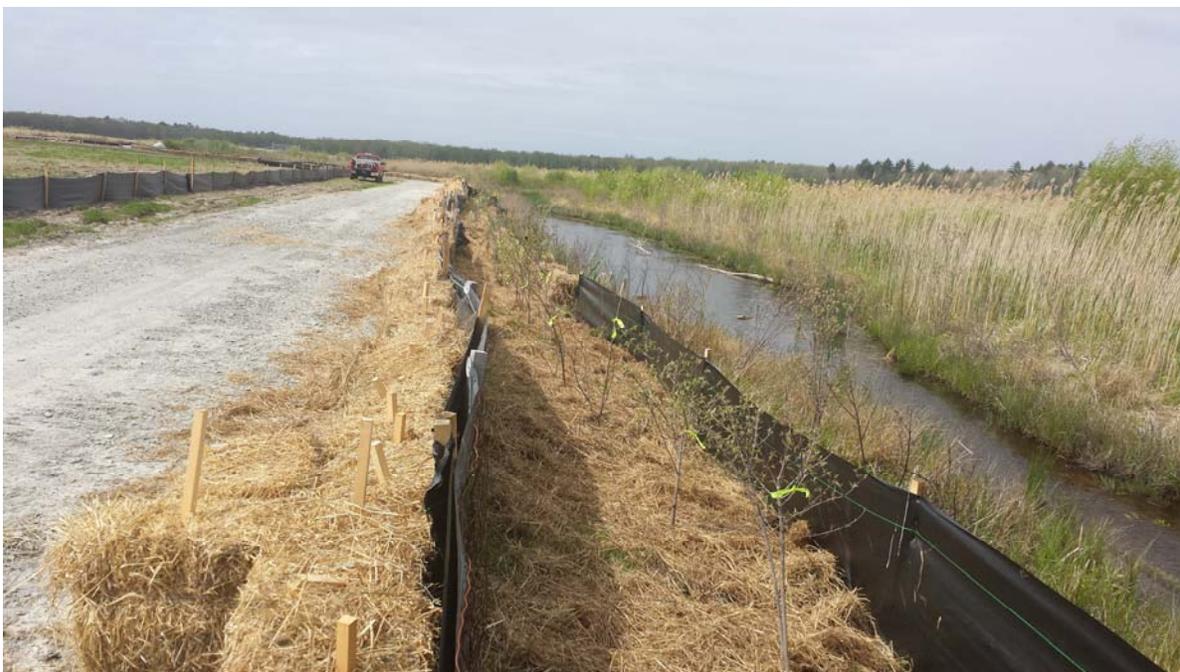
Photo 11 – View of restoration area after seeding and hay mulch reapplied.

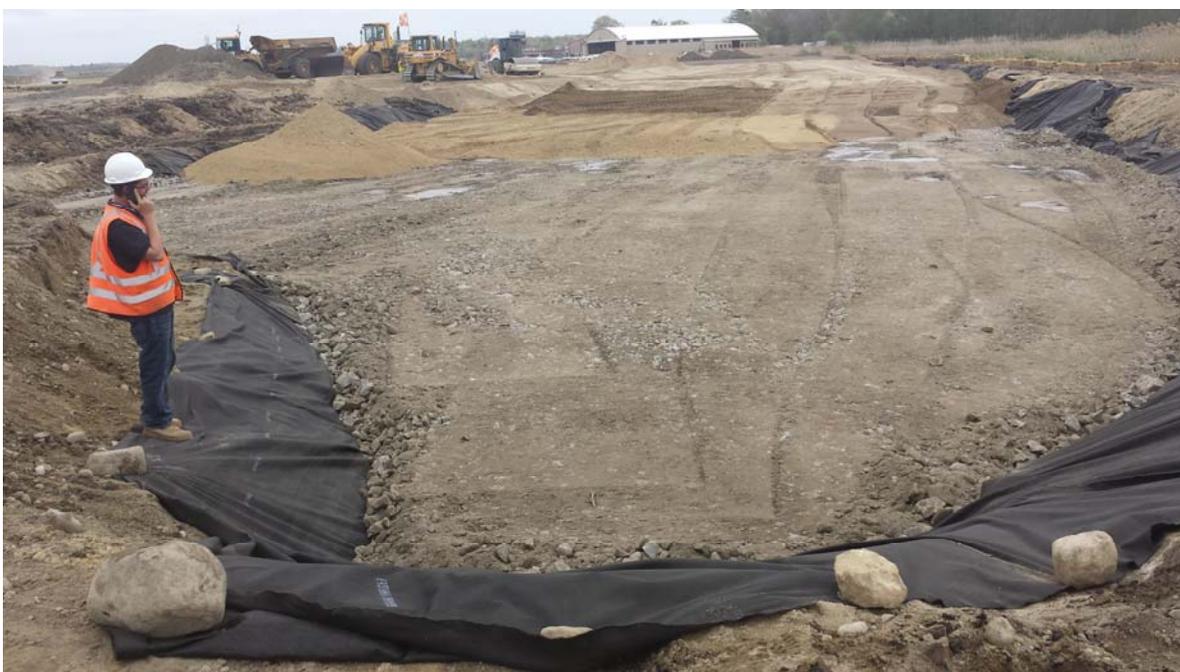
Photo 12 – View of completed excavation of un-suitable material on Taxiway A – dewatering ceased.
