**New Bedford Regional Airport  
Runway Safety Improvements Project – Phase 4  
Reconstruct, Mark, and Groove Runway 5-23  
MassDEP File No. SE049-0635**

**ENVIRONMENTAL MONITOR INSPECTION FORM**

Date/ Time of Inspections: **5/22/14 (10am to 4pm), 5/29/14 (10am-4pm)**

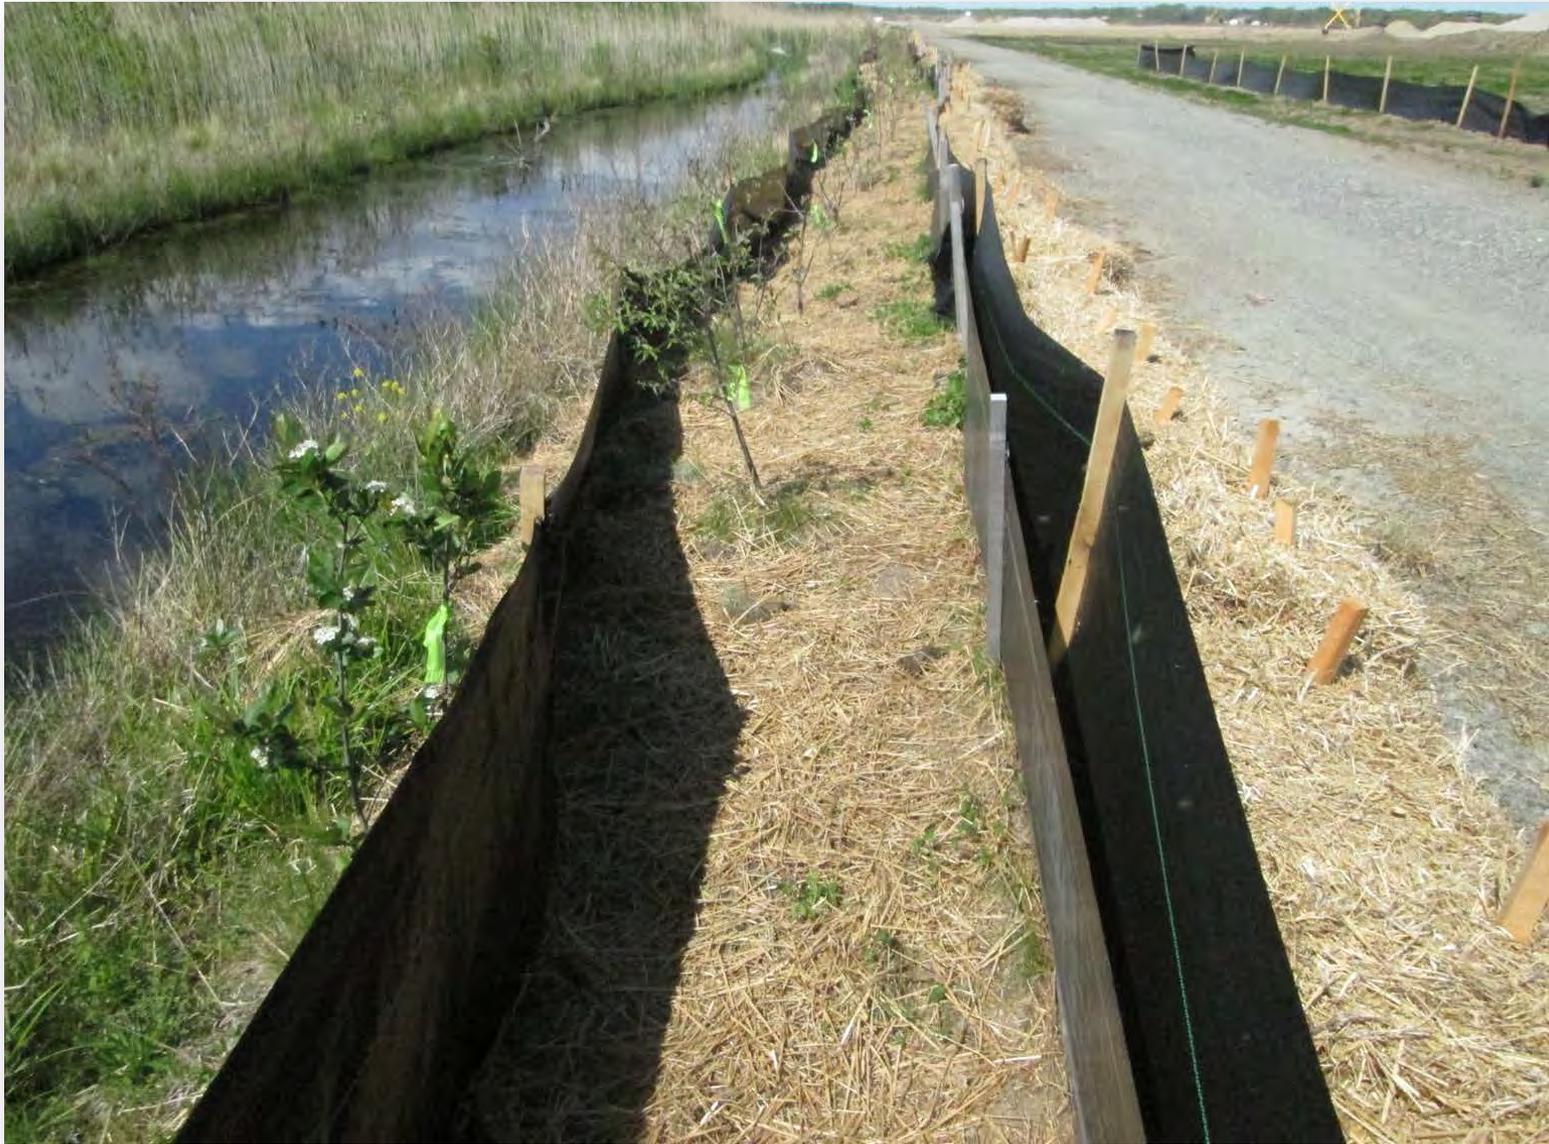
View of restored west ditch bank area, erosion control seed mix was applied on May 16<sup>th</sup>.

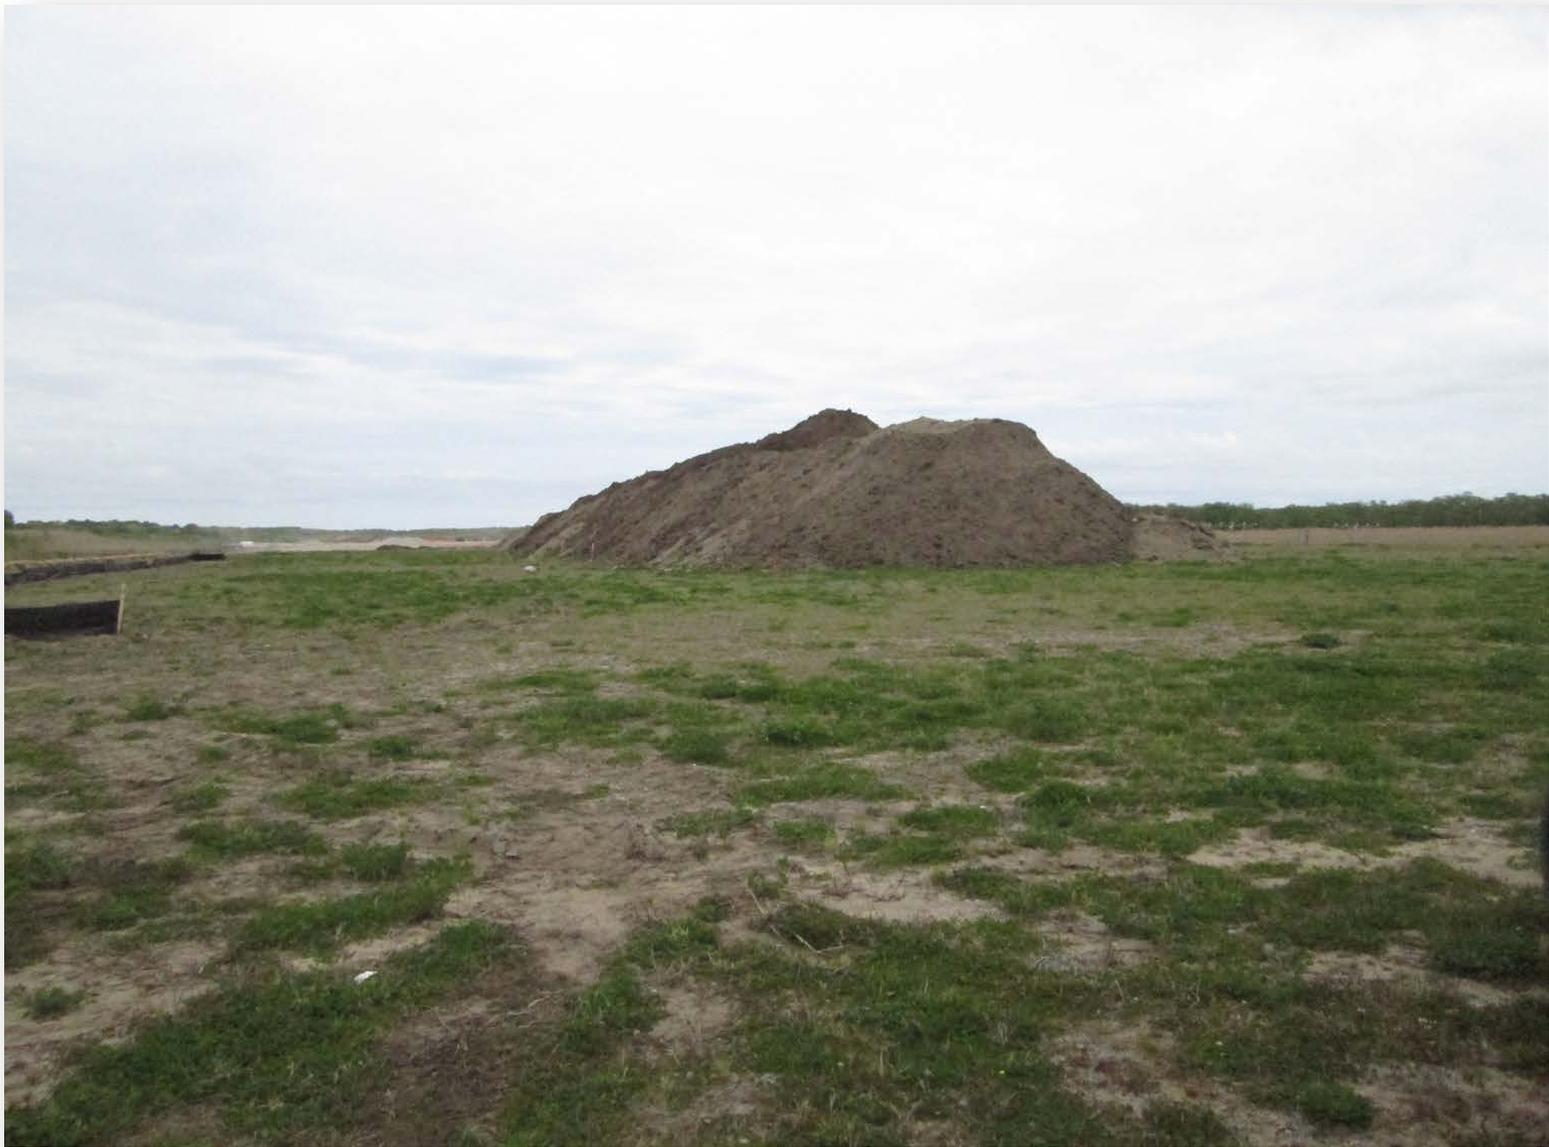
| Control Measure | Cleaning or Repair Needed | Comments/Recommendations from the EM |
|---|--|---|
| Stockpiling Materials | <input type="checkbox"/> yes <input checked="" type="checkbox"/> no <input type="checkbox"/> n/a | The 100-ft buffer zone is staked proximate to the stockpile area. One large stockpile is located within the central portion of the Runway 5 RSA and consists of sediment from stripping the Runway 5 end. The EM and WS discussed sowing the stockpile with annual rye if required under the NPDES CGP; Epsilon understands the WS is looking into this further in consultation with the site contractor. |

View of sediment stockpile in Runway 5 RSA. This material is outside the 100 foot buffer zone as staked in the field.

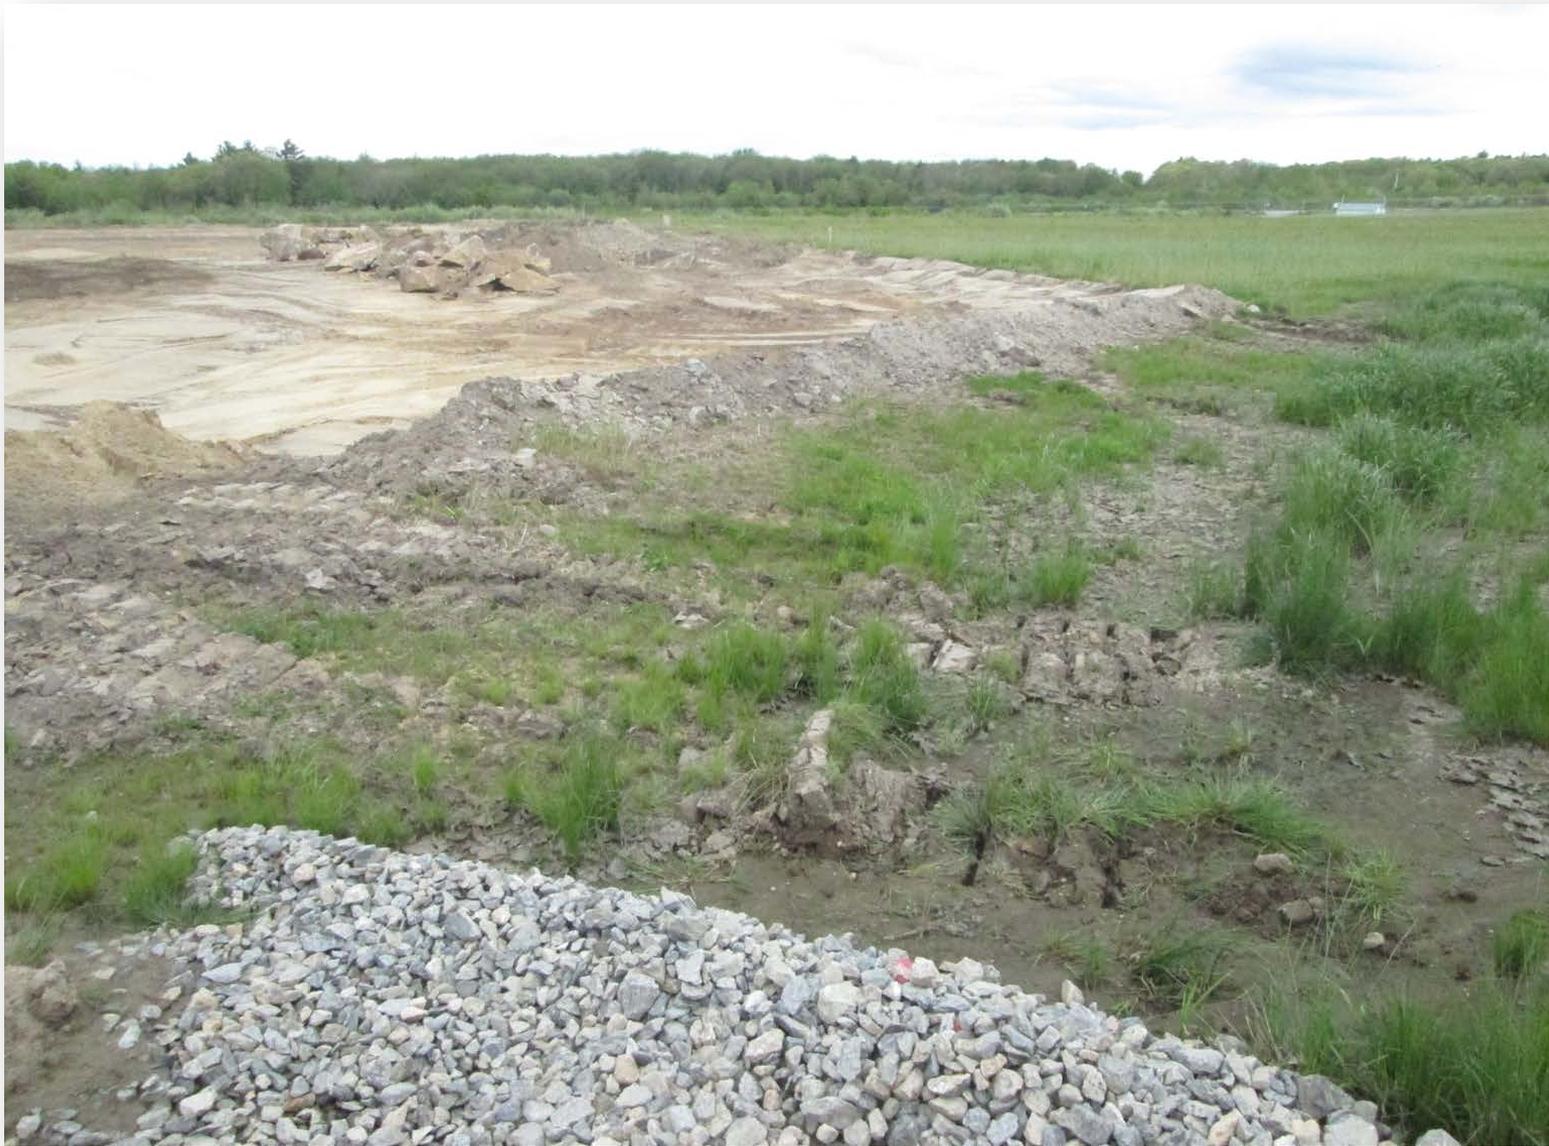
View of earthen berm protecting the infiltration trench at Runway 23 end. Photo taken from gravel road.

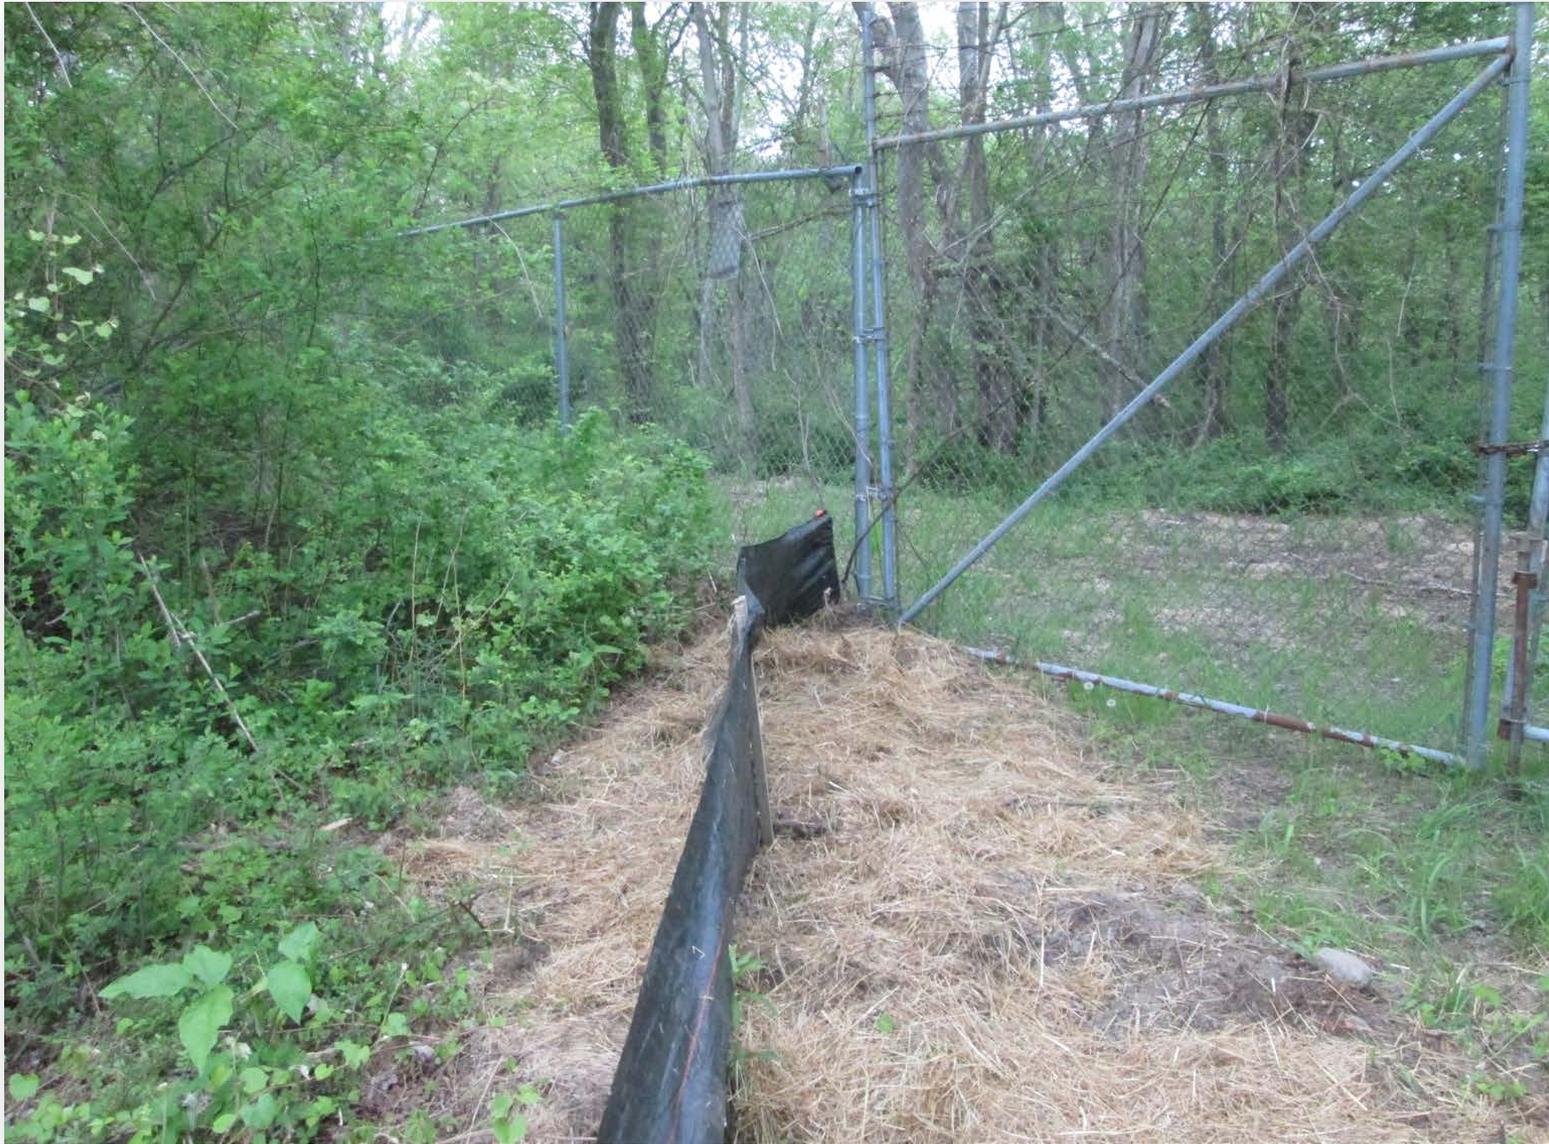
| Control Measure | Cleaning or Repair Needed | Comments/Recommendations from the EM |
|---|--|---|
| Box Turtle Barriers, Gates and Protection Measures | <input type="checkbox"/> yes <input checked="" type="checkbox"/> no <input type="checkbox"/> n/a | The contractor has closed the gaps in turtle fencing and extended a line of fencing in the Colonial hangar area as per Oxbow's week of 5/15 request. Turtle barrier is in good condition. The moveable gate installed at the West Ditch arch culvert was functioning properly at the time of inspection on 5-29-14. |

View of turtle barrier extension near Colonial Air hangars, modified as per Oxbow's direction.

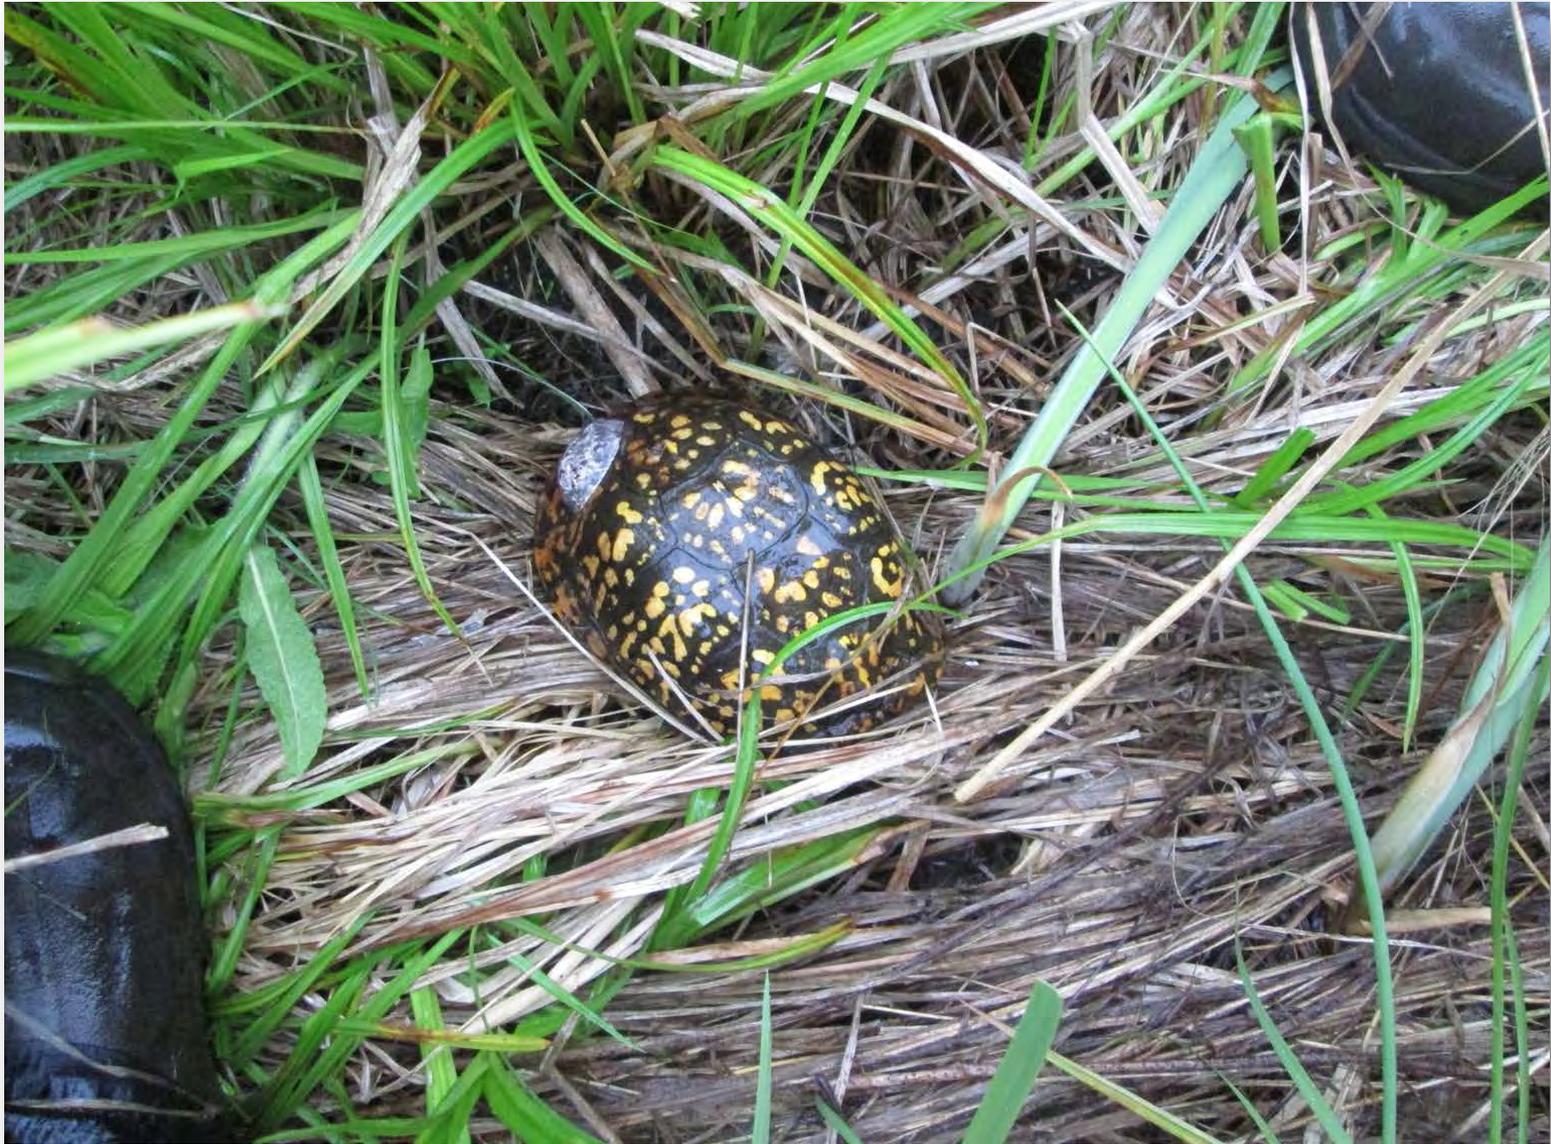
Radio tagged Eastern Box Turtle found utilizing Wetland Mitigation Site 6. Epsilon reported siting to Oxbow.

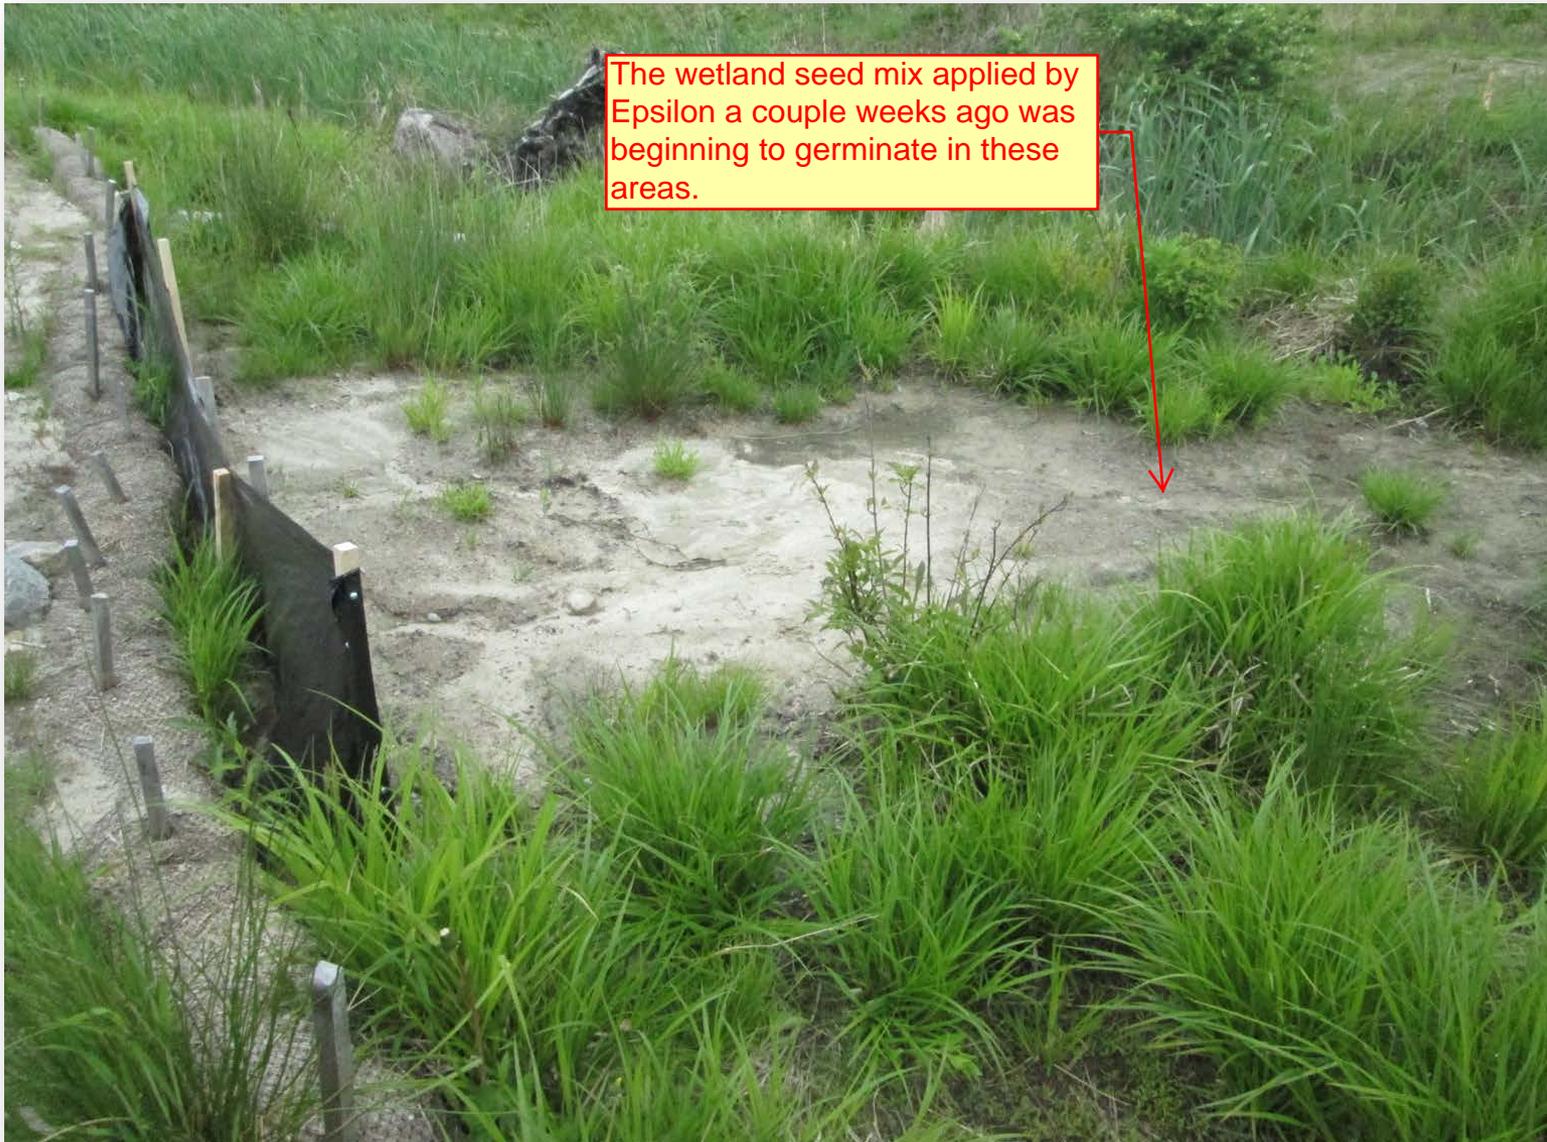
Although not part of Phase 4, Epsilon inspected Wetland Mitigation Sites 5, 6, and 10, and the turtle areas as part of ongoing monitoring efforts. In March the Airport installed additional silt fence at the interface of Turtle Area 3 and Site 6, Epsilon then seeded the area with a "wet-mix" in early April. Since then some additional sediment (approximately 12 ft by 6 ft area) has migrated from Turtle Area 3 into Wetland Site 6. The two rows of silt fence and straw wattles have not adequately contained the sand during heavy rain events. Epsilon is working with the Airport to identify a long term solution to prevent erosion from a purposefully unstable sandy environment into the adjoining wetland mitigation area. One option that we will explore further involves the installation of a compost filter berm along the interface of these two areas. With this approach the compost tube(s) would eventually go to seed and create a natural berm. Epsilon intends to discuss with the IO at their convenience and get their input on possible solutions. We will provide MassDEP and the NHESP with a recommendation in the near future.

View of sand migrating from Turtle Area 3 into Wetland Mitigation Site 6. This is a very small area (~12'x 6'). This area presents an ongoing challenge due to the purposefully unstable turtle nesting area located upgradient of the constructed wetland. The sediment is generated from a very small watershed (top of turtle nesting area), however it continues to hold enough energy to erode into this mitigation area. Epsilon is exploring long term solutions. See discussion of compost filter tubes.

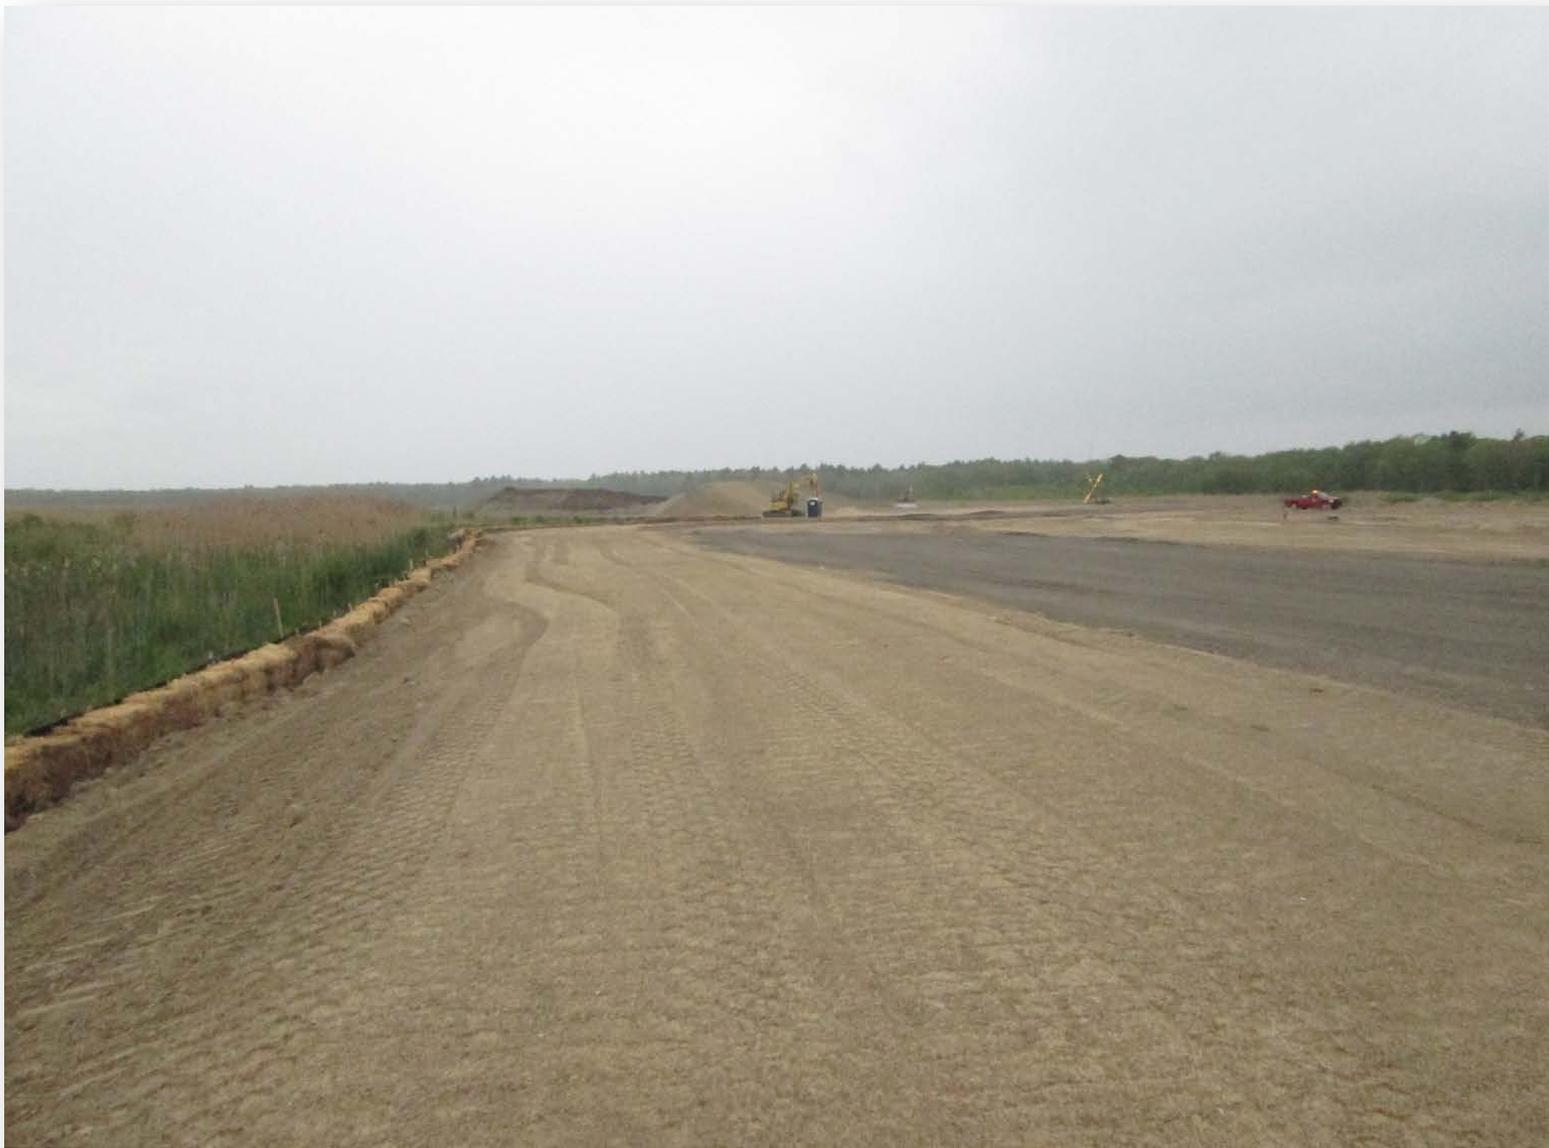
View of active construction, looking at Runway 5 end.

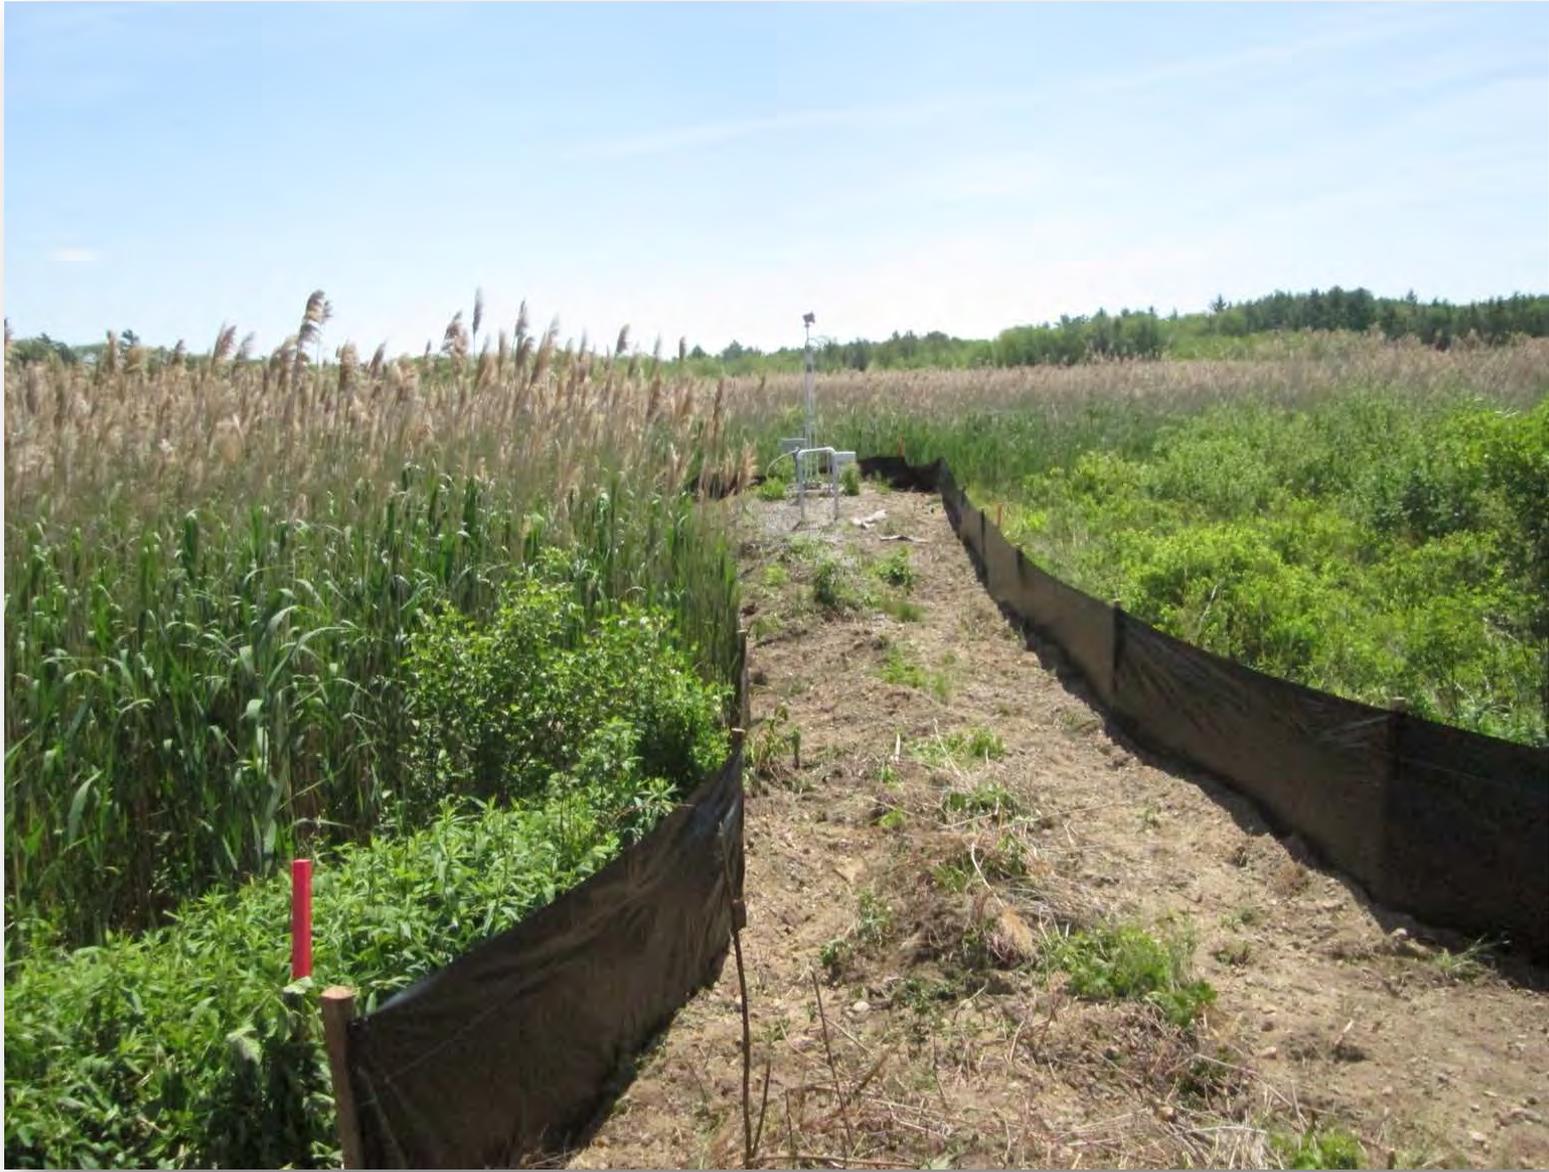
View of silt fence being installed at one of the MALSR light stations at Runway 5 end. RAMCO was actively installing this feature; haybales to follow.

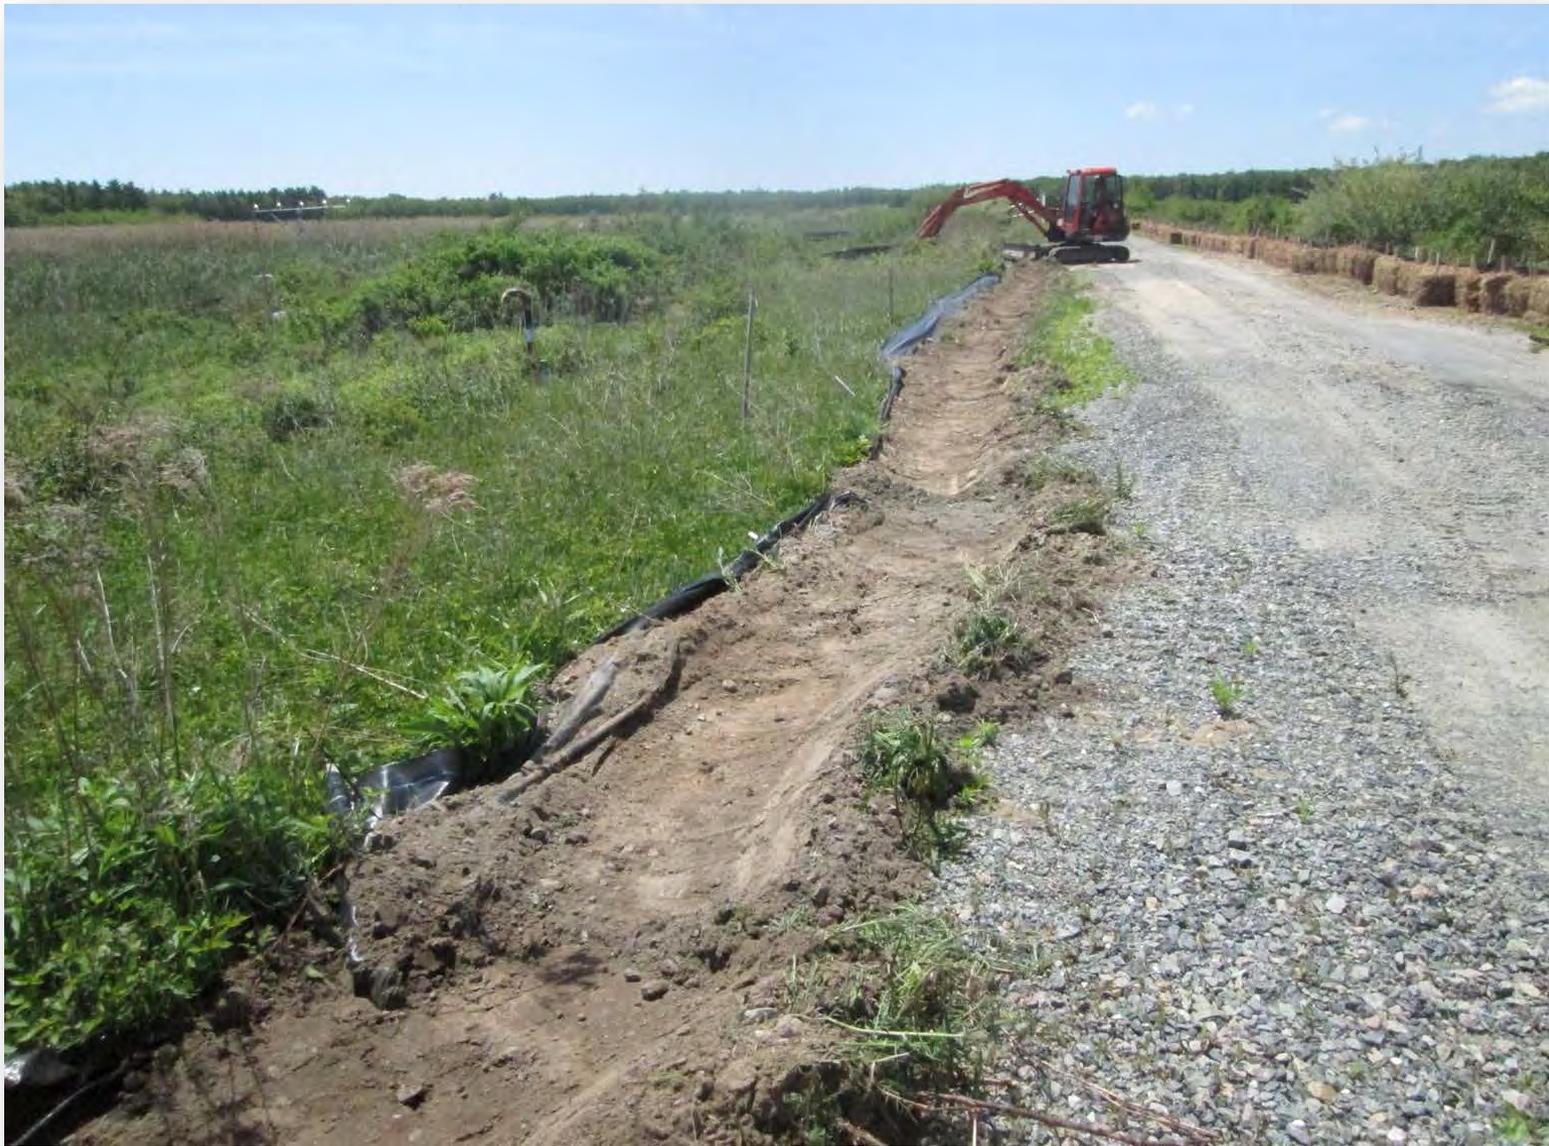
View of shallow trench for the placement of compost filter tubes along the ILS road. Old silt fence to be removed.

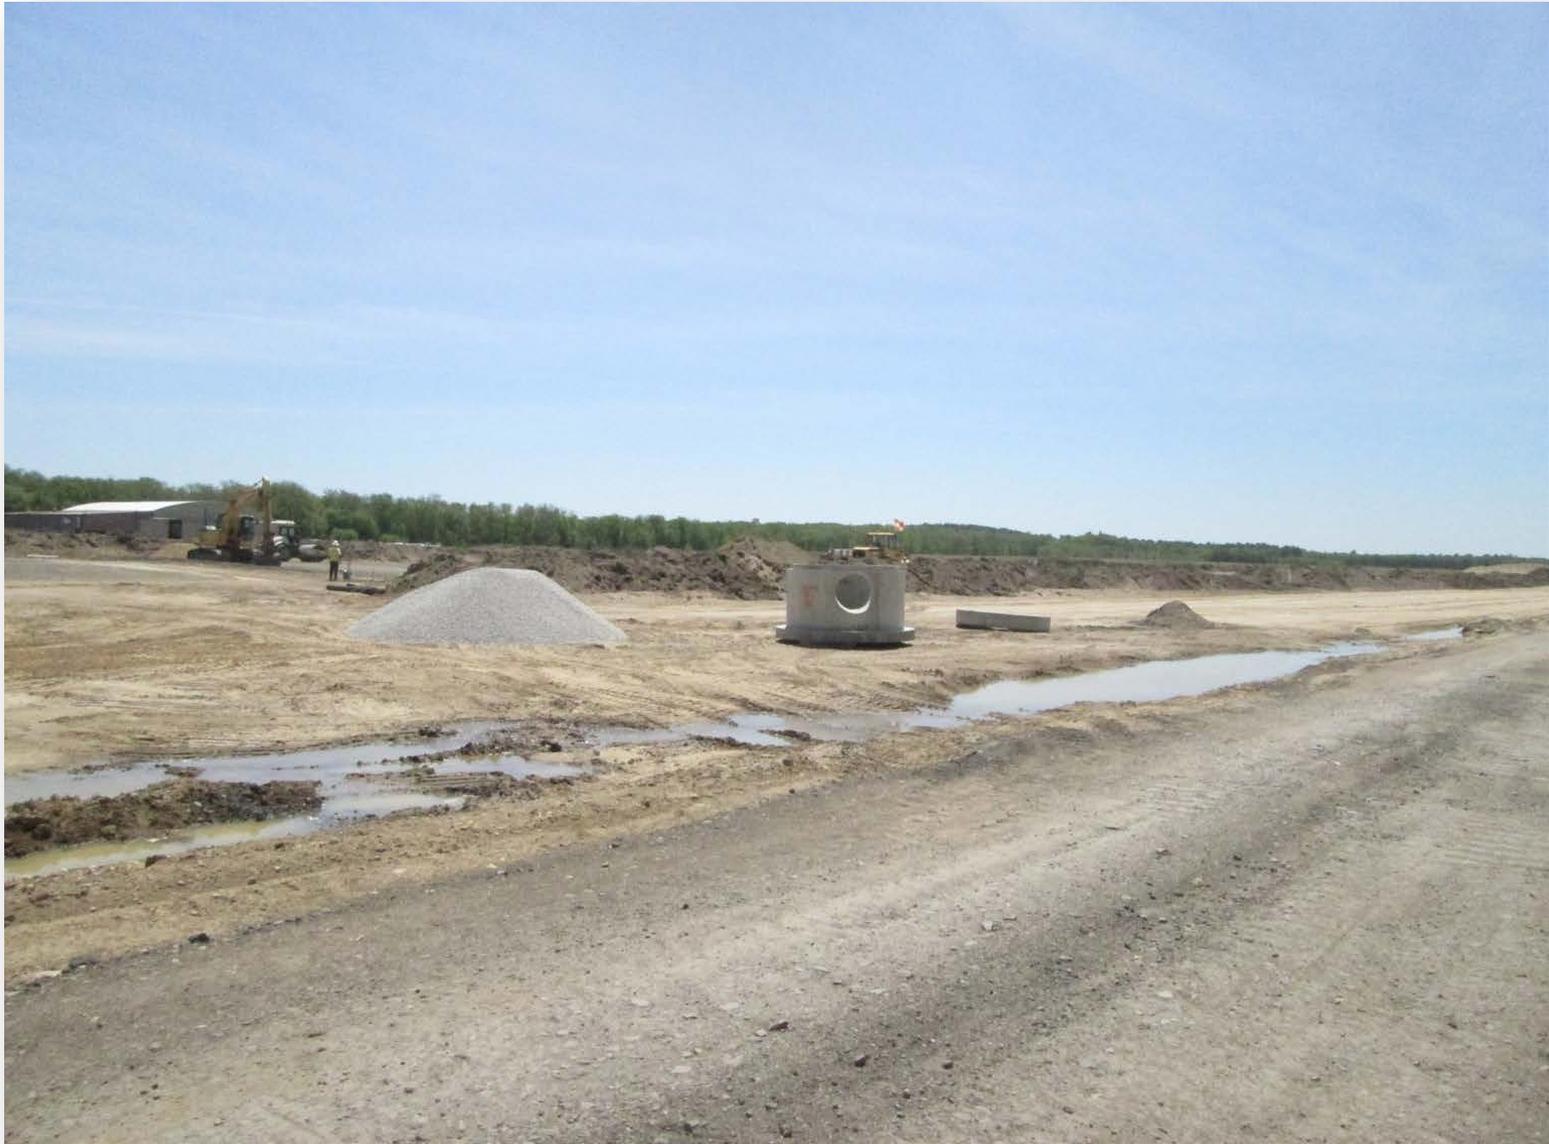
View of new stormwater catch basin and active construction.

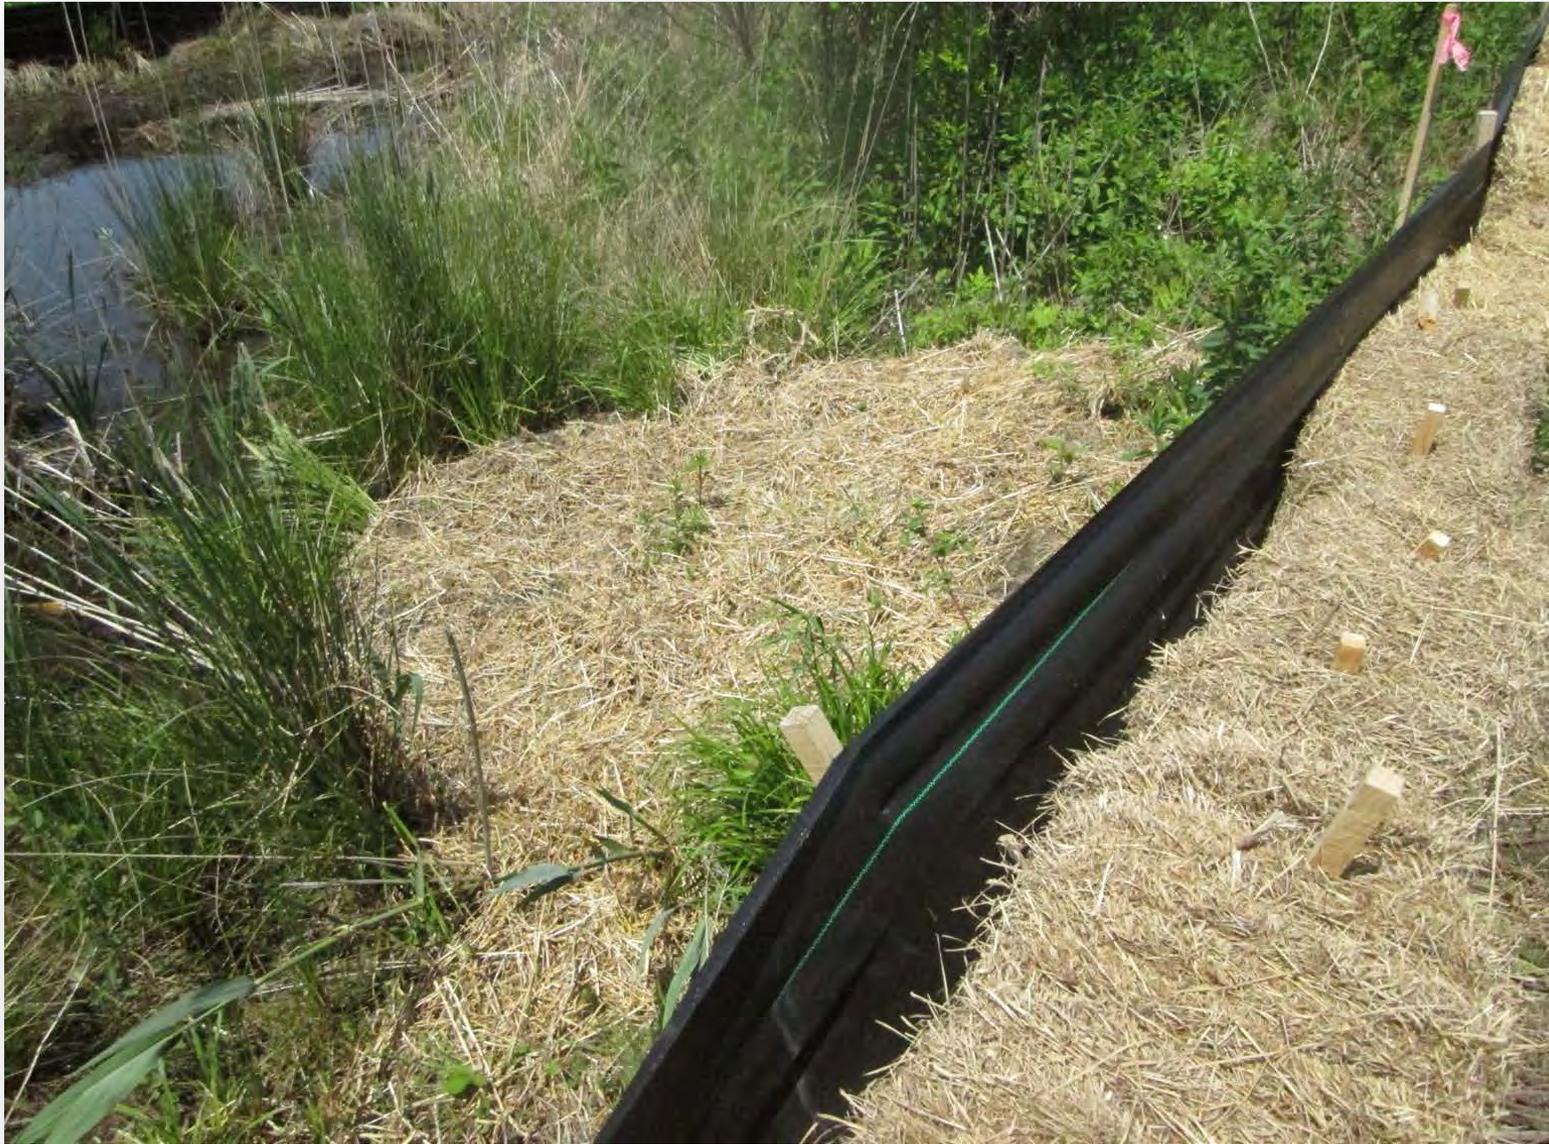
| Control Measure | Cleaning or Repair Needed | Comments/Recommendations from the EM |
|---|--|---|
| Site Clean-up and Stabilization | <input type="checkbox"/> yes <input checked="" type="checkbox"/> no <input type="checkbox"/> n/a | Small area of earth disturbance along the West Ditch (near the middle portion of Runway 5 north end) as a result of removal of existing stormwater infrastructure. This area was stabilized with straw. No further action is required at this time. |

View of stabilized area post removal of existing stormwater infrastructure.

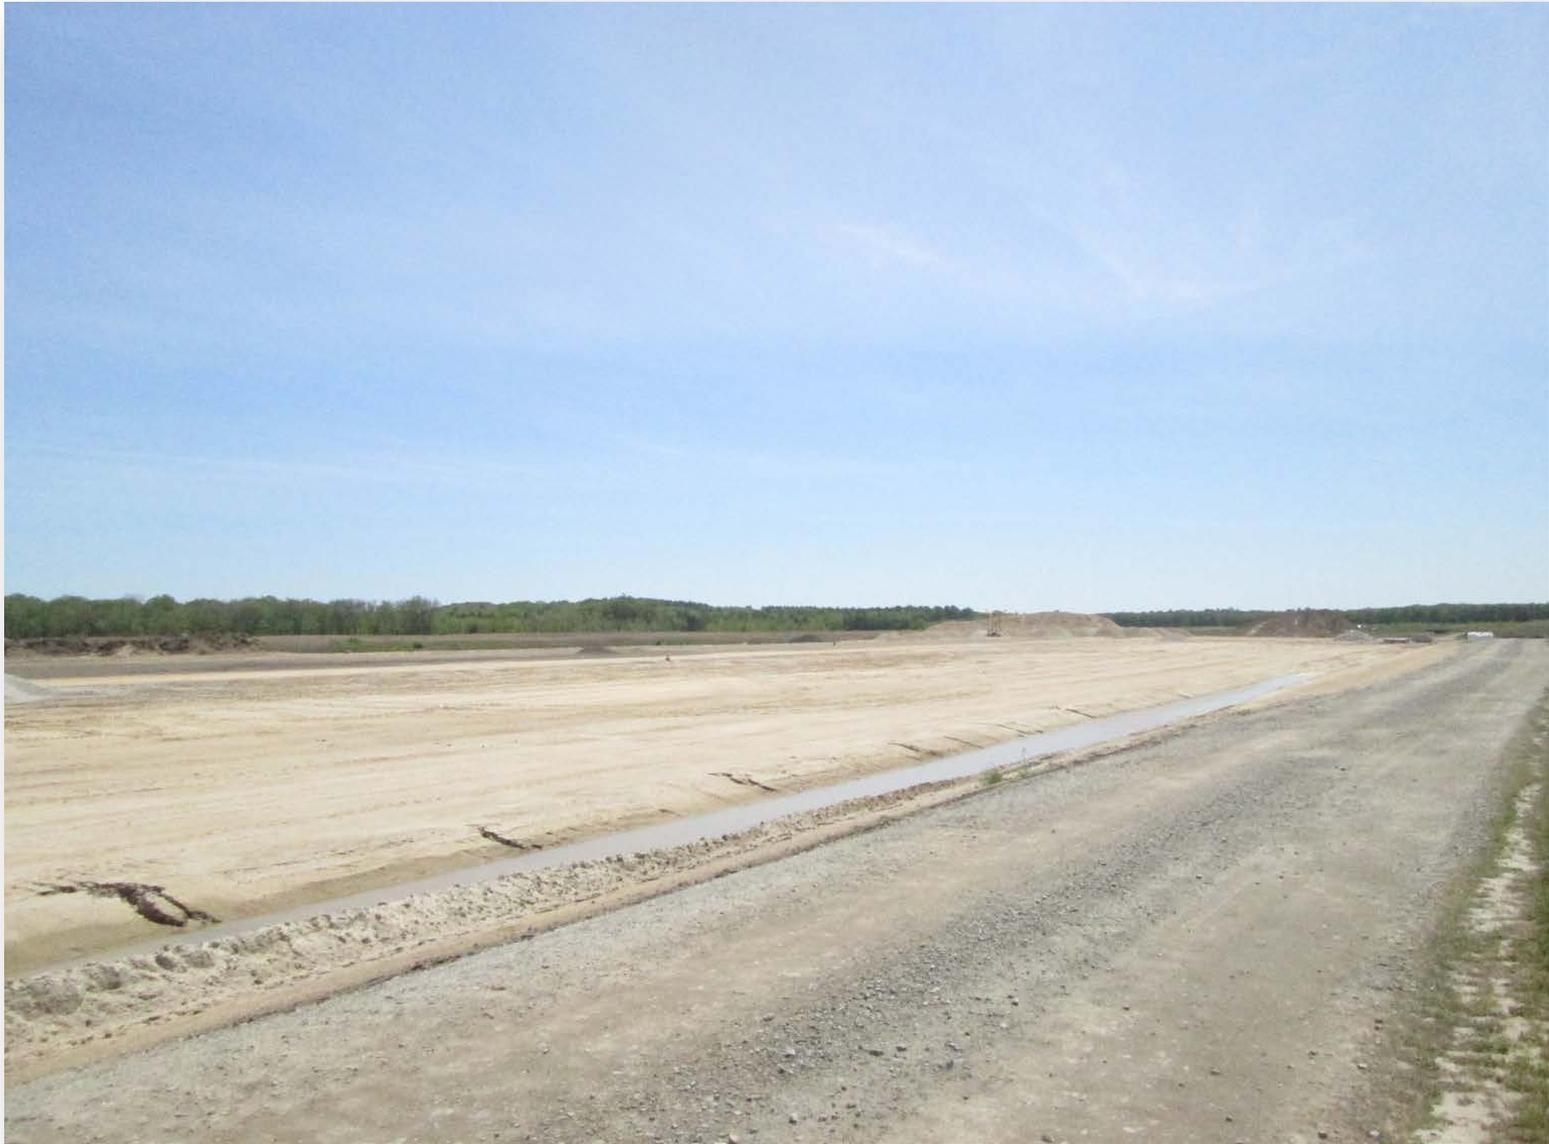
View of constructed infiltration trench, surface stormwater control.
