**New Bedford Regional Airport  
Runway Safety Improvements Project – Phase 4  
Reconstruct, Mark, and Groove Runway 5-23  
MassDEP File No. SE049-0635**

**ENVIRONMENTAL MONITOR INSPECTION FORM**

Date/ Time of Inspections: **5/22/14 (10am to 4pm), 5/29/14 (10am-4pm)**

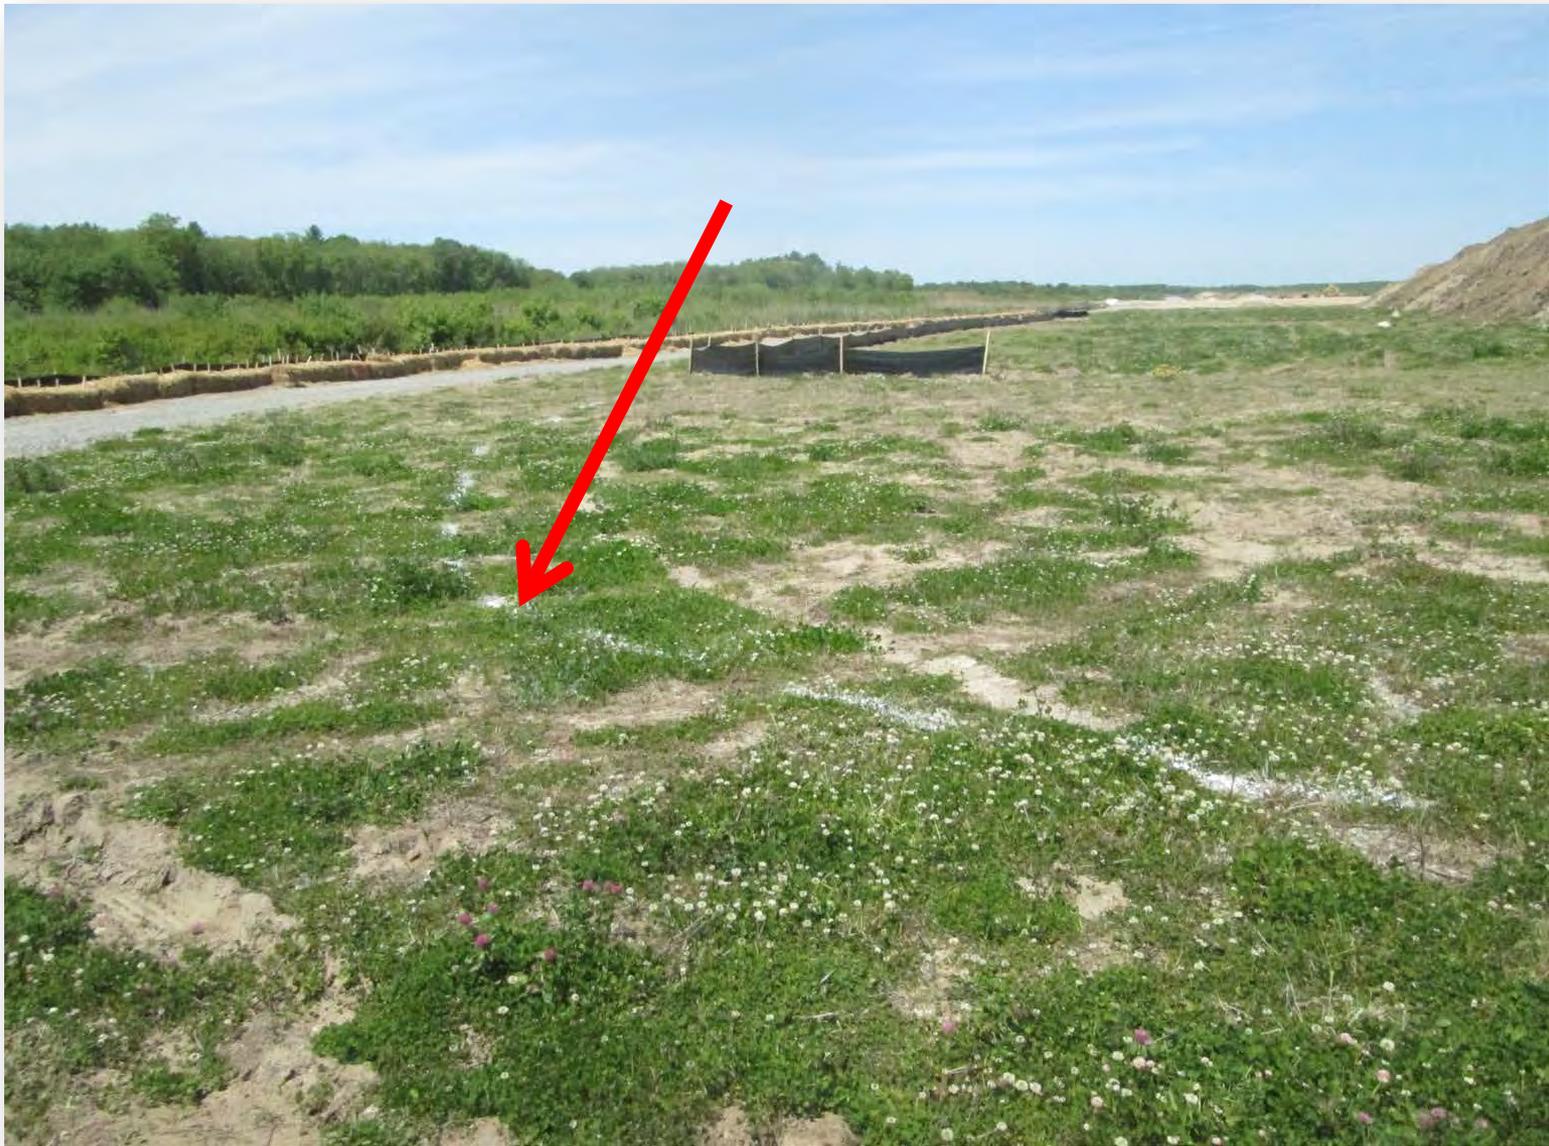
Note white spray paint depicting the approximate location of the “u-shaped” secondary silt fence recommended by the EM, IO, and WS and to be installed May 30<sup>th</sup>. See ASG letter to MassDEP dated May 30<sup>th</sup> for additional detail.

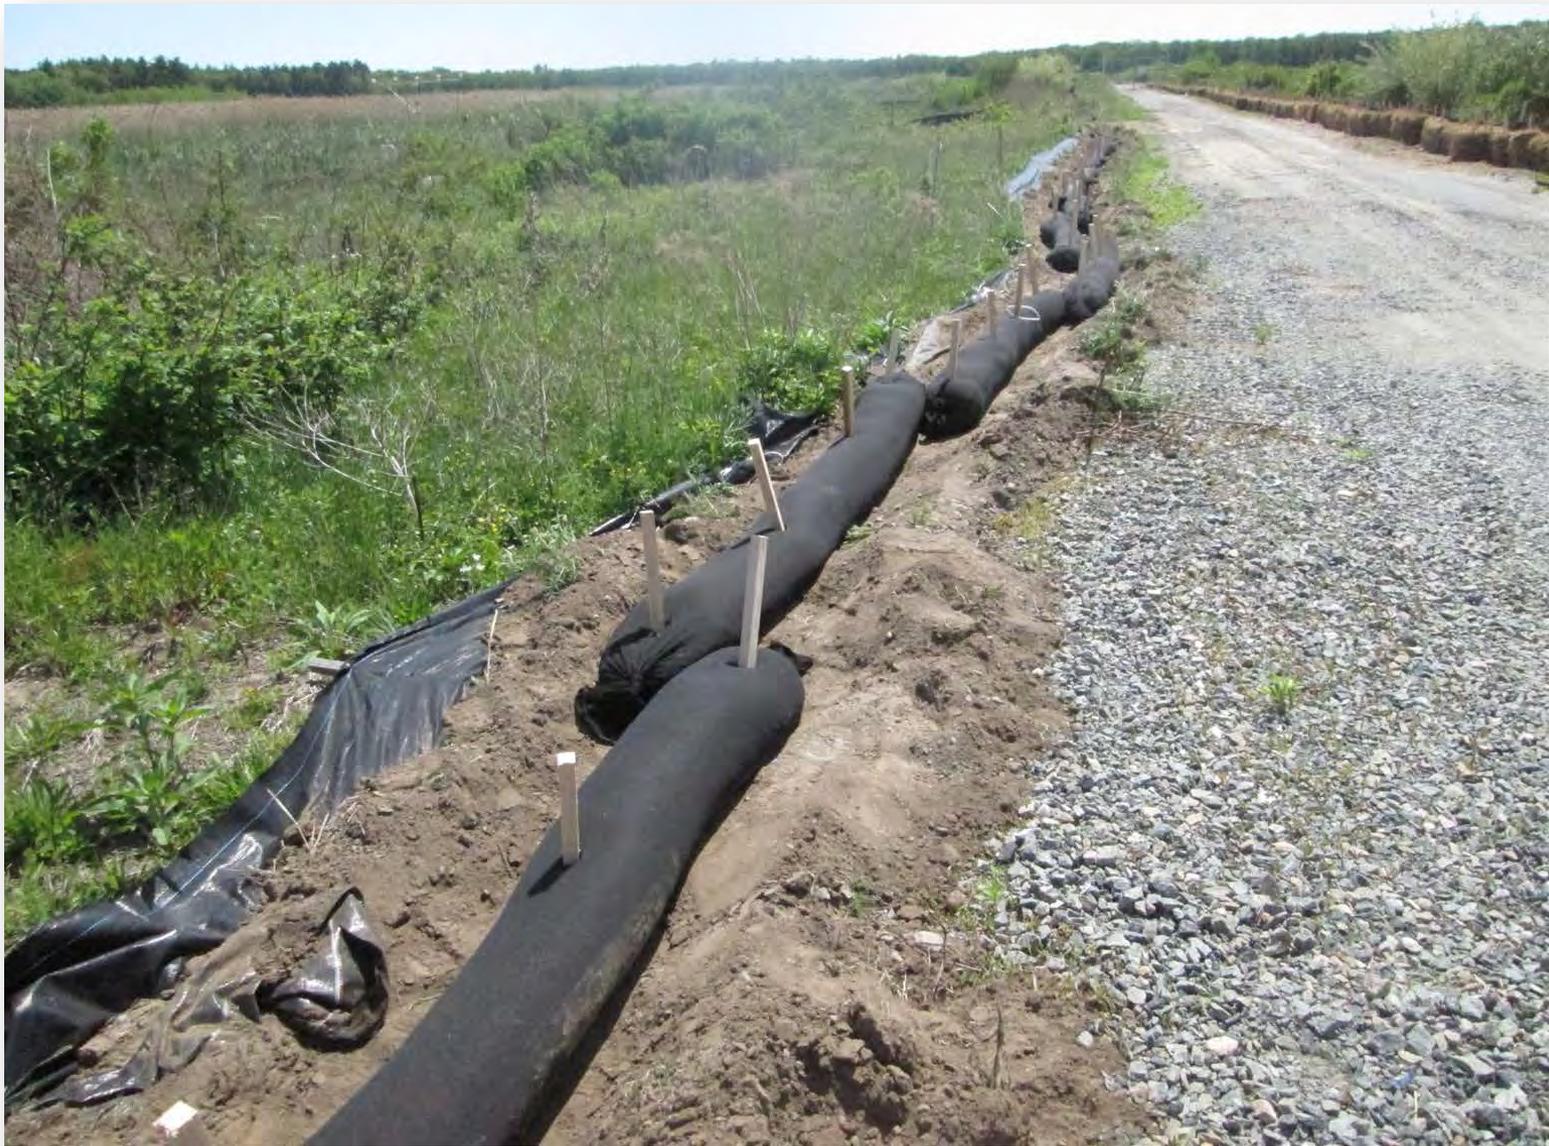
View of partially installed compost filter tubes. As per conversation with Joe Rogers (WS), the contractor will backfill sediment to ensure 2-4 inches of contact along the entire length of this erosion control. Excess material was moved to the ILS road side of the control to ensure that sediment does not impact the adjacent wetlands. Epsilon will conduct a follow up inspection next week.

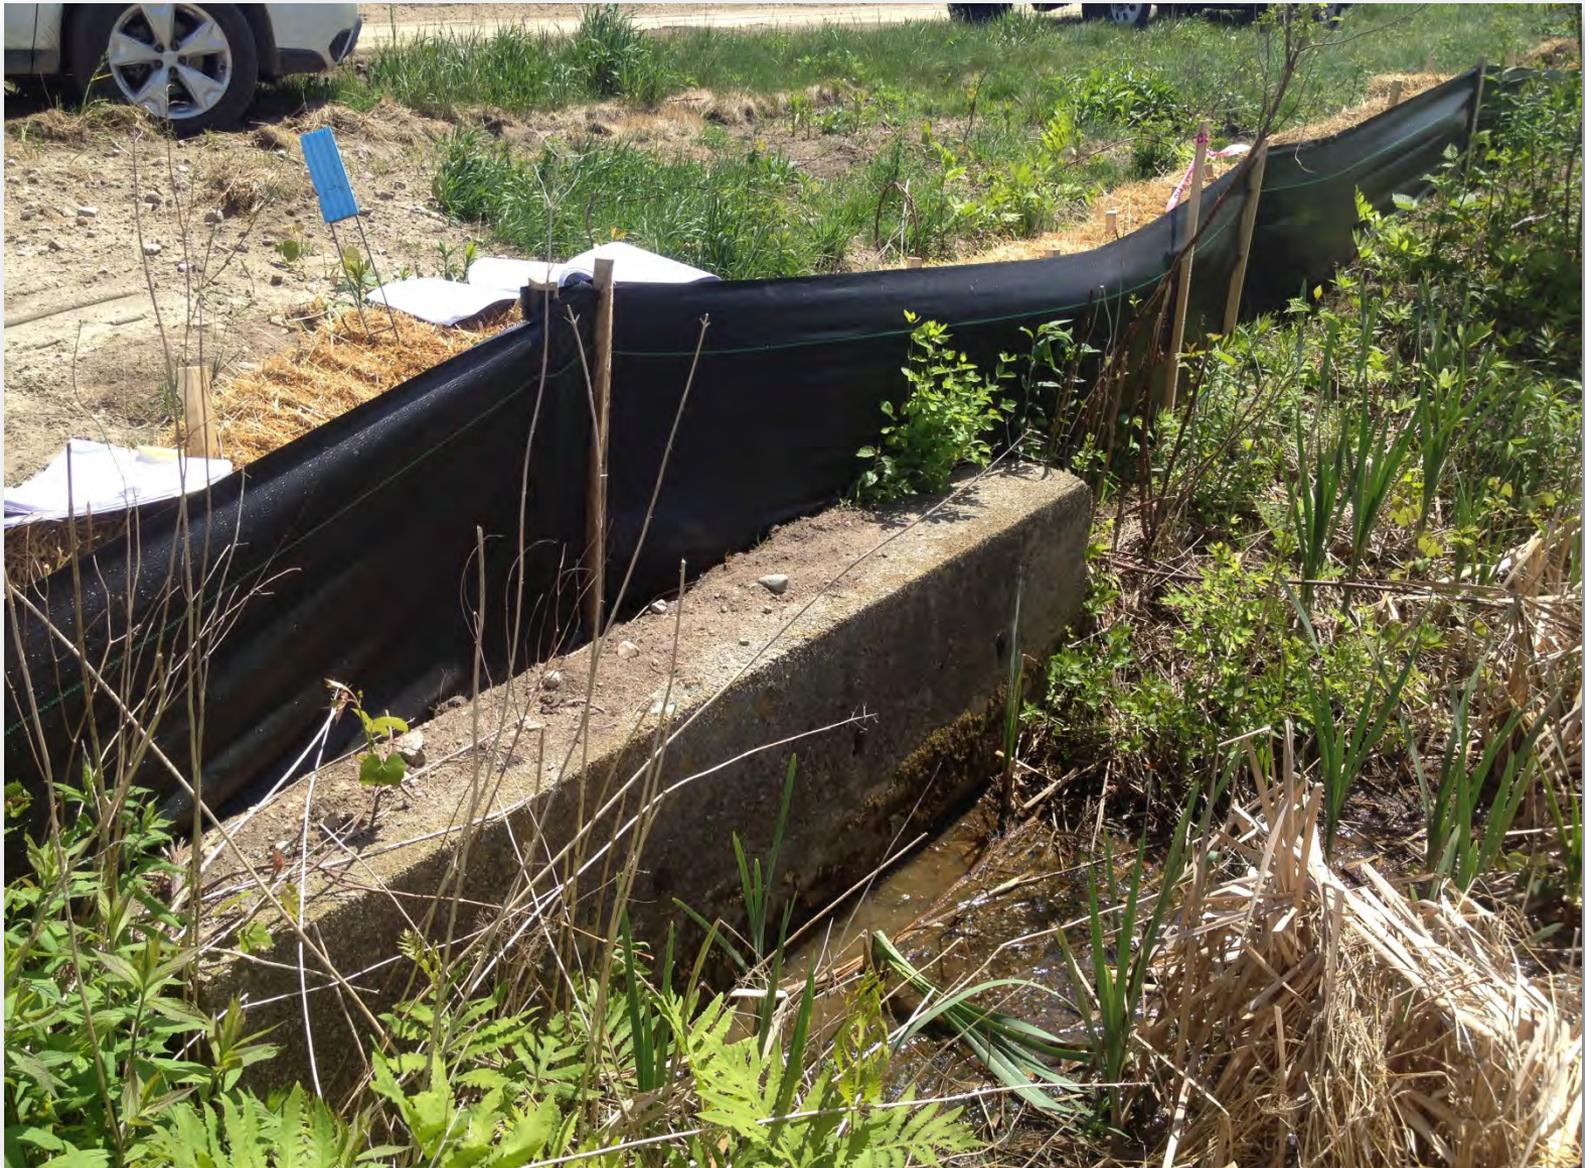
| Control Measure | Cleaning or Repair Needed | Comments/Recommendations from the EM |
|---|--|--|
| Erosion Control Devices | <input checked="" type="checkbox"/> yes <input type="checkbox"/> no <input type="checkbox"/> n/a | Erosion controls have been installed within all active work zones along the Work Area 1 (Runway from Taxiway B to 5 end) and 2 (Runway 23 end) and are complete. Erosion control appears properly tailed in and hay bales are appropriately staked. Areas where previous failures were observed are continuing to be monitored and no additional issues have been observed. The contractor has an emergency supply of silt fence present on the site. The contractor received authorization to install compost filter tubes along the ILS road from MassDEP and the NHESP on Wednesday May 28, 2014. As requested by MassDEP a detail of the compost filter tube has been provided and is attached to this EM report. Additional erosion controls have been installed and are discussed in detail below. Epsilon informed the RE that in one select location the erosion controls should be shifted down gradient of a headwall that is scheduled to be removed to accommodate the upgraded drainage system in order to better protect the adjacent wetlands. Epsilon installed a stake in the |

| Control Measure | Cleaning or Repair Needed | Comments/Recommendations from the EM |
|---|--|---|
| | | centerline of where the controls should be shifted. See attached photo for clarification. |

View of erosion controls installed on upland side of existing (and now offline) headwall that is scheduled to be removed to accommodate the new storm water BMPs/infrastructure. Epsilon directed the RE to relocate ~10 – 15 feet of the controls to the downstream side of the headwall during the removal and installation process
