Re: Independent Observer's Monthly Report, Time Period: May 1 to May 31,
2014, New Bedford Regional Airport Safety Improvements Project
DEP File No. SE 049-0635

GZA GeoEnvironmental Inc.	REPORT NO: 41 DATE: May 1, 2014	Page 1 of 7
	PROJECT No: 15.0166235.30	
	LOCATION: New Bedford Regional Airport New Bedford, MA	
	PHOTOS: 1-10

**PROJECT: Reconstruct, Mark and Groove Runway 5-23, DEP File #SE-049-0635,
NHESP File No. 96-0737**

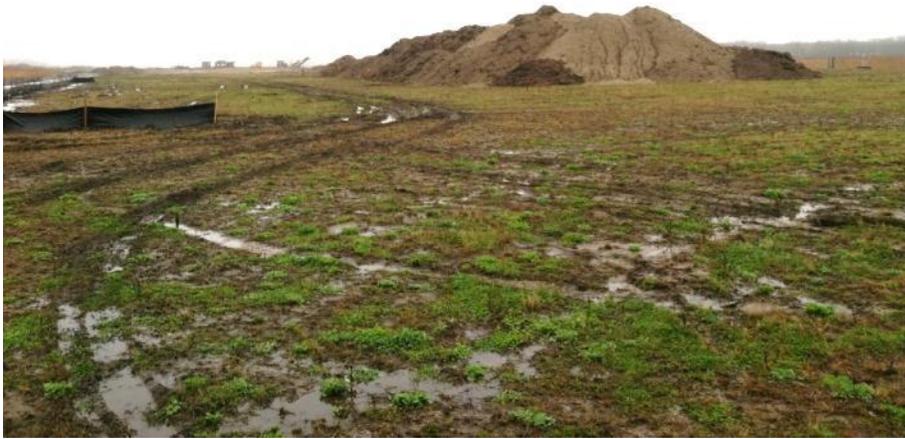
1. Contractor began scraping loam and stockpiling in 5-end RSA, silt fence installed to the northwest of these piles adjacent to the gravel access road edging the RSA (**Photo 1**). It was reported by EM that these stockpiles were located outside of the 100' Buffer Zone offset from the wetland line at the West Ditch.

Photo 1: Stockpile of loam in RW5 RSA, silt fence barrier observable on left of picture.

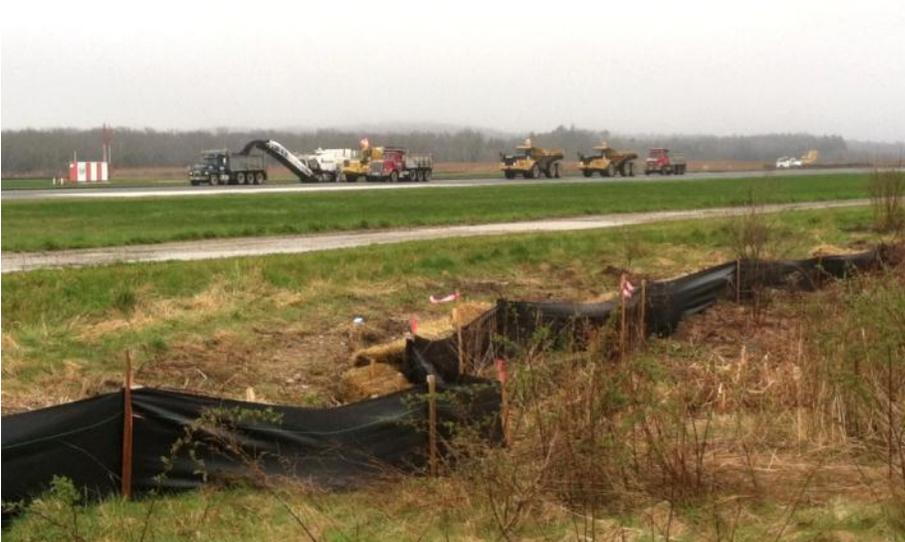
2. Pavement milling was ongoing (**Photo 2**), the millings are being reused as a top base along the gravel access road located north and west of the RW5-end by Contractor (**Photo 3**) in an effort to control dust along this route.
3. Silt fence installation complete upon site visit on May 1, 2014, yet hay bales had yet to be placed (**Photo 4**).

Photo 2: Pavement milling ongoing on RW5-end. The silt fence and hay bale barrier is in the foreground.

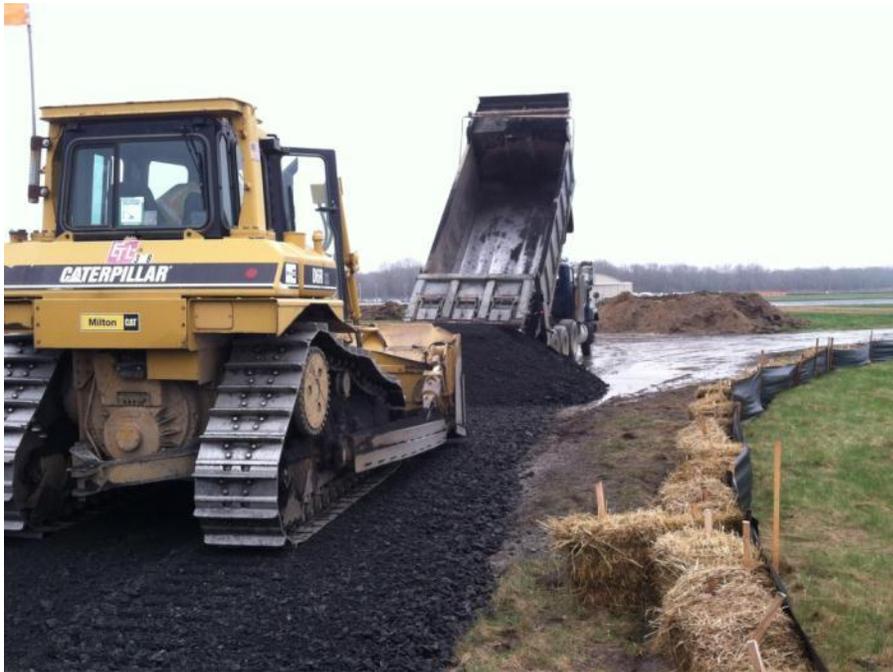
Photo 3: Millings are being reused as dust control along the gravel access road located north and west of the RW5-end.

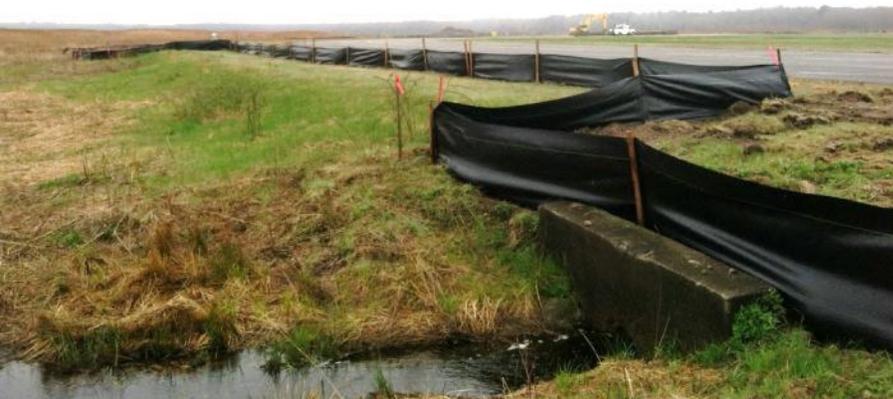
Photo 4: Silt fence installation complete upon site visit on May 1, 2014. The addition of hay bales is planned as indicated on the approved site plan.

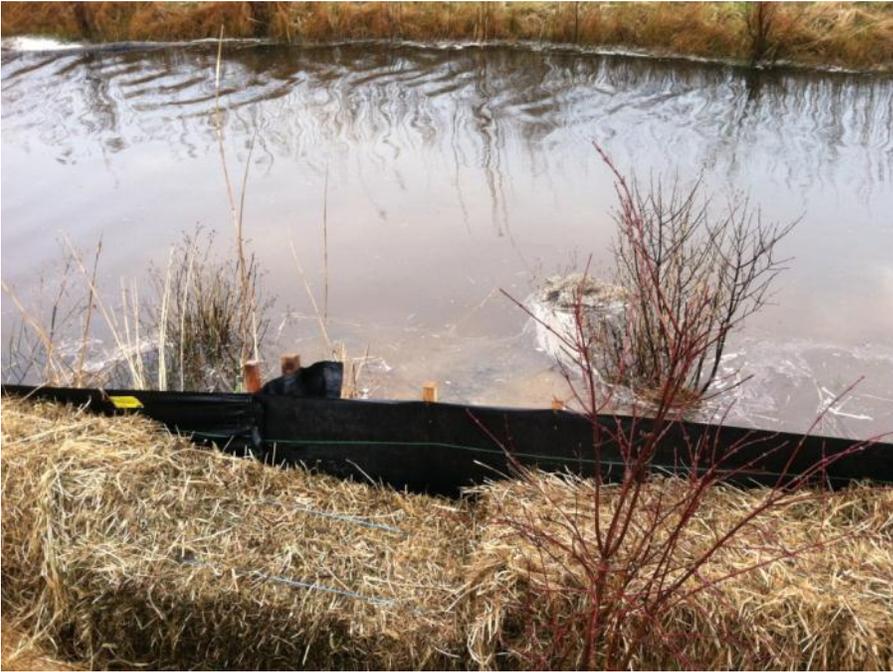
4. On May 1, 2014 a failure of a portion of the silt fence located along the West Ditch was observed after its subsequent repair, and although the failure point in the silt fence had been repaired, suspended solids and sediment were observed within the water column of the West Ditch (**Photo 5**), the measureable amount was undeterminable at the time, subsequent inspection will occur.
5. It was observed that the erosion controls had not yet been installed to 100% completion, as the plans require that silt fence and hay bales were to be installed together, the latter had not yet been set into place (it was reported by the contractor that hay bales for installation in this location, had been delivered to the site on that day), (**Photo 6**).
6. Two other failures in this silt fence were also observed to have occurred, these were each corrected.

Photo 5: Suspended sediment was observed within the water column of the West Ditch following the installation of silt fence and hay bales earlier in the day.

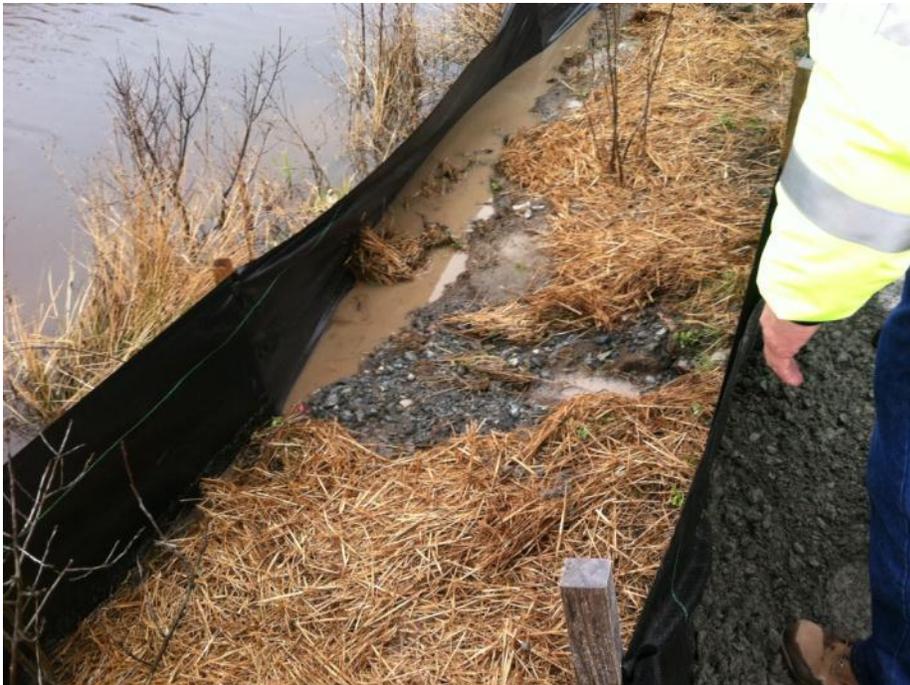
Photo 6: Failure point of silt fence on West Ditch, observable lack of hay bales as required per the plan.

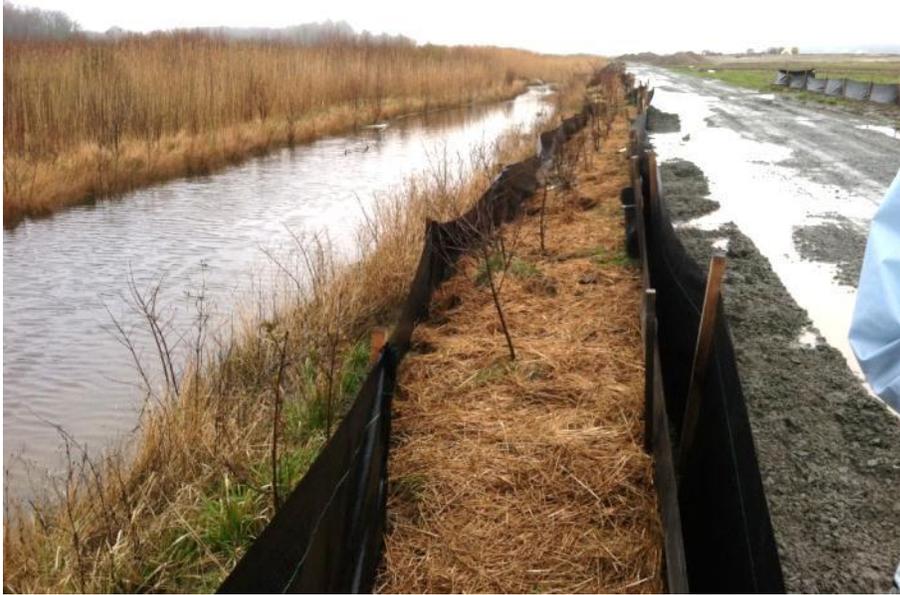
7. Upon the installation of a length of silt fence located in adjacent to the West Ditch, RAMCO (“sub-contractor”) damaged roughly 50 planted shrubs (Phase 3). The Environmental Monitor, in conjunction with the Wetland Scientist, developed a plan to correct the mistake, this involved the resetting of the shrubs, reseeding of the disturbed area, as well as the spreading of loose straw. A portion of this area is now contained within two rows of silt fence, one from phase 4 as well as one from a previous phase (**Photo 7**).
8. Many planted shrubs from previous phase in West Ditch, adjacent to concrete end wall were observed to not be present as of spring 2014 (**Photo 8**).

Photo 7: Along the West Ditch a silt fence was improperly location and resulted in damage to ~50 shrubs and disturbance to the soil. A restoration plan is reported to be in development.

1. **Develop a strategy to reduce the water load in RW5 RSA area. Possible strategies include pumping of water out of the haul road into filter bags in upland areas or raising the grade of the gravel access road.**
2. **Provide a restoration plan that includes a quantification of wetland impact for the E&S failure area at the RW 5 RSA.**
3. **Remove existing sand that has migrated into Site 6 from Area 3. Develop a plan to prevent this movement in the future.**
4. **Determine extent of shrub mortality at concrete end wall along West Ditch.**

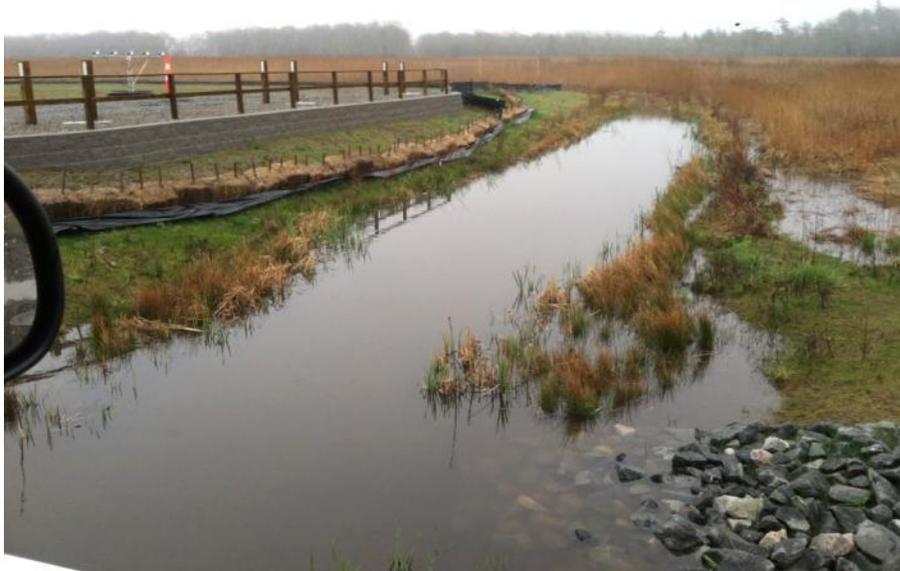
Photo 8: Shrubs planted during previous phase were not observed along a portion of the West Ditch, adjacent to concrete end wall for cross culvert.

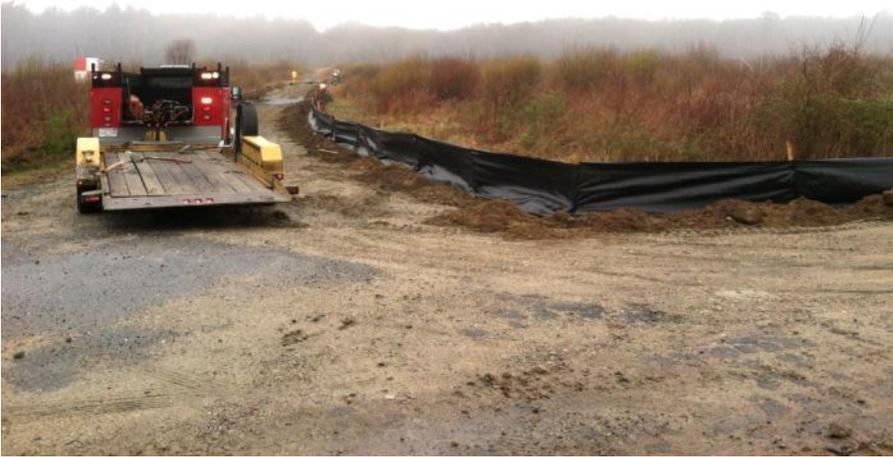
9. Installation of silt fence with hale bale rows observed upon site visit (**Photo 9**), total length of silt fence had yet to be completed as of site visit.

**Photo 9:
Installation of silt
fence with bale rows
observed
upon site visit (May
1, 2014).**

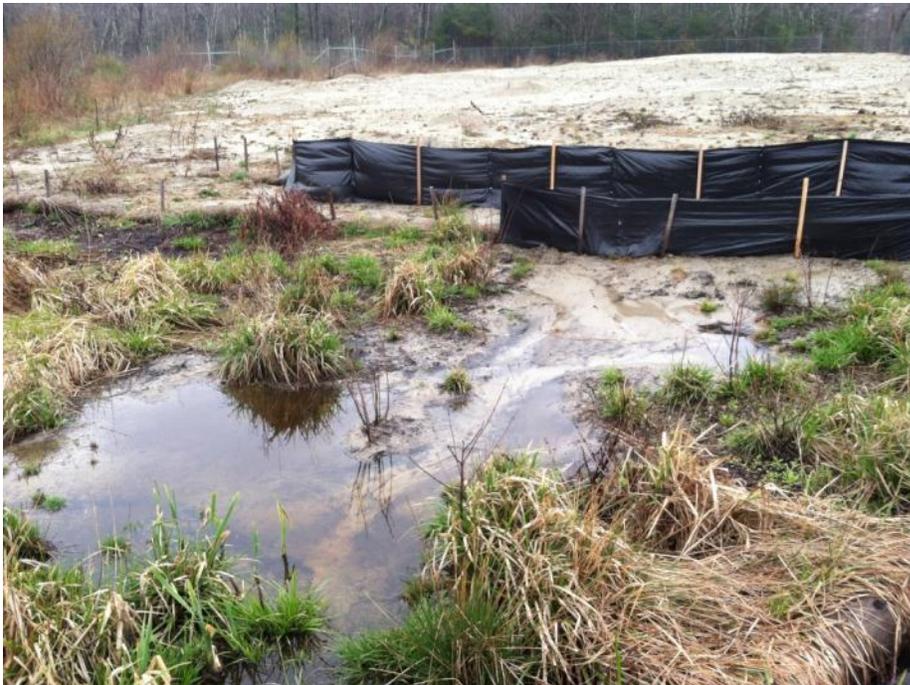
11. Sediment (sand) was observed beyond the Site 6 limits originating in Area 3. Several rows of silt fence along with straw wattles were observed, although the sediment observed was beyond these barriers (**Photo 10**).

**Photo 10: Sediment
(sand) was
observed beyond
the Site 6 limits
originating in Area
3 despite two rows
of silt fence and
straw wattles.**

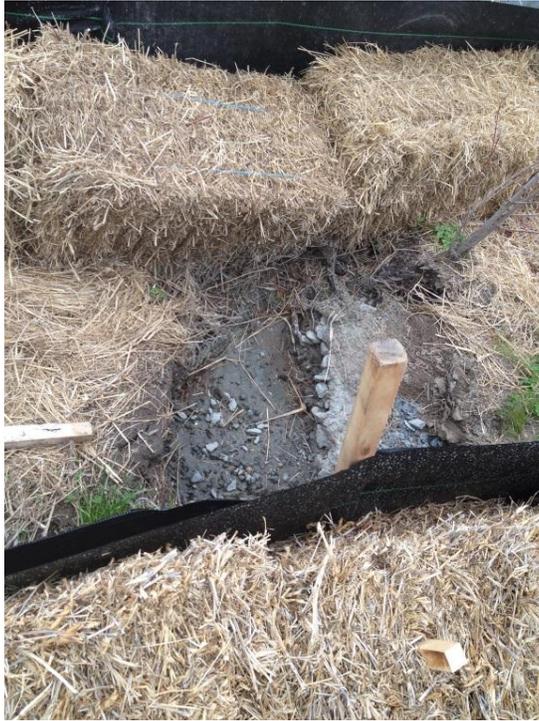
Photo 3: A sedimentation barrier breach occurred along the silt fence line of the West Ditch. Measures have been taken to stop further sedimentation into the West Ditch.

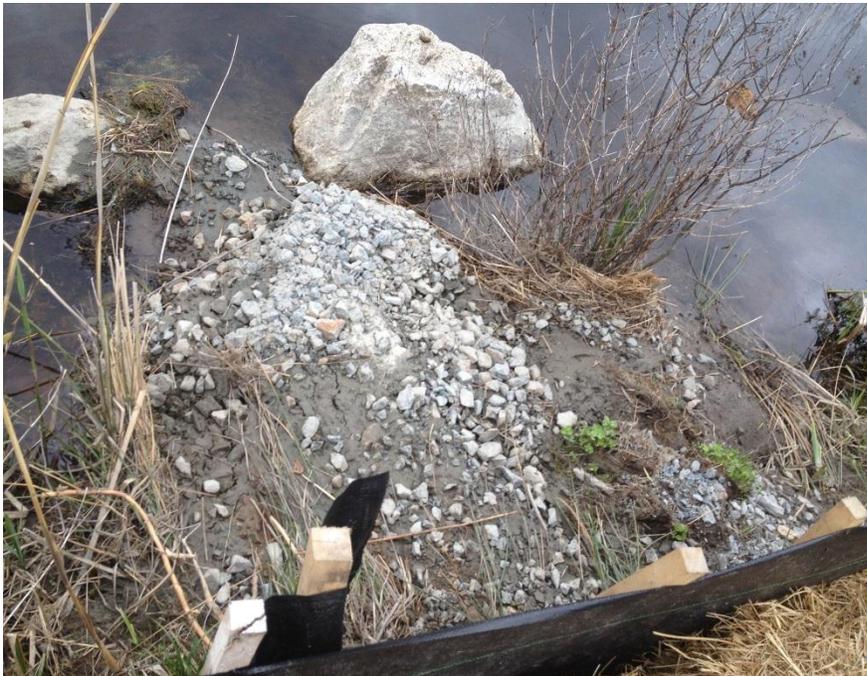
Photo 4: Sediment and graded materials from the haul road were discharged into the West Ditch due to the failure of the sediment control.

This photo is just beyond the area shown in Photo 3. Accumulated sediment will be removed by hand.

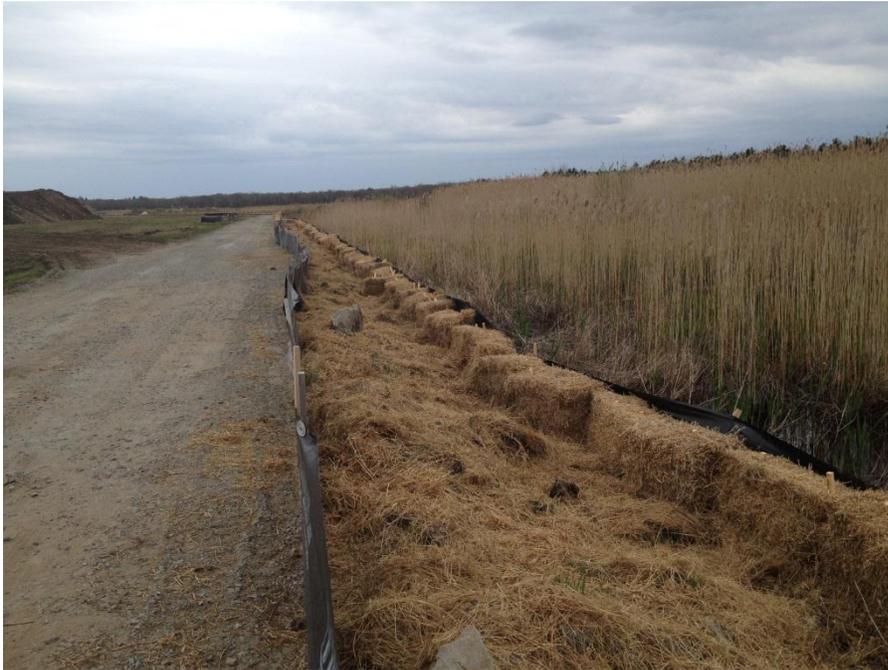
A portion of the Restoration Area that was disturbed is now contained within two rows of silt fence, one from Phase 4 as well as one from Phase II and loose straw has been placed in areas where the soil was disturbed (**Photo 5**). Many planted shrubs from a previous work phase along the West Ditch were removed and many were replanted. The EM explained that they and the WS are monitoring the development of the affected shrubs. The EM stated that flags would be placed at the damaged plants for continued monitoring (**Photo 6**).

Photo 5: The Restoration Area that was disturbed was secured by establishing a row of silt fence and hay bales near the top of the slope adjacent to the wetland and placing loose straw on the disturbed soil.

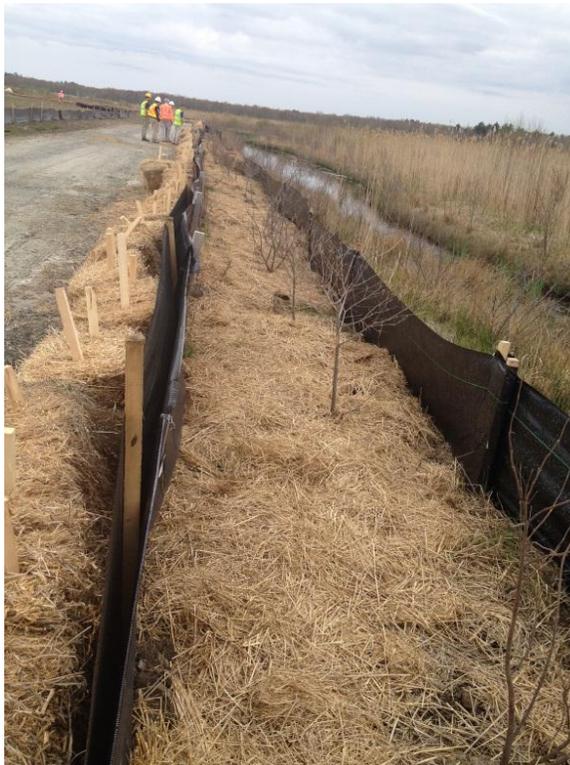
Photo 6: The Phase II Restoration Area shrubs that were damaged were replanted to the extent possible and will be monitored for survivorship.

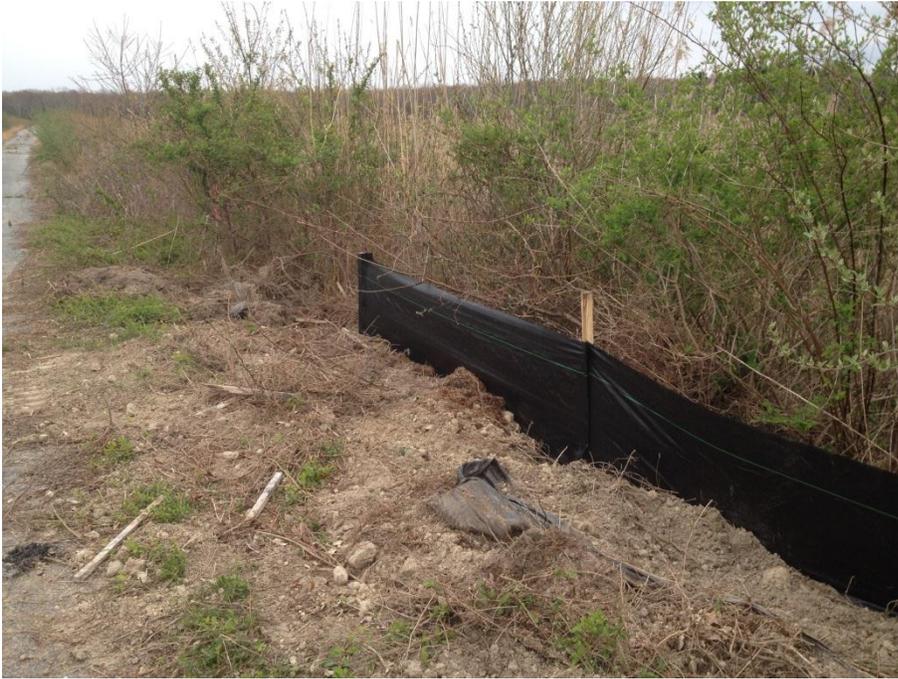
Silt fence has been partially installed along the ILS road. The Contractor is seeking approval to substitute a filter sock or compost tube for the silt fence required on the approved plans. The Contractor reports that the perimeter road on the north side of the ILS road is “shrinking” in width and they need to widen it for construction access (**Photo 7**).

Photo 7: The Contractor proposes to use silt sock/compost tube along the western end of the ILS road instead of a silt fence/hay bale barrier. MassDEP approval will be sought for the change to the E&S barrier before implementation can occur.

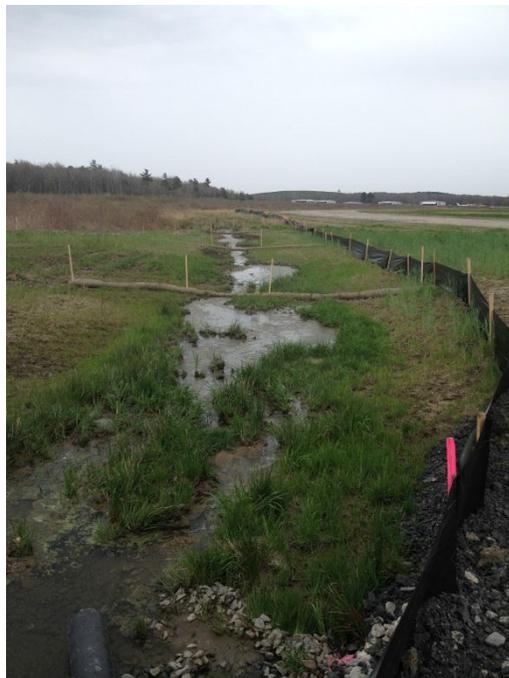
A temporary culvert was observed to have been placed in upland area under the temporary access road on the RW23-end; however, the infiltration basin is adjacent to the wetland and appears to be now connected (**Photo 8**).

Photo 8: An infiltration swale was established on the on the RW23-end to control water on the haul road.

- 1. Develop a more long-term strategy to reduce the water load in RW5-end RSA. Strategies may include pumping of water into filter bags in upland areas or raising the grade of the gravel access road;**
- 2. To prioritize removing the solids and sediments that was deposited into the West Ditch as a result of the erosion control failure;**
- 3. Submit a Restoration Plan to repair damage to the Phase II restoration area to MassDEP as soon as possible so that appropriate repairs can be implemented; and**
- 4. Visually monitor water quality and perform necessary corrective maintenance in temporary swale on RW23-end.**

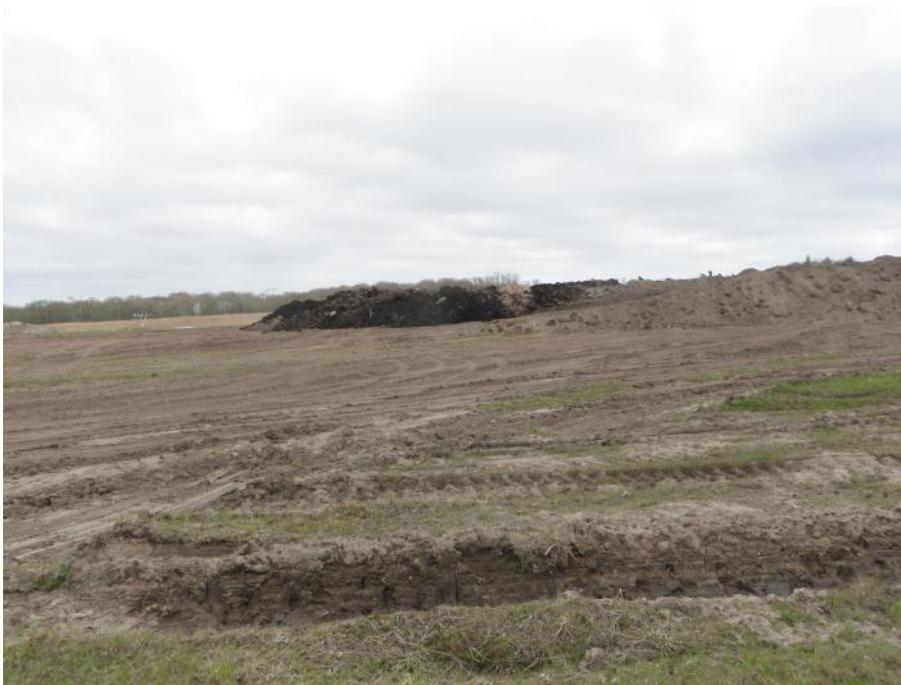
Photo 2: Stockpiled material remains in the RW5 RSA. Additional organic material from the Taxiway A construction is obvious at the northern end of the pile.

No perimeter controls were observed around the stockpile.

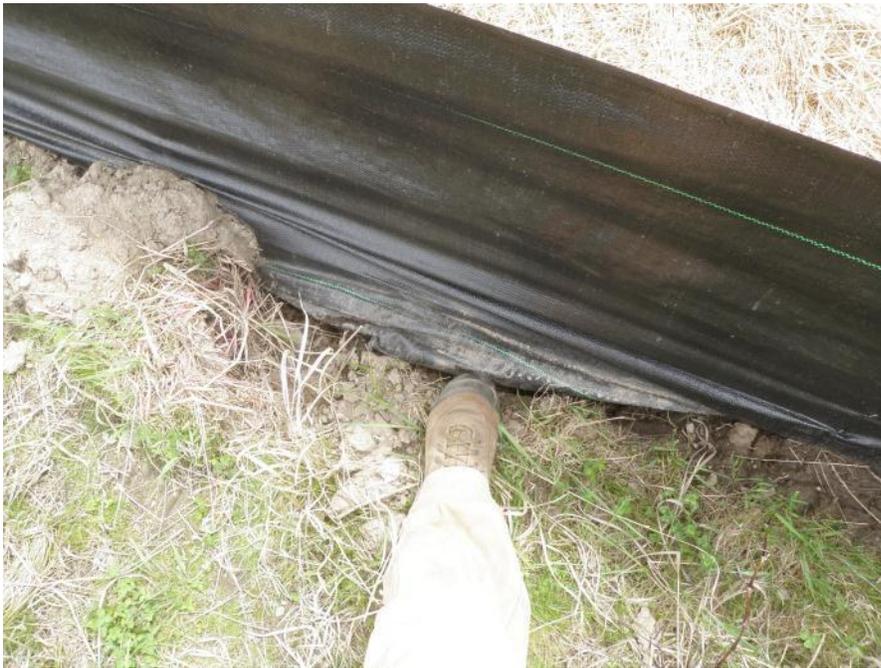
Photo 3: A small section of the newly installed silt fence barrier along the West Ditch was not set into the ground properly. The section was repaired during the inspection.

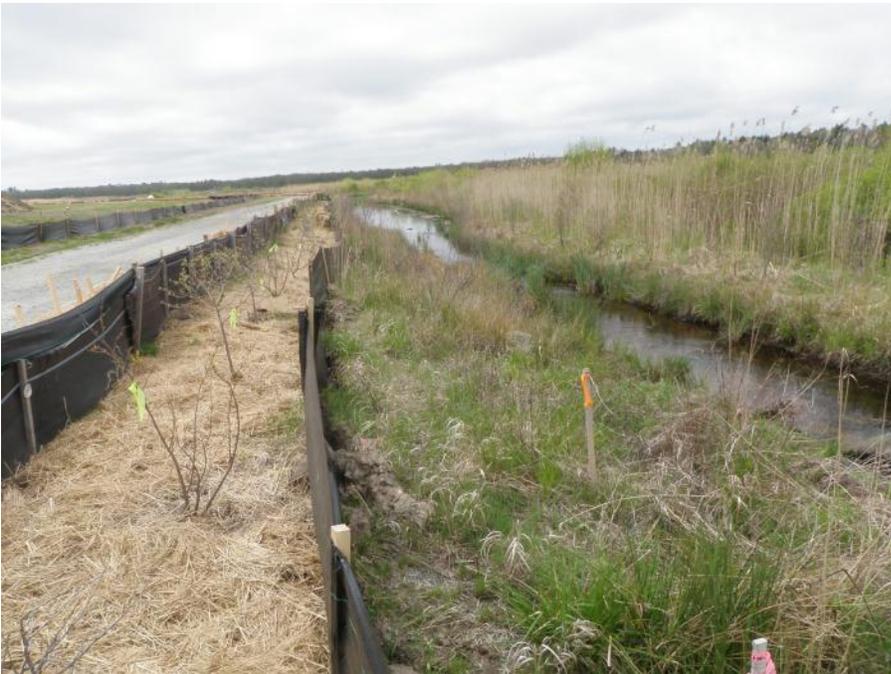
Photo 4: The recently repaired area along the West Ditch appeared to be stable. Although, exposed soil outside was observed and should be covered with mulch to prevent sedimentation into the wetland.

1. Continue to monitor the E&S barriers throughout the site;
2. Cover any exposed soil surfaces with mulch that are located between the E&S barrier and the West Ditch;
3. Continue to monitoring the replanted shrubs for viability issues; and
4. Monitor pending weather conditions and plan work accordingly.

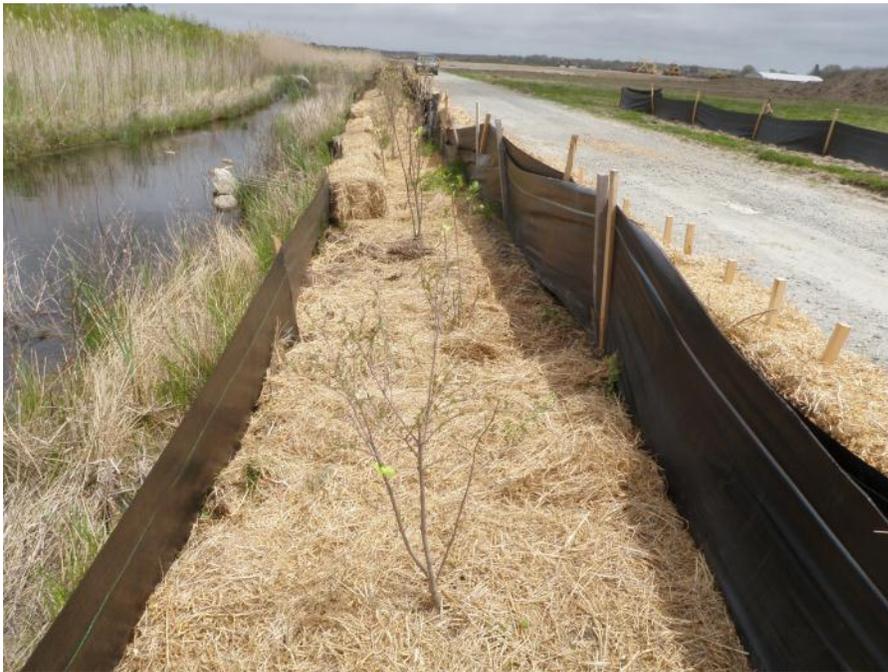
Photo 5: The vast majority of the replanted shrubs appear to be healthy and putting out leaves normally. A few shrubs appeared to be stressed as evidenced by weak leaf growth or no obvious leaves.

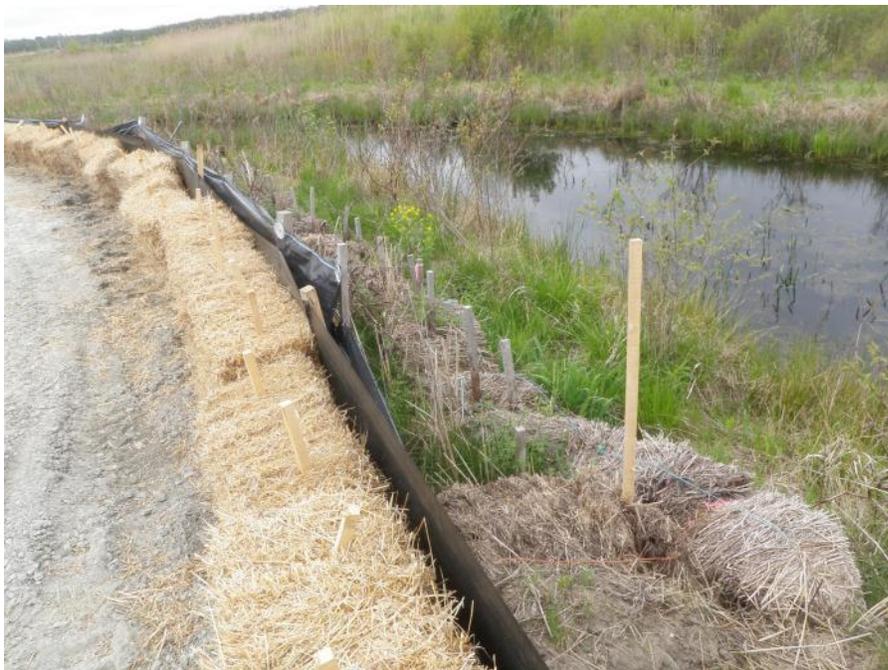
Photo 6: The older hay bale barrier located at the curve in the haul road near the ILS road intersection and the West Ditch appears to be unnecessary. The removal of the hay bales is likely to allow more vegetation to develop in this area.

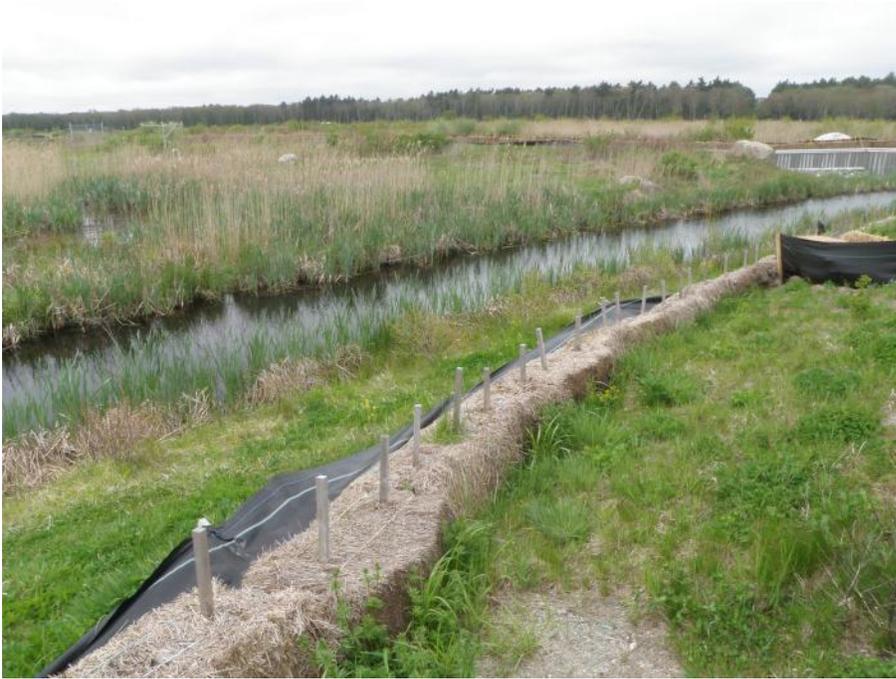
<u>ILS Road</u>		
<ul style="list-style-type: none">• The lower row of planted shrubs along the West Ditch, south of the RW5 RSA are not visible and based on site conditions are assumed to have drowned. The upper row appeared to be healthy (Photo 7).

Photo 7: The lower row of planted shrubs along the West Ditch, south of the RW5 RSA are not visible and based on site conditions are assumed to have drowned. The upper row appeared to be healthy.

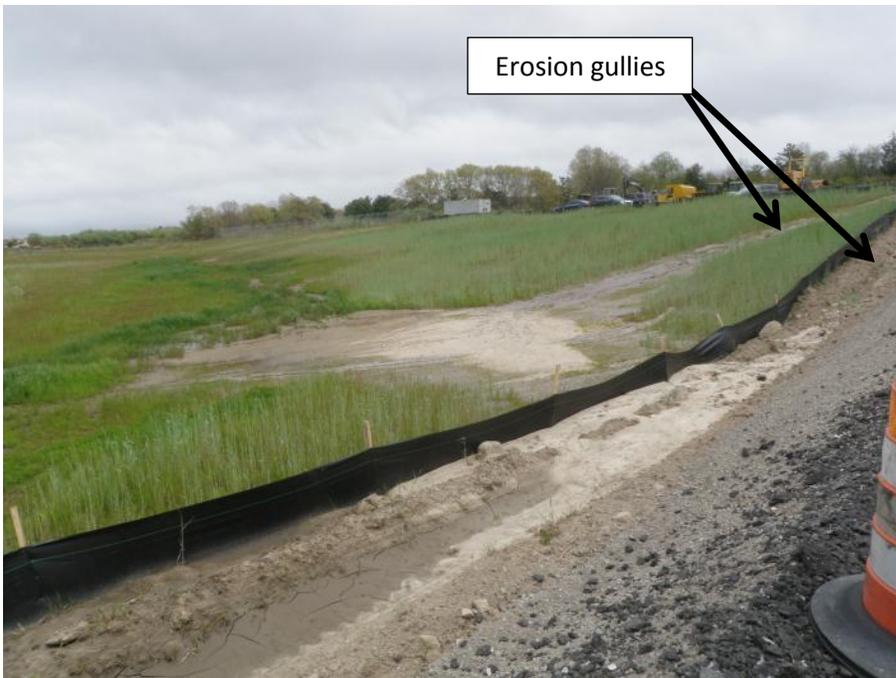
Photo 8: Two erosion gullies were observed near the access road to the RW 23 end. However, no evidence of sedimentation was observed down gradient (wetland side) of this area.

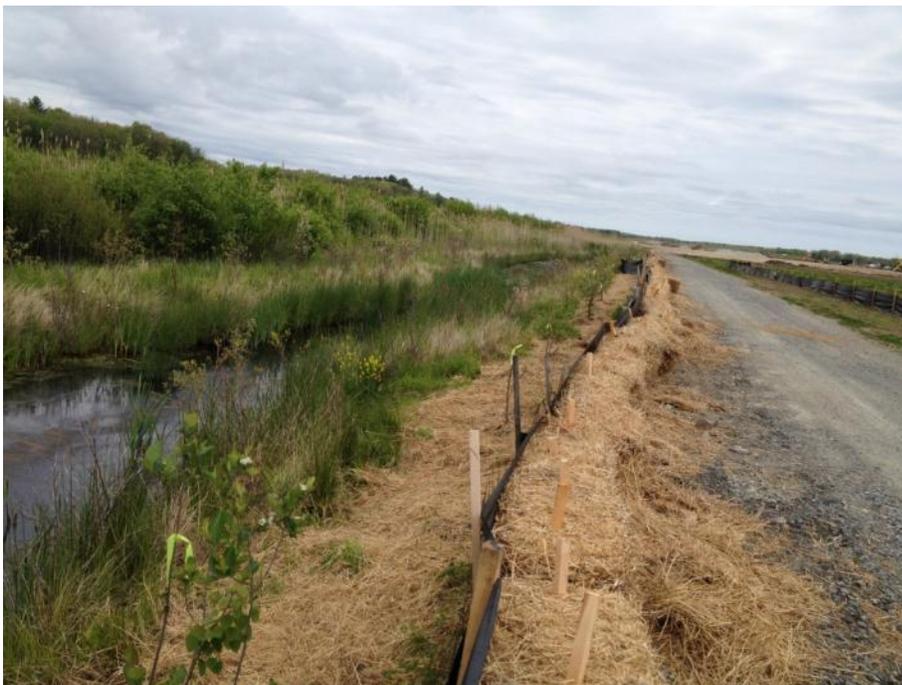
Photo 2: The EM placed green flags on restoration plantings that were damaged/removed during contractor activity. The WS and EM are monitoring health and survivorship of the impacted plants.

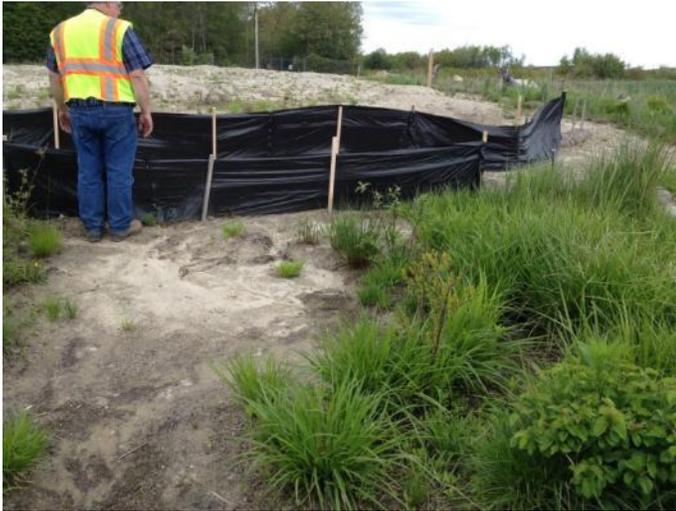
- Sand materials from the Area 3 was evident in Site 6 and the accumulated sand area is approximately 200 square feet in size (**Photo 5**). Based on the configuration and current condition of the E&S controls in this area, it is assumed that some corrective actions had previously been taken (**Photo 6**). The EM indicated that some mitigation measures, such as additional silt fence and hand-removing accumulated sand from the wetland had previously been completed. The EM further indicated that they were developing a long-term plan to address the sand migration issue. Please note that Area 3 and Site 6 were constructed during a previous Phase of the overall project.

Photo 5: Some material from Area 3 has migrated into the Site 6 wetland replication area (~ 10' x 20' area impacted). Temporary measures have been taken to arrest the migration of additional sand.

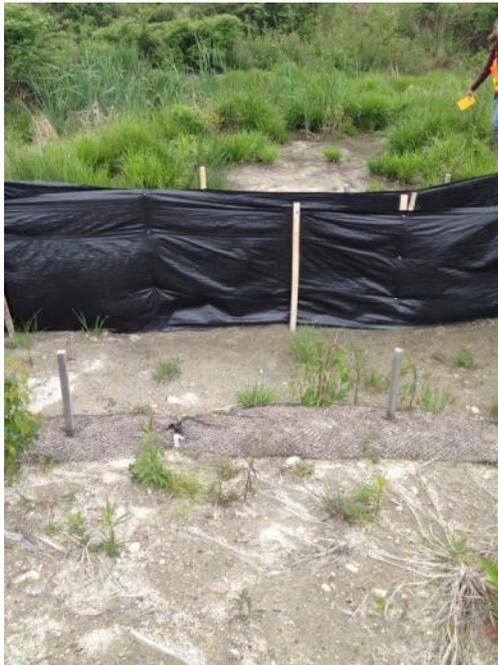
Photo 6: Multiple layers of silt fence and straw wattles have been installed to help control migration of sand from Area 3 into Site 6.

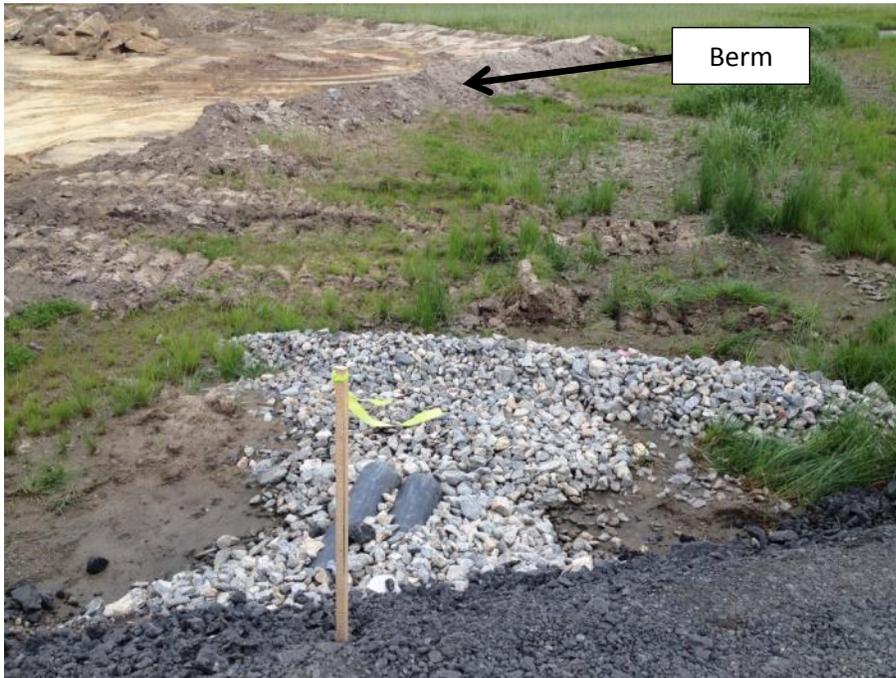
- The WS reported that there appears to be groundwater seeping into the site on the RW 23-End and a berm was constructed to keep water from ponding on the access road and outside of the wetland; however, a machine ran over the berm and flattened the grade closest to the inlet side of the cross culverts (**Photo 7**).
- The infiltration trench continues to receive water but no evidence of sedimentation was observed in the wetland on the down-gradient side of the road (**Photo 8**).
- The water control truck applied water to the Runway 23 work area during the sit einpection.

Photo 7: A berm has been constructed around the lower portion of the work area on the RW23-End to address groundwater issues in the work area. A piece of heavy machinery appears to have backed over the berm.

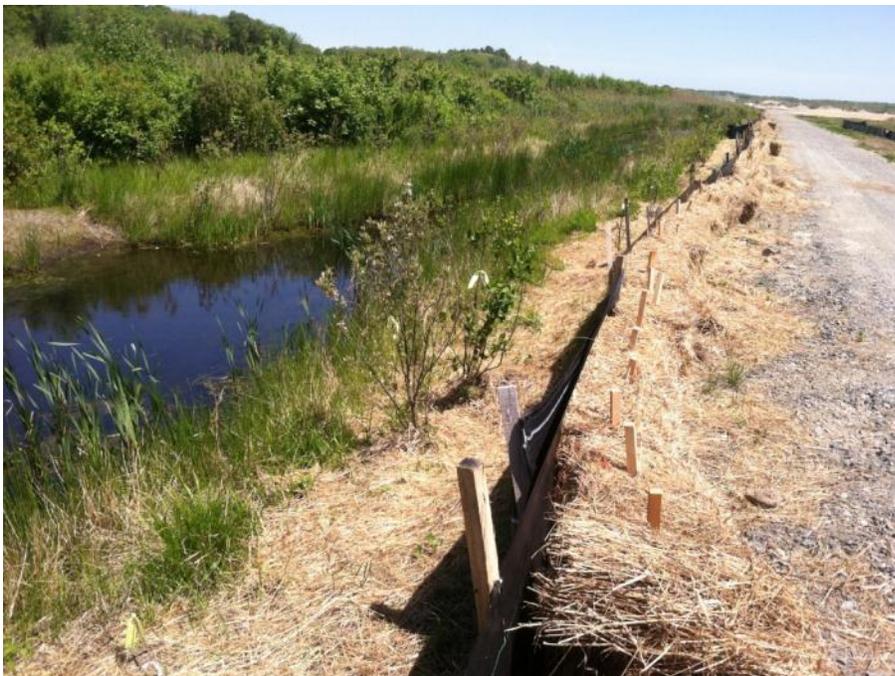
- The EM/WS indicated that currently 55 shrubs along the West Ditch had been damaged and two are currently dead. The EM stated that a true count will occur in August when enough time has elapsed to fully be able to gauge recovery (**Photo 4**).
- The West Ditch Restoration Area remains stable (**Photo 5**).

Photo 4: View of previously damaged shrub plantings along haul road West Ditch.

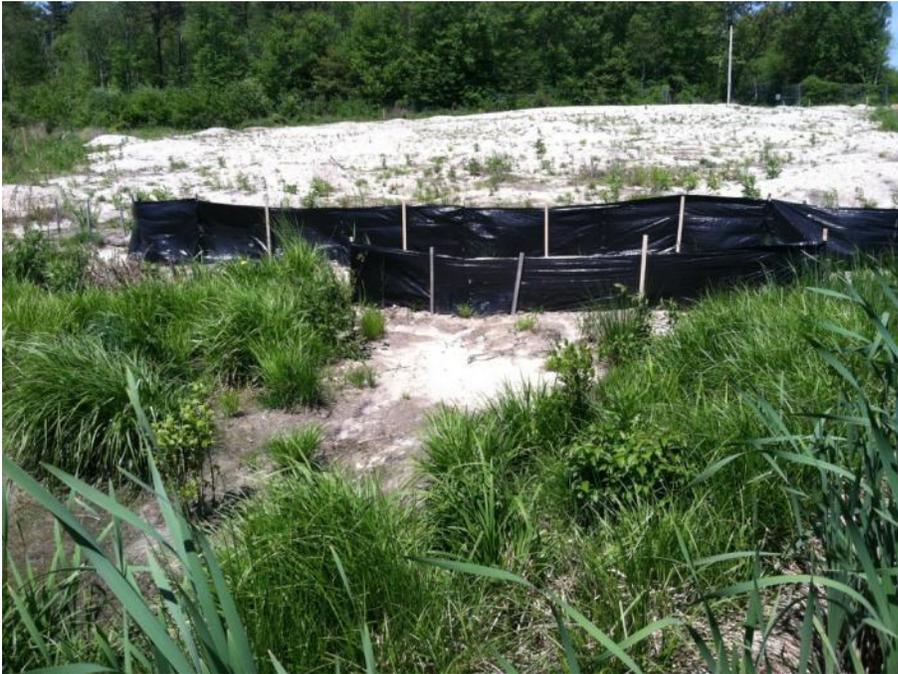
- Accumulated sand is evident in Site 6 and originating from Area 3 (**Photo 9**).

Photo 9: Sedimentation was observed in Site 6 originating from Area 3.

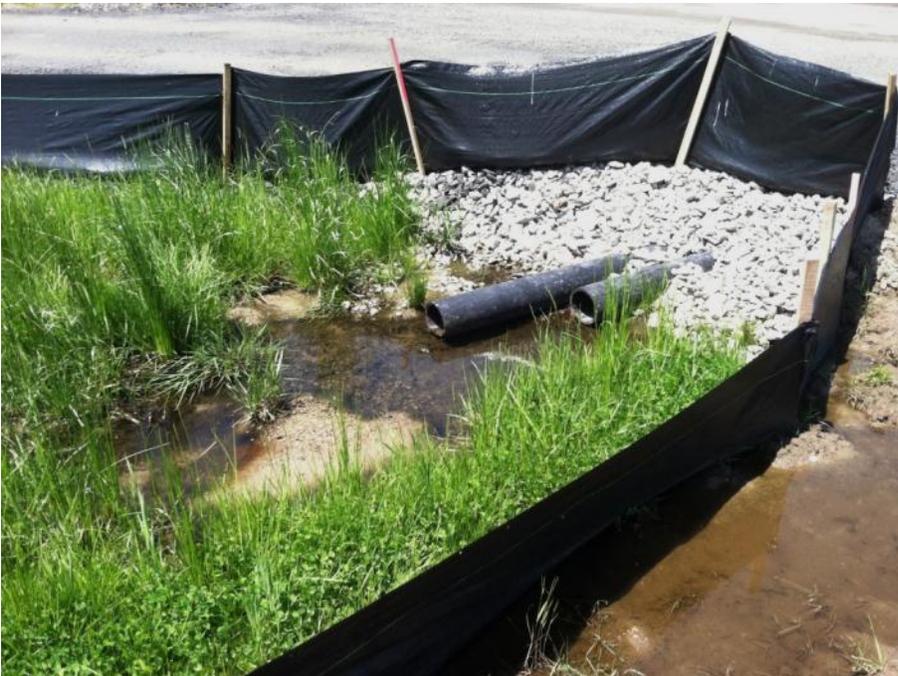
Photo 12: Temporary culverts along gravel access road on RW23-End observed to be successfully conveying flow and preventing ponding on upstream side.
