JM Fiske Environmental

NEW BEDFORD REGIONAL AIRPORT  
RUNWAY 5-23 – PHASE 4  
Reconstruct, Mark and Grove  
Weekly Environmental Report  
WEEK 8  
2014 June 14-20

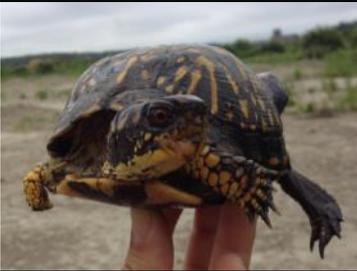
<p>Box turtle # 35 (aka “Lefty”) was found just off the sand in the turtle habitat replication area #3. This turtle was found on Thursday by Oxbow Associates and relocated to the general area. Note the missing right front foot.</p>

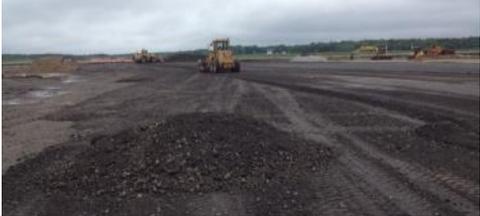
<p>Grading work started on Runway 5 in project work area II.</p>

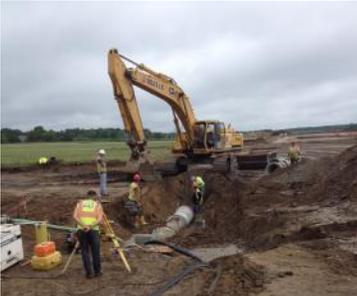
<p>Drainage pipe installation continued in project work area II on the north side of Runway 5.</p>

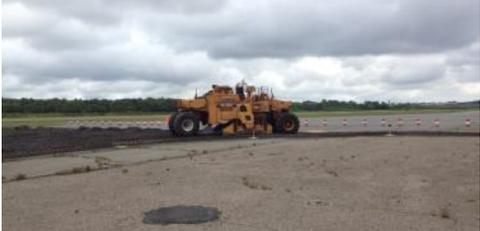
<p>An area of pavement between Taxiway D and Taxiway B was ground up. The section was included course stone and many concrete structures which increased the difficulty of the process.</p>

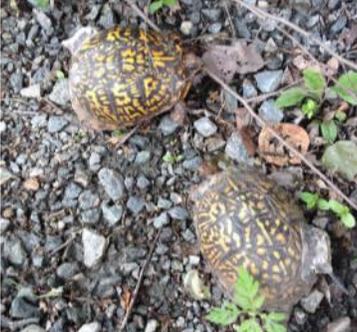
<p>While walking turtle #303 to the restoration area, box turtle #33 was found between the Shawmut Ave gate and the rolling hangar gate. This turtle was also released in Turtle Restoration area #3.</p>

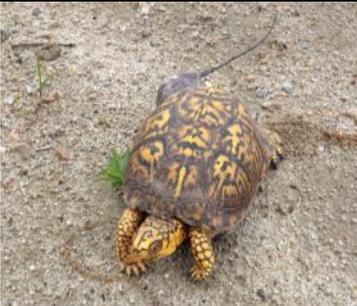
<p>At the end of the day, Turtle #2230 was found between the Shawmut Ave gate and the rolling hangar gate. This turtle was also released in Turtle Restoration area #3. Three of the four turtles found today were trying to access the contractor trailer area and were successfully excluded by the turtle barriers.</p>

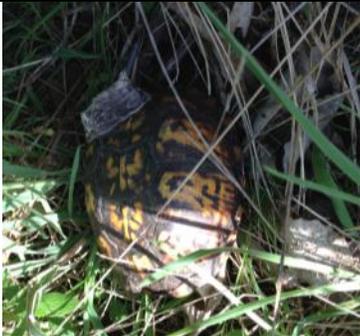
<p>Box turtle #44 was found on the north west side of turtle habitat restoration area #3. The turtle was left undisturbed.</p>

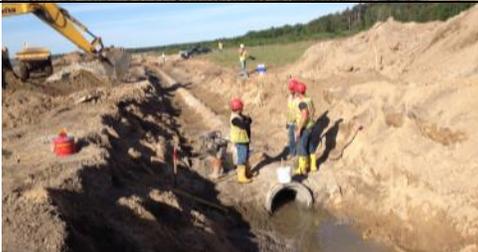
<p>Drainage pipe installation continued on the north side of Runway 5 past the intersection with Taxiway B.</p>

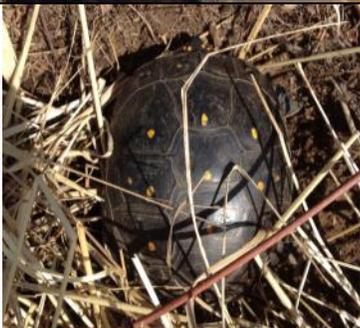
<p>A painted turtles have been found in increasing numbers on the ILS road.</p>

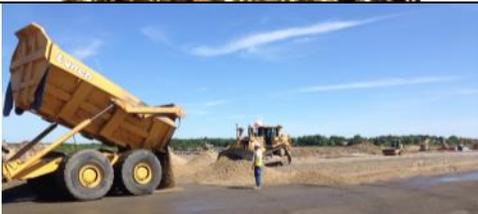
<p>PT209 was distributed, roughly graded, watered, and rolled on the north side of Runway 5.</p>

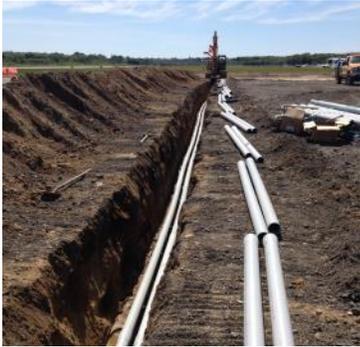
<p>The electrical subcontractor trenched and installed conduit across Runway 5 near the intersection with Runway 14/32.</p>

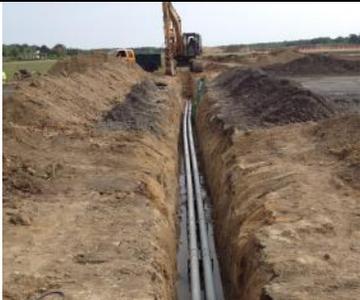
<p>The electricians completed and backfilled their conduit trench across Runway 5. The also excavated, installed, and poured concrete in the conduit trench across Taxiway B on the north side of Runway 5.</p>

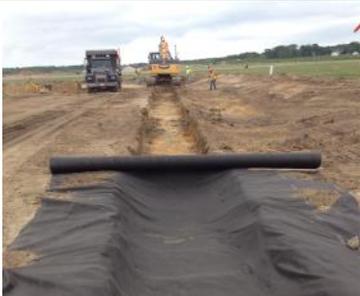
<p>Infiltration trenches were installed parallel to the south side of Runway 5. Trenches for curtain drains along the side of Runway 5 were also excavated.</p>

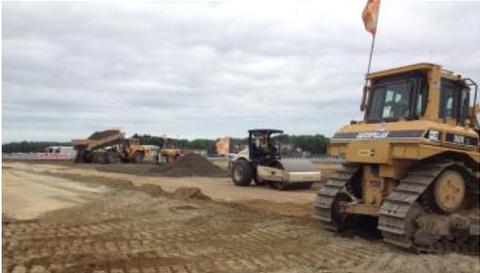
<p>Runway 5 and Taxiway B were repeatedly graded, watered, and rolled throughout the day. Excess material was removed from the site and suitable material was delivered.</p>

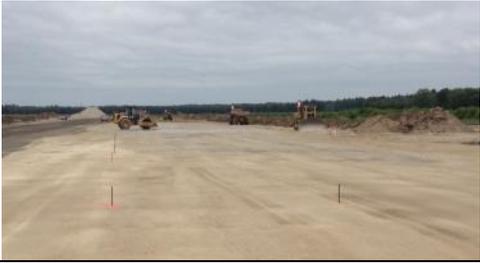
<p>Paving subcontractor Lynch continued to laydown PT209 on the north side of Runway 5 in work area I. They reached the end of the runway by mid-afternoon. The material was distributed, watered, and rolled. Density, thickness, and elevation measurements were made throughout the day.</p>

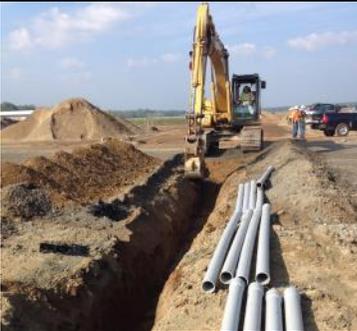
<p>A conduit trench was excavated and conduit installed by electrical subcontractor. Concrete was poured in the trench similar to the previous installations.</p>

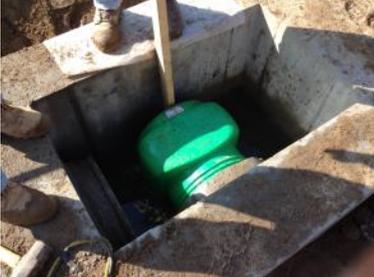
<p>End caps with a 90° downward facing opening were installed in the catch basins to limit the transport of debris through the pipe.</p>

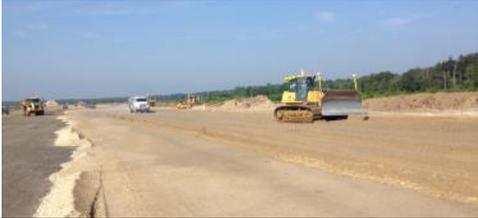
<p>Paving sub-contractor Lynch continued to distribute, water, and roll PT209 on the north side of Runway 5.</p>

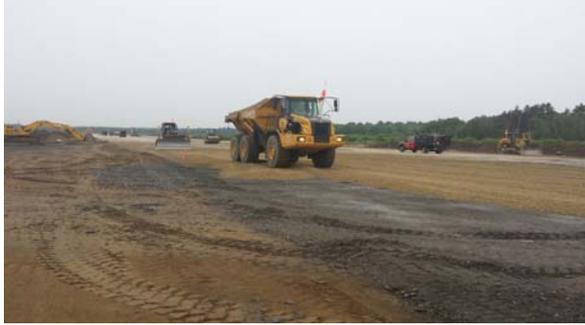
<p>Electrical Contractor continues trenching and electrical installation. Dewatering observed. Water pumped to grass area with no storm water discharge observed..</p>	
<p>Paving sub-contractor Lynch continued to distribute, water, and roll PT209 on the north side of Runway 5.</p>

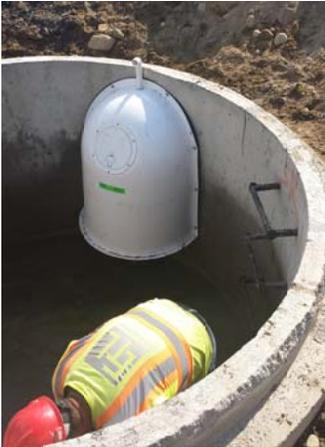
<p>ETL installed a “Snout” BMP designed to trap sediment, floatables and oil in basin.</p>

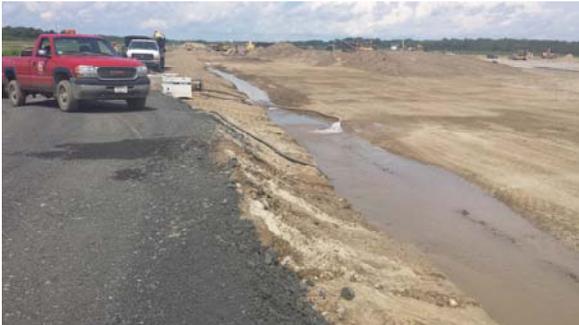
<p>While installing SNOOUT BMP – ETL dewatered basin to swale (blind ditch) on runway side of access road. Discharge was monitored and no release from swale was observed.</p>

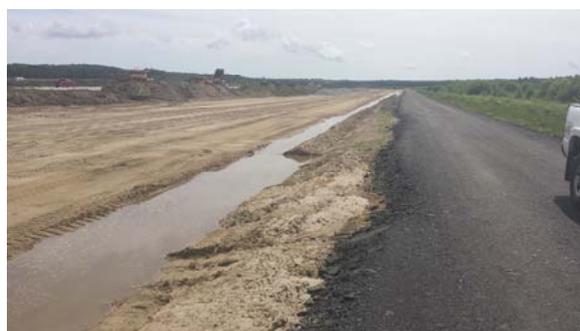
Additional view of dewatering are in swale.

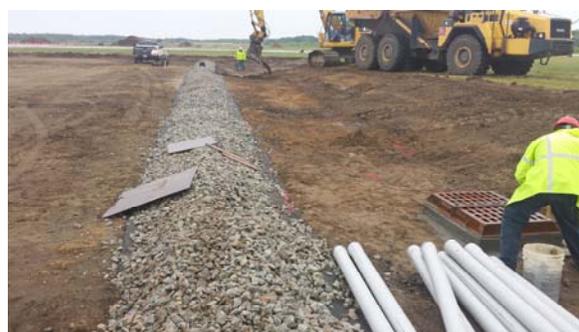
Grates were added to new drain structures adjacent to infiltration trenches under construction on 5 end of runway.

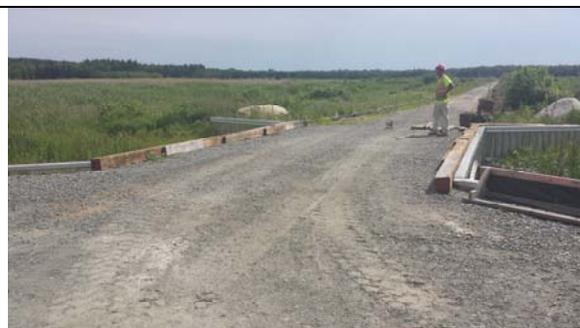
8x8 timbers were placed inside of headwall railing on west ditch culvert to protect the culvert from damage during the tree removal. The movable turtle gates were reinstalled and inspected at the end of the day.

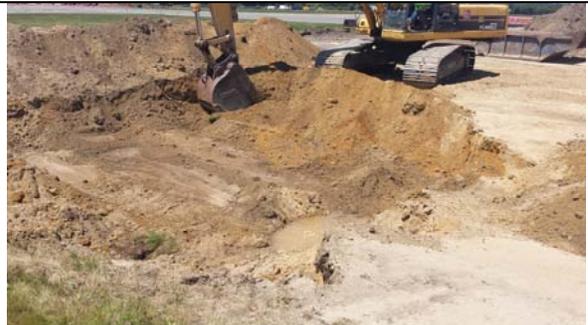
Work begins on 23 end near intersection on drainage installation.

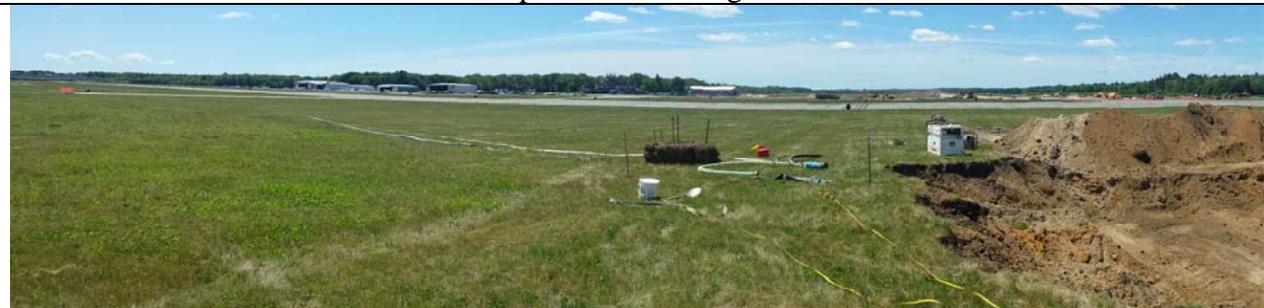
Below - View of beginning of drainage installation with dewatering setup.  
Pumps dewatered to grass.

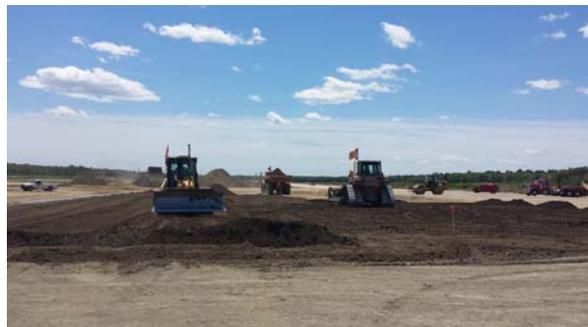
Loam is being placed between Taxiway B and D Area is expected to be hydro-seeded next week ,

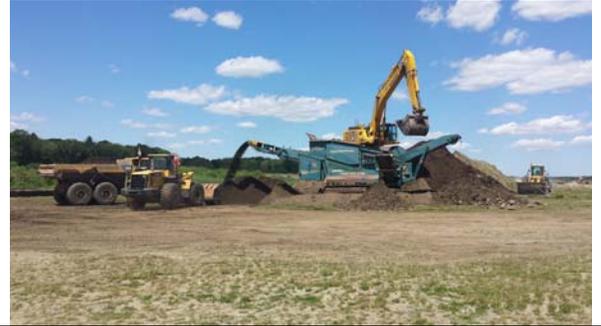
<p>Screening of large loam pile at end of Runway 5</p>

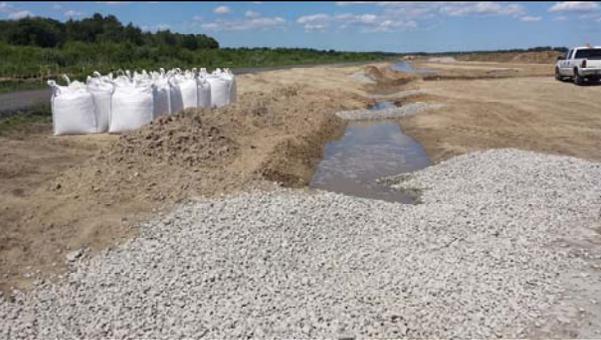
A yellow excavator is shown screening a large pile of dark loam. A yellow wheel loader is positioned nearby on a dirt field under a blue sky with scattered clouds.
<p>Installed check dams and stone swale to reduce water elevation in swale along access road.</p>

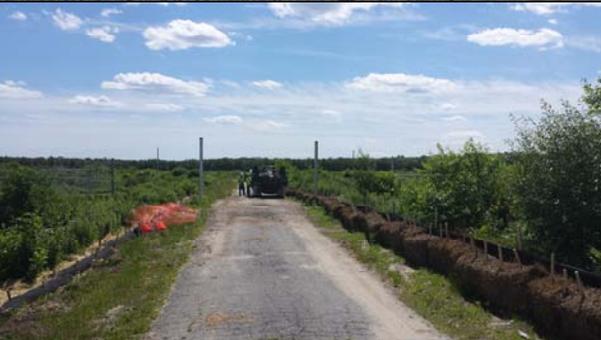
A construction site showing a stone swale and a check dam. Several white sandbags are lined up on the left side of the dirt road, and a white van is parked on the right.
<p>Cosco Fencing was on site to remove gate on ILS road in preparation of North Dartmouth clearing phase</p>

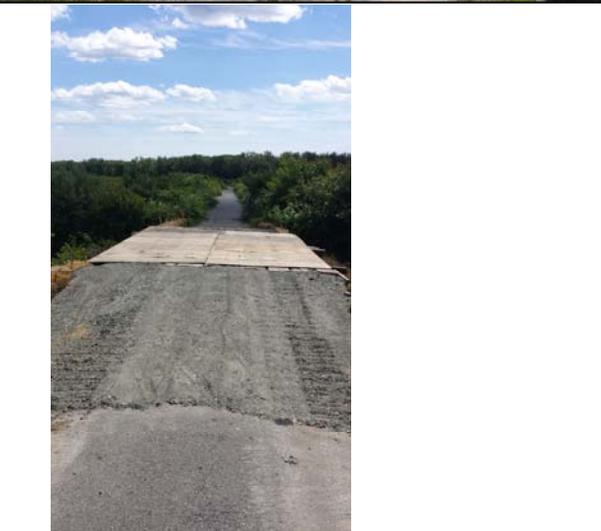
A long, straight dirt road stretching into the distance, flanked by green vegetation and a line of Cosco fencing. The sky is blue with light clouds.
<p>A temporary timber mat bridge was installed over the Paskamanset River Culverts that are failing to allow for access to the North Dartmouth section of the project.</p>
