MassDEP File No. SE 049-0635

New Bedford Regional Airport Runway Safety Improvements Project

Post Construction Monthly Wetlands Plantings Assessment – June 2014

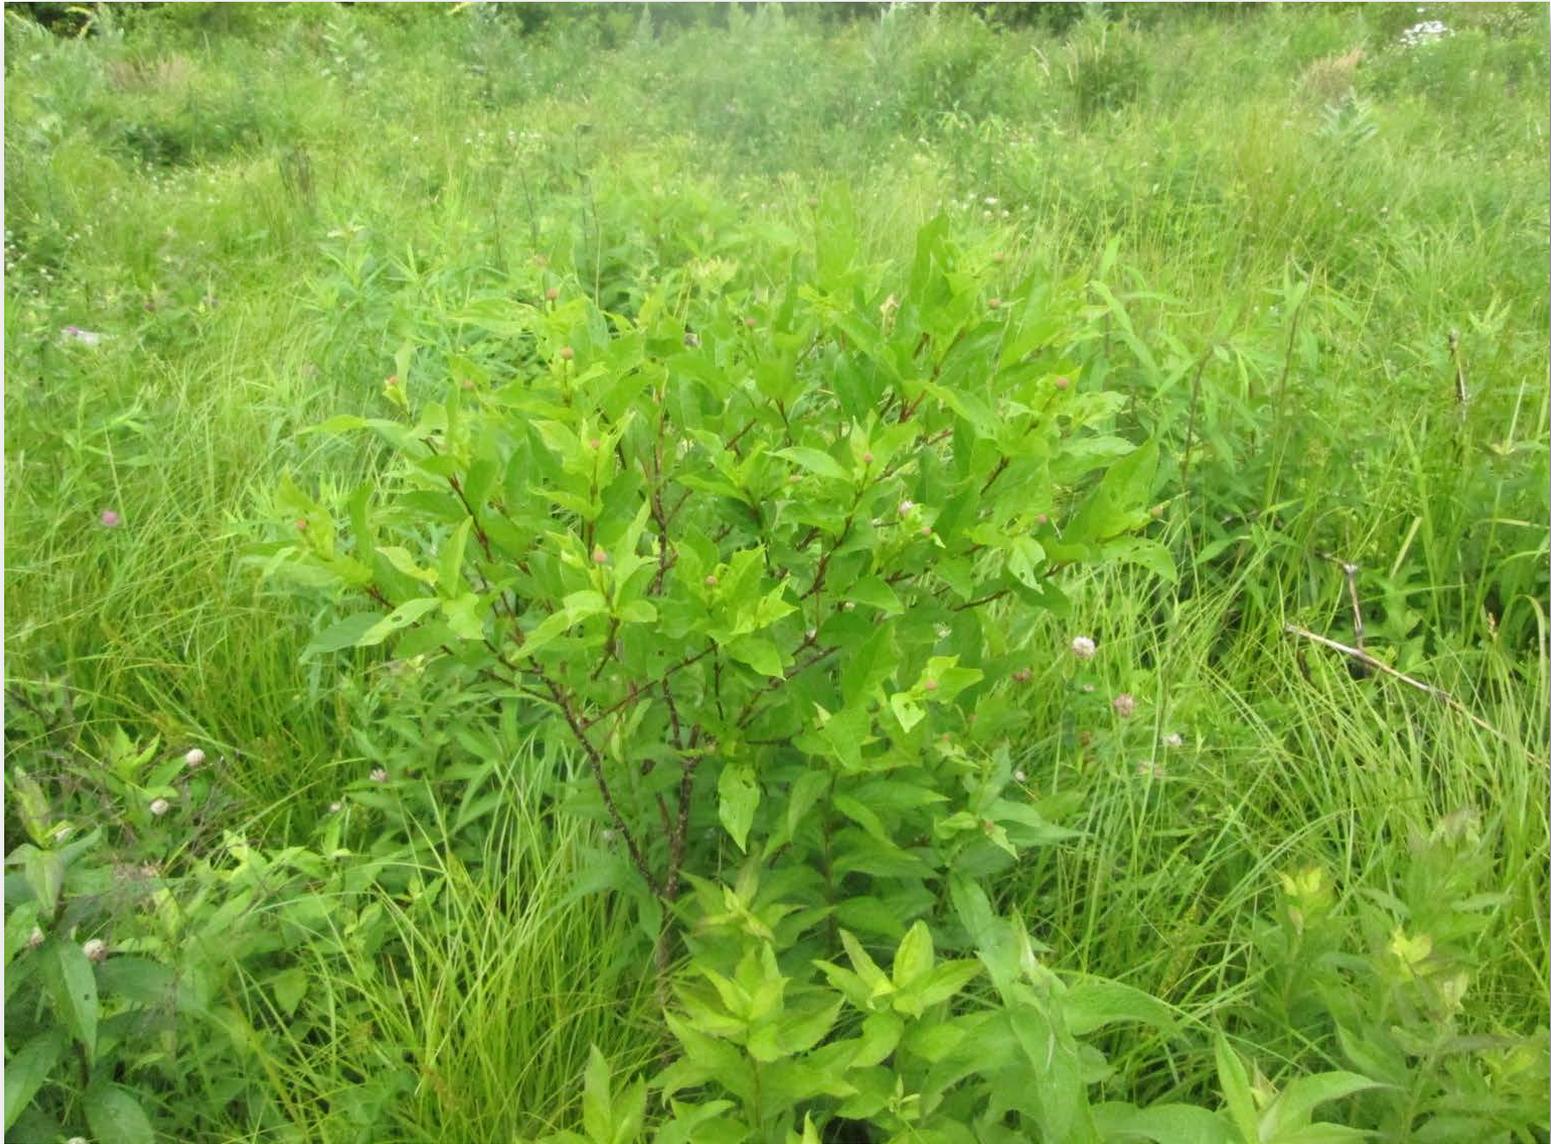
Typical view of hearty buttonbush in Site 5.

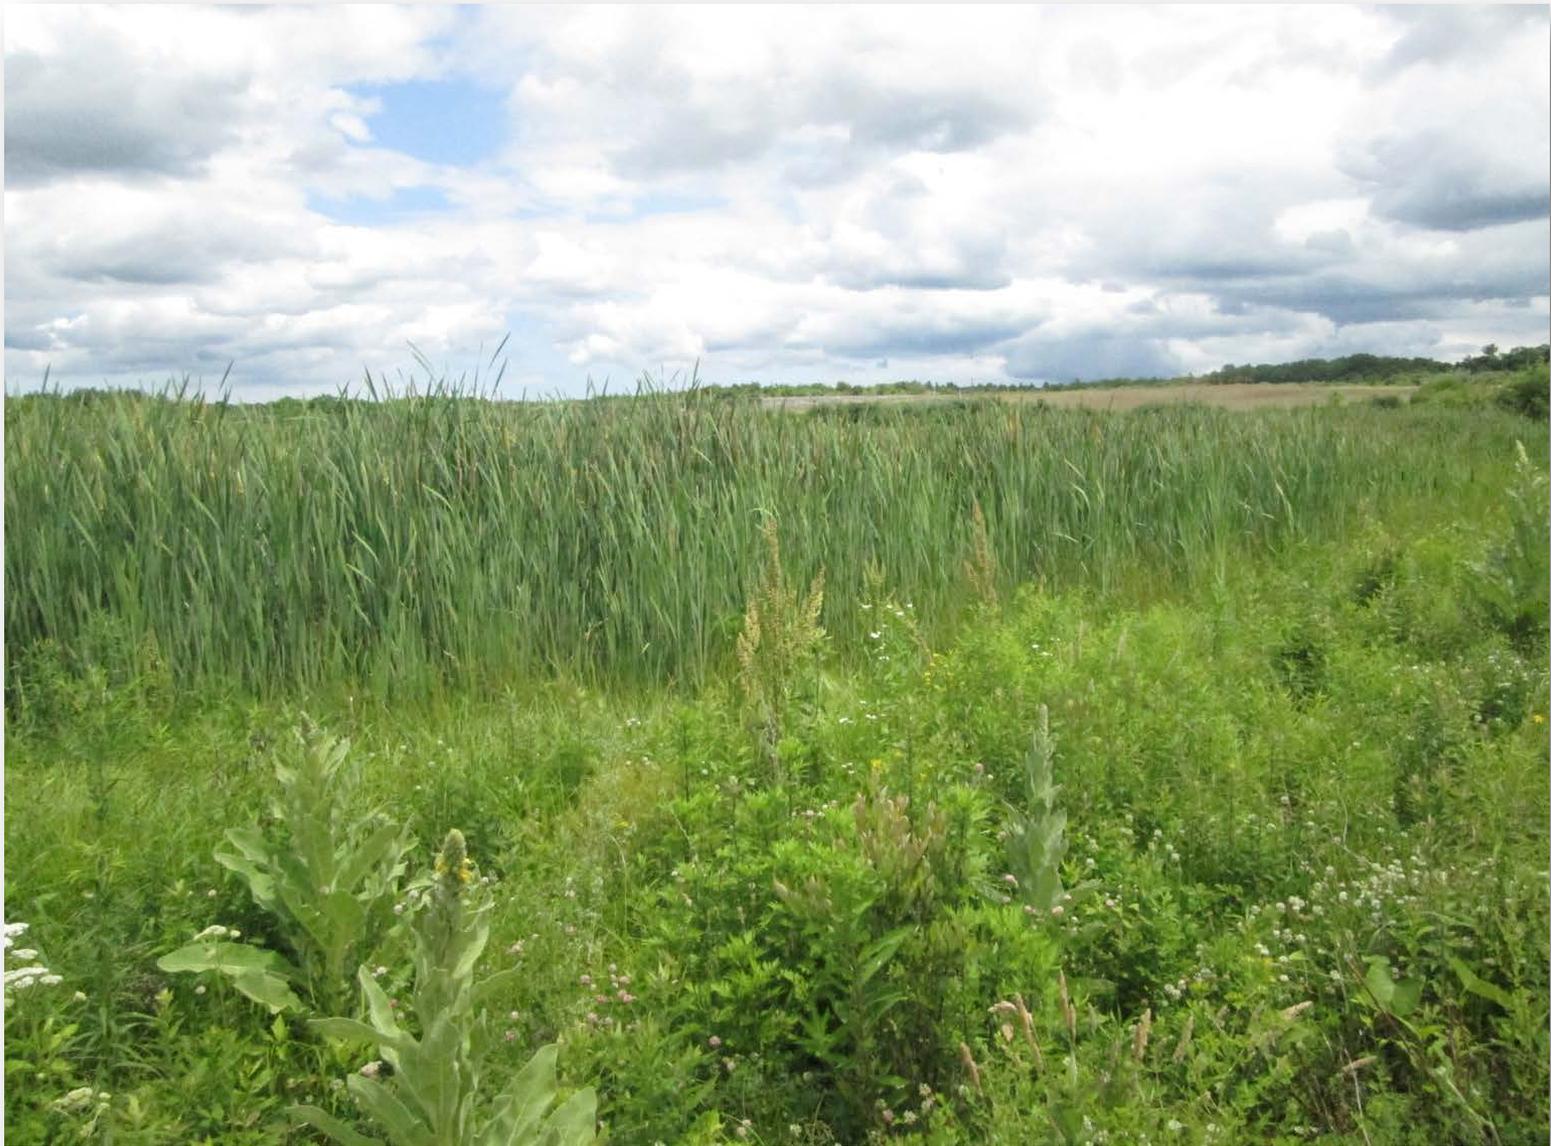
View of cattail fringe around Site 5 vernal pool from photo station, looking north.

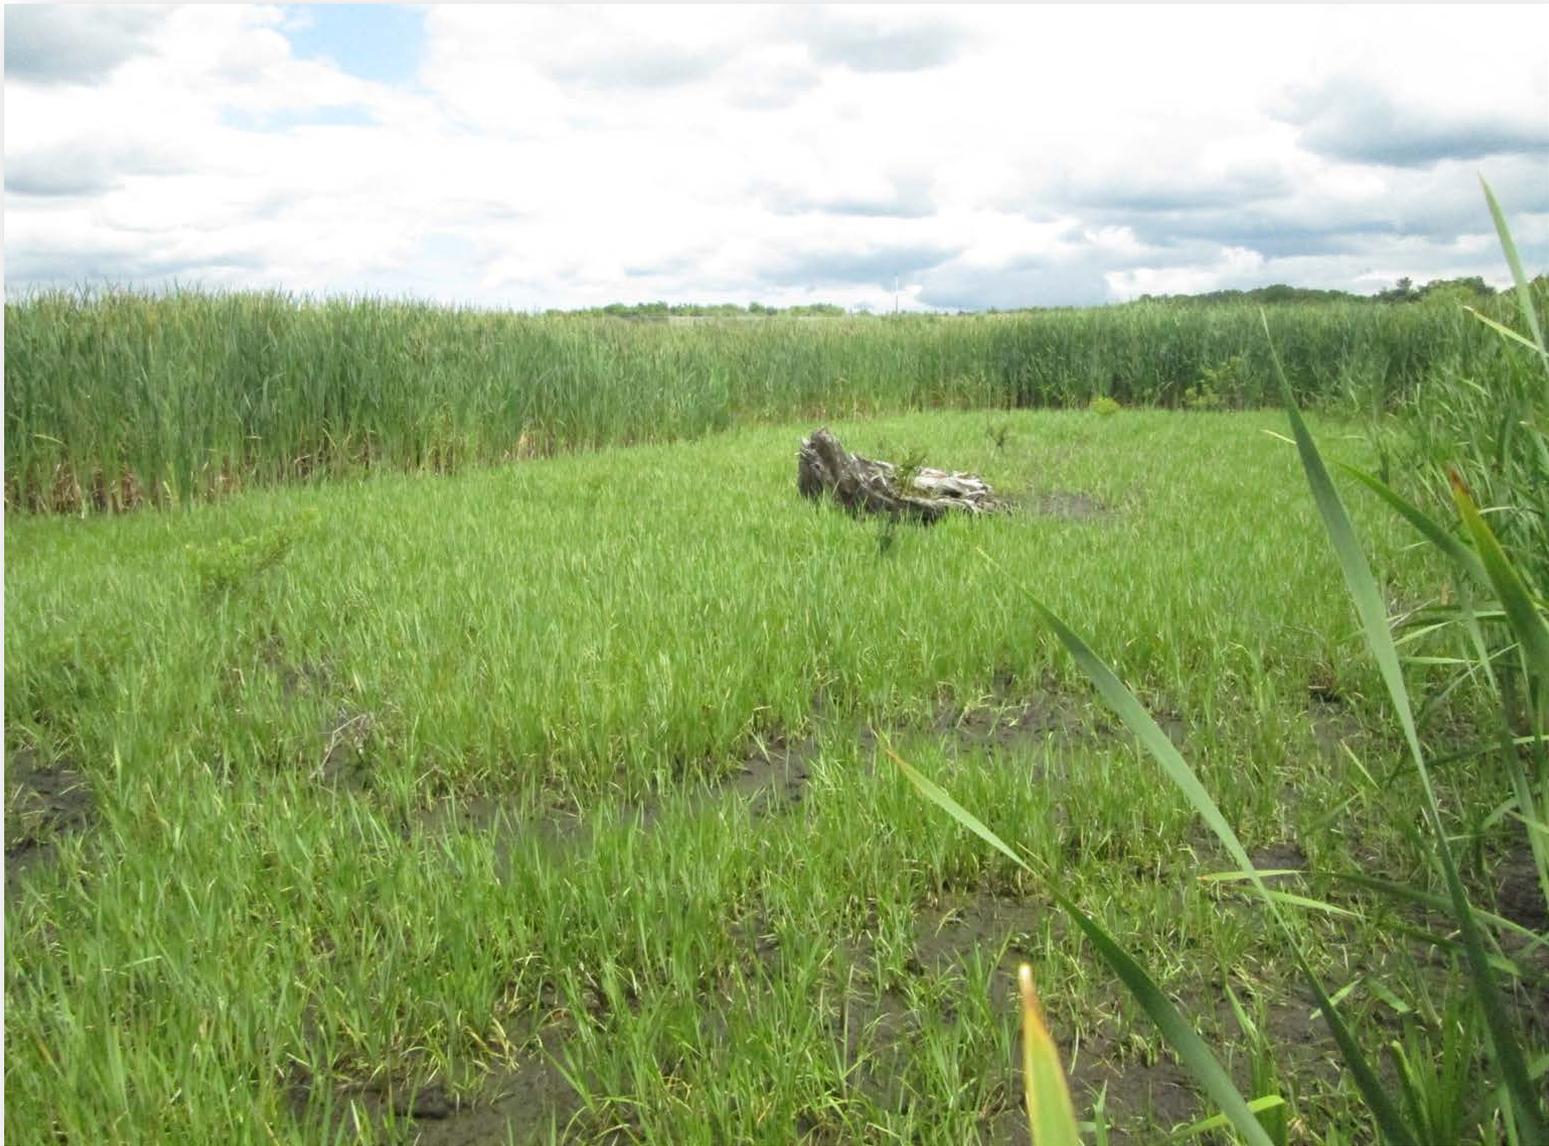
View of vernal pool edge in Site 5. This pool is saturated and soil lacks structure (due to saturation), yet standing water has evaporated. Note the herbaceous vegetation growing in the bottom of the pool (a new observation as pool historically had a mucky exposed substrate); not clear if it is Typha or another plant species. Vegetation will need to be keyed out during flowering period as the plants mature.

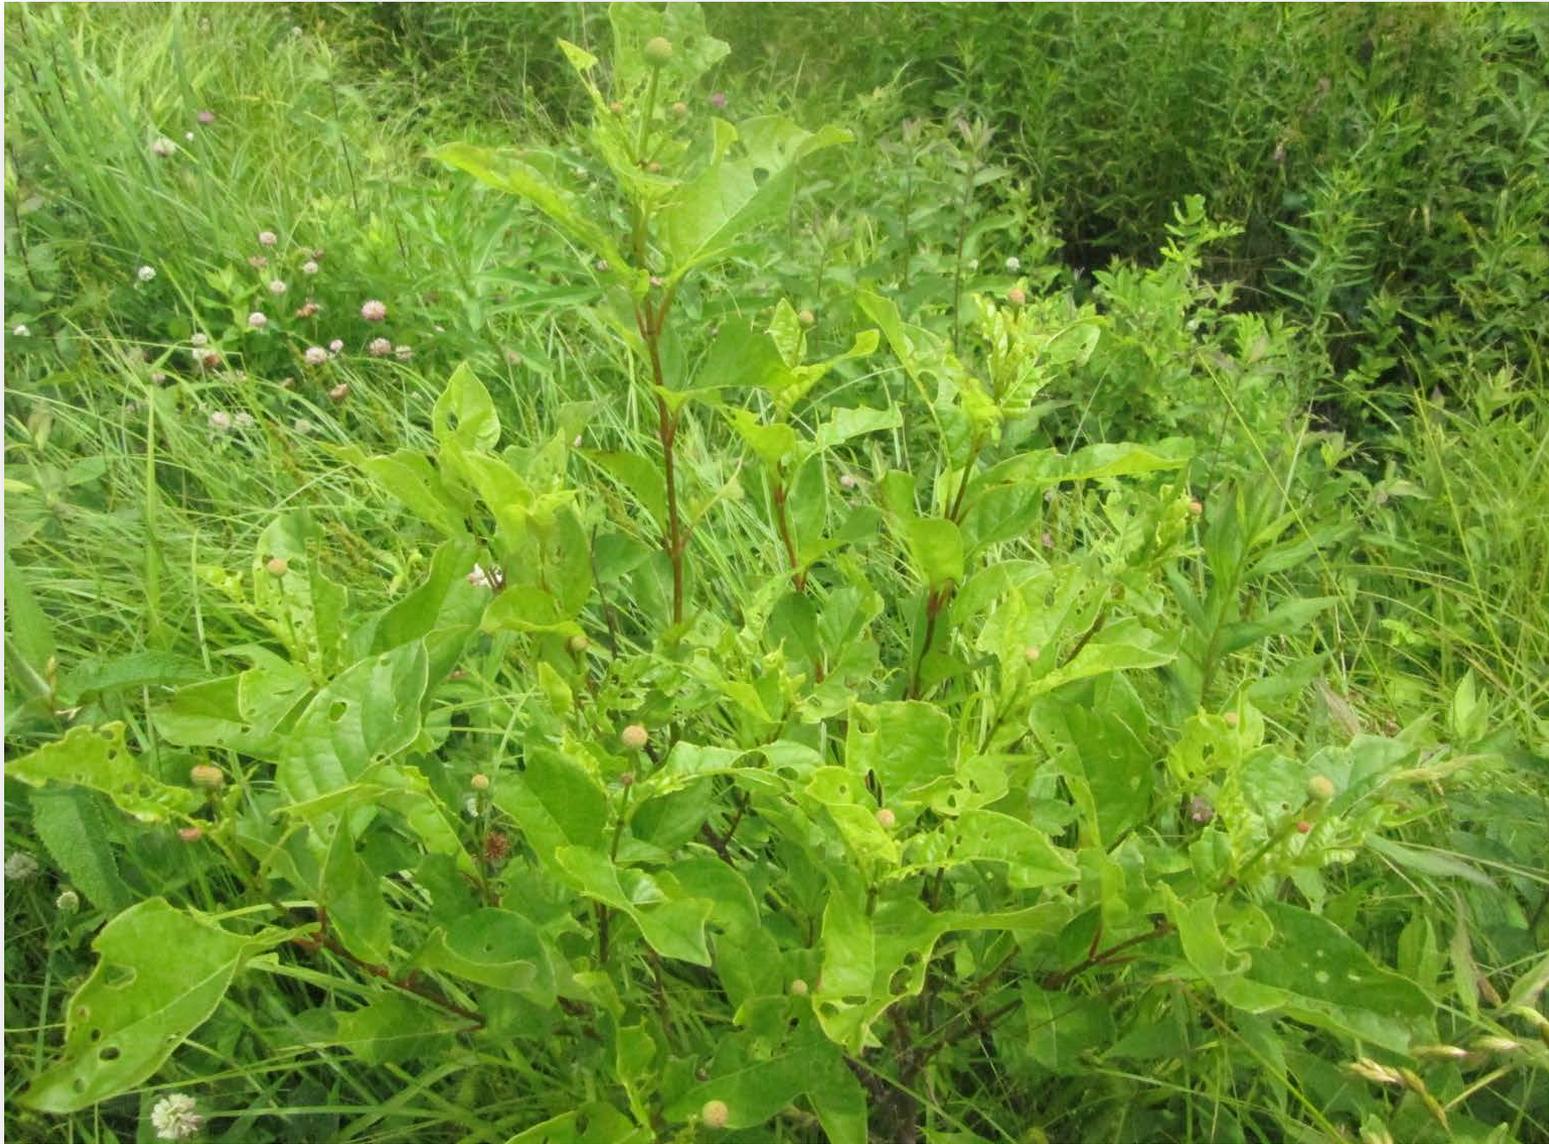
This buttonbush has some insect damage; one of only two shrubs observed with insect damage in Site 5.

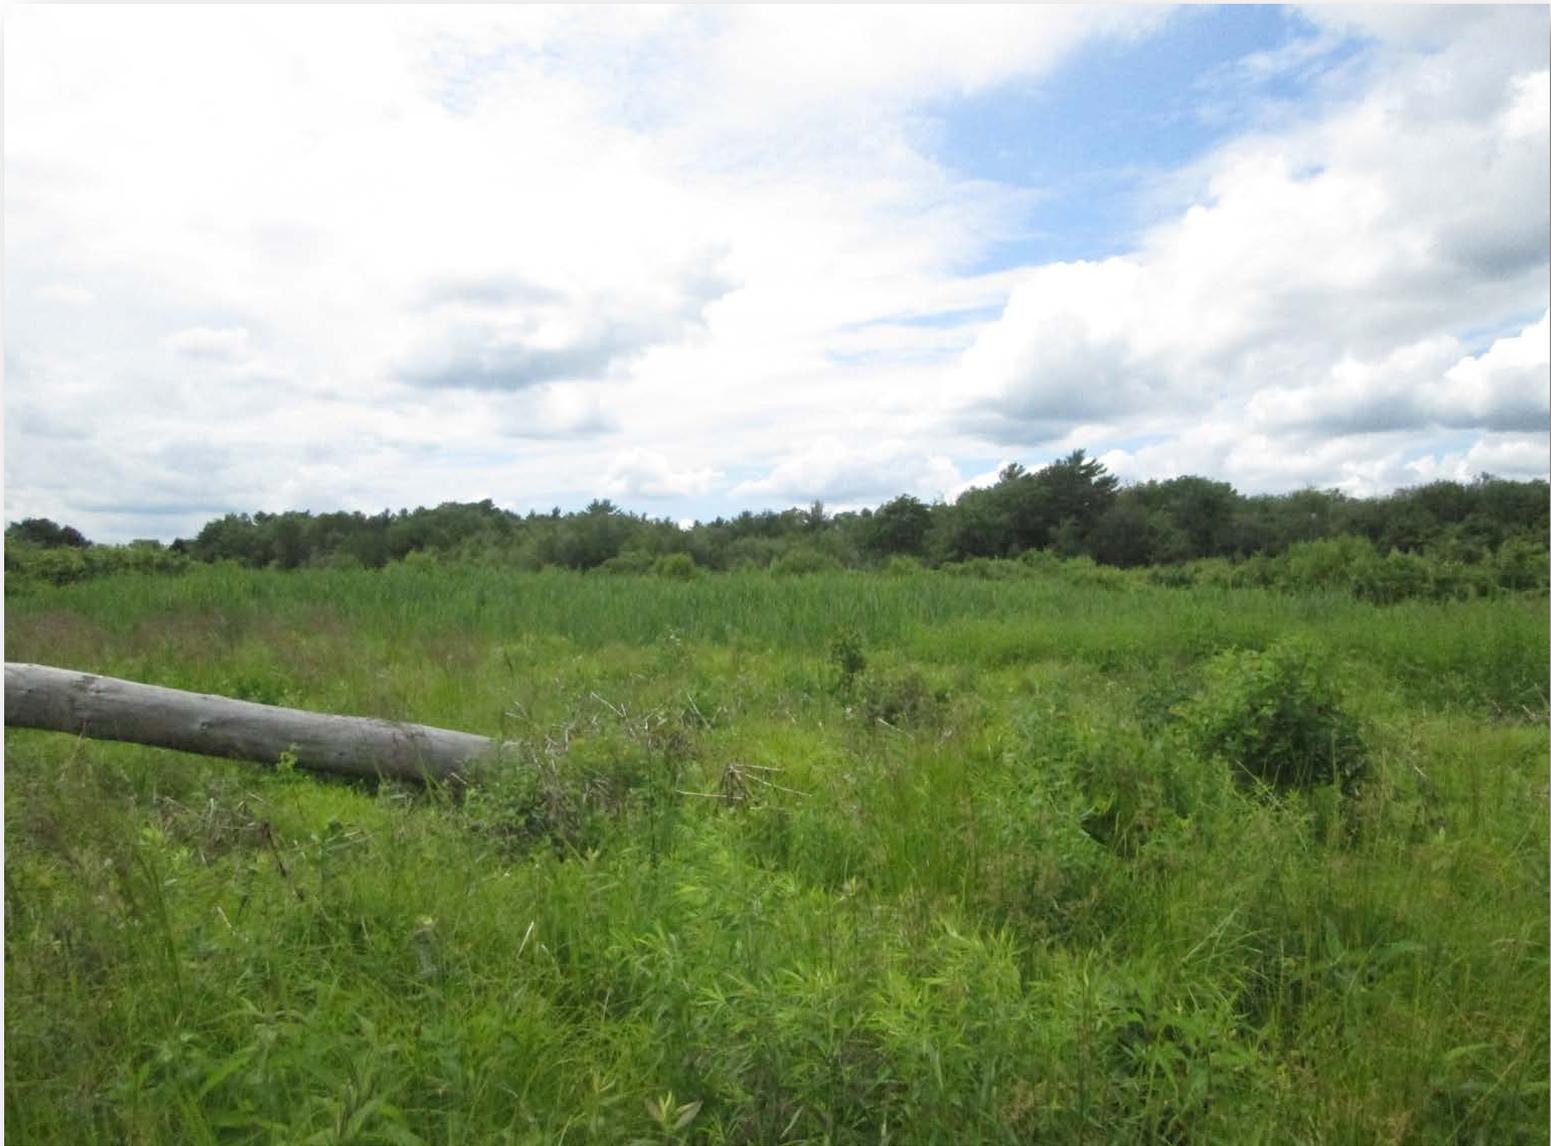
View looking southwest within Site 5. Very dense herbaceous plant growth and predominantly healthy woody shrubs throughout.

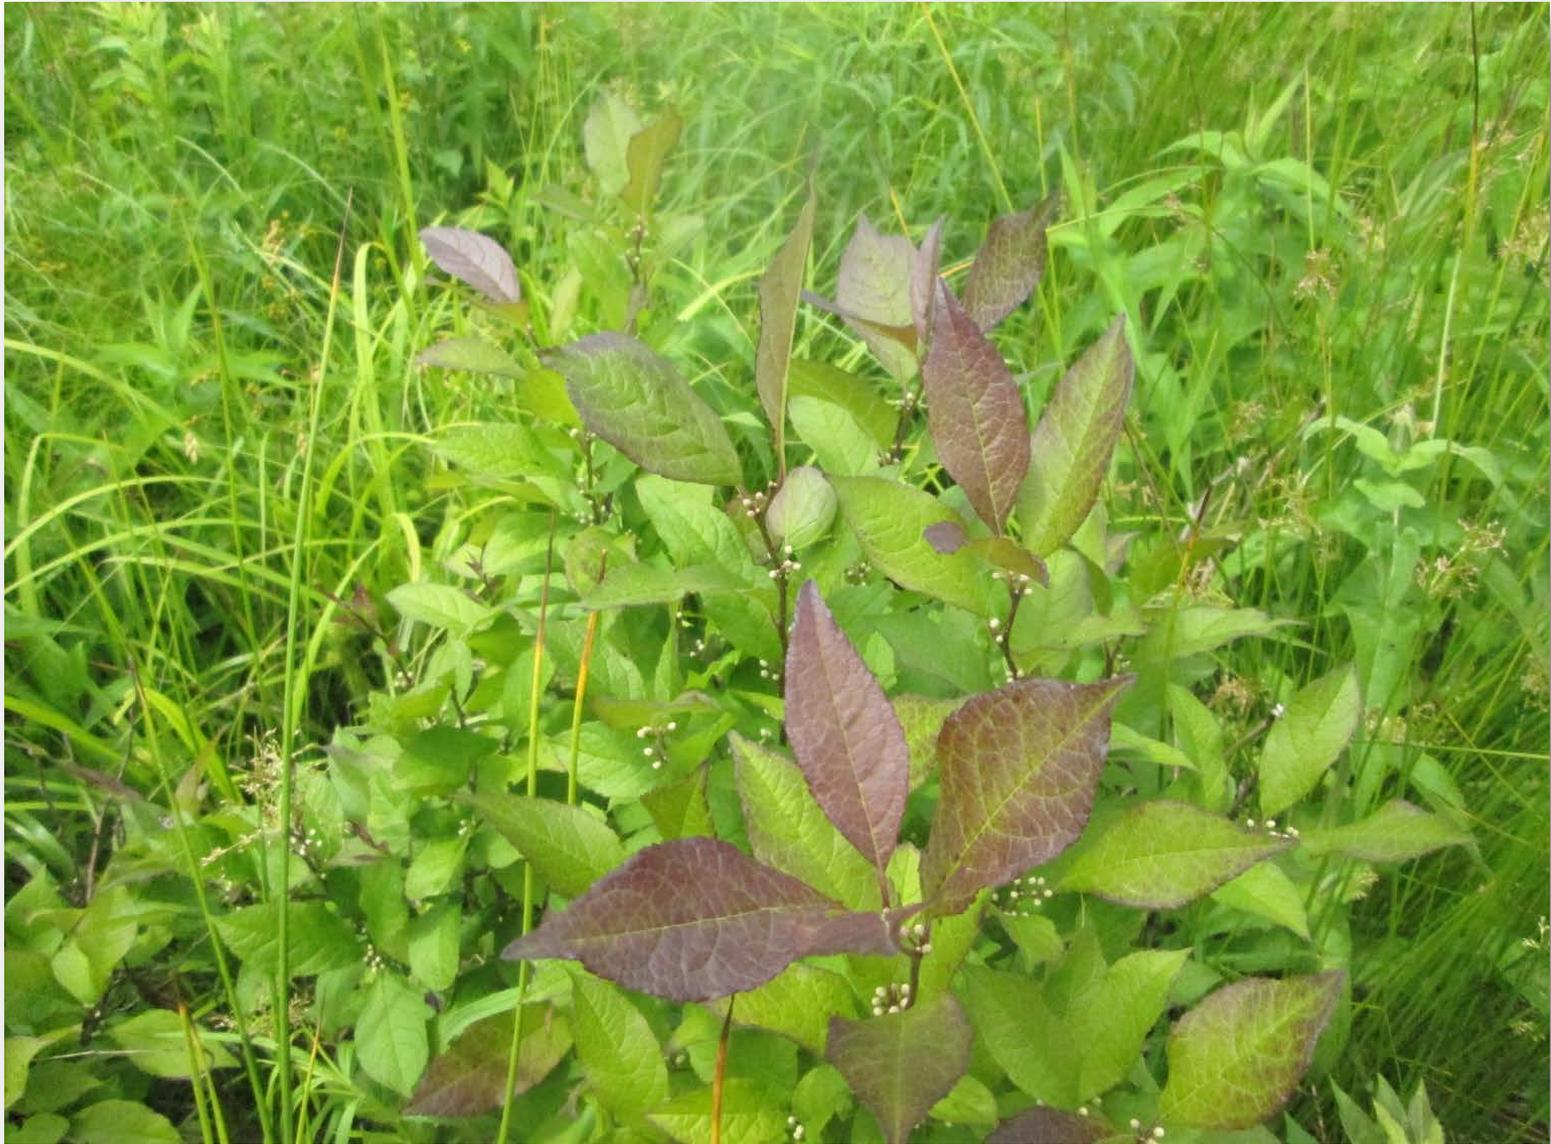
View of healthy winterberry in Site 5.

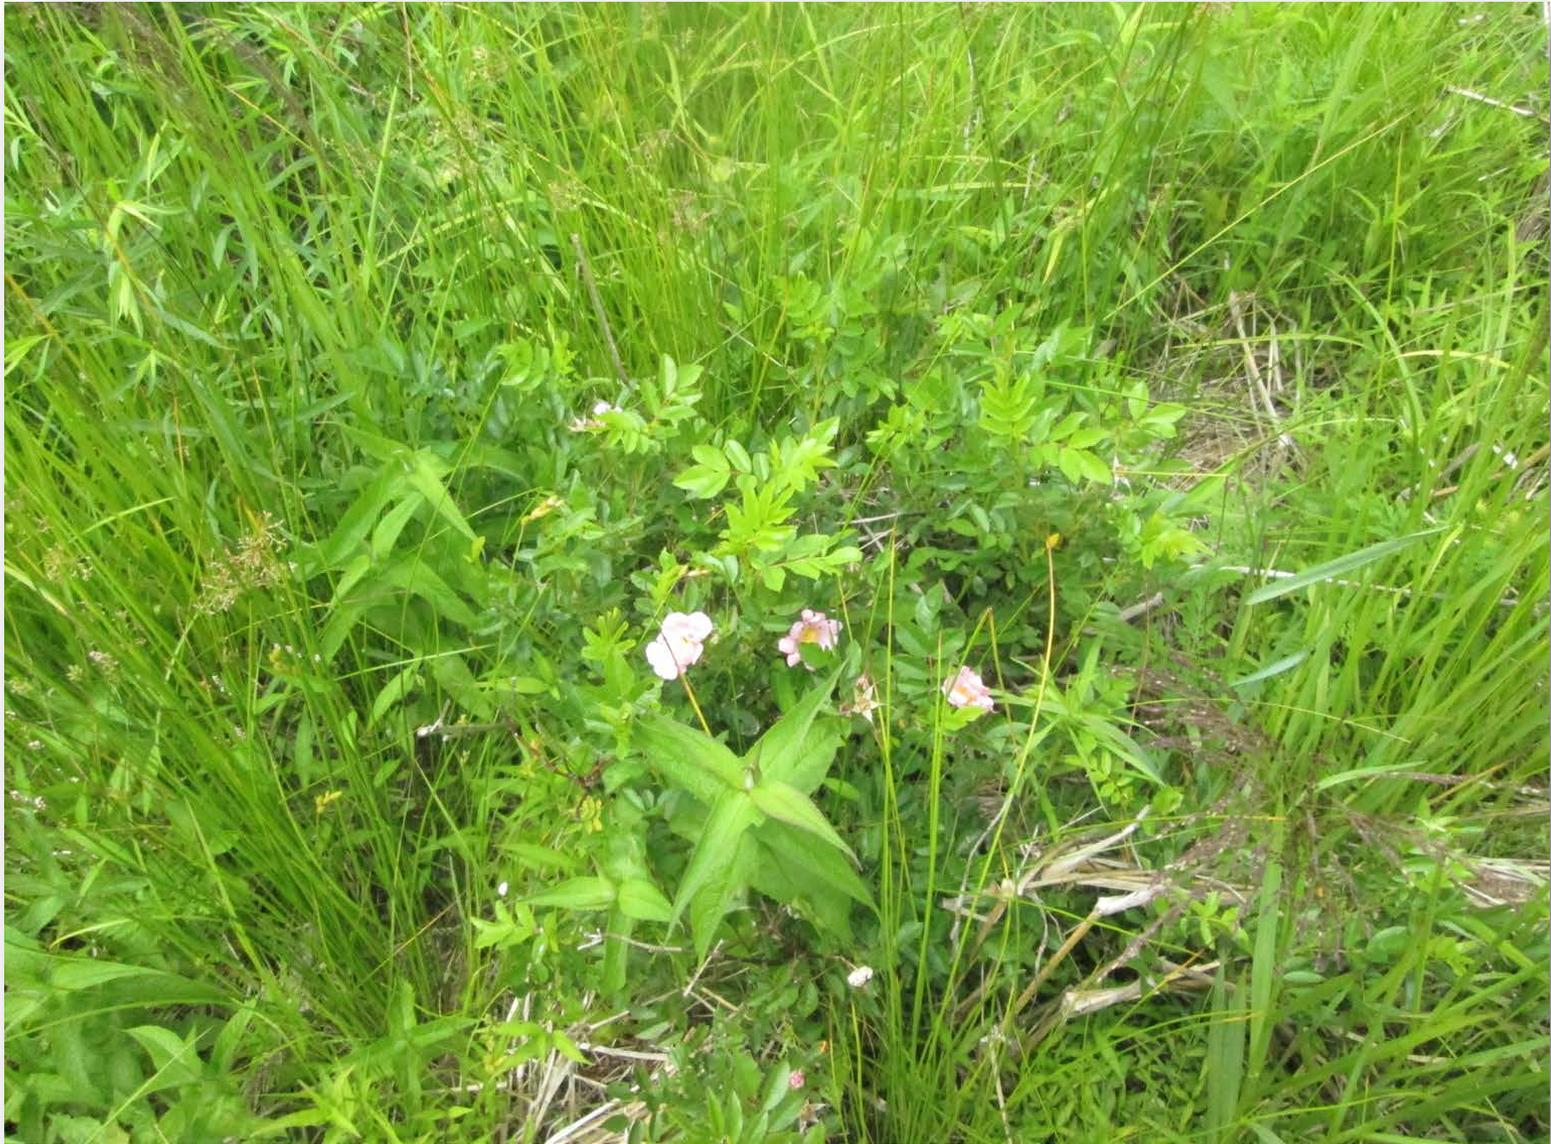
View of flowering swamp rose in Site 5.

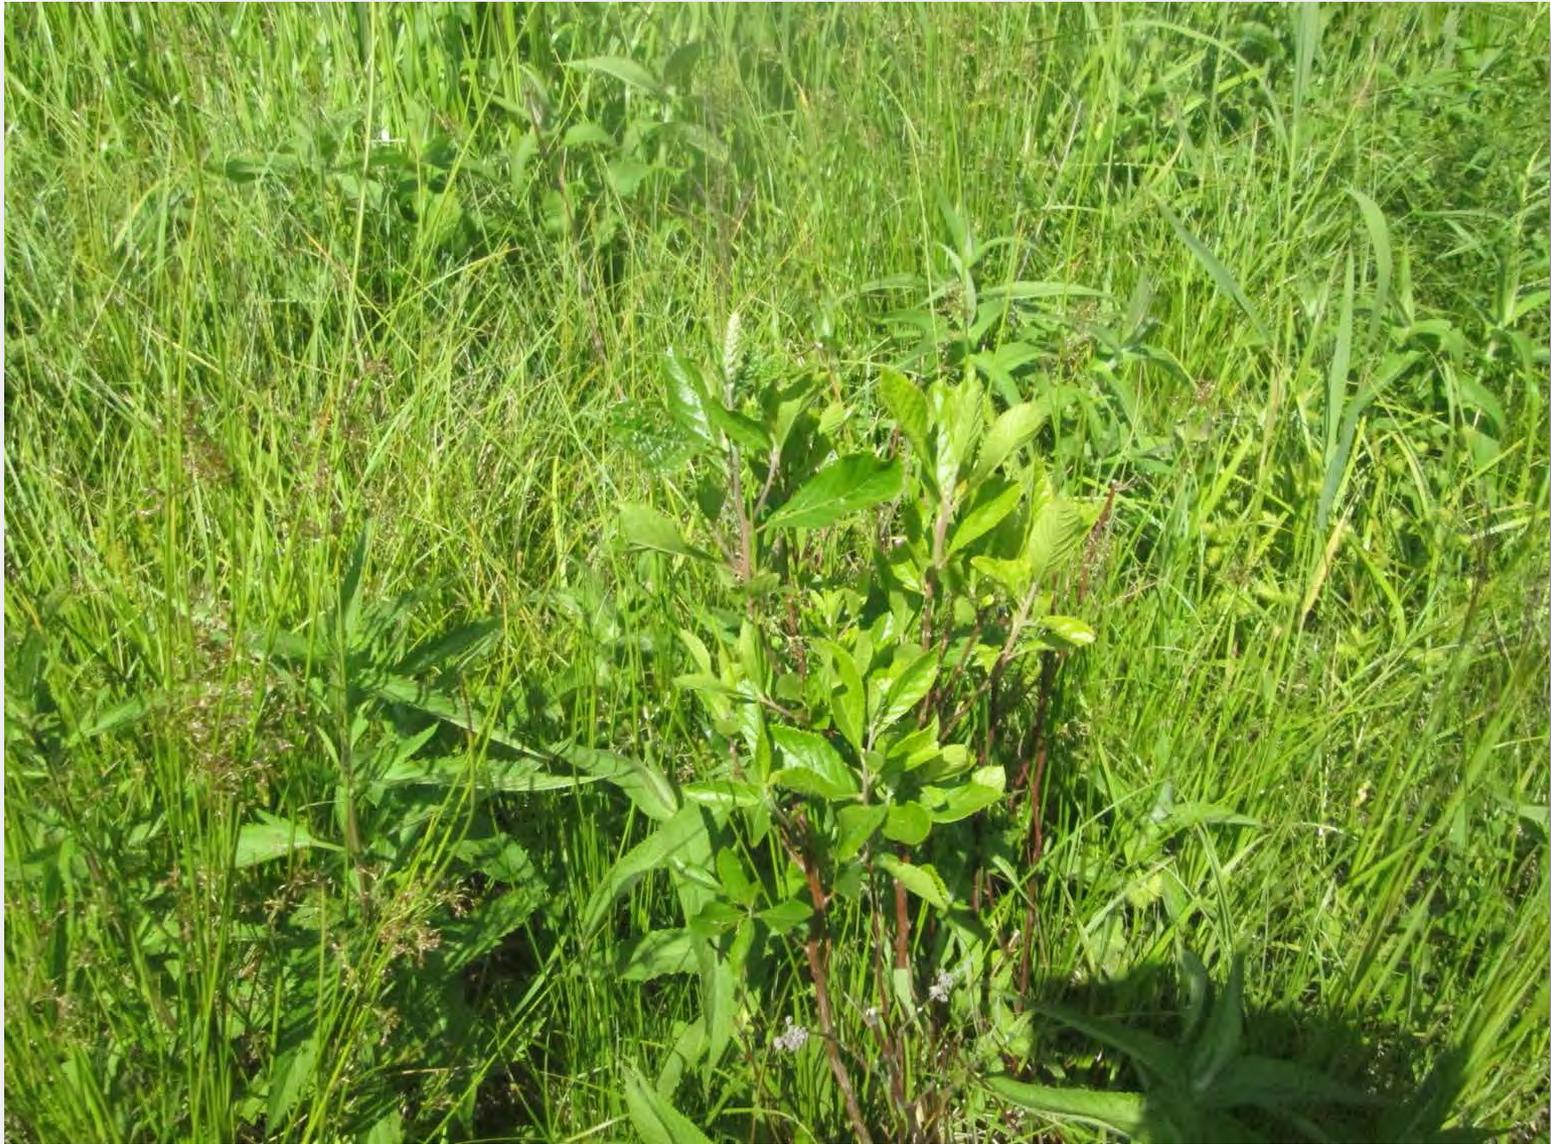
View of healthy sweet pepperbush in Site 6.

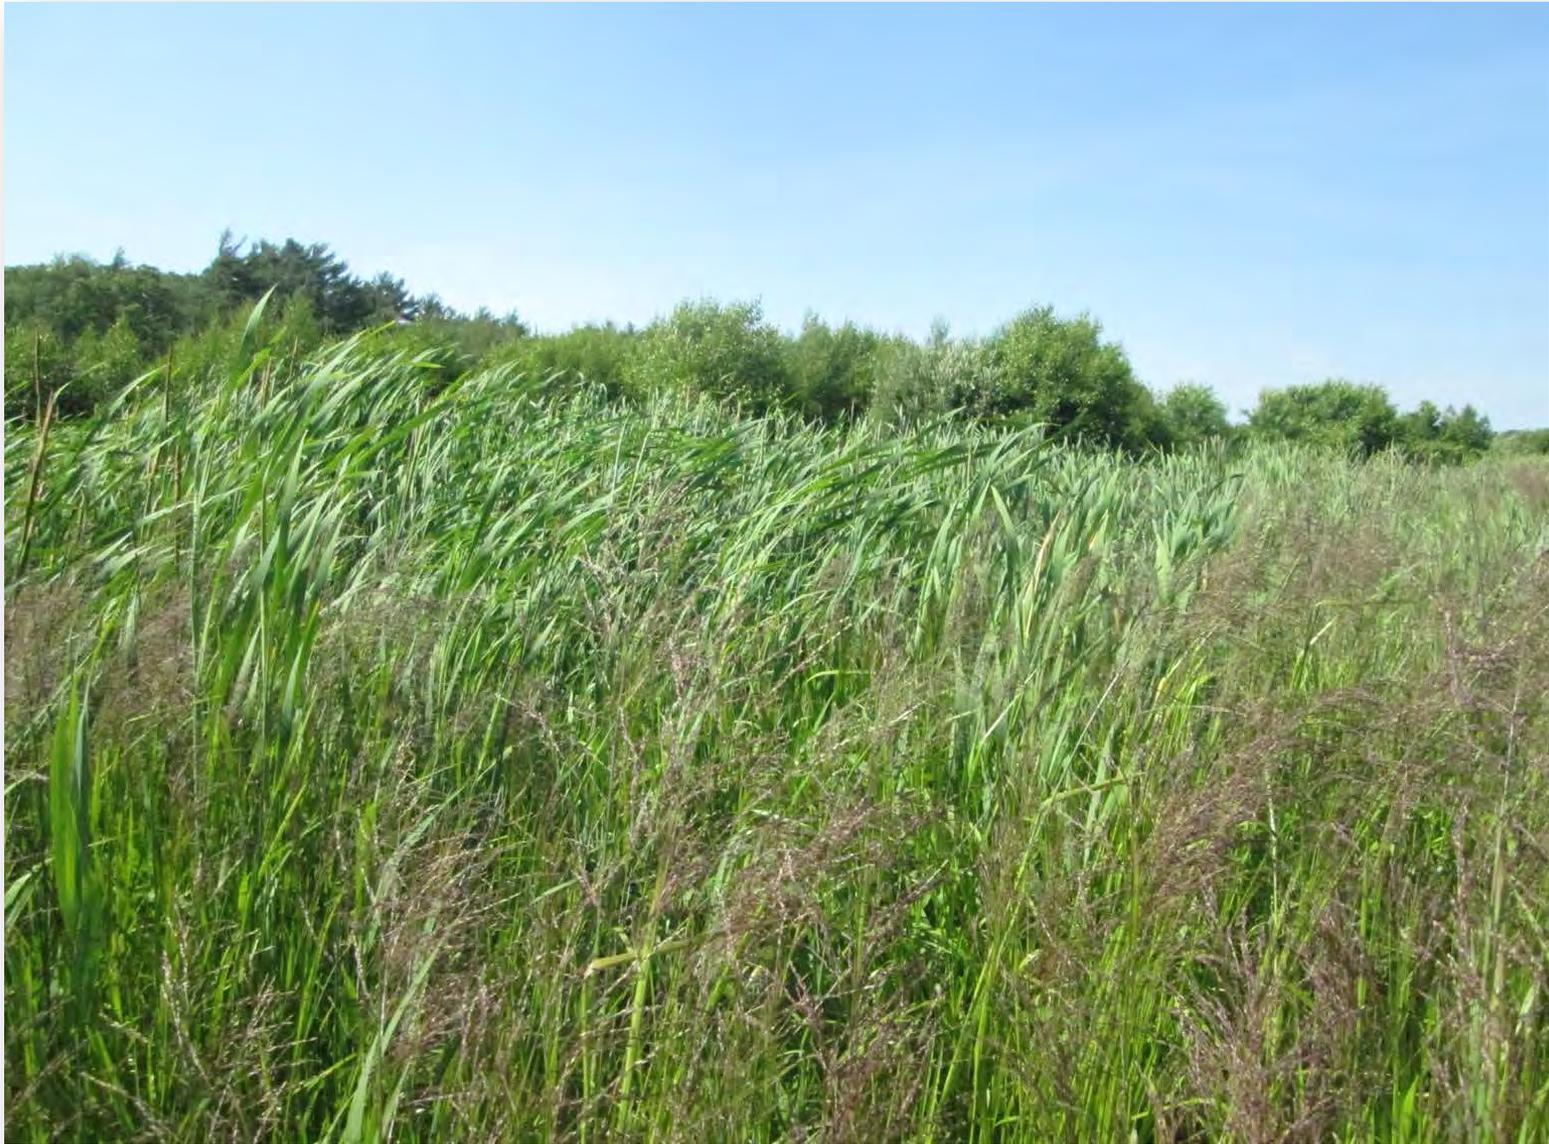
Typical view of representative vegetated growth in Site 6 (very dense and robust).

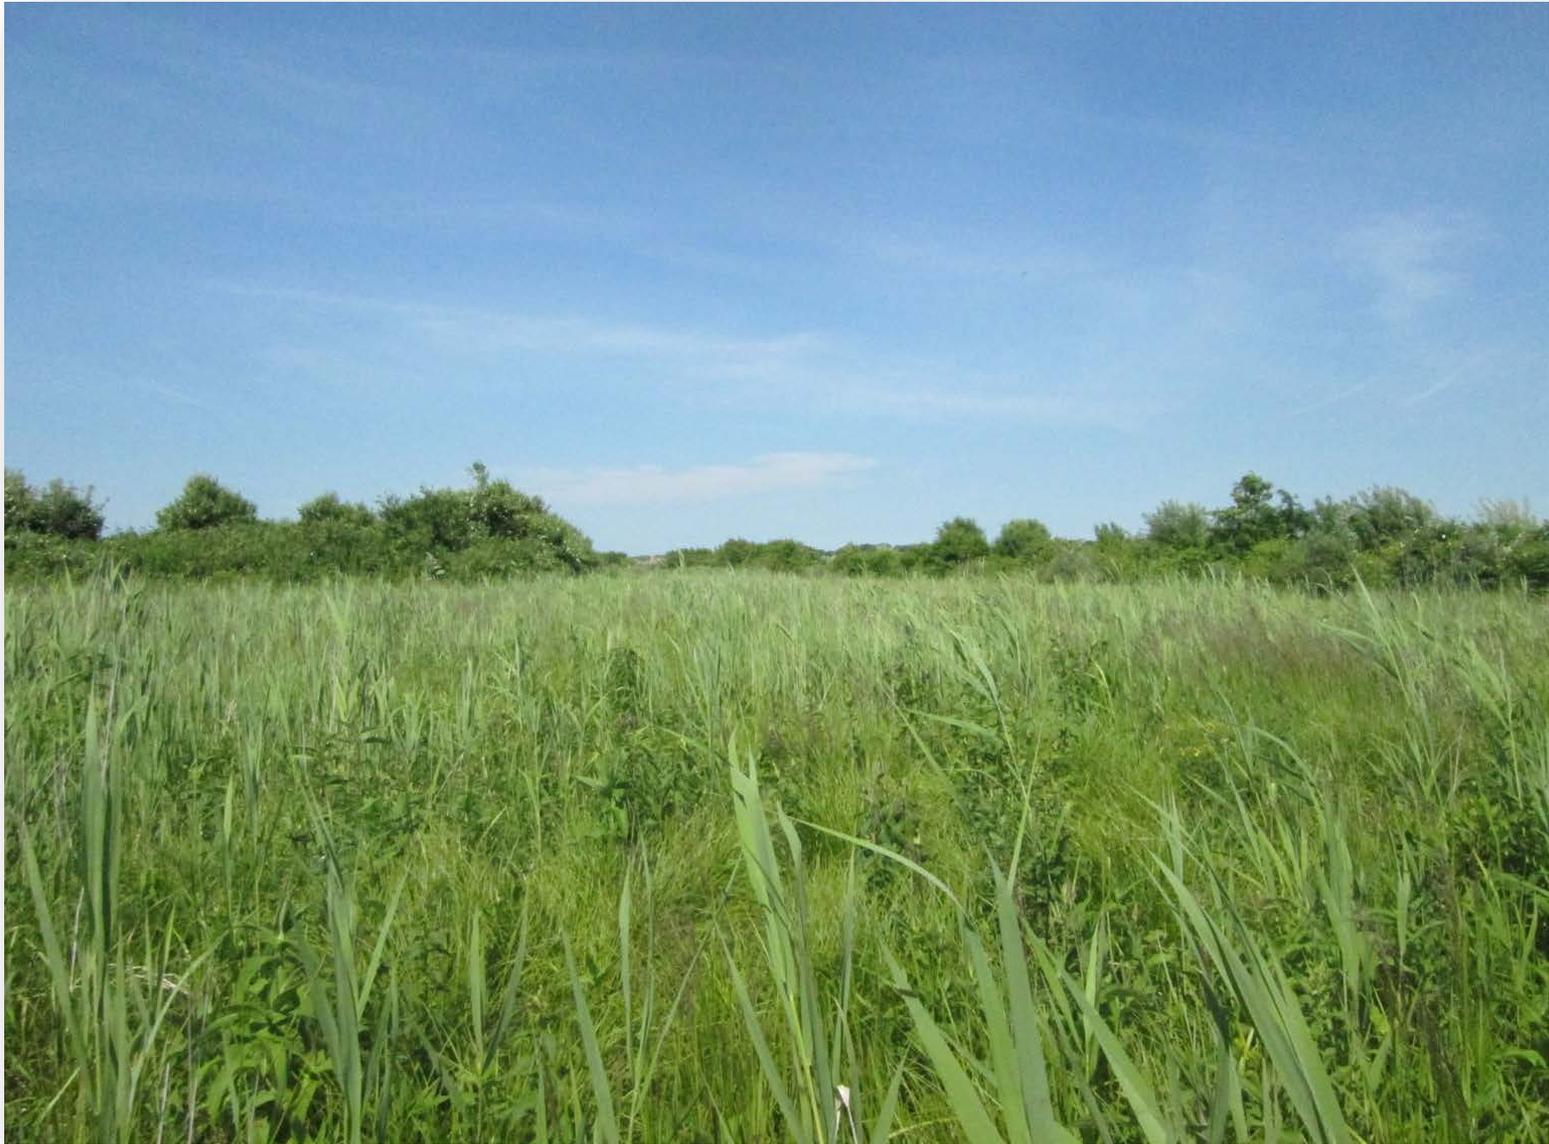
Epsilon positively identified common reed (*Phragmites australis*) at all three Wetland Mitigation Sites and within the West Ditch. Based on visual estimates there is between 90% and 95% cover with primarily native herbaceous wetland plant species throughout the vast majority of all Site 6 and Site 10 mitigation sites. The encroachment of common reed at these in Site 10 appears to be no different at this point as compared to observations made in November of last year and May 2014 (trace amounts to 5% throughout). Common reed in the southern 1/3 of Site 6 appears to have increased by ~2-5% since last month. Some areas within this southern lobe are up to 10%

View of representative vegetated growth in southern 1/3 of Site 6, note presence of phragmites (scheduled to be treated late summer 2014).

common reed. The common reed was interspersed amongst cattails and other native wetland plant species. The Airport has scheduled an herbicide treatment in Sites 6 and 10 in late summer. We will continue to keep an eye on these areas in the interim. Epsilon observed and harvested individual common reed plants at Site 5 in May; no additional common reed individuals were found in June. We will continue to keep an eye on Site 5 and advise the Airport in the event treatment measures are determined to be necessary as per the approved ISMP. No new individual multiflora rose plants (*Rosa multiflora*) sprouts were found in Site 5 or 10. Site 6 had a few new rose sprouts, predominately on the edges of the mitigation area and immediately adjacent to established rose plants along the West Ditch. We will continue to keep an eye on these areas and advise the Airport in the event treatment measures are determined to be necessary as per the approved ISMP.

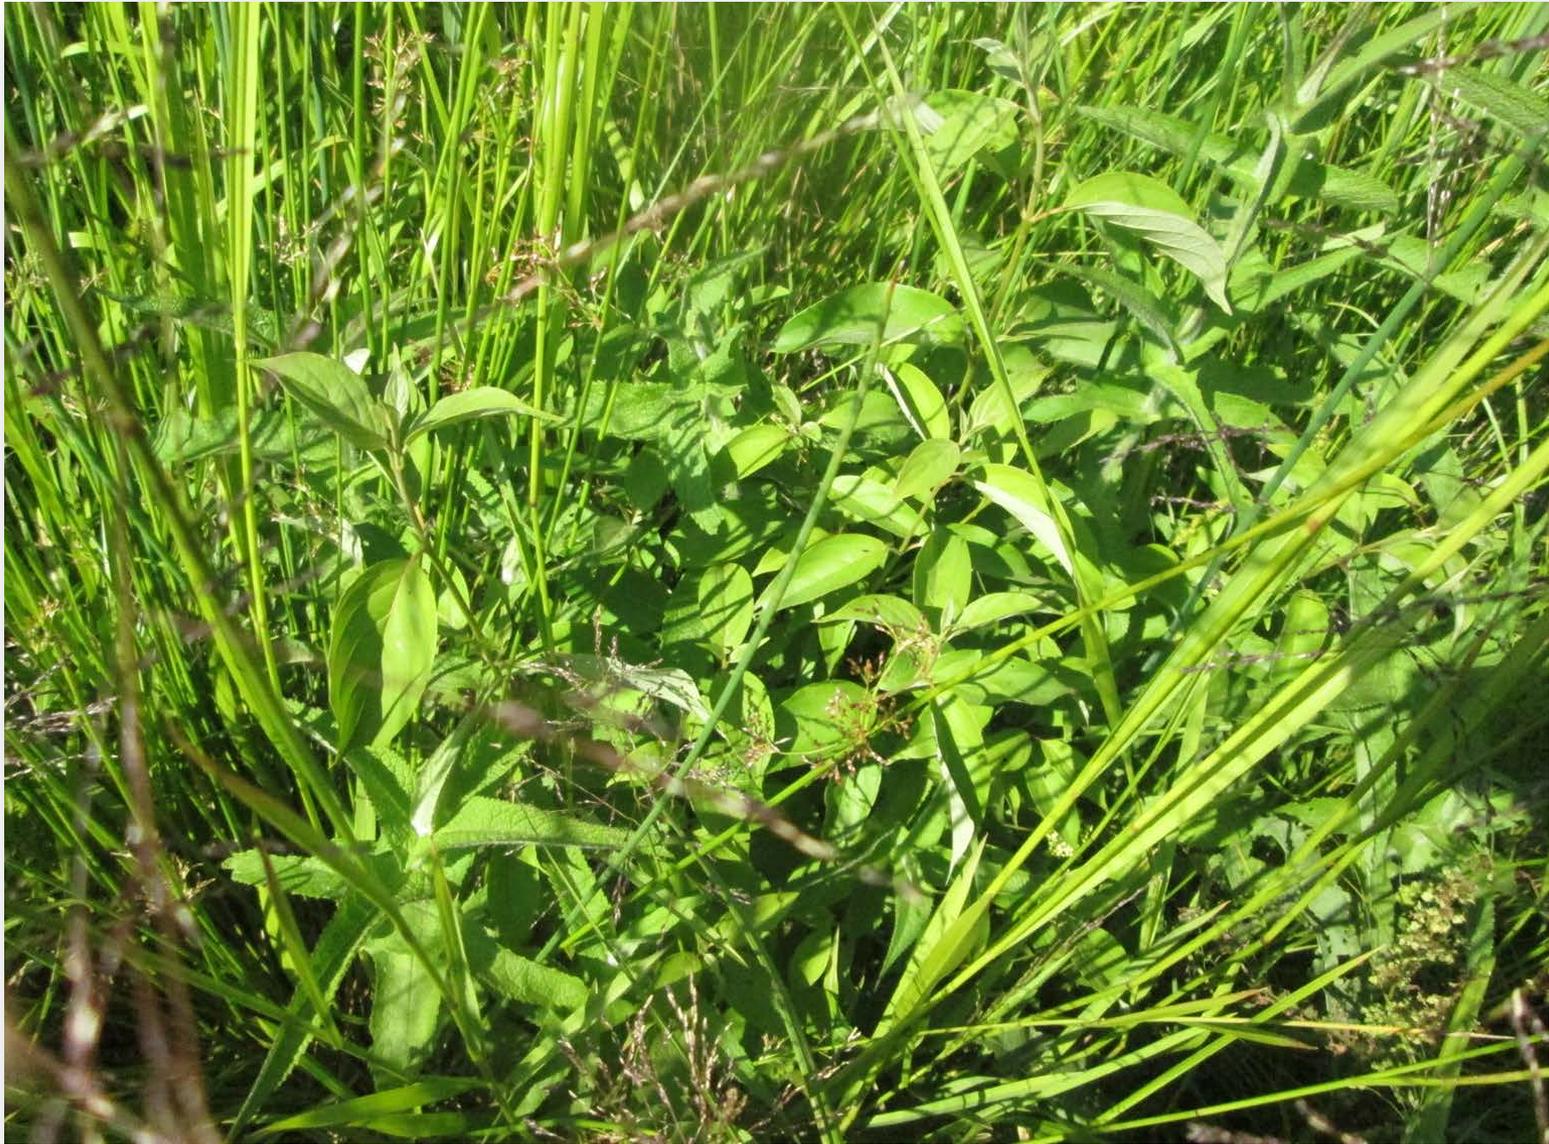
View of healthy dogwood growing within dense herbaceous vegetation in Site 6.

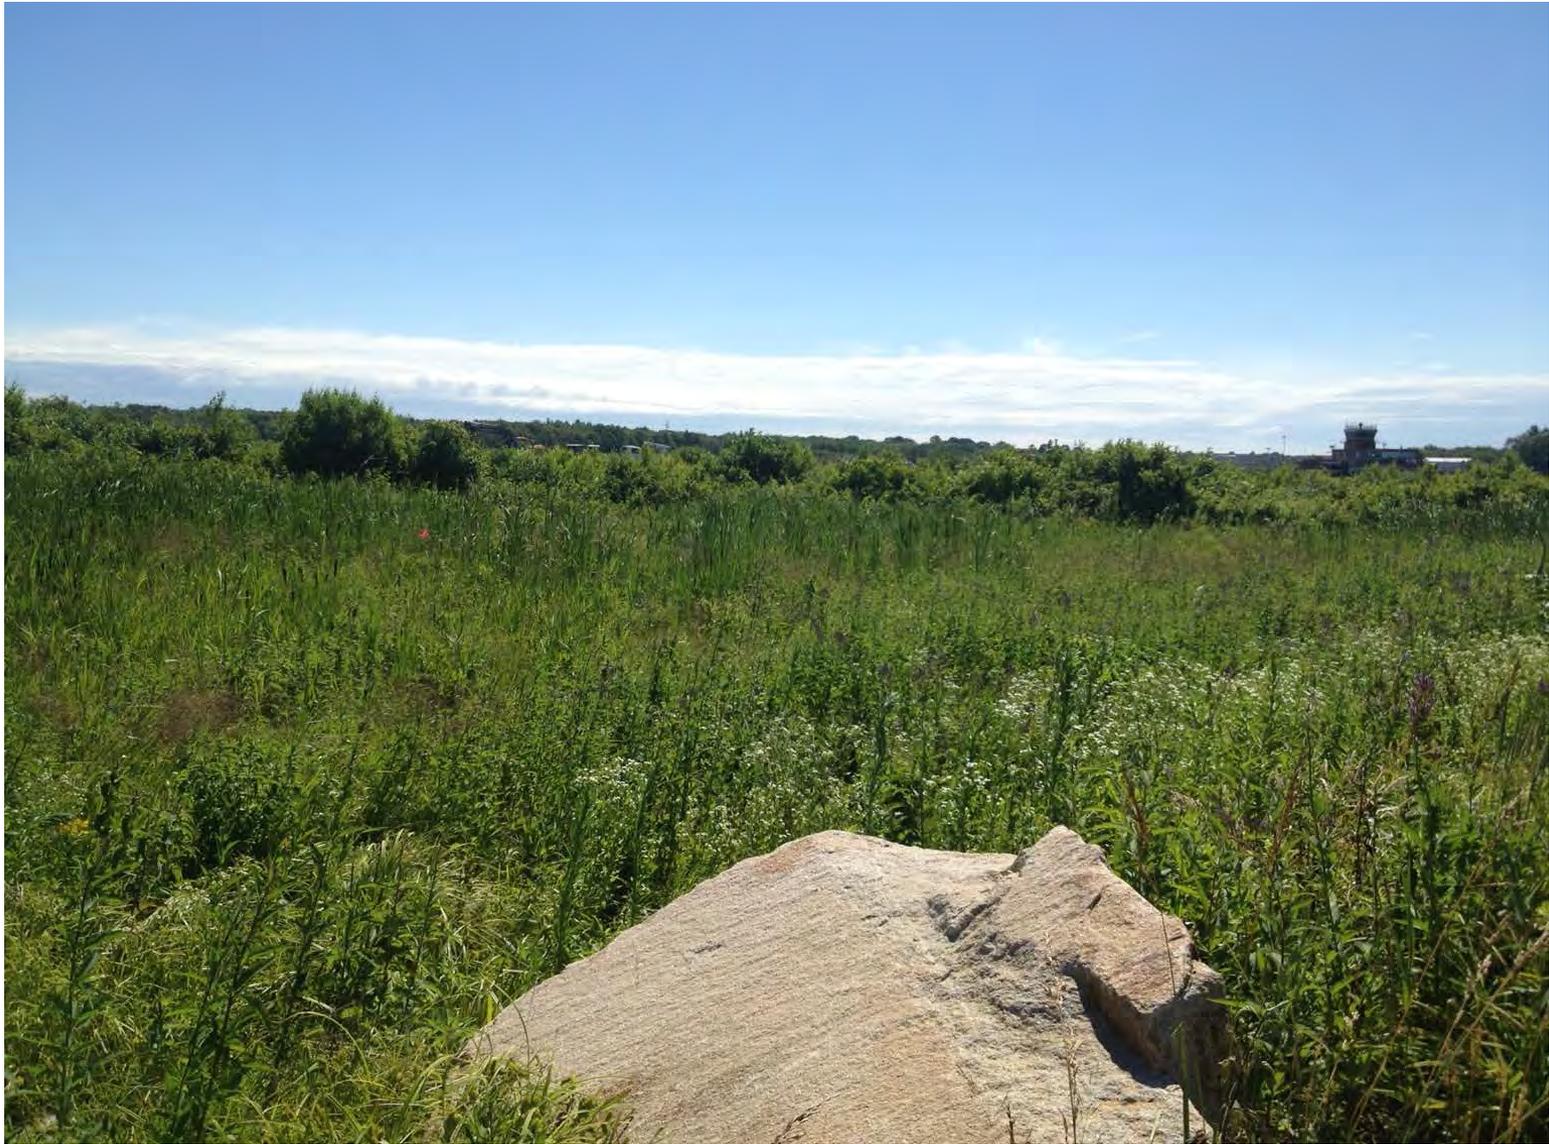
Typical view of plant growth in first 1/3 of Site 6 from Turtle Area 3 vantage point.
