MassDEP File No. SE 049-0635

New Bedford Regional Airport Runway Safety Improvements Project

Post Construction Monthly Wetlands Plantings Assessment – June 2014

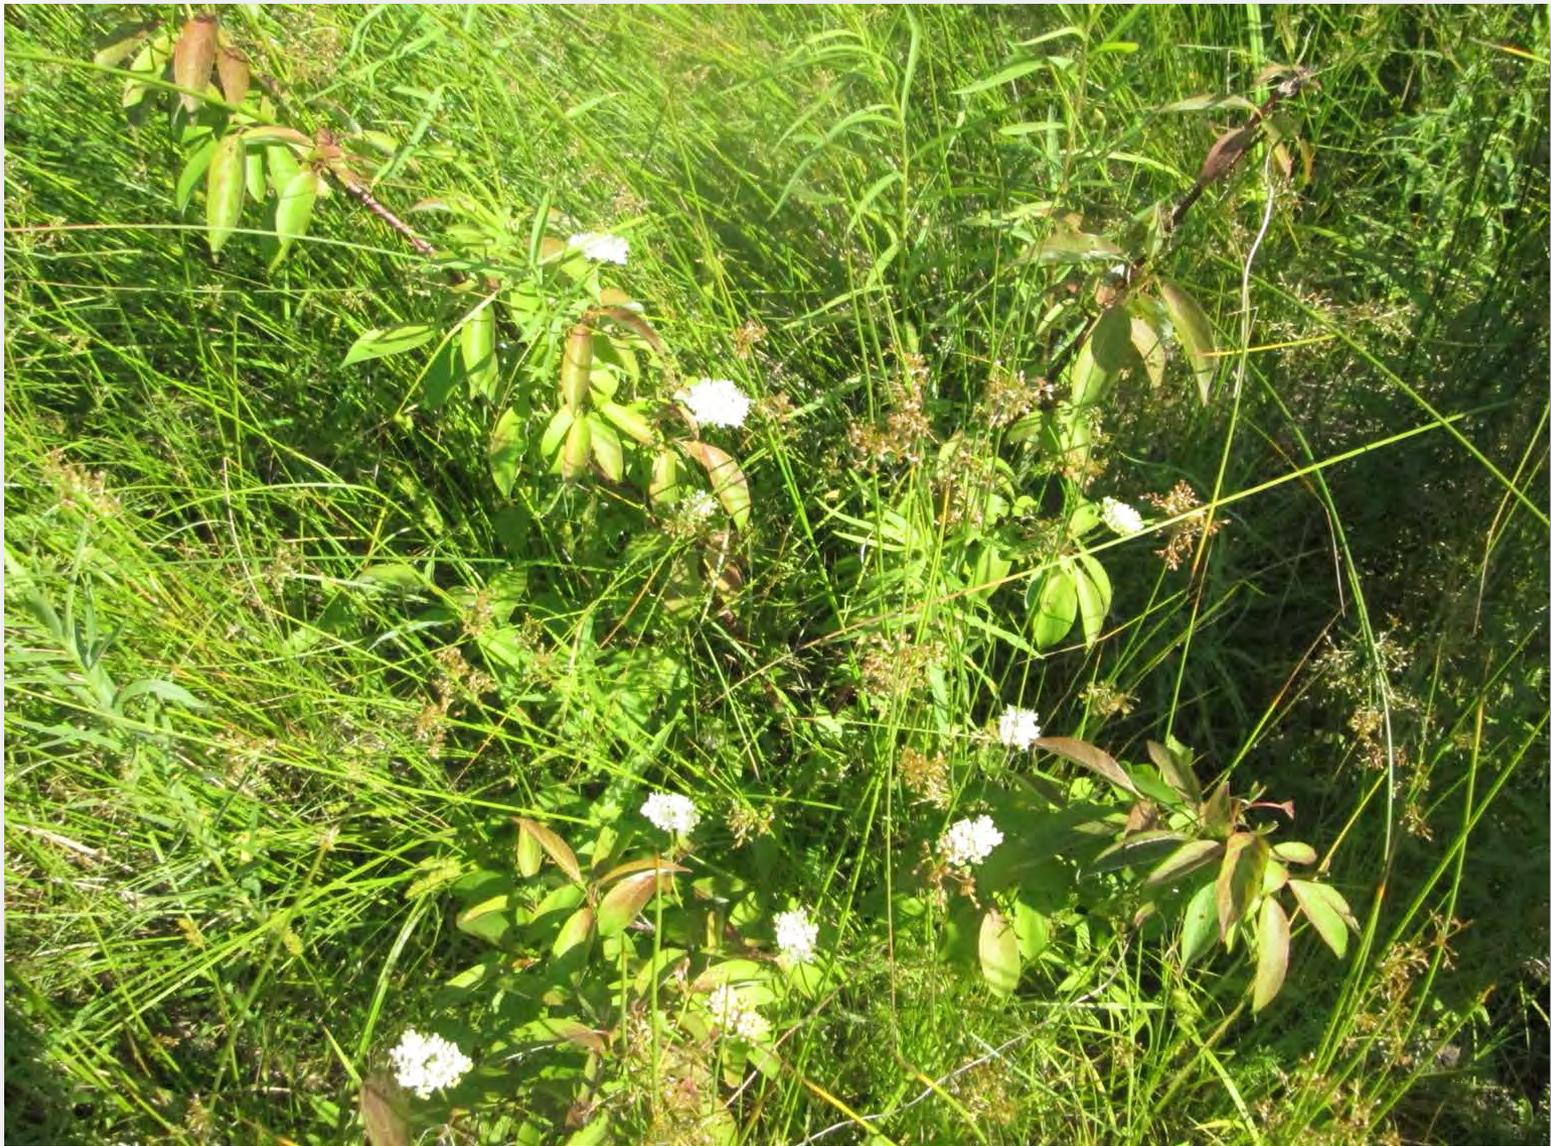
View of healthy flowering American elderberry in Site 6.

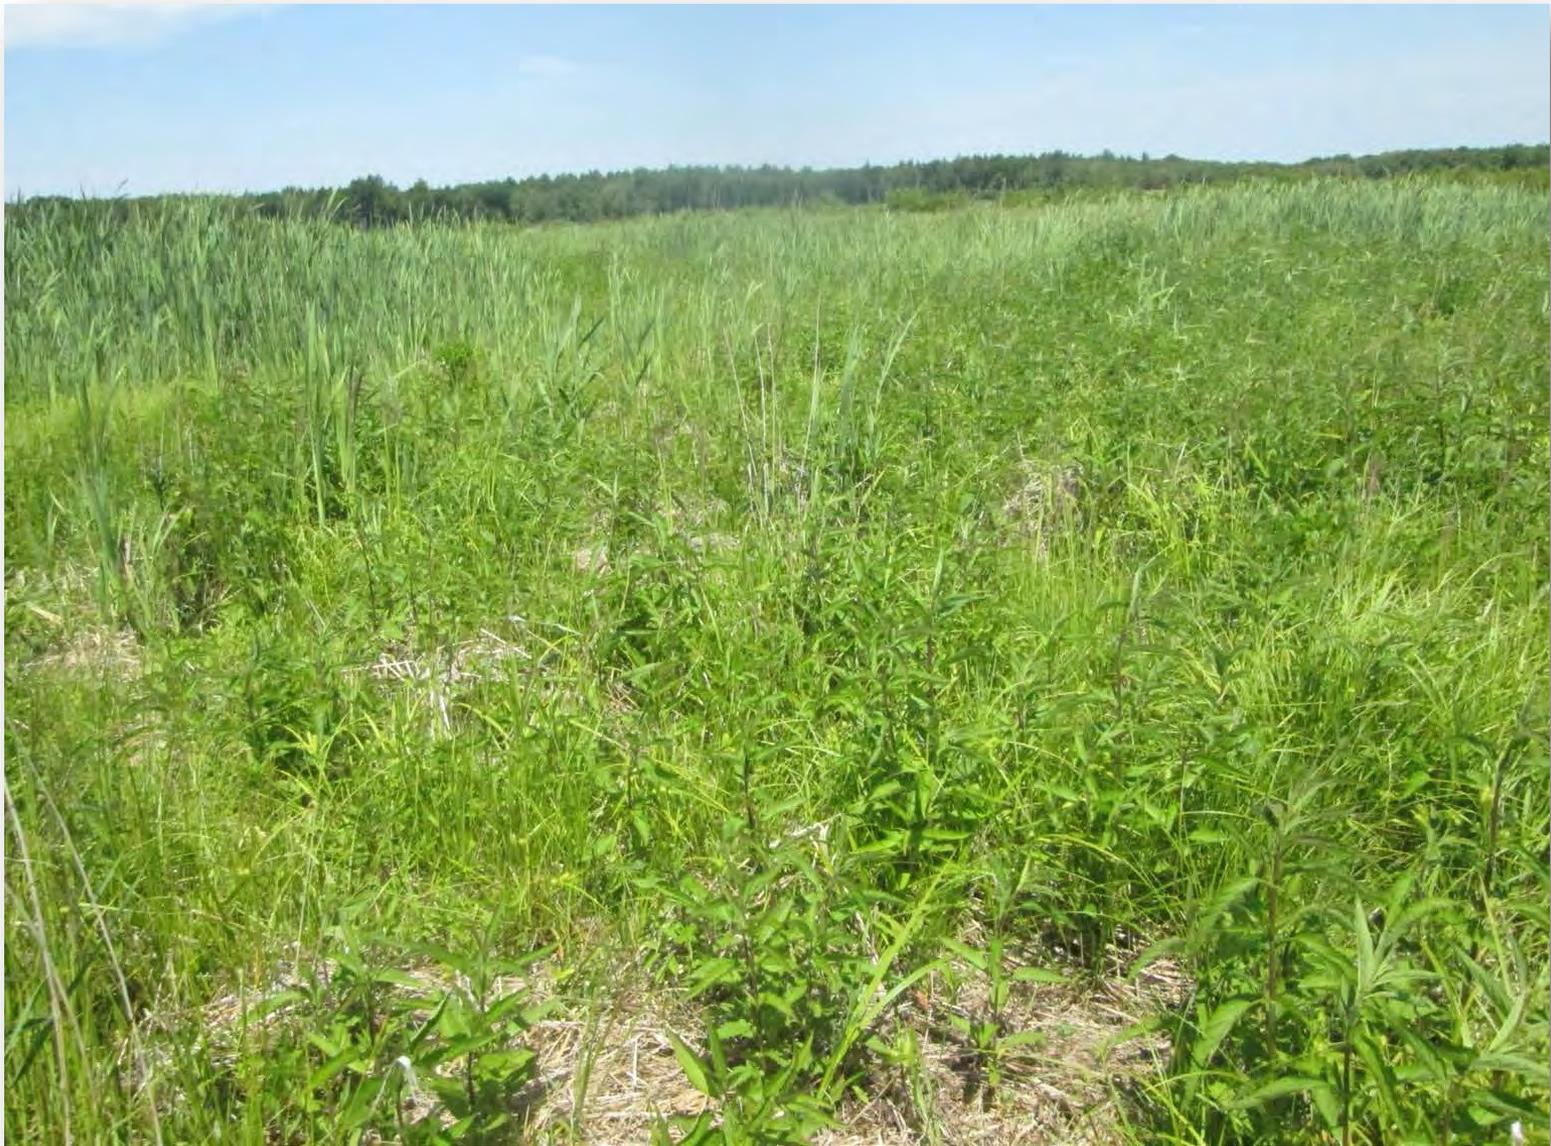
Typical view of Site 10, looking south.

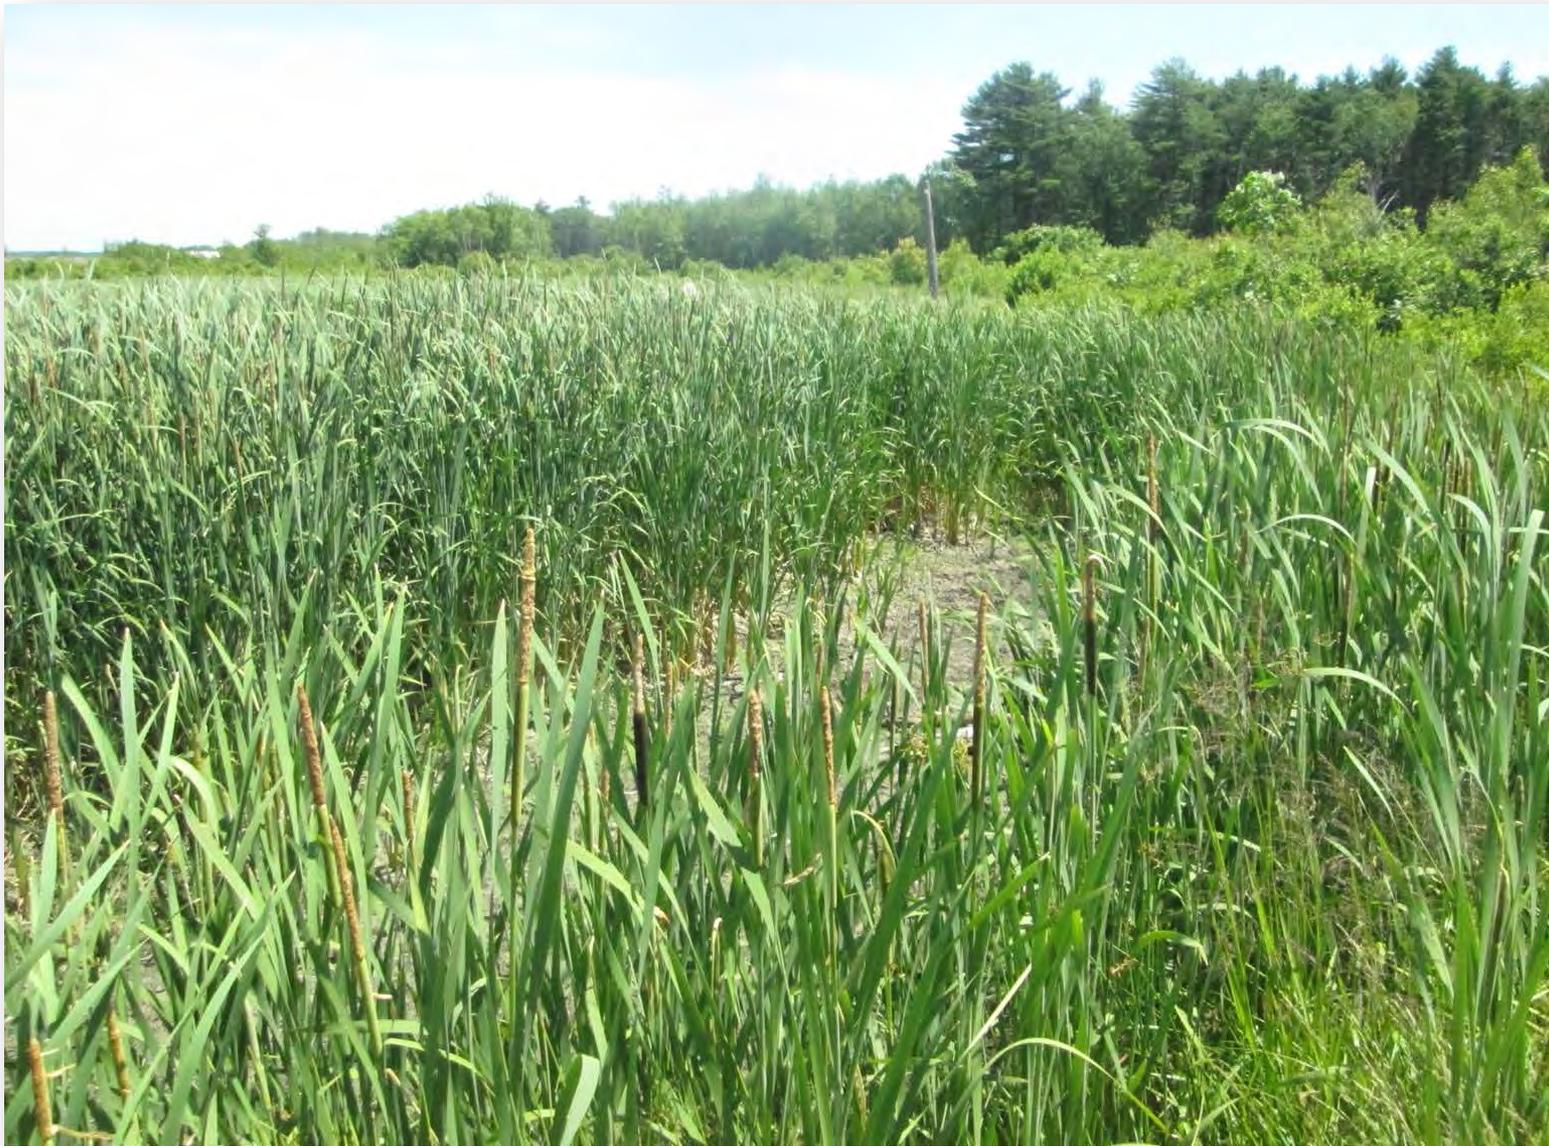
View of northernmost vernal pool and cattail fringe in Site 10, looking northeast.

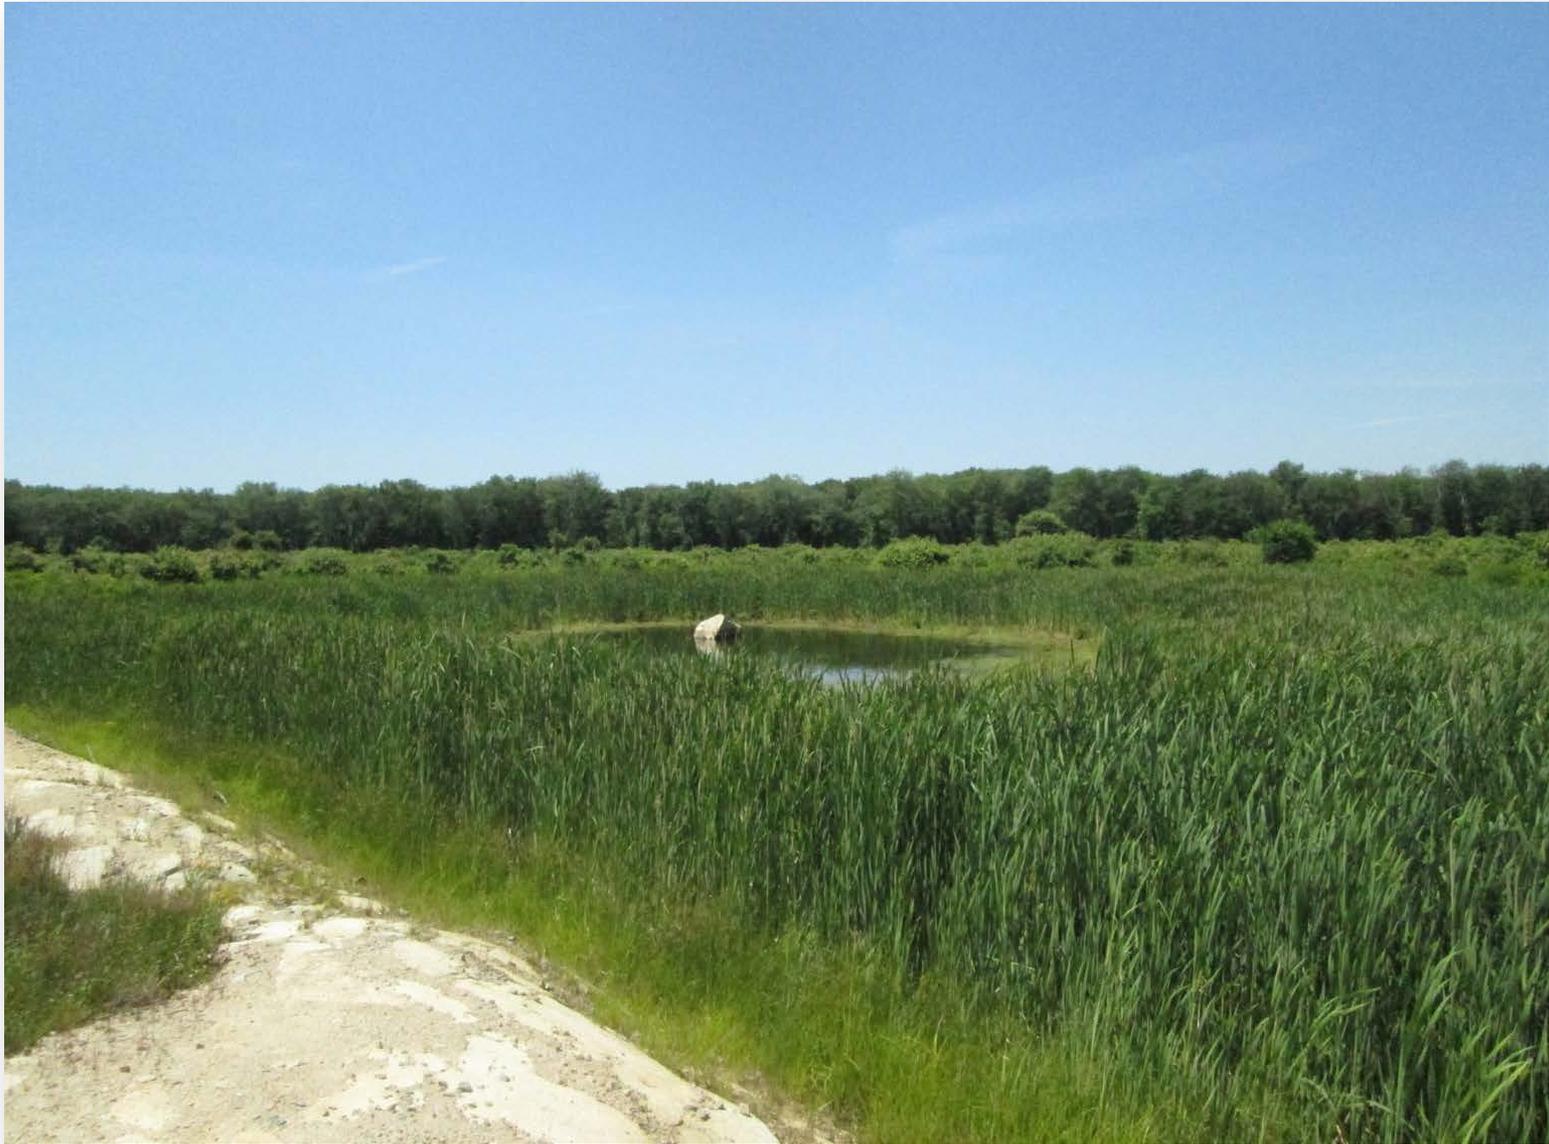
View of southernmost vernal pool in Site 10. Water levels have dissipated since May visit. Note watermark on center rock.

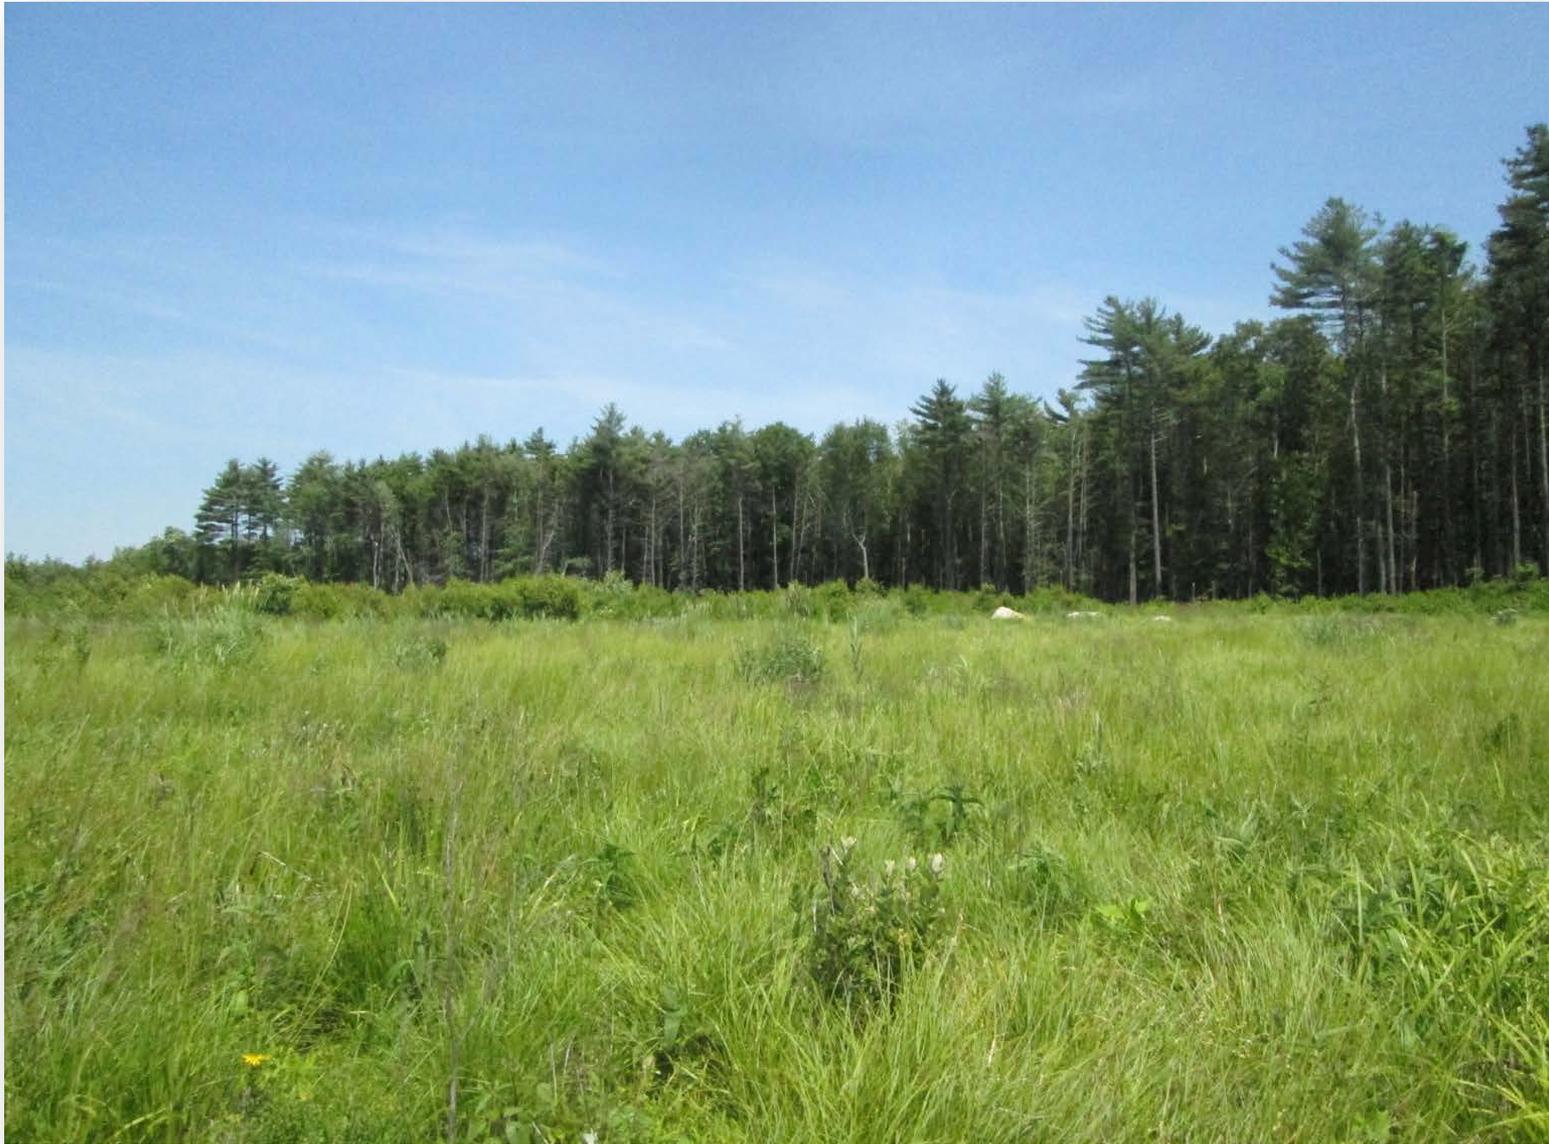
View of southeasternmost portion of Site 10, looking east. The wetland seed mix is extremely hearty and diverse throughout this stretch.

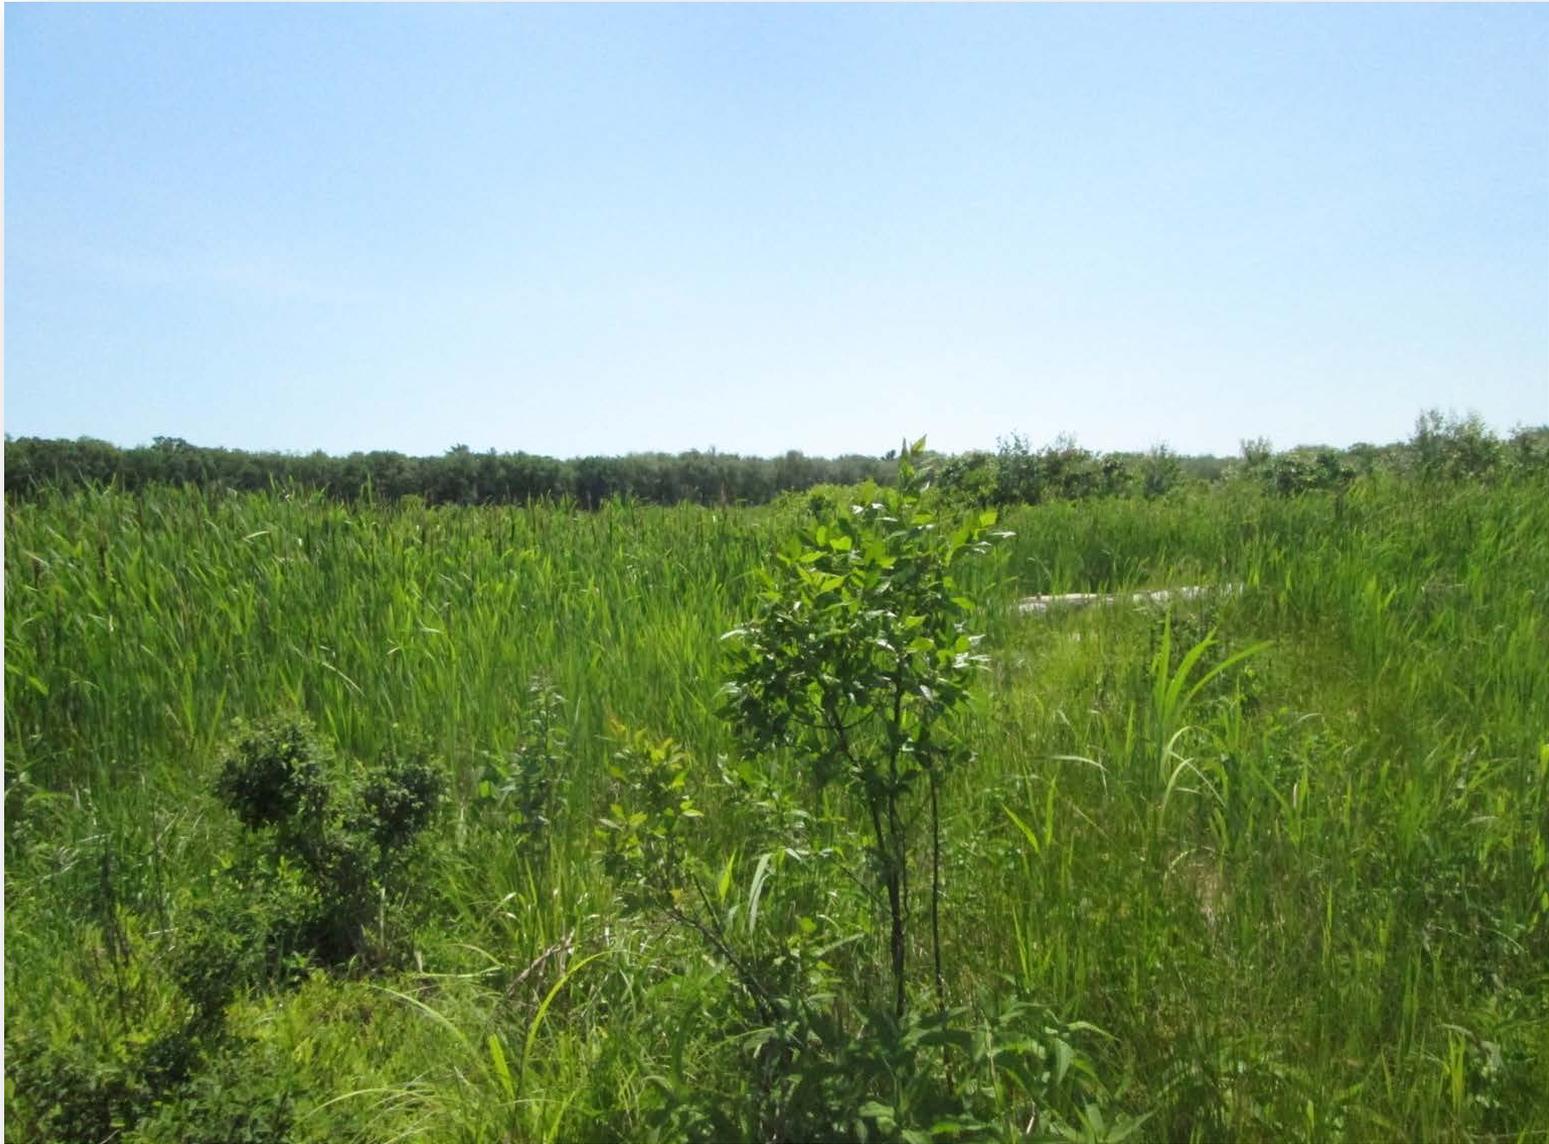
View of robust herbaceous vegetation and healthy alder planted in Site 10.

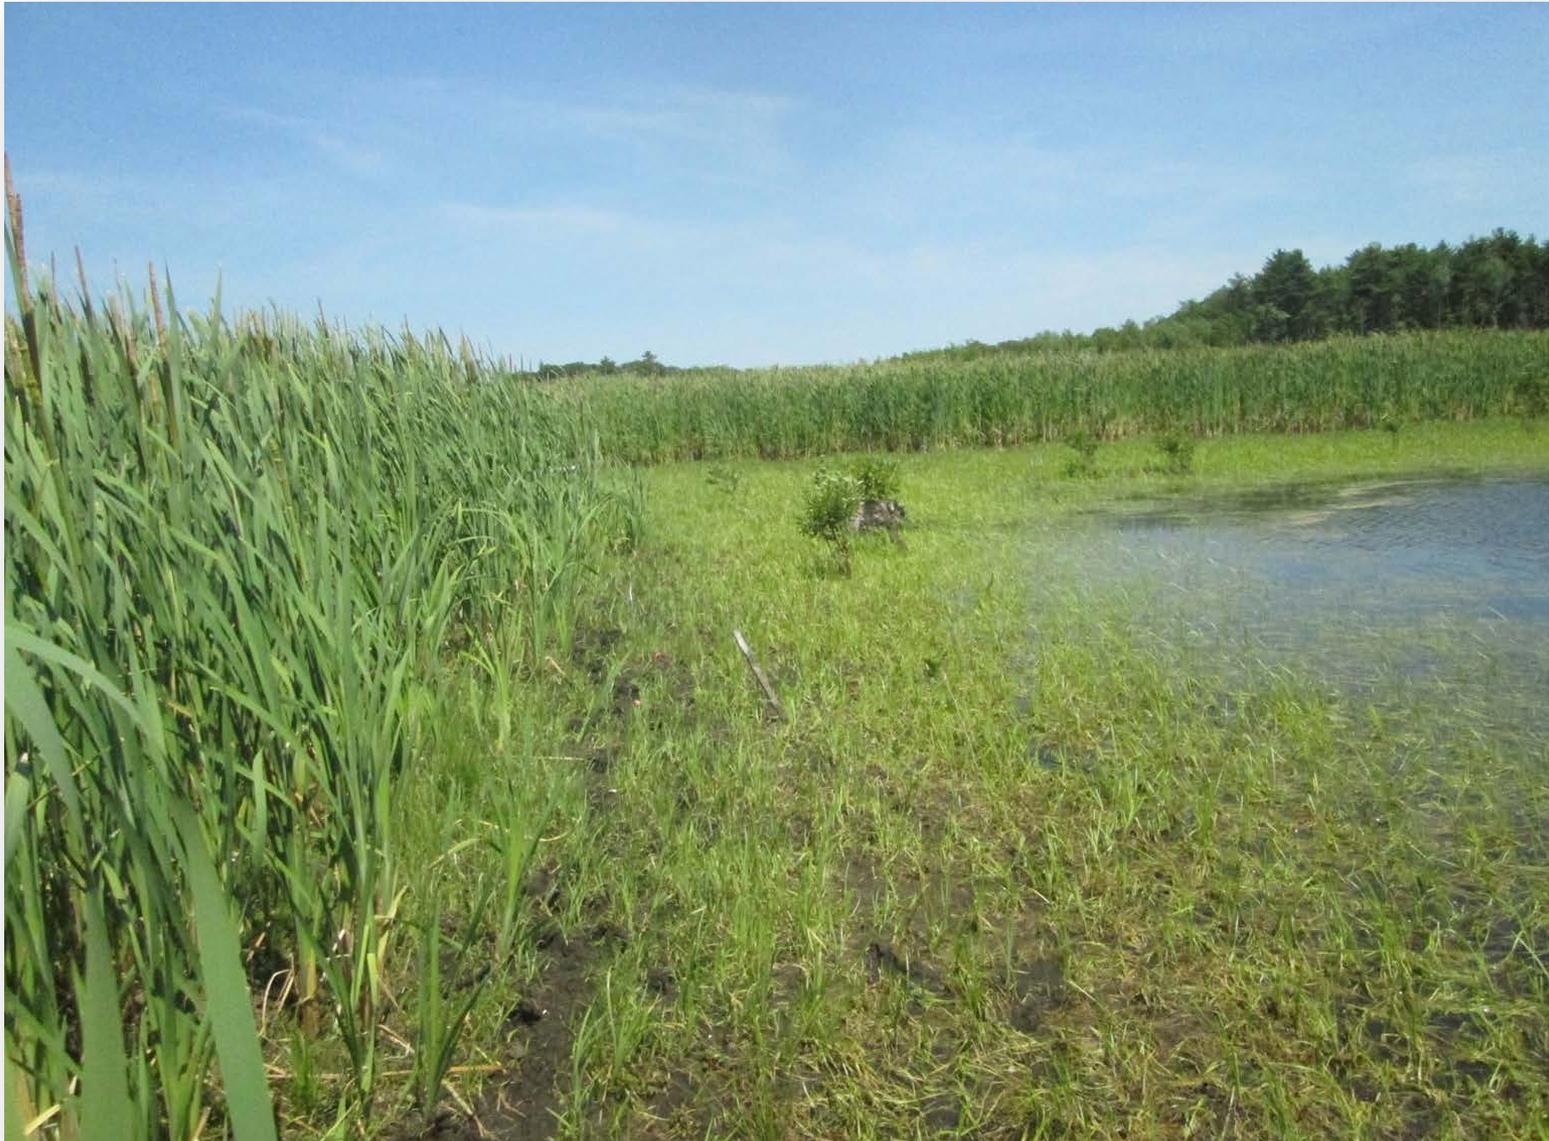
View of western vernal pool in Site 10. Water levels have dissipated, shrubs planted along the fringe are starting to leaf out. Evidence of wildlife utilization observed in the soil.

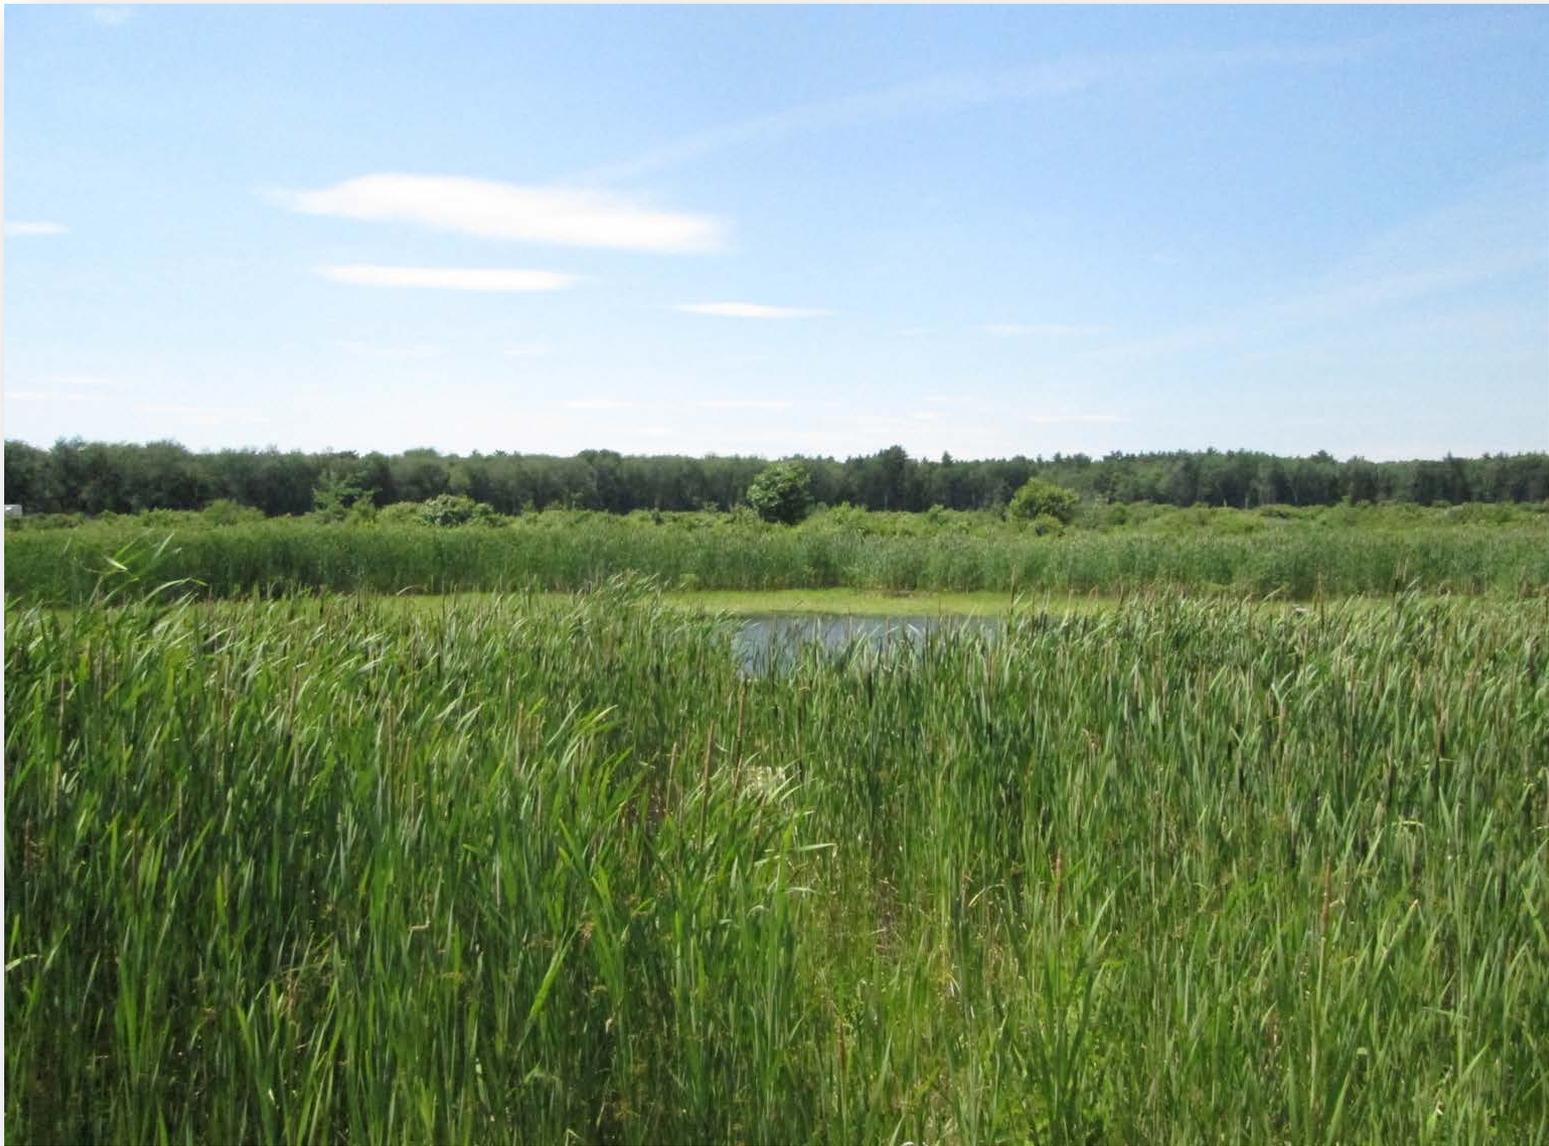
View of western vernal pool in Site 10 and cattail fringe, looking west.

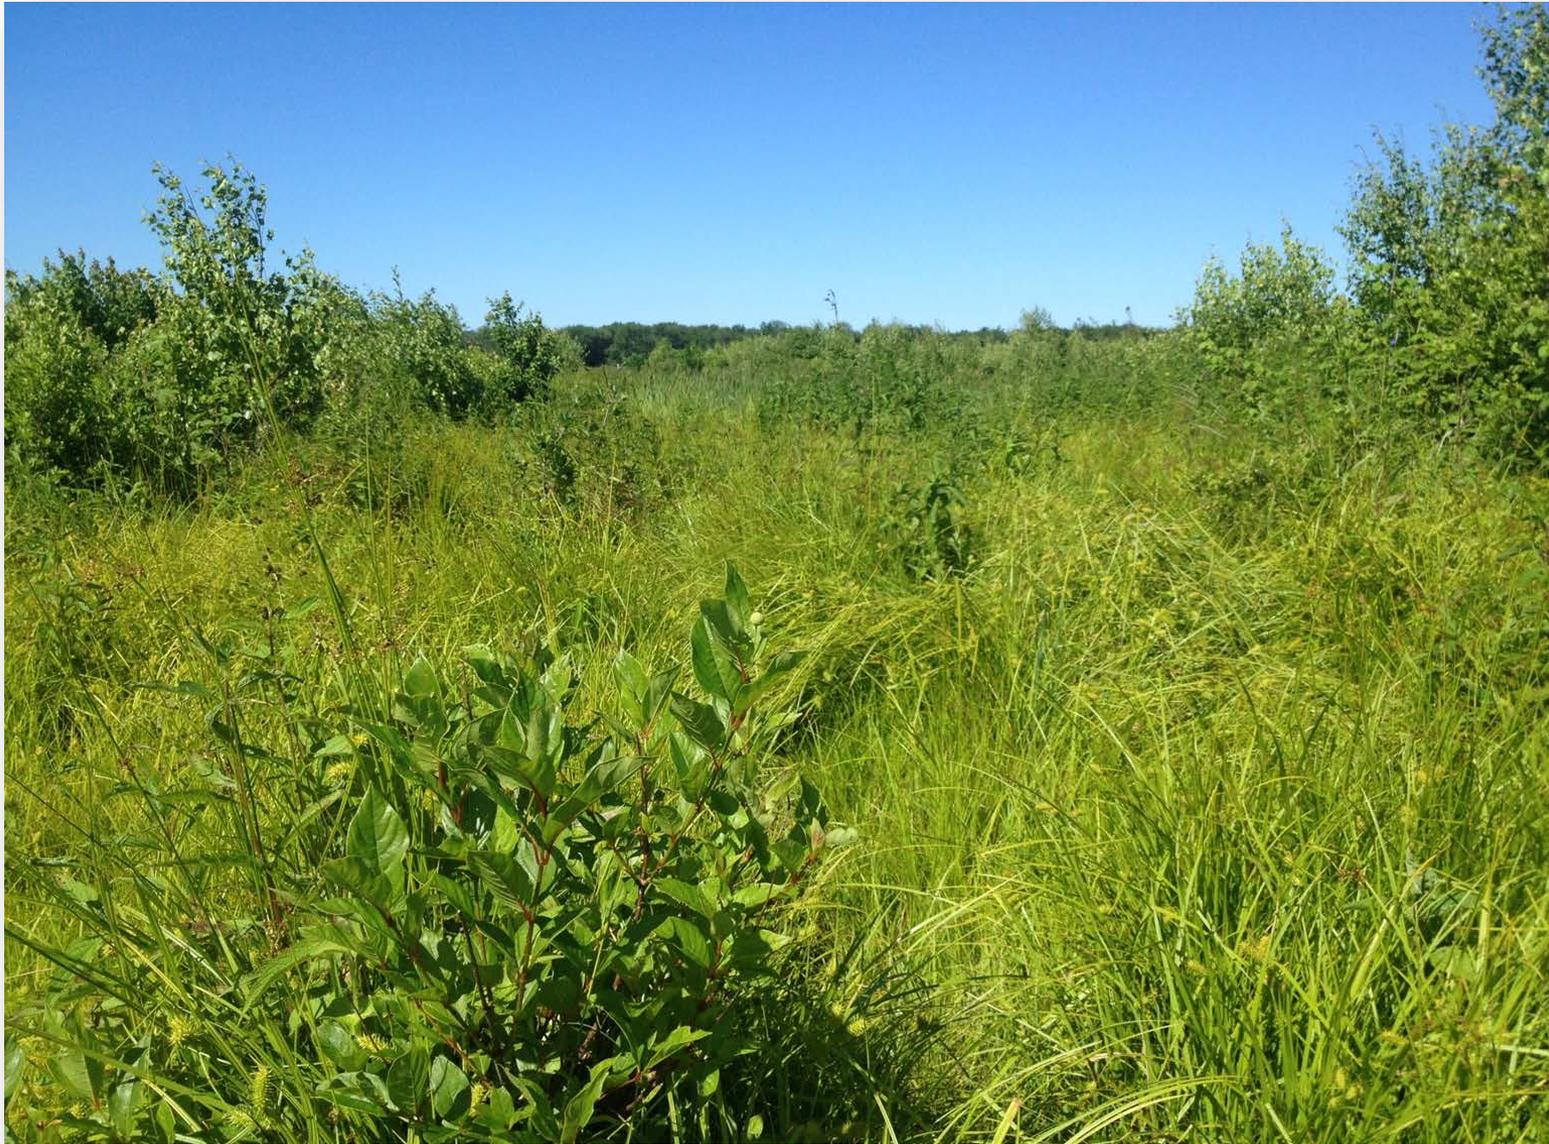
View of robust and healthy plant growth as you enter Site 10.

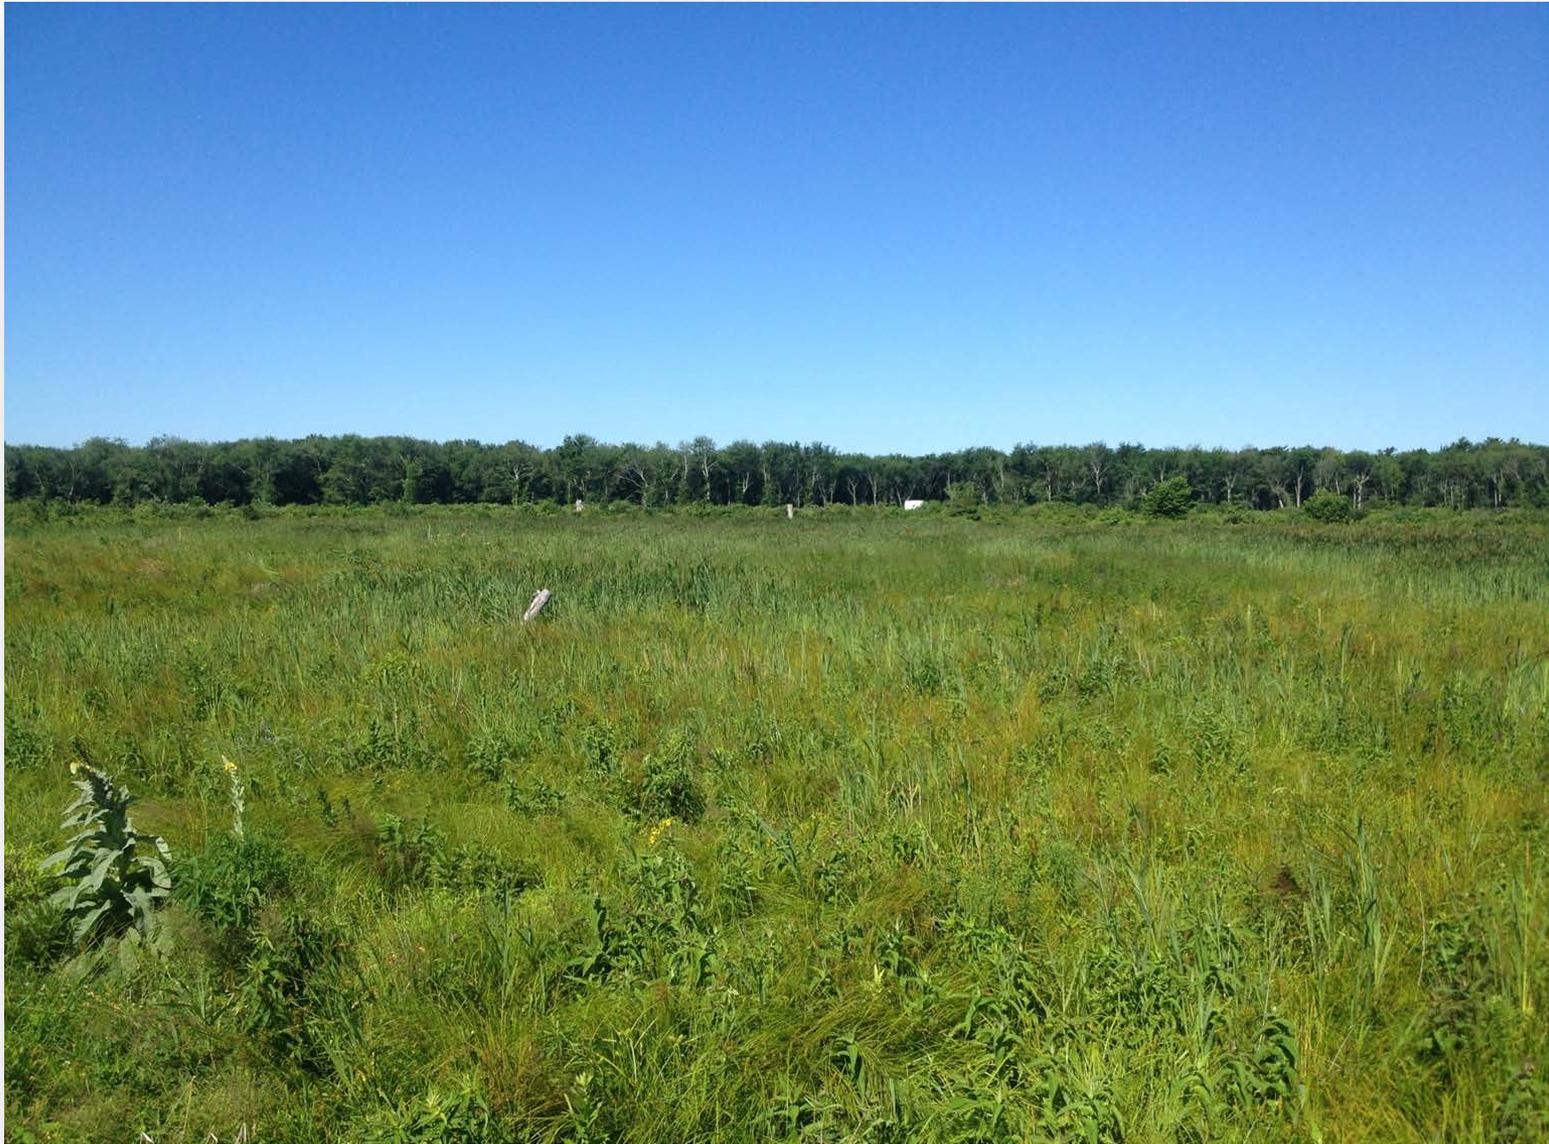
Typical view of overall plant growth in Site 10.

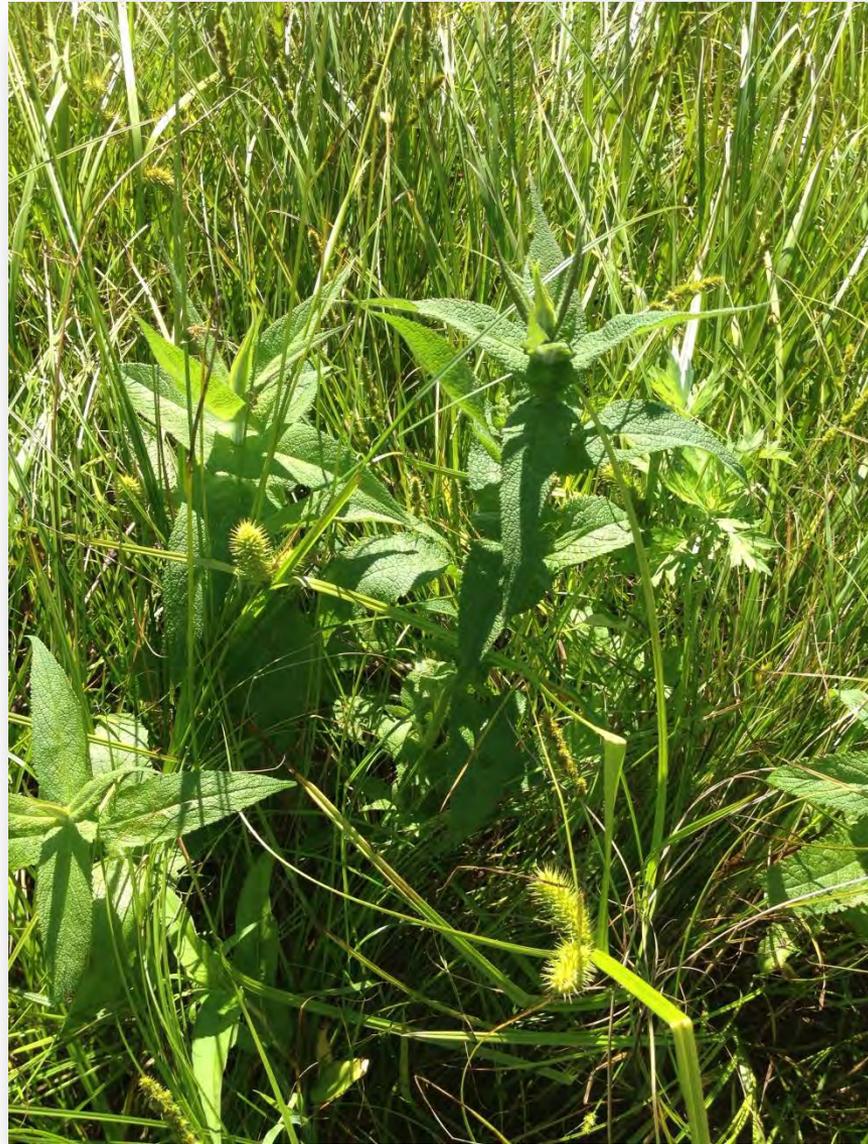
Typical view of healthy joe-pye weed in Site 10.

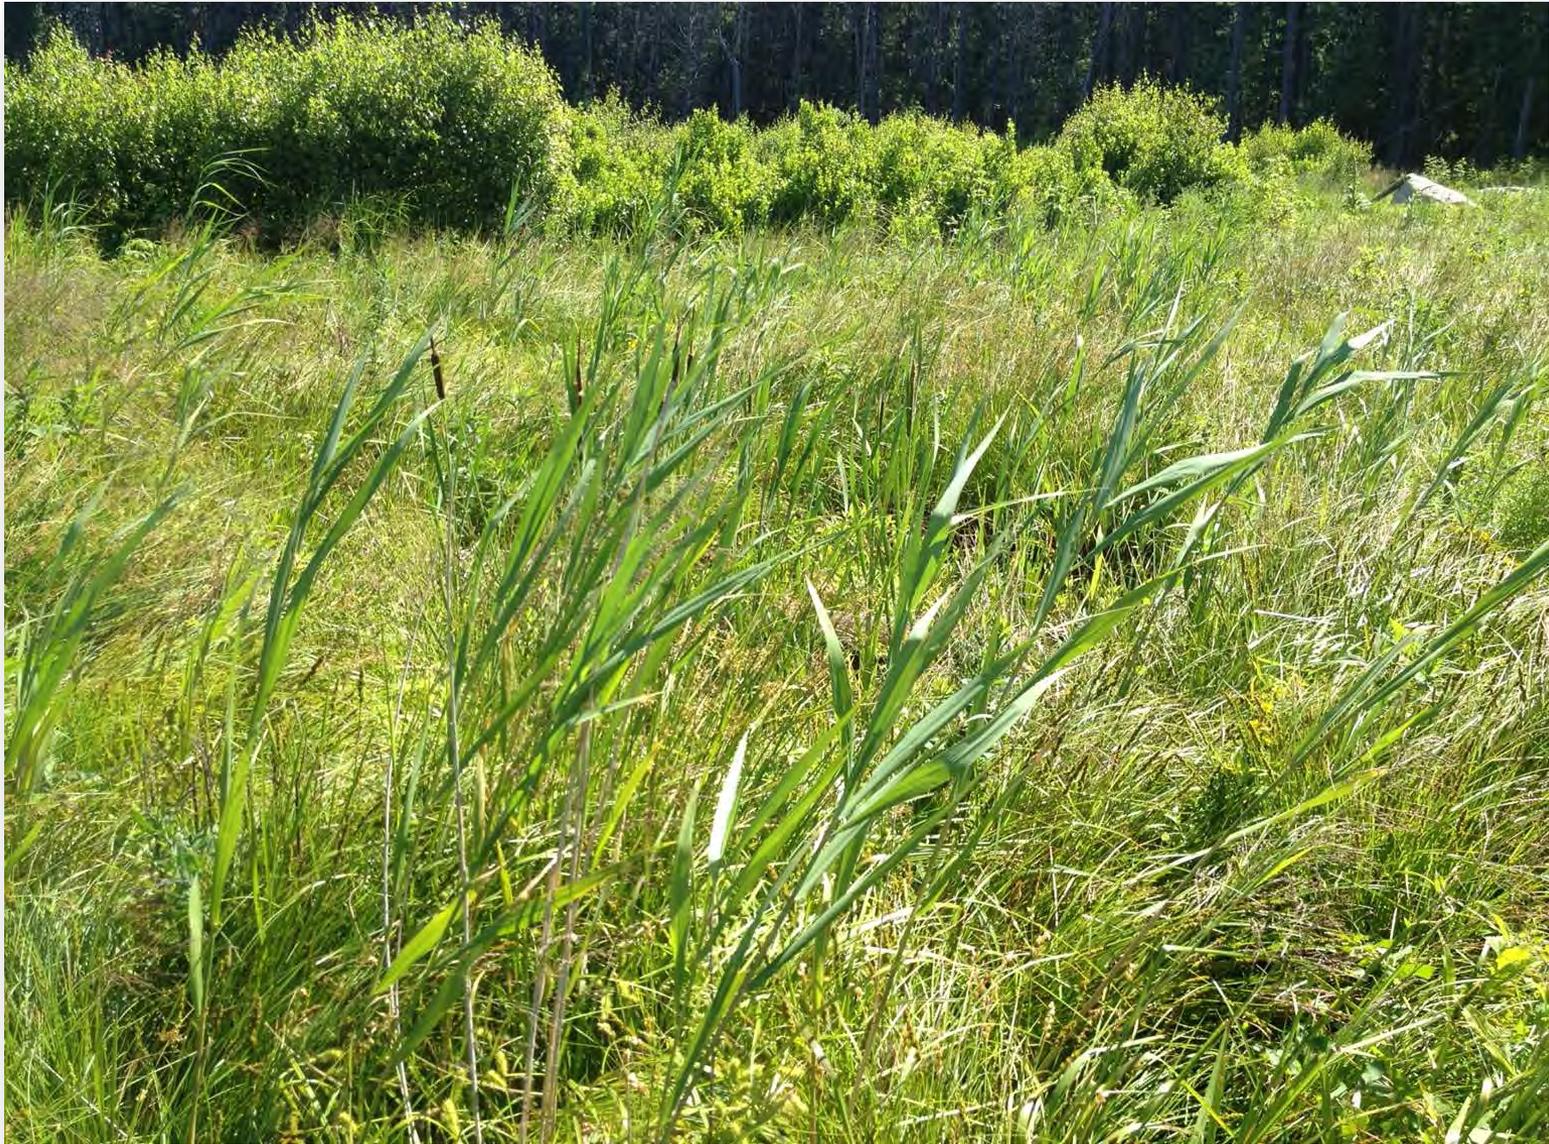
Typical view of sporadic phragmites pockets encroaching into Site 10 (scheduled to be treated late summer 2014).

common reed. The common reed was interspersed amongst cattails and other native wetland plant species. The Airport has scheduled an herbicide treatment in Sites 6 and 10 in late summer. We will continue to keep an eye on these areas in the interim. Epsilon observed and harvested individual common reed plants at Site 5 in May; no additional common reed individuals were found in June. We will continue to keep an eye on Site 5 and advise the Airport in the event treatment measures are determined to be necessary as per the approved ISMP. No new individual multiflora rose plants (*Rosa multiflora*) sprouts were found in Site 5 or 10. Site 6 had a few new rose sprouts, predominately on the edges of the mitigation area and immediately adjacent to established rose plants along the West Ditch. We will continue to keep an eye on these areas and advise the Airport in the event treatment measures are determined to be necessary as per the approved ISMP.

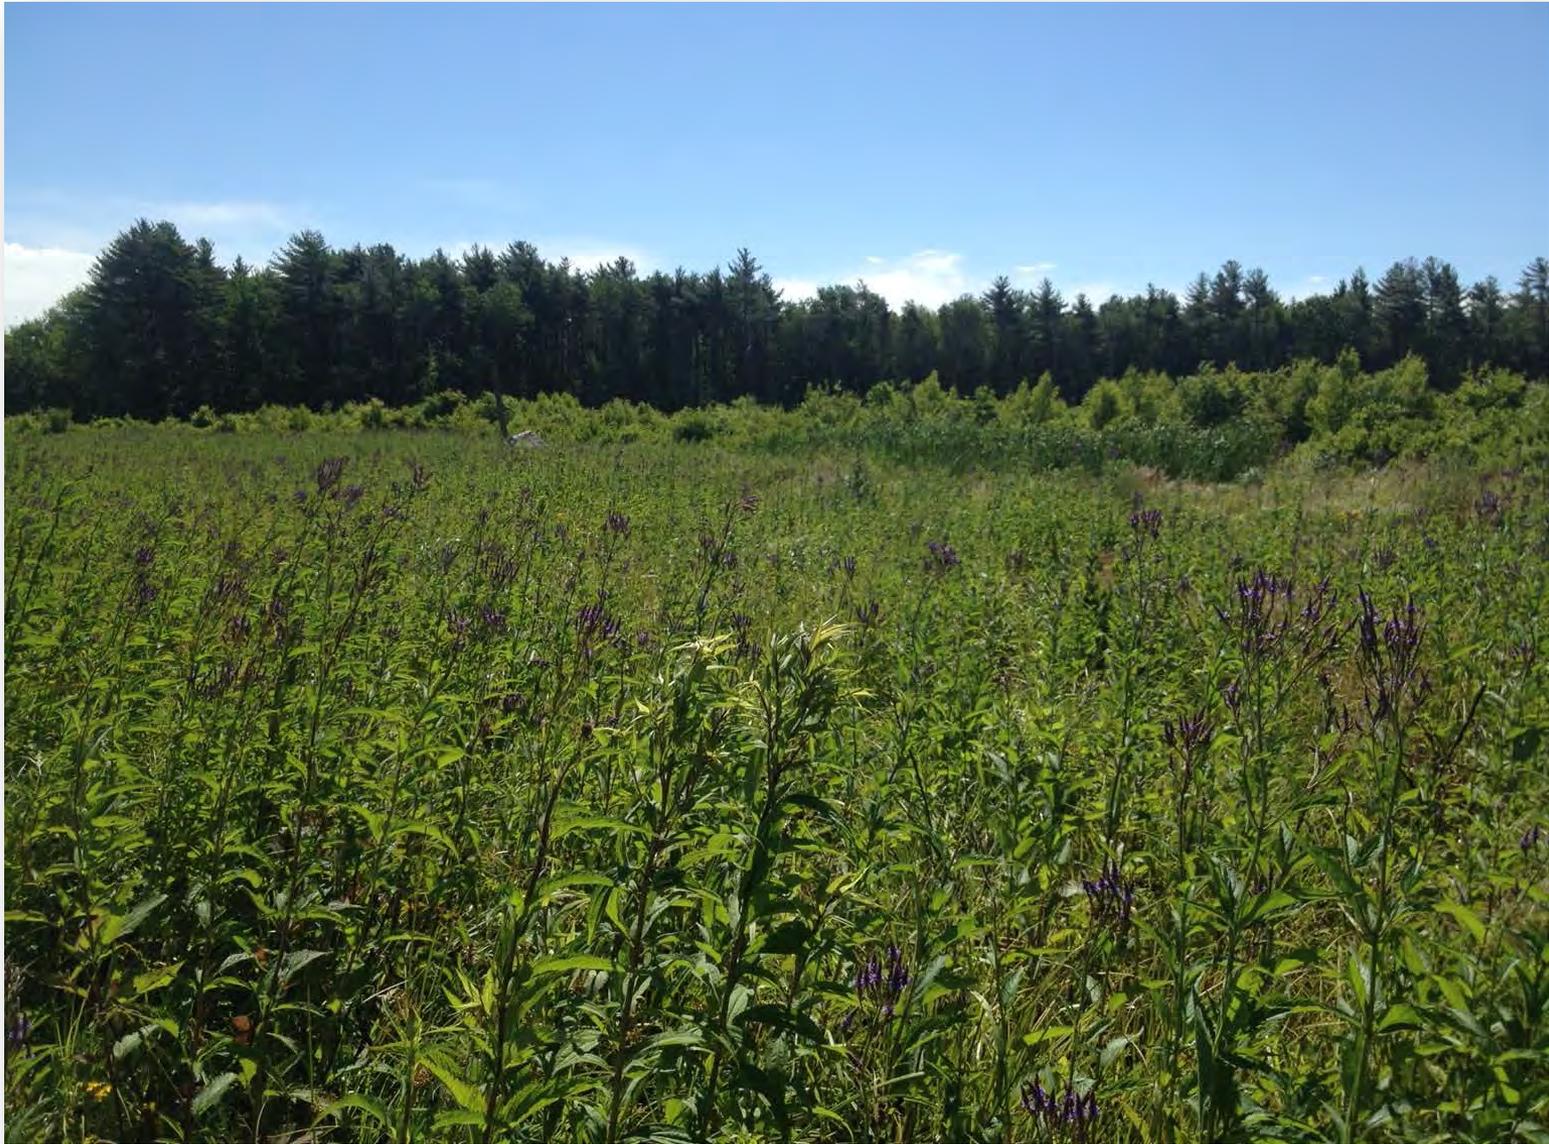
Typical view of herbaceous plant growth in Site 10; common vervain (purple flower) in foreground.
