NB Airport Site Photos

July 5, 2014

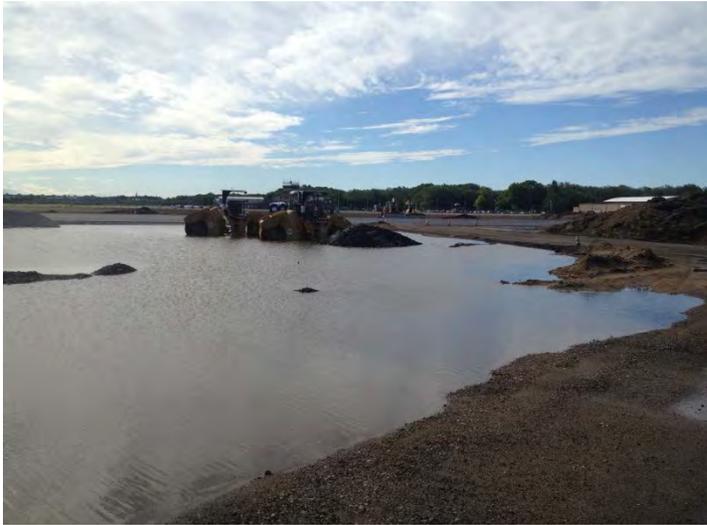
Rollers and equipment should be removed from flooded areas as soon as conditions allow. Confirm that there was no leaking of fuel or oils.

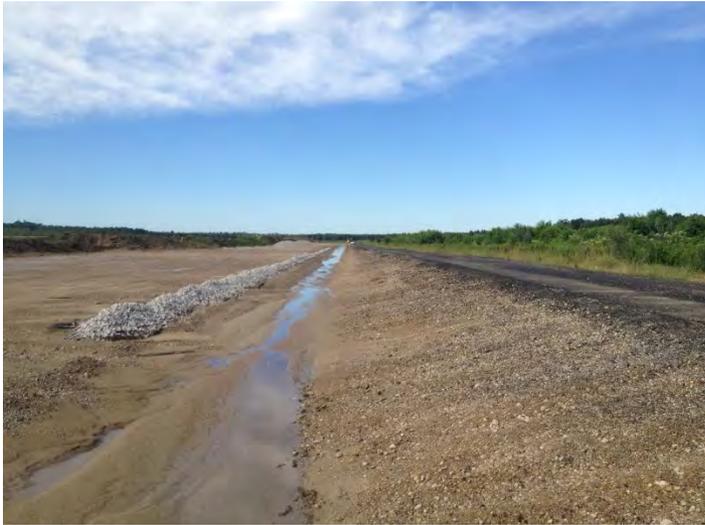
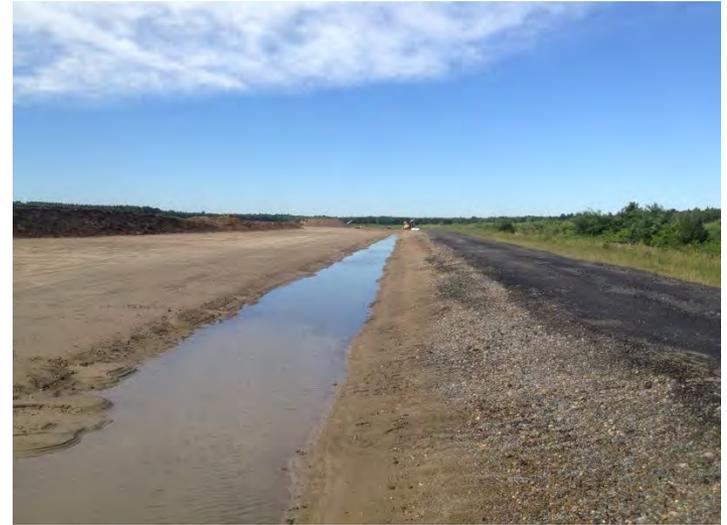
Please inspect swale and make sure it continues to contain water and function as intended.
Determine if sediment should be removed to provide storage during construction.

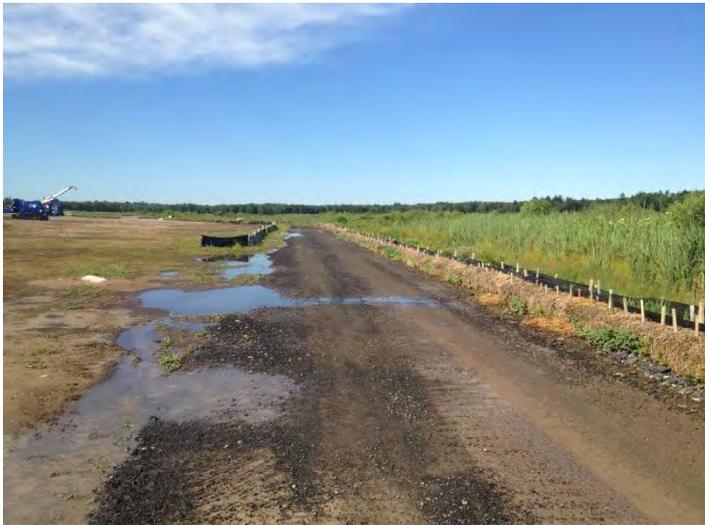
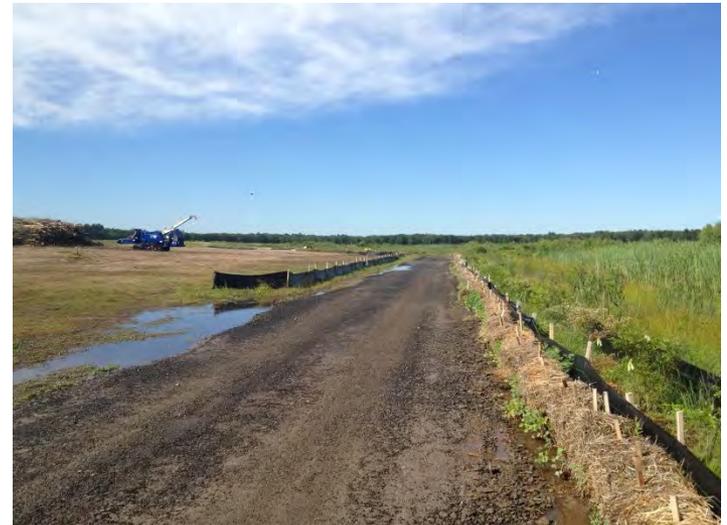
Gravel access road held up very well; I did not see any issues.
Please re-inspect all erosion controls and repair as necessary.
They looked good on Saturday.

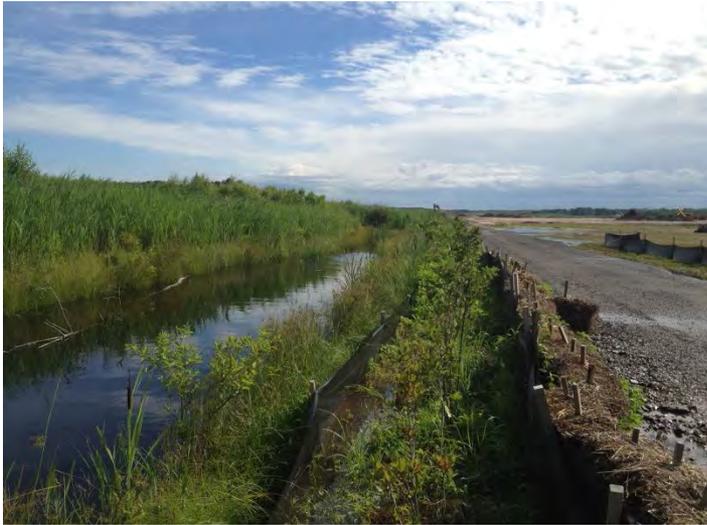
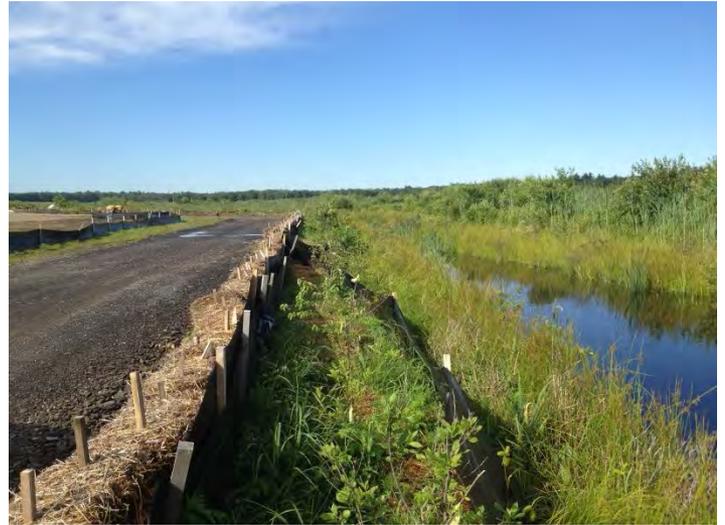
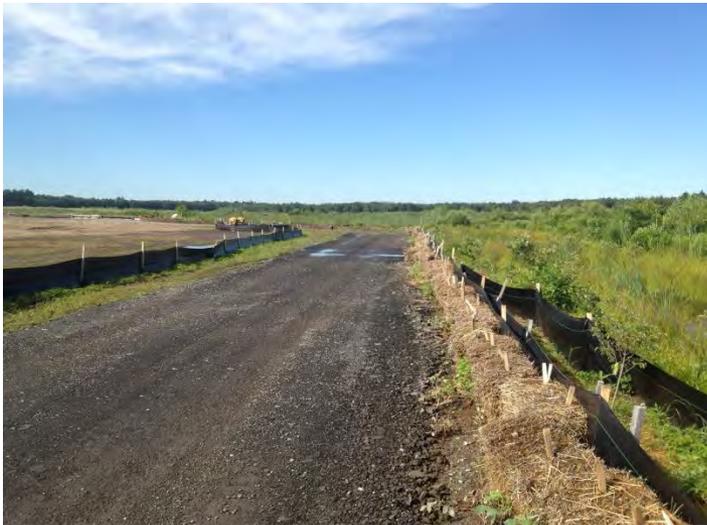
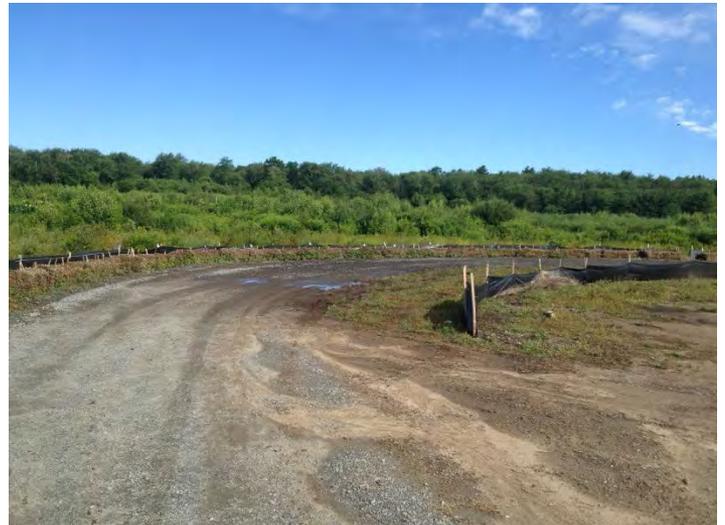
Same comment as above; please re-inspect gravel access road and repair erosion controls as necessary. They looked good on Saturday.

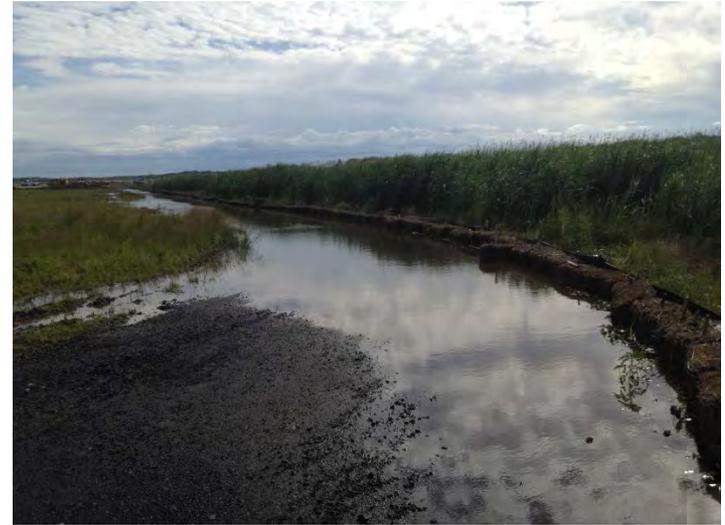
This view is where the access road turns the corner away from the West Ditch; could not access as road was under water. Please inspect and repair erosion controls as soon as conditions allow. Road may require additional stabilization measures.

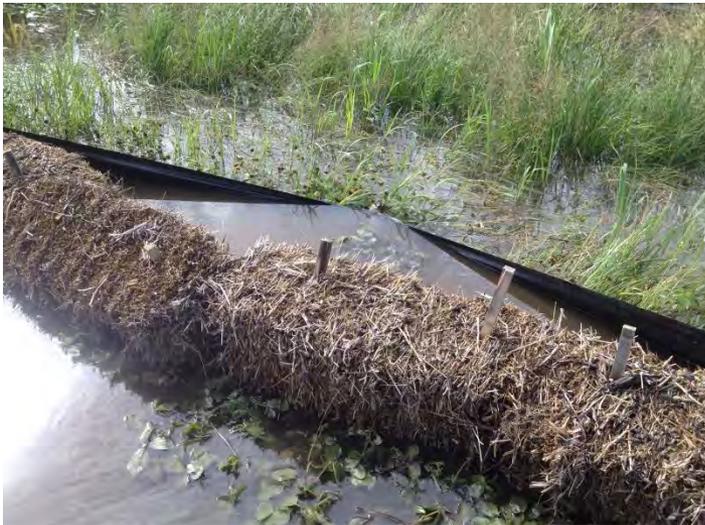
These controls are on the back side of the gravel access road that was under water; water was overflowing controls but was not turbid. Repair controls when conditions allow.

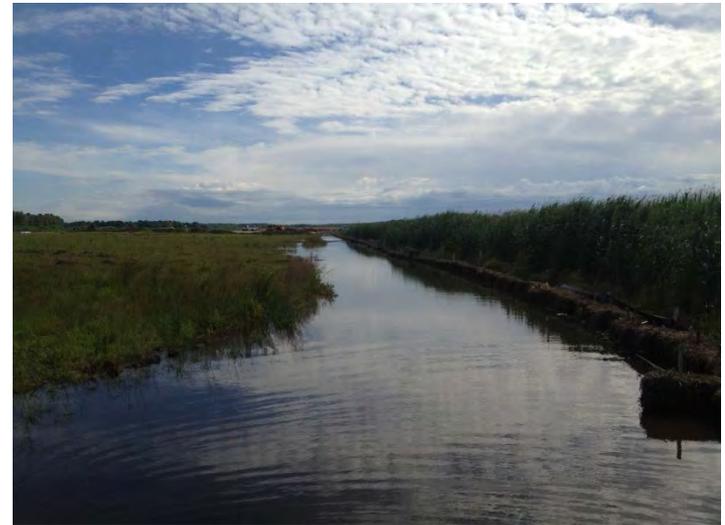
Another view of gravel access road under water. Please inspect road and adjacent wetlands as soon as conditions allow.

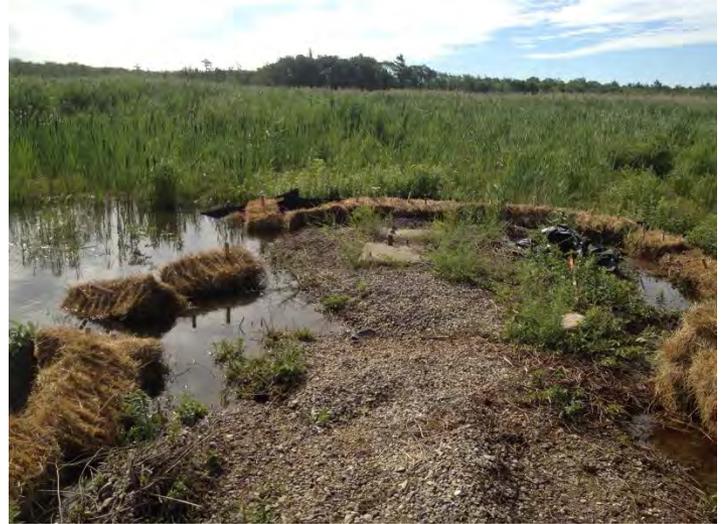
Typ. view of controls at one of the MALSR light stations that will need to be repaired before work commences in these locations.

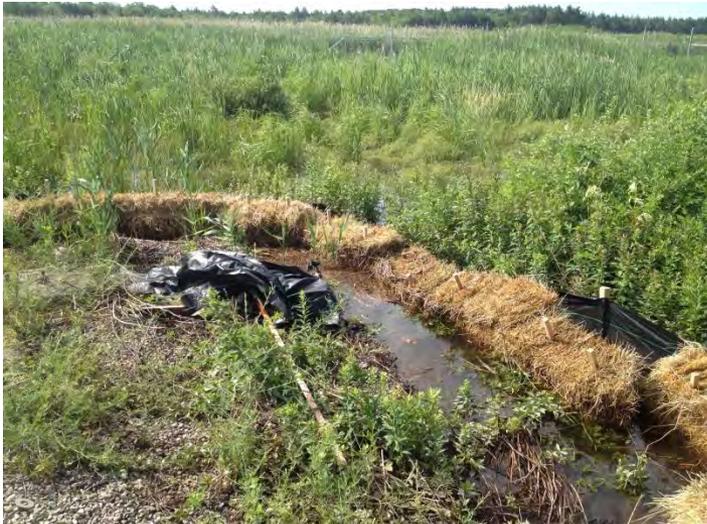
Another view of one of the MALSR light stations where controls need to be repaired.

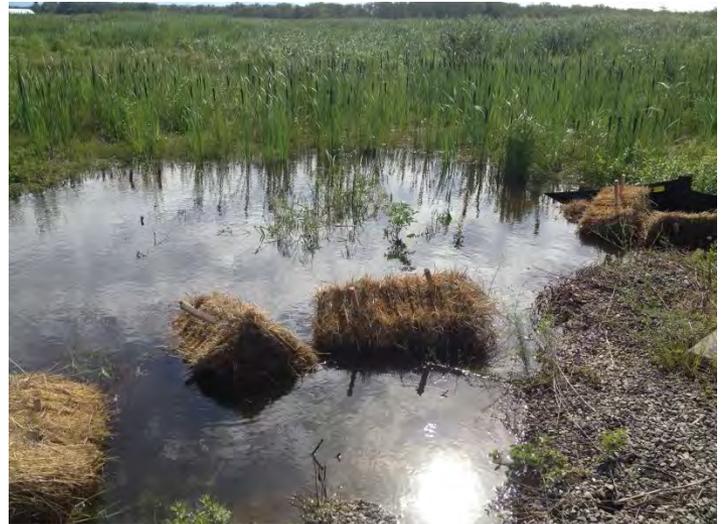
Another view of one of the MALSR light stations where controls need to be repaired.

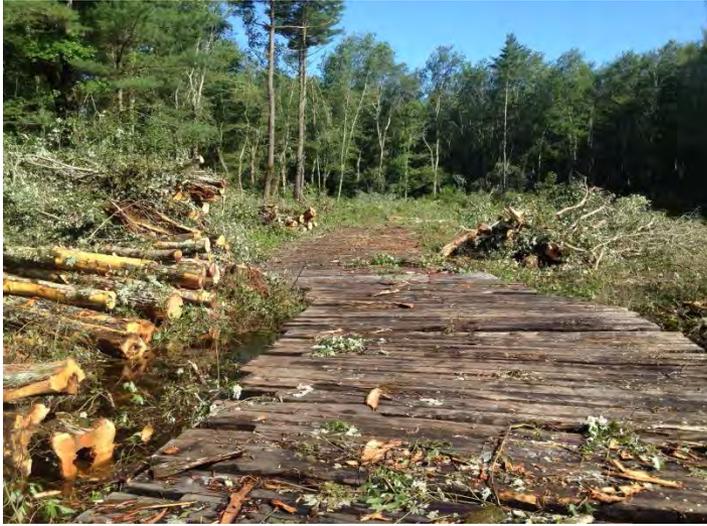
Swamp mats were in good shape at the beginning of the primary access road.

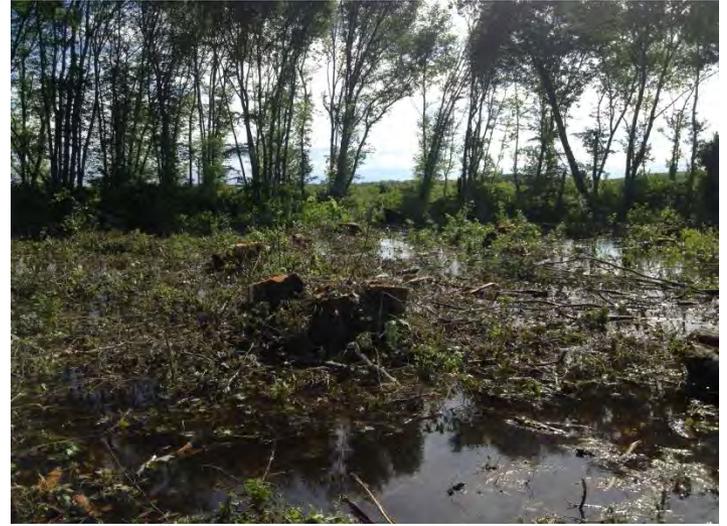
Typical view of high water condition in Dartmouth wetlands. Will be difficult to perform turtle sweeps and cut vegetation until water recedes later in the week.

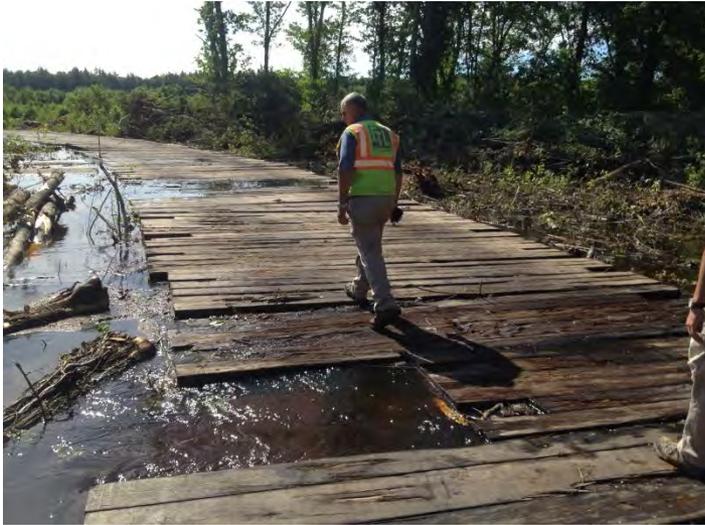
View of section of swamp mats where they were beginning to float and one or two mats shifted. Note flowing water through the mats (good velocity). Wagner Wood will need to pull a plan together with ETL and WS after assessing situation.

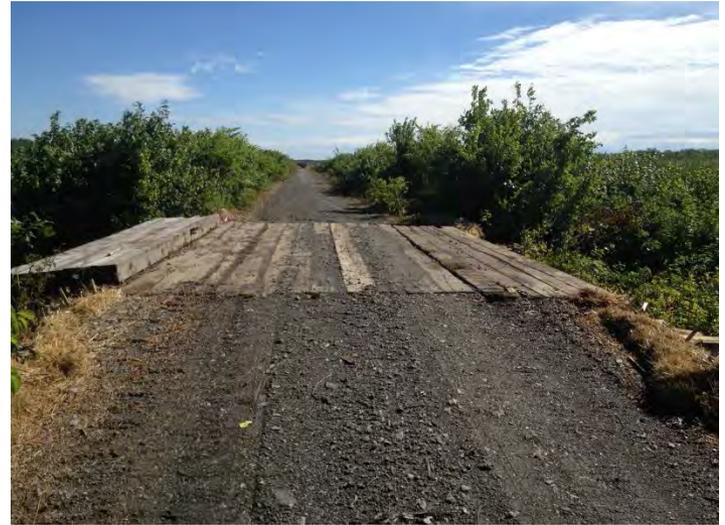
The bridge across the old pipes on the ILS road held up nicely. No problems observed to the bridge or the pipes.

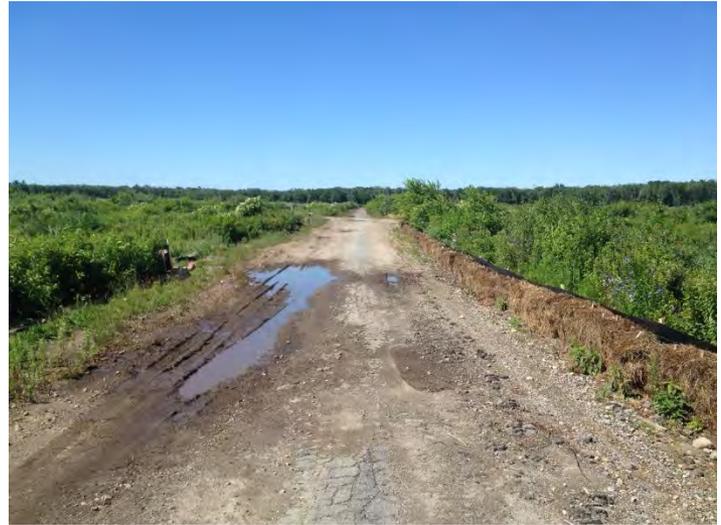
Typical view of ILS road leading to Dartmouth ... looked good.

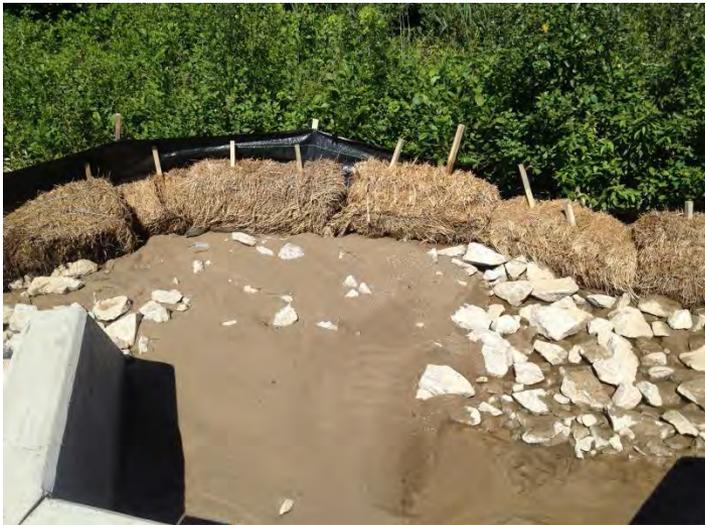
This is either the 1st or 2nd newly installed headwall at the 5 end; sediment needs to be removed from sump and erosion controls repaired. There was a minor breach but no evidence of siltation in adjacent wetland. This should be an early action item on Monday.

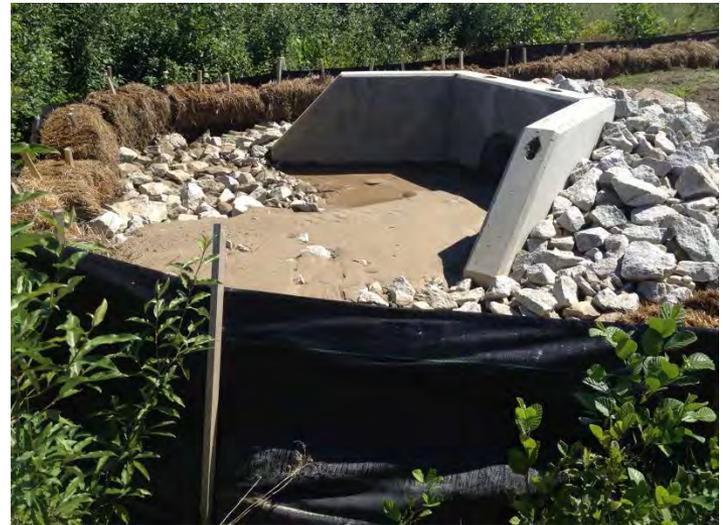
Another view ... same structure. Please address on Monday.

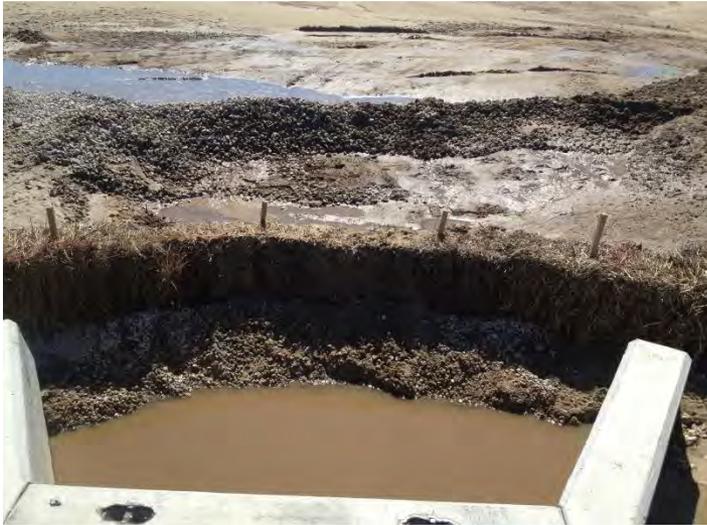
This is the inlet to the structure depicted on the prior photos; controls should be inspected and repaired as necessary; determine if sediment should be removed from this up gradient depression as well.
