**New Bedford Regional Airport
Runway Safety Improvements Project – Phase 4
Reconstruct, Mark, and Groove Runway 5-23
MassDEP File No. SE049-0635**

ENVIRONMENTAL MONITOR INSPECTION FORM

Date/ Time of Inspections: **7/3/14 (all day), 7/5/14 (morning) and 7/10/14 (all day).**

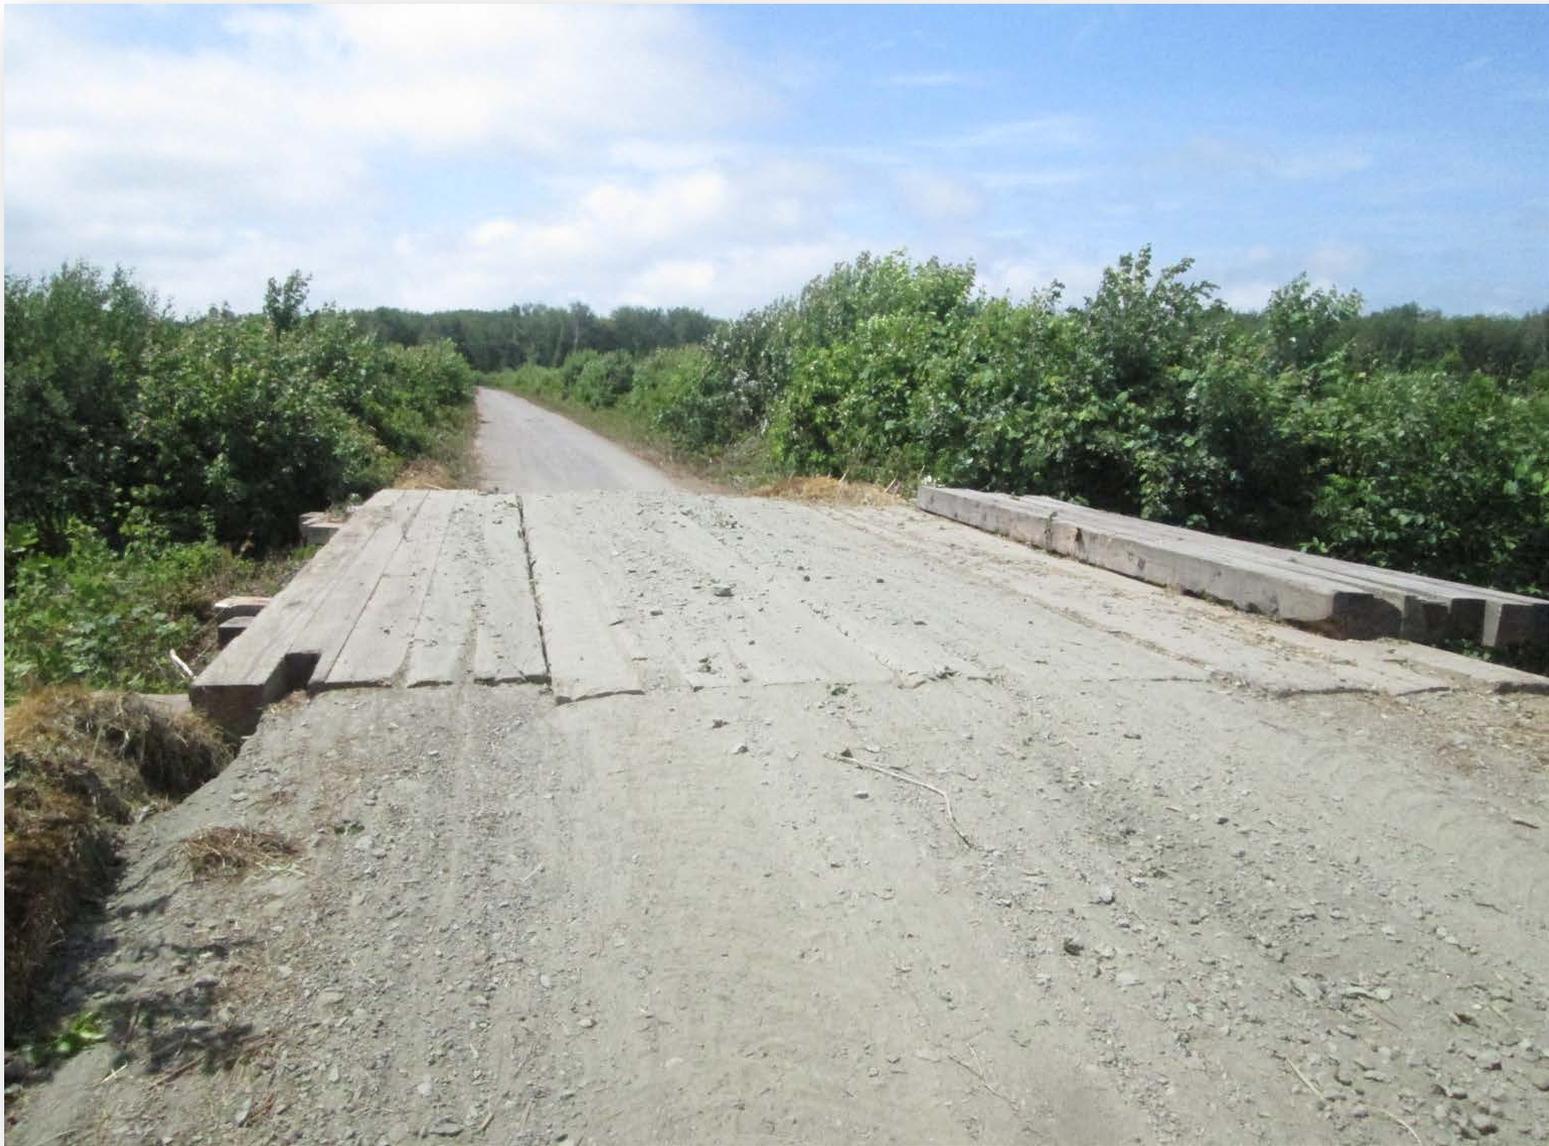
View of timber mats installed on paved ILS road to protect underlying culverts at Paskamansett River crossing. This area has held up nicely over the past two weeks.

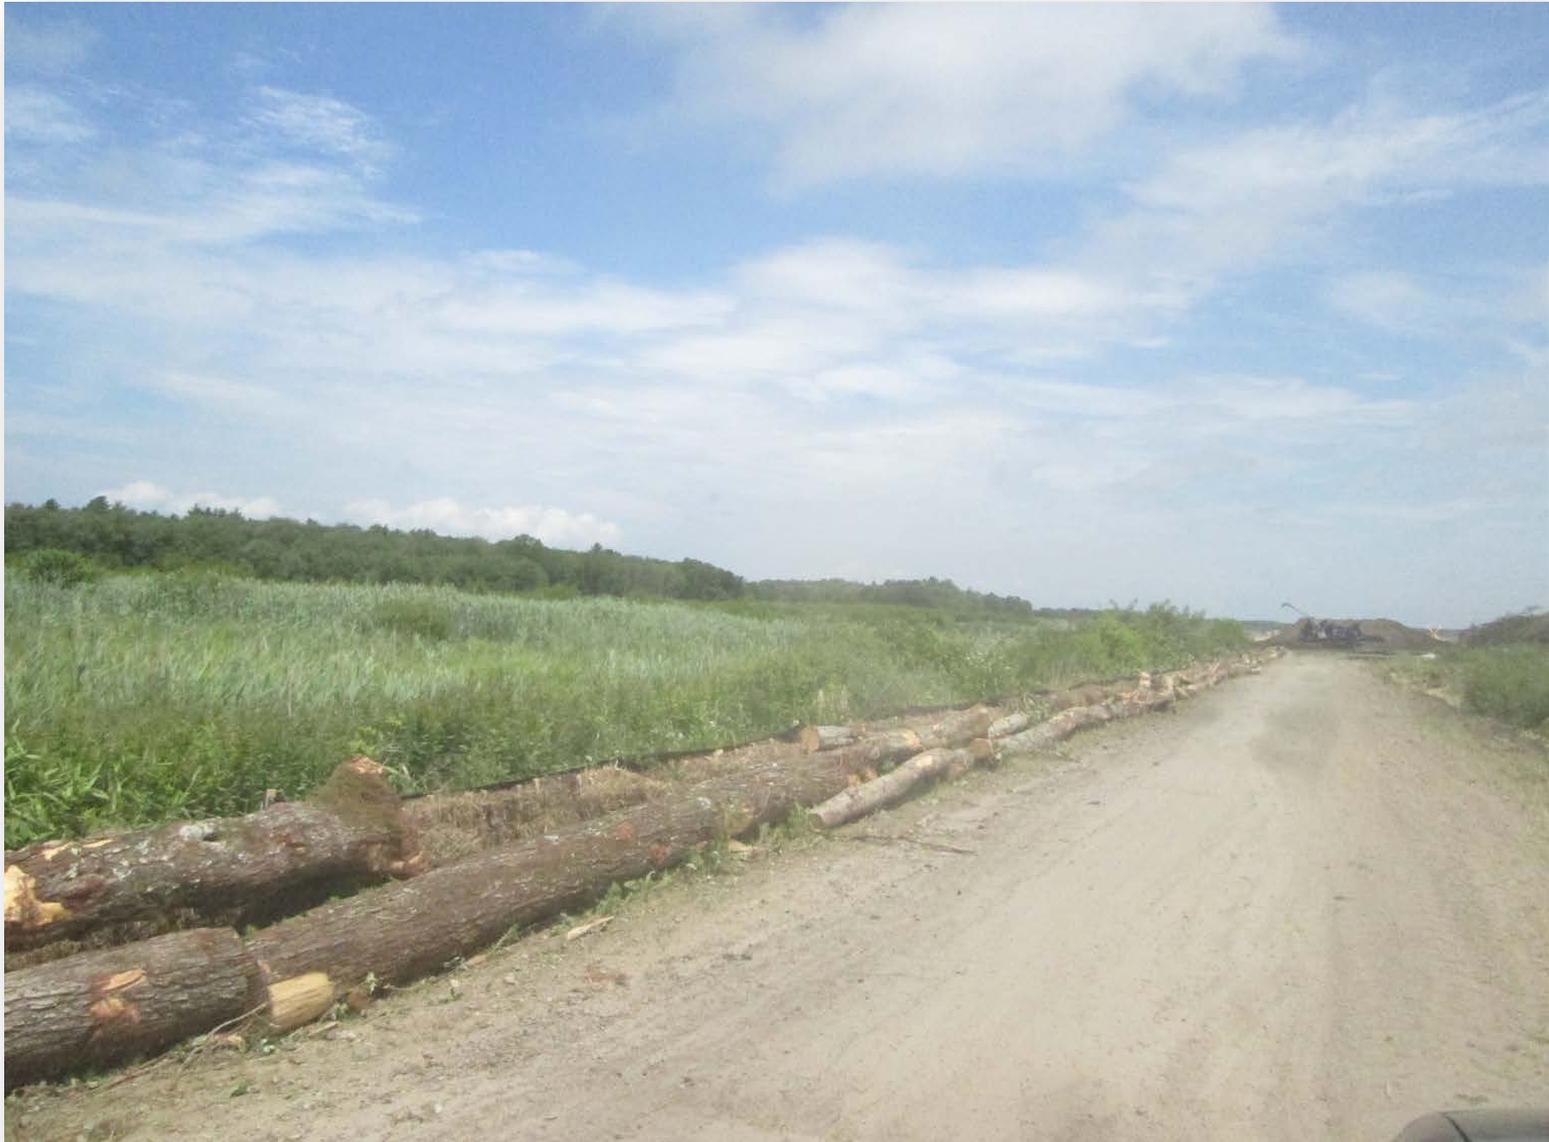
View of logs arming existing hay bale sediment controls with felled trees along a portion of the ILS road (from the culvert to the wildlife fence)

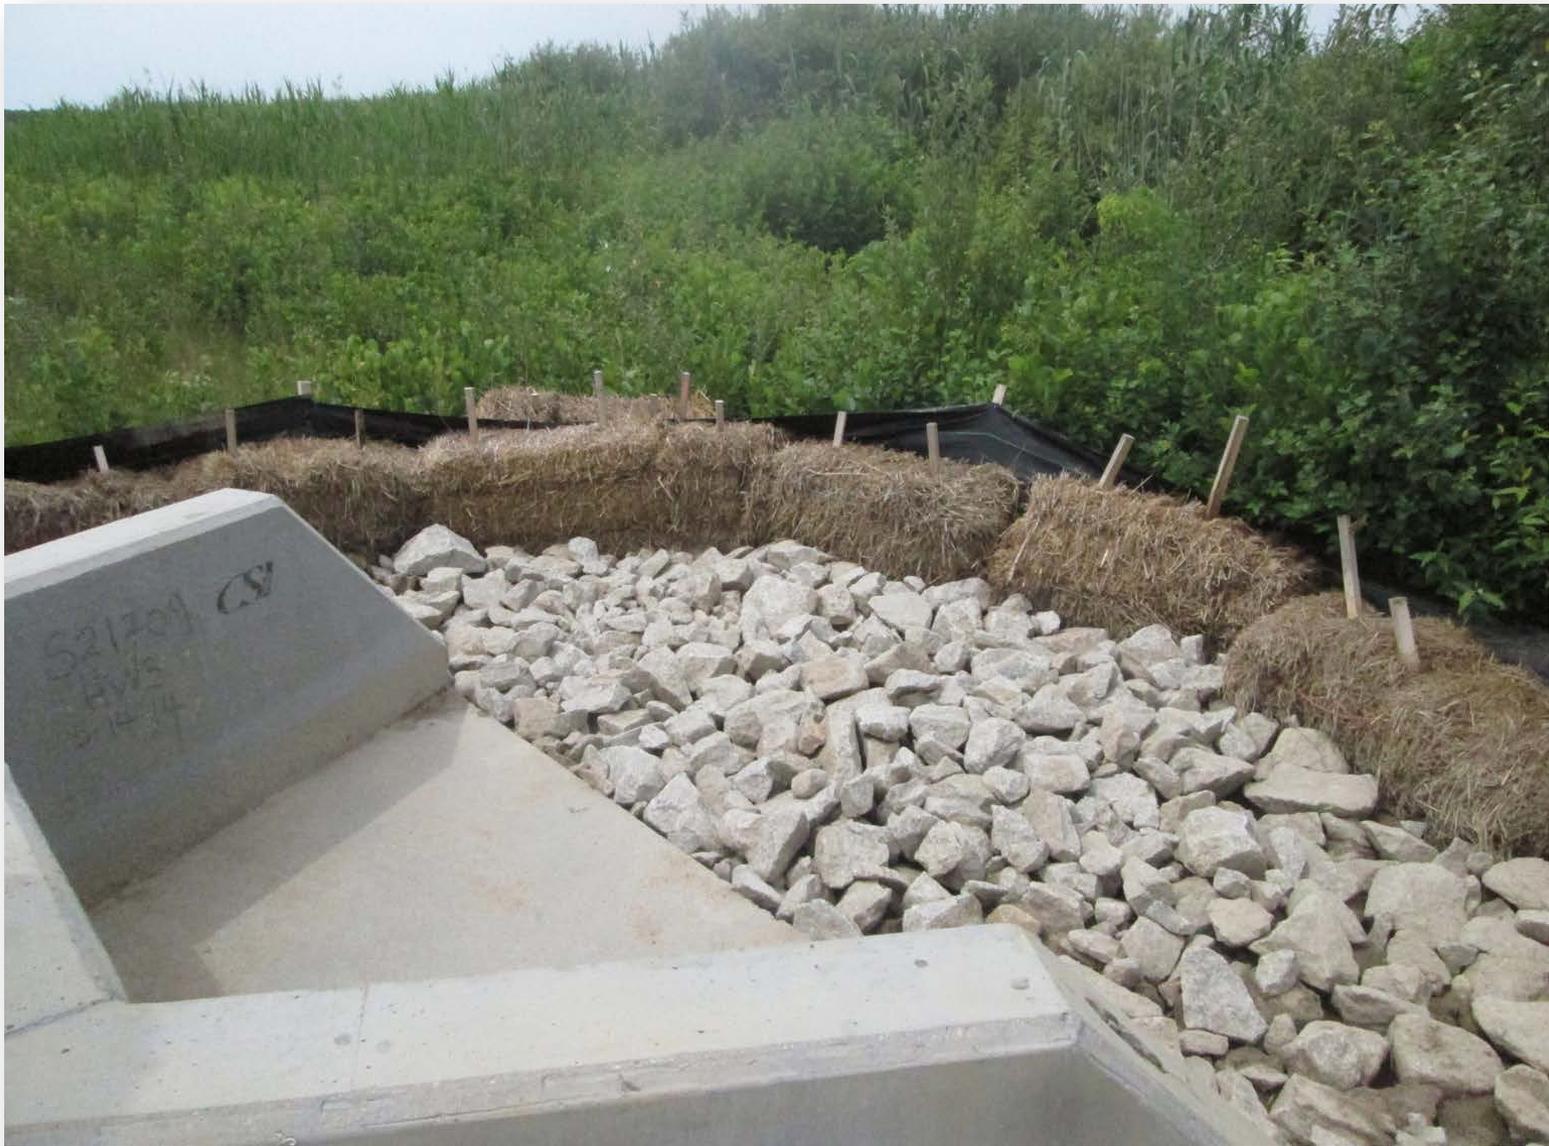
View of newly installed headwall by 5 end, noted in 7/5 photos. This area has been hand cleared of sediment from prior tropical storm event and erosion controls repaired. The double row of straw bales is where the minor breach occurred.

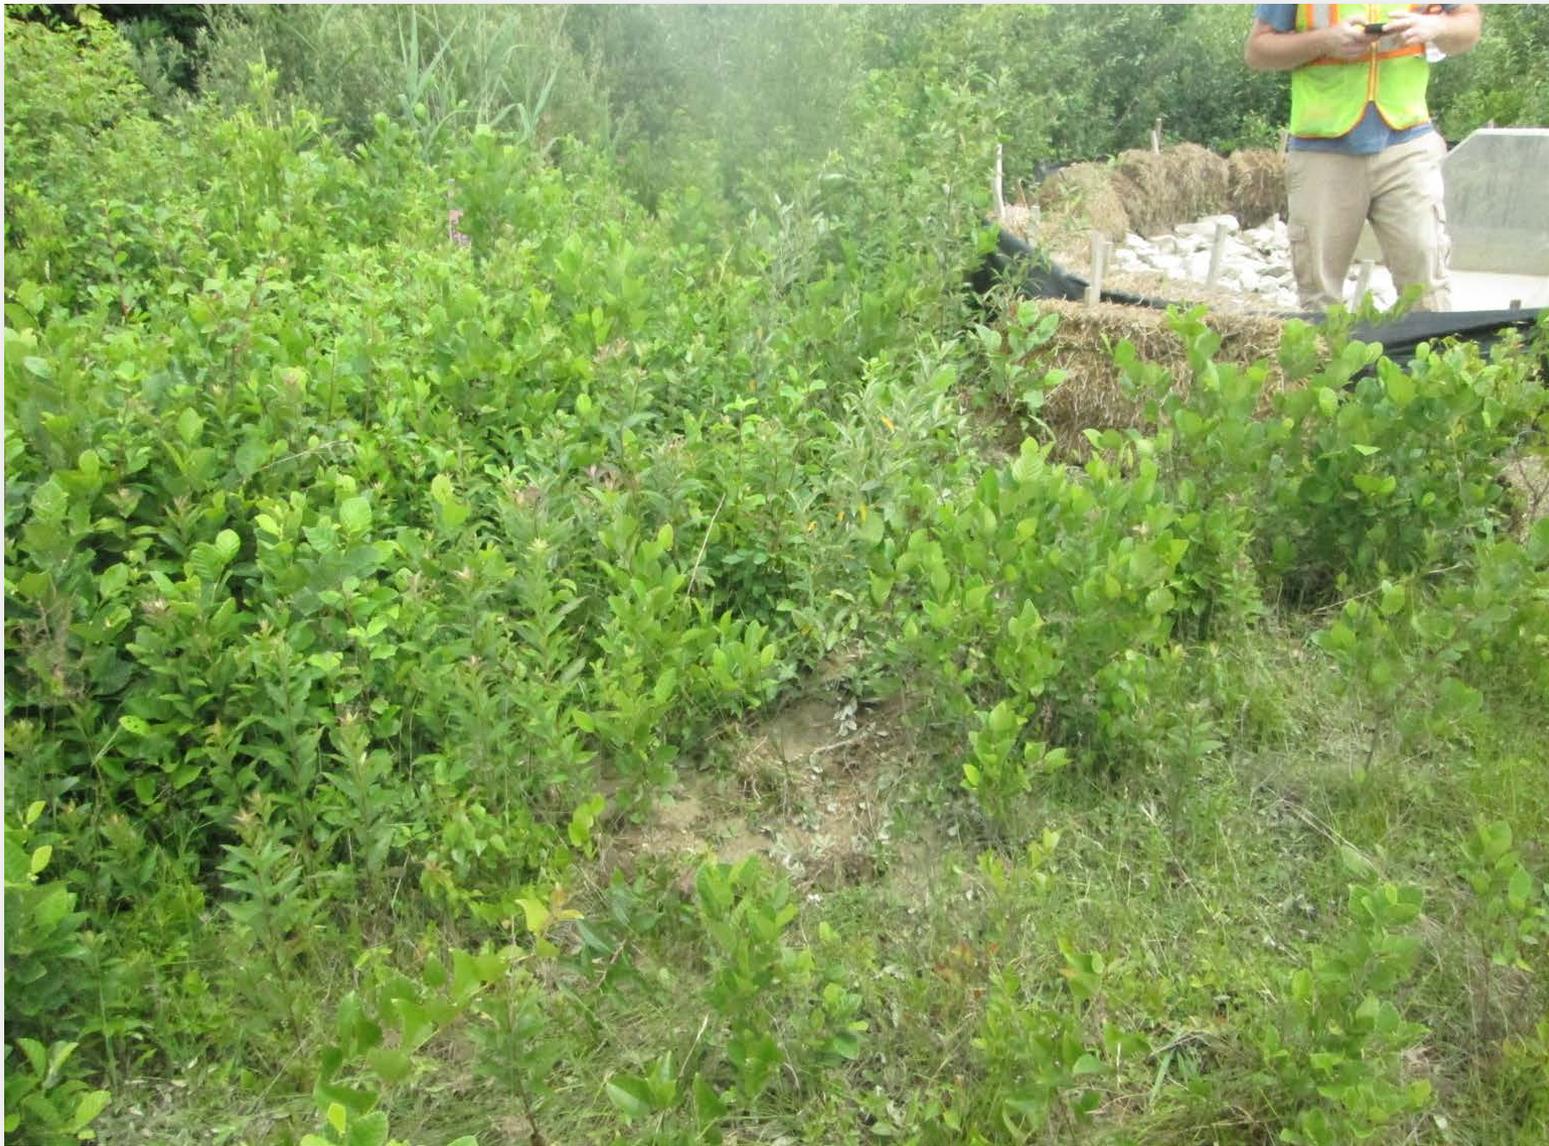
View of minor sediment deposit area downgradient from the headwall. This area is adjacent to the wetland and has been hand cleared.

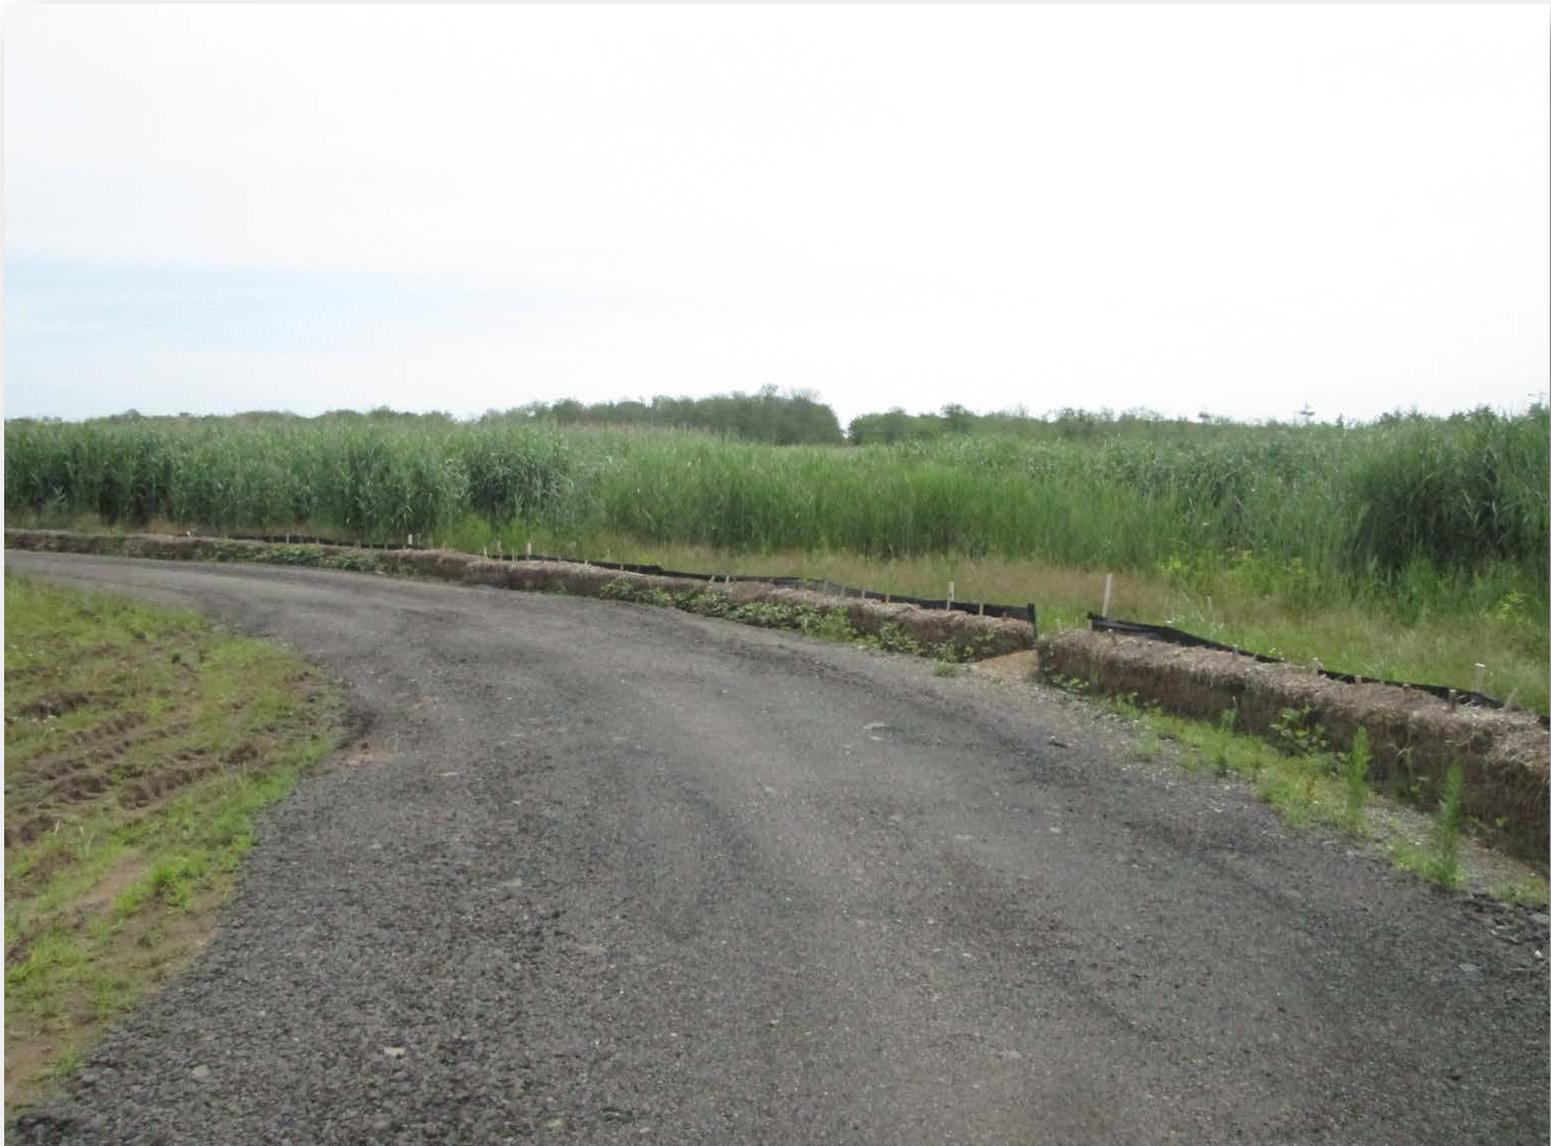
View of the RW 5 end corner previously underwater in the 7/5 photos. Straw bales and silt fence were re-staked where necessary.

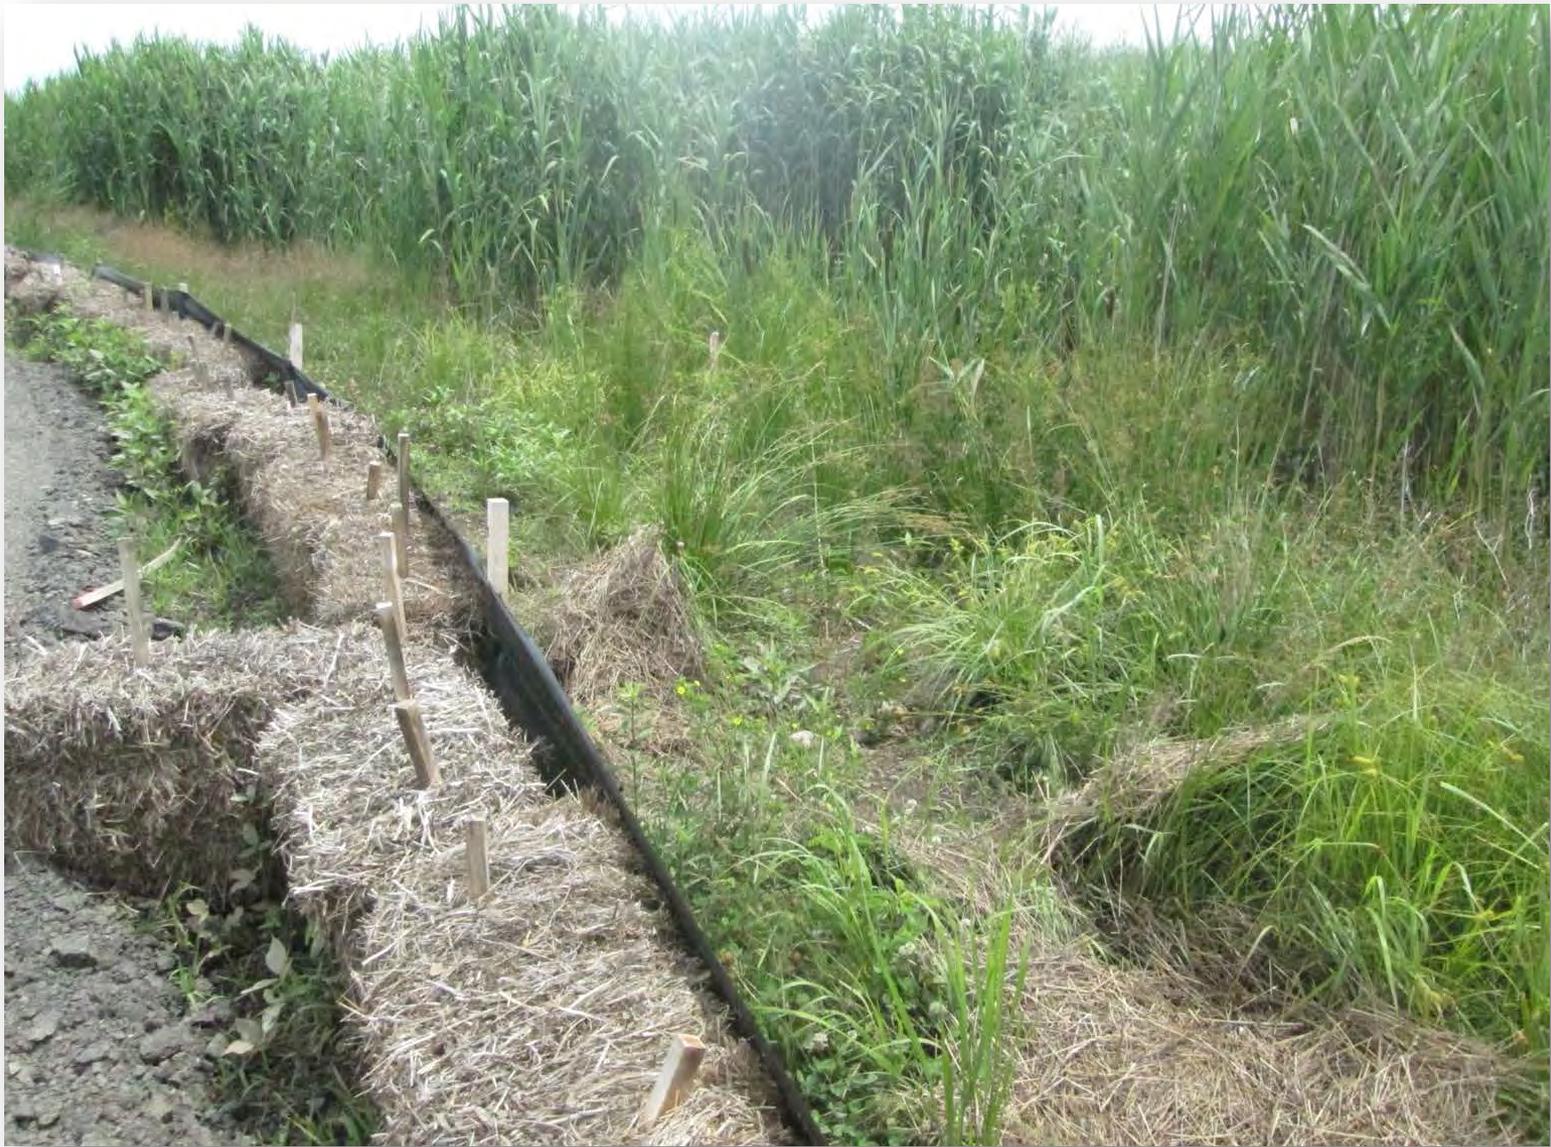
View of area where water overtopped the silt fence from tropical storm. This area was hand cleared of sediment as necessary.

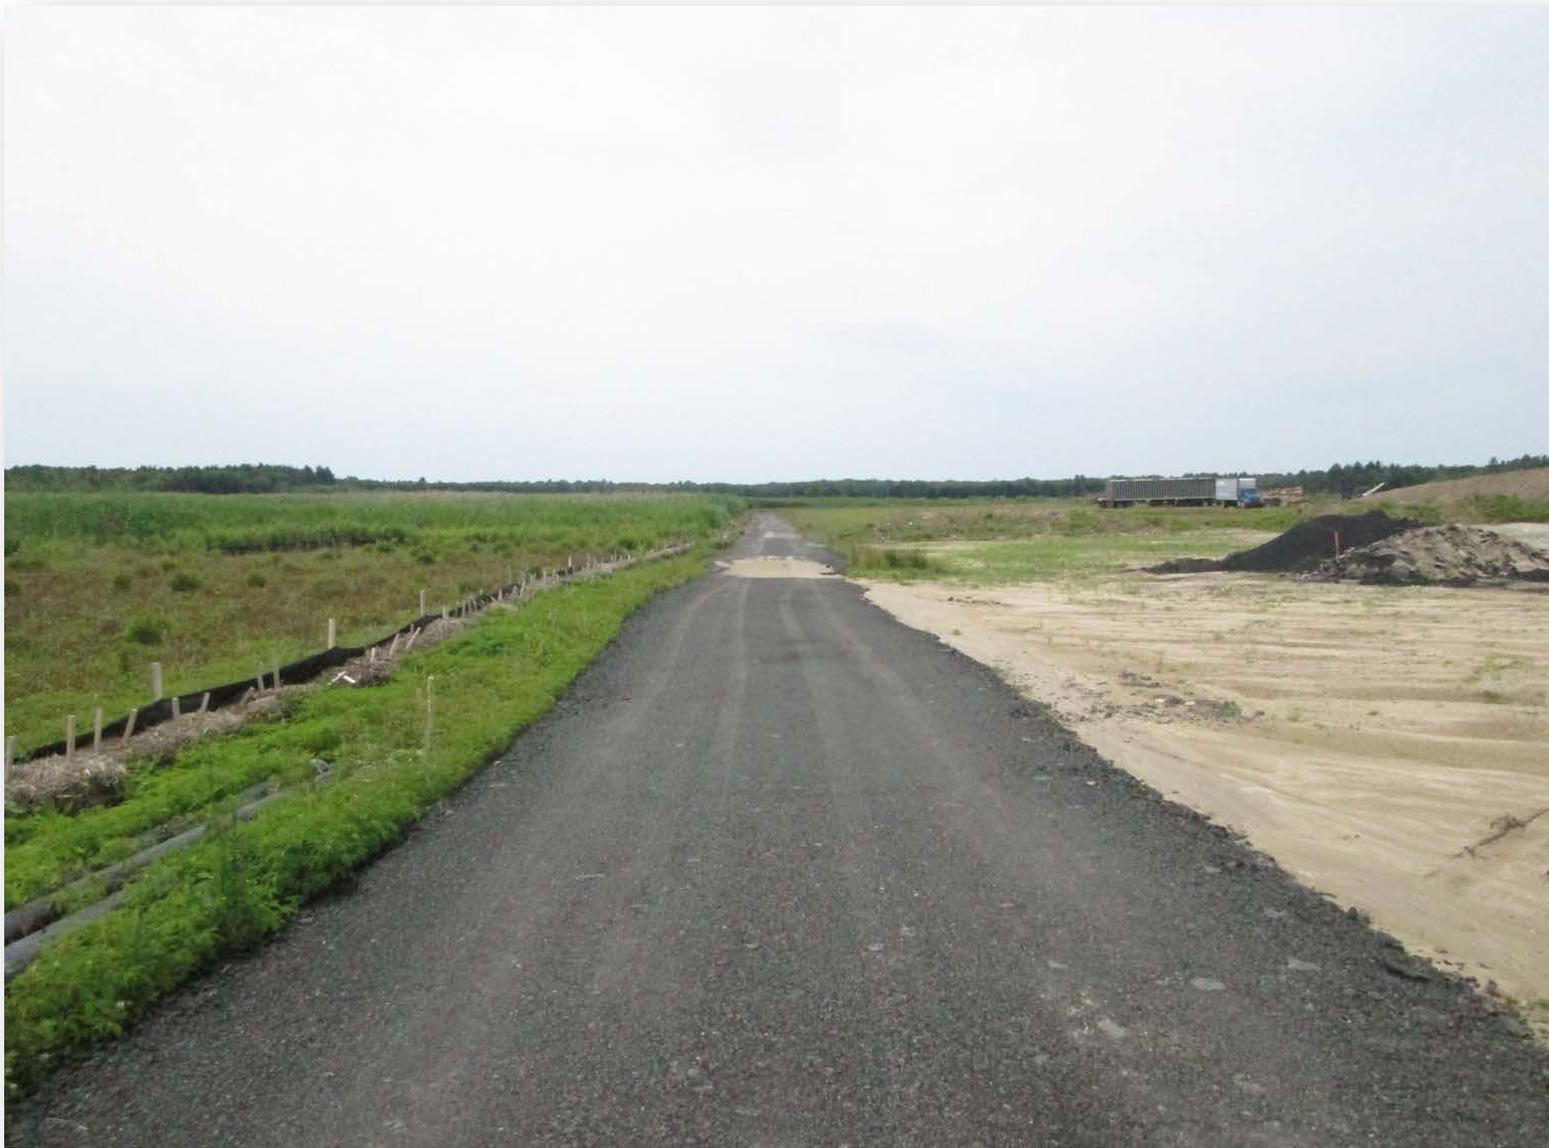
View of minor sediment movement across the access road. Sediment did not reach the silt fence.

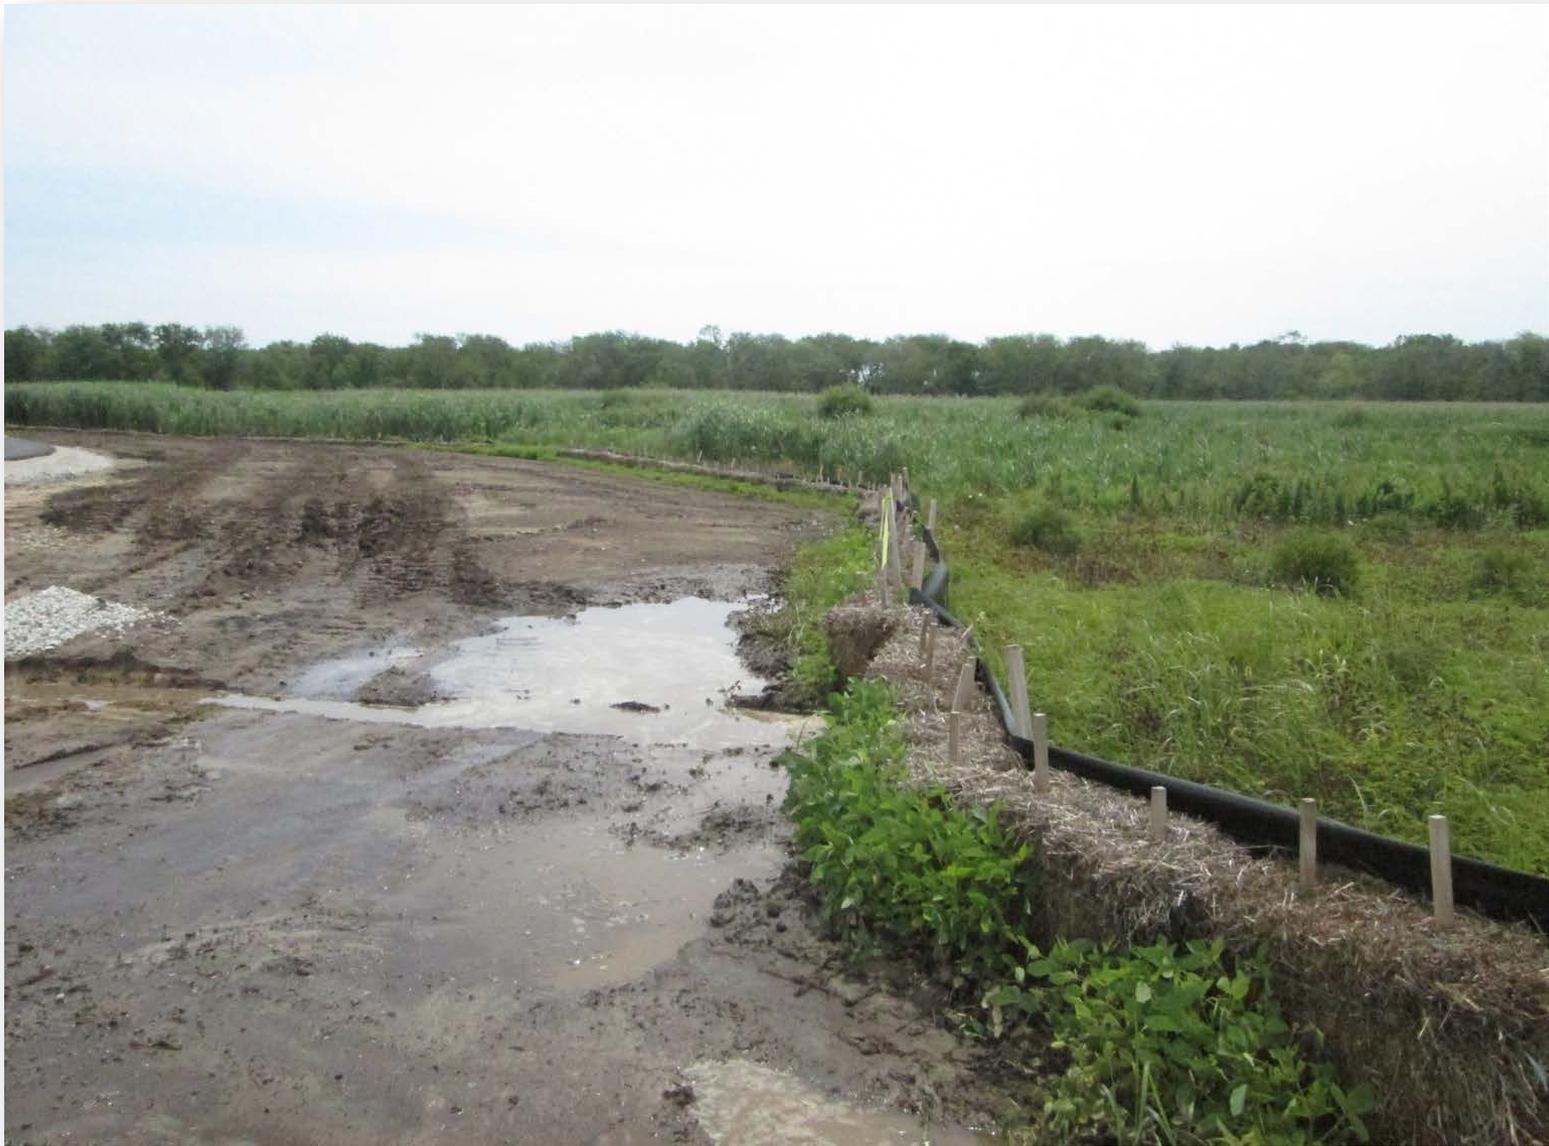
View of low spot in work zone. No sediment was found behind the silt fence and the controls were functioning as intended.

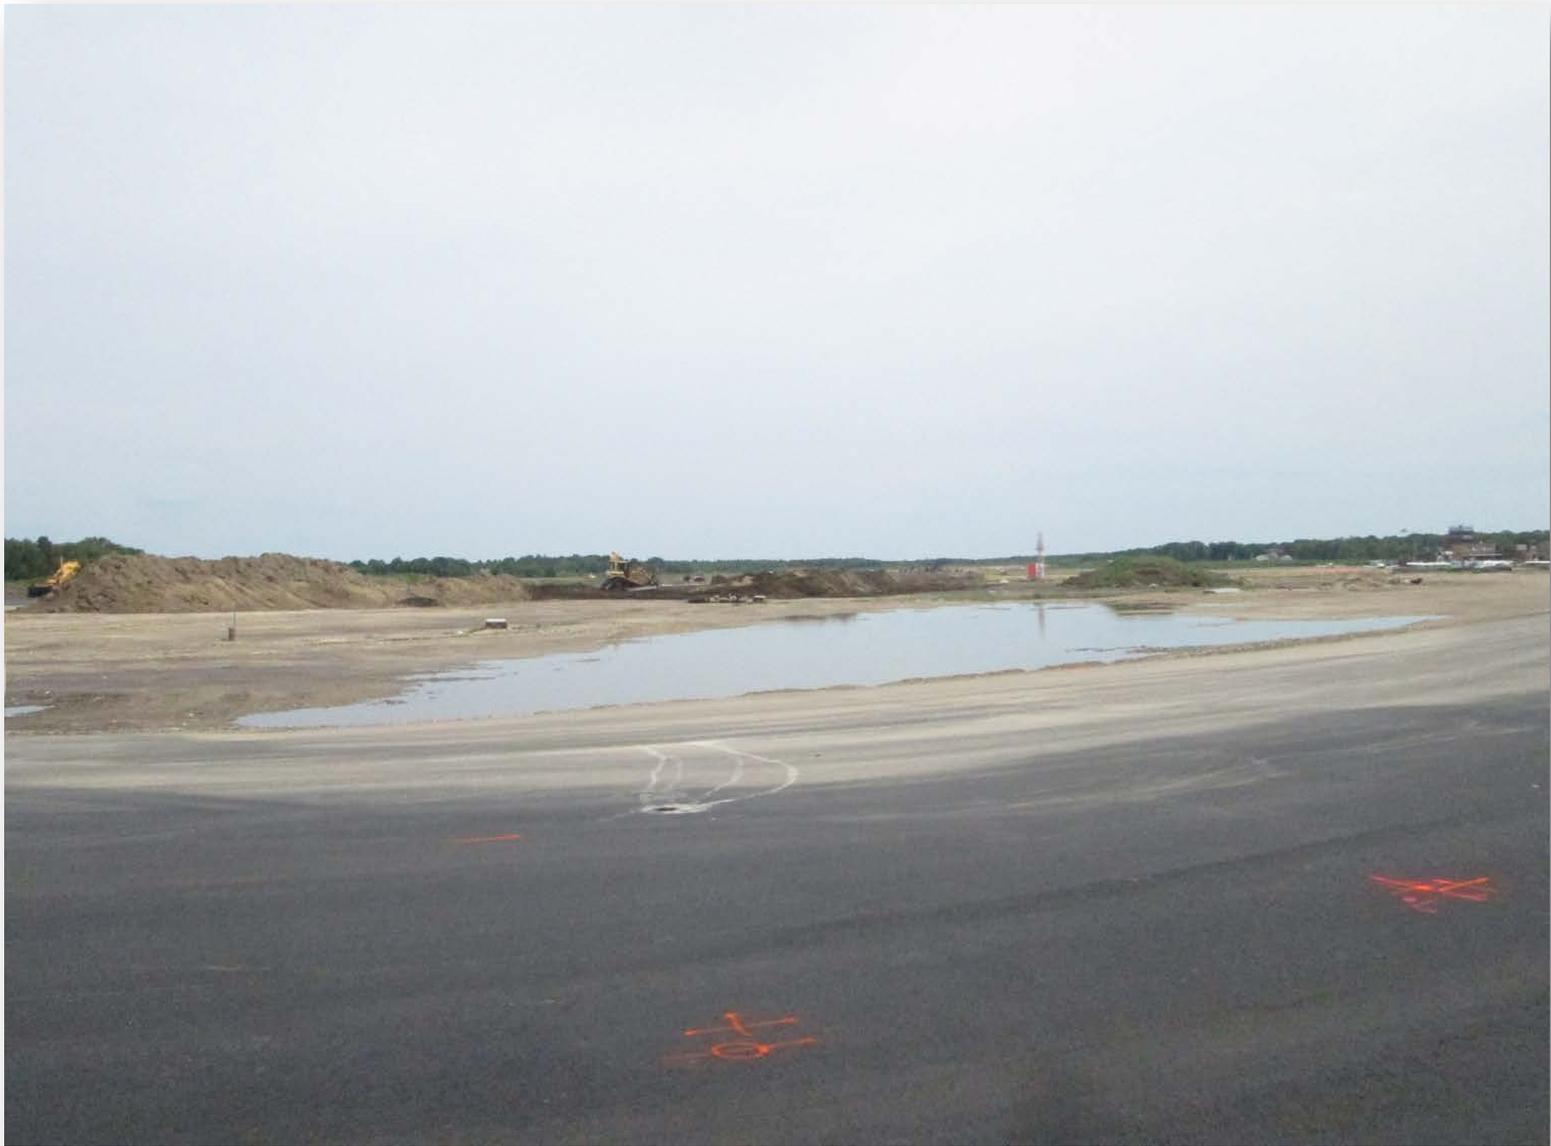
View of area where rollers and equipment from the electrical subcontractor were stored during the storm. No evidence of fuels or oils were noted on the soil surface.

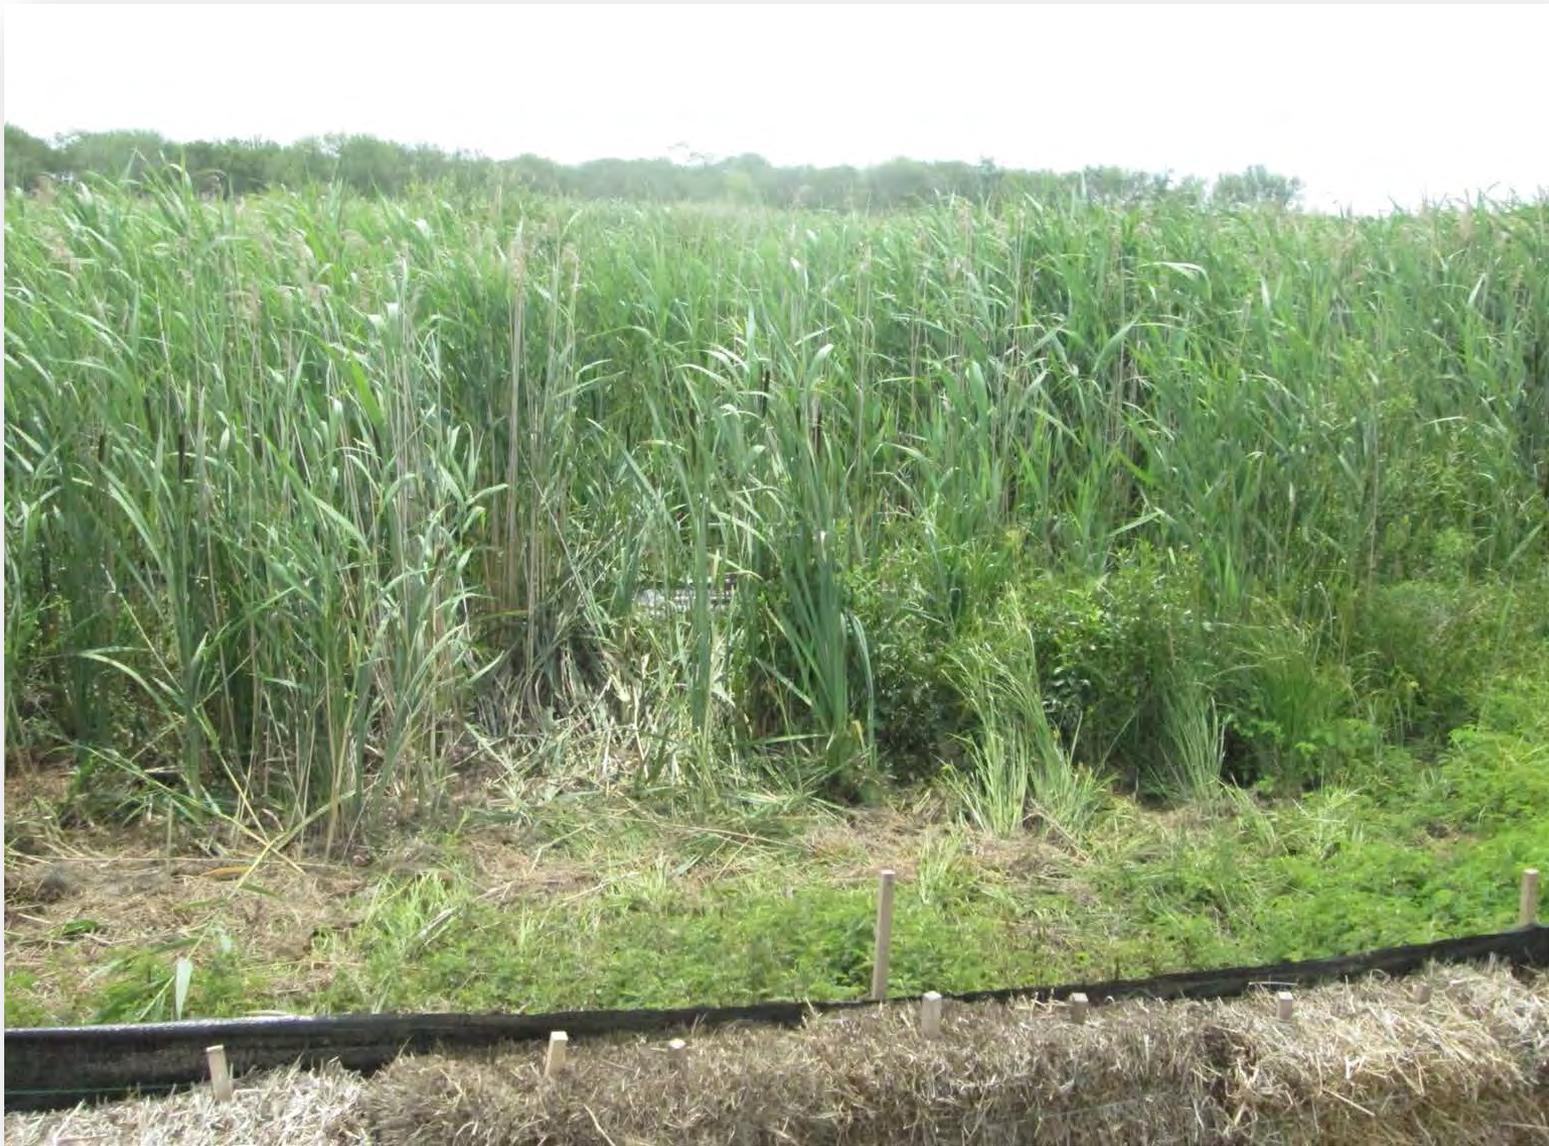
View of another area where water overtopped the silt fence. This area was hand cleared as necessary.

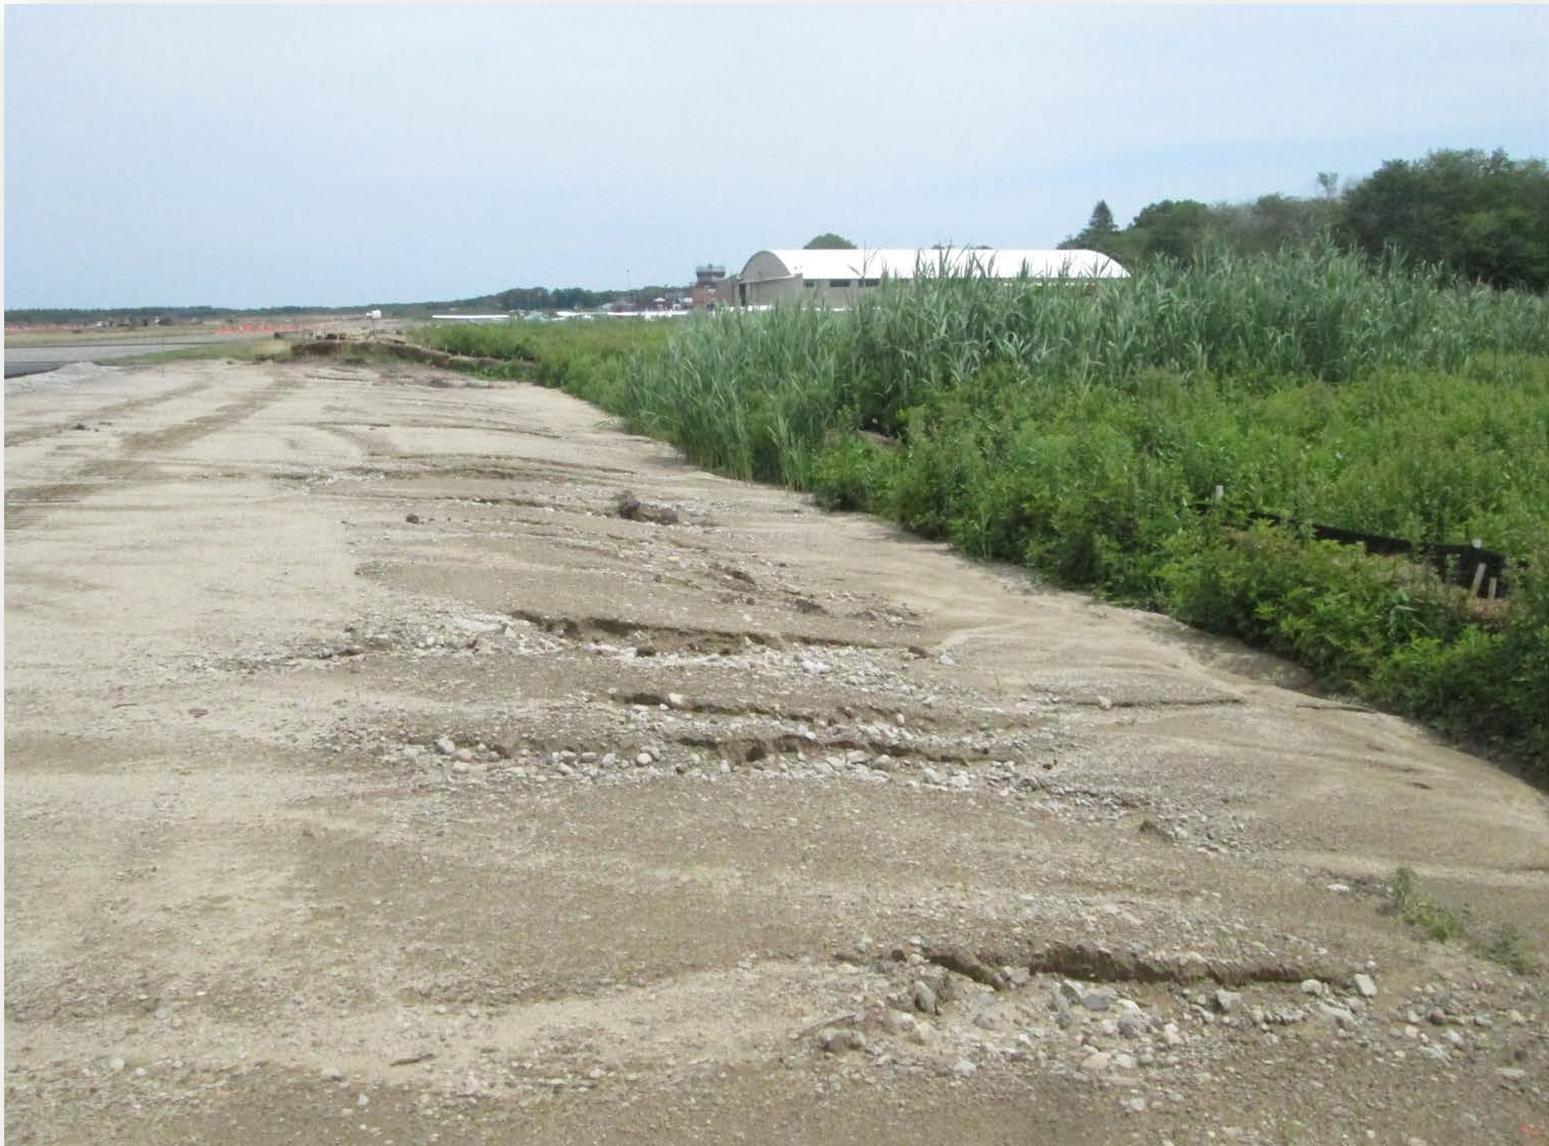
View of sediment movement down the exposed slope. Sediment was contained by silt fence. This area will need to be reshaped prior to seeding.

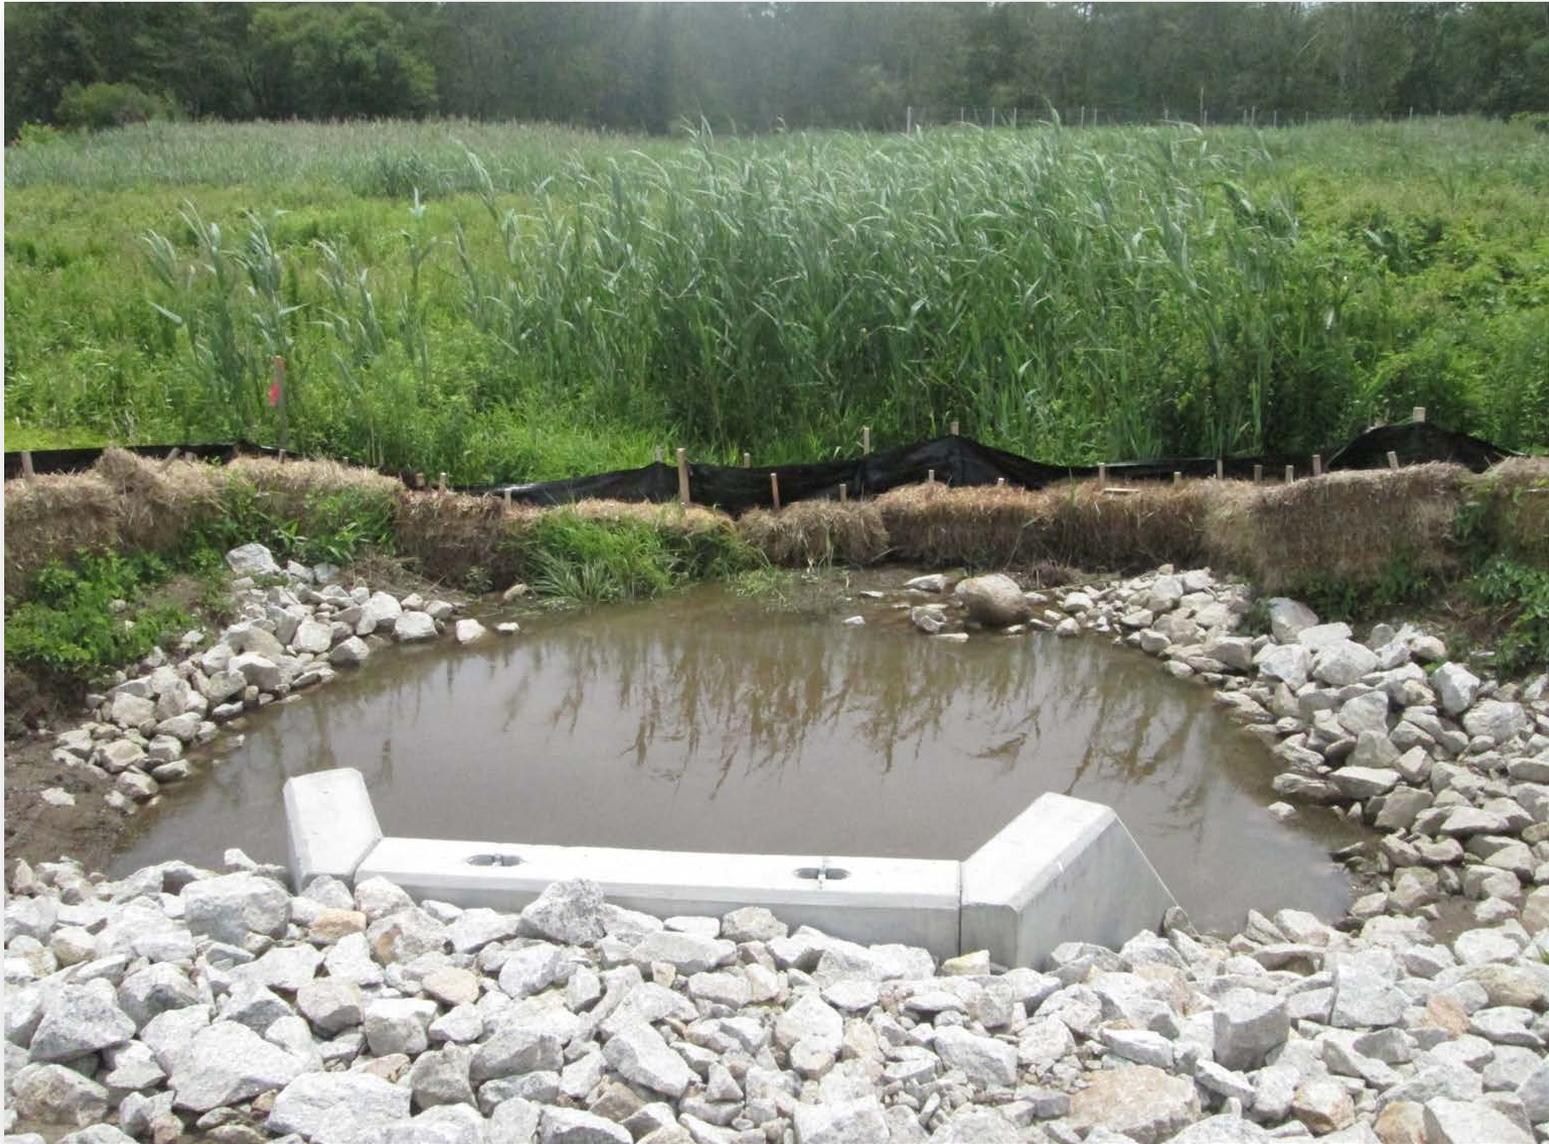
View of south headwall. Sediment laden water could be caused by overland flow or movement from the catch basin. This area will need to be fixed and stabilized.
