**New Bedford Regional Airport
Runway Safety Improvements Project – Phase 4
Reconstruct, Mark, and Groove Runway 5-23
MassDEP File No. SE049-0635**

ENVIRONMENTAL MONITOR INSPECTION FORM

Date/ Time of Inspections: **7/3/14 (all day), 7/5/14 (morning) and 7/10/14 (all day).**

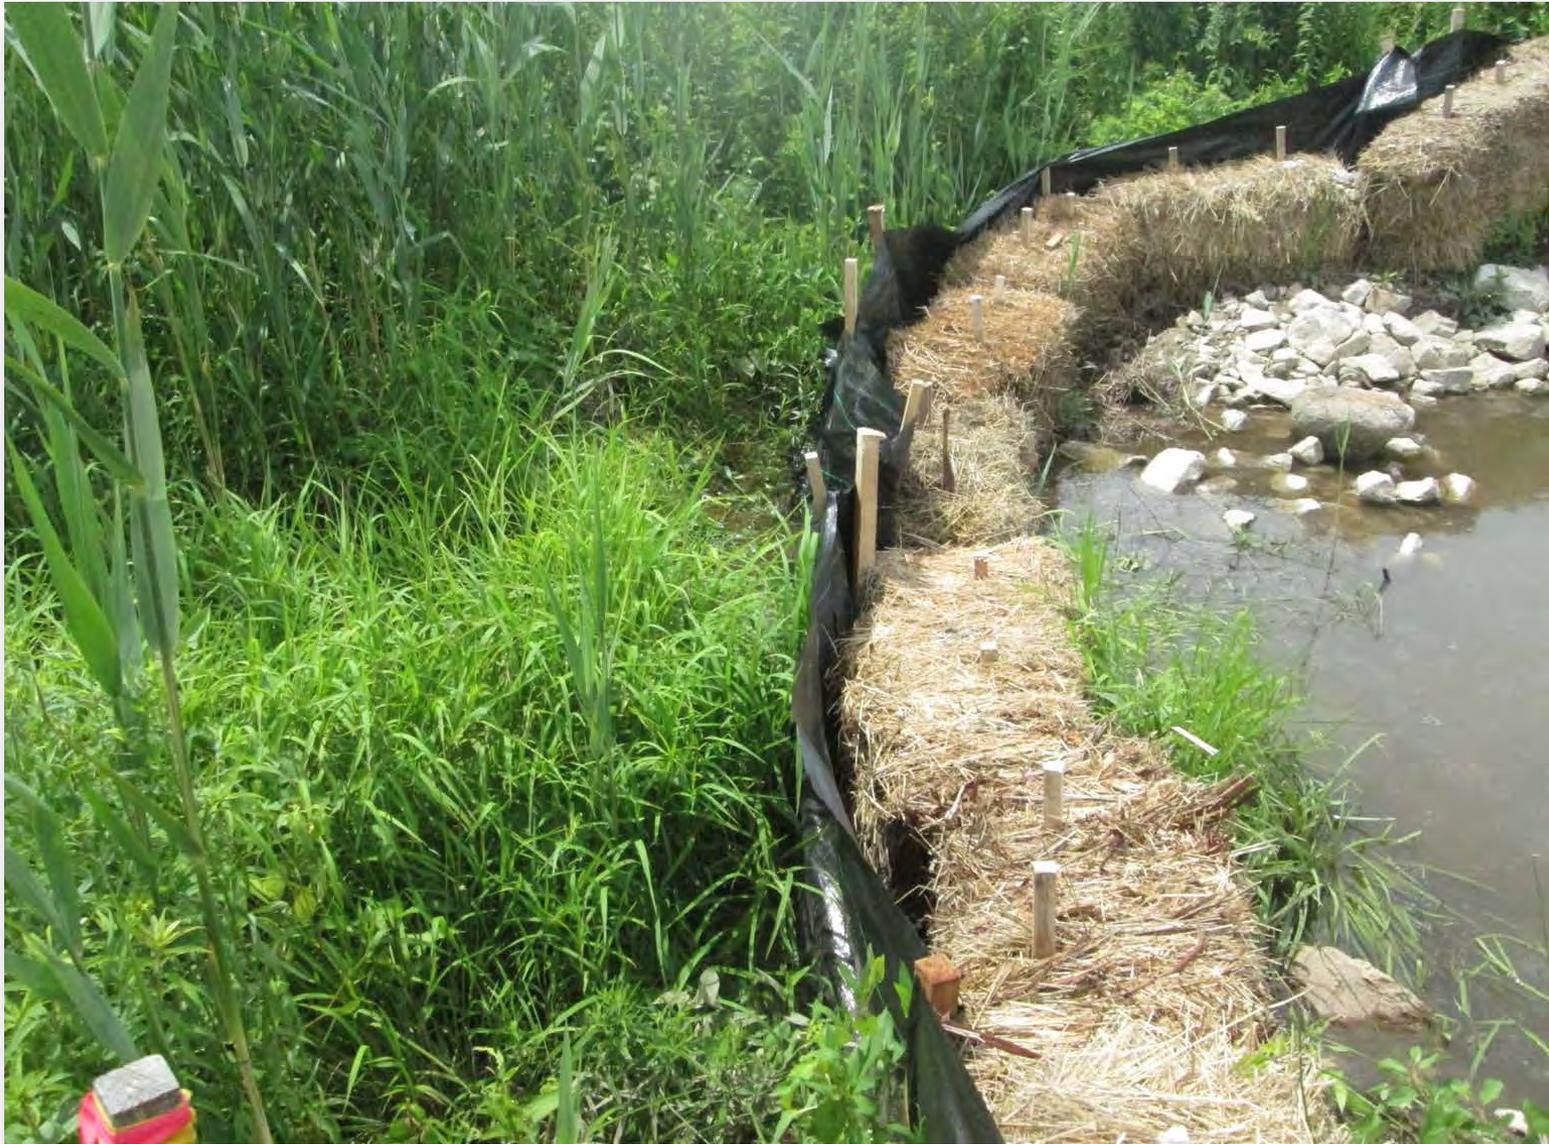
Two small rips in the silt fence were observed and the WS was notified immediately.

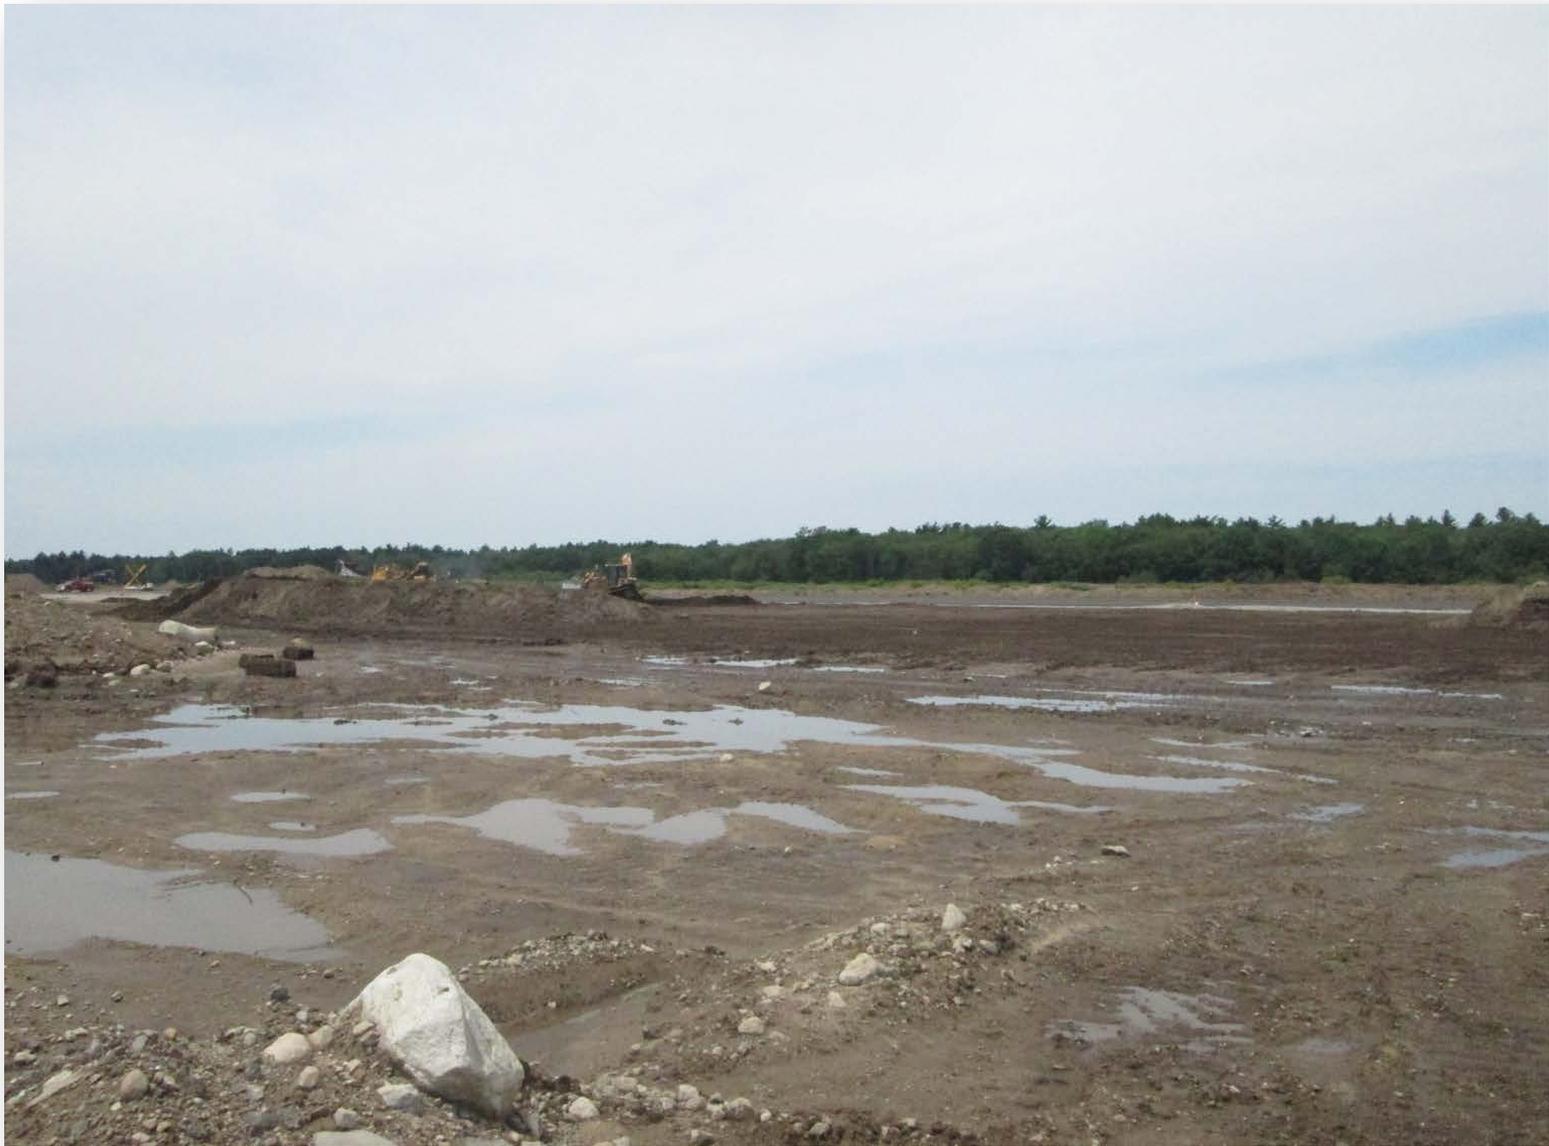
View of area between Runway and Taxiway that may have been sediment source. There is an open trench where the taxiway was cut to remove existing stormwater infrastructure immediately upgradient from the headwall.

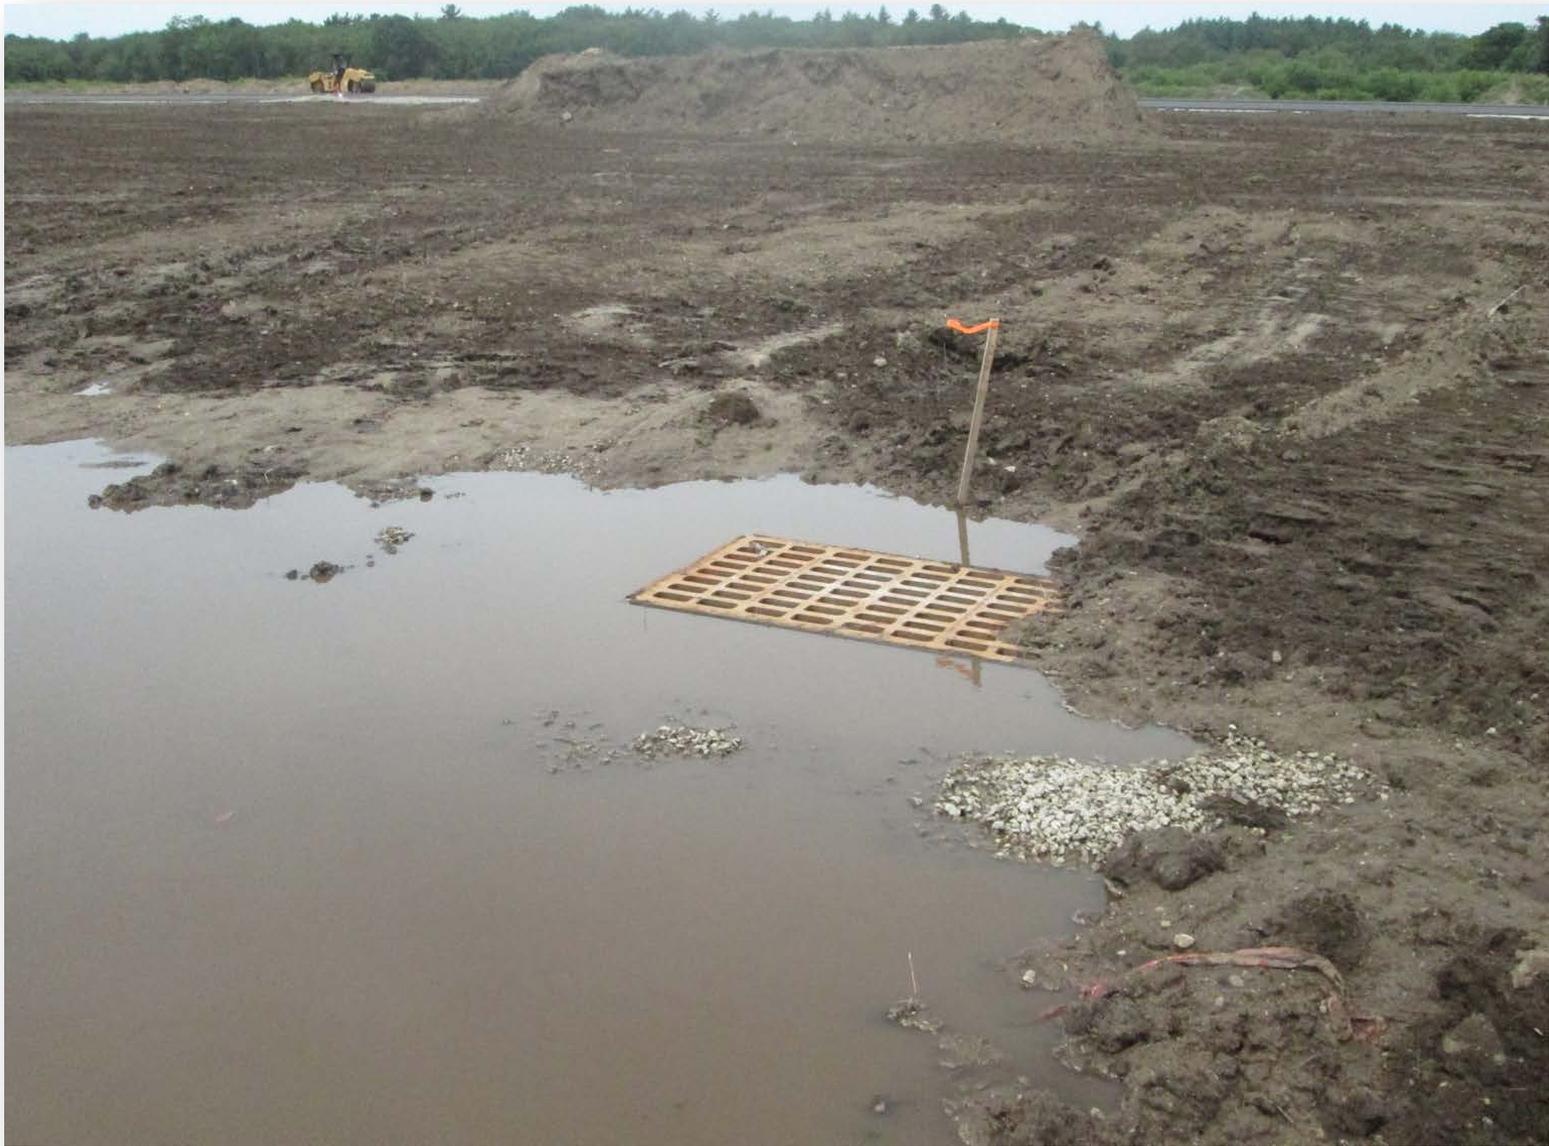
View of catch basin. This area will need to be addressed. The EM spoke with the WS regarding this catch basin.

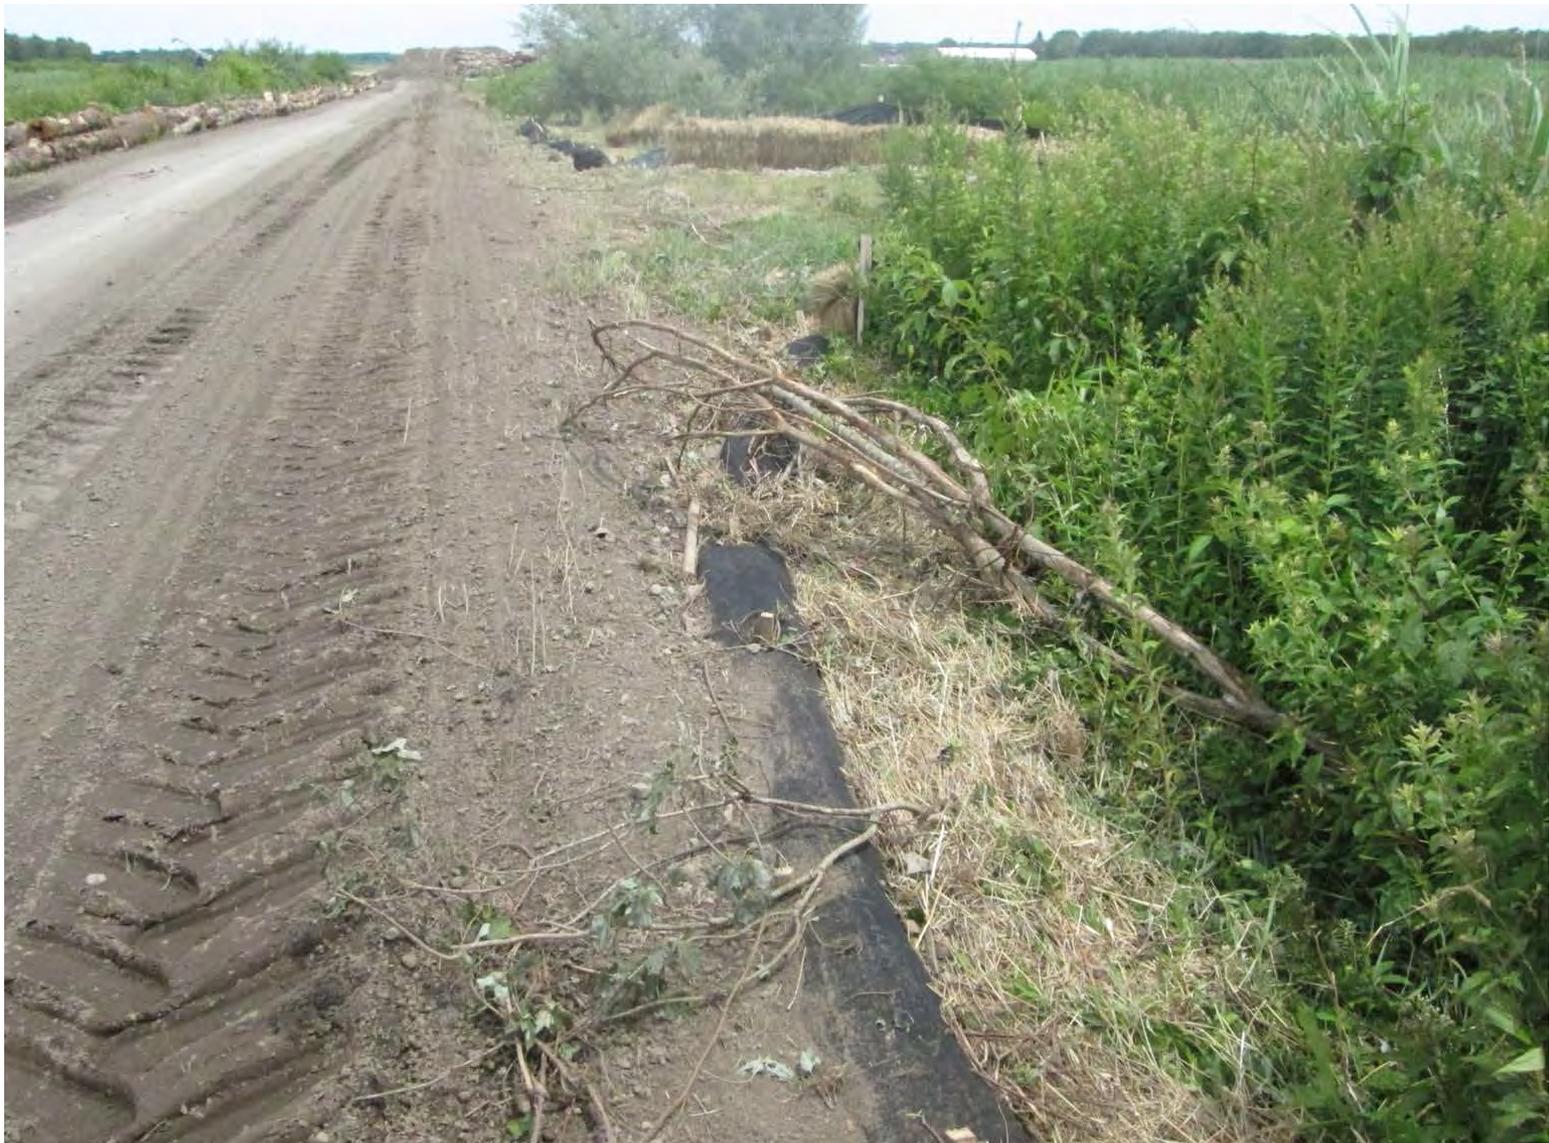
View of compost tubes along ILS road. These controls, although degraded, did not have sediment downgradient the tubes or within the wetland. This controls will be replaced or repaired prior to earth work trenching for utility installation.

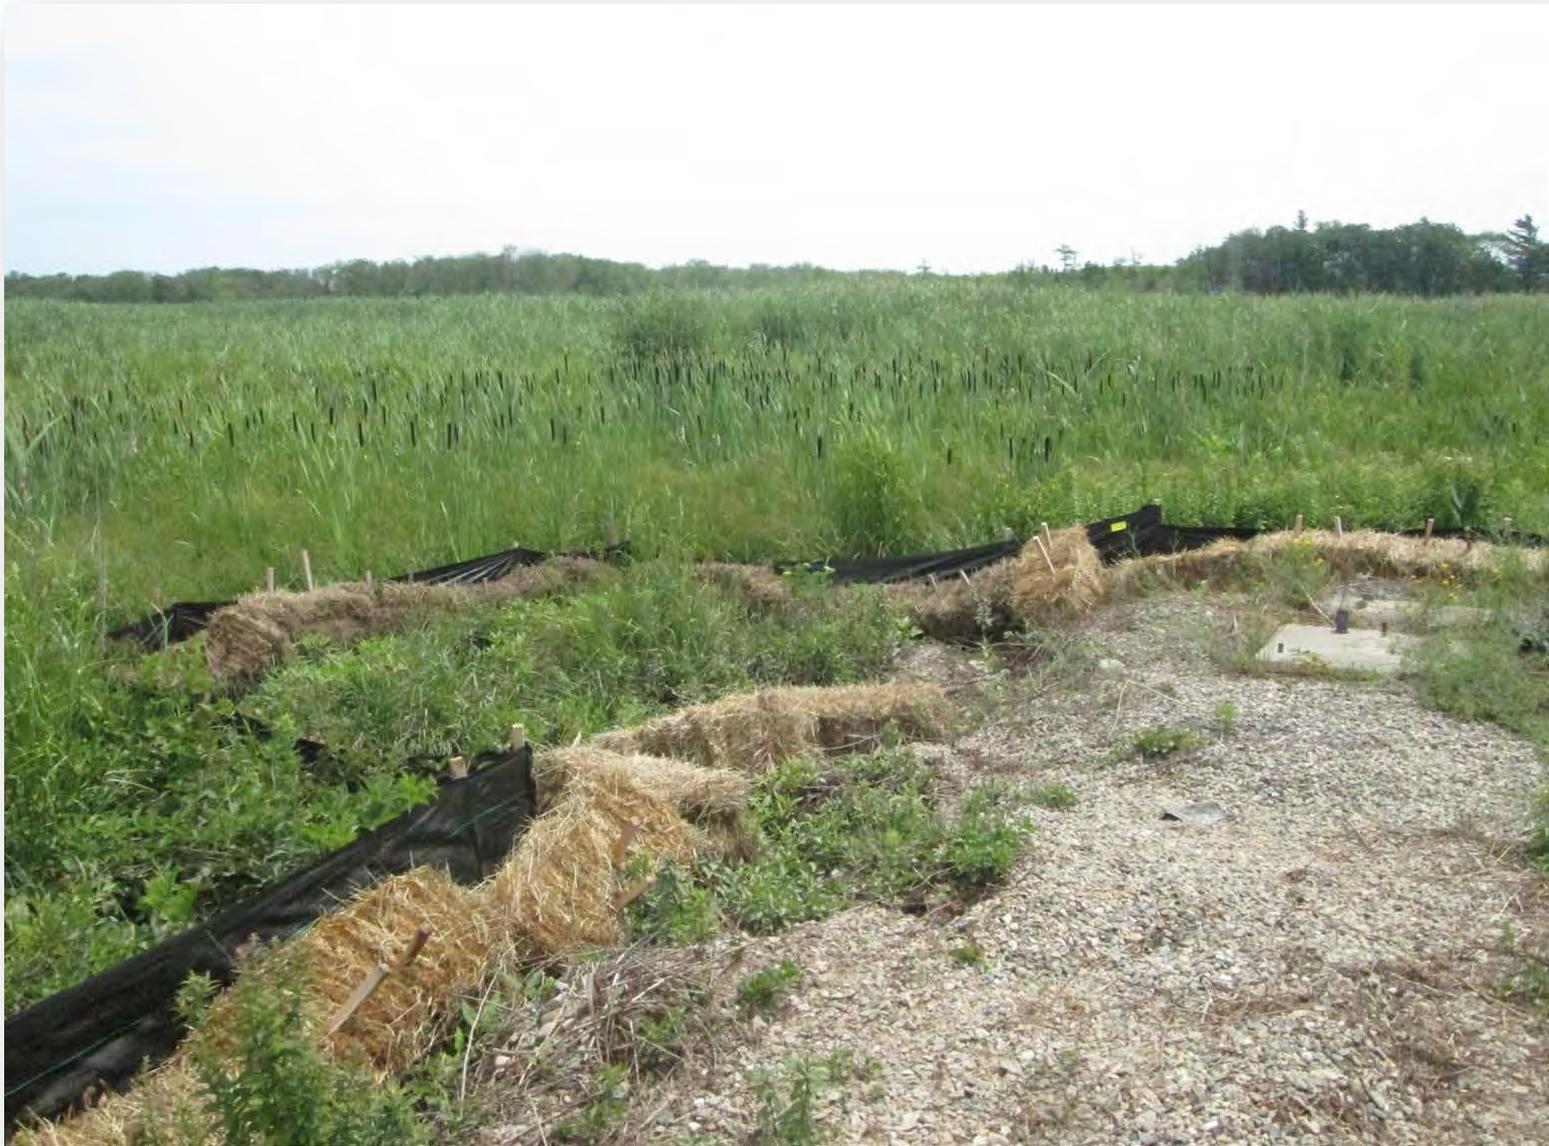
View of example MALSR erosion controls. These erosion controls will be fixed prior to the start of work in these areas. The contractor will likely leave these as is until after the 81 hour shut down.

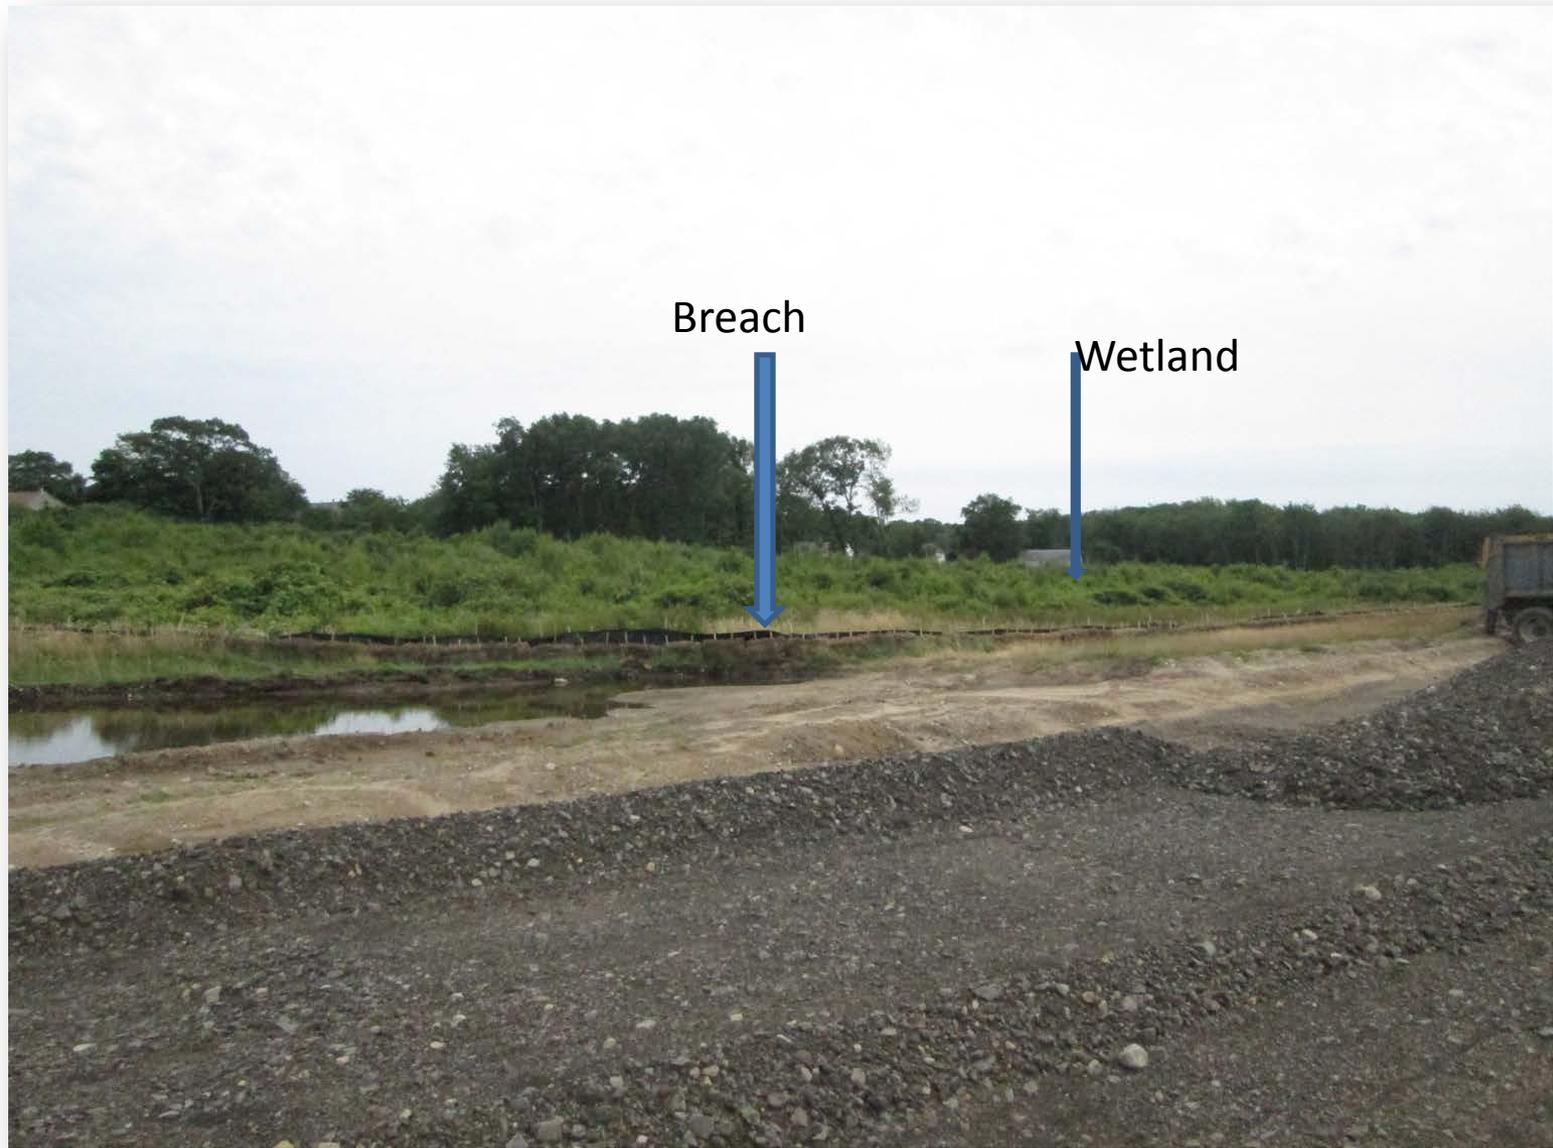
View of temporary drainage ditch at RW 23 end. There was a breach in this area that was repaired. No sediment was observed downgradient the silt fence or reached the wetland.

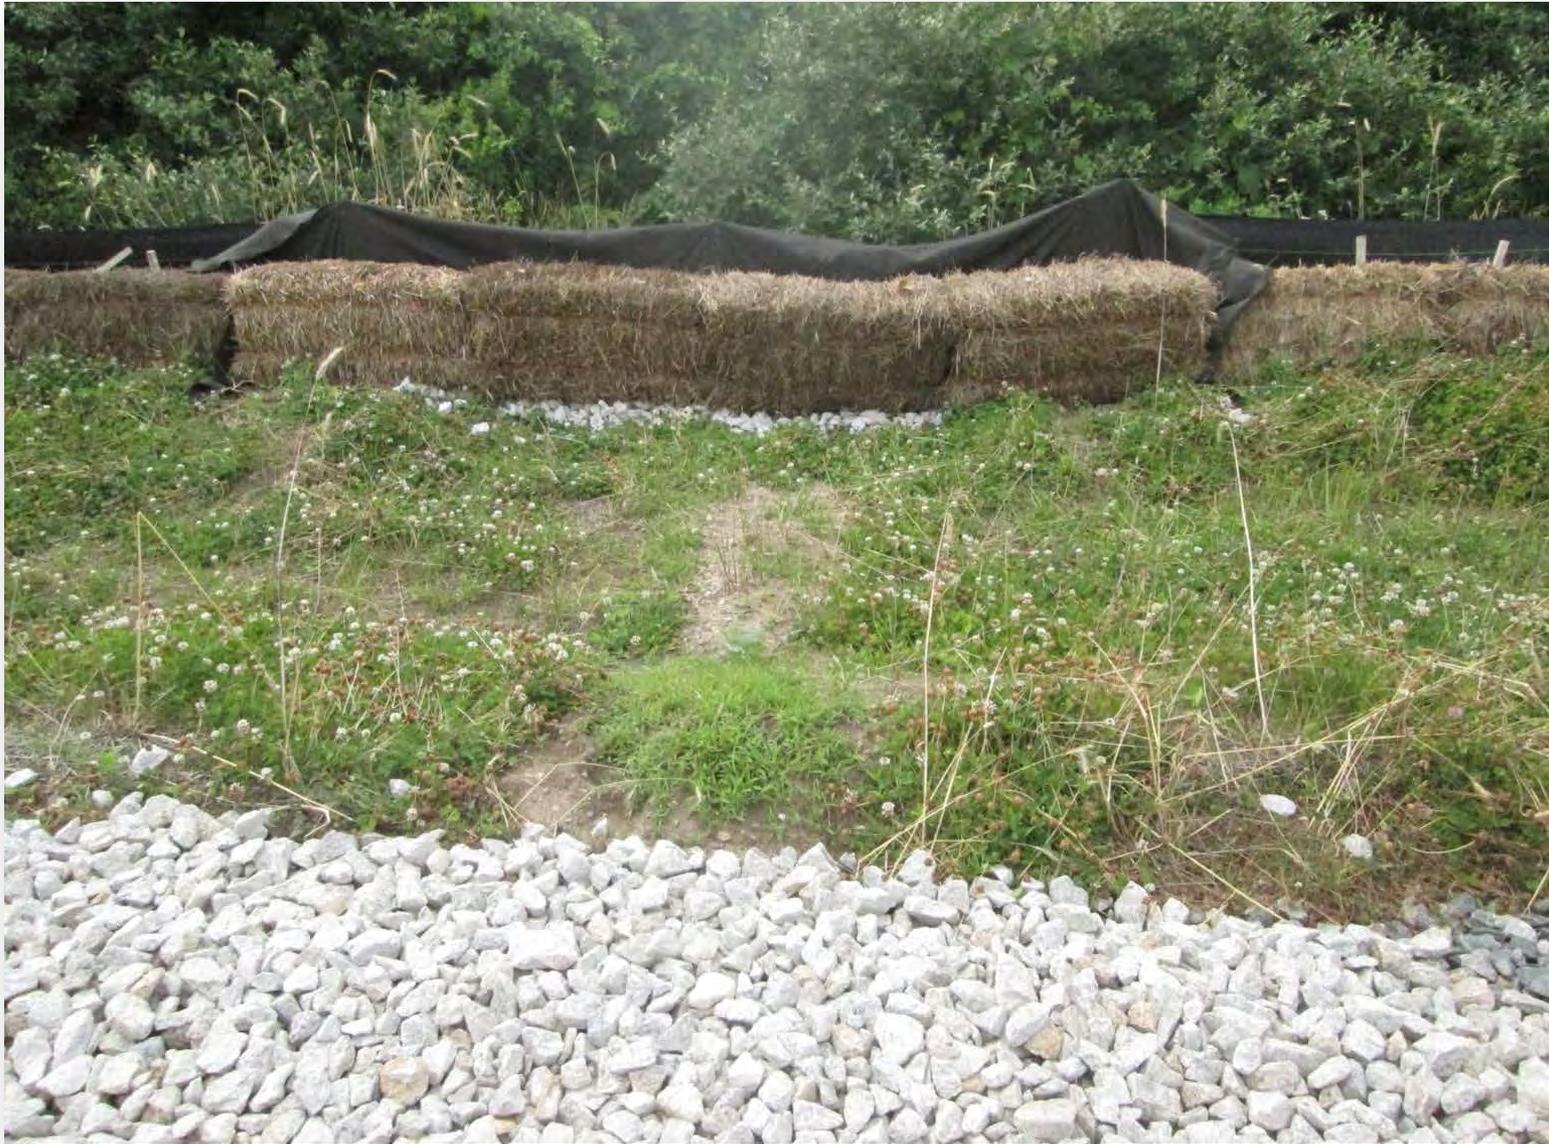
View of erosion control/ turtle barrier breach. This area was fixed and no sediment reached the downgradient wetland.
