JM Fiske Environmental

NEW BEDFORD REGIONAL AIRPORT
RUNWAY 5-23 – PHASE 4
Reconstruct, Mark and Grove
Weekly Environmental Report
WEEK 10
2014 June 28-July 5

NEW BEDFORD REGIONAL AIRPORT
RUNWAY 5-23 – PHASE 4
Reconstruct, Mark and Grove
Weekly Environmental Report
WEEK 11
2014 June 11

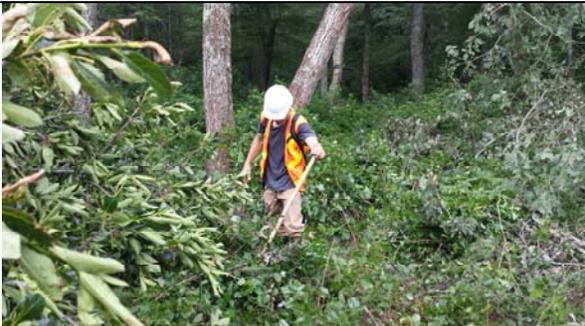
<p>JM Fiske was on site at 6AM to review site conditions in the logging area. Turtle sweeping was limited due to the amount of flooding resulting from the 6.36 inches of rain over the weekend. JM Fiske Turtle sweeping with Oxbow. Majority of logging area flooded.</p>

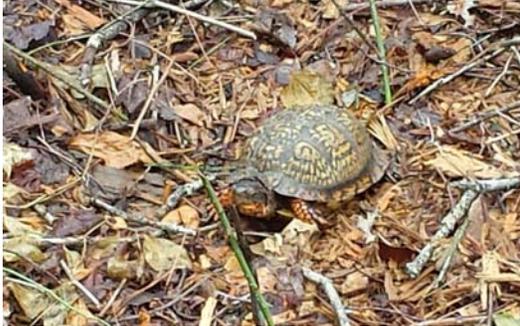
<p>One box turtle found at end of timber mat road.</p>

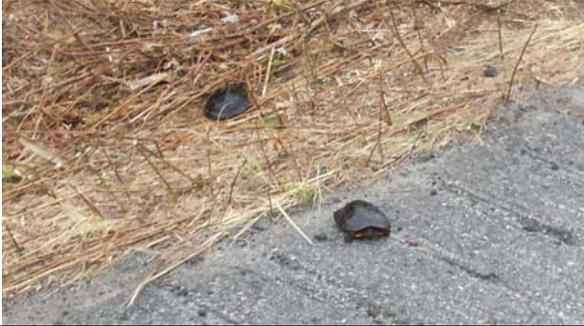
<p>2 spotted turtles were located on the ILS road. Oxbow documented the turtles and they were put back out of the way of equipment.</p>

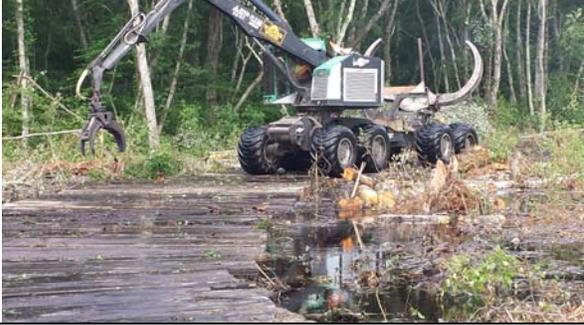
<p>Because of the flooding, Wagner Wood only worked off the existing timber mat road and removed previously cut timber adjacent to the road. In the afternoon, it was noted that flexing of the timber mats was causing some isolated and localized disturbance of soils. The logging operation was shut down for the day while a solution was identified.</p>

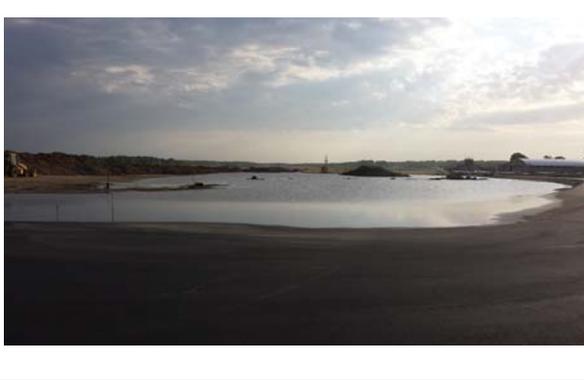
<p>The area between taxiway A and the 5 end of the runway was still flooded on Monday from the rain over the weekend. The equipment that was in the area had already been moved. The single catch basin in this area was covered with fabric and no drainage into the system was occurring at the time of the inspection.</p>

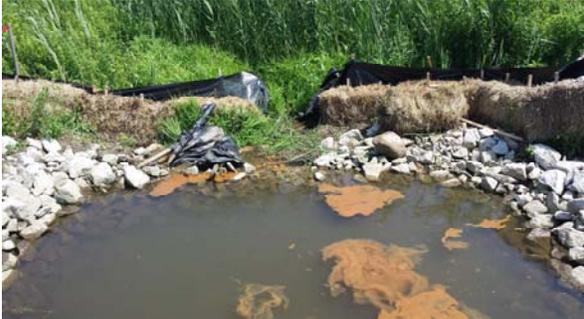
<p>The outlet from the catch basin in the flooded area by taxiway A was clear, however there was some evidence that fine sediment did discharge from this point however the sediment did not have sufficient size or depth to be removed. The fence and hay bales were repaired by the end of the day Monday 7/7/2014</p>

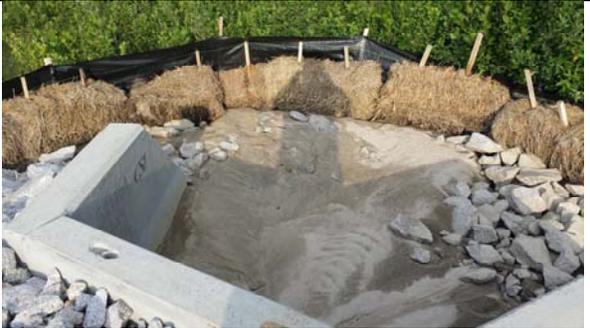
<p>This is a photo of the outlet to the cross culvert under that access road on the north side of the 5 End. Sediment for the swales und slopes above the inlet overwhelmed the stone check dams that were in place and the water undermined both the hay bales and silt fence.</p>

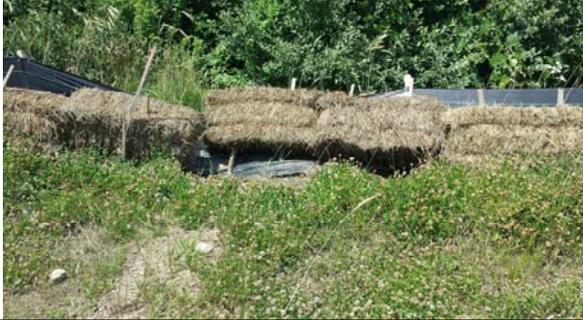
<p>Several sections of silt fence and hay bales were dislodged around the airport. These were all repaired by Wednesday July 9.</p>

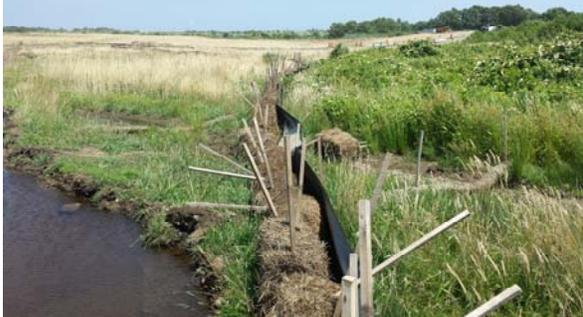
<p>The silt fence near the proposed extension of taxiway A at the 23End was knocked over in the storm event. This was repaired on Wednesday July 9. No sediment discharge was observed.</p>

<p>The silt fence and hay bales at the 23 end Taxiway A extension as noted on the Monday 7/7/2014 report were repaired today.</p>

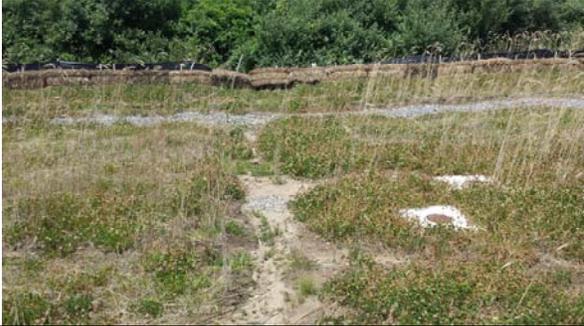
<p>The silt fence and hay bales on the north side of the 23 End were undermined. This area was a concern at the start of the project. The storm water that gets to this point is not from the existing construction. The fence was repair and stone was added to help prevent further undermining.</p>

<p>The hay bales and silt fence on the north side of Runway 23 were repaired today. Stone was added to both the infiltration trench and to underneath the hay bales to allow for a relief vale for storm water. This section of fence is a turtle barrier and does not receive construction storm water.</p>

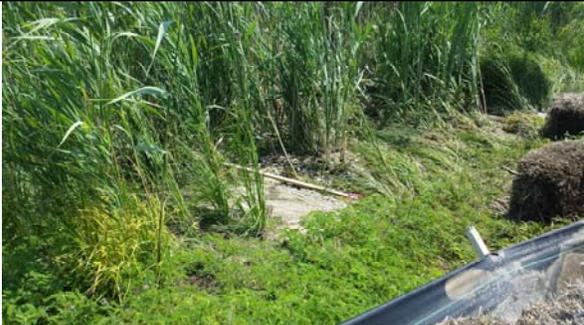
<p>Silt fence was down in several places along the south side of the 5 End. The silt fence was repaired. And the sediment was removed by hand.</p>

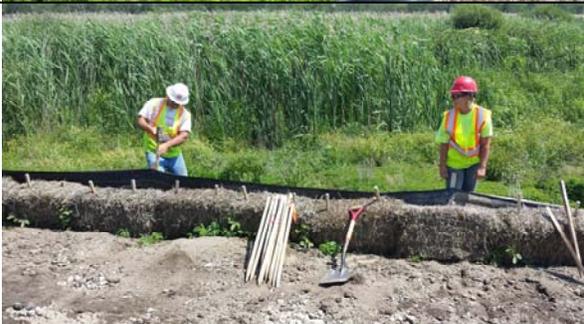
<p>ETL was very proactive and repaired all silt fence and hay bales. They hand removed sediment that got beyond the BMPs as needed and identified.</p>

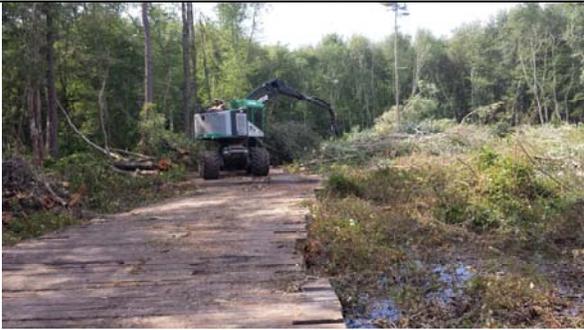
<p>The forwarder picked up the trees from the edge of the timber mat road and moved out. The timber mat road was monitored for flexing and to ensure there were no water quality issues. The mats were adjusted in several locations and extra layers added to make the road more rigid. In addition mats were removed and replaced to make bridge sections that would allow the free flow of water.</p>

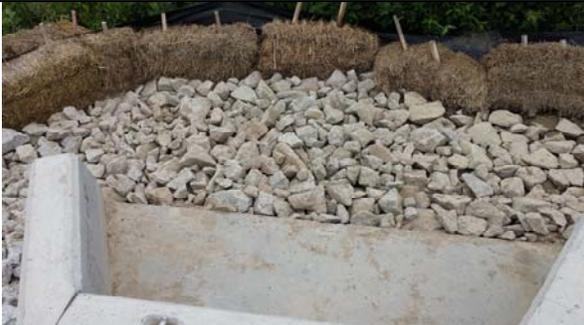
<p>JM Fiske conducted a total of 5 hours of turtle sweeping</p>	
<p>Work continues on 23 End with electrical, drainage and runway preparation.</p>	
<p>Lynch continues to pave 5 end of runway and the taxiway A on the 5 end.</p>	
<p>The culvert outfall on the north side of the 5 end was re-inspected. Everything was in place and appears ready for the next storm.</p>

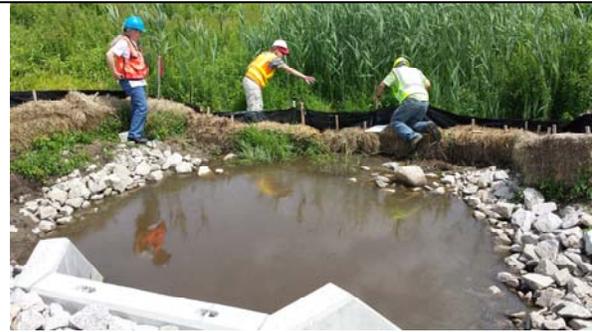
During the weekly inspection with Sarah Porter, City of New Bedford, we observed a slight increase in turbidity in the outfall from the new drainage from the area between Taxiway A and the 5 End of the runway. There is some evidence of sediment on the other side but this is most likely the result of the rain from the hurricane. Additional measures are planned for this location including increased protection around the single catch basin flowing into this structure and additional hay bales to increase the amount of water storage

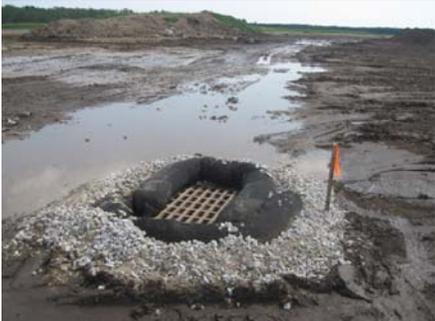
<p>The Best Management Practices for the catch basin in the center of the area between Taxiway A and the 5 End of the runway had become dislodged. Upon discovery, ETL immediately mobilized to repair and replace the catch basin protection. This was completed before the end of the day on July 11, 2014</p>

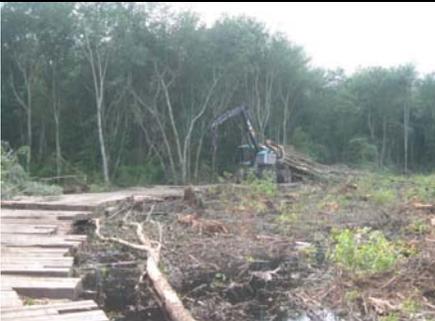
<p>The timber mat road continues to be monitored multiple times per day. . The use of wooden mats has been critical in minimizing impact and disturbance within the cut-over wetland.</p>

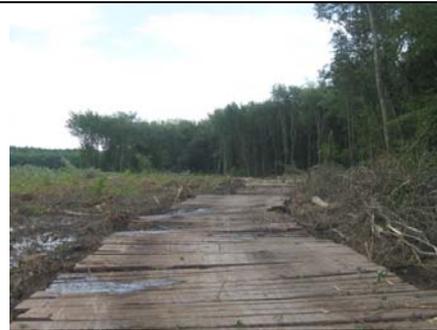
Brush was piled against the edge of wooden mats to help bind any dislodged organic soils as the heavy forwarder passed over the mat road.
