INDEPENDENT OBSERVER REPORT

GZA GeoEnvironmental Inc.	REPORT NO: 52 Page 1 of 6
		DATE: July 16, 2014
		PROJECT No: 15.0166235.30
		LOCATION: New Bedford Regional Airport New Bedford, MA
		PHOTOS: 1-8
PROJECT: Reconstruct, Mark and Groove Runway 5-23, DEP File #SE-049-0635, NHESP File No. 96-0737		
Weather: Raining, 72°F, 1.8" of rain per www.wunderground.com		Observer: Seth Taylor, Dan Nitzsche
OBSERVATIONS & RECOMMENDATIONS:		
<p><u>Overview: July 16, 2014</u></p> <p>The IO conducted a site inspection today since the weather prediction was for heavy rain and no regularly scheduled weekly Construction Meeting was set for this week due to the 81 hour paving program. The site received approximately 1.8" of rain overnight into the mid-day hours. We observed the high water overwhelming sections of the sediment control barriers and turbid water was discharging into adjacent wetlands.</p> <p>The Contractor was only working in the intersections of the RW5/23 and RW14/32. All other work was suspended.</p> <p><u>Phase 4 Observations: July 16, 2014</u></p> <p><u>RW5 & West Ditch Area</u></p> <ol style="list-style-type: none">1. It appears that one hay bale was removed along a section of se

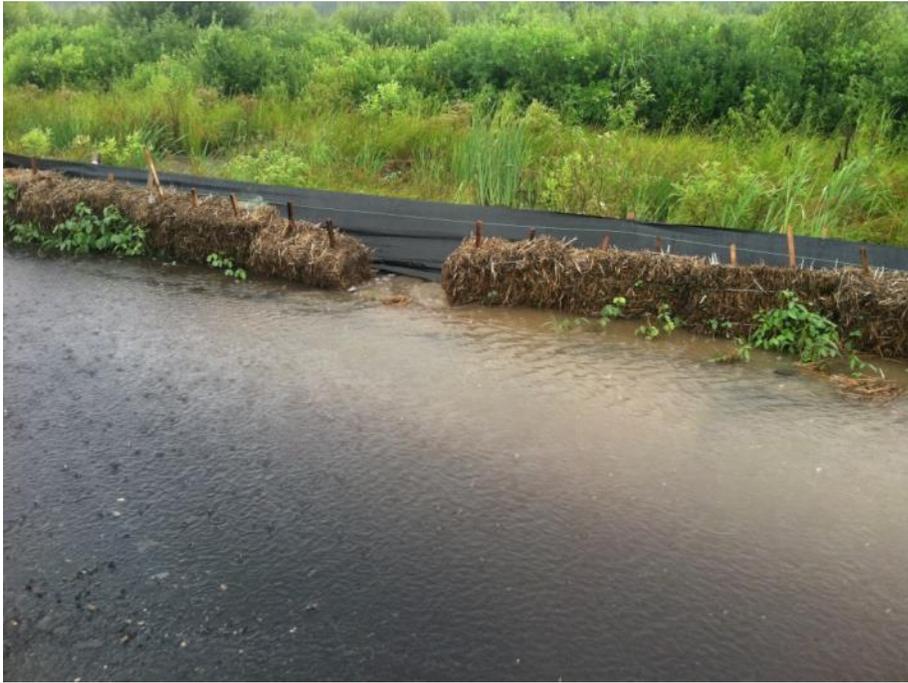
View Facing: East

Photo 1: It appears that one hay bale was removed along a section of sedimentation barrier along the RW5 haul road. It was difficult to determine how, but the bottom flap of the barrier was elevated resulting in flow bypassing the barrier.

1. Replace the removed hay bale (Photo 1) and reinstall the bottom silt fence flap into the ground.
2. The use of powdered flocculent on the disturbed soils would provide some degree of sediment reduction and adhesion to the barriers prior to flows passing into the wetlands.
3. Repair or replace the inlet protection (Photo 5).
4. Repair or replace other damaged barrier locations.
5. Consider using sediment logs at the distal end of the infiltration trench to better clean up sediment before flow enters the outlet culvert.
6. Monitor weather and plan work accordingly. As occurred today, not working during a large rain event is a BMP.

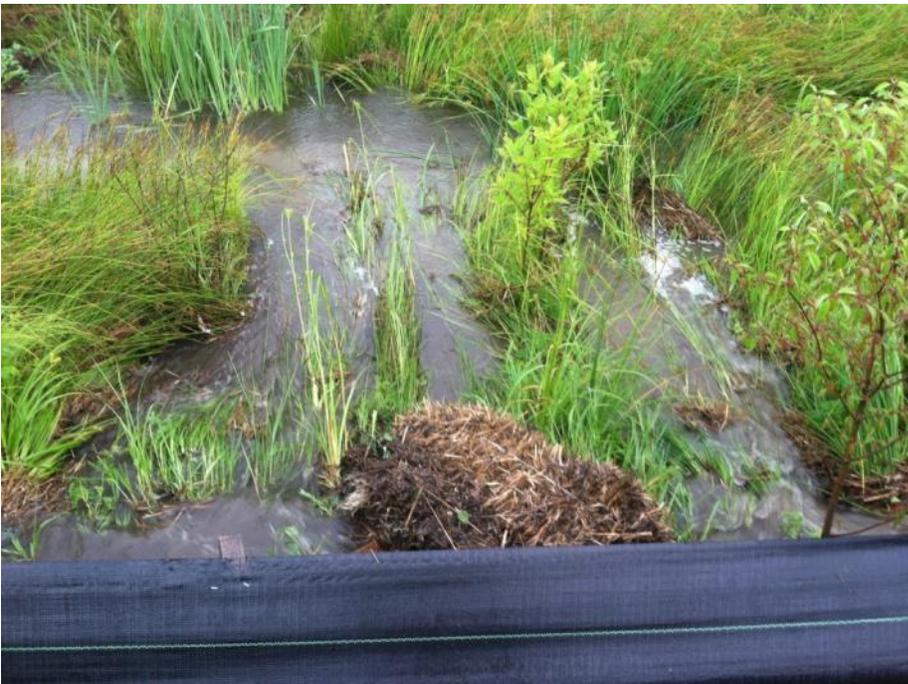
View Facing: West

Photo 2: The removed hay bale was observed on the wetland side of the barrier and the bypassing flow was observed to be turbid.

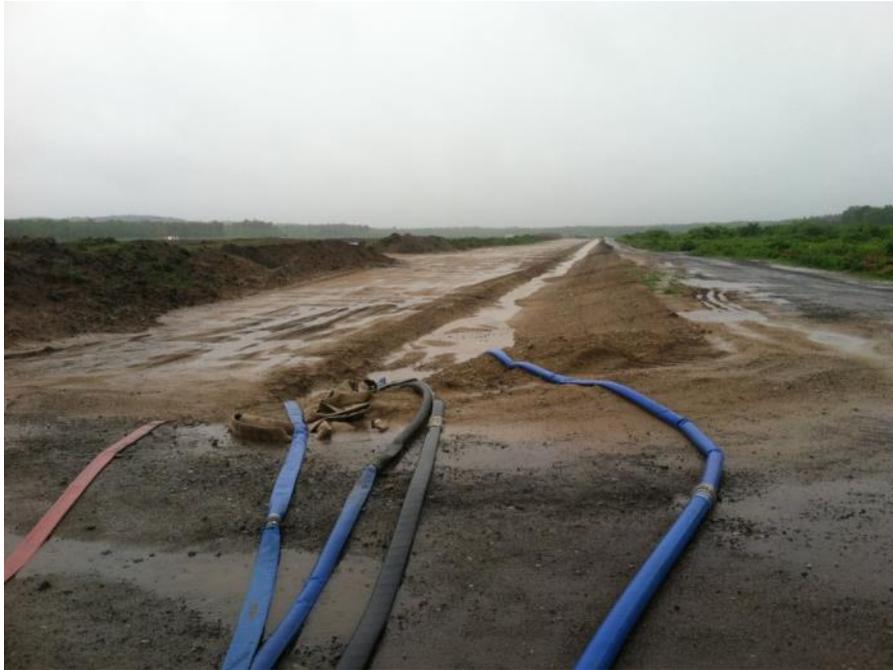
**View Facing:
Southwest**

Photo 3: Dewatering activities appear to have been ceased at the time of the inspection but several pump lines were observed to be setup to discharge water to the infiltration trench along RW5.

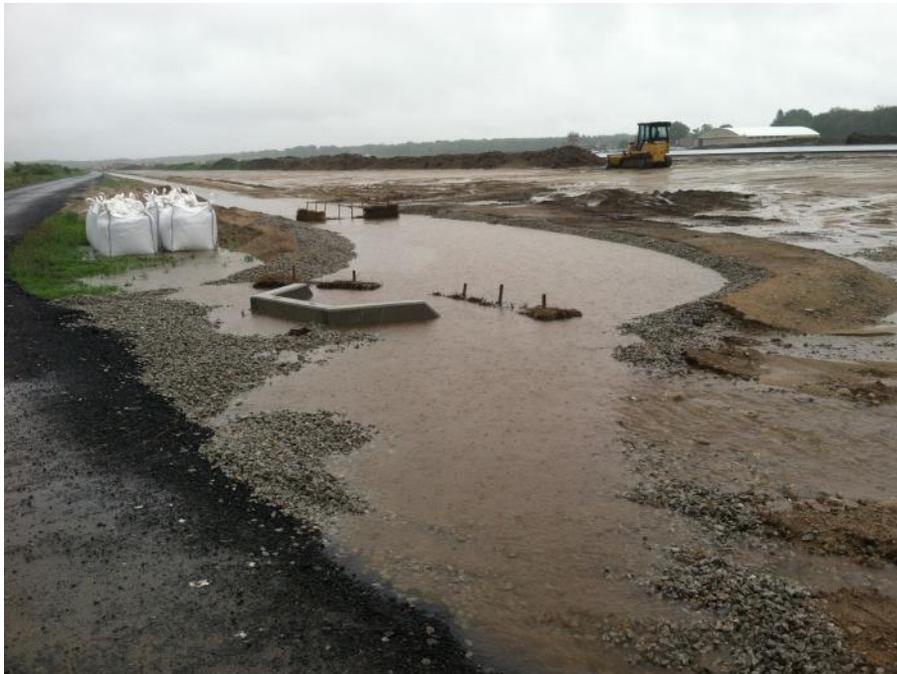
**View Facing:
Northeast**

Photo 4: The dirty flow from the infiltration trench is being conveyed to the wetland via the culvert system.

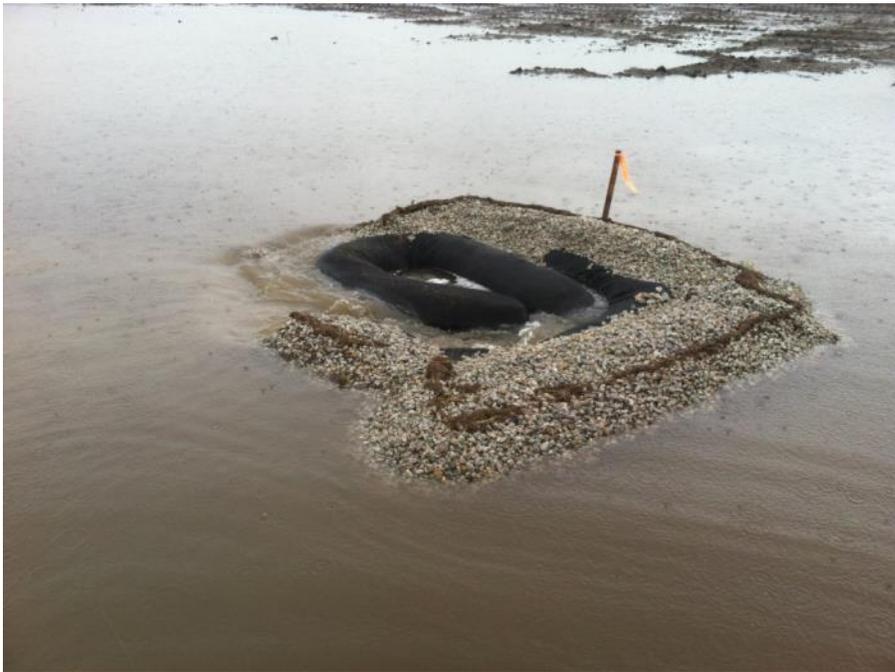
View Facing: West

Photo 5: A catch basin in the infield of the RW5 area was conveying dirty water from the ponded work area.

The inlet protection/compost tube appeared to be floating and not secured or stopping sediment.

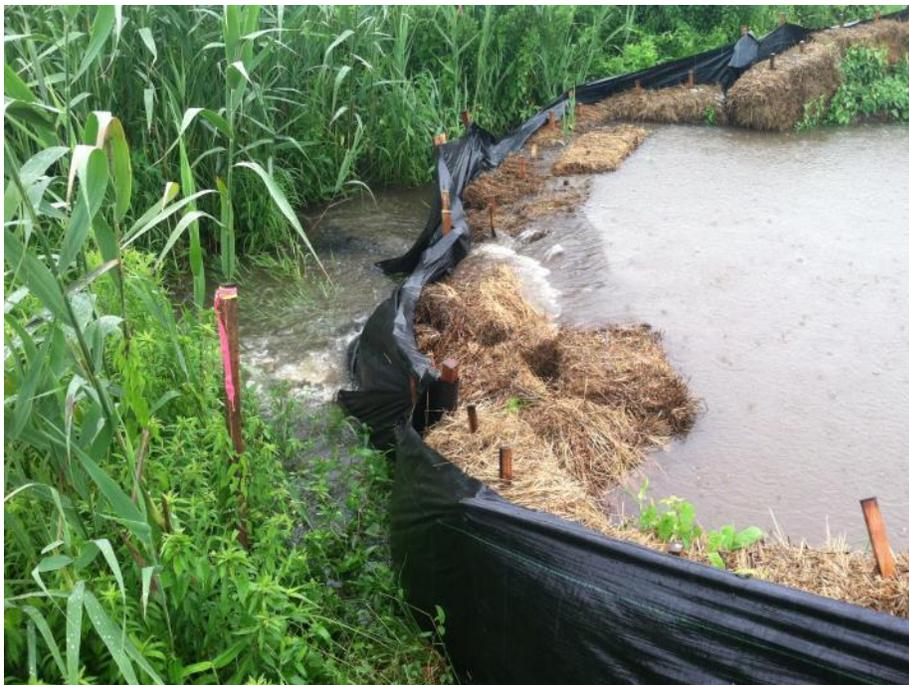
View Facing: South

Photo 6: The silt fence/hay bale barrier was overwhelmed by the flood water and dirty water was entering the adjacent wetland.

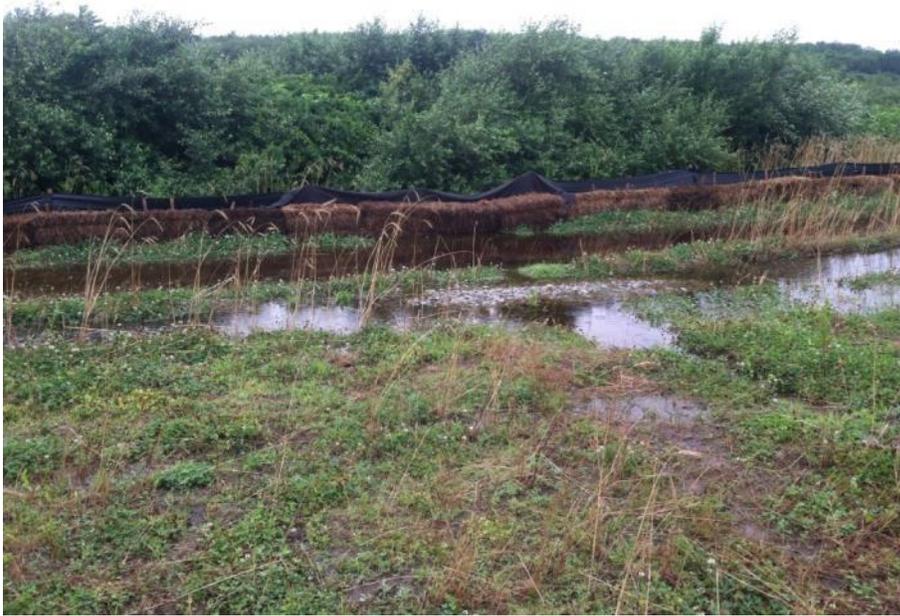
View Facing: North

Photo 7: Water was observed passing through the silt fence and hay bale barrier.

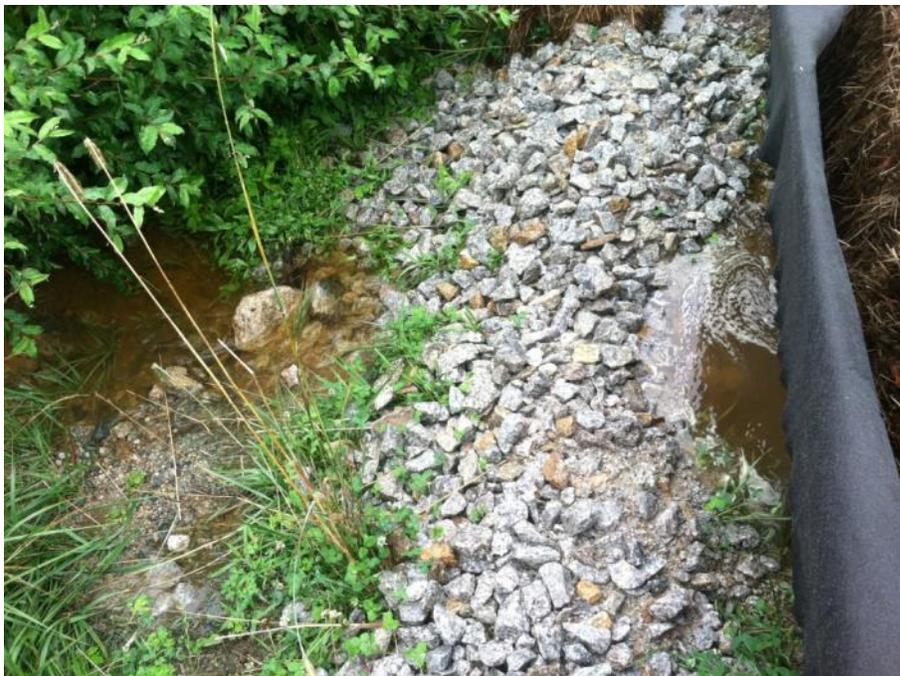
View Facing: North

Photo 8: The flow was discolored but may be more from organics leaching out of the hay bales than from sediment as the ponded water on the runway side of the barrier was observed to be fairly clear with very little suspended material.
