**New Bedford Regional Airport
Runway Safety Improvements Project – Phase 4
Reconstruct, Mark, and Groove Runway 5-23
MassDEP File No. SE049-0635**

ENVIRONMENTAL MONITOR INSPECTION FORM

Date/ Time of Inspections: **7/29/14 (morning), 7/31/14 (afternoon), 8/7/14 (morning).**

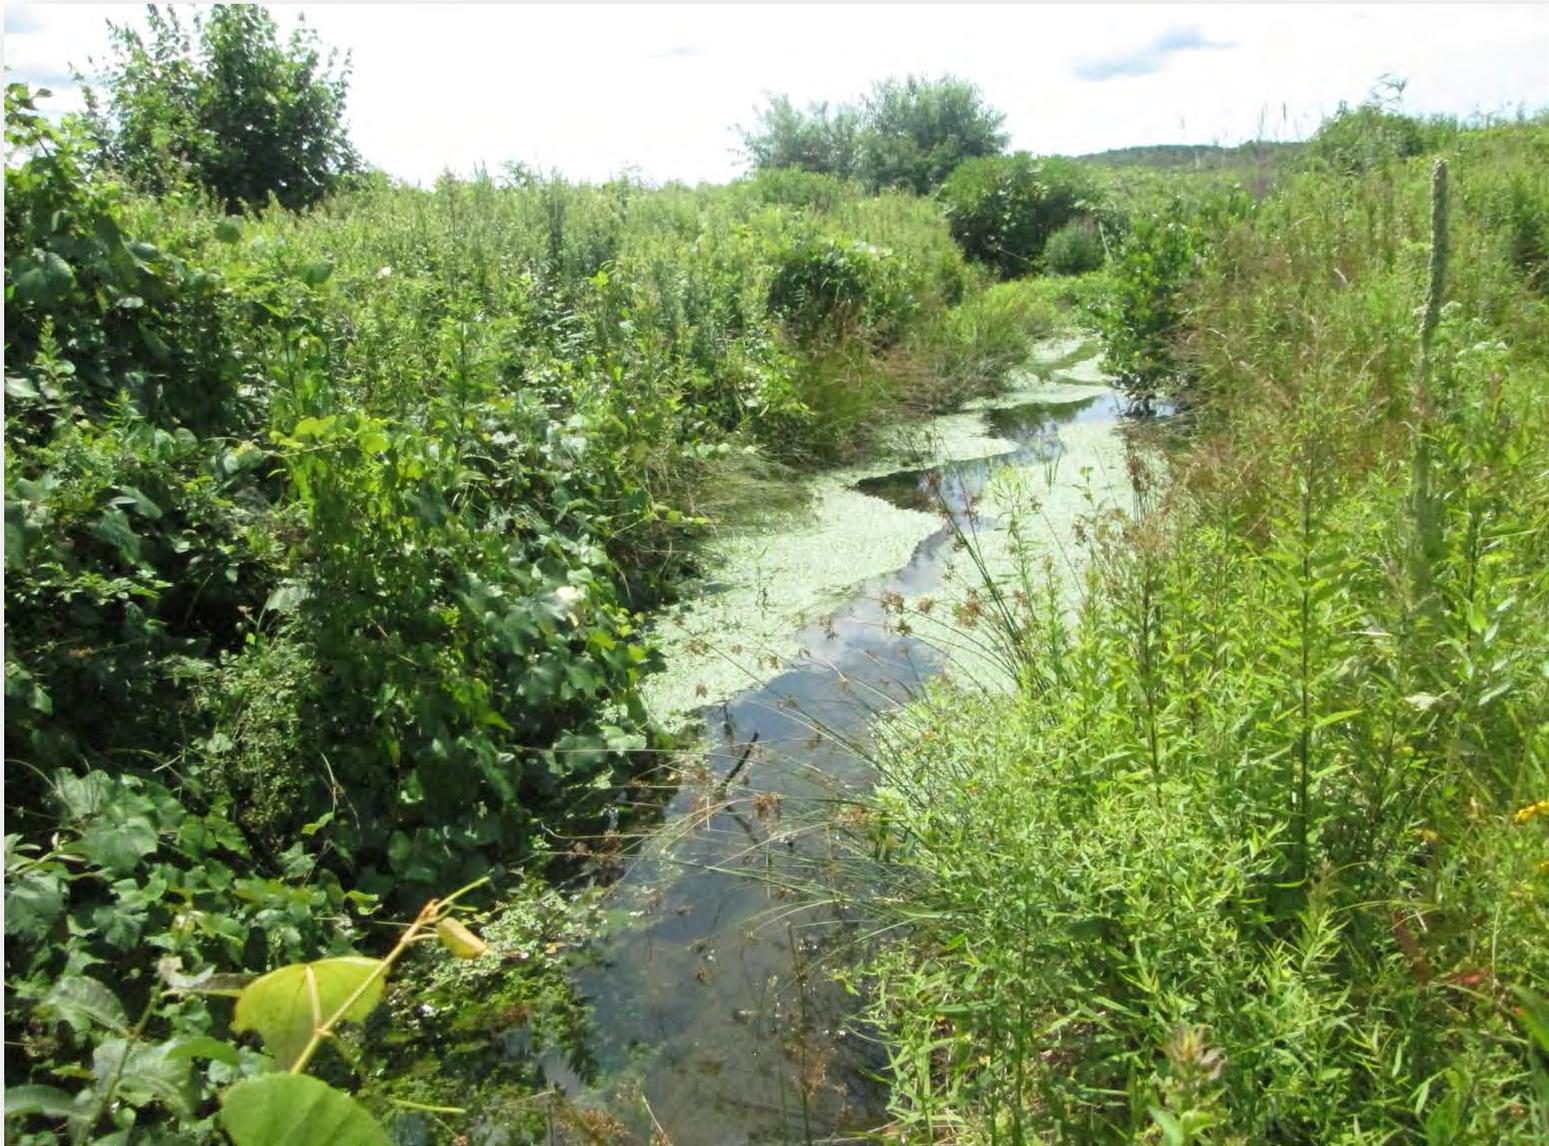
View of West Ditch immediately downstream Catch Basin 1 headwall. This was the location of the previous coffee colored water photo. Any accumulated sediment has settled and is not appreciable.

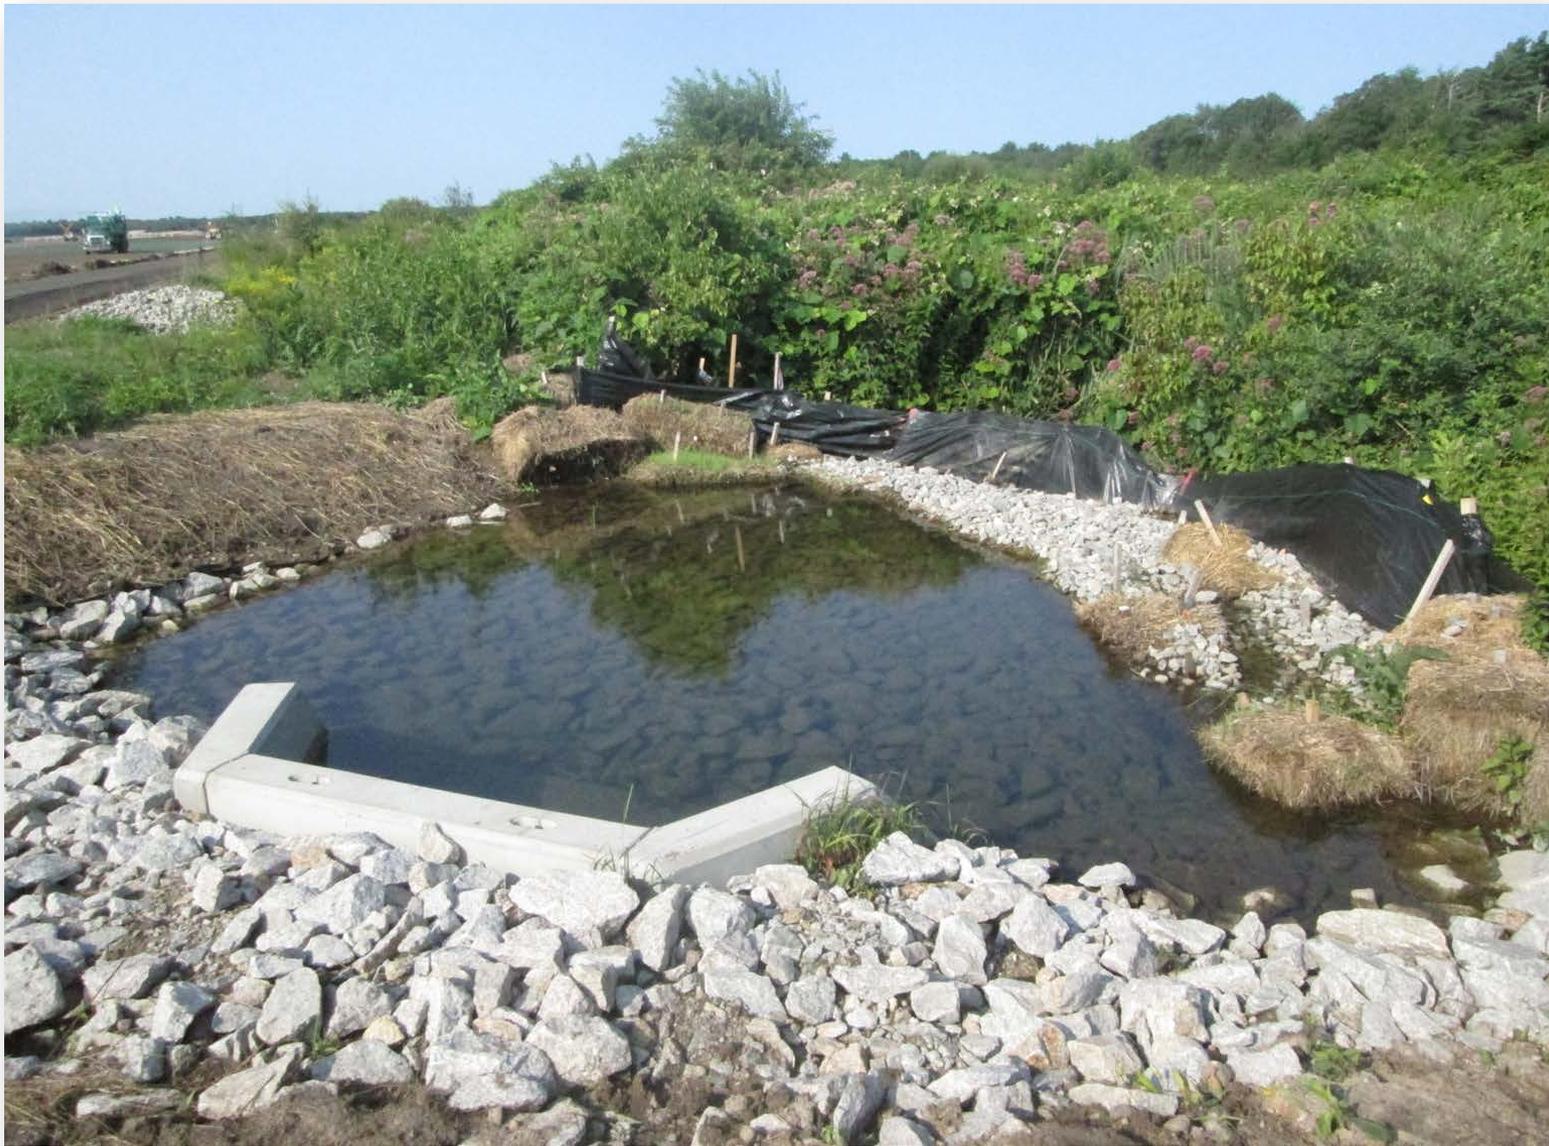
View of catch basin 1 head wall. Water is clear and still flowing through the constructed double hay bale, rock, and double silt fence. Note that hay was temporarily spread in this area. The slopes will be hydroseeded by COB 8/7/14.

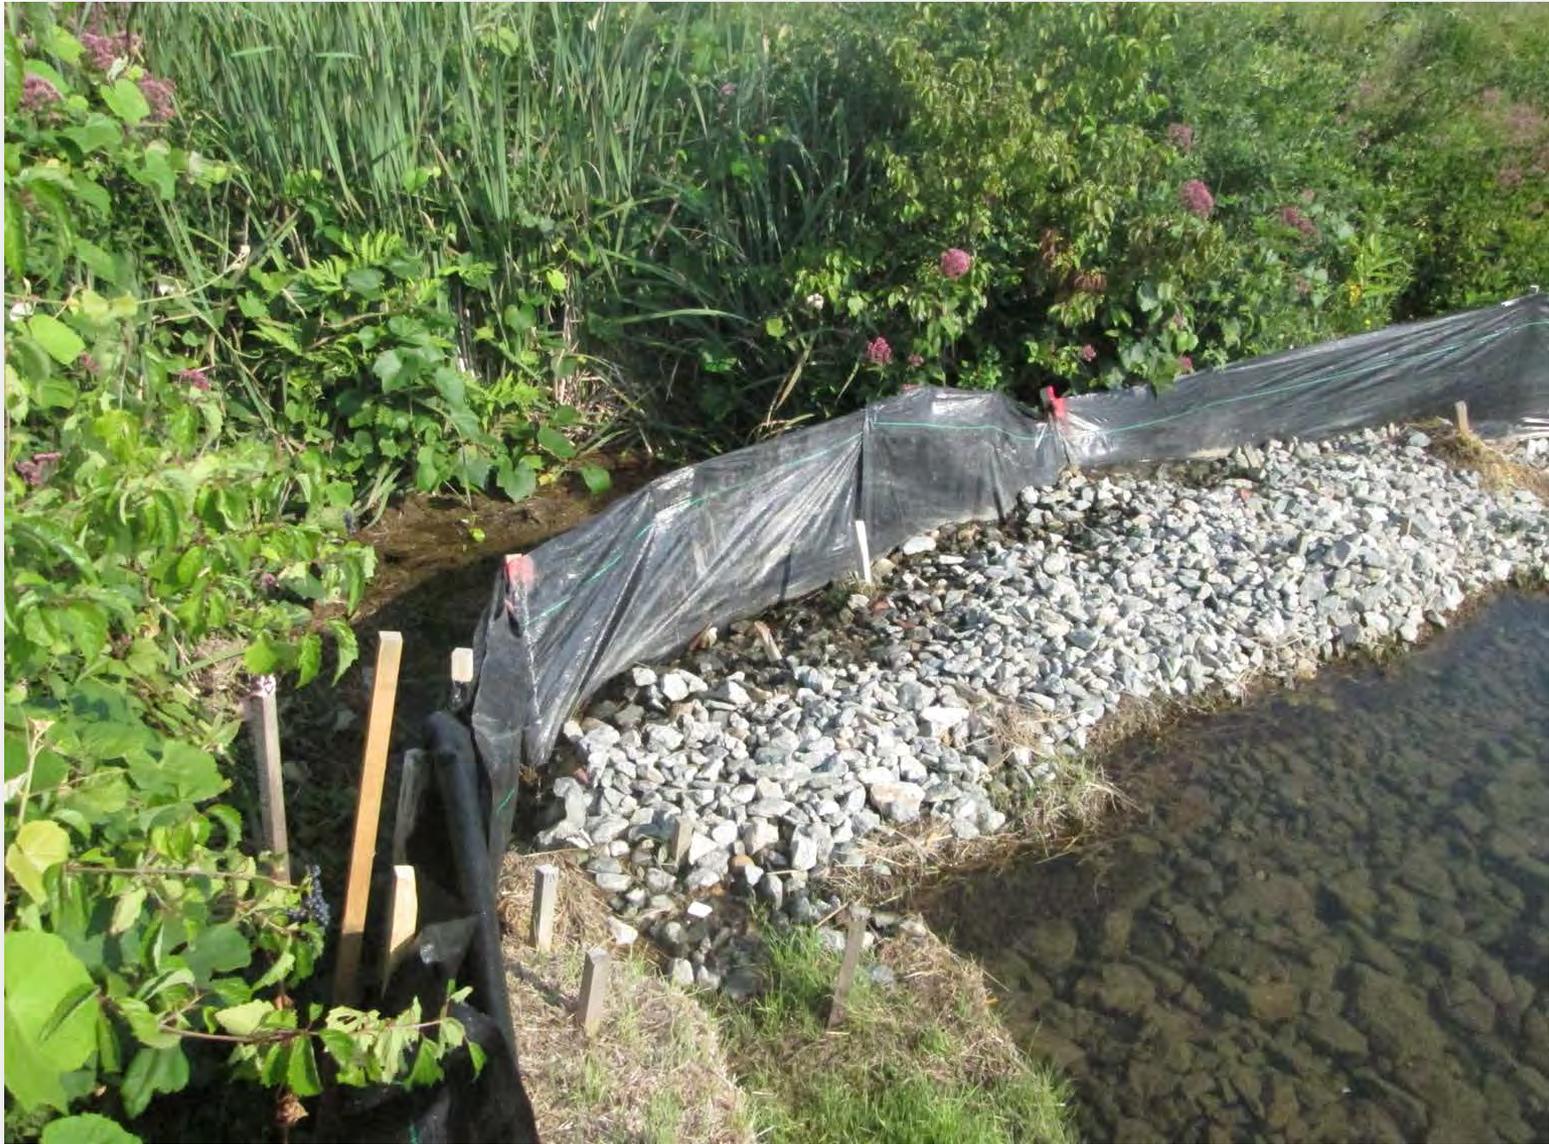
View of controlled water release at this headwall and into the west ditch.

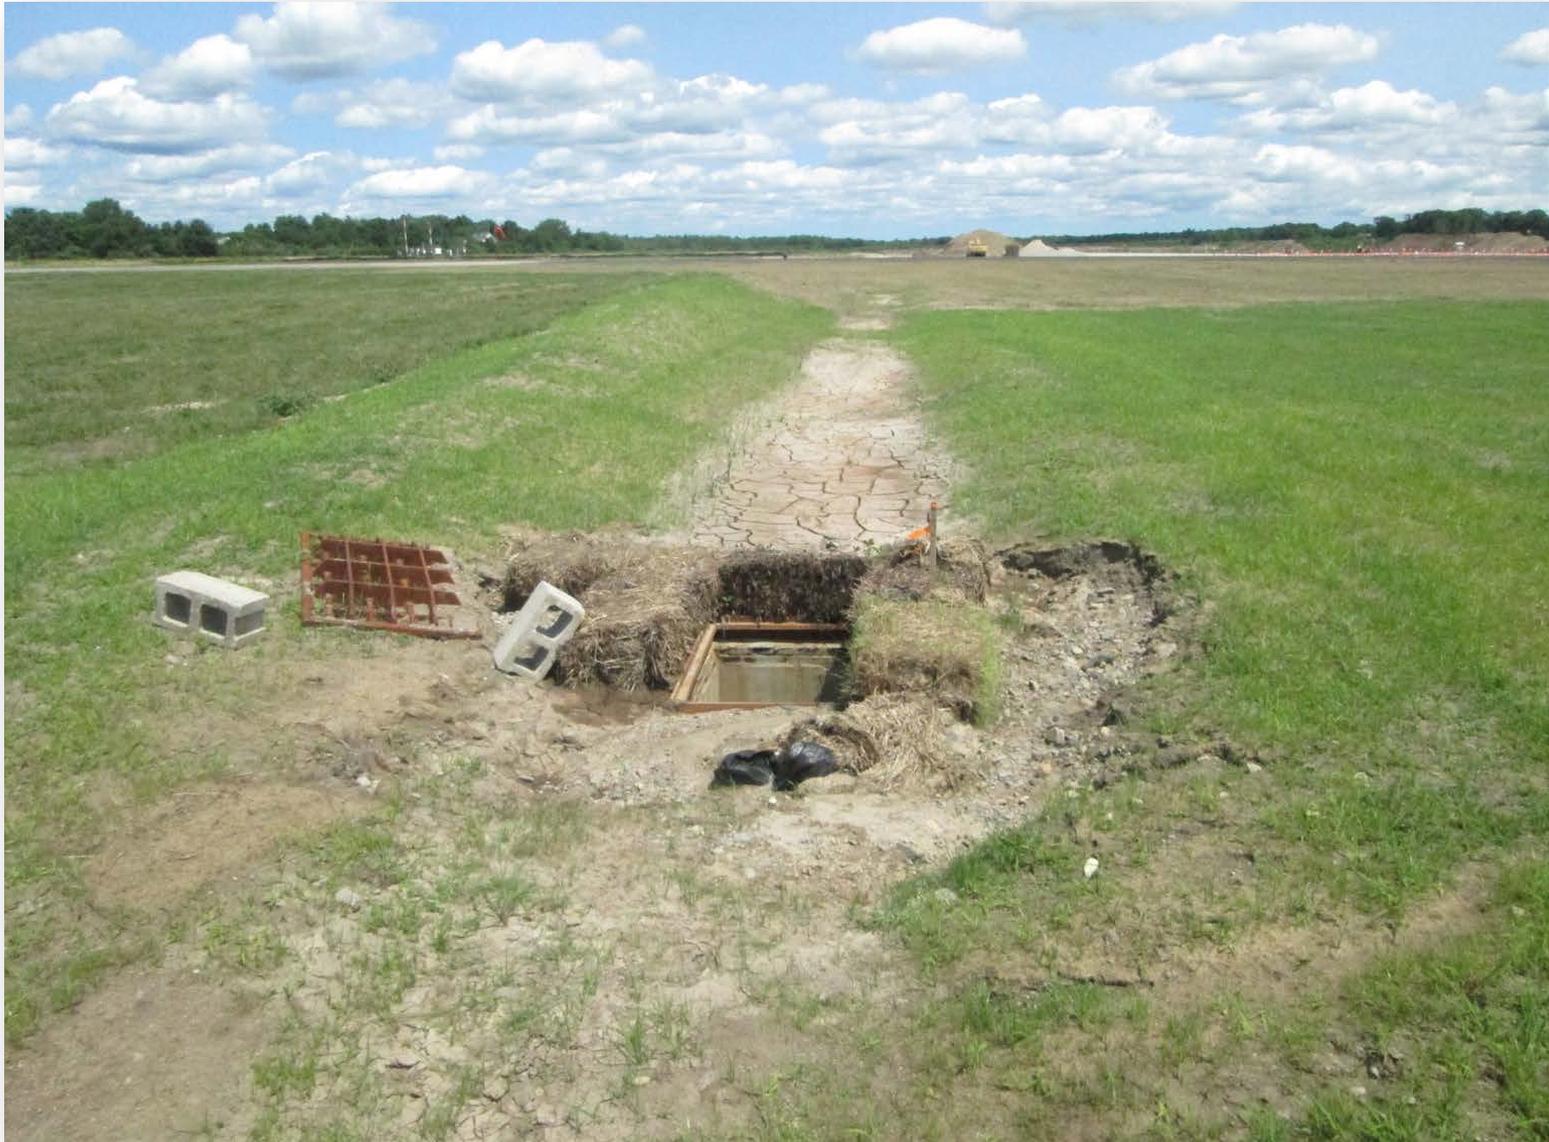
View of open catch basin 3, serving the catch basin 1 headwall. The team observed this feature during the MassDEP/ New Bedford ConComm site visit. The catch basin was properly protected by close of business that day and accumulated sediment was removed from the swale.

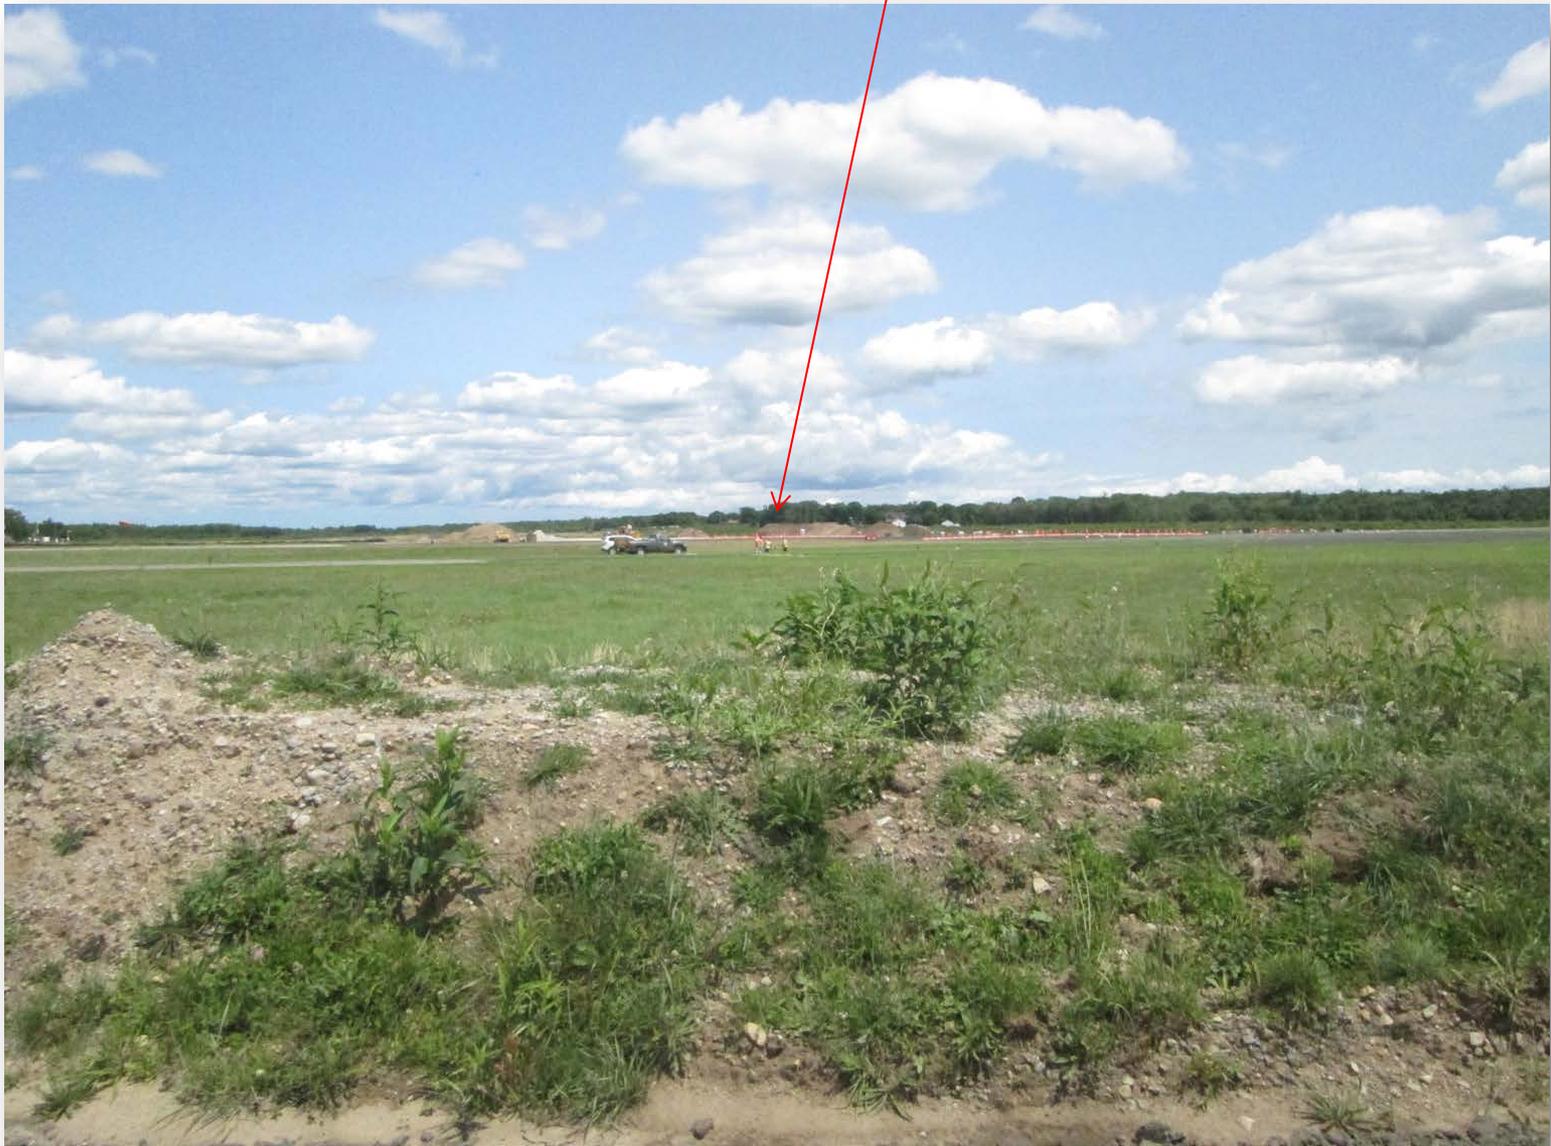
View of contractor fixing catch basin 3 within 20 minutes of reporting.

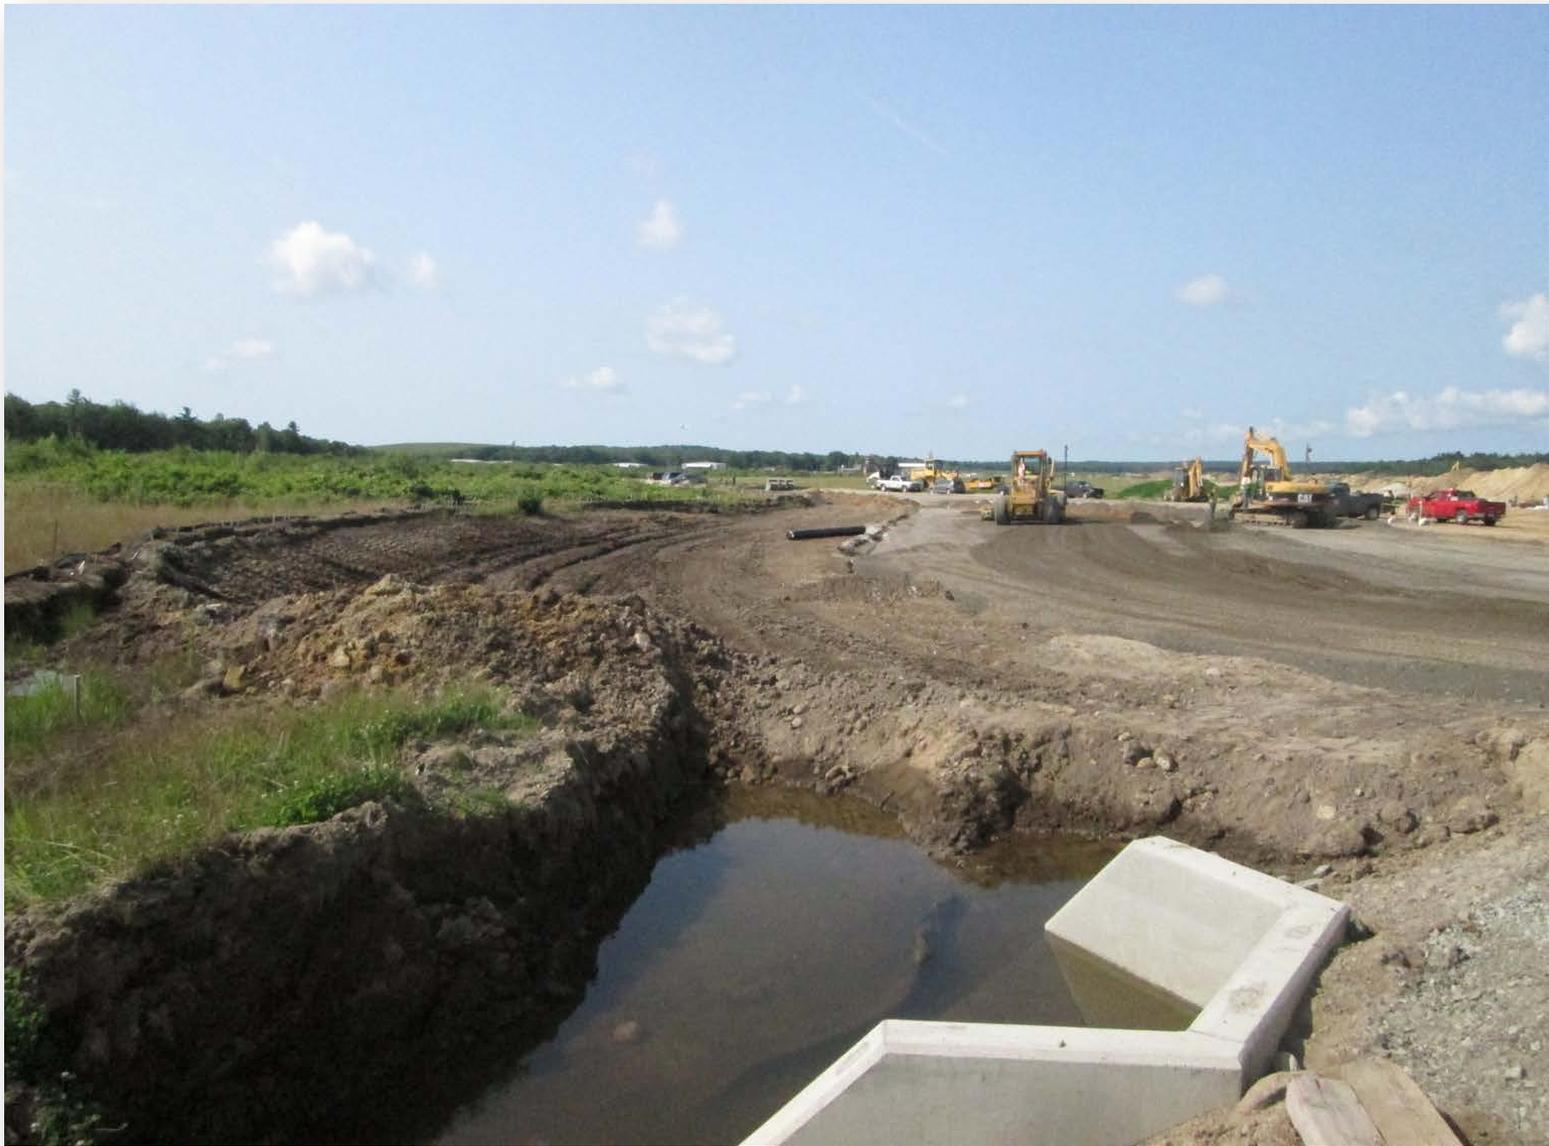
View of interim stormwater swale condition at the Runway 23 end, the contractor is subgrading Taxiway "A".

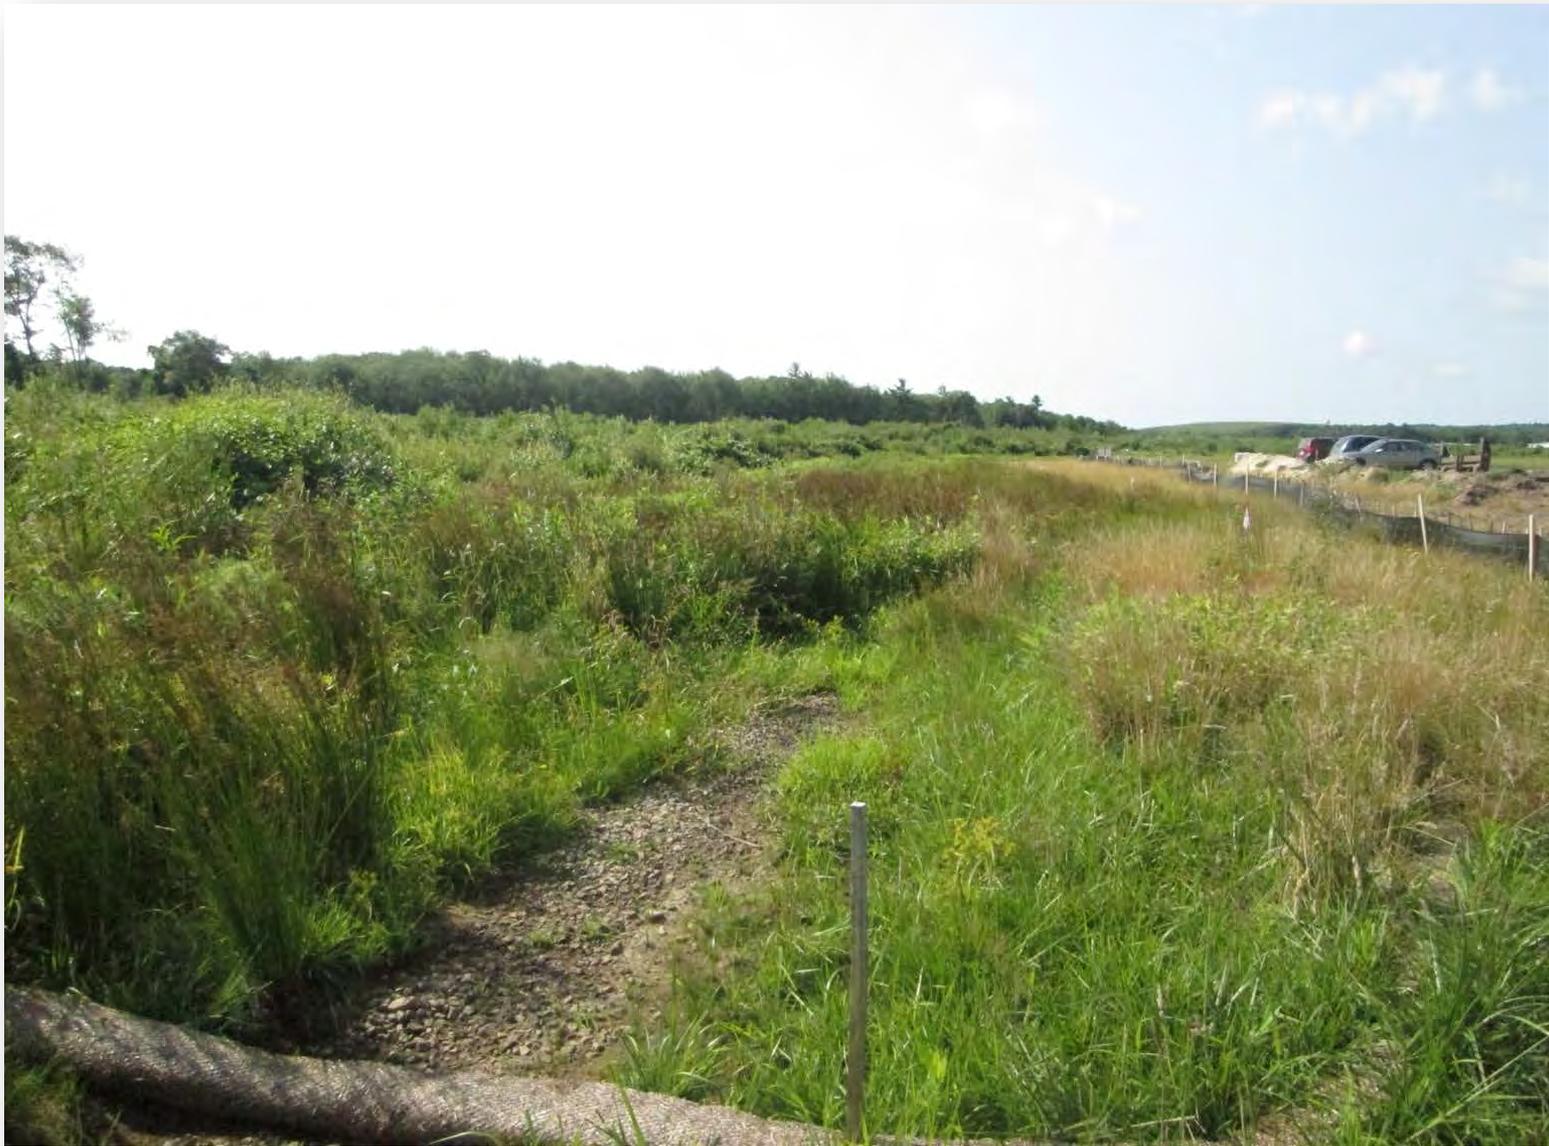
View of wetland downgradient from interim condition swale. Erosion controls upgradient are in good condition.

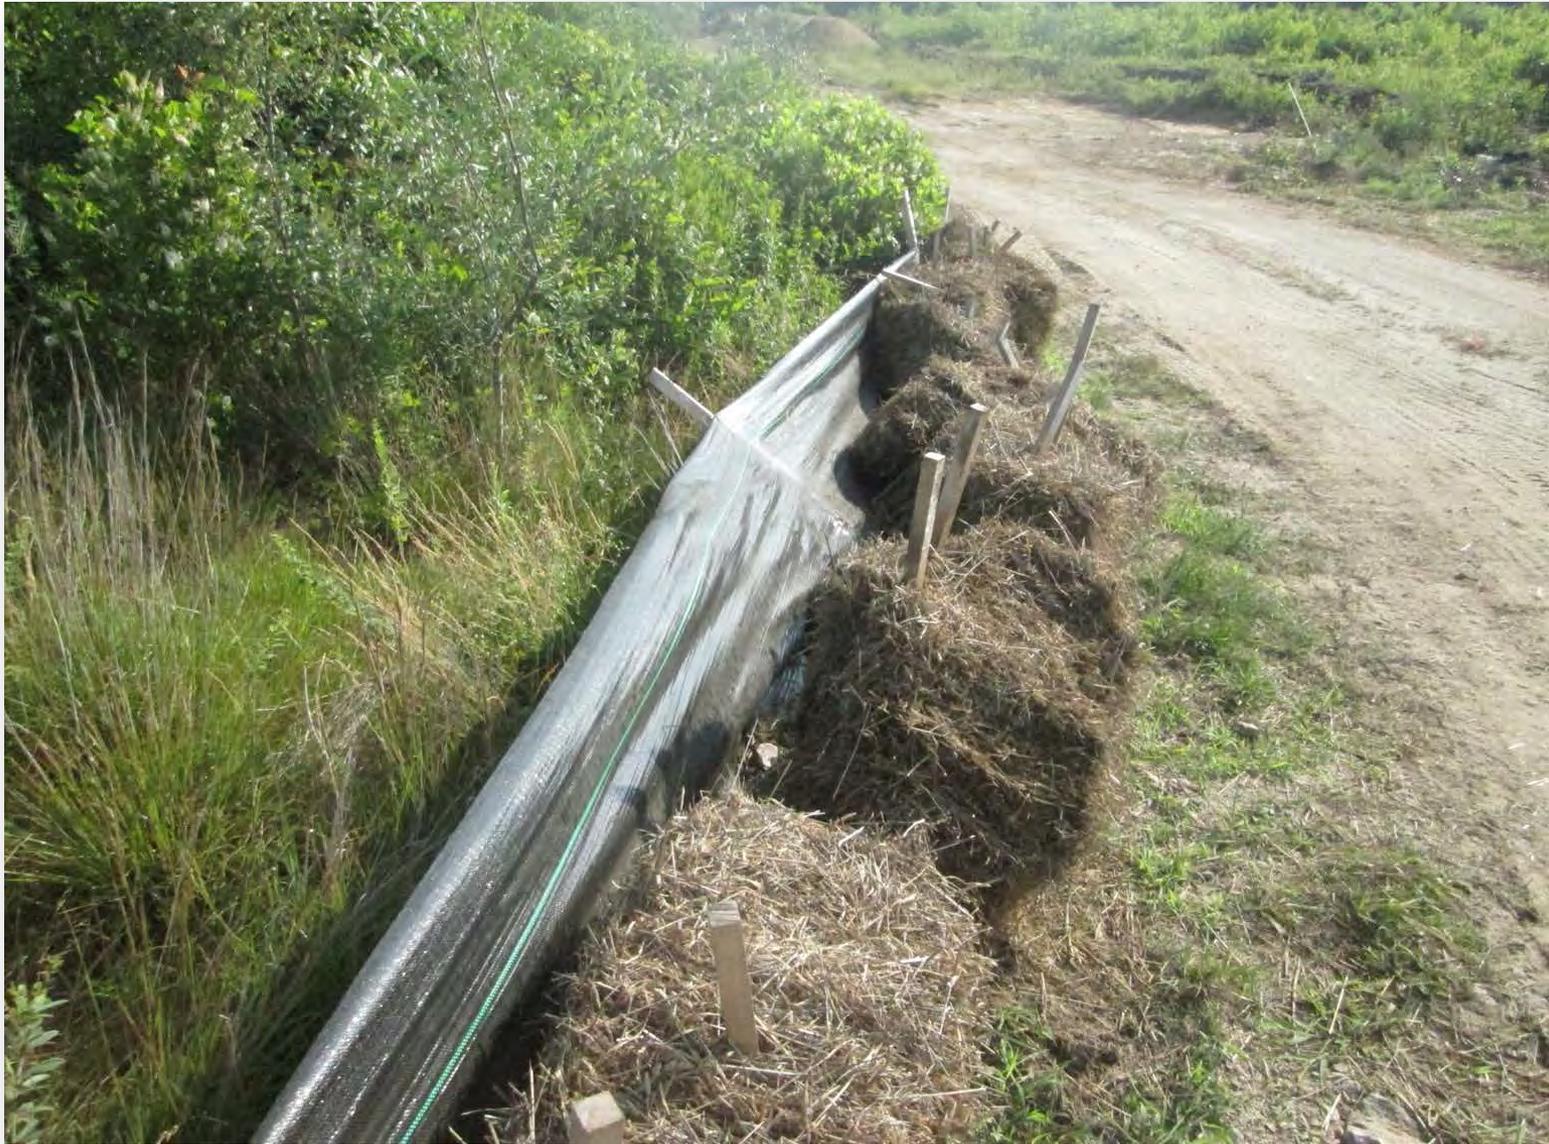
View of discrete issue with erosion controls at the area north of New Plainville Road. A truck hit controls. Contractor will restake and repair.

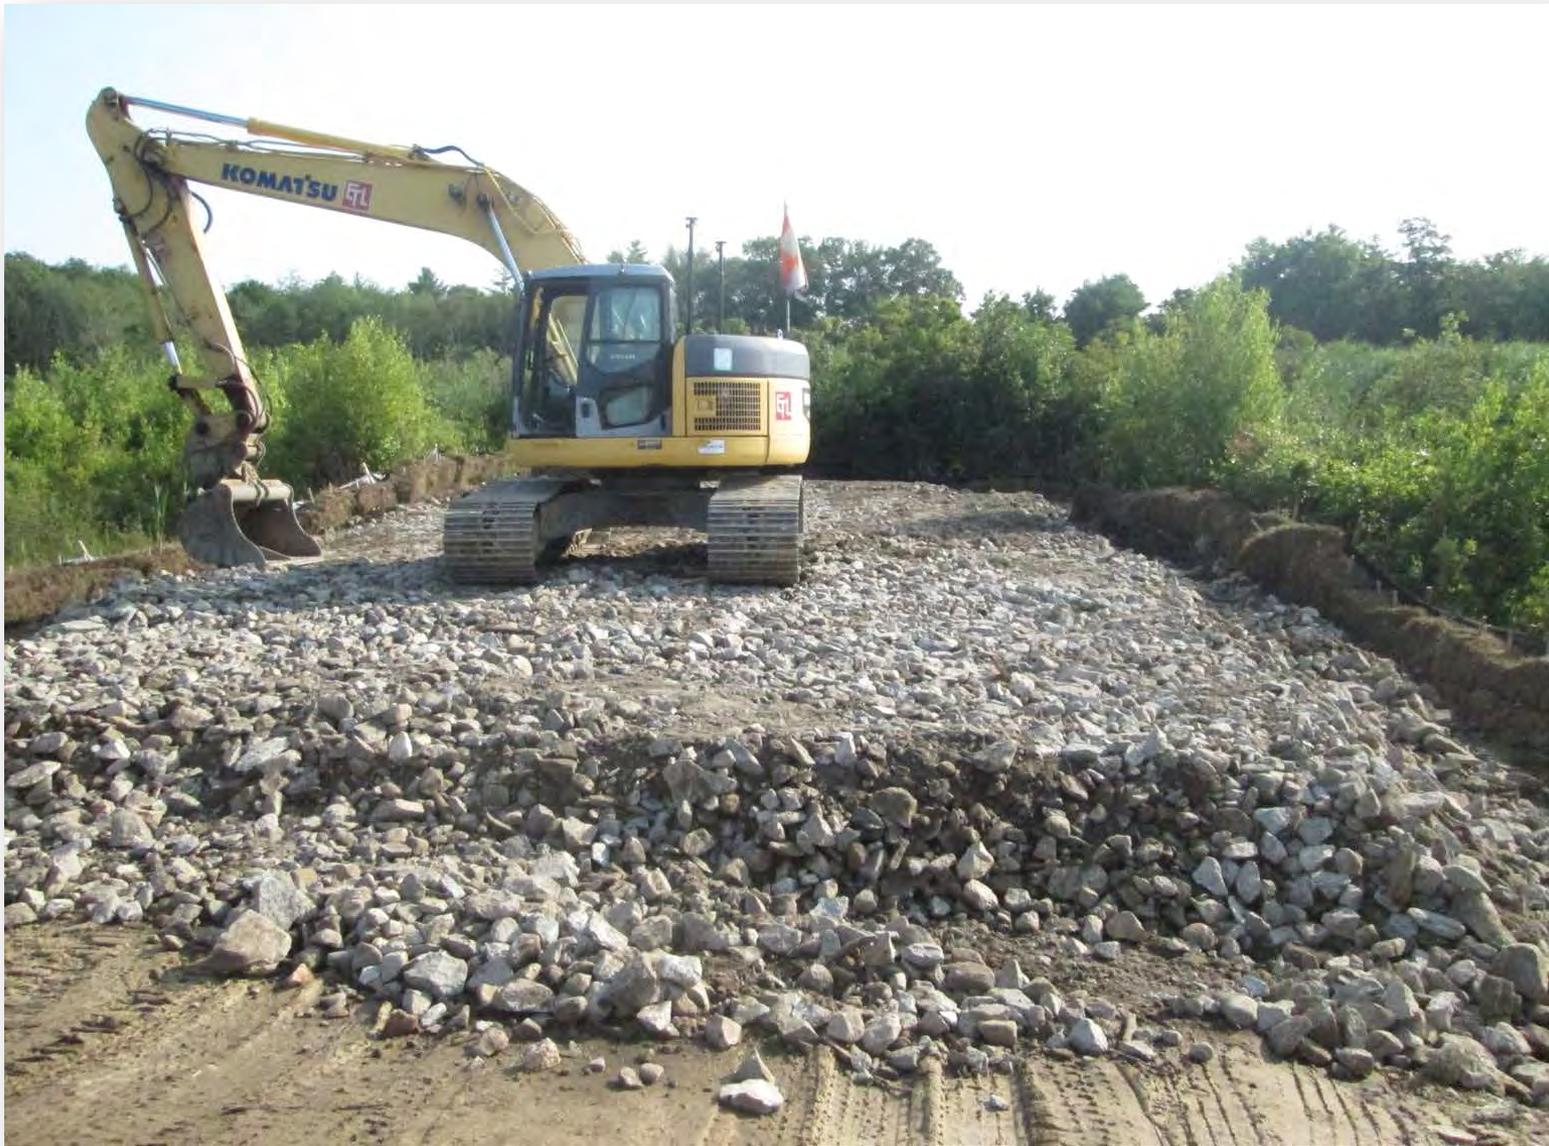
View of subbase within wetland fill at the Runway 23 MALSR end. Erosion controls are in good condition.

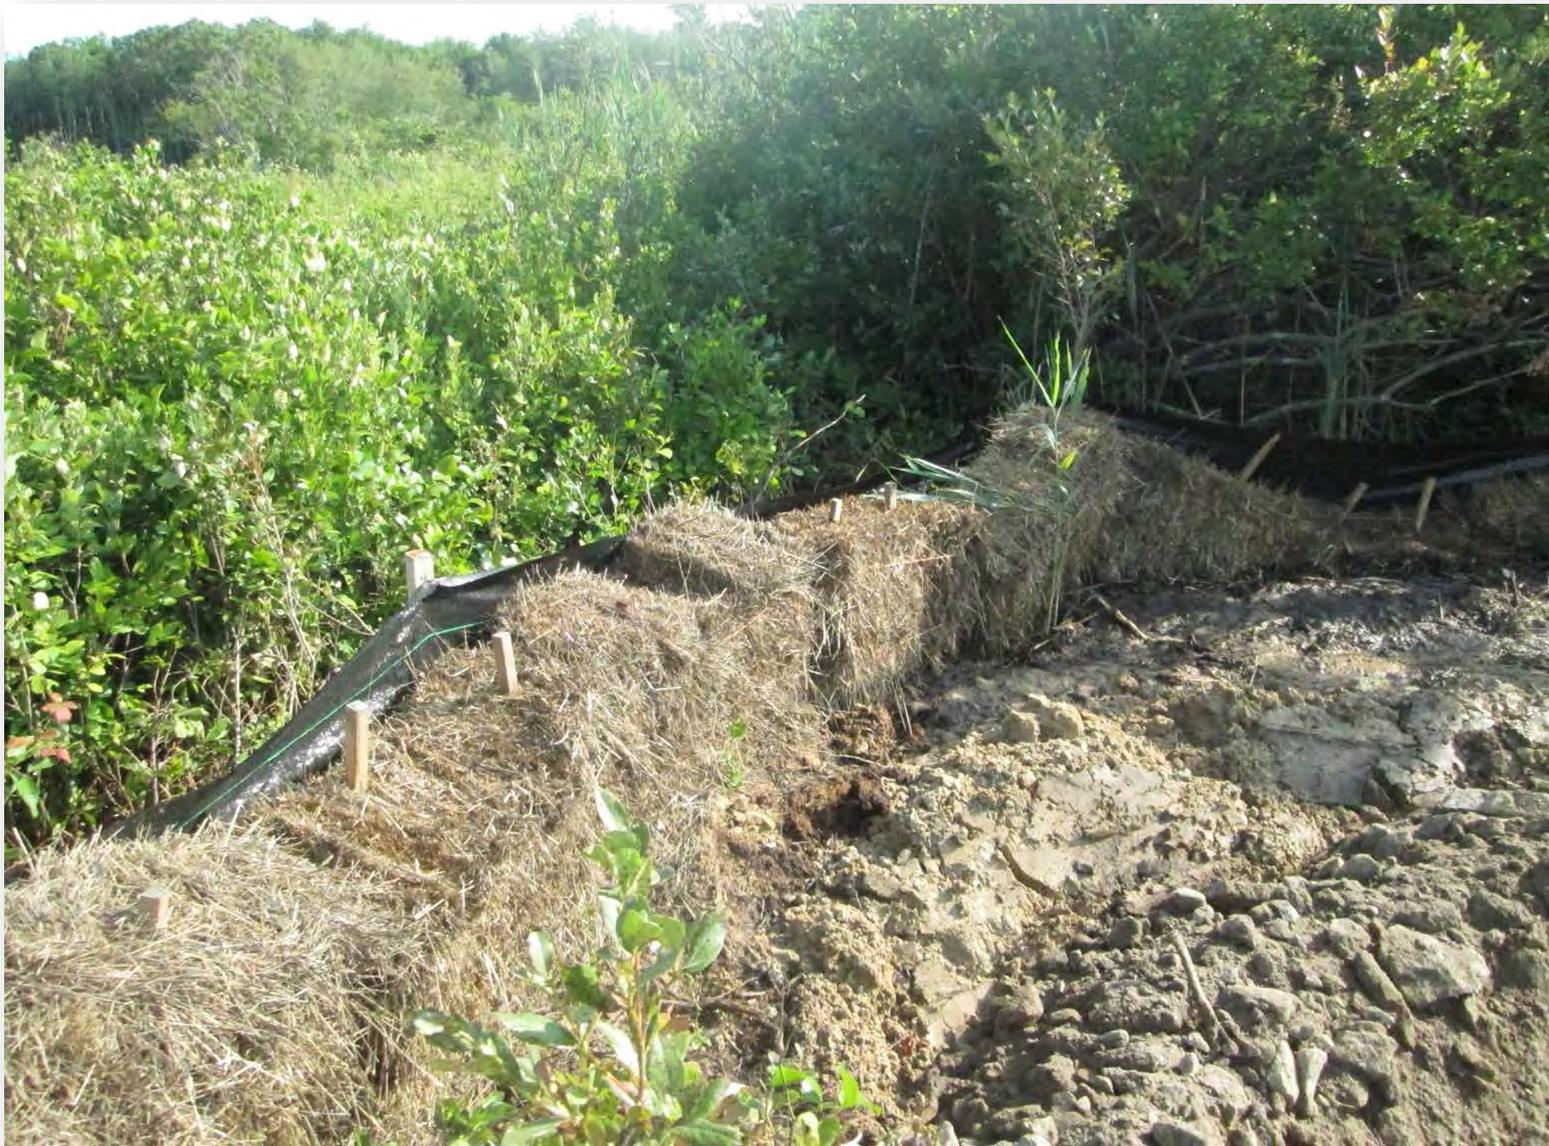
Typical view of erosion controls in Runway 23 end MALSR fill area.

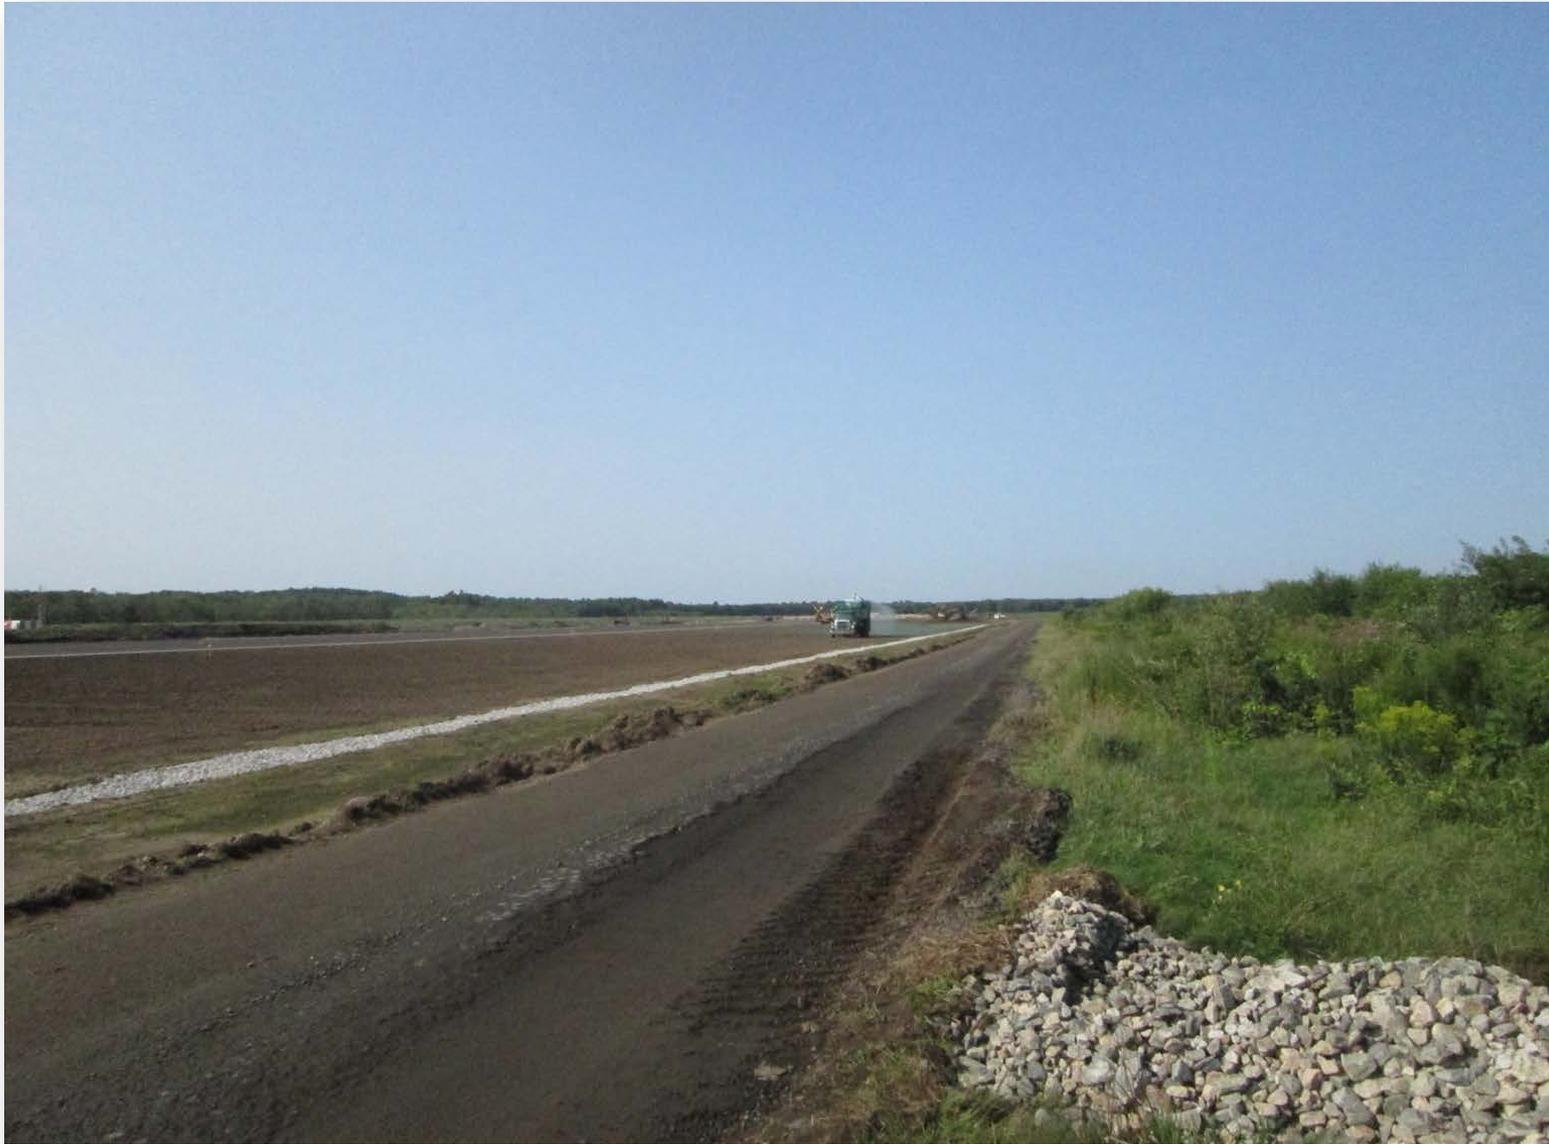
Hydroseeding operation near Runway 5 end.

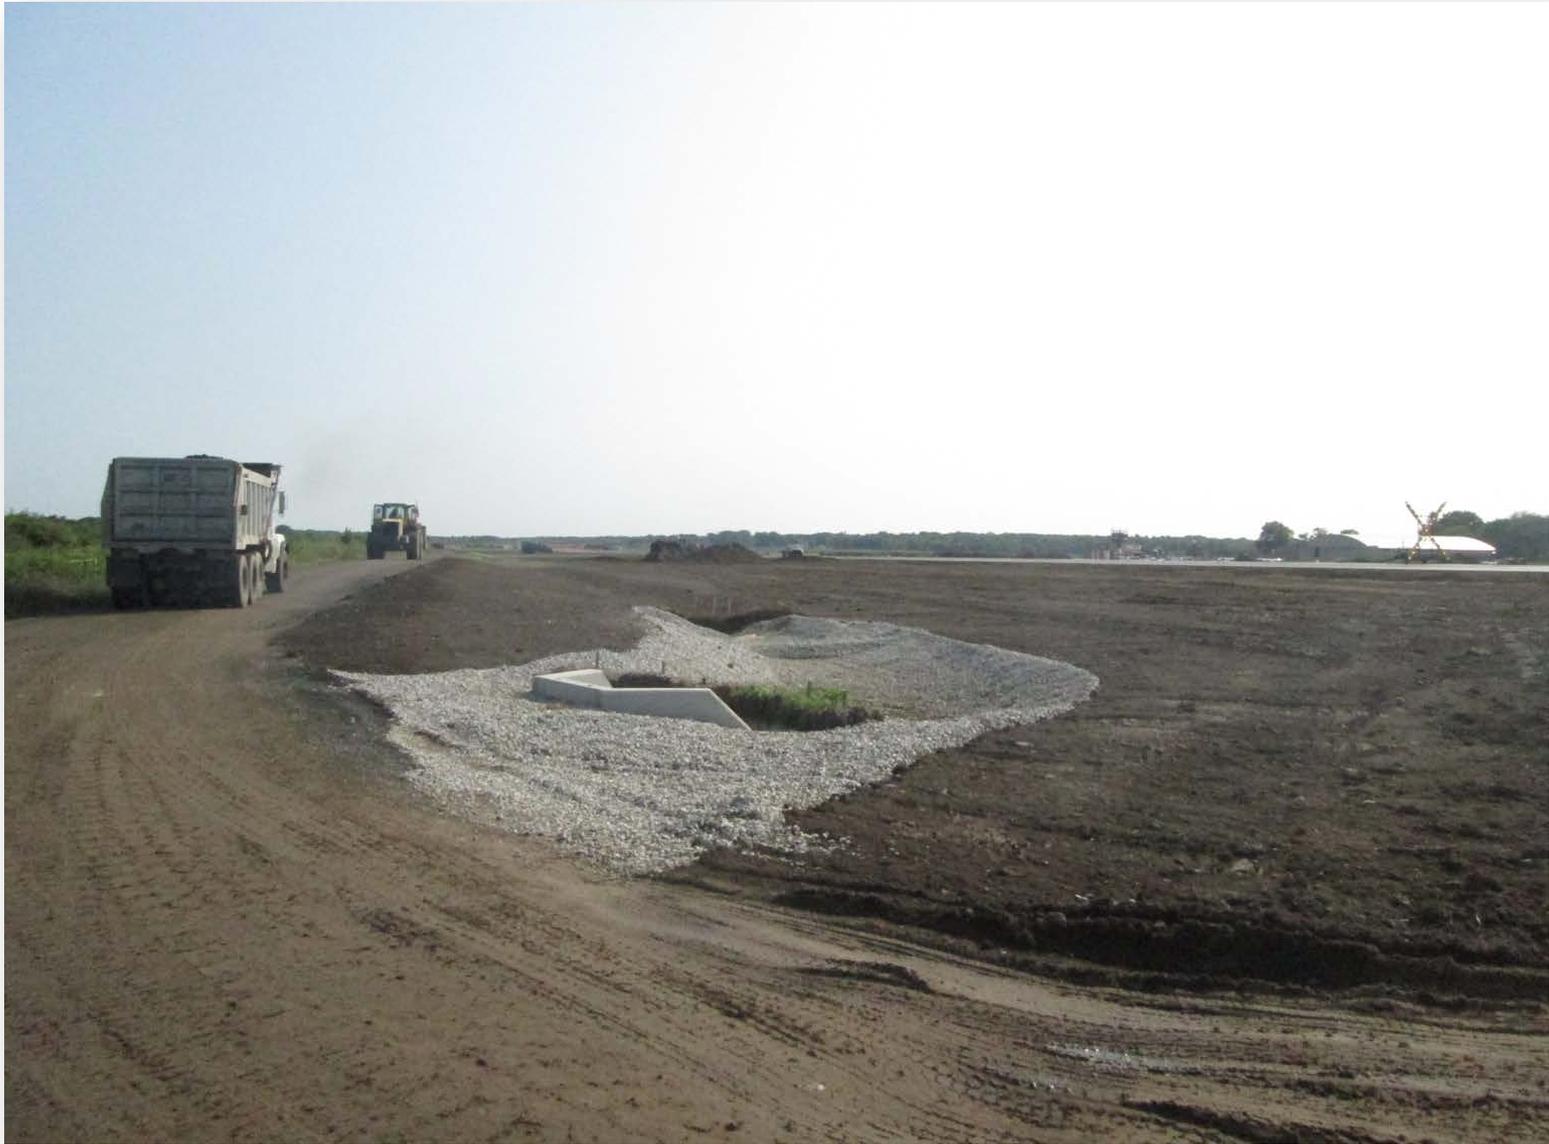
View of spread topsoil adjacent to Runway 5 end, adjacent headwall is dry and erosion controls are in good condition.
