**New Bedford Regional Airport
Runway Safety Improvements Project – Phase 4
Reconstruct, Mark, and Groove Runway 5-23
MassDEP File No. SE049-0635**

ENVIRONMENTAL MONITOR INSPECTION FORM

Date/ Time of Inspections: **7/29/14 (morning), 7/31/14 (afternoon), 8/7/14 (morning).**

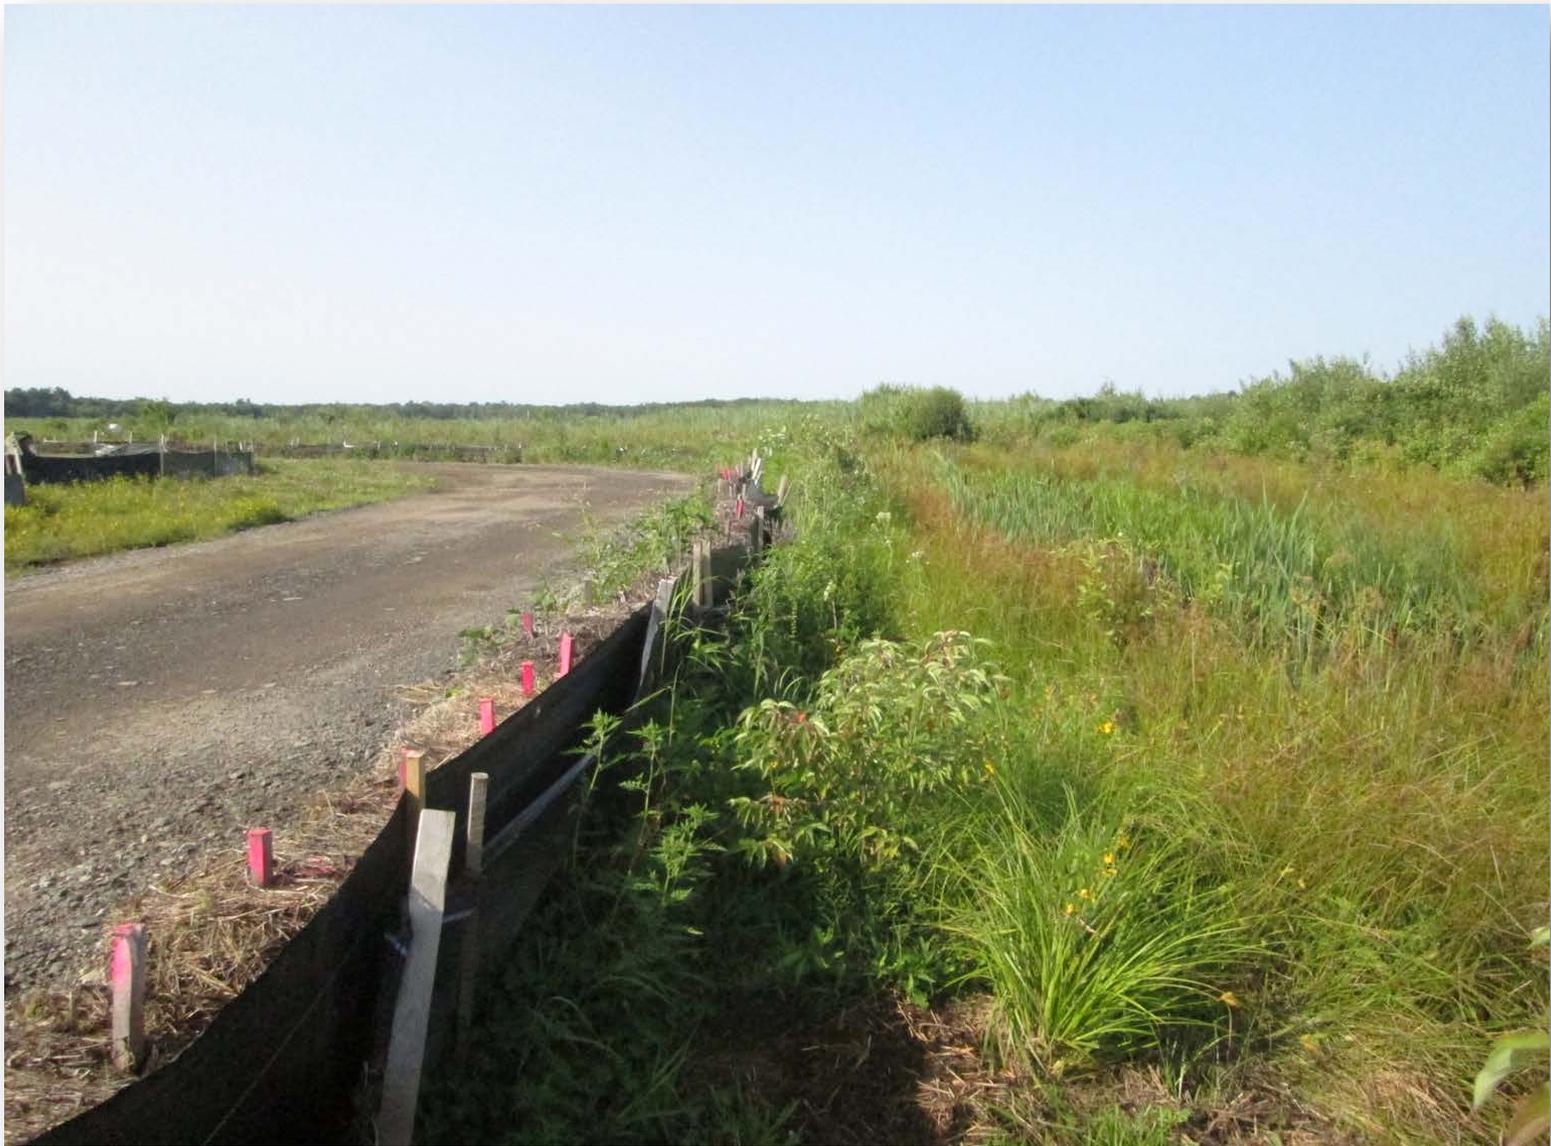
View of repaired and restaked erosion controls at the blow out area on Runway 5 RSA end. Restaked hay bales were painted.

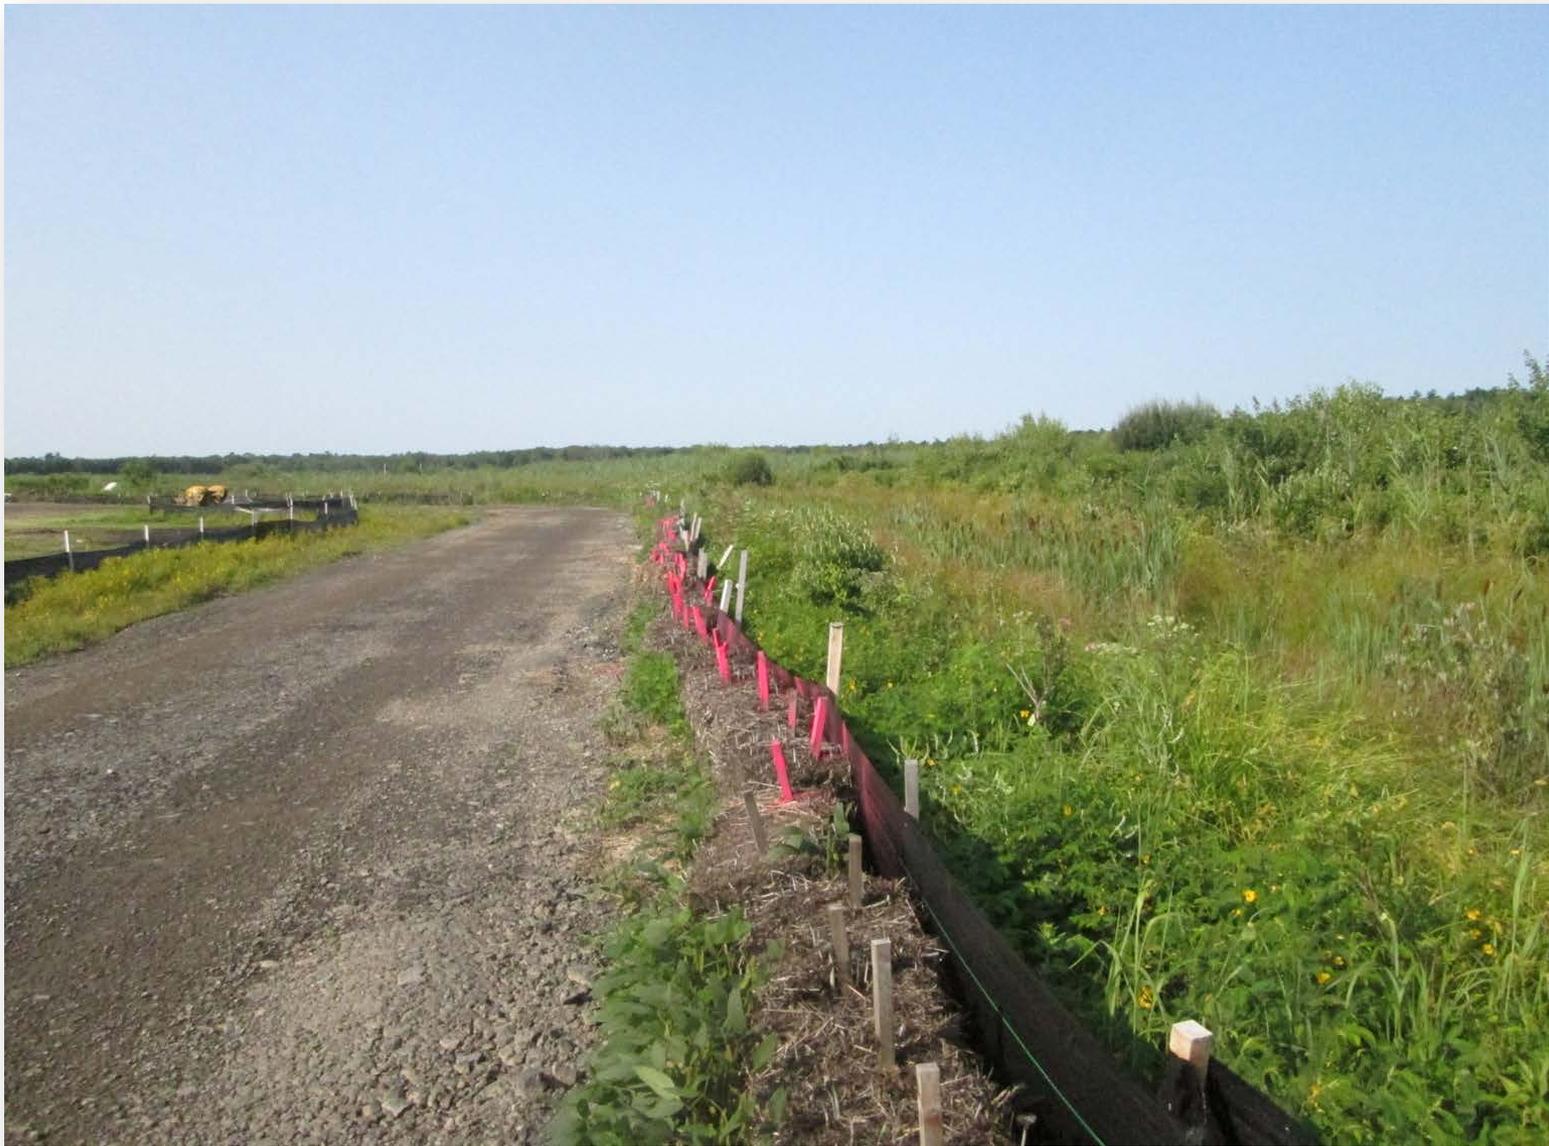
Another typical view of re-staked erosion controls and gravel access road.

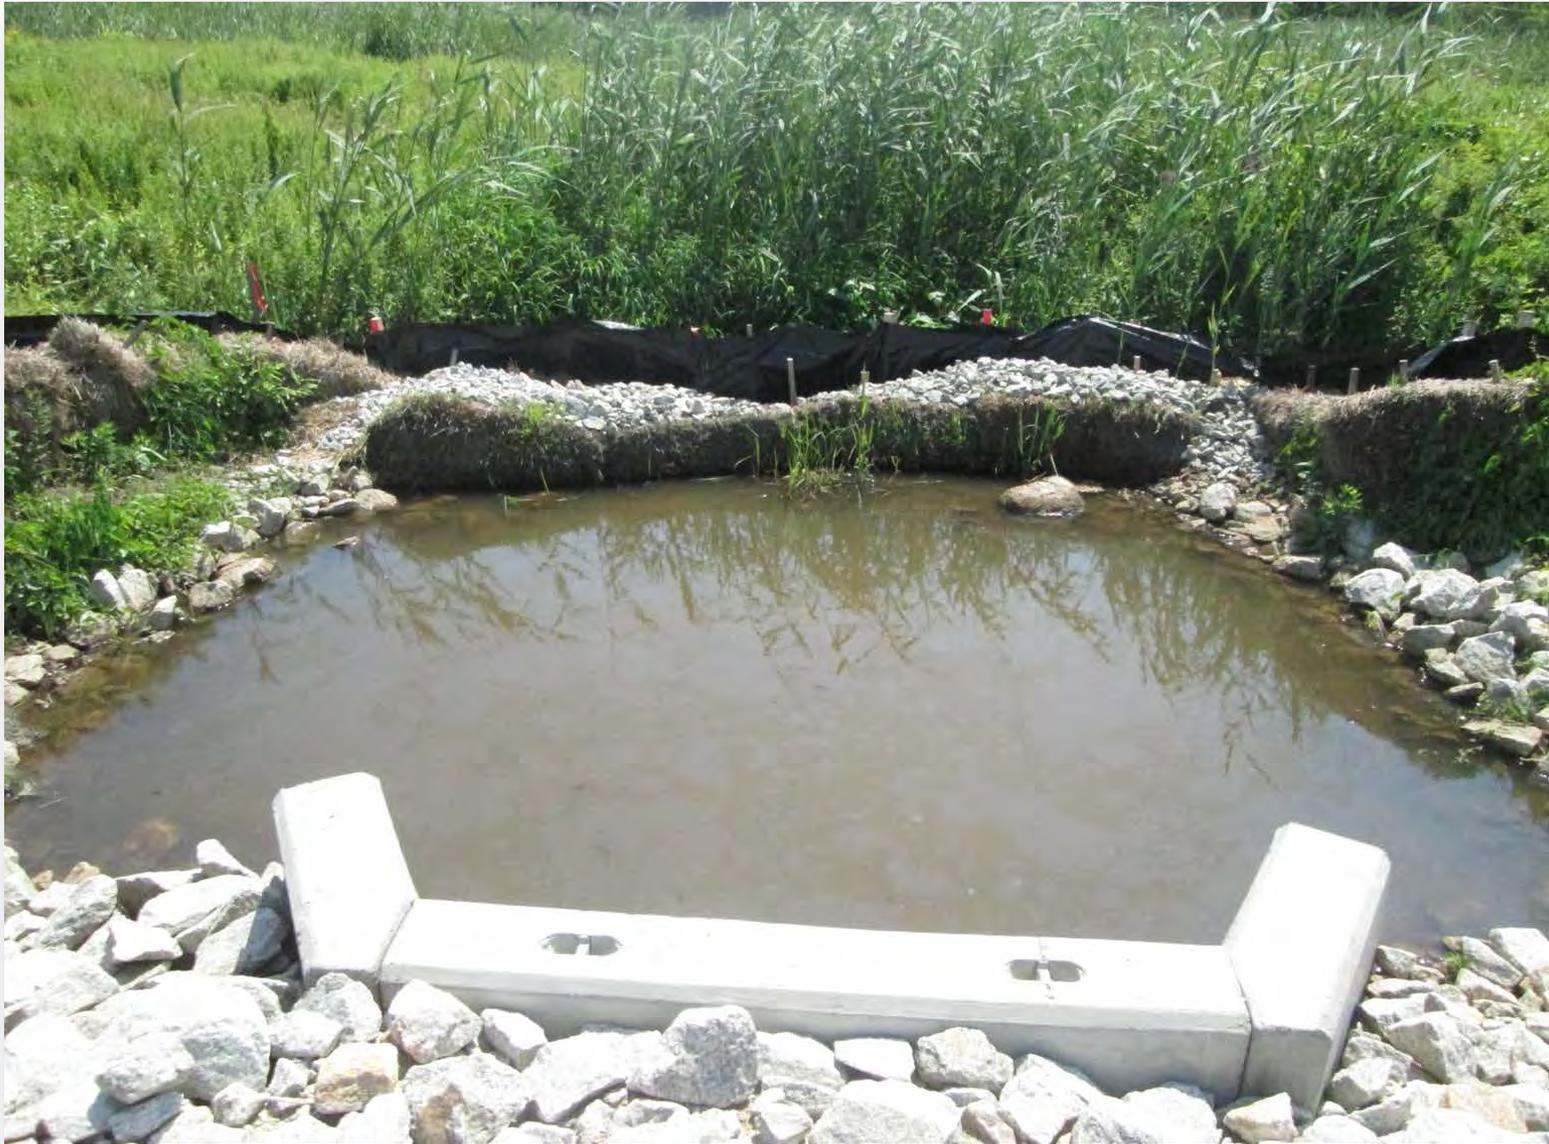
View of headwall from catch basin 11. Hay bales and silt fence are properly staked and retaining this cloudy water.

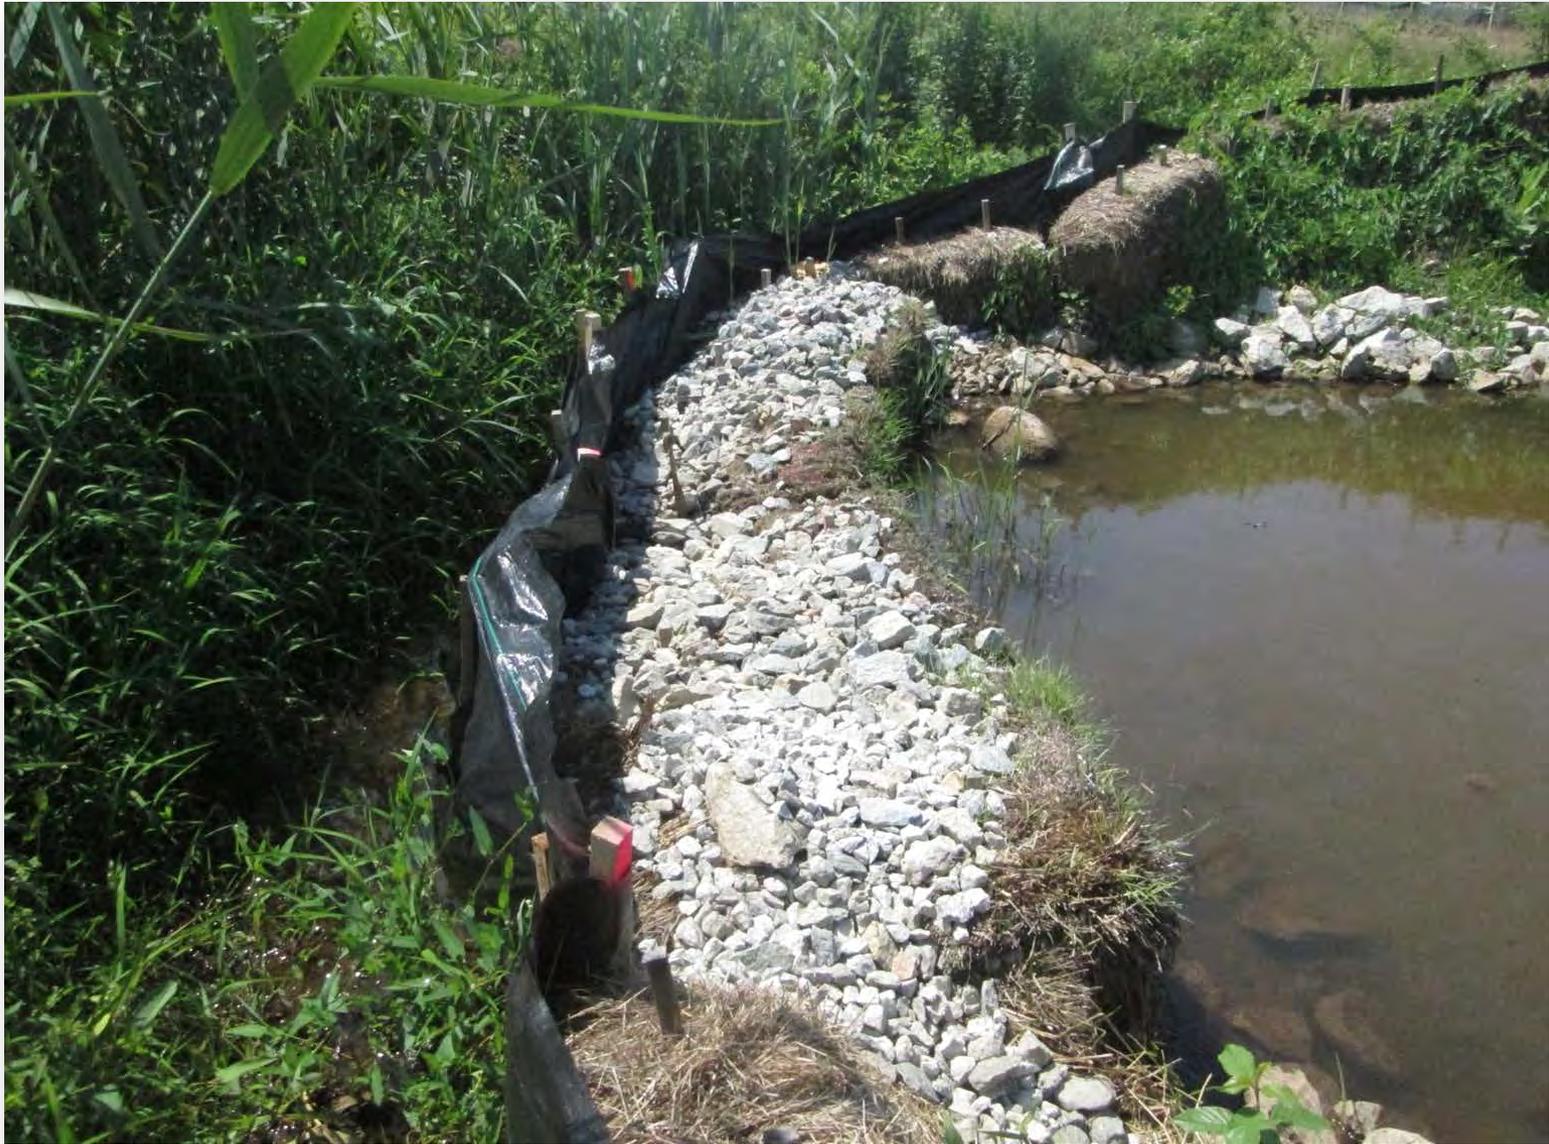
View of erosion controls, no water is seeping, moving through the erosion controls untreated.

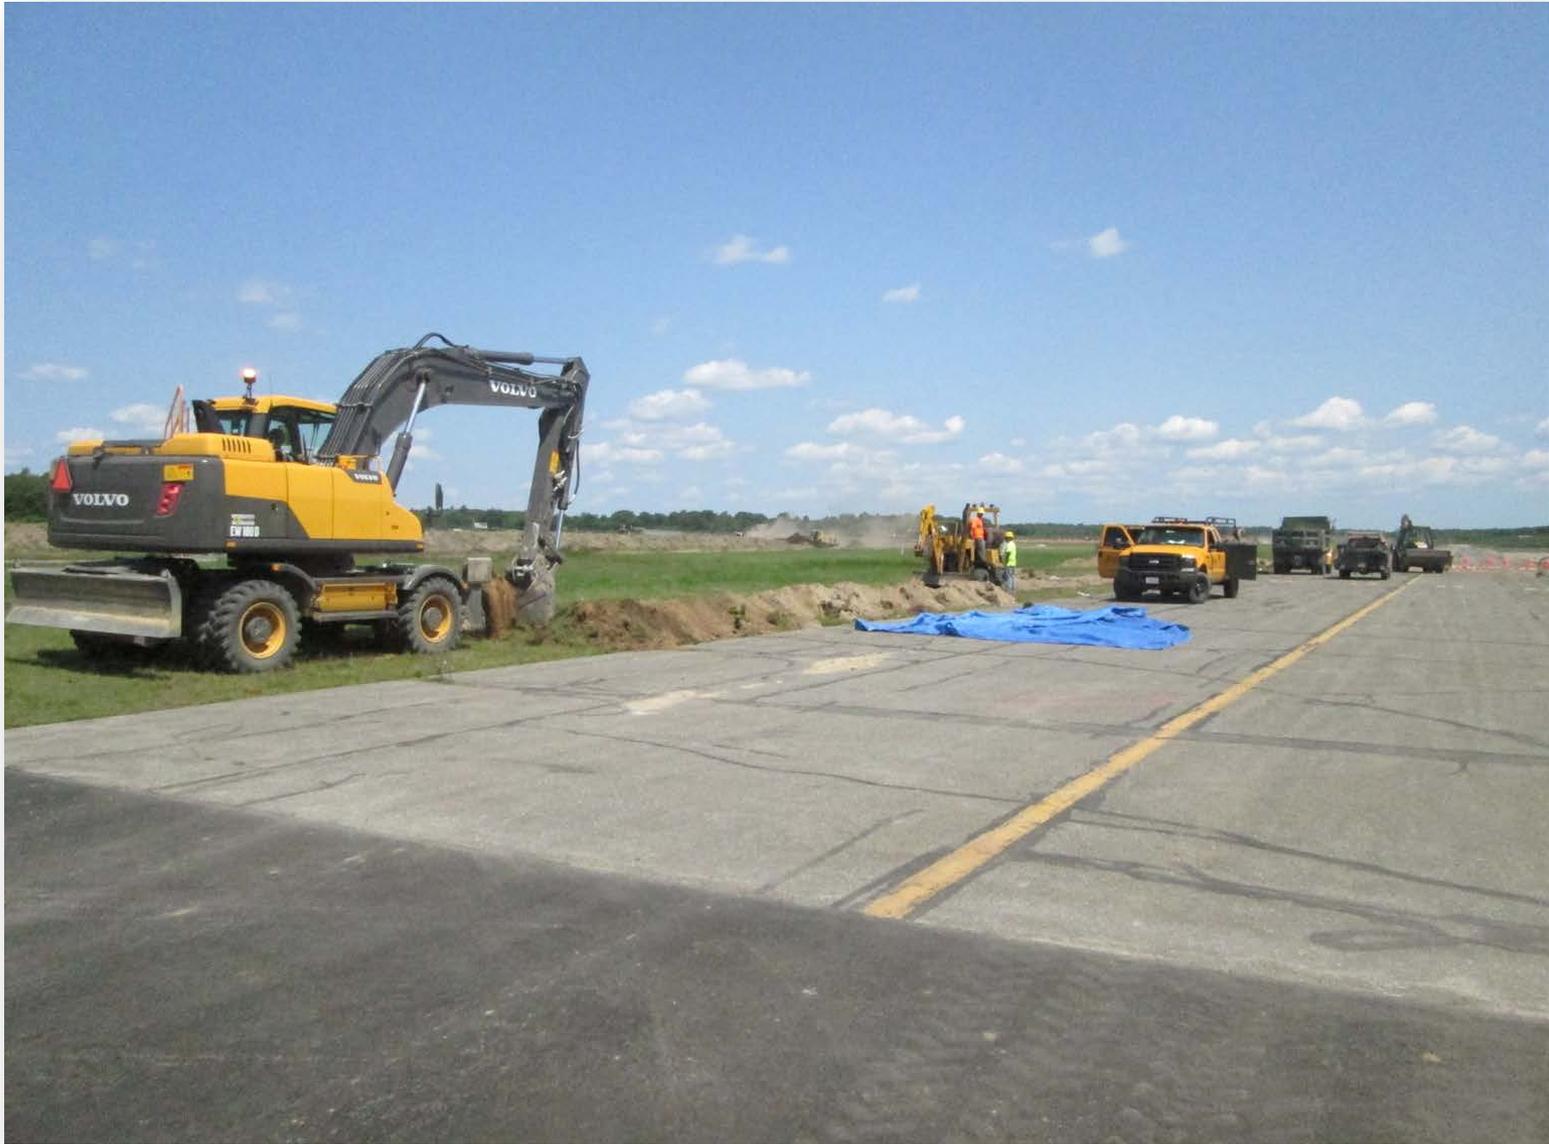
View of electrical trenching operations.

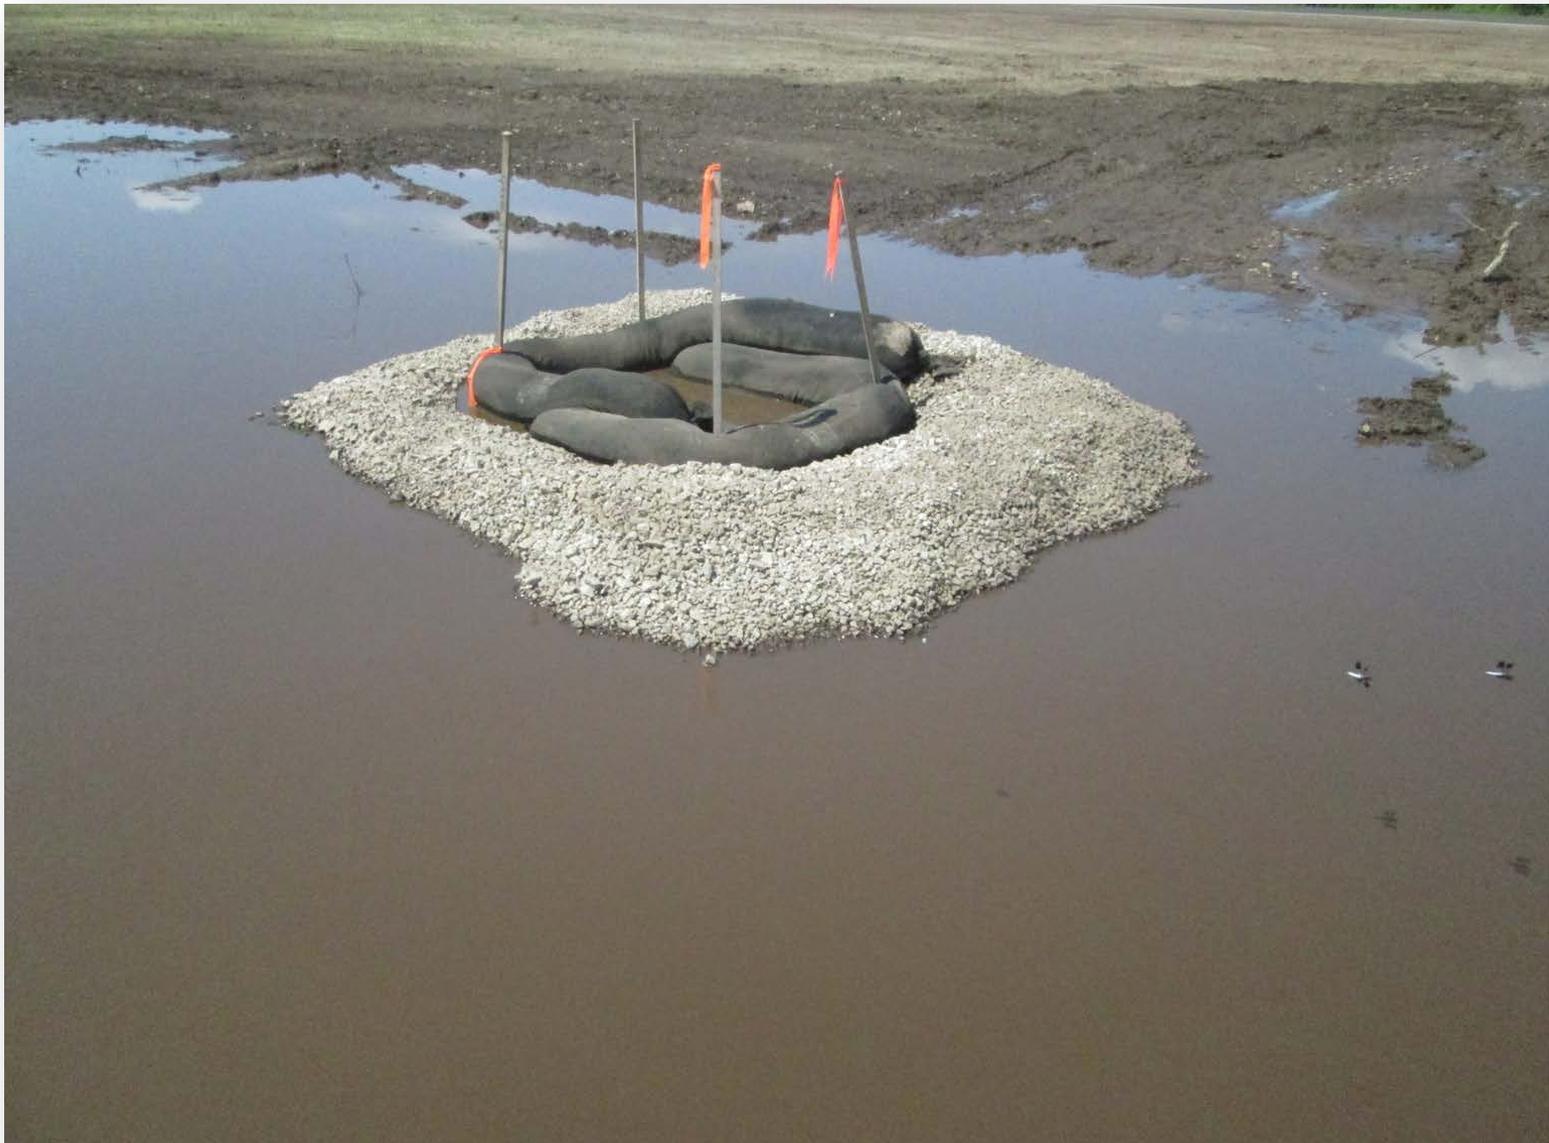
View of properly armed catch basin 11. Compost tubes are properly staked.

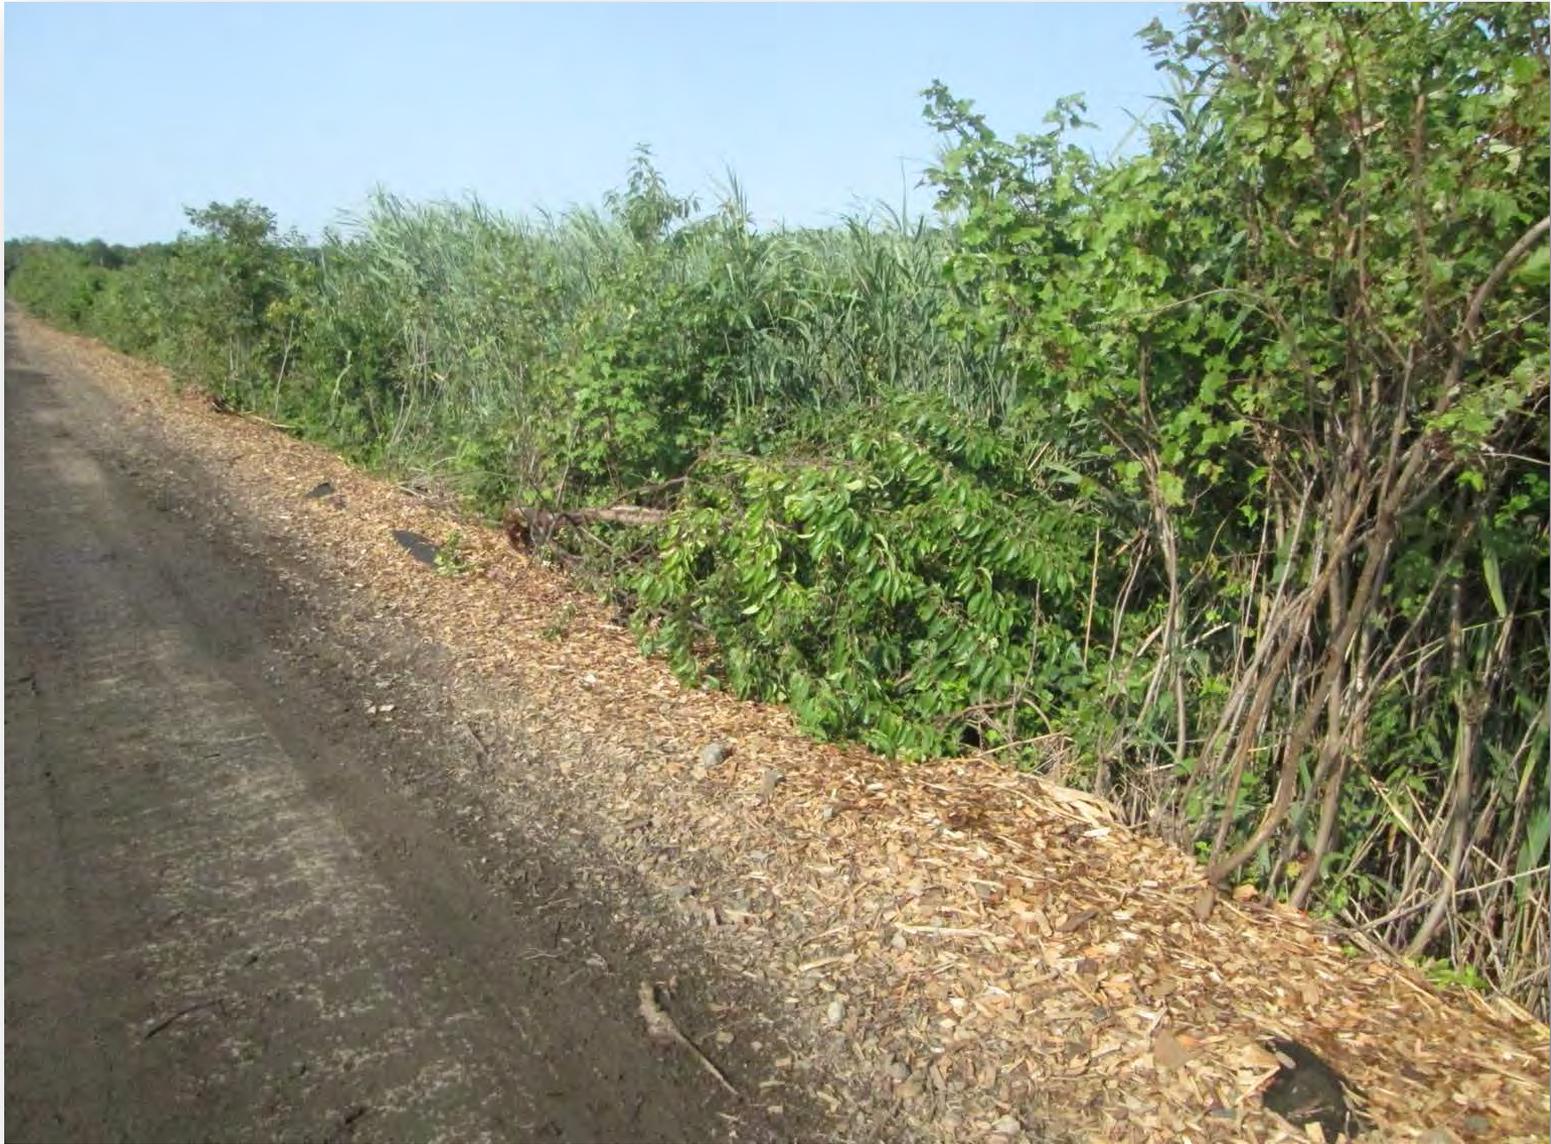
View of wood chips along ILS road.

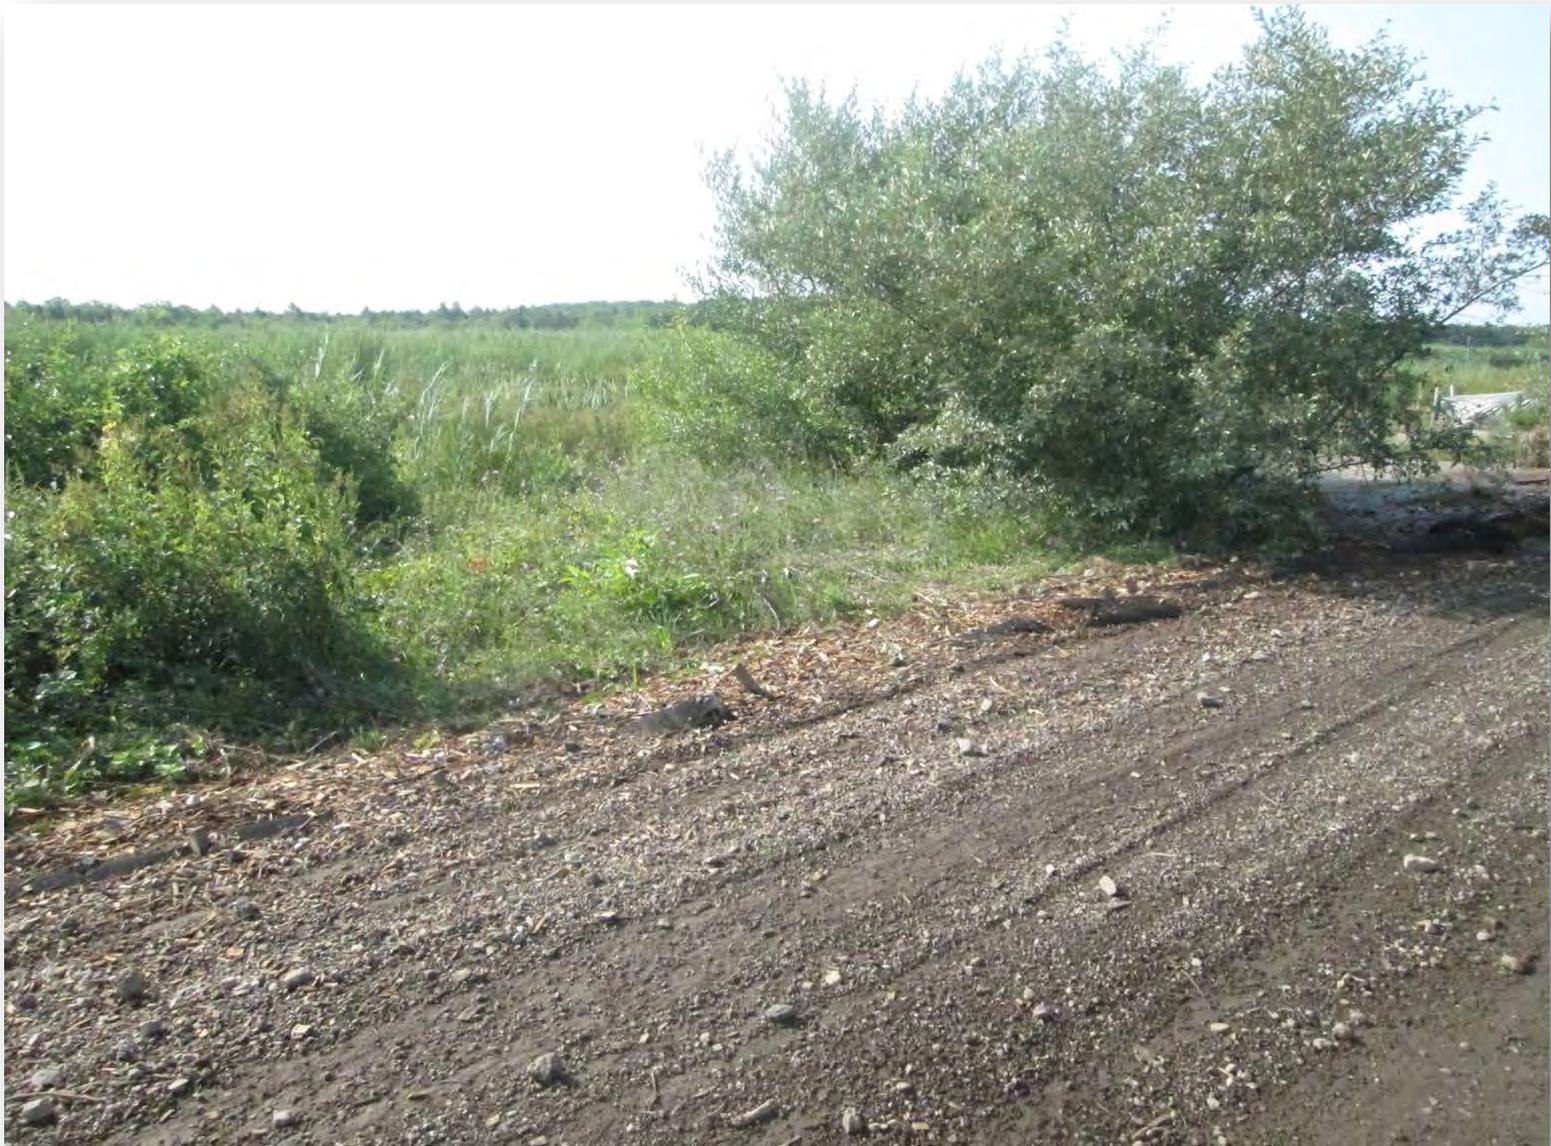
Another view of wood chips along the ILS road.

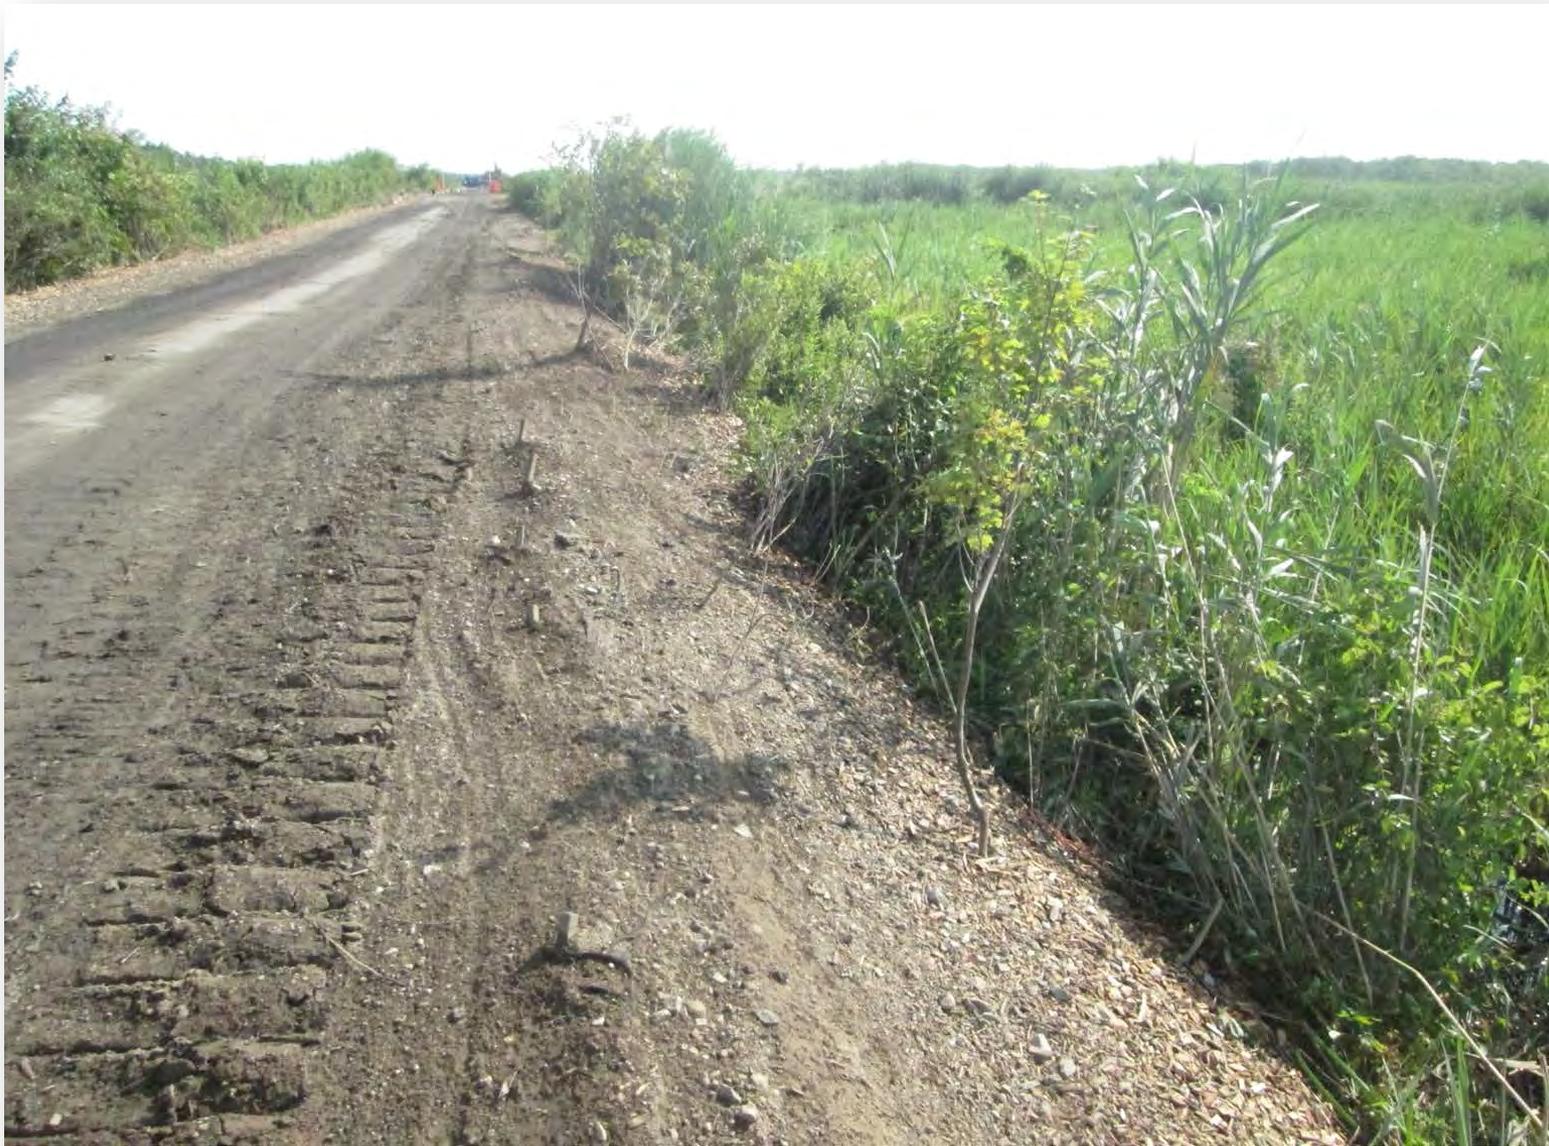
View of area where twitch has mobilized wood chips either downslope or further down the road. The side slopes are still very well armed and no movement within the wetland was observed.

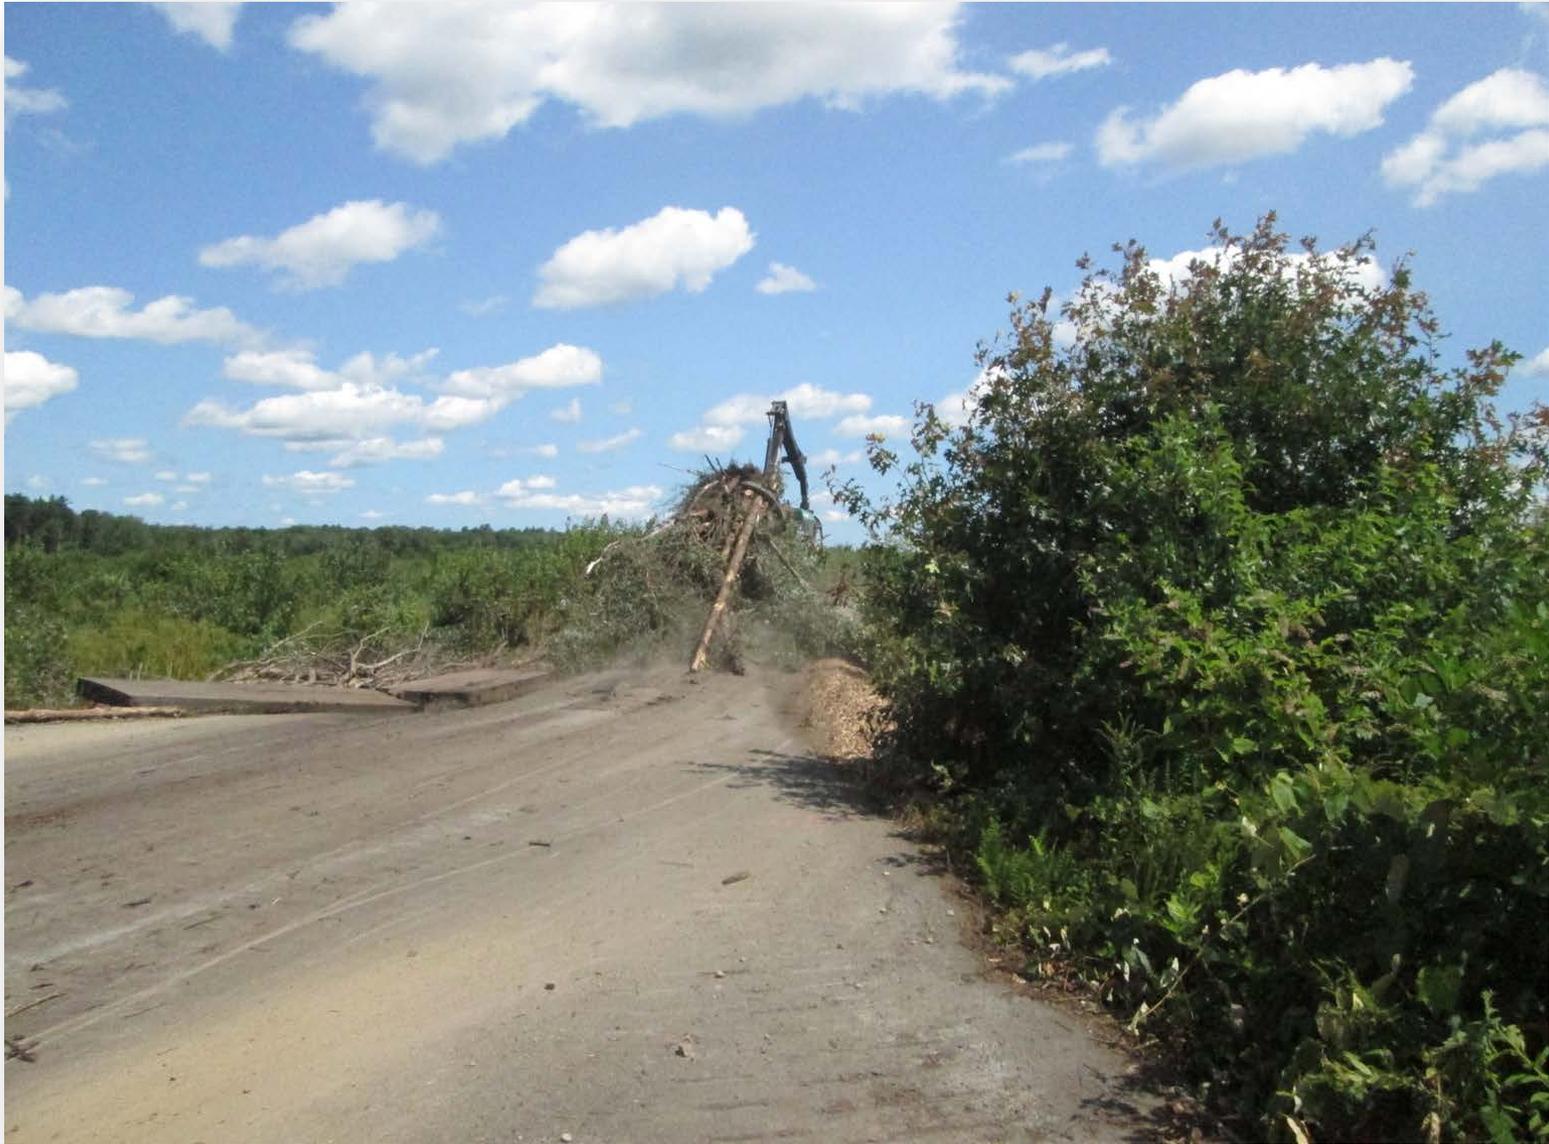
View of logging “twitch” transported down the ILS road.

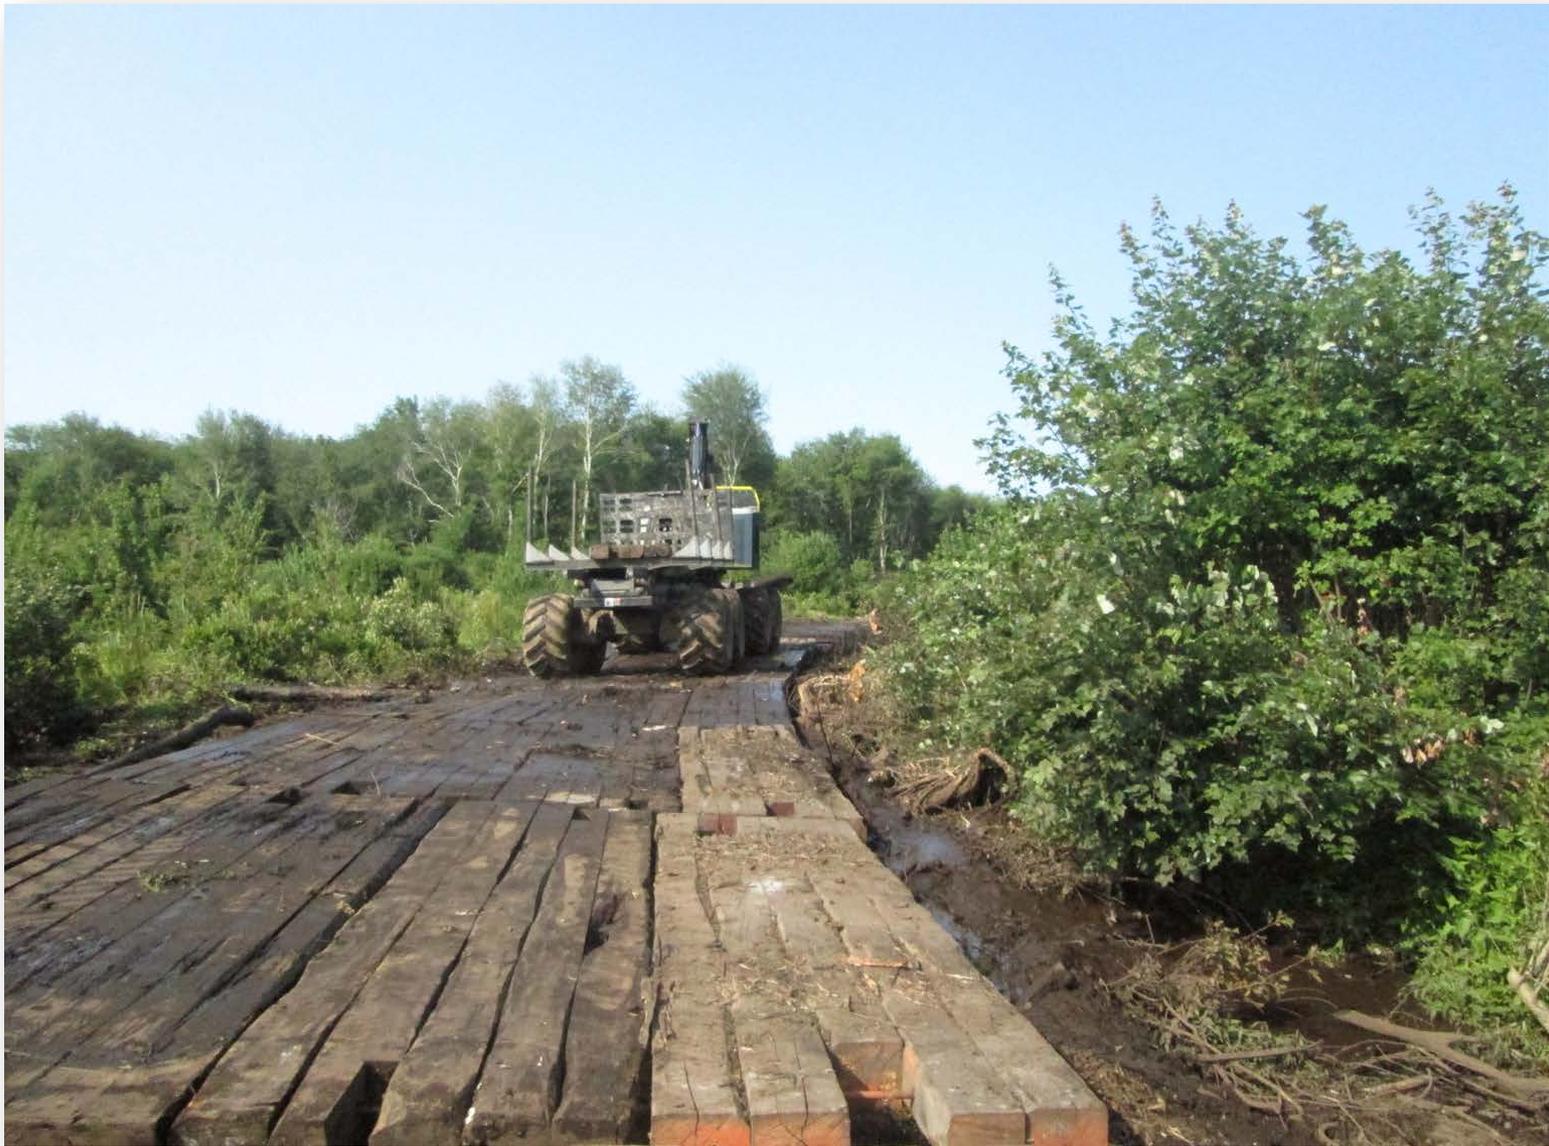
View of contractor resetting and inspecting the timber mat road.

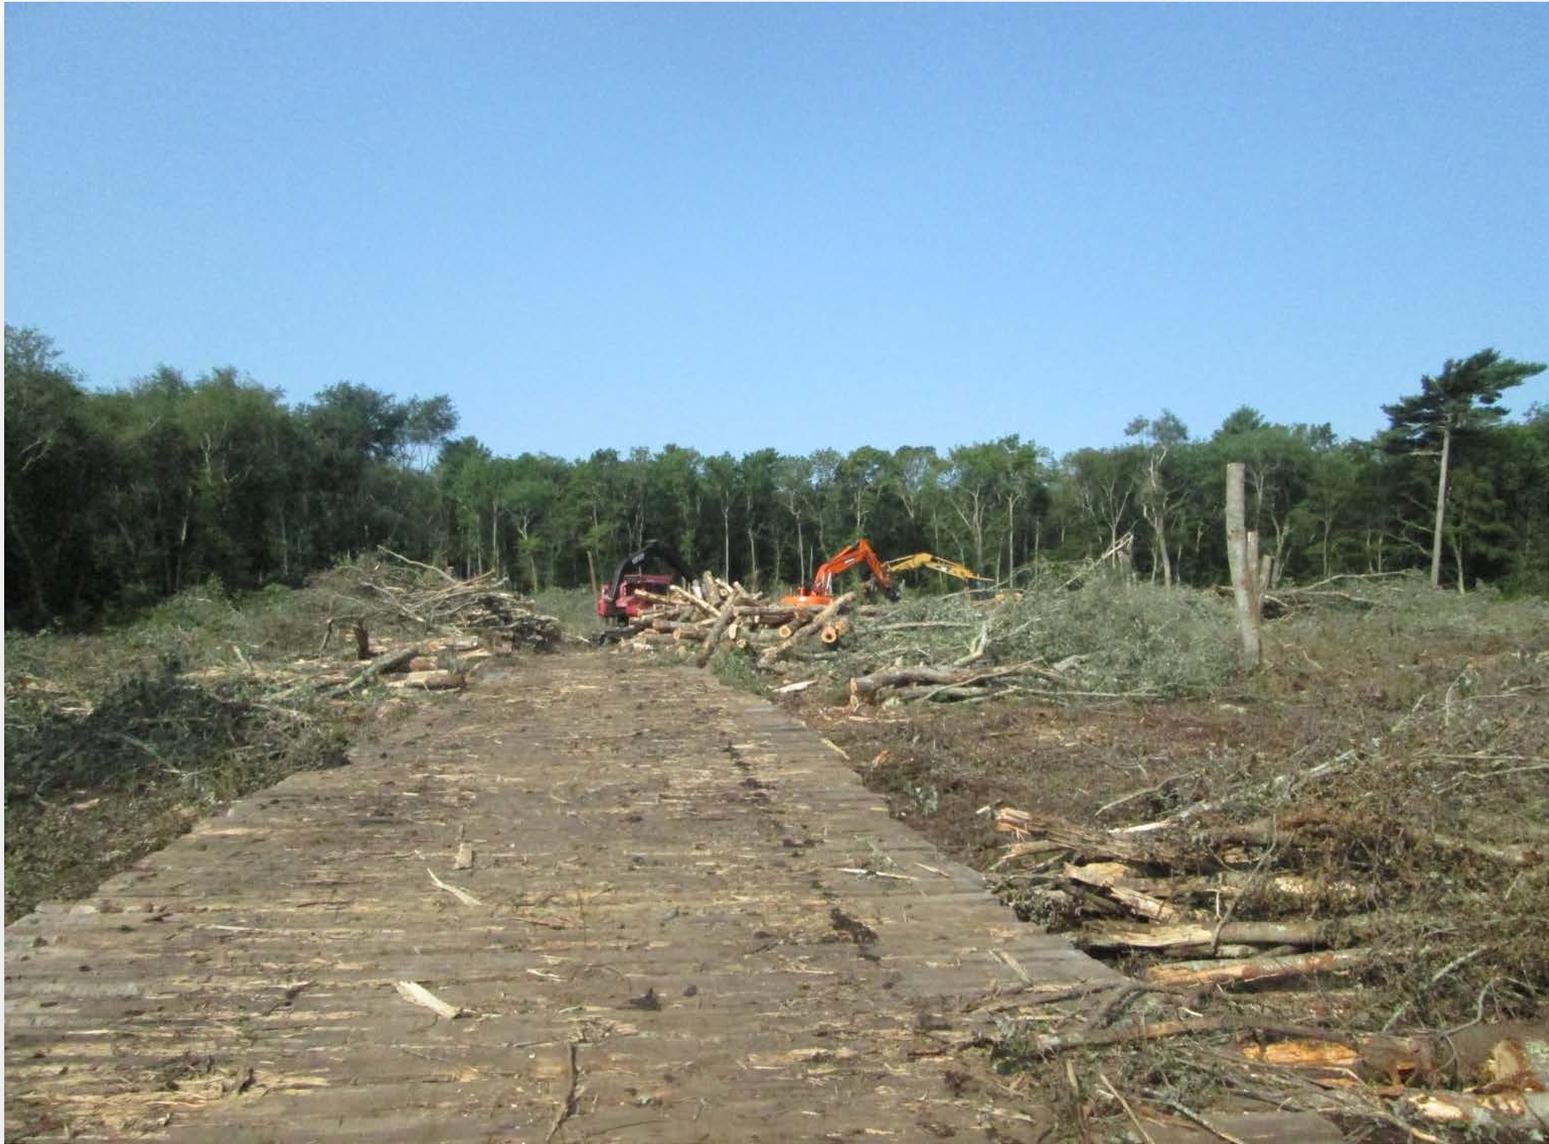
View of processing operation while the contractor waits for clearance from the turtle sweep folks.

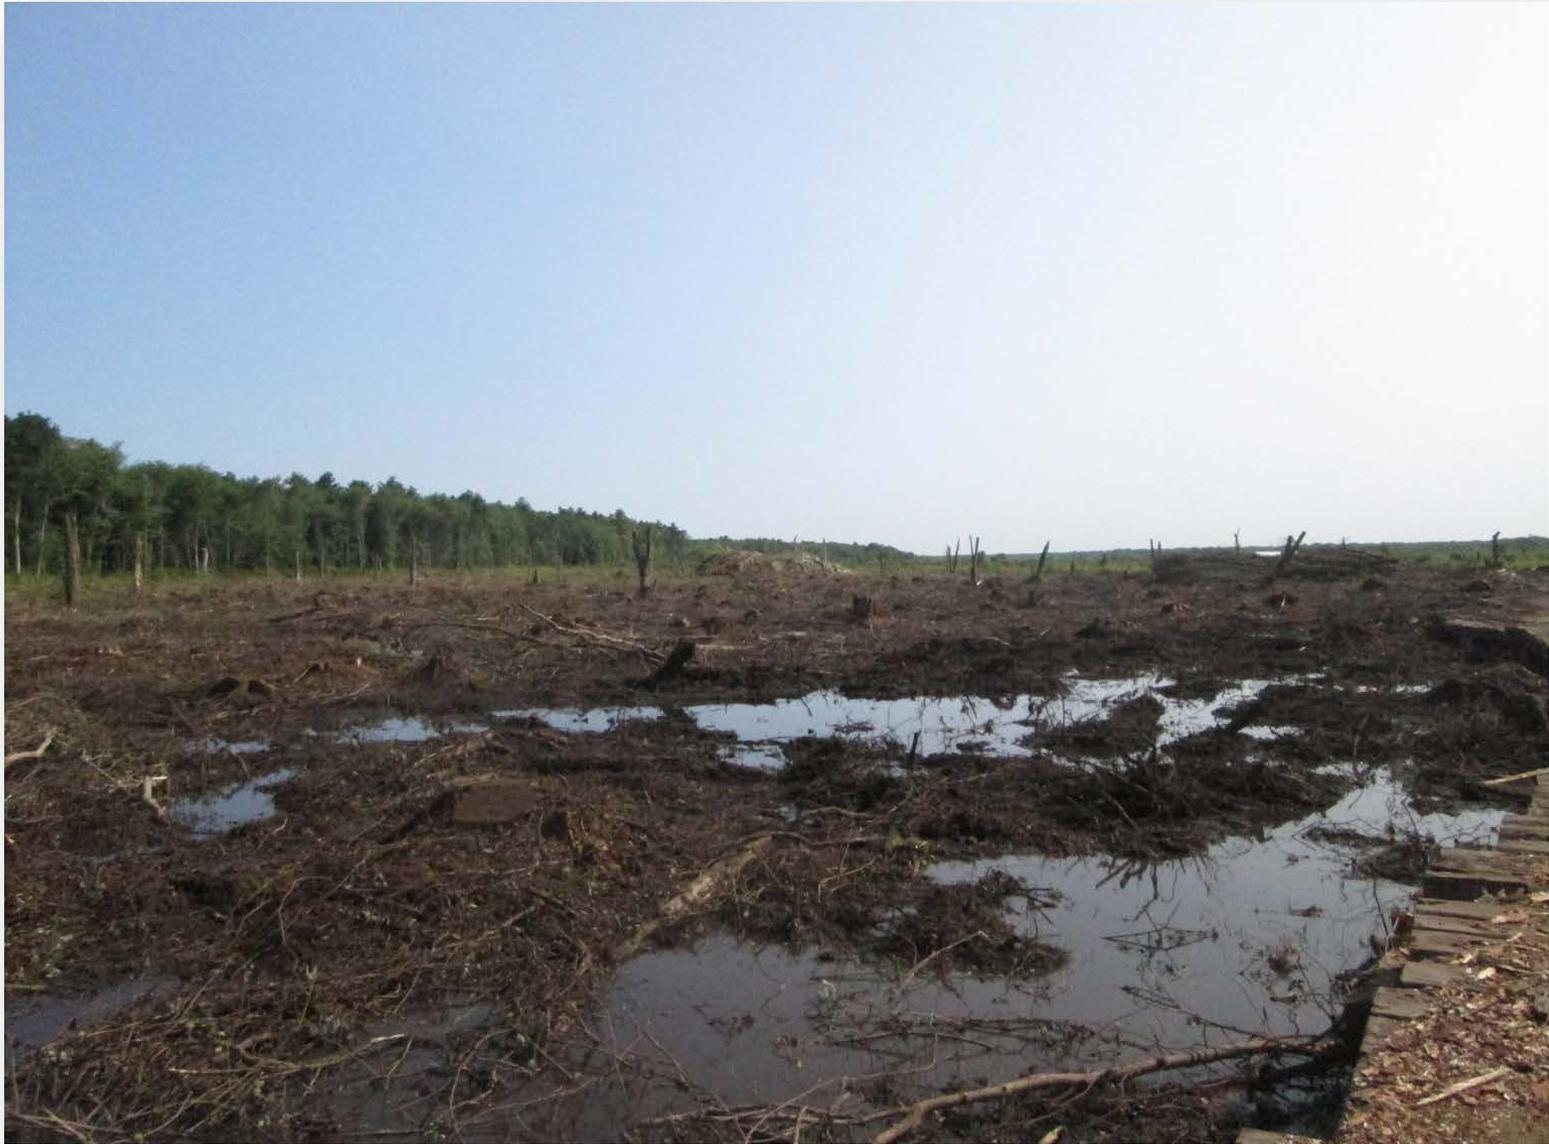
View of portion of tree clearing (note snags in the background).
