JM Fiske Environmental

NEW BEDFORD REGIONAL AIRPORT  
RUNWAY 5-23 – PHASE 4  
Reconstruct, Mark and Grove  
Partial Weekly Environmental Report  
WEEK 15  
August 2 to August 8, 2014

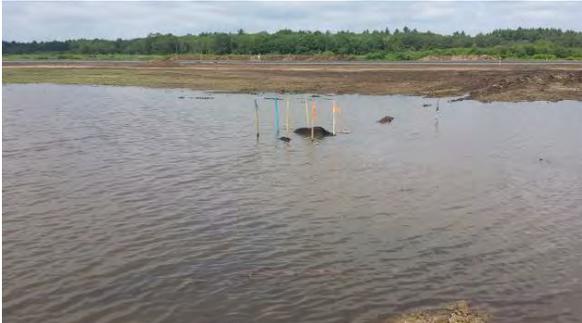
Turtle sweep conducted at 6:00AM in preparation for clearing operation	
Area between Taxiway A and RW5 flooded again due to rain over weekend.

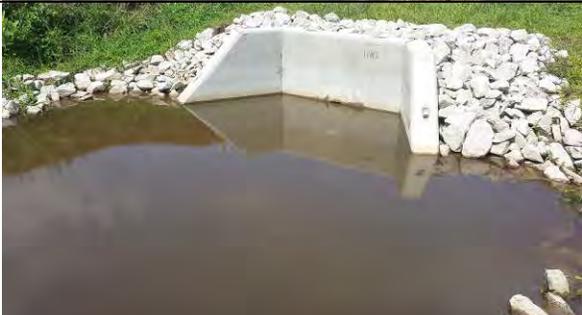
Outlet to CB 11 slightly cloudy. No turbid discharge observed beyond silt fence hay bale barrier..

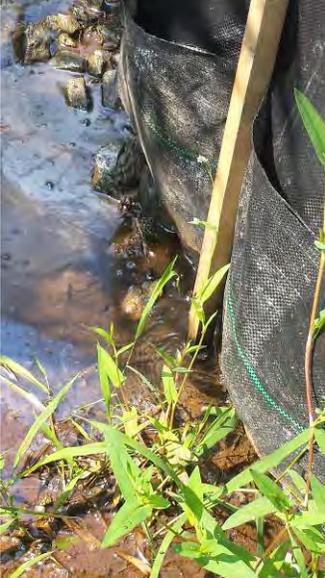
<p>Water at CB11 outfall on wetland side of fence. Water is clear. Sheen is from bacteria in water and not oil.</p>

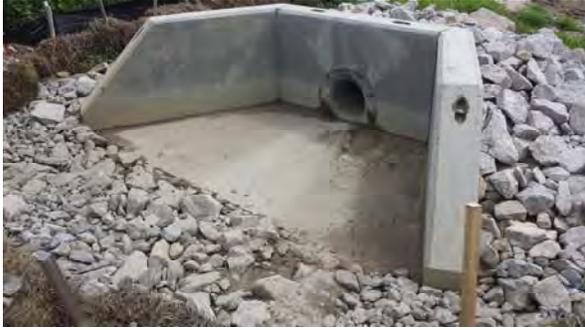
A photograph of a blue excavator with a large bucket attachment, working on a large pile of dark brown loam. The excavator is positioned on a dirt and gravel area, with a green field in the background under a cloudy sky.
<p>Cross culvert outfall. No water flowing on Monday. All silt fence and hay bales intact and secure.</p>

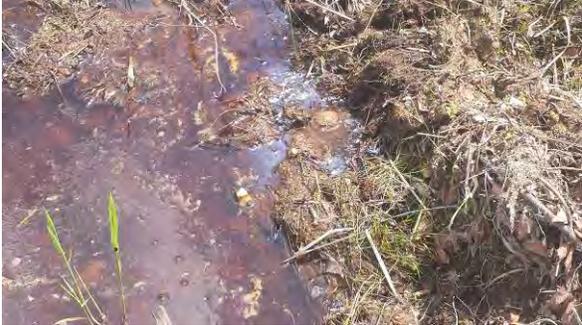
A photograph showing a long trailer loaded with numerous wooden mats or pallets, parked on a paved surface. The mats are stacked high and secured with straps.
<p>Resident engineer asked WS to investigate water quality on MLSAR fill area at end of RW23 MLSAR. Water was brown with tannins and had sheen from bacteria. No water quality issues observed.</p>

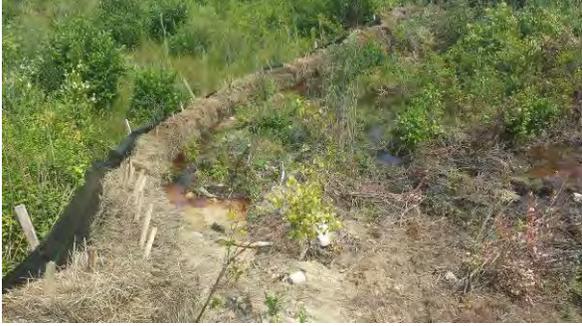
A close-up photograph of a ditch or stream. The water is a dark, murky brown color, indicating the presence of tannins. There is some debris and vegetation along the banks.
<p>Silt fence and hay bales along RW 23 MLSAR inspected. One hay bale out of position was re-installed.</p>

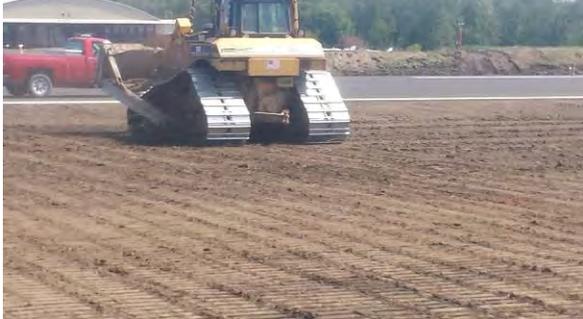
<p>Tracking of loam up and down slope along north side of RW5</p>

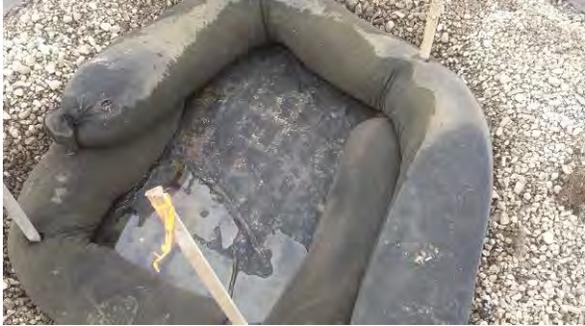
A wide-angle photograph of a construction site with a large, flat, dry area of earth and some small puddles, bordered by green grass.
<p>CB 11 remains protected by stone, filter sock and fabric cover. Very slow trickle observed entering basin.</p>

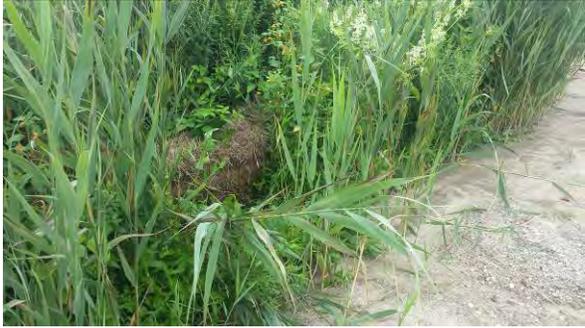
<p>Silt fence and hay bales along south side of Taxiway A (RW5 end) in place but covered up by growth of vegetation</p>

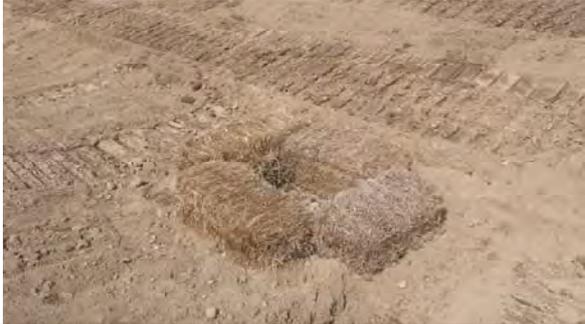
A photograph showing a silt fence and hay bales that have been almost completely obscured by tall, green grasses and other vegetation growing along the edge of a gravel area.
<p>Catch basin protection in swale on north side of RW23 in place. Catch basins closed to storm water. Asked ETL to install stakes on hay bales.</p>

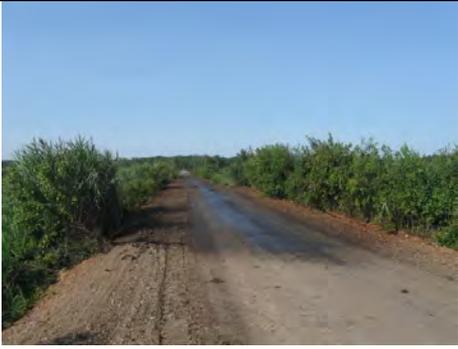
<p>ITS Road: The biomass chips used as a bmp at the edge of the road have worked well – these chips have prevented any soil from reaching the wetlands. Due to the continued twitching of the tree tops, this bmp has been compromised. A new row of chips needs to be re-established to provide maximum protection to the adjacent wetlands. .</p>

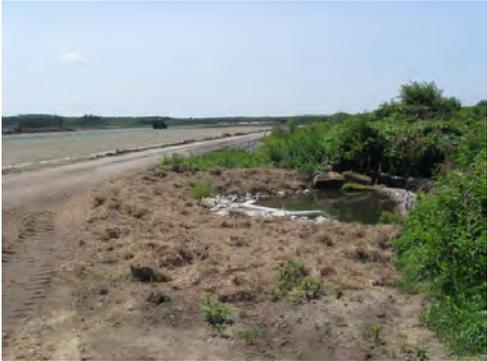
<p>Headwall 1 at edge of Access Road: The area at the outlet was seeded and mulched last Friday. The mulch square footage was extended and covered with a thicker layer of mulch today. The clarity of outflow was excellent.</p>

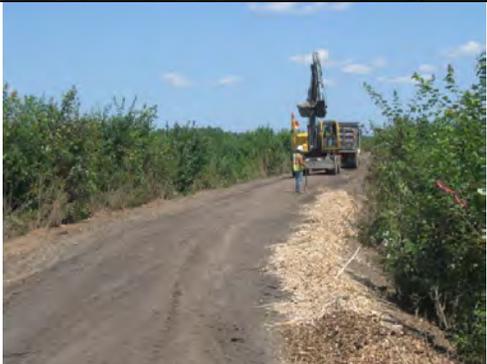
<p>ITS Road (the most southern end) looking north: ETL reinforces the chip bmp on the southside of this road.</p>

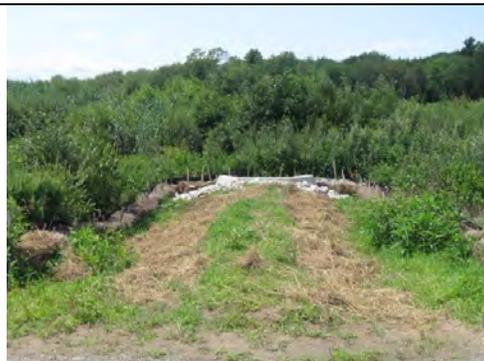
Headwall 2 - adjacent the Access Road: An area of exposed soils between the headwall and access road was mulched with hay.
