**New Bedford Regional Airport
Runway Safety Improvements Project – Phase 4
Reconstruct, Mark, and Groove Runway 5-23
MassDEP File No. SE049-0635**

ENVIRONMENTAL MONITOR INSPECTION FORM

Date/ Time of Inspections: **8/14/14 (morning), 8/19/14 (morning), 8/21/14 (morning).**

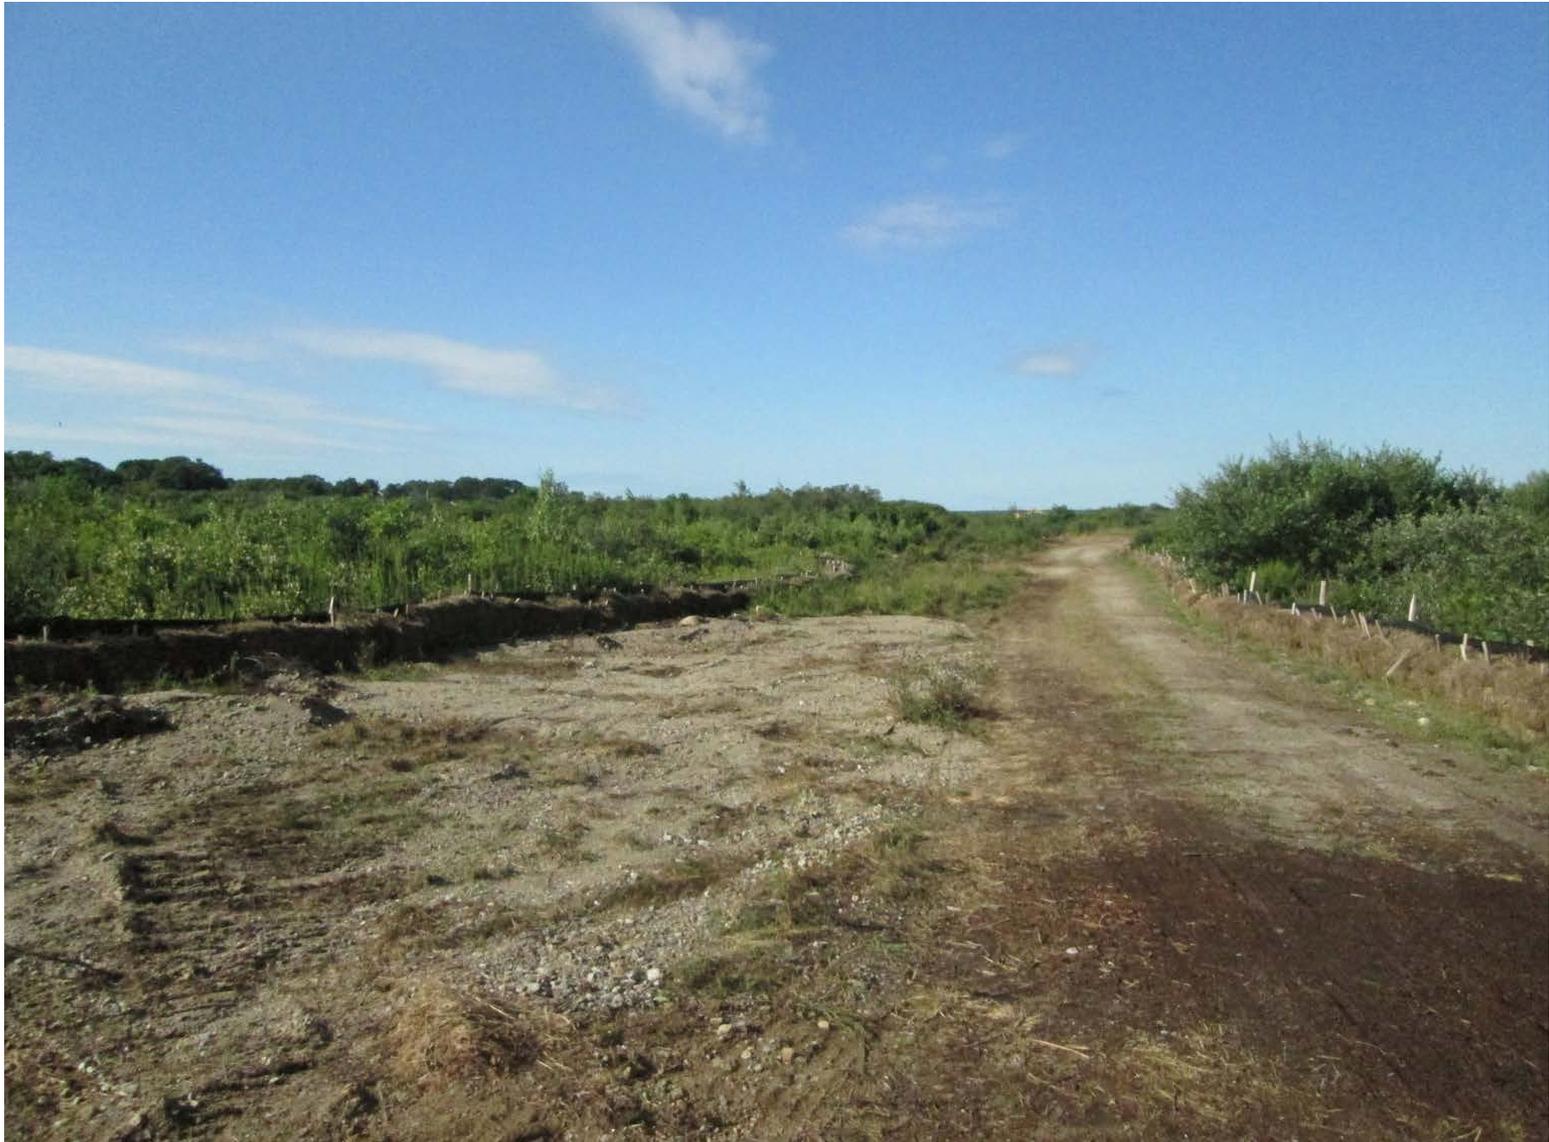
Erosion controls at Area 5, north of New Plainville Road.

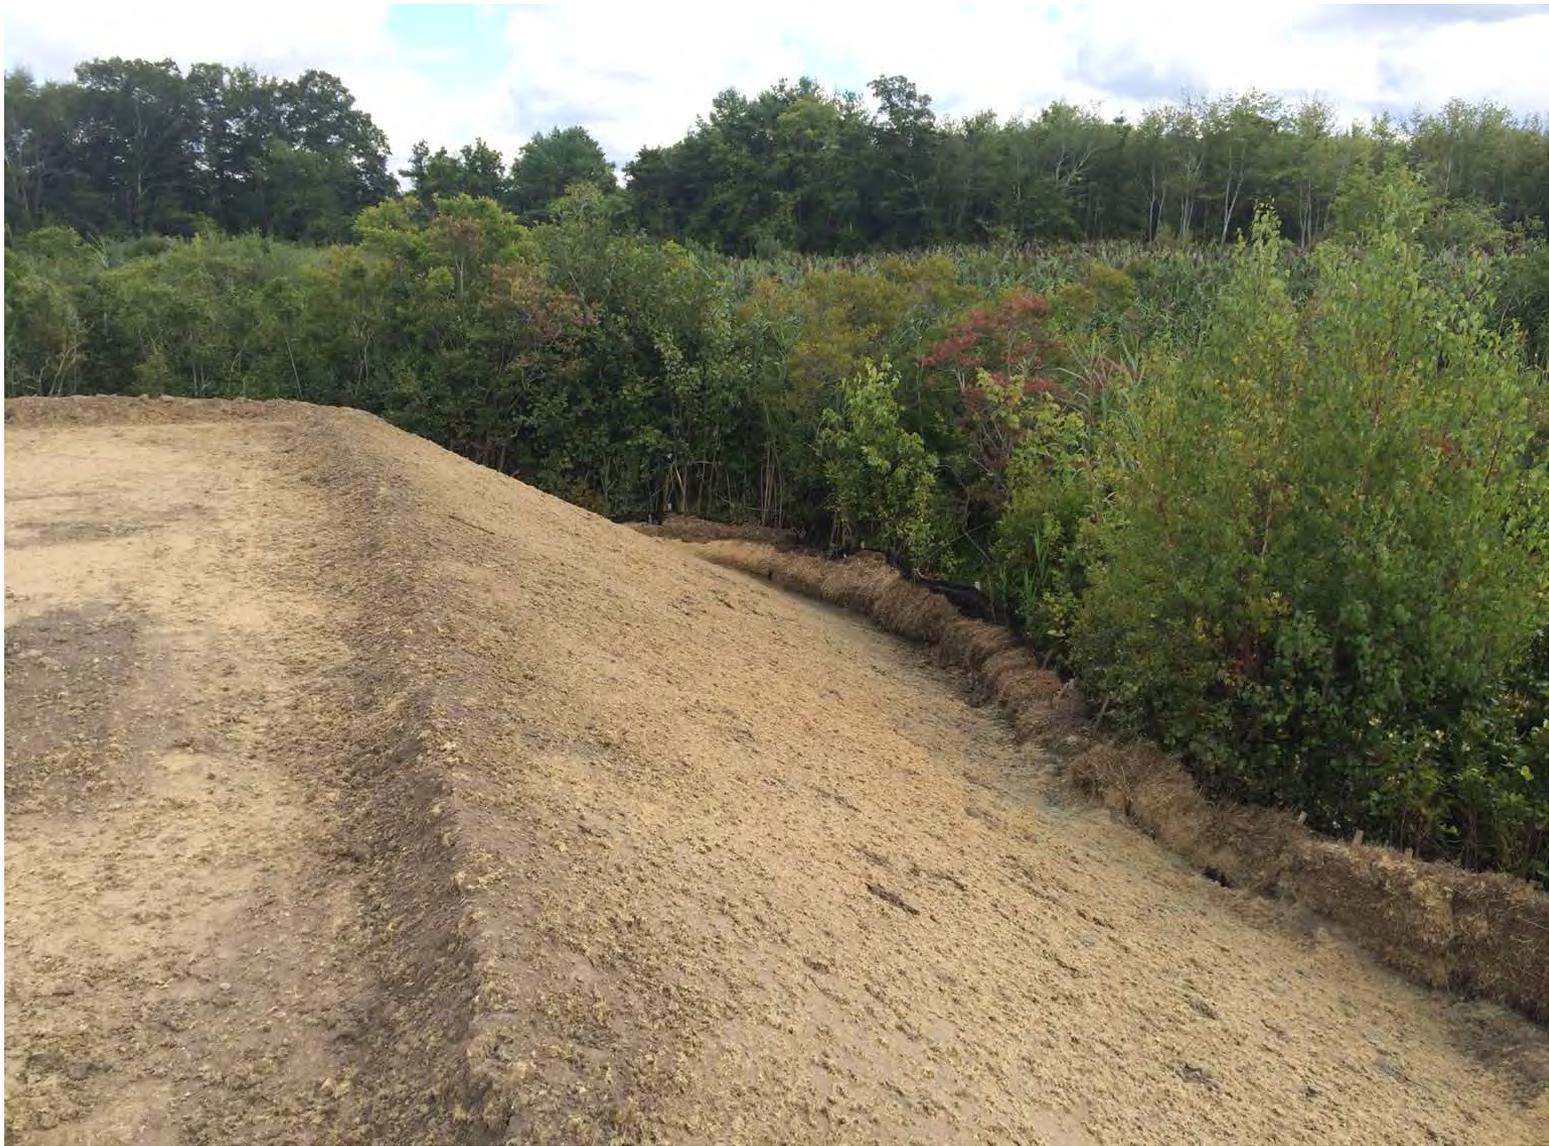
View of MALSR fill area, last light pole for Runway 23 end, north of New Plainville Road.

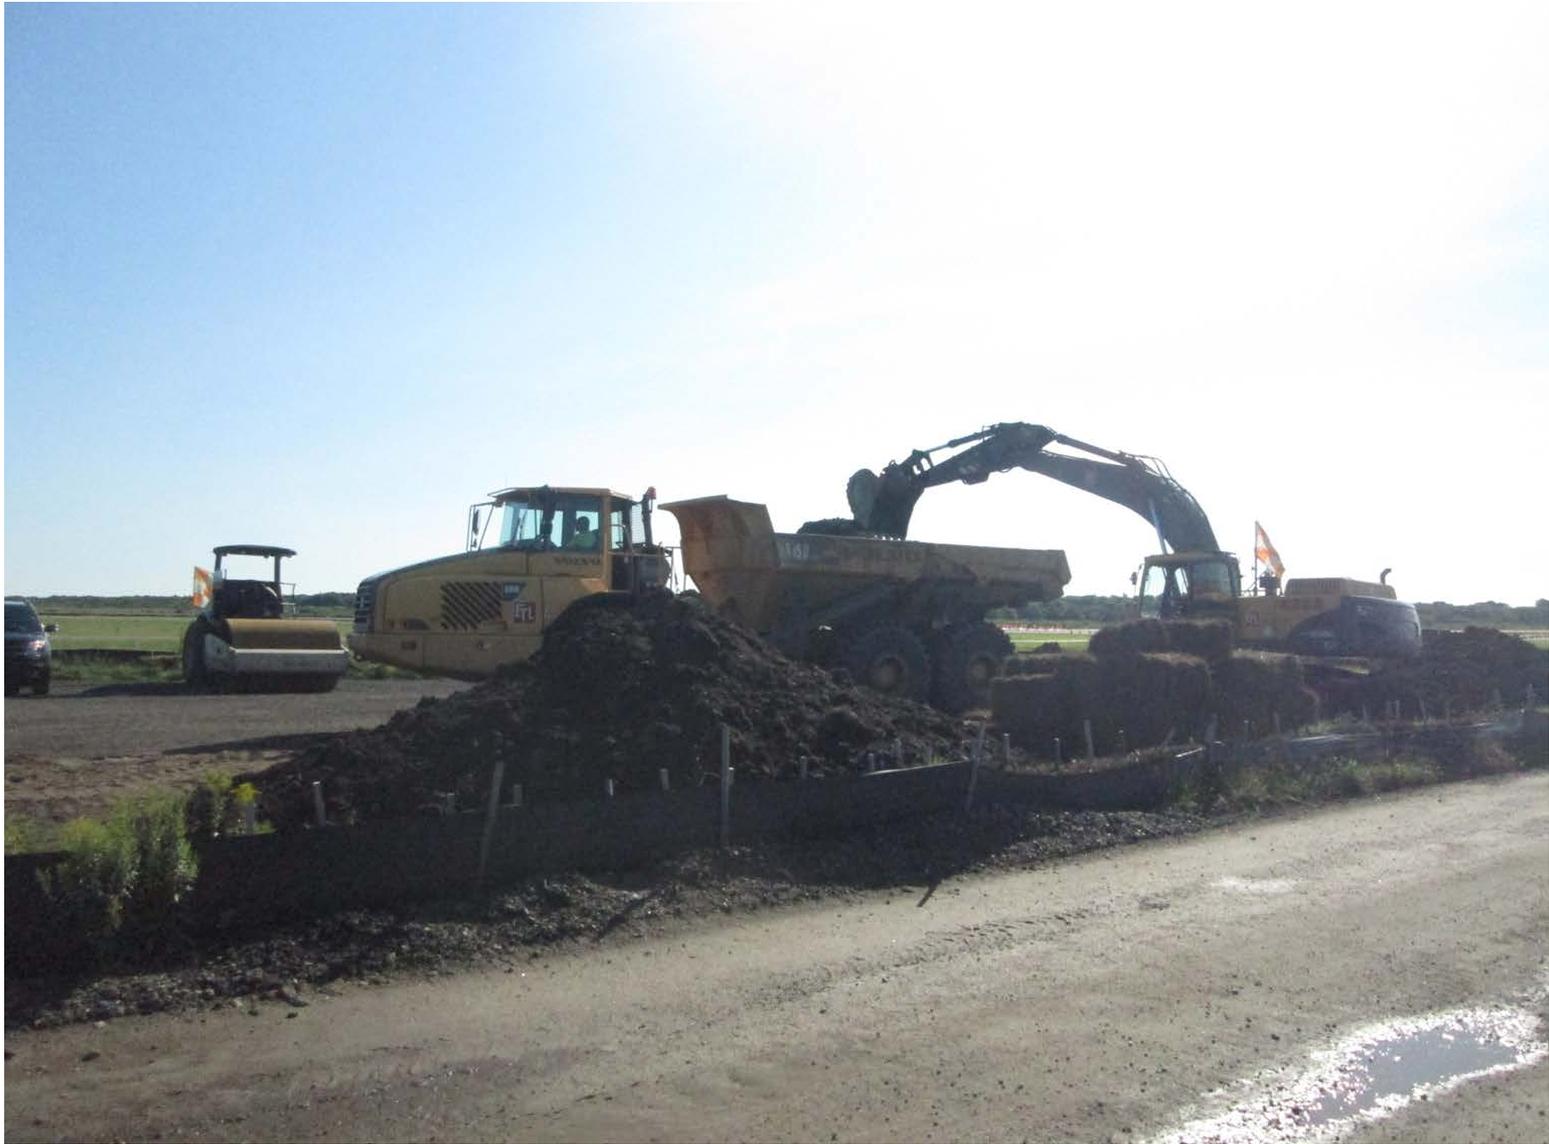
View of soil stockpiles within the contractor laydown area.

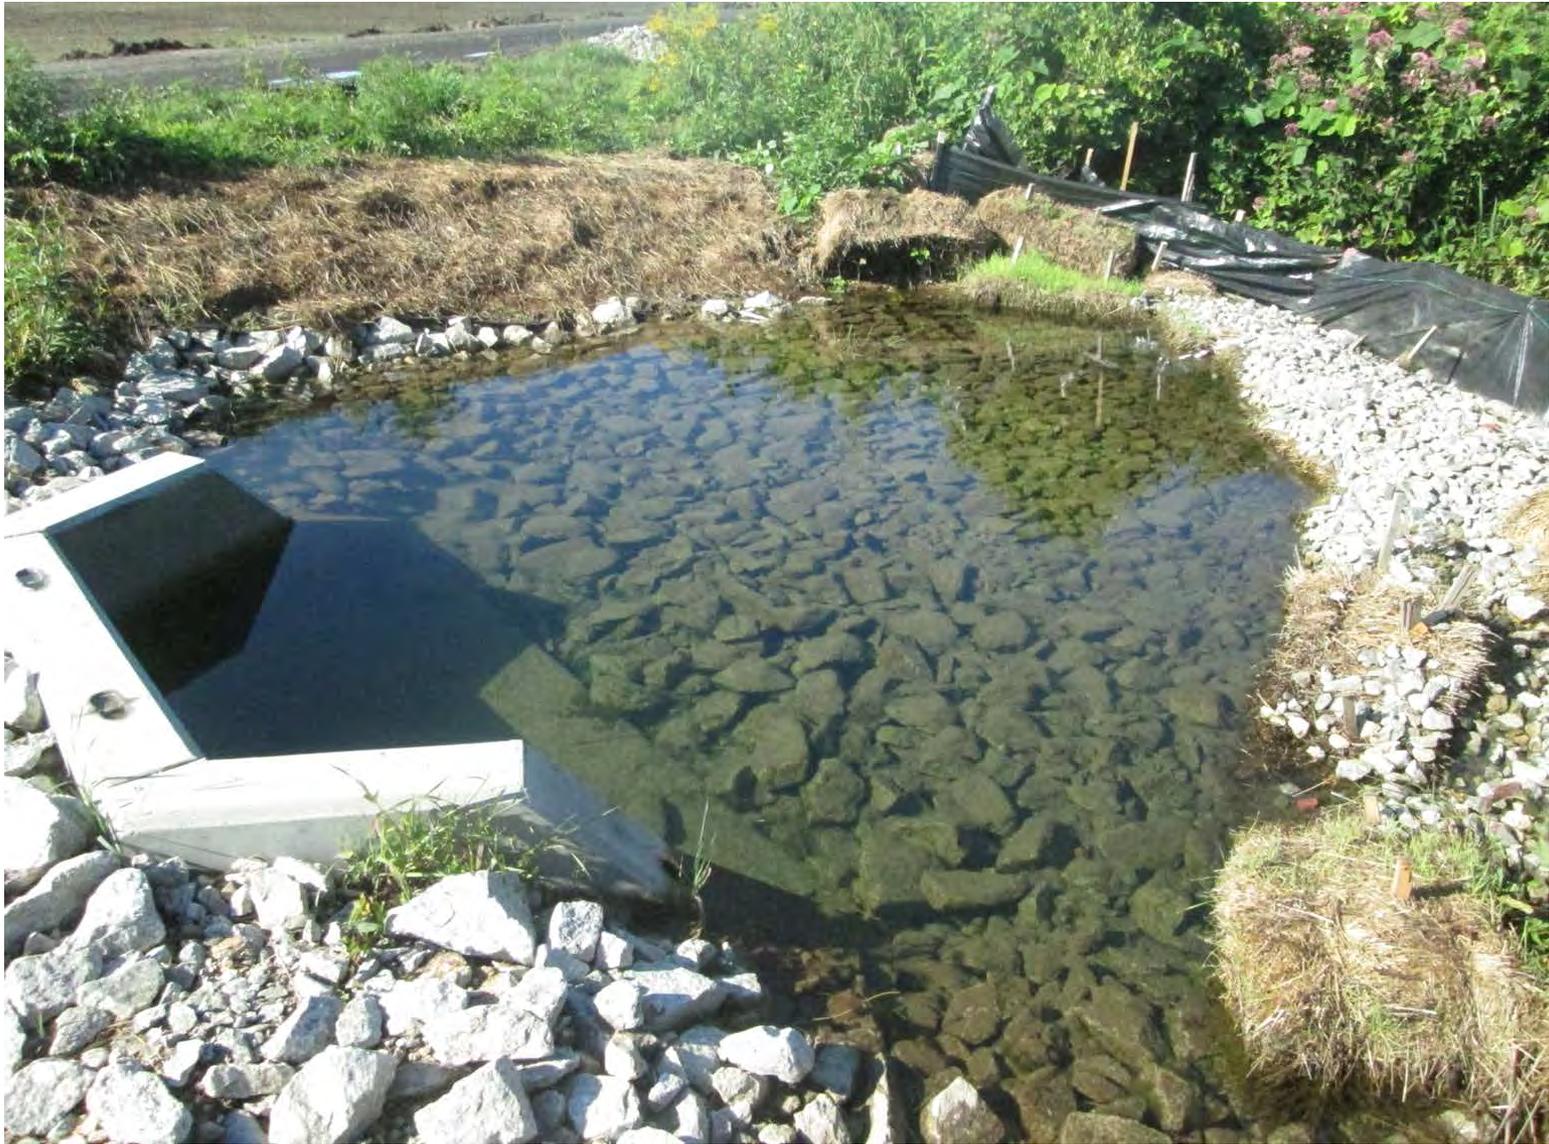
View of headwall outfall from Catch Basin 1, water at this catch basin has been clear. Photo taken on 8/14/14 after 0.5 inch rain event.

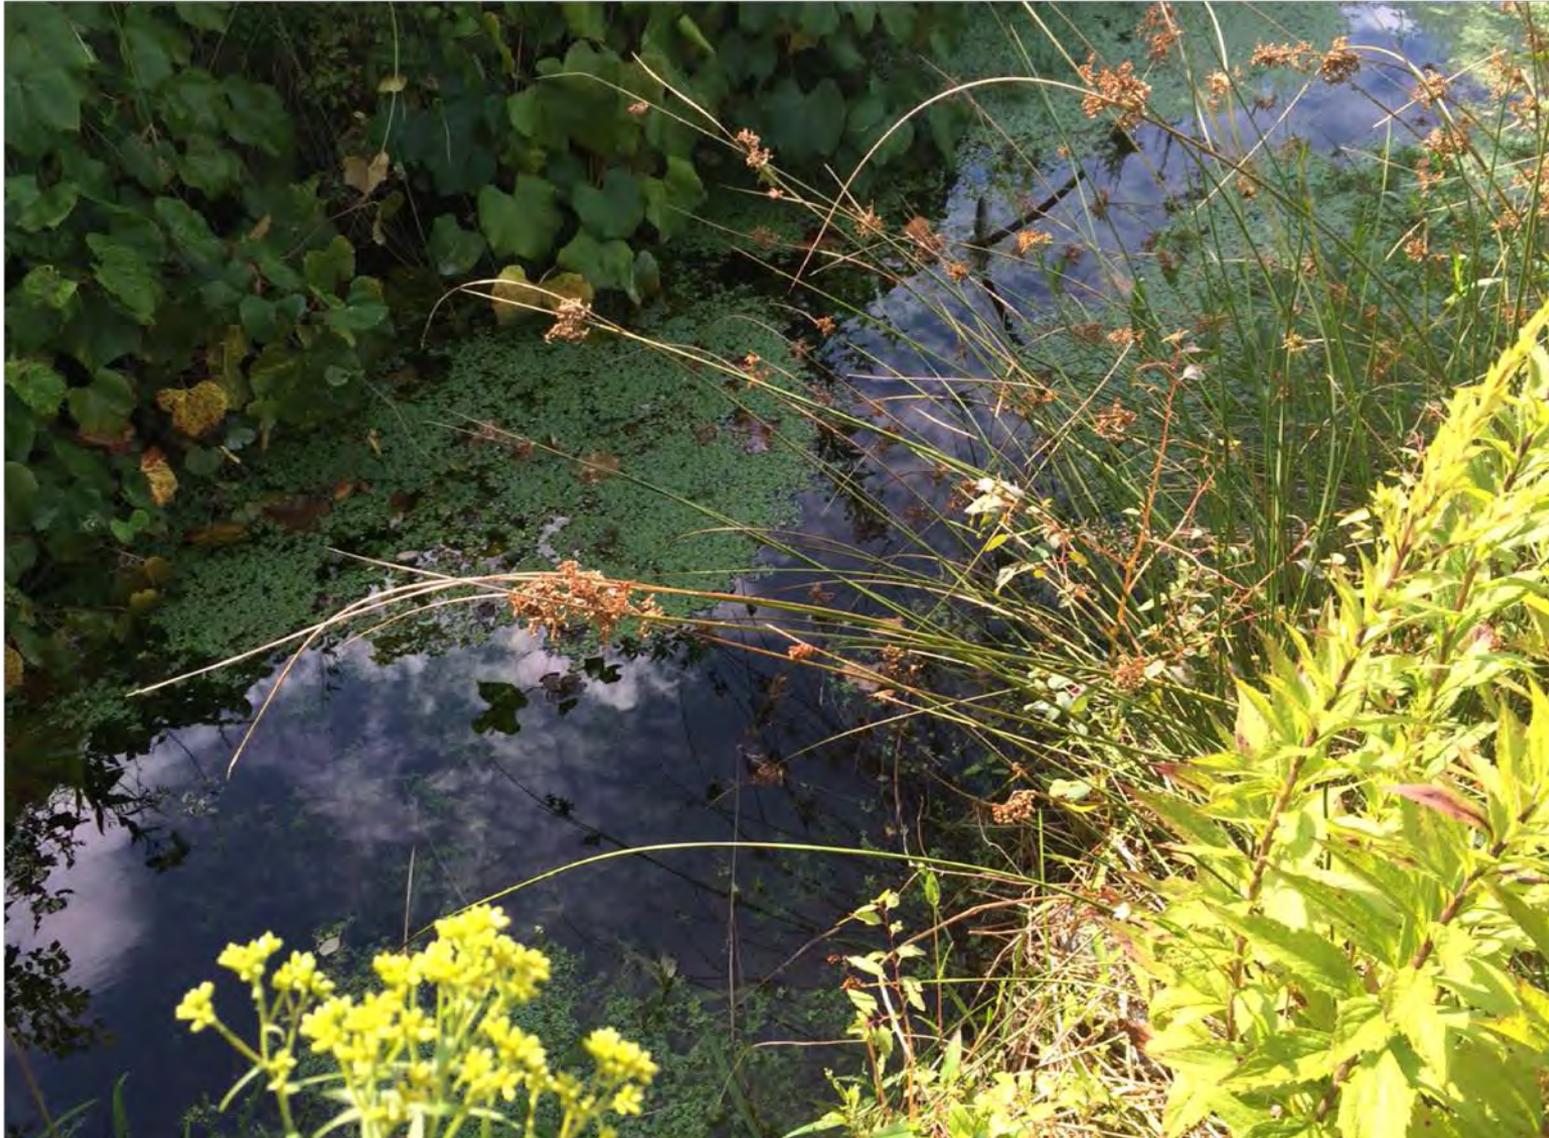
View of water down gradient from headwall (CB#1) in west ditch.

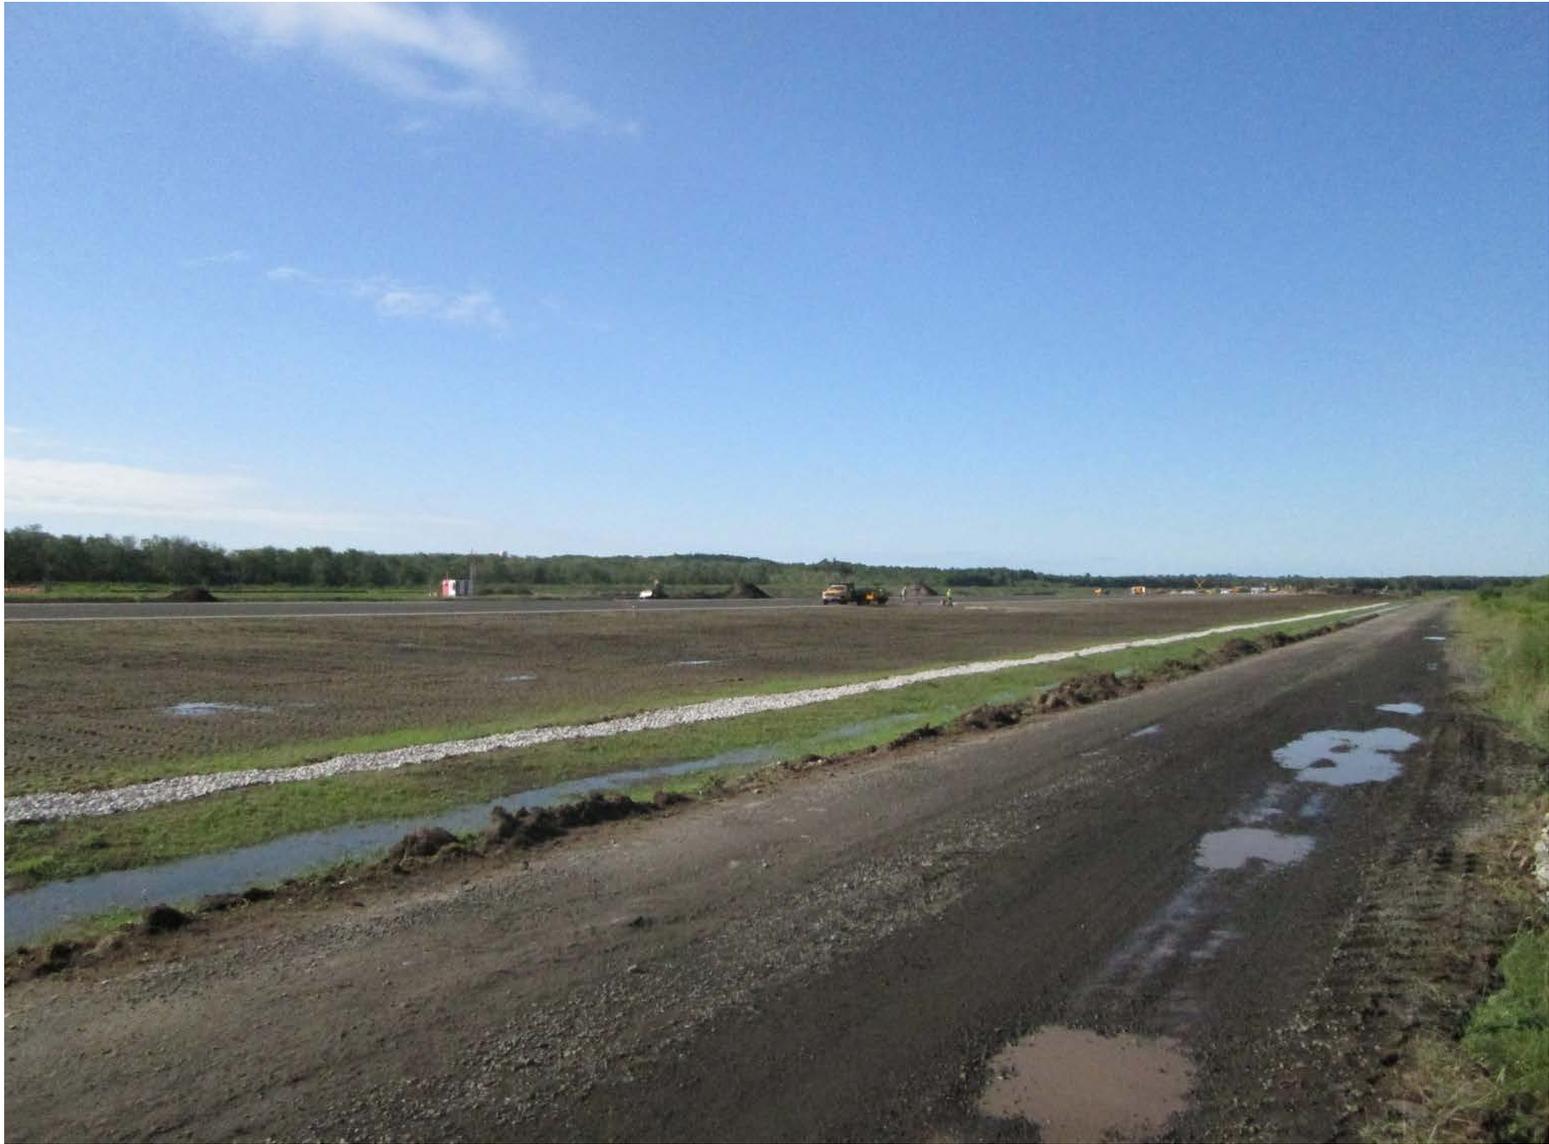
View of infiltration trench and west side of Runway after rain event.

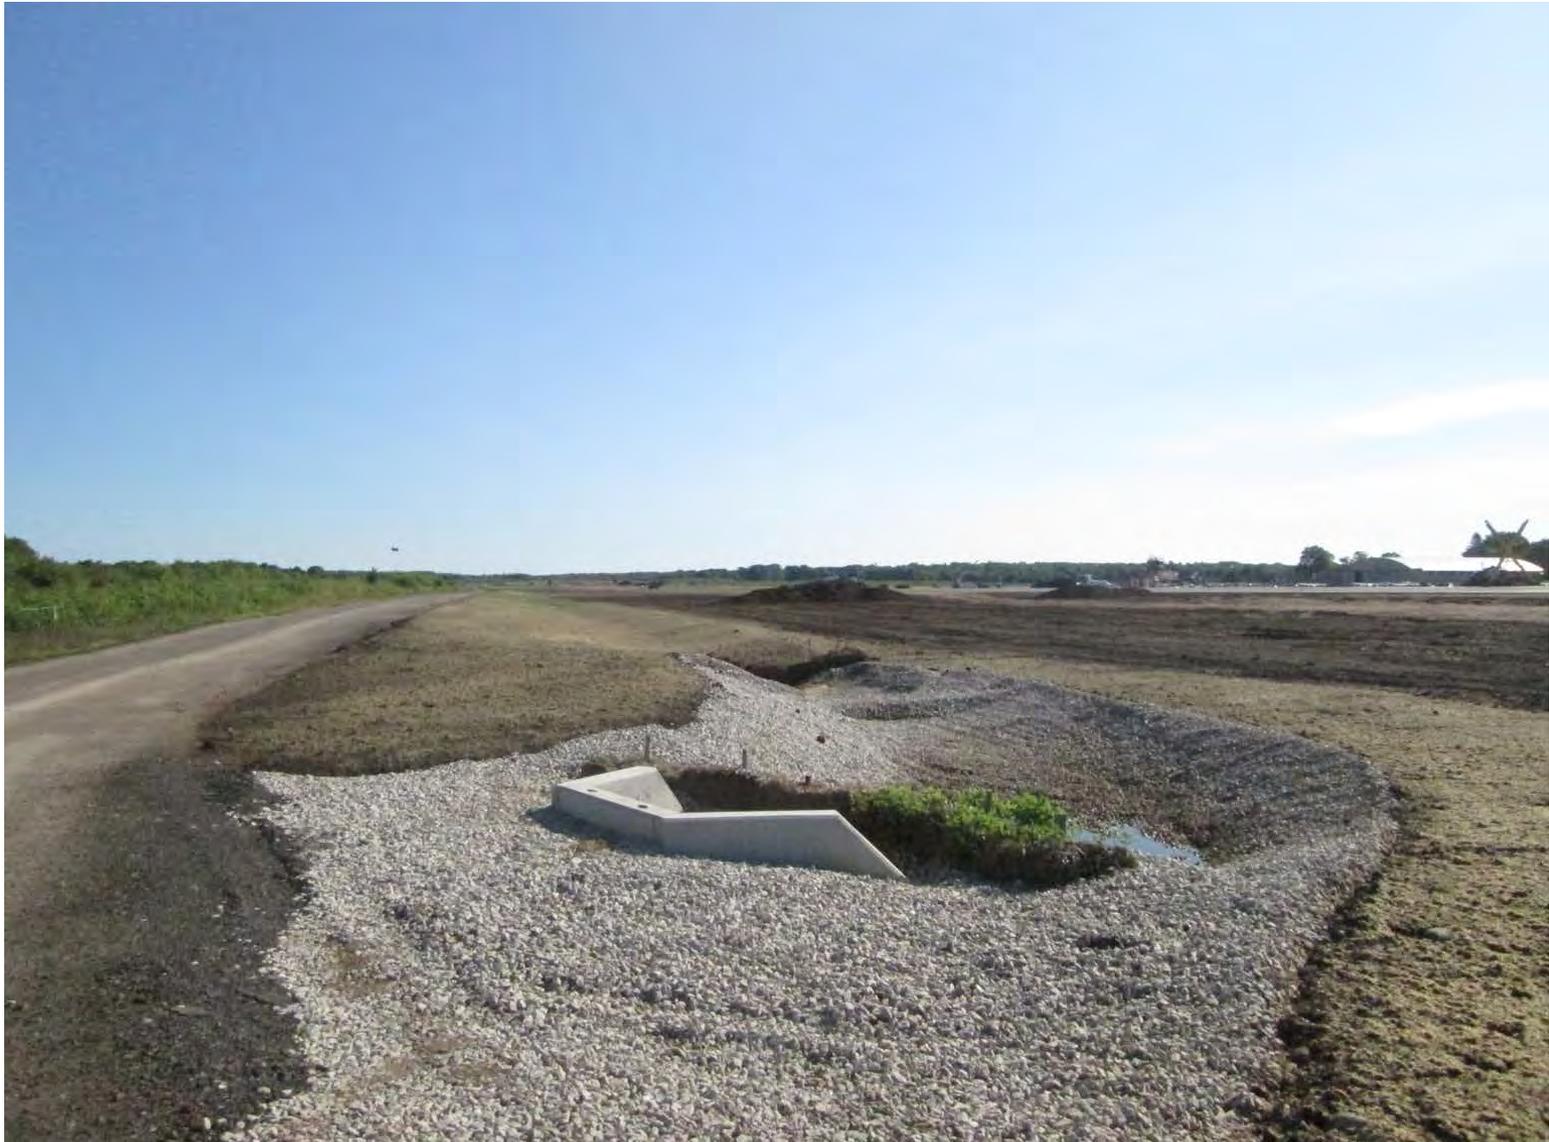
View of infiltration trench after rain event.

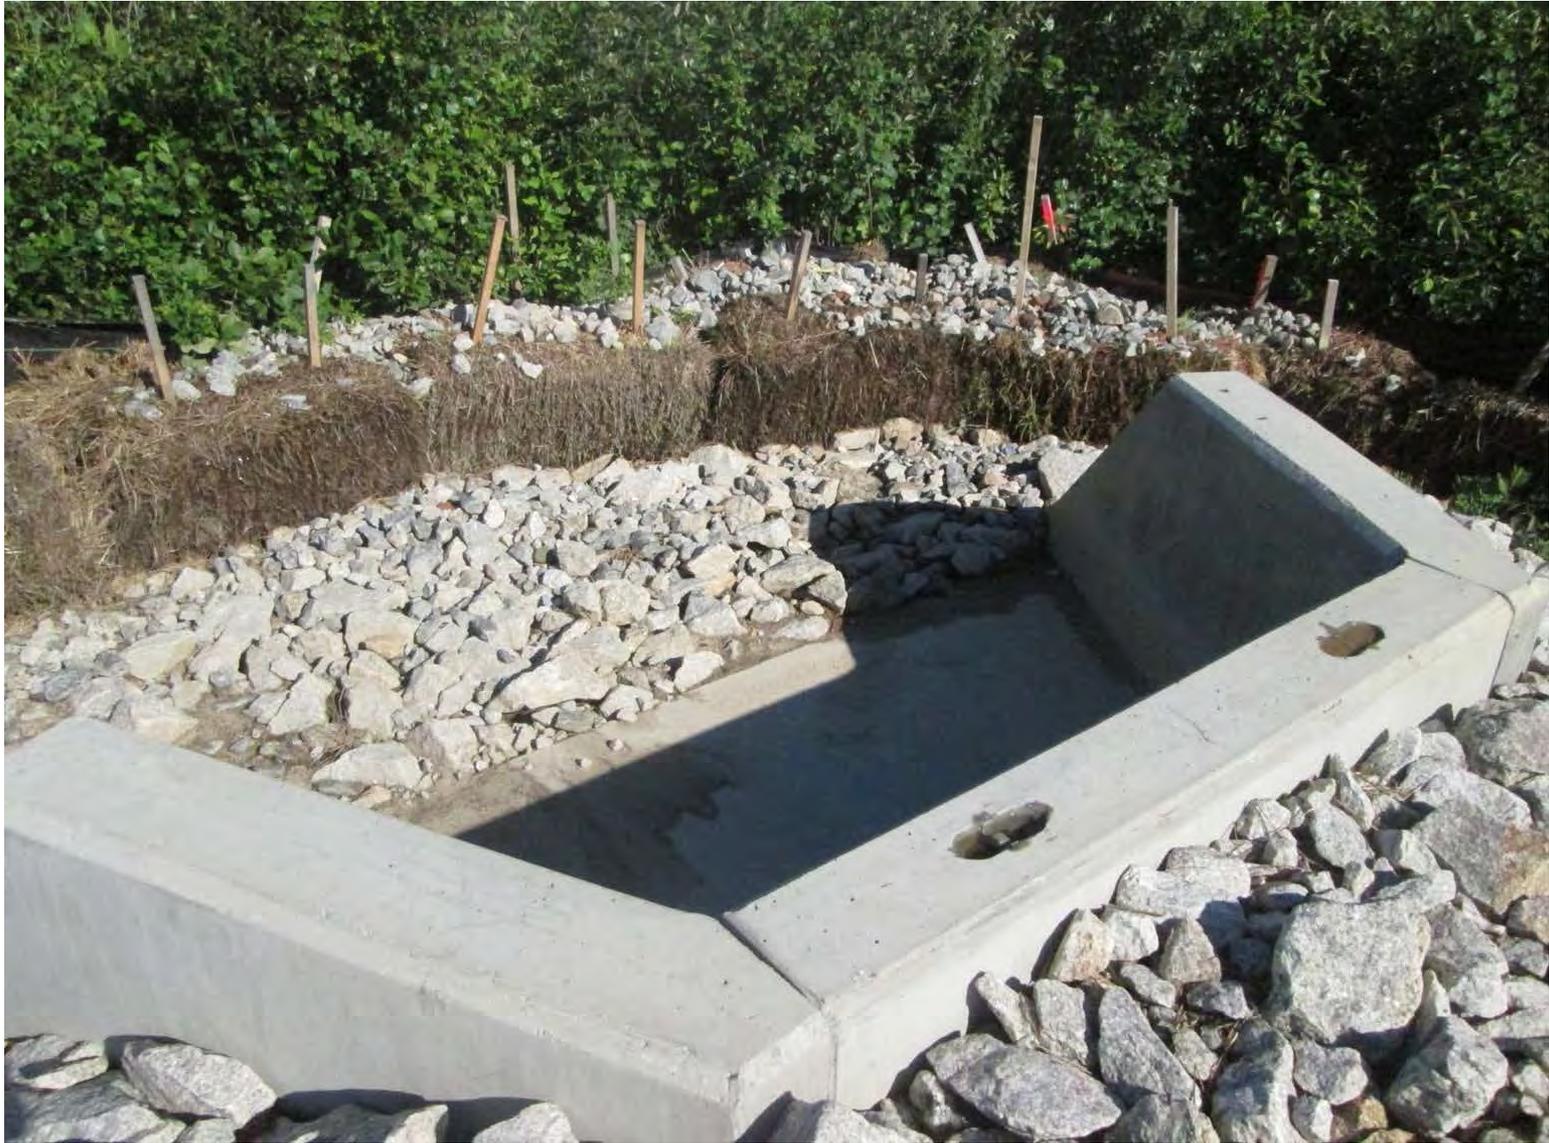
View of southern headwall from infiltration trench. No water has been observed in this headwall in the past two weeks.

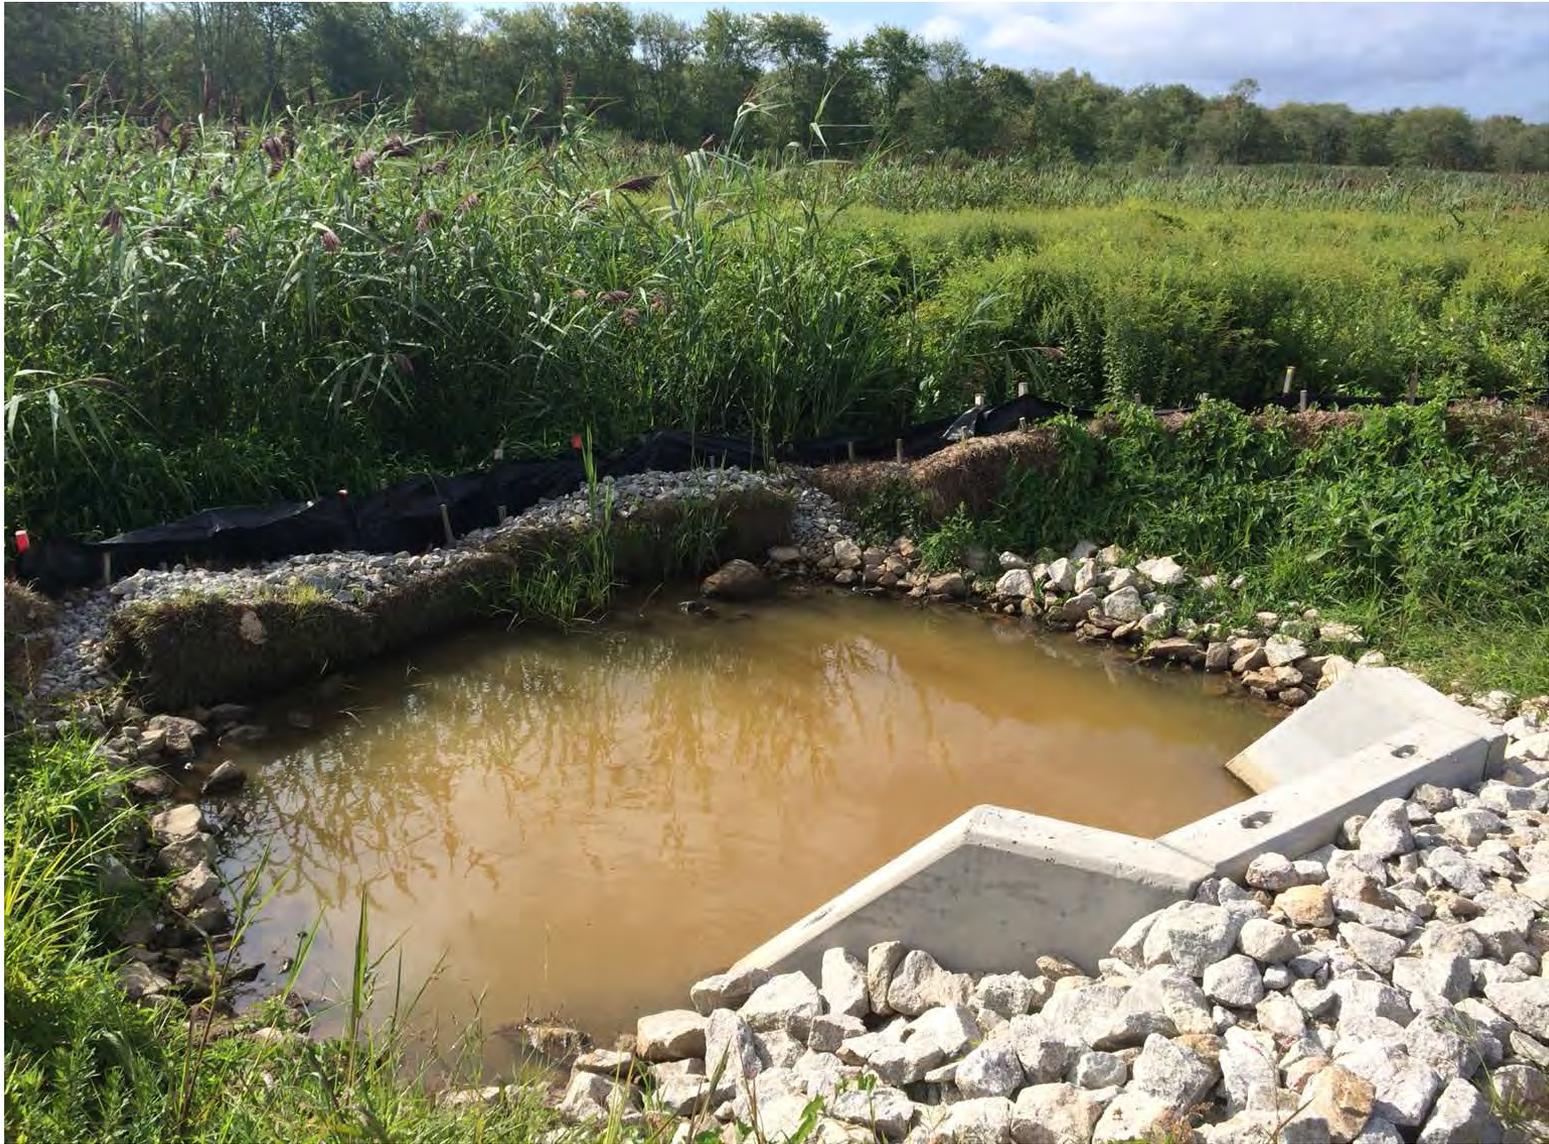
View of headwall leading from Catch Basin 11. This catch basin has been closed off for weeks, no change in water turbidity.

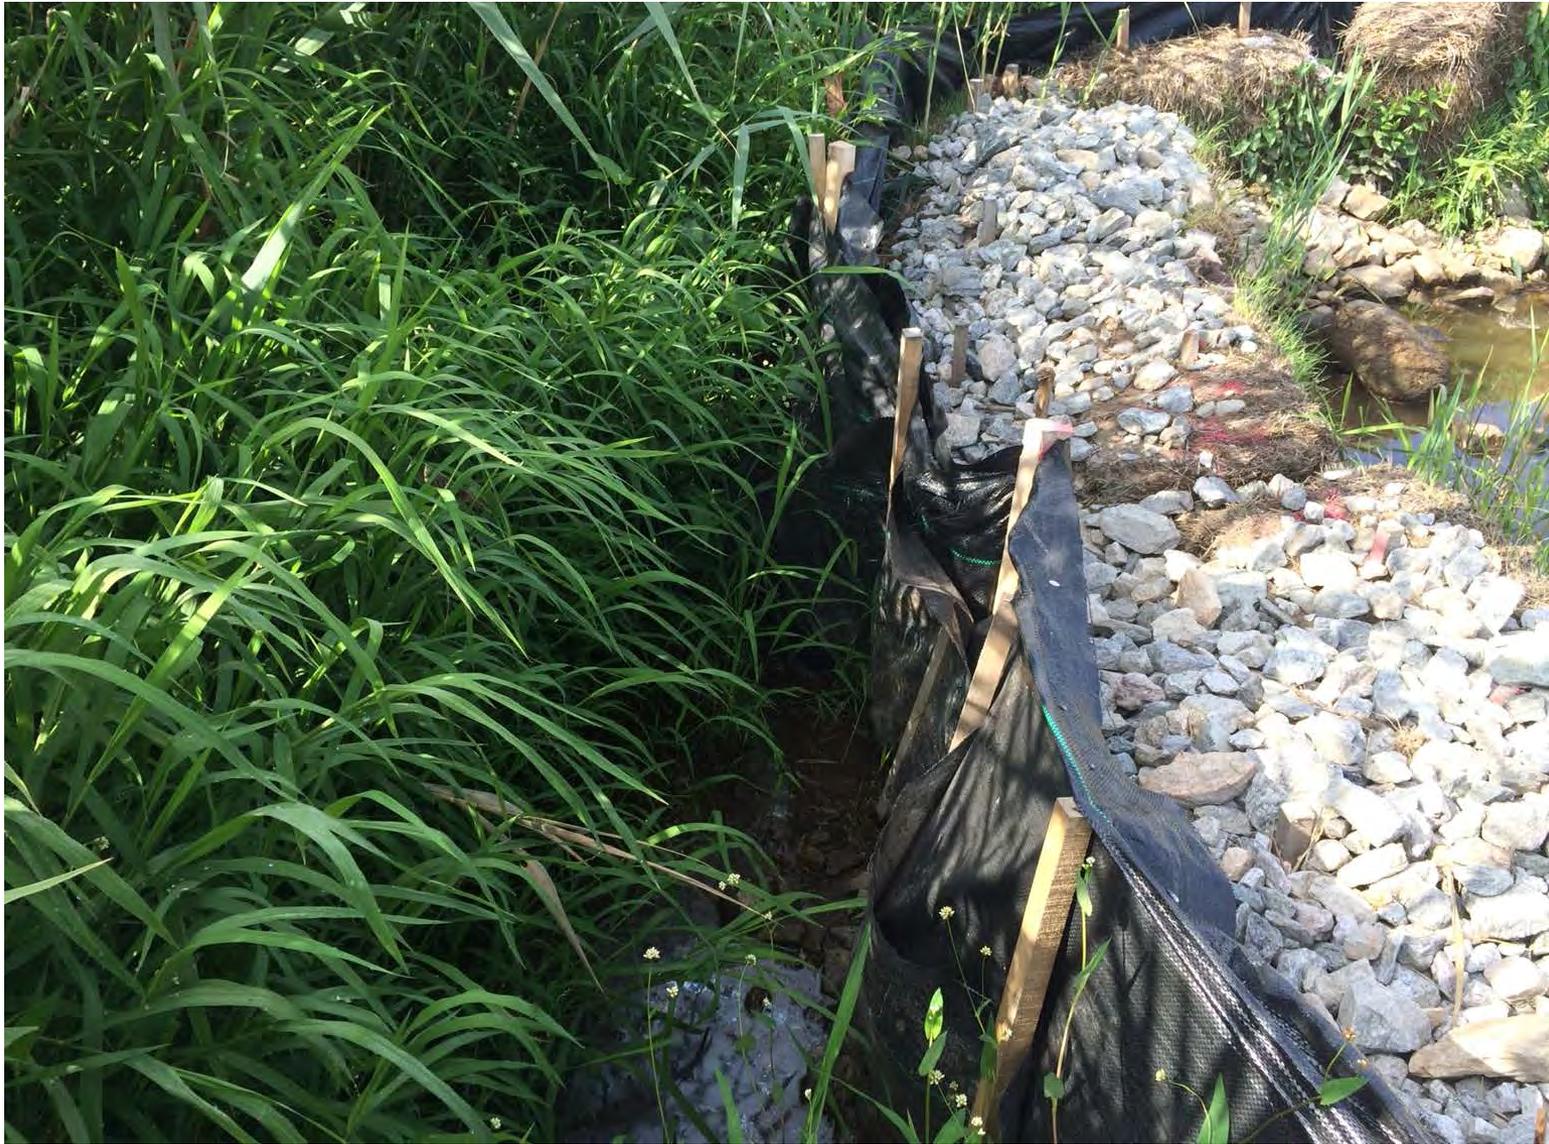
View of water downgradient of CB11 headwall. No appreciable sediment has accumulated.

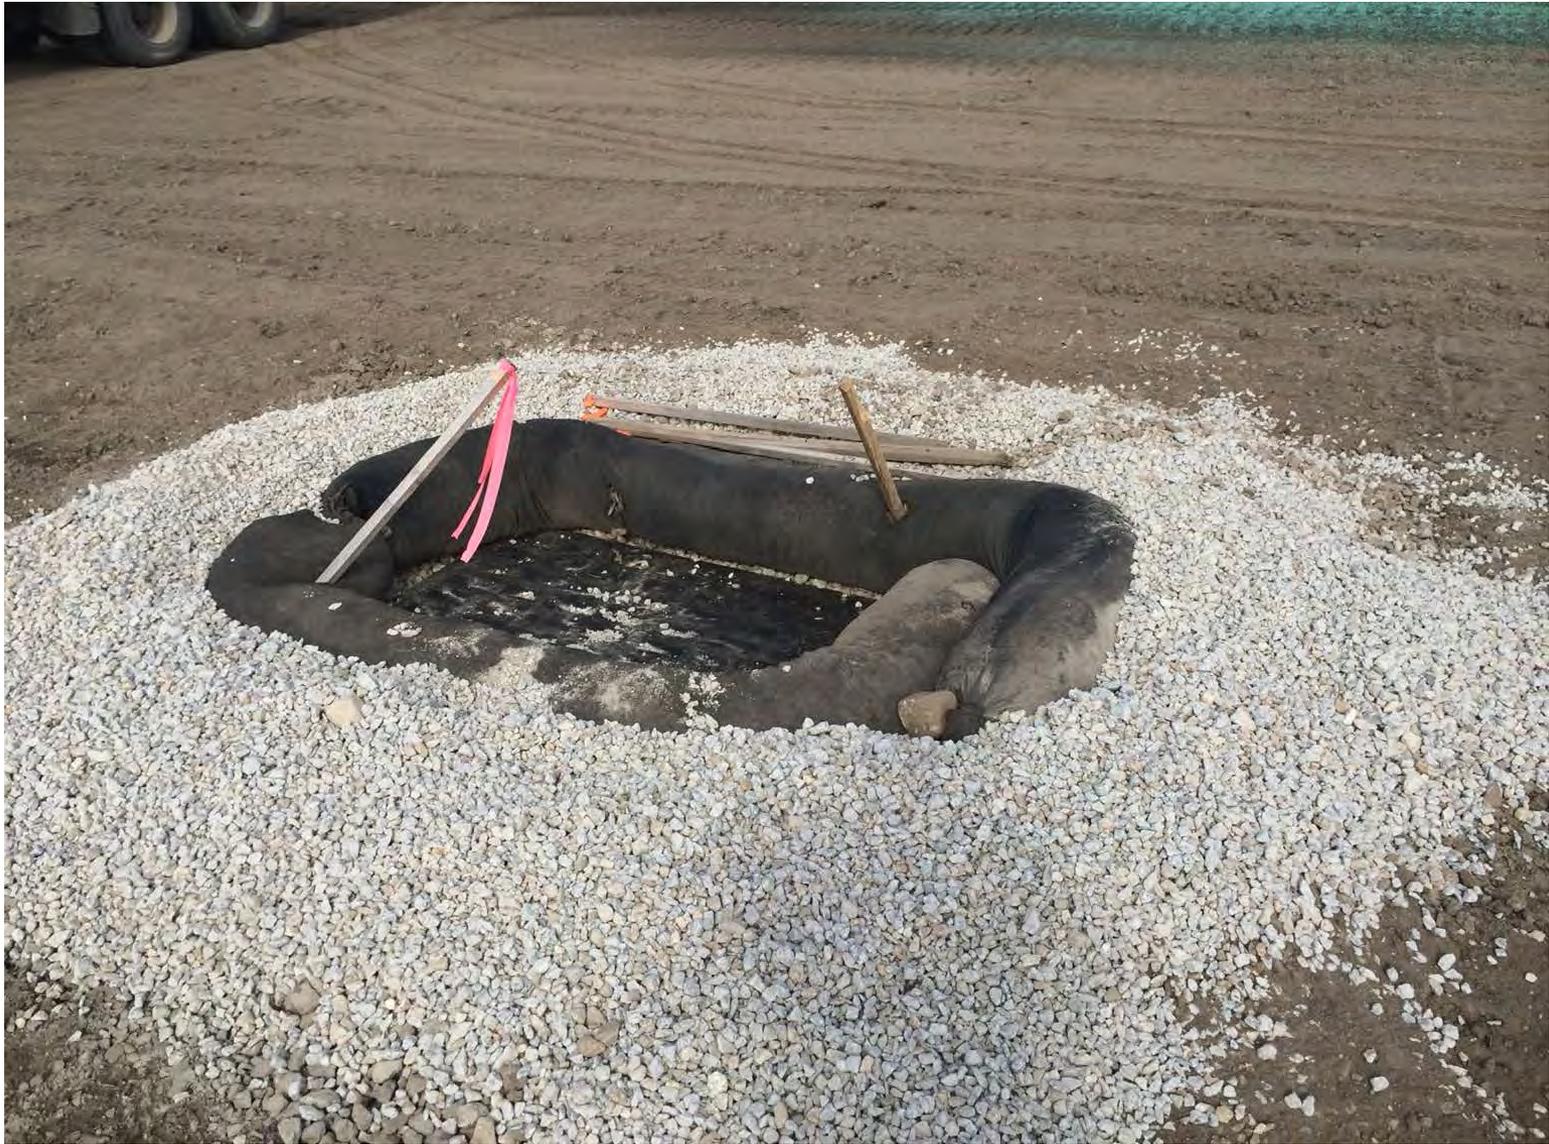
This catch basin 11 has been taken off line. Erosion controls are in good condition.

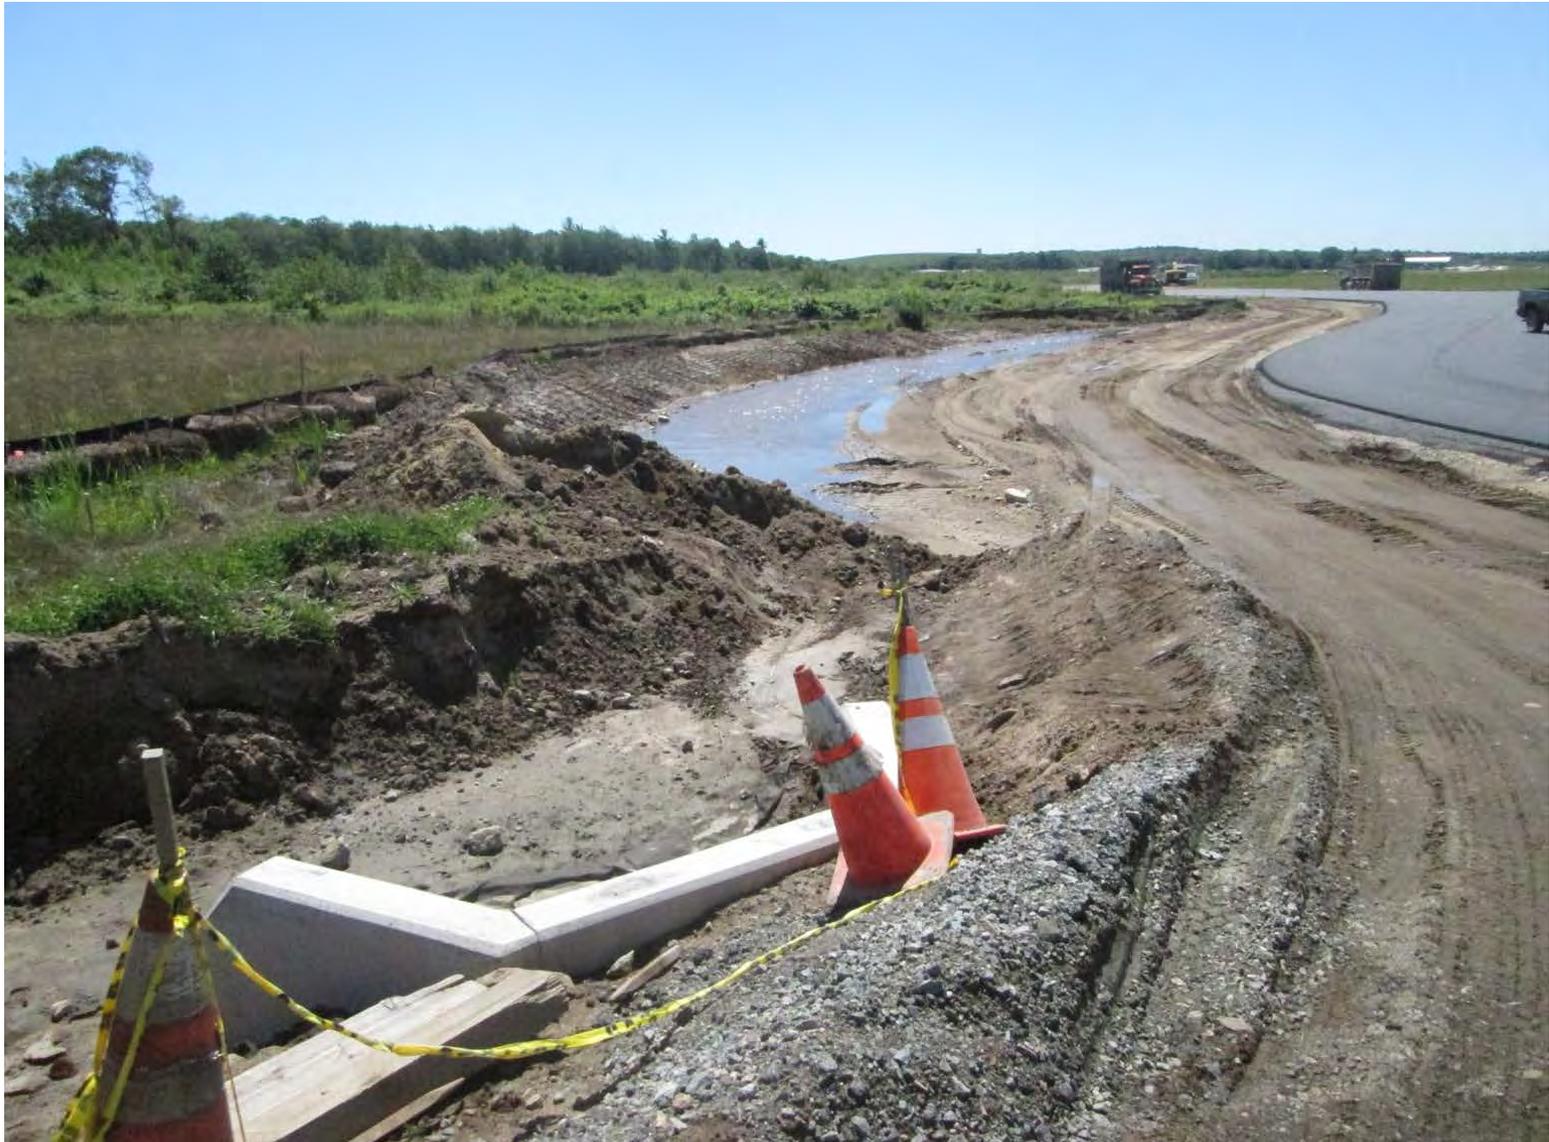
View of Runway 23 end interim condition.

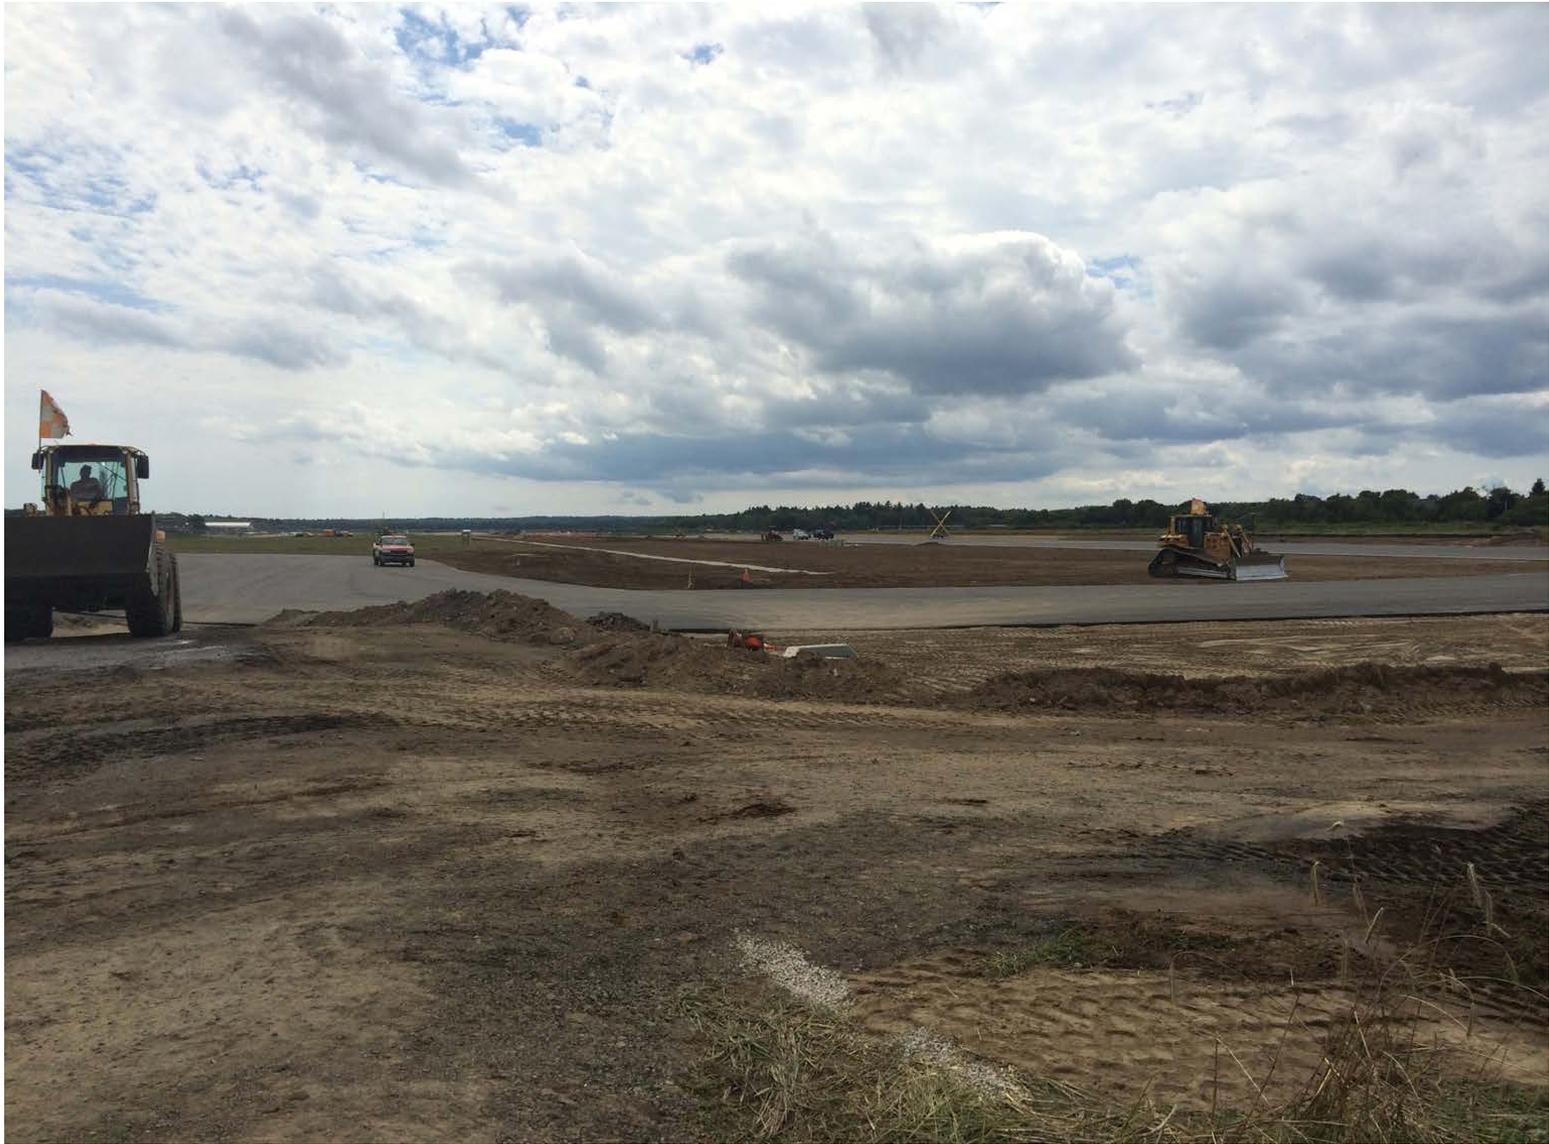
View of paving operations at Runway 23 end.
