**New Bedford Regional Airport
Runway Safety Improvements Project – Phase 4
Reconstruct, Mark, and Groove Runway 5-23
MassDEP File No. SE049-0635**

ENVIRONMENTAL MONITOR INSPECTION FORM

Date/ Time of Inspections: **8/14/14 (morning), 8/19/14 (morning), 8/21/14 (morning).**

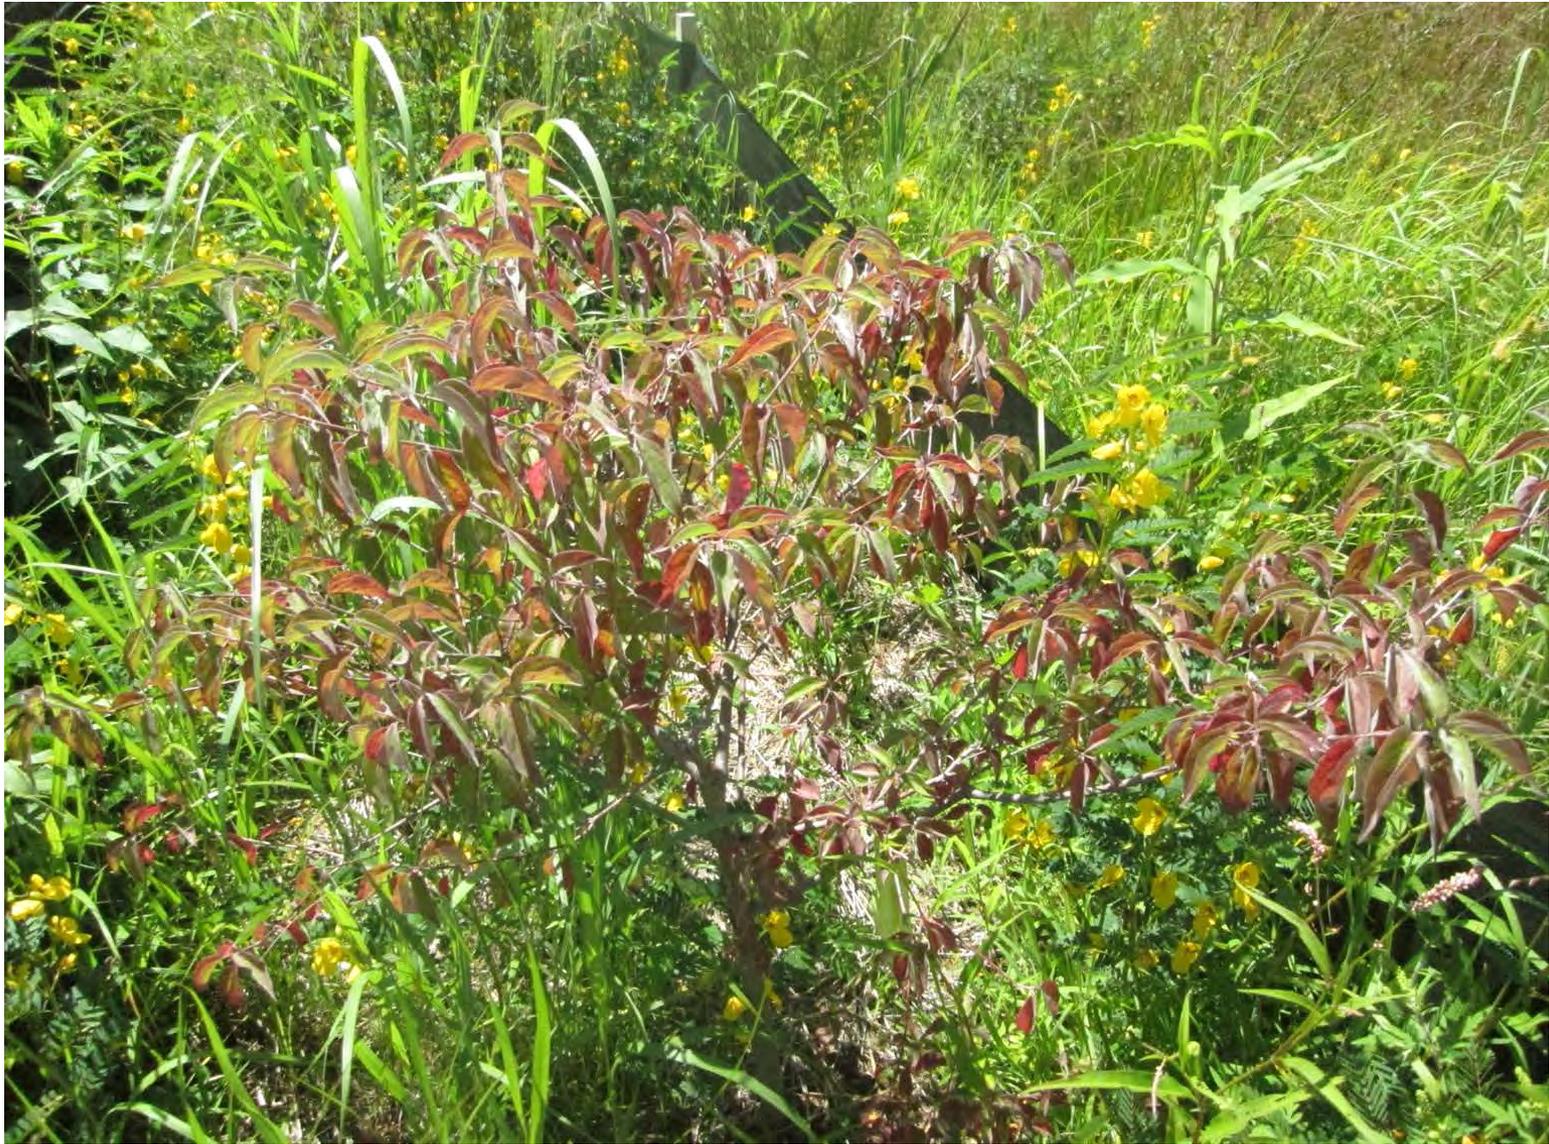
View of stressed dogwood previously reinstalled by site contractor in west ditch restoration area.

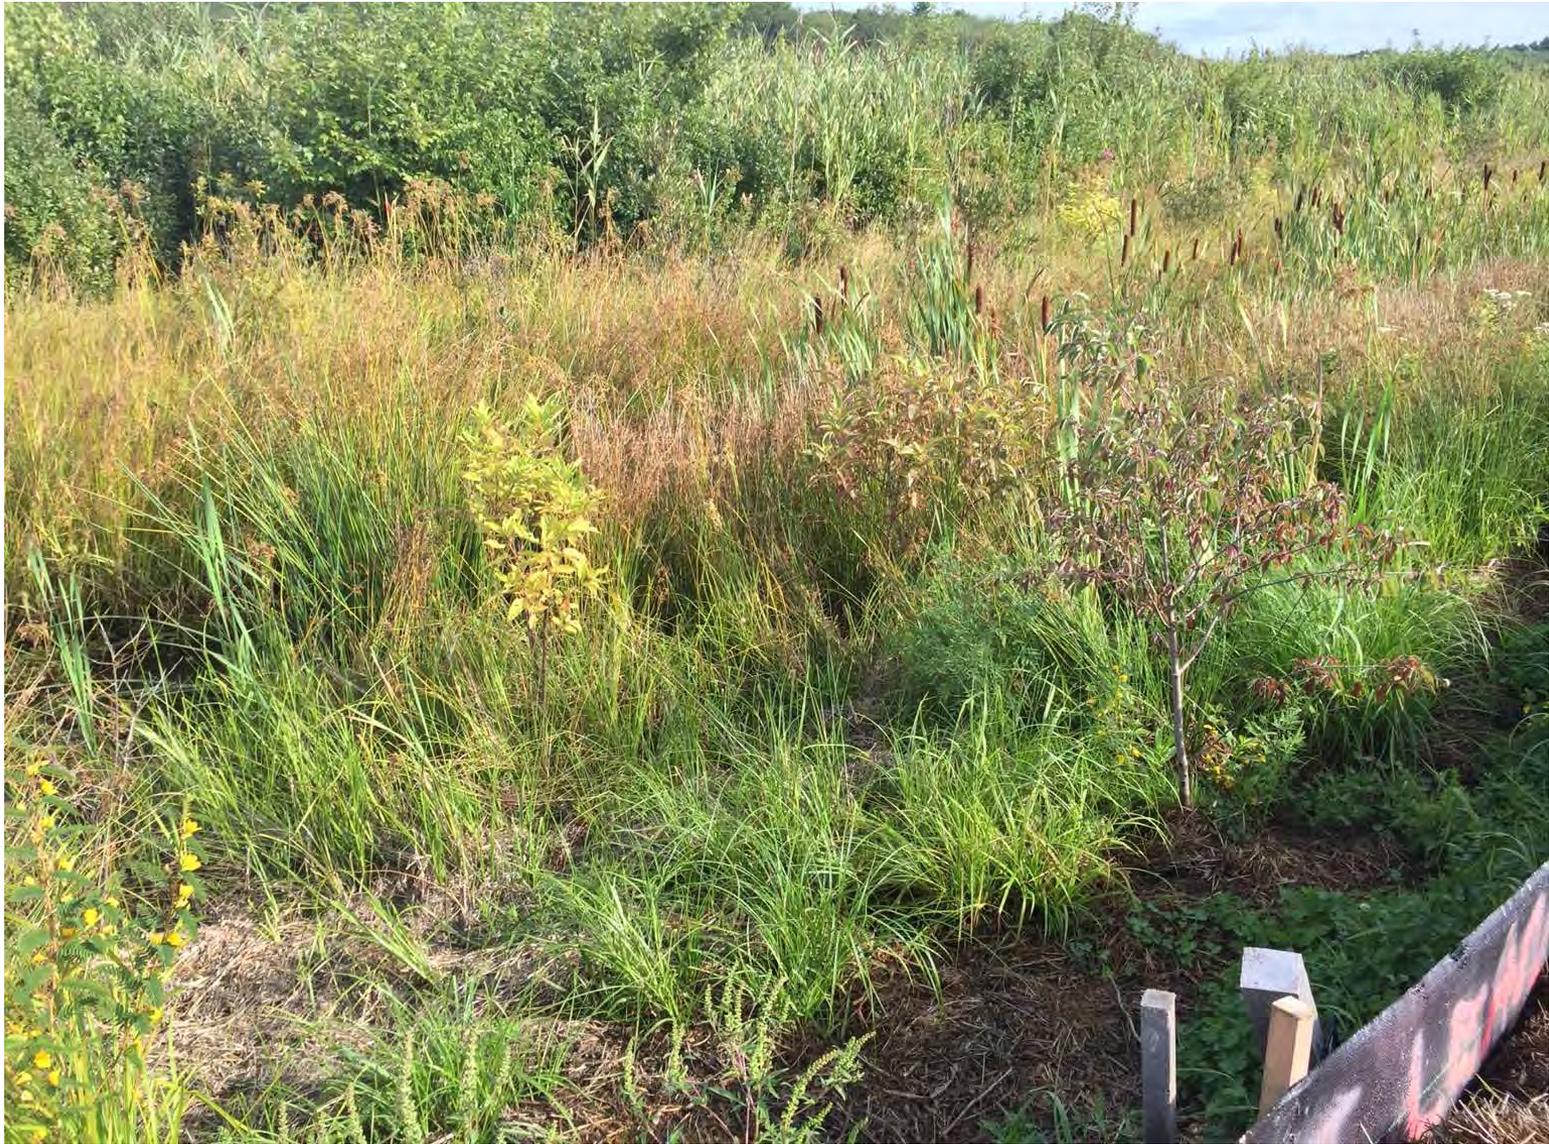
View of blow out area from the 2 inch rain in late July. This area is starting to reestablish.

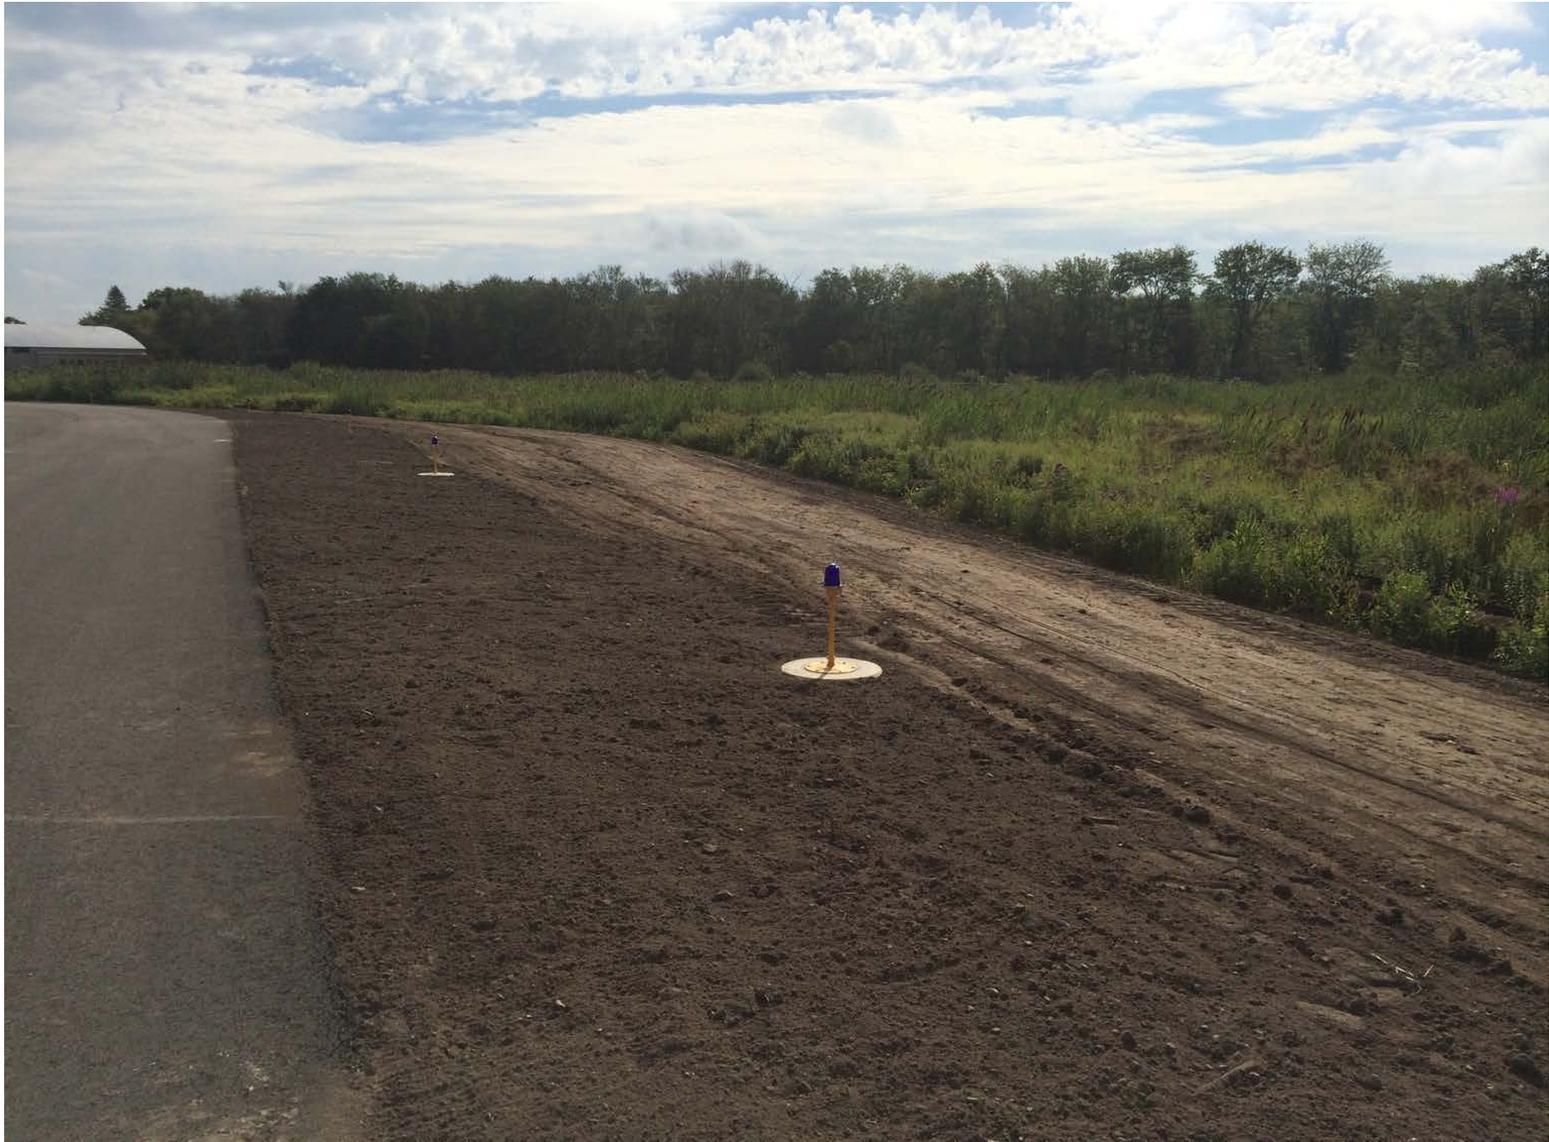
View of regraded slope next to Taxiway A – 5 end, and new taxiway lights.

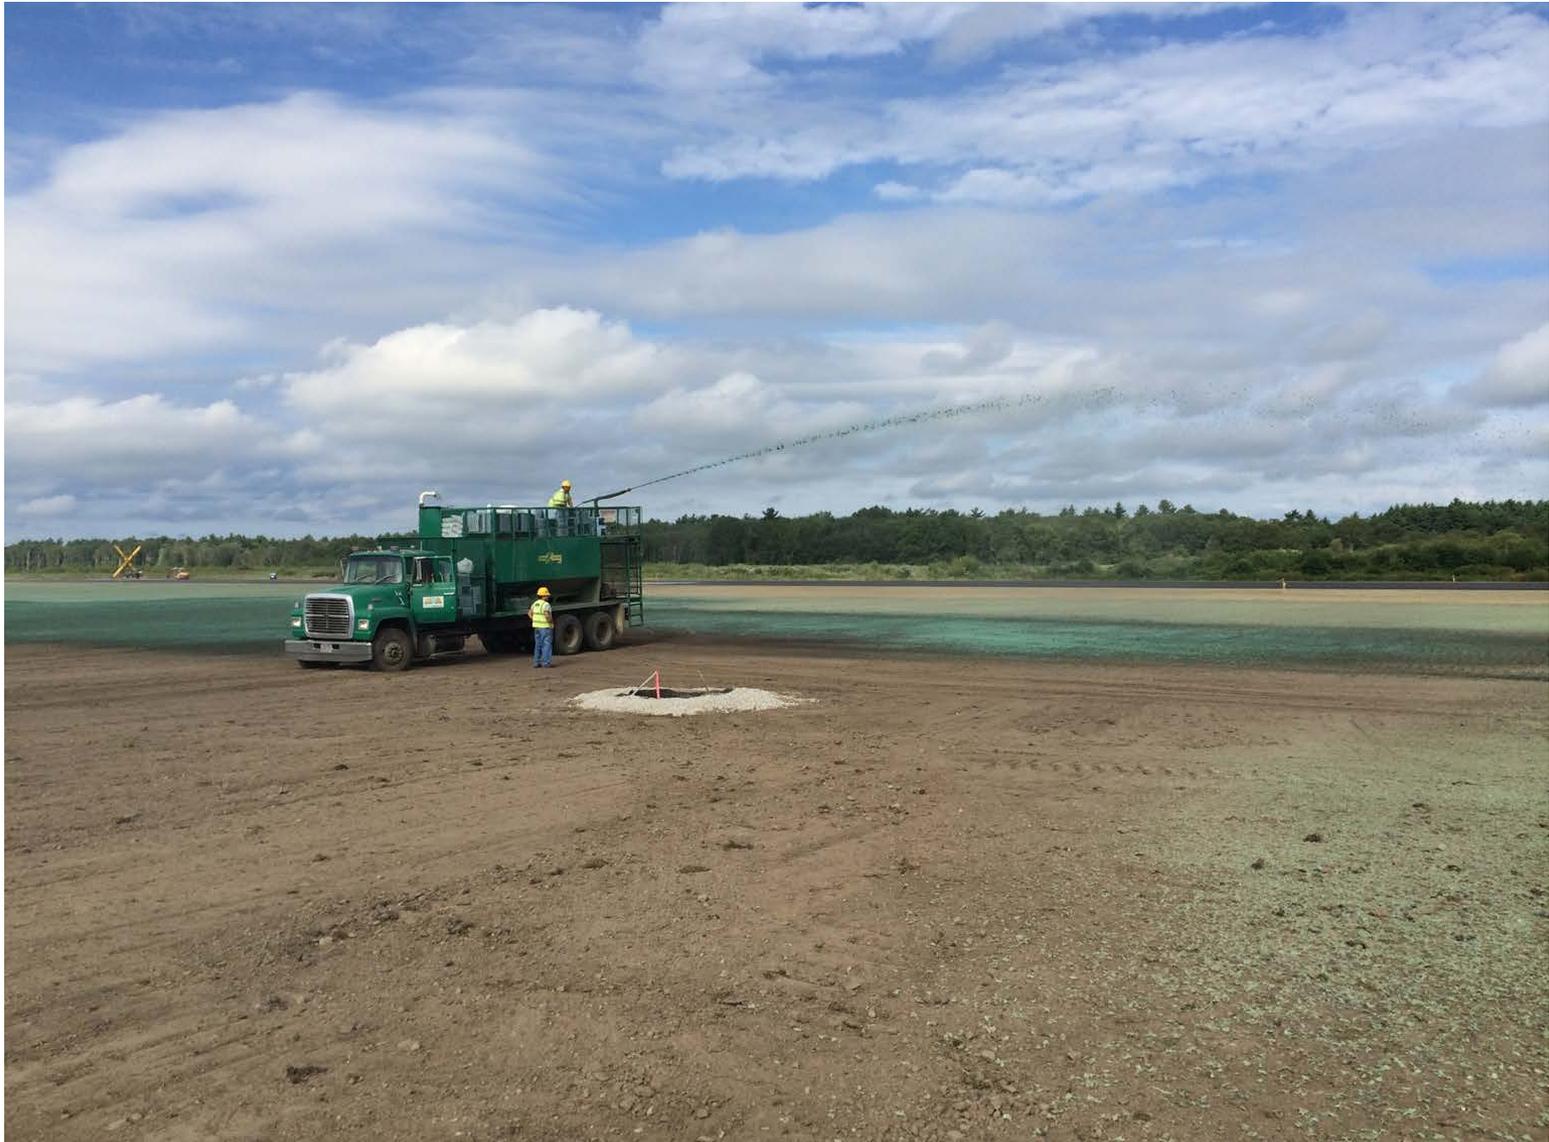
View of hydroseeding the infield adjacent to catch basin 11.

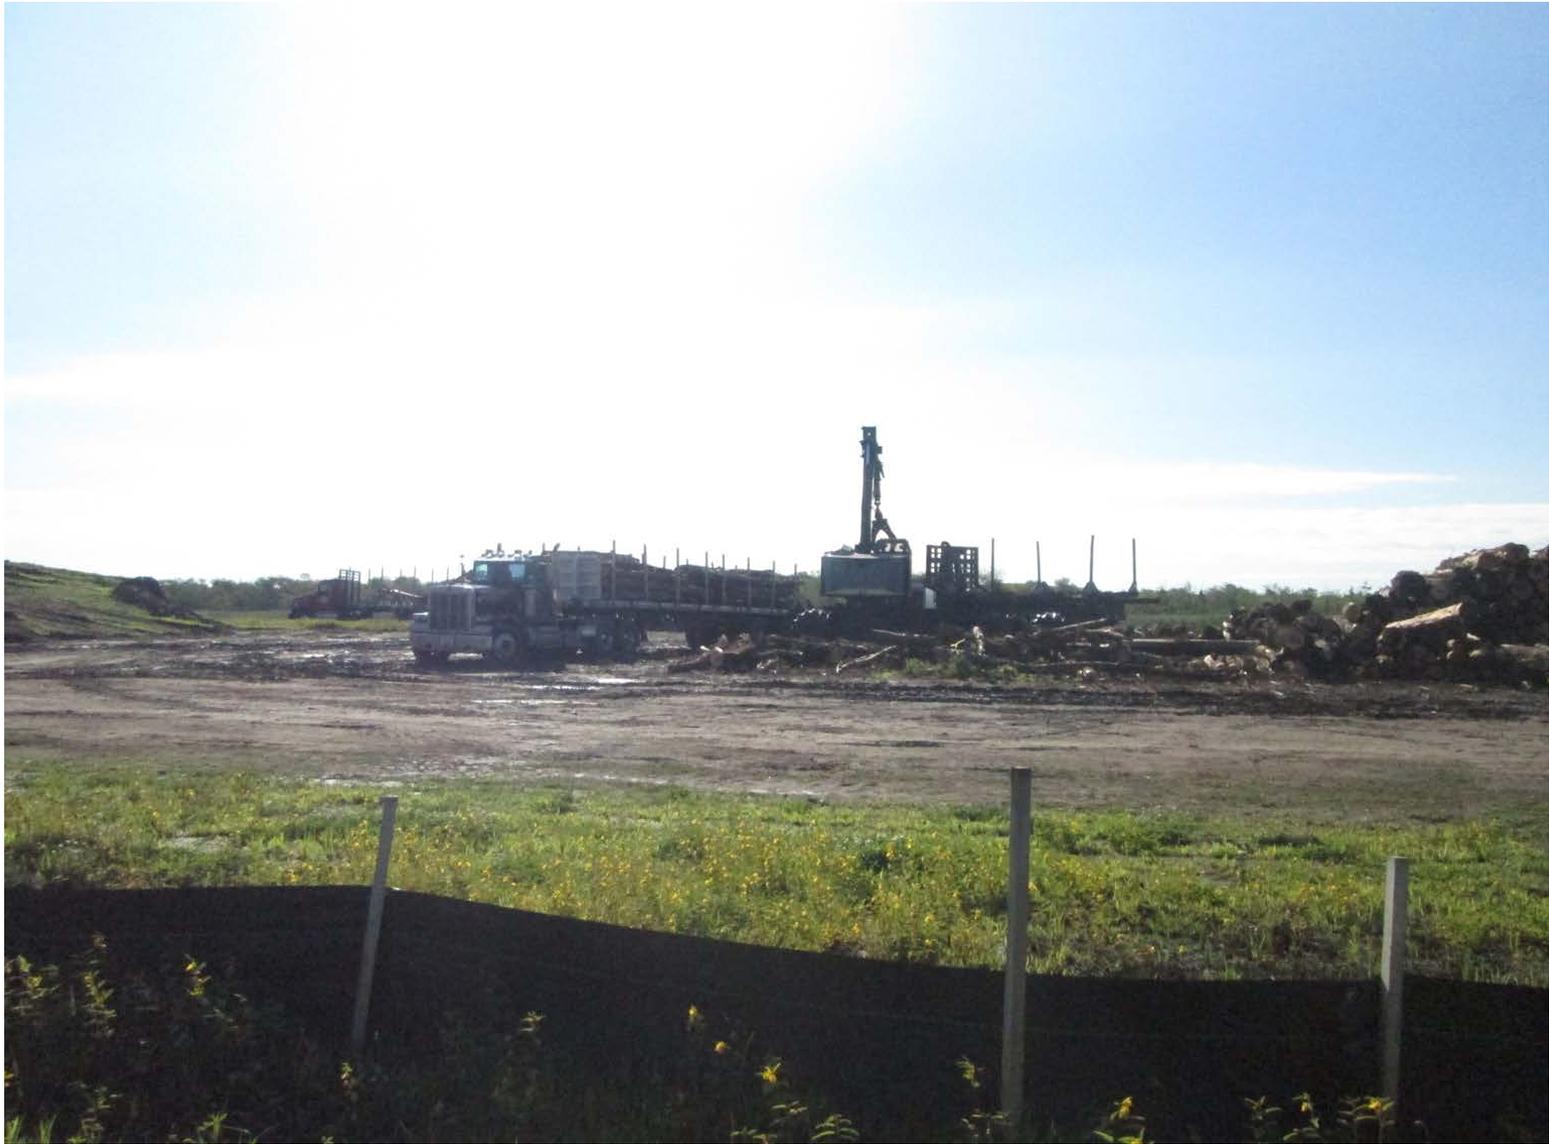
View of logging stockpile and processing operations.

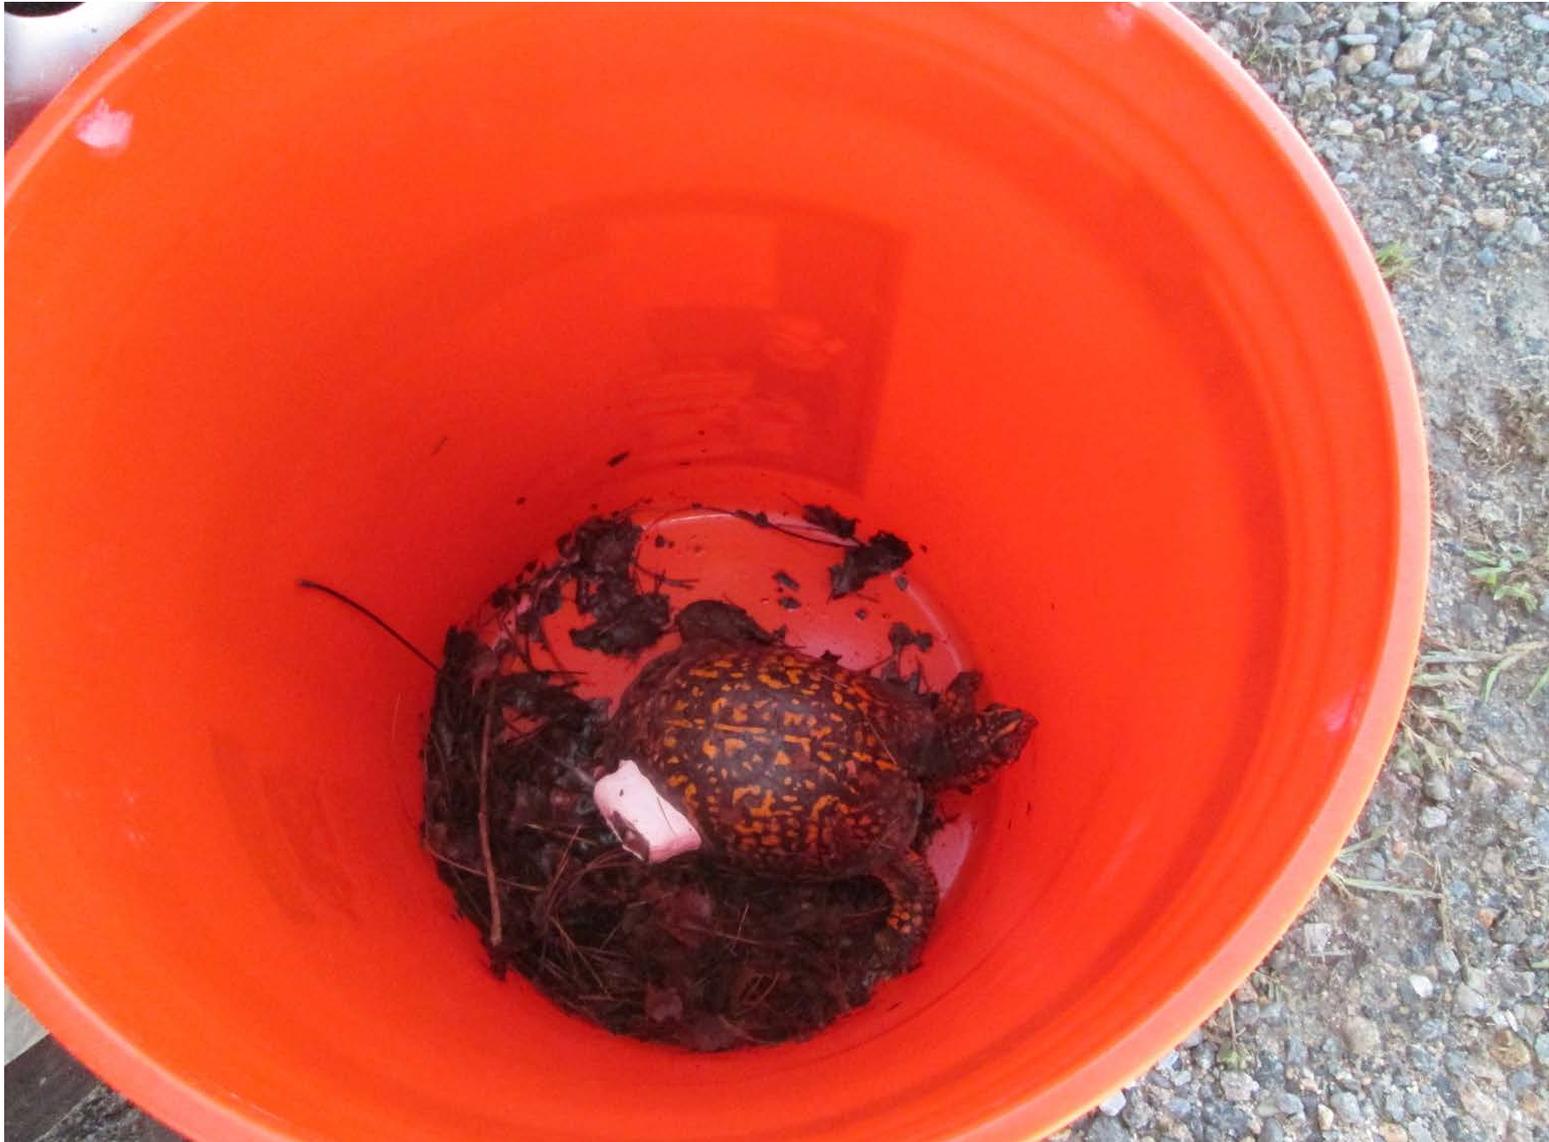
View of newly discovered turtle during the Dartmouth turtle sweeps. This turtle has been processed and will be released after turtle sweeps are completed for the day. Photo taken 8/14/14.

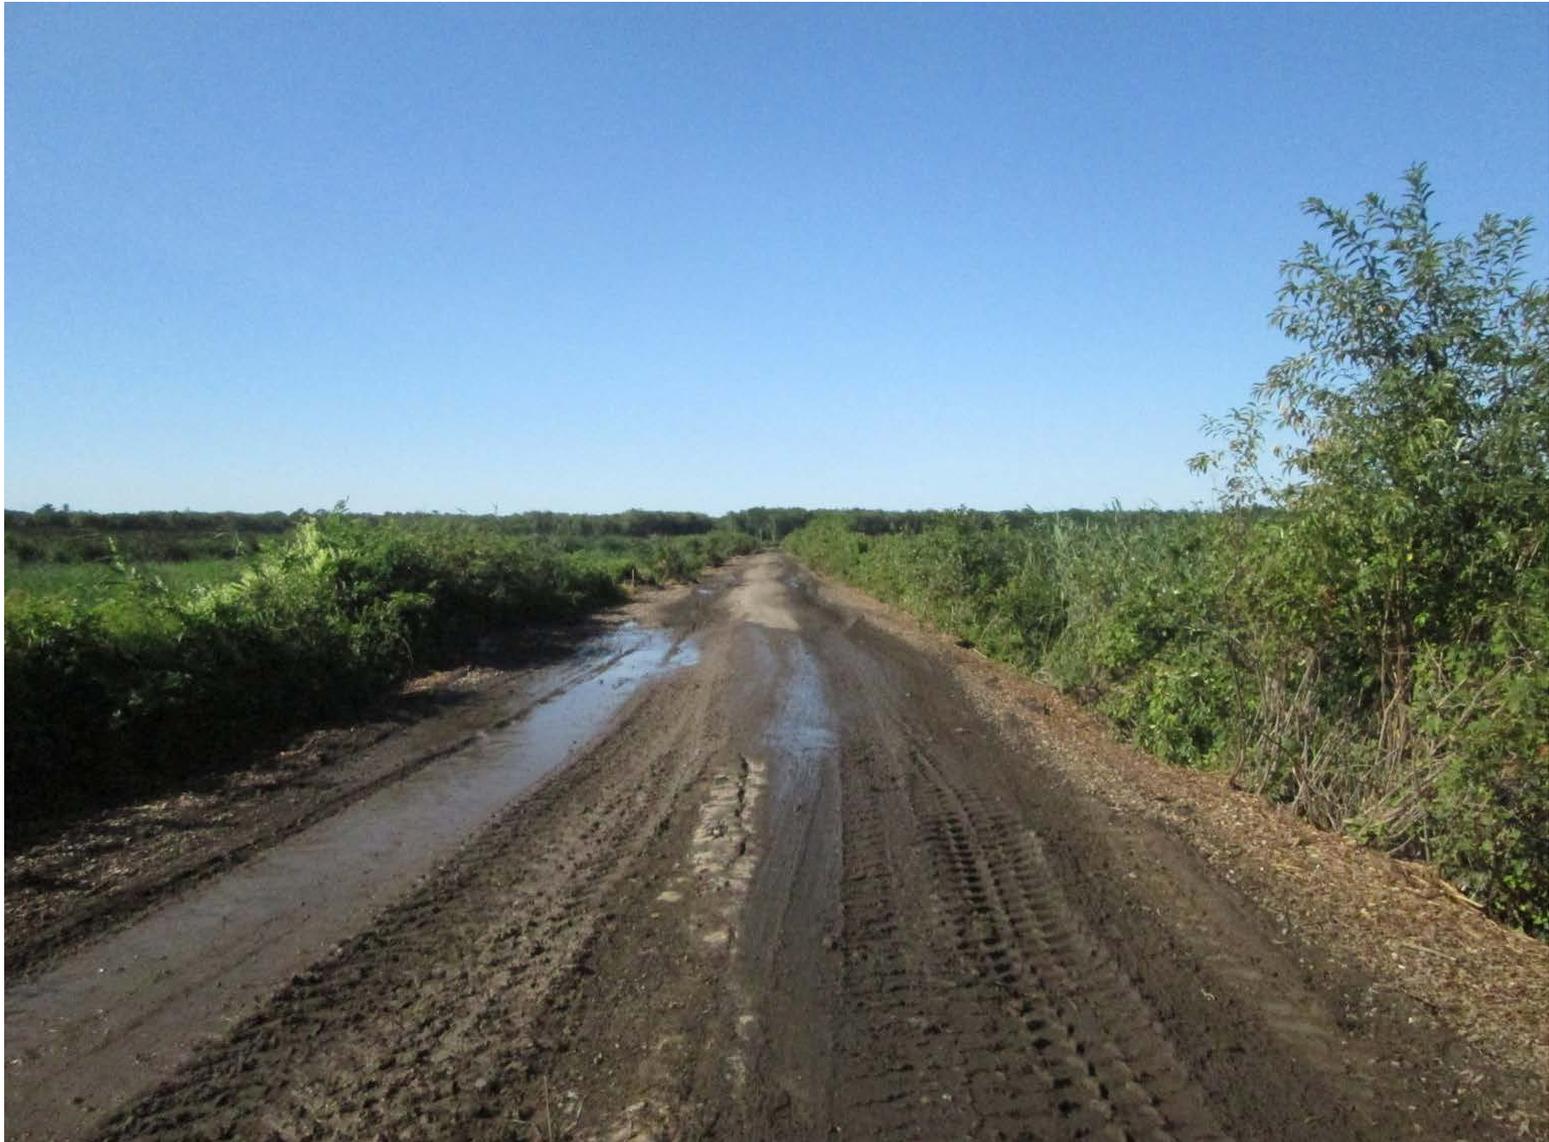
View of ILS road from 8/14/14. Generally in good condition.

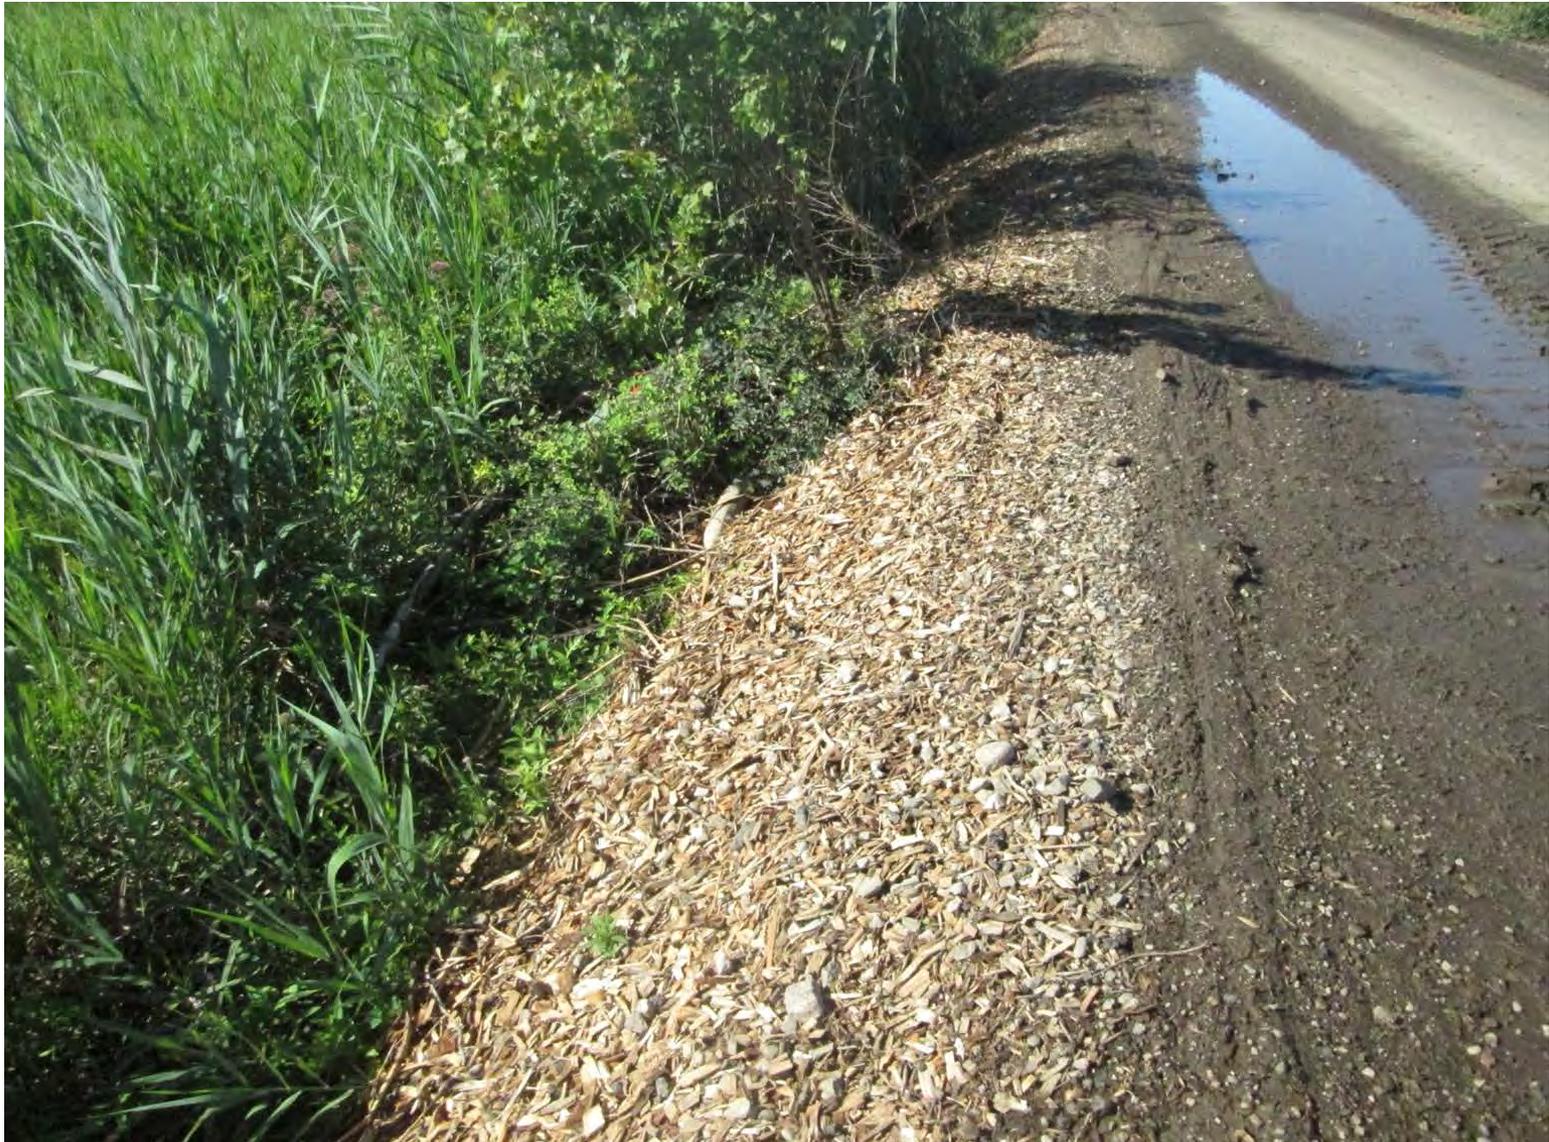
Close up of ILS wood chips on 8/14/14.

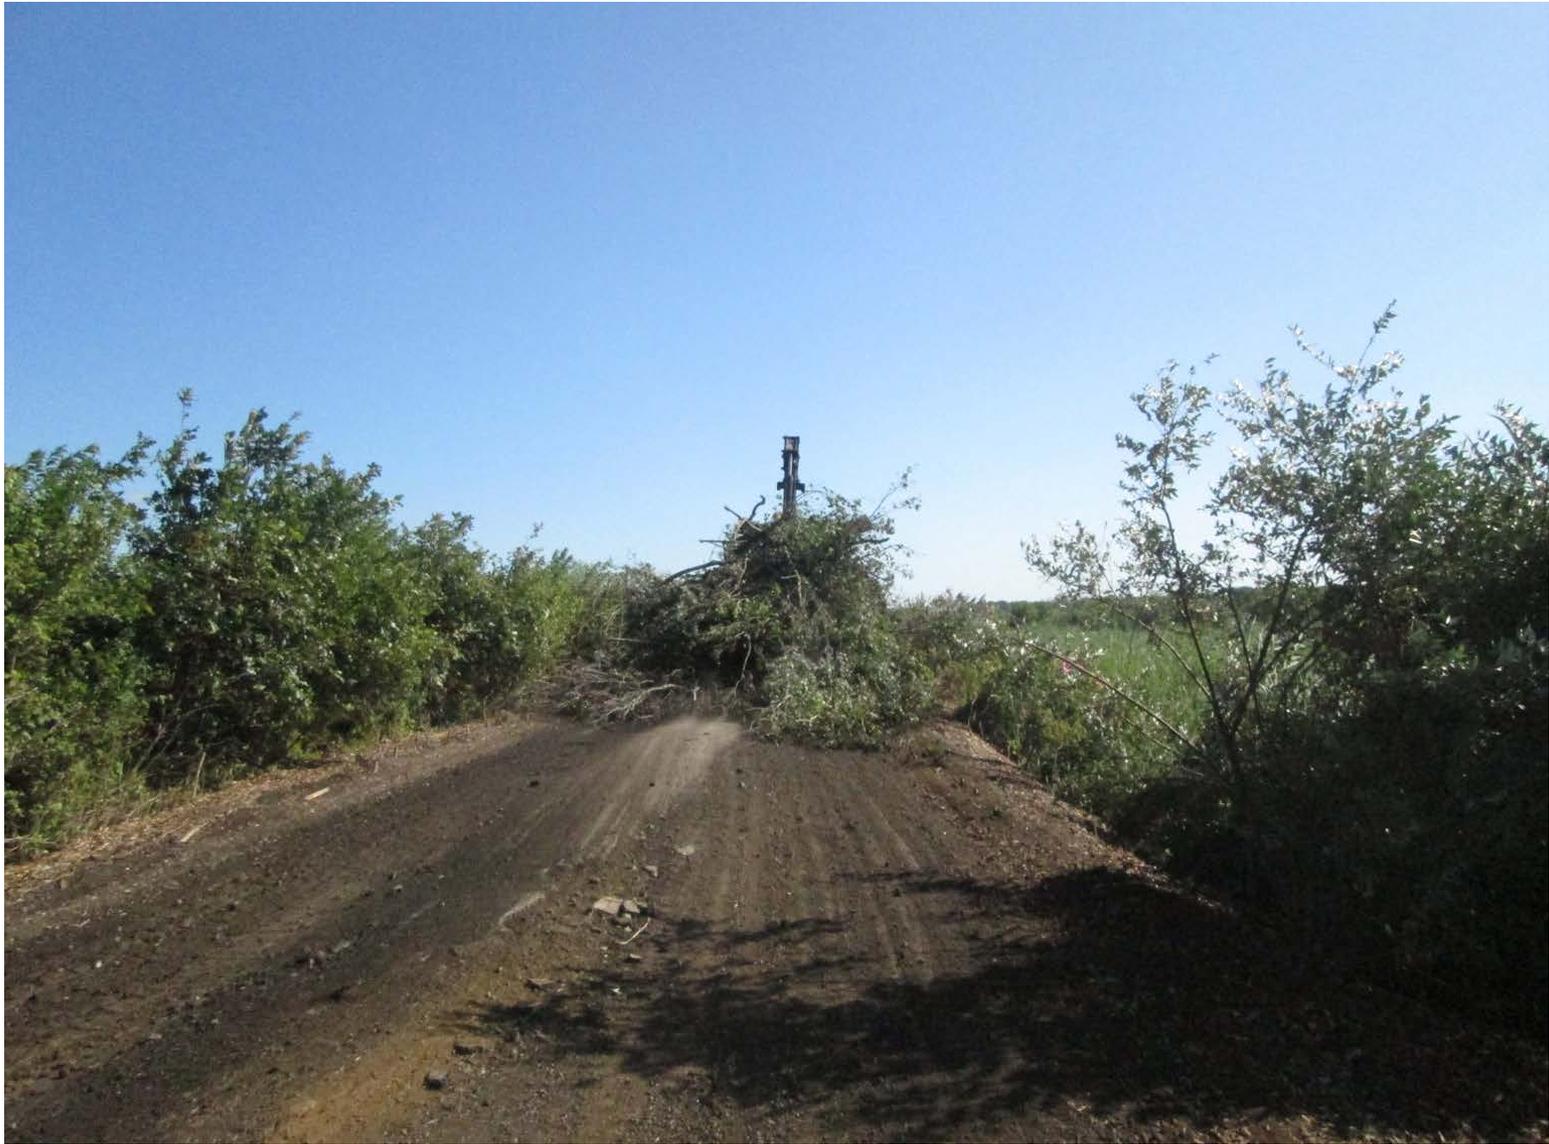
View of dragging slash on 8/14/14.

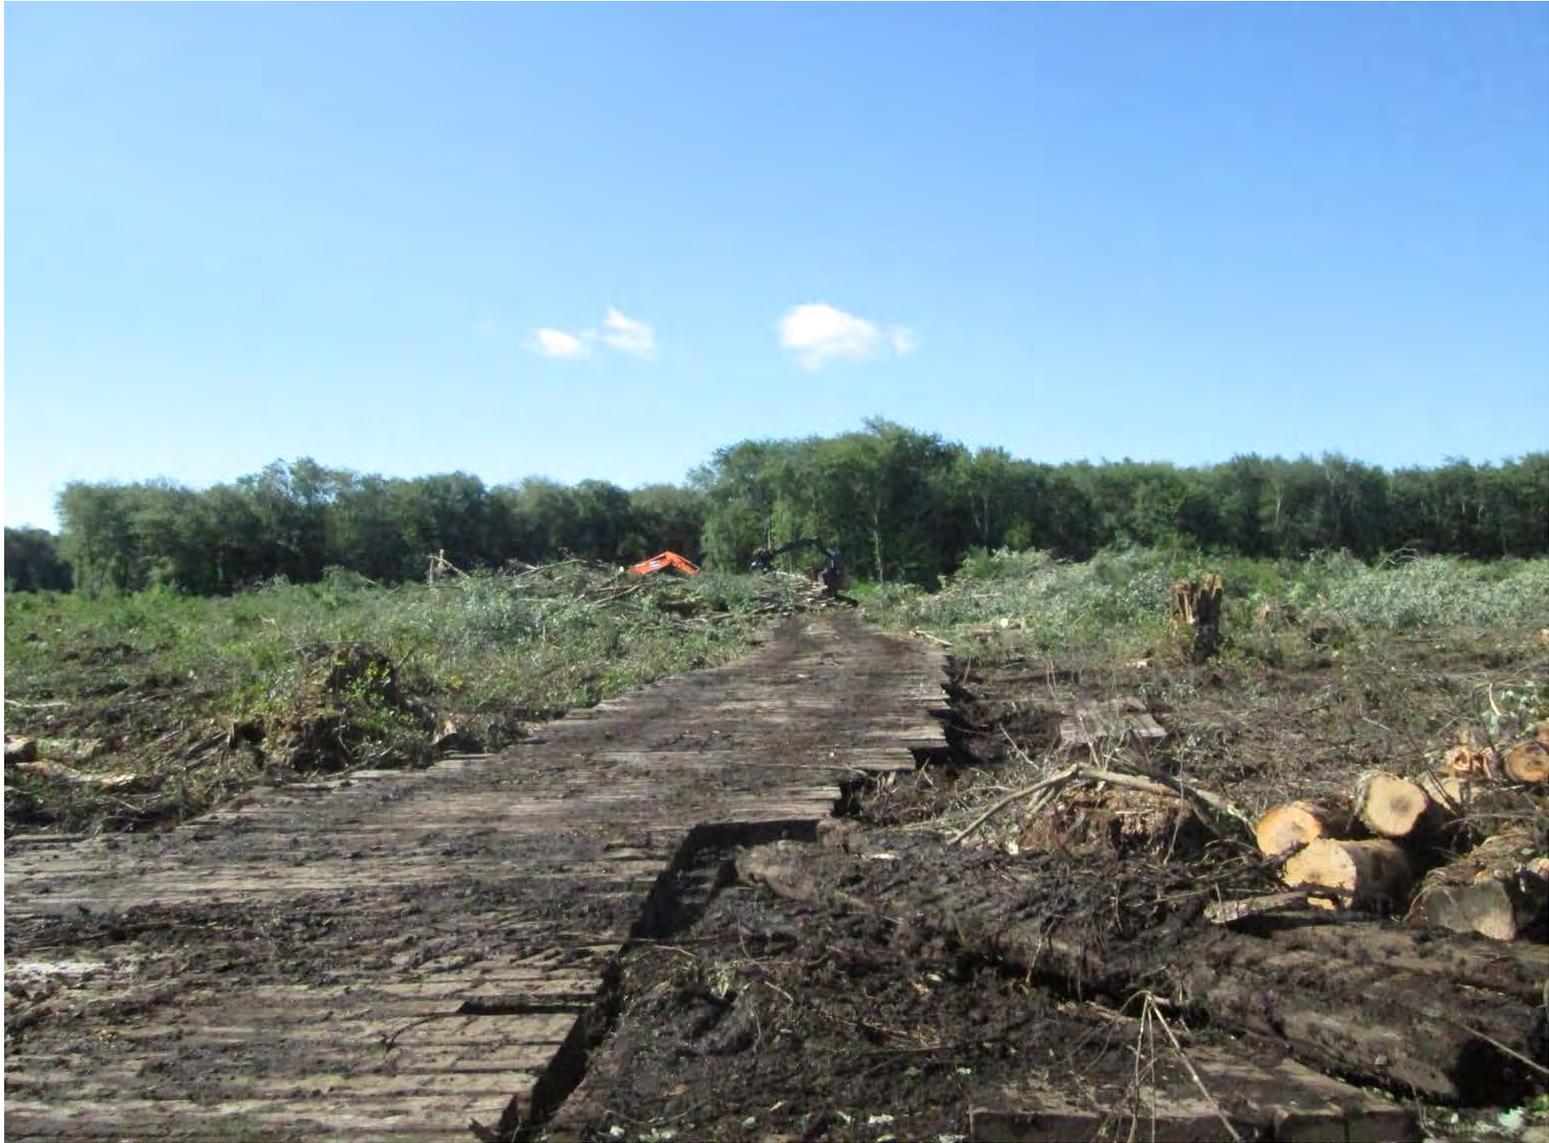
View of ongoing logging operations as of 8/14/14.

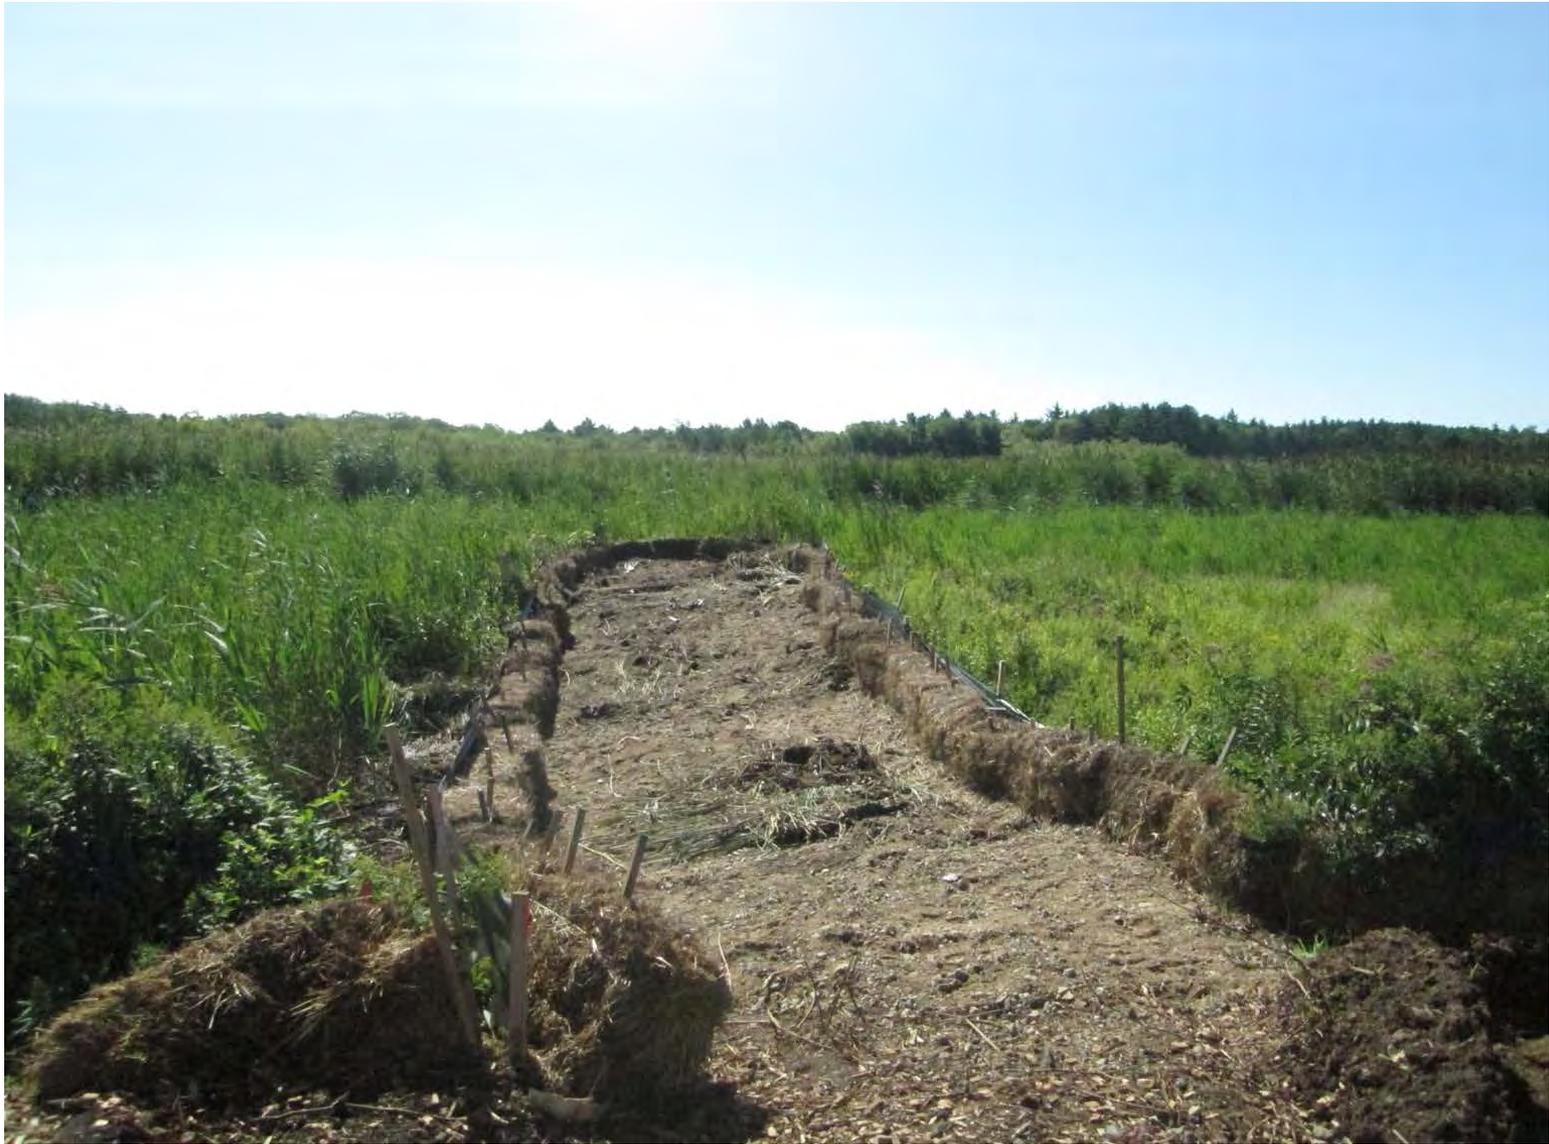
View of repaired erosion controls on Runway 5 end MALSR prior to work.

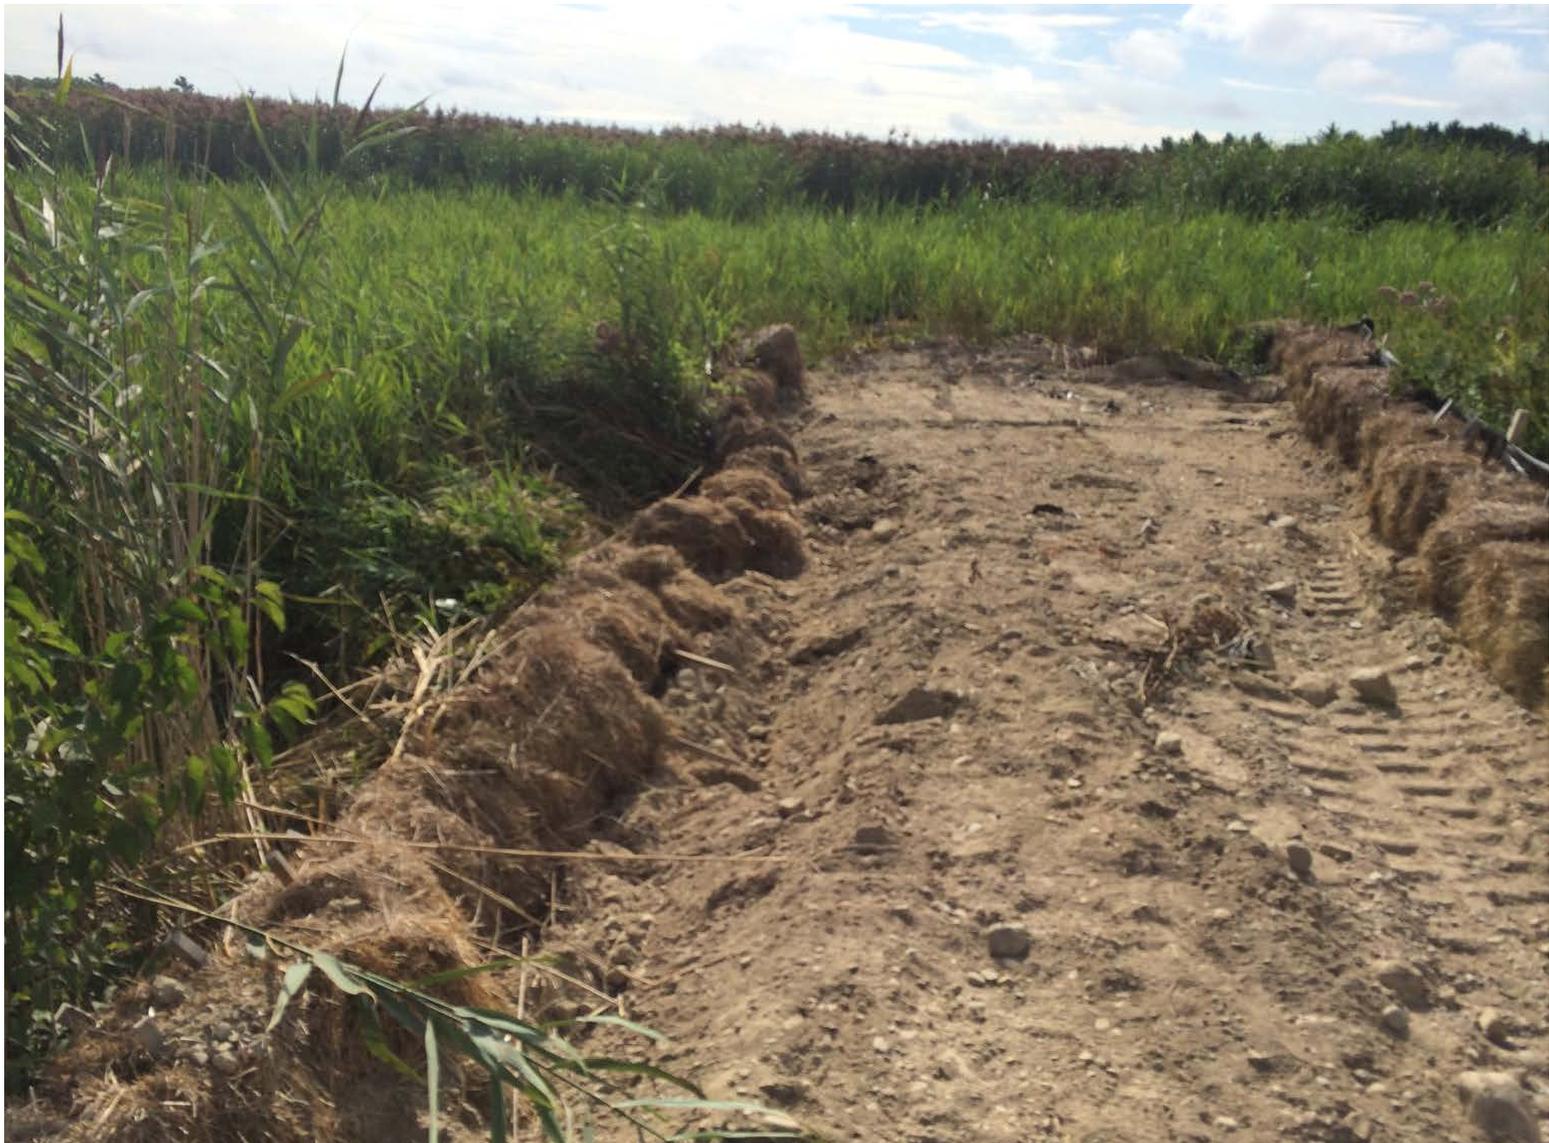
no yes If yes, describe: **One new release as noted above within the MALSR area. This sediment release was hand cleared and hay was used for stabilization. Previous minimal sediment discharges noted in previous reports were inspected and not new work is currently necessary.**

View of erosion controls on Runway 5 end MALSR, second to last light pole area. It appears that heavy machinery brought down a portion of the silt fence. The EM reported this to WS.

no yes If yes, describe: **The EM recommends that erosion controls are reestablished immediately along the ILS road and erosion controls are repaired or replaced as necessary within the MALSR areas before additional heavy equipment work occurs in these areas.**

Describe any corrective action required at this time: **Reestablish sediment controls along the ILS road and MALSR as needed. WS continues to work with ET&L to mitigate any potential erosion issues.**
