**New Bedford Regional Airport
Runway Safety Improvements Project – Phase 4
Reconstruct, Mark, and Groove Runway 5-23
MassDEP File No. SE049-0635**

ENVIRONMENTAL MONITOR INSPECTION FORM

Date/ Time of Inspections: **8/14/14 (morning), 8/19/14 (morning), 8/21/14 (morning).**

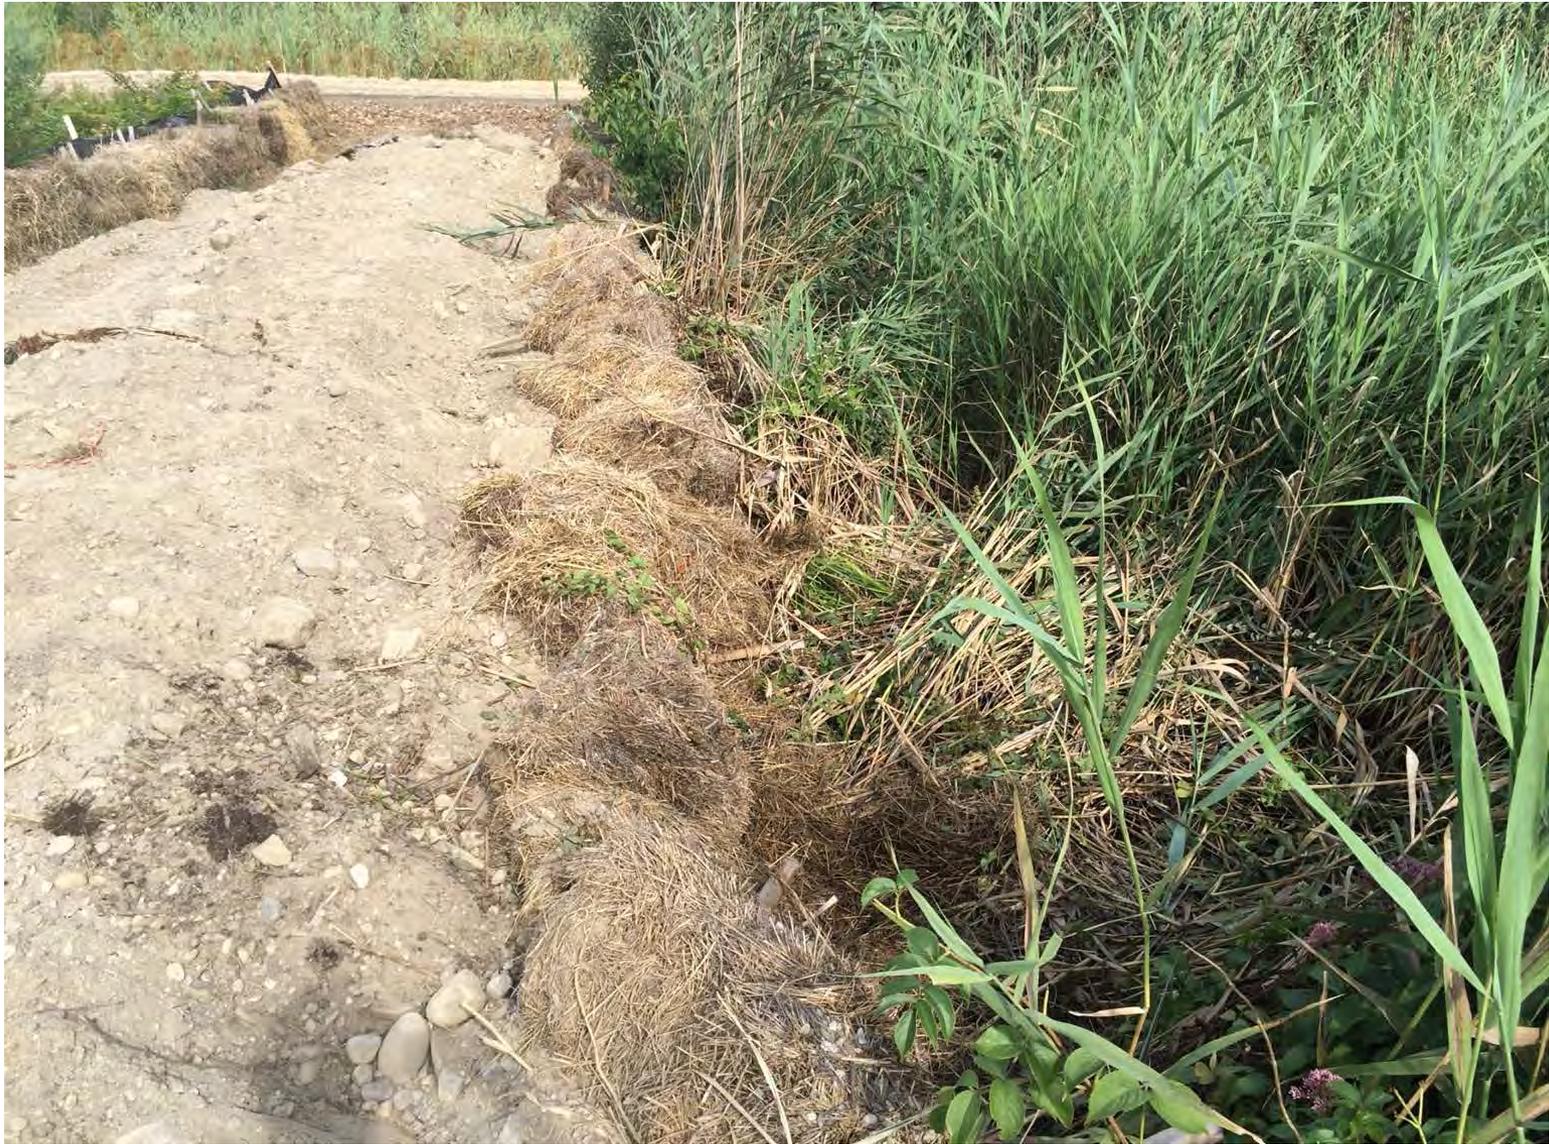
View of sediment removed from wetland adjacent to the second to last light pole MALSR work area, silt fence is still in poor condition.

no yes If yes, describe: **The EM recommends that erosion controls are reestablished immediately along the ILS road and erosion controls are repaired or replaced as necessary within the MALSR areas before additional heavy equipment work occurs in these areas.**

Describe any corrective action required at this time: **Reestablish sediment controls along the ILS road and MALSR as needed. WS continues to work with ET&L to mitigate any potential erosion issues.**

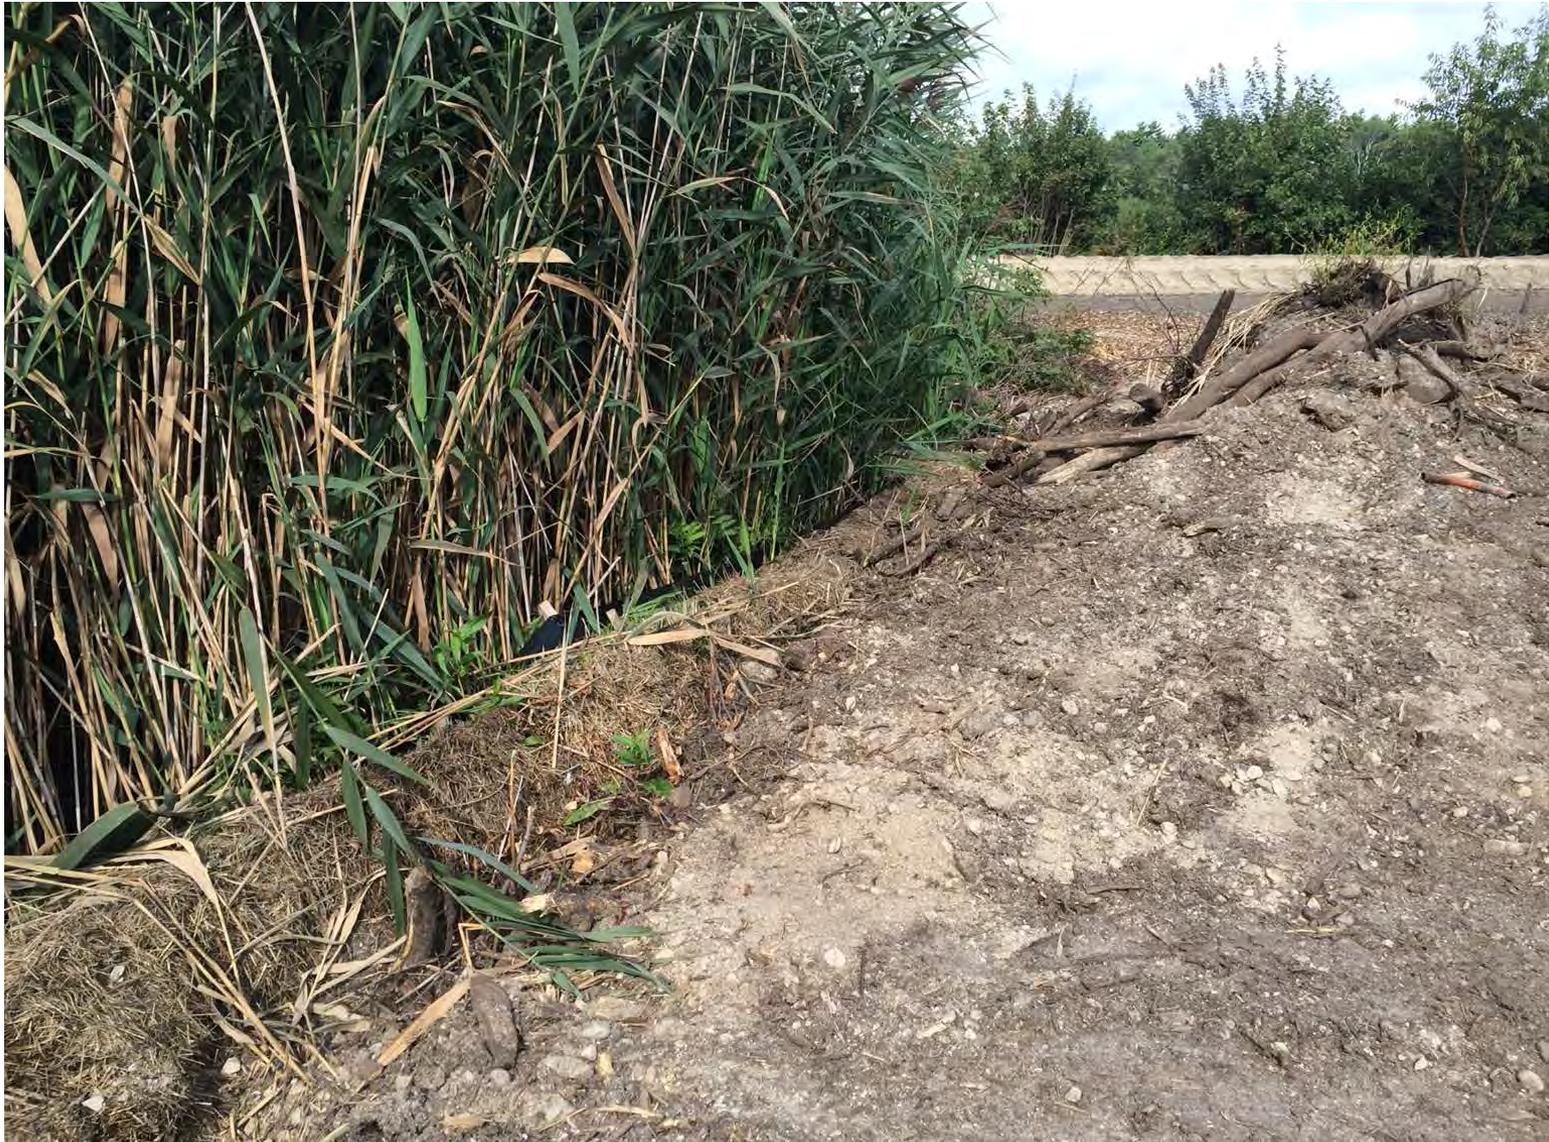
View of last light pole MALSR work area. Silt fence should be restored in this area too.

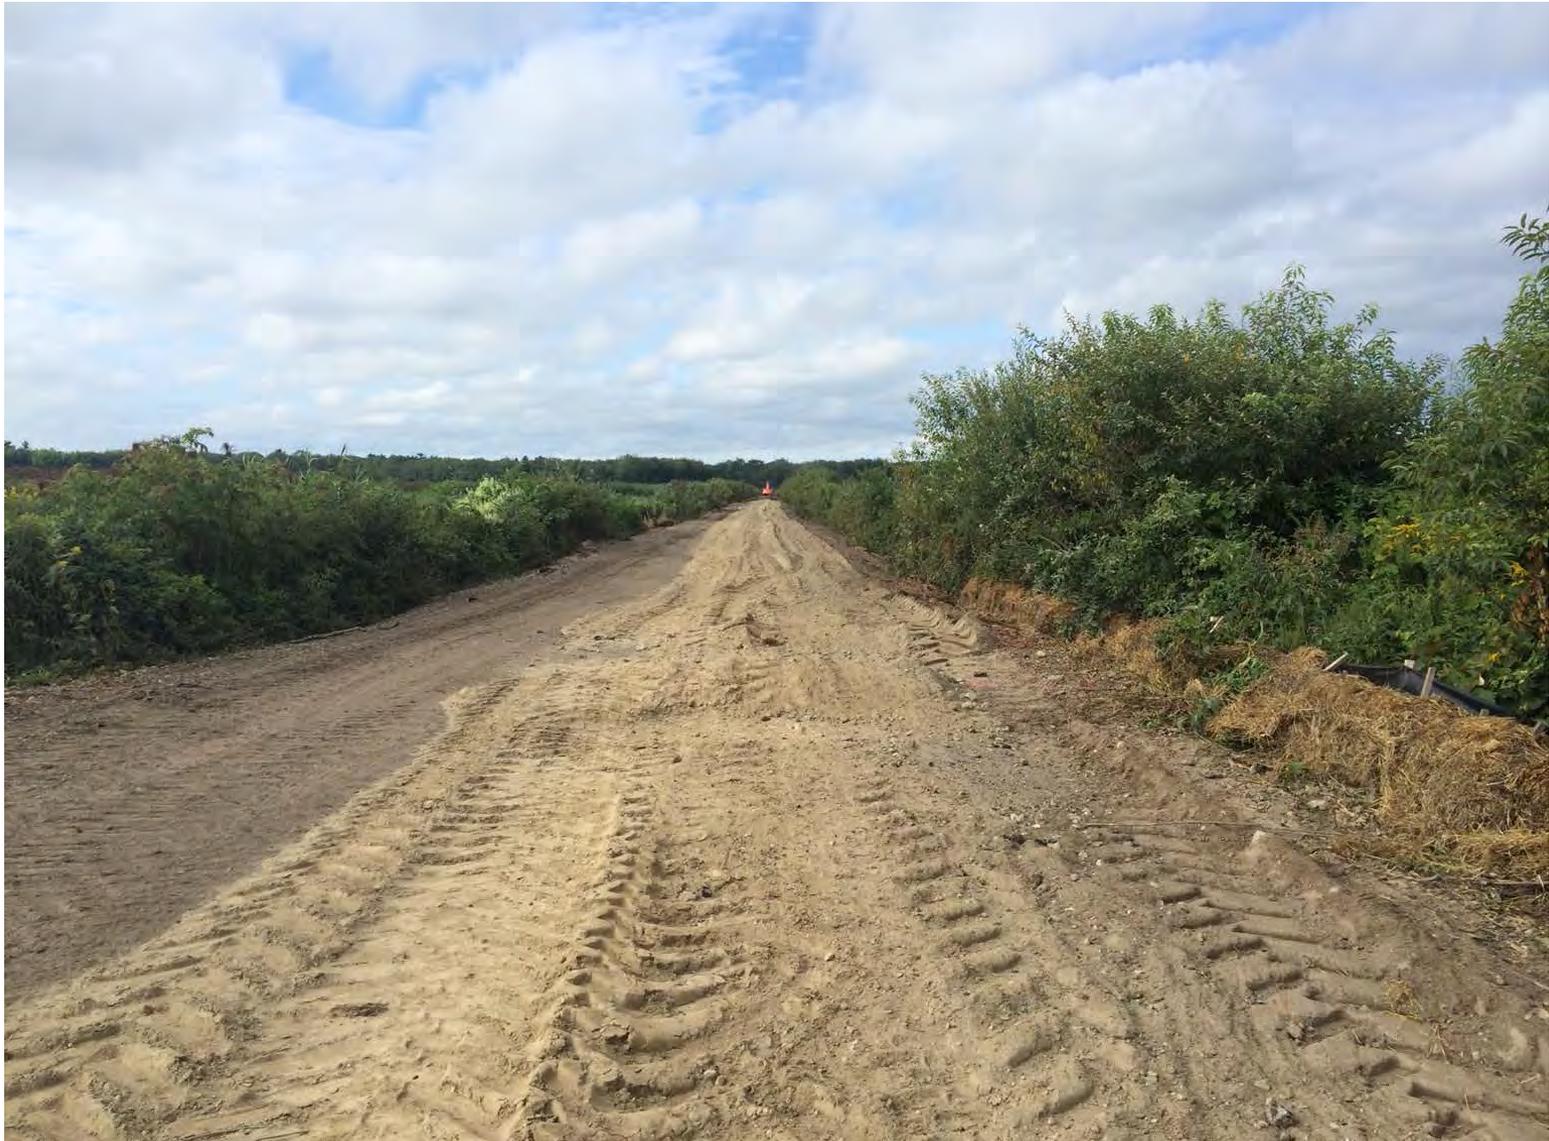
View of ILS road after pavement was rototilled. Erosion controls adjacent to work are in fair condition in this area.

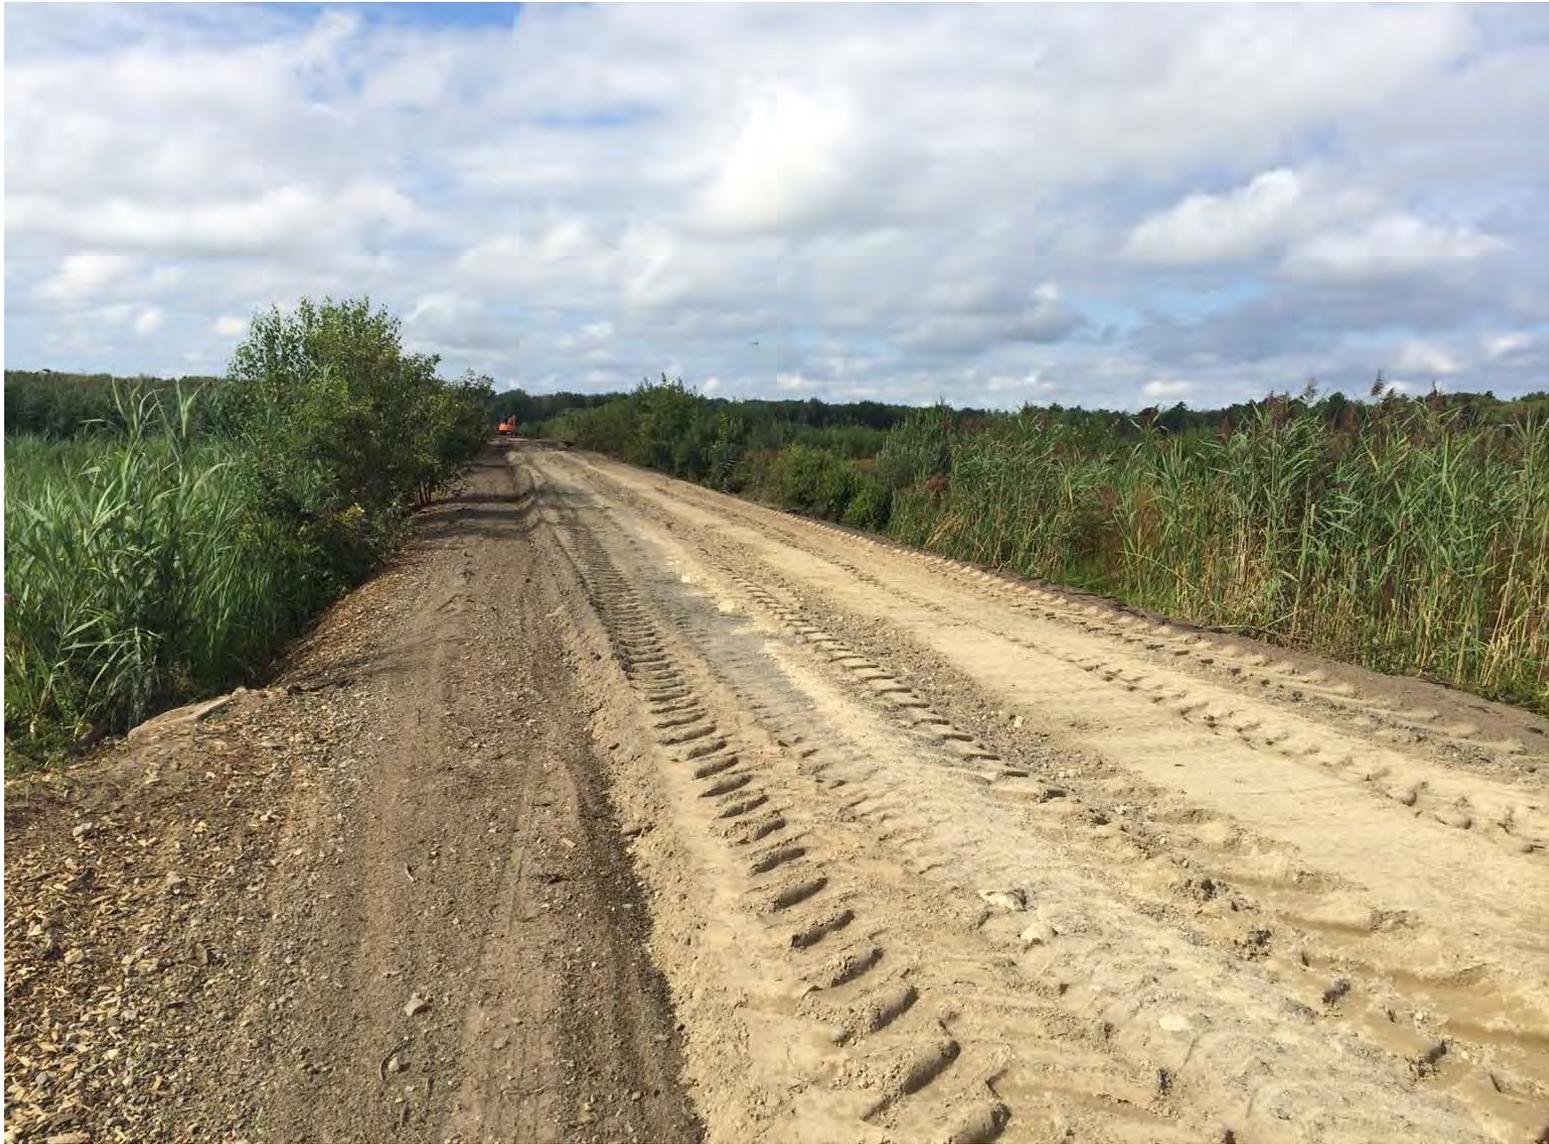
Control Measure	Cleaning or Repair Needed	Comments/Recommendations from the EM
Overall Adherence to Environmental Permits		The project site was in generally good condition during the inspection period except for the ILS road.

View of ILS road after pavement was rototilled. Erosion controls adjacent to work are in poor condition in this area. EM recommended that no work occur until erosion controls are reestablished and that erosion controls be placed as soon as possible.

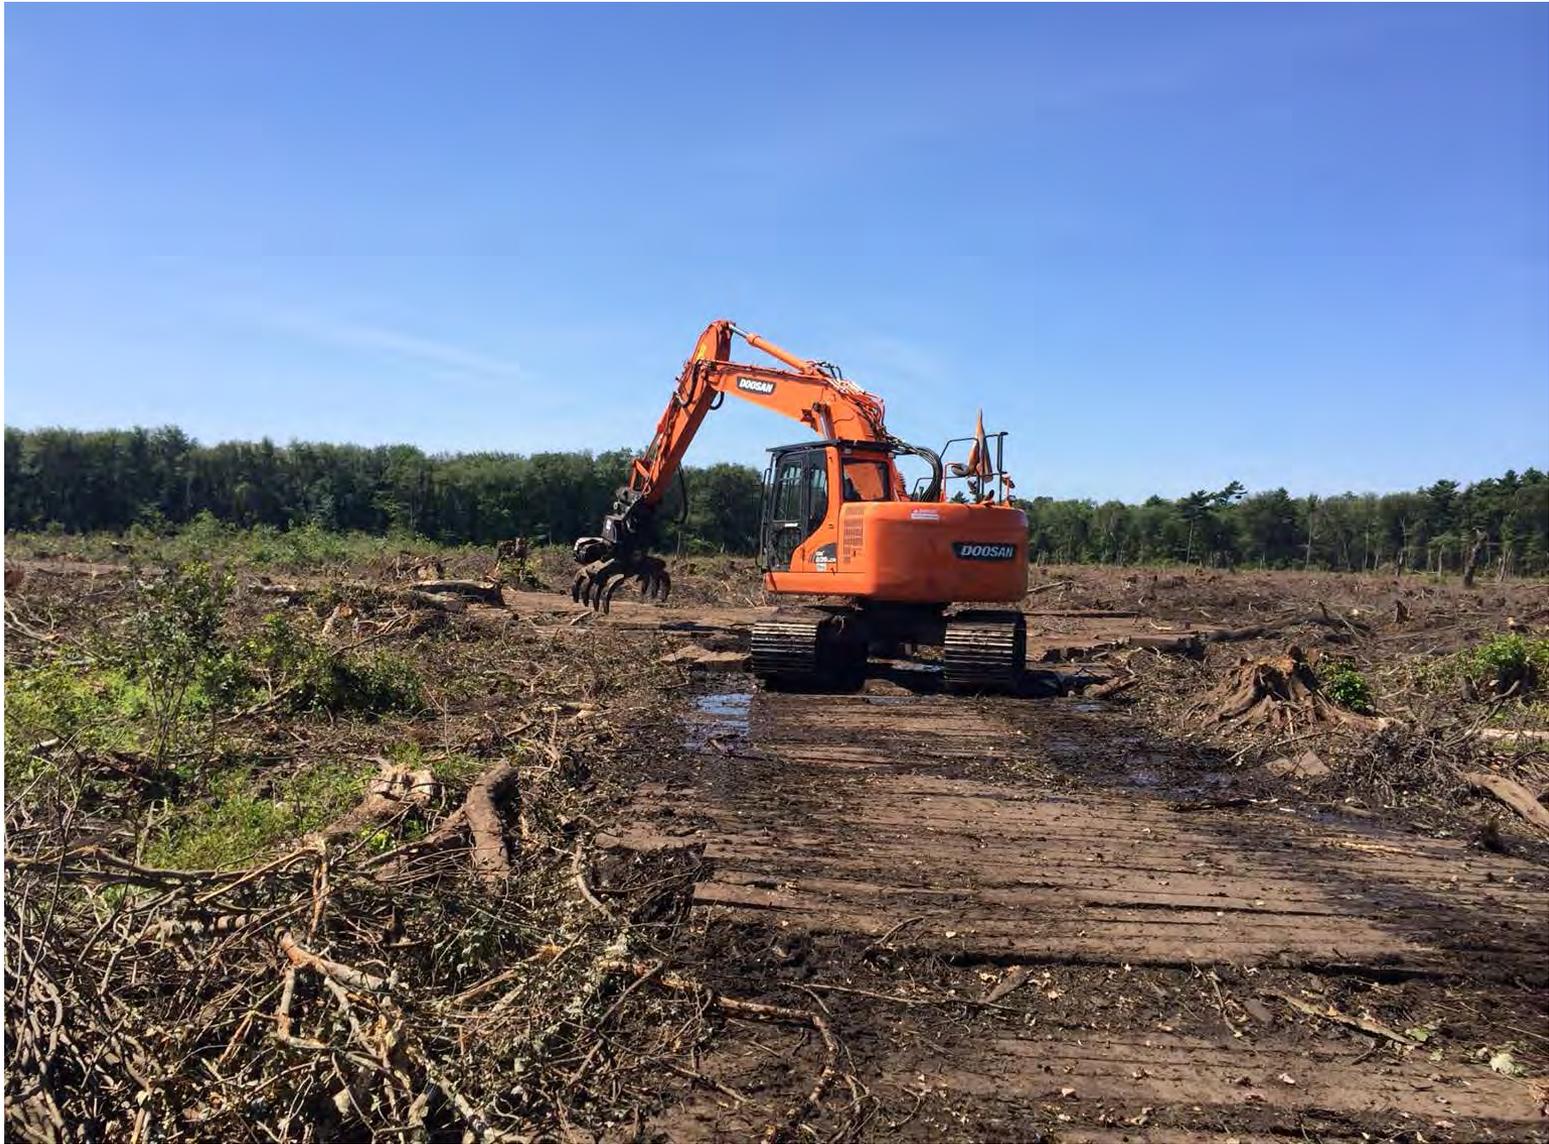
View of tree contractor pulling timber mat road.

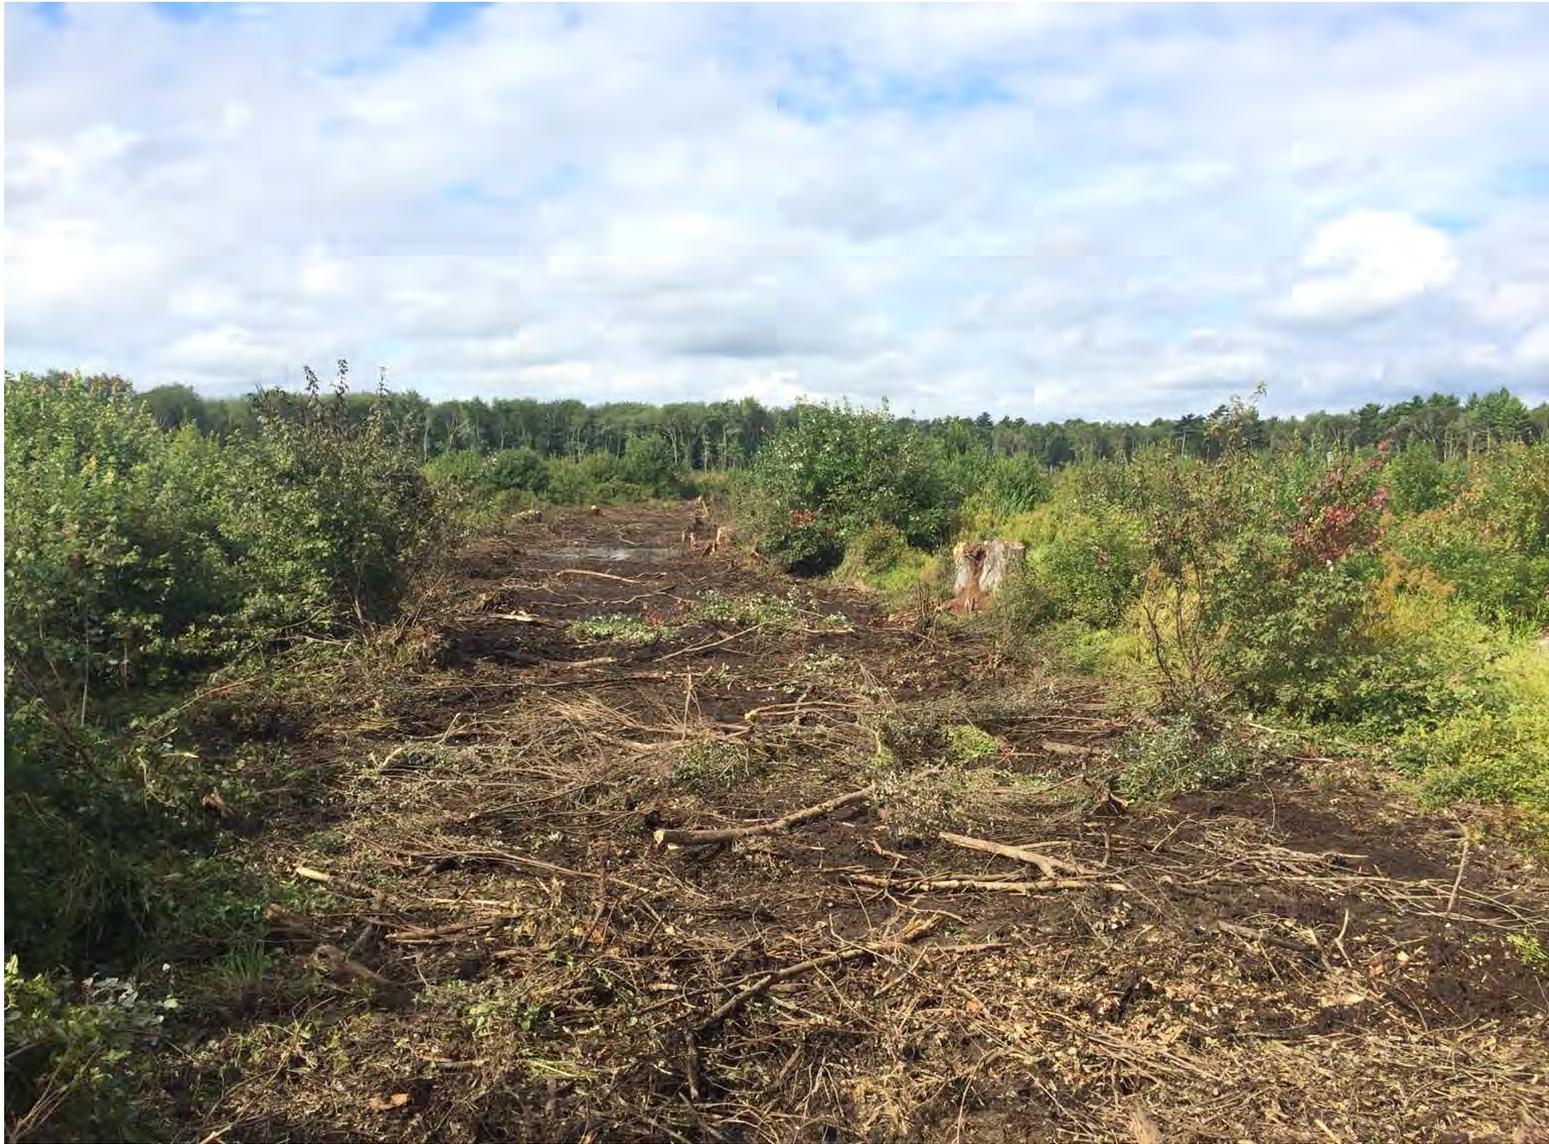
View of abandoned timber mat road.

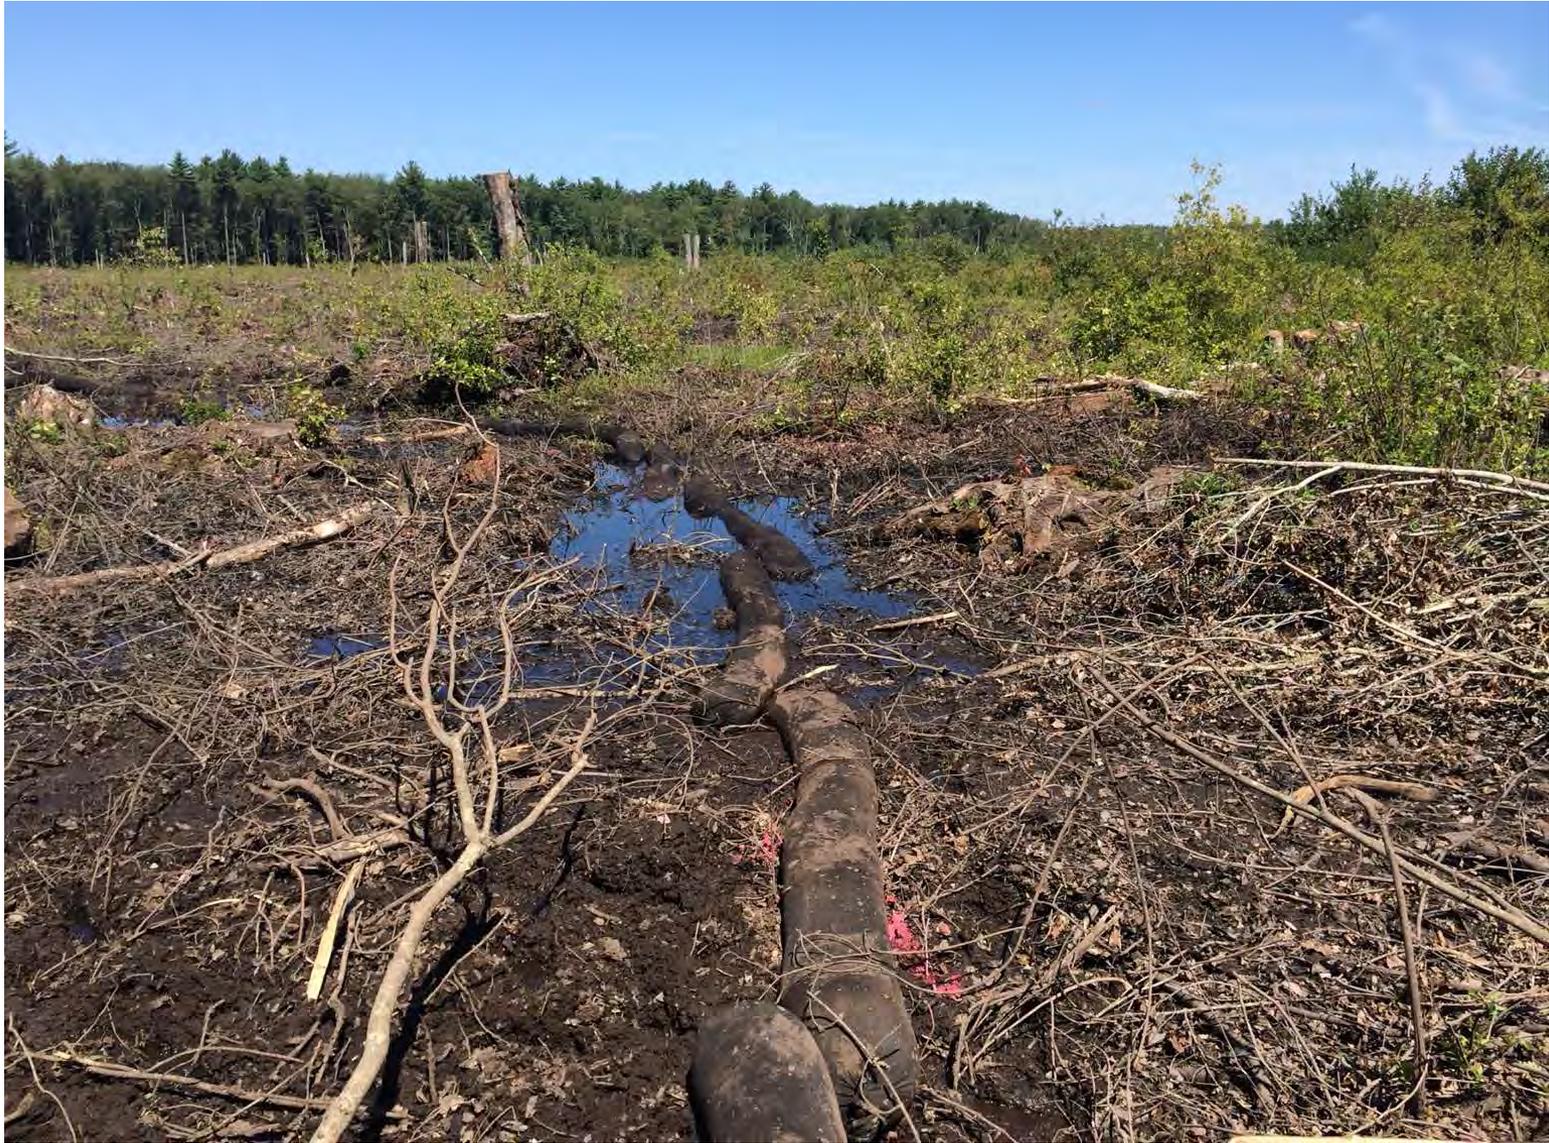
View of installed fiber rolls within the Dartmouth tree clearing area.
