JM Fiske Environmental

NEW BEDFORD REGIONAL AIRPORT
RUNWAY 5-23 – PHASE 4

Partial Weekly Environmental Report

August 16 to August 22, 2014

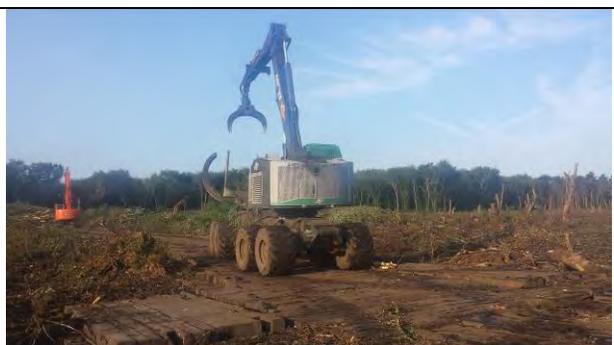
Turtle sweep of ILS road. Wagner wood completed cutting operation and is now focusing on getting material out of cleared area.

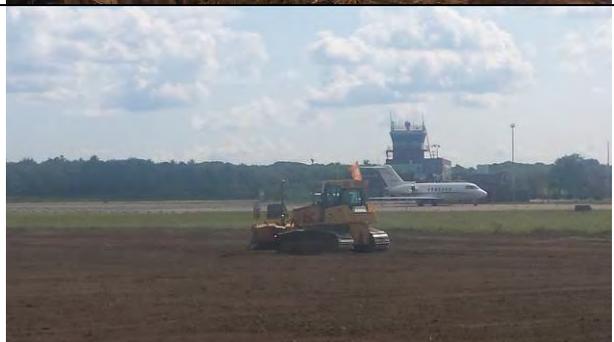
ETL is final grading and preparing for hydroseeder expected on Monday.

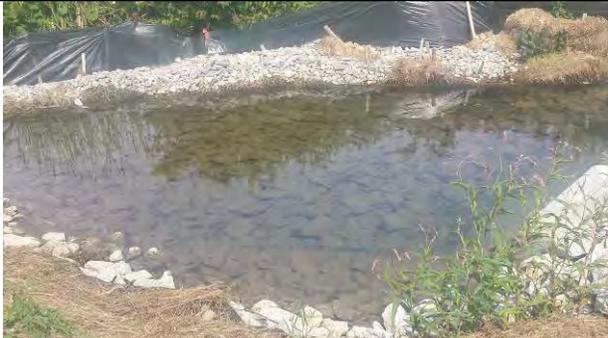
<p>Drainage culvert outfall is clear.</p>

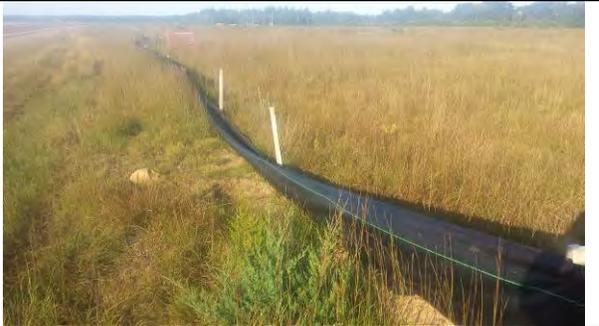
<p>Short section of turtle barrier on RW23 end north side was down. Fence was repair immediately.</p>

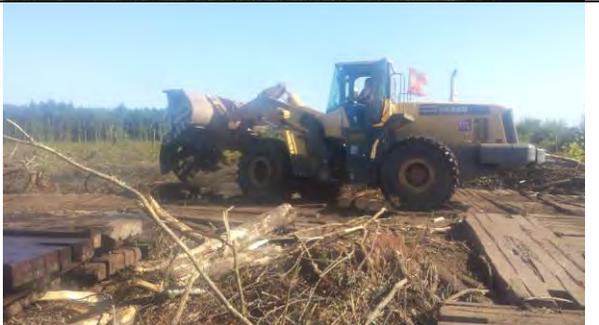
<p>ETL loader was used to transport filter rolls out to clearing area as part of stormwater runoff mitigation requirement Variance Condition #32</p>

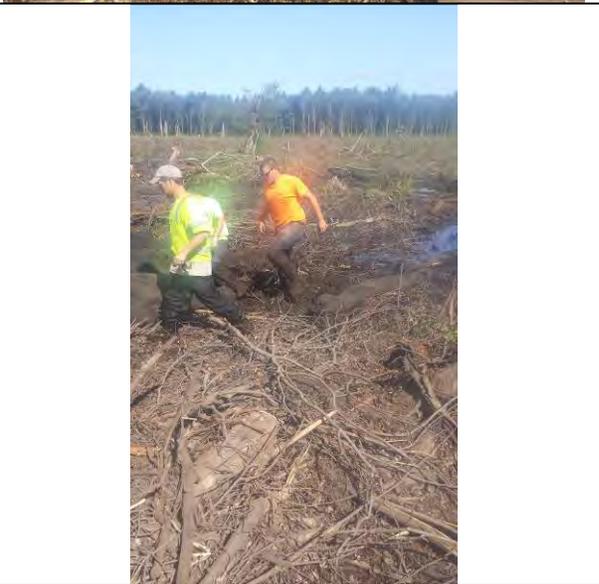
<p>RAMCO crew worked to lay out filter rolls. Conditions were such that they were up to their hips in organics and the uneven ground and material left from the clearing operation made the work next to impossible.</p>

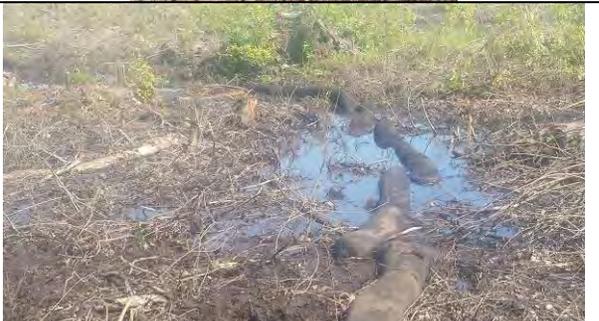
<p>Placement of filter rolls according to plan was not possible due to undulating ground. RAMCO quit project due to unsafe conditions. Request to modify permit condition #32 submitted to MADEP</p>

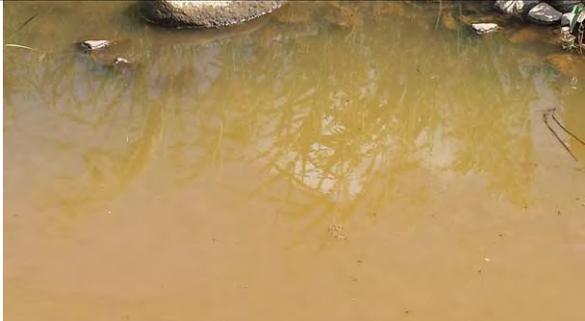
<p>The water at the CB11 outfall continues to be cloudy. No flow is coming from catch basin and no discharge was observed into wetland.</p>

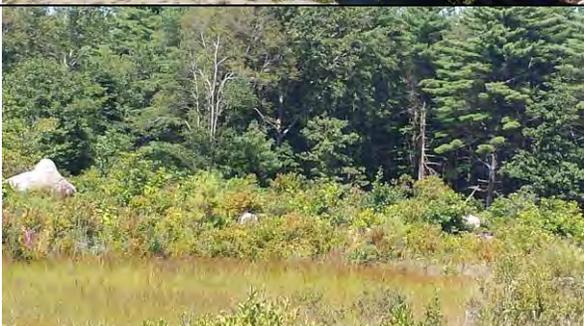
A photograph of a large black truck with a trailer loaded with stacks of dark log mats. A white excavator is positioned next to the truck, appearing to be in the process of loading or unloading the mats. The scene is outdoors on a dirt area.
<p>Wetland replication area and adjacent wetlands reviewed. Noted un-delineated upland area between replication area and proposed replication area and recommended review by WS and EM together.</p>

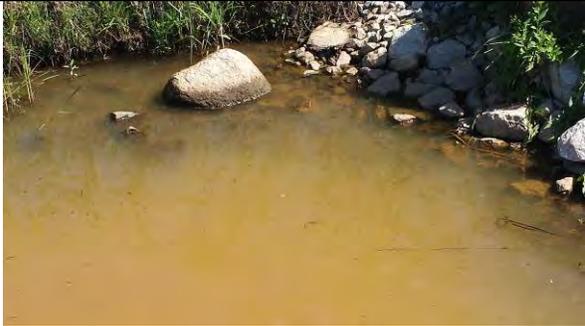
<p>All discharge point inspected. Outlet to CB11 water still brown. There is no flow into the area and no discharge to the adjacent wetland.</p>

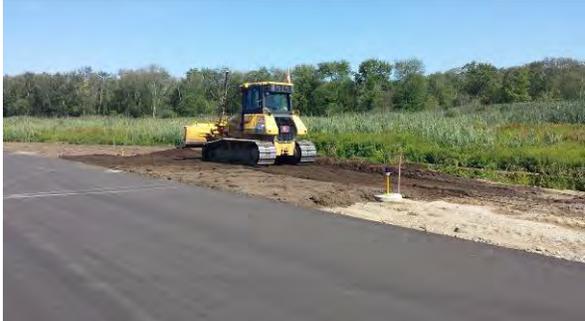
<p>ETL spreading loam along outside of of RW5 Taxiway A. All silt fence and hay bales inspected. All in place.</p>

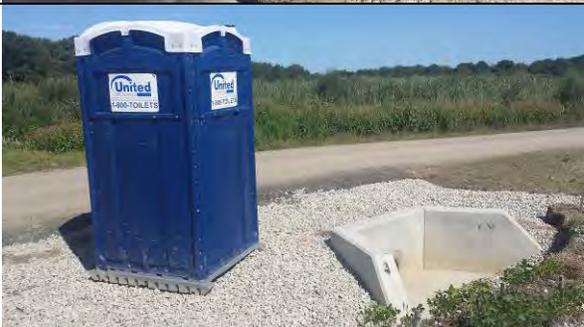
<p>Portable toilet was located at RW5 end of project. Location was next to cross culvert. ETL was asked to move it to a location more than 100 feet from a wetland or culvert.</p>

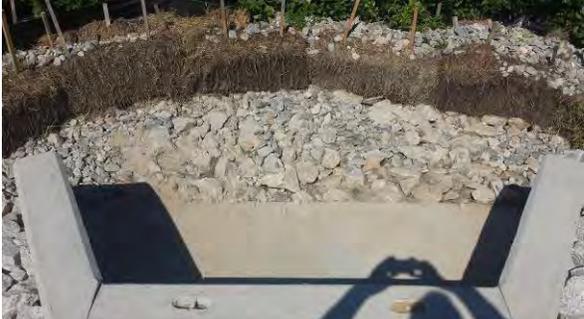
<p>Discharge locations inspected. No issues identified.</p>

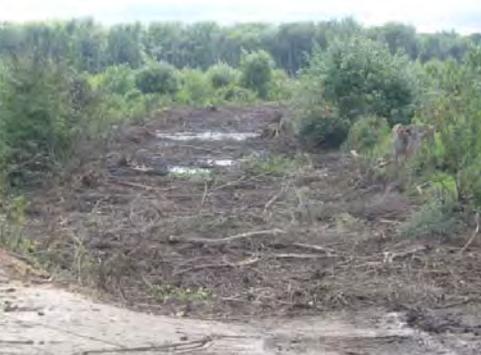
<p>Wetland Cutting Area: Wagner Wood finalizes removing the log mats. The section of wetland previously covered by mats showed no adverse effect.</p>

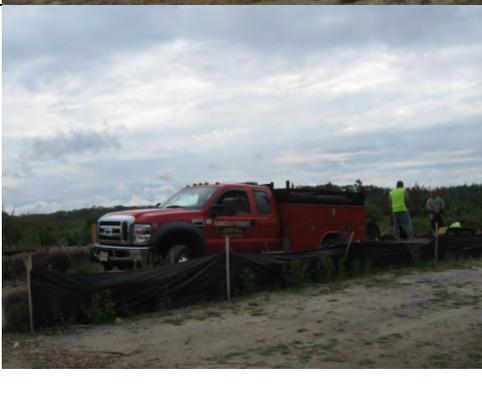
<p>ILS Road: Ramco arrives at 7:00 am. The crew loading up socks to install along the ILS Road.</p> <p>Either sock or Silt fence is planned for both sides of this road.</p> <p>Based on the amount of log and tree top twitching that occurred on this road, the biomass chip installation worked effectively. No migration of soils occurred.</p>

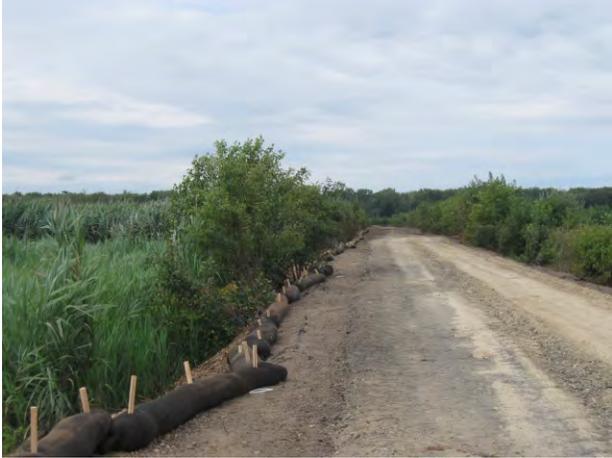
<p>ILS Road: Socks installed. Ramco will return on Monday to finish the remaining bmp installation with silt fence.</p> <p>Two repairs to two individual areas will be made to the existing silt fence and bales in the future MALSR areas along this road. Approximately forty feet will be improved upon.</p> <p>Lastly, the graveled pad (off the new Planeville Road/RW23 End) will have excelsior matting placed on the steep slopes.</p>

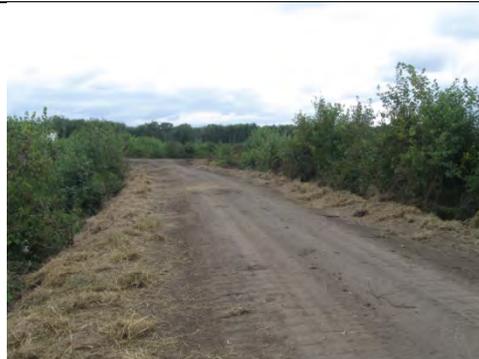
ILS Road: The seed was then covered with a thin layer of mulch.

As this section of road will no longer be used, this bmp measure was considered adequate given the minimum potential for erosion and also approved beforehand by the New Bedford Conservation Administrator.
