August 11, 2014

Subject: New Bedford Regional Airport – Phase 4
Reconstruction, Mark and Grove Runway 5-23
Re: Silt Fencing Issue – West Ditch Monitoring

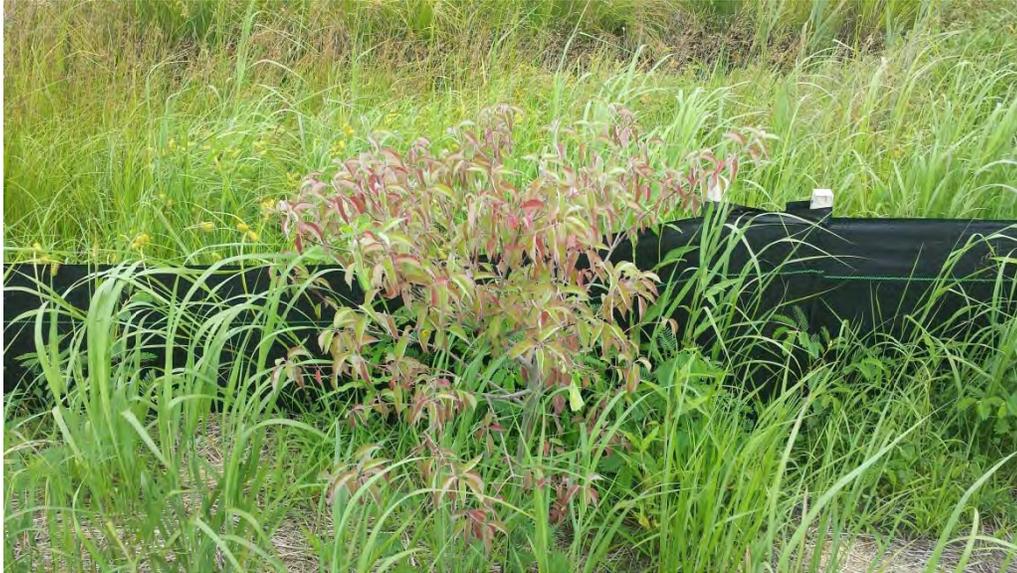
All areas are vegetated or stabilized with hay mulch. 53 of the 55 shrubs are alive.

View of buffer looking toward West Ditch.

The area is stable and no further remedial actions are recommended with the exception of replacing the 2 dead shrubs.

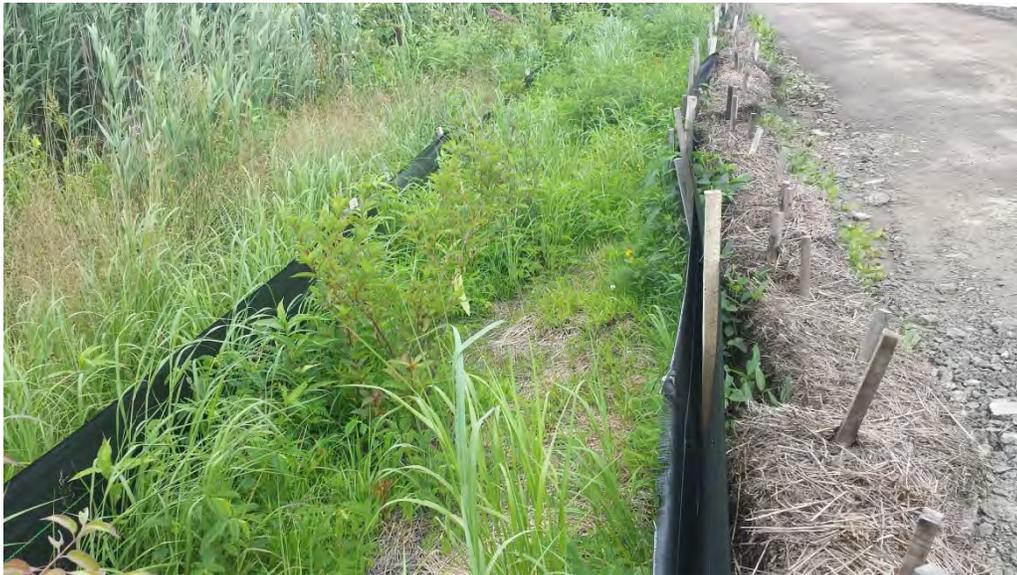
Additional view of buffer area.
