JM Fiske Environmental

NEW BEDFORD REGIONAL AIRPORT
RUNWAY 5-23 – PHASE 4

Partial Weekly Environmental Report

WEEK 19

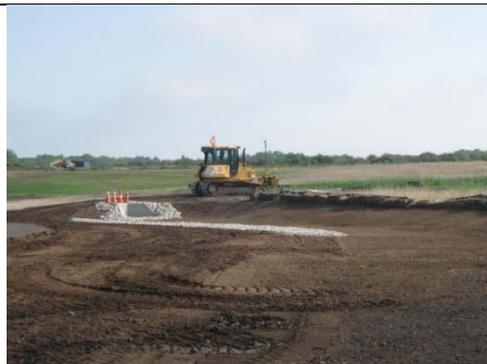
RW23 End; Headwall at foot of Access Road;
Inlet Side: Final loaming.

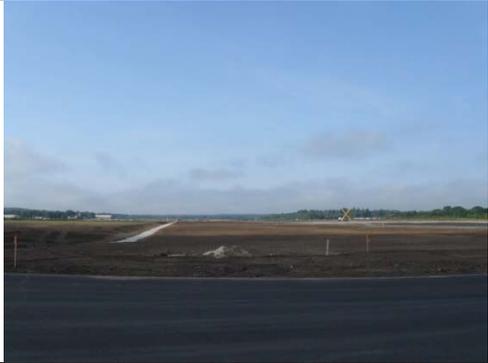
<p>Area between RW23 and the Taxiway: Final loaming.</p>

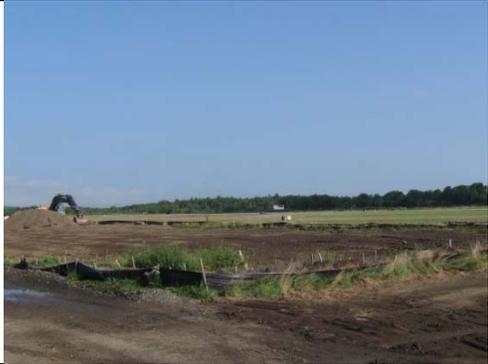
<p>RW5 End: ETL Parking/Equipment Storage Area: Southern end was loamed.</p>

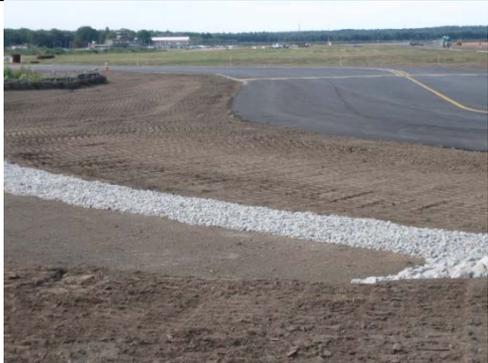
<p>RW23 End; Headwall at foot of Access Road; Outlet Side; Discharge swale looking south: Area is all loamed</p>

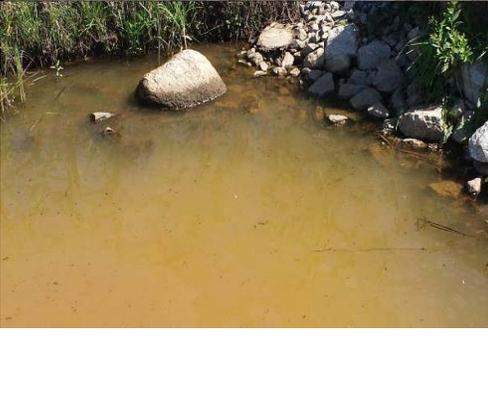
<p>RW5 End: The discharge area from CB11 remains turbid. Once the area adjacent CB11 is fully stabilized, this discharge area will need to be dewatered and cleaned. The limited flowage that is reaching the adjacent wetland through the silt fence//hay bale and stone combined bmp is clear.</p> <p>At all other discharge points, flowage is either clear or storm drains have been temporarily sealed.</p>

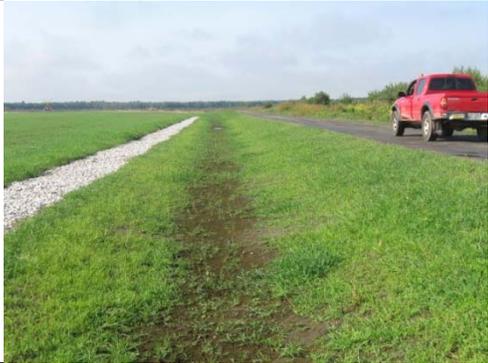
<p>RW5 Side: The Drainage Swale adjacent the Access Road: Several sections at the bottom of the swale did not germinate. These sections should be hydro-seeded before the on-site hydro-seeding is finalized.</p>

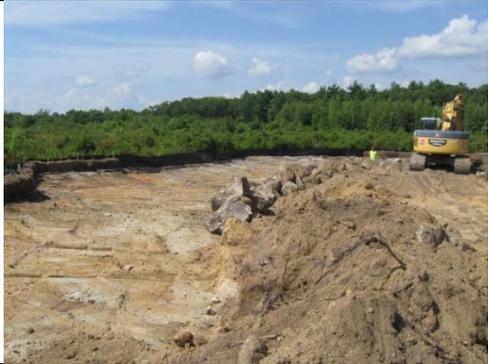
<p>Mitigation Area: Excavation progress by ETL (3:30 pm Tuesday)</p>

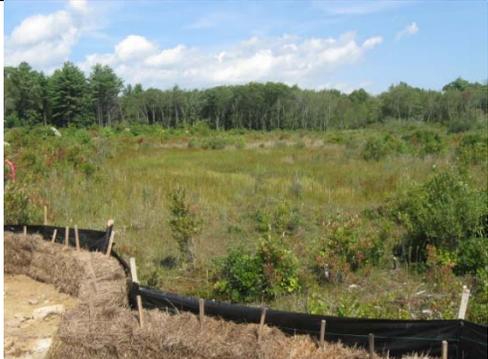
<p>Mitigation Area: The elevation at the surface of the adjacent wetland was measured at 89.0 feet.</p>

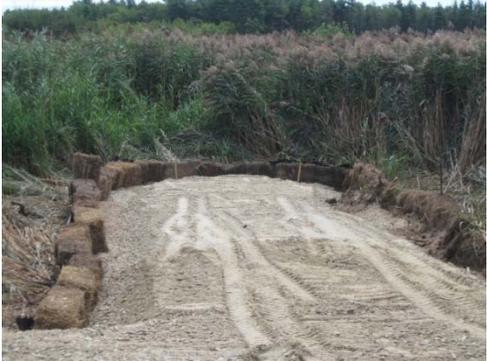
<p>Adjacent the ILS Road; MALSR pad; Depth of gravel was increased.</p> <p>A BMP repair was completed including replacing a section of silt fence, properly toeing-in, and replacing a row of hay bales. .</p>

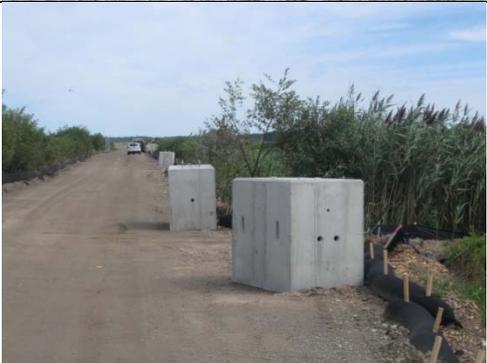
<p>Adjacent the ILS Road; Footings being positioned at each MALSR pad. .</p>

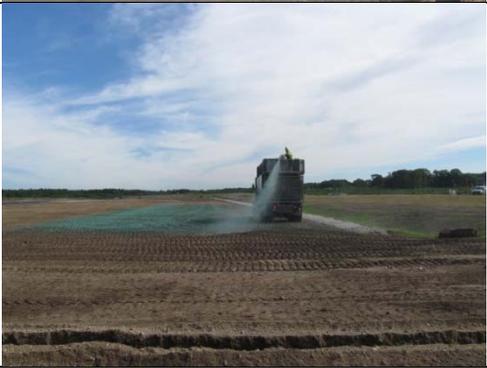
<p>RW23; Southside of RW; Looking northeast: Hydro-seeding being completed.</p> <p>A new trench for some additional electrical work at forefront of photo.</p> <p>Hydro-seeding occurred this past Saturday as well (two trucks).</p>

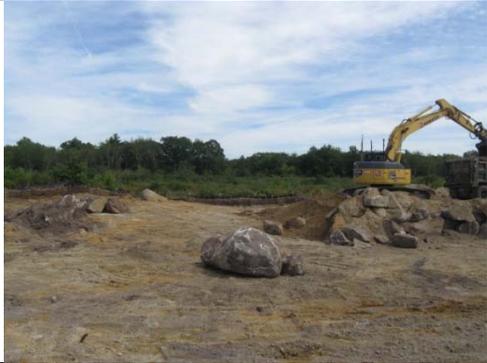
<p>Mitigation Area: Excavation continues. Progress is slow due to the number of boulders being unearthed. The rough grade is being temporarily established at 88 feet. The pit and mound topography will be formed from this elevation.</p>

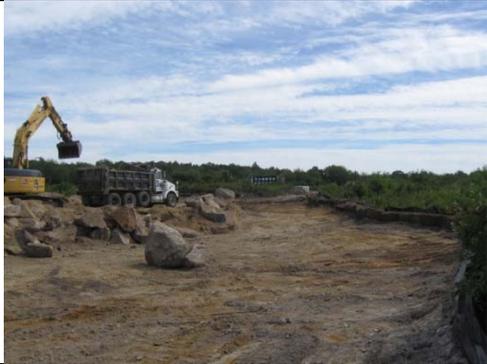
<p>Mitigation Area: Some stones have been left within the excavation to help accentuate future habitat value.</p>

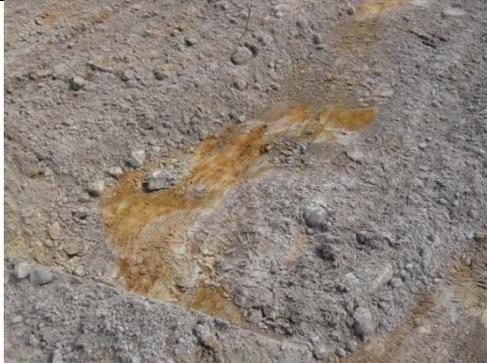
<p>Mitigation Area: Mottling was evident at the 88 foot elevation</p>

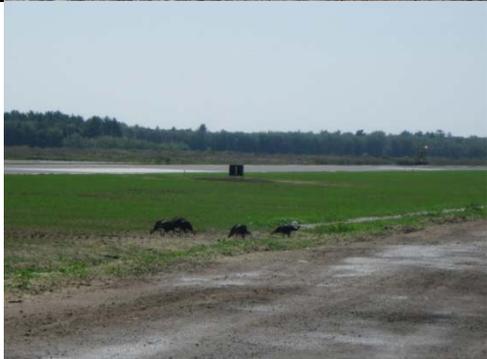
<p>RW5: Seed predation by the resident turkey population.</p>

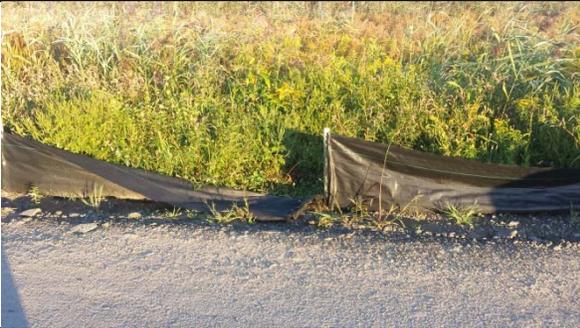
<p>During early morning turtle sweep a torn section of silt fence along access road was identified. It was immediately repaired.</p>

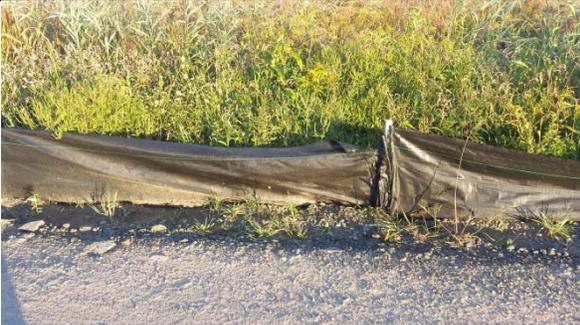
<p>Photo of the repaired fence</p>

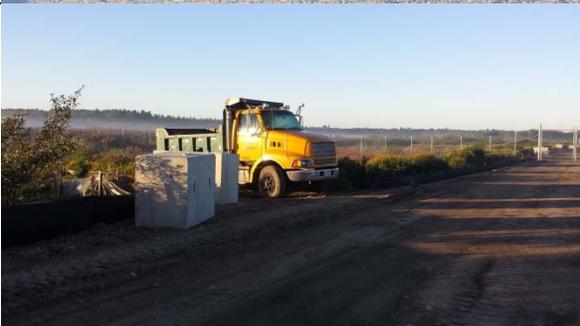
<p>Some equipment was left over night. ELT and sub-contractors were reminded that no equipment was to be left overnight within 100 feet of wetlands.</p>

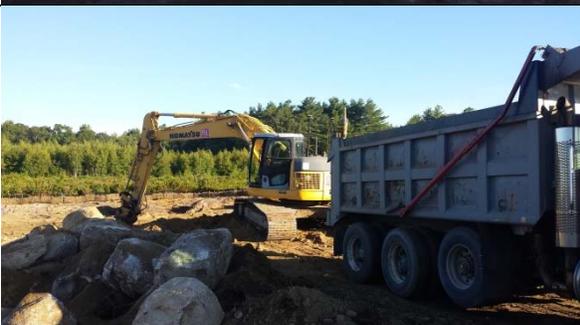
<p>Excess material continues to be hauled away from the wetland replication area.</p>

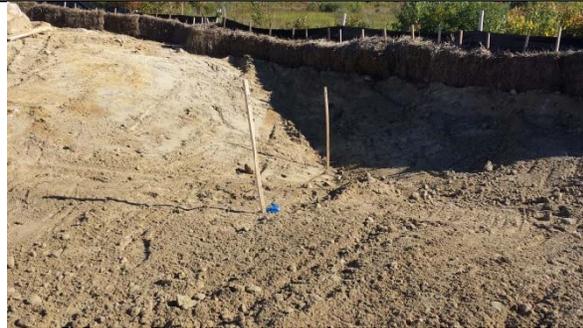
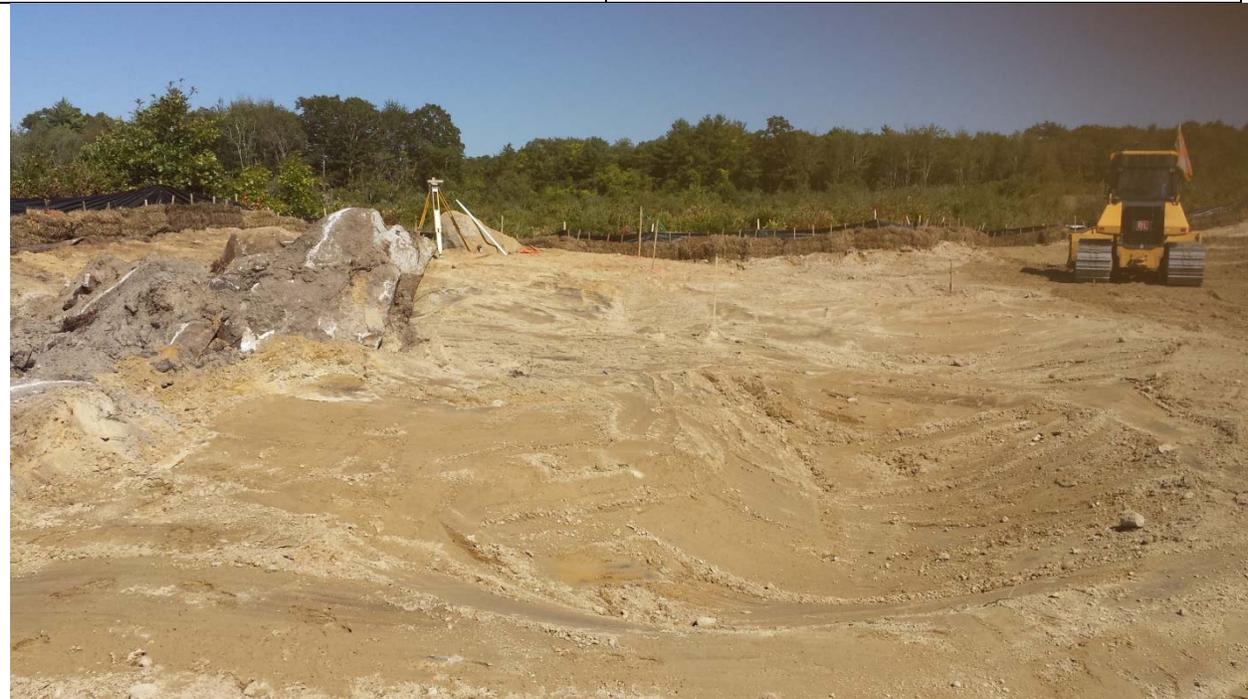
Elevations were re-checked. A series of pit and mound was excavated to subgrade. The result was reviewed with the EM. Elevations were agreed to be good. The spacing of 20 feet on center between mounds was determined to be too close with a 2 foot height difference. The next set was put 30 feet on center. This was determined to be a maximum distance between mounds. The final grading was to vary the distance from 20-30 feet on center and vary the sizes of pits and mounds.

At the end of the day 4 pits were excavated and boulders were placed based on the locations of the pits and mounds and the edge of the wetland replication area.

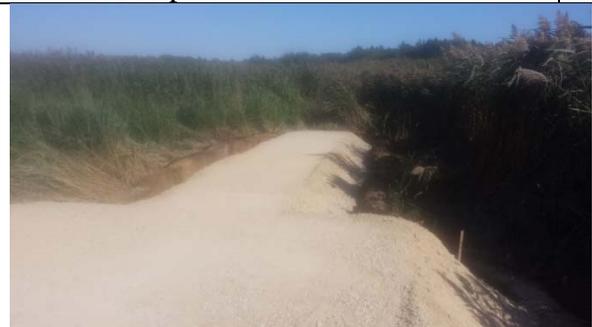
ILS Road inspected at end of day. No equipment stored. Moulison placing light bases in preparation of installation tomorrow.

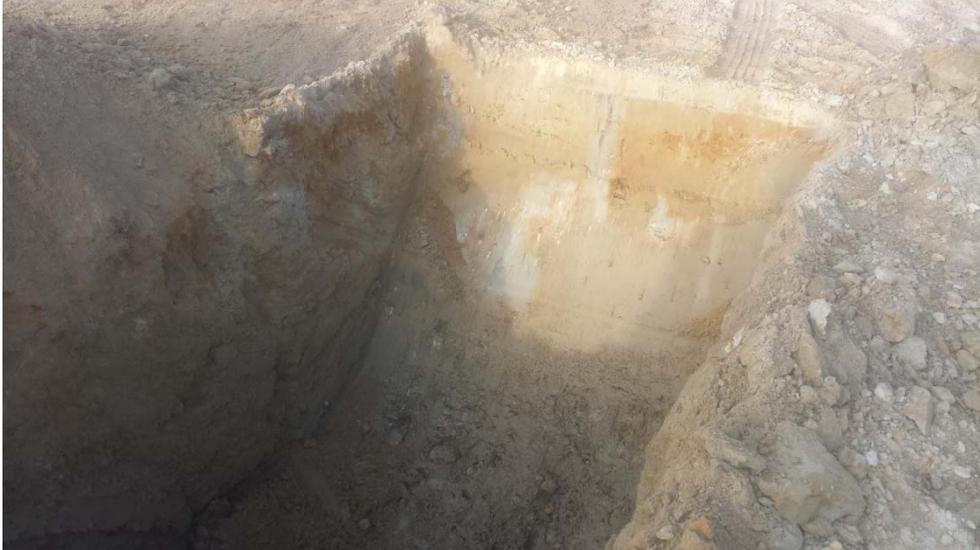
A deep test pit was dug below the preliminary excavation. Redoximorphic features were strong throughout the profile. Free water was encountered at 2 feet below the excavation and saturation was approximately 18” below.

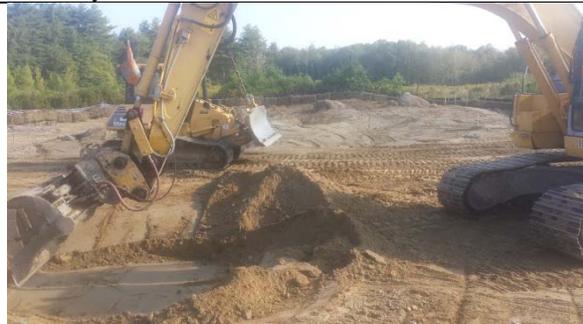
In discussions with the EM on site it was decided to make one or two of the pits to be slightly larger in size to help promote the establishment of coastal swamp amphipods. Preparation is being made to collect material from known sources to seed the area.

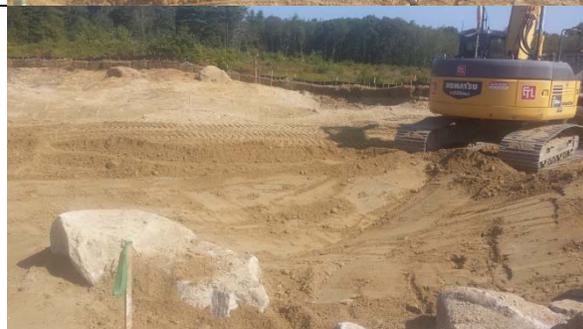
Selected large boulders were placed within the wetland replication area per plan and specification.

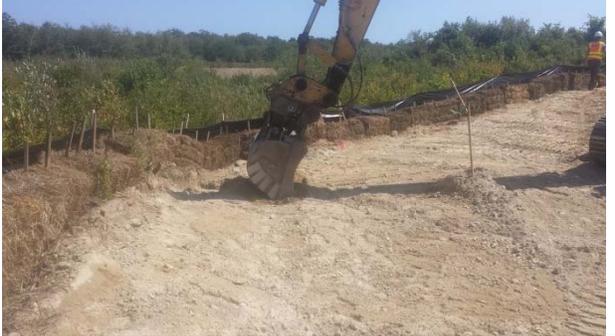
<p>A more linear depression was dug adjacent to a small cattail area to ensure good surface hydrologic connection.</p>

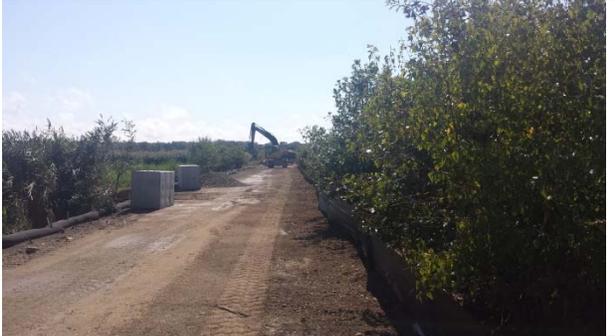
<p>Electrical work on the ILS road was inspected. Several light bases were installed today. The work required NO dewatering for installation.</p>

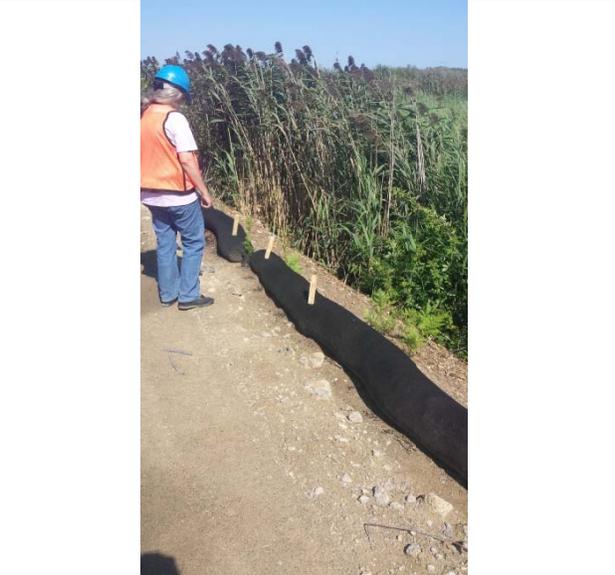
<p>BMPs along ILS road were inspected during the weekly tour of the site with Sarah Porter. Most of the BMPs were in good condition except as noted below.</p>

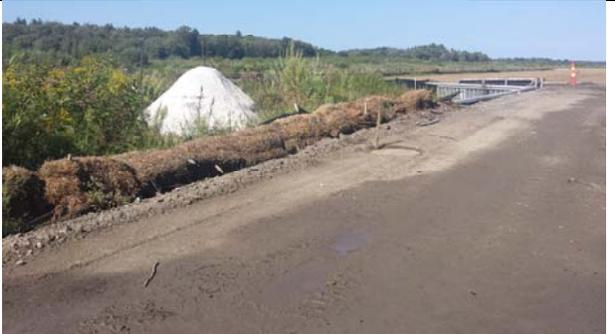
<p>Two sections of silt fence and hay bales have been knocked over. These are located near the West Ditch culvert. There is no water quality issues associated with this. ETL has been notified and will repair on Monday.</p>

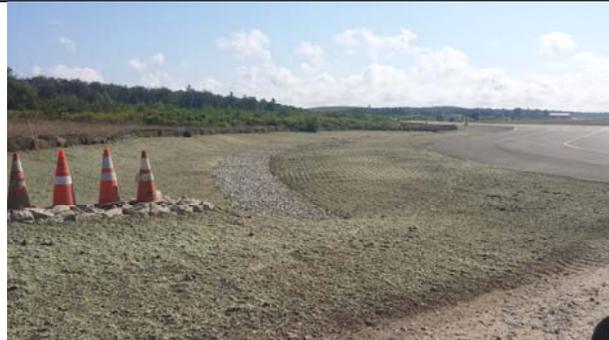
M.O.N. Landscaping was on site today and has completed most of the hydro-seeding on the RW23 side.

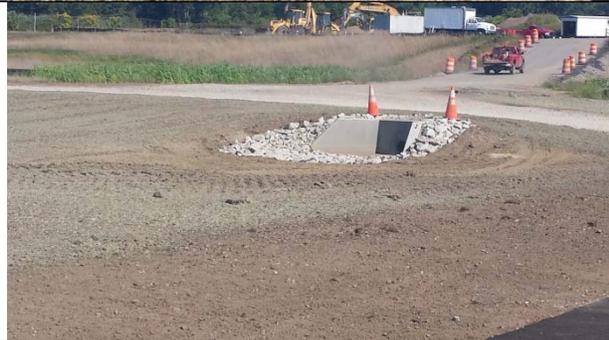
Stabilization of the cross culvert under the ILS road on the RW23 end was completed.
