NEW BEDFORD REGIONAL AIRPORT
RUNWAY 5-23 – PHASE 4

Reconstruct, Mark, and Groove

Partial Weekly Environmental Report

WEEK 20

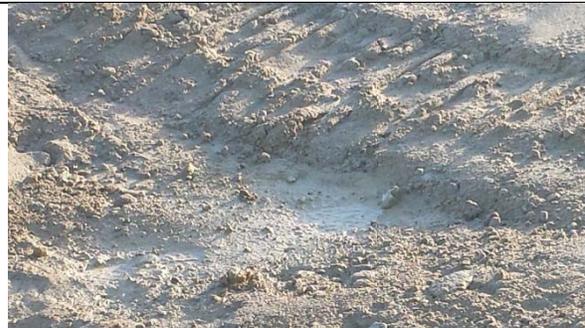
The site received 0.28 inches of rain Sunday night. The bottoms of the pits were saturated in the wetland replication area

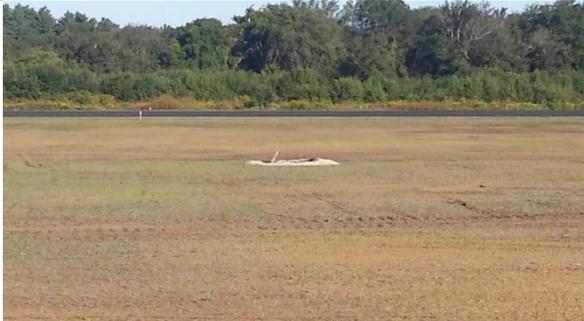
<p>Grass continues to germinate on hydro-seeded areas. This is a view of the area round CB 11 on the south side of RW5</p>

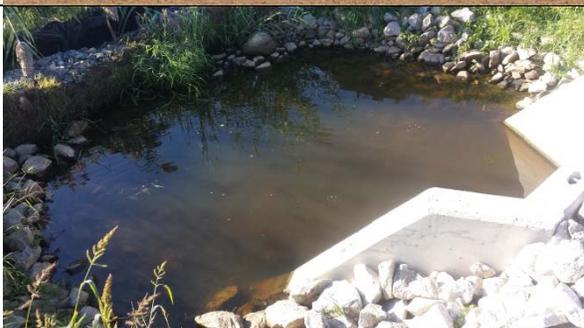
<p>Culvert outfalls were inspected. All were clear with only a brownish tinge to the CB11 outfall.</p>

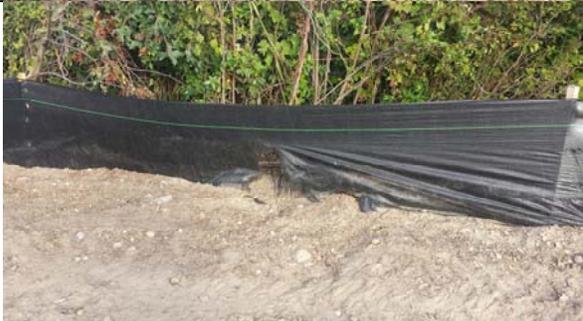
<p>A section of silt fence on the ILS road RW5 end was identified that had a tear in it. ETL was notified and was scheduling a crew to repair it.</p>

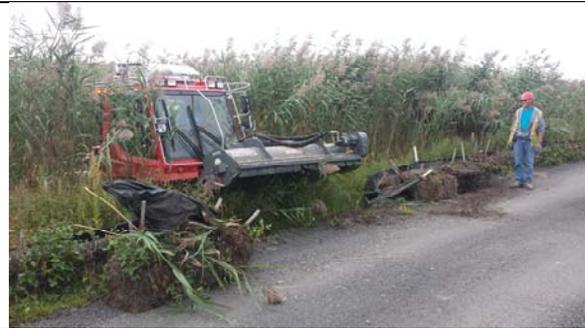
The airport brought out its phragmites mowing machine and had to breach the perimeter controls in several places. The fencing was repaired after they crossed.

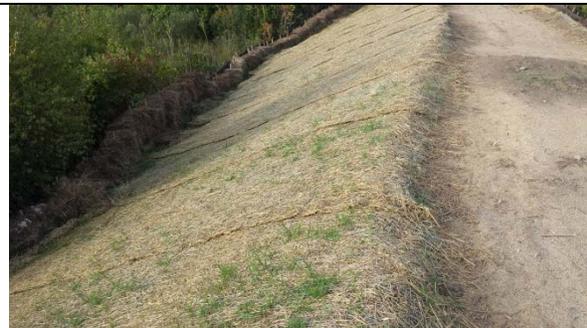
The RW23 end ILS road was inspected. The fill area for the last MLSAR is stable and grass has germinated on the slopes.

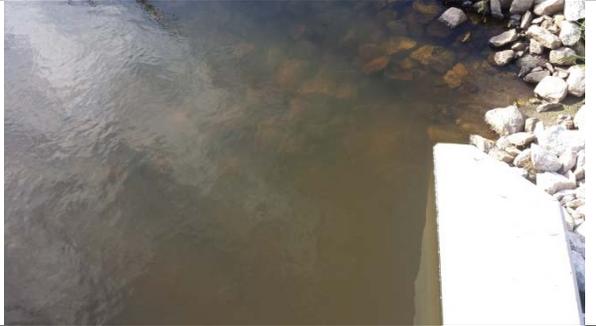
<p>Stormwater outfalls were inspected. All were clear or dry.</p>

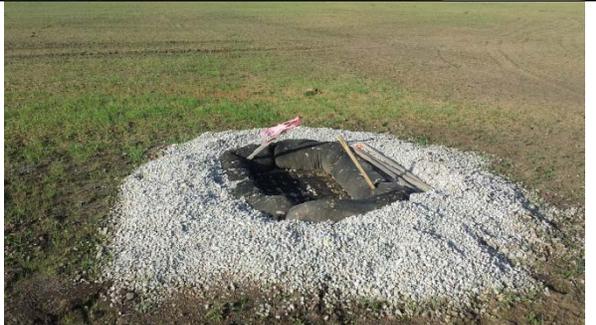
<p>Catch Basin protection was inspected and all were in good working order.</p>

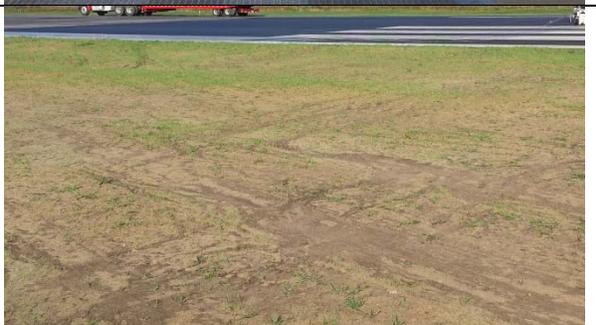
<p>Some areas of concentrated flows causing rilling in the hydro-mulch were noted. The seeding will be monitored and areas where germination is weak will need to be redone.</p>

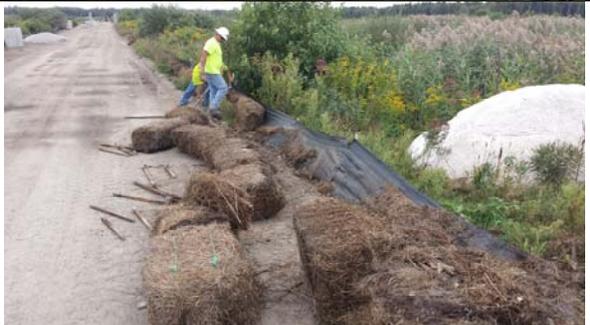
<p>Hay bales and silt fence that had been knocked down on the RW5 ILS road were repaired. No water quality issues occurred because this was down.</p>

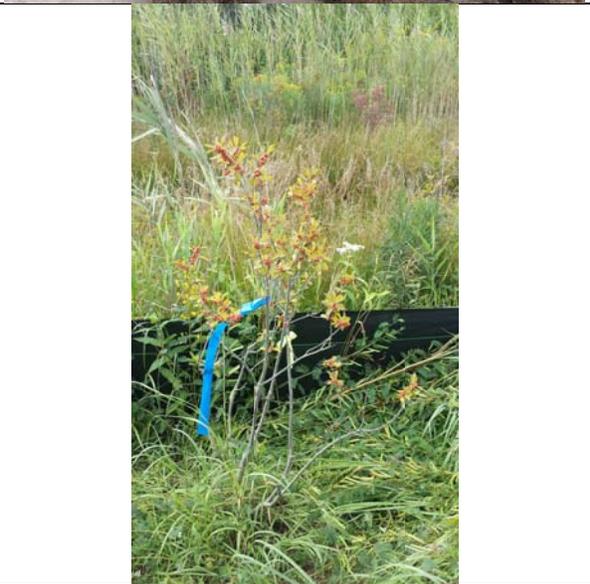
<p>Shrubs along the West Ditch buffer that were impacted when the silt fence was installed were re-identified. They were marked with more visible blue flagging and each of the plants was rated for height and health. The results will be reported in a separate report.</p>

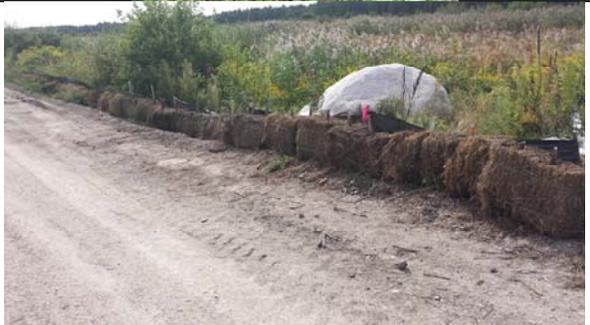
<p>View of the repaired silt fence and hay bales along the ILS road</p>

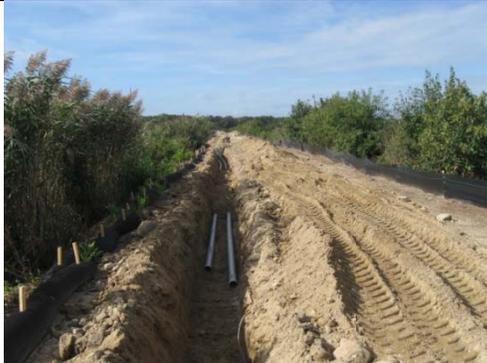
<p>RW 5 Side; ILS Road; Conduit being installed; The adjacent erosion control bmps are preventing migration of disturbed soils to the nearby wetlands.</p>

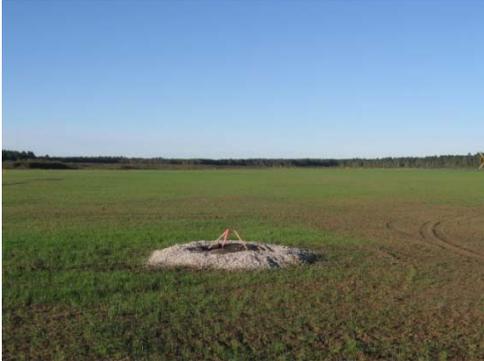
<p>RW 5; CB 11; The area surrounding CB 11 has germinated well. It has been recommended that the discharge outlet be de-watered and cleaned of any excess sediment.</p>

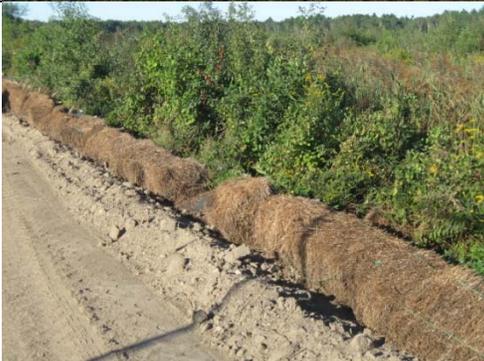
<p>RW 5; ILS Road; a 30 to 35 foot section of silt fence along this road needs to be repaired. This section is situated just beyond the wildlife gate on the north side. It has been scheduled for repair w/ETL for early next week.</p>

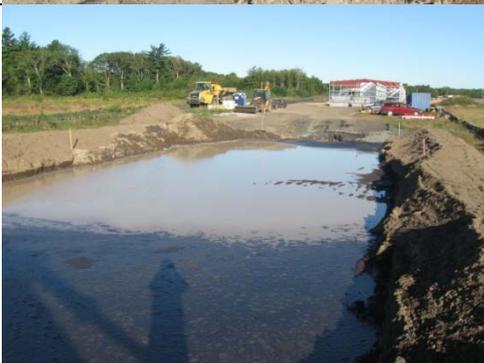
<p>RW 5 Side; Earlier ETL Equipment/Parking Area; Dewatering Basin; RW tailings/slurry are being properly contained here.</p>

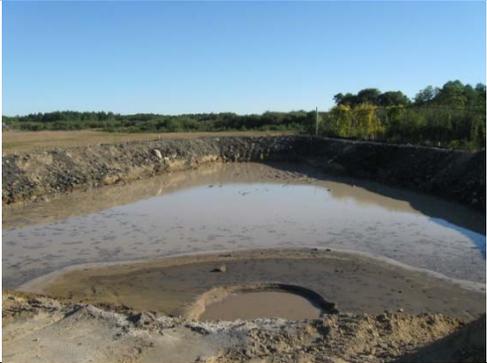
<p>RW 23 Side; Earlier ETL Equipment/Parking Area; Dewatering Basin; RW tailings/slurry are being properly contained here.</p>

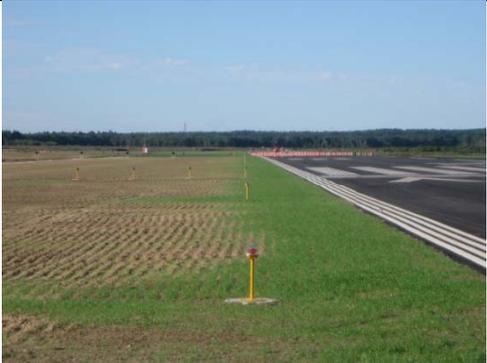
<p>RW 23; RW lighting in place on the south side of RW 23. There is no evidence of the previous ditch line and the surface area is well grassed.</p>

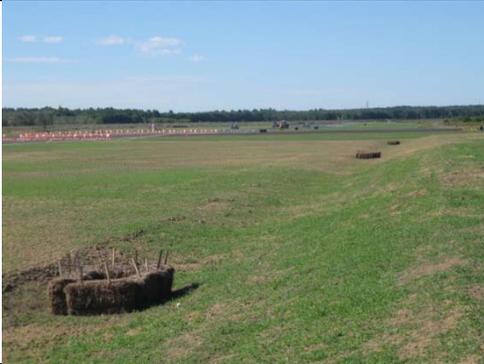
<p>RW 23; Drainage Swale; North side; Three storm drains are positioned here. These have been scheduled for inspection next week with Frank and ETL.</p>

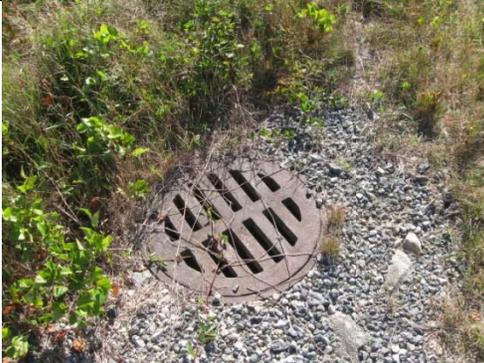
<p>RW 23; Between the Drainage Swale and Northern Silt Fence Perimeter; Two other storm drains were noted – both contained sediment. It is unclear at this time if these two storm drains are connected with the storms drains in the last photo. If there is a connection (i.e., not abandoned), these two storm drains should be cleaned.</p>

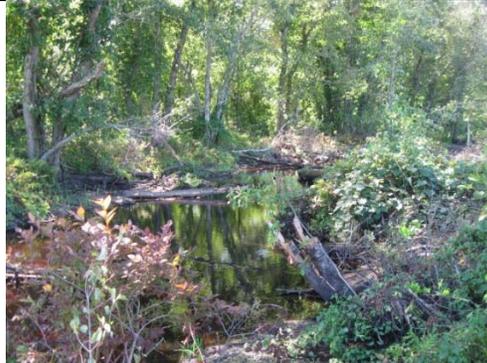
<p>RW 5 Side; The Wetland Cut-Area; The area adjacent the river was inspected. There is no evidence of soil migration from the cut area towards the river. The surface water within the river was crystal clear and there was no evidence of any adjacent erosion.</p>

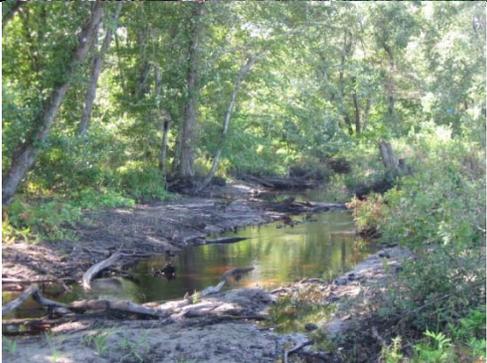
<p>RW 5 Side; The Wetland Cut-Area; A second area adjacent the river was inspected. Again, the water was very clear with no evidence of any soil migration.</p>

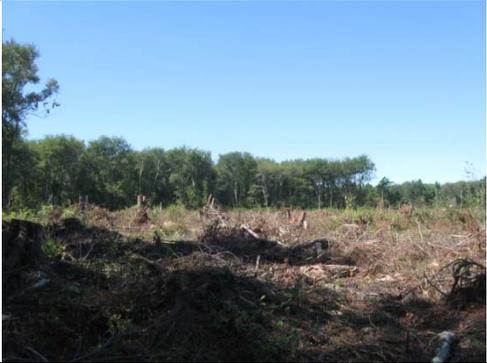
<p>RW 5 Side; The Wetland Cut-Area; The Area immediate adjacent the river; A very thick layer of logging debris/brush is evident. This layer not only covers any exposed soils but would slow any movement of water that occurs. It was also noted that a new herb layer was becoming established.</p>

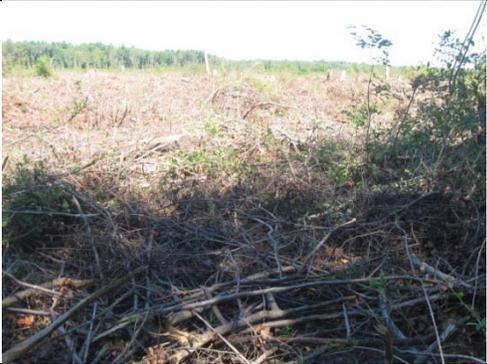
<p>RW 5 Side; The Wetland Cut-Area; The Area immediate adjacent the river; This photo shows a close-up of the remaining logging residue. In many places it is piled two to three feet thick. It is difficult to see how existing soils would become mobile and be a potential issue here.</p>
