NEW BEDFORD REGIONAL AIRPORT  
RUNWAY 5-23 – PHASE 4

Reconstruct, Mark, and Groove

Partial Weekly Environmental Report

September 13 to September 19, 2014

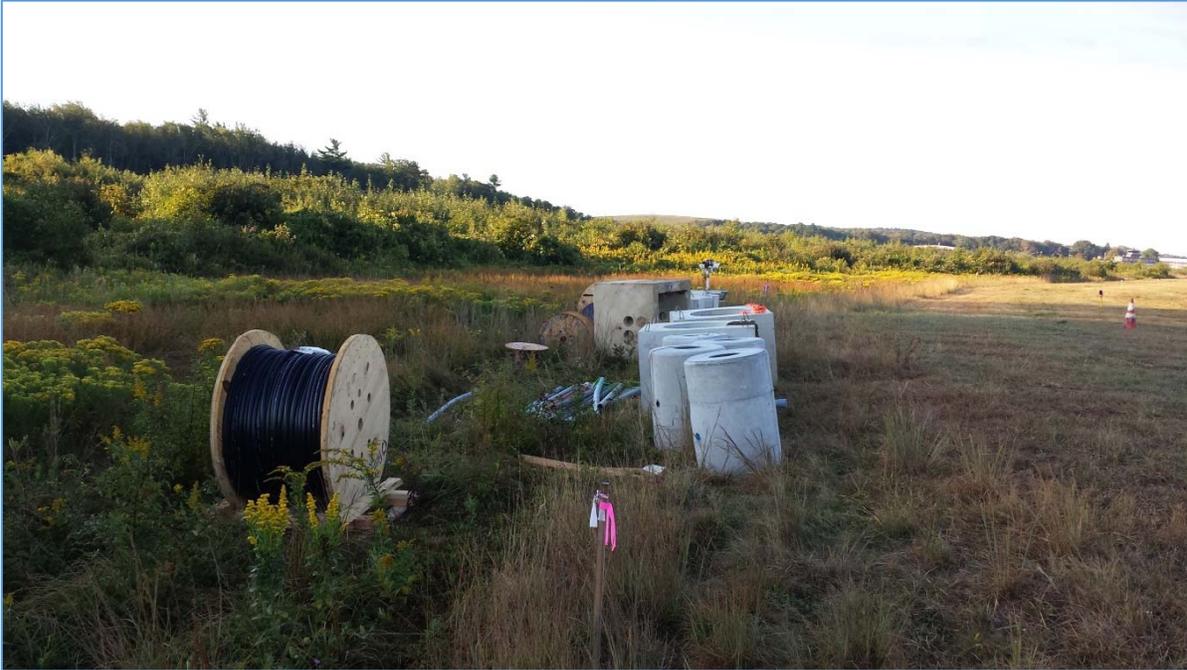
Over the weekend we received a report of a wetland encroachment. Upon investigation on Monday AM we identified several electrical structures and associated materials placed along the wetland boundary by RW23 – Taxiway A, just past the southwest end of the silt fence. Several of the concrete structures were just over the line and a spool of electrical wire was approximately 4 feet into the wetland.

The wetland at this time is dry and consists of low herbaceous vegetation. There was no evidence of water quality issues related to this encroachment.

The electrical contractor was immediately notified and had the materials removed. Equipment did not need to enter the wetland to retrieve the material. A visual inspection of the area shows no indication of soil disturbance or rutting resulting from the placement.

All materials were removed. No remedial action is required in this area. The wetland stakes were inspected and are in place.

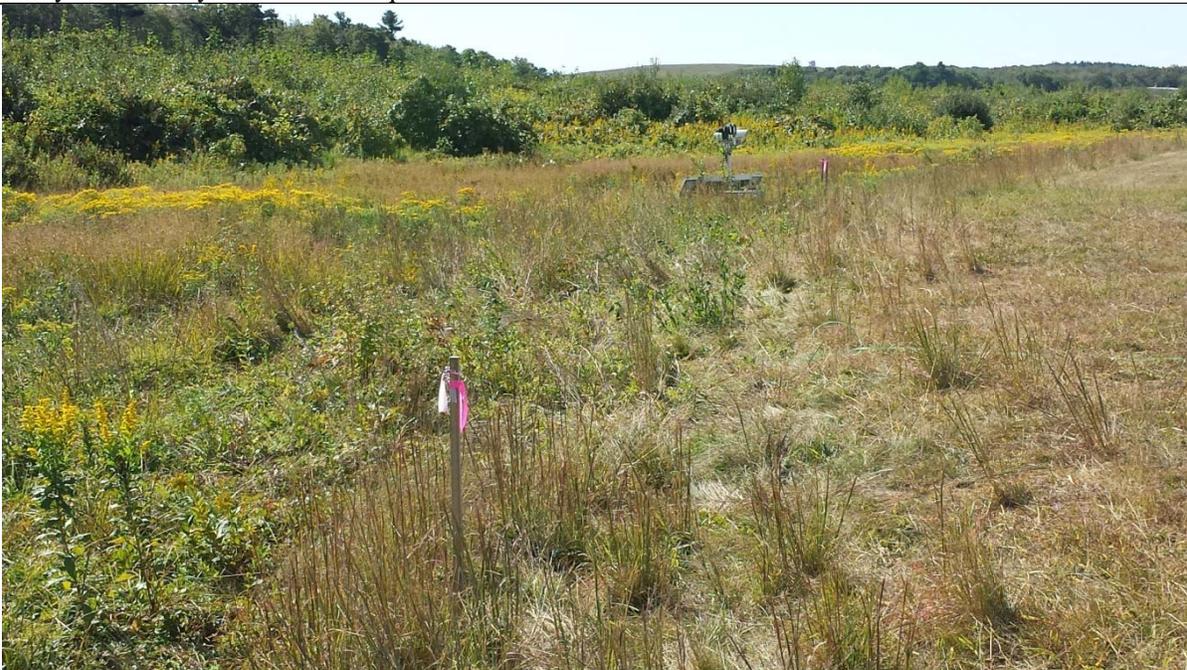
An inspection of Taxiway A on the RW23 end identified concrete structures and 2 spools of electric wiring that were stored in or immediately adjacent to the wetland along the edge of the Taxiway. This was placed here during the runway shutdown by the FAA that required all structures to be more than 250 feet off the centerline of the runway.

The electrical contractor was notified and the structures were immediately moved. The area was inspected and there are no signs of soil disturbance or rutting in this area as a result of the activity.

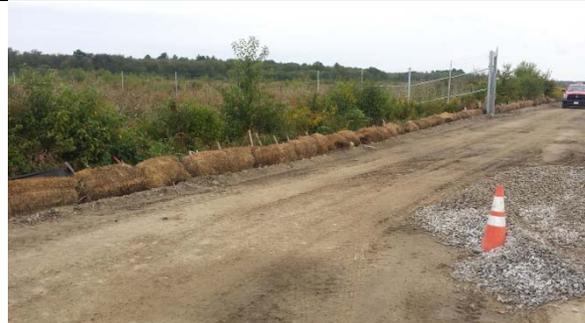
ILS Road and MALSAR inspections on the RW5 end were done. Several area of hay bales and silt fence along the ILS road need reset

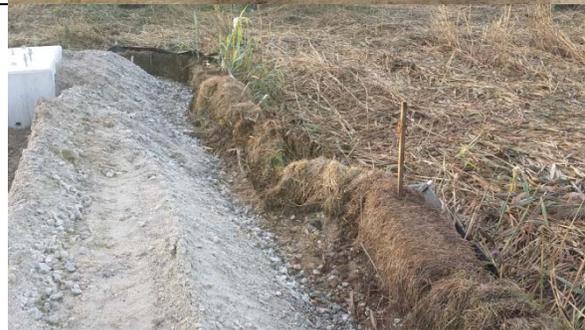
The MALSAR areas were functioning but will also need to be reset in several sections.

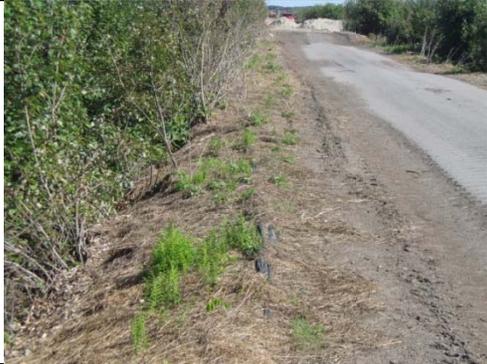
<p>RW 5; ILS Road; The most southern end; A herb layer is becoming established on edge of road.</p>

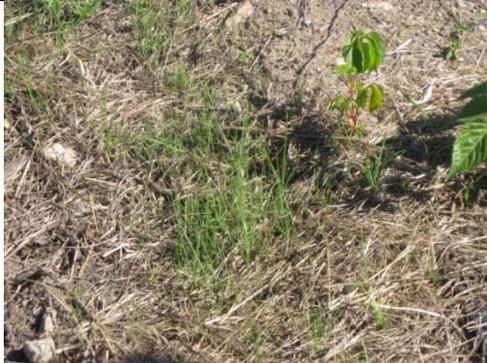
<p>RW 5; ILS Road; Southern end; Along the edge of road previously mulched and seeded, grass has begun to grow. Rain would benefit the seeded area.</p>

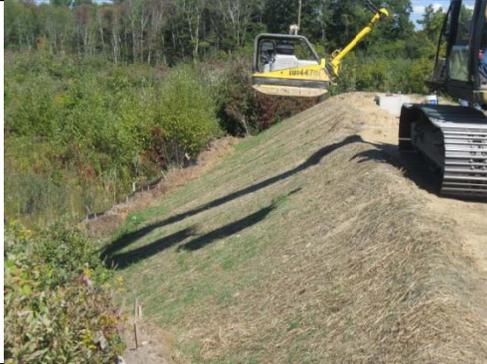
<p>ILS Road; off Plainville Road; MALSR End; green grass showing through previously installed blankets – no erosion was noted on any of the adjacent slopes</p>

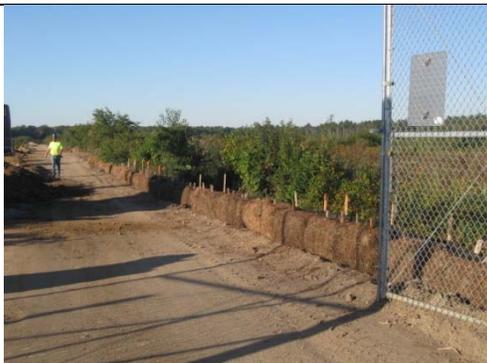
<p>RW 5; ILS Road; A 30 to 35 foot section of silt fence/hay bales was repaired late Wednesday afternoon by ETL</p> <p>The weekly 10:00 Field Office Meeting was held. Responsible for providing the Safety component</p>

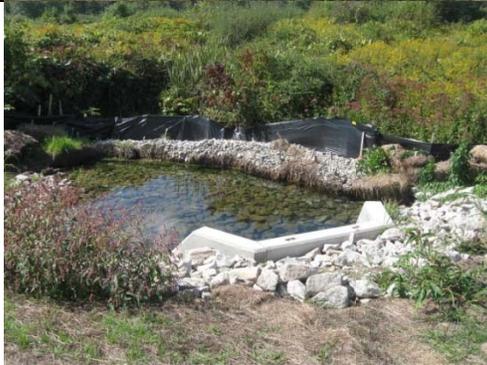
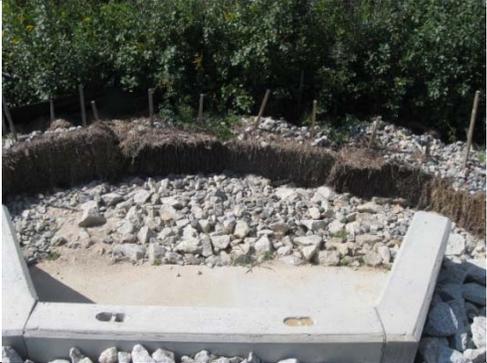
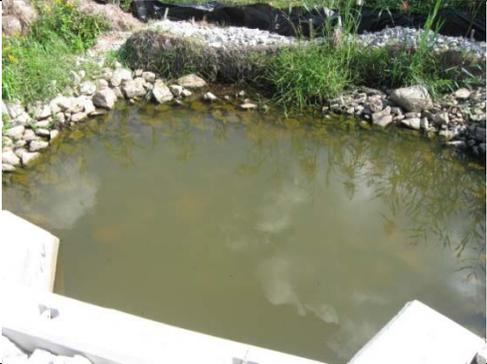
<p>RW 5 Side; All potential discharge points checked:</p> <ul style="list-style-type: none"><li>* Most northern headwall/outlet (along main access road) – the contained discharge was very clear</li><li>* More southern headwall/outlet (along main access road) – 2nd photo below - no discharge</li><li>* Headwall/outlet from CB11 – 3<sup>rd</sup> photo - some cloudiness but contained; This discharge point will be dewatered and the stone cleaned next week.</li></ul>

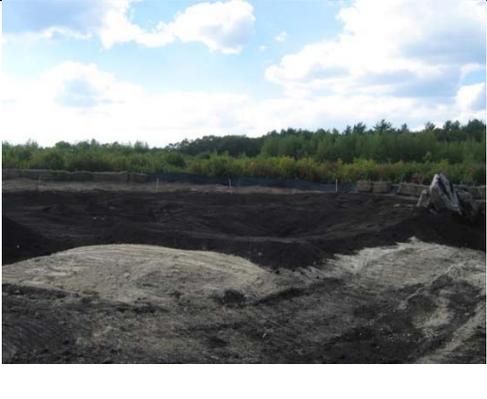
<p>Mitigation Area; late afternoon; more wetland soil installed. At least three truck loads are scheduled to arrive on Friday.</p> <p>2 pm Meeting with the New Bedford Conservation Administrator and Amanda. Viewed the RW 23 side, the Mitigation Area, and the ILS Road on the RW 5 side. During the review, it was noted that sections of silt fence needed repair – will coordinate repair with ETL</p>

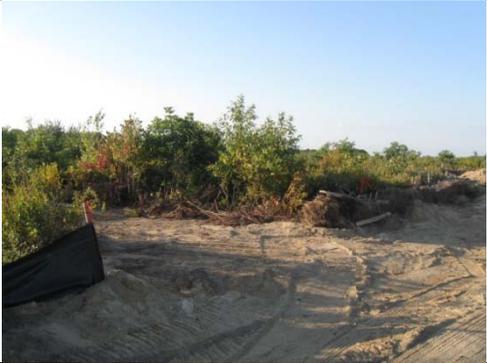
<p>ILS Road; off the Plainville Road; End of road; Some large boulders were removed from the edge of this road leaving a section without silt fence.</p>

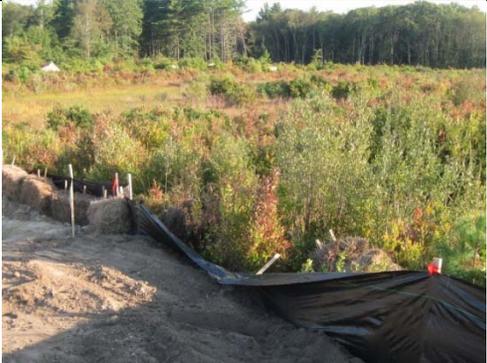
<p>Mitigation Area: A section of silt fence on the perimeter was noted sagging.</p>

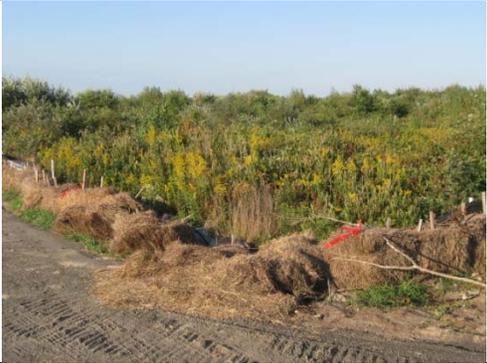
<p>ILS Road; Off the Plainville Road; Section of Road into the Mitigation Area; Due to the difficulty of backing into this area to deliver the wetland soils with a trailer truck, this section of hay bales was accidentally compromised. Trucking is scheduled to be completed on Monday and the repair will be made then</p>

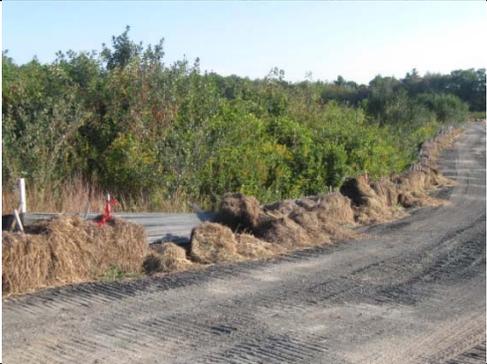
<p>ILS Road; Off the Plainville Road; Due to the narrow width of the construction work zone here, (new excavation is occurring immediately adjacent the road on the south), a stretch of hay bales along the silt fence was compromised.</p>
