NEW BEDFORD REGIONAL AIRPORT
RUNWAY 5-23 – PHASE 4

Reconstruct, Mark, and Groove

Weekly Environmental Report

WEEK 22

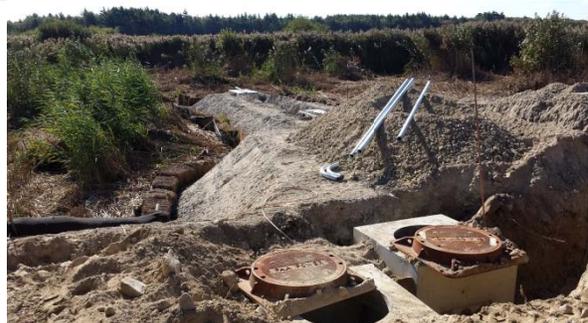
Work on th RW5 end this week focuses on finishing the conduit and ground installation for the MLSAR work and preparing the ILS road for paving.

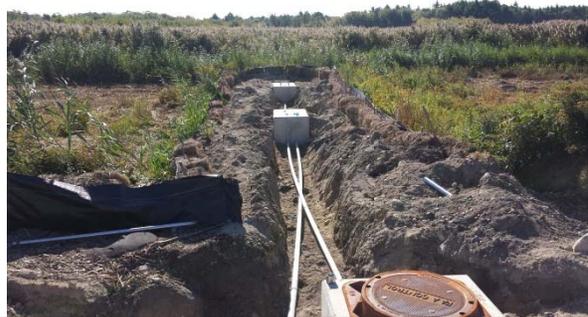
As part of the back filling work the electrical contractor will reposition some silt fence and hay bales. After the work is completed, ETL will come back through and fix any additional sections that need repair.

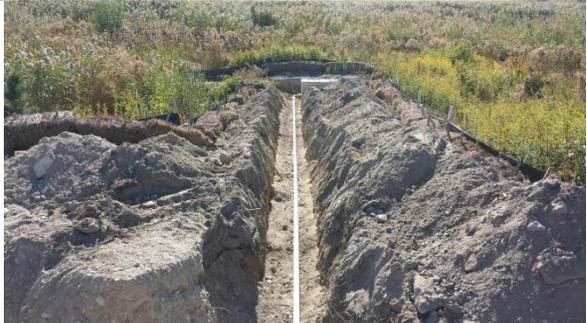
<p>Because of the narrow work area excavated material was up the side of some hay bales. The bales in very tight sections were leaning out. In no case was there any observation of sediment or materials outside the work zone.</p>

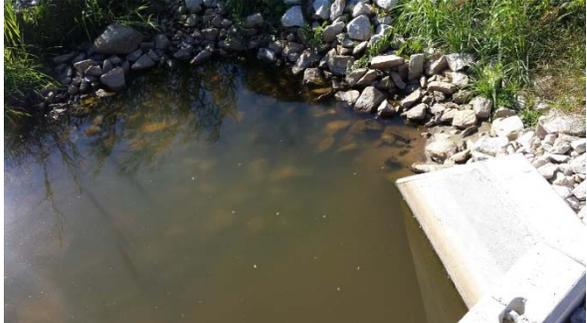
<p>Inspection of culvert outfalls showed clean water and no sediment discharges</p>

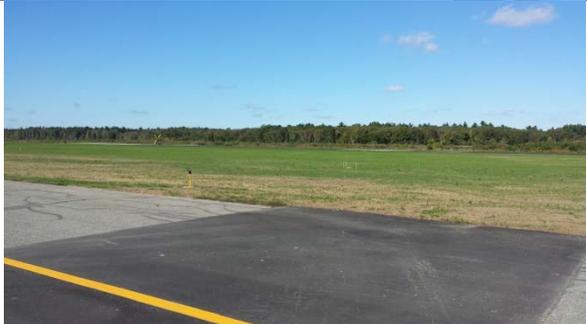
<p>Grass continues to become established along the sides of the runway.</p>

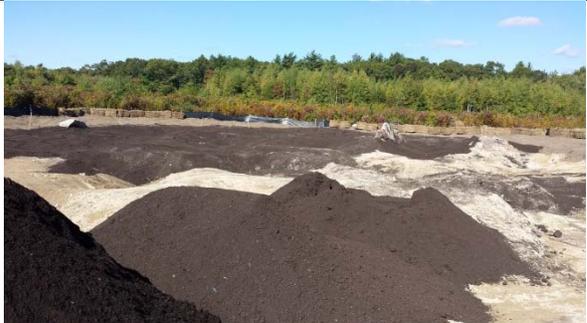
<p>Additional loads of organic topsoil were delivered to the wetland replication area. The site was not worked today.</p>

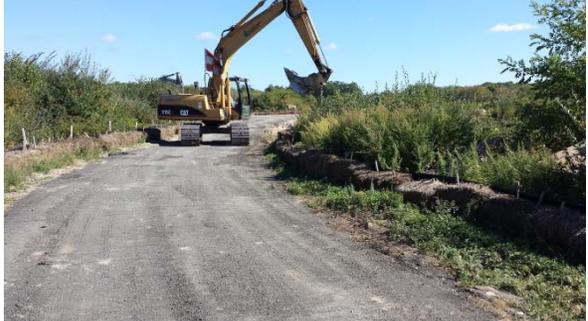
<p>Trenching and installation of conduit on the RW23 end MLSAR (across New Plainville Road) continues.</p>

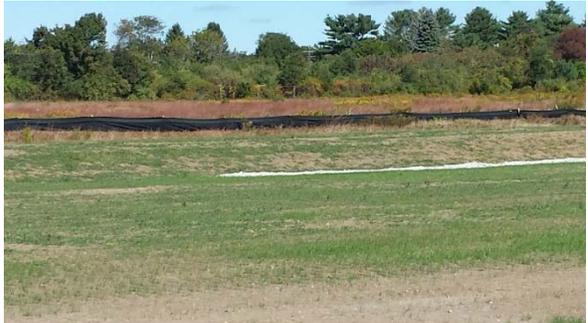
<p>WS conducted inspection of silt fence, vegetation growth and stabilization in preparation for project completion and removal of BMPs</p>

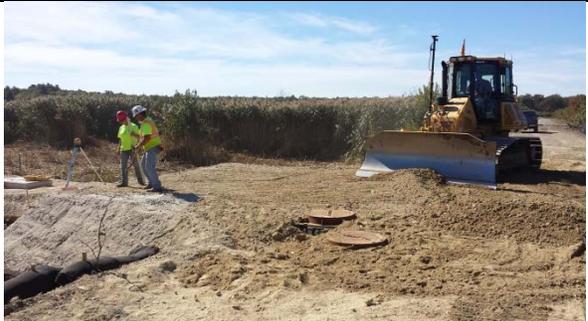
<p>Grading in preparation of paving at end of week commenced today..</p>

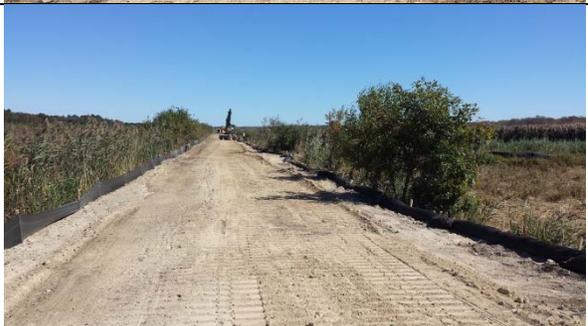
<p>Backfilling of conduit lines and MLSAR continues on RW5</p>

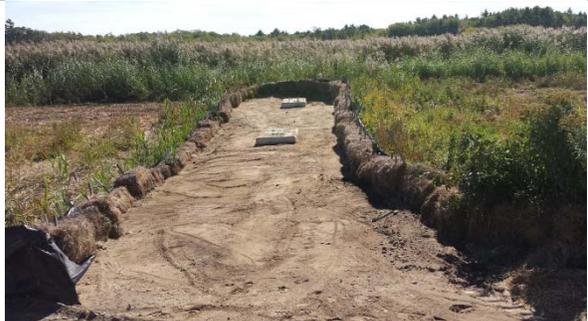
<p>RW 5 MLSAR area backfilled and completed. Hay bales and silt fence reset as needed. The area will have a layer of stone for final stabilization per plan.</p>

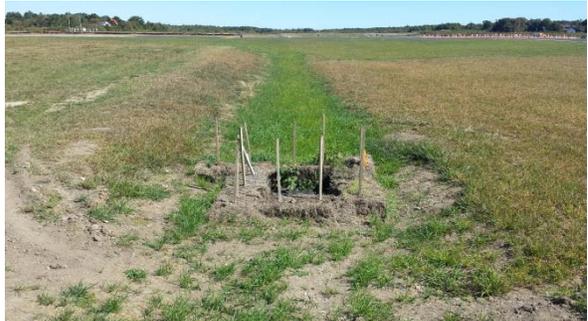
<p>Taxiway B was shut down for a portion of the day for additional painting and marking. During the shutdown, the catch basins and swales between the taxiway and runway 14-32 were inspected. Areas where the electrician trenched after the hydro-seeding will need to be touched up.</p>

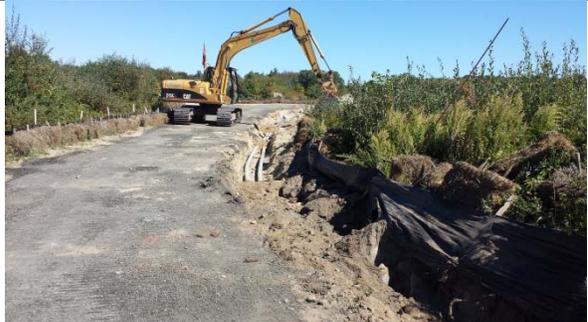
<p>Hay bales were removed along the silt fence on the RW23 access road across New Plainville Rd. The established construction zone was too tight to trench and this gave just enough room to work. The hay bales will be replaced as soon as the trench is backfilled and compacted.</p>

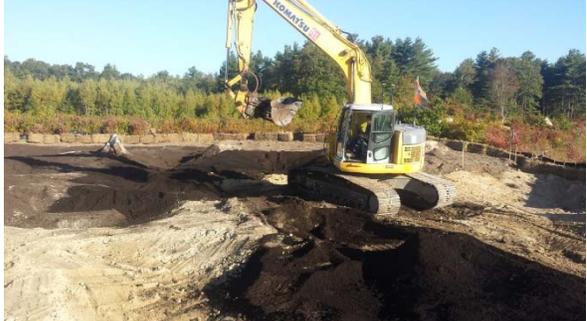
<p>ETL received several more loads of wetland topsoil yesterday and the excavator was on site to install.</p>

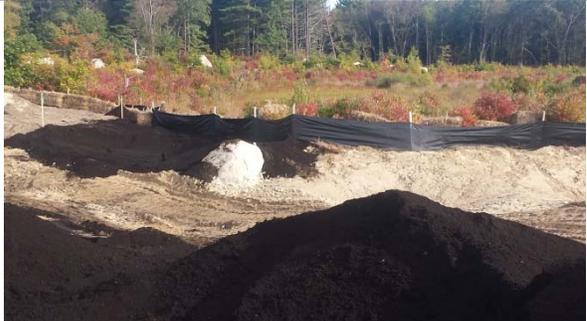
<p>In the Wetland Replication Area, hay bales were temporarily removed on the downhill side so that the wetland topsoil could be blended into the existing grade of the adjacent wetland areas.</p>

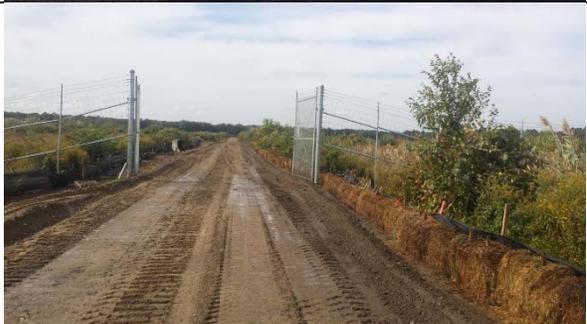
<p>Grading on the RW5 ILS road was completed in preparation for paving on Friday.</p>

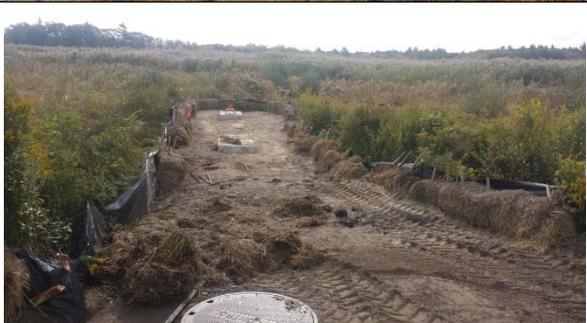
<p>Work on the RW5 MALSR backfilling continues. Some areas of hay bales will need to be replaced but the crew made sure the silt fence and where possible the hay bales were in place and functioning.</p>

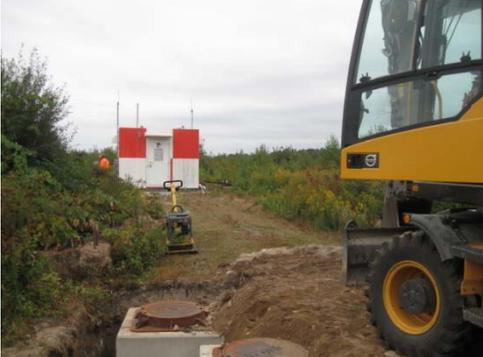
<p>RW 5; ILS Road; Spur Road to MALSR Bldg: Ditch to be excavated today for more conduit – this area is contained between silt fence and hay bales.</p>

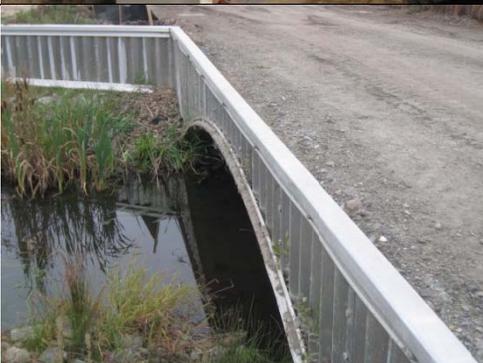
<p>RW 5; the Arch Culvert at entrance of ILS Road: Hard packed sediment has accumulated on the brim of the culvert (from the prior skidding of logs and biomass). As part of the final punch list this should be removed.</p>

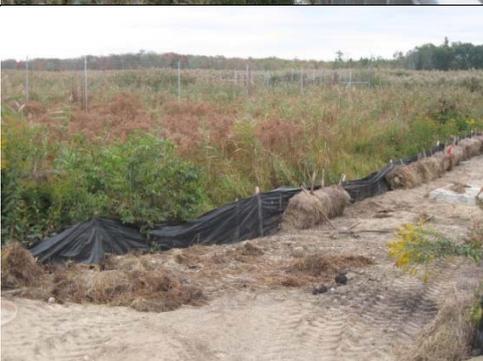
<p>RW 5; ILS Road; MALSR gravel pad; Recent excavation has encroached upon a section of silt fence. ETL was notified and a repair is planned for tomorrow</p>

<p>RW 5; ILS Road; MALSR pad; Silt fence repair completed (earlier photo). An extra effort was noted here by Pam and Mark of ETL as this required shifting a substantial of gravel w/hand shovels from against and the top of a toppled row of hay bales. New hay bales were installed and staked.</p>

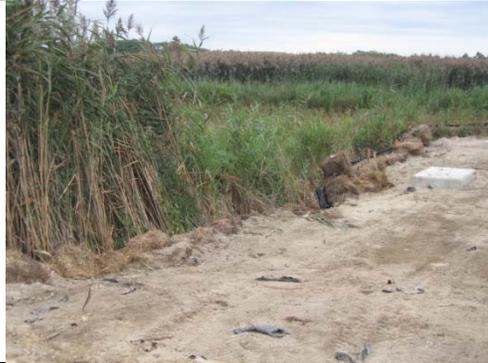
<p>RW 5; ILS Road; A second MALSR gravel pad; Recent excavation has encroached upon a section of silt fence. ETL was notified and a repair is planned for tomorrow</p>

<p>RW 5; ILS Road; MALSR pad; A second silt fence repair was completed at a second MALSR pad. Old bales that had been damaged by the earlier excavation were replaced and double staked.</p>

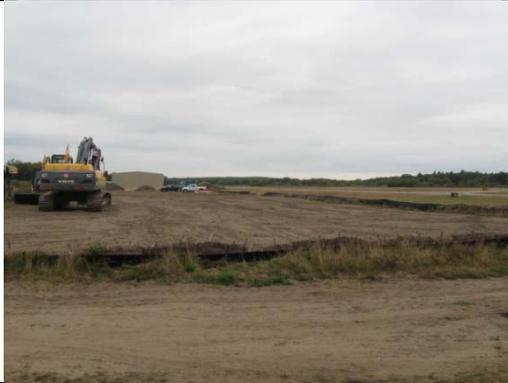
<p>RW 5; The earlier ETL Equipment and Storage Area used as a temporary dewatering basin: The RW grindings have been hauled away, the basin filled in, and loamed.</p>

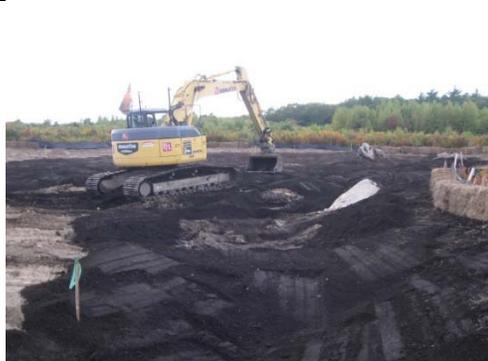
<p>Mitigation Area: Early am spreading of wetland soil.</p>

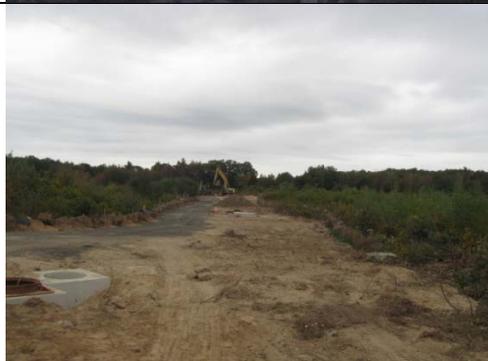
<p>RW23 end; ILS Road (across from the New Plainville Road): The MLSAR excavation at the edge of the road has been refilled and smoothed.</p>

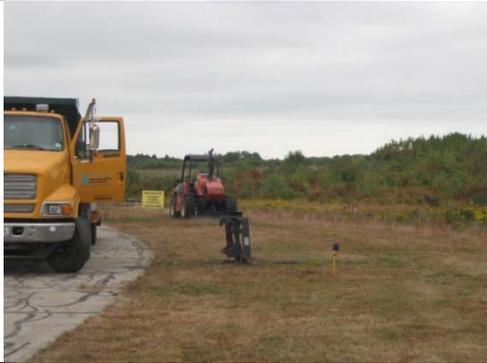
<p>RW 23; Adjacent Taxiway: Moulison equipment and a truck were parked too close to the wetland resource area. Upon request the equipment and truck was removed.</p>

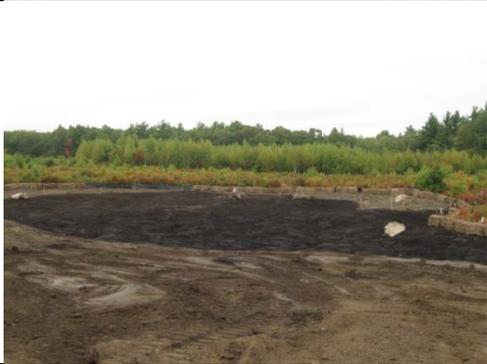
<p>Mitigation Area: Late Thursday afternoon - the wetland soil installment has been completed.</p> <p>MON indicated a plant delivery date of Wednesday or Thursday of next week (by telephone on Friday).</p>

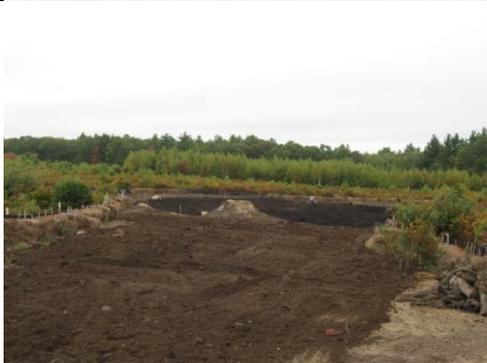
<p>Mitigation Area: The adjacent upland area at the Mitigation Area was also loamed.</p>

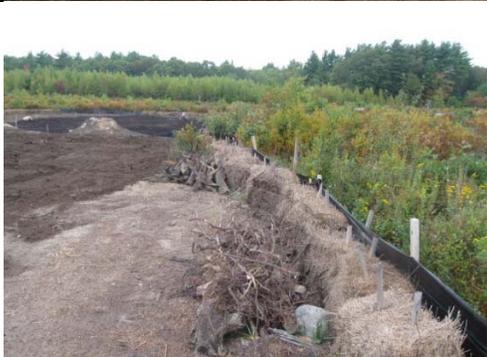
<p>Mitigation Area: Woody debris and brush is being collected (edge of hay bales) to eventually spread onto the pit and mound topography. 10% of the total square footage will be covered. Larger logs/stumps will be included as well.</p>

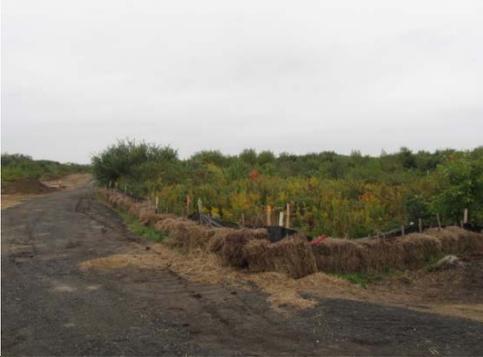
<p>ILS Road (off the Plainville Road): Due to a trailer truck hauling wetland soil cutting a corner too sharply, a section of silt fence and row of hay bales has been repaired three separate times in less than a week.</p>

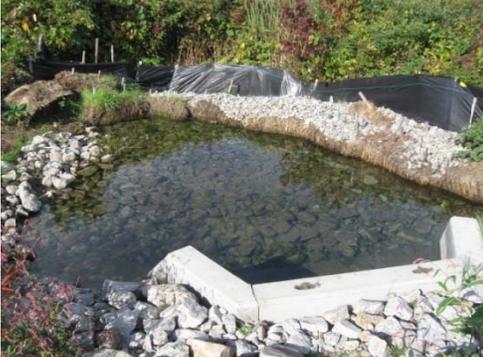
<p>RW 5; The project site received 0.19 inches of precipitation yesterday evening. All discharge points were checked. At the first headwall (off access road) water quality was excellent.</p>

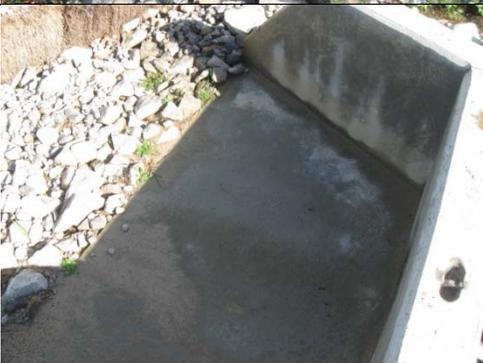
<p>RW 5: Even w/ the (0.19) rain received last night, the headwall at the foot of the swale (along access road) showed no evidence of discharge. All precipitation appeared to be absorbed into the adjacent loamed area.</p>

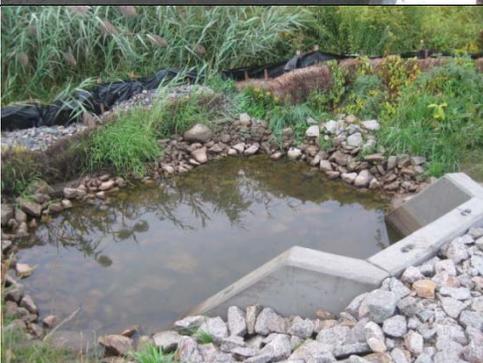
<p>RW 5; Outlet/discharge from CB 11; No discharge was noted with last night's rain. The Water clarity was a bit cloudy probably due to a re-suspension of very fine soil/sediment within the outfall.</p>

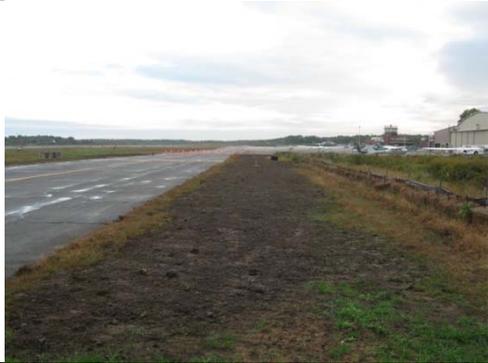
<p>RW 5: Loam applications continue on both sides of the runway.</p>

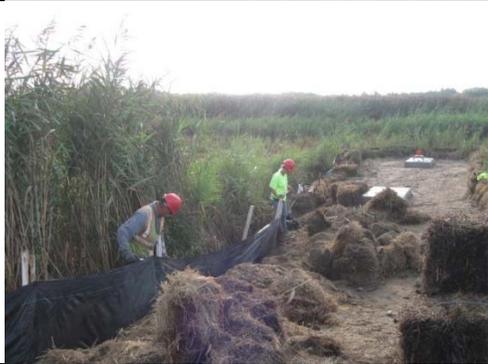
<p>RW 5; ILS Road; MALSR pad; Gravel that was almost overtopping the existing row of hay bales was pulled back, straightened, and tightened by Pam and Mark of ETL in a very conscientious and methodical manner.</p>

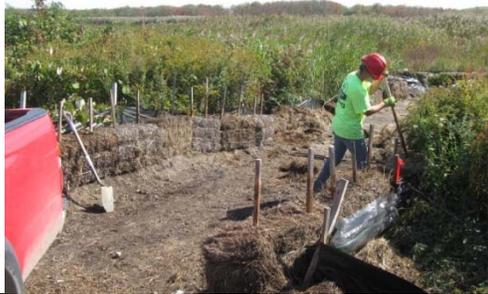
<p>RW 5; ILS Road; MALSR pad; A silt fence repair was completed at a third MALSR pad. Old bales that had been damaged by the earlier excavation were replaced and double staked. The silt fence was also tightened.</p> <p>JM Fiske assisted by finding and transporting the replacement hay bales.</p>

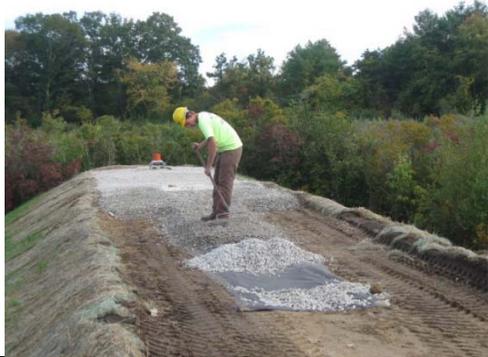
<p>RW 23 Side; ILS Road (off the Plainville Road); The Terminus MALSR pad; ¾ inch stone being placed.</p>

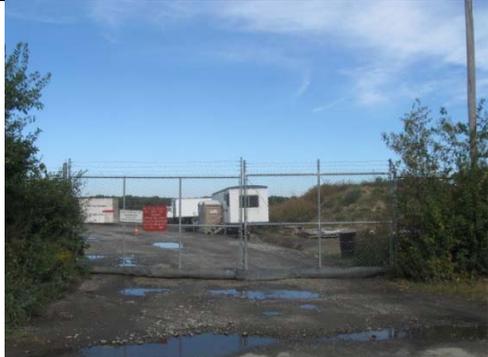
<p>RW 23 Side: Limited activity noted on the RW 23 side. The gate was semi-closed to discourage entry.</p>
