NEW BEDFORD REGIONAL AIRPORT
RUNWAY 5-23 – PHASE 4

Reconstruct, Mark, and Groove

Weekly Environmental Report

WEEK 22

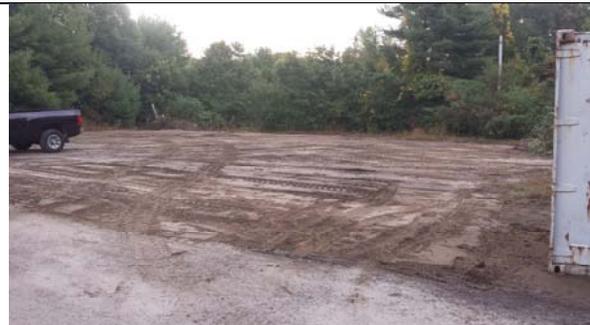
The loam piles near the office trailers were removed and the area was regraded. The access road used by the contractor will remain at the end of the project.

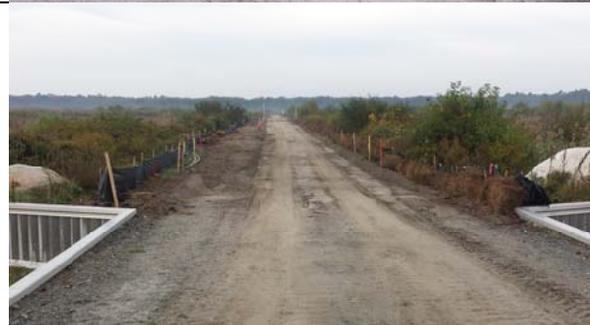
There was little activity on the site today. No work was done on the ILS road. The majority of current work is touch up on loam along the edge of the runway and electrical work.

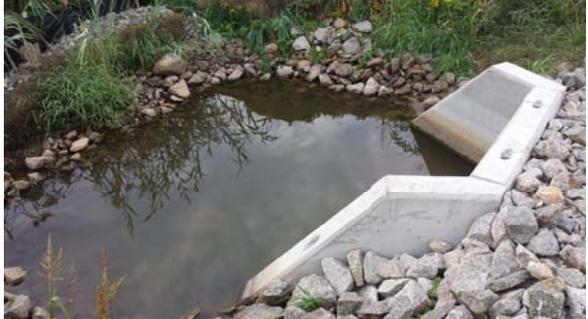
<p>Headwalls and discharge points were inspected. No issues observed.</p>

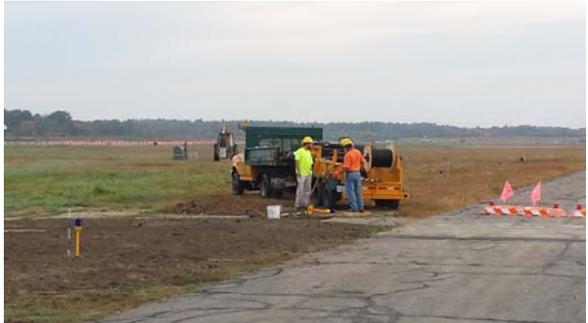
<p>The electricians were installing lights along Taxiway A. Minor localized soil disturbances were occurring.</p>

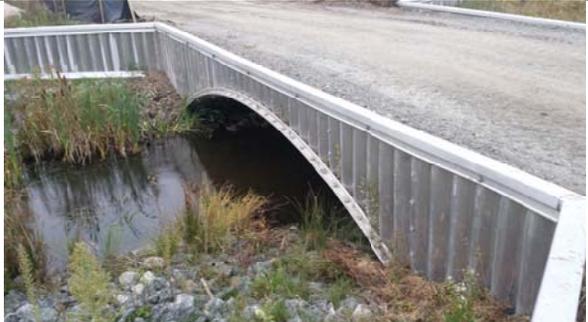
<p>The culvert lip noted in last week's report was cleaned using a putty knife and 5-gallon bucket.</p>

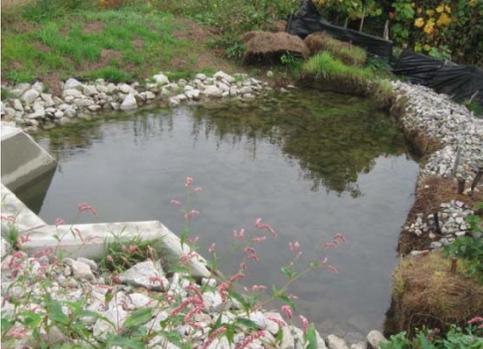
<p>RW 5; Adjacent the Access Road; Headway 1; Outlet End: All discharge points were checked at just after 6:00 am. At this point in time, water quality was satisfactory at all three discharge points. There was no noticeable increase of flowage.</p>

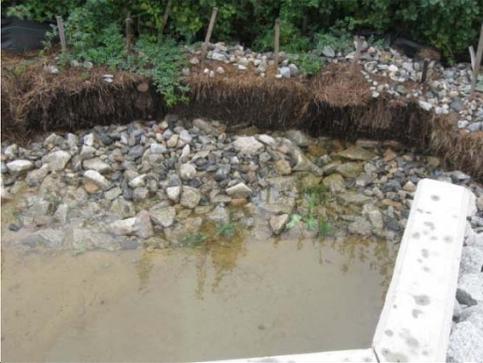
<p>RW 5; Adjacent the Access Road; Headwall 2; Tail of Adjacent Swale; Outlet End. A very small quantity of flowage was noted</p>

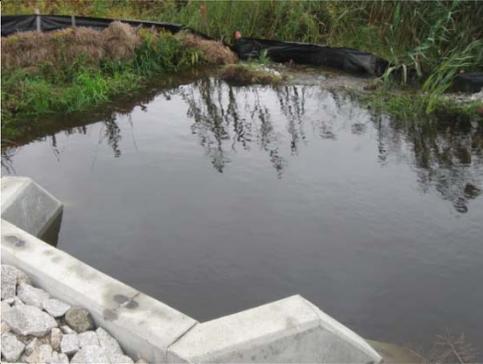
<p>RW 5; Headwall 3; Discharge from CB 11: Some additional flowage noted.</p>

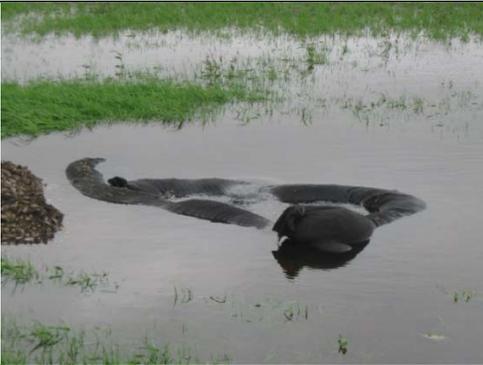
<p>The weekly field office 10:00 am meeting was attended today by Earle Chase of JM Fiske Environmental. Project site “close-ot” activities and planning were discussed primarily. Had to leave early to oversee continued planting activities at the Mitigation Area.</p>	
<p>RW 5; Between Taxiway A and RW 5; CB 11: This catch basin is surrounded by a small amount of flowage. Ample soil infiltration should occur during today and early tomorrow.</p>

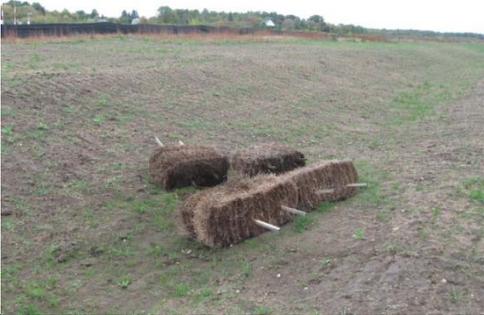
<p>RW 23; Northside; Adjacent Swale; The erosion control measure at this storm drain needs repair as the adjacent area has exposed soils.</p>

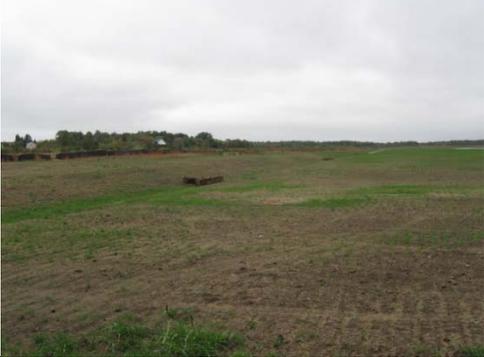
<p>RW 23; Northside; Adjacent Swale; Germination of the grass in this area is less than 50%. Consider a supplemental seeding.</p>

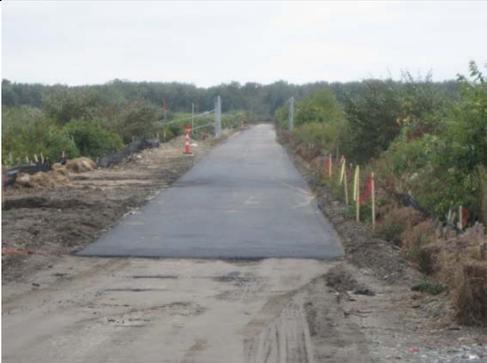
<p>RW 5 Side; ILS Road: The surface of the road was paved today. Final stabilization efforts are needed.</p>

<p>JM Fiske completes a project site inspection with the New Bedford Conservation Administrator – her only concern is the stabilization of the edge of the ILS Road to protect the wetlands.</p>
