MassDEP File No. SE 049-0635

New Bedford Regional Airport Runway Safety Improvements Project

Post Construction Monthly Wetlands Plantings Assessment – September 2014

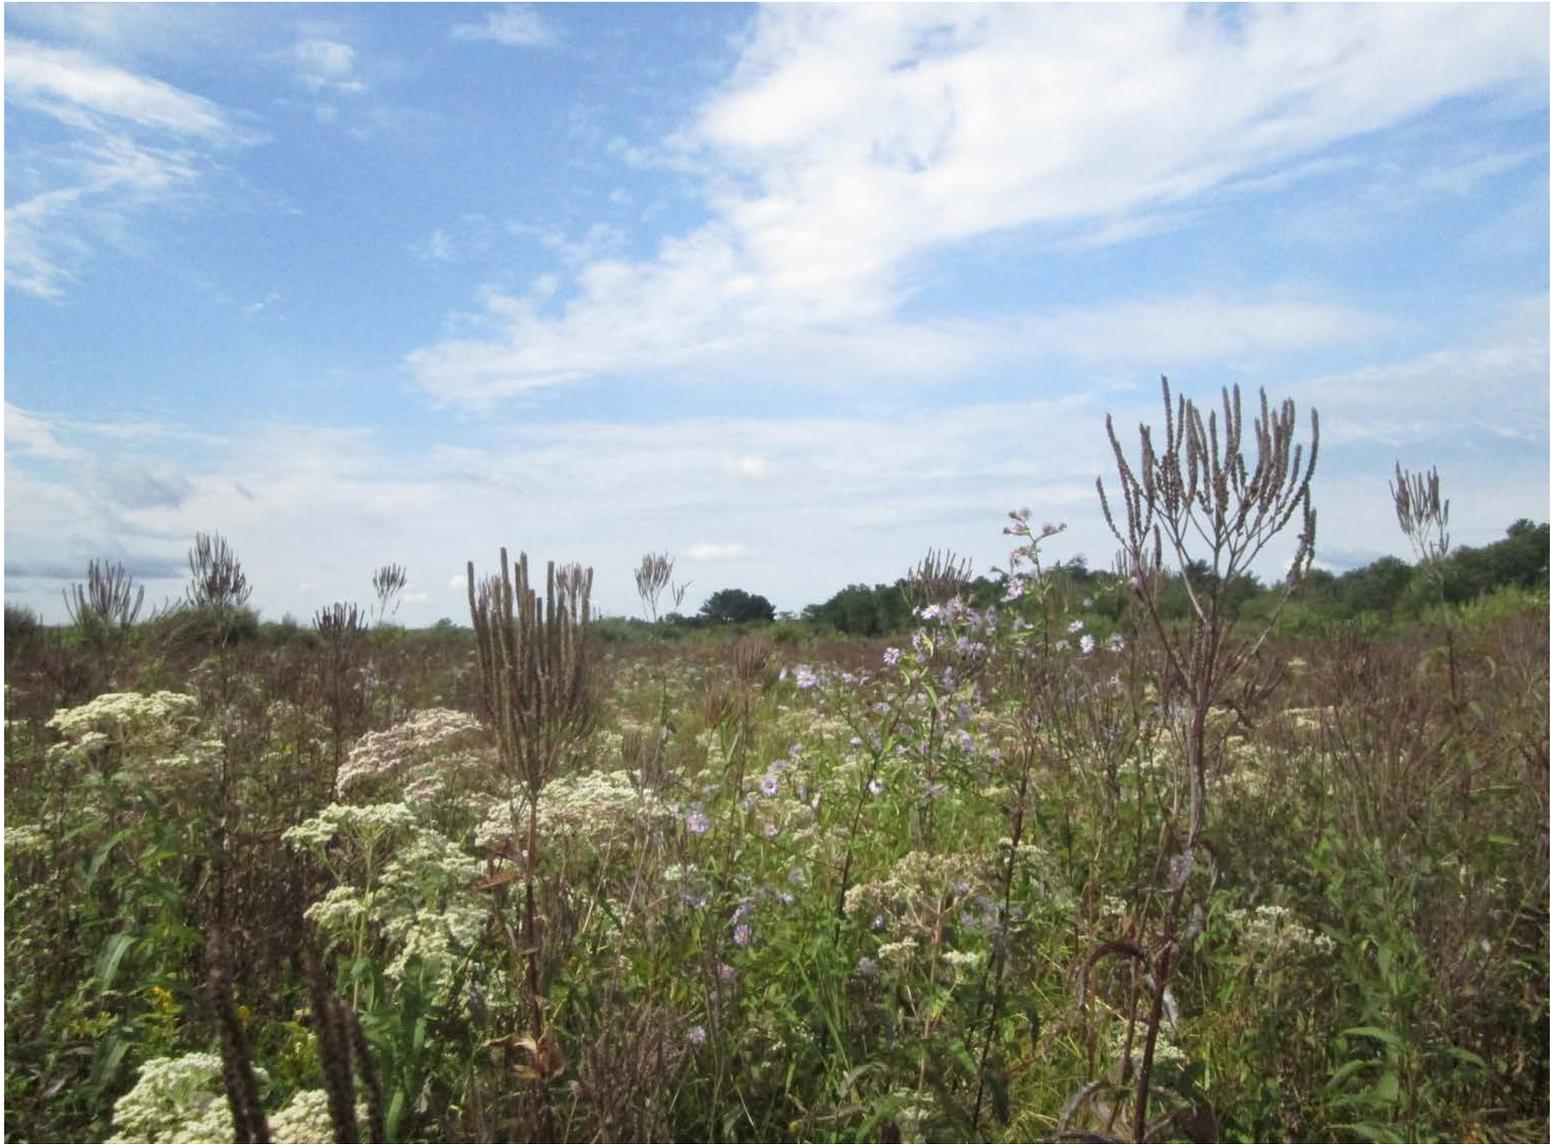
View of Site 5.

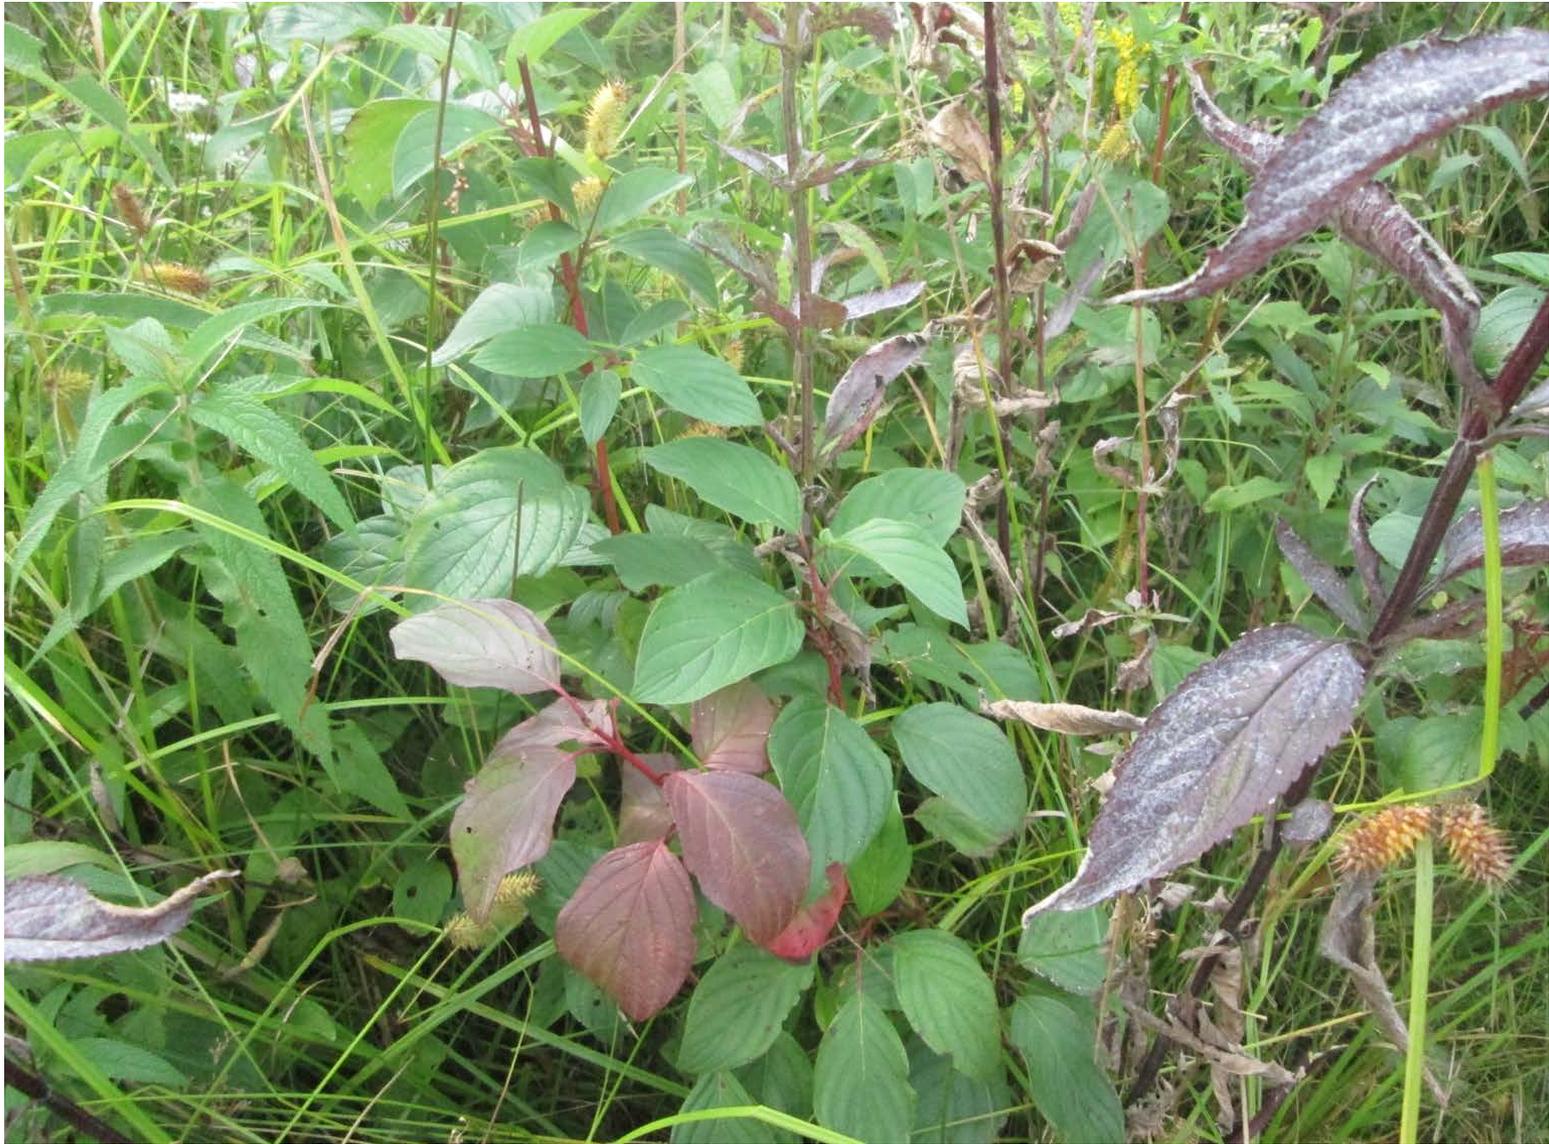
View of healthy silky dogwood in Site 5.

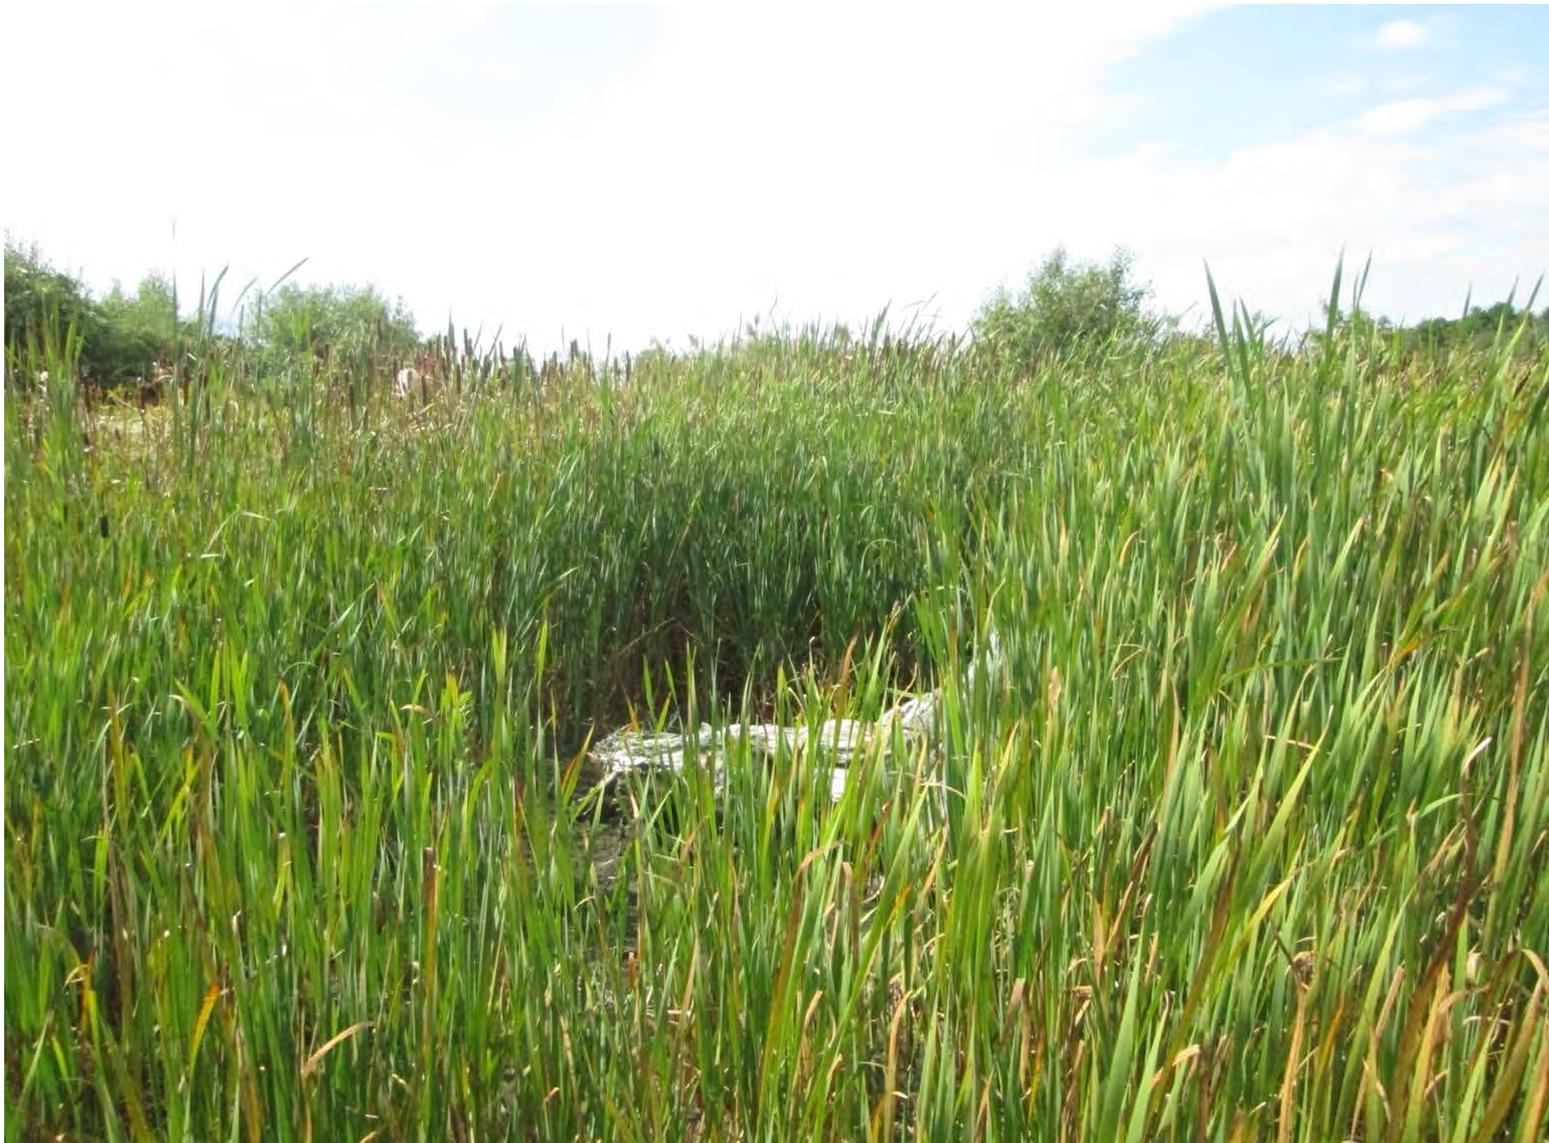
The areas of native cattail (*Typha latifolia*) seem to be stabilized and appeared to remain essentially in the same locations as described and the area quantified in the 2013 end of year report. The cattails are generally interspersed in the lower elevations of the three mitigation sites among other herbaceous cover types, woody plantings, micro-habitat features (boulders, pits-and-mounds, large woody debris) and areas of open water / vernal pools resulting in good horizontal habitat diversity. As a result of the dry conditions, cattail plants at the Site 5 vernal pool and the northern vernal pool in Site 10 have increased inward by vegetative growth.

View of vernal pool, Site 5 (note further encroachment of cattail towards center of the pool).

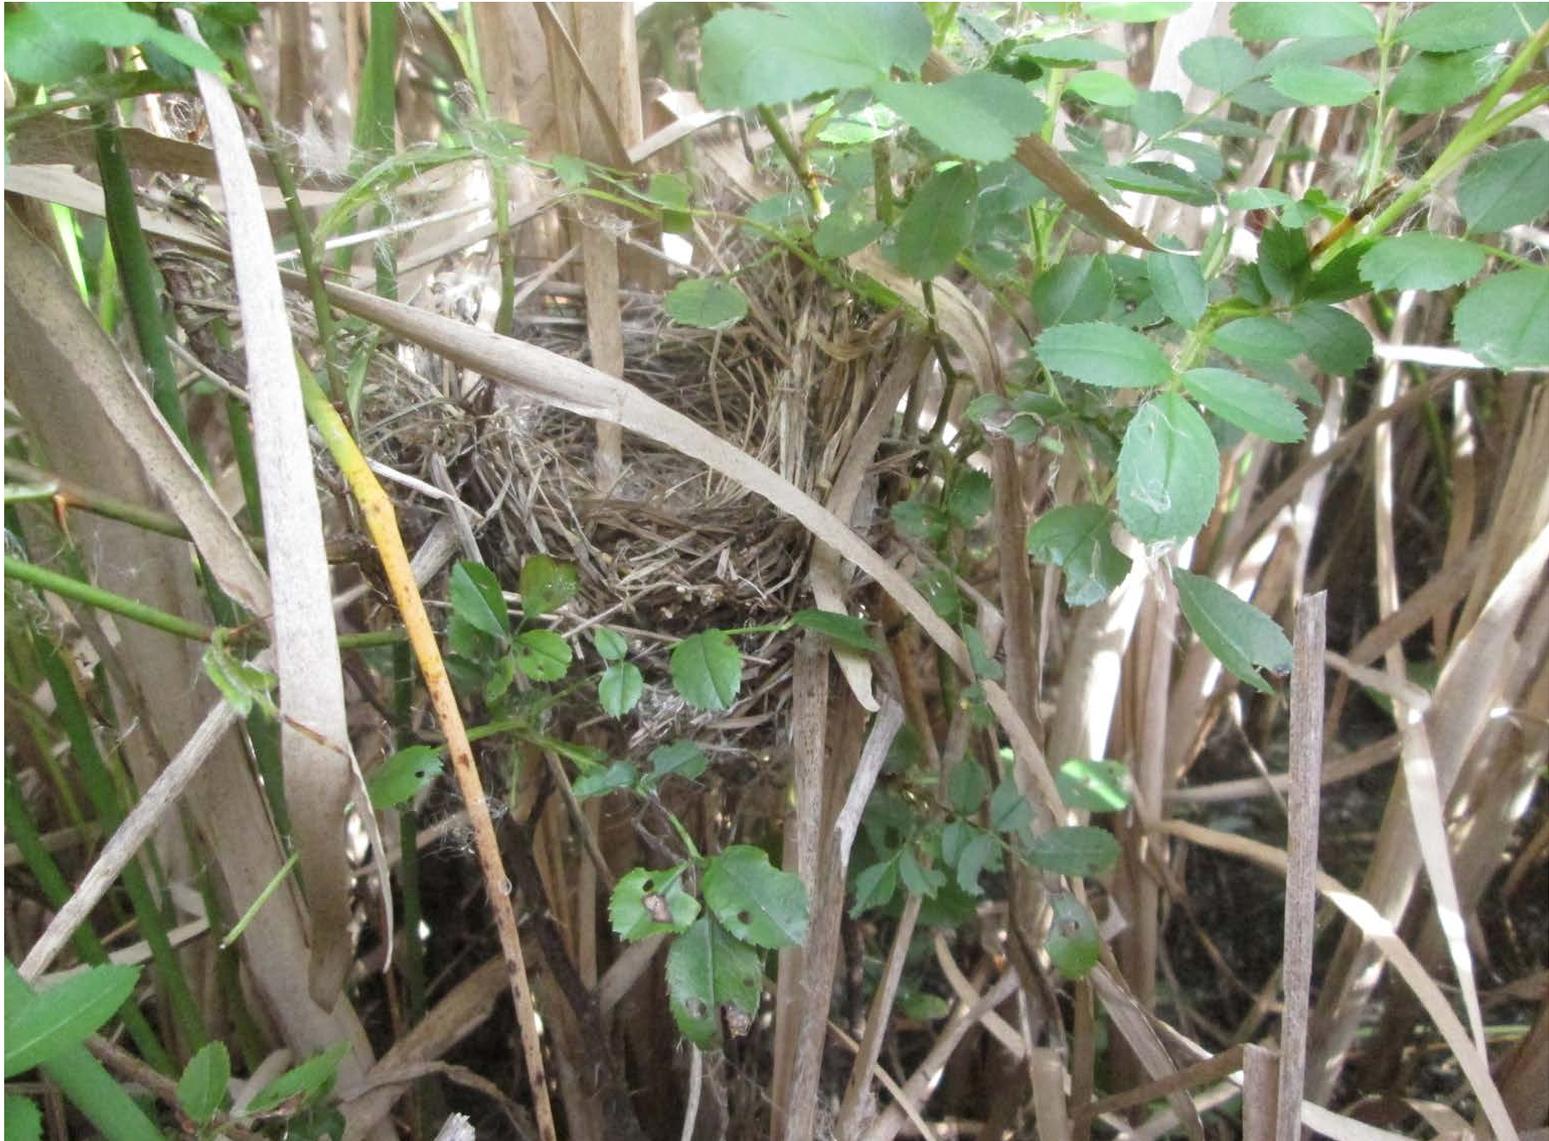
View of nest found within cattail area of Site 5 vernal pool. Likely red wing blackbird nest.

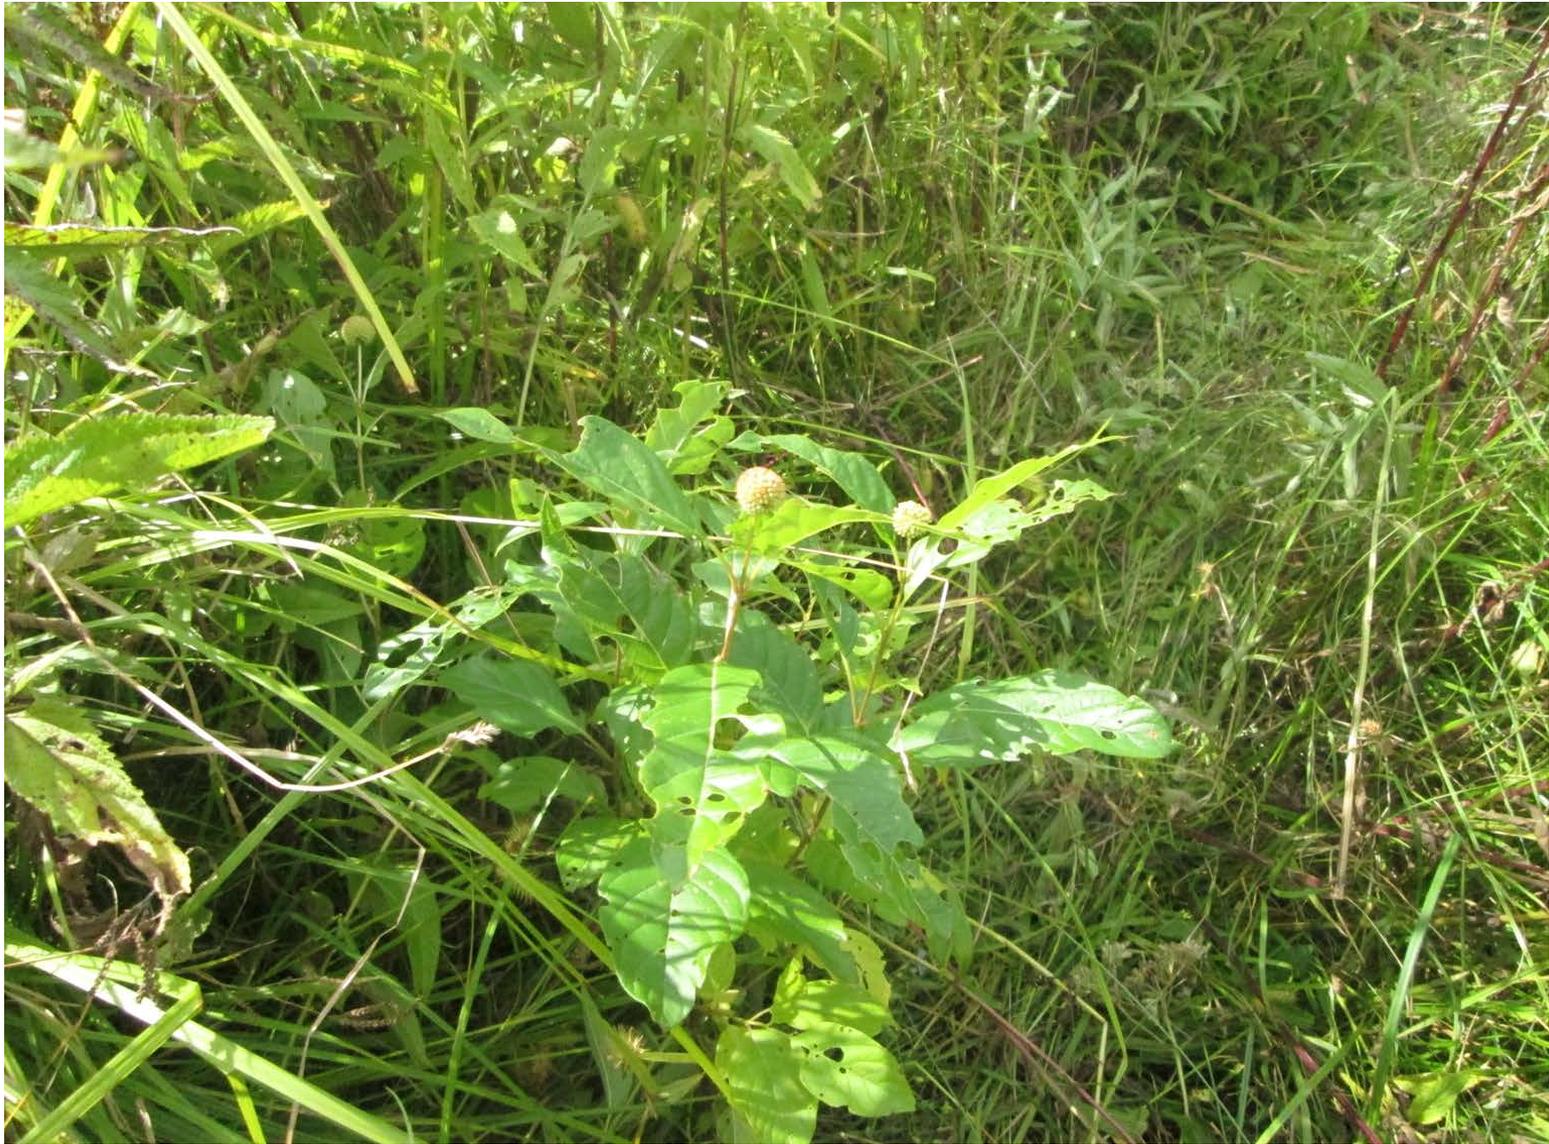
View of buttonbush at vernal pool fringe, Site 5 (some insect damage).

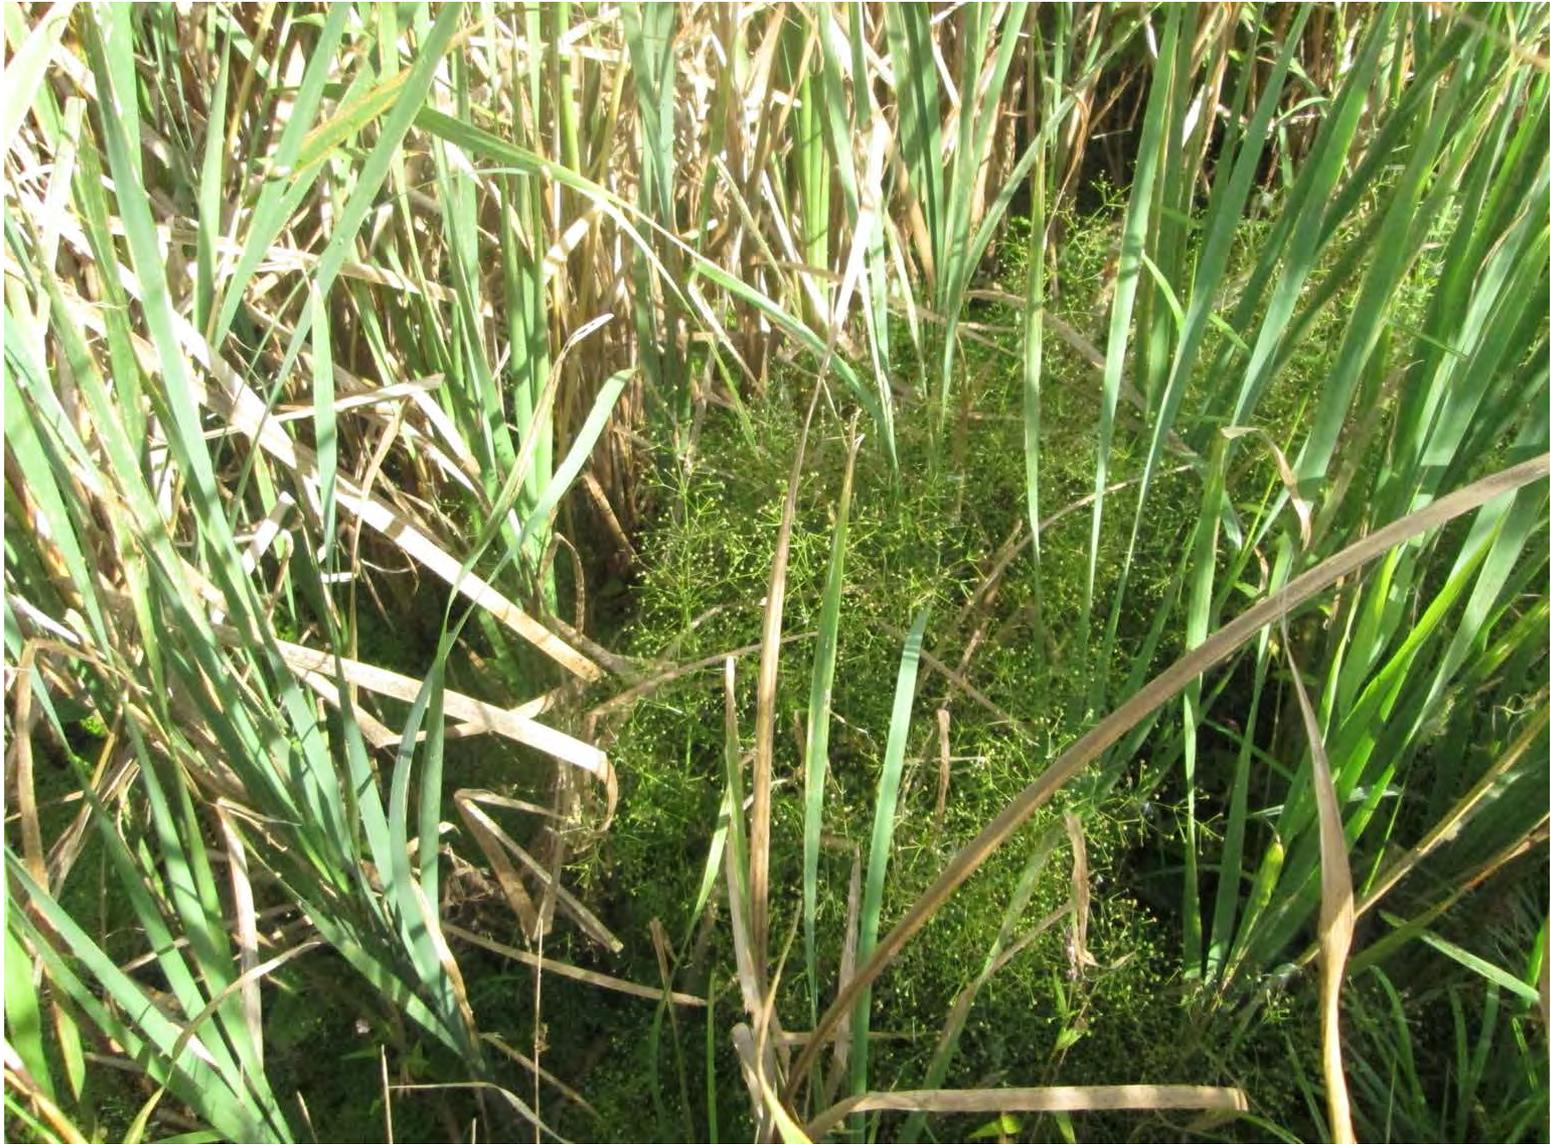
View of mud plantain (*Heteranthera* spp.) at Site 6.

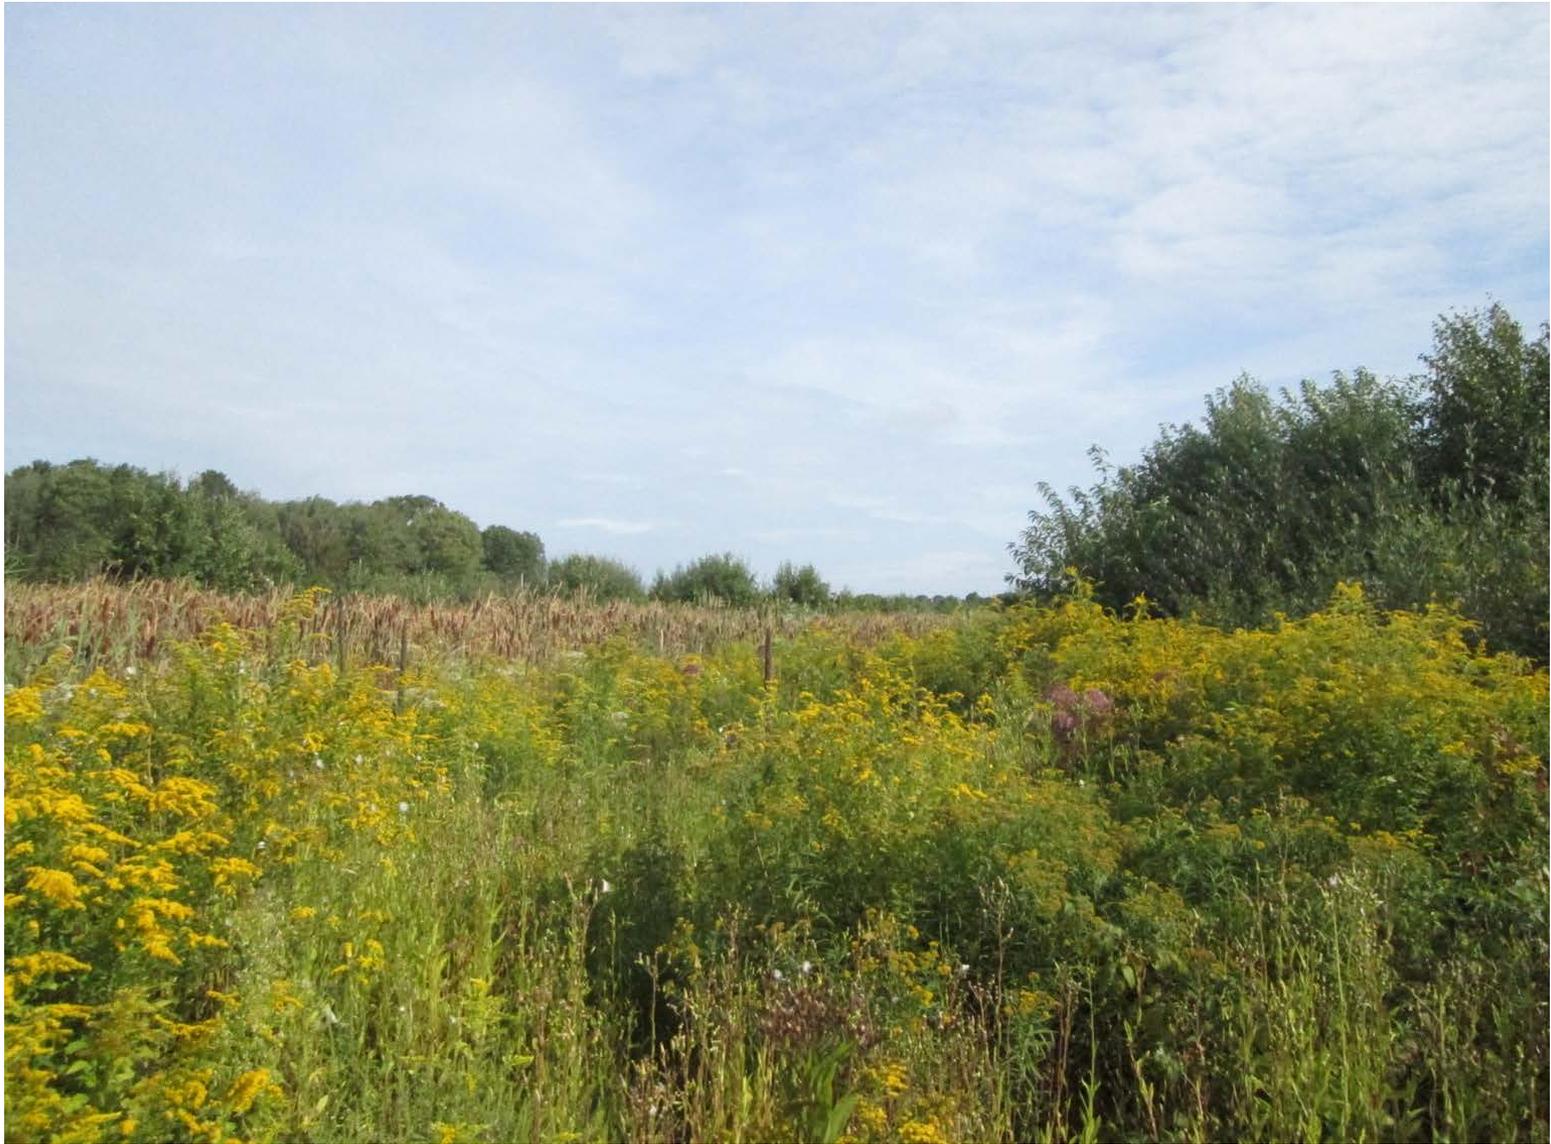
View of Site 6.

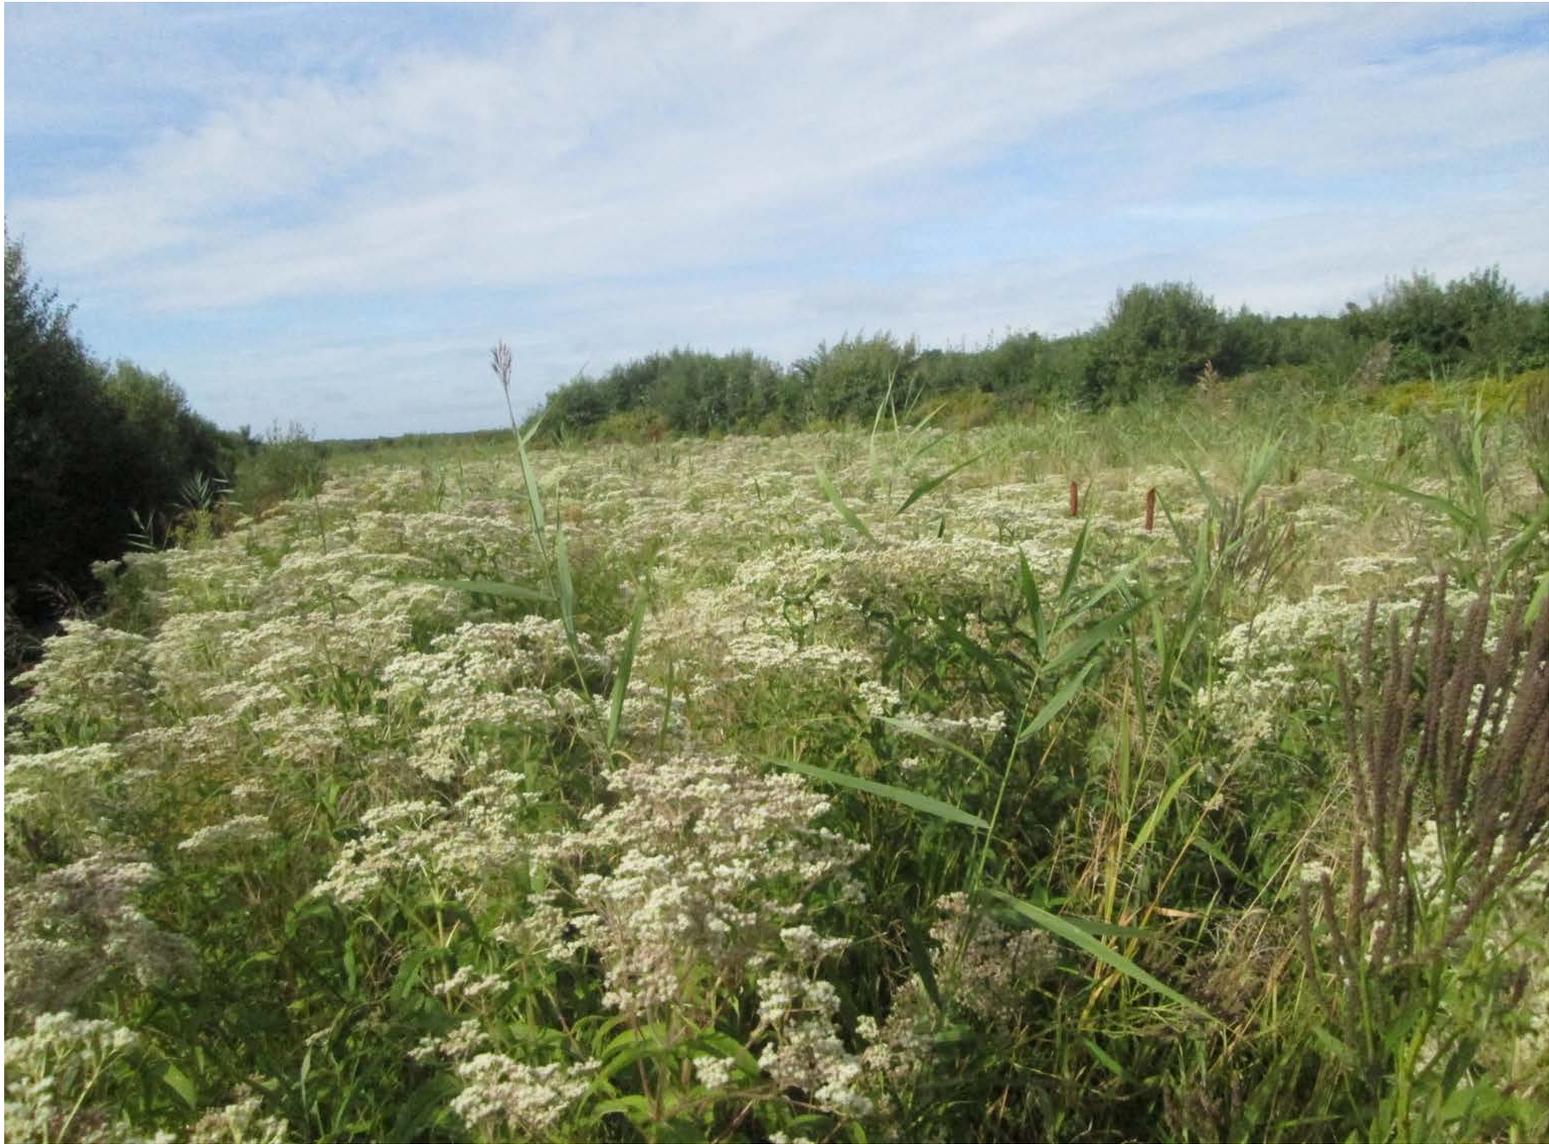
Based on visual estimates there is between 90% and 95% cover with primarily native herbaceous wetland plant species throughout the vast majority of all Site 6 and Site 10 mitigation sites. The encroachment of common reed at these in Site 10 appears to be slightly increased at this point as compared to observations made in November of last year (trace amounts to 5% throughout); the highest concentration of common reed is located in the southernmost section of Site 10. Common reed in the southern 1/3rd of Site 6 appears to have a similar concentration as compared with June observations; some areas within this southern lobe are up to 10% common reed. The common reed was interspersed amongst cattails and other native wetland plant species.

View of Site 6, post herbicide treatment of phragmites.

Epsilon was also onsite to assist Aquatic Control Technology (ACT) with logistics for their common reed (*Phragmites australis*) control herbicide management. ACT applied herbicide treatment for Sites 5, 6 and 10 and Area 1 and 3. The proper permits were obtained and the Board of Health was previously notified as per MassDEP approved protocols. Phragmites and multiflora rose (*Rosa multiflora*) were treated throughout these areas as plants were encountered. At the time of the treatment the concentration of common reed has not increased as compared to what was reported in July and August:

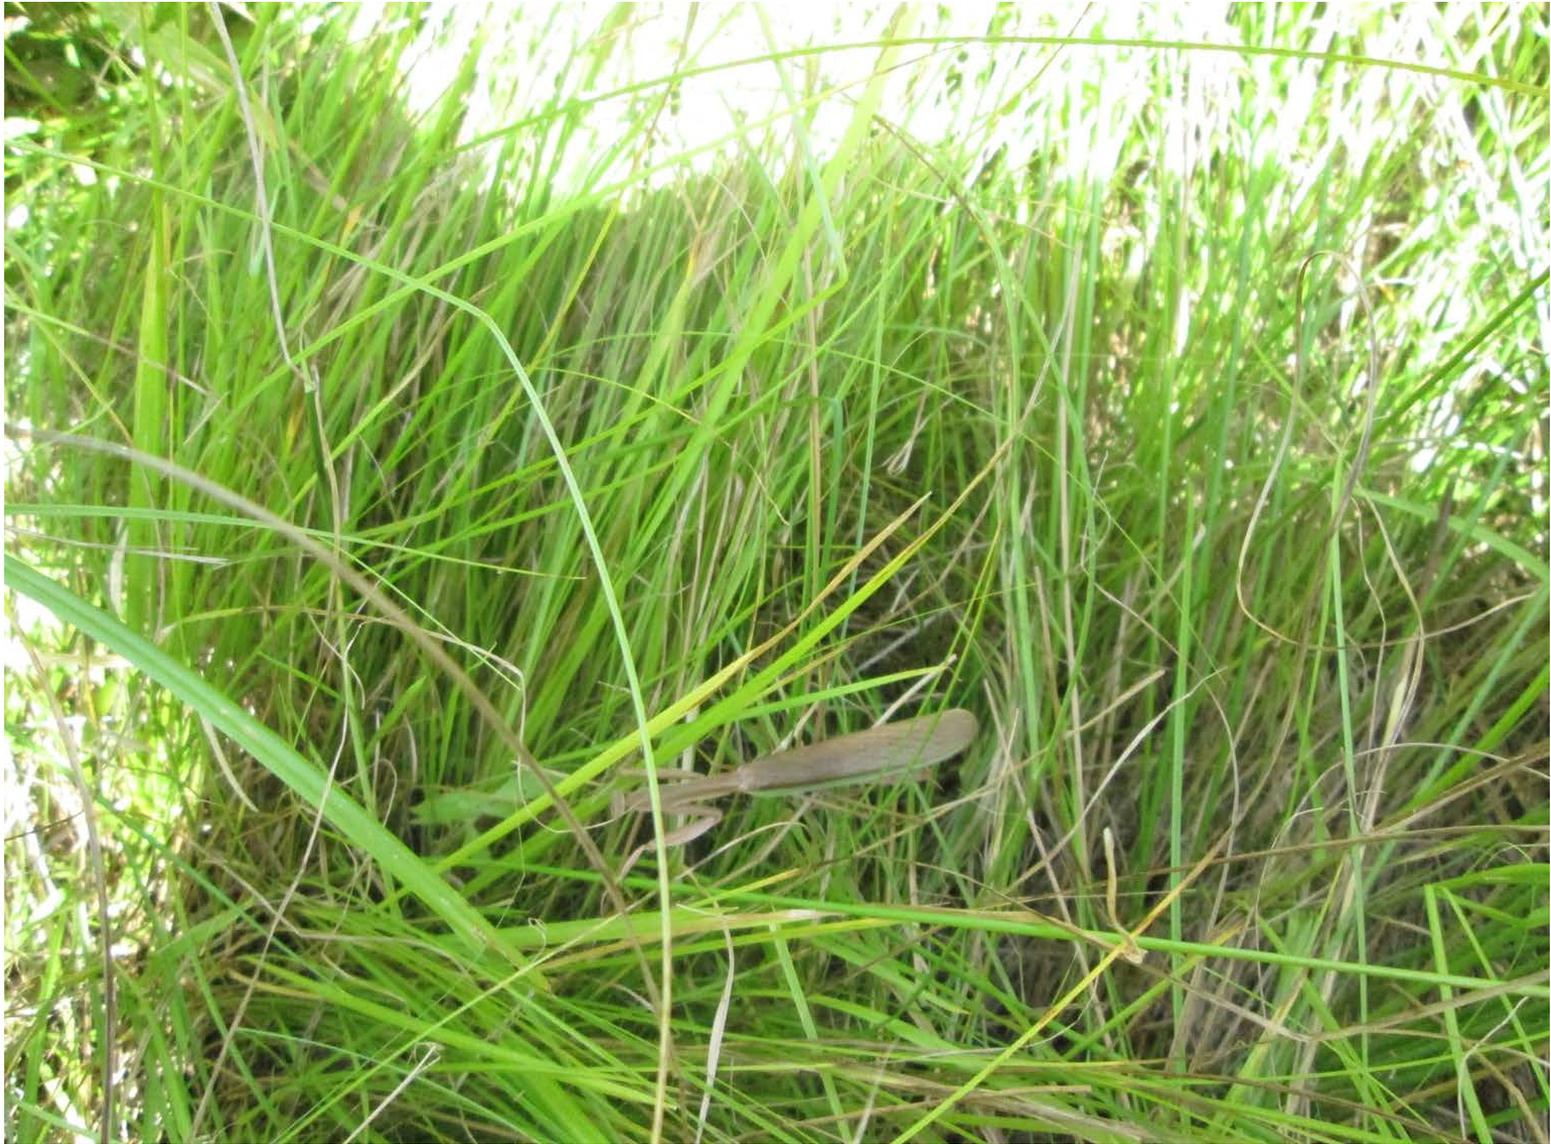
Praying mantis found at Site 6.

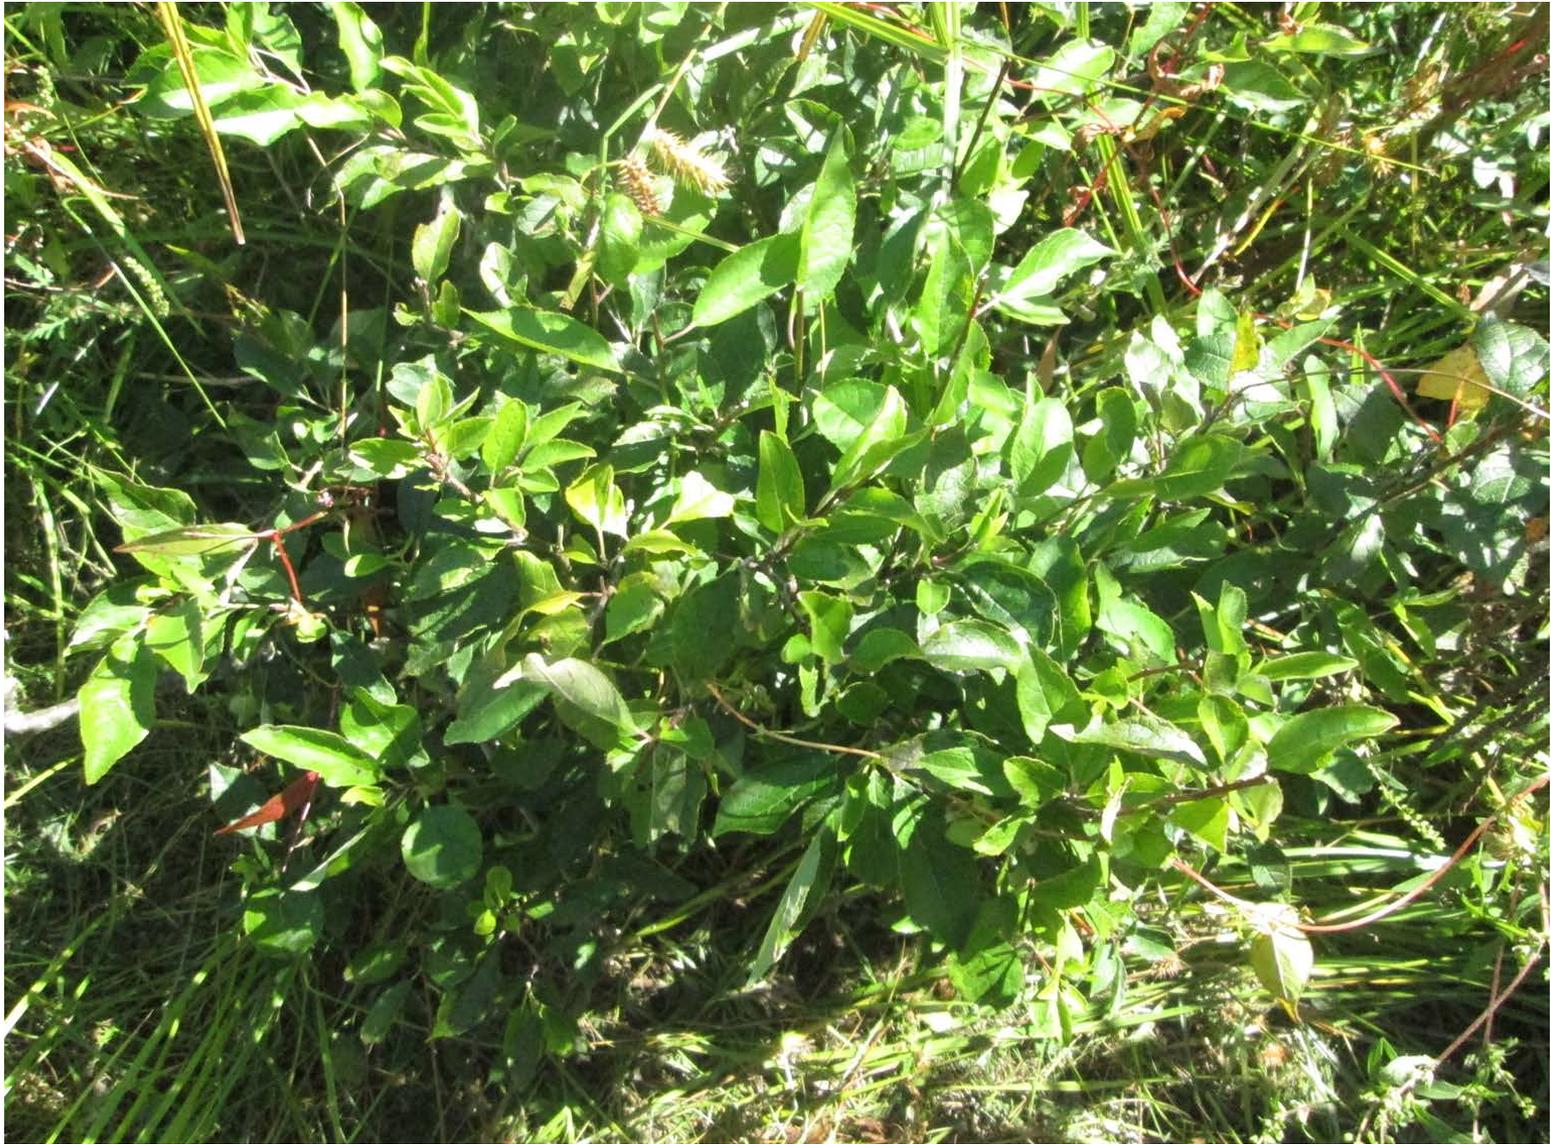
View of healthy Ilex at Site 6.

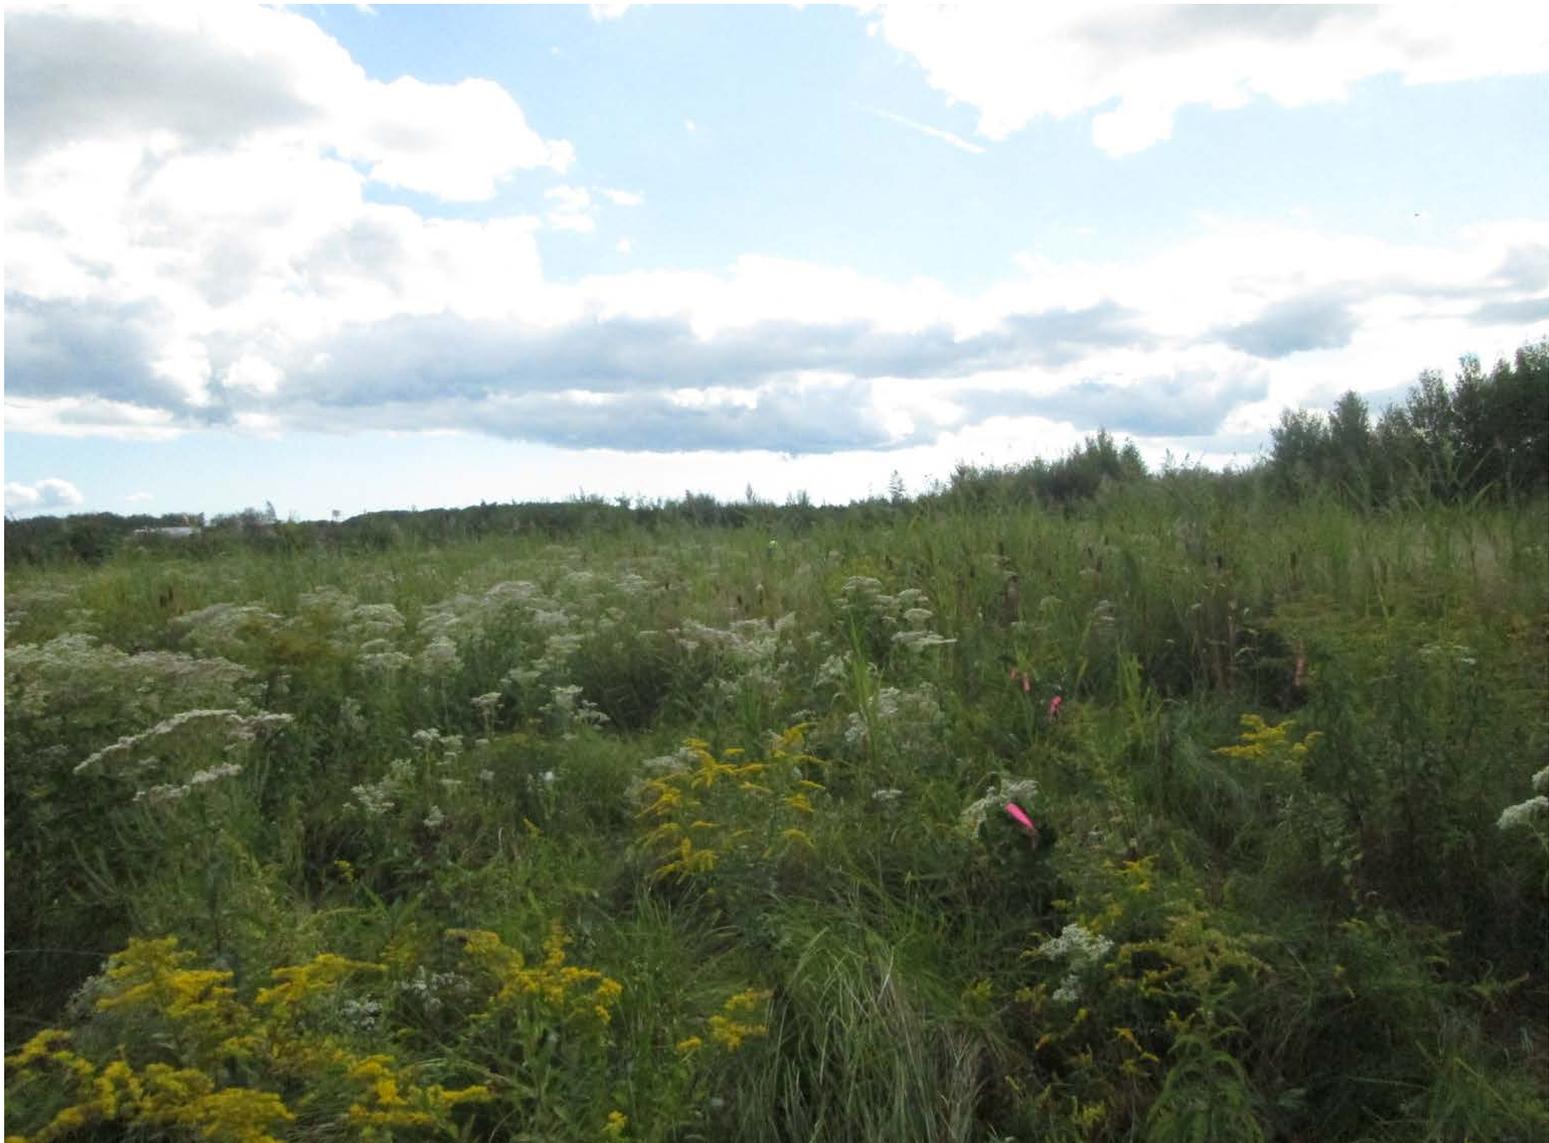
View of Site 6, newly planted shrubs were flagged with pink surveyors ribbon.

Epsilon was onsite during the week of September 15th to review and accept 1,565 supplemental shrub plantings from the Phase 2 mitigation contractor. Twenty (20) replacement plants were planted within the West Ditch, 75 replacement shrubs were planted within Site 5, 570 replacement shrubs were planted within Site 6, and 900 replacement shrubs were planted within Site 10. These plants were given filter fabric treatment around the base of each shrub to suppress plant growth in the immediate area.

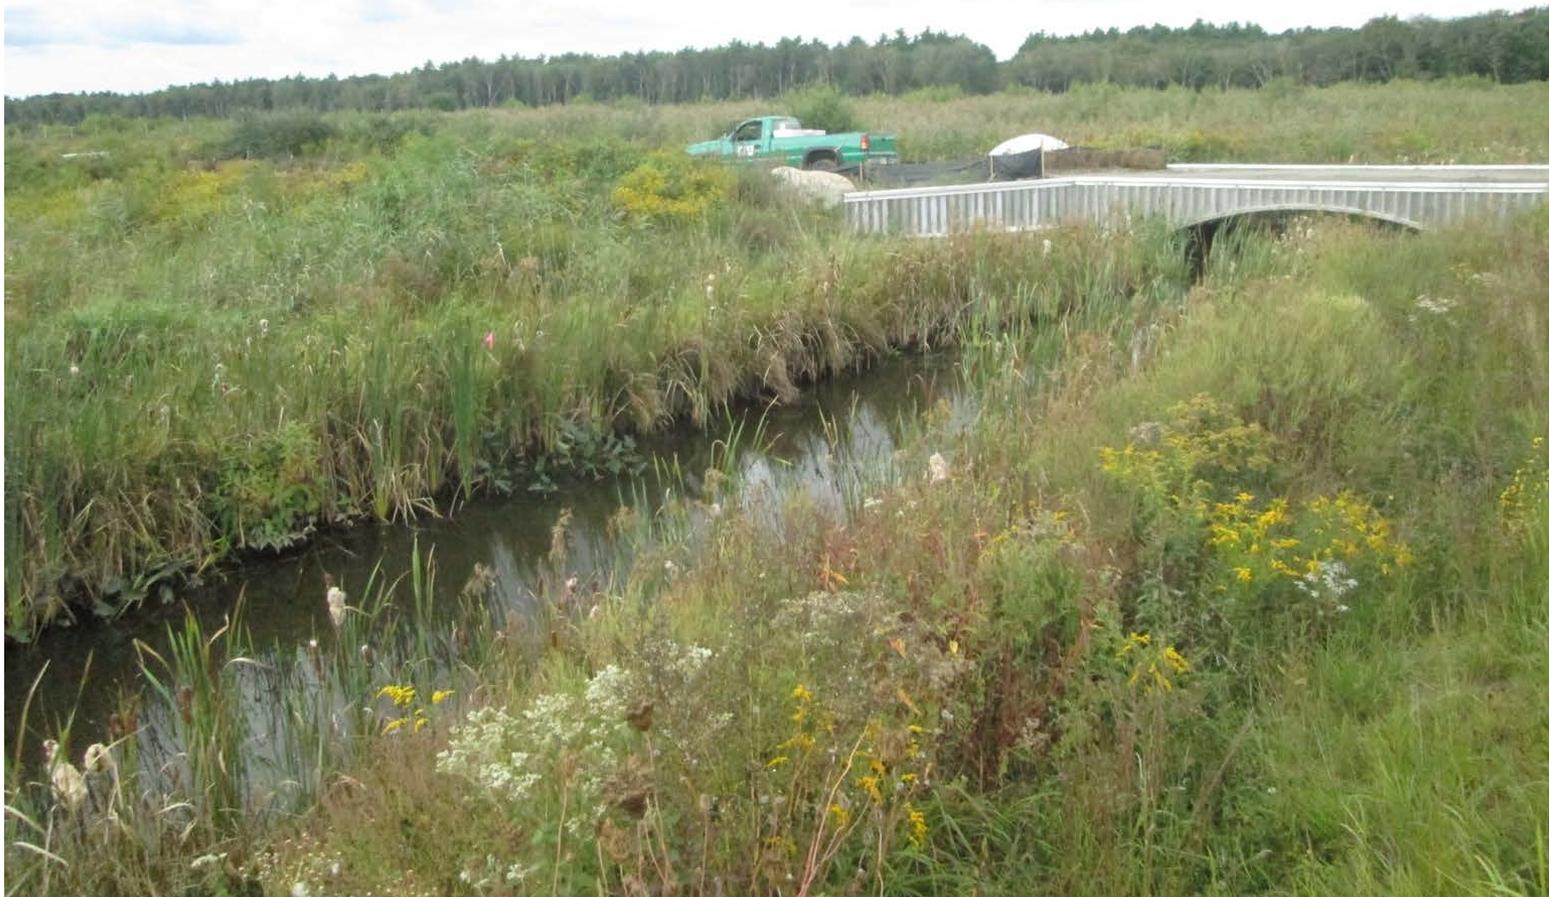
Shrubs within the West Ditch are vigorously growing and appear healthy. As reported in the first EM report for Phase 4, a portion of the West Ditch restoration area (approximately 450 linear feet) was disturbed during erosion control installation. The contractor has implemented the restoration work and monitoring is ongoing. Many of the affected shrubs look good and are vigorously growing, especially in light of the impact they withstood. Some of the shrubs are growing less vigorously than their unaffected neighbors or exhibiting signs of stress. We reassessed these plants, in addition to ten additional plants identified by the WS. Two plants were dead, while seven additional plants were in poor condition and were unlikely to develop well over time. As such, we recommend that these nine shrubs are replaced this growing season utilizing the recommended hay mulching discussed in Dan Nitzsche, GZA (IO) September 25, 2014 email. We have informed the site contractor accordingly. The side slopes that were seeded are now exhibiting growth including some species identifiable from the erosion seed mix. Except where noted, the side slopes were well vegetated with a robust and established mixed layer of herbaceous vegetation. Rooted aquatic vegetation remained persistent on the bottom of the West Ditch. The following species were identified along the West Ditch at the time of inspection: silky dogwood, winterberry holly, buttonbush, maleberry, pussy willow (*Salix discolor*), highbush blueberry, red chokeberry, and northern arrowwood. There are some common reed popping up through the bank and bed of the West Ditch; there is a fair amount to common reed located at either end of the West Ditch, where the ditch ties into common reed monocultures (approximately 40 feet on south end and 20 feet on north end). The erosion seed mix is robust and established at the time of inspection.

View of West Ditch.
