MassDEP File No. SE 049-0635

New Bedford Regional Airport Runway Safety Improvements Project

Post Construction Monthly Wetlands Plantings Assessment – September 2014

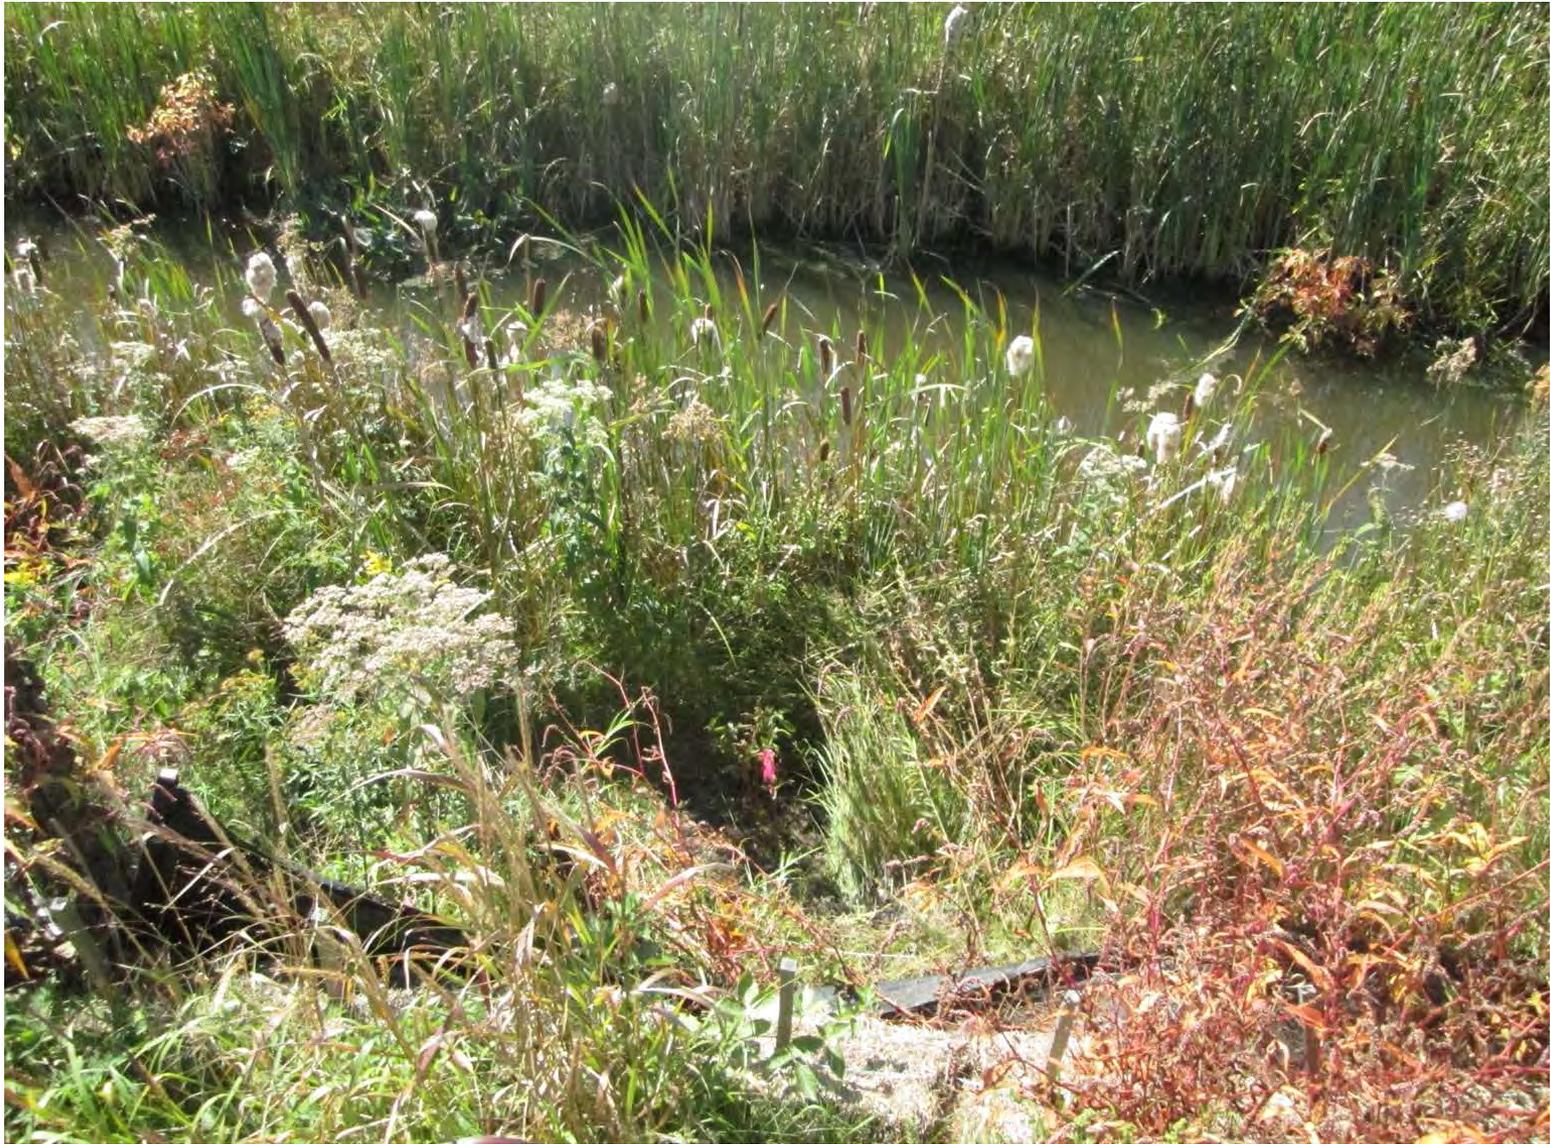
View of newly planted shrub along West Ditch.

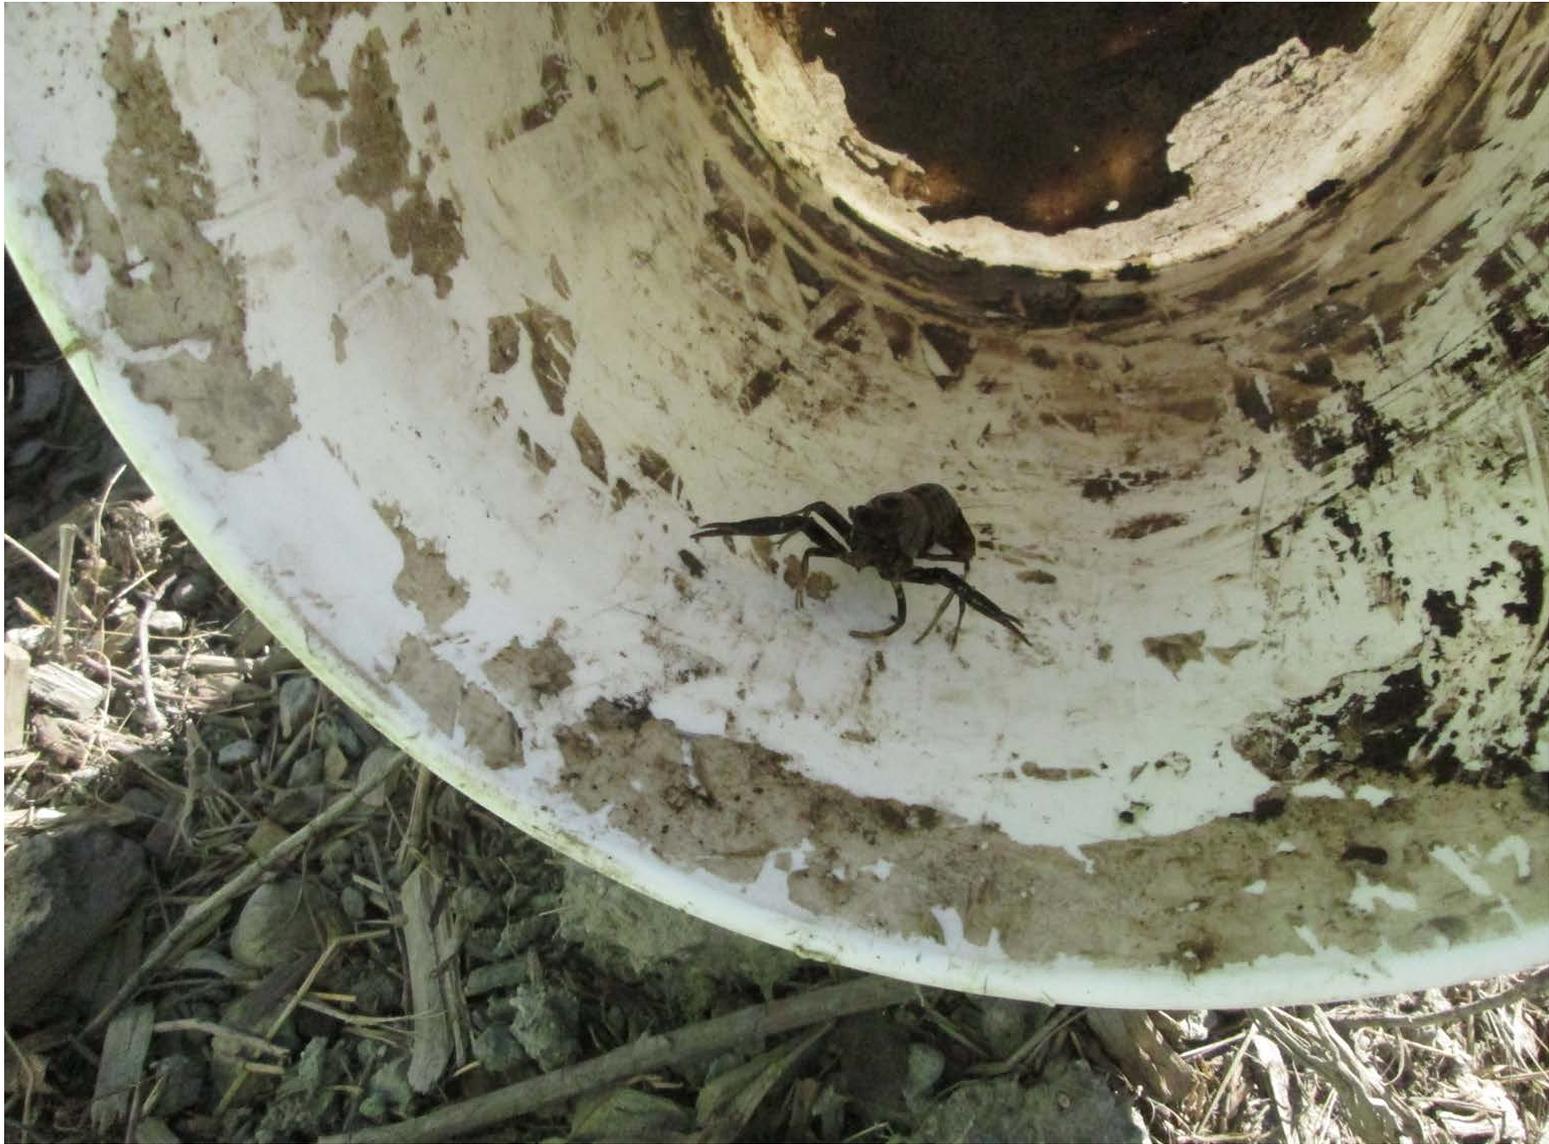
Crayfish found at West Ditch while watering newly planted shrubs.

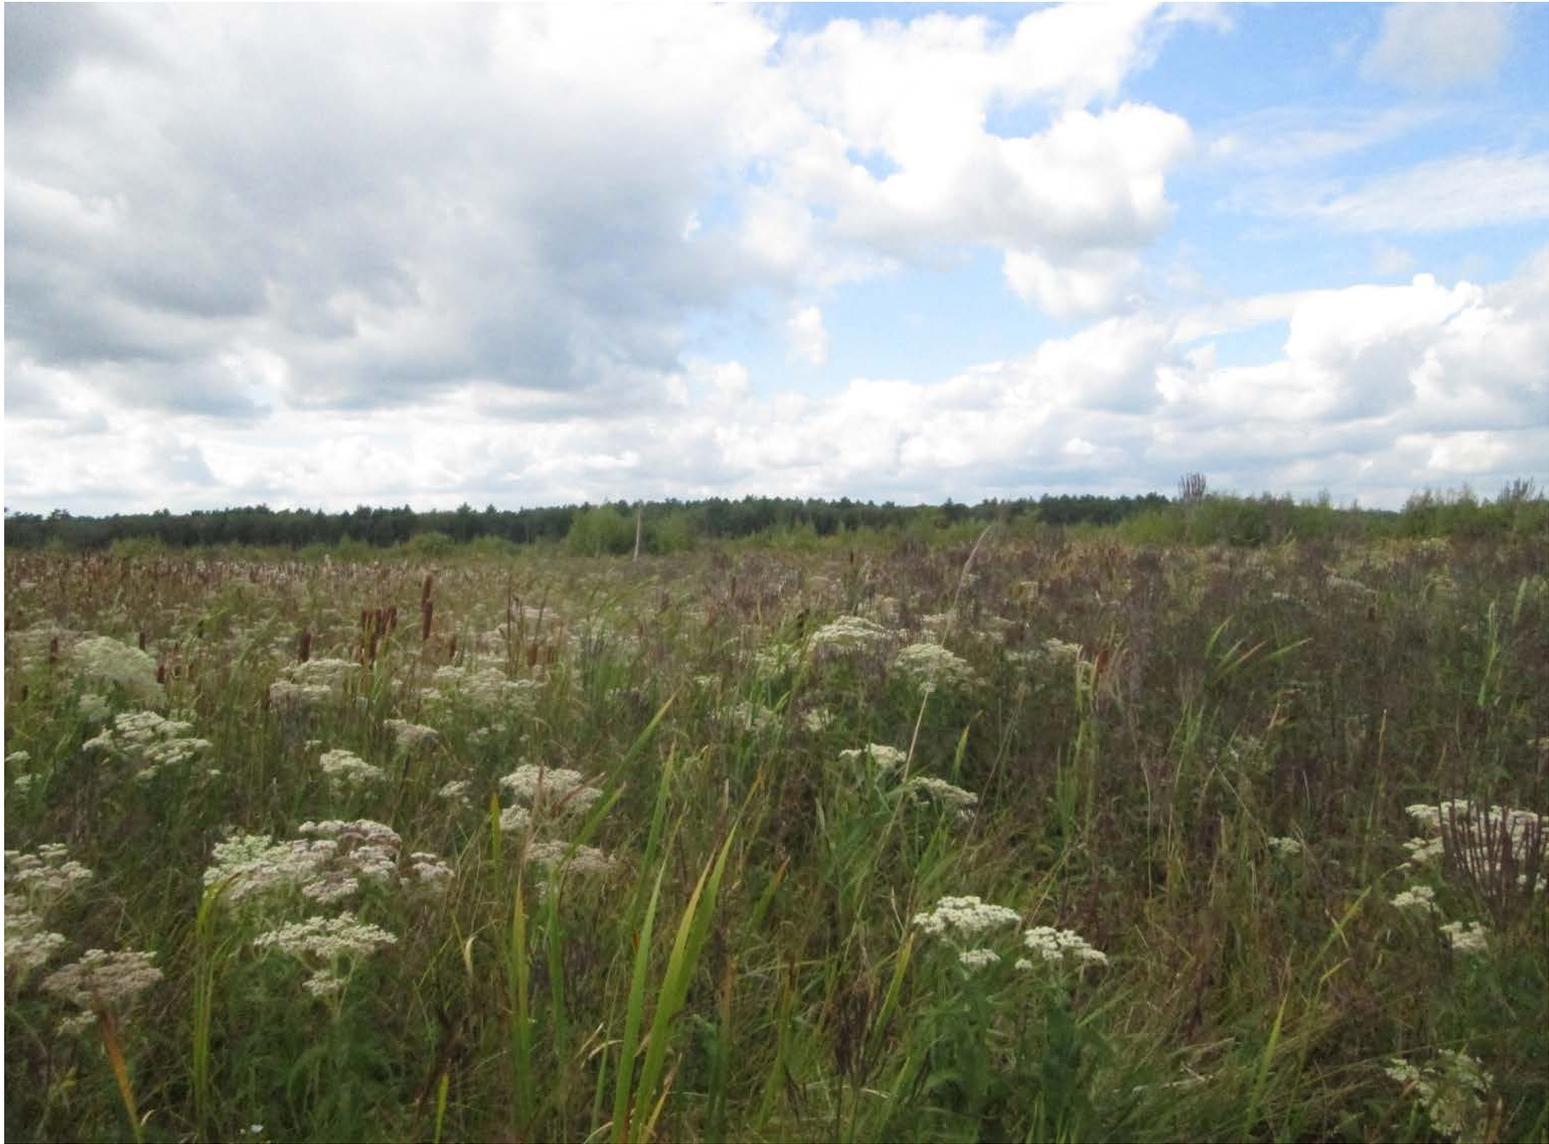
View looking south over Site 10 from restored access road to Site 10.

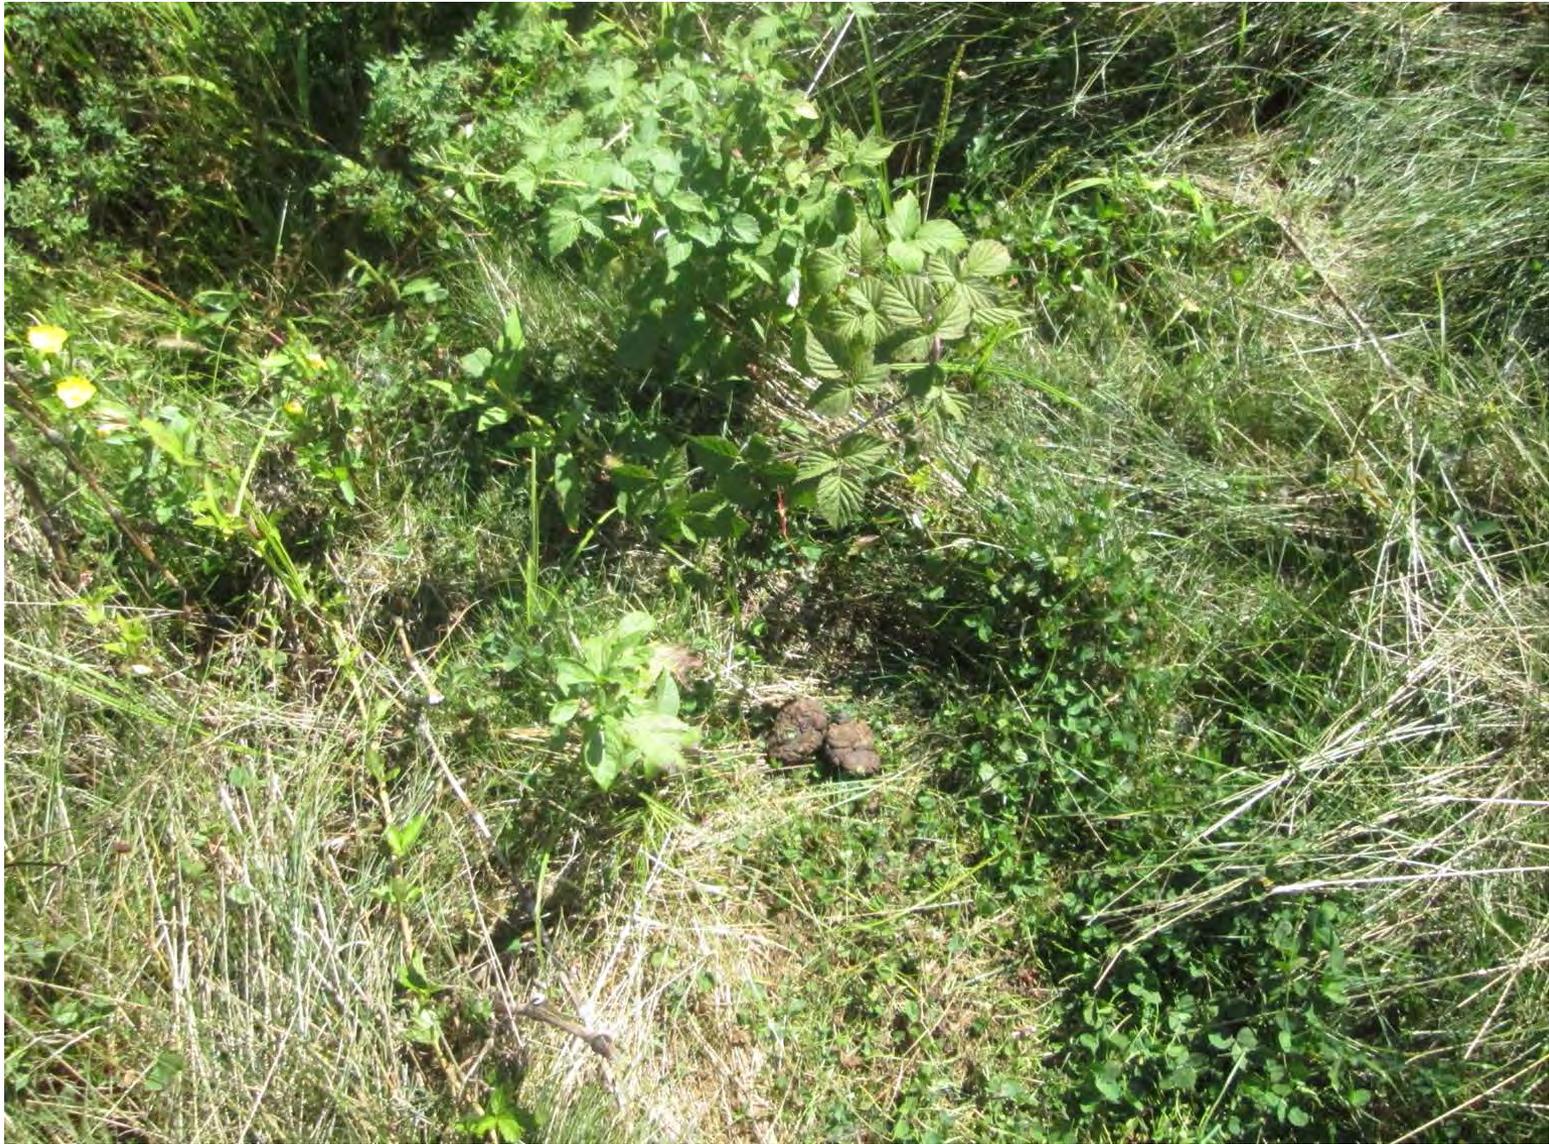
View of a healthy alder and scat.

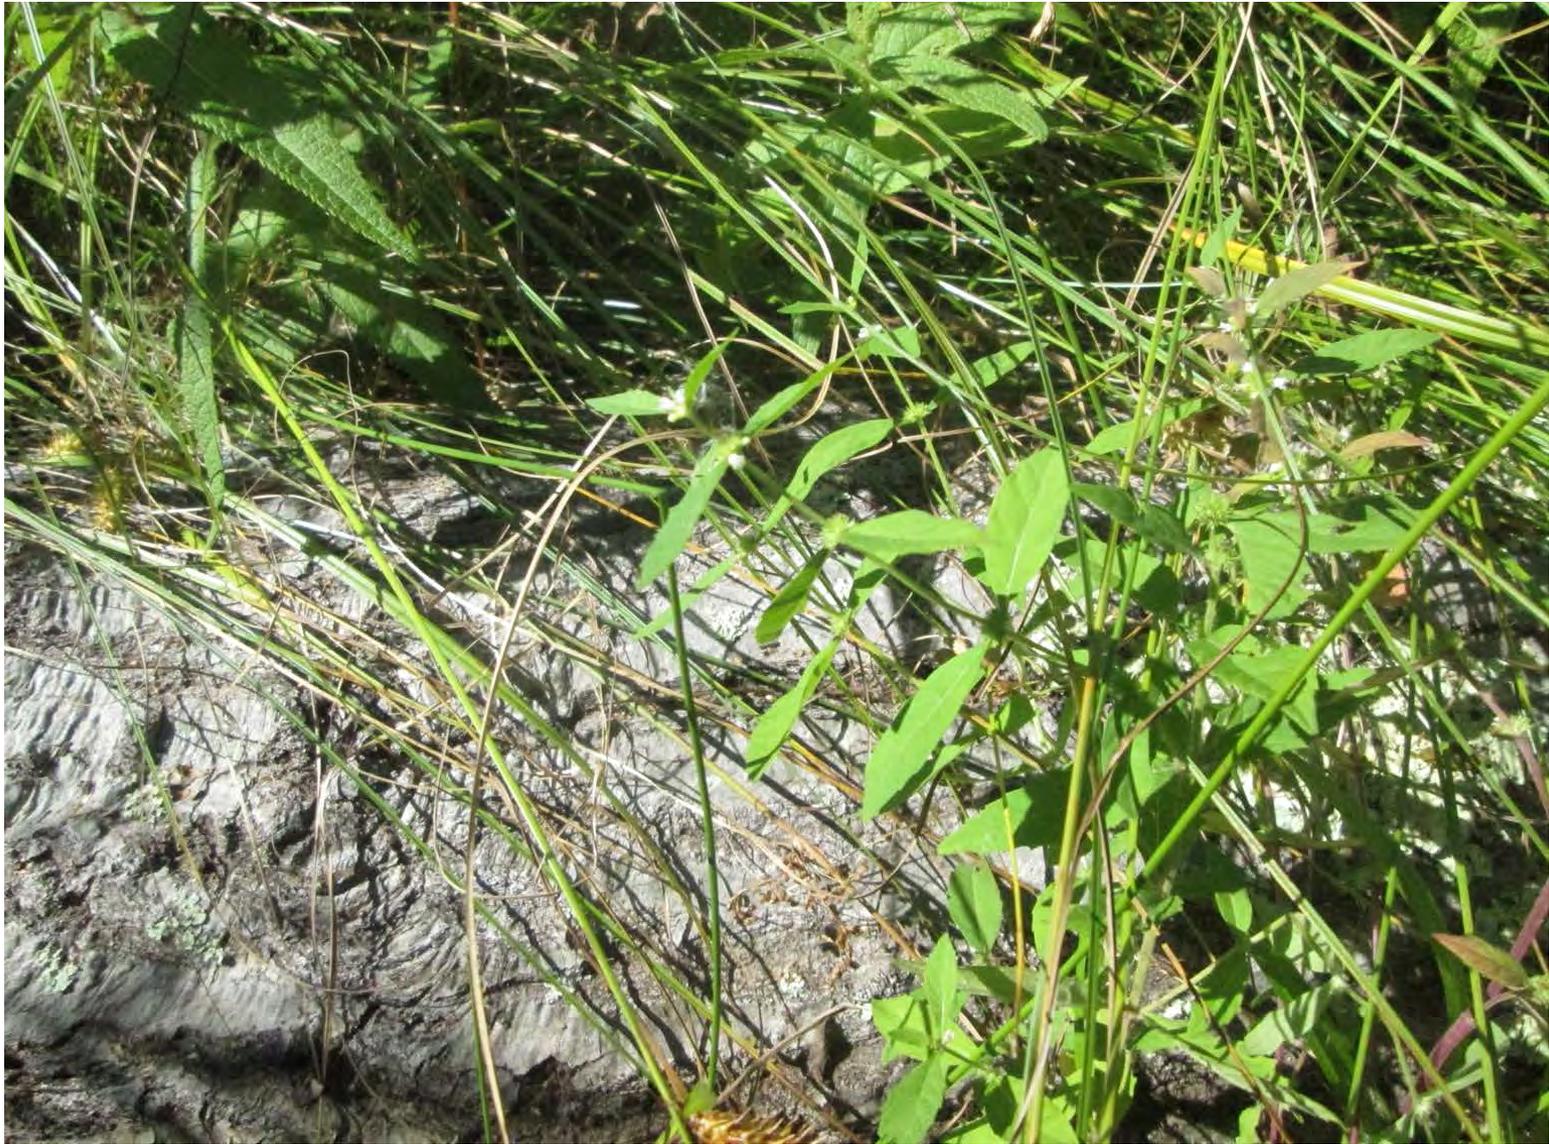
View of algal crust and water horehound, a pioneer to the site.

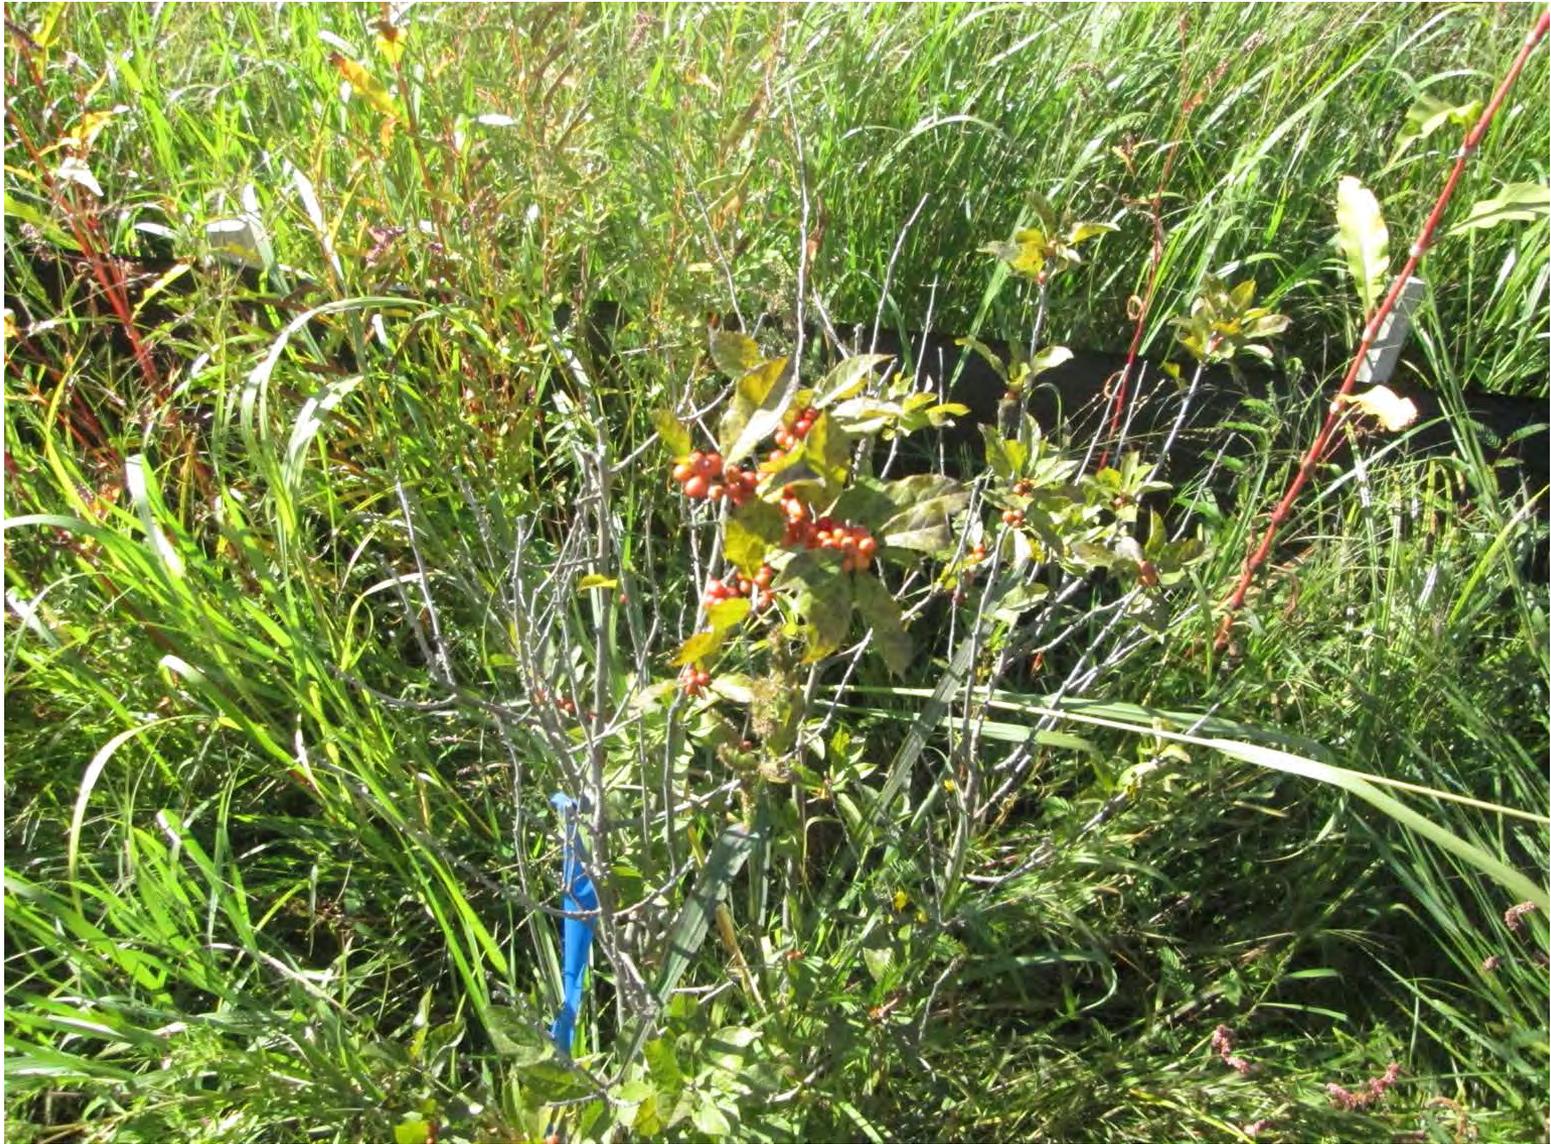
View of Ilex in Site 10.

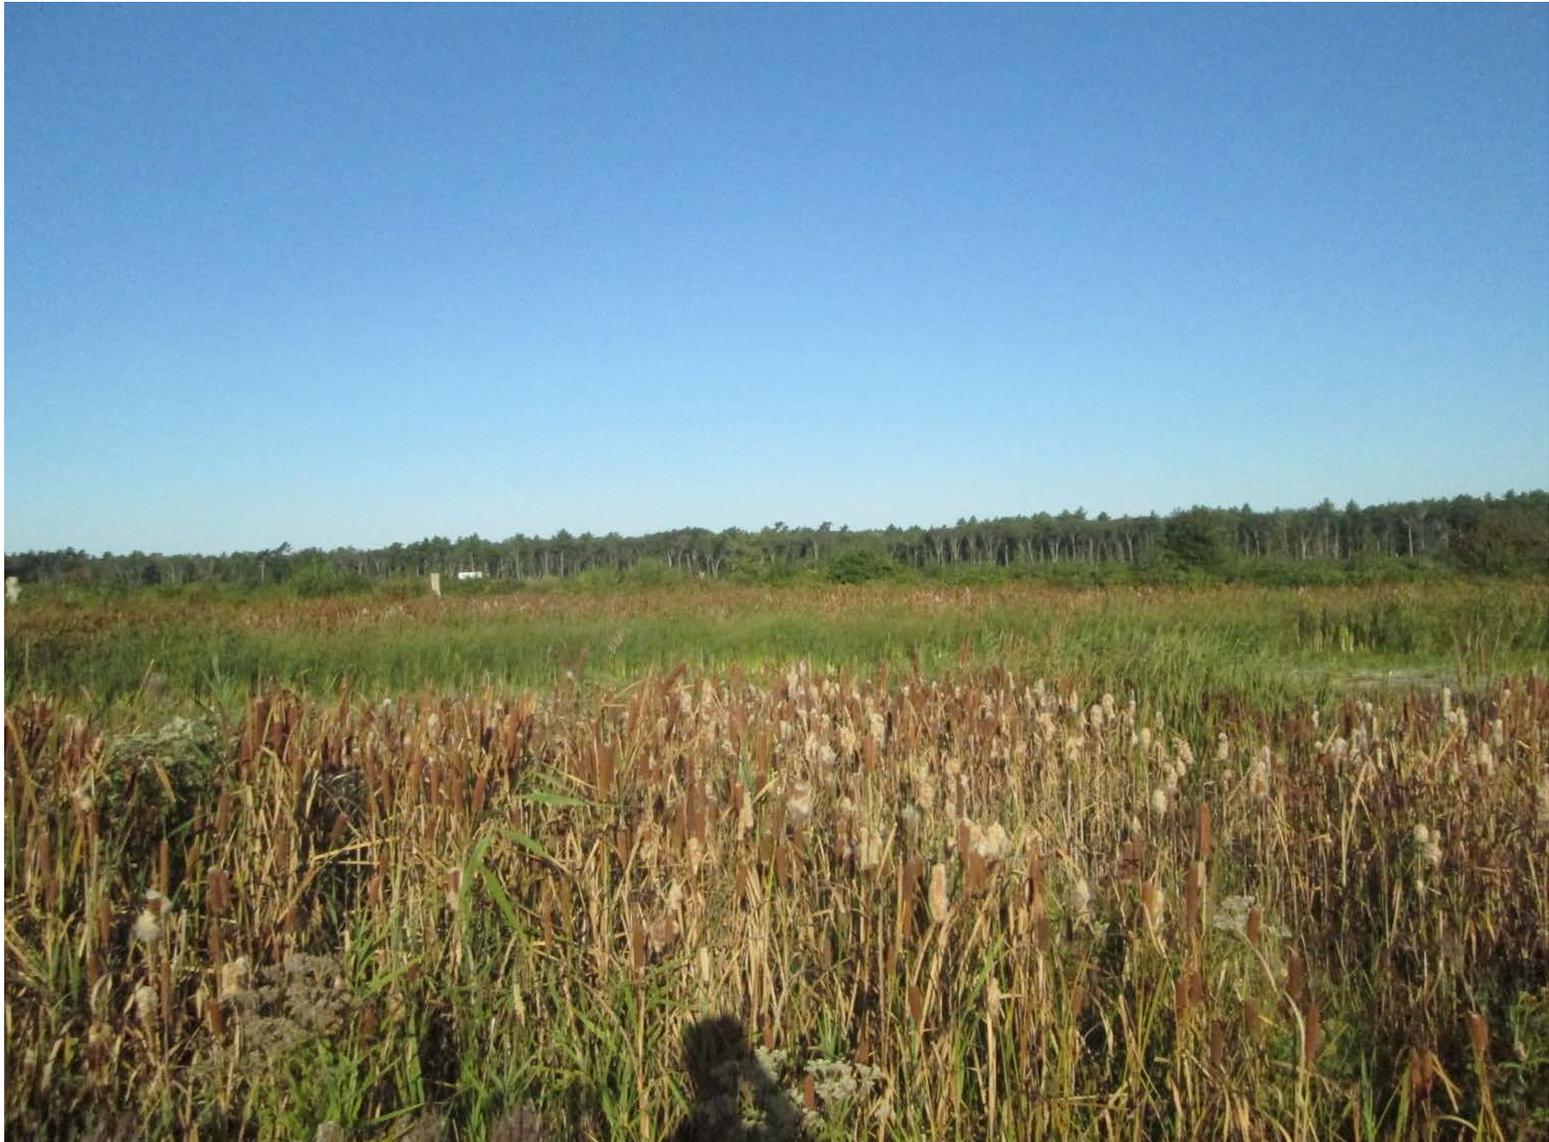
View of western vernal pool in Site 10 (downgradient behind cattail fringe). The Vernal Pool is almost dry.

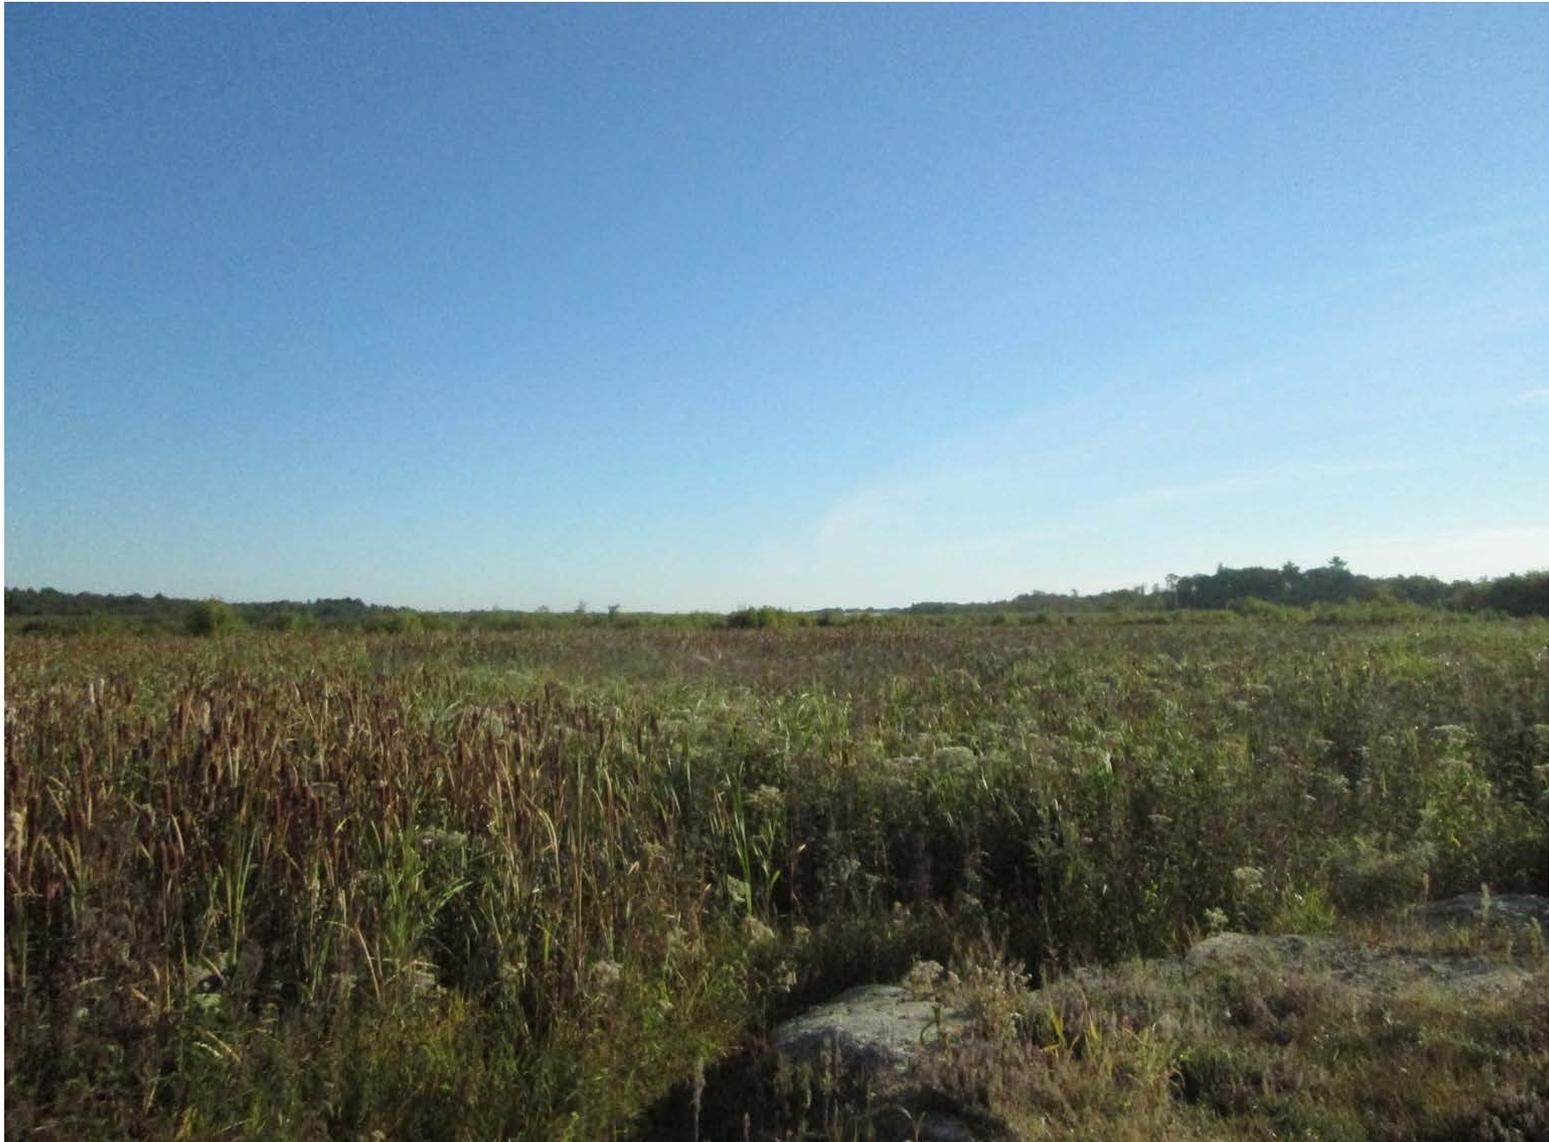
View of cattail fringe around perimeter of northern vernal pool in Site 10. No water was present within vernal pool.

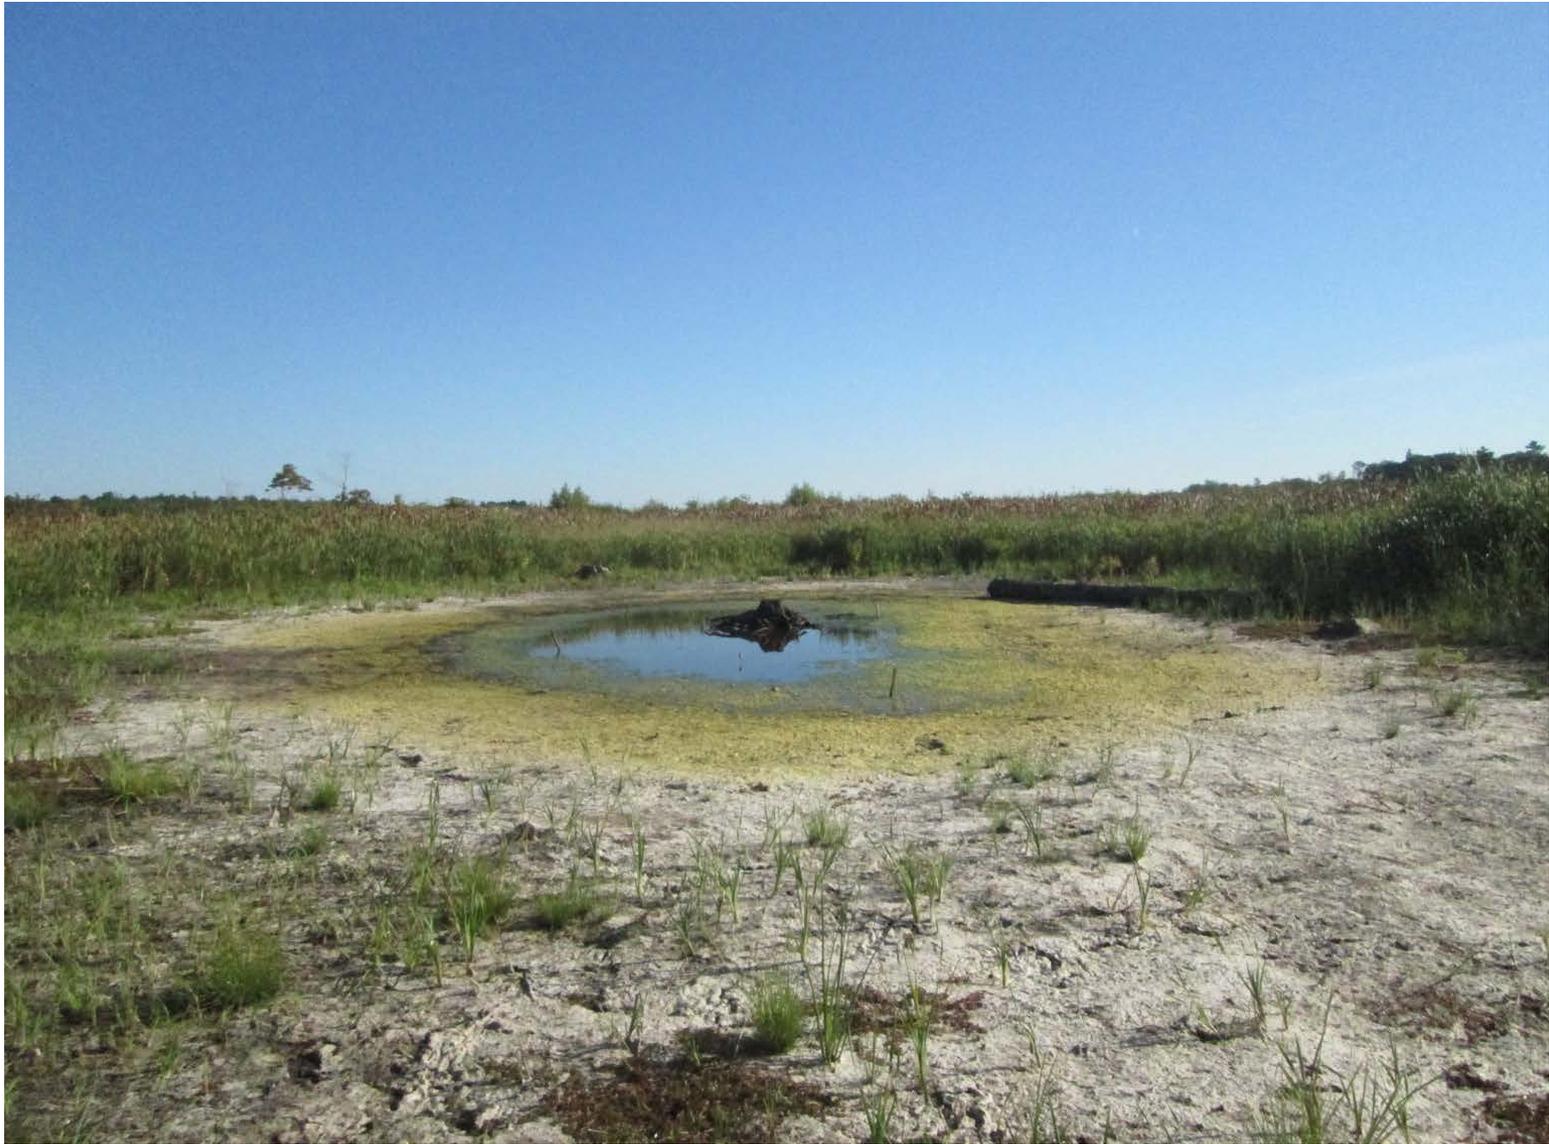
View of algal crust in southern vernal pool.

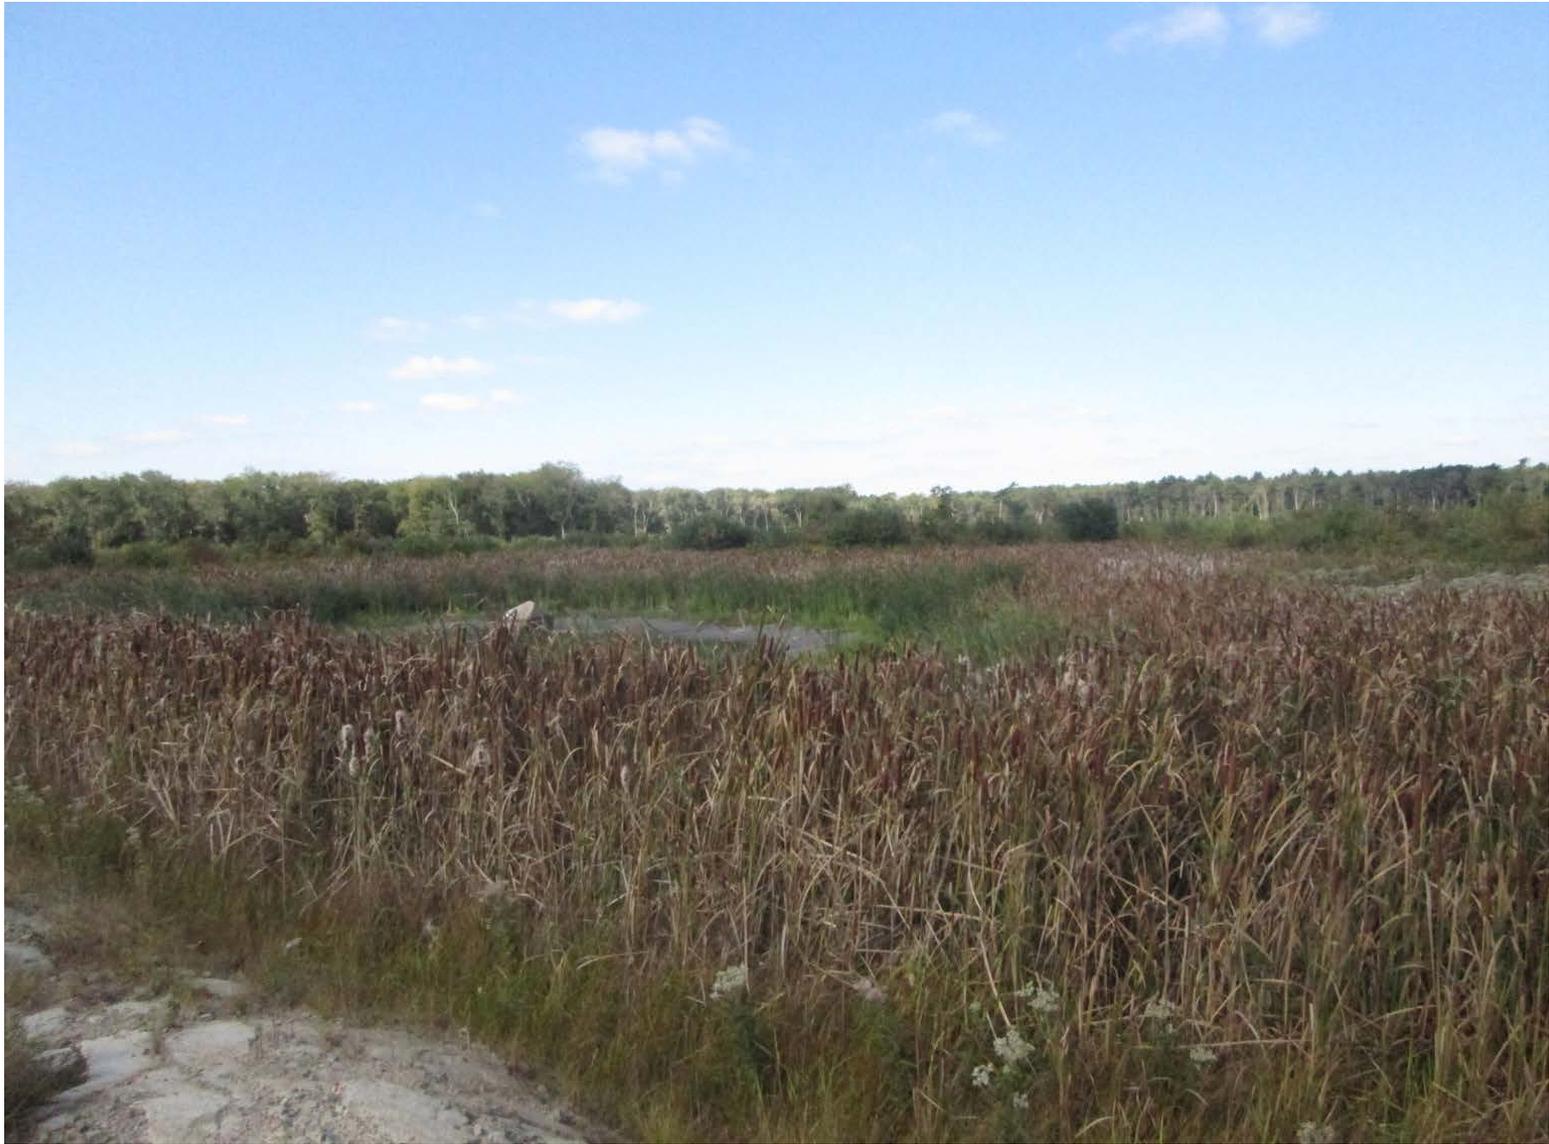
View of southern vernal pool in Site 10. Vernal pool is almost dry.

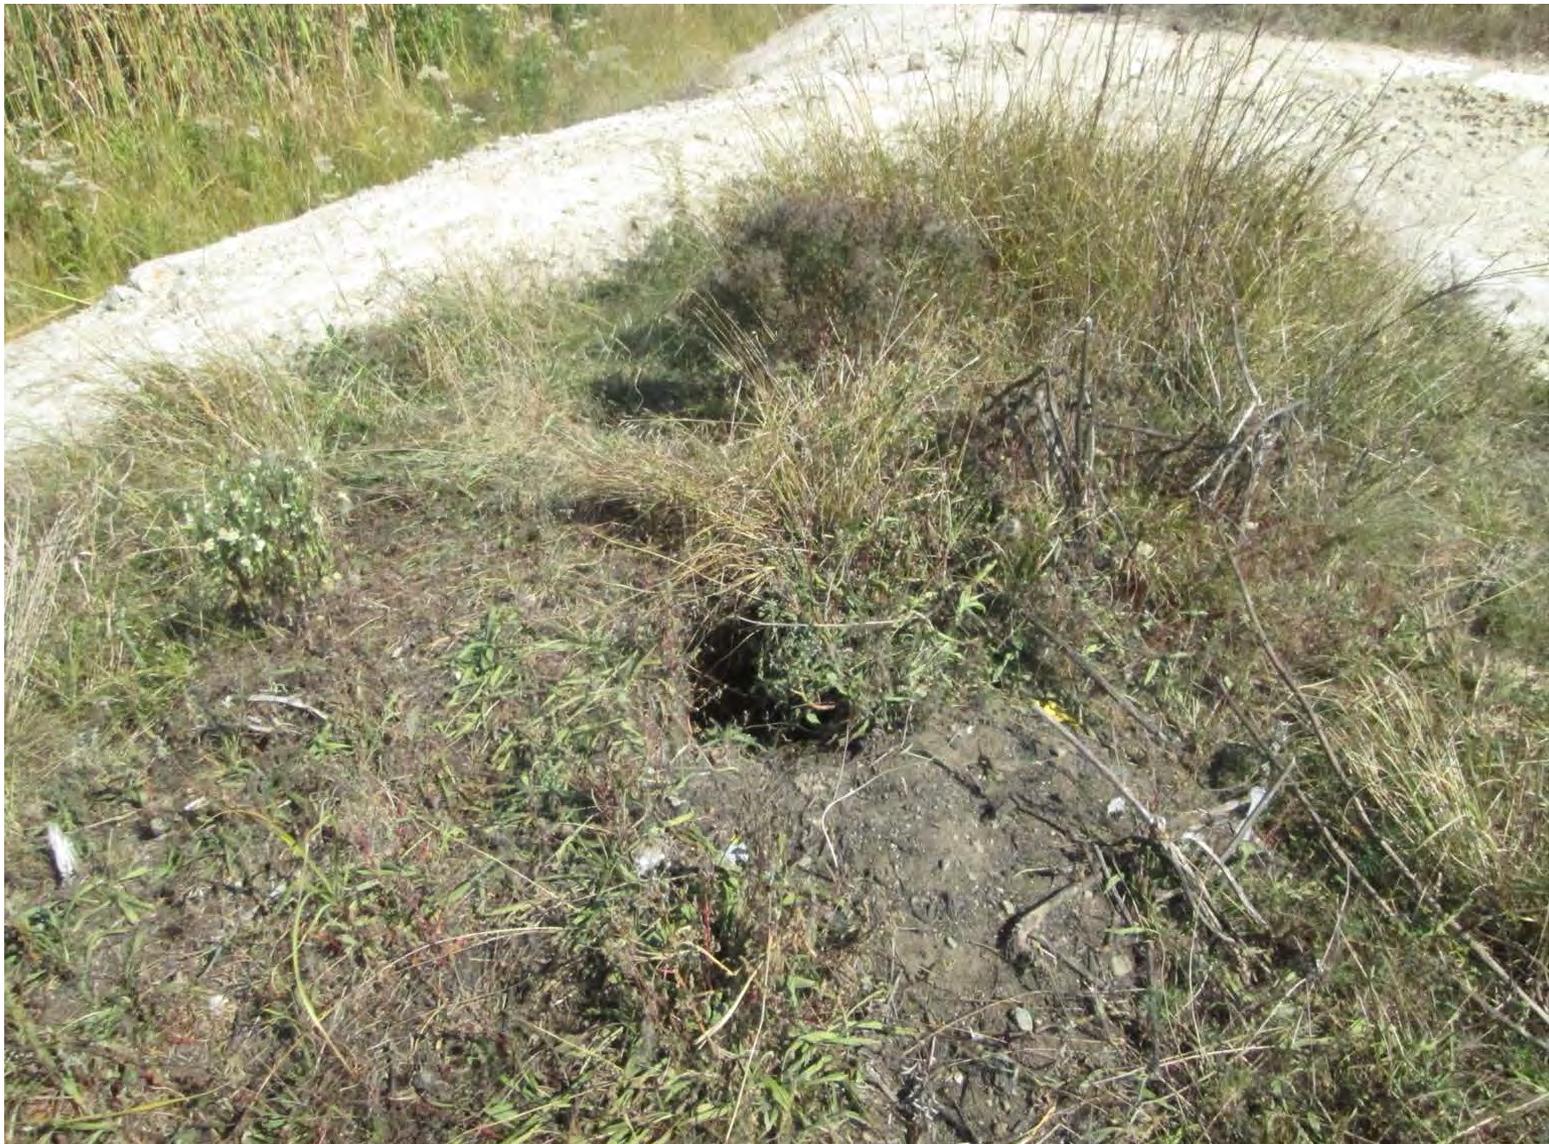
View of animal burrow in Site 10.

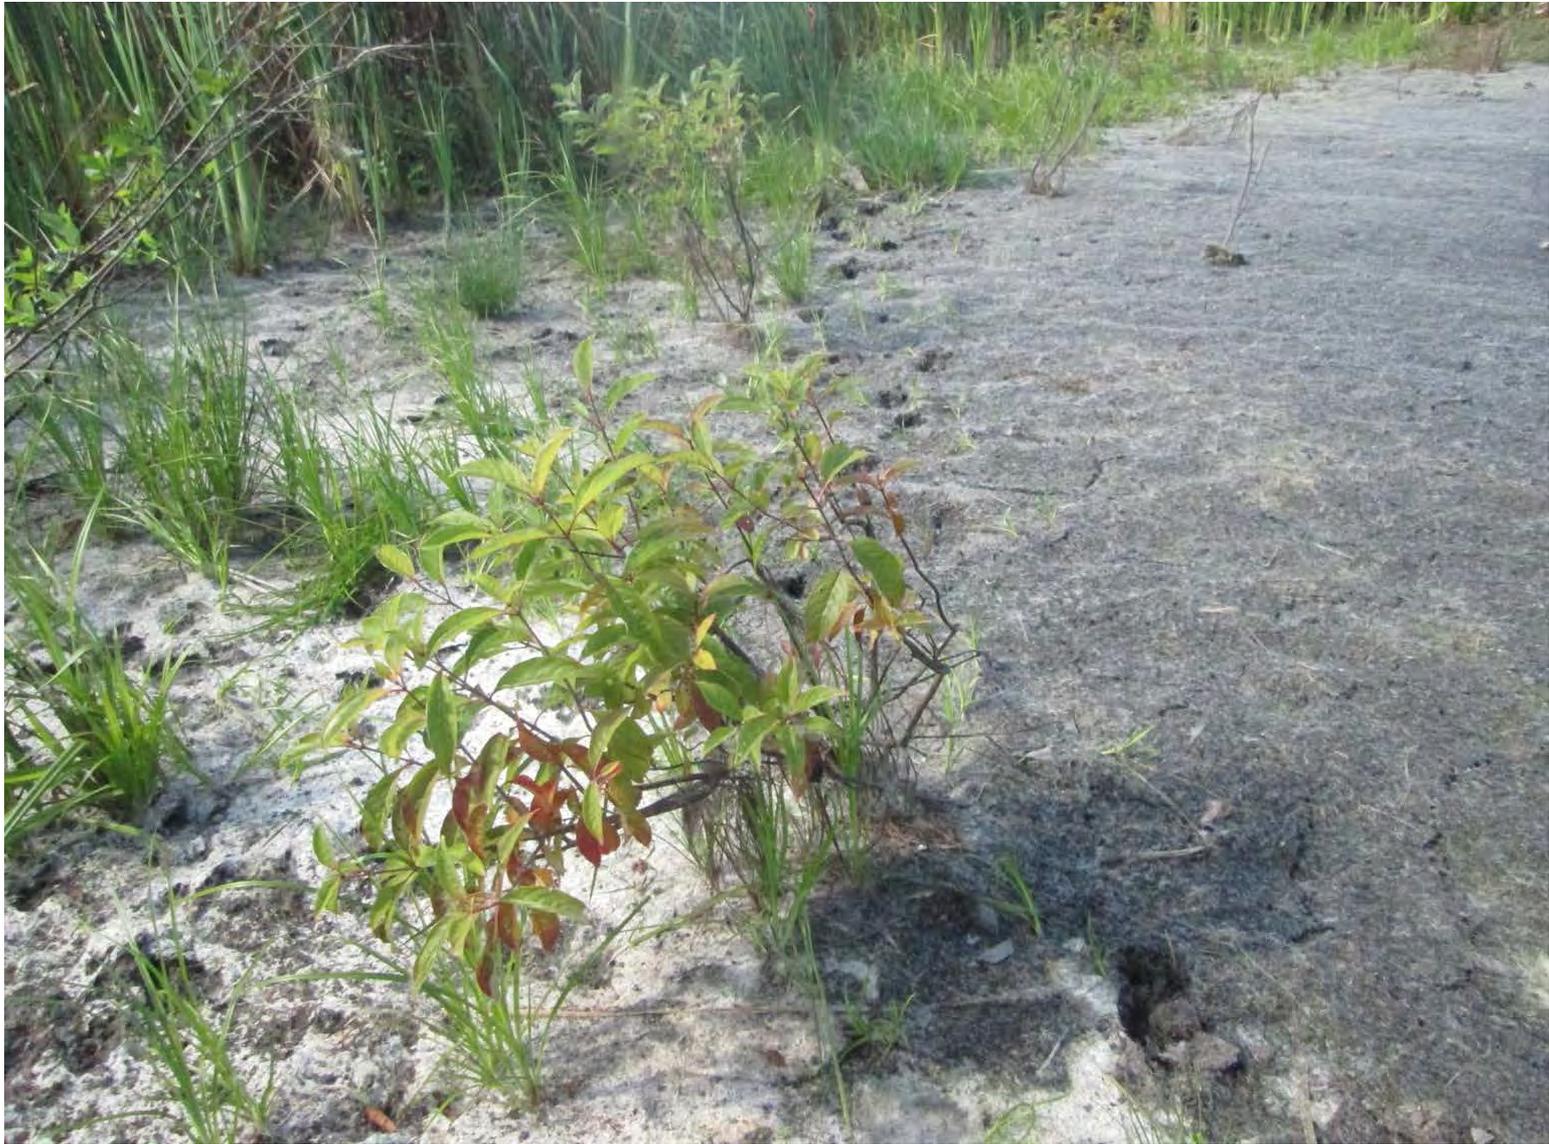
View of buttonbush at edge of vernal pool (south) in Site 10.
