**New Bedford Regional Airport
Runway Safety Improvements Project – Phase 4
Reconstruct, Mark, and Groove Runway 5-23
MassDEP File No. SE049-0635**

ENVIRONMENTAL MONITOR INSPECTION FORM

Date/ Time of Inspections: **8/28/14 (morning), 9/2/14 (morning), 9/4/14 (morning).**

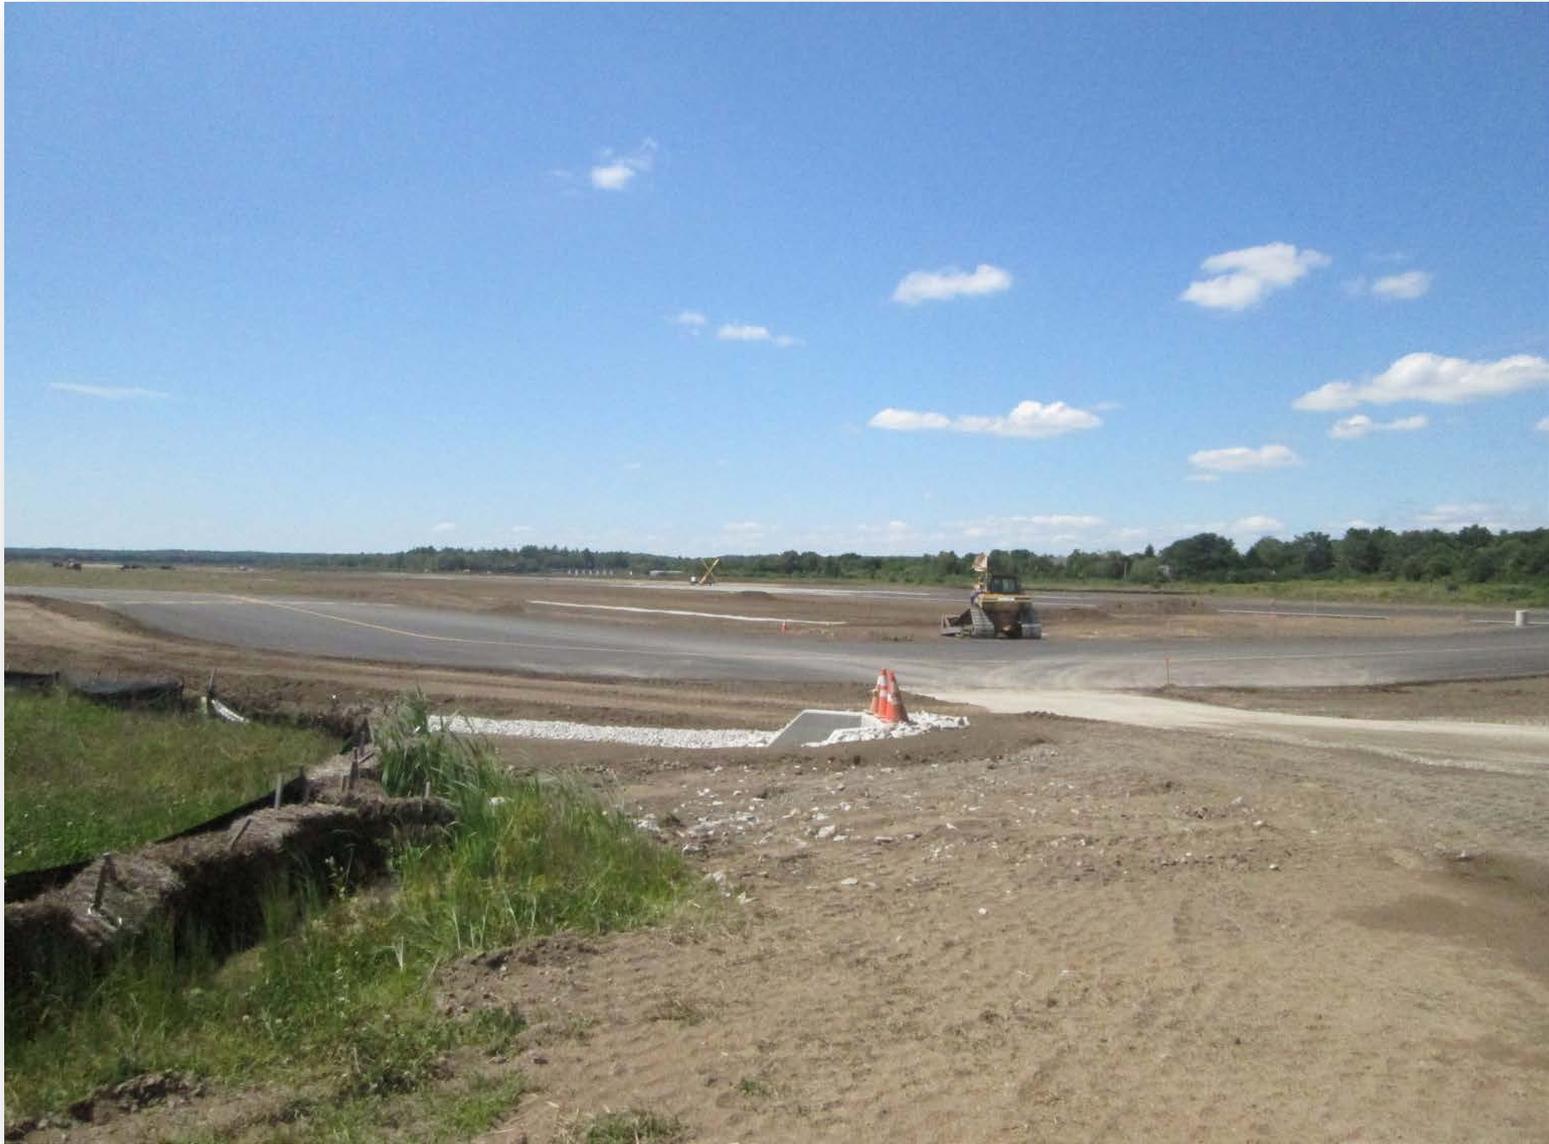
View of spreading loam on the Runway 23 end, week of 8/28/14.

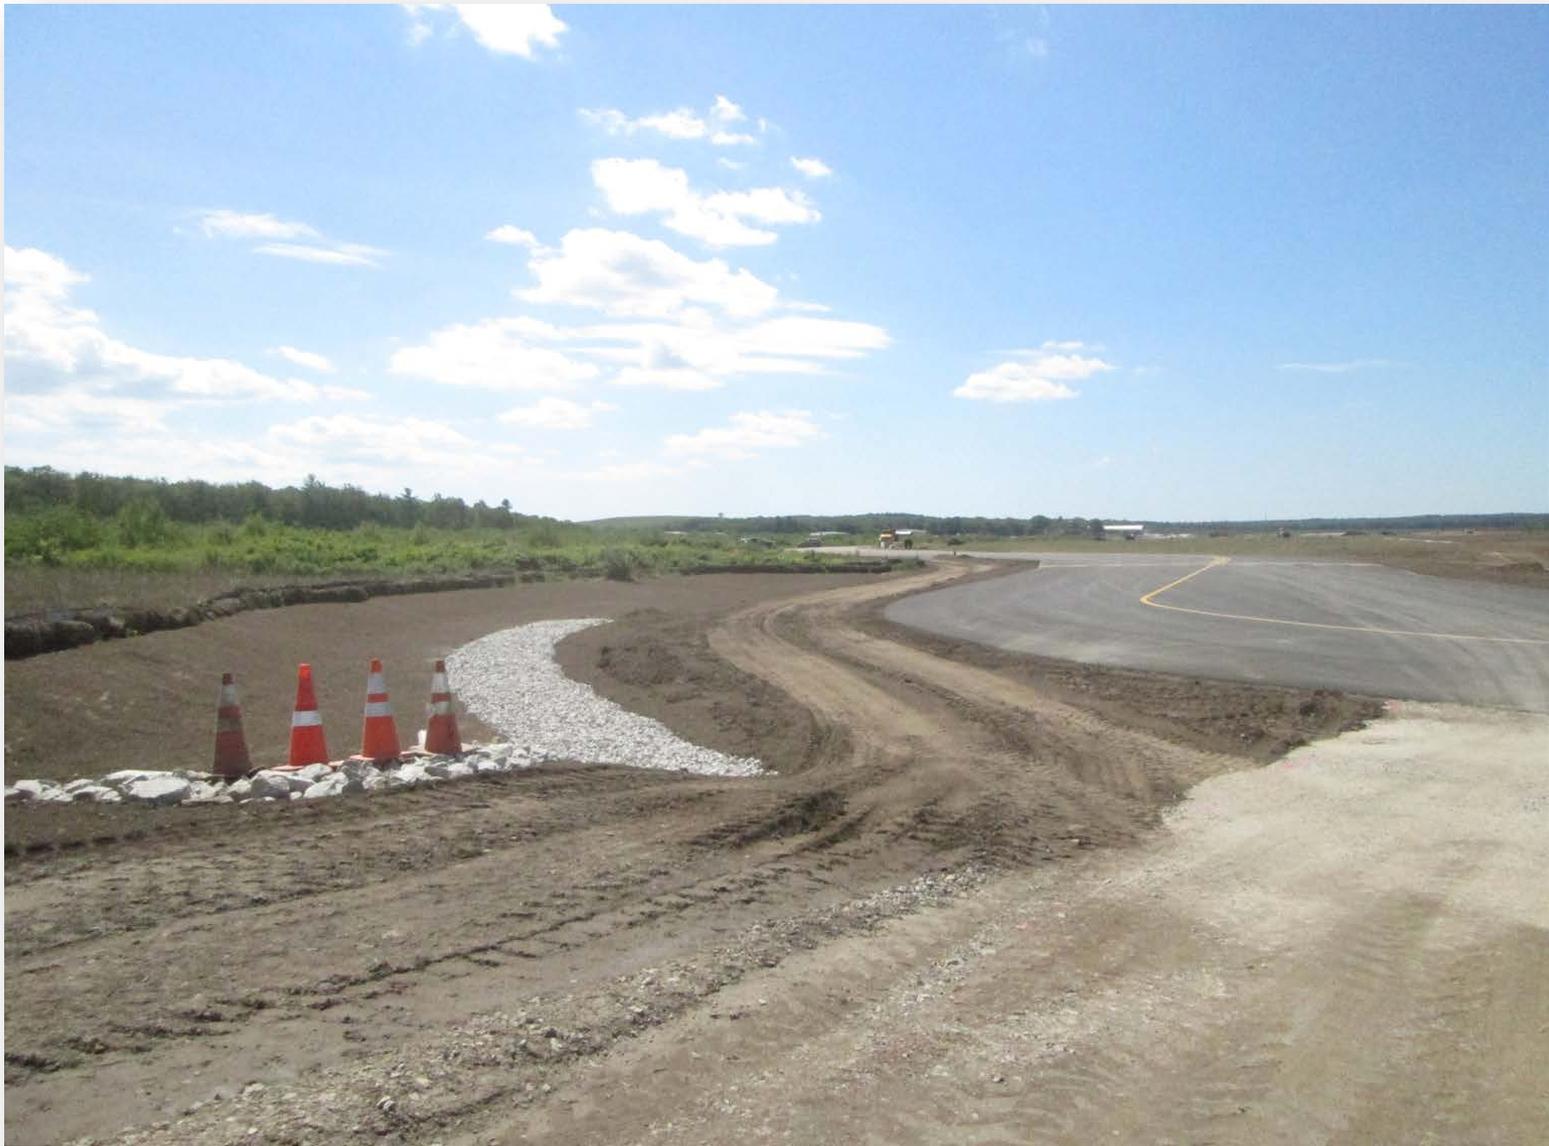
View final grade stormwater drainage for Runway 23 end/ taxiway A, week of 8/28/14.

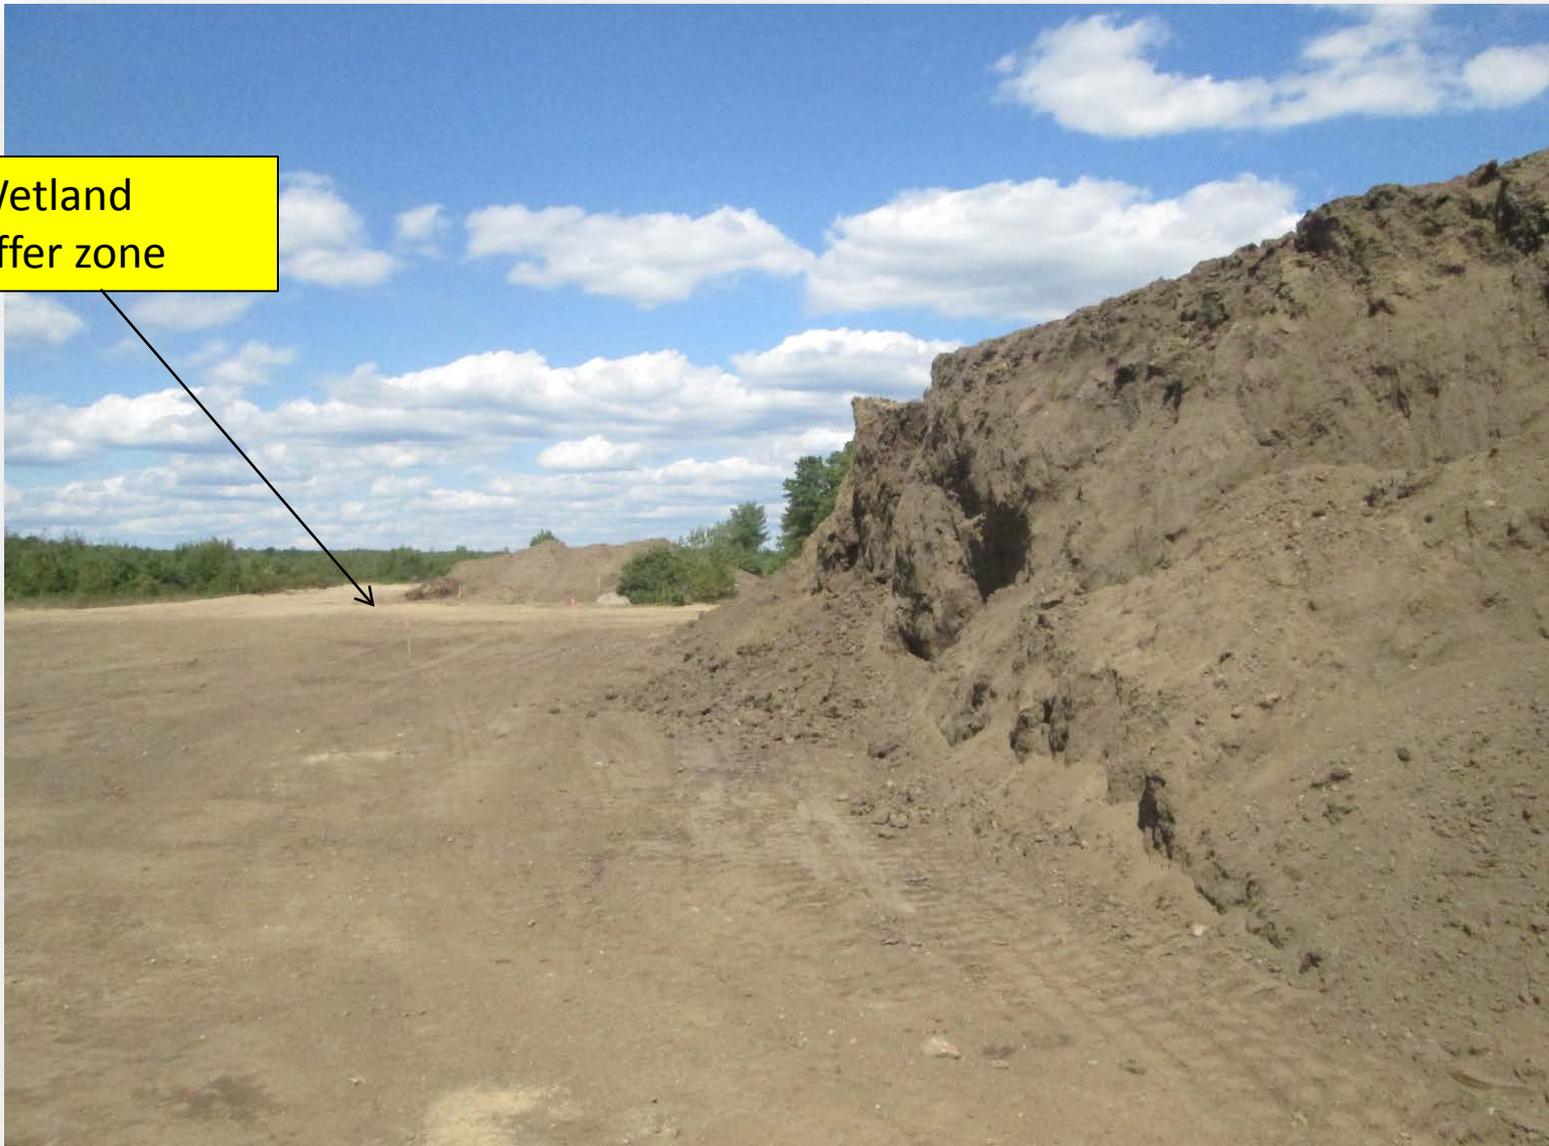
~Wetland
buffer zone

Soil stockpile site off of Aviation way. 100 ft wetland buffer was identified with stakes and flagging.

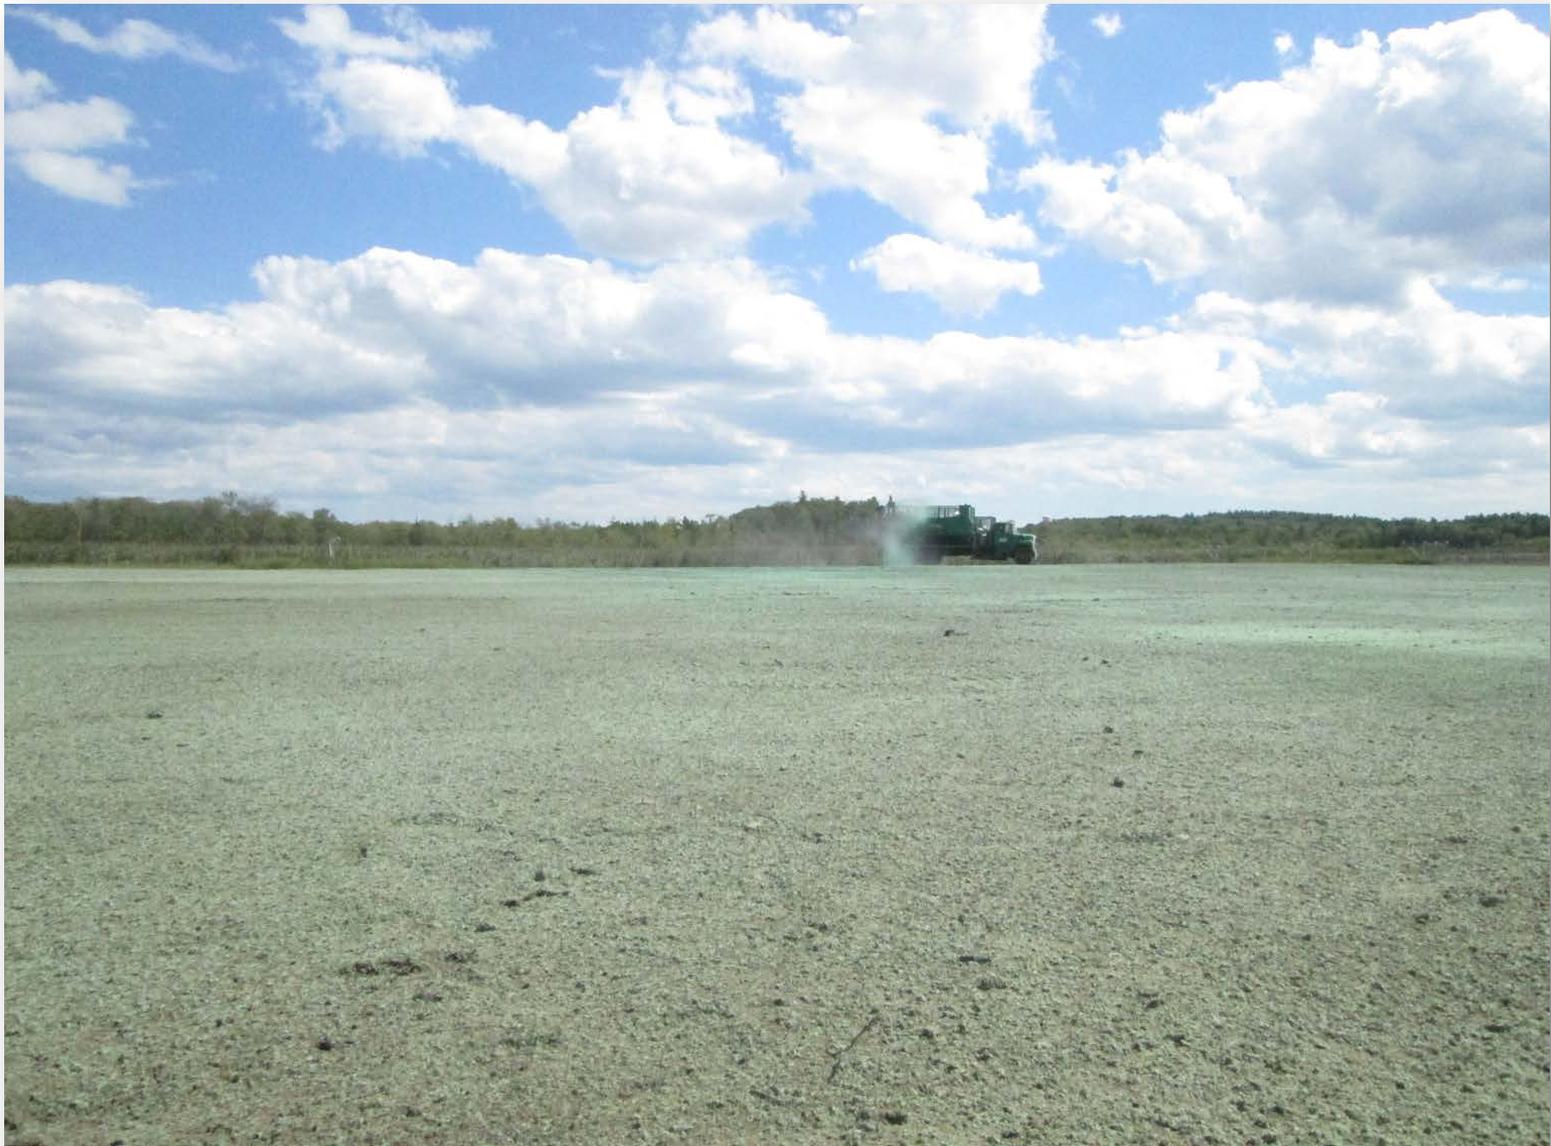
View of hydroseeding infield on 8/28/14 visit.

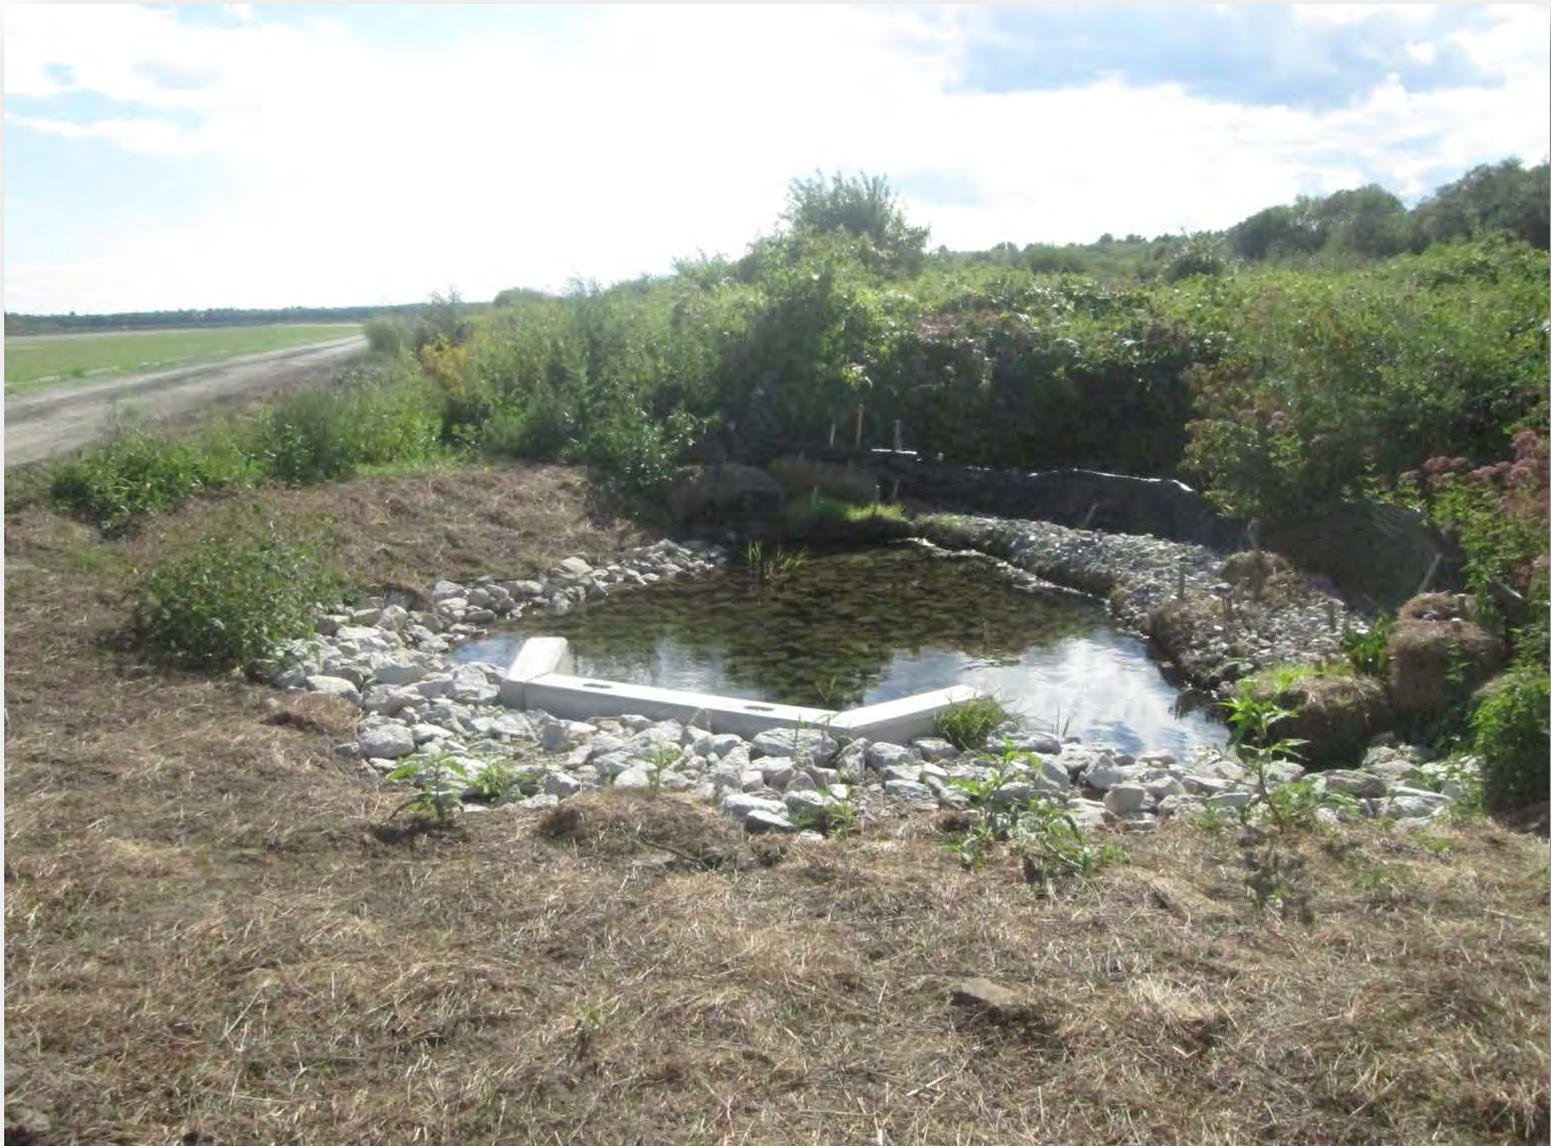
View of headwall leading from Catch Basin 1 & 3. Water has been clear for weeks. Slow movement percolating through the rock check dam and silt fence.

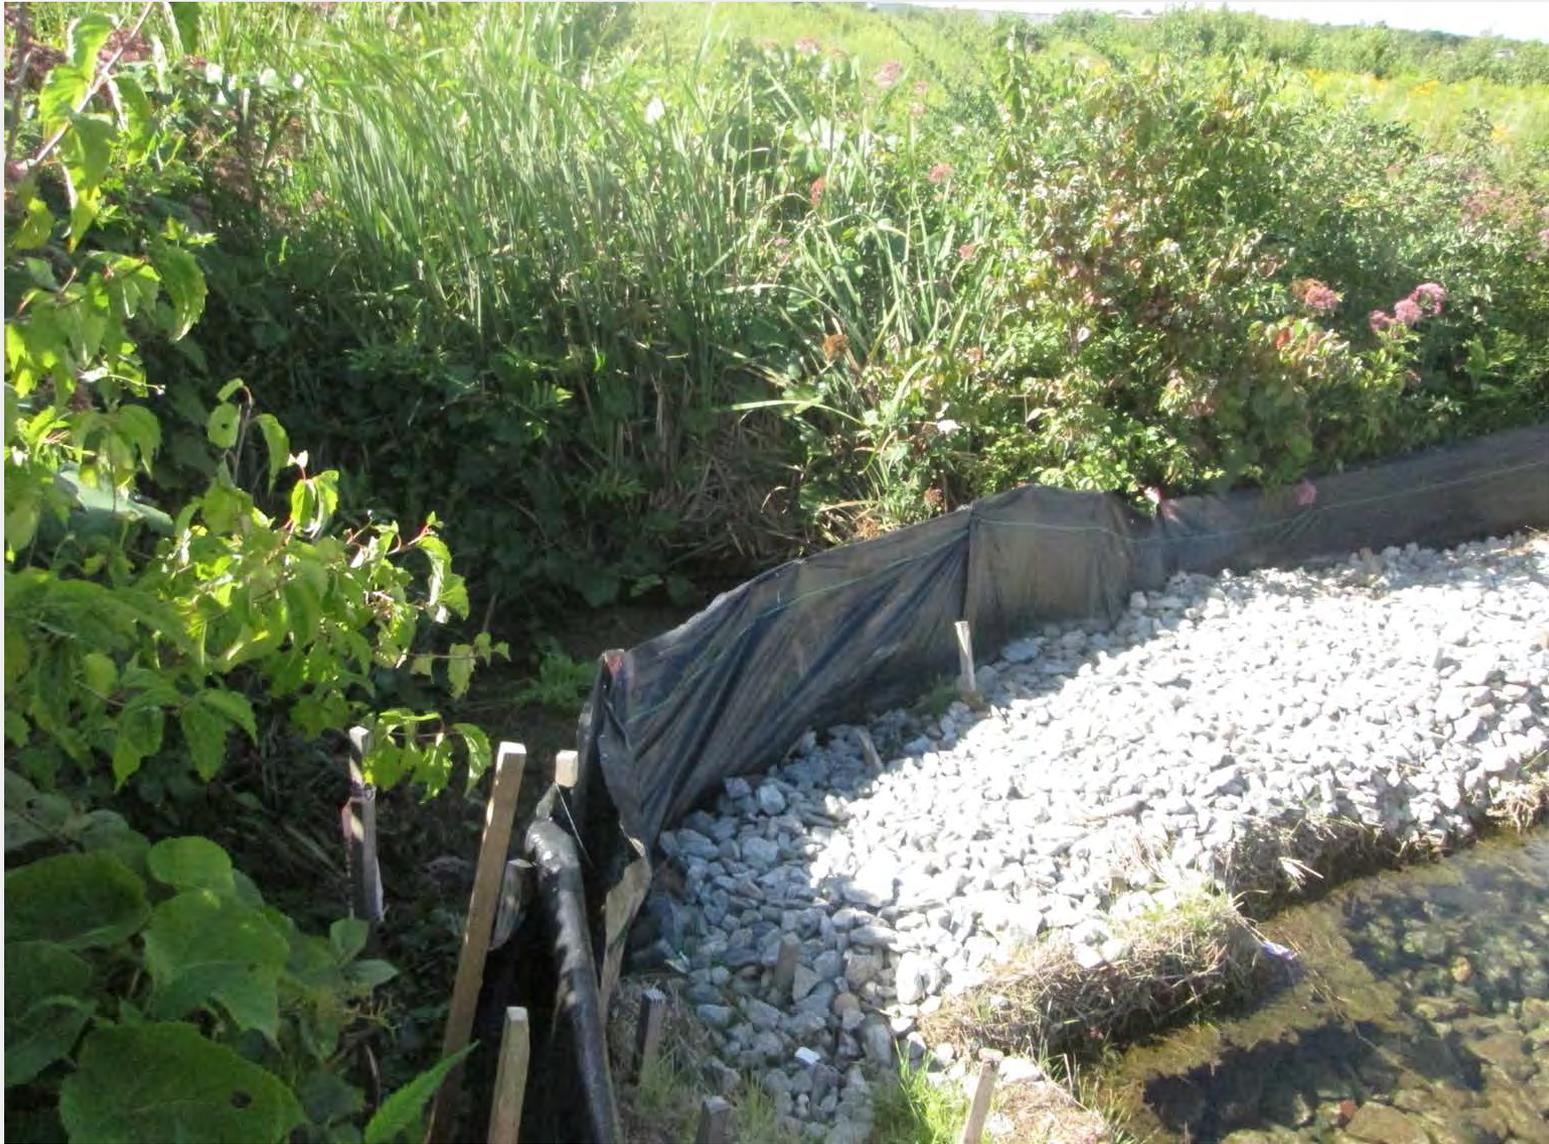
No appreciable sediment has been observed at this outfall.

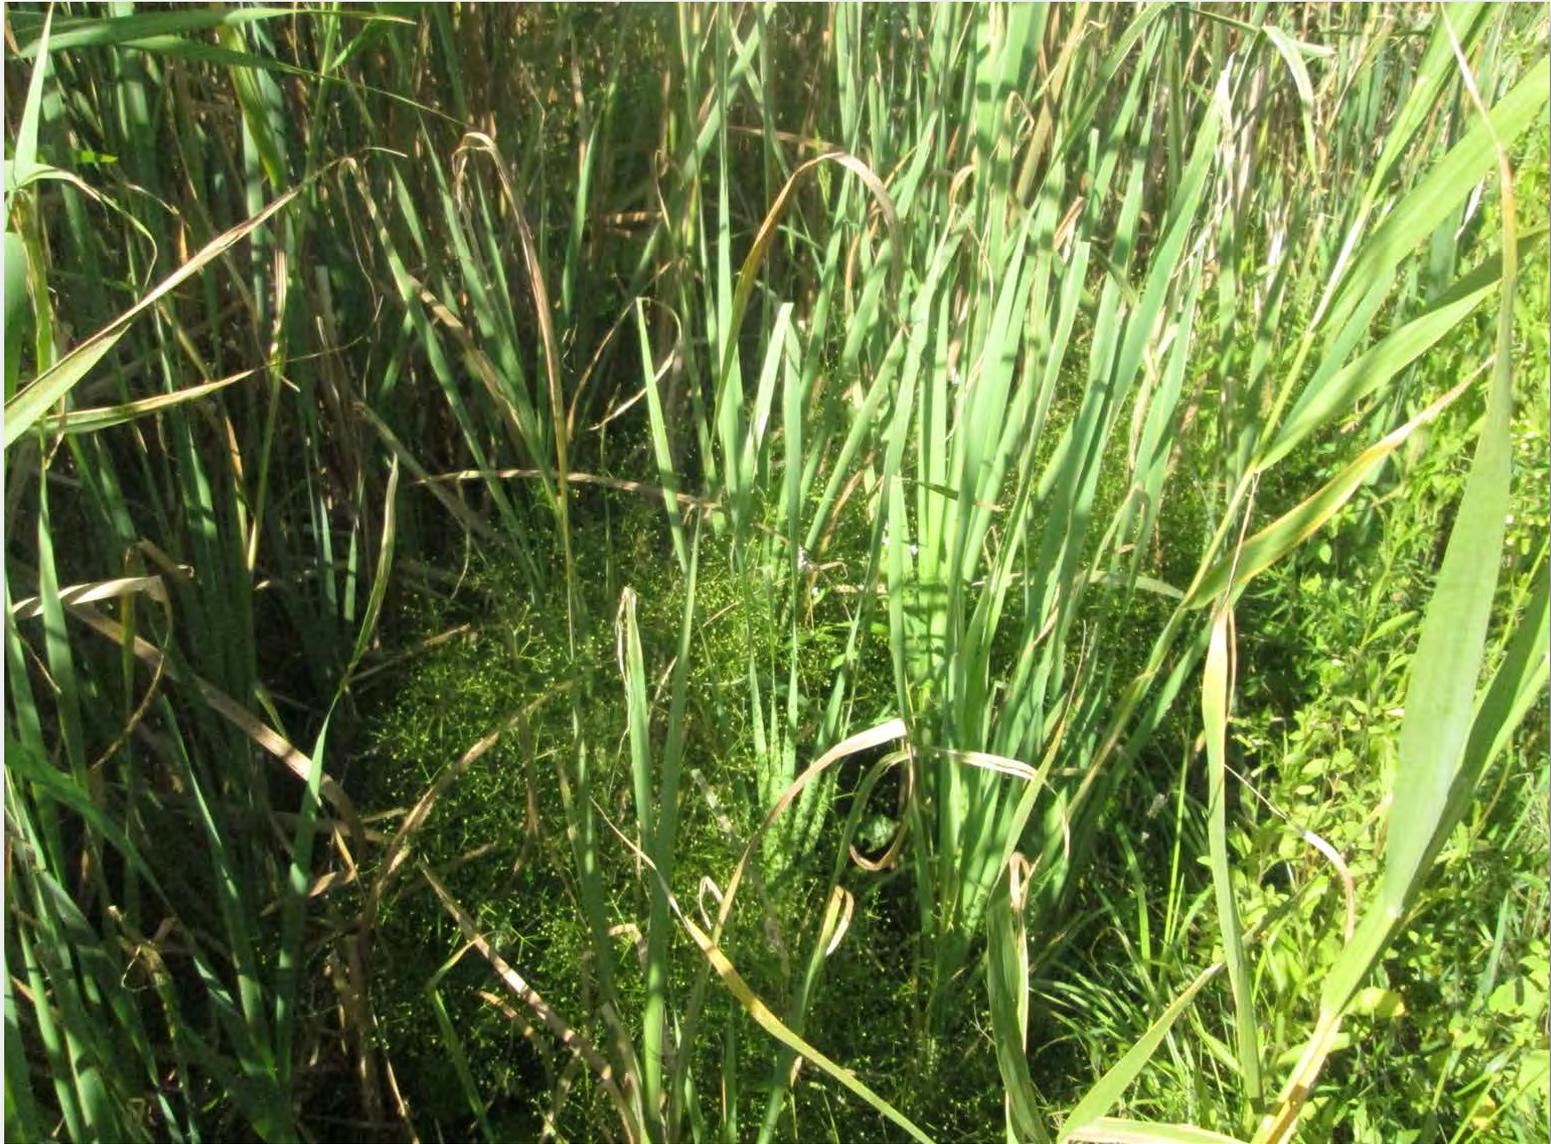
View of West Ditch immediately downstream headwall 1 & 3. Water levels are down.

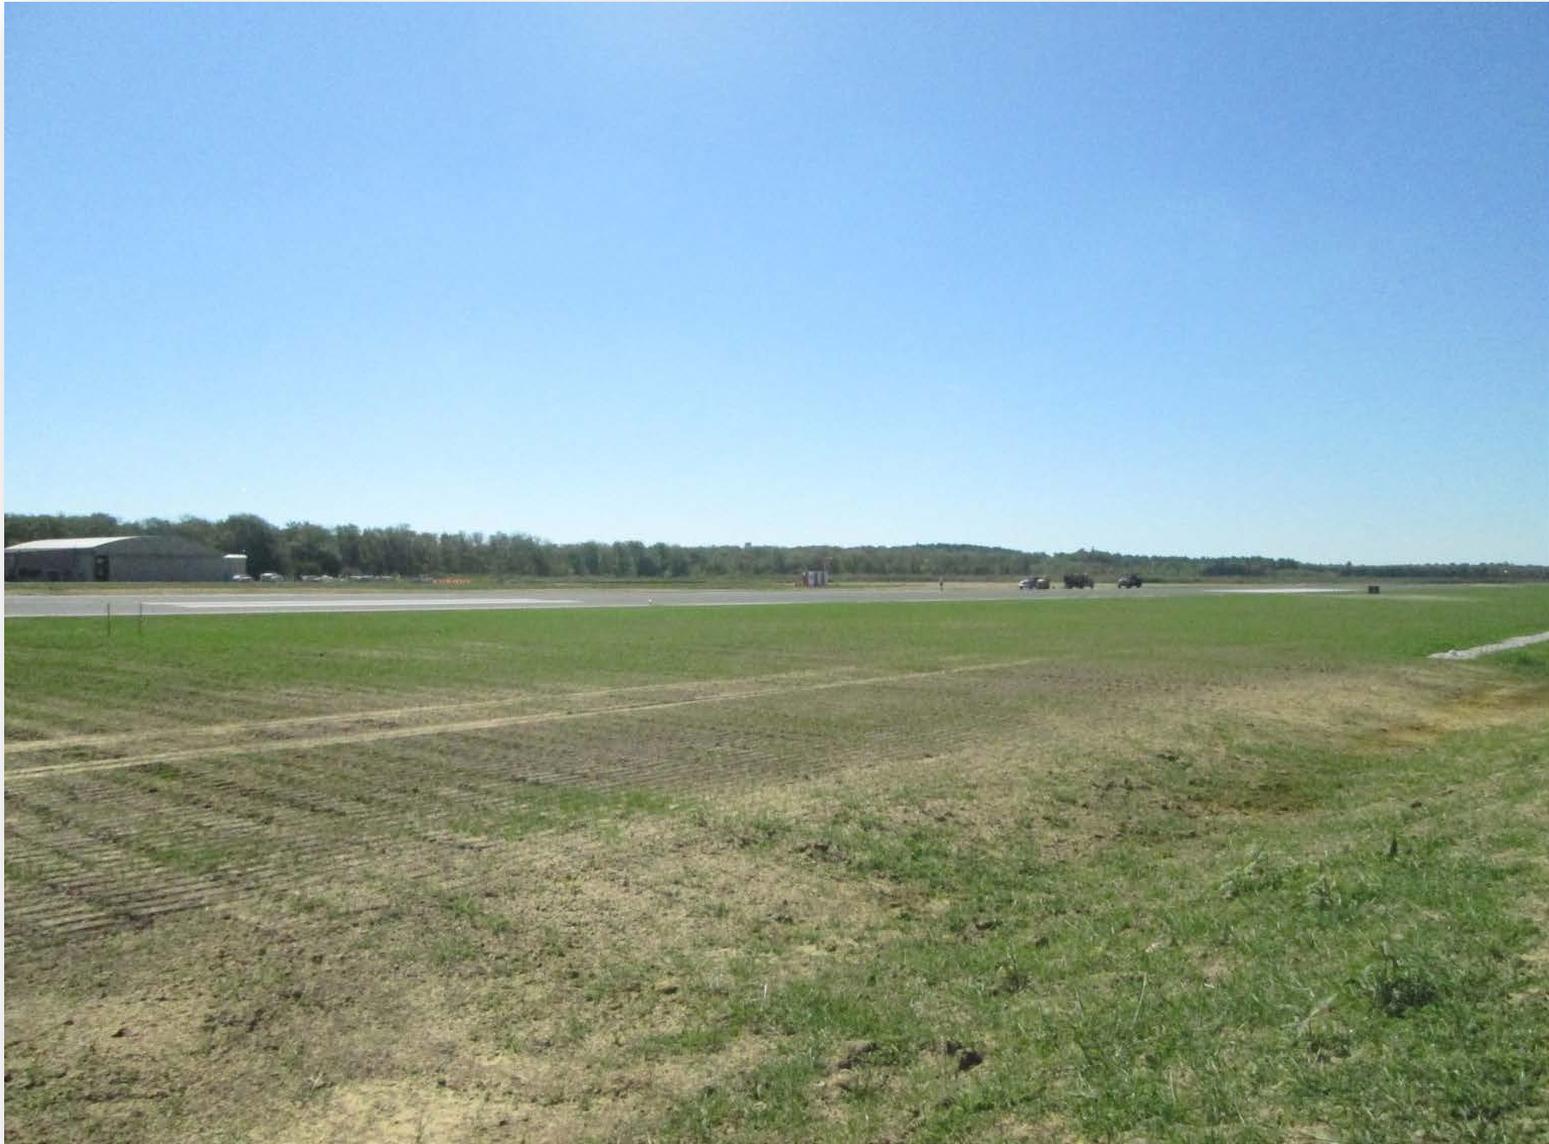
View of vegetation establishment post hydroseeding. This was one of the first areas to be seeded.

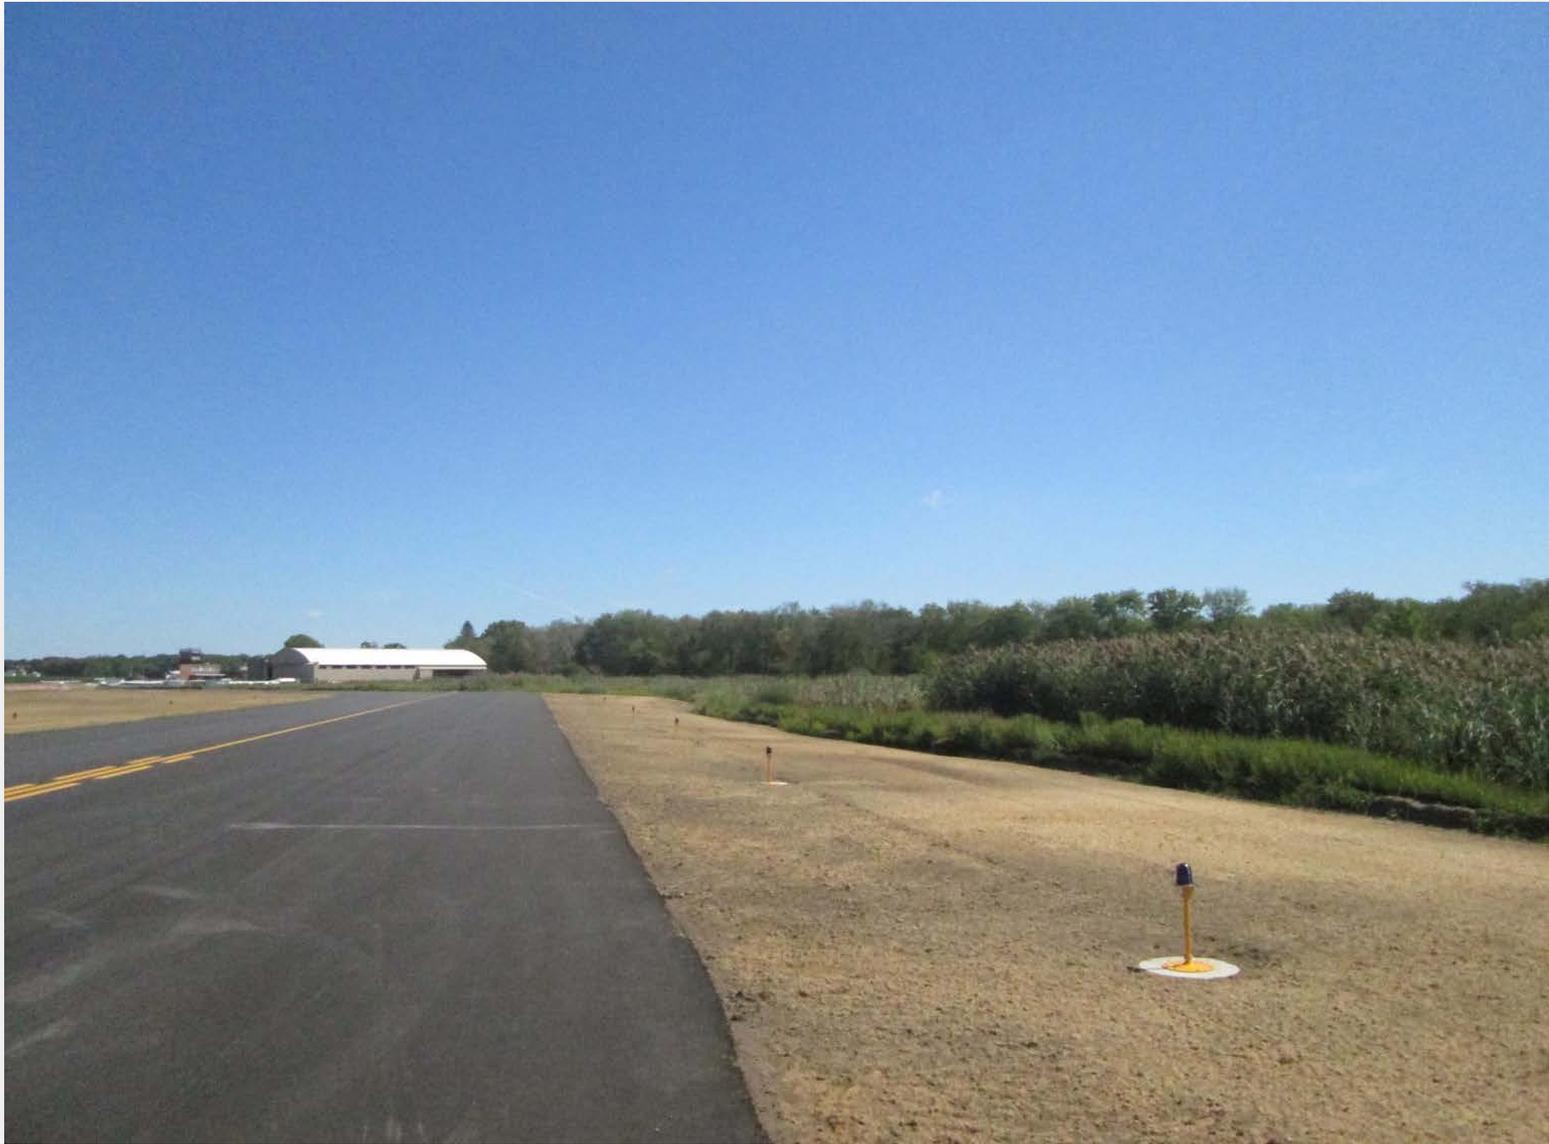
View of reshaped sideslopes south of Taxiway A. Taxiway lighting is completed.

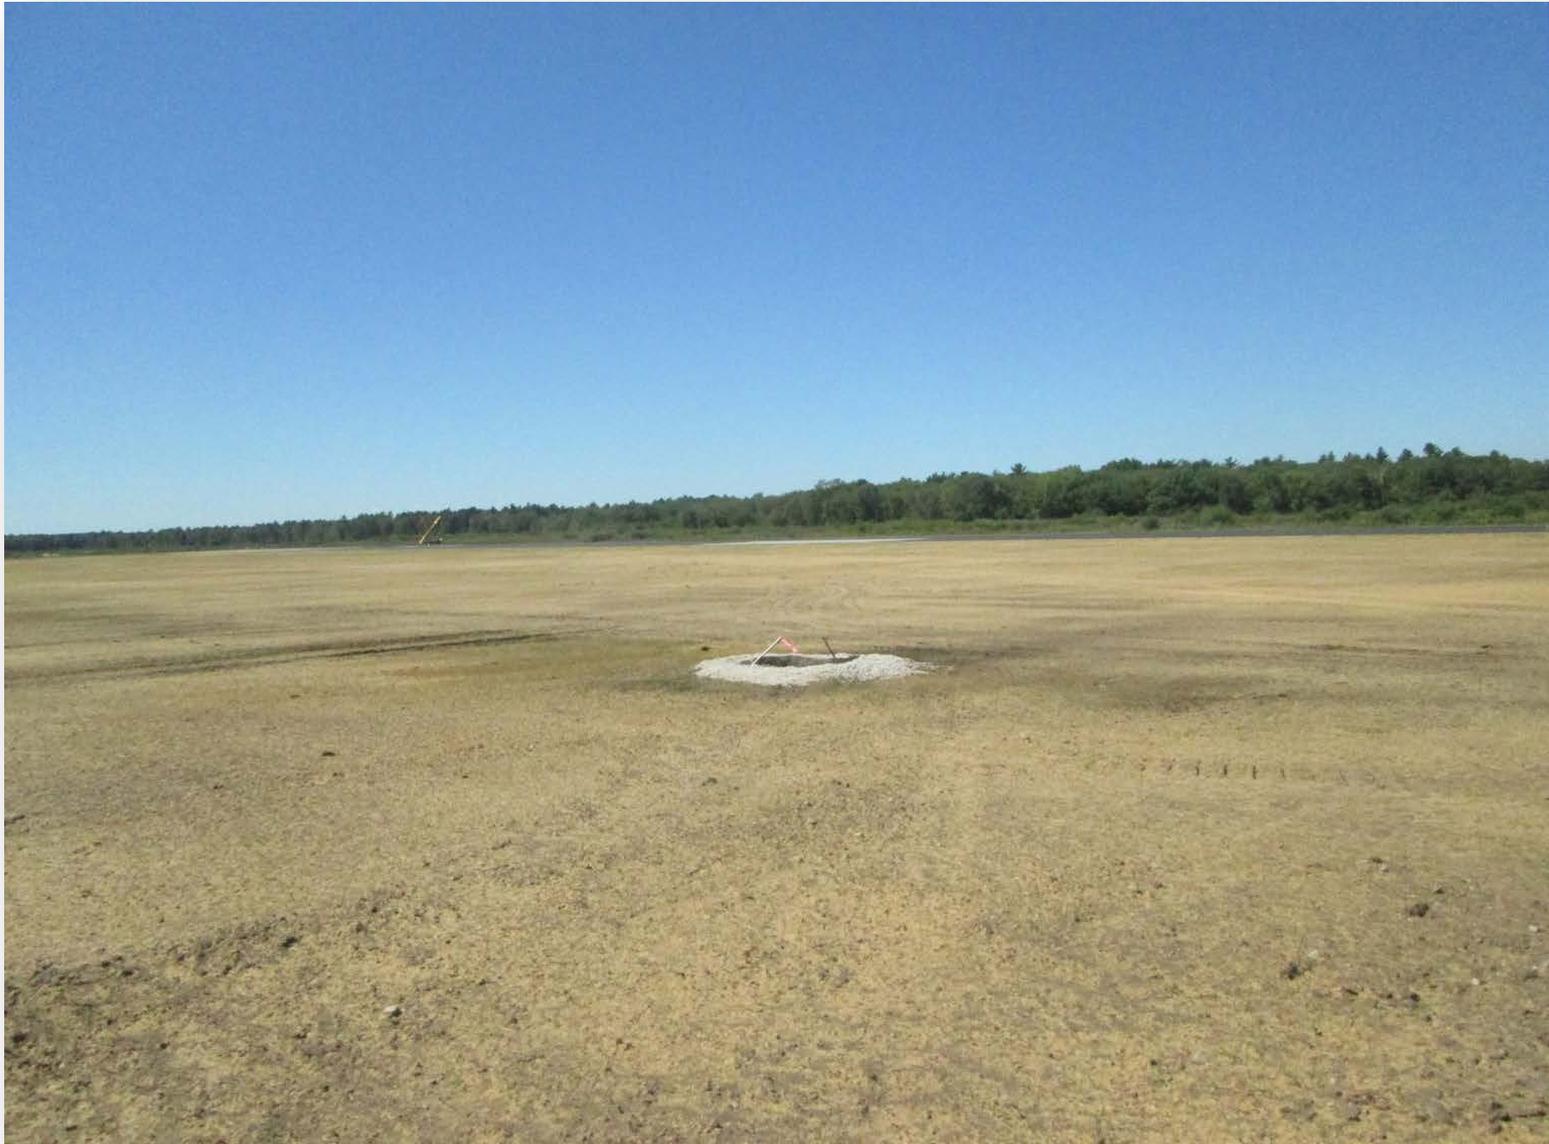
View of hydroseeded area adjacent to closed off catch basin 11.

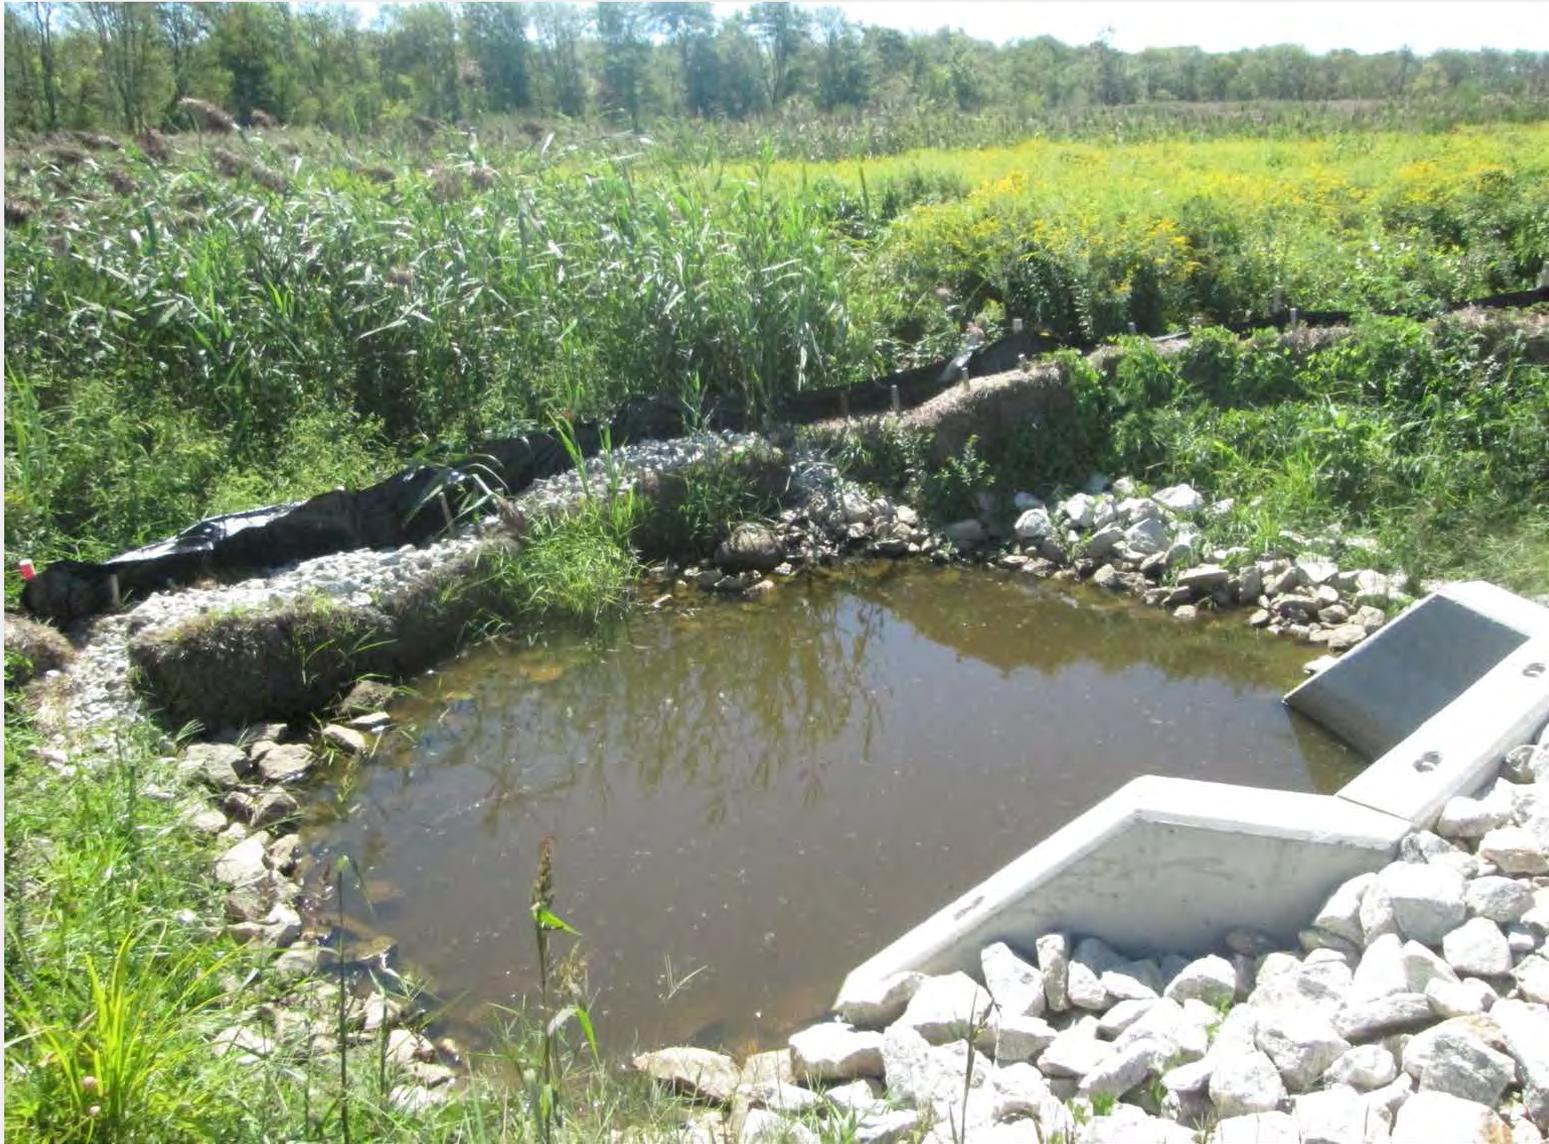
View of headwall from catch basin 11. Water is still turbid. This system will be cleaned out as part of punch list work.

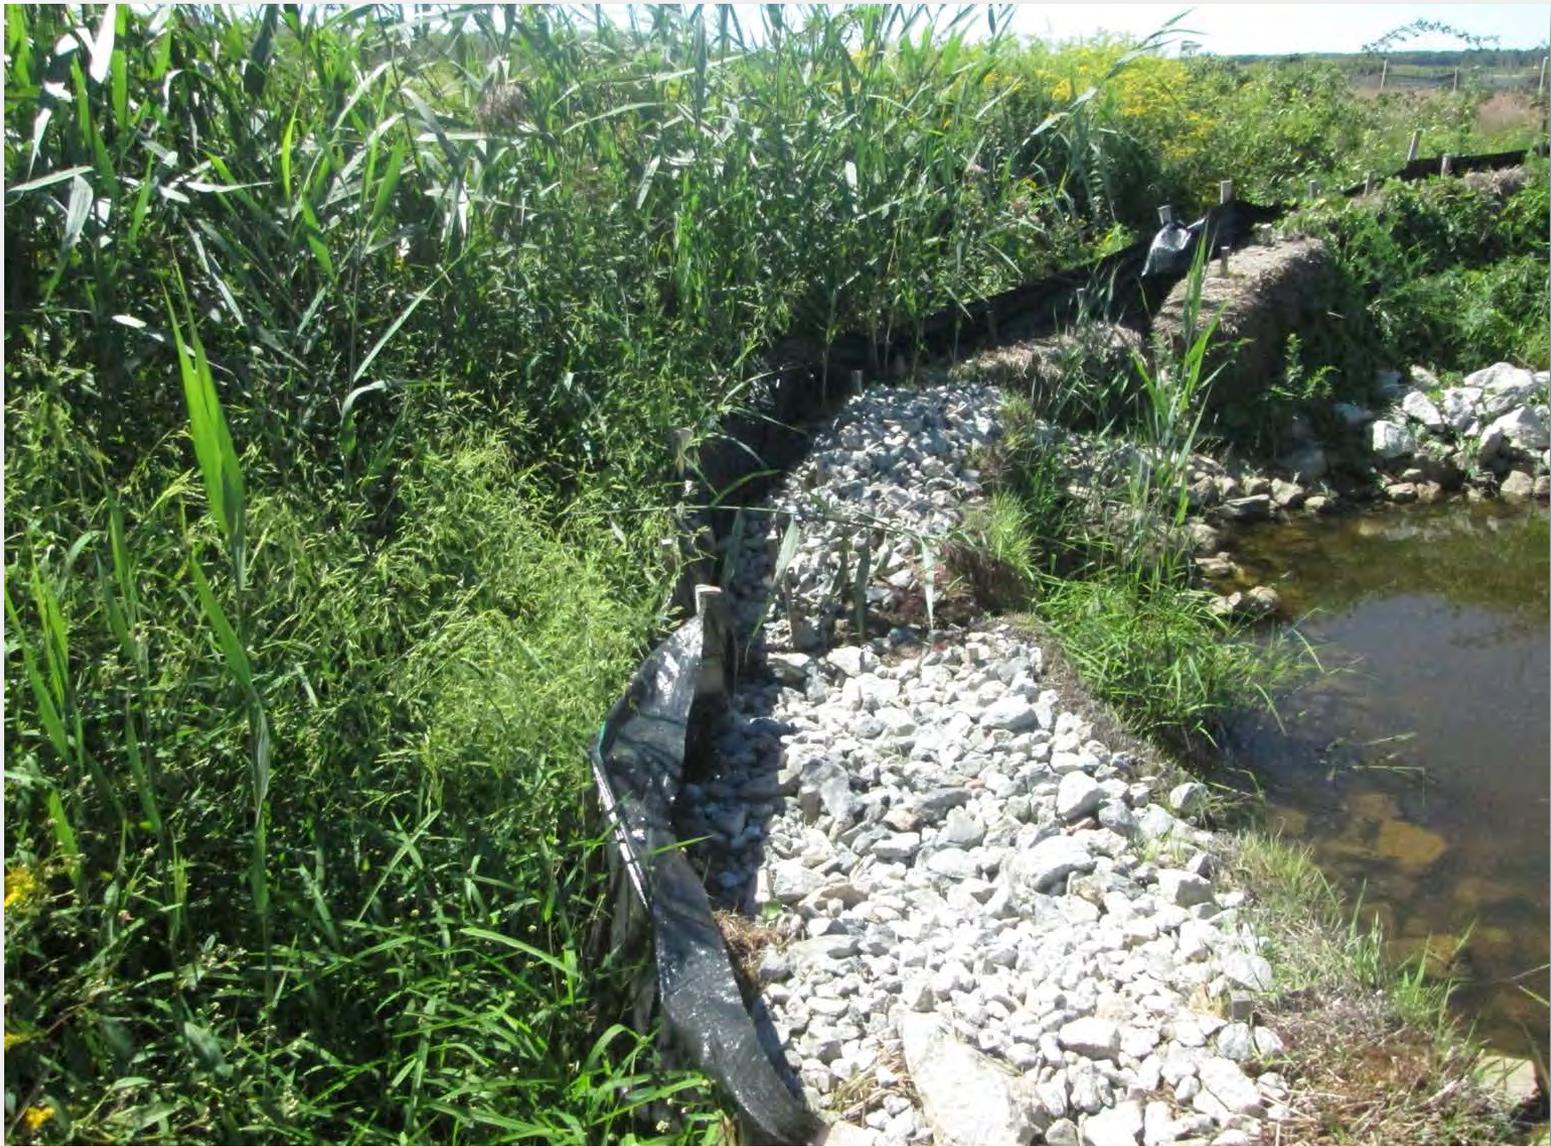
No appreciable sediment has been observed at this outfall.
