**New Bedford Regional Airport
Runway Safety Improvements Project – Phase 4
Reconstruct, Mark, and Groove Runway 5-23
MassDEP File No. SE049-0635**

ENVIRONMENTAL MONITOR INSPECTION FORM

Date/ Time of Inspections: **8/28/14 (morning), 9/2/14 (morning), 9/4/14 (morning).**

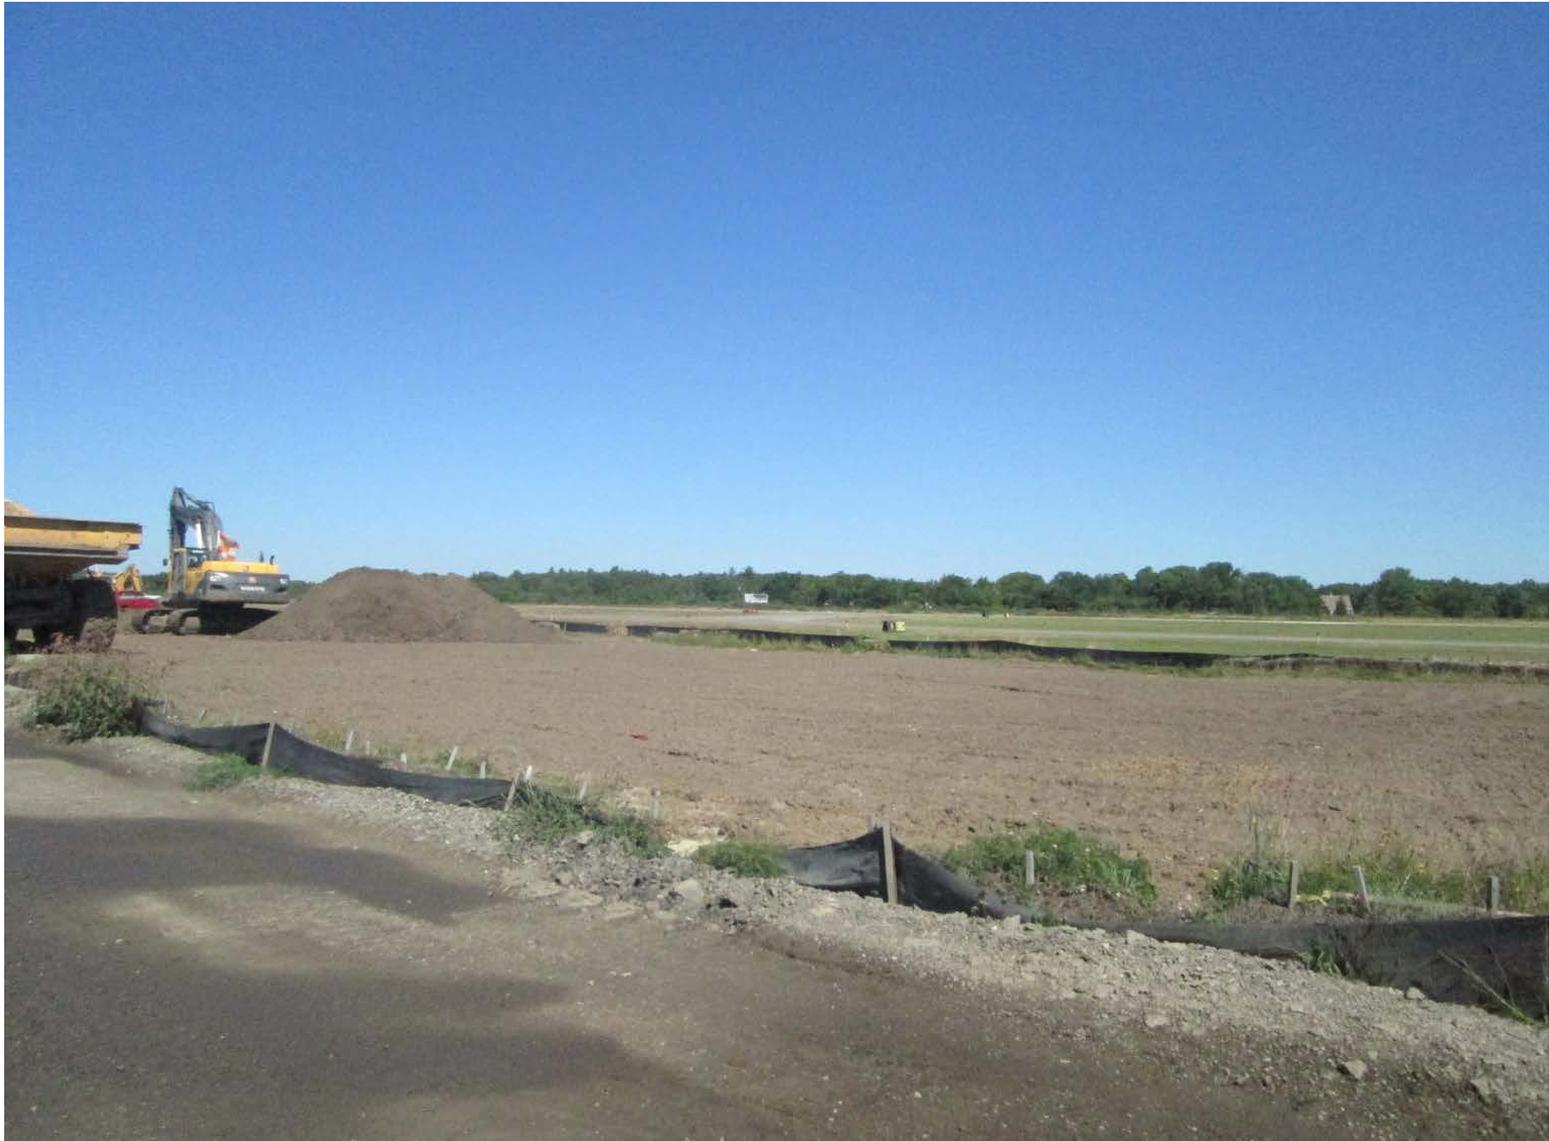
View of spreading loam in Contractor's laydown area. Erosion controls are in poor shape in this area but are generally no longer needed with work wrapping up and equipment removed from the site.

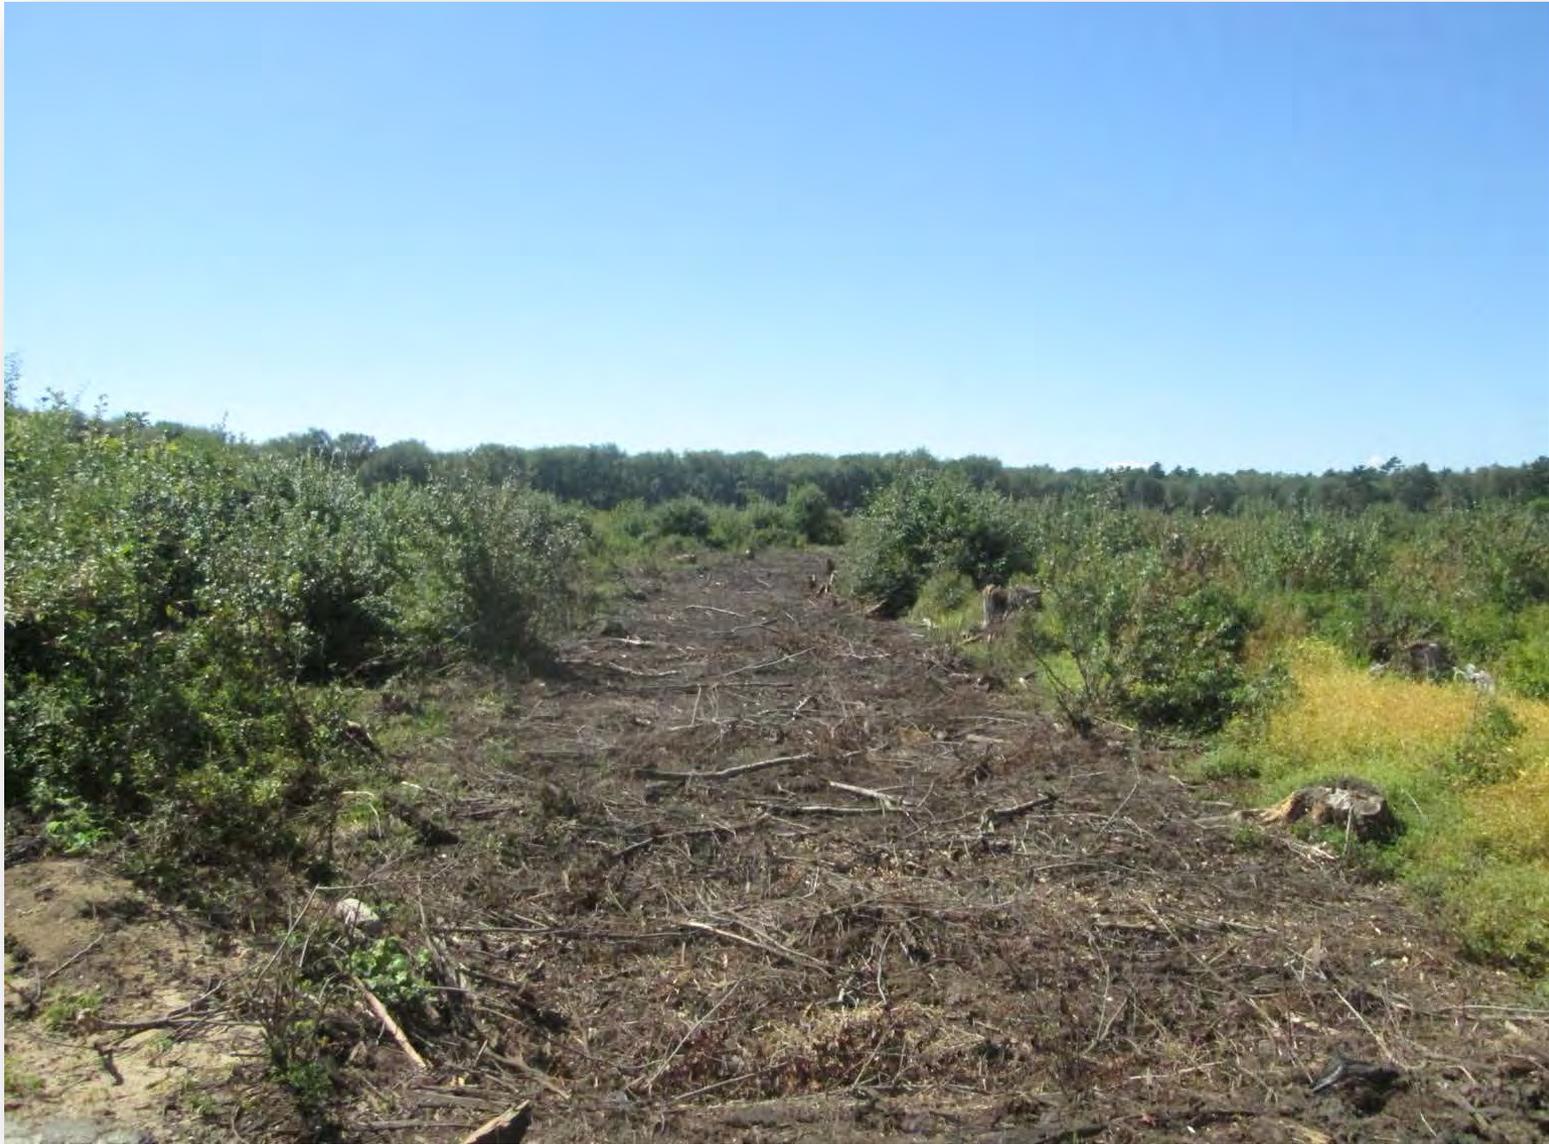
| Control Measure | Cleaning or Repair Needed | Comments/Recommendations from the EM |
|---|--|--|
| Timber Swamp Matting in Wetlands for Tree Clearing in Dartmouth | <input type="checkbox"/> yes <input checked="" type="checkbox"/> no <input type="checkbox"/> n/a | The contractor completed removal of the timber mats during the last EM cycle. This general area where the matting was placed is stable and is in good condition. |

View of former timber mat road leading to tree clearing area in Dartmouth.

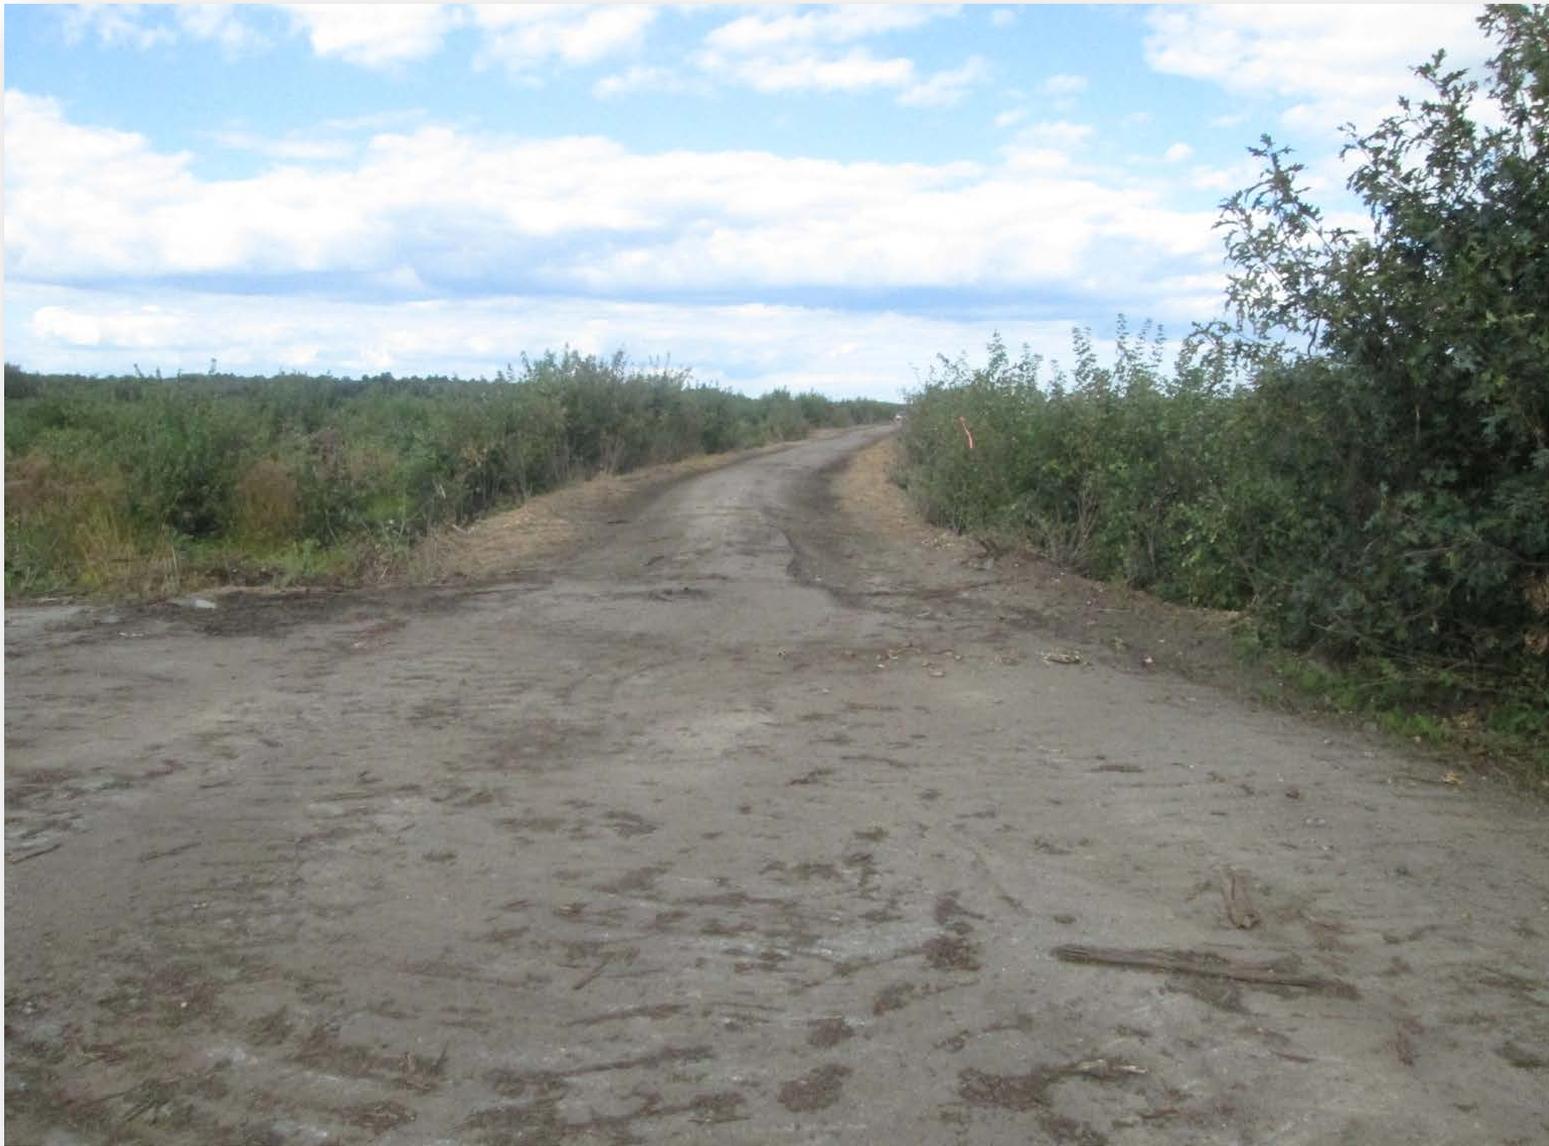
View of ILS road south of the Paskamansett River. The WS hand-seeded and spread hay along the sideslopes.

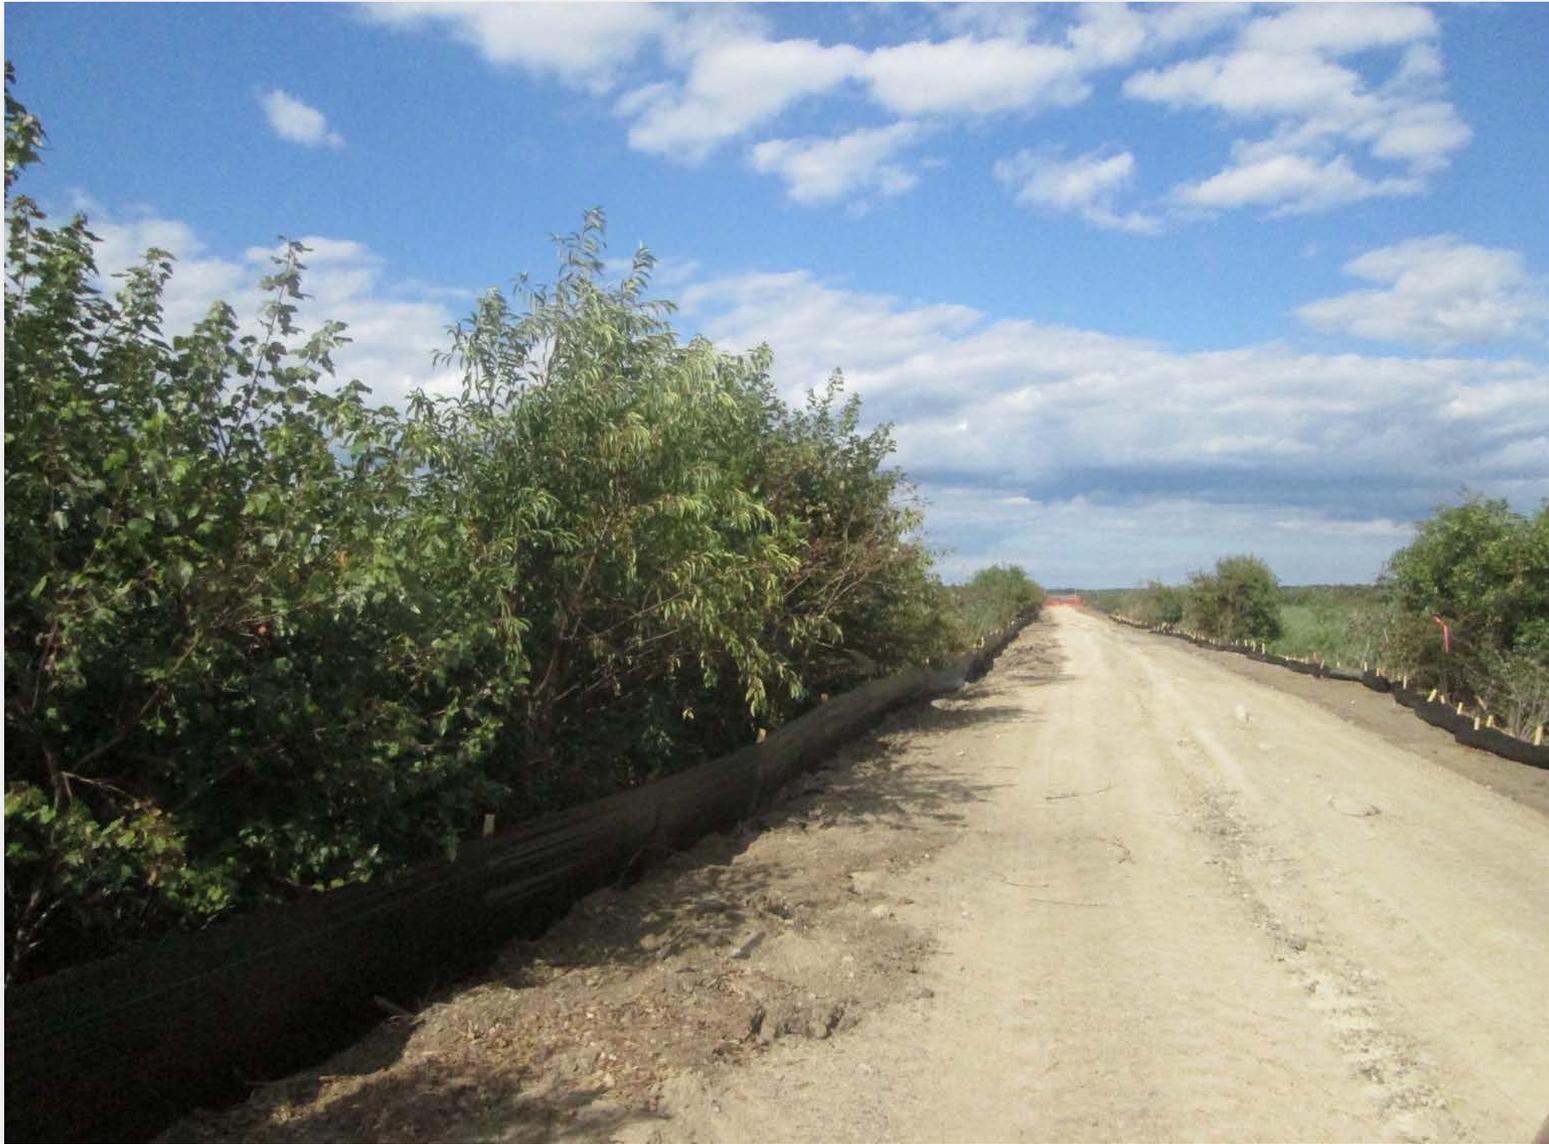
View of reestablished silt fence & compost tubes along the ILS road.

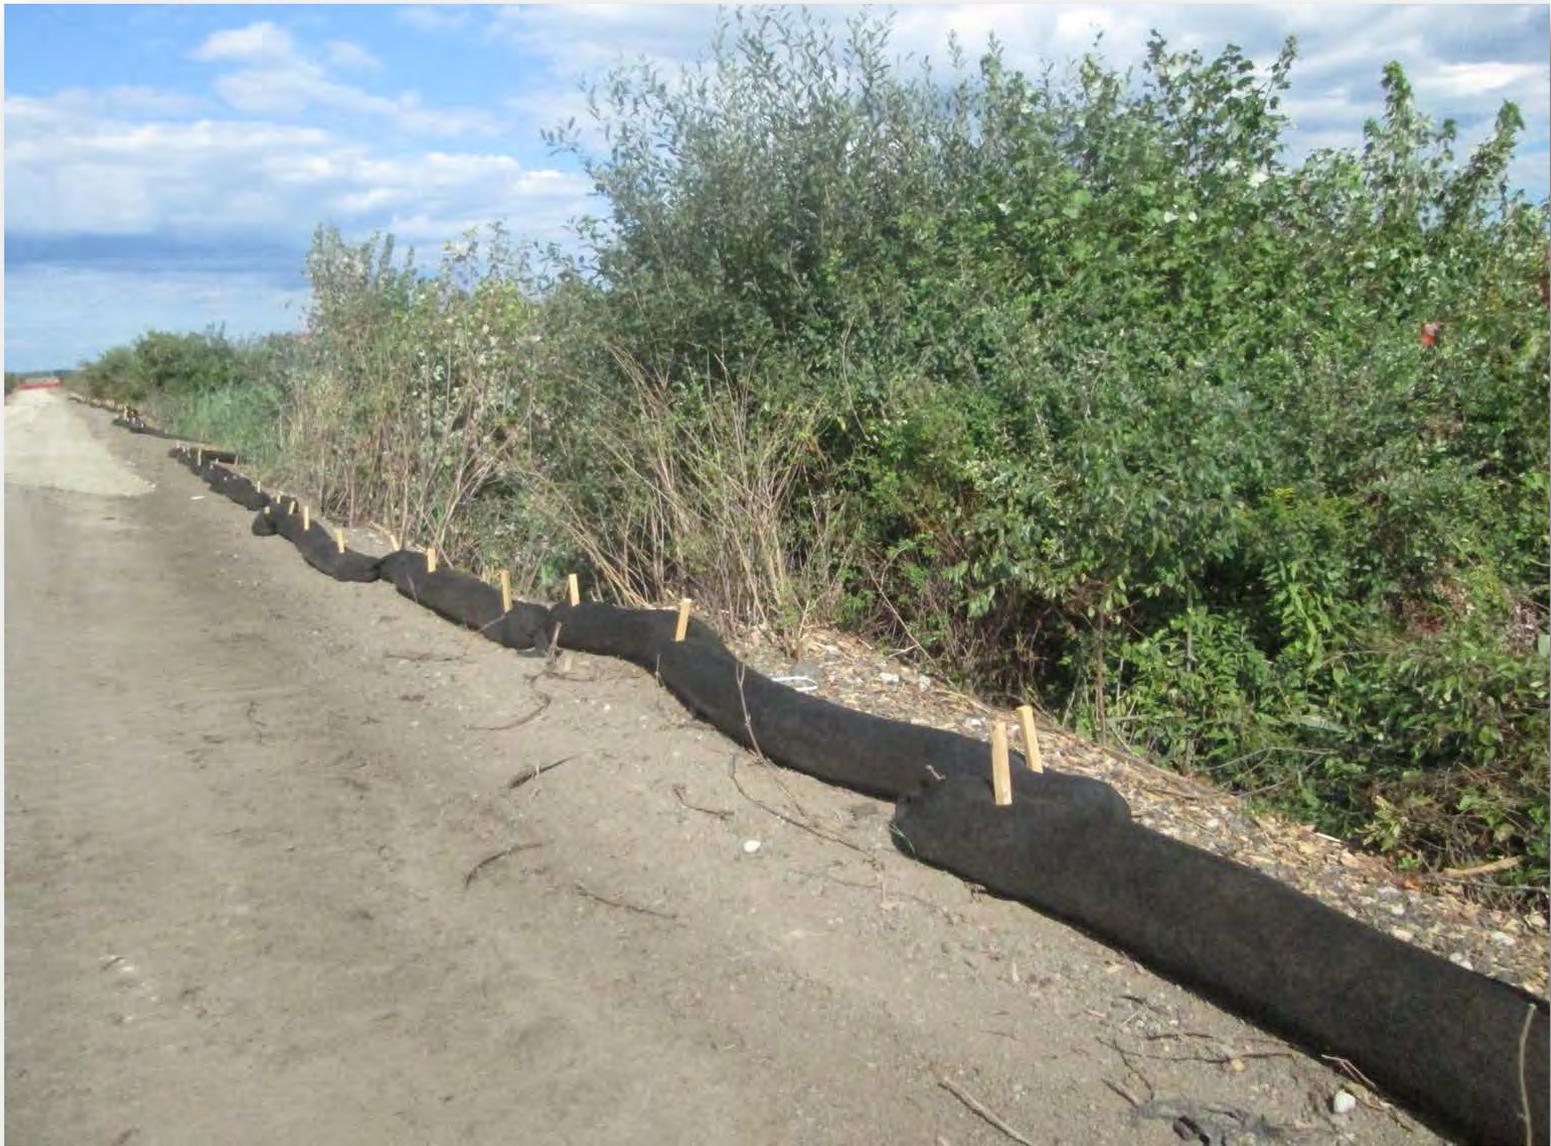
Compost tubes along the ILS road.

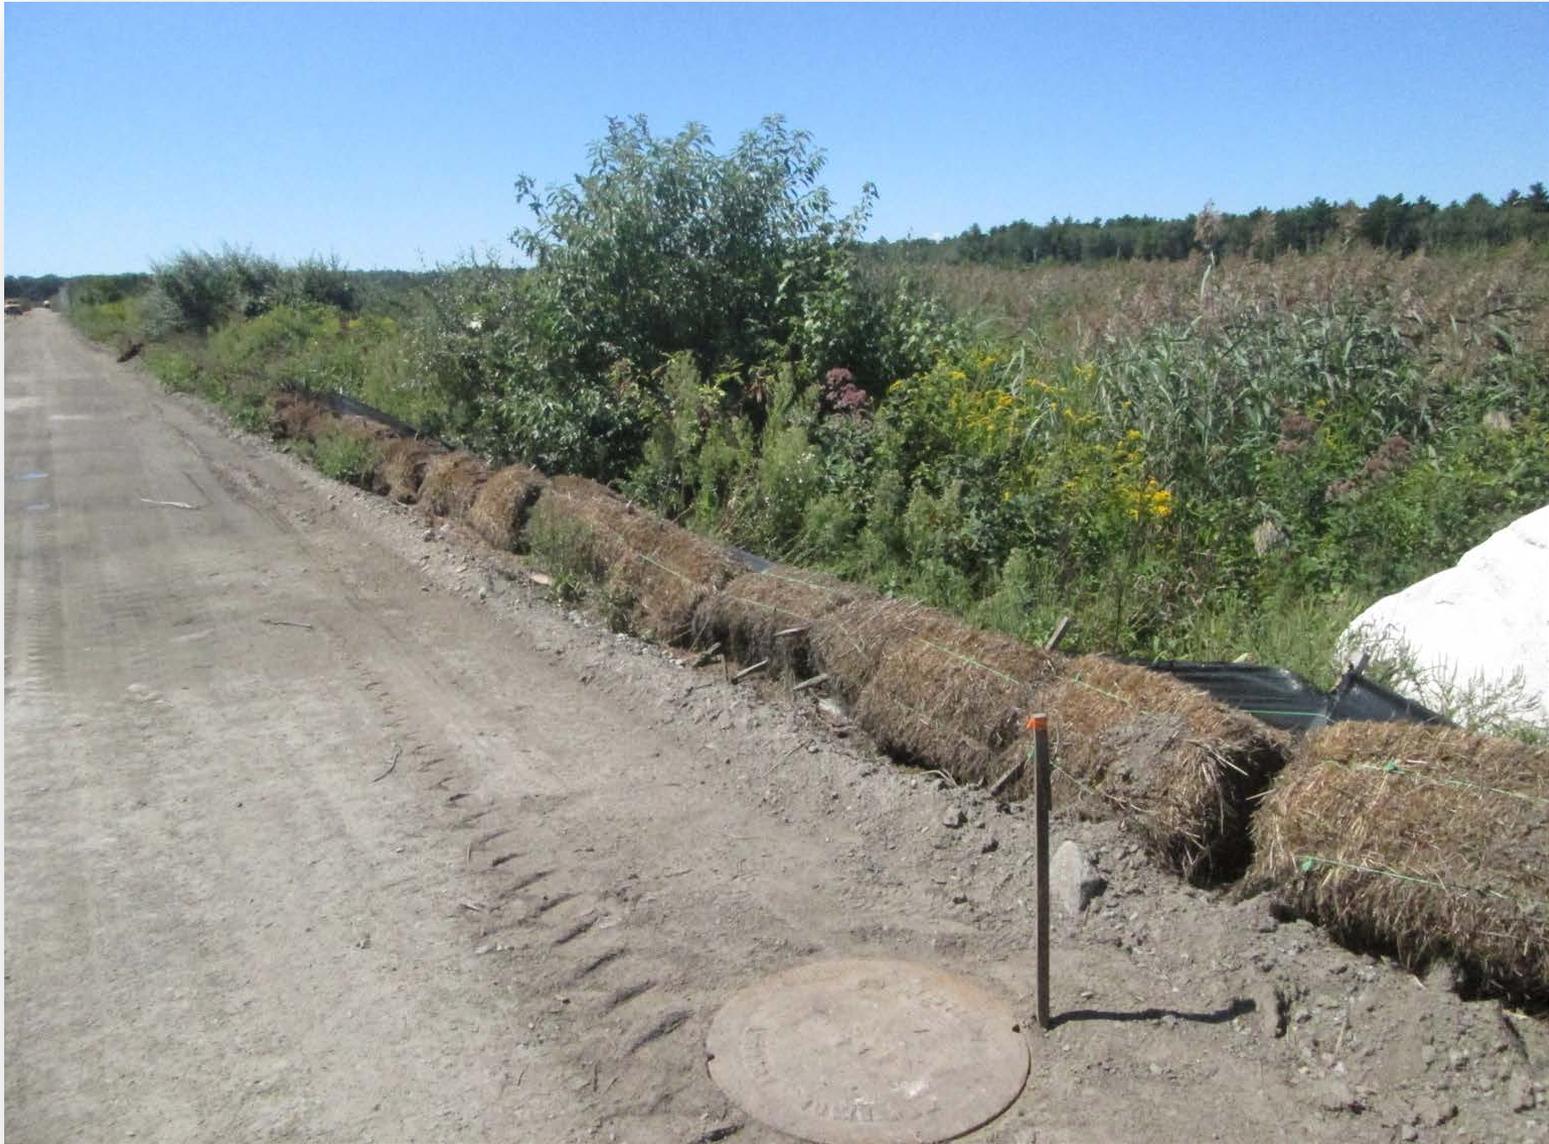
View of electrical manhole and a example discrete section of silt fence/ hay bales that have been disturbed. These erosion controls are still tailed in, however they need to be straightened up.

Describe any corrective action required at this time: **Refresh sediment controls along the ILS road in discrete areas as necessary. WS continues to work with ET&L to mitigate any potential erosion issues.**

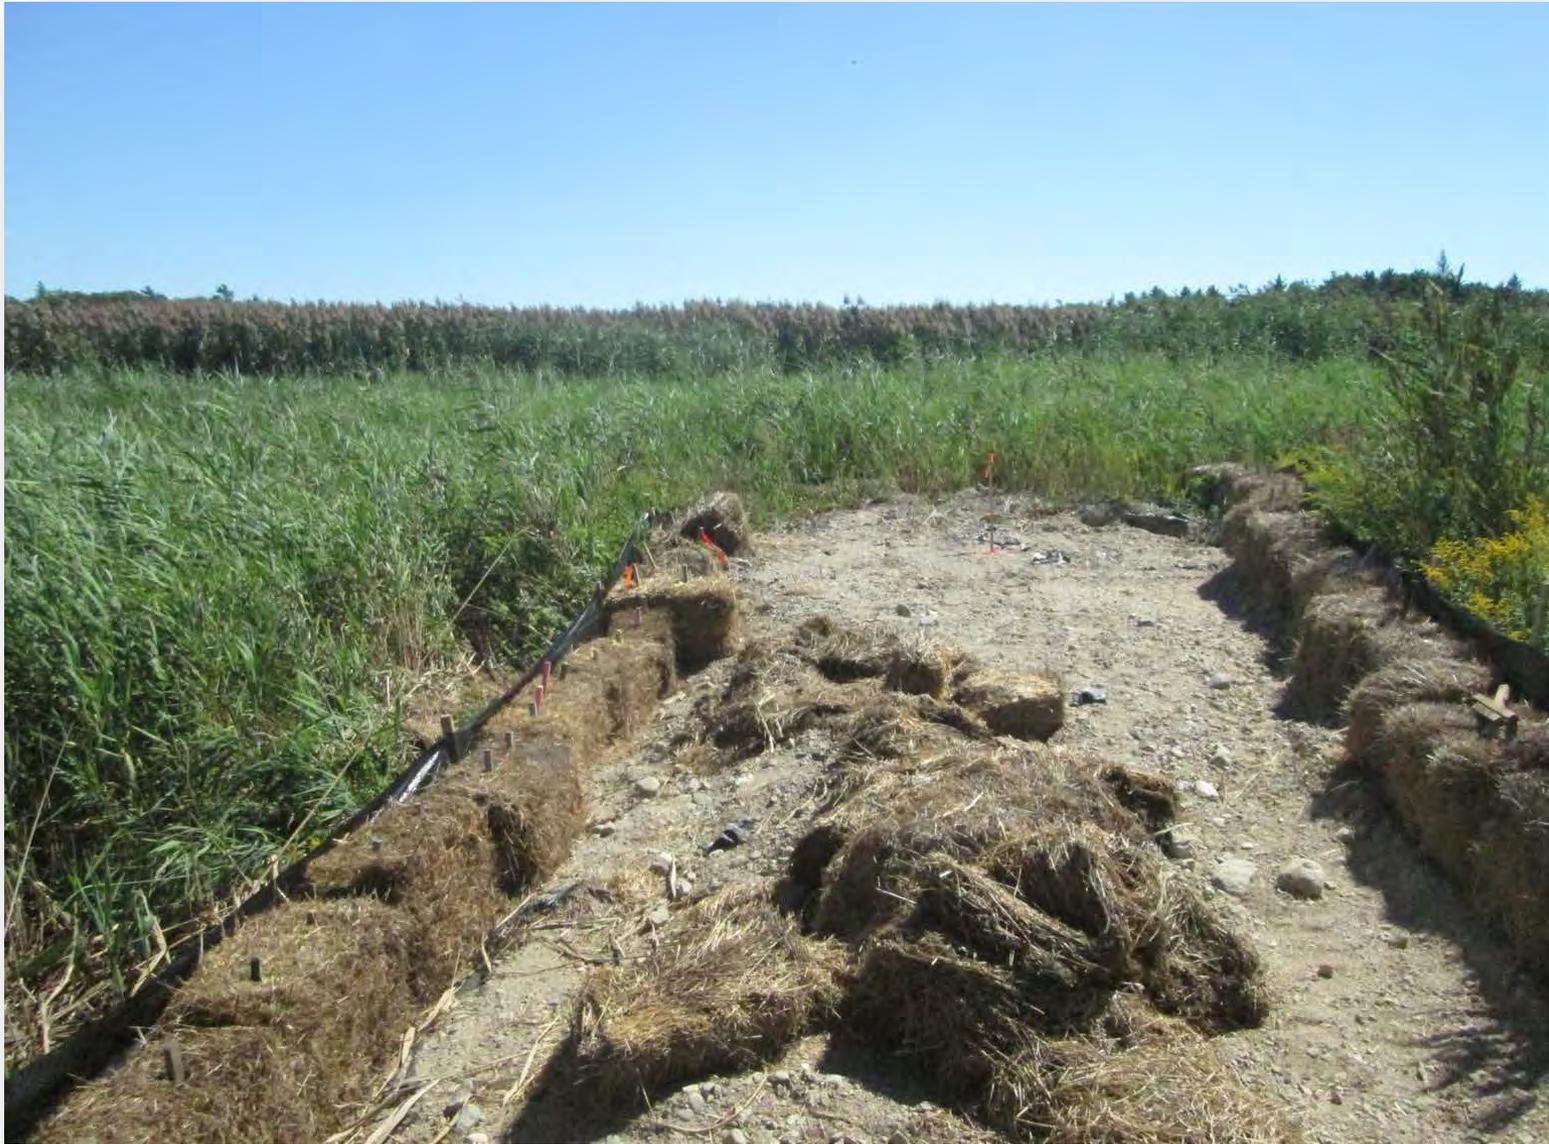
View of repair work of silt fence/hay bales in the area reported in Report #9. Sediment was removed from the wetland and erosion controls were fixed.

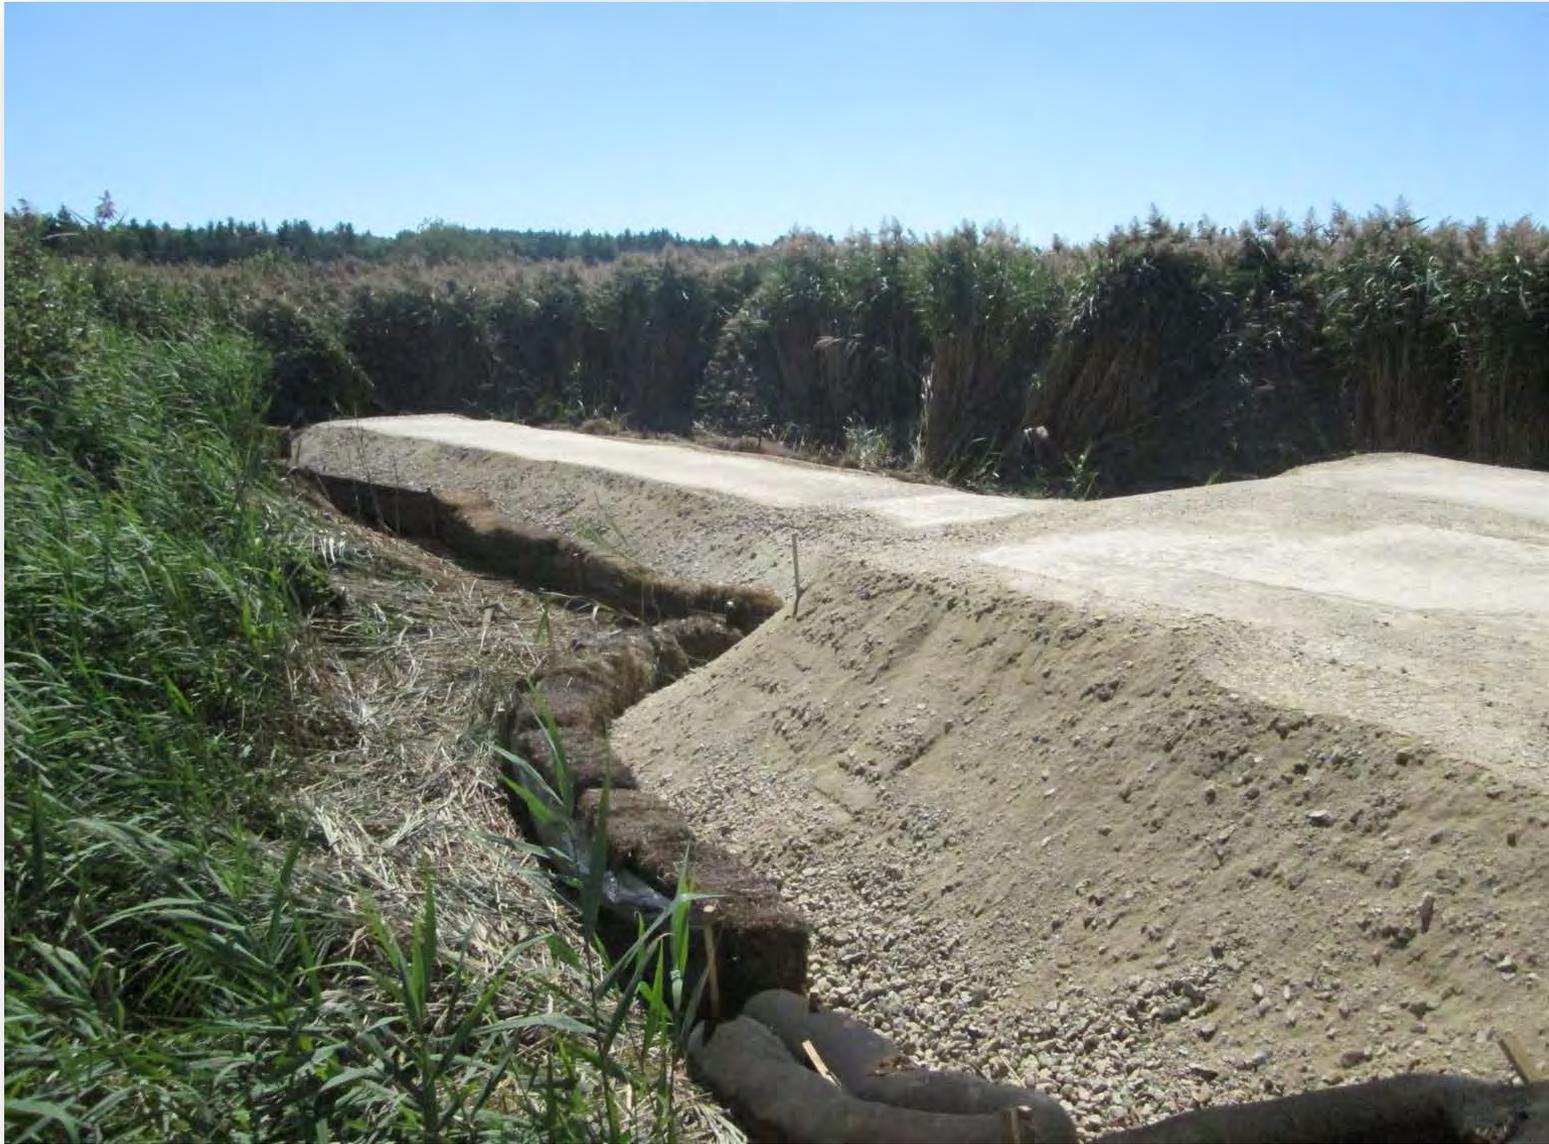
View of MALSR lighting pad at furthest portion of Runway 5 end MALSR. Erosion controls in good condition.

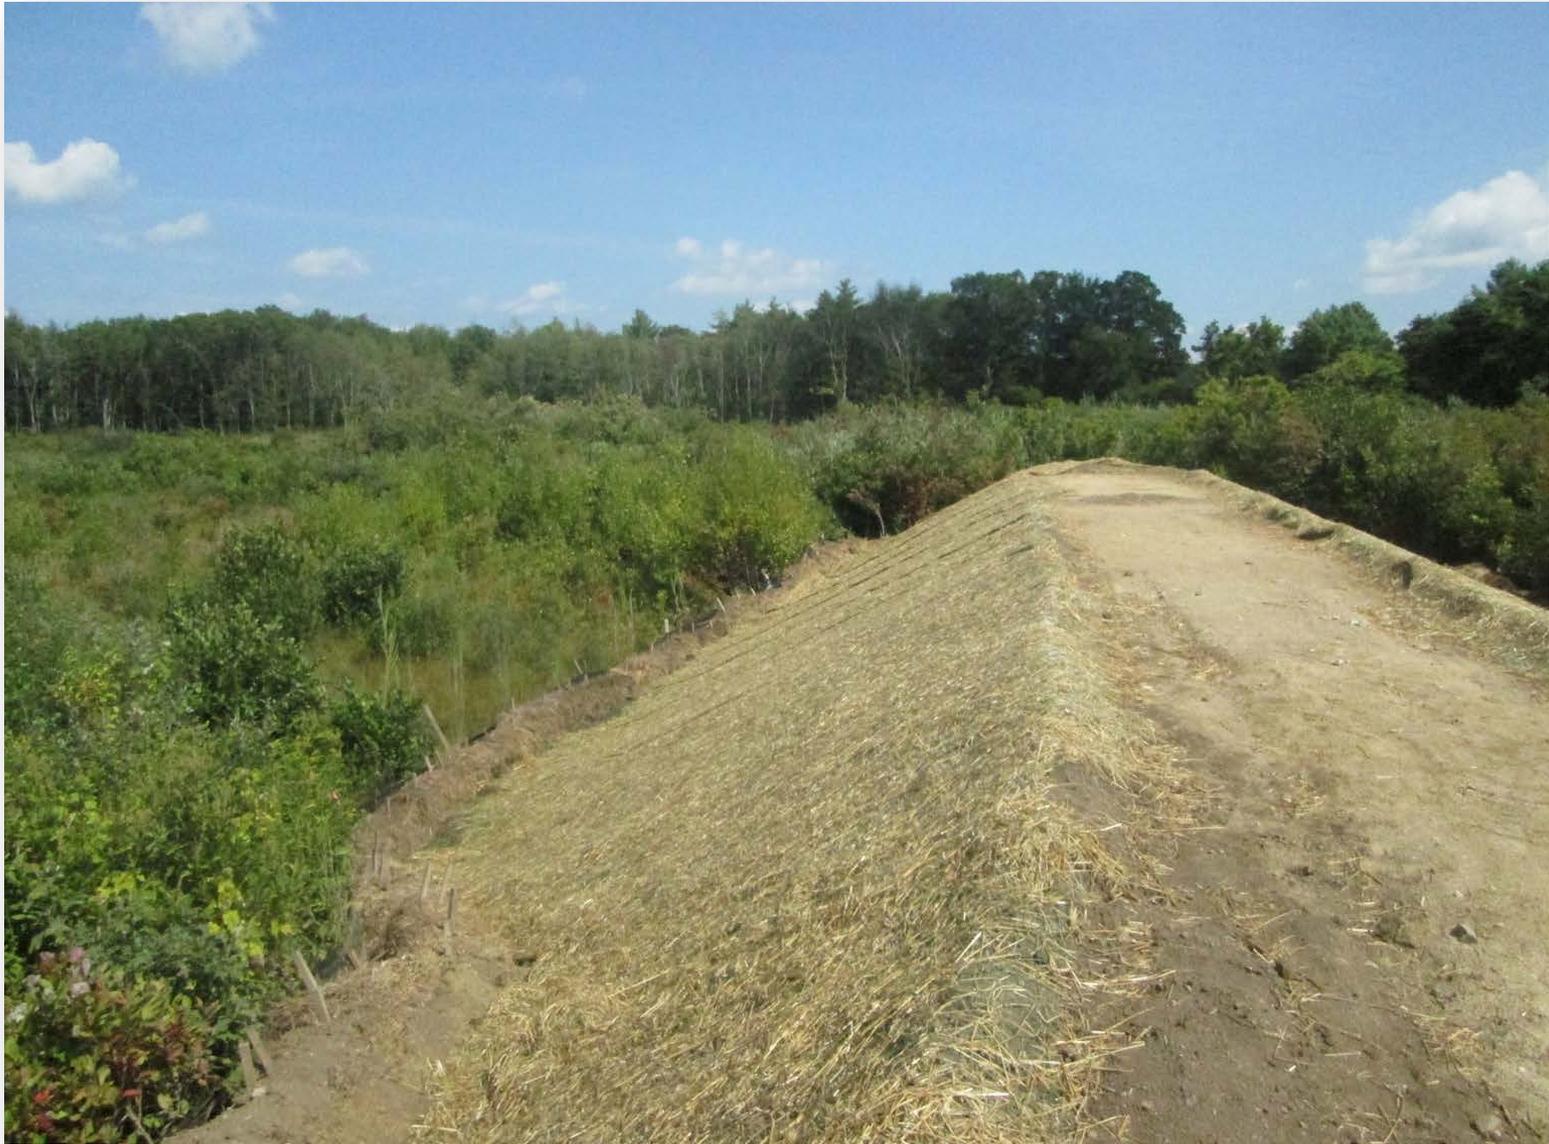
View of MALSR lighting pad at furthest portion of Runway 23 end MALSR. Erosion controls in good condition and slopes well protected with hay.

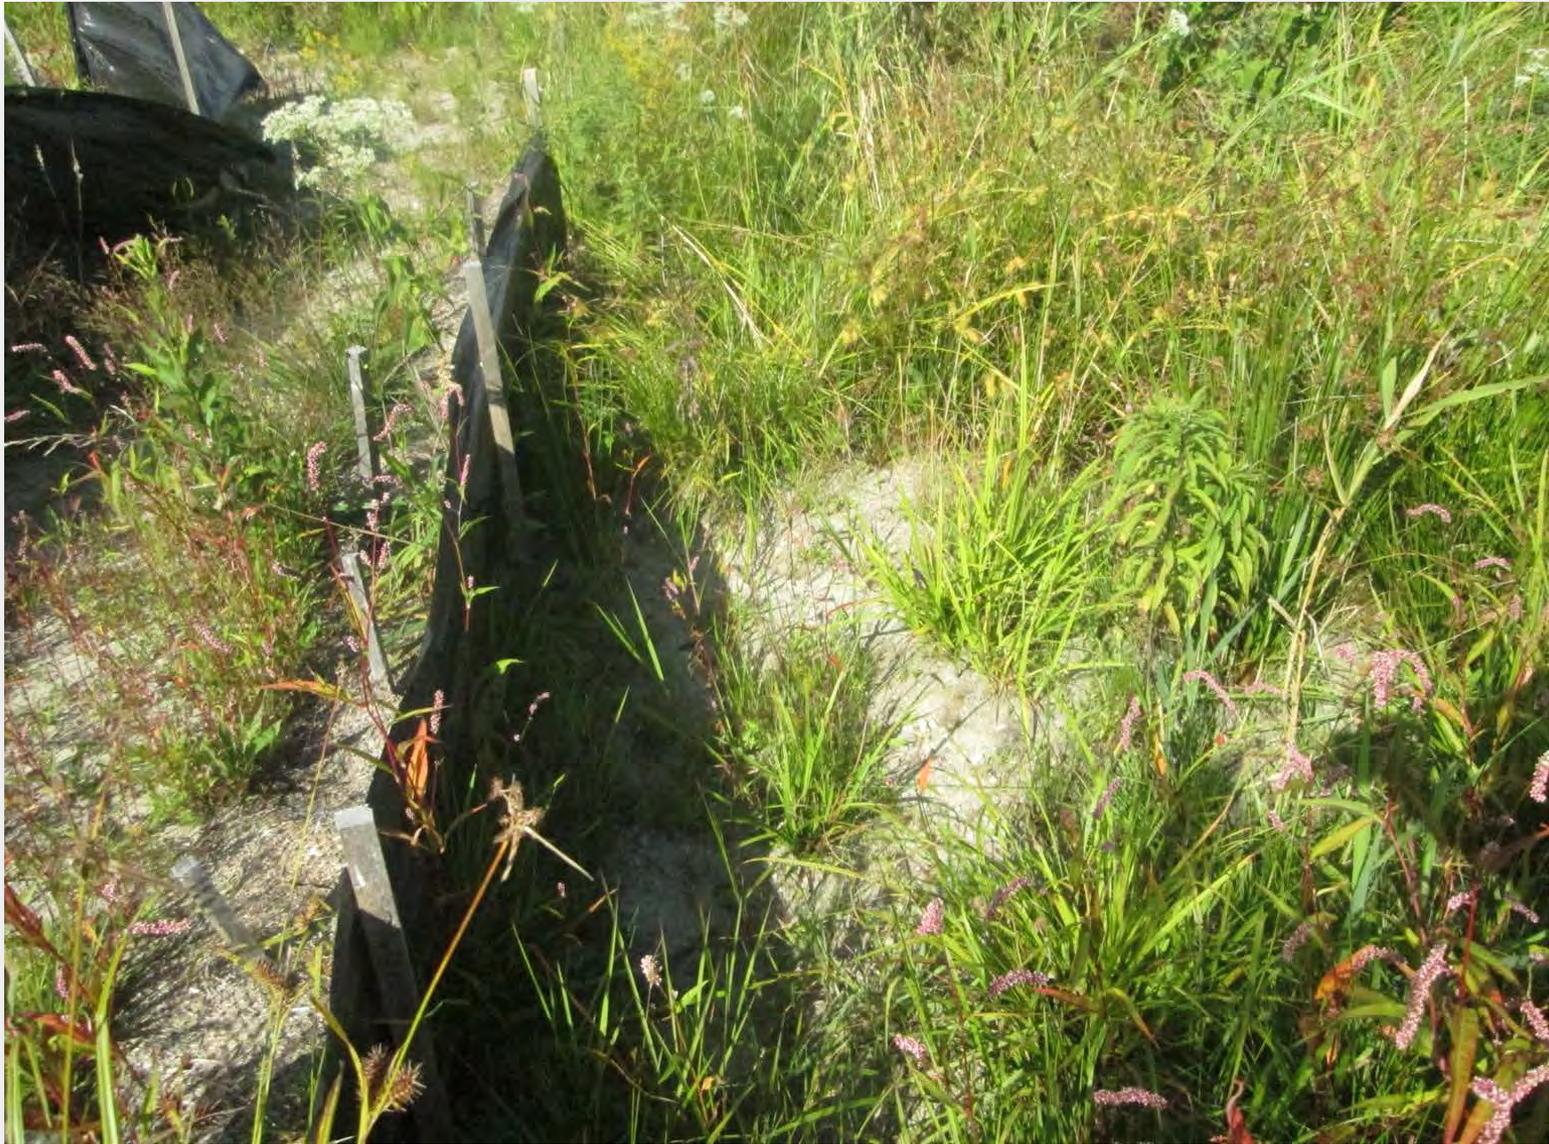
Open action items from the June 12 meeting with MassDEP: (1) formal proposal to stabilize interface between Turtle Area 3 and Site 6 with mulch (continuing with “wait-and-see” approach as the area has vegetated and the sand is not currently migrating; it continues to hold up well following rain events); and (2) a follow up response to MassDEP’s June 4, 2014 email regarding potential long term stabilization measures for runoff near West Ditch (the need for any additional long term runoff control measures will be determined after work is complete and site is stabilized; likely that no additional measures will be necessary based on current observations following larger storm events).

View of area between Turtle Area 3 and Site 6. This site appears to be relatively stable and responding to seeding. No additional discharges noted and vegetation is filling in nicely in the transition zone.

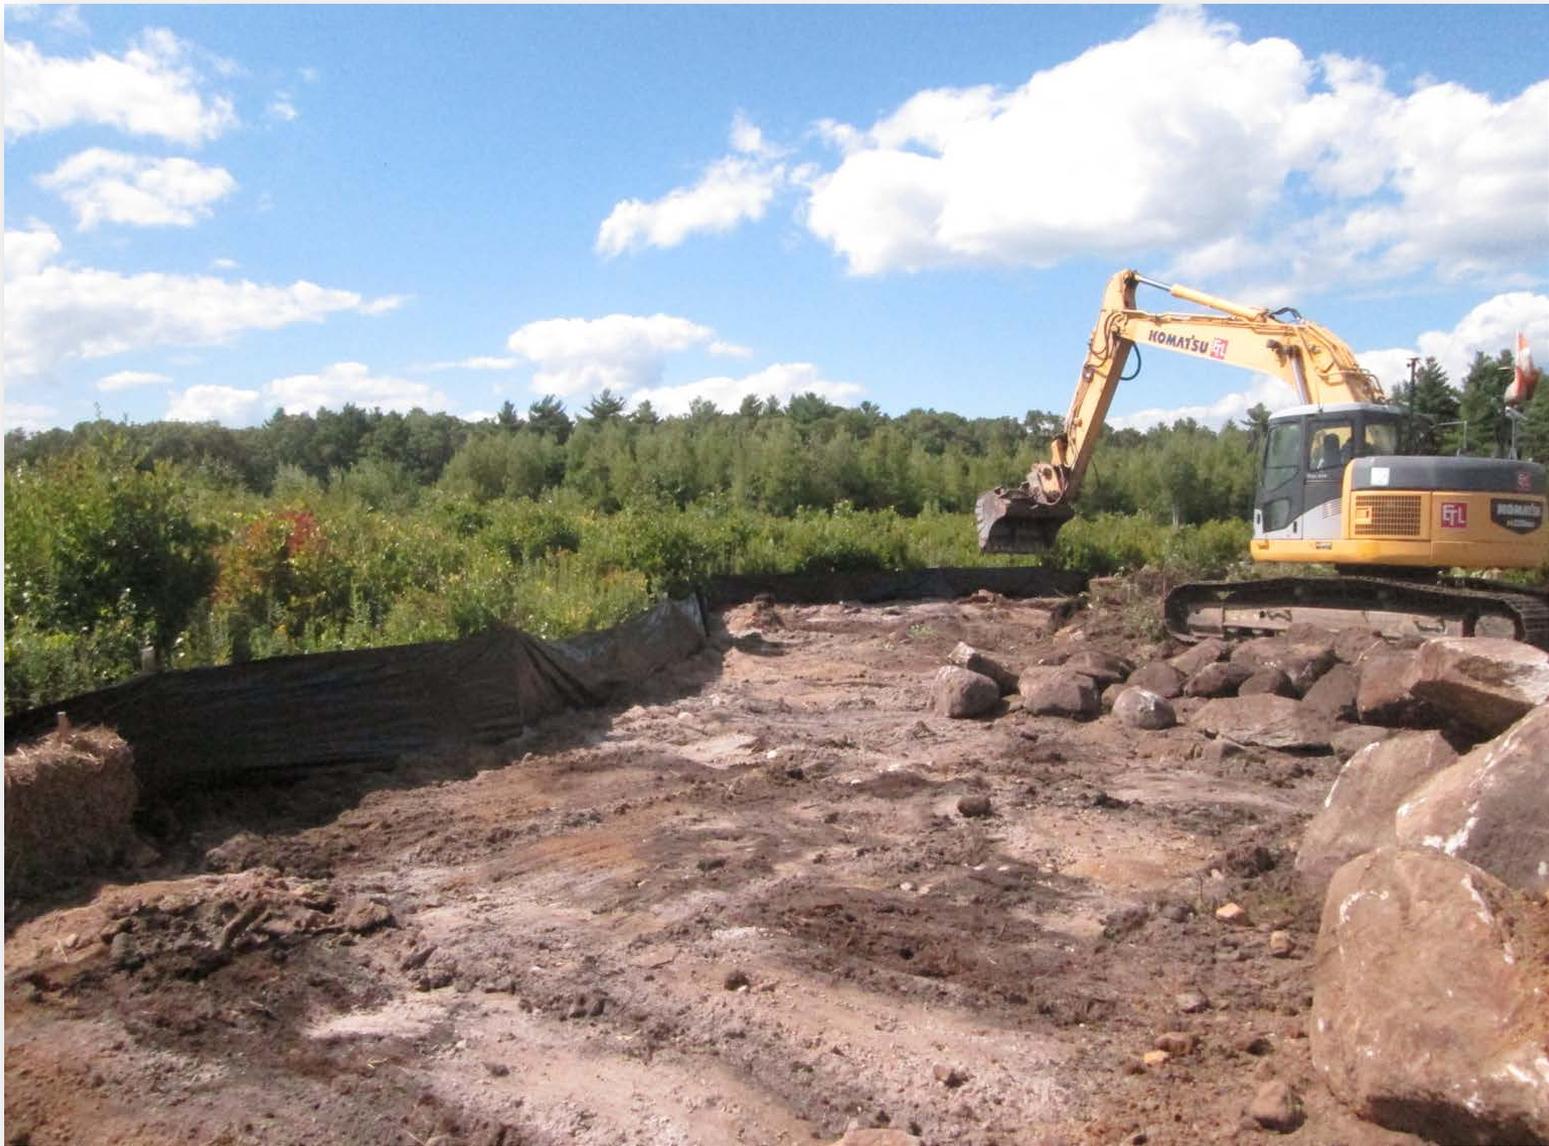
View of overburden excavation in wetland mitigation site. Note grey subgrade with iron redox staining.

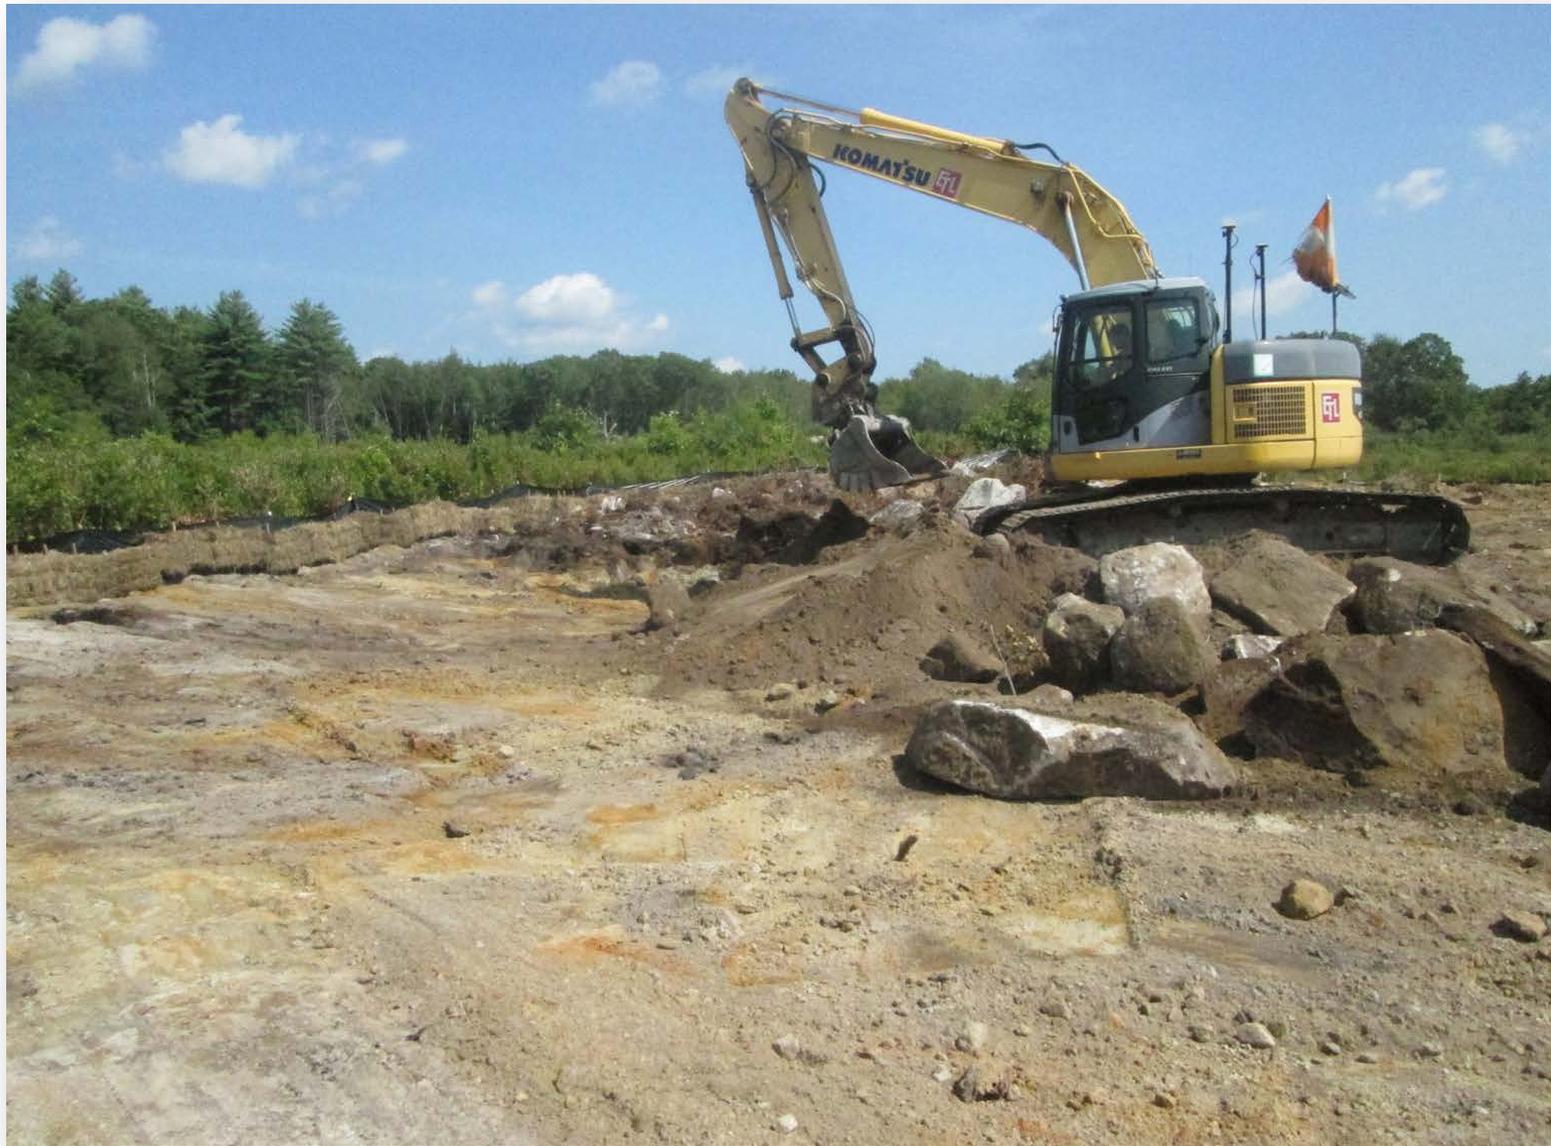
View of overburden excavation in wetland mitigation site. Note grey subgrade with iron redox staining.
