**New Bedford Regional Airport
Runway Safety Improvements Project – Phase 4
Reconstruct, Mark, and Groove Runway 5-23
MassDEP File No. SE049-0635**

ENVIRONMENTAL MONITOR INSPECTION FORM

Date/ Time of Inspections: **8/28/14 (morning), 9/2/14 (morning), 9/4/14 (morning).**

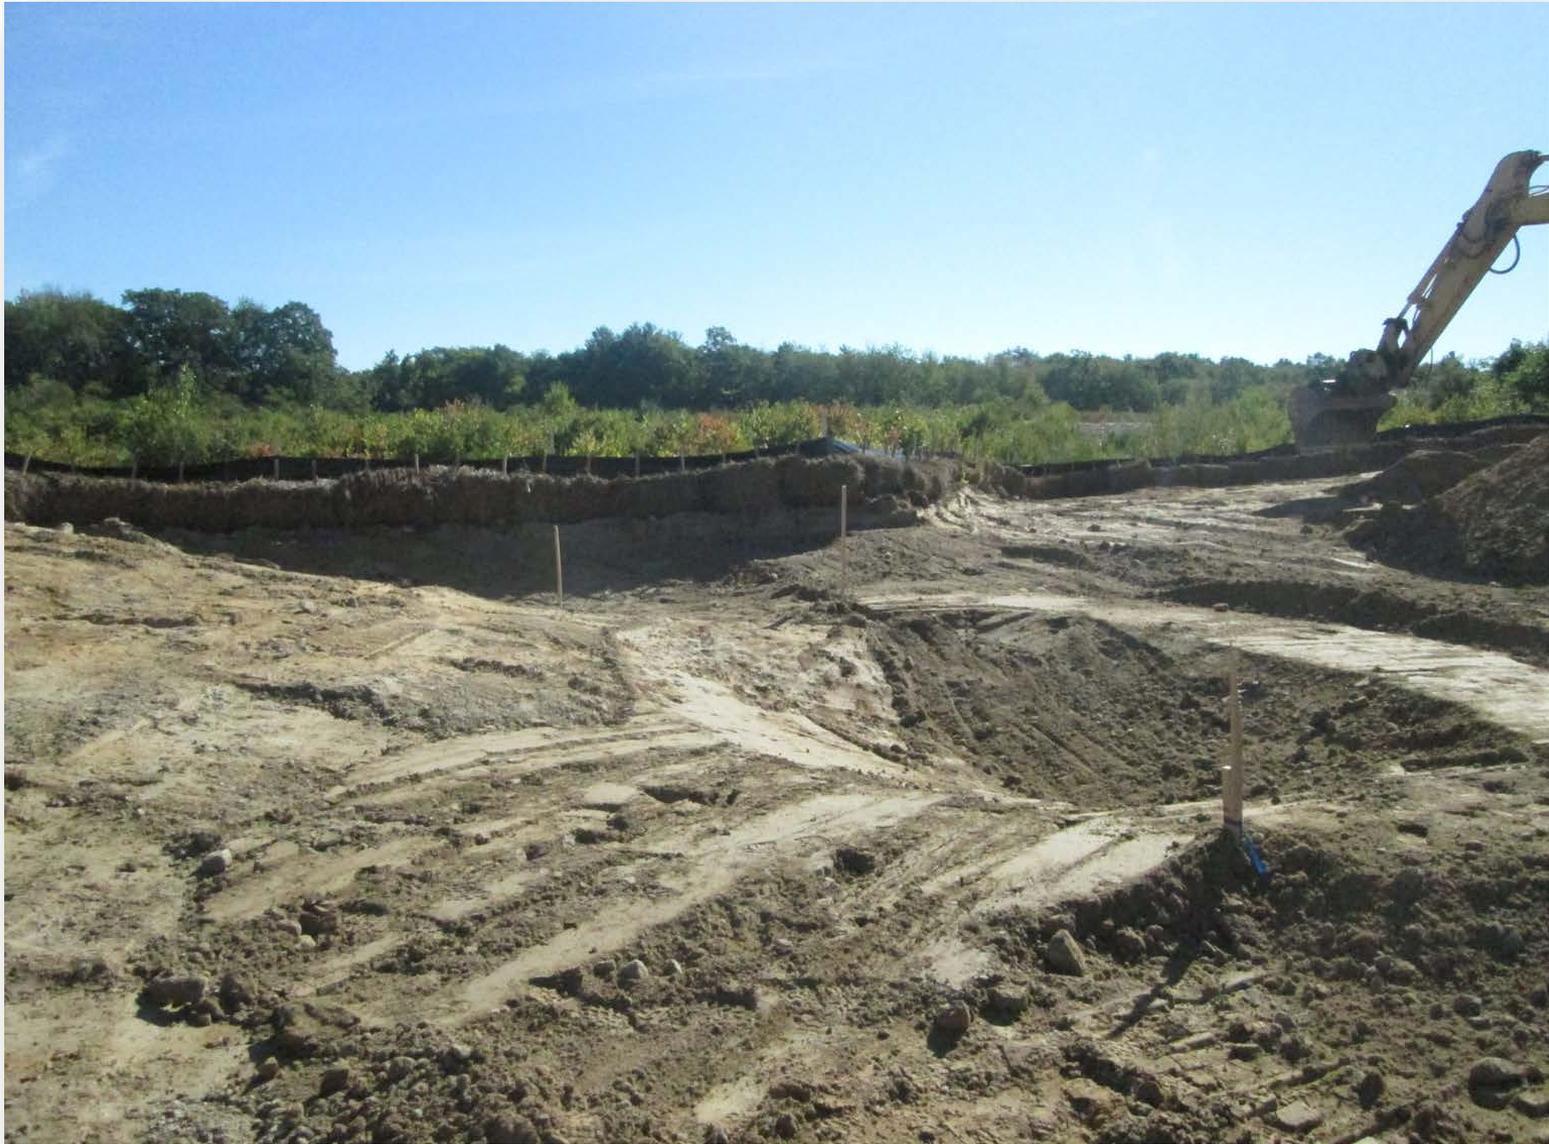
View of ongoing work to construct pits and mounds micro-topography in the wetlands mitigation site.

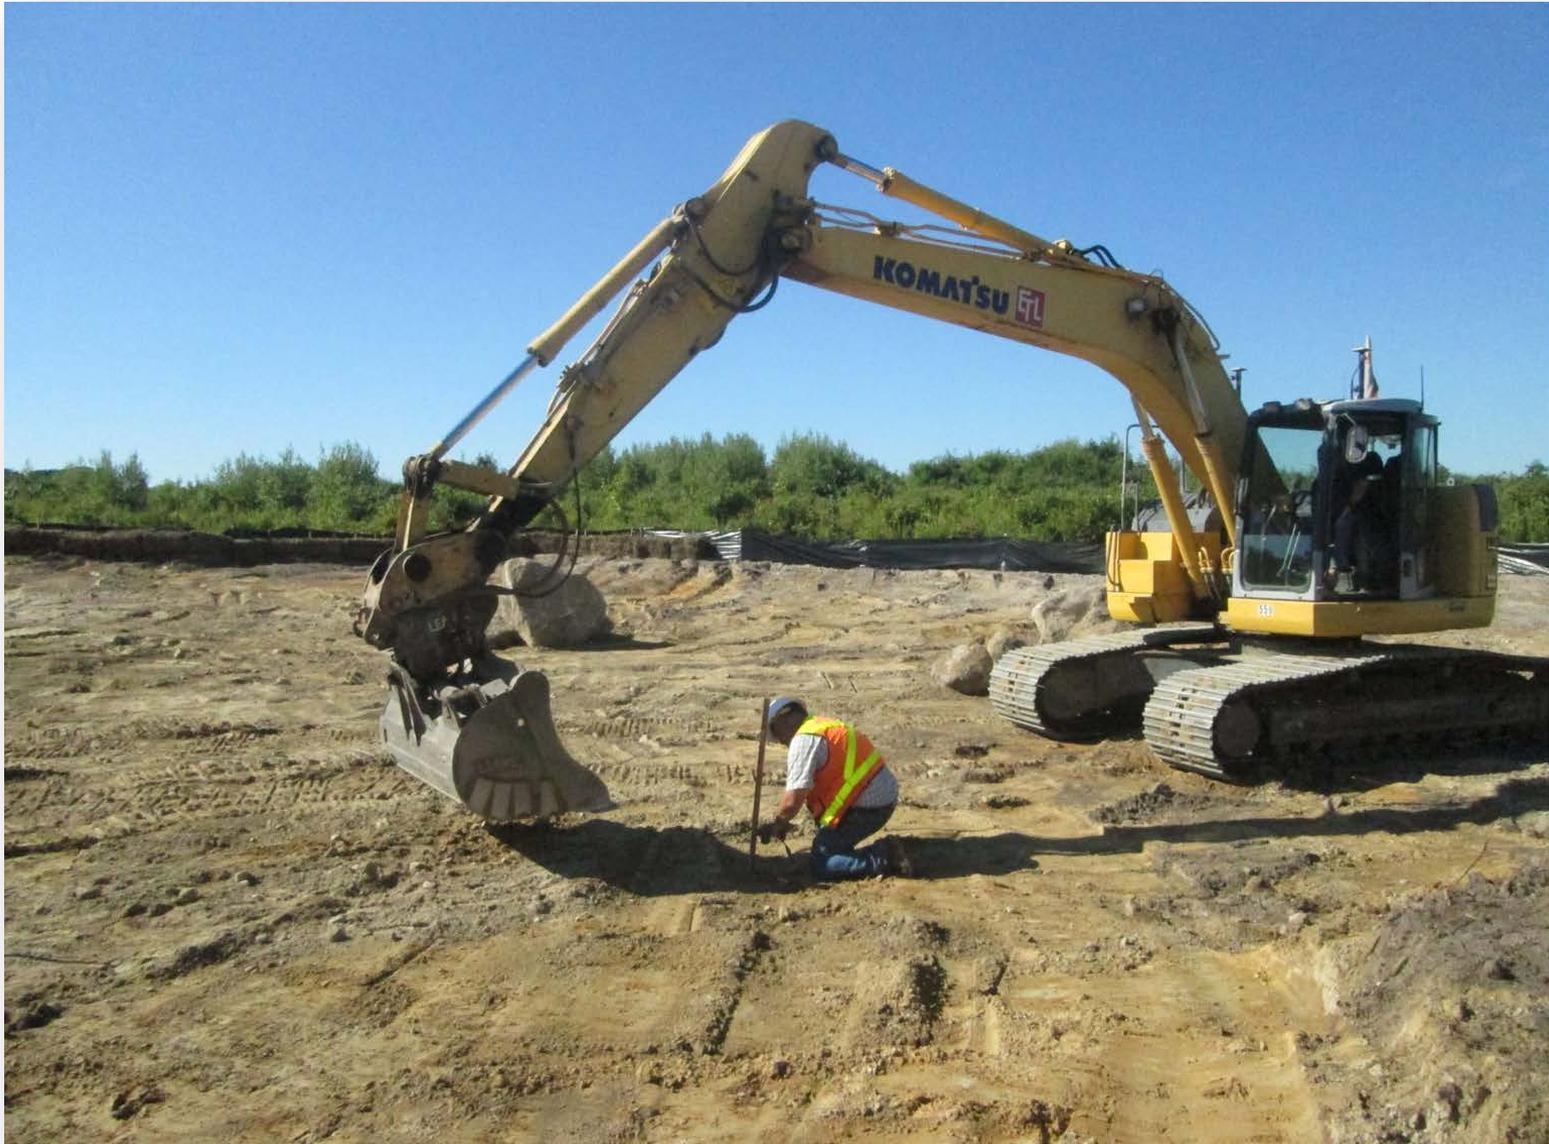
View of WS staking out areas for pits.
