**New Bedford Regional Airport  
Runway Safety Improvements Project – Phase 4  
Reconstruct, Mark, and Groove Runway 5-23  
MassDEP File No. SE049-0635**

**ENVIRONMENTAL MONITOR INSPECTION FORM**

Date/ Time of Inspections: **9/25/14 (morning), 10/2/14 (morning), 10/9/14 and 10/15/14.**

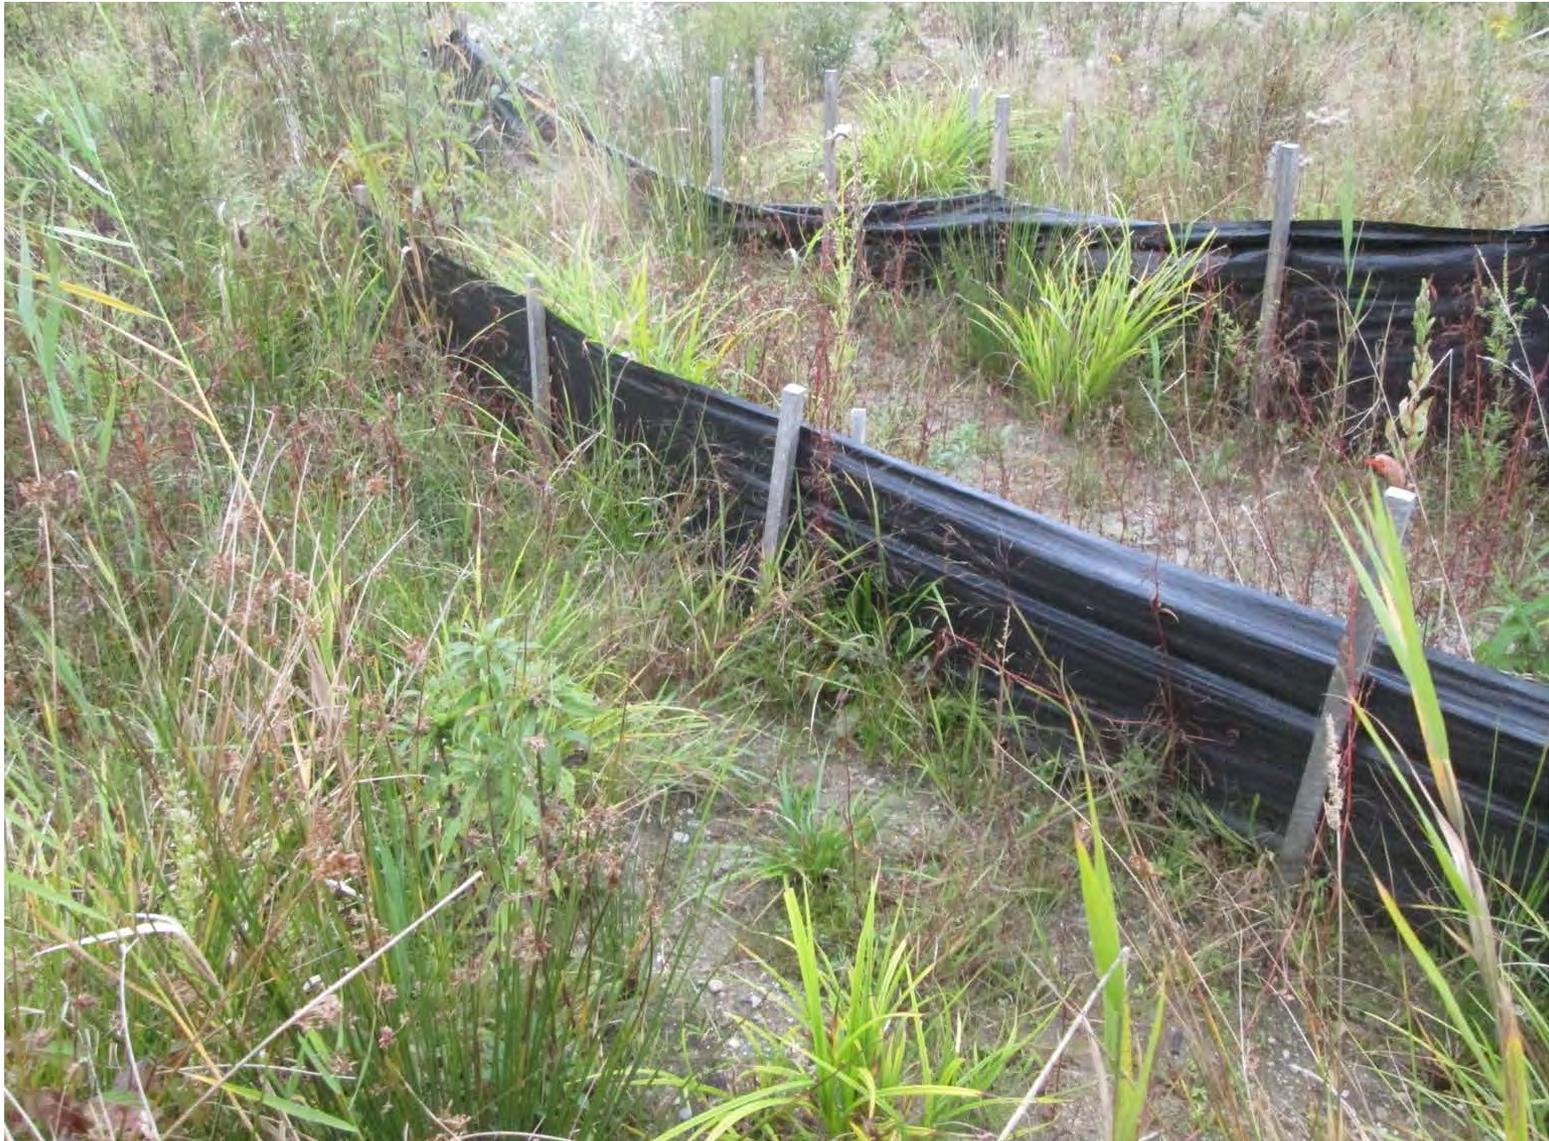
View of Site 6, at intersection of Site 6 and Area 3. This area has grown in nicely over the course of 2014. The pants have stabilized both the wetland creation area and turtle habitat area.

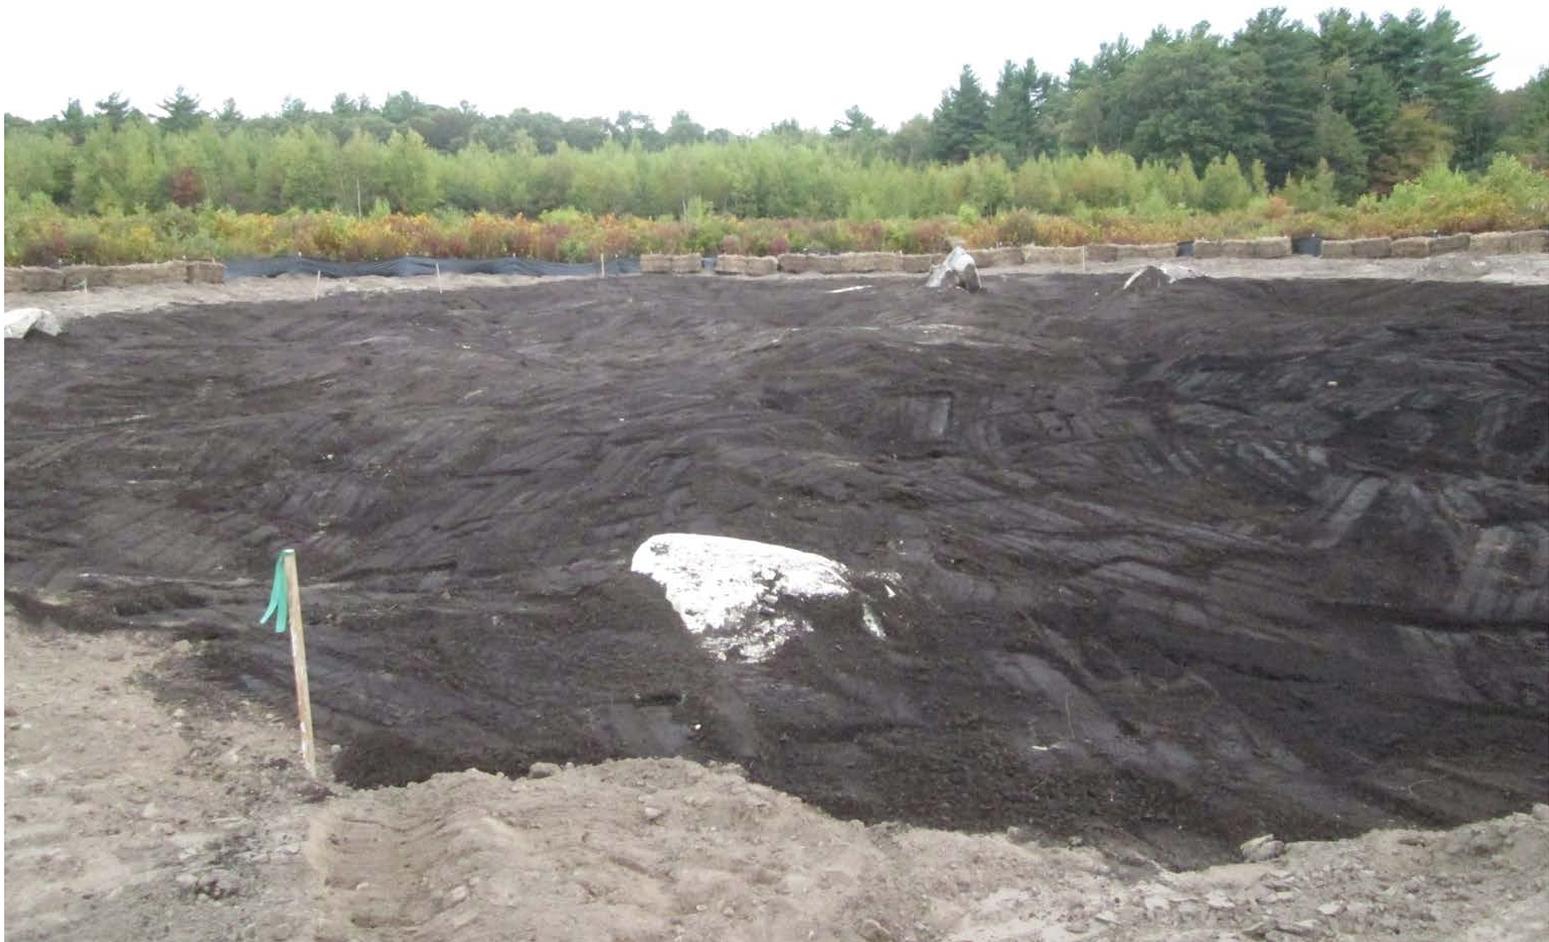
View of graded wetland replication area from 9/25.

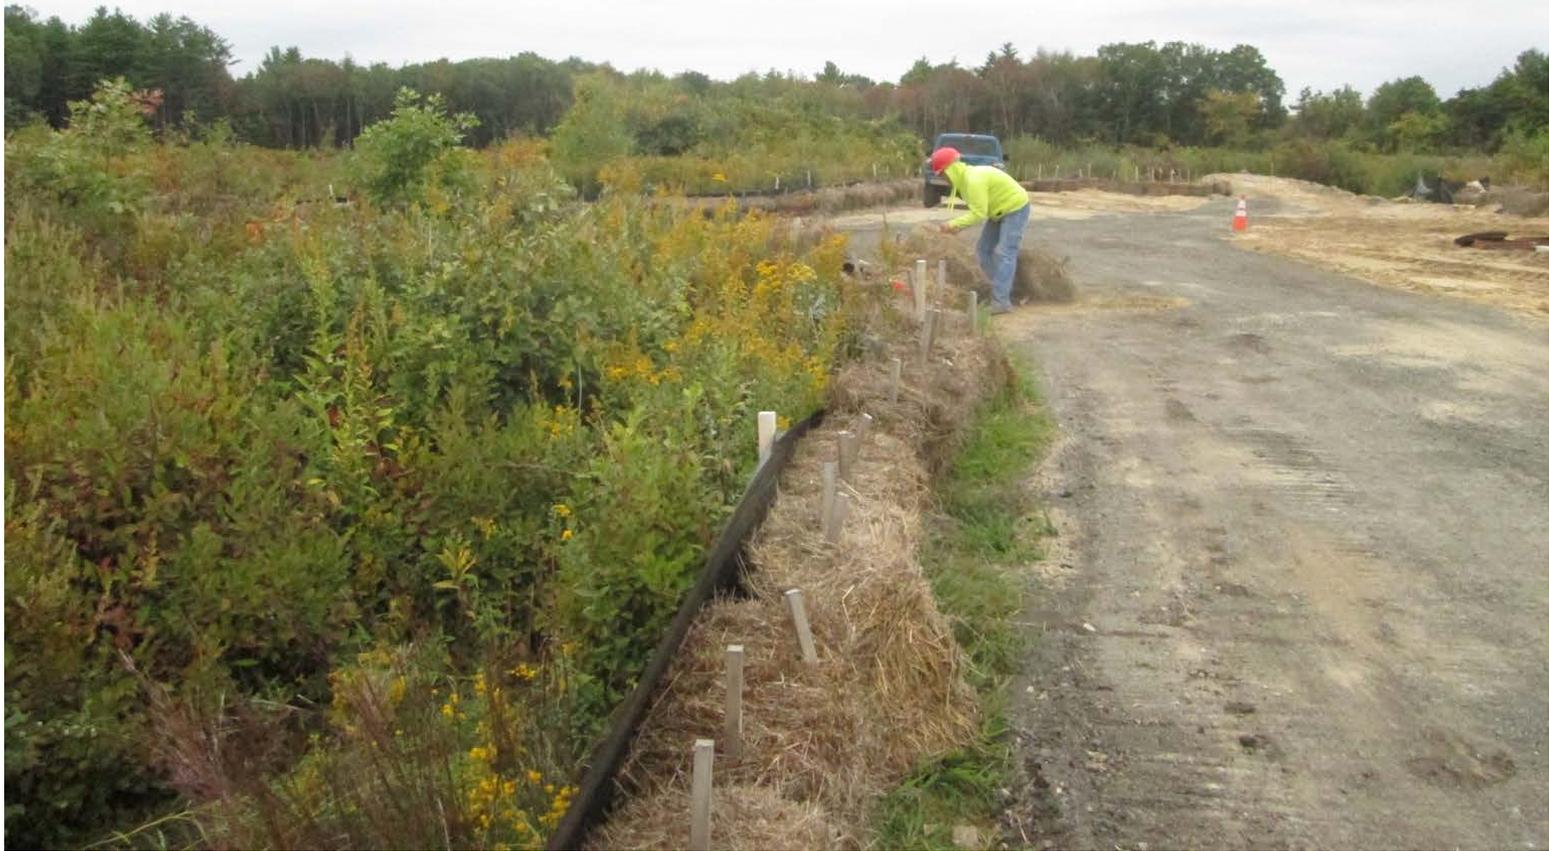
View of contractor repairing silt fence in Area 5, 9/25.

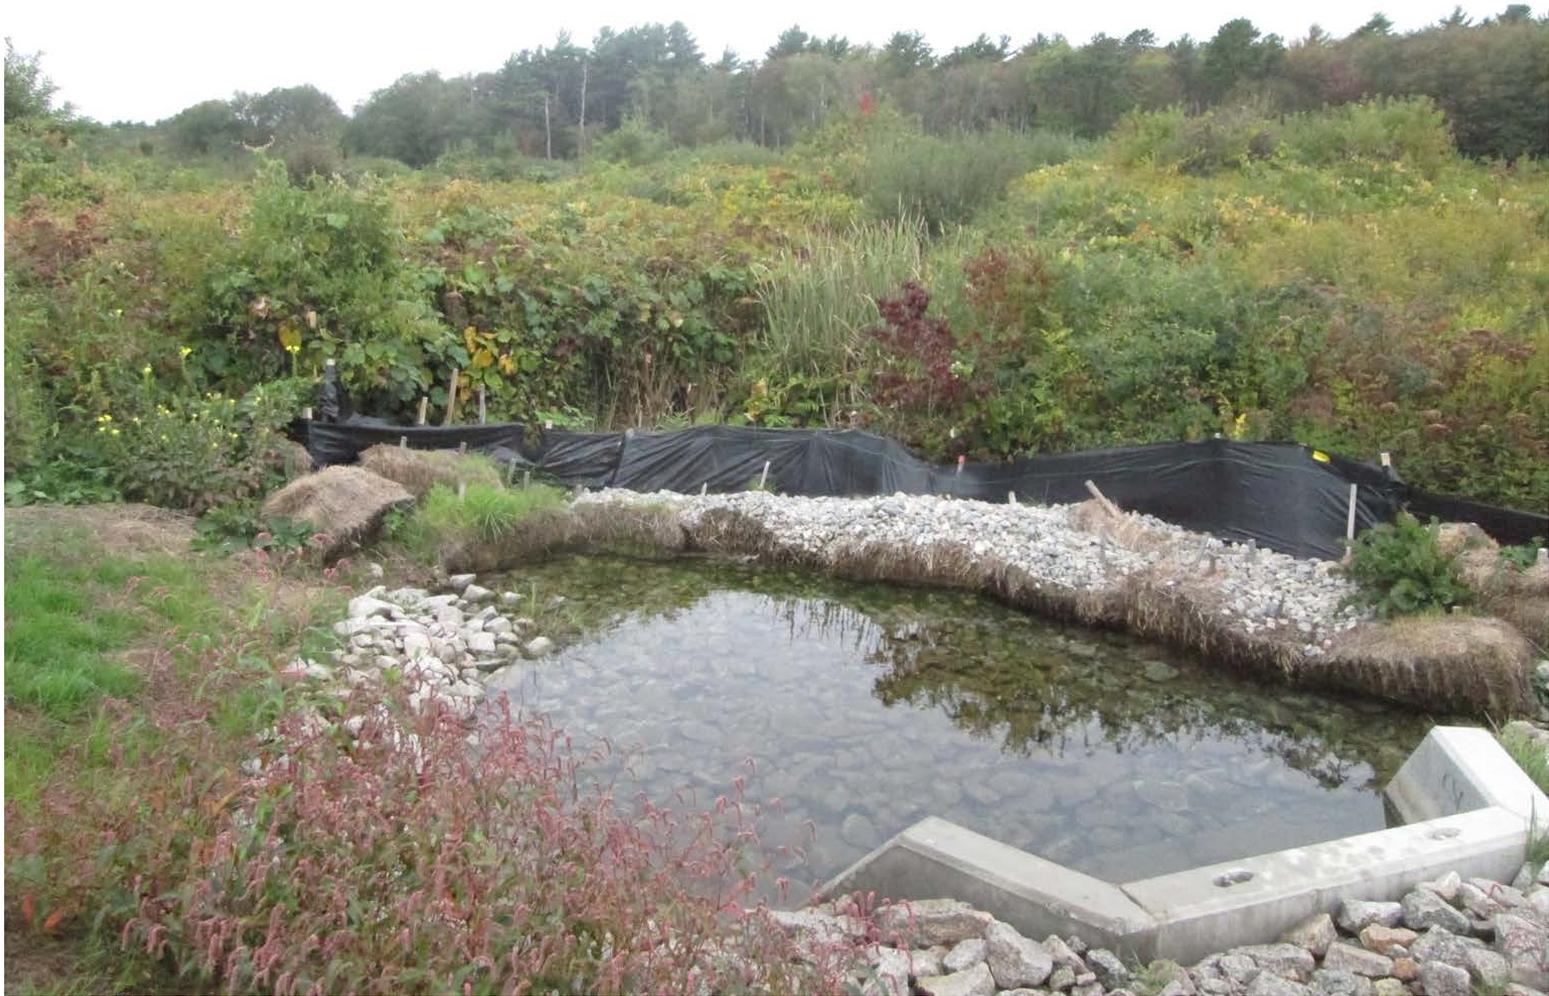
View of catch basin 3 headwall. Area remains stable.

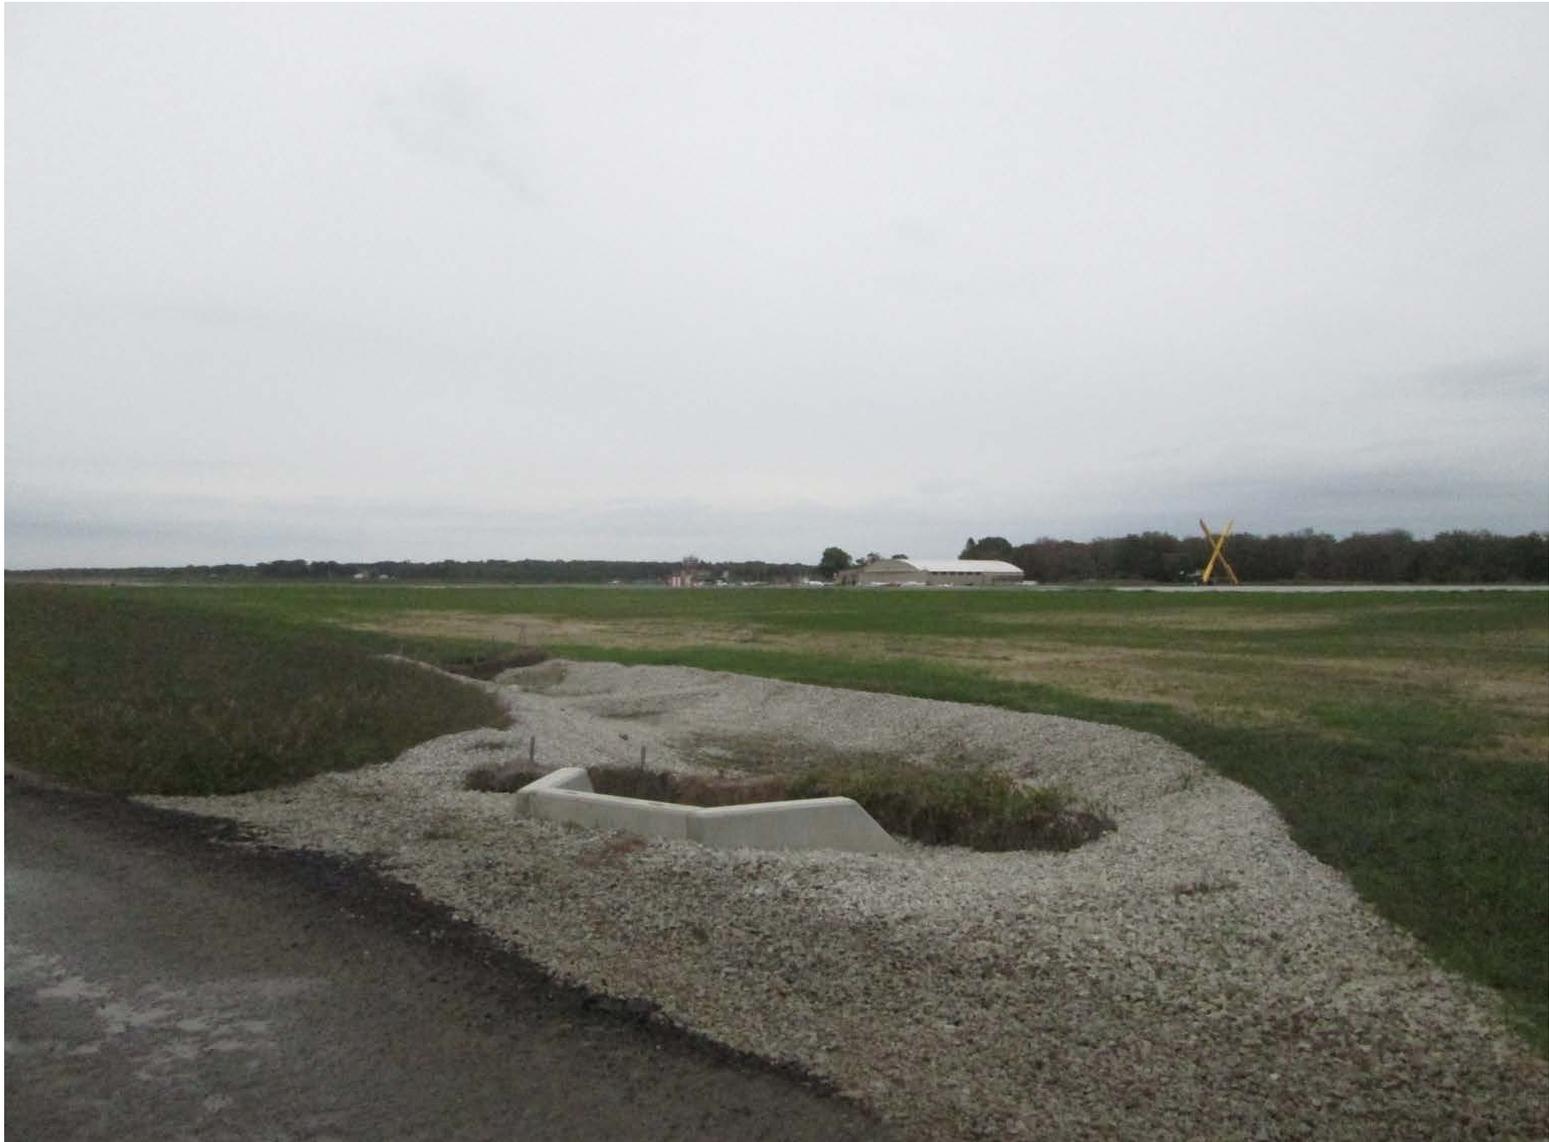
View of drainage swale, from 9/25. Check dams were removed this week.

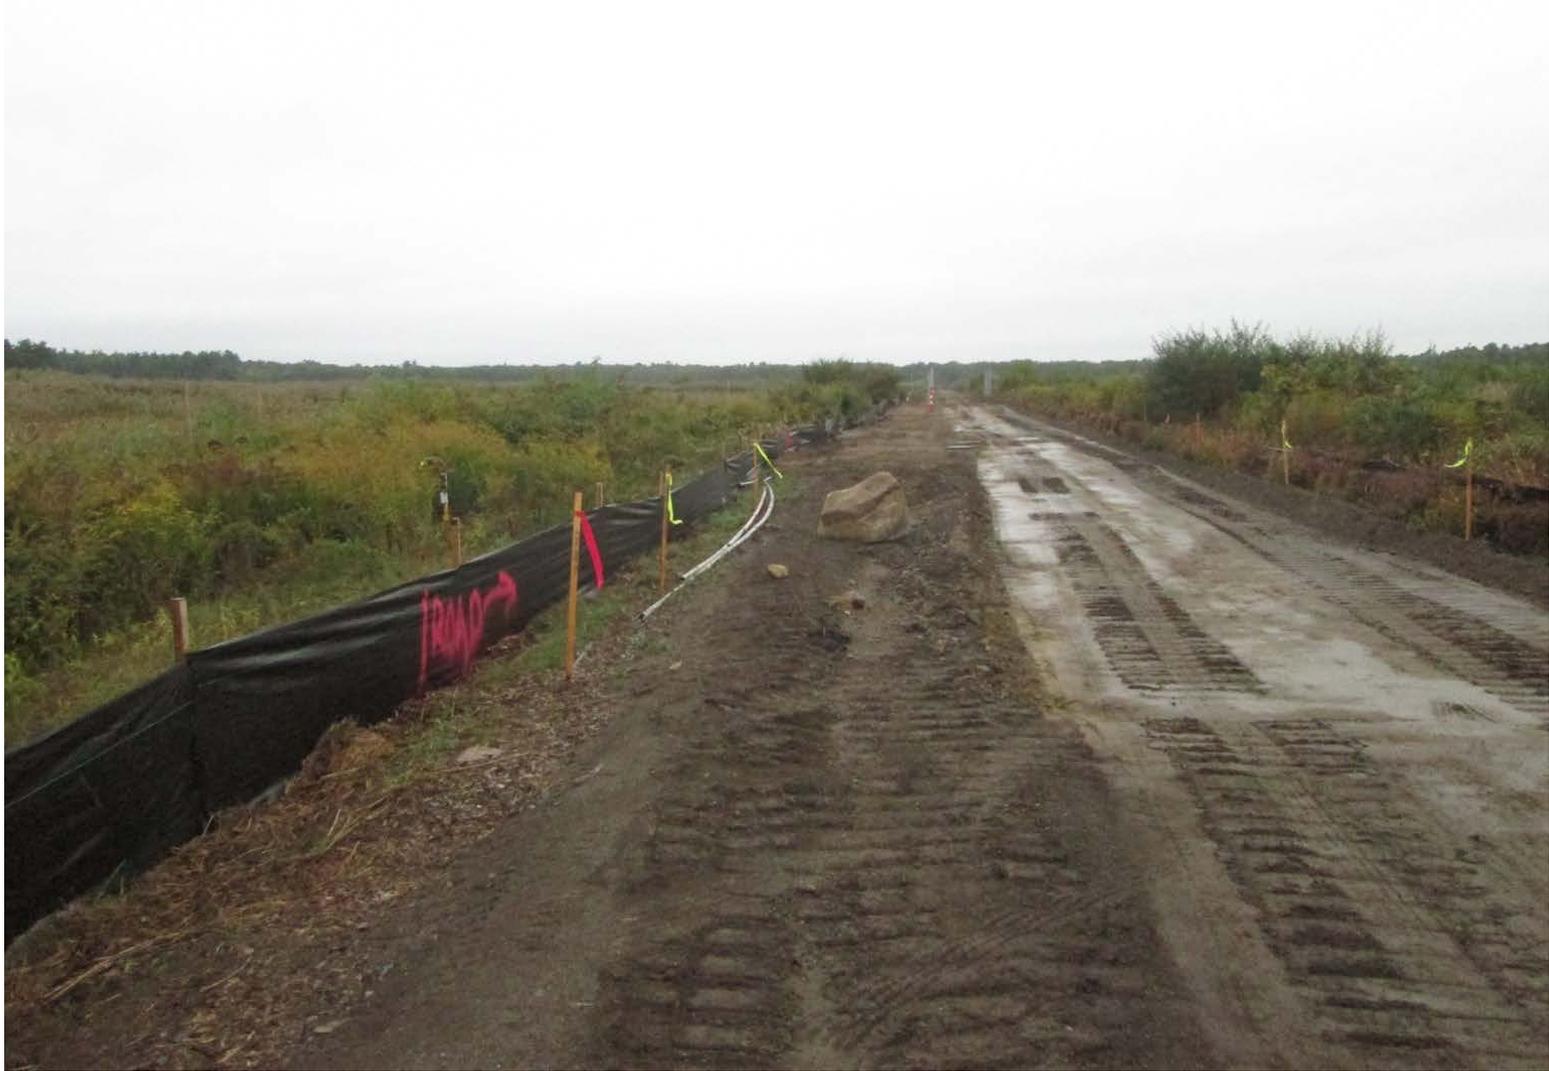
View of silt fence repairs along ILS road.

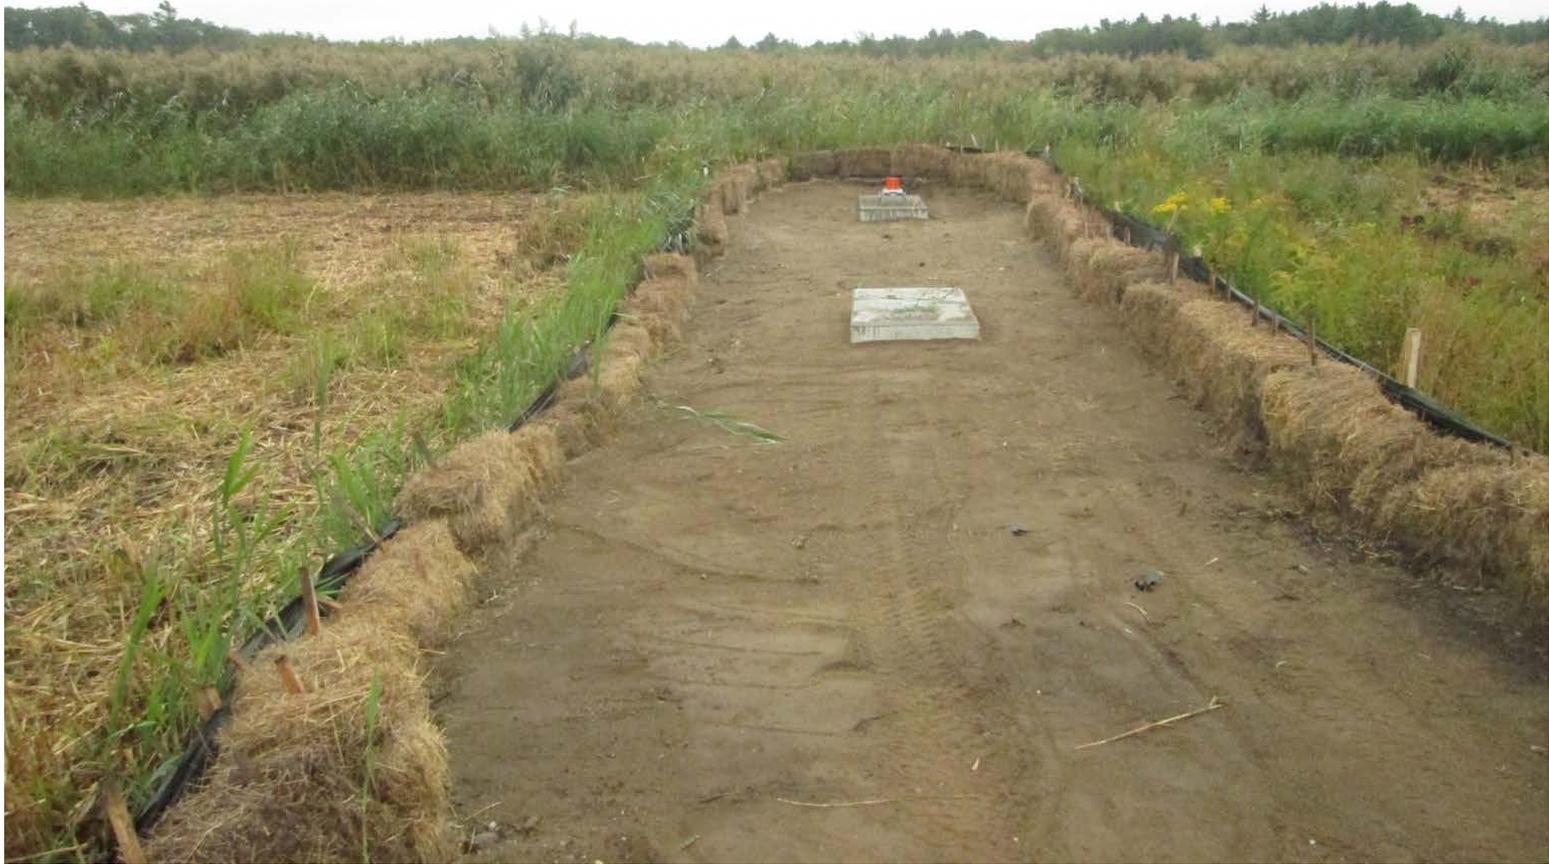
View of MALSR silt fence repairs from 9/25.

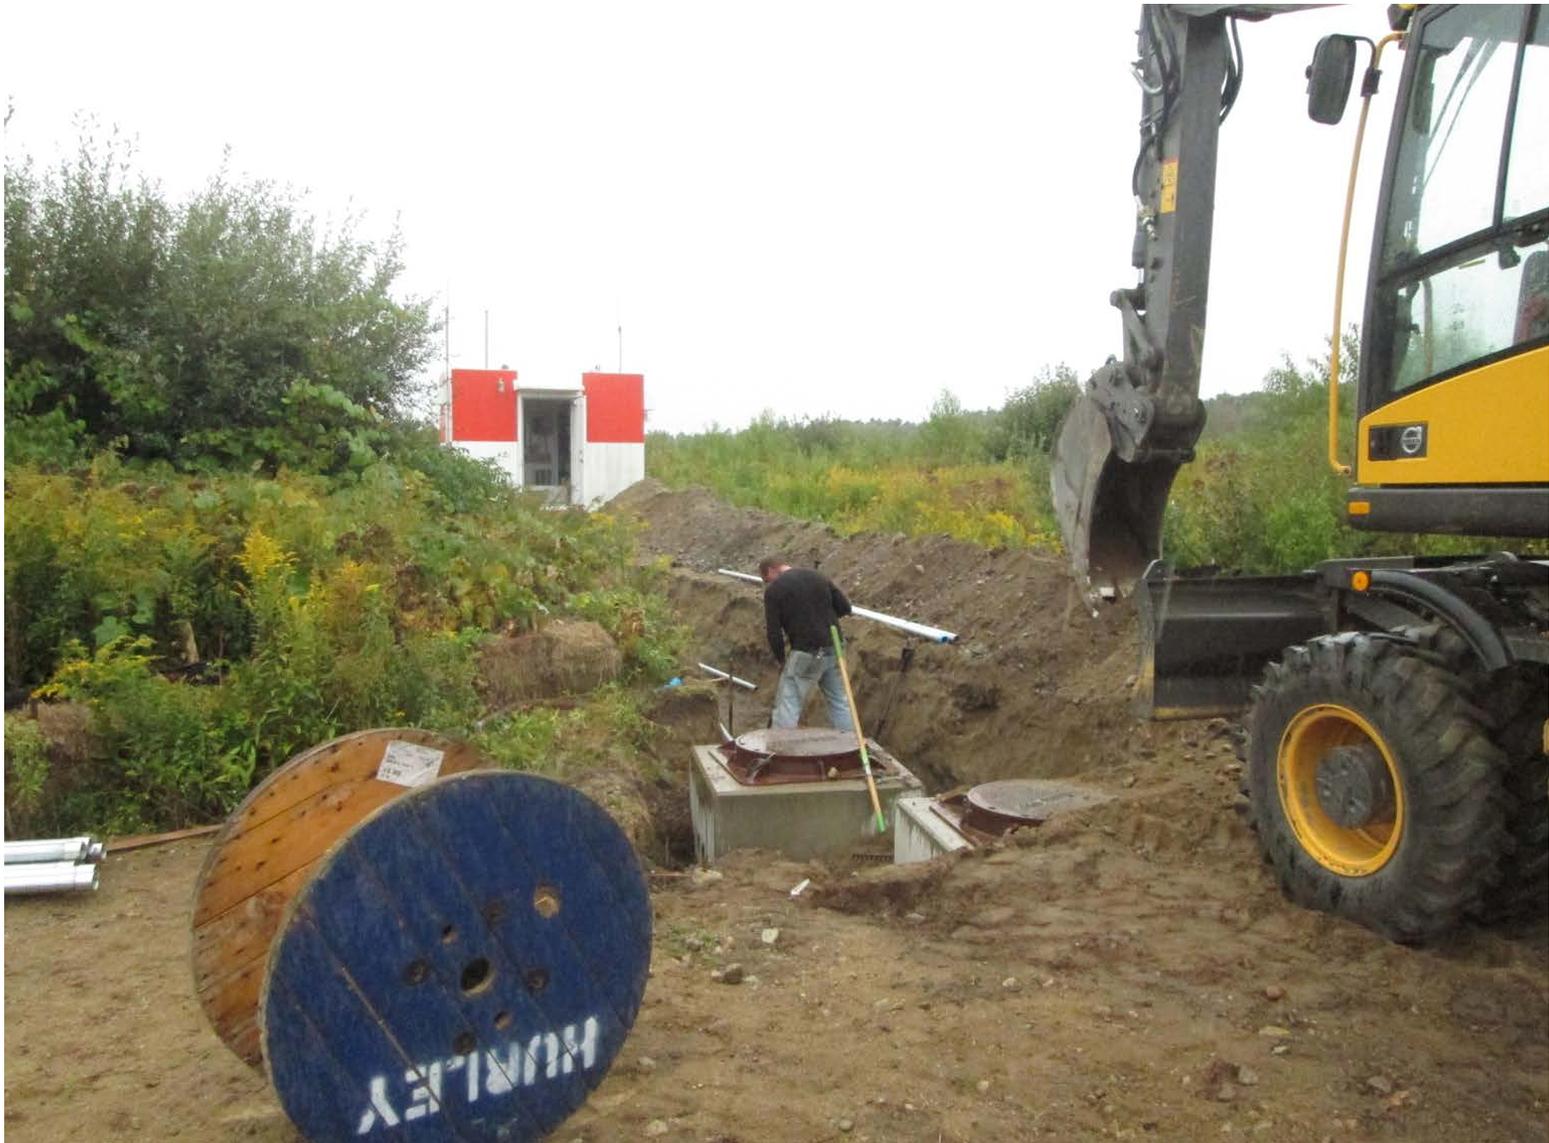
View of new electrical installation to the FAA shack at 5 end, 9/25.

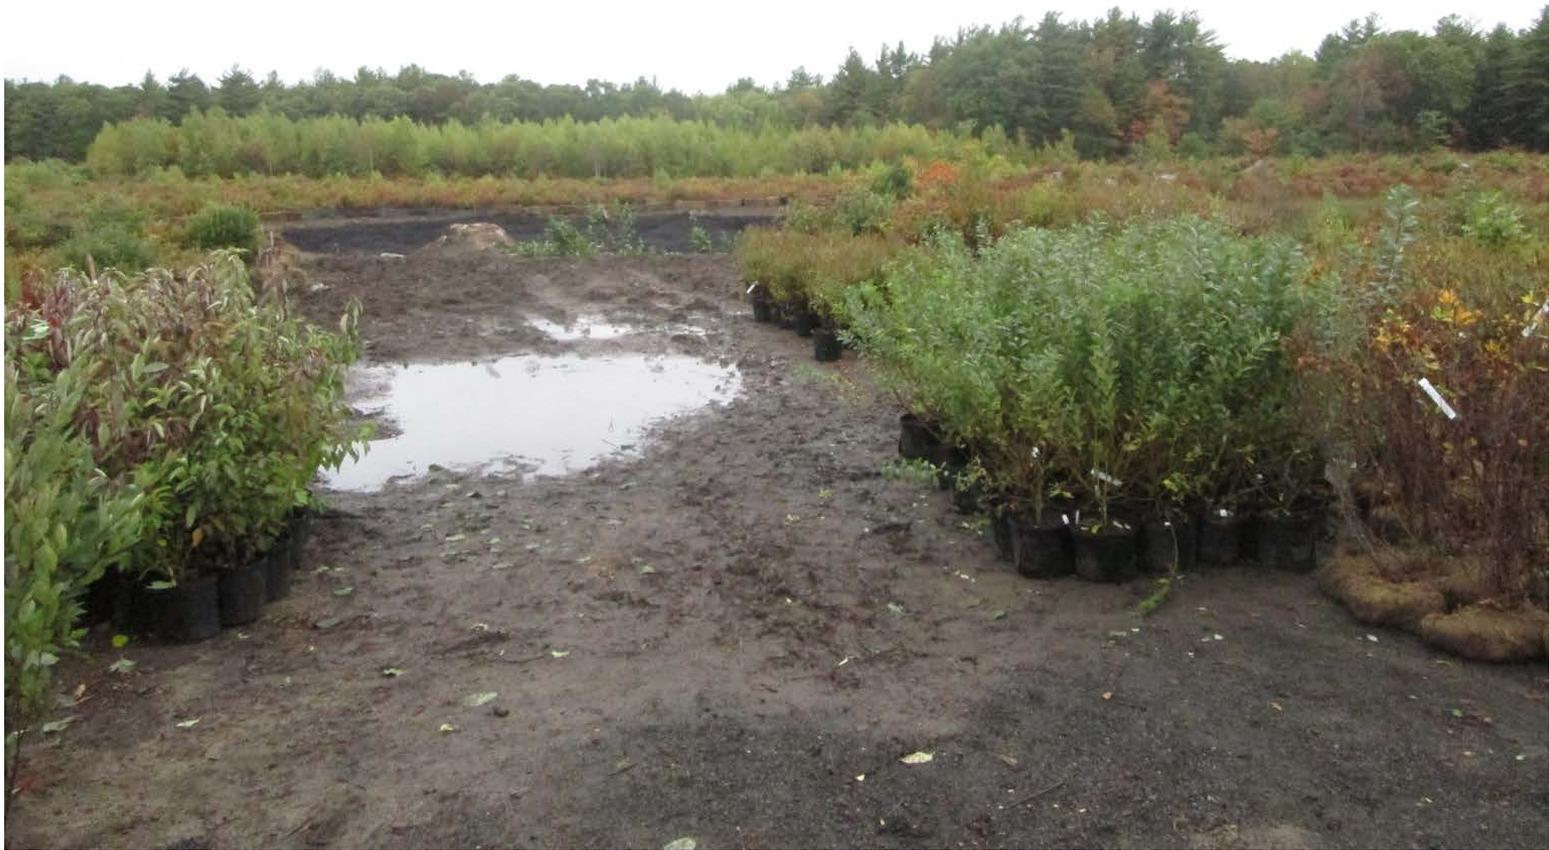
View of wetland plants staging area once delivery occurred on 10/2. Plants were installed on 10/2 and 10/3.

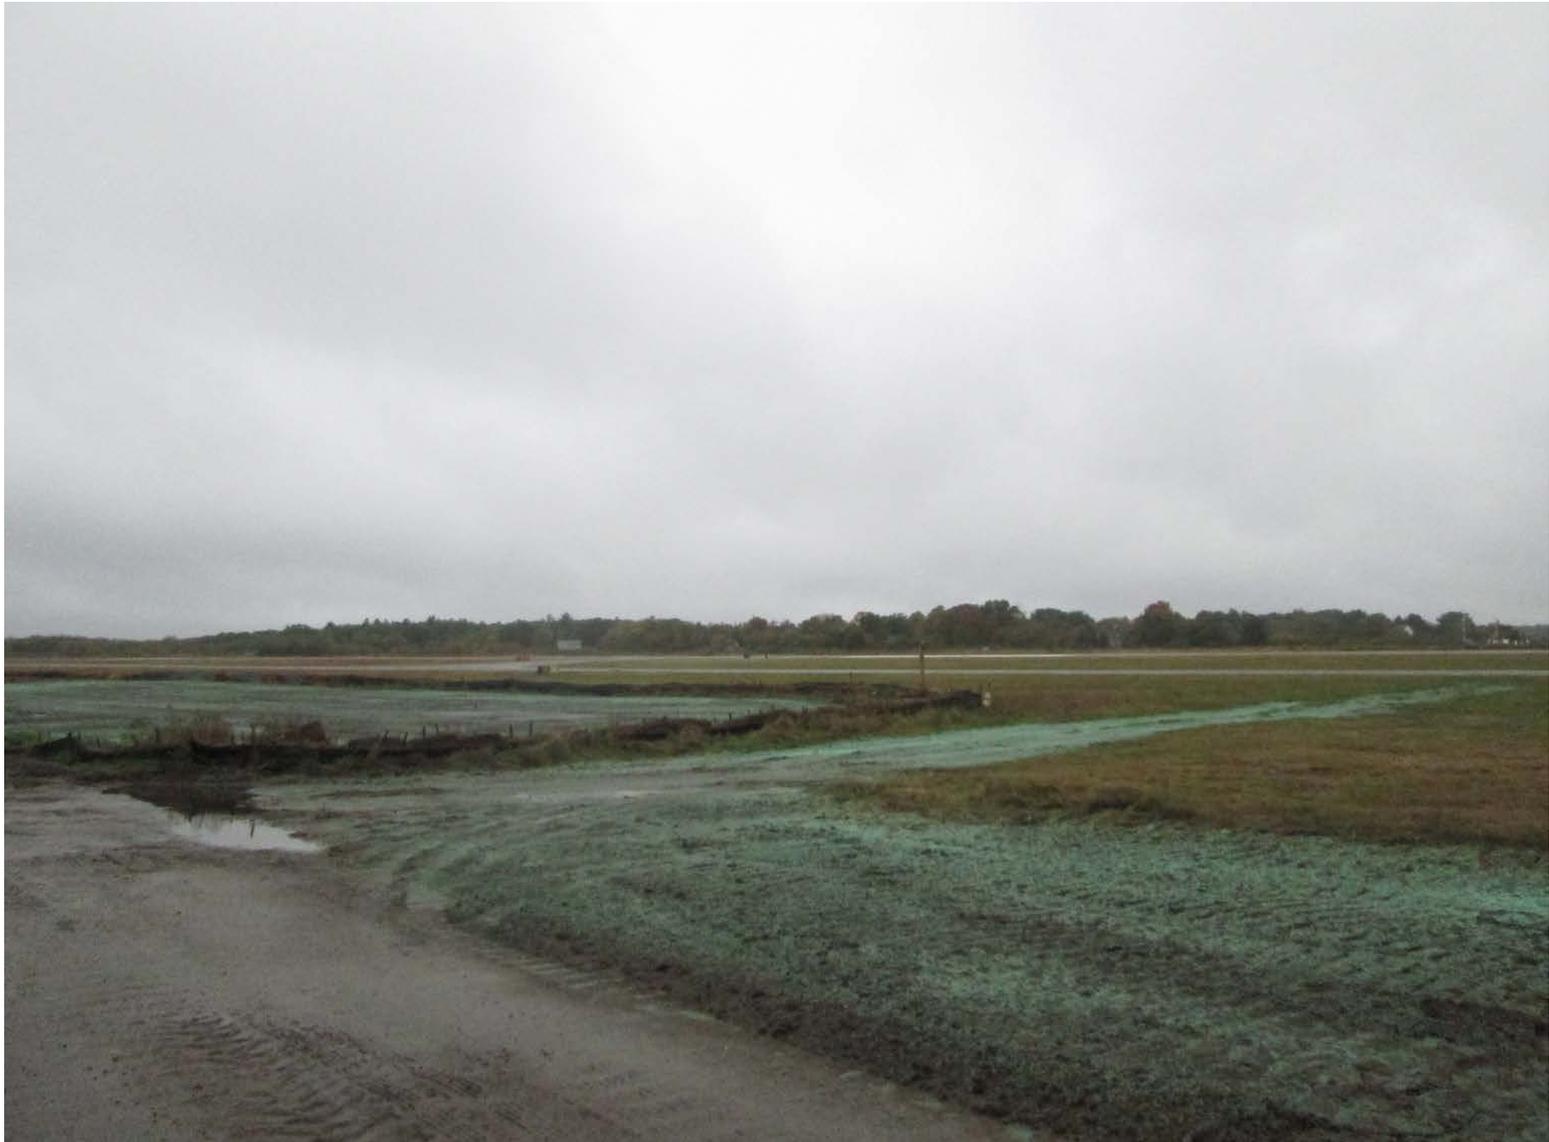
View of hydroseeded staging and laydown area 10/2.

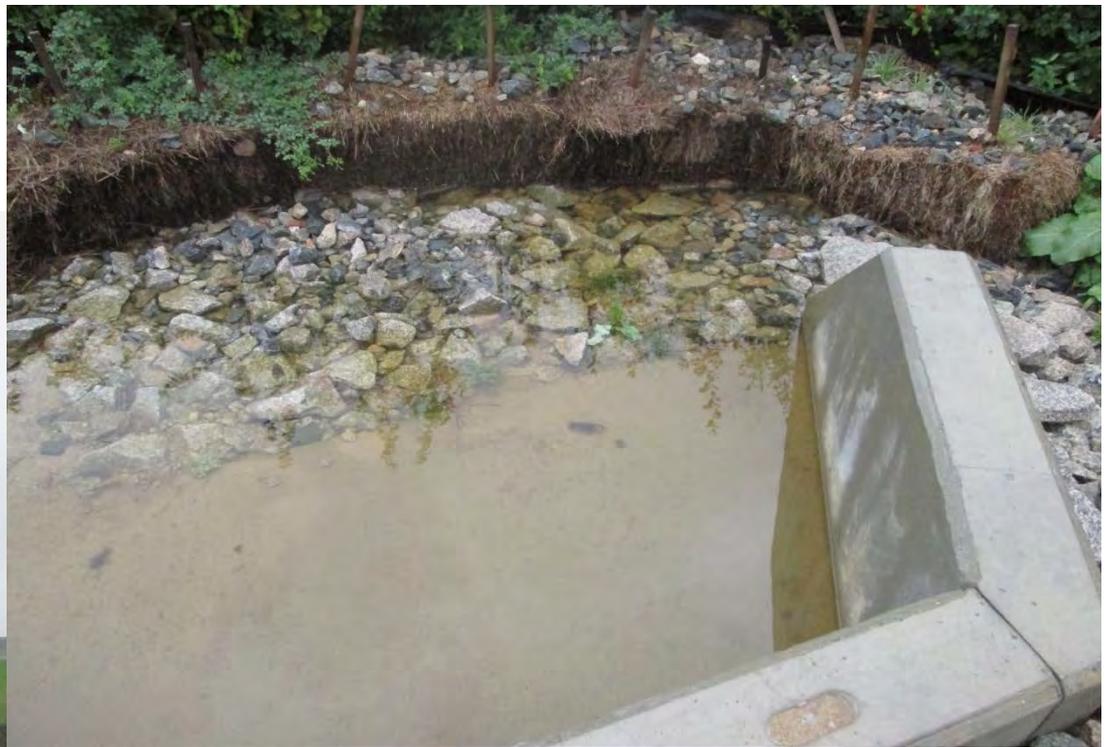
IMG\_4146

View of water within headwall. Crayfish present. Check dams will be removed, rock re-spread and sediment (from previous months) cleaned out prior to removal of erosion controls.

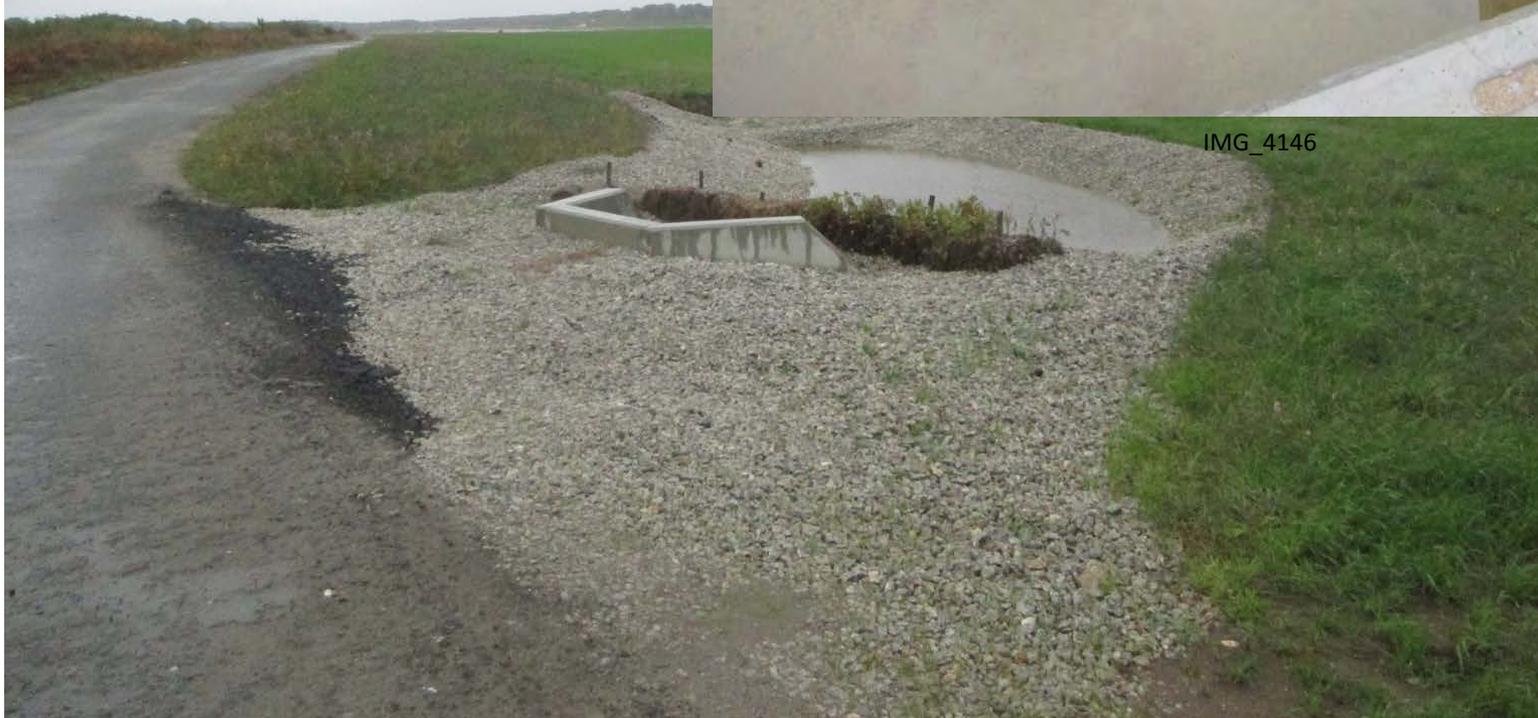
View of water within drainage swale

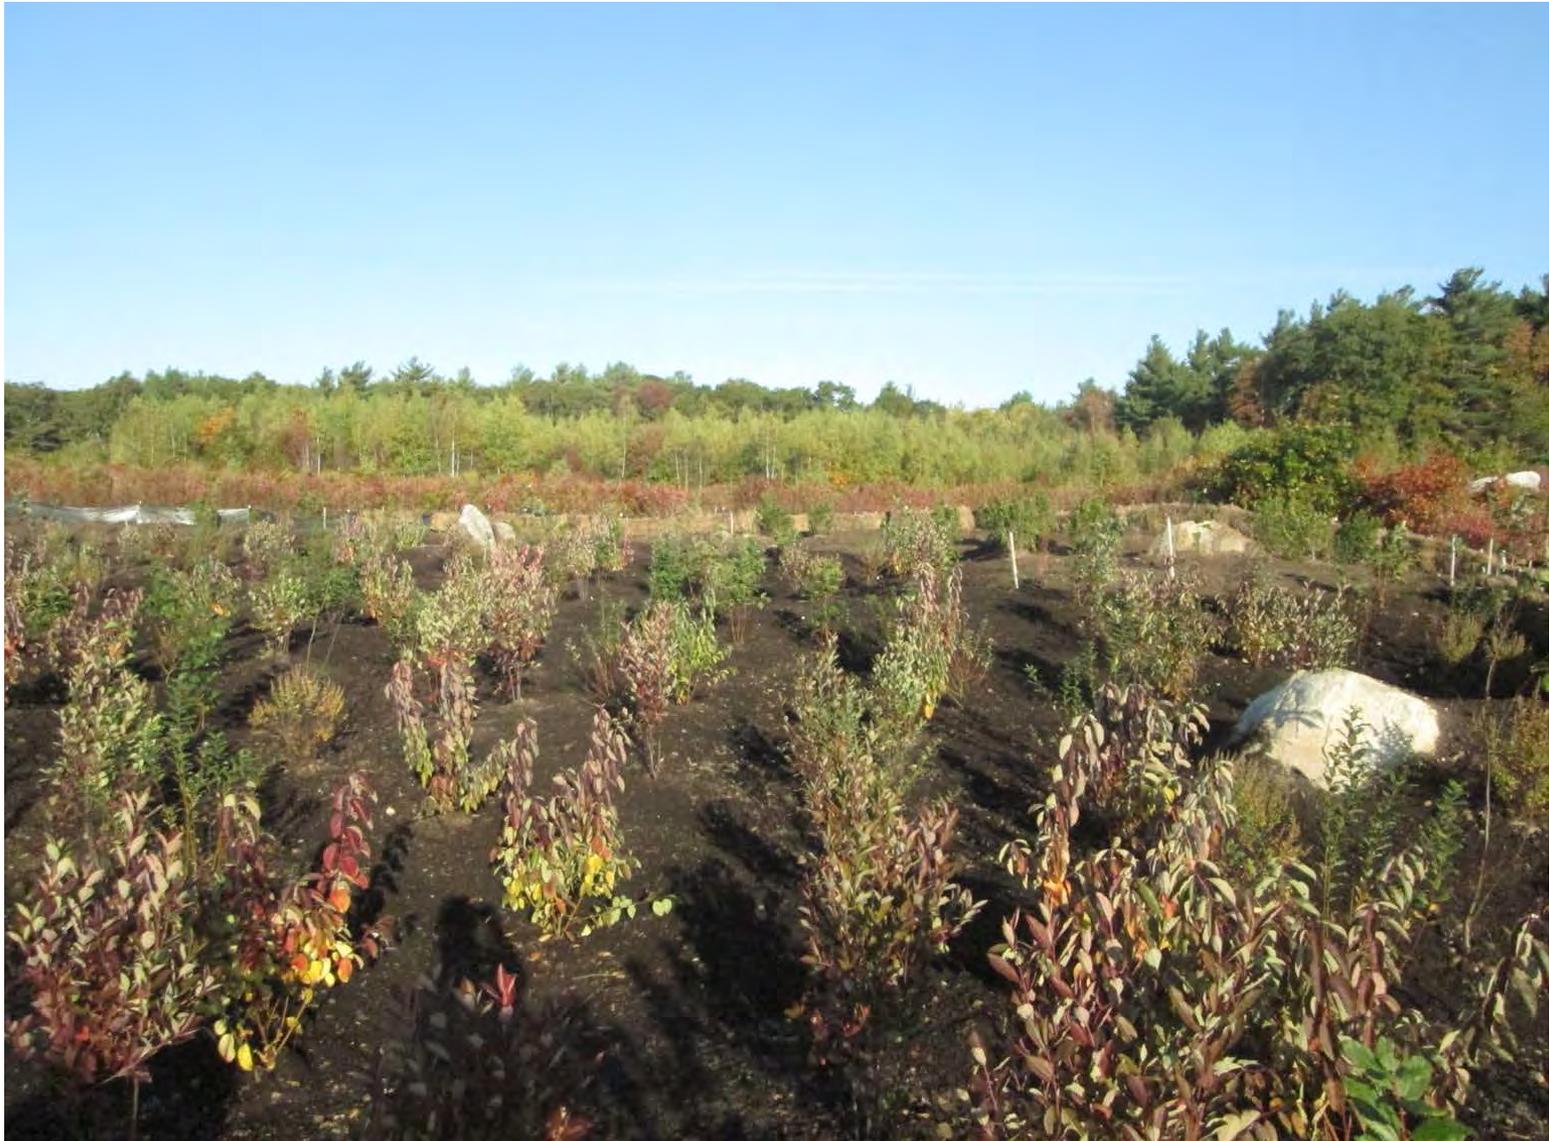
View of planted wetland replication area, 10/9.

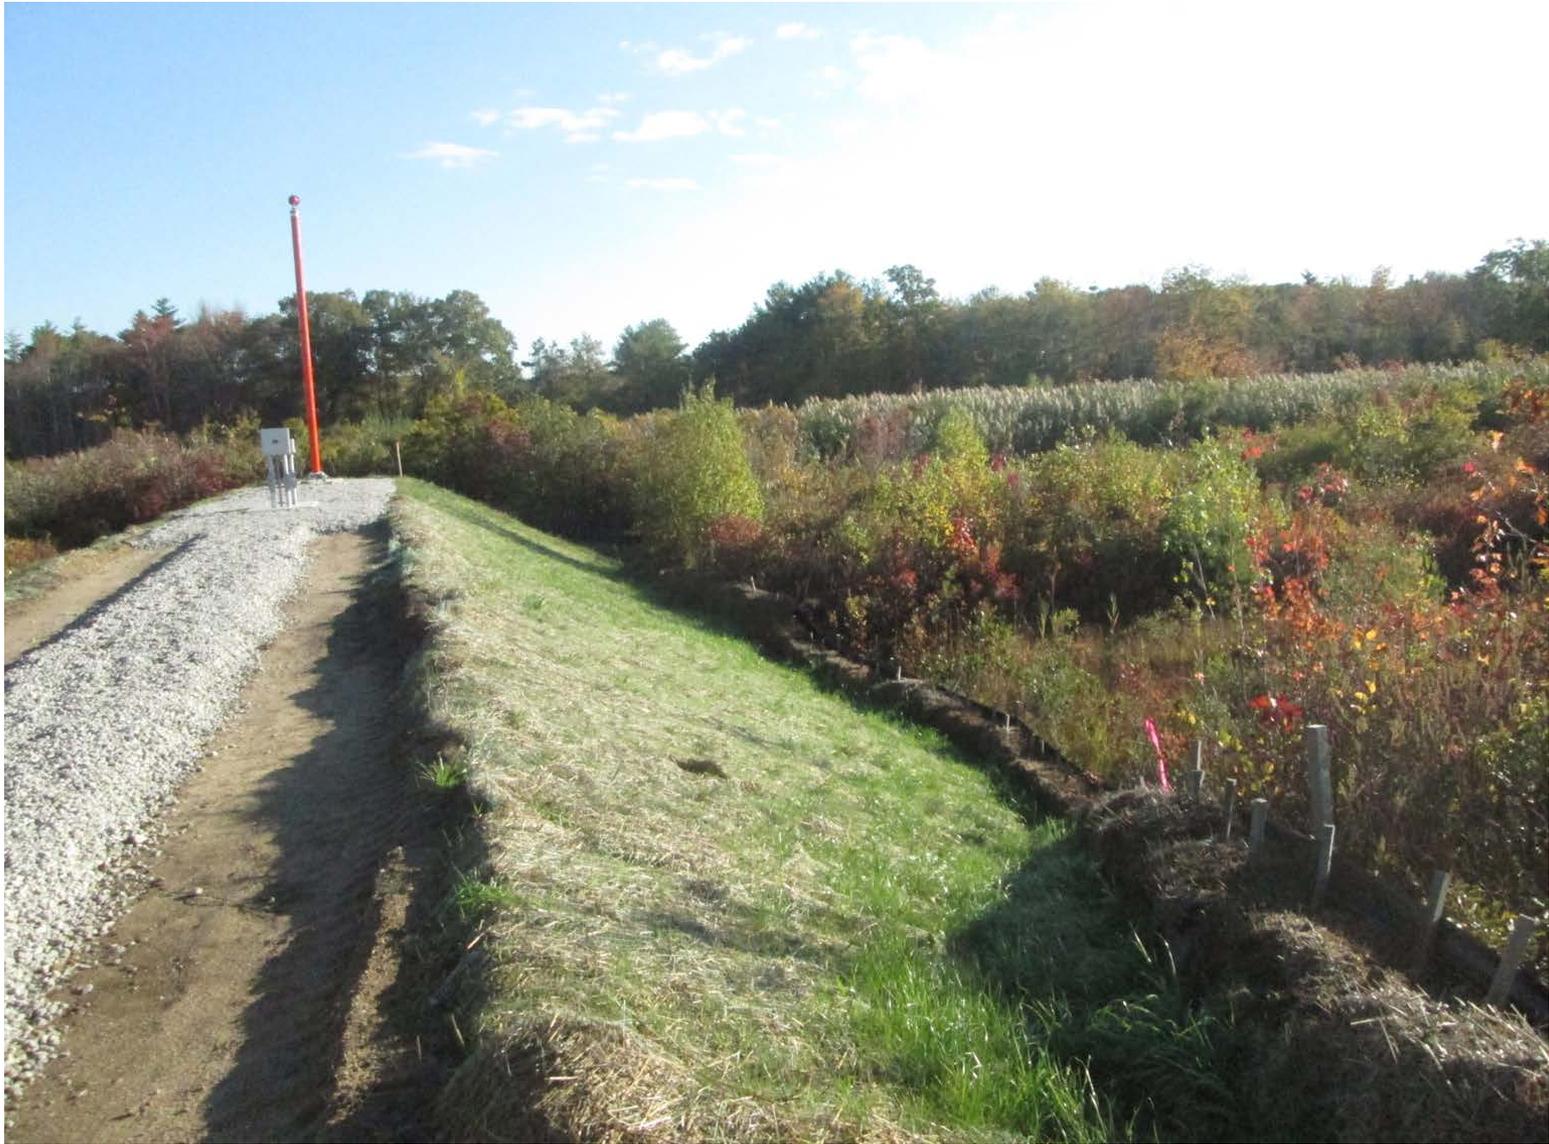
View of MALSR 23 end wetland fill area. Stone was laid. Erosion control matting was repaired (10/9).

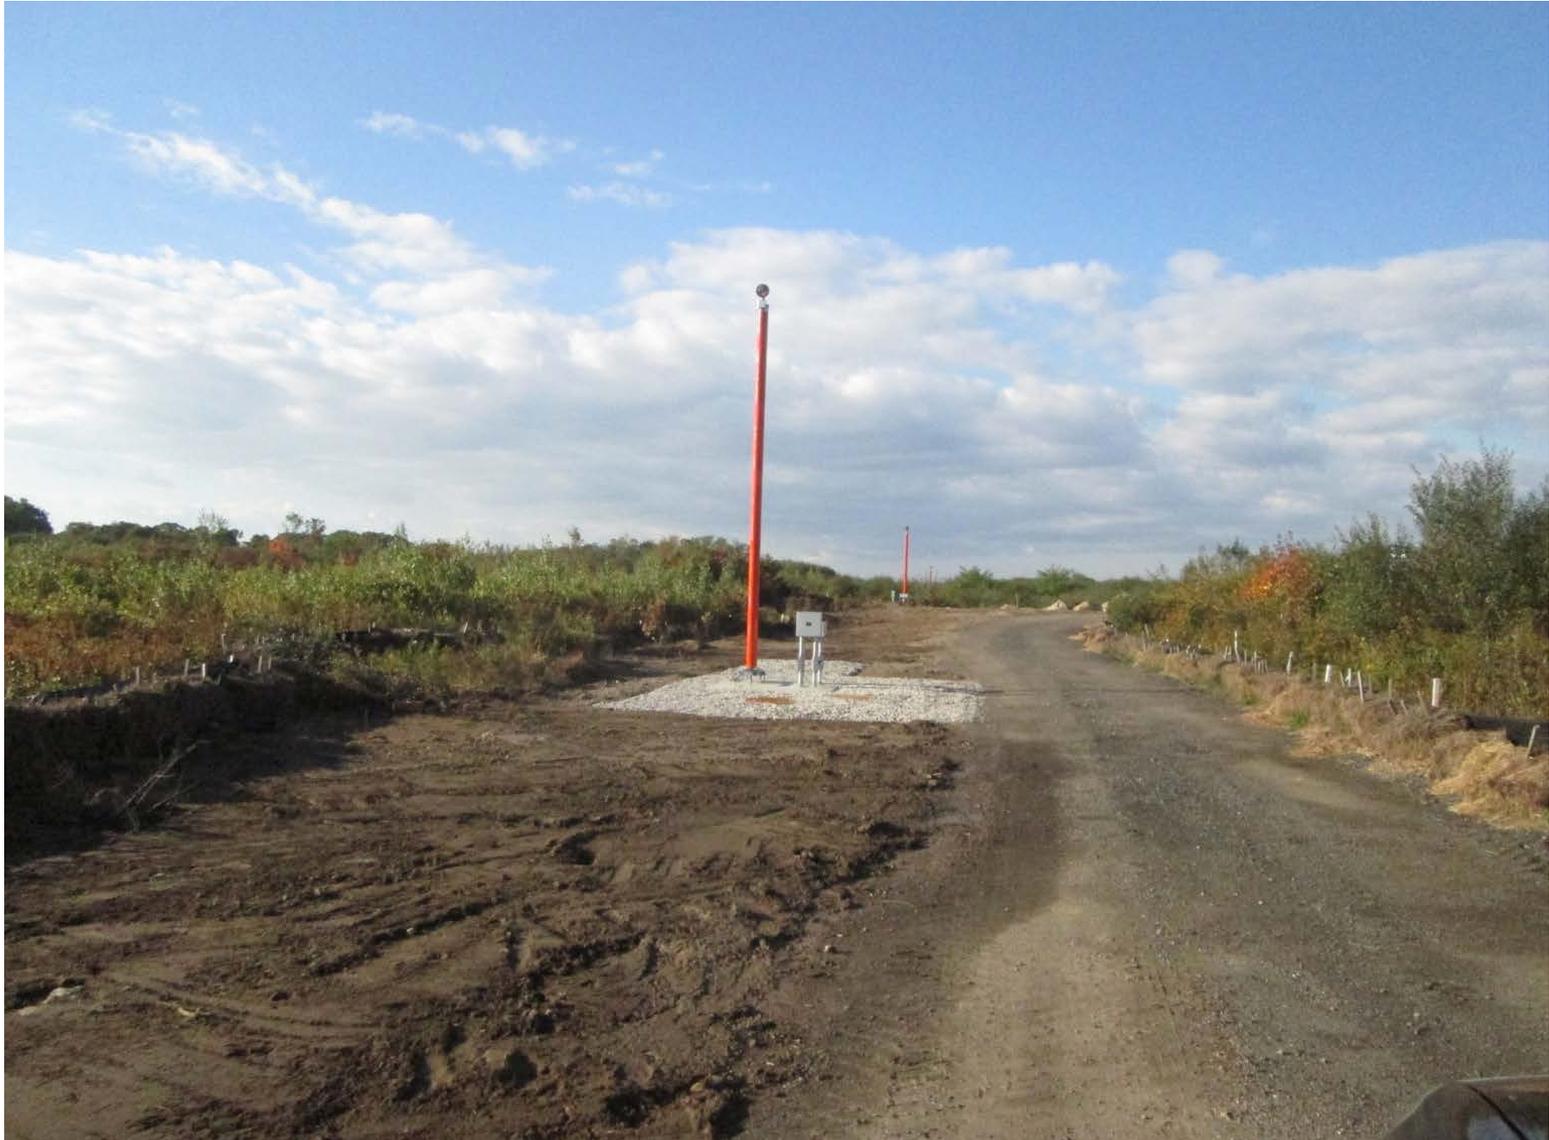
View of MALSR along 23 end. Erosion controls are in good condition.
