**New Bedford Regional Airport  
Runway Safety Improvements Project – Phase 4  
Reconstruct, Mark, and Groove Runway 5-23  
MassDEP File No. SE049-0635**

**ENVIRONMENTAL MONITOR INSPECTION FORM**

Date/ Time of Inspections: **9/25/14 (morning), 10/2/14 (morning), 10/9/14 and 10/15/14.**

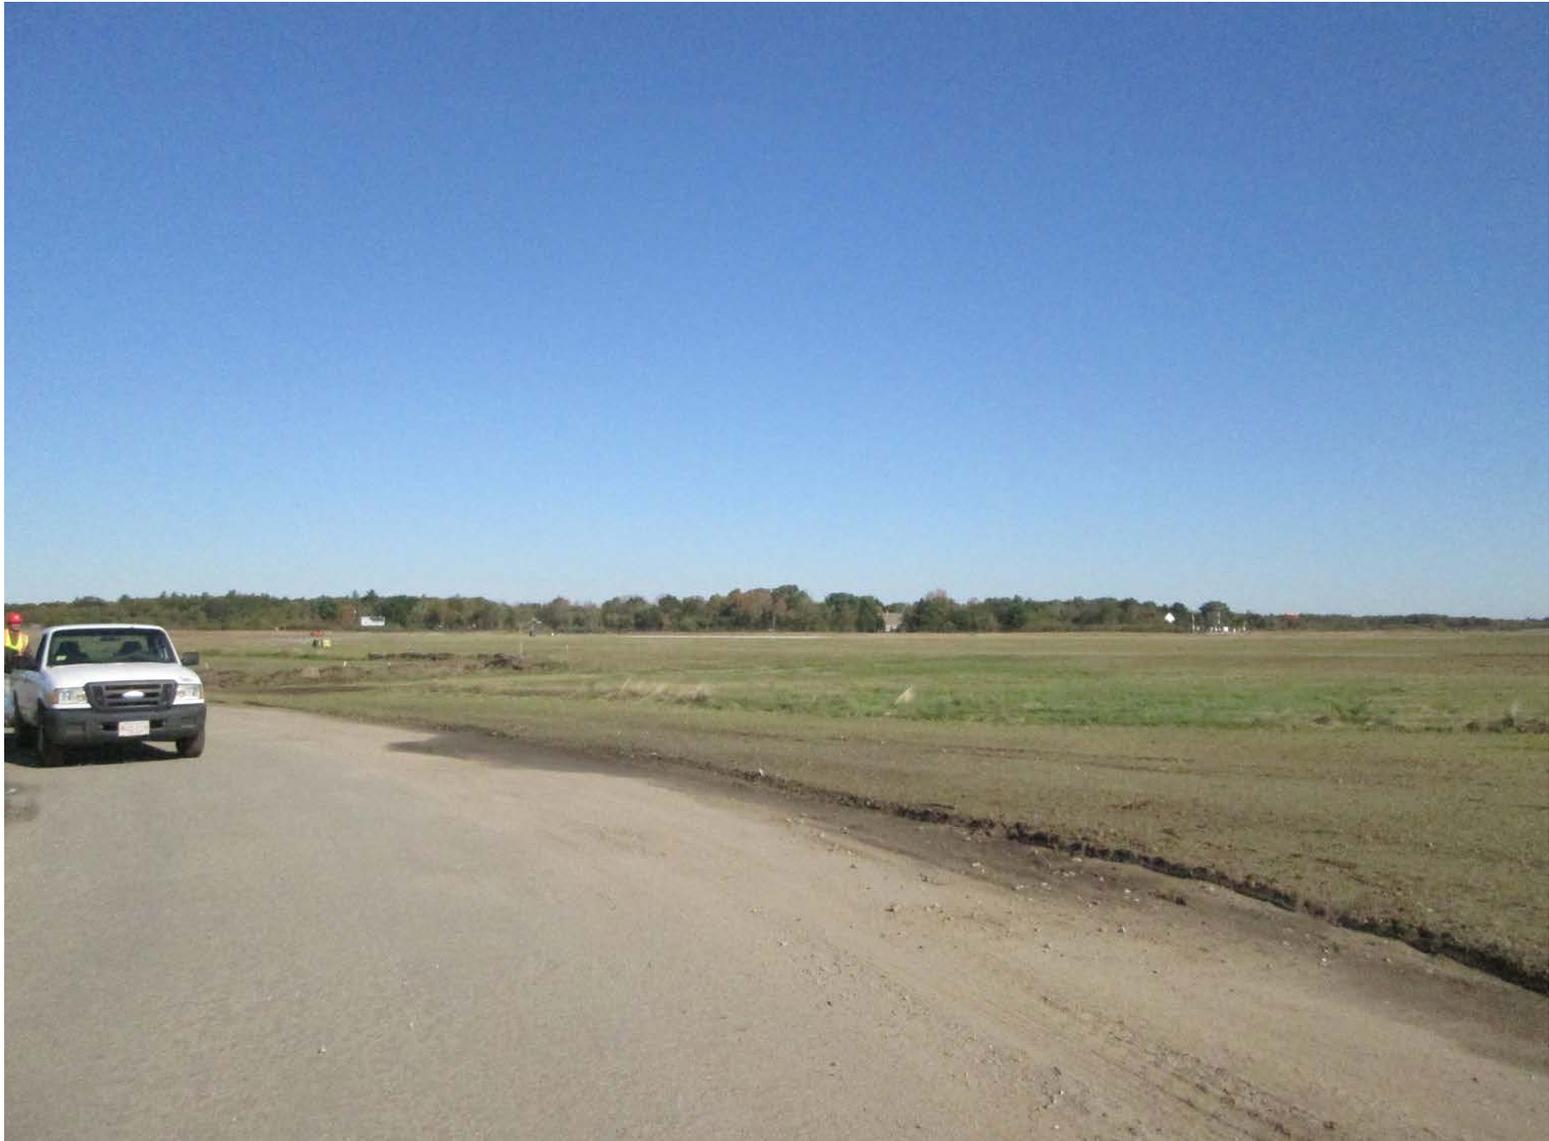
View of seed germination from last weeks hydroseeding (10/9)

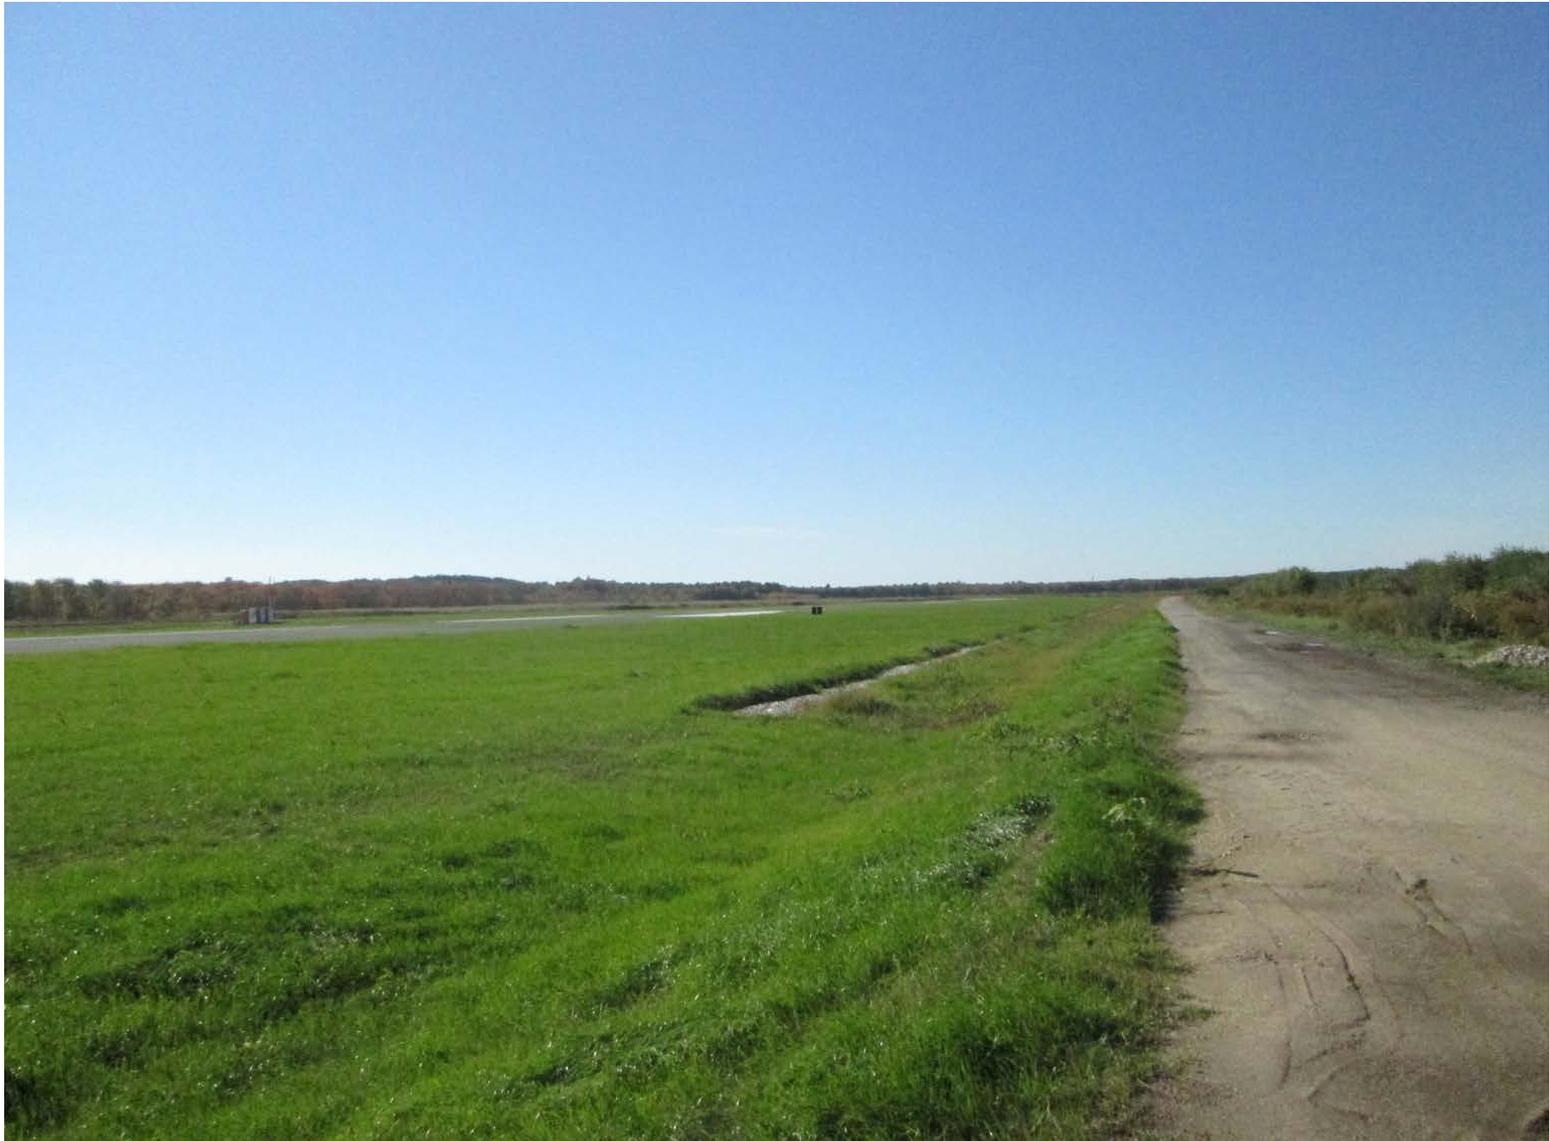
View of infiltration trench and newly established grass (10/9).

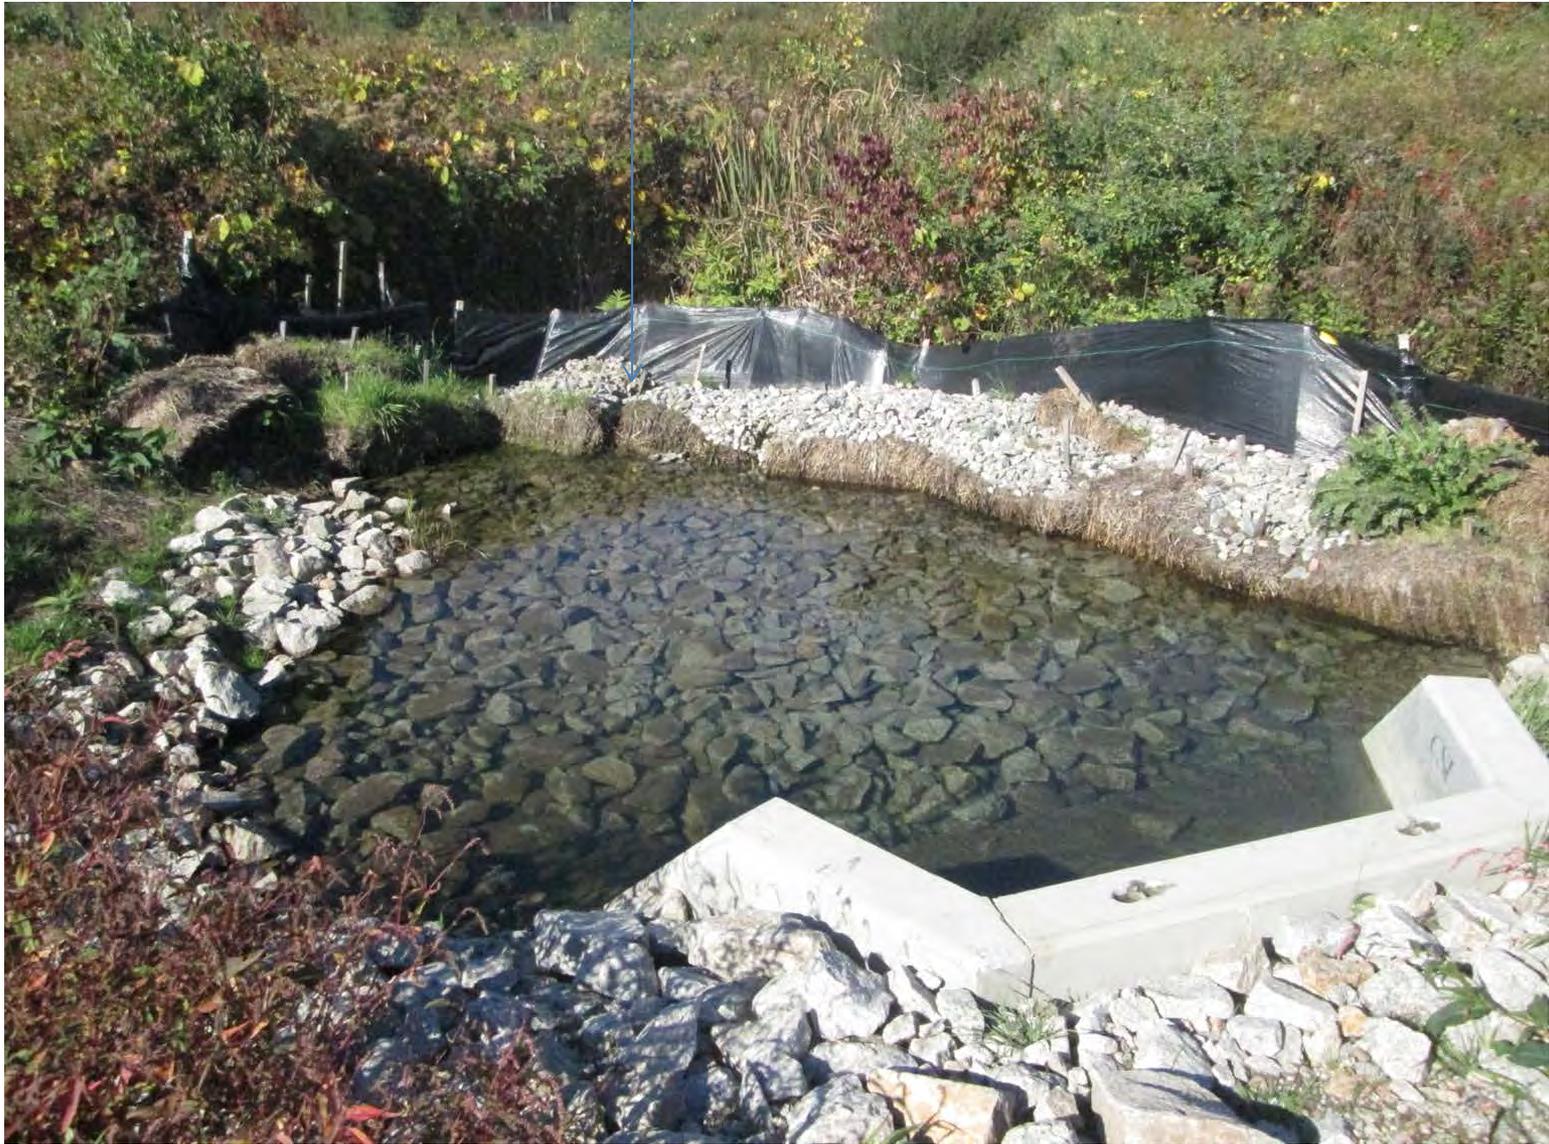
View of headwall from catch basin 3. Water is still clear, no sedimentation apparent downslope. Evidence of high flow after rain event (channelization in rock) 10/9.

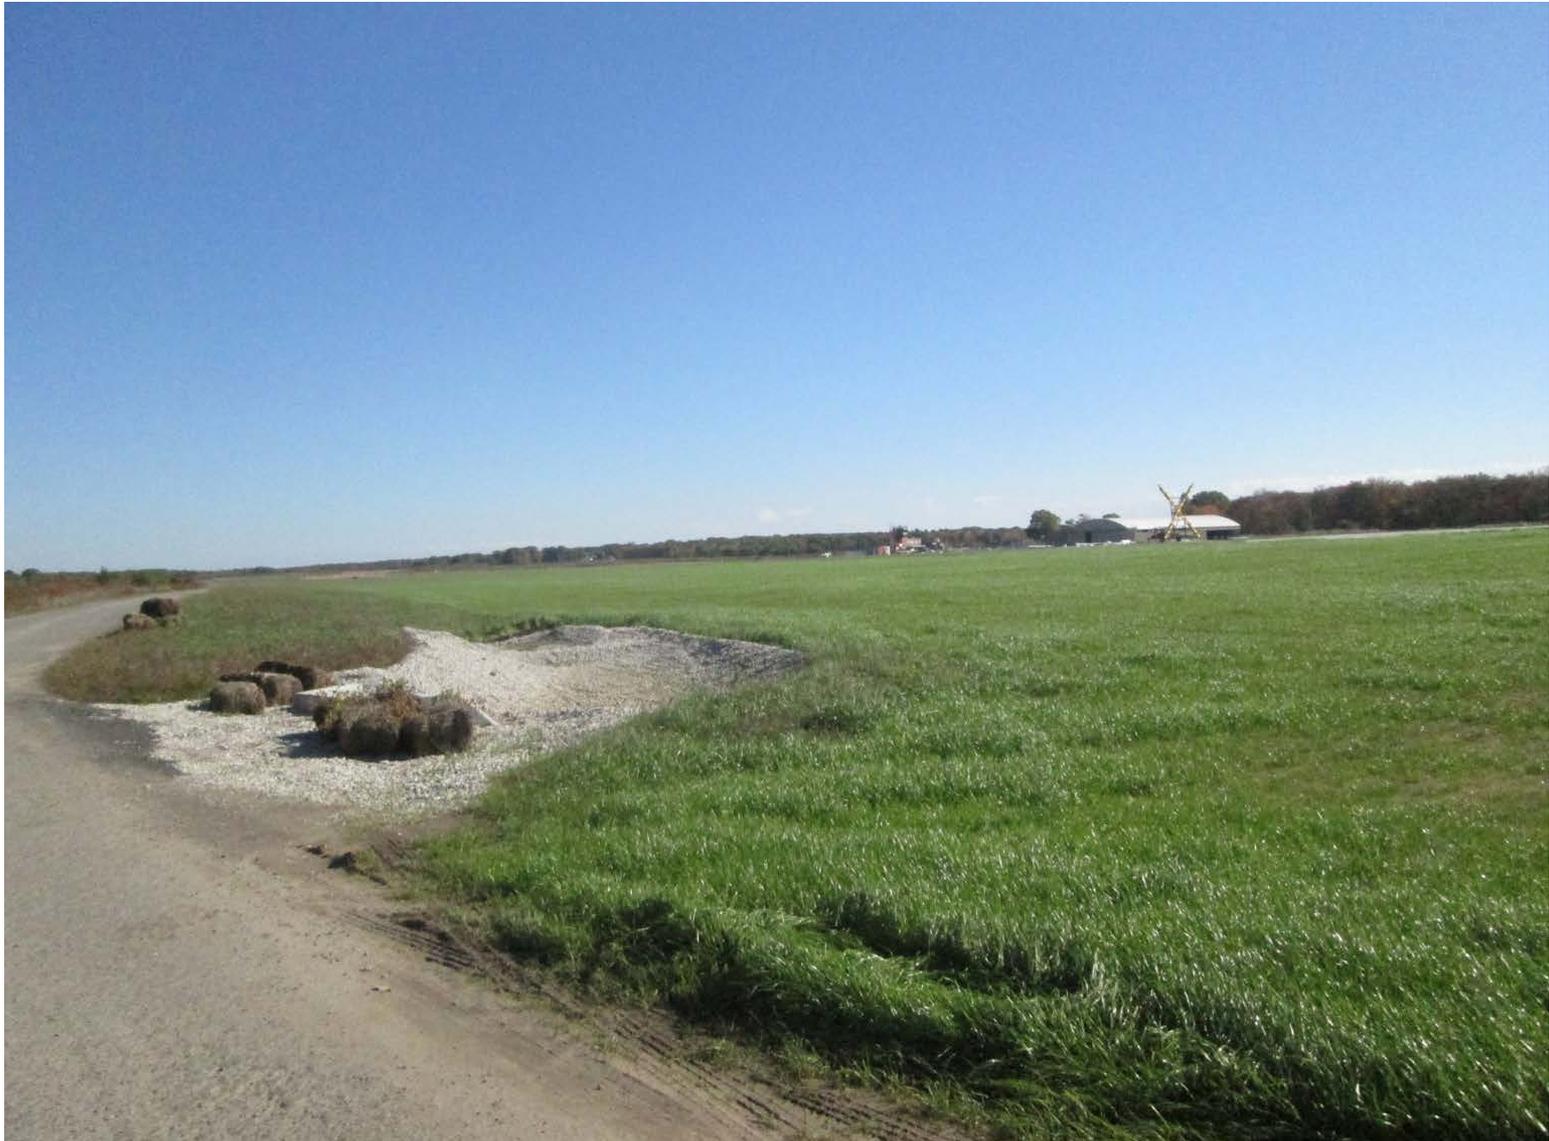
View of removed haybale check dams. This area will be re-graded to smooth grade. 10/9

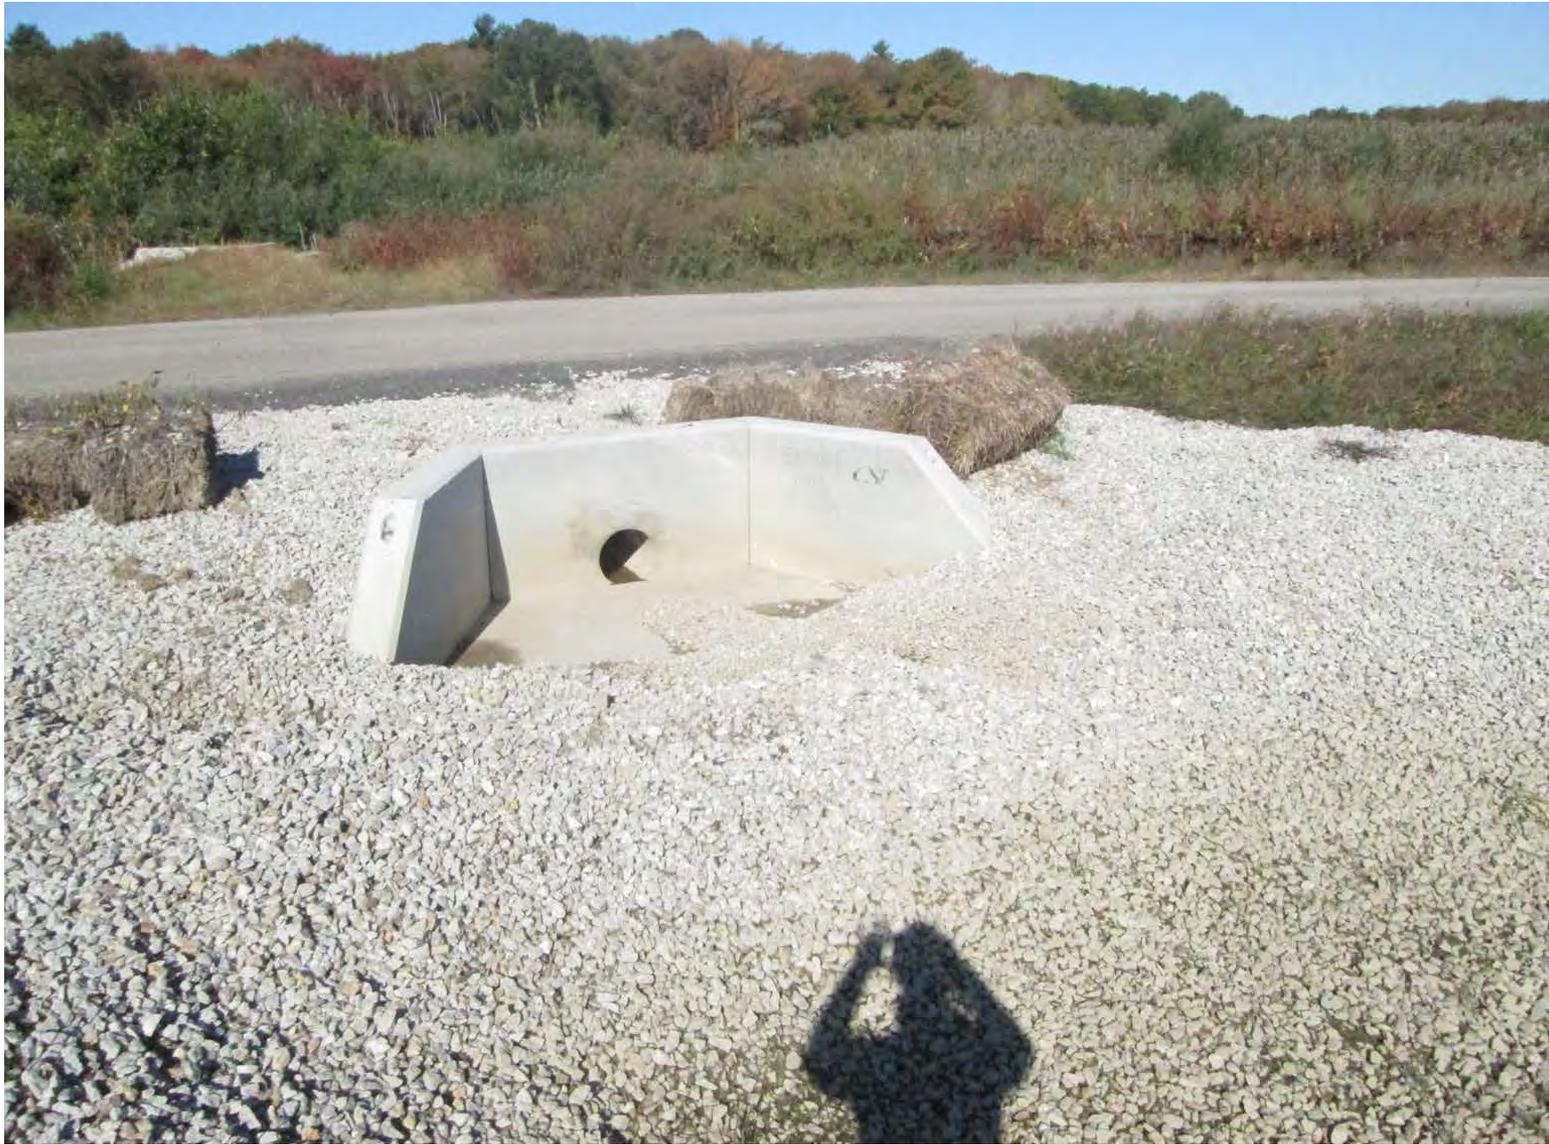
View of rock movement that will be regraded.

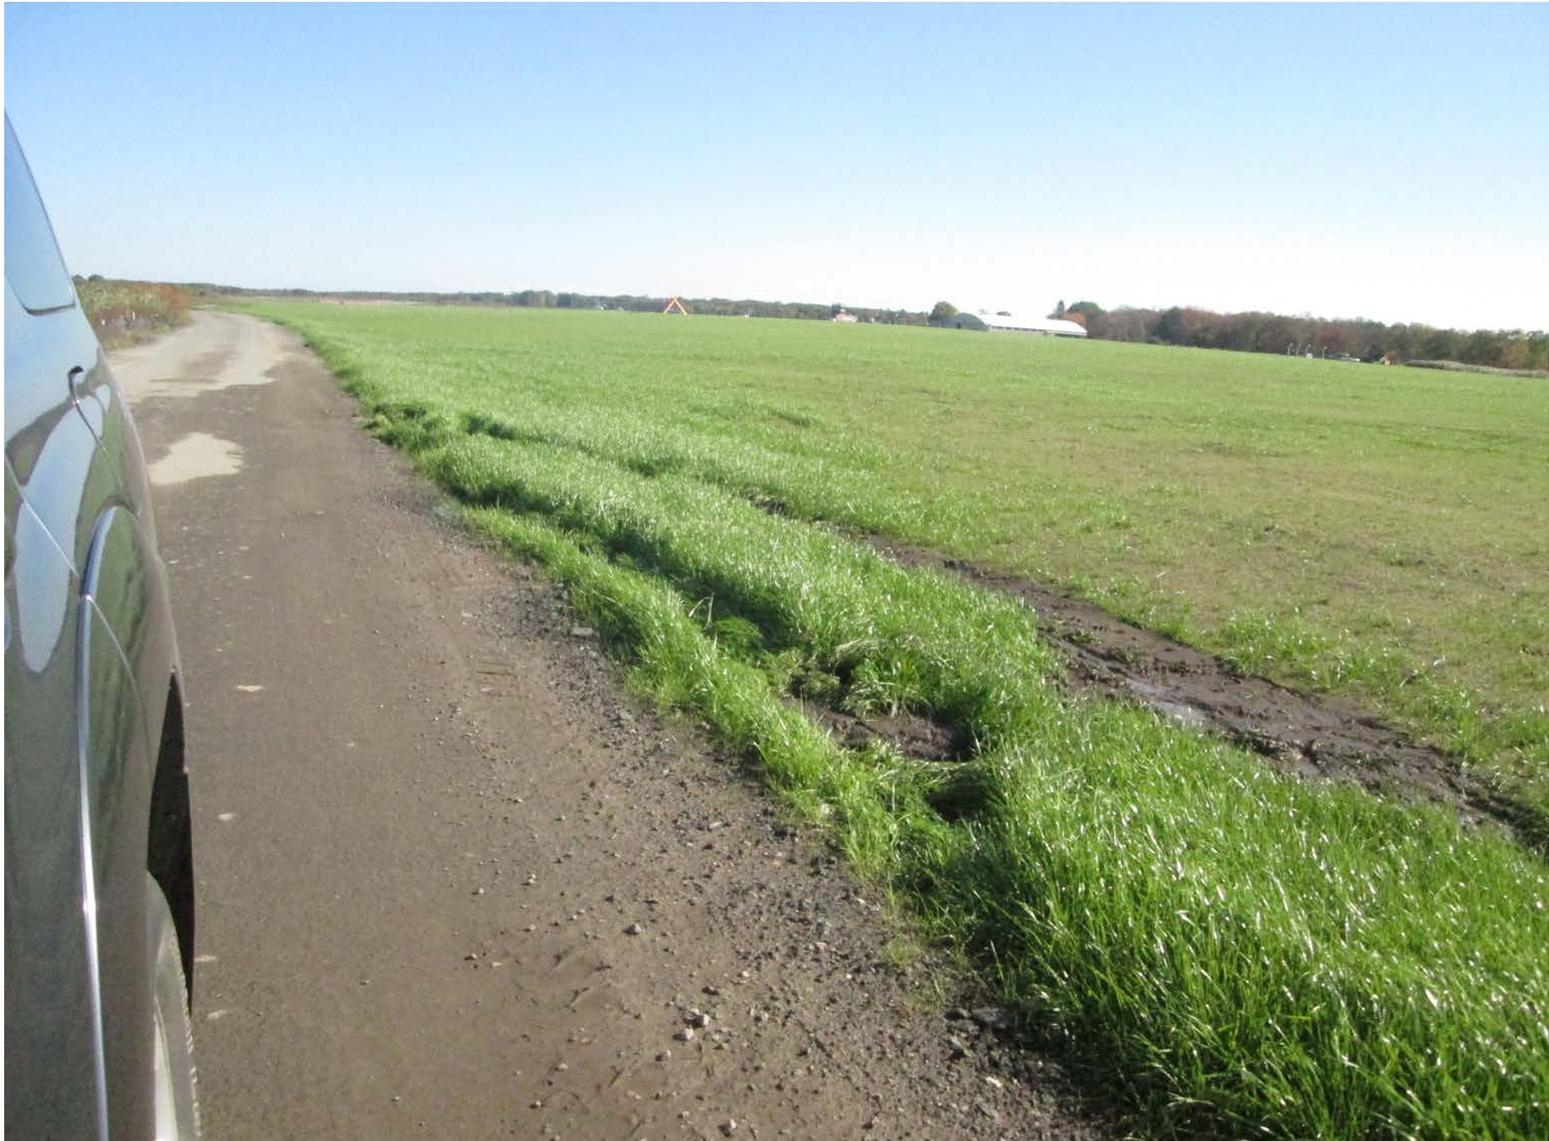
View of minor ruts along RW 5 RSA, within the 100 ft buffer to be repaired. 10/9

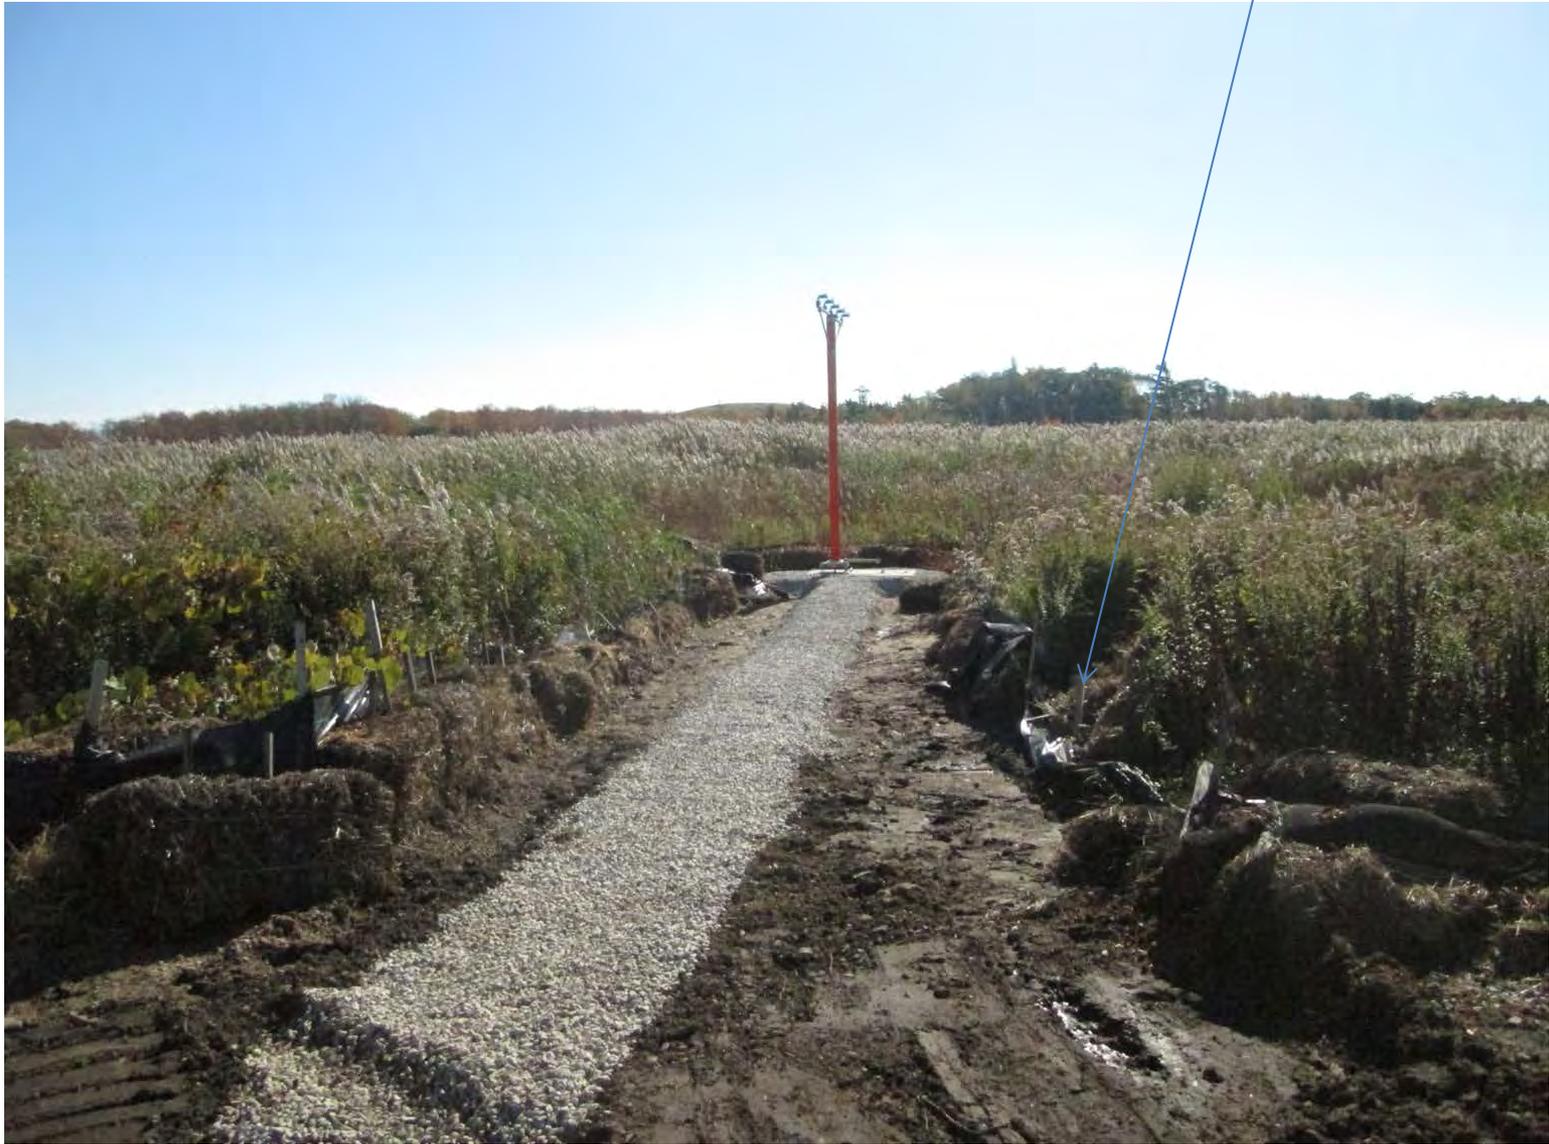
View of MALSR at 5 end. Area where erosion controls will need to be repaired. WS was notified. 10/9

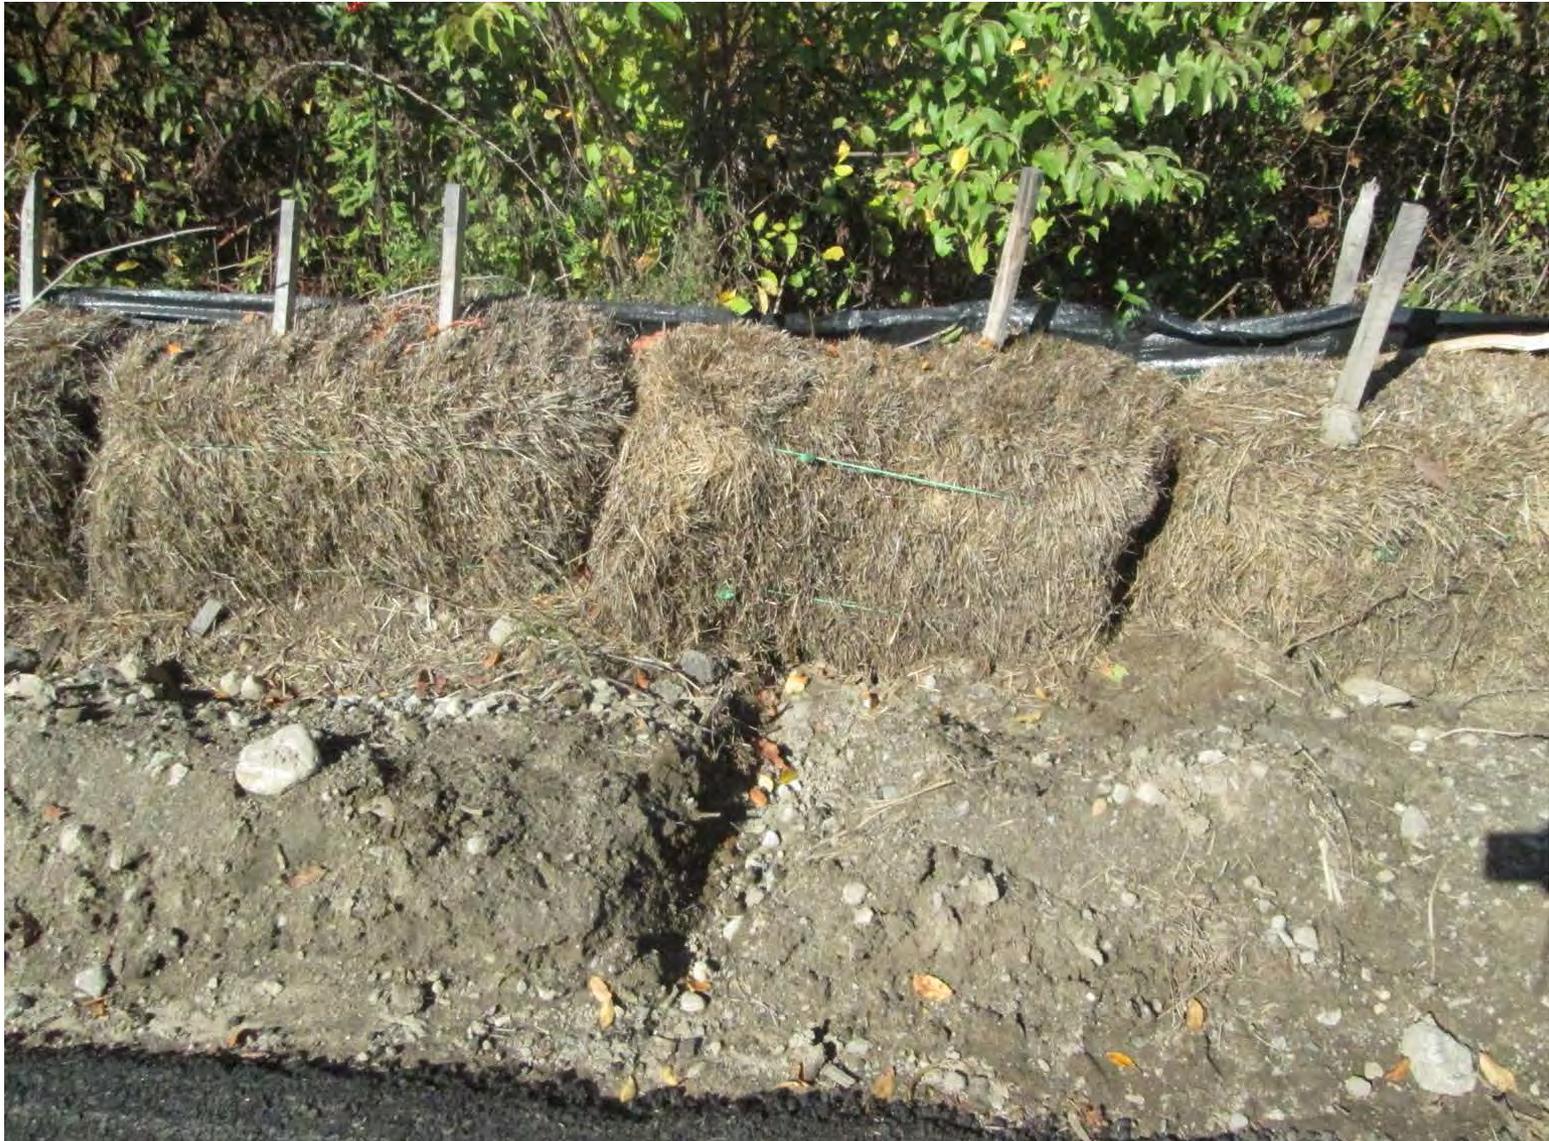
Trench goes under silt fence, silt fence was un-toed in this area. Trench continues to top of slope. No sediment was noted at this time within wetland. 10/9. This area was subsequently repaired as noted in separate WS report.

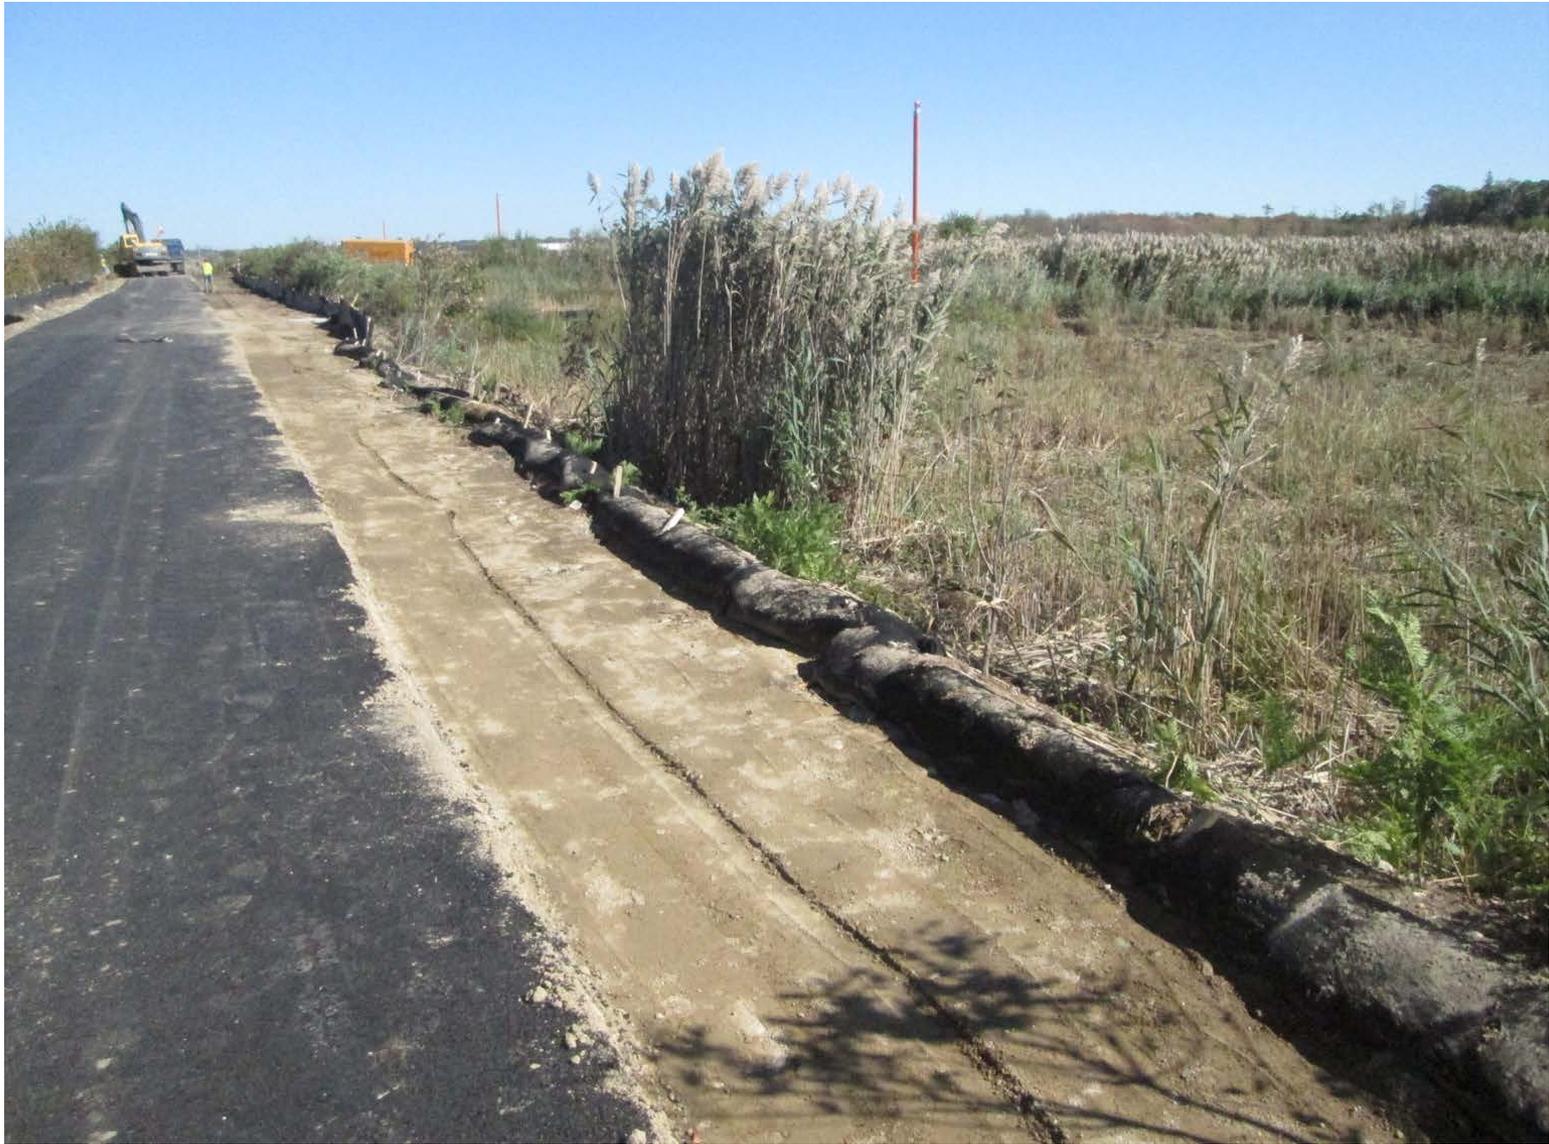
View of dense grade stabilization along ILS road.

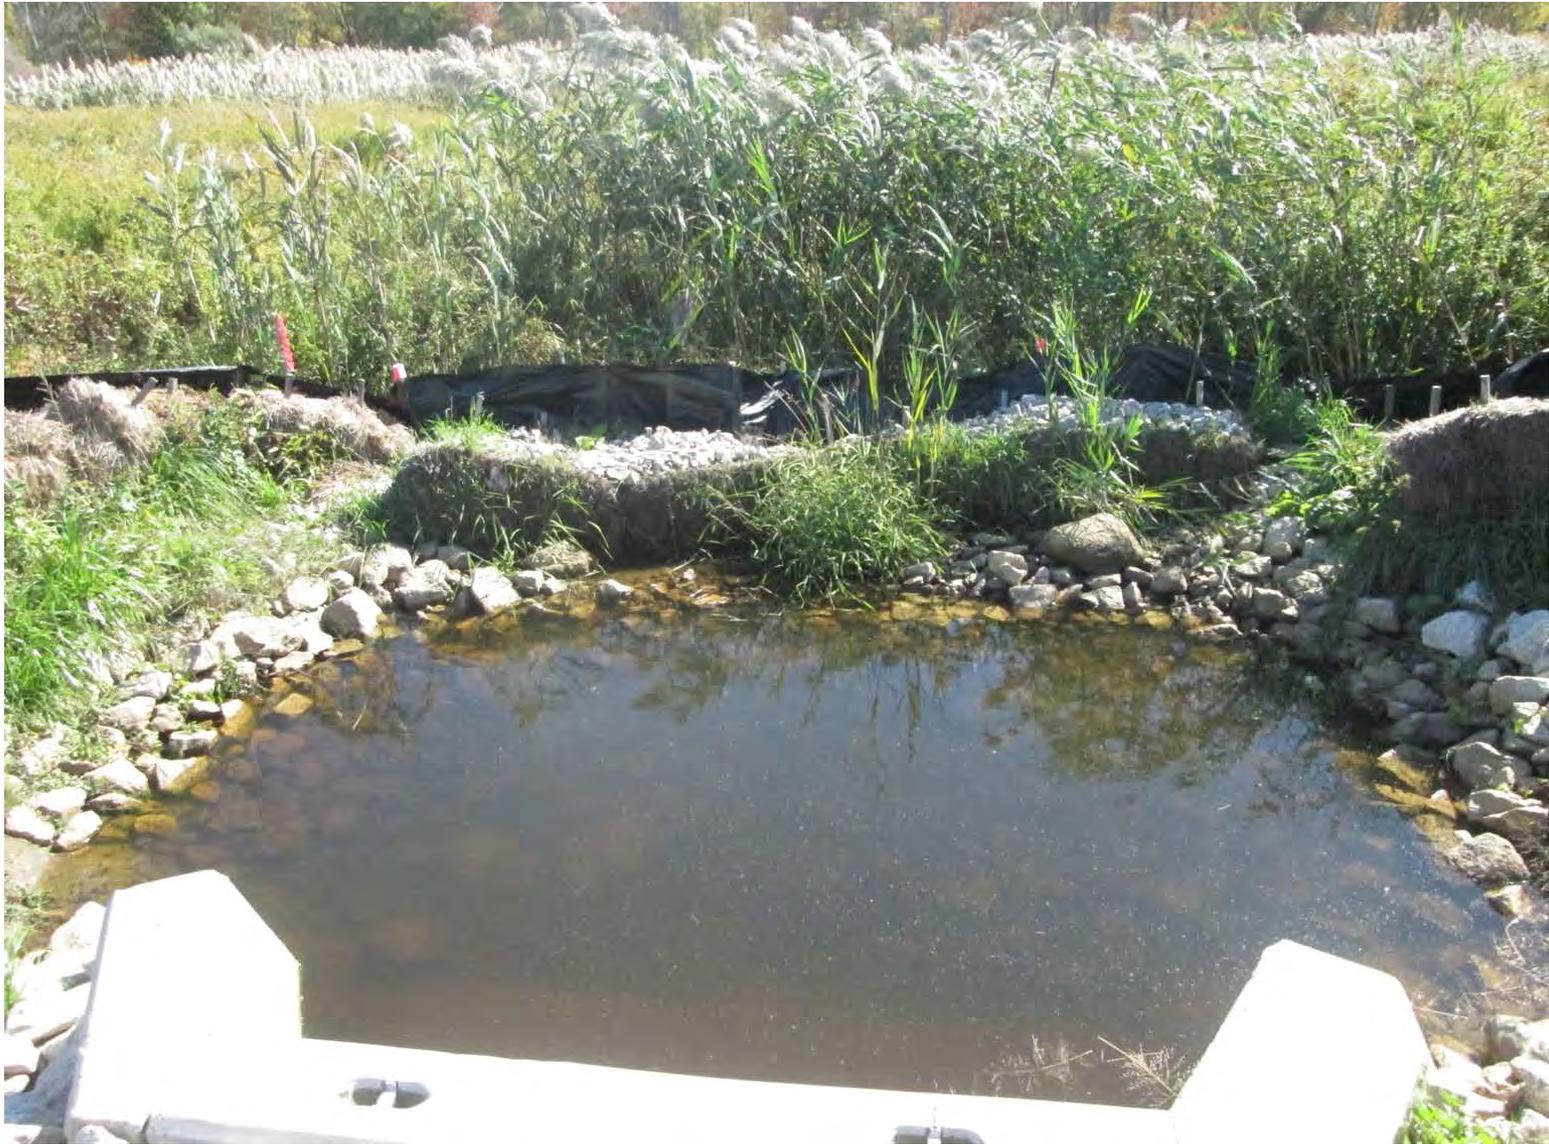
View of catch basin 11 headwall. 10/9.

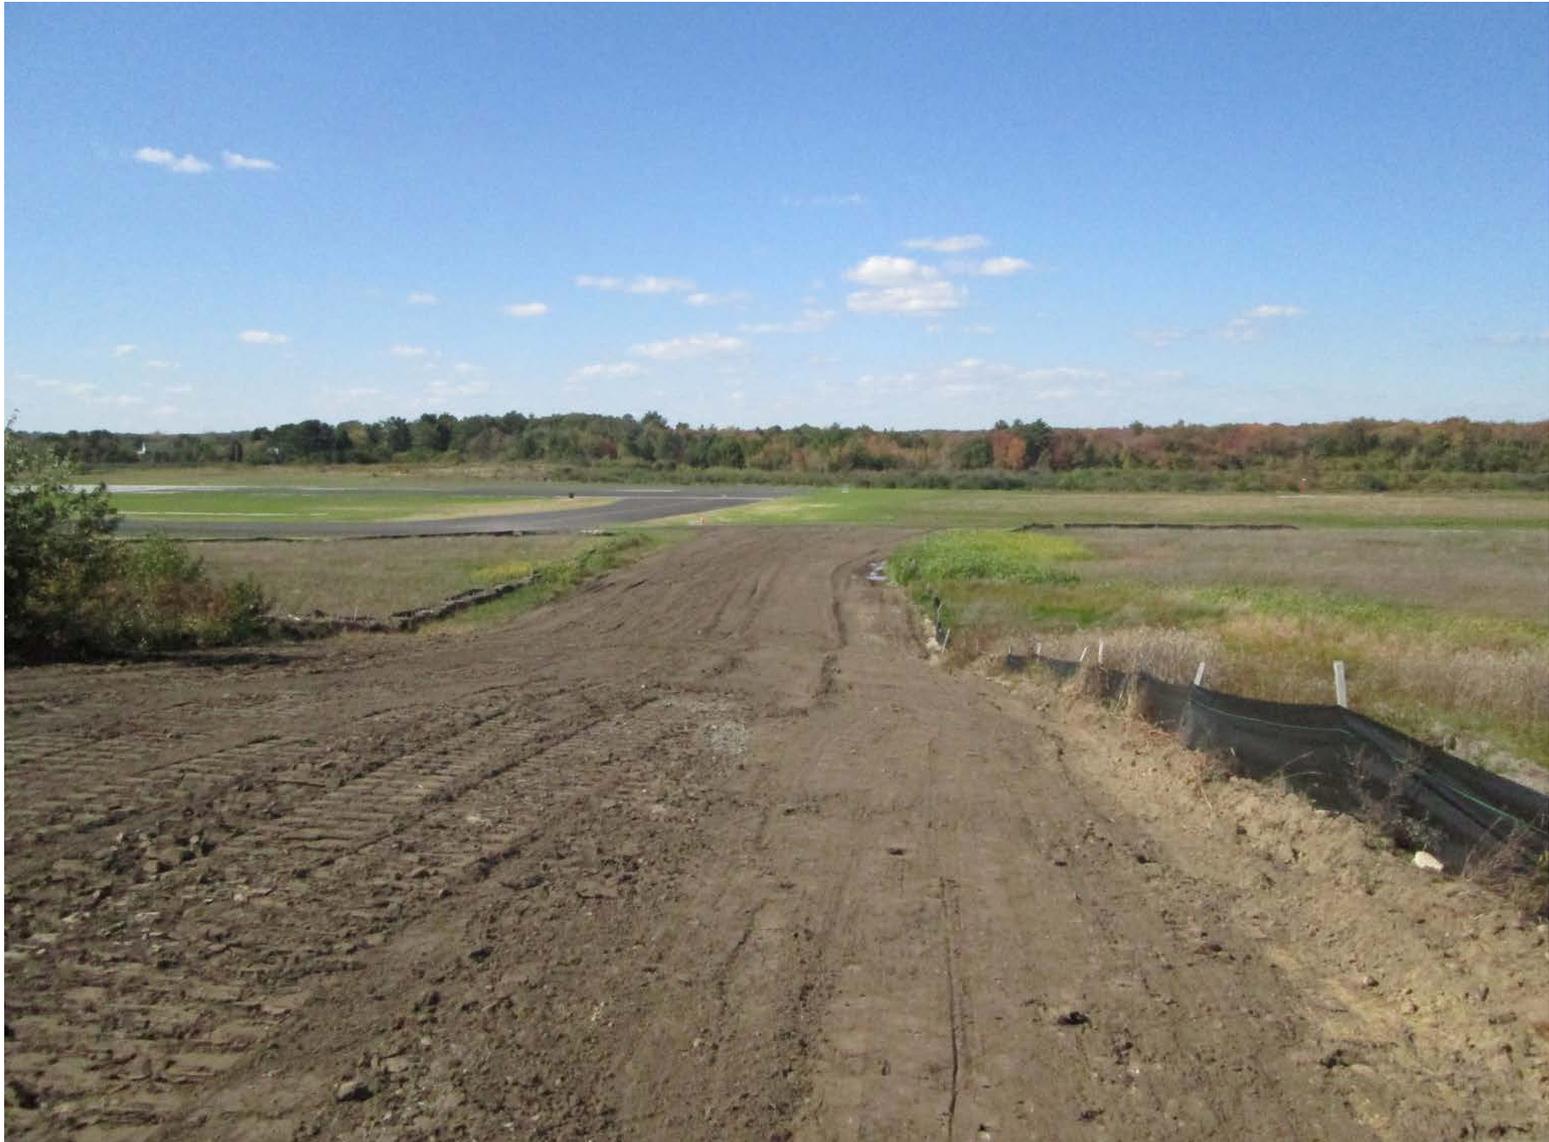
View of reclaimed temporary road on RW 23 end. Hydroseeding will take place tomorrow. 10/9.

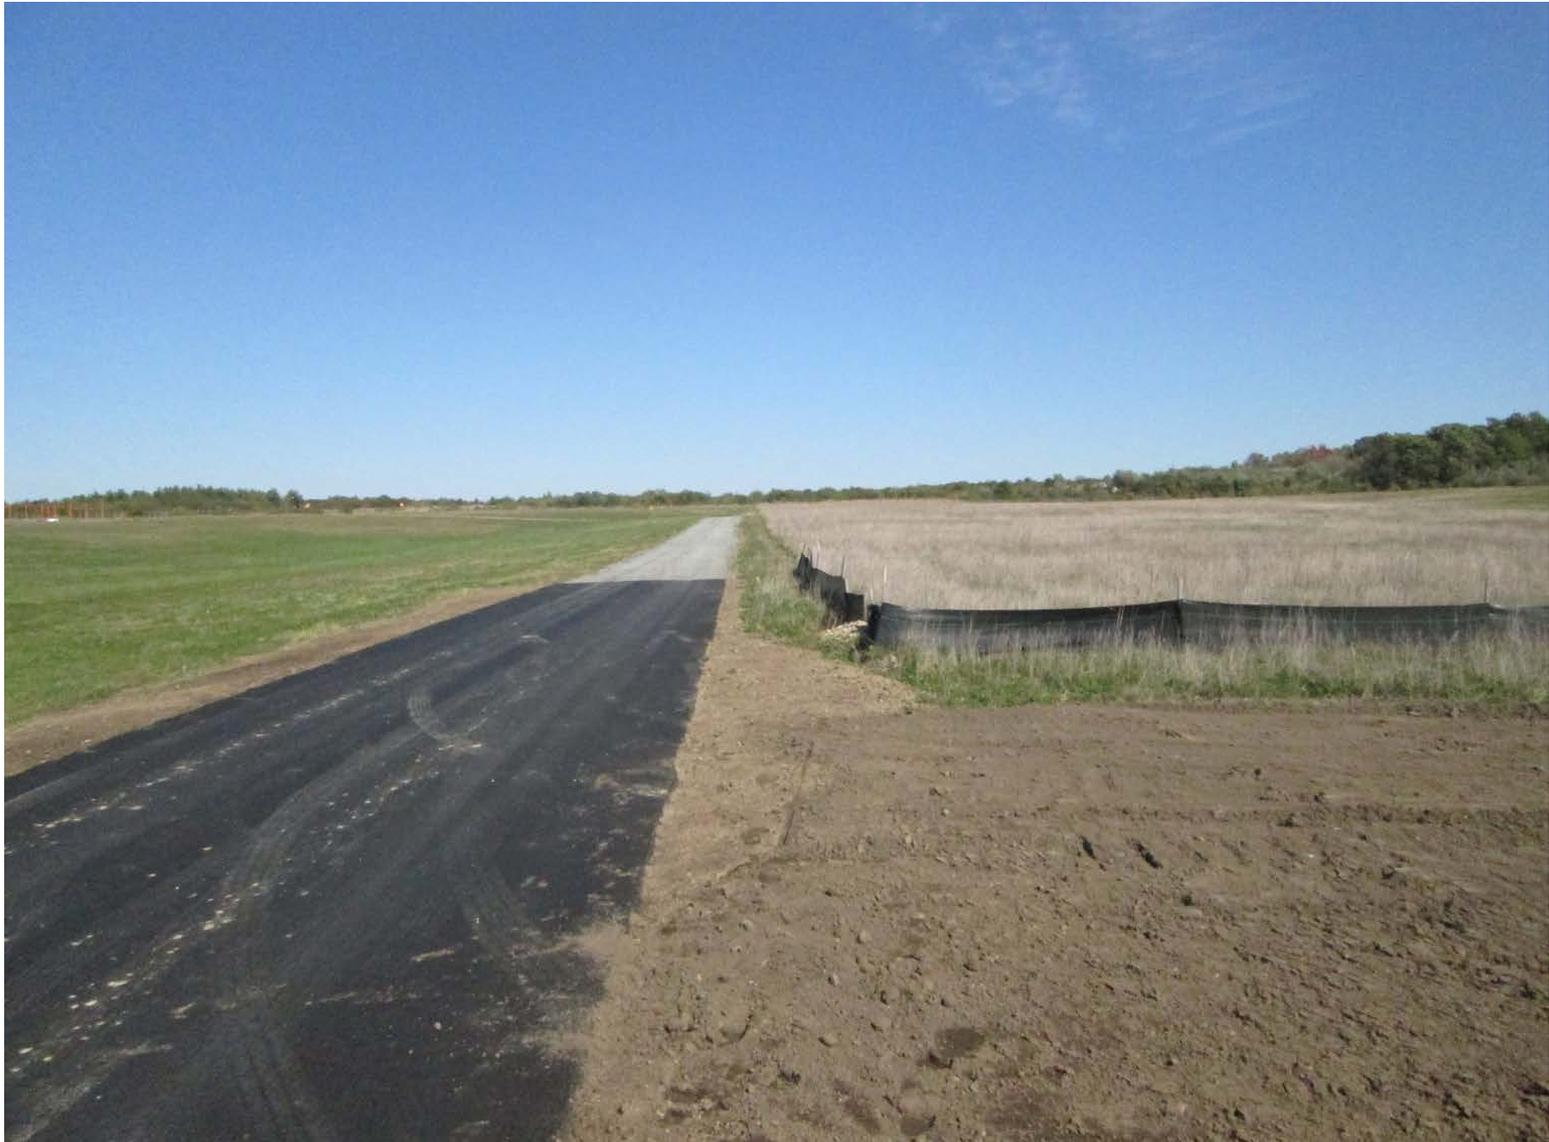
View of paved TX A stem and removed turtle barriers along RW 23 end. 10/9.

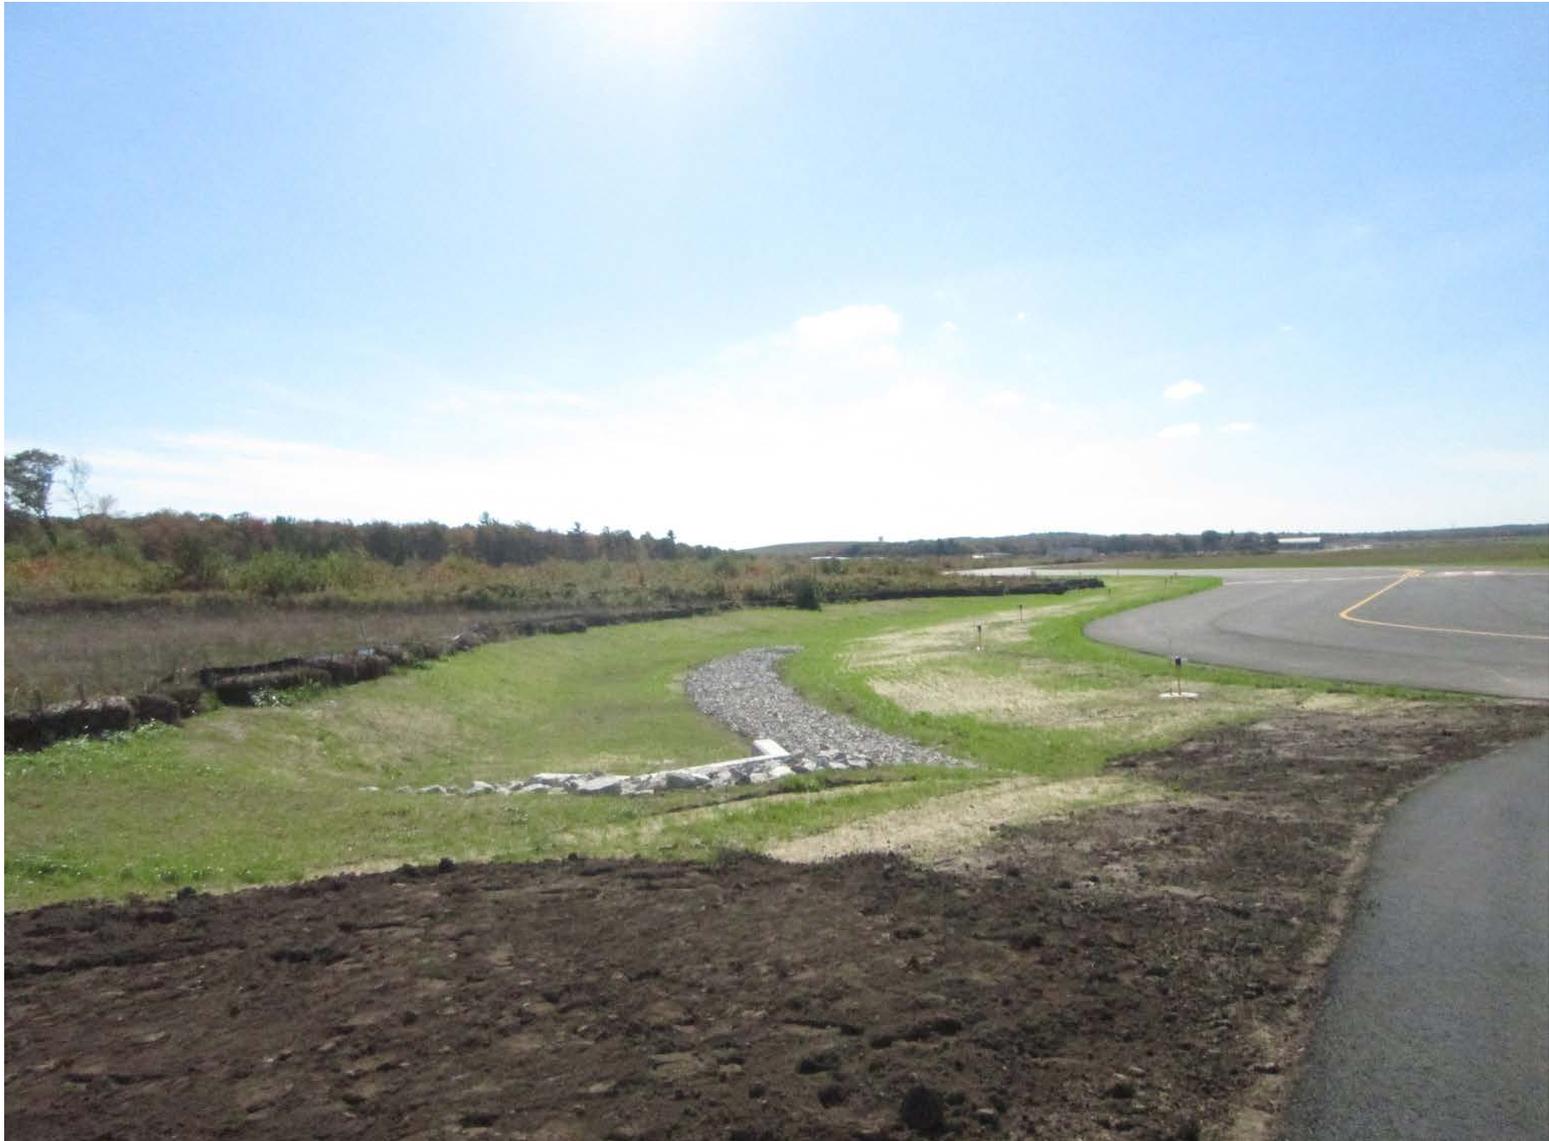
View of infiltration trench next to TX A at RW 23 end. 10/9.
