**New Bedford Regional Airport  
Runway Safety Improvements Project – Phase 4  
Reconstruct, Mark, and Groove Runway 5-23  
MassDEP File No. SE049-0635**

**ENVIRONMENTAL MONITOR INSPECTION FORM**

Date/ Time of Inspections: **9/25/14 (morning), 10/2/14 (morning), 10/9/14 and 10/15/14.**

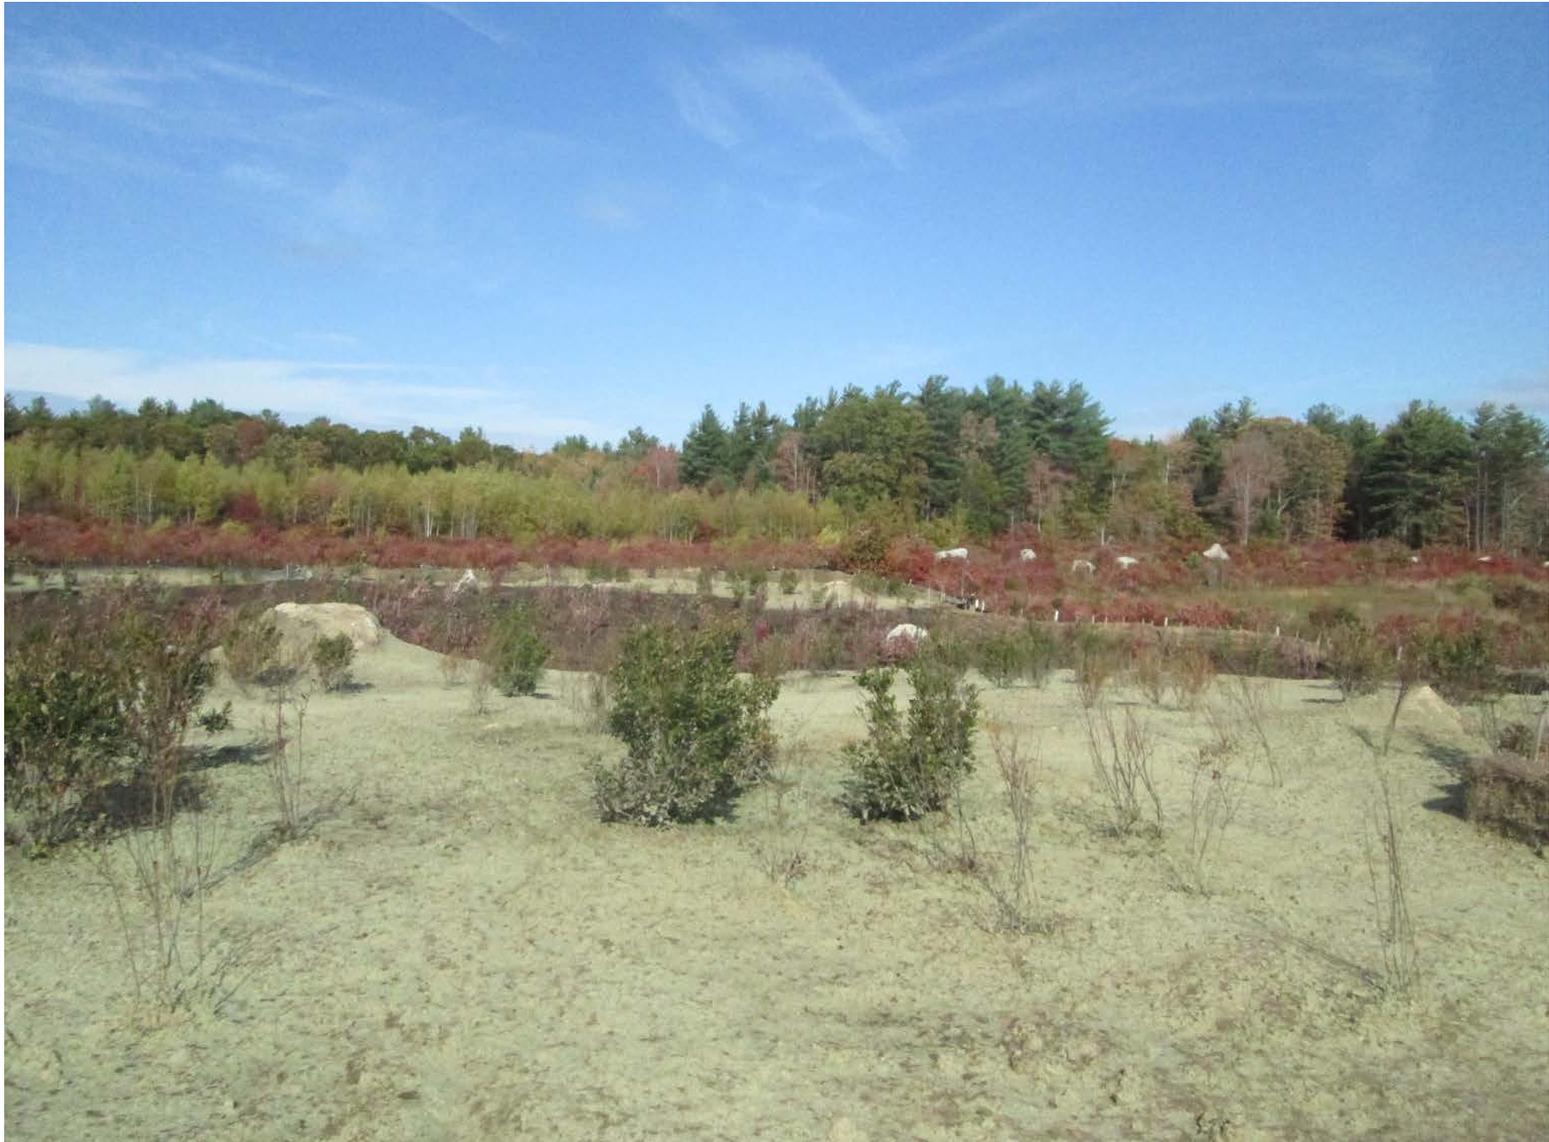
View of hydroseeded side slope adjacent to wetland replication area taken 10/15. This area will receive jute matting early next week.

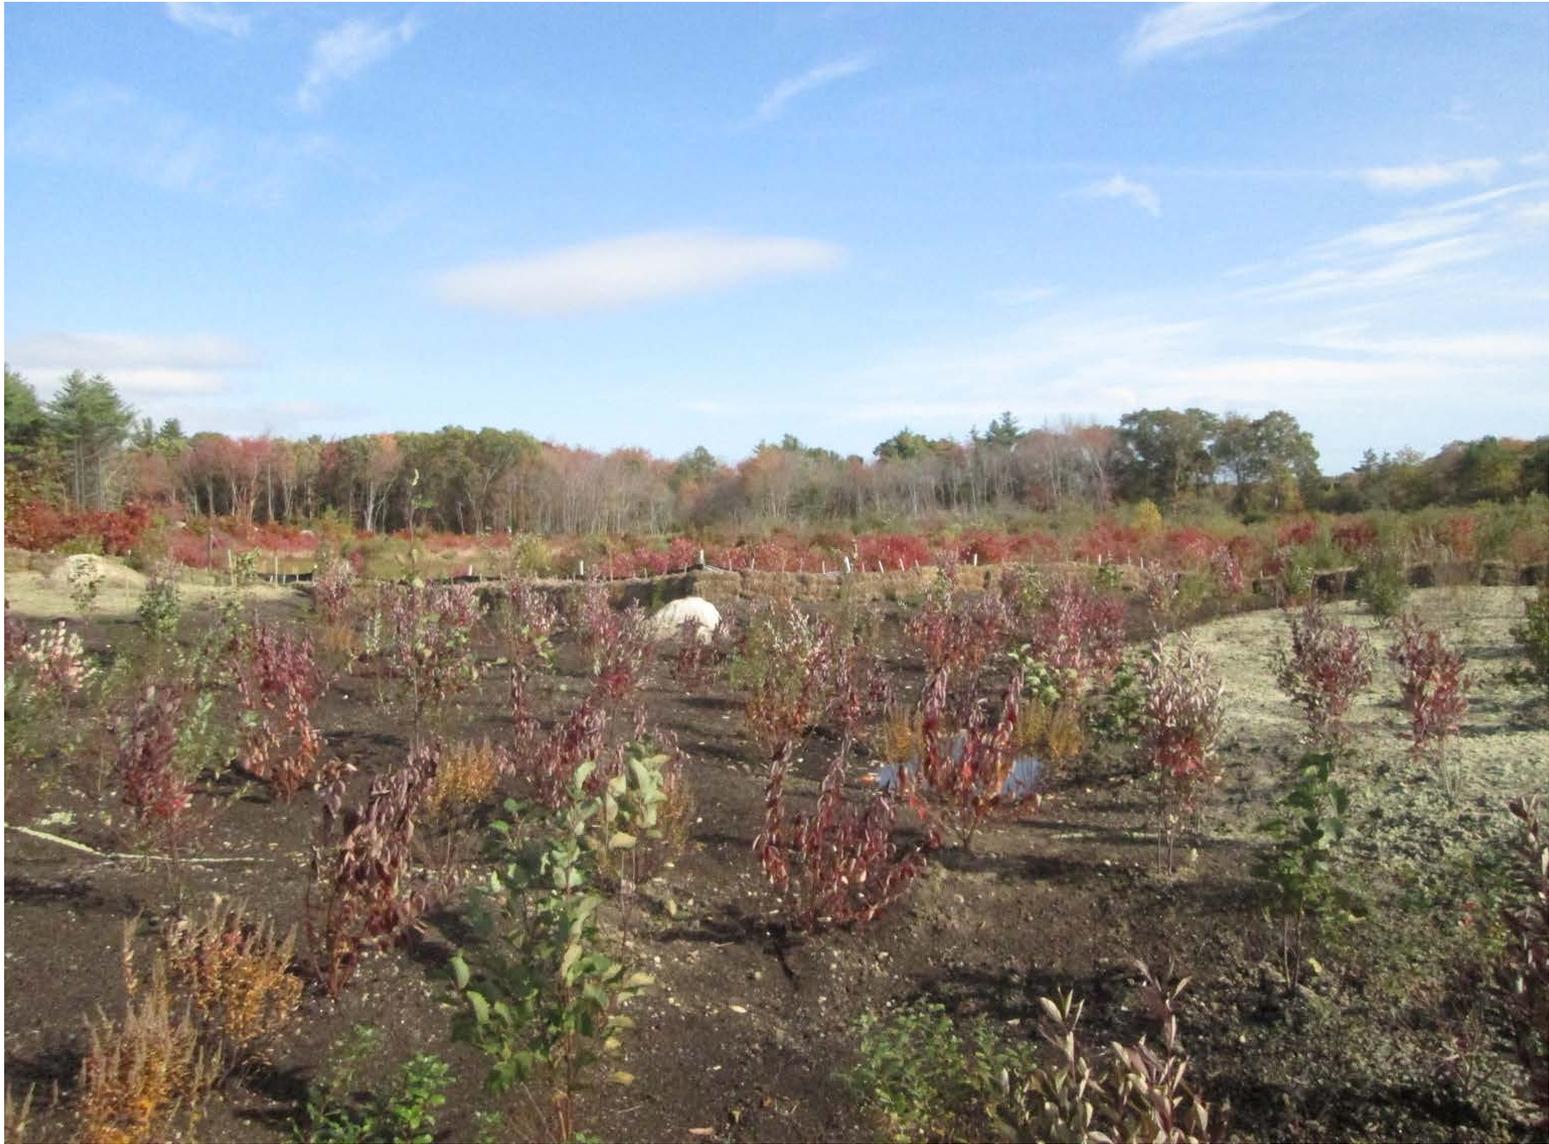
View of replication area. Seed was hand sown with the New England wet mix on 10/3. On 10/15 no evidence of sprouting yet.

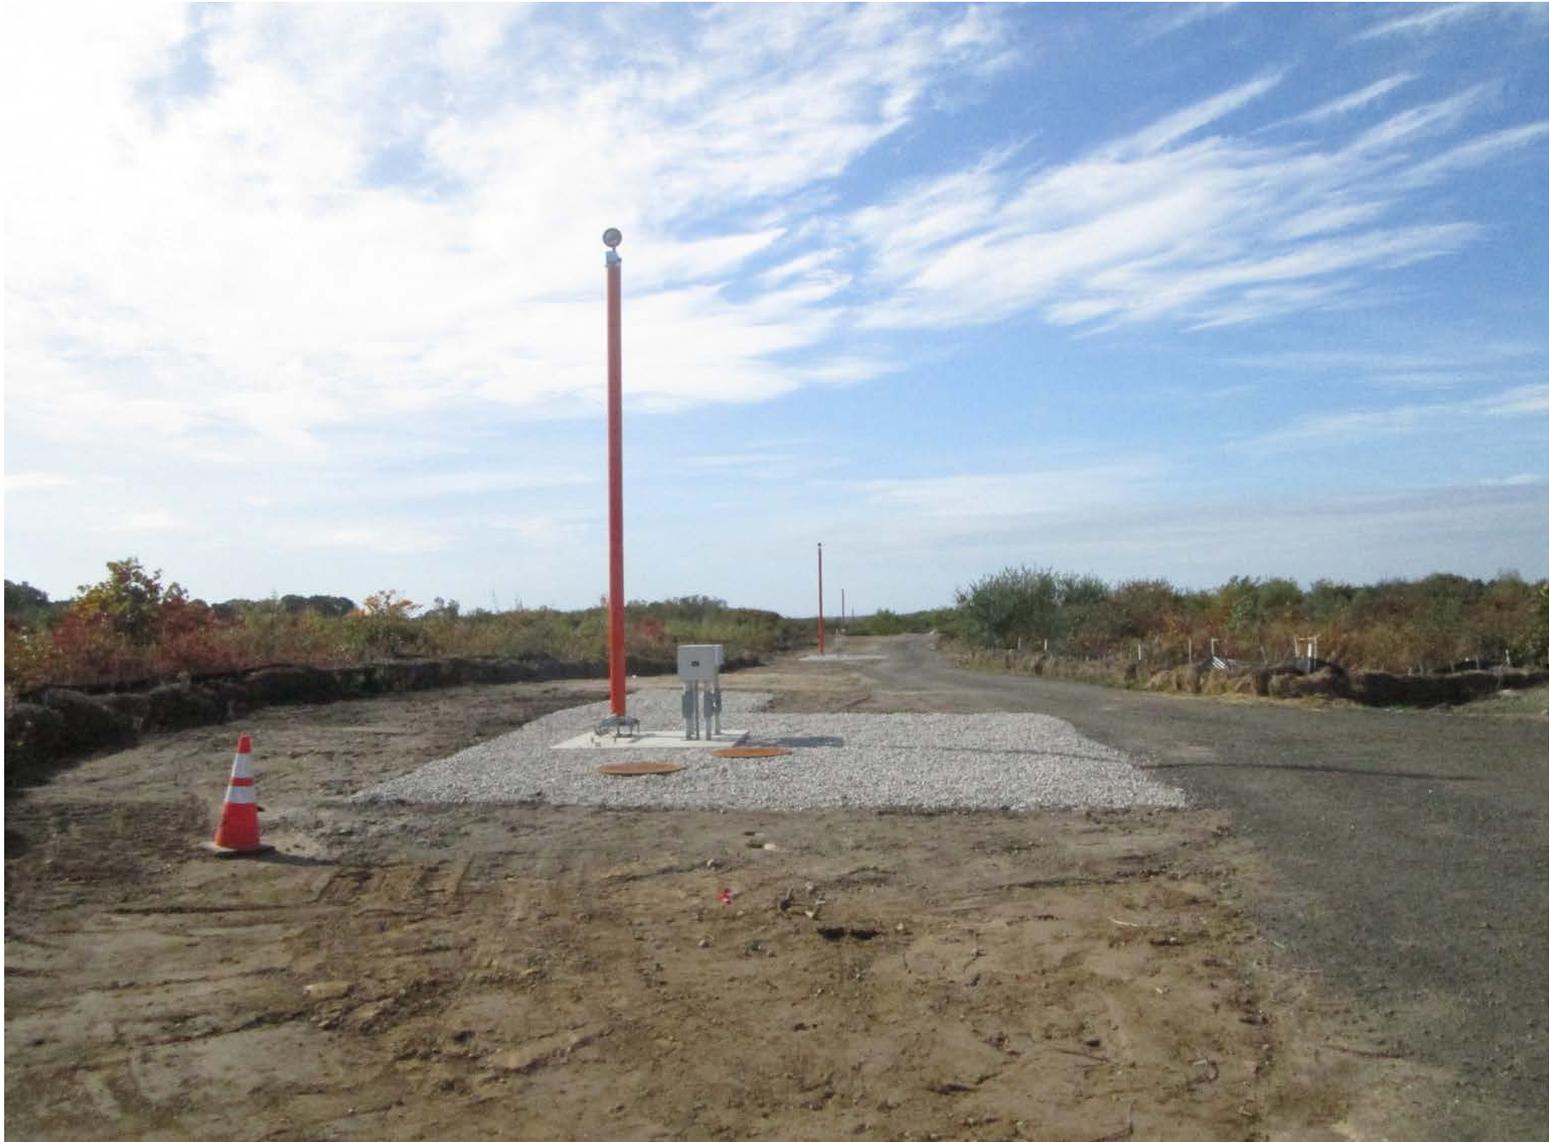
View of "Area 5" MALSR (23 end). Once work is completed we recommended that the contractor remove turtle barriers. Silt fence adjacent to wetland resources should stay in until ground is stabilized. (10/15)

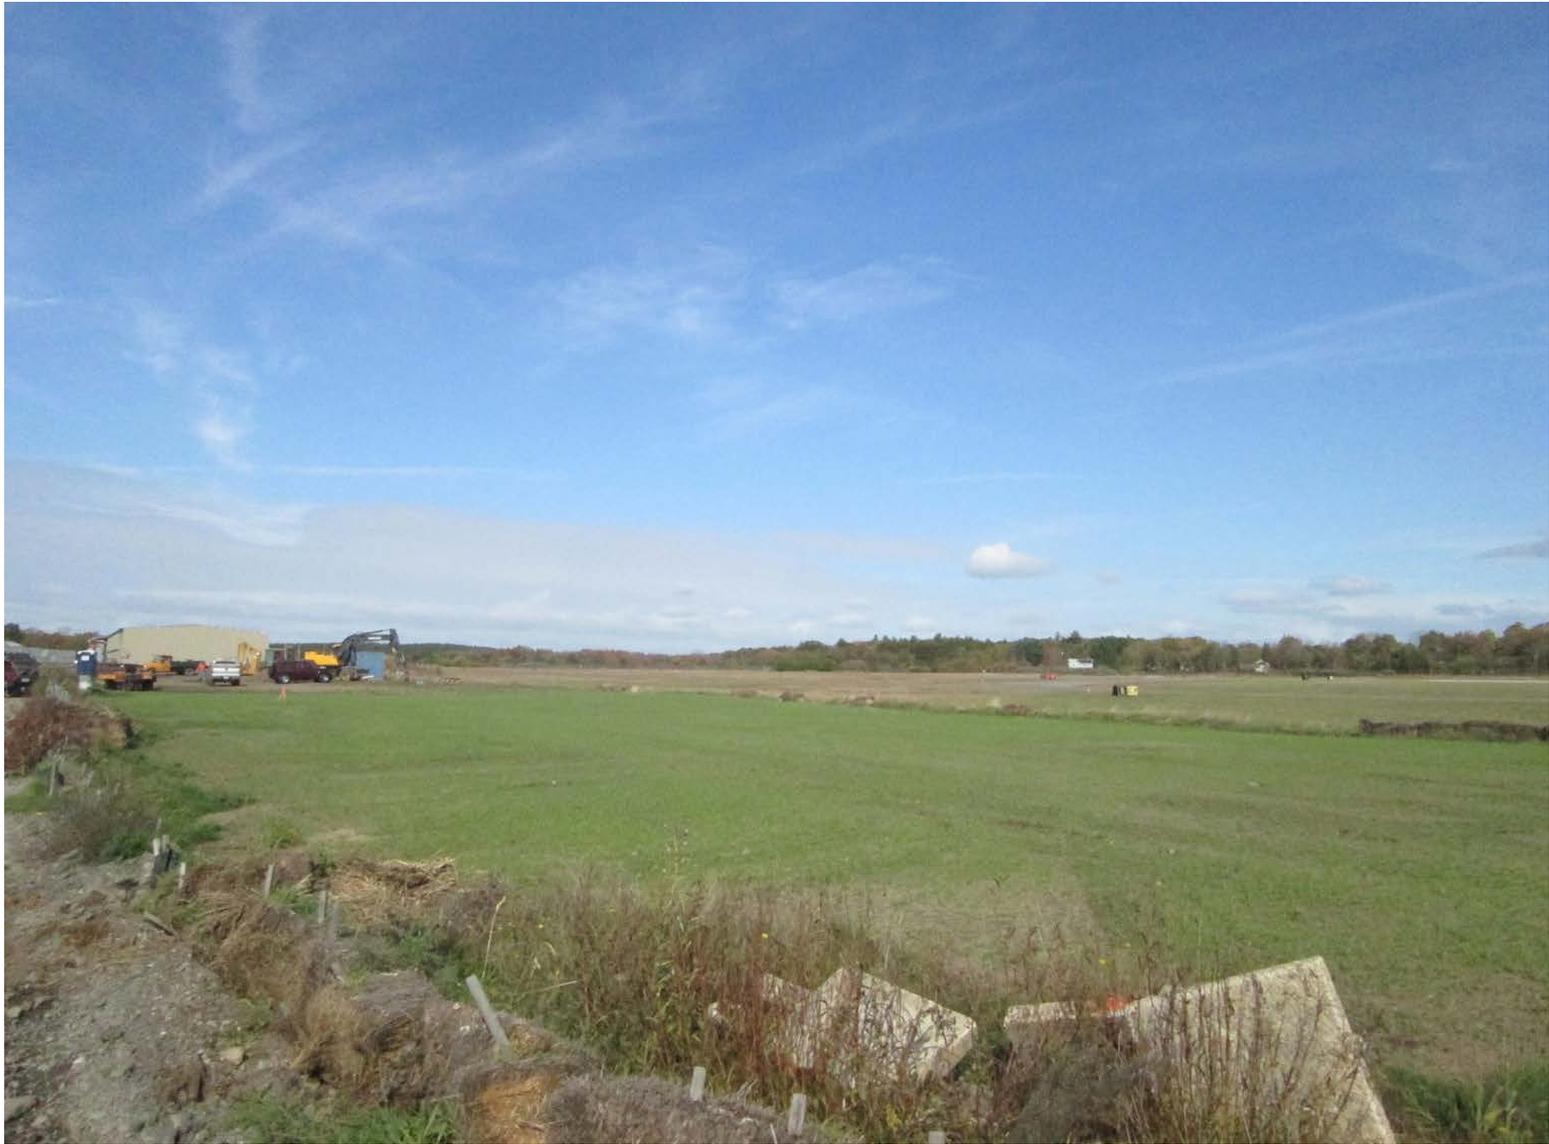
View of staging area hydroseeding. We recommended that silt fence within laydown area be removed while approximately 200 feet along outside silt fence remain in place until ground is stabilized and contractor removes all equipment.

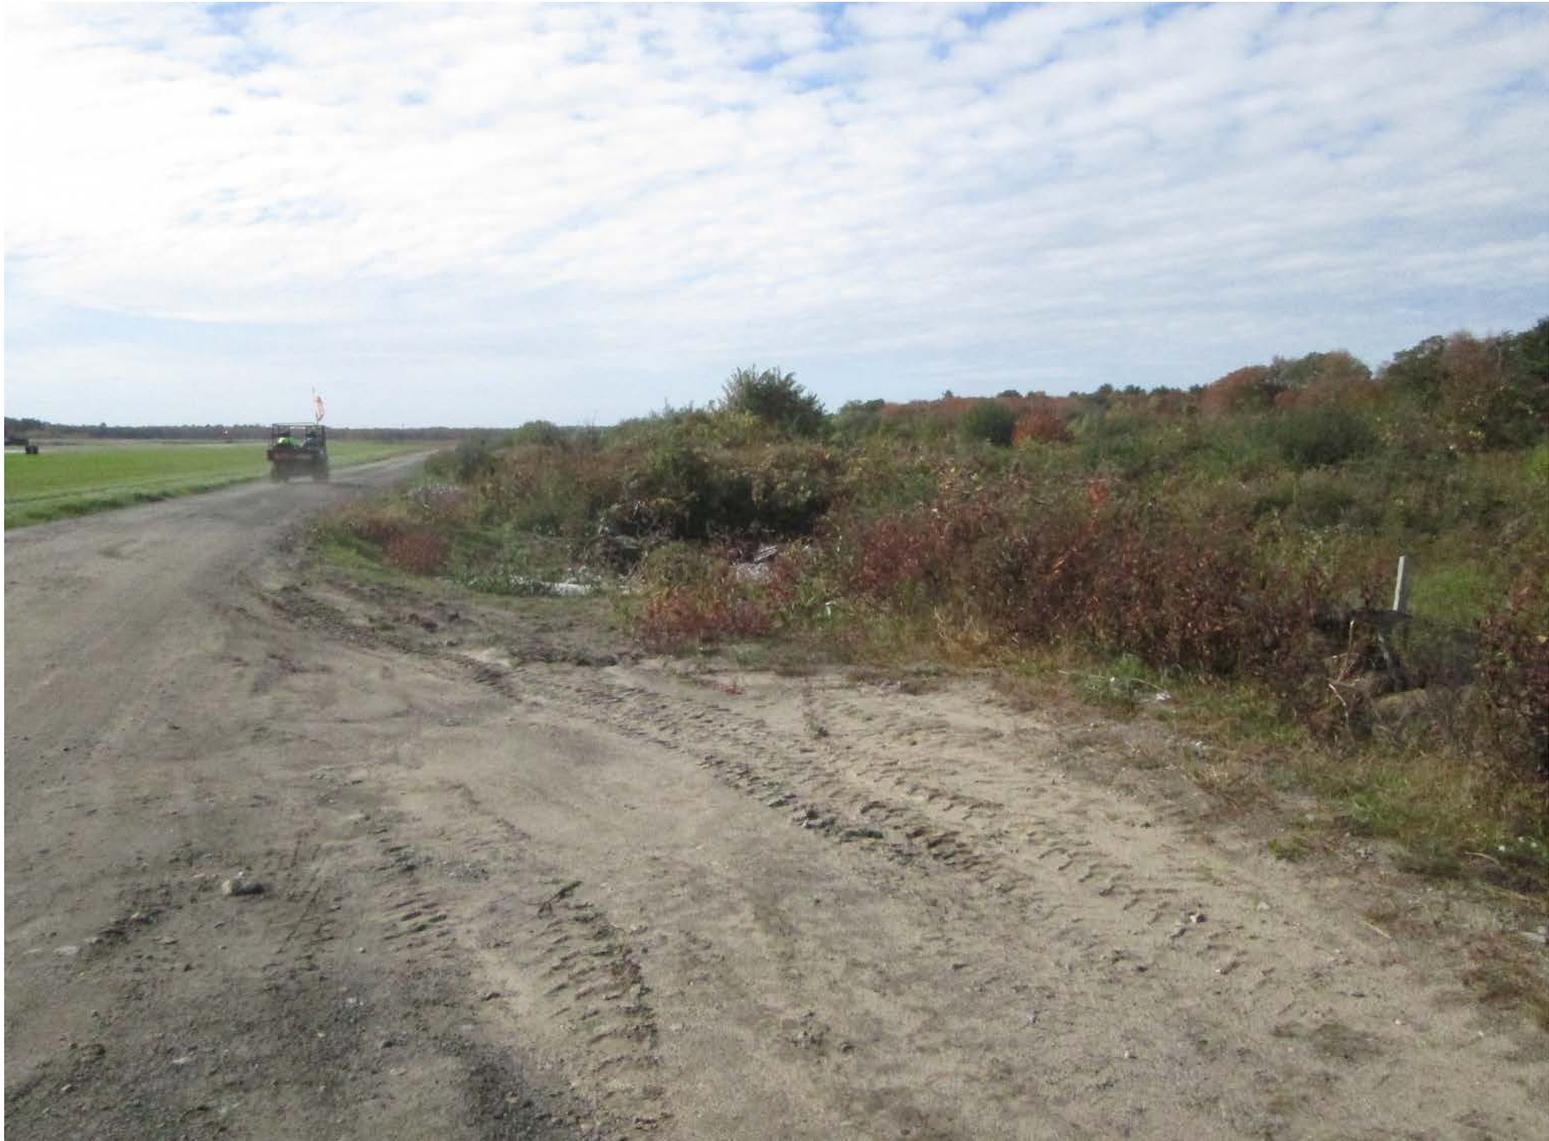
View of discrete area at intersection (up gradient headwall CB 3) that needs stabilization. We recommended silt fence remain in this discrete area until contractor addresses area (10/15)

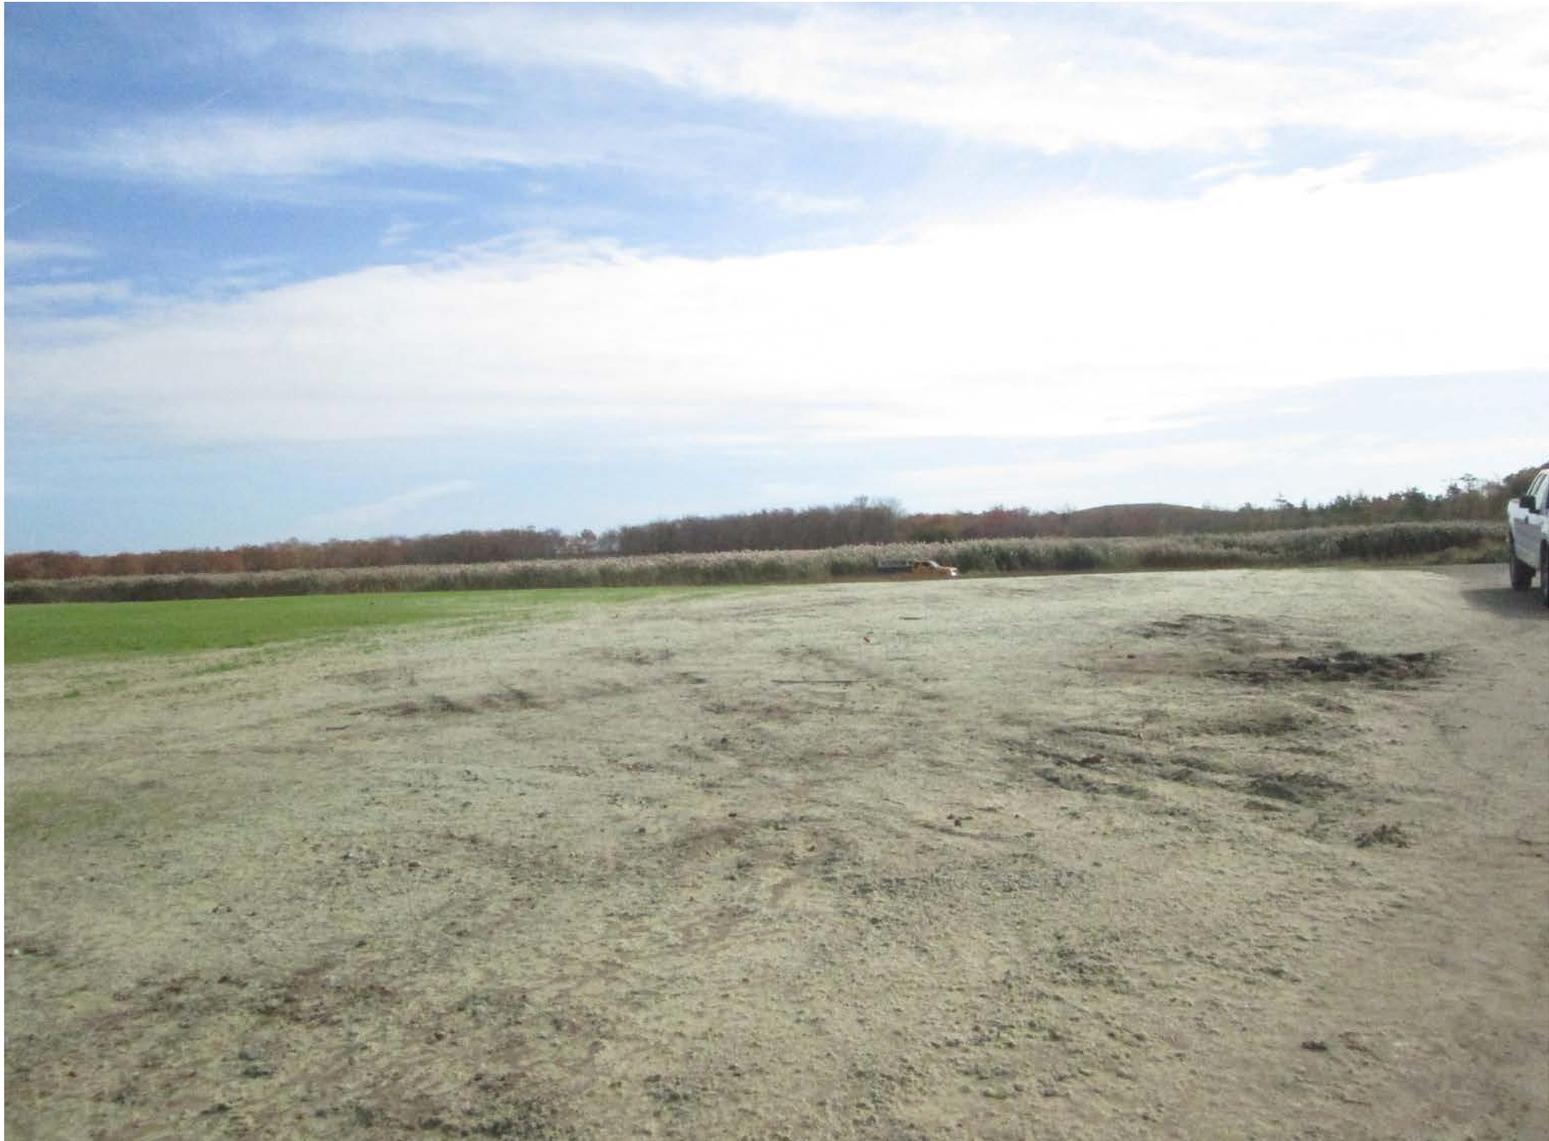
View of hydroseeded area at top of RW 5 RSA. This area was previously used for staging. Erosion controls around the top of the RSA should not be pulled until this area is stable. (10/15)

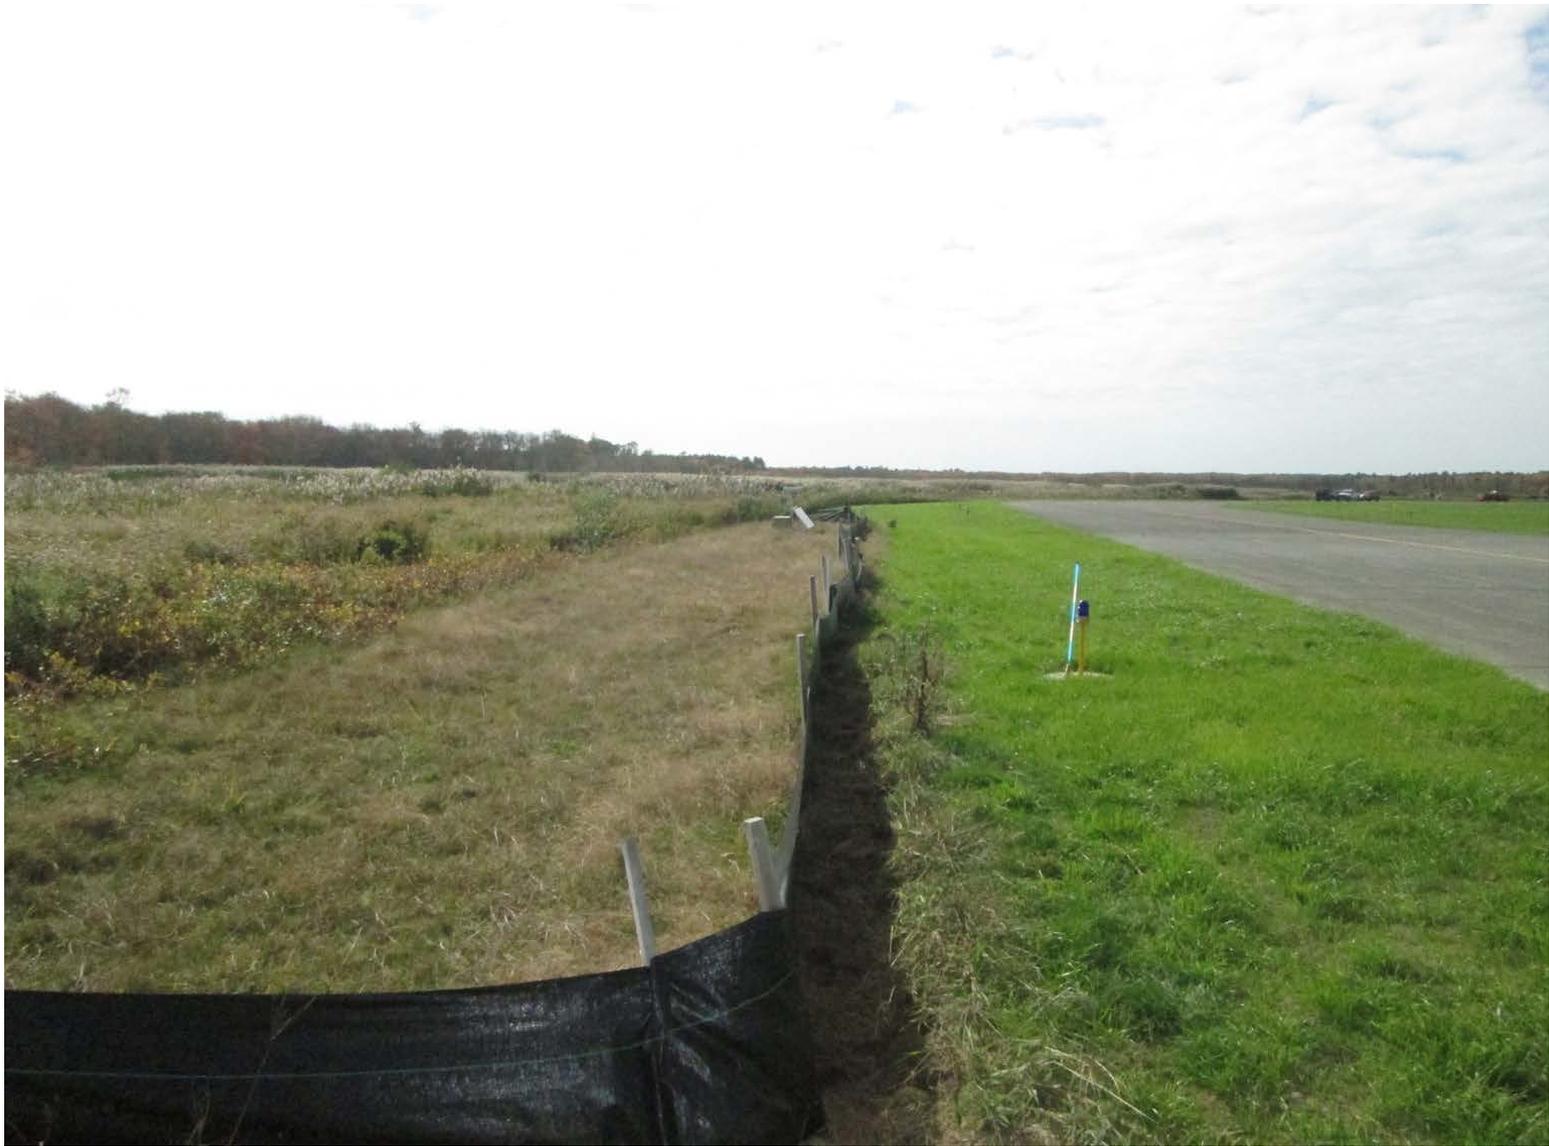
View of erosion controls currently left along Taxiway A, hay bales were removed and silt fence checked (10/15).

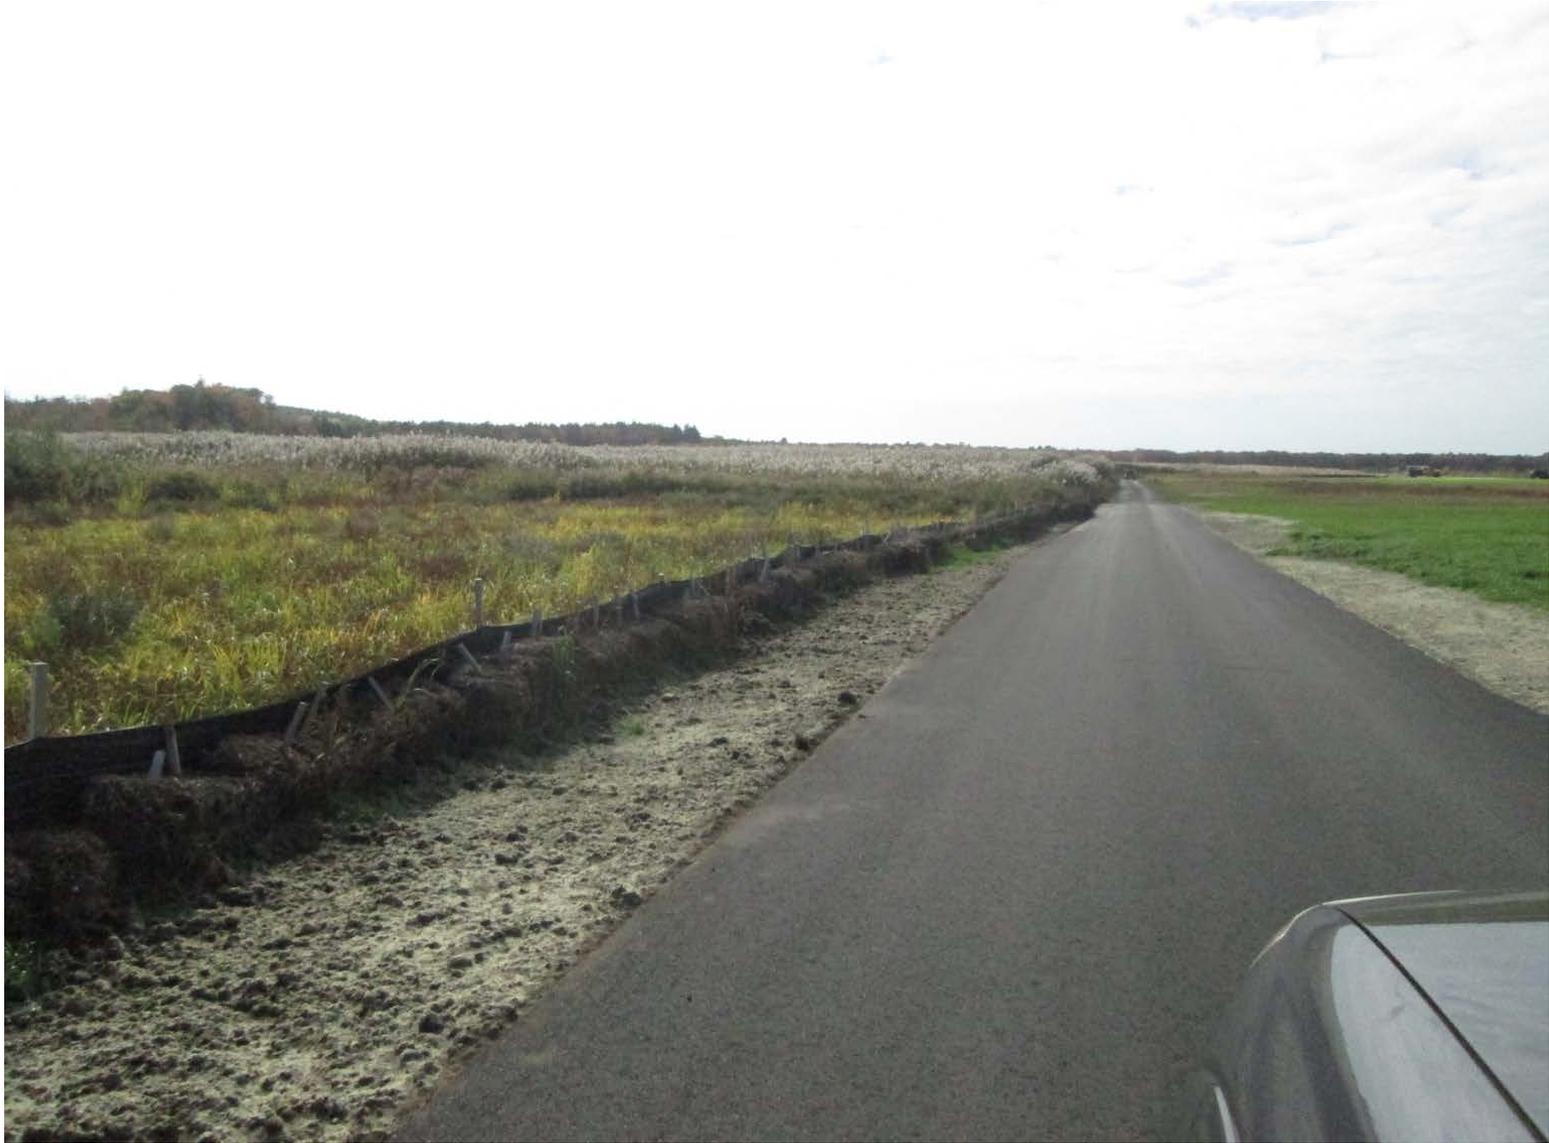
View along lower RW 5 RSA. Erosion controls will remain until stable (10/15).

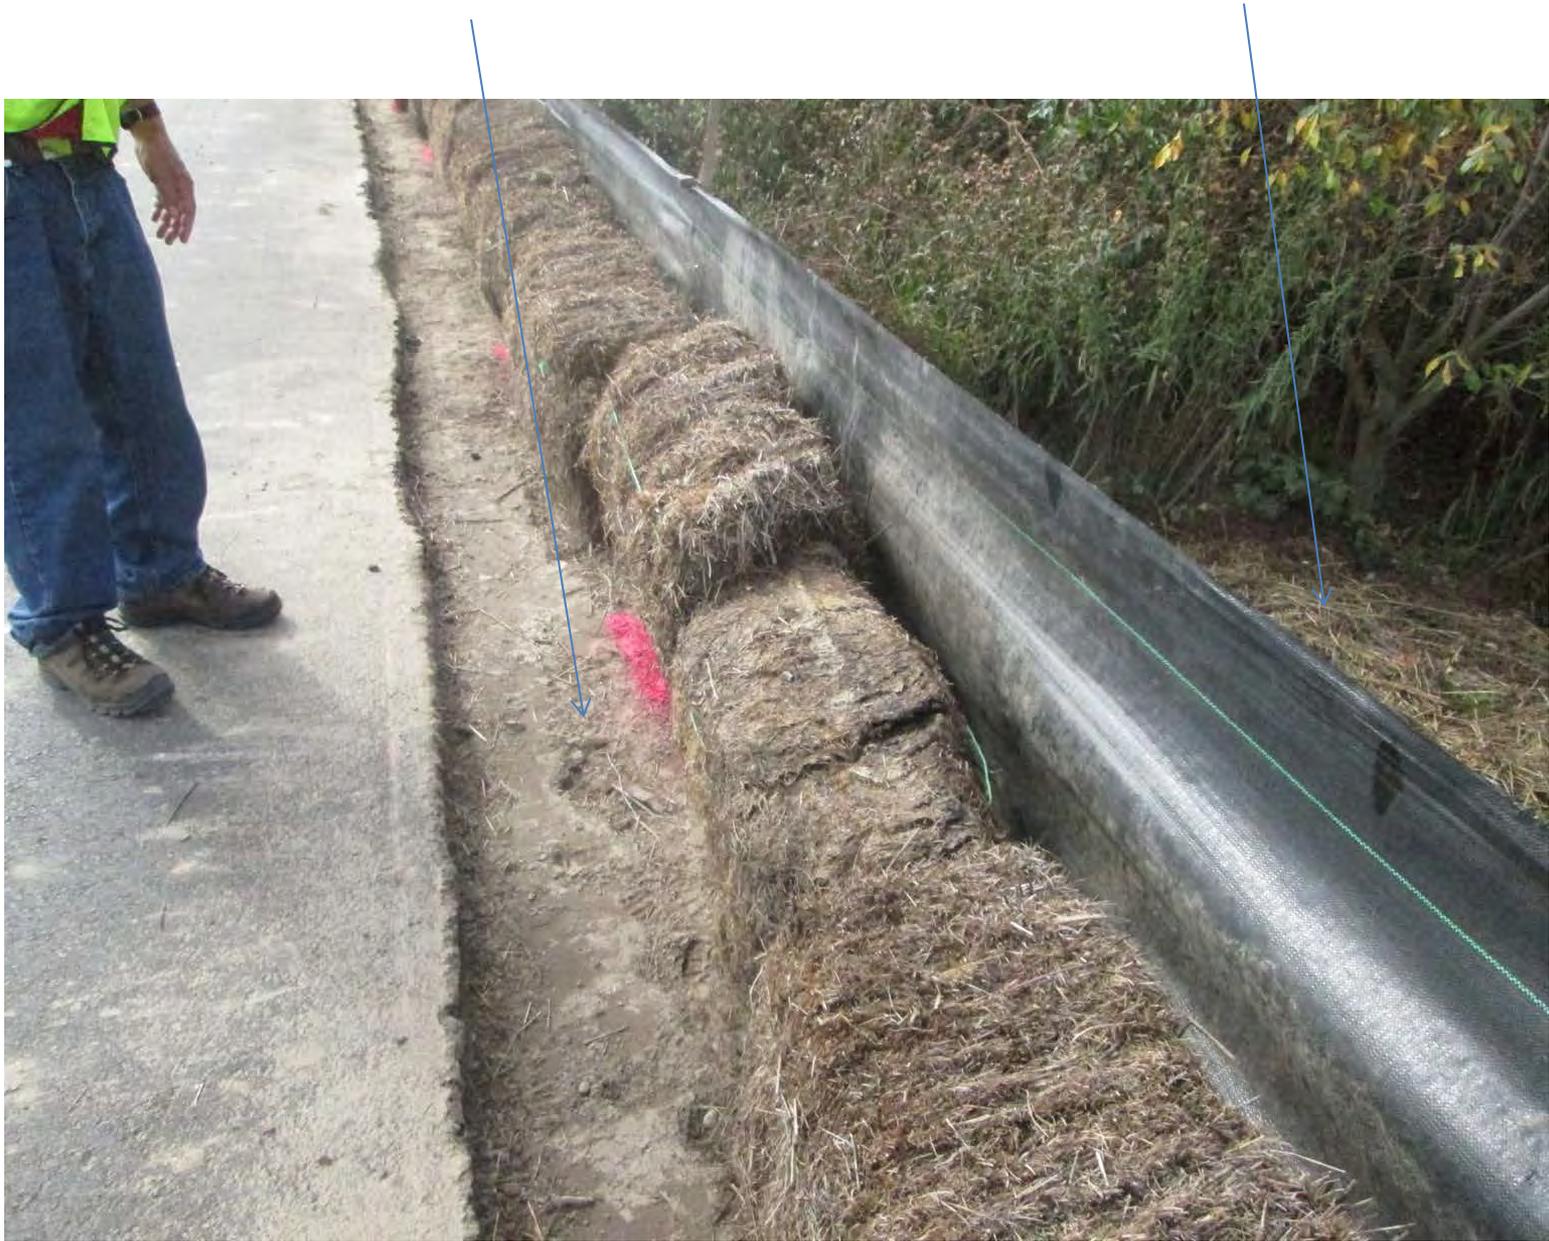
View of fixed trench (example) along ILS road. The trench was fixed on both sides of the silt fence, stabilized with hay, and the silt fence was retoed (10/15).

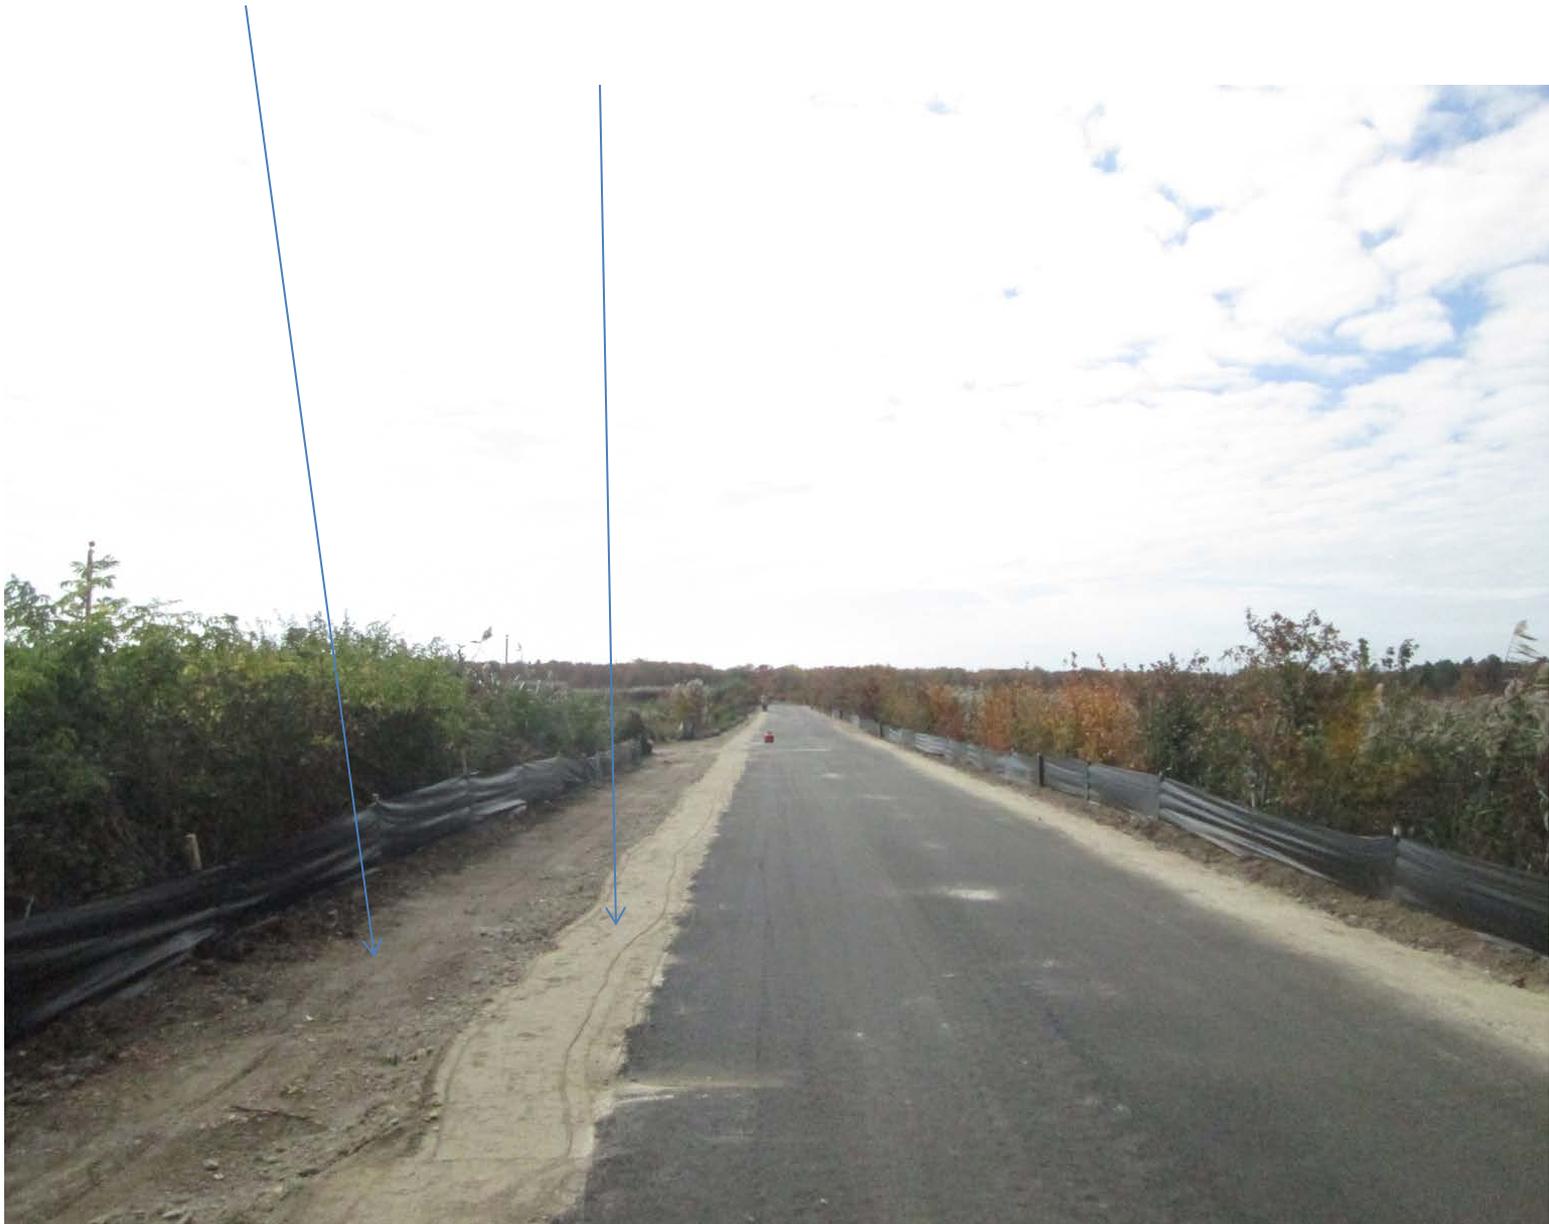
View of 2-feet of packed gravel adjacent to paved ILS road. The other area will be stabilized with loam and seed. The gravel boarder will remain in place (10/15).

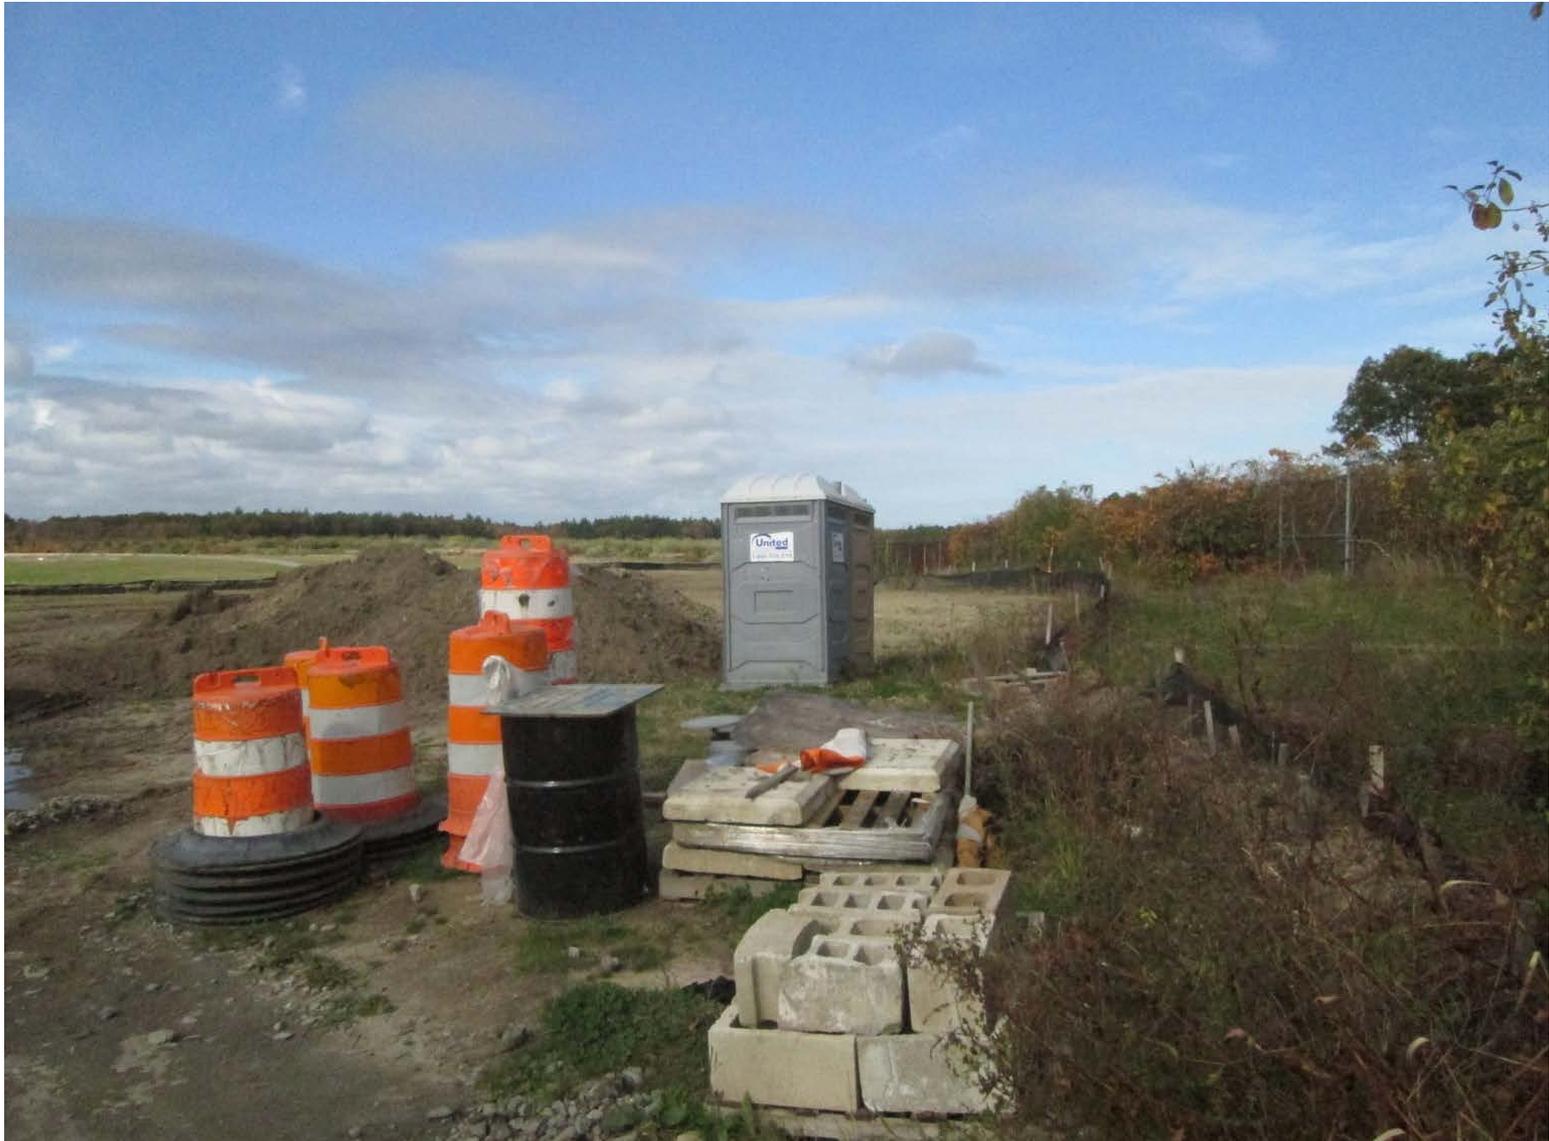
View of hydroseeded staging area along RW 23 end (10/15). Side slope (where temporary road was installed) was hydroseeded and will receive jute matting to further stabilize the area 10/15.
