NEW BEDFORD REGIONAL AIRPORT
RUNWAY 5-23 – PHASE 4

Reconstruct, Mark, and Groove

Weekly Environmental Report

WEEK 24

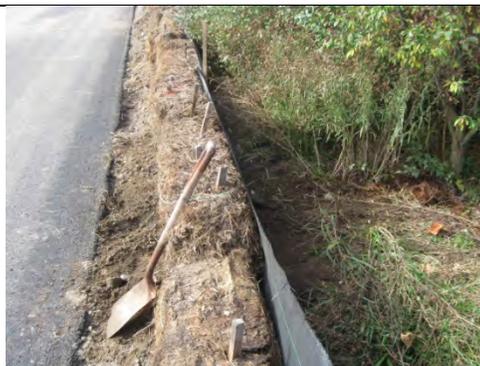
ILS Road; RW 5 End: The existing hand shovel trench was filled in on both sides of the hay bale/silt fence bmp.

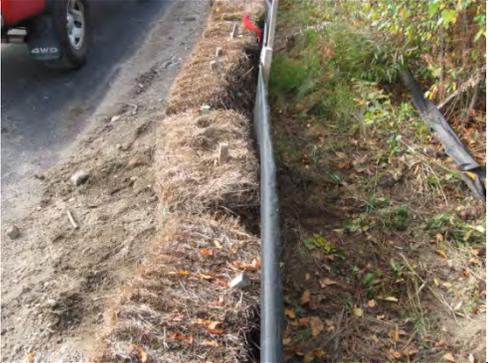
<p>ILS Road; RW5 End: A second hand shovel trench was filled in.</p>

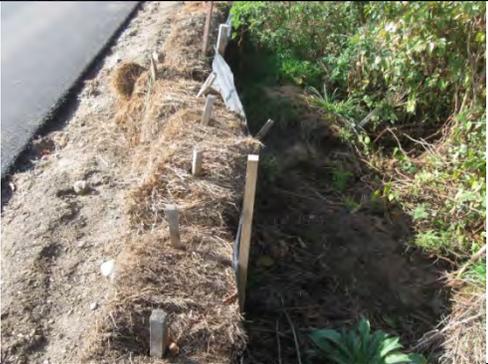
<p>ILS Road; RW5 End: A third hand shovel trench was filled in.</p>

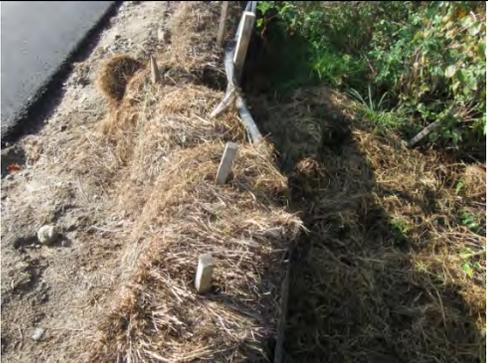
<p>ILS Road; RW5 End: All of the shovel trenches on the back side of the silt fence (i.e., the previous three photos) were mulched with hay to cover any exposed soils.</p>

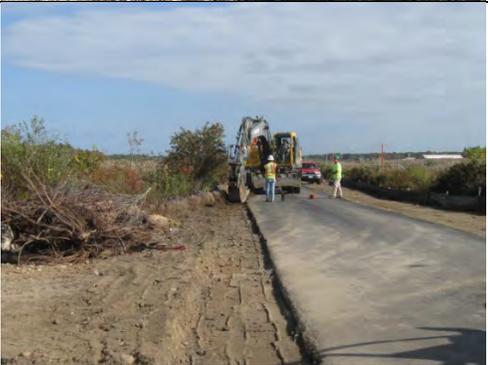
<p>ILS Road; RW5 End: The three or so remaining shovel trenches were smoothed as excess fill material was removed between the pavement and existing silt fence. An application of gravel will be placed here and tamped down.</p>

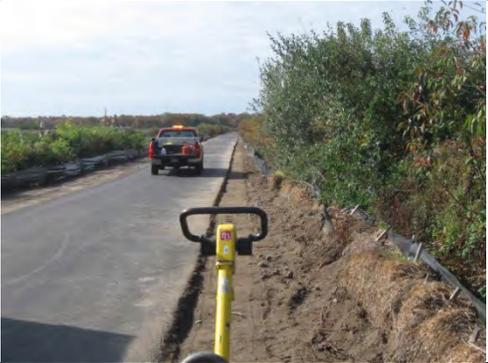
<p>ILS Road; RW5 End: This is another photo showing that all the shovel trenches have been smoothed/corrected as excess material at the edge of the pavement was removed. The gravel has just been tamped.</p>

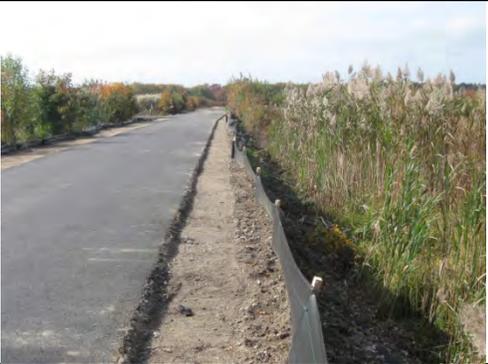
<p>ILS Road; RW5 End: Lastly, this is another photo showing that excess soils have been removed from the edge of the road in preparation of final stabilization activities.</p> <p>Moulison is also finalizing electrical work (pulling wires) along the ILS Road.</p>

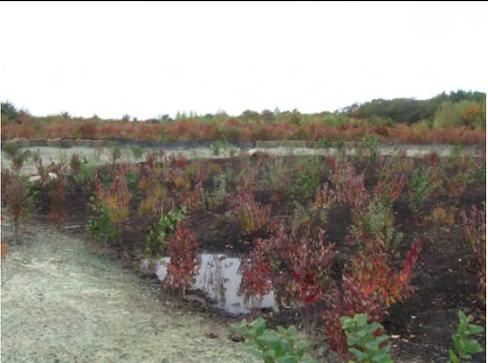
<p>Mitigation Area; off the Plainville Road: The lighter area at the perimeter of the pit and mound topography at the wetland was seeded by MONS. Note the hydrology at one of the inner pits. An inspection of the recently planted wetland shrubs revealed that the plants were growing well.</p>

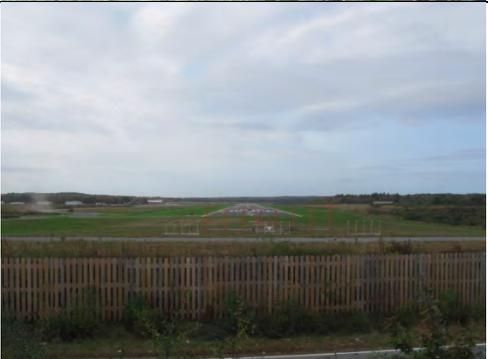
<p>RW 23: Today there was minimum construction activity on the RW 23 side. The recent rains have helped to green up the areas that were hydroseeded adjacent the runway.</p>

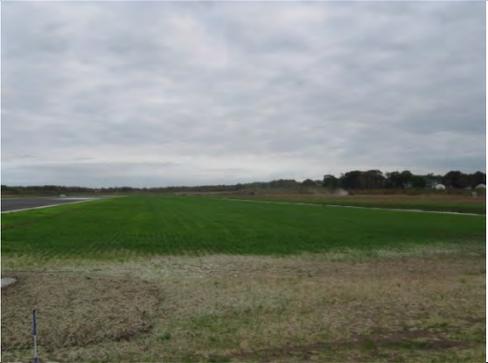
<p>RW 23: This photo shows a close-up of the grassed area between RW 23 and the Taxiway. The recent rains have helped to finally green up these areas. The area at the forefront has been recently hydroseeded.</p>

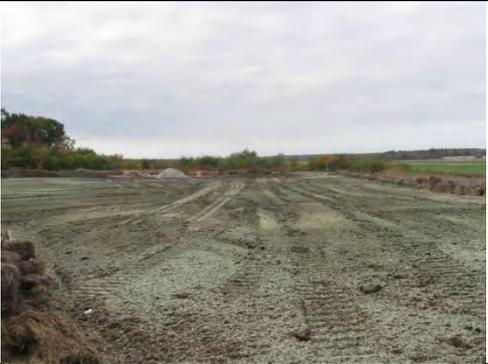
<p>RW 23; off Access Road; Previous Parking/Equipment Area; this area was recently hydroseeded.</p>

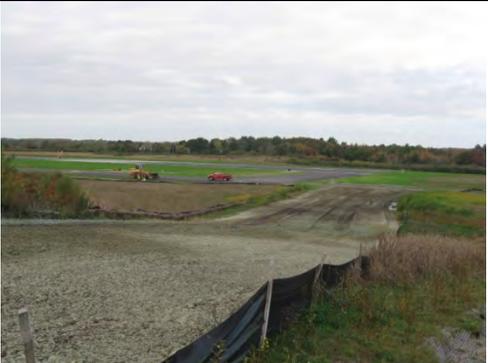
<p>Earlier Access Road to RW 23; this area was also hydroseeded.</p>

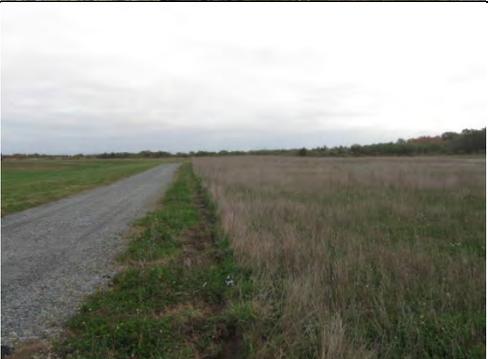
<p>RW 23 Side: Much of the perimeter of silt fence and hay bales on the RW 23 side have been dismantled. Hay bales alone have also been removed from much of the RW 5 Side.</p>

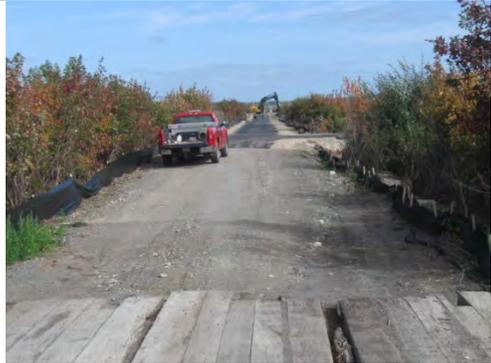
<p>RW 5; ILS Road: Work continues along the edge of the ILS Road with the application of a strip of gravel as part of the final stabilization activities.</p> <p>On the section between the bridge and recently installed pavement there appears to be no stabilization activities – edge of road stabilization efforts should be included here as well.</p>

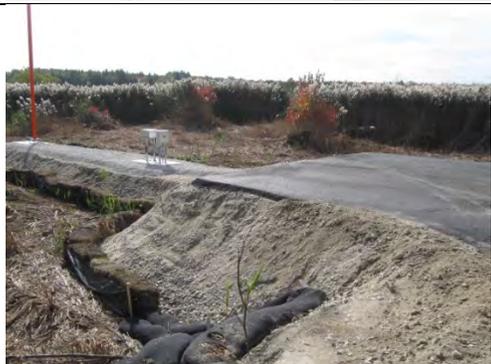
<p>RW 5; ILS Road; MALSR Graveled Pad: Steep slopes here still require loam, seed and blankets.</p>

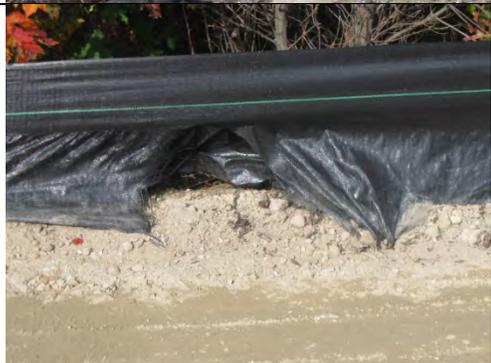
<p>RW 5; ILS Road; A late afternoon inspection revealed a breach in the silt fence along the edge of the ILS Road. This needs to be repaired.</p>

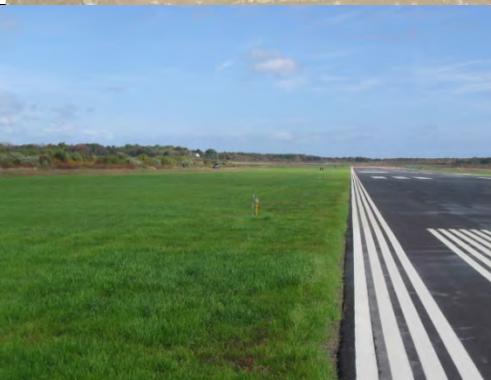
<p>RW 5; the Grassed Area between the RW and Access Road; Recent rains continue to accelerate the growth on the grass. Both the height and density of the grass have increased providing better stabilization.</p> <p>A 1pm meeting was held among all at the airport terminal. Final activities were discussed.</p>

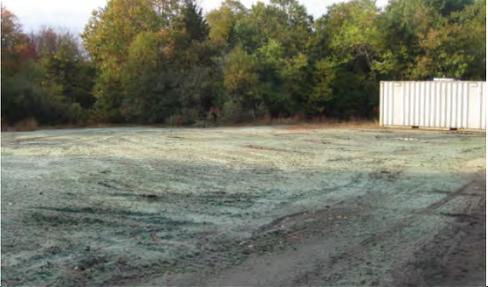
<p>RW 5 Side; Across from the Field Trailer: The stock pile of loam was removed and this area was hydroseeded and put to rest.</p>

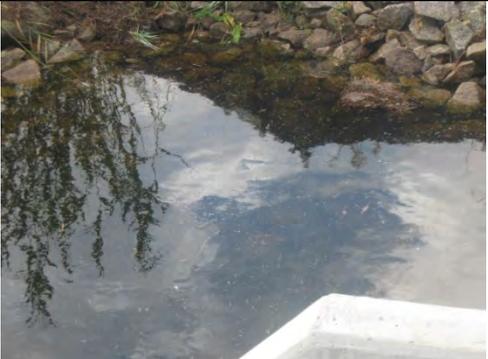
<p>RW 5 Side: CB 11 Discharge Outlet; Altogether three discharge points were checked with no evident water quality issues.</p>

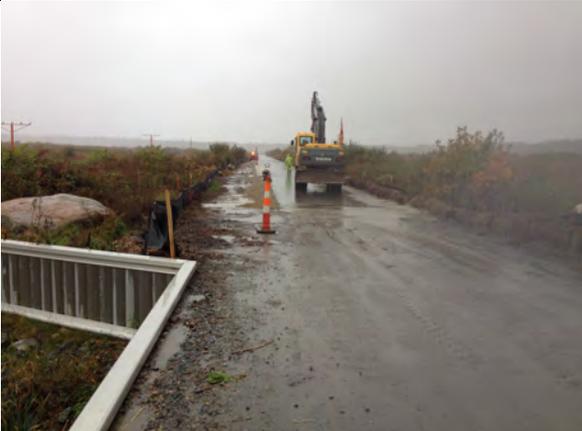
<p>RW 5 End ILS Road Grading and loaming of along ILS road. Task abandoned due to the heavy rain. Will resume Monday October 20, 2014.</p>

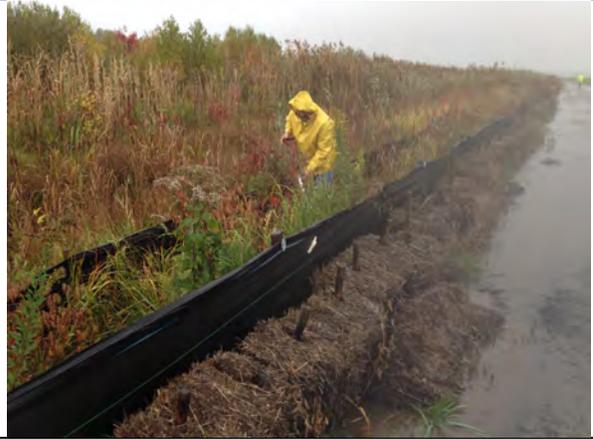
RW 5 End ILS Road West Ditch

Installation of replacement plants along the West Ditch. Nine Aronia melanocarpas were installed. All were healthy, some fruiting.

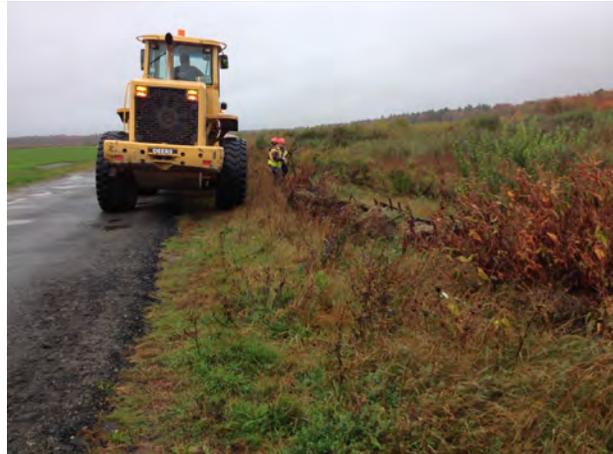
RW 5 End ILS Road Removal of silt fence within areas heavily vegetated and stable.

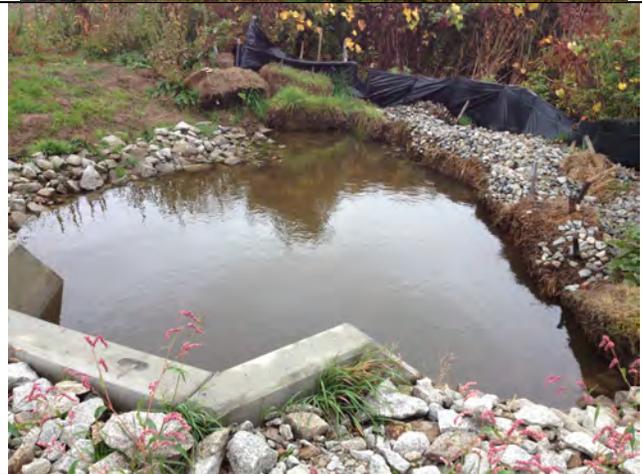
Catch Basin #1 outfall west of Taxiway B slight turbidity at outfall.

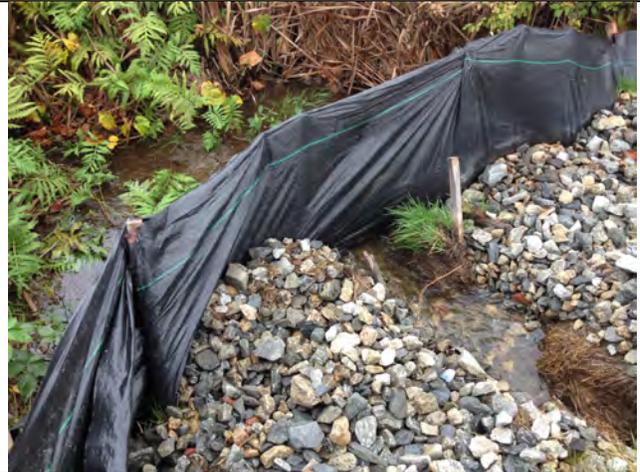
Catch Basin #1 outfall west of Taxiway B no turbidity on downstream side of stone check dam. Erosion and sedimentation controls to remain in place.

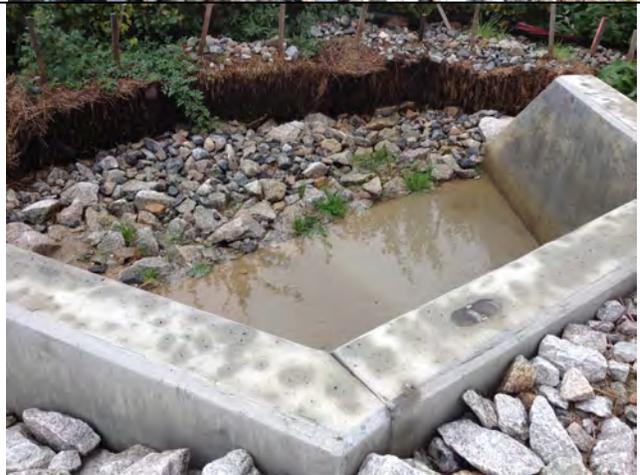
RW 5 End Concrete Headwall/Outlet for Infiltration Trench Water flowing clean out from infiltration trench. Catch Basin 11 wasn't inspected. Runway open and couldn't access.
