MassDEP File No. SE 049-0635

New Bedford Regional Airport Runway Safety Improvements Project

Post Construction Monthly Wetlands Plantings Assessment – November 2014

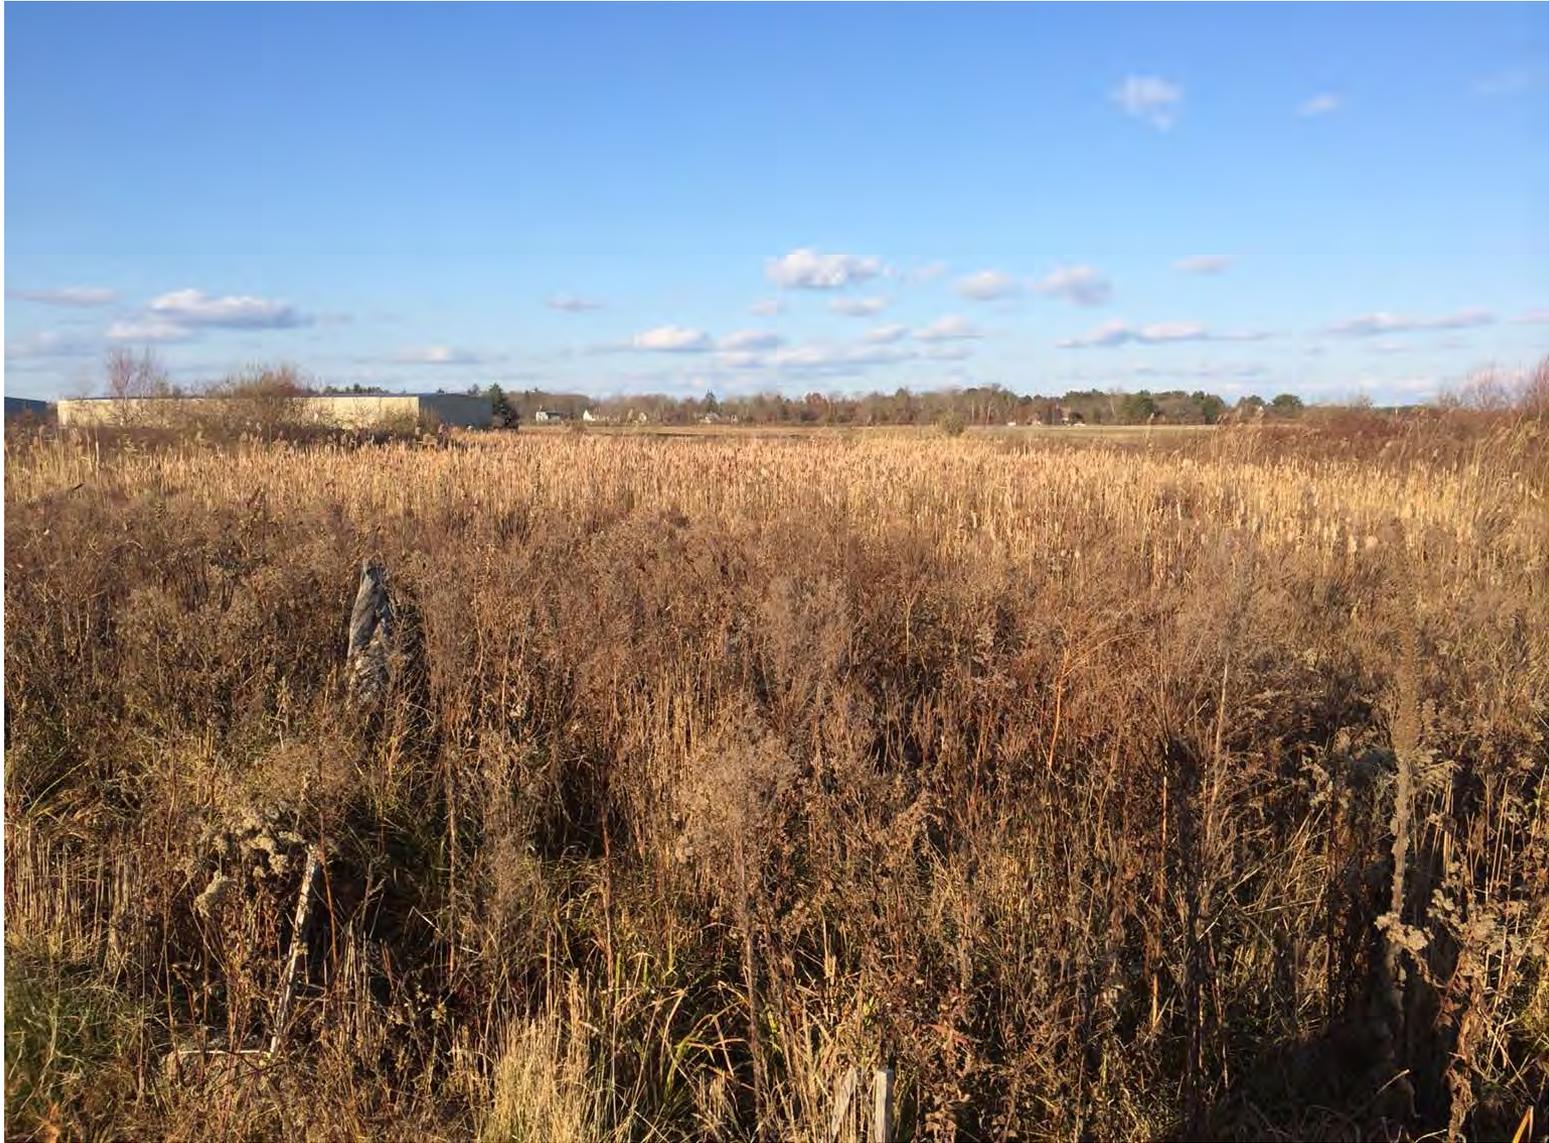
View looking north at Site 6.

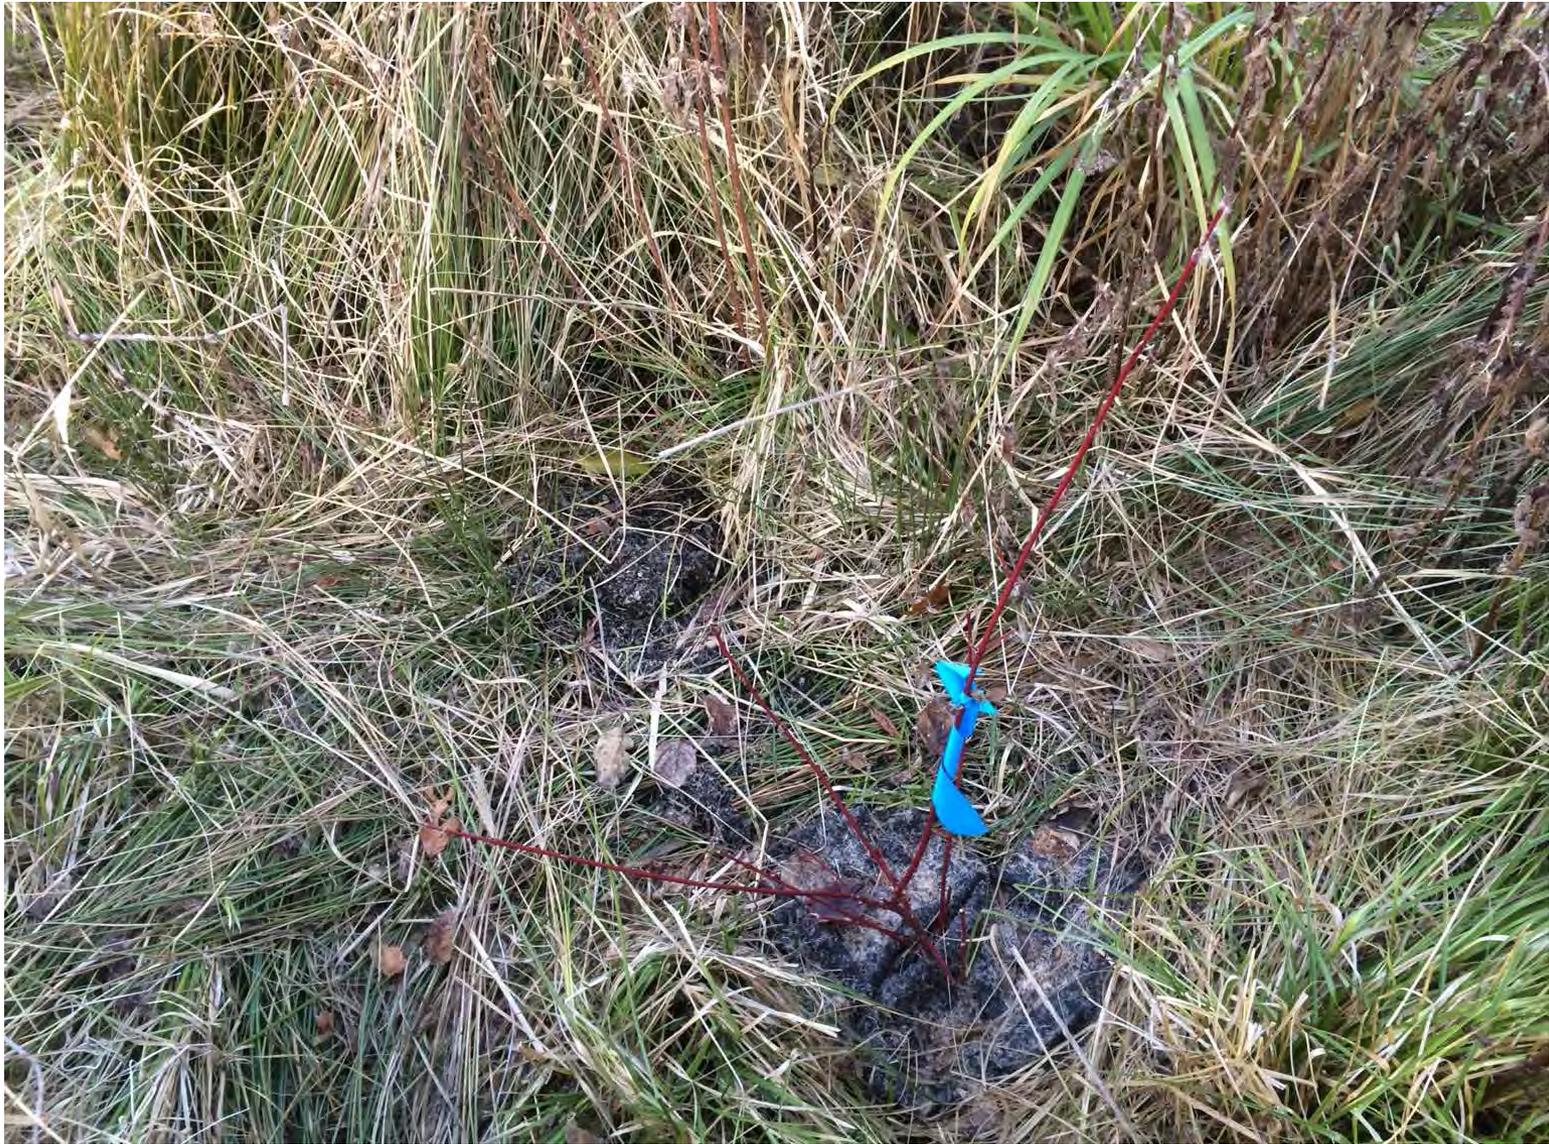
View of replacement dogwood shrub in Site 6.

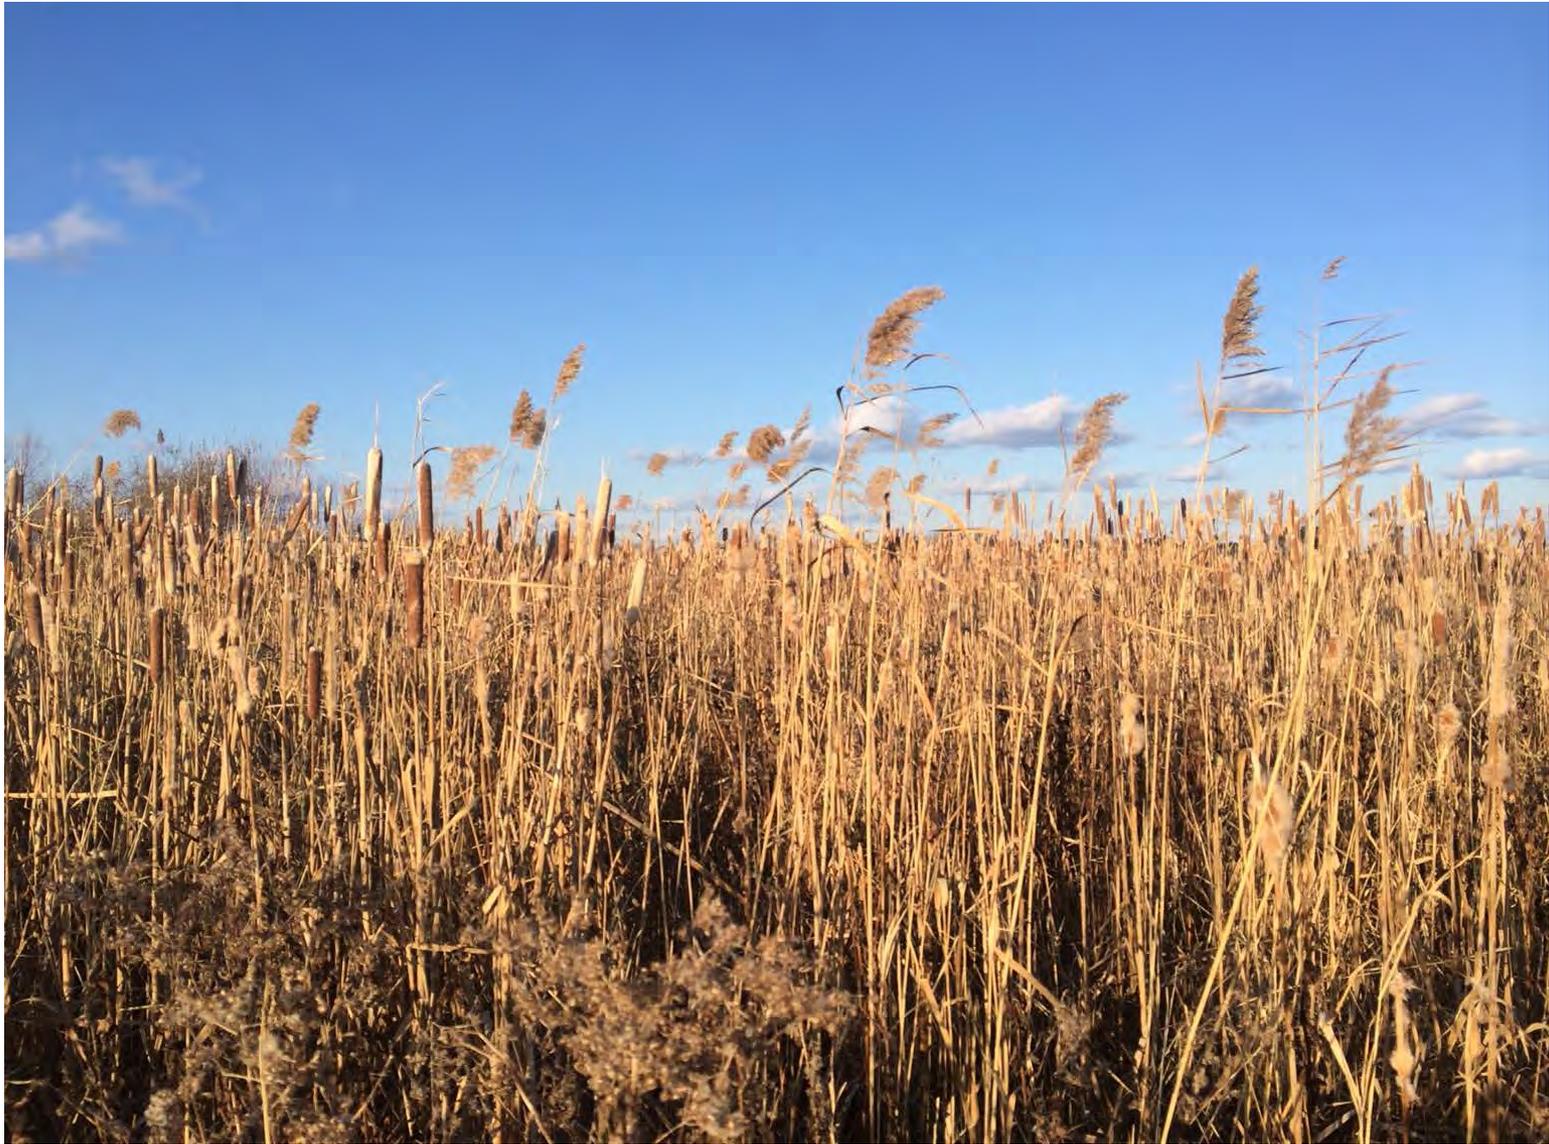
View of highest concentration of Phragmites in Site 6.

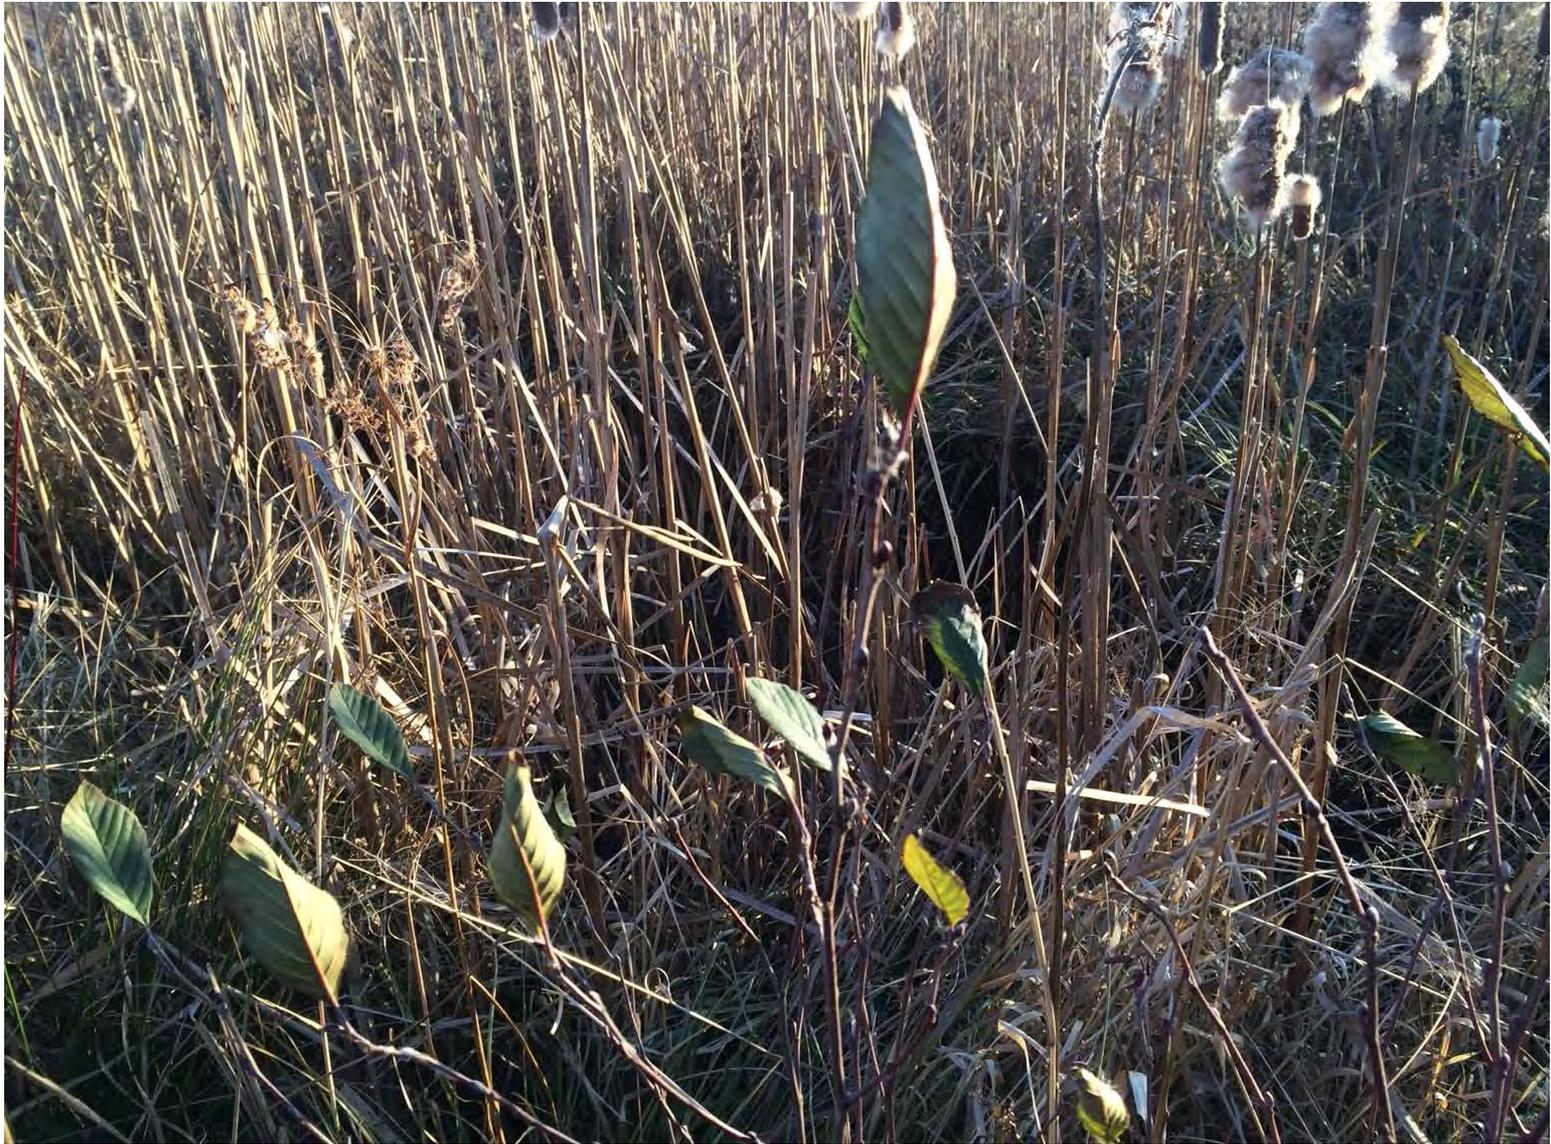
View of senescing alder shrub in Site 6.

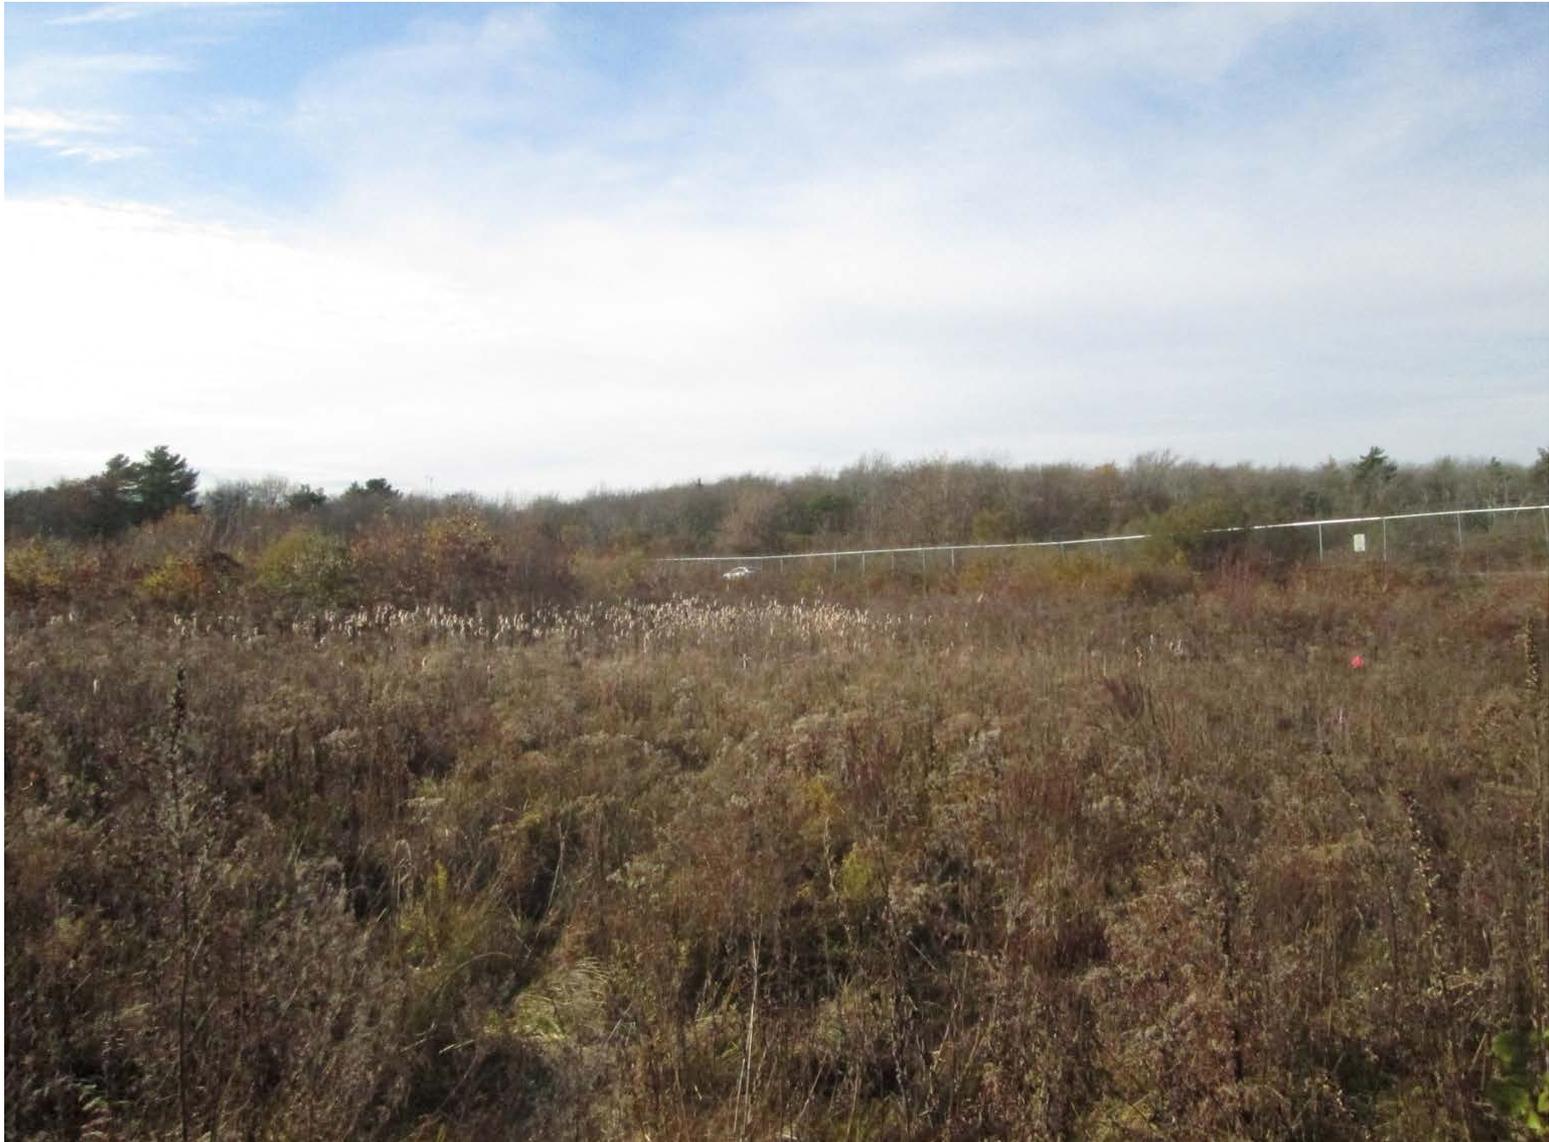
Overview of Site 5 from entrance.

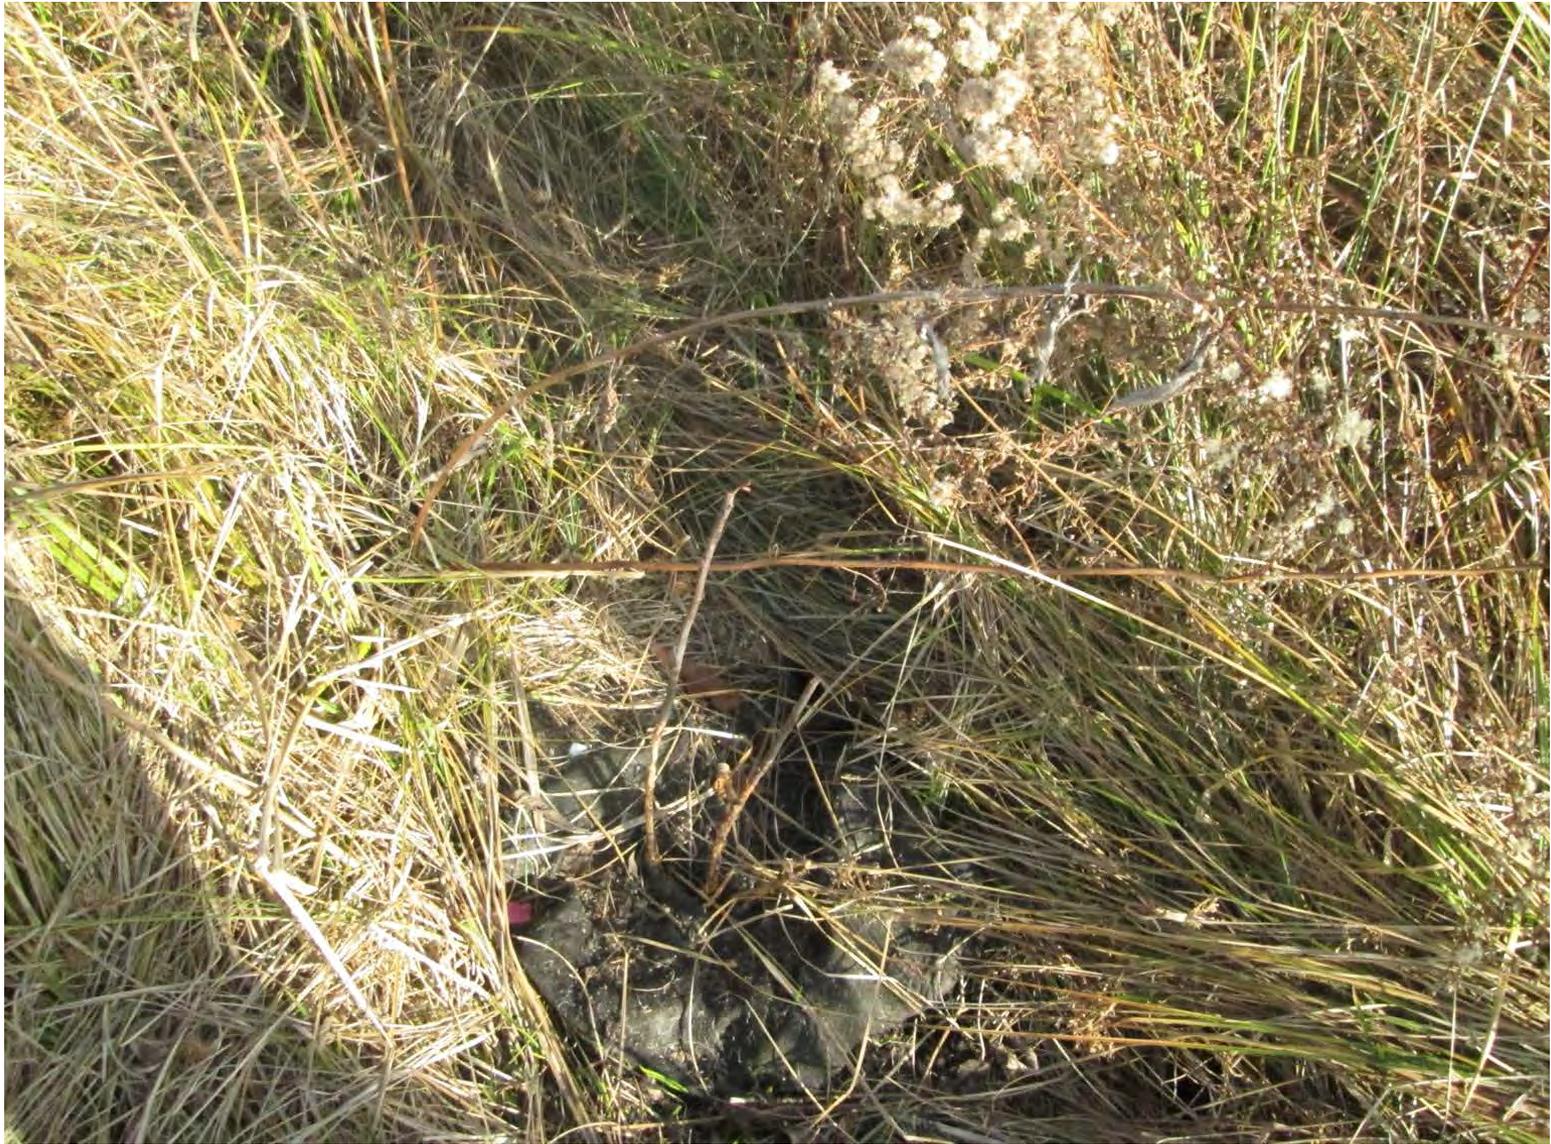
Typical view of deer browse on replacement shrub.

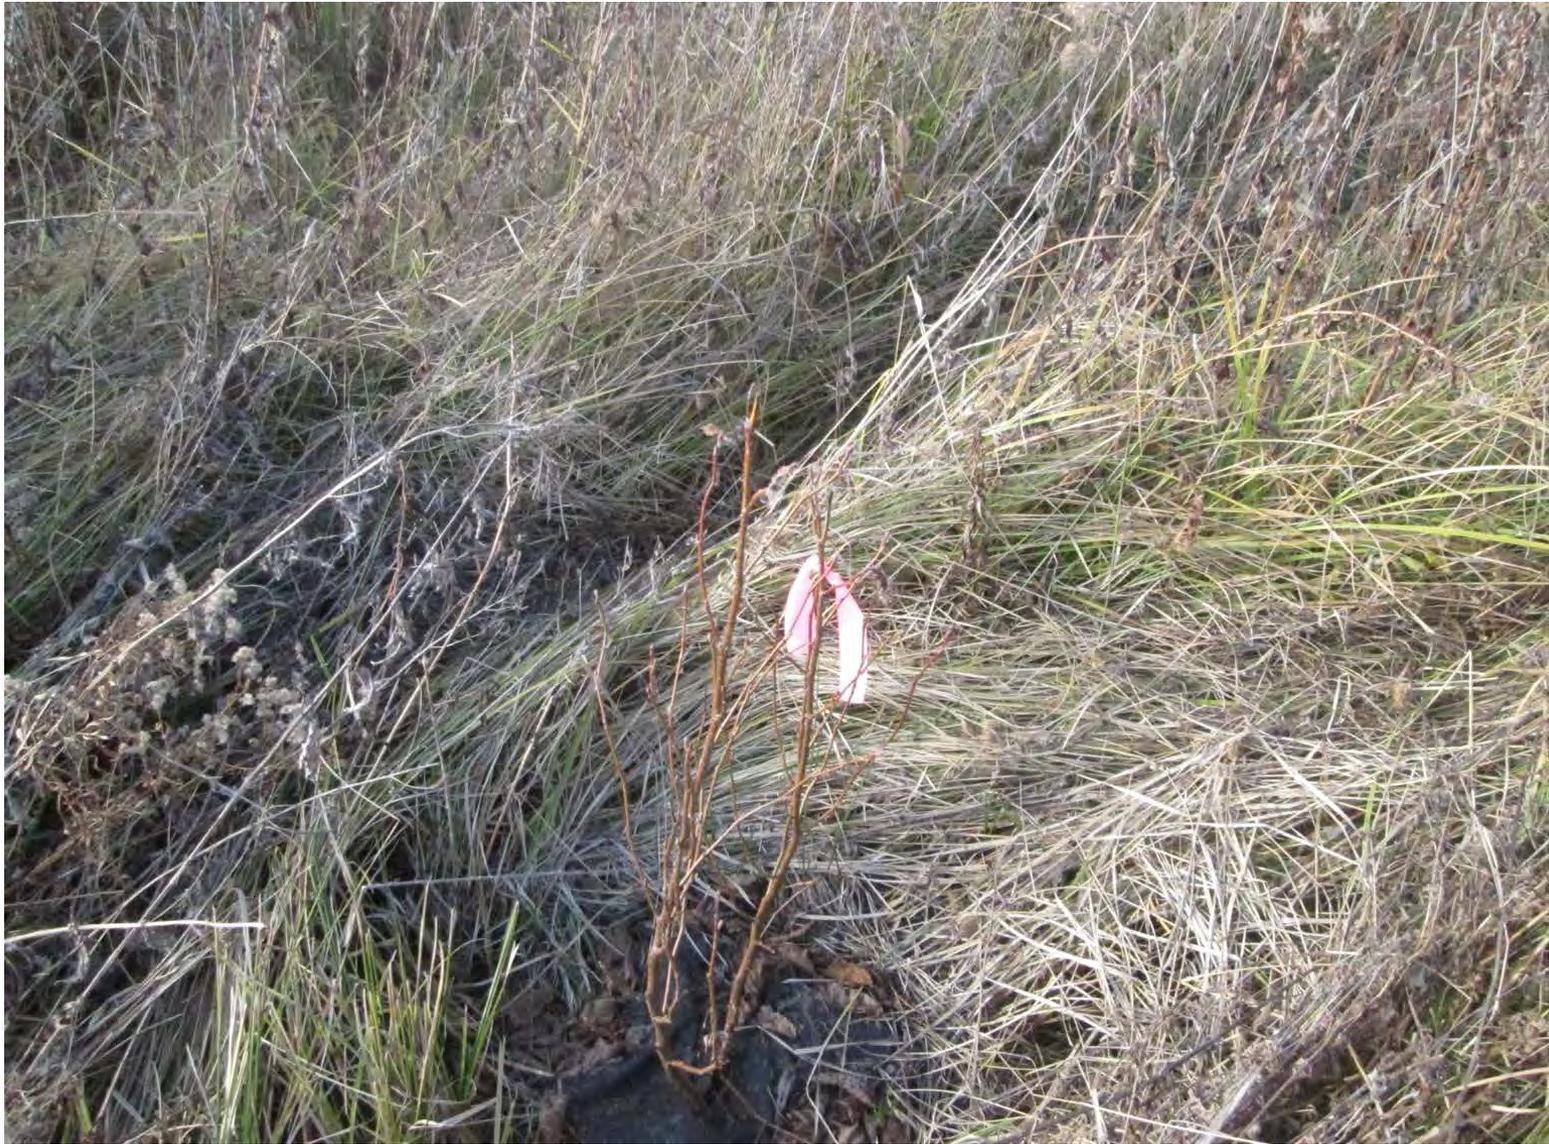
Typical view of replacement shrub in Site 5.

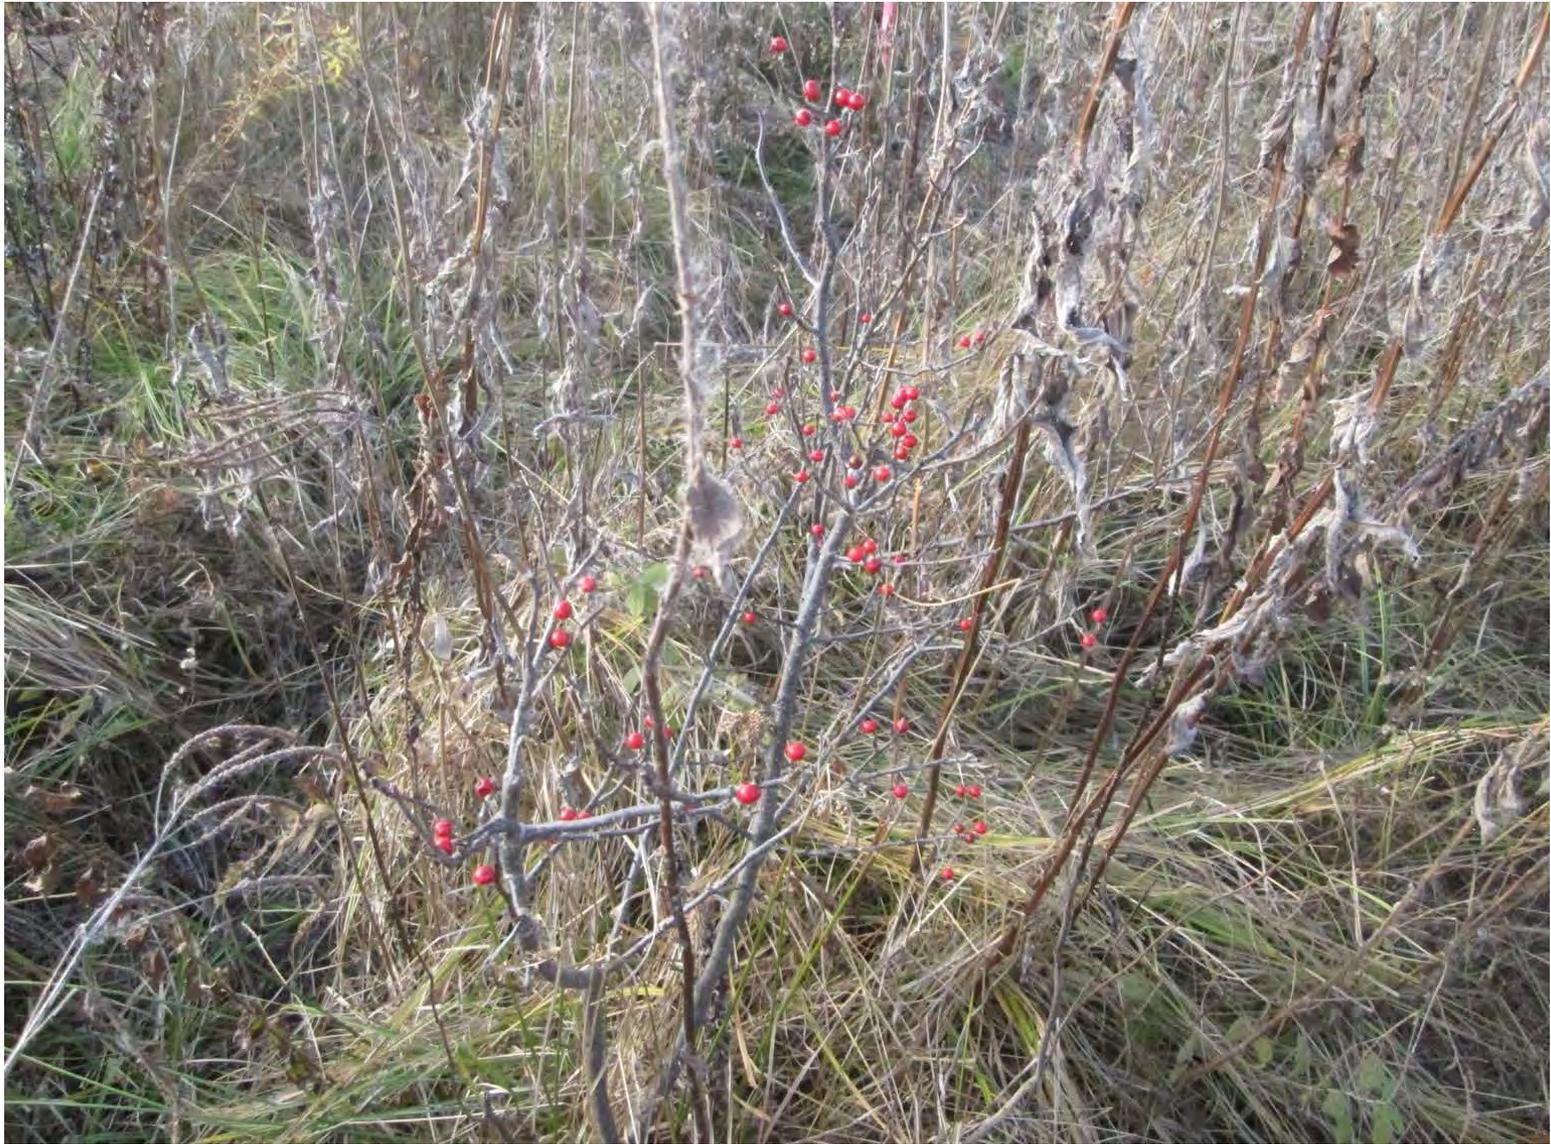
View of winterberry in Site 5.

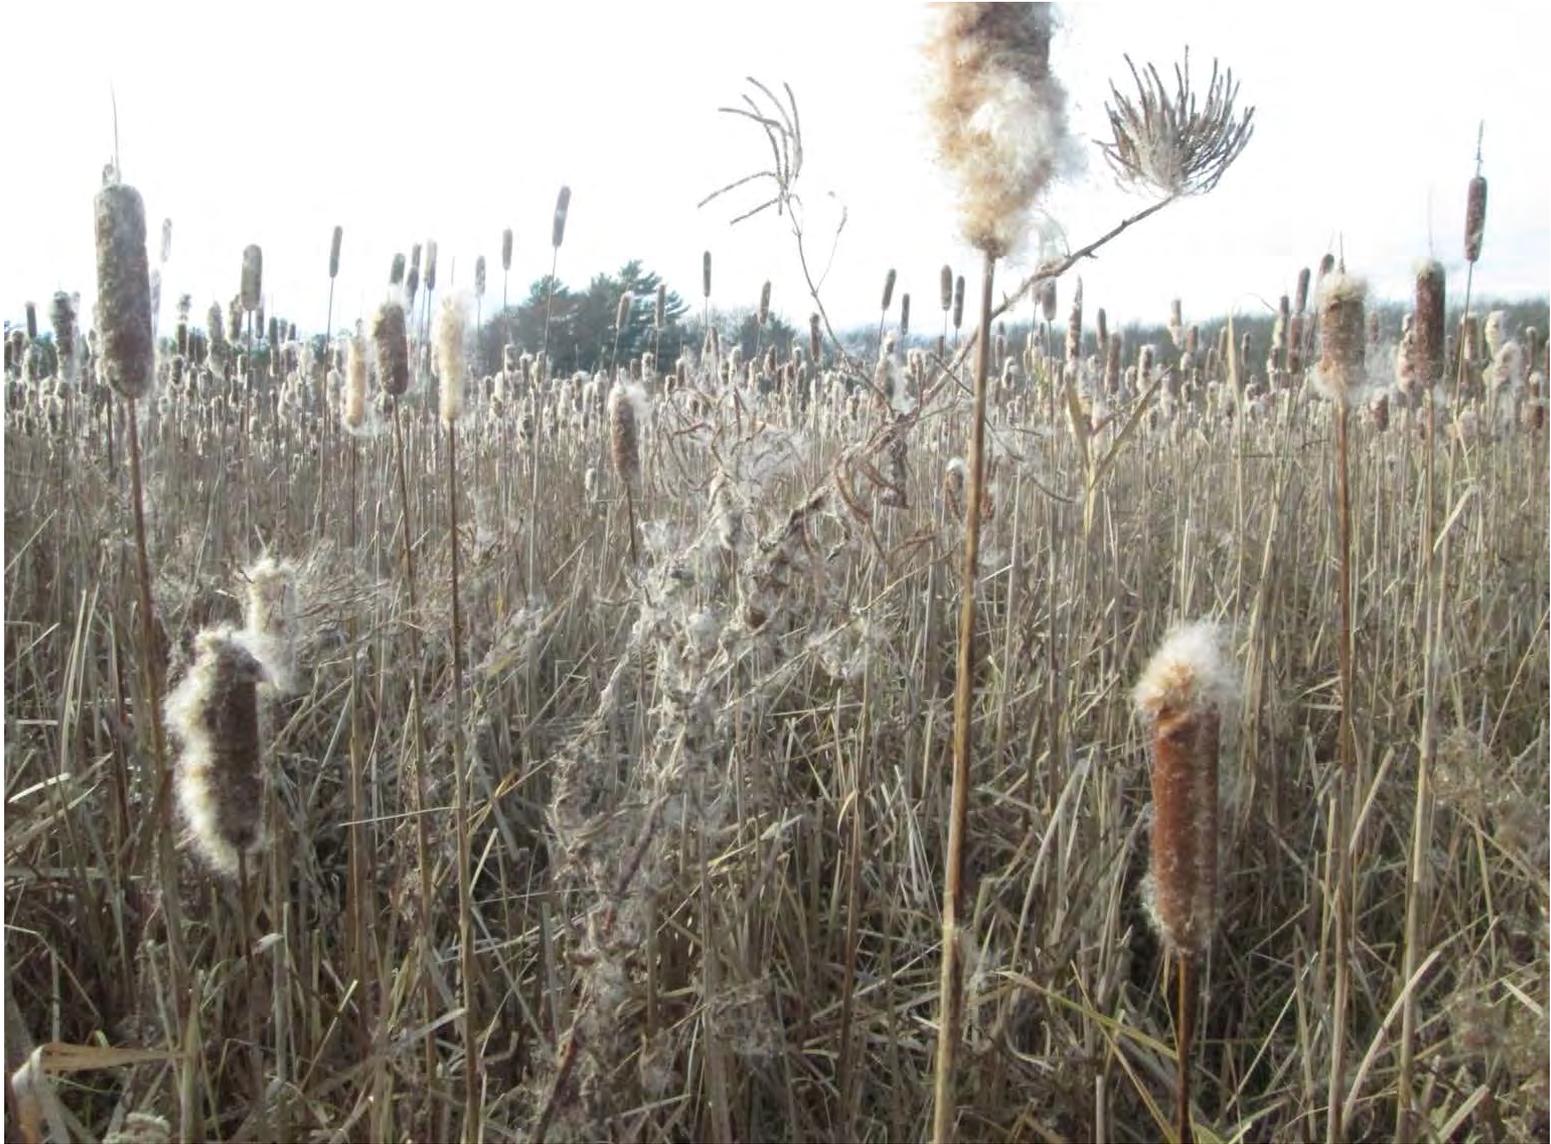
The areas of native cattail (*Typha latifolia*) seem to be stabilized and appeared to remain essentially in the same locations as previously described in October's report although they have encroached further into the vernal pool(s), particularly at Site 5. This area was re-quantified during the November 2014 meander survey and will be presented in the year end mitigation report. The cattails are generally interspersed in the lower elevations of the three mitigation sites among other herbaceous cover types, woody plantings, micro-habitat features (boulders, pits-and-mounds, large woody debris) and areas of open water / vernal pools resulting in good horizontal habitat diversity.

View of cattail fringe on vernal pool, Site 5.

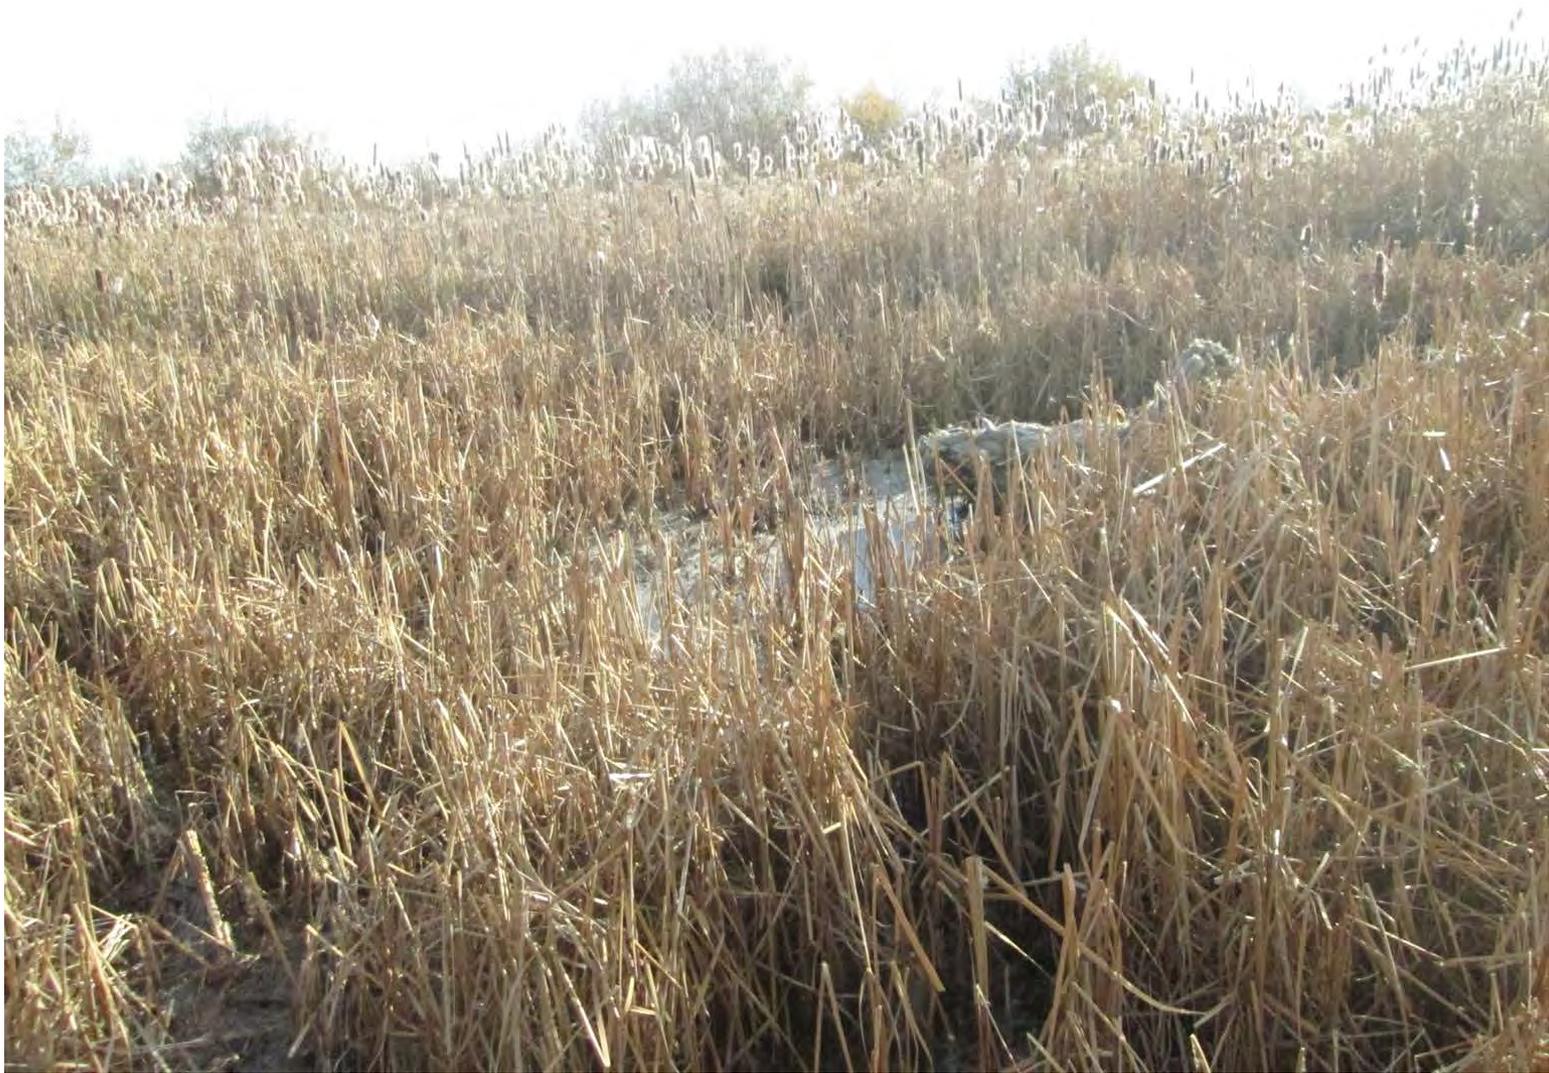
View of central portion of Site 5, water has not increased as significantly as in the other mitigation areas.

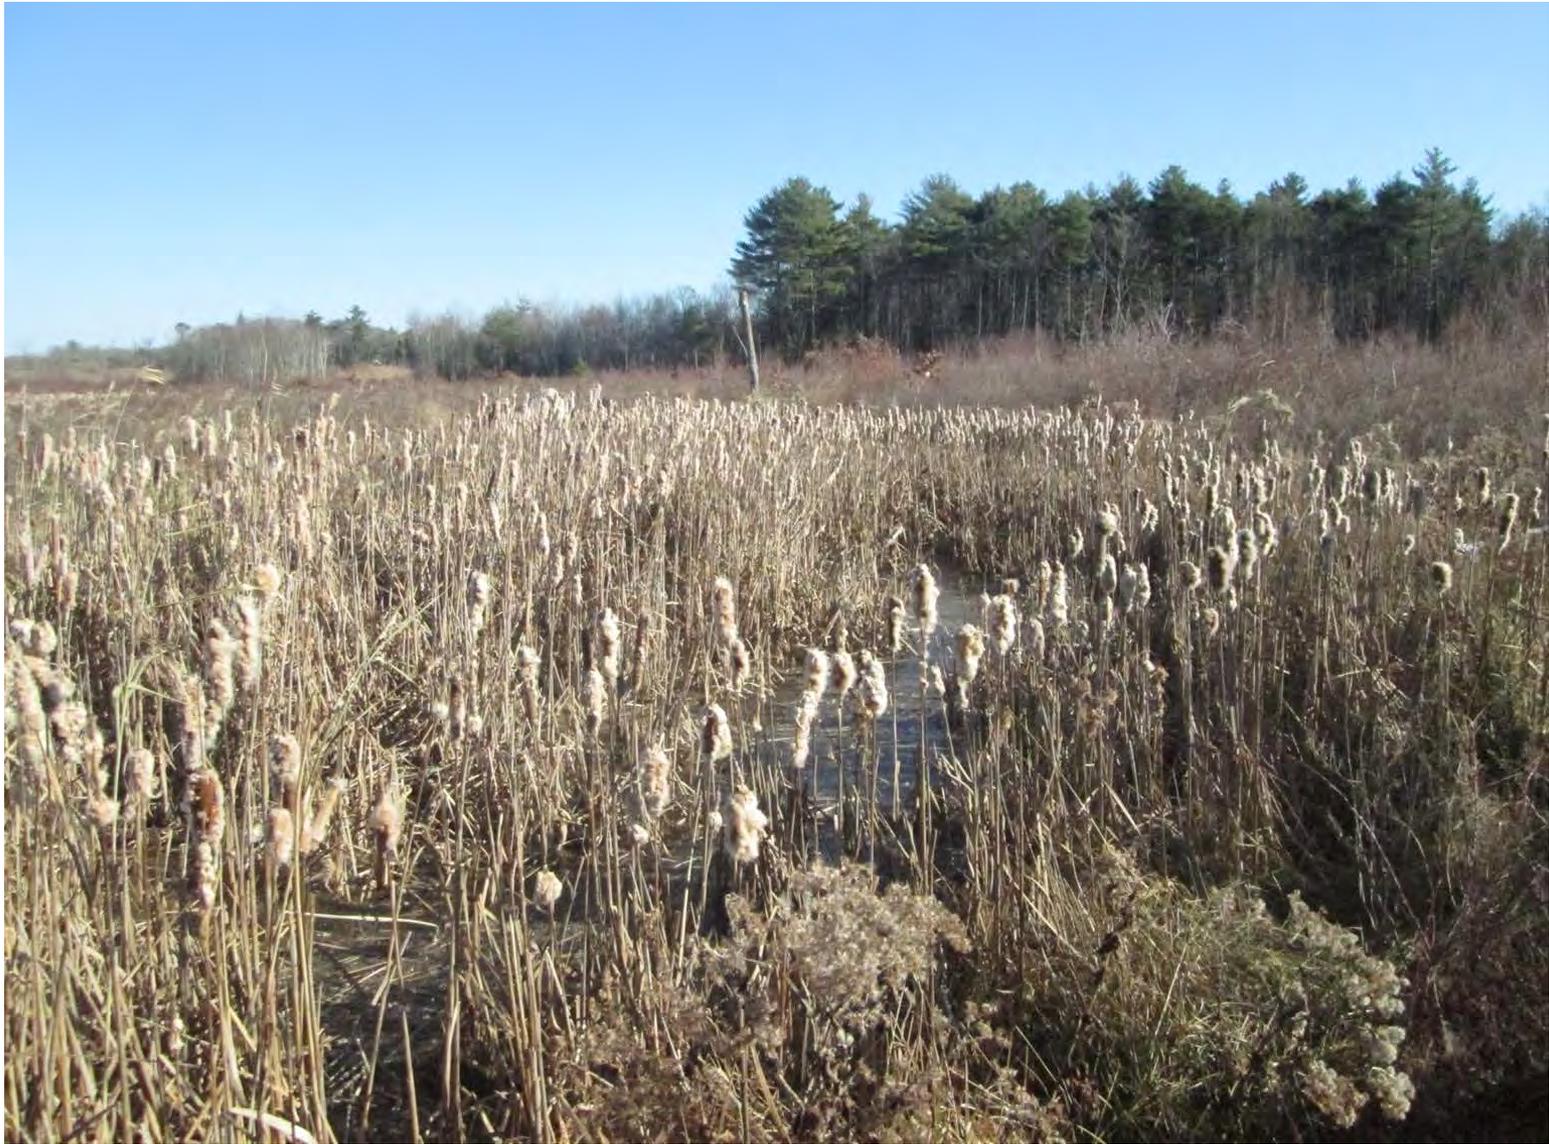
View of smaller northern vernal pool in Site 10. Water was at least 2 feet deep.

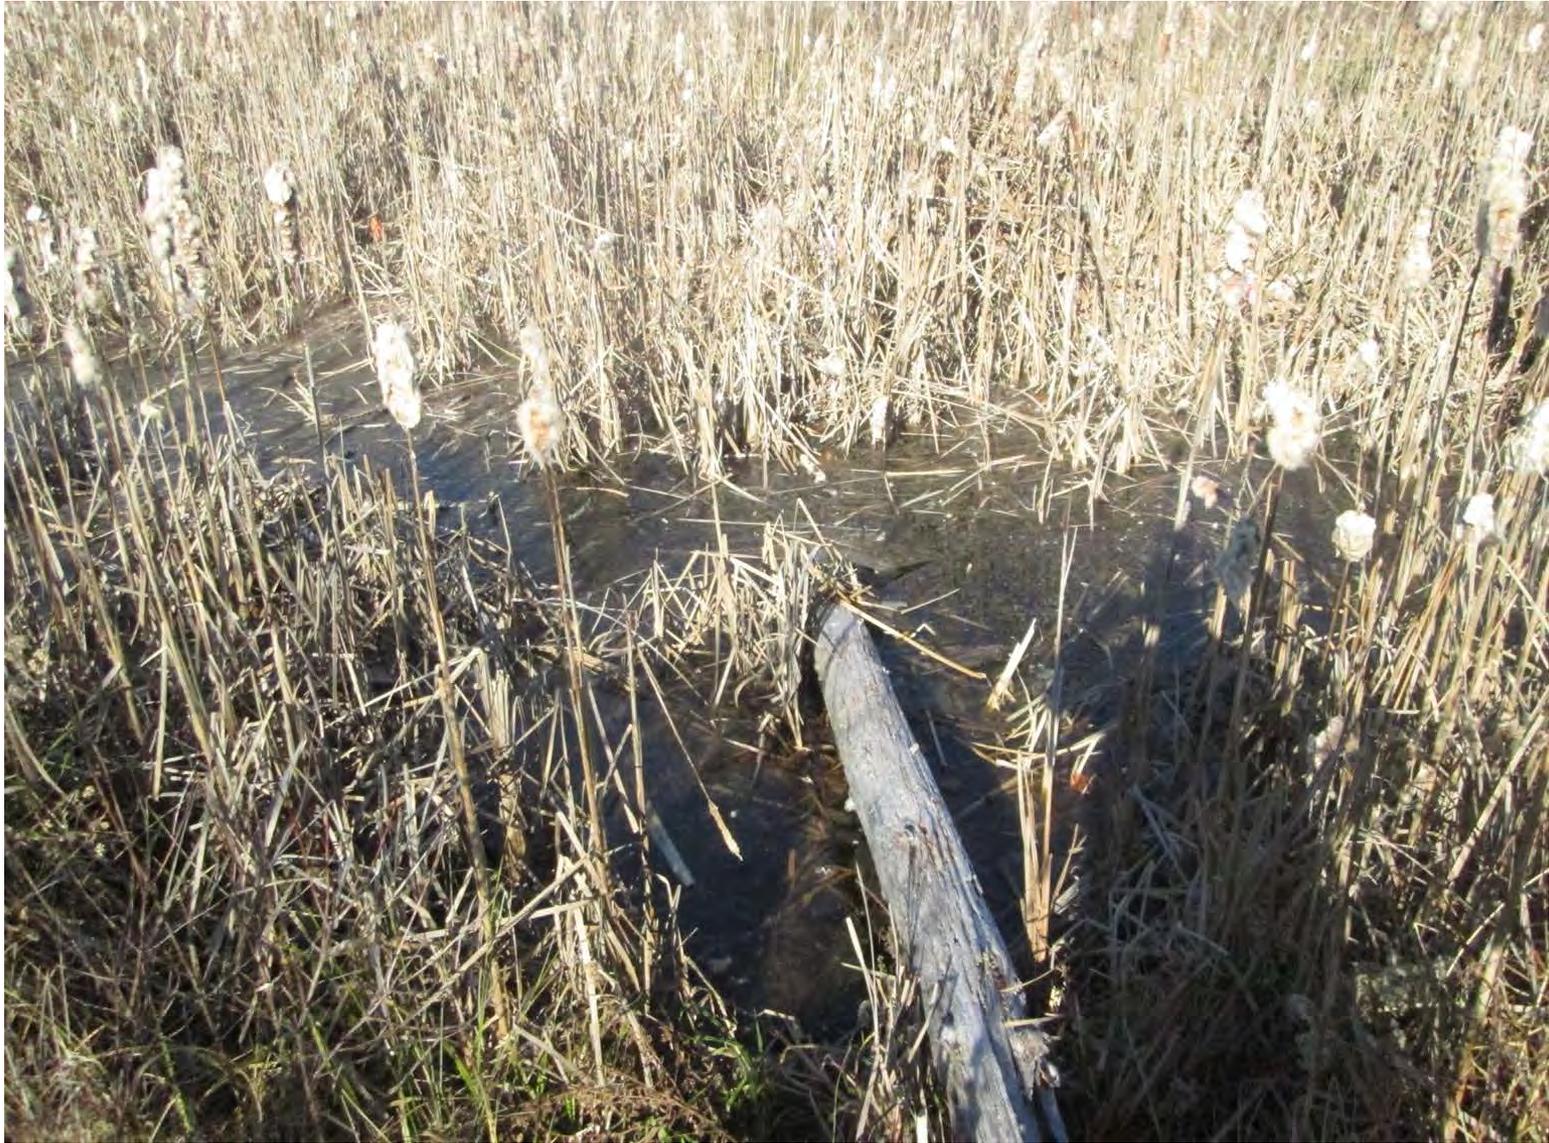
View of newly placed large woody debris within vernal pool, for basking and attachment sites.

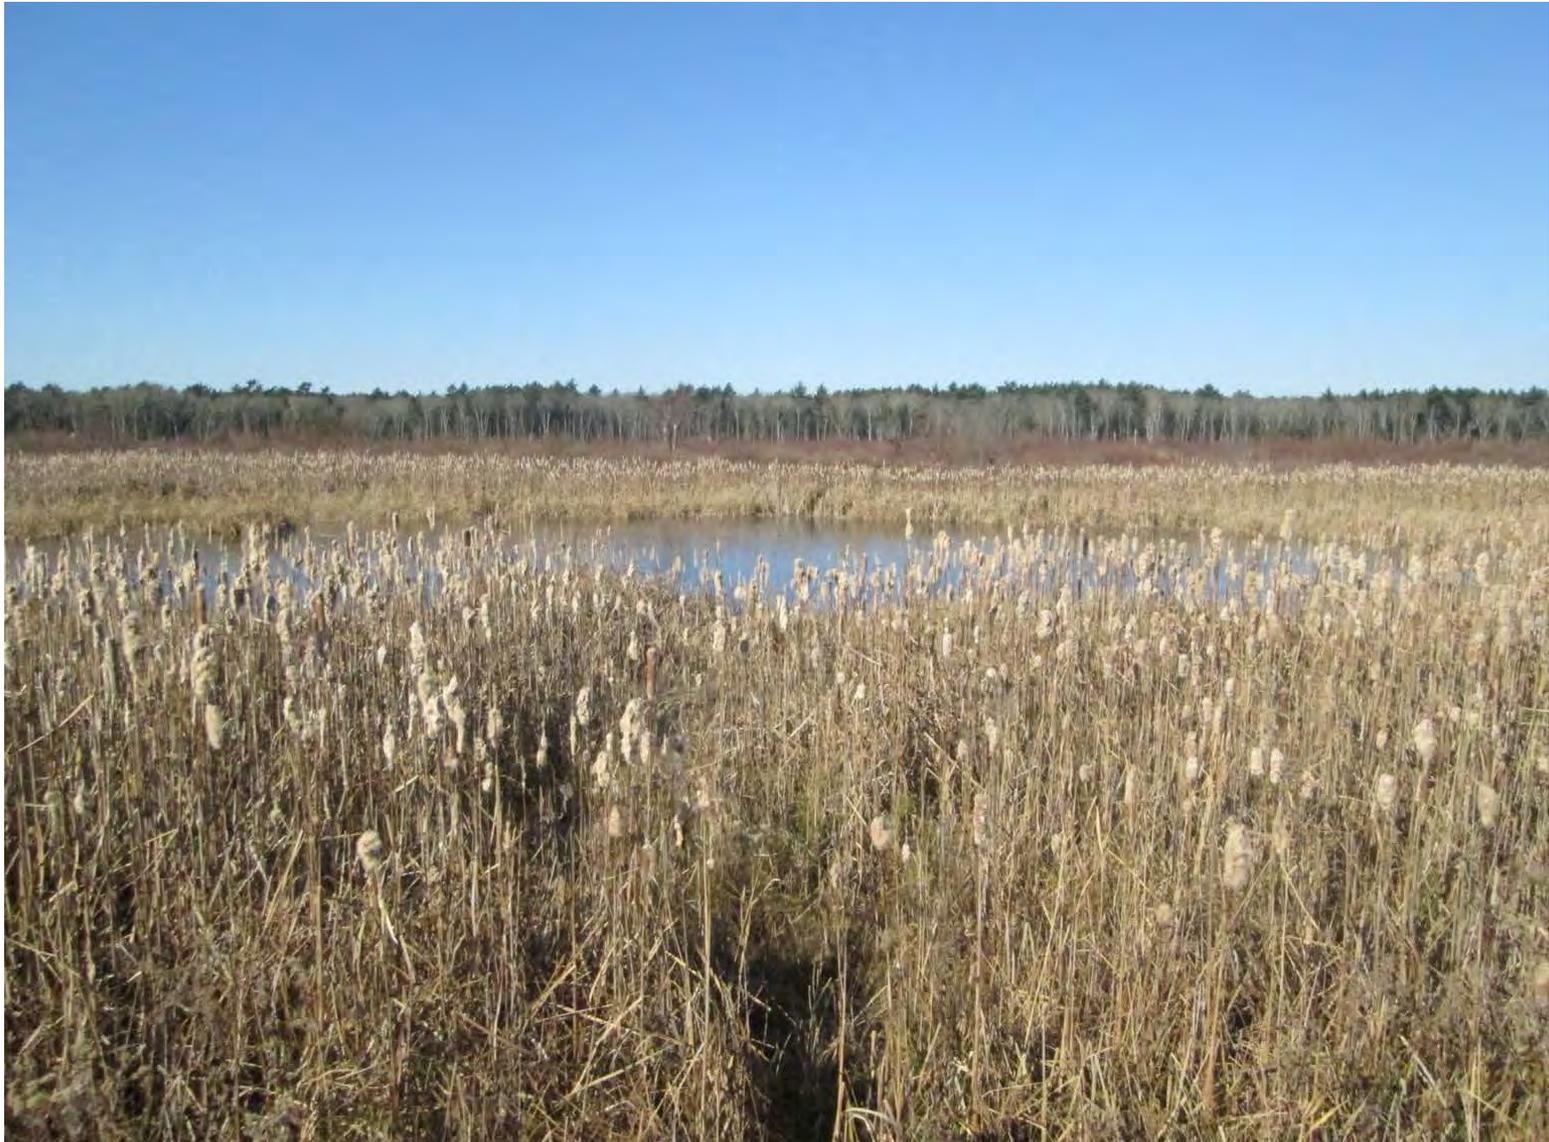
View of western vernal pool in Site 10. Water appears relatively full.
