MassDEP File No. SE 049-0635

New Bedford Regional Airport Runway Safety Improvements Project

Post Construction Monthly Wetlands Plantings Assessment – November 2014

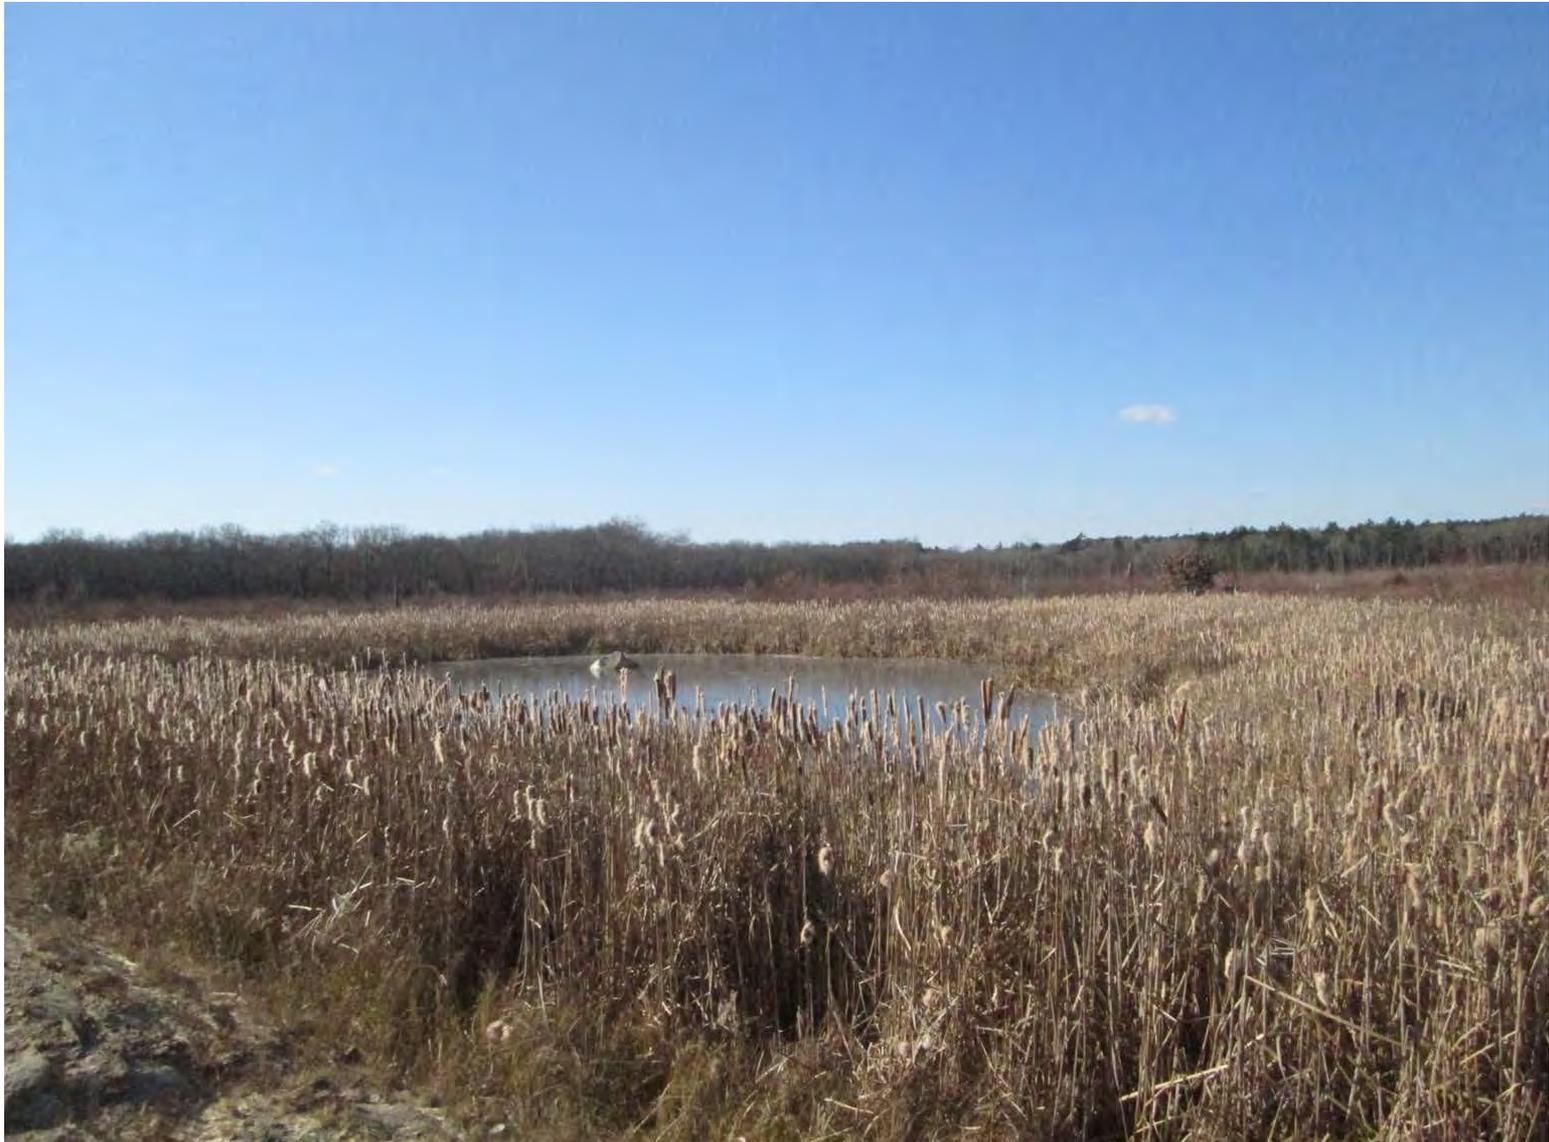
View of southern vernal pool in Site 10. Water was relatively high.

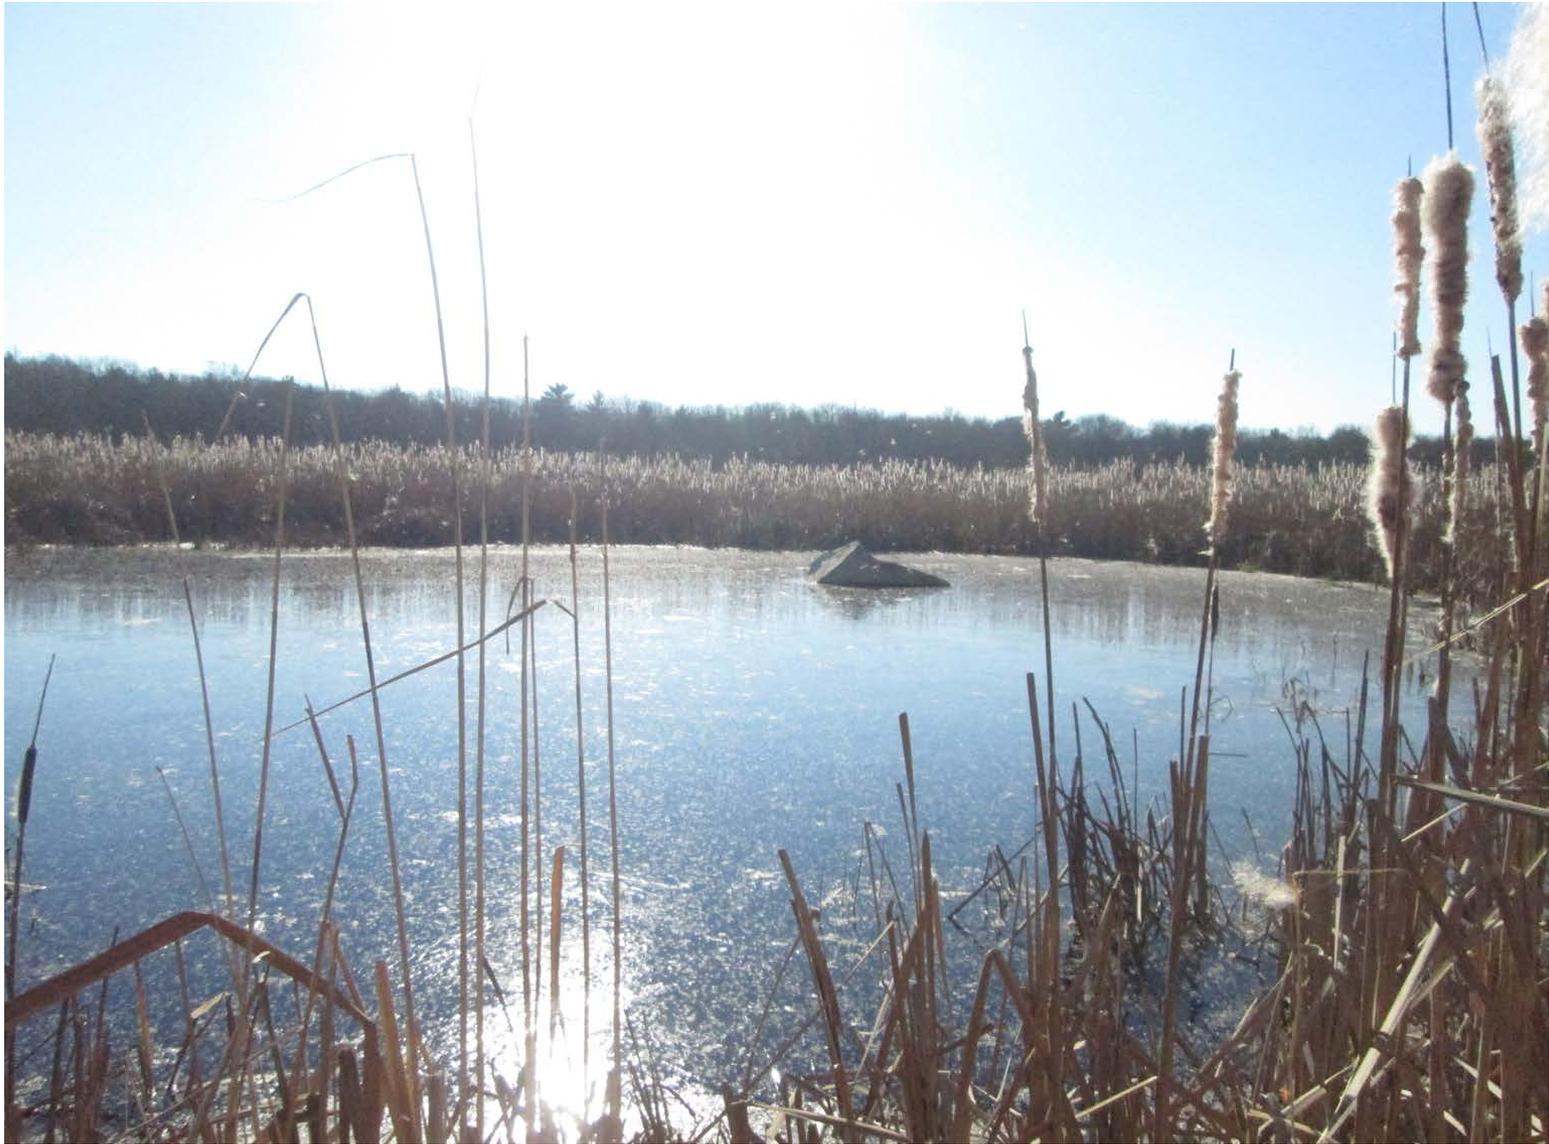
Based on prior water rings on rock in center of southern vernal pool, water is almost at bankfull.

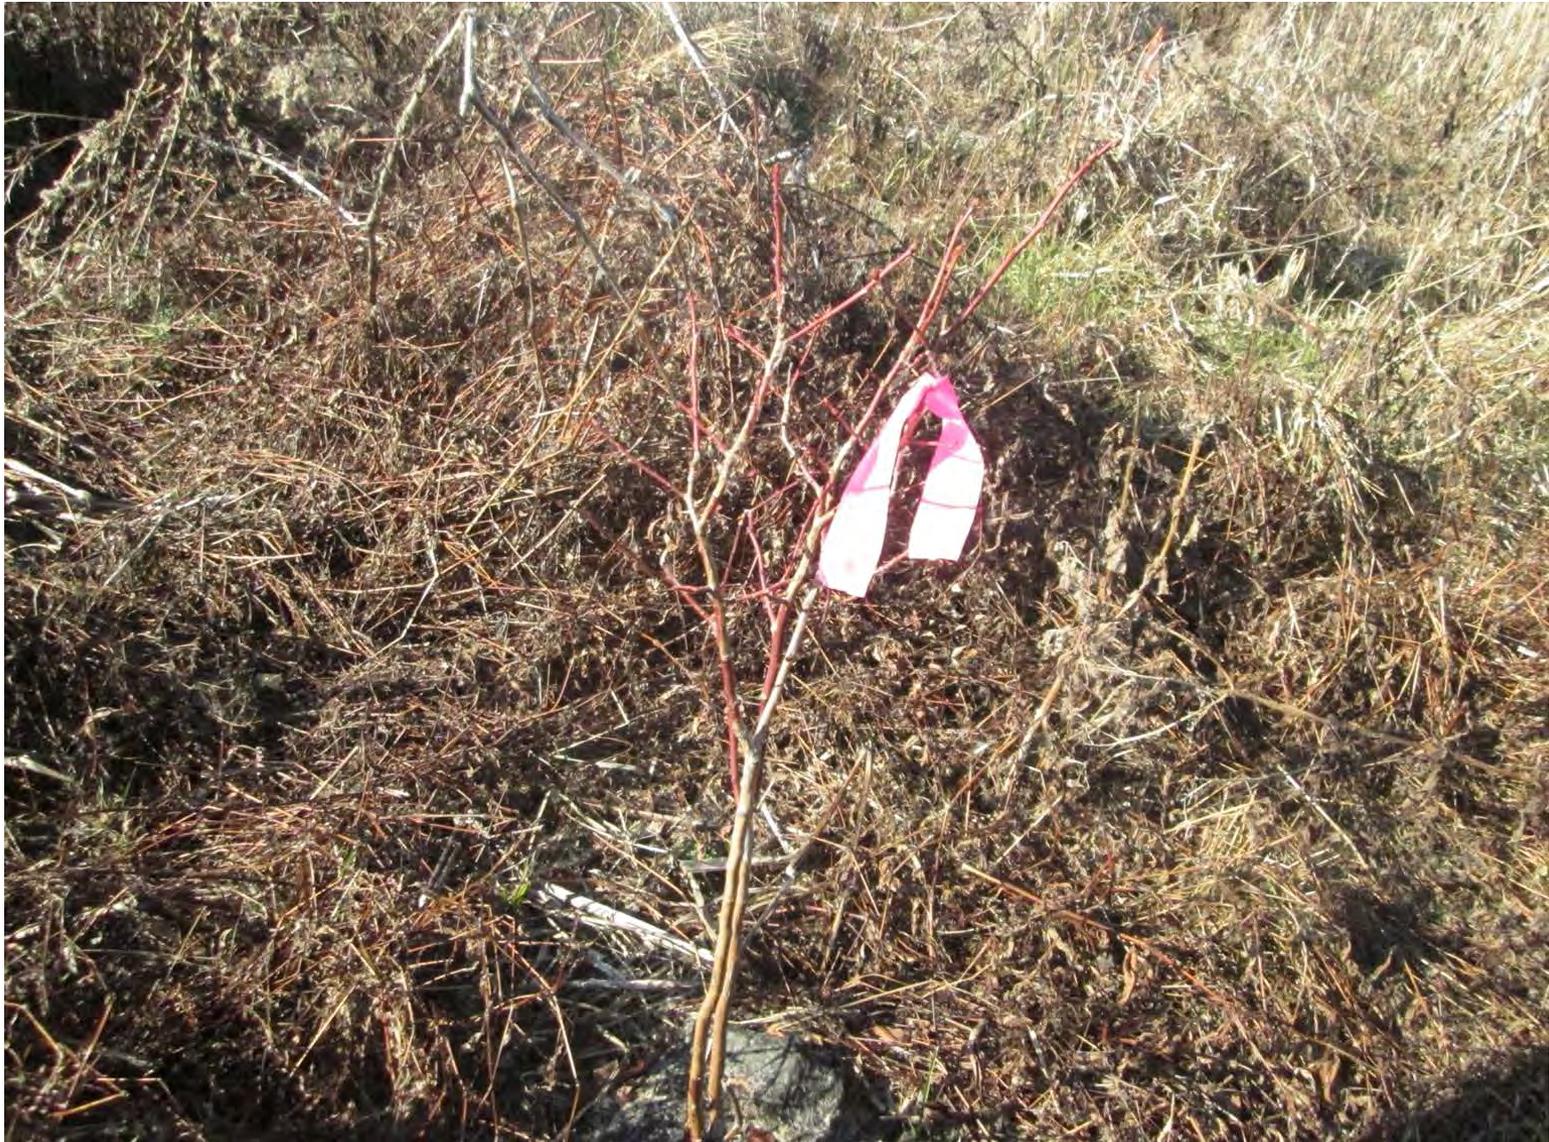
View of replacement blueberry shrub in Site 10.

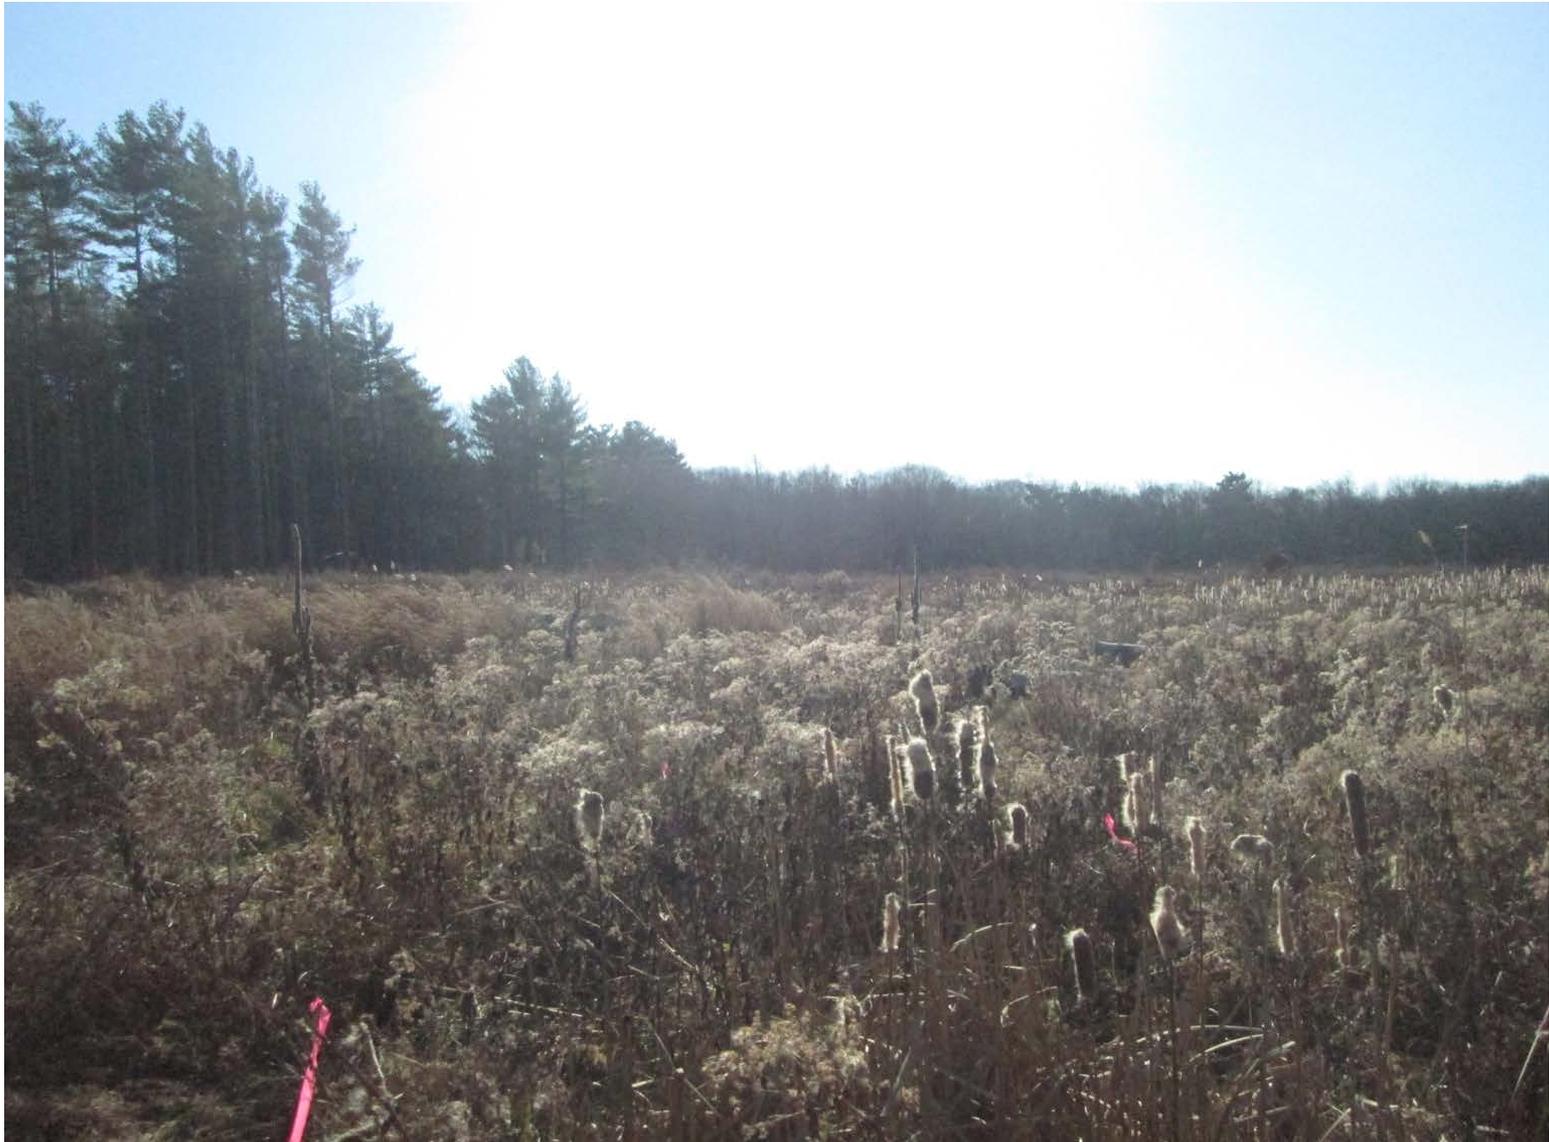
Typical view of southern portion of Site 10.

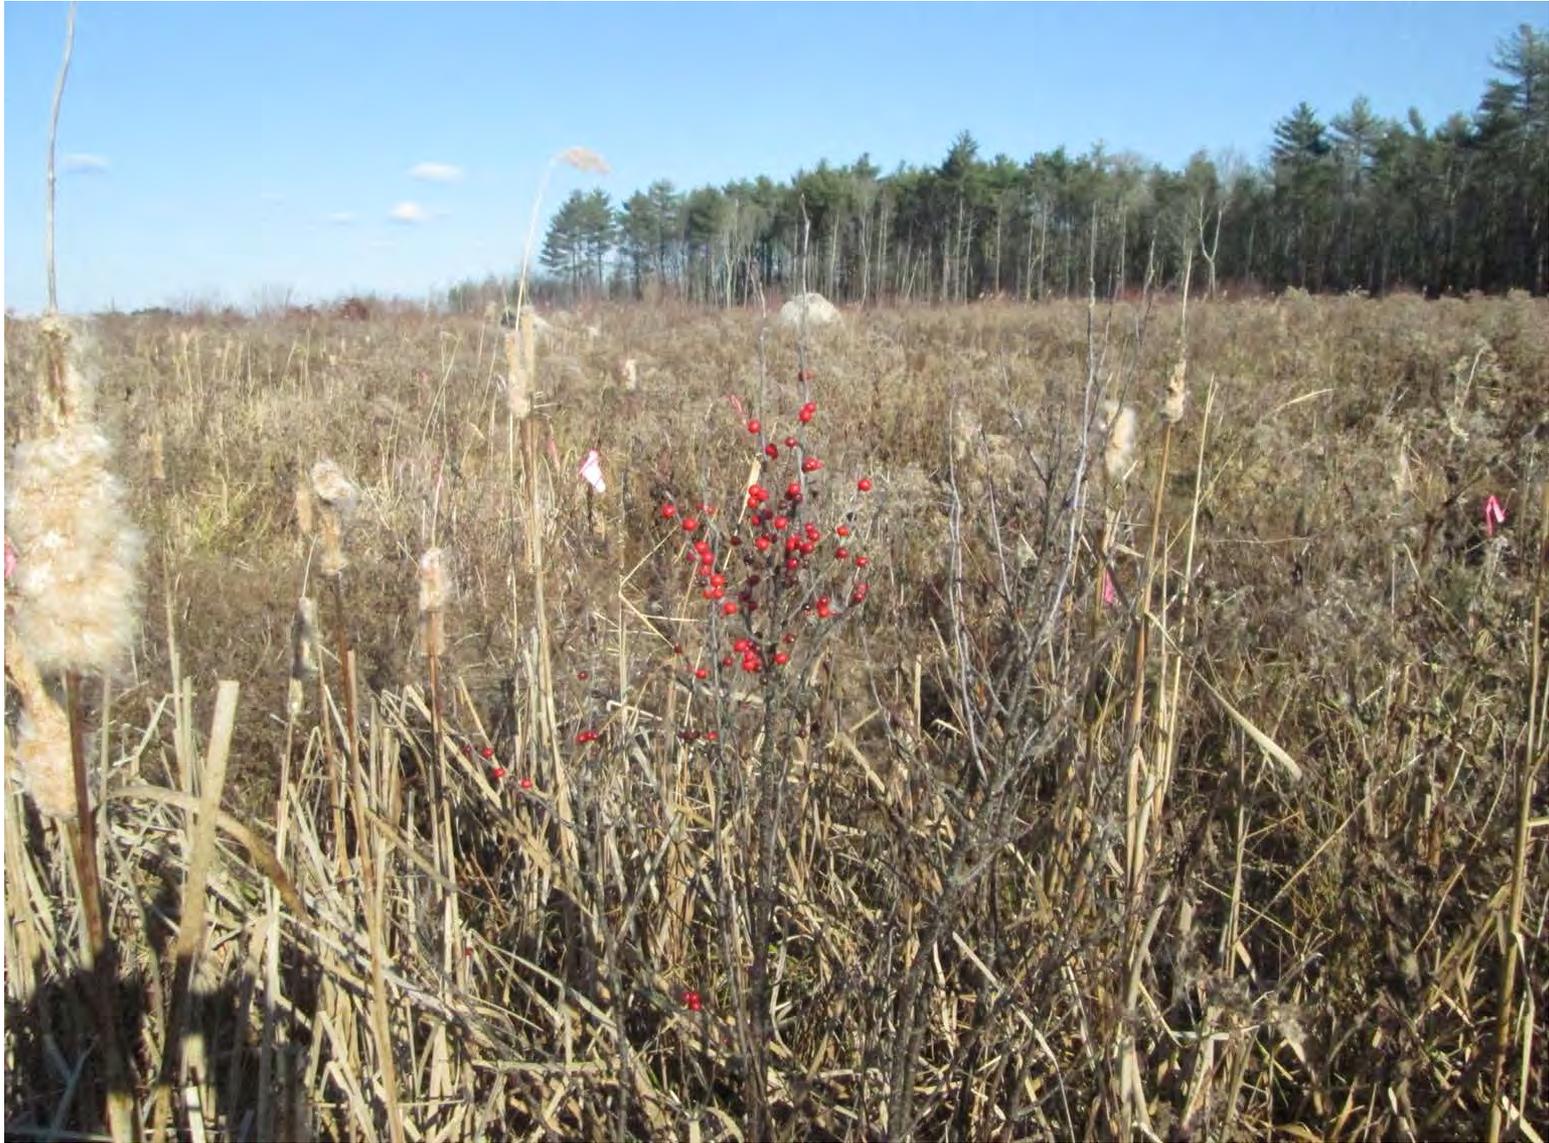
View of winterberry in Site 10.

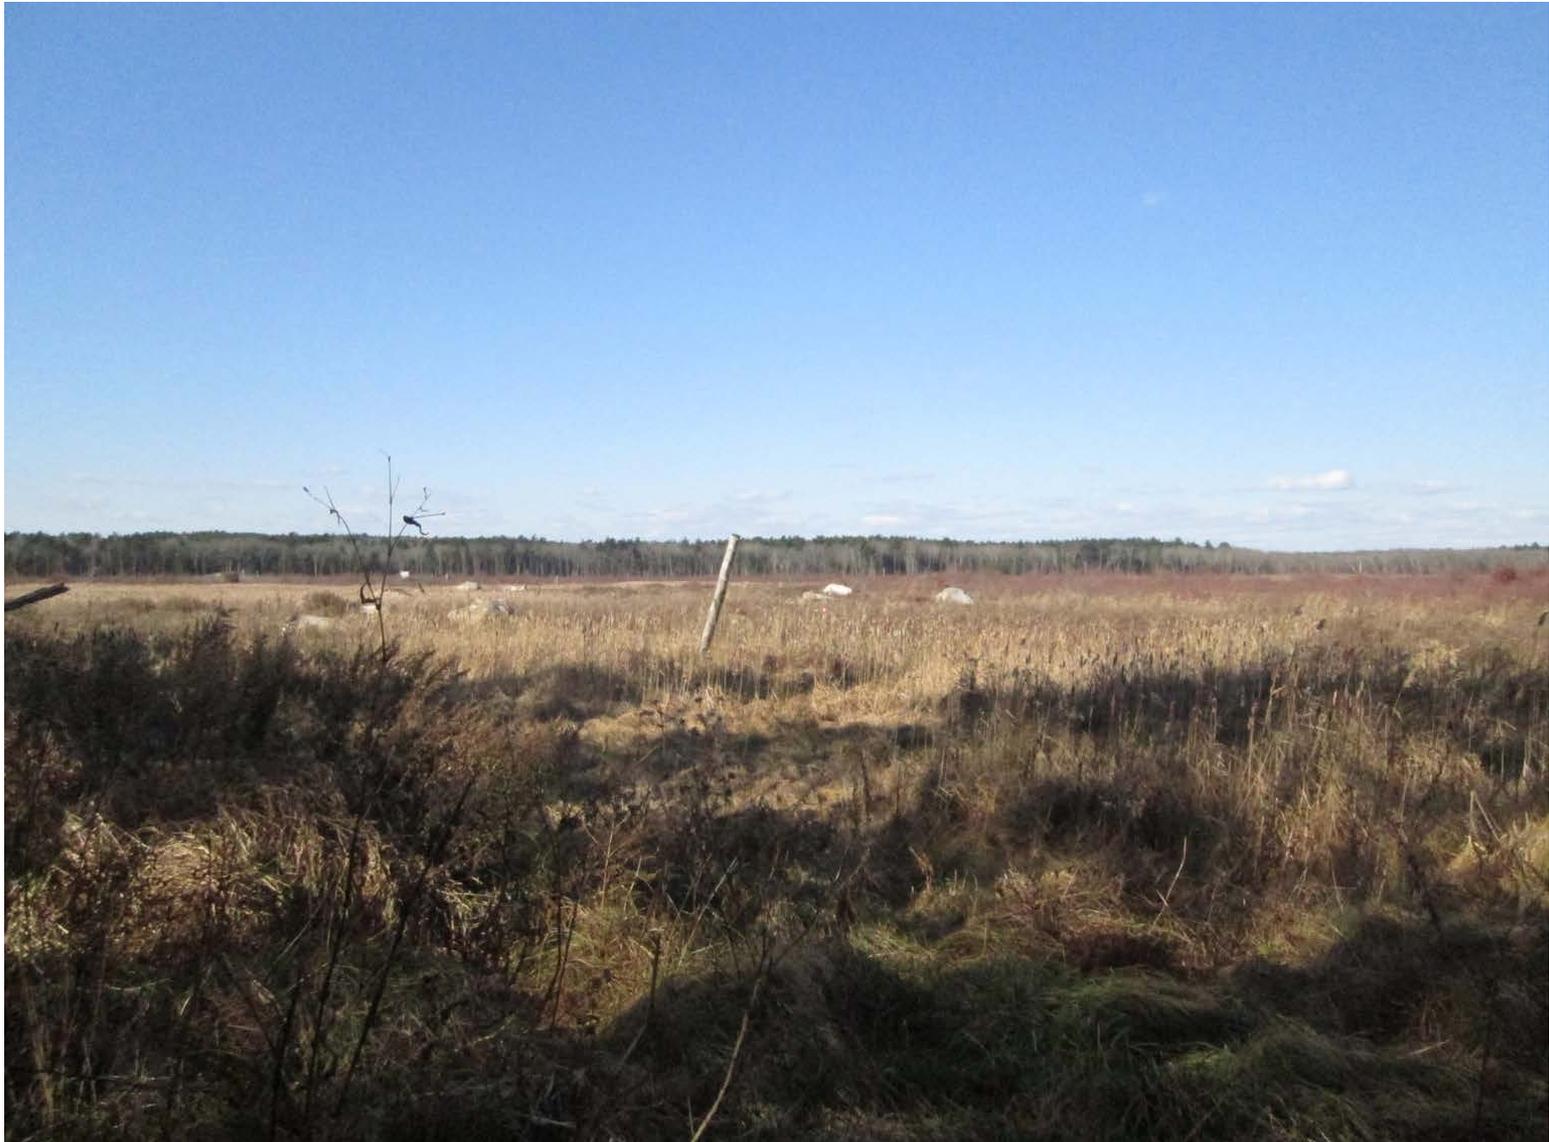
View of Site 10 looking west from the southernmost portion of the site.

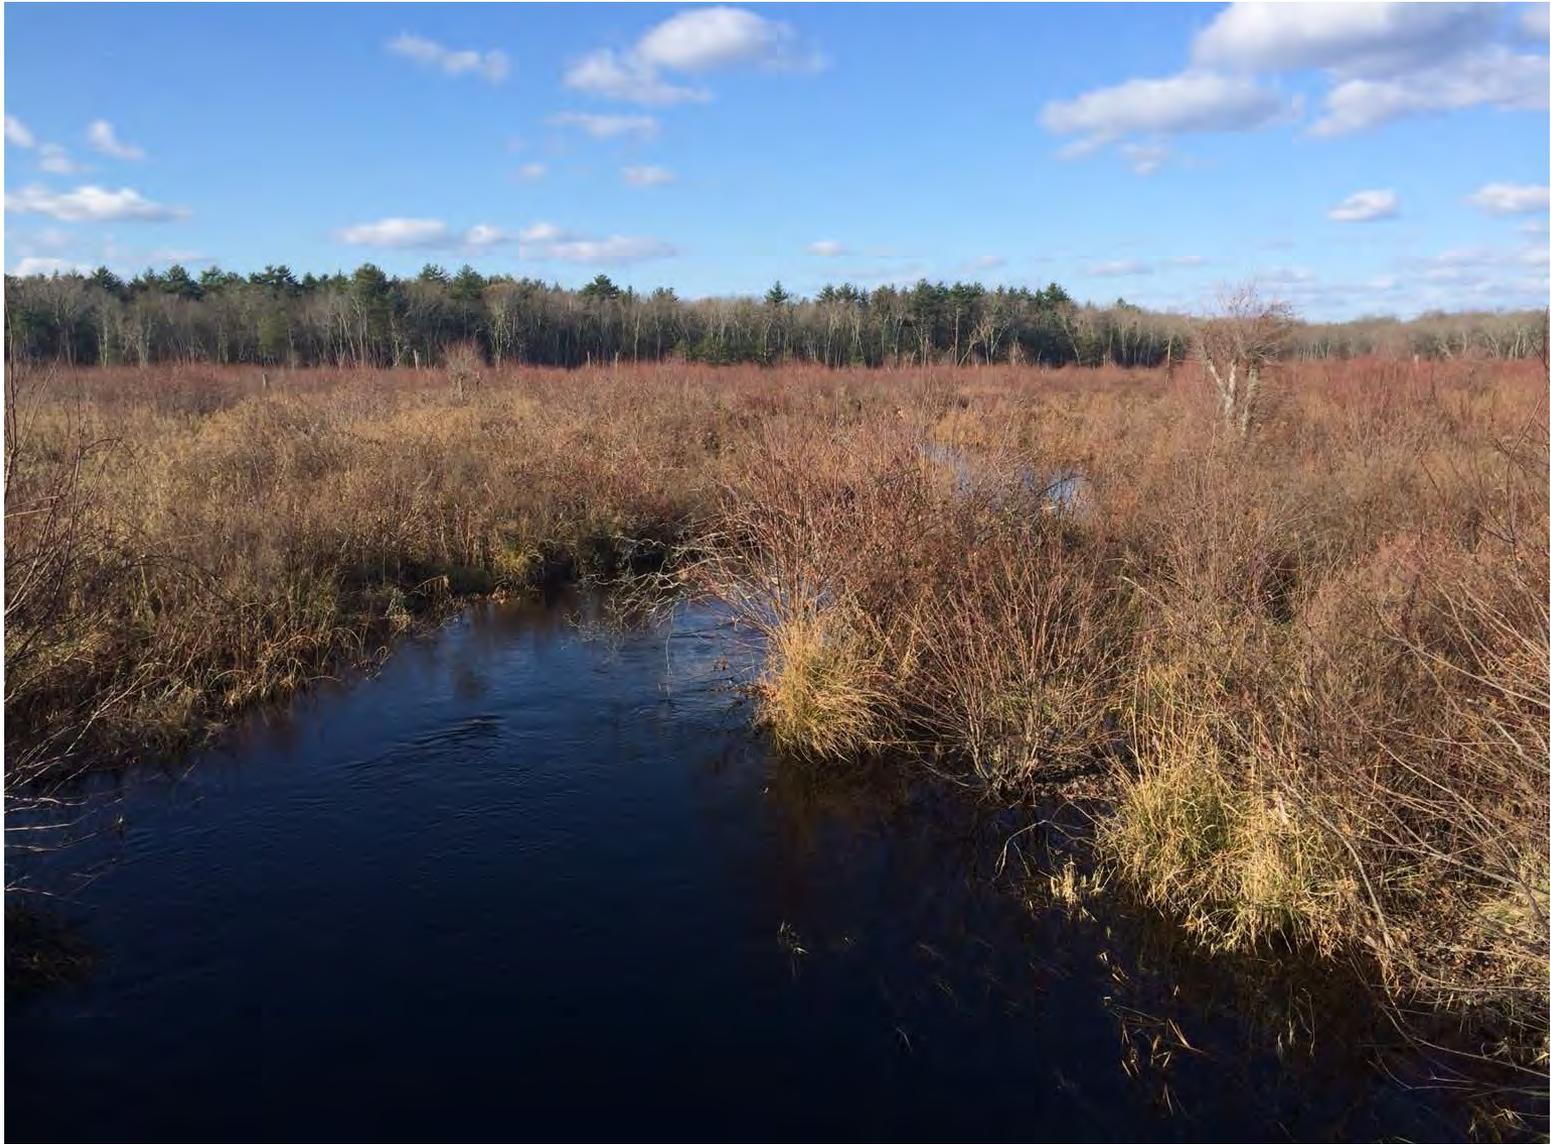
View of Paskamansett River, water is high.

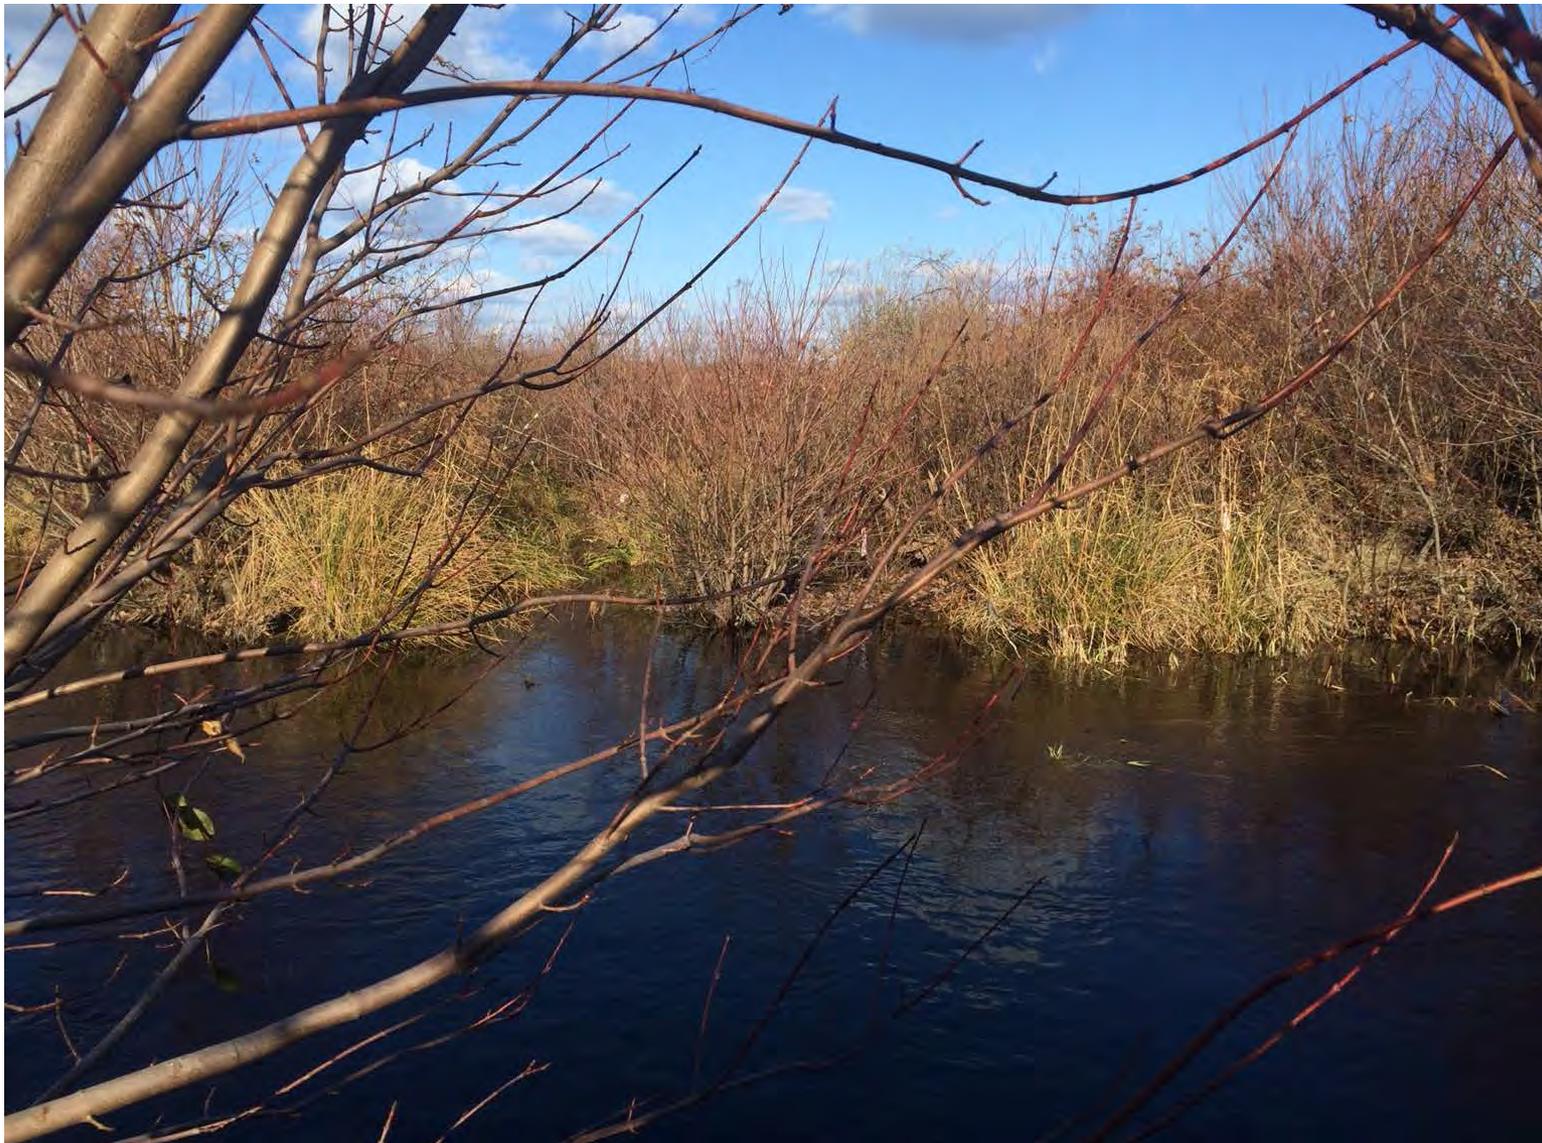
View of vegetated banks of Paskamansett River, many of the planted shrubs are 5 to 7 feet tall.

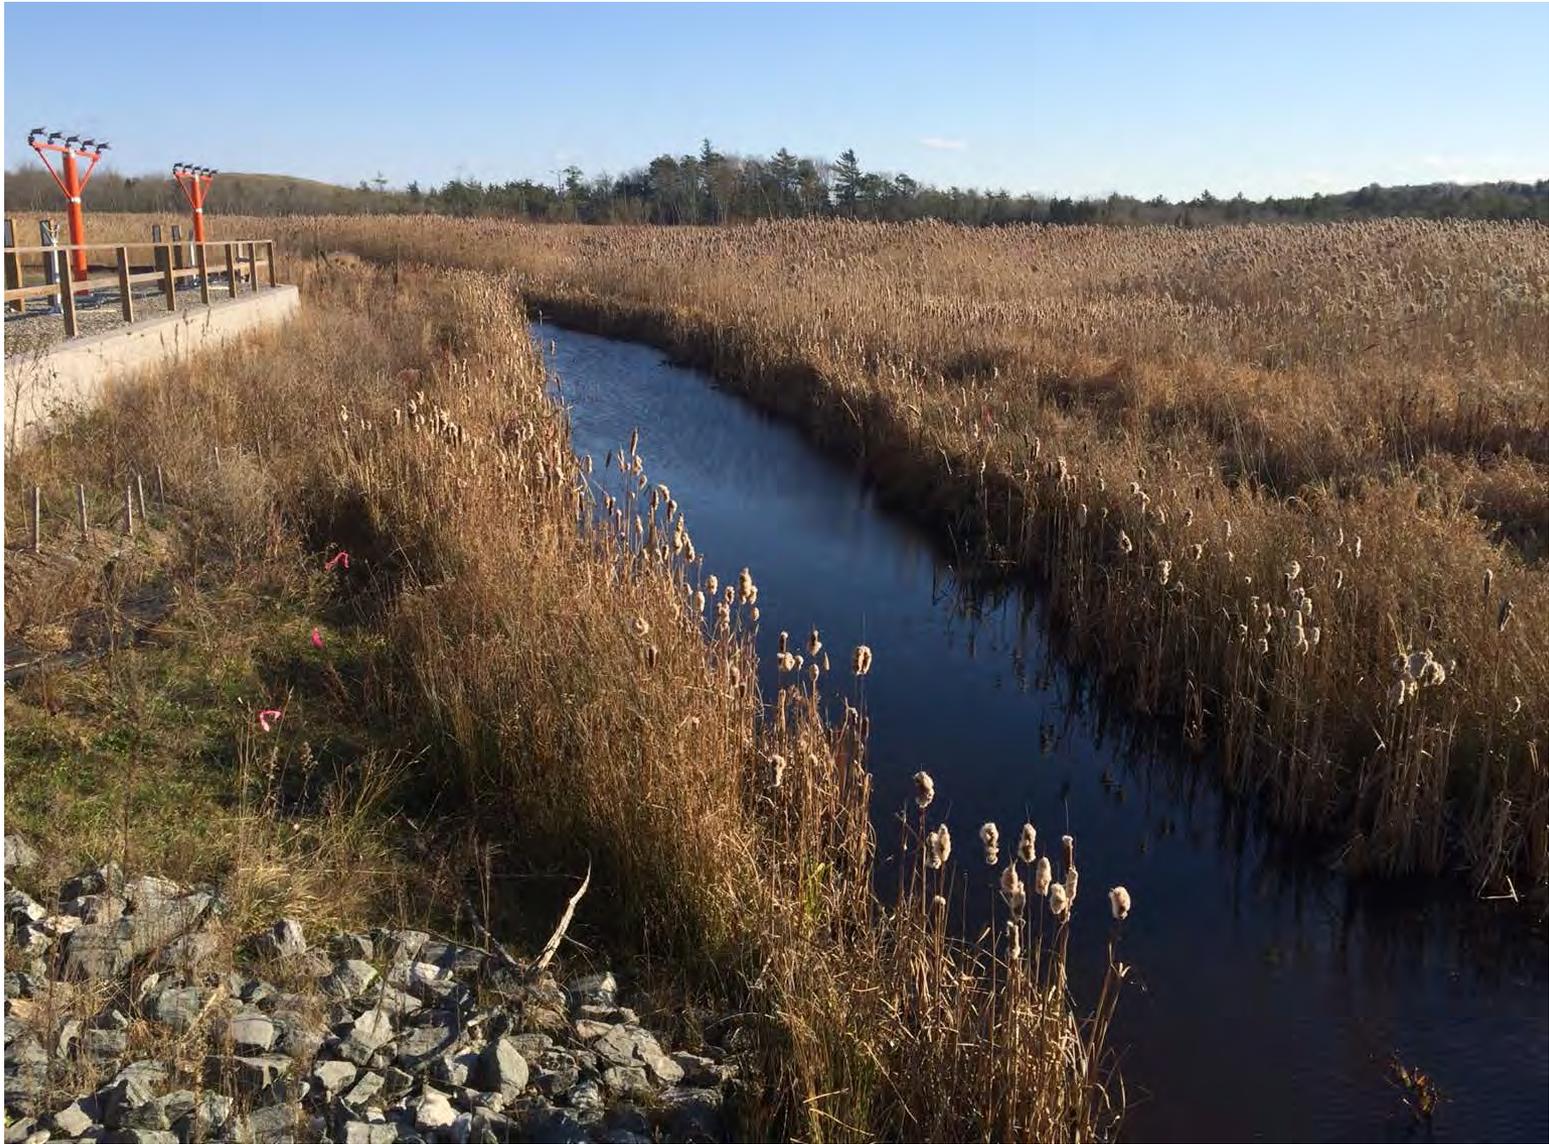
View of southern portion of West Ditch during high water condition.

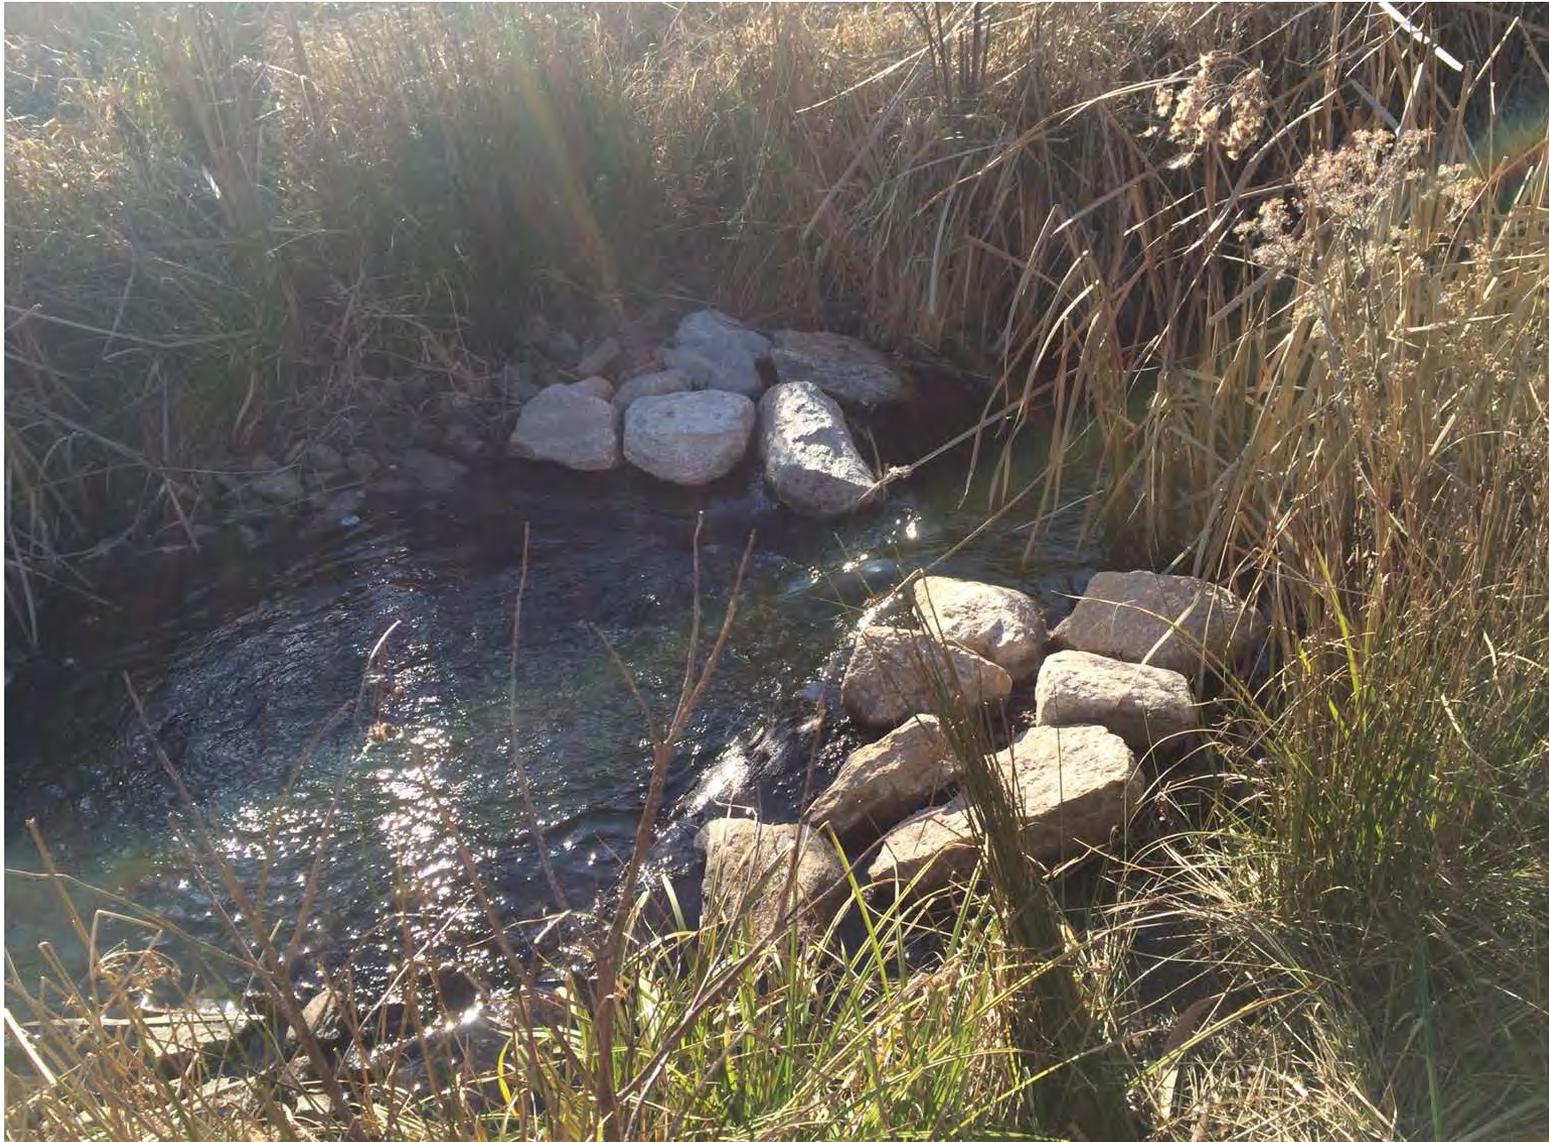
View of newly installed large rocks as part of channel constrictor to shore up design.

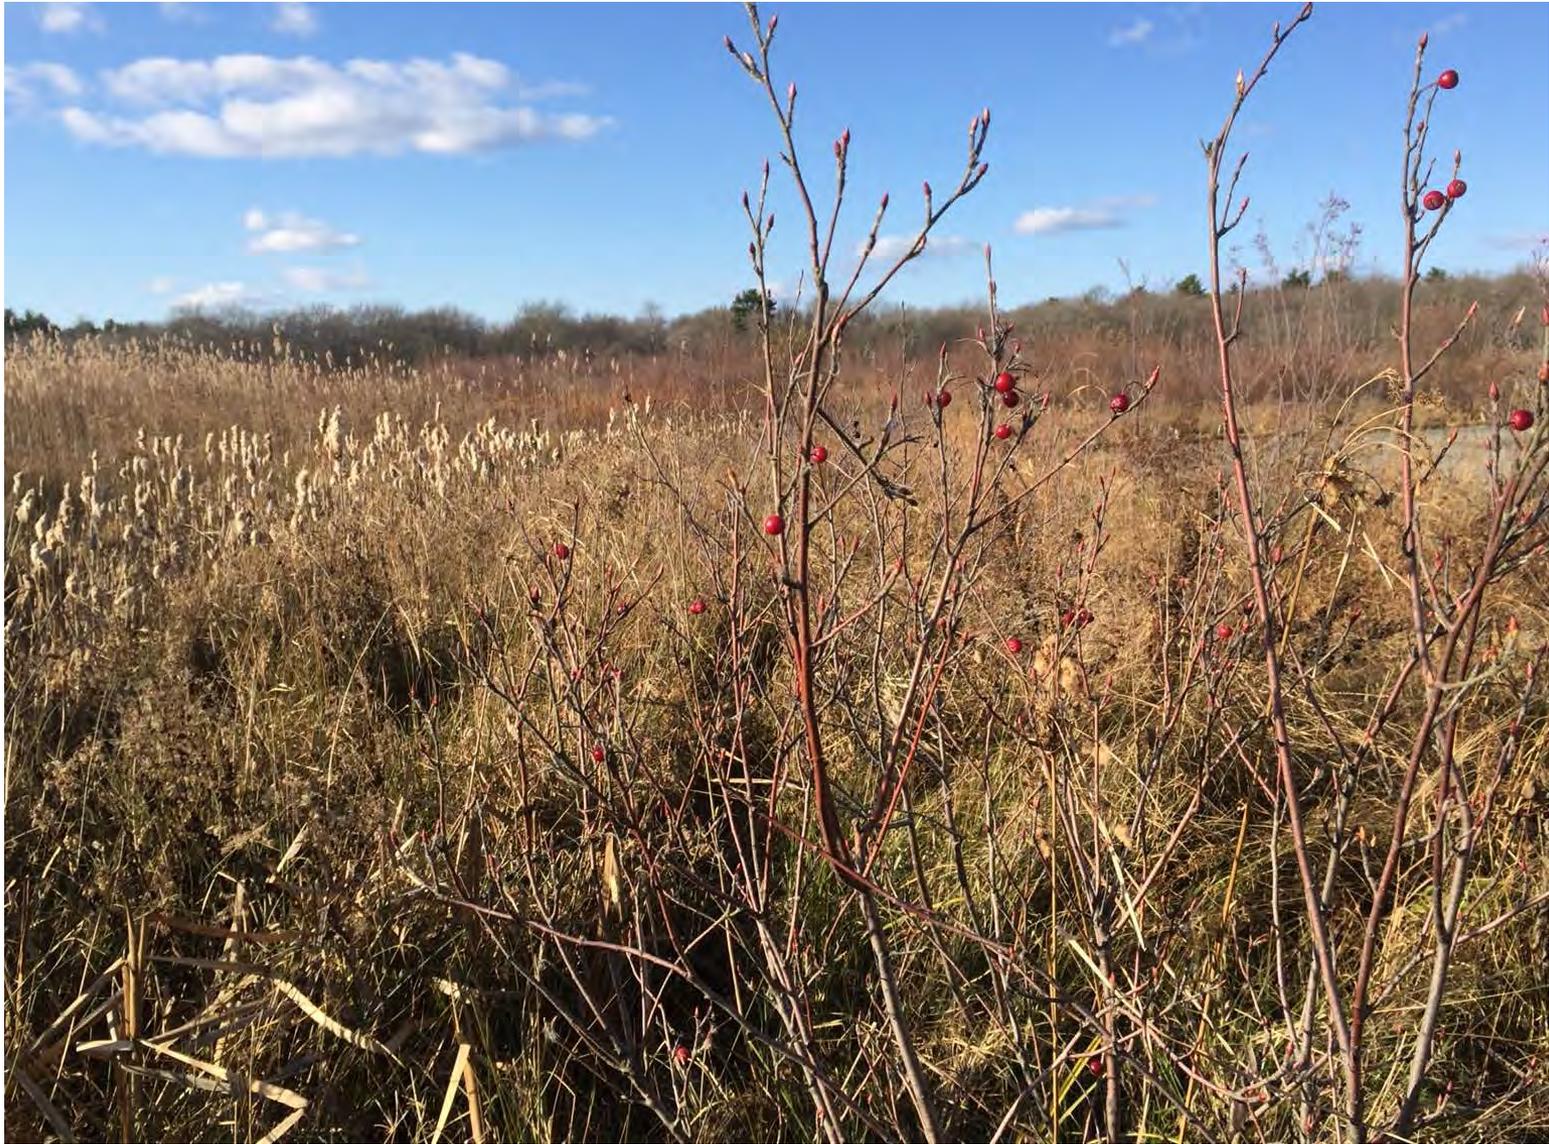
View of planted Aronia shrub along West Ditch.

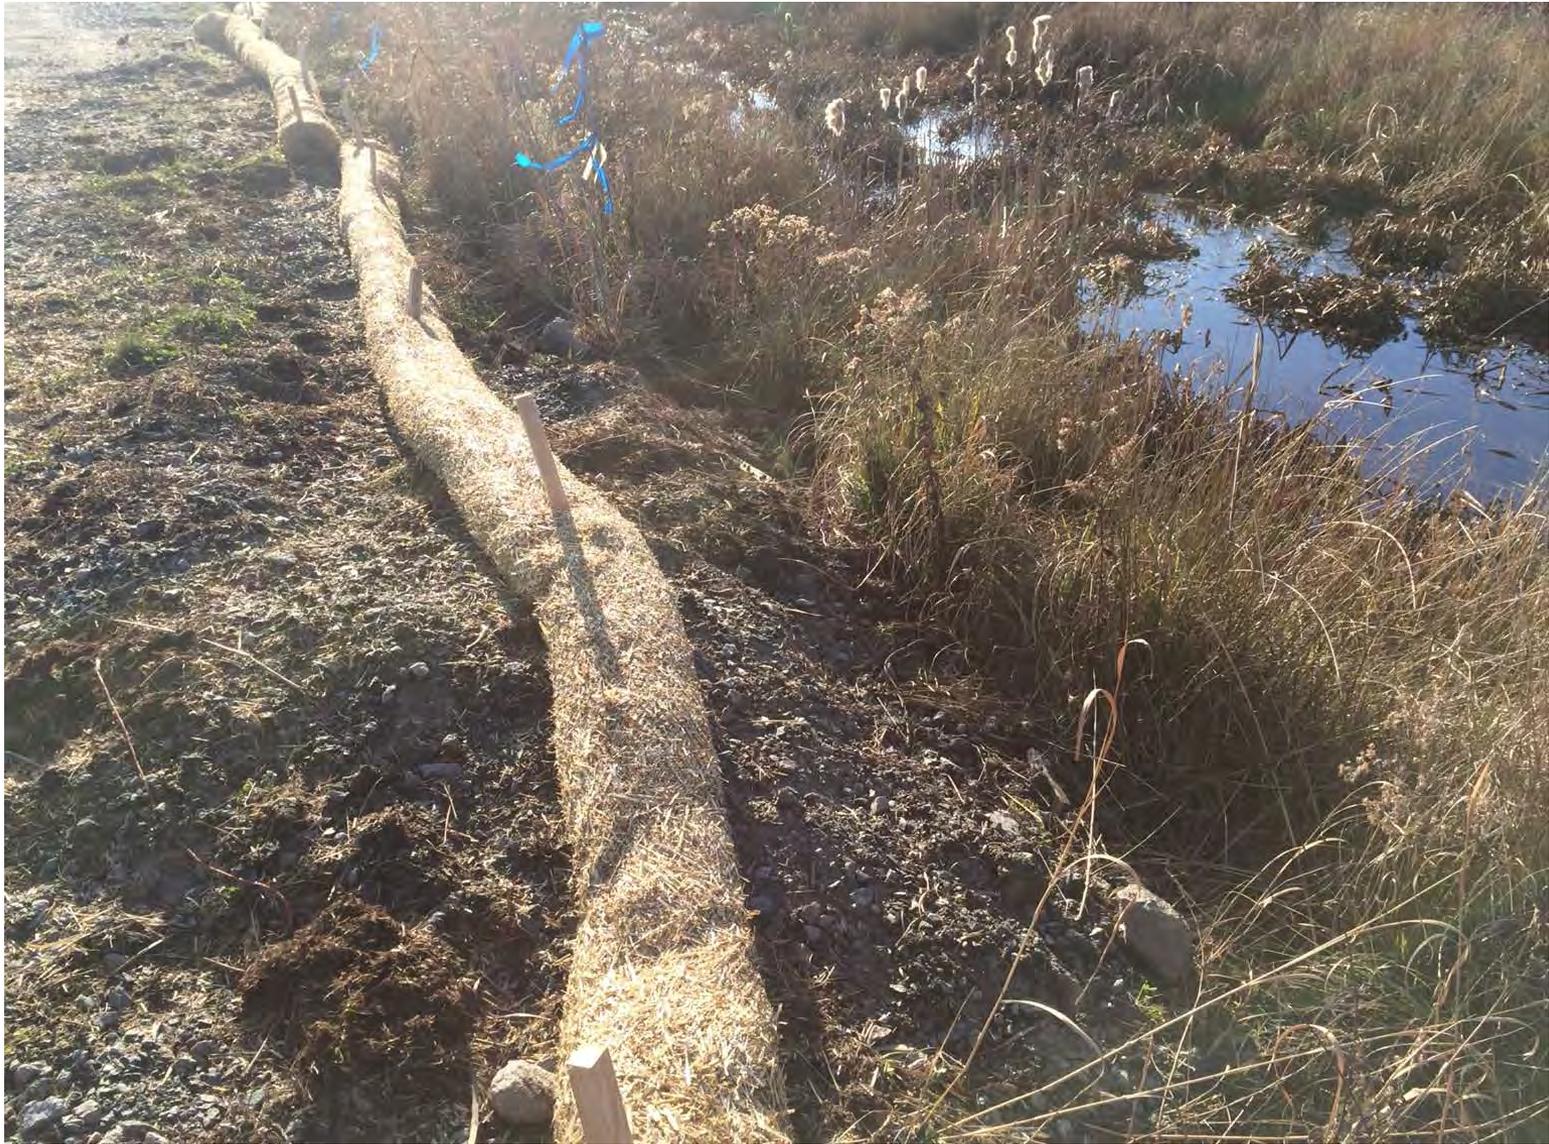
View of straw wattle installation along West Ditch.

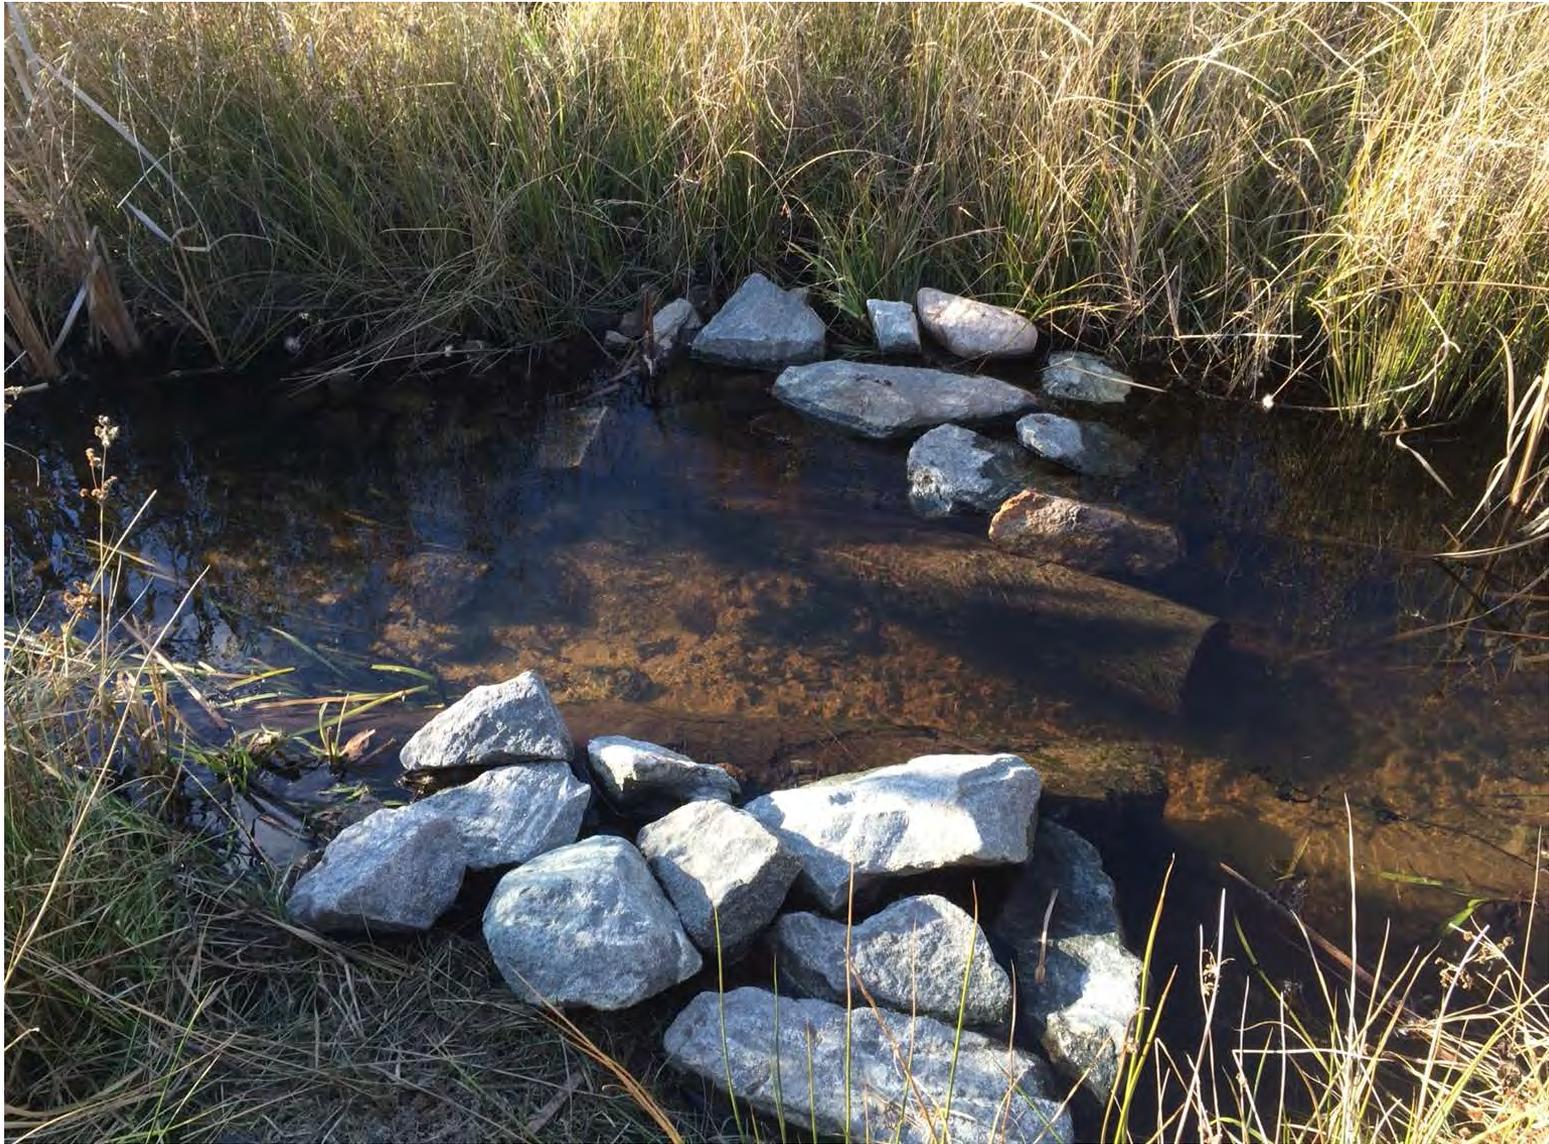
View of newly installed large rocks as part of 2nd channel constrictor to shore up design.
