MassDEP File No. SE 049-0635

New Bedford Regional Airport Runway Safety Improvements Project

Post Construction Monthly Wetlands Plantings Assessment – November 2014

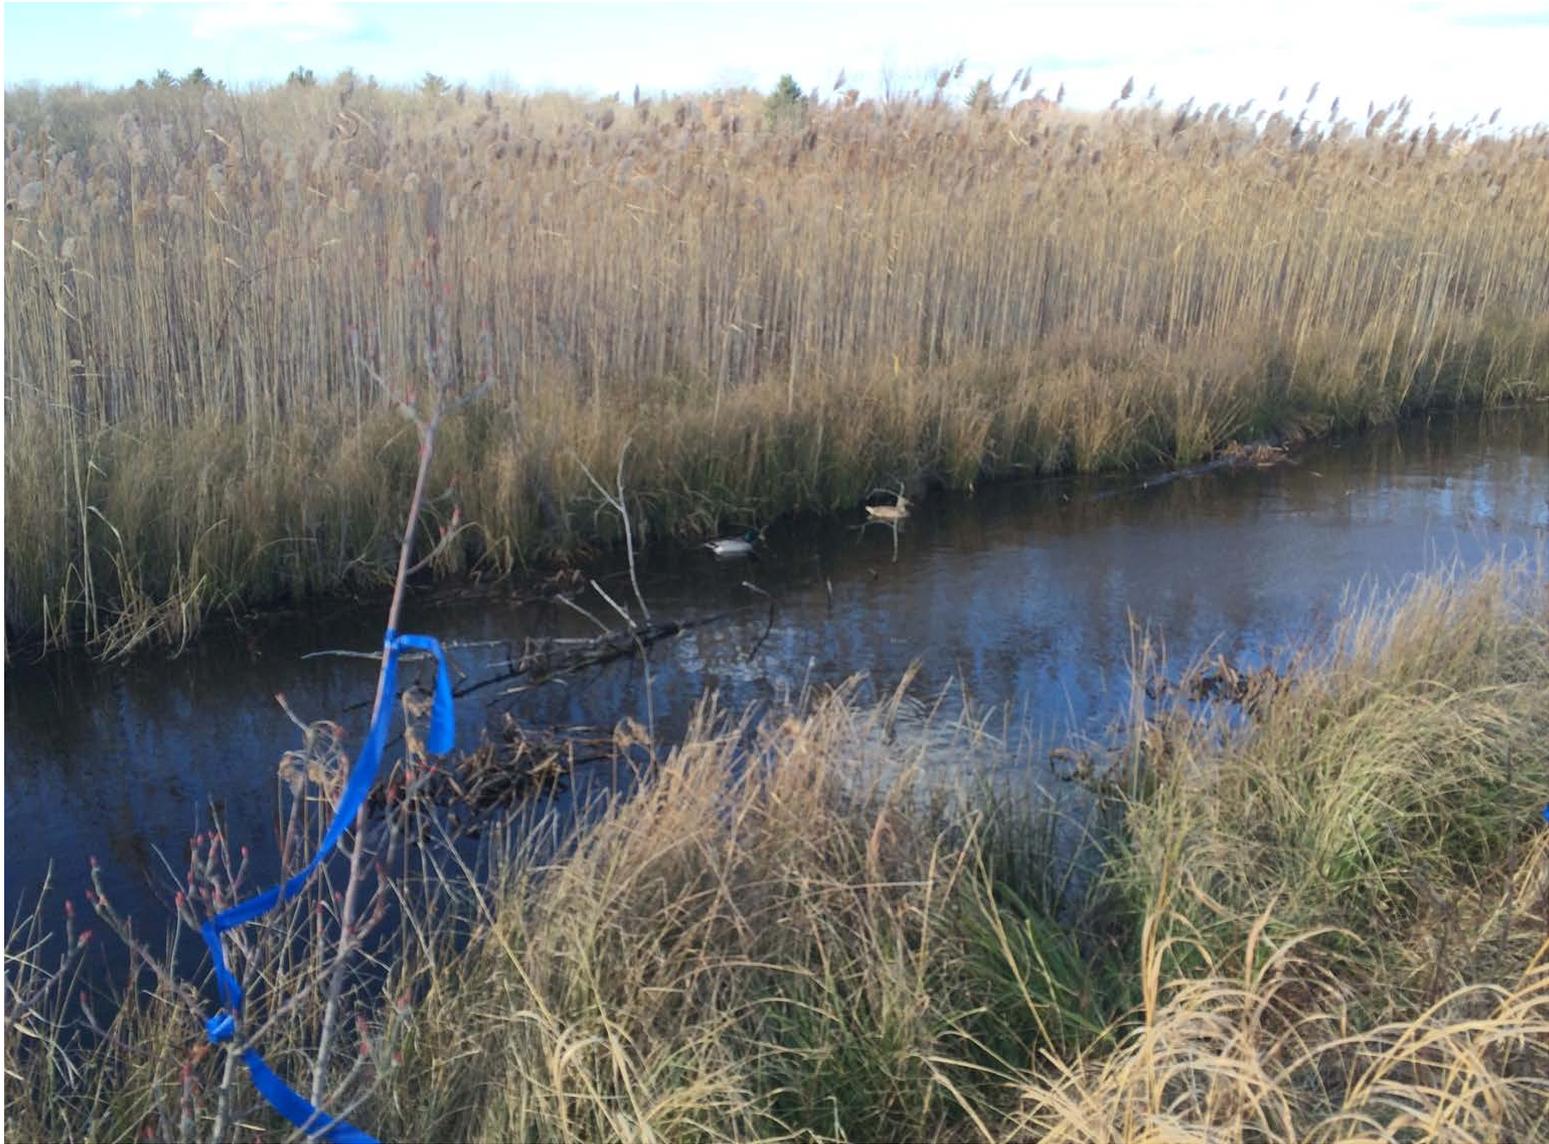
View of West Ditch and mallards utilizing resource.
