May 23, 2013

**Subject: Spring 2013 Cap Inspection
Keith Middle School
New Bedford, Massachusetts**

SITE PHOTOGRAPHS
April 2013 Cap Inspection
Keith Middle School
New Bedford, Massachusetts

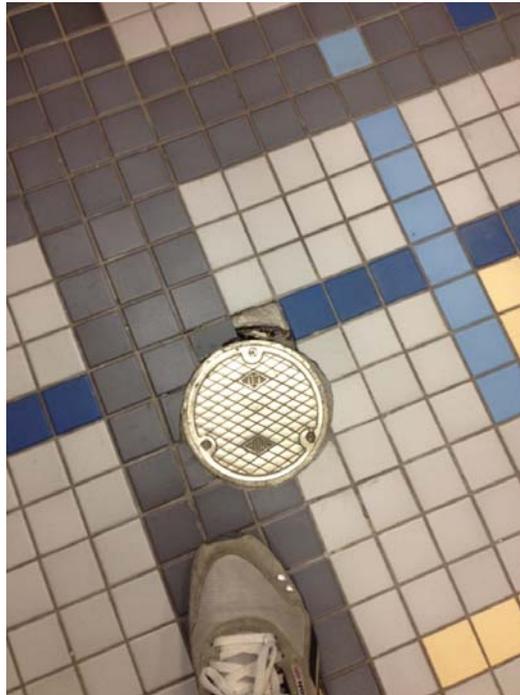
A crack greater than 1/4-inch wide was observed in the Men's Gym Locker Room, see Photograph #1. The crack was discussed with Gary Gomes who informed TRC that it would be repaired. Four cracks in the boiler room floor are less than 1/4-inch wide and have not increased in size, see Photographs #2 and #3. Three minor cracks in storage room 44 are also less than 1/4-inch wide and have not increased in size, see Photograph #4. The majority of interior concrete floors are covered with tiles or other type of flooring material. Based on visual inspection and conversations with current employees, there are no breaches or other significant damage or deterioration of the interior surficial flooring materials or, where visible, concrete floors. No construction was occurring within the building at the time of the inspection.

1) A crack greater than 1/4-inch wide was observed around the floor drain in the Men's Gym Locker Room, see Photograph #1.

1) Crack in Men's Gym Locker Room floor.

- A crack greater than 1/4-inch wide was observed in the Men's Gym Locker Room and should be repaired.
- Animal burrows were observed on the north, west, and southwest slopes.

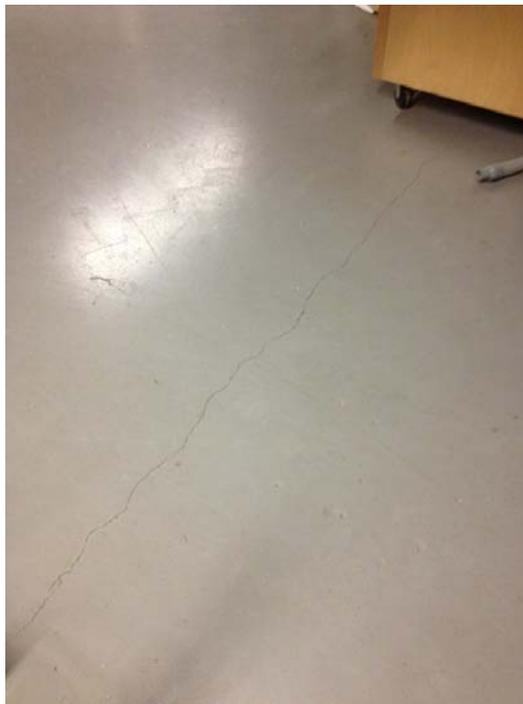
2) Minor crack in boiler room floor.

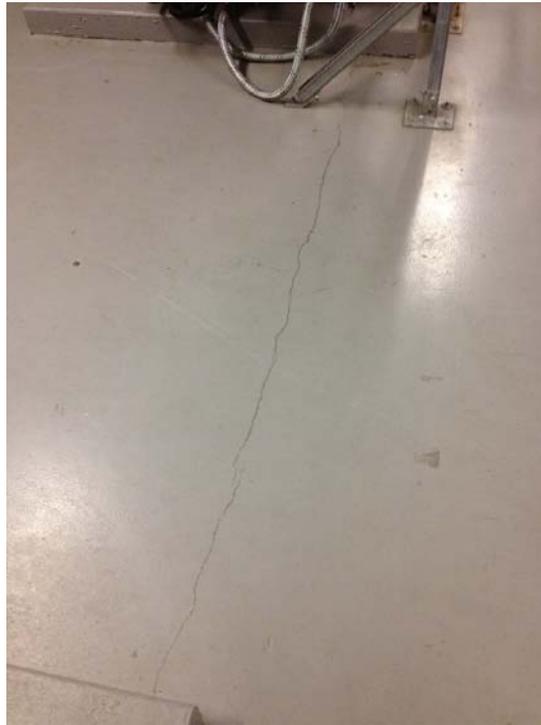
3) Minor crack in boiler room floor.

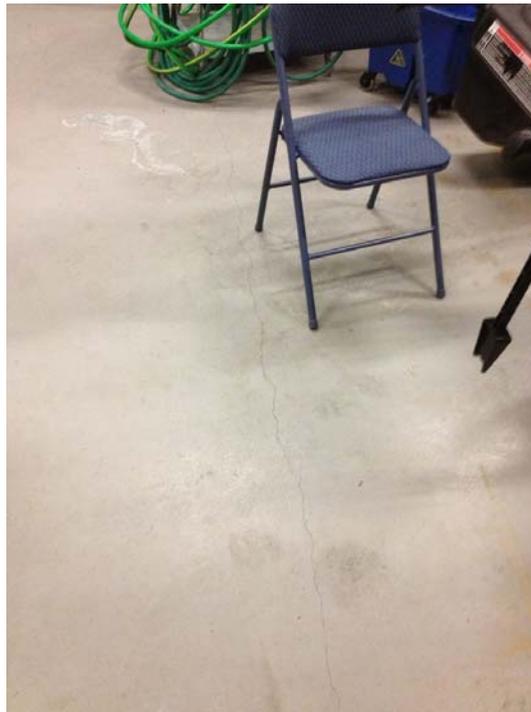
4) Minor crack in storage room 44 floor.

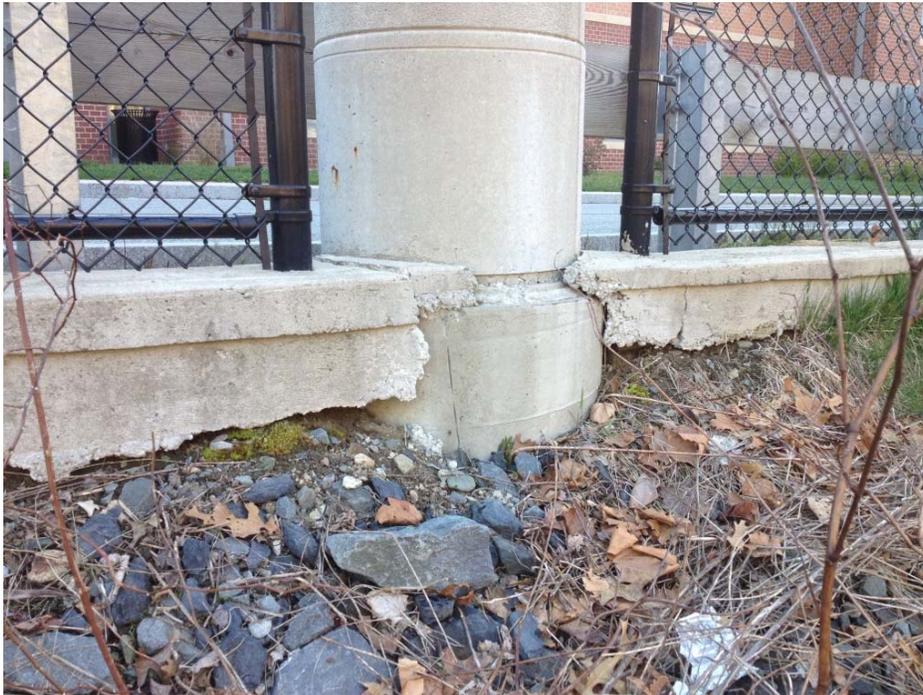
- Sloughing riprap is undermining the concrete fence support at the top of the slope, and filling the outlet of the storm water drainage culvert on the west side of the Site. Areas of soil erosion were observed along the upper slope, as well as a crack in the concrete fence support. The area appears relatively stable at this time, but the condition is likely due to an increase in steepness. The crack in the concrete fence support is not identified as a cap integrity issue, nor is the riprap accumulating in the culvert outlet, but these issues should be addressed to maintain the integrity of the fence and the function of the culvert.

- 1) The structural integrity of the fence may be compromised if the sloughing and erosion continues, see Photograph #5. The cap soils beneath the riprap may also become exposed and susceptible to erosion. The area appears stable at the moment, but the condition is likely due to an increase in steepness beyond the cap design slope. The extent of erosion seems similar to the conditions observed during several previous inspections. See inspection report letters dated January 24, 2013, May 4, 2012 and August 31, 2011.

5) Undermining of concrete structure for fence west of school.

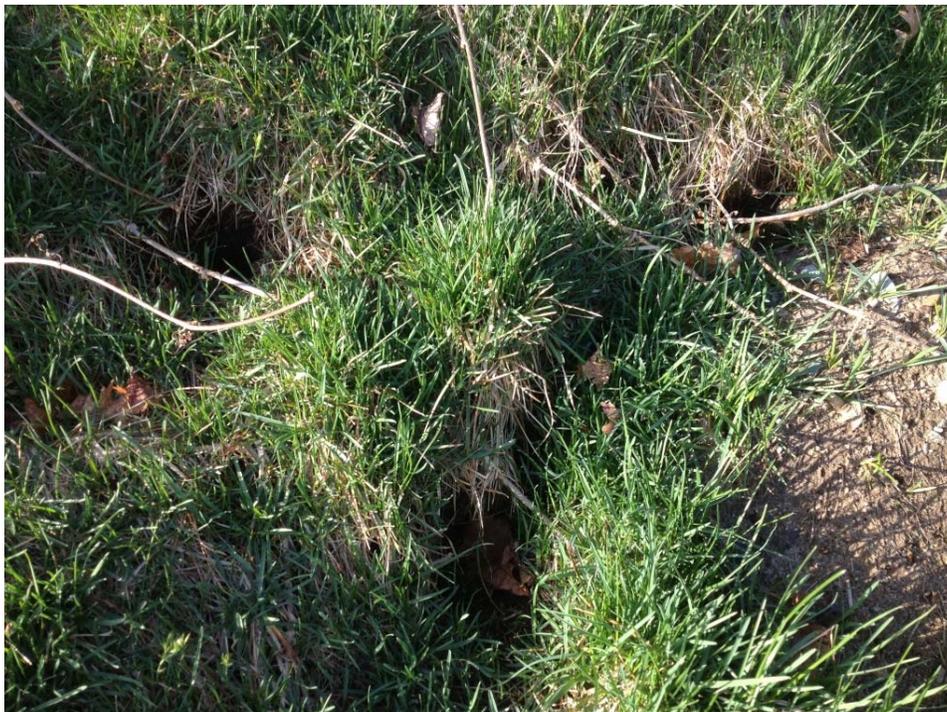
- 2) Animal burrow holes were observed on the slopes to the north, west and southwest of the school, see Photographs #6, #7 and #8. Potentially deep rooted vegetation was observed on the slope to the south and west of the school and should be cut down, see Photographs #9 and #10.

6) Animal burrows at northern slope of cap.

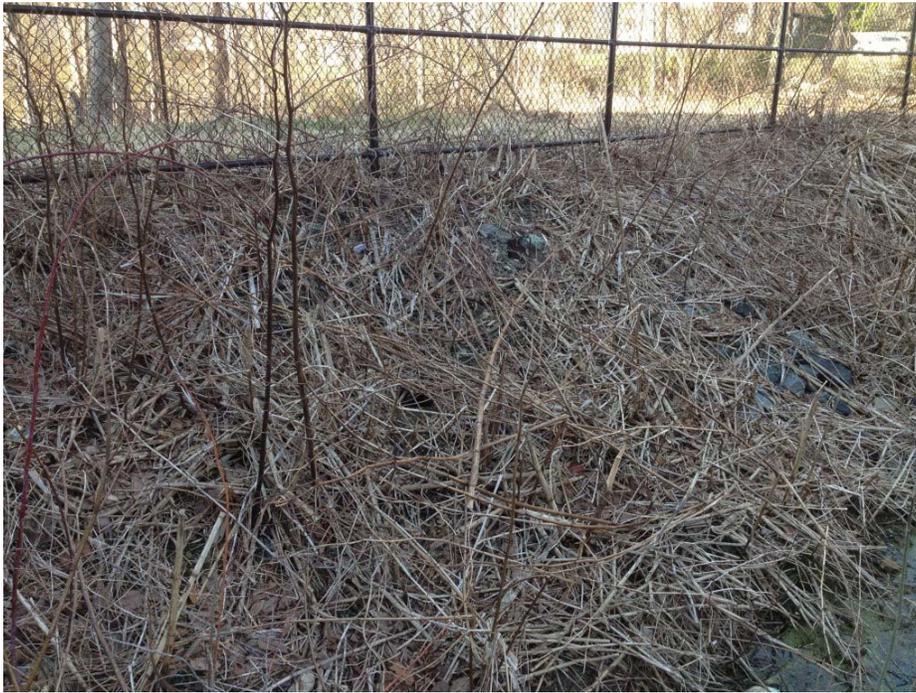
7) Animal burrows along land bridge to the west of the school.

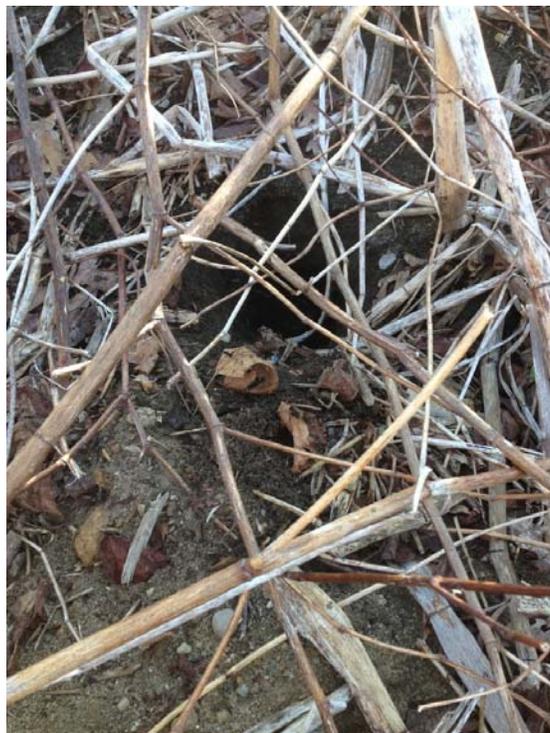
8) Animal burrows at southwestern slope of cap.

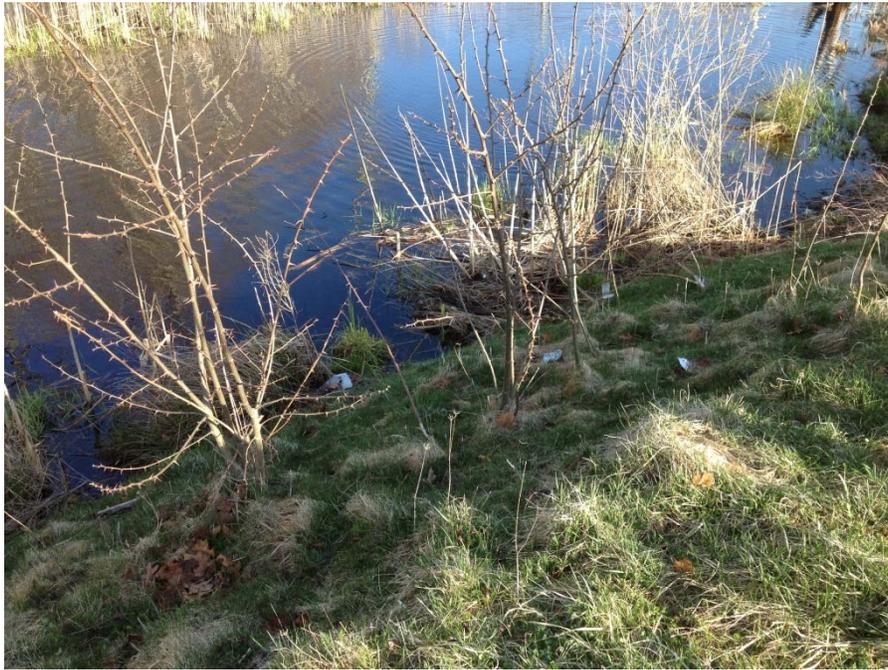
9) Potentially deep-rooted vegetation at western slope of cap.

- Potentially deep rooted vegetation was observed on the ridge of the western, southern and southwestern slopes and should be cut down.

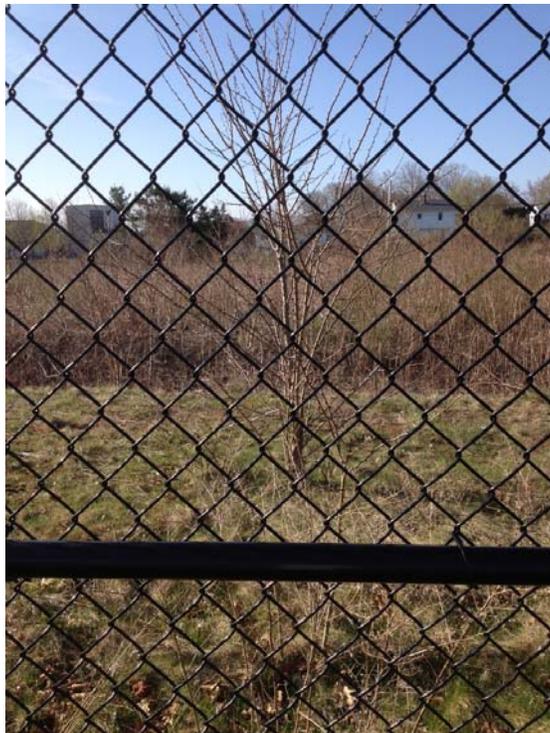
10) Potentially deep-rooted vegetation at southern slope of cap.

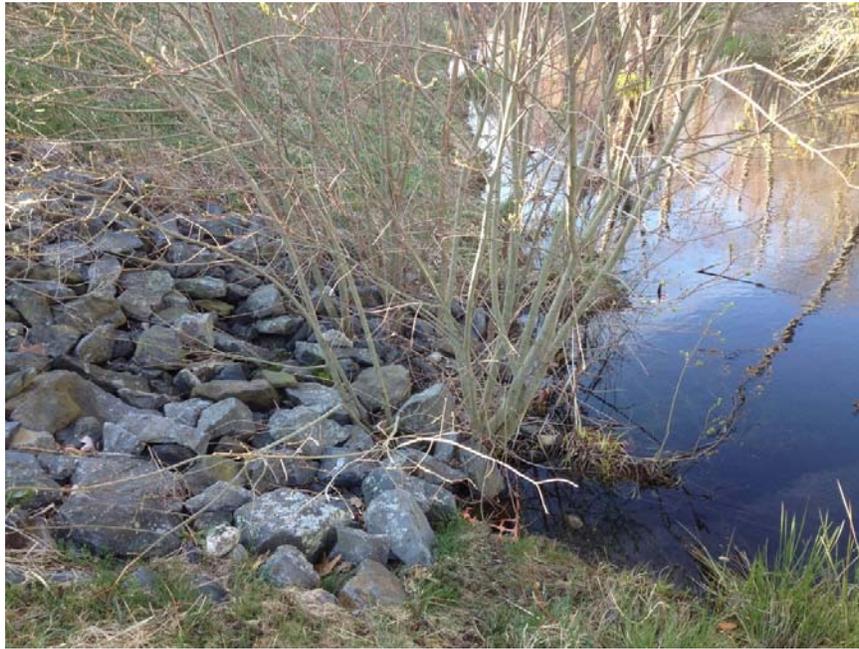
- 3) Potentially deep rooted vegetation was observed by riprap at the base of the slope to the west of the school, see Photograph #11. The orange snow fence protruding in this location appears to be located at the transition from the school slope area to the wetland remediation area. The area appears very stable, is covered in large-diameter riprap, and does not show any signs of erosion. The deep rooted vegetation in this area should be cut down to ground level.

11) Potentially deep-rooted vegetation at western slope of cap by rip rap.
