August 31, 2011

**Subject: Summer 2011 Cap Inspection  
Keith Middle School  
New Bedford, Massachusetts**

**SITE PHOTOGRAPHS**  
**August 2011 Cap Inspection**  
**Keith Middle School**  
**New Bedford, Massachusetts**

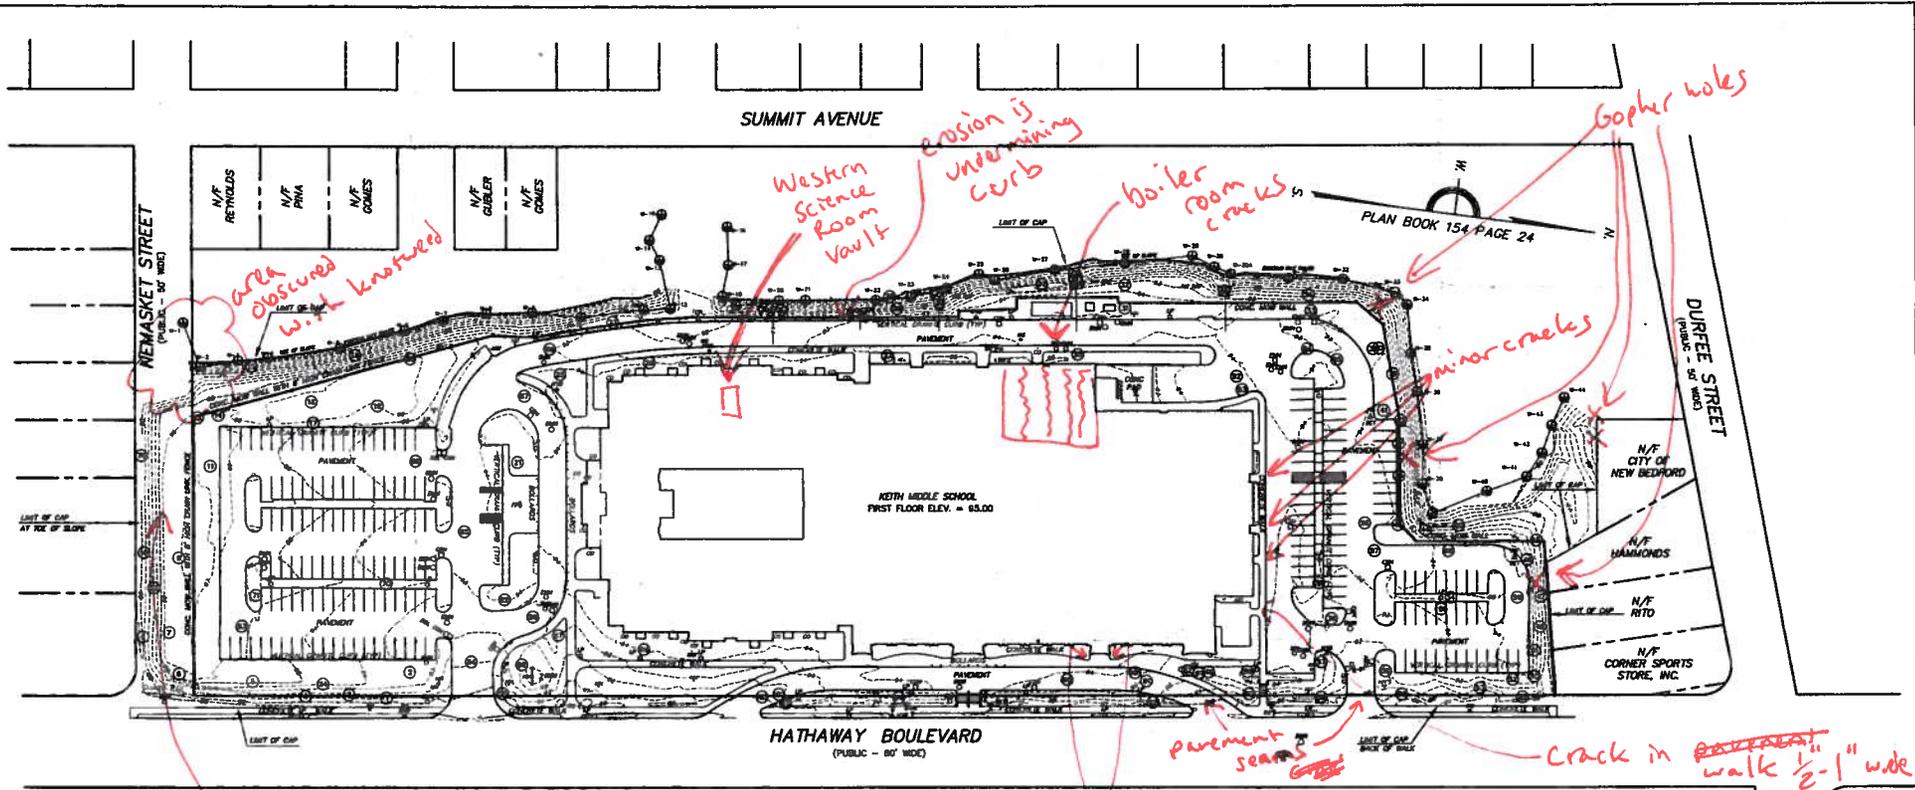
**AS-BUILT PLAN OF LAND**  
 LOCATED ON  
 HATHAWAY BOULEVARD  
 NEW BEDFORD, MASSACHUSETTS  
 OWNED BY  
 CITY OF NEW BEDFORD  
 DECEMBER 11, 2006 SCALE: 50 FEET TO AN INCH

area OK, but needs topsoil

erosion under walkway. need to address landscaping

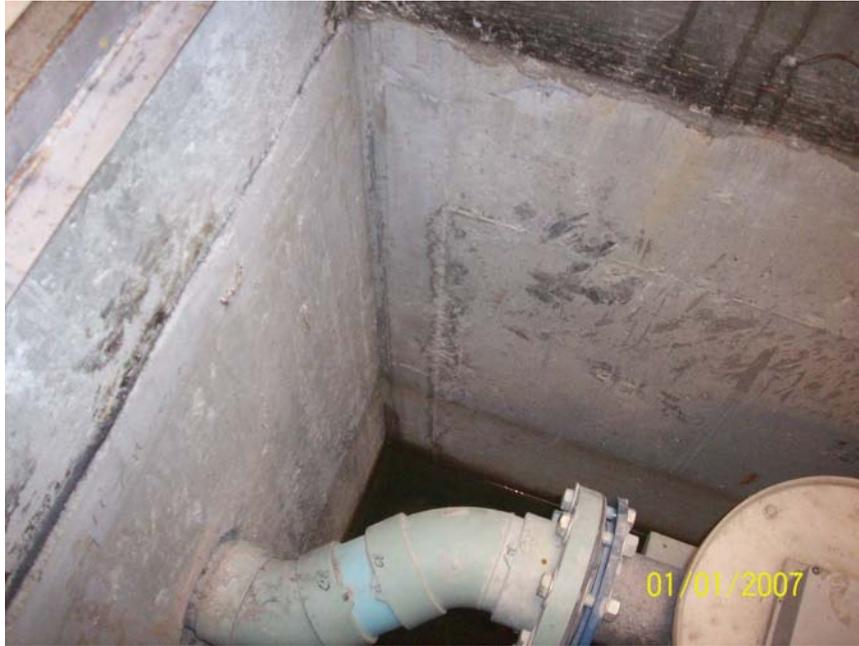
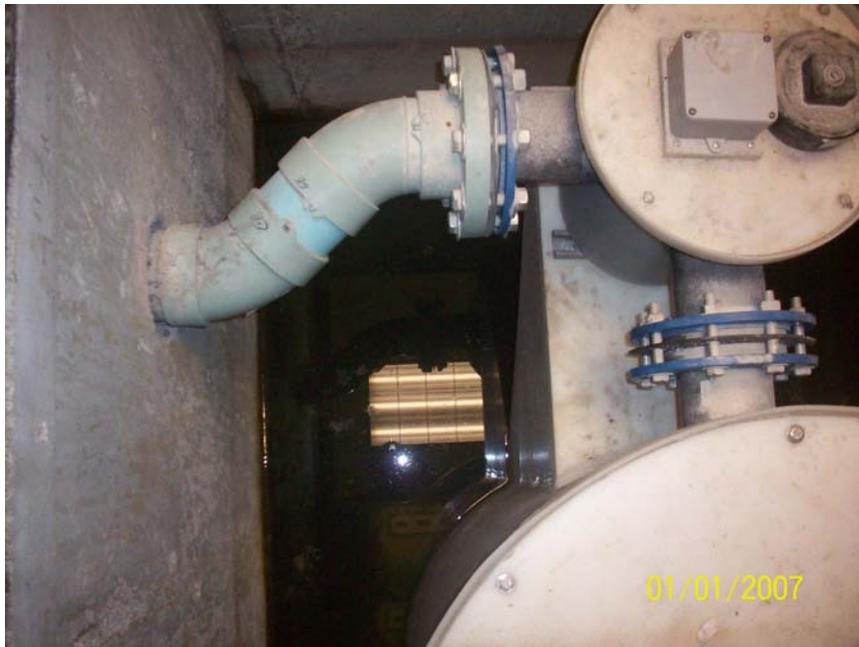
Based on TRC's inspection, the concrete floor within the footprint of the building is currently acting to prevent exposure to the impacted fill beneath. Four minor cracks were noted in the boiler room floor. Approximately one foot of standing water was observed in a sub-slab vault adjacent to the western science classroom. The source of the water in the vault is not known at this time but the volume of water appears to have increased since the April 2011 inspection. The vault space is traversed by drain lines from the science rooms. Alternatively, the water could indicate groundwater seepage, although observations of topography in the vicinity of the building and the water level in the wetland to the west of the school suggest that the groundwater elevation would be lower than the floor of the vault. Note that site compounds of concern are listed as non- or minimally-volatile, and

Approximately 1 foot of water was observed in the sub-slab concrete vault located adjacent to the western science classrooms, see Photographs #1 and #2. The bottom of the vault could not be fully examined due to the presence of water, and the source of the water could not be determined.

The observable portions of the concrete vault and associated piping appeared intact, but the source of the water in the vault could not be determined. The presence of this water should be investigated further.

**1) Standing water in science room vault.**

**2) Standing water in science room vault.**

fabric. Also, we are available to discuss potential follow-up regarding the observation of water in the vault.

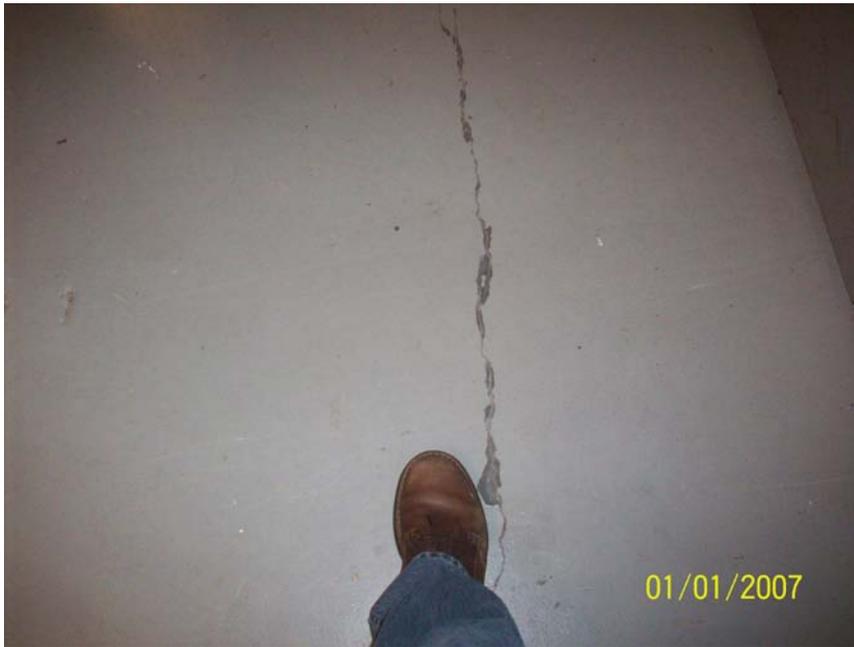
Four cracks in the boiler room floor are less than 1/4-inch wide, see Photograph #3. Pipe penetrations appeared intact, see Photograph #4. The majority of interior concrete floors are covered with tiles or other type of flooring material. Based on visual inspection and conversations with current employees, there are no breaches or other significant damage or deterioration of the interior surficial flooring materials or, where visible, concrete floors (with one potential exception noted below). No construction was occurring within the building at the time of the inspection.

**3) Minor crack in boiler room floor.**

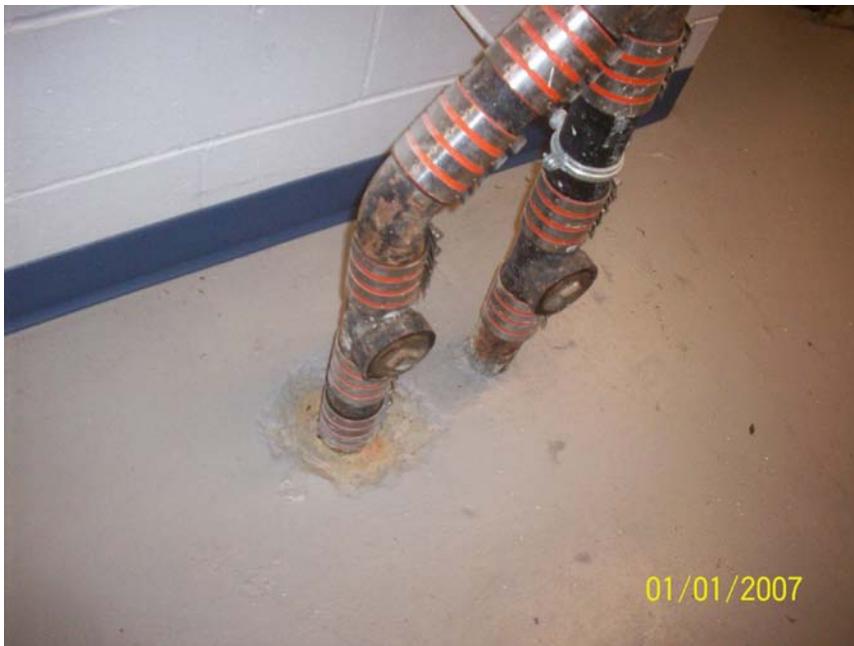
**4) Pipe penetrations in the boiler room.**

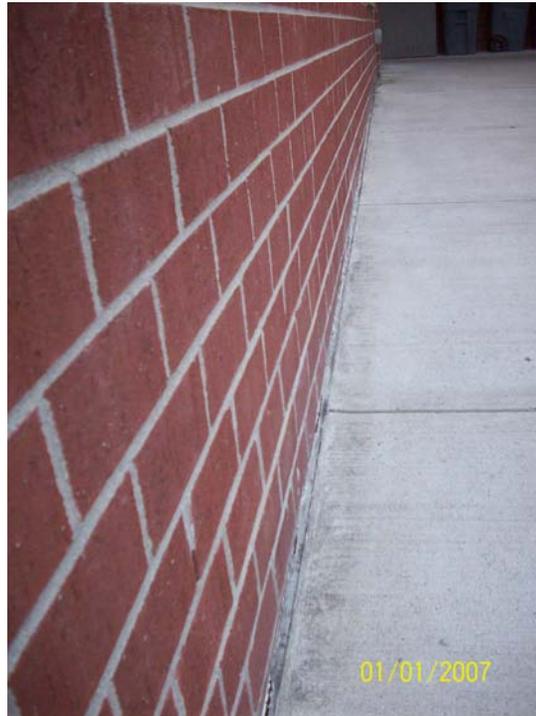
In several areas around the exterior of the school building, a bead of caulking exists in the joint between the foot of the brick building walls and the concrete walkways. The caulking prevents weather elements (i.e., rain, snow, and ice) from entering the joint space. The caulking appeared deteriorated in several areas, and was observed separating from the wall and walkway surfaces. Although conditions were not indicative of a potential for soil exposures, TRC recommends repair/replacement of the caulking. Continued infiltration of weather elements into the joint could eventually separate and deteriorate the walkway.

1) Approximate 1/2-1 inch crack in concrete, see Photographs #6 and #7. 2) Caulking in joints between brick walls and concrete walkways is deteriorating, see Photograph #5. 3) Separation of the seams of the asphalt parking lot entrances, see Photograph #8

**5) Caulking at seam between building wall and concrete walk near the service entryway. Observations did not indicate potential for soil exposure.**

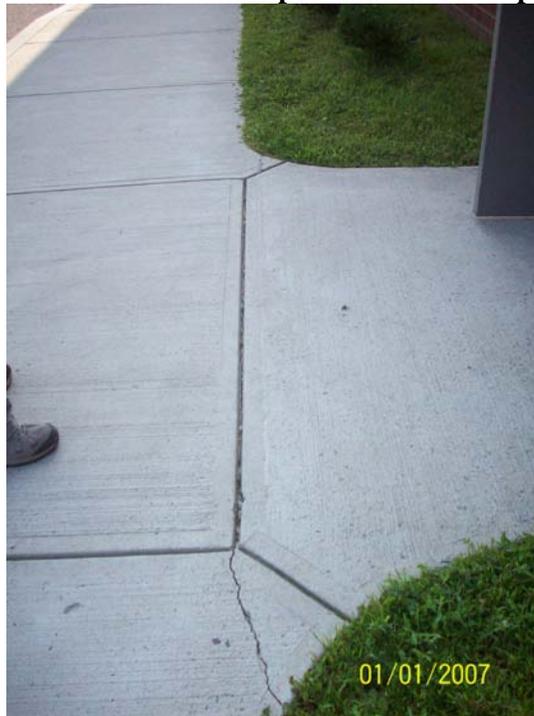
**6) Minor crack in walkway leading to community room area.**

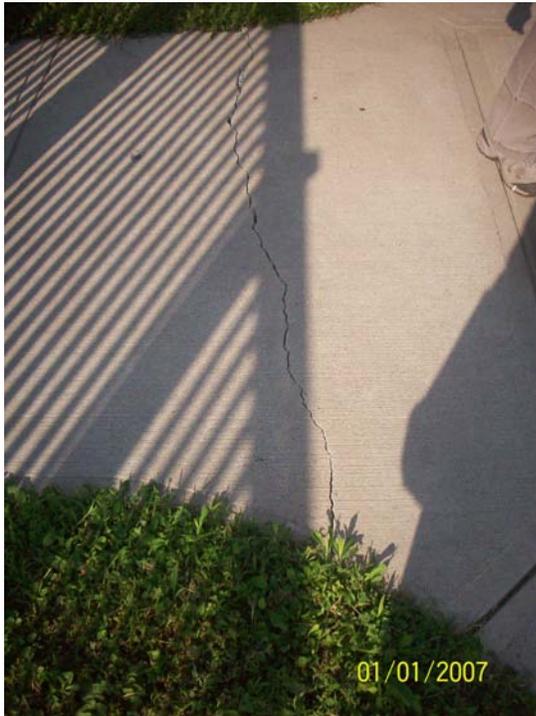
A concrete walkway leading to the community room at the northeast corner of the building exhibited a crack of approximately ½ to 1 inch in width. Cracks greater than ¼-inch are unacceptable in accordance with the LMMIP. This area should be scheduled for maintenance or repair per the LTMMIP. Cracks in the asphalt entrances to the school parking lots have become wide enough for grass to grow through and should also be addressed.

**7) Significant crack in walkway leading to community room area.**

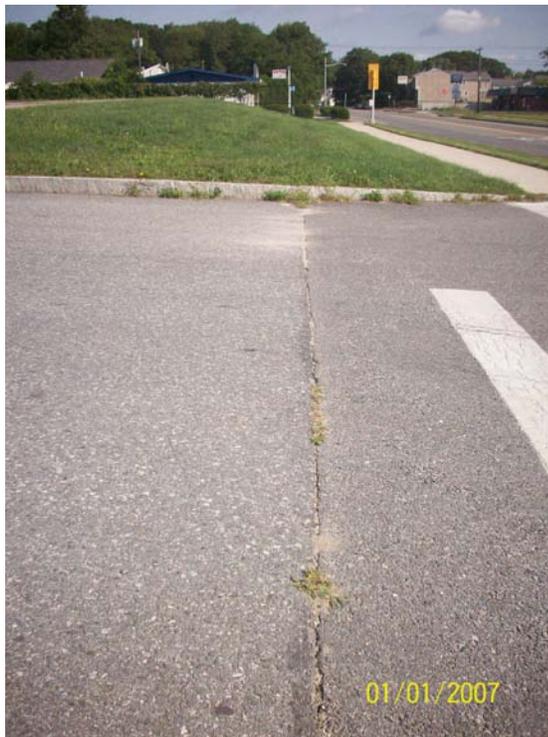
**8) Crack in asphalt parking lot north of school.**

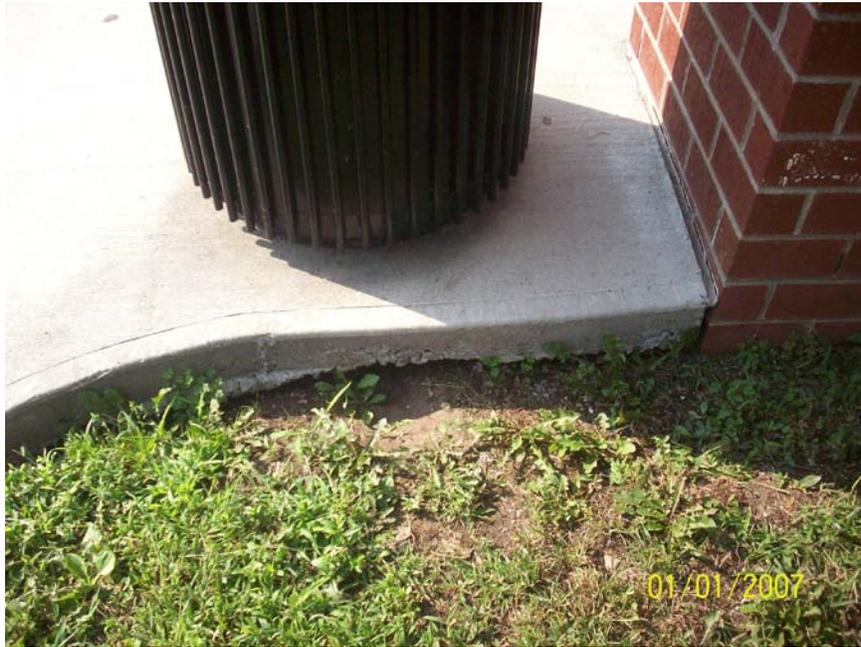
- Erosion of landscaped areas was observed adjacent to the concrete walkway entering the school building at the northern entrance from Hathaway Boulevard. The erosion has resulted in a loss of approximately 4 to 5 inches of soil. If this remains unrepaired, it could also compromise the integrity of the concrete walkway.

2. Erosion of landscaped areas was observed adjacent to the concrete walkway entering the school building at the northern entrance from Hathaway Boulevard, see Photograph #9. The erosion has resulted in a loss of approximately 4 to 5 inches of soil. If left unrepaired, this could also compromise the integrity of the concrete walkway.

**9) Undermining of concrete walkway.**

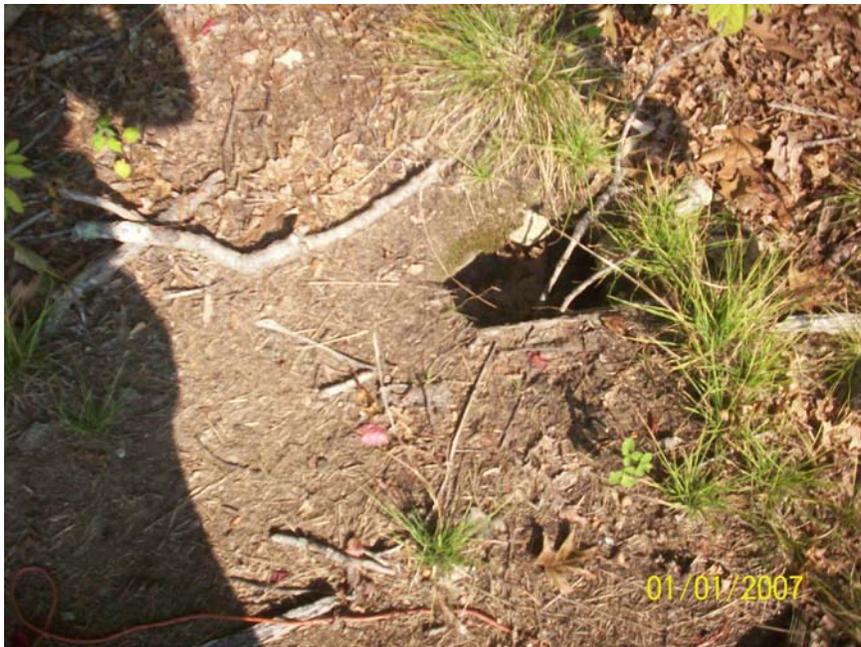
- Several small holes exist along the northern edge of the cap, which appear to have been burrowed by small animals.
- Sloughing riprap is undermining the concrete fence support at the top of the slope, and filling the outlet of the storm water drainage culvert on the west side of the Site. Very minor areas of soil erosion were observed in along the upper slope. The area appears stable at this time, but the condition is likely due to an increase in steepness beyond the cap design slope.

**11) Animal burrow north of school.**

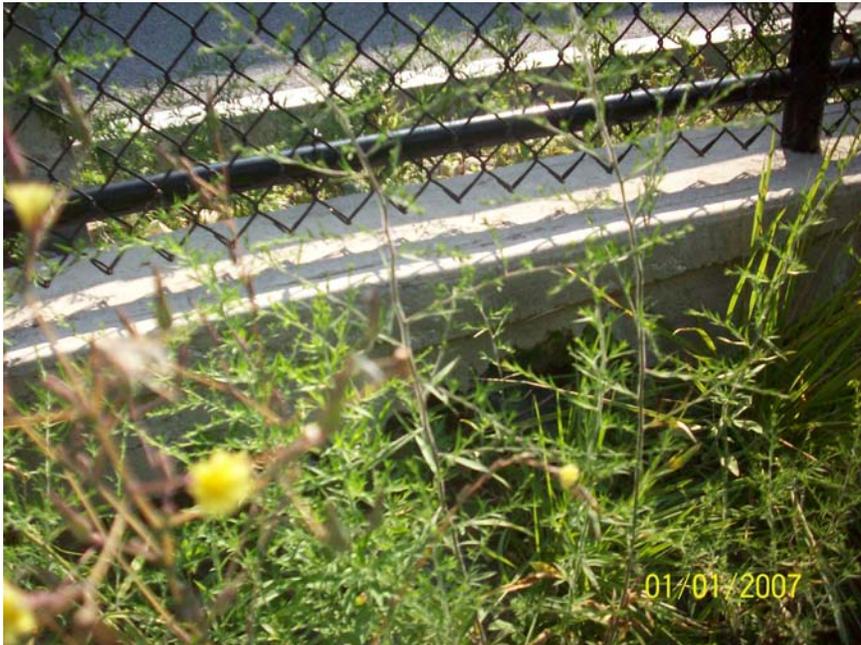
1. The structural integrity of the fence may be compromised if the sloughing and erosion continues, see Photograph #12. The cap soils beneath the riprap may also become exposed and susceptible to erosion. The area appears stable at the moment, but the condition is likely due to an increase in steepness beyond the cap design slope. The extent of erosion seems similar to the conditions observed during several previous inspections. See inspection report letters dated May 11, 2010 and December 7, 2010.

**12) Undermining of concrete structure for fence west of school.**

At this time the black separation fabric that demarcates the underlying contaminated fill from the clean imported fill is not visible. However, these areas should be repaired in order to prevent further erosion or cap damage that could eventually expose the separation

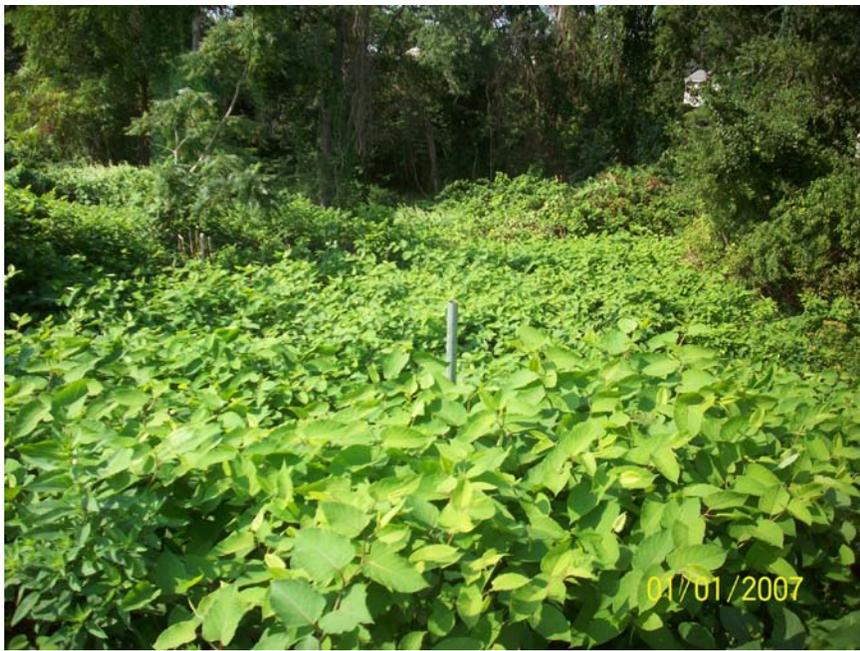
- Vegetation is sparse along the southern edge of the cap. Topsoil and perennial vegetation may prevent future erosion in this area.
- Knotweed appears to have taken root in a significant area on the southwestern edge of the cap.

**13) Knotweed-covered portion of cap southwest of school.**

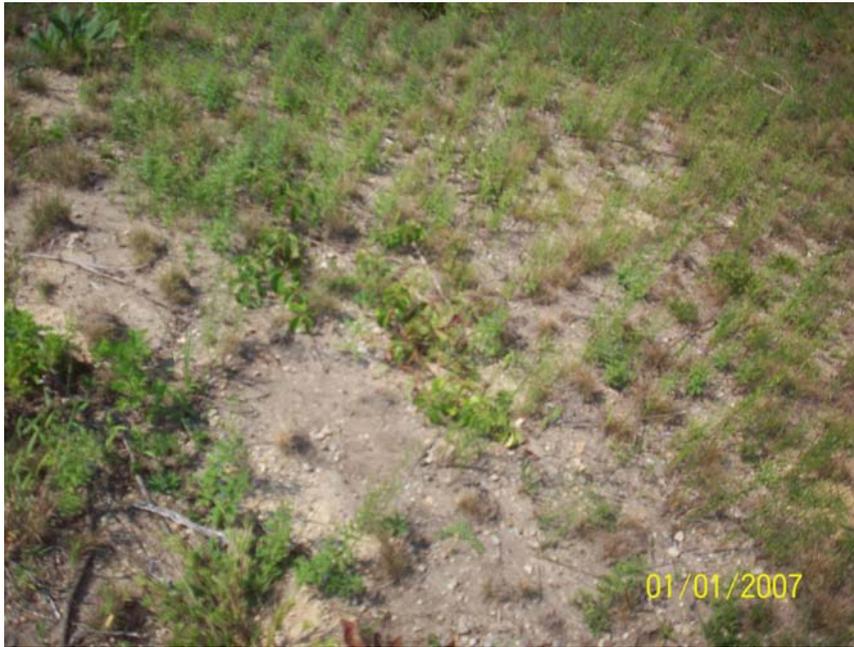
1. Some minor erosion had occurred in the past on the southern slope of the cap, as noted in the prior inspection report (dated December 7, 2010). Vegetation is present, although sparse in some areas, see Photograph #14. It is recommended that more topsoil and vegetation be added to limit future erosion.

**14) Sparse vegetation on portion of cap south of school.**
