May 4, 2012

**Subject: Spring 2012 Cap Inspection  
Keith Middle School  
New Bedford, Massachusetts**

**SITE PHOTOGRAPHS**  
**April 2012 Cap Inspection**  
**Keith Middle School**  
**New Bedford, Massachusetts**

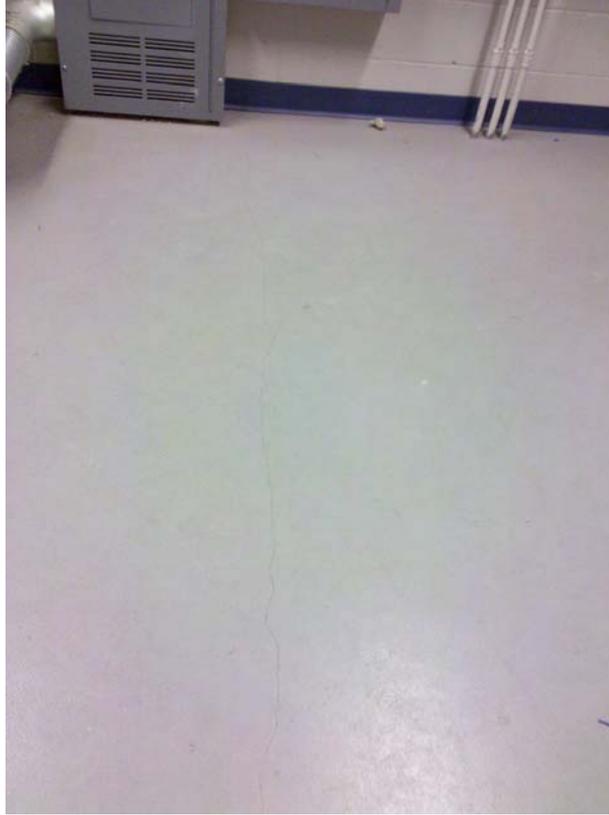
Based on TRC's inspection, the concrete floor within the footprint of the building is currently acting to prevent exposure to the impacted fill beneath. Four minor cracks were previously noted in the boiler room floor and still do not present a significant issue at this time. Three very minor cracks were also observed in storage room 44, and also do not require repairs at this time. Two hairline cracks were also noted in the Main Electric Room and the Emergency Generator Room. Each of the nine cracks noted above appears in a general east-to-west orientation.

**1) Minor crack in electric room 54 floor.**

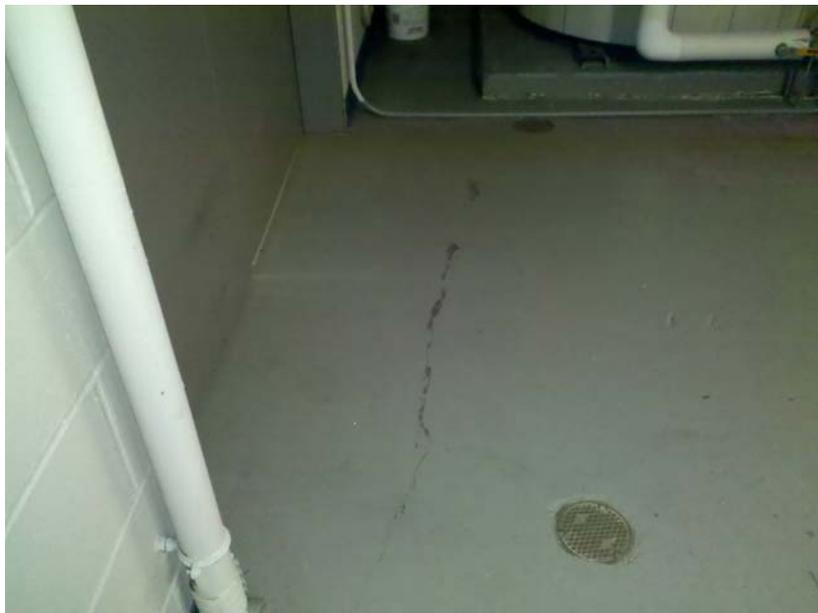
Four cracks in the boiler room floor are less than 1/4-inch wide, see Photographs #2 and #3. Three minor cracks in storage room 44 are also less than 1/4-inch wide, see Photograph #4. The majority of interior concrete floors are covered with tiles or other type of flooring material. Based on visual inspection and conversations with current employees, there are no breaches or other significant damage or deterioration of the interior surficial flooring materials or, where visible, concrete floors. No construction was occurring within the building at the time of the inspection.

**2) Minor crack in boiler room floor.**

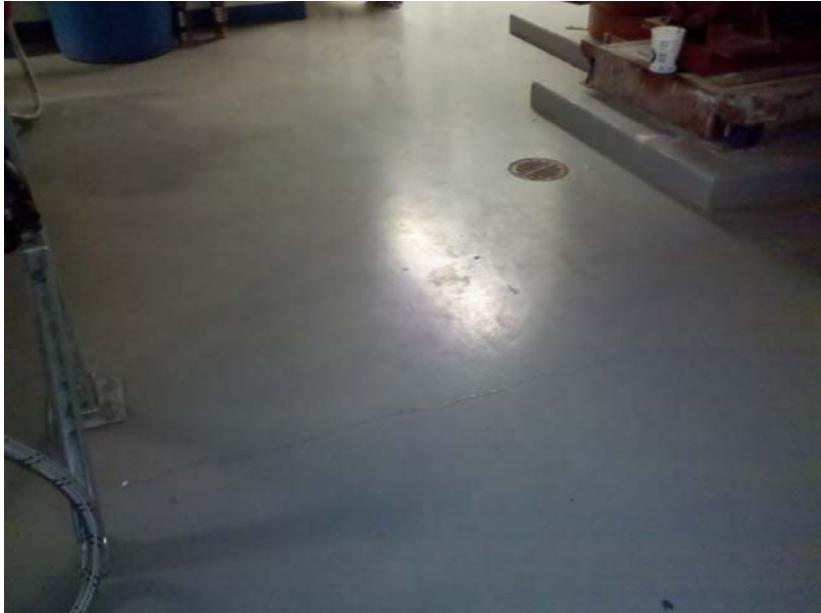
**3) Minor crack in boiler room floor.**

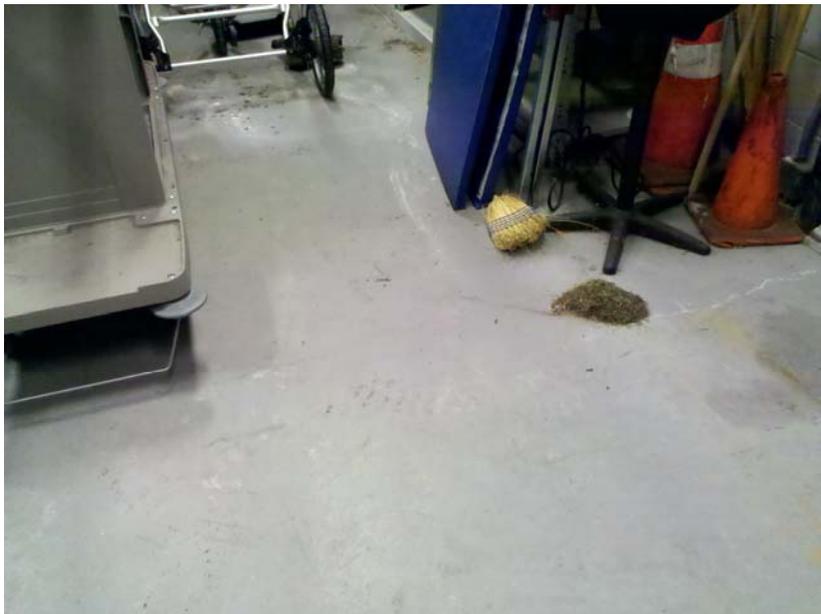
**4) Minor crack in storage room 44 floor.**

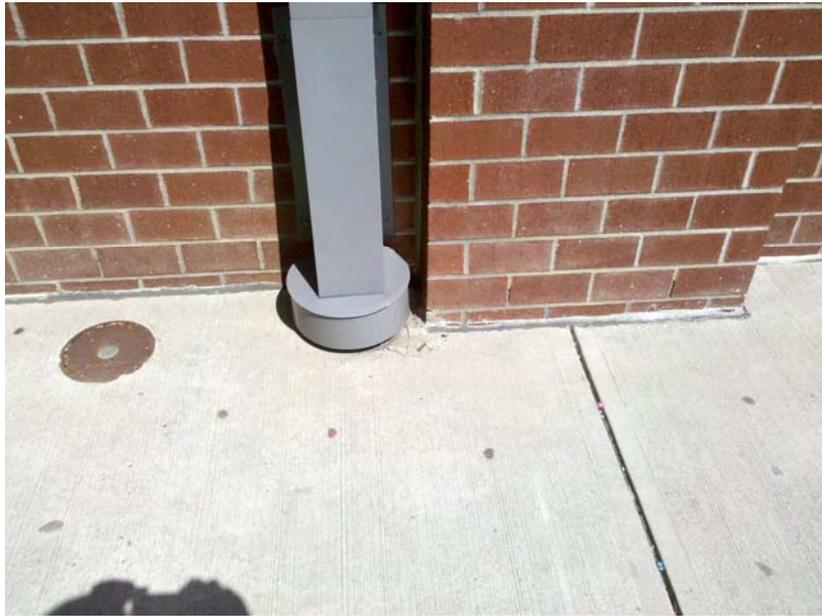
**5) Minor cracking of concrete next to light post.**

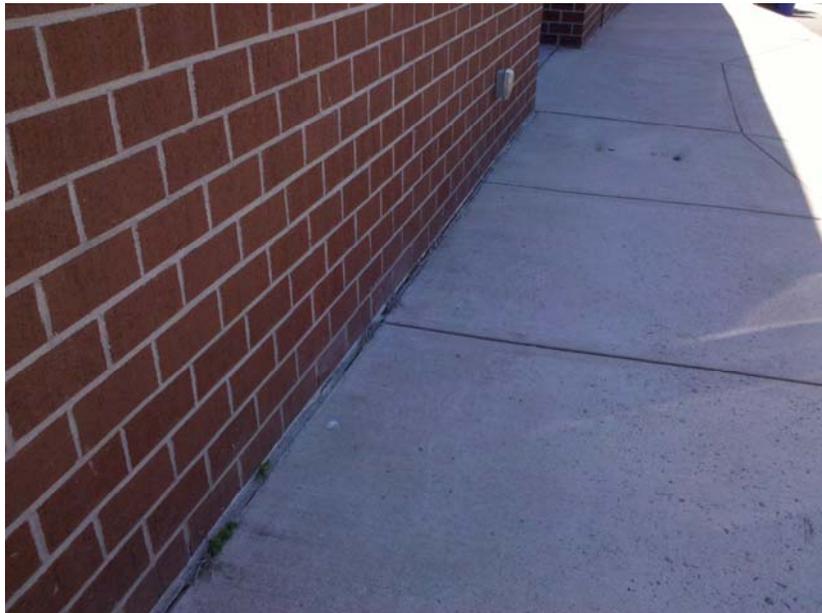
In several areas around the exterior of the school building, a bead of caulking has been installed in the joint between the foot of the brick building walls and the concrete walkways. The caulking prevents weather elements (i.e., rain, snow, and ice) from entering the joint space. As noted in previous reports, the caulking appeared deteriorated in several areas, and was observed separating from the wall and walkway surfaces. Although conditions were not indicative of a potential for soil exposures, TRC recommends repair/replacement of the caulking. Continued infiltration of weather elements into the joint could eventually separate and deteriorate the walkway.

**6) Vegetation growing between building and concrete sidewalk near loading docks.**

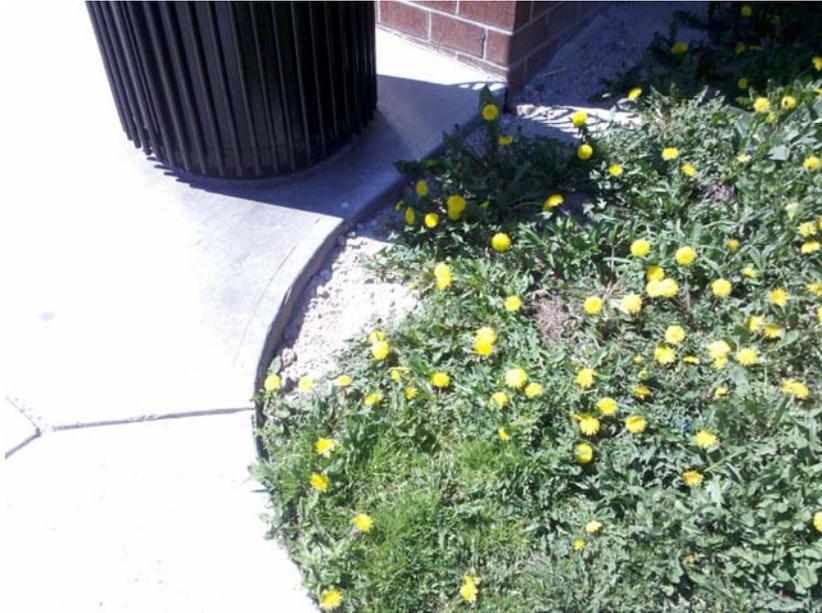
**7) Repair to prevent undermining of concrete walkway at northeastern entrance (repaired prior to December 2011).**

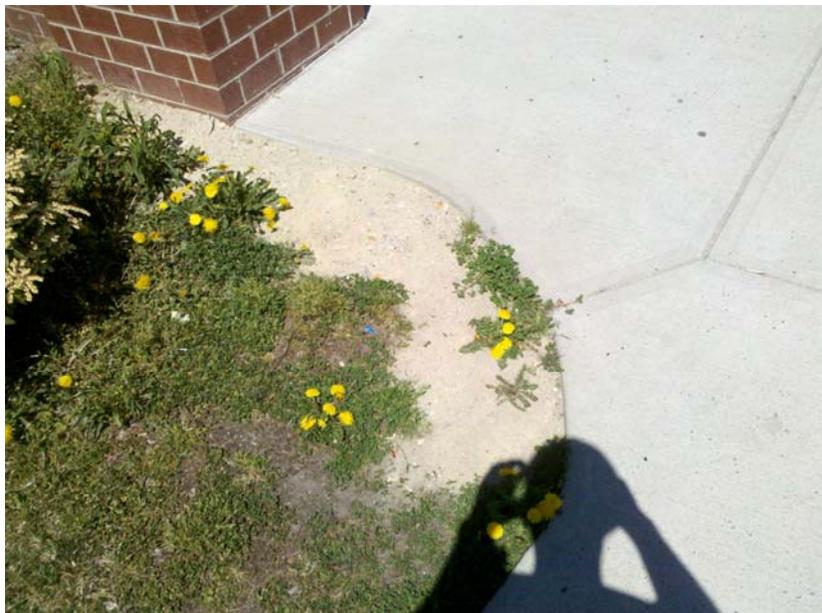
**8) Repair to prevent undermining of concrete walkway at northeastern entrance (repaired prior to December 2011)..**

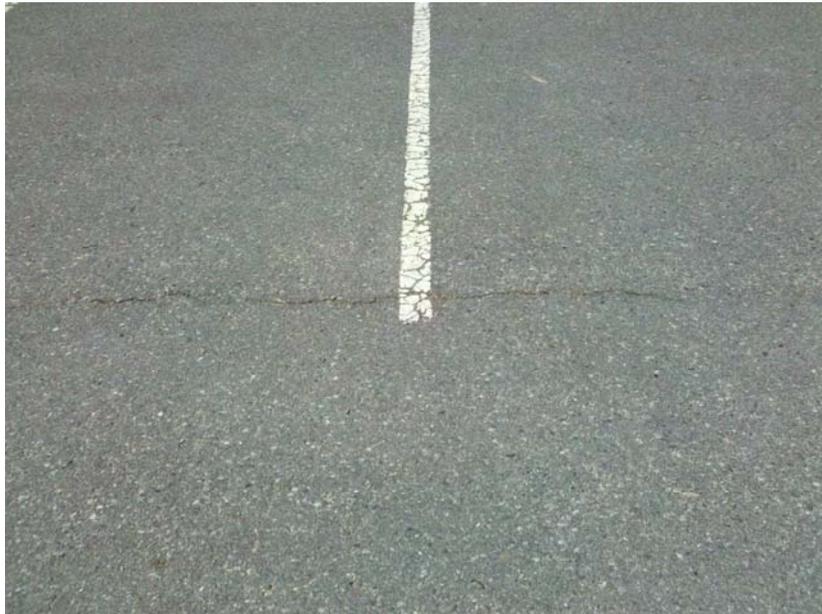
Cracks and seams greater than ¼-inch were again observed in the asphalt parking lots. The Plant Engineer indicated that repair would be scheduled for the summer of 2012. The asphalt seams at the entrances to the school parking lots have become greater than ¼-inch and should be repaired.

**9) Crack in asphalt parking lot north of school.**

Repair of the asphalt cracks and seams could be completed with an elastic asphalt filler/sealer or similar product.

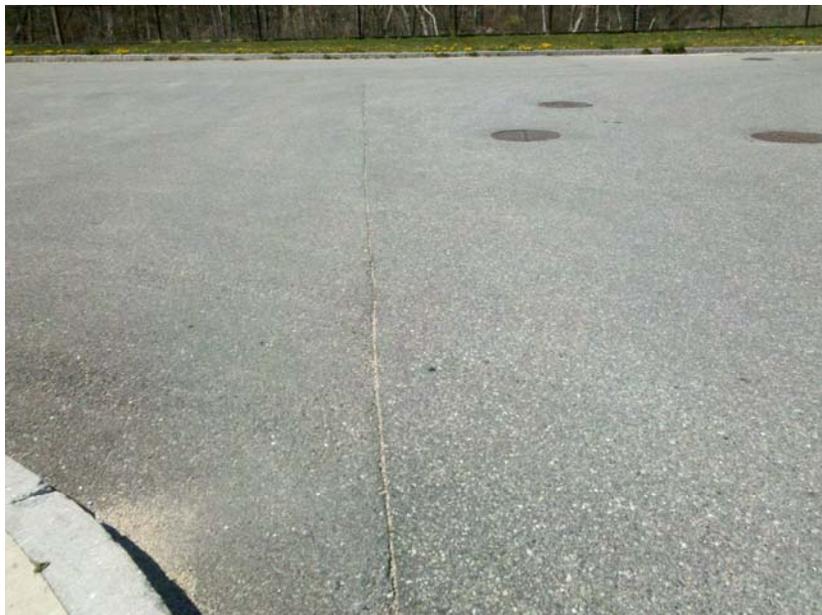
**10) Seam in asphalt pavement near loading docks.**

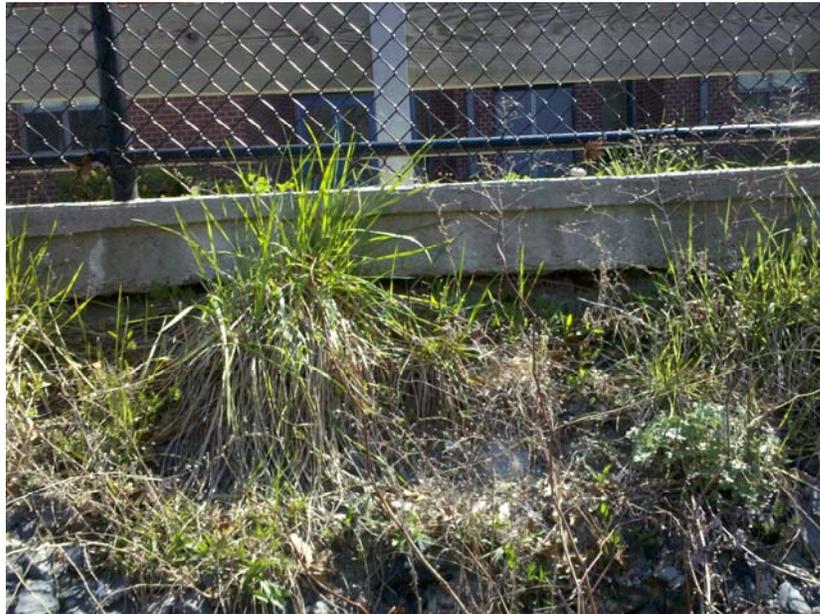
- Sloughing riprap is undermining the concrete fence support at the top of the slope, and filling the outlet of the storm water drainage culvert on the west side of the Site. Areas of soil erosion were observed along the upper slope, as well as a crack in the concrete fence support. The area appears relatively stable at this time, but the condition is likely due to an increase in steepness beyond the cap design slope. The crack in the concrete fence support is not identified as a cap integrity issue, but should be addressed to maintain the integrity of the fence.

1) The structural integrity of the fence may be compromised if the sloughing and erosion continues, see Photograph #11. A crack in the concrete fence support was also observed, see Photograph #12. The cap soils beneath the riprap may also become exposed and susceptible to erosion. The area appears stable at the moment, but the condition is likely due to an increase in steepness beyond the cap design slope. The extent of erosion seems similar to the conditions observed during several previous inspections. See inspection report letters dated August 31, 2011 and May 4, 2011.

**11) Undermining of concrete structure for fence west of school.**

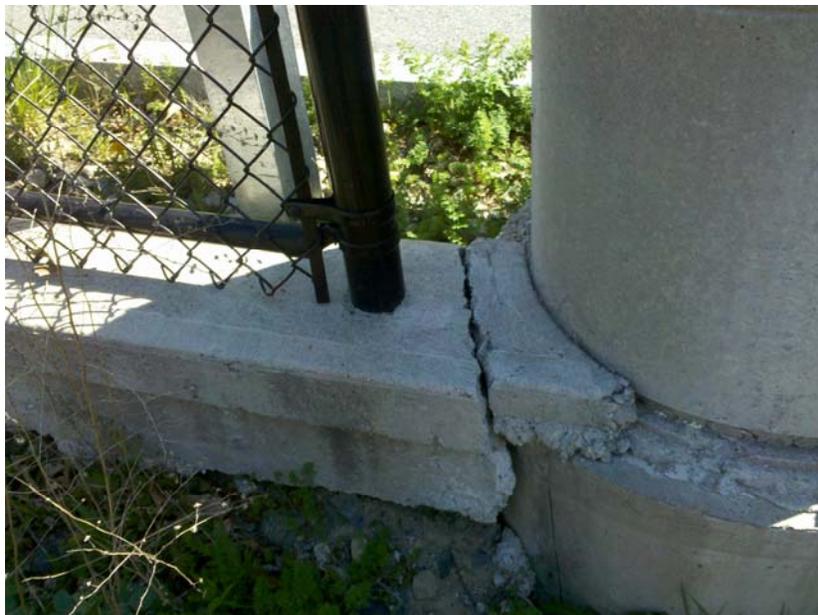
**12) Crack in concrete fence support.**

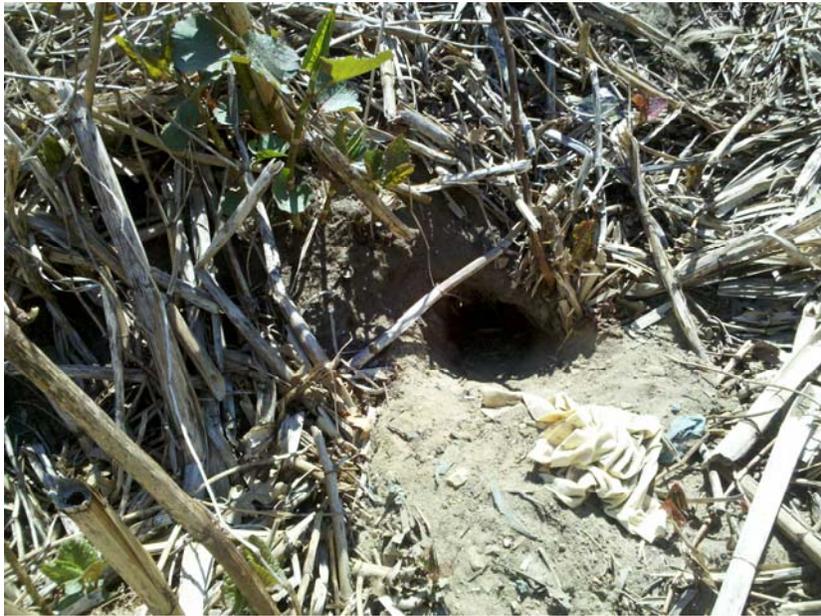
- Several new small holes were observed along the very northern edge and southwestern edge of the cap, which appear to have been burrowed by small animals.

2) New animal burrow holes were observed on the slopes to the north and southwest of the school, see Photograph #13.

**13) Animal burrow at southwest corner of cap. Knotweed has been cut back.**
