Project Number 115058

June 19, 2008

Subject: Spring 2008 Cap Inspection
Keith Middle School
New Bedford, Massachusetts

SITE PHOTOGRAPHS
May 2008 Cap Inspection
Keith Middle School
New Bedford, Massachusetts

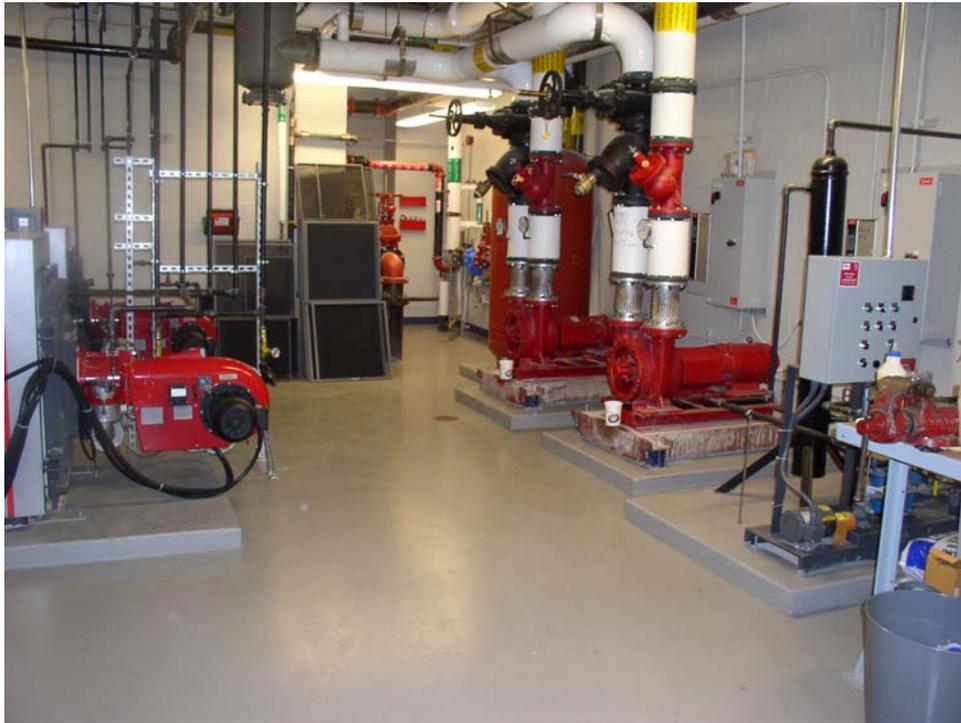
1) Boiler in Boiler Room.

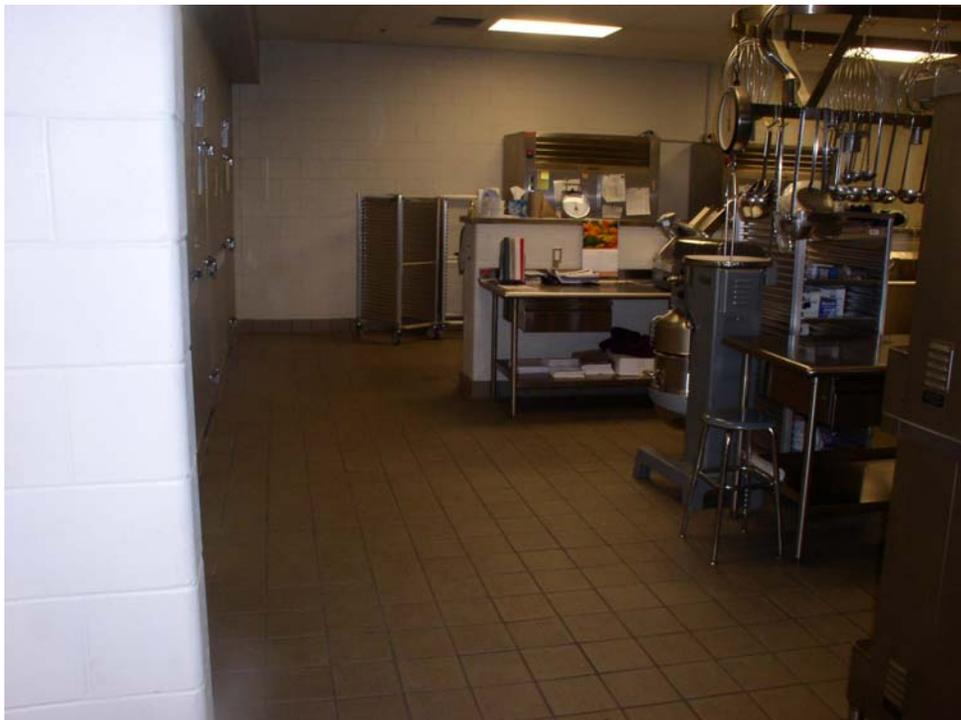
2) Kitchen.

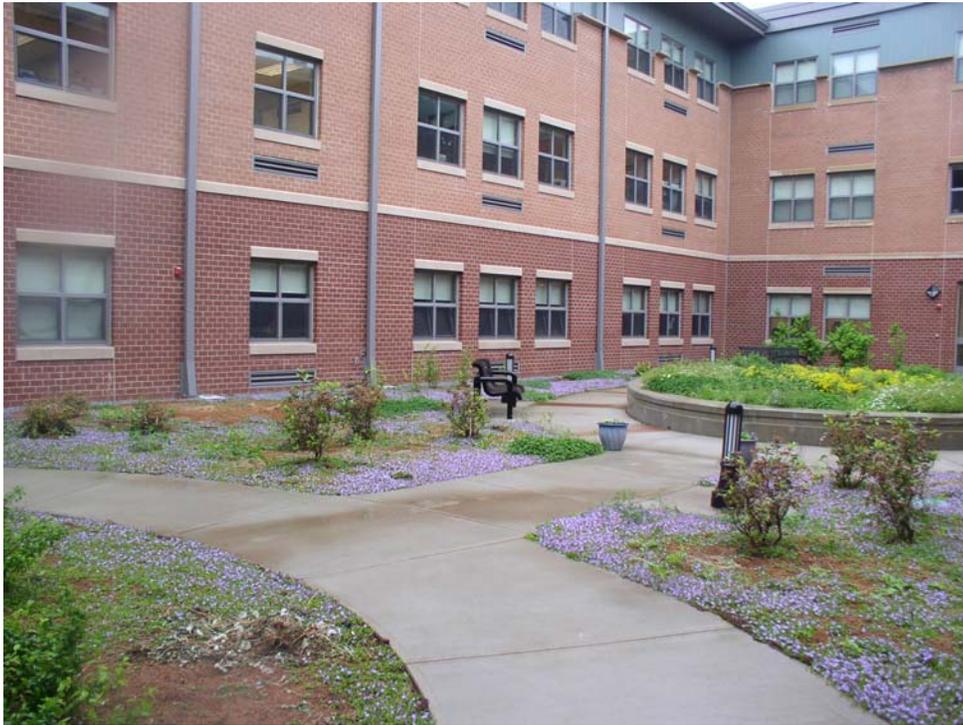
3) Courtyard looking North.

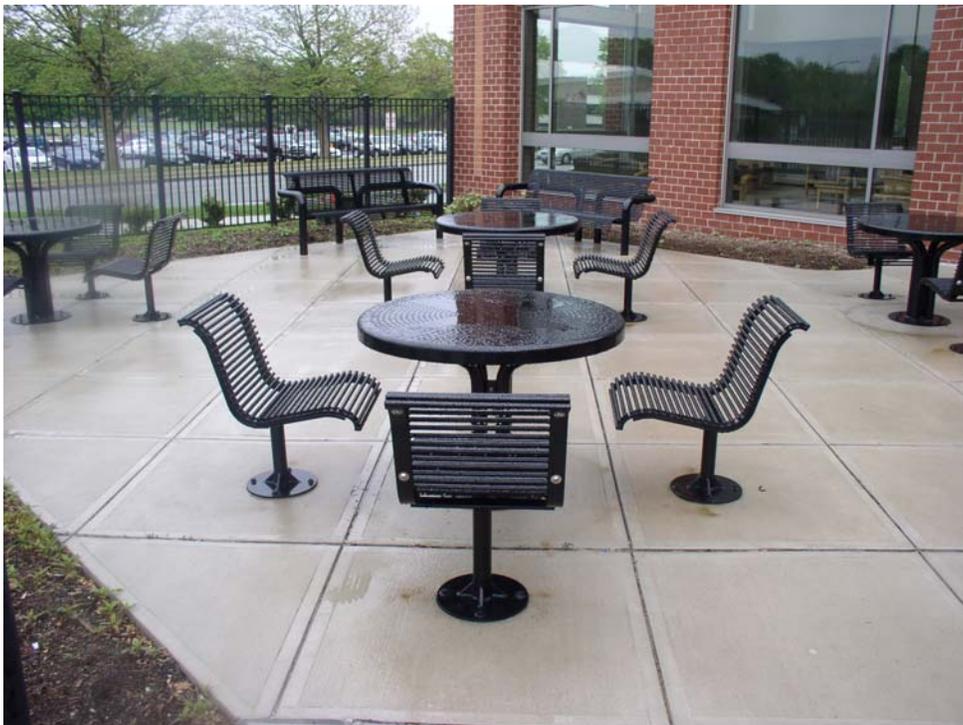
4) Community Room courtyard.

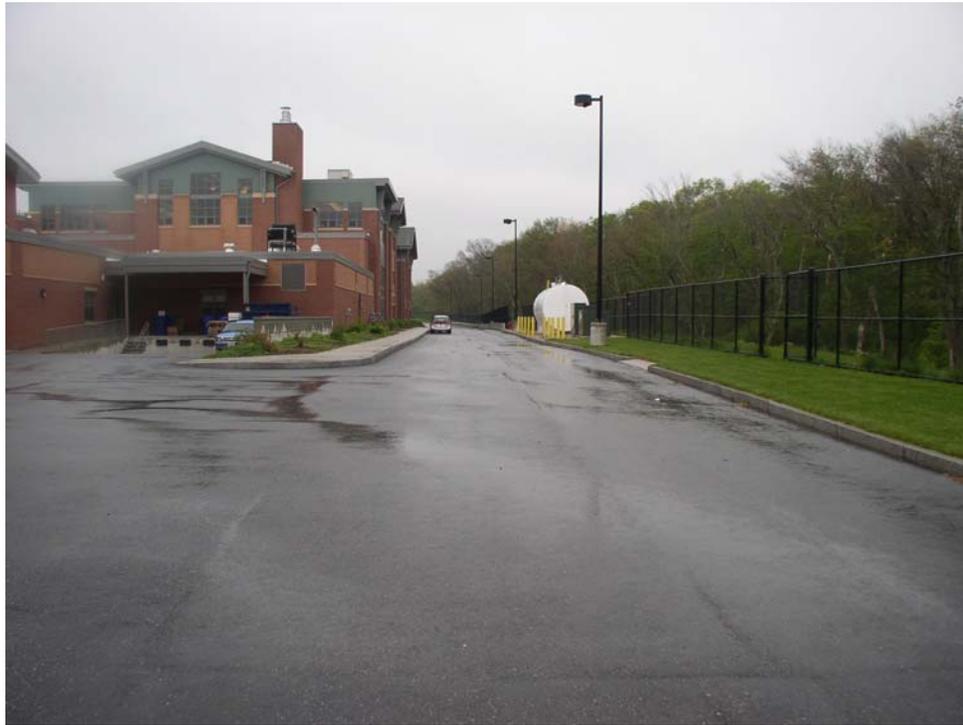
5) West side of School looking South.

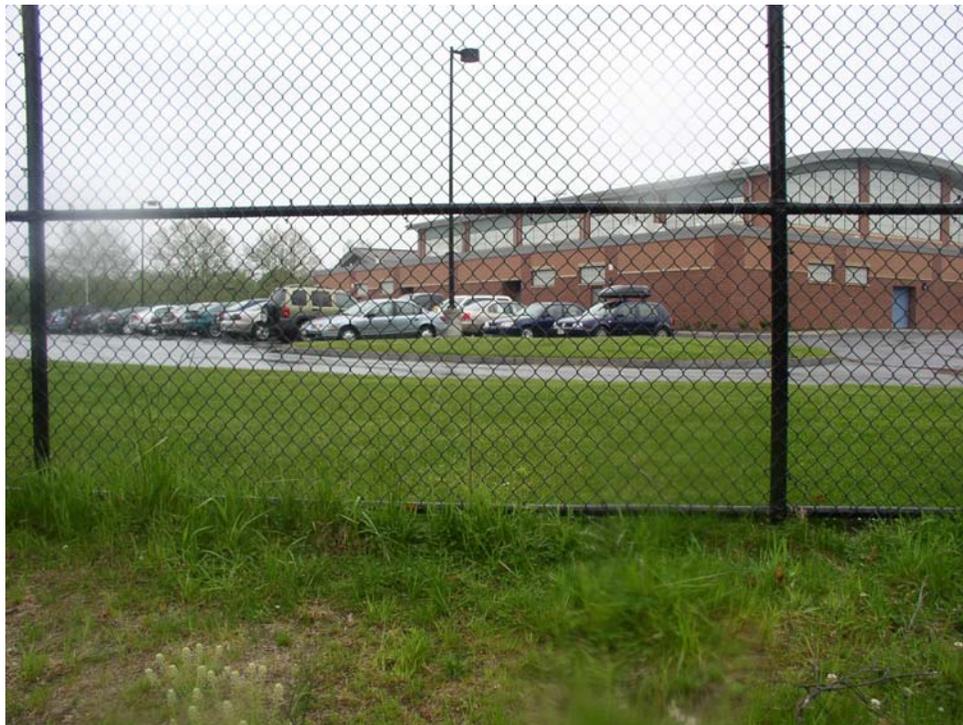
6) North Parking Lot facing Southeast.

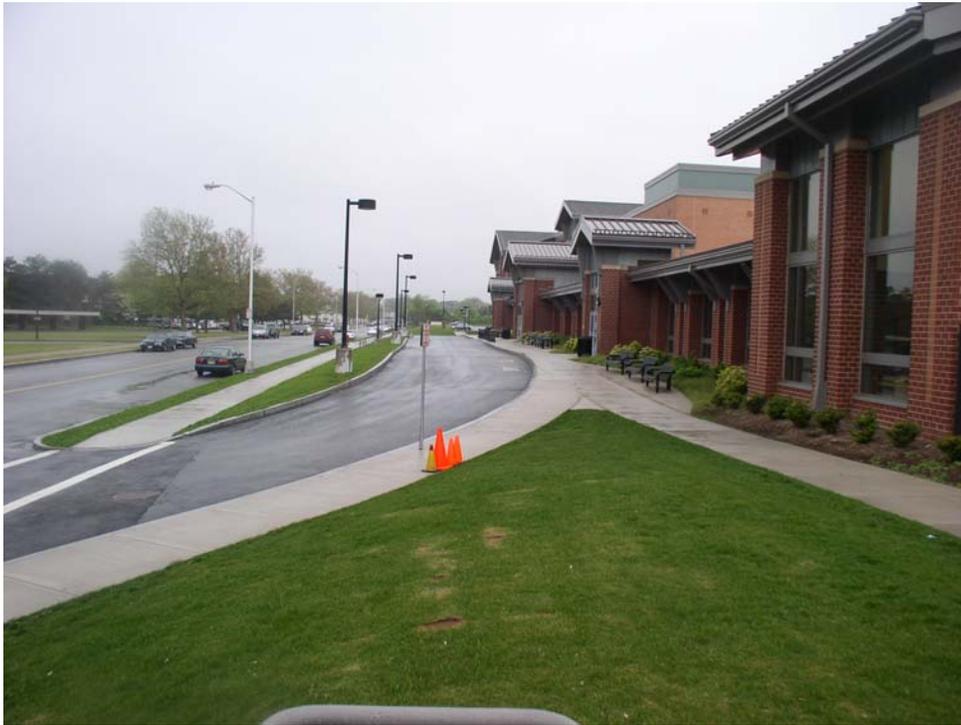
7) East side of School facing South.

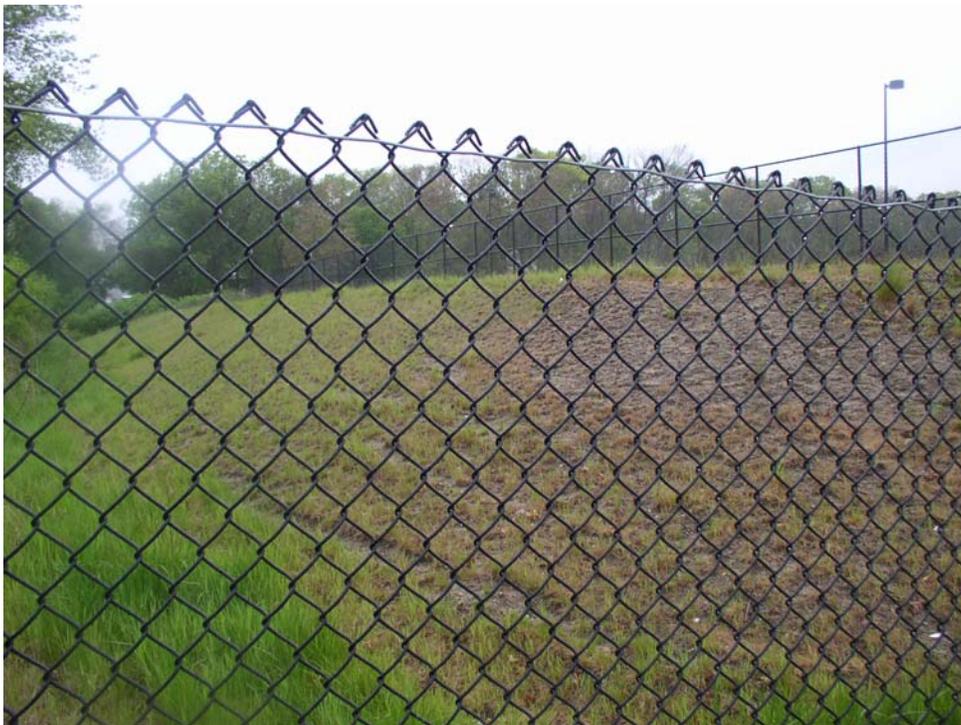
1. The ground surface at the southeastern corner of the school property is sparsely vegetated. See Photograph #8.
2. The slope failure in the steep slope between the wetland to the west and the southern parking lot to the east The hay bales, silt fence and geotextile filter fabric were all in good condition at the time of the inspection and no further slumping was observed. A permanent repair is required and has been designed. The City is in the process of soliciting cost estimates from a contractor.

8) Vegetation at Southeast corner of property.

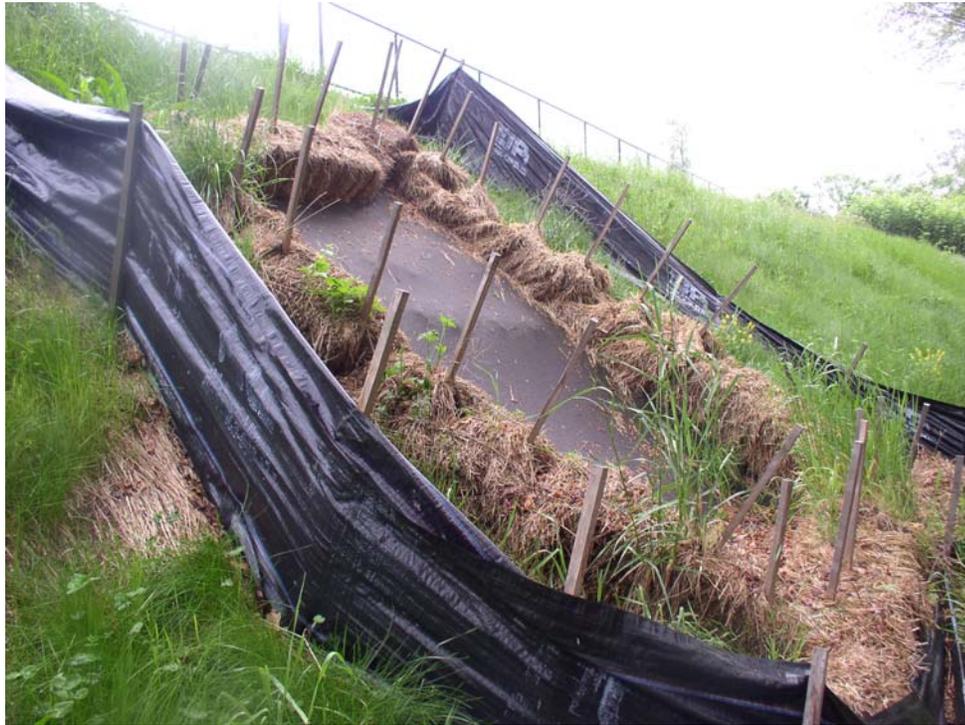
9) Temporary slope failure repair.

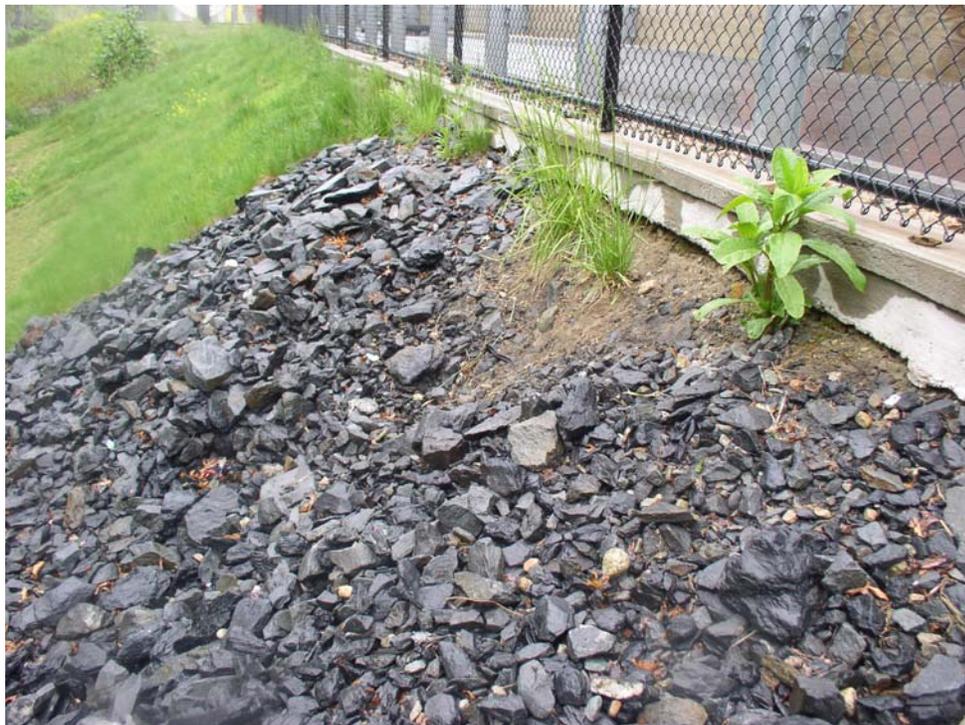
3. Riprap stabilization rock placed around the outlet of one of the storm water drainage culverts is falling down the slope and filling the end of the culvert. The outlet in question is the fourth outlet south of the above ground oil storage tank. The falling riprap has undermined the concrete fence support at the top of the slope and the deposited rock is impeding the flow of water from the culvert. The structural integrity of the fence may be compromised if the sloughing of the riprap continues. The cap soils beneath the riprap may also become exposed and susceptible to erosion. See Photograph #10.

10) Sloughing rip rap at culvert outlet. Note undermining of fence support.

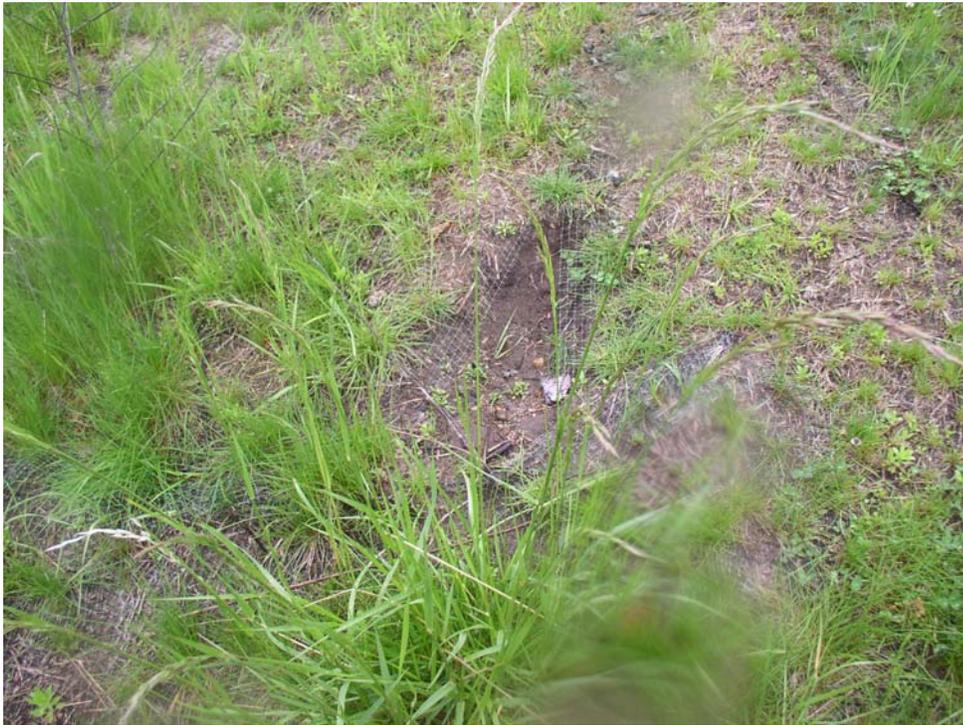
4. There is minor erosion at the northwestern corner of the property that is approximately 2 to 3 inches in depth. The rill runs the length of the slope. See Photographs #11 and #12.

11) Minor erosion Northwest corner.

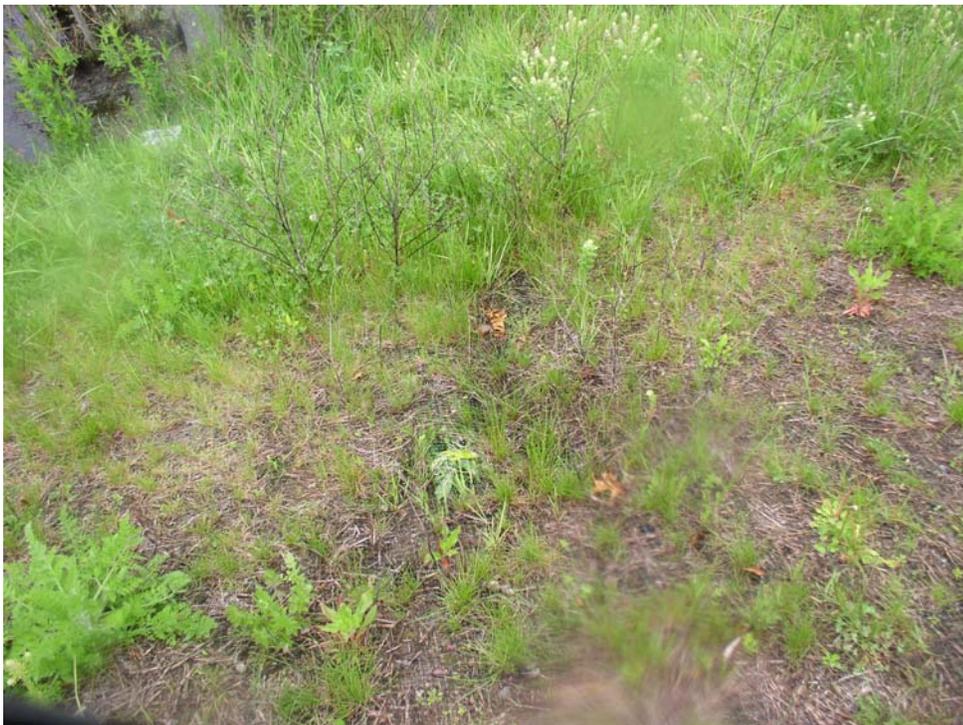
12) Minor rill Northwest corner.

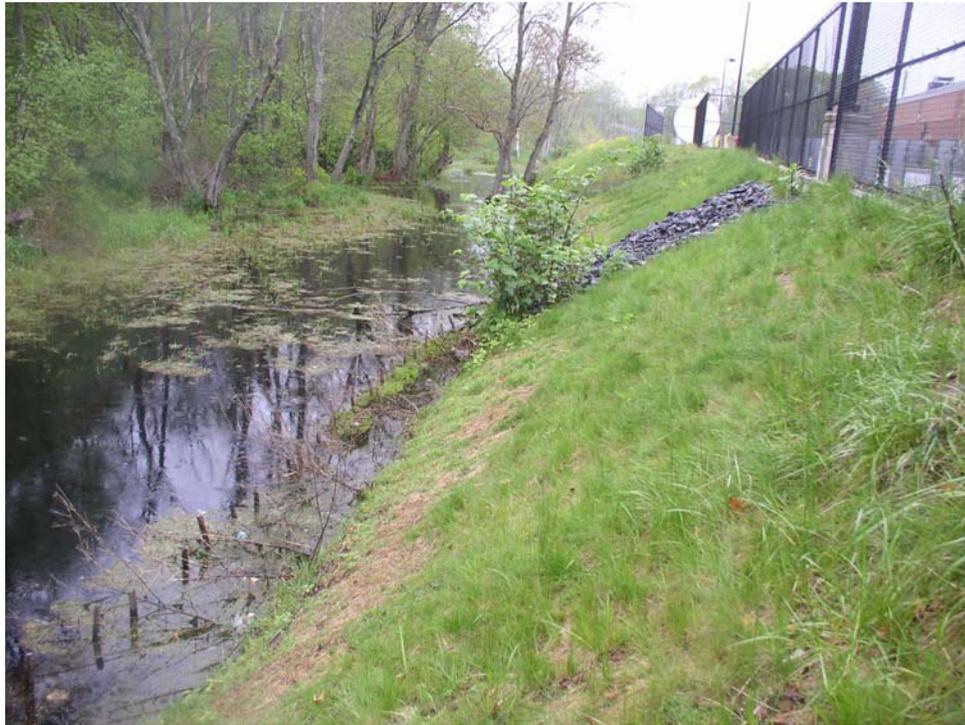
13) Vegetation just north of slope failure. Eastern slope facing North.

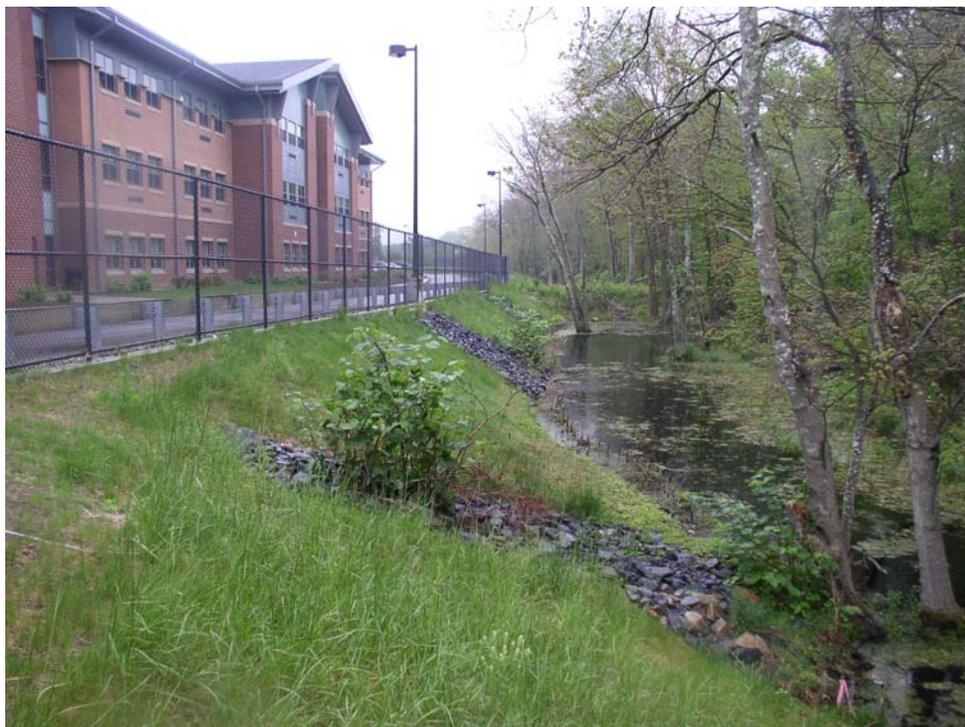
13) Eastern slope facing South.

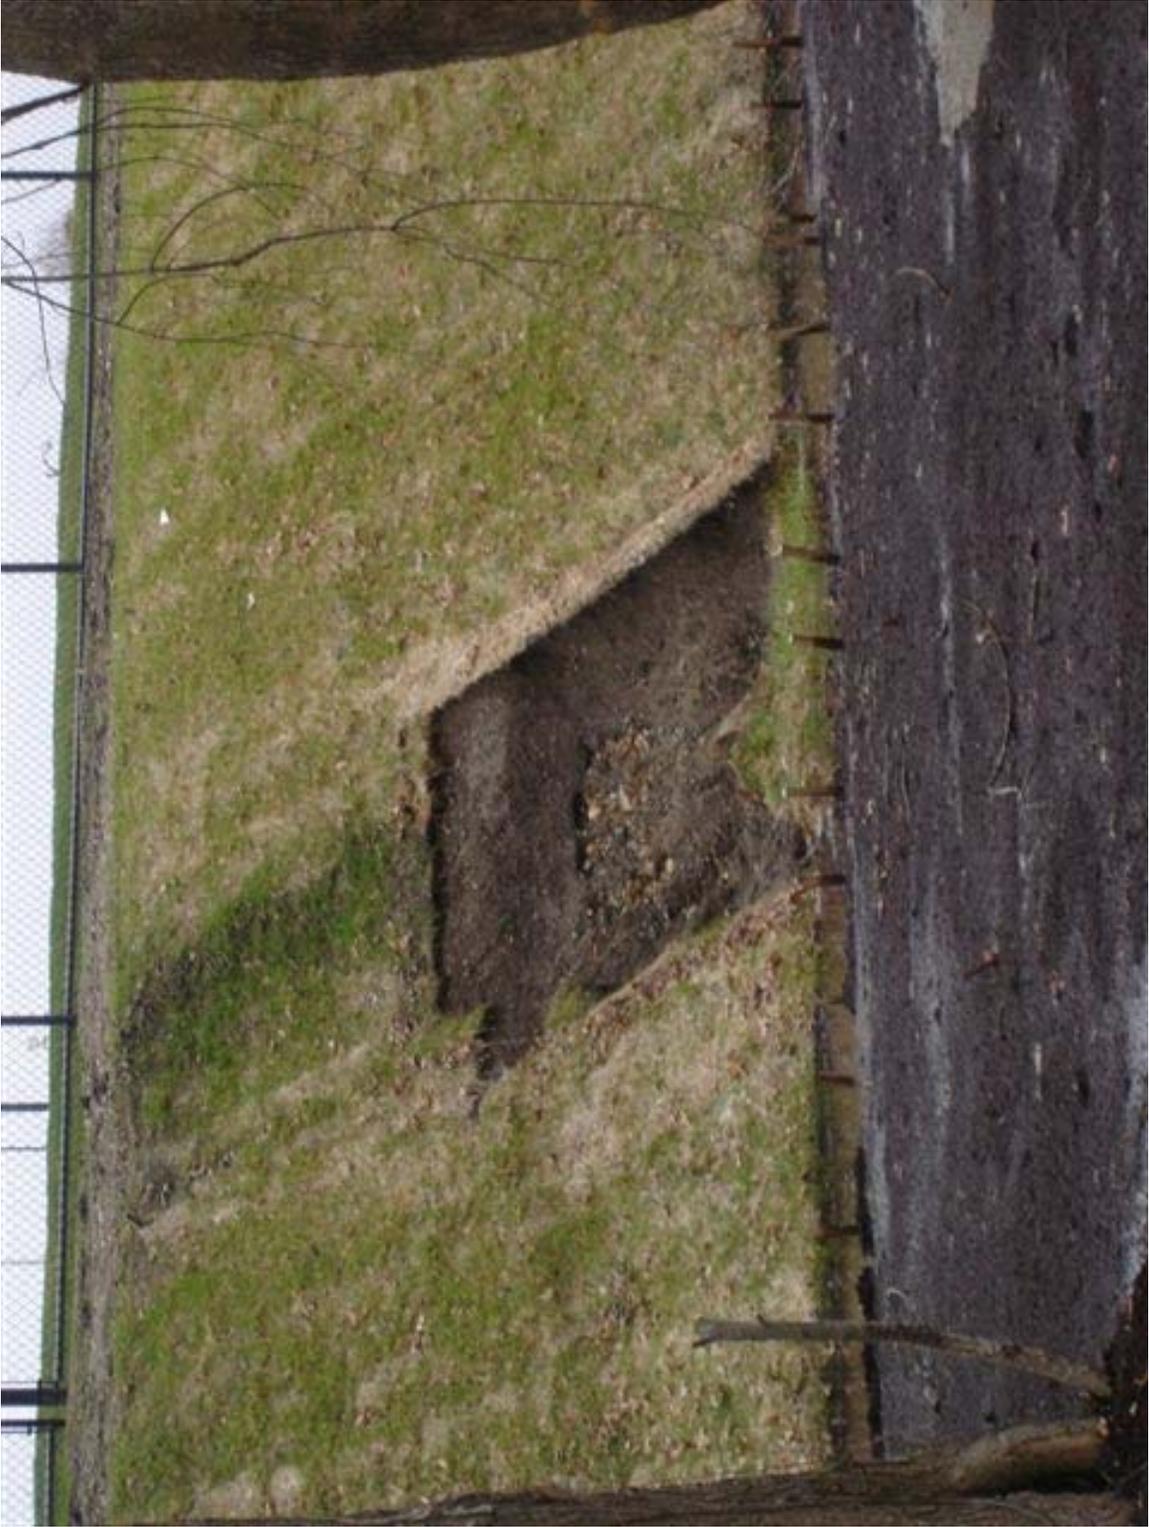
April 2006 Slope Failure Photograph

(Prior to Temporary Repair)
