**Subject: Fall 2010 Cap Inspection
Keith Middle School
New Bedford, Massachusetts**

CAP INSPECTION FORM KEITH MIDDLE SCHOOL

SITE PHOTOGRAPHS
November 2010 Cap Inspection
Keith Middle School
New Bedford, Massachusetts

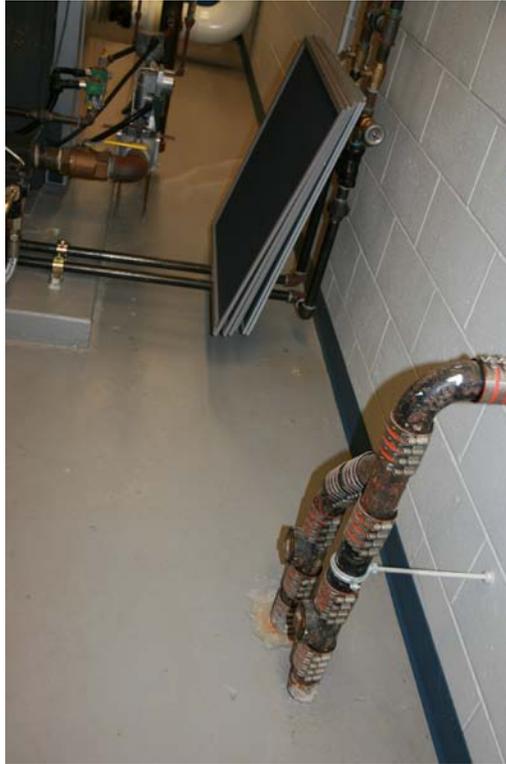
1) Pipe penetrations in boiler room.

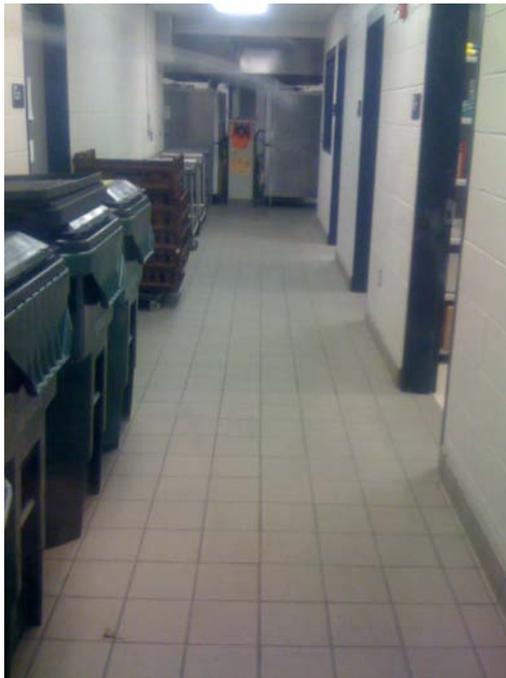
2) Kitchen.

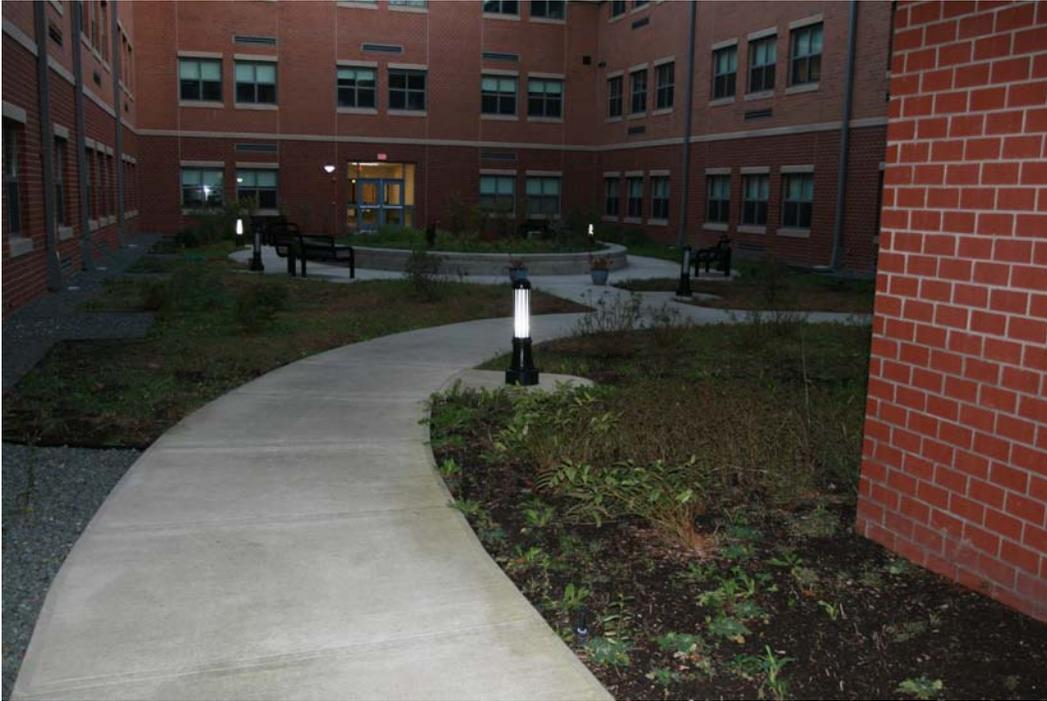
3) Courtyard looking North.

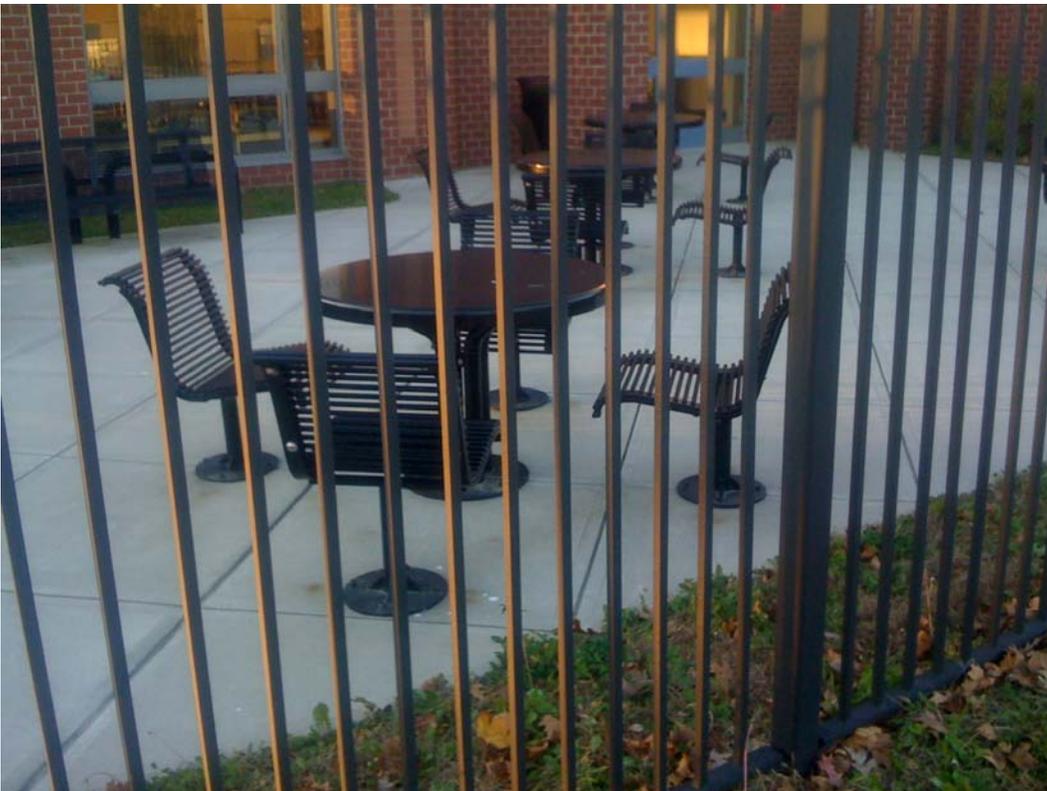
4) Community room courtyard.

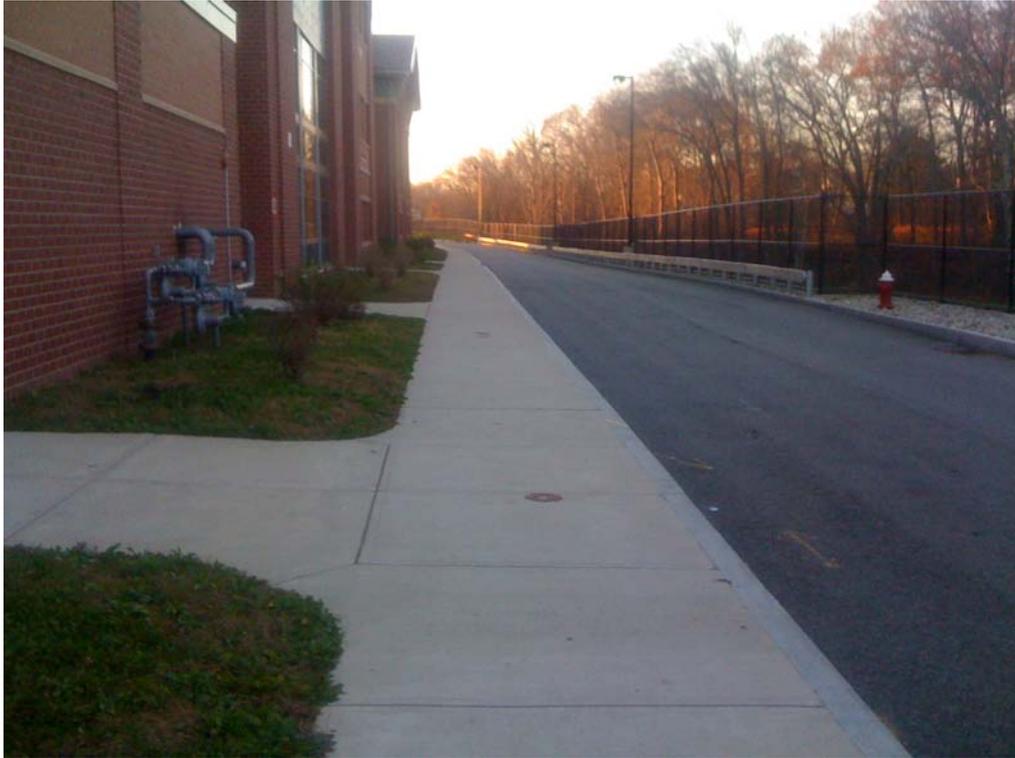
5) West side of school looking South.

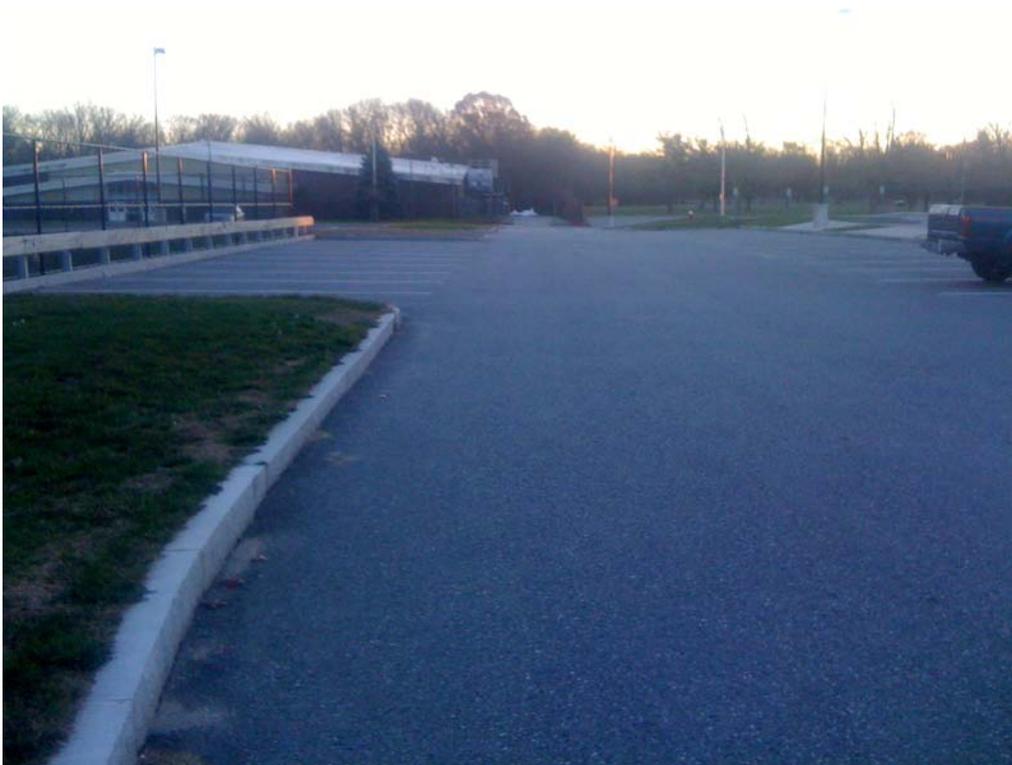
6) North parking lot facing Southeast.

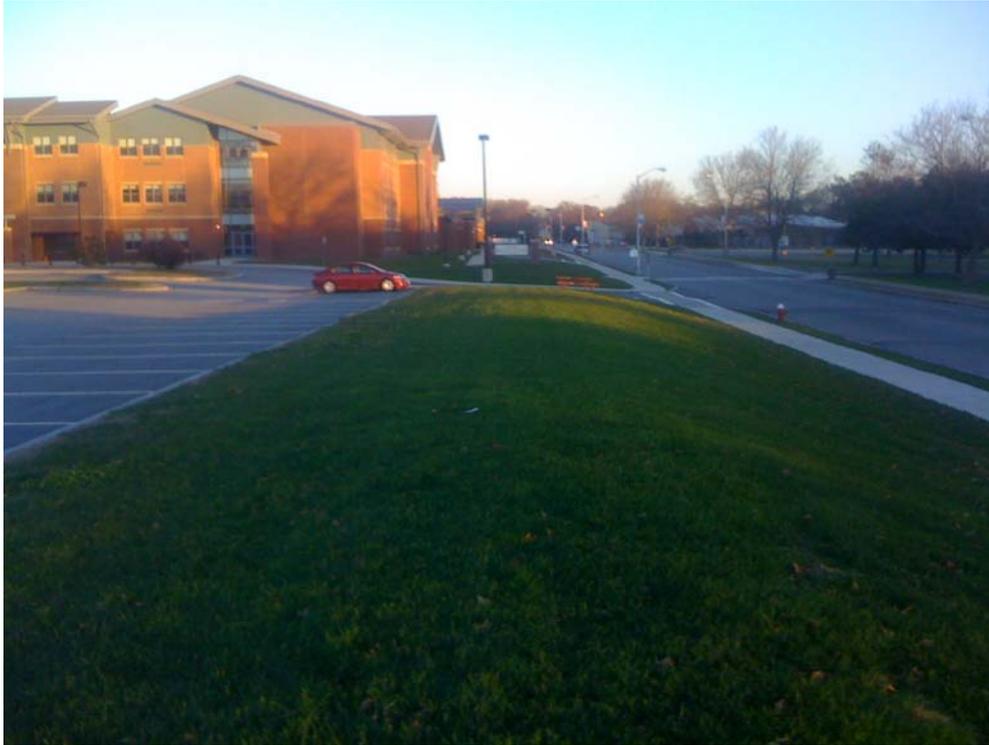
7) East side of school facing North.

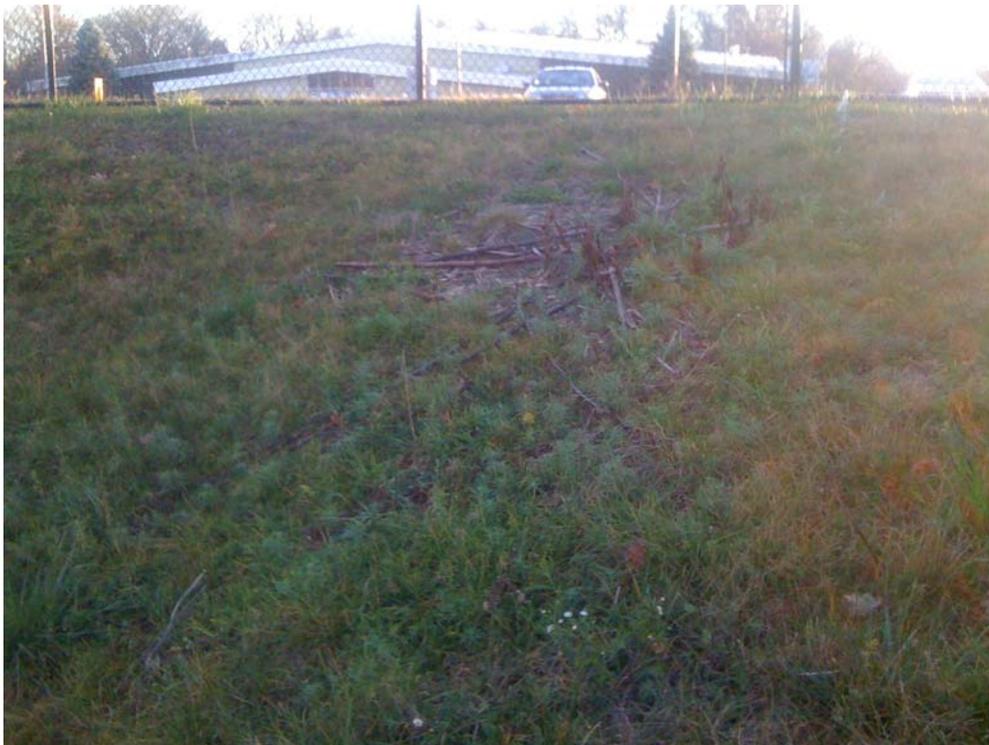
8) Cut woody vegetation.

1. Woody growth was cut along the perimeter of the cap, adjacent to the wetlands, including the growth in front of discharge structures. See Photographs #8, #11, #10, #13. The repair is adequate. TRC recommends cutting back any vegetative growth in front of the discharge structures if any returns in the spring.

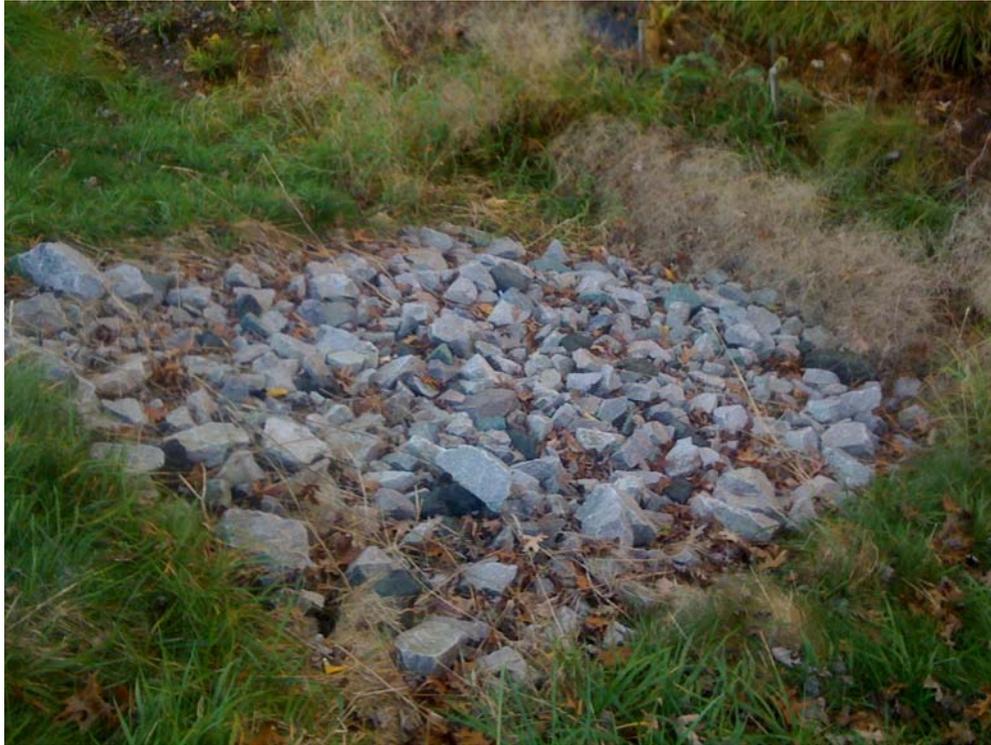
9) Temporary slope failure repair.

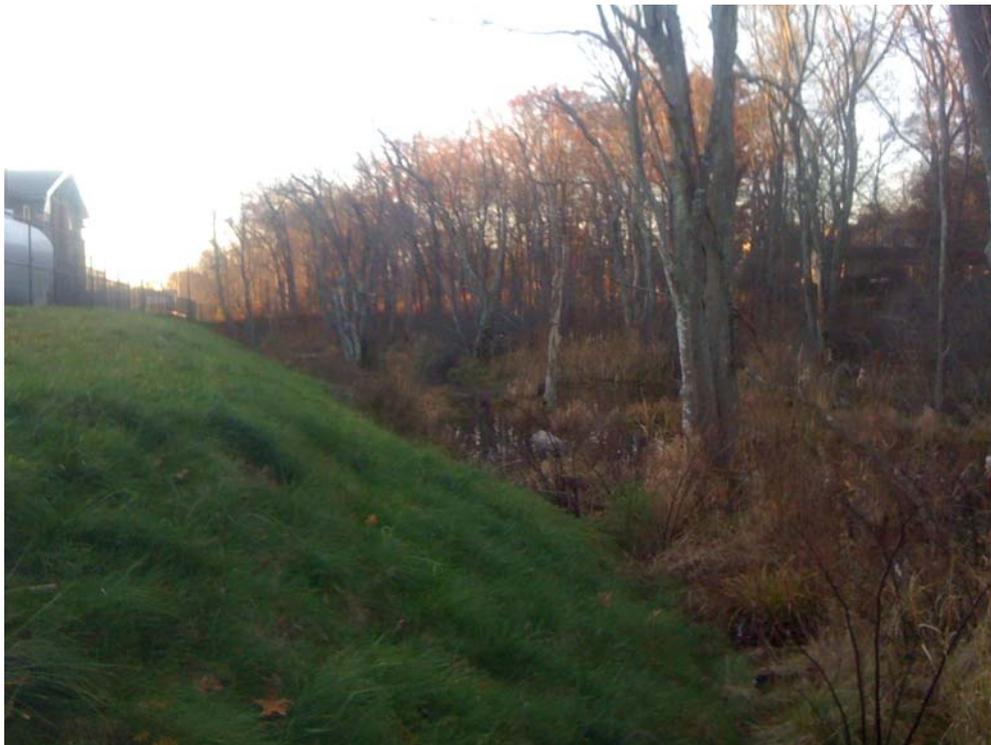
10) Western slope facing south.

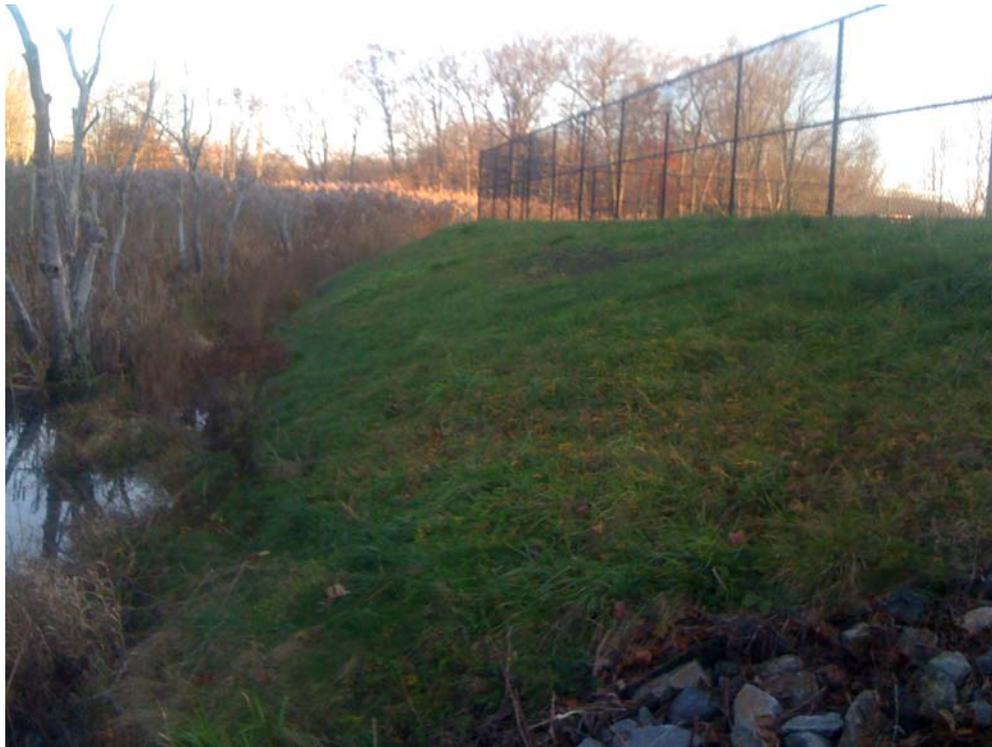
11) Eastern slope facing north. Woody vegetative growth cut.

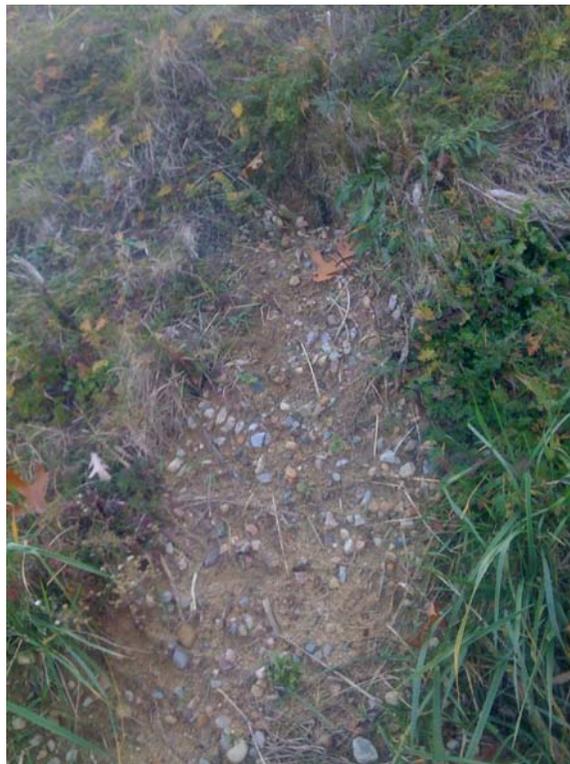
12) Filled in gopher hole.

2. Gopher hole was filled in. See Photograph #12.

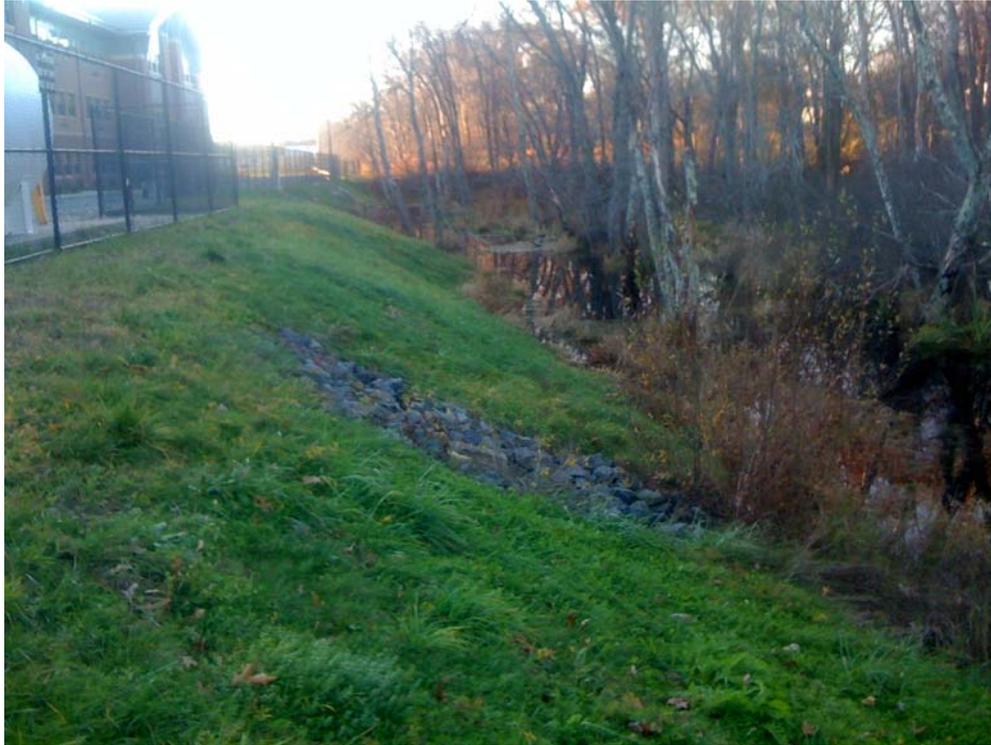
13) Eastern slope facing South.

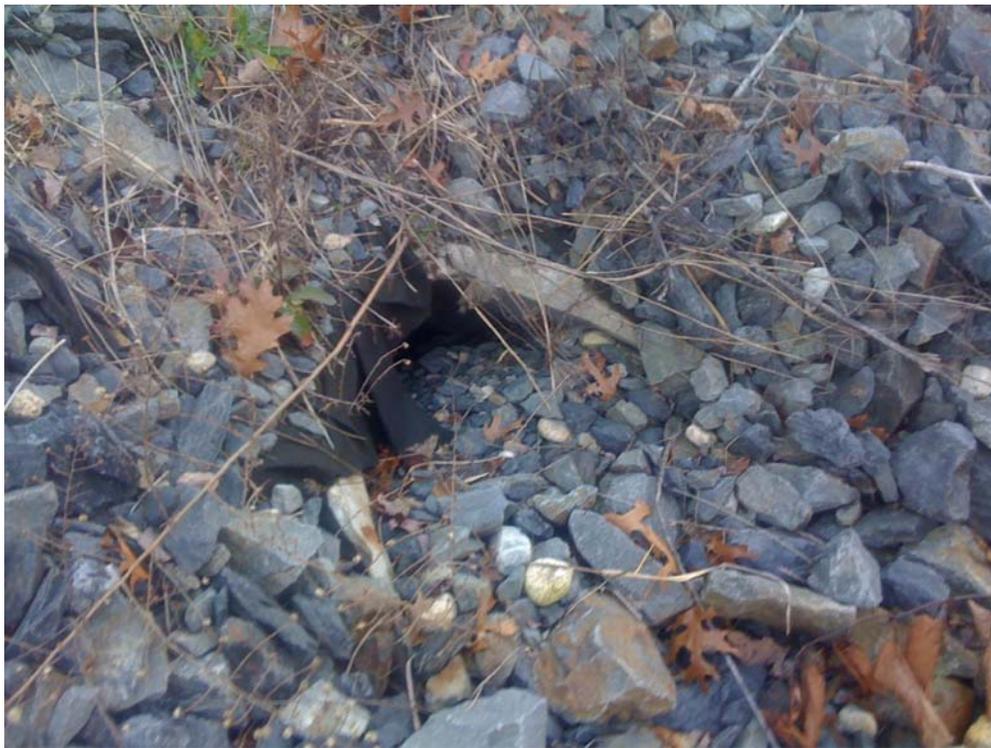
1. Riprap stabilization rock placed around the outlet of one of the storm water drainage culverts is falling down the slope and filling the end of the culvert. The outlet in question is the fourth outlet south of the above ground oil storage tank. The falling riprap undermined the concrete fence support at the top of the slope. See Photographs #14 and #15. The structural integrity of the fence may be compromised if the sloughing of the riprap continues. The cap soils beneath the riprap may also become exposed and susceptible to erosion. The area appears stable at the moment. The extent of erosion seems similar to the conditions observed during the previous inspection. See inspection report letter dated May 11, 2010, Attachment 3, Photograph #10.

14) Culvert filled in with riprap.

At this time the black separation fabric that demarcates the underlying contaminated fill from the clean imported fill is not visible. However, these areas should be repaired in order to prevent further erosion or cap damage that could eventually expose the separation fabric. Please refer to the attached Cap Inspection Form for additional details concerning observed conditions.

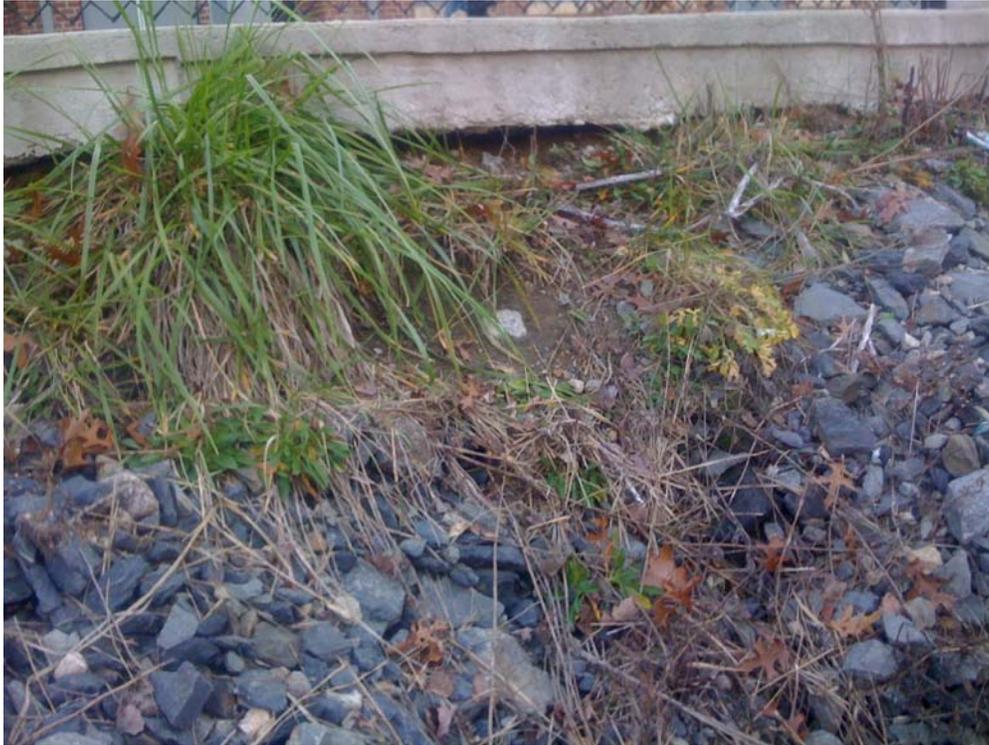
15) Undermining of concrete fence support. No evident change.

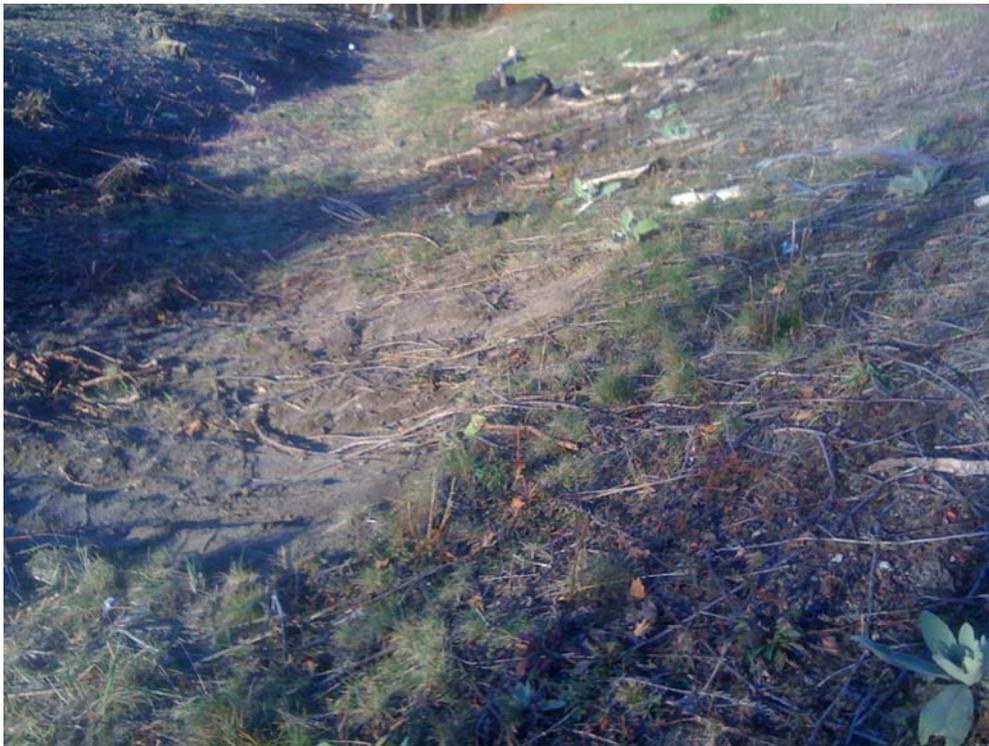
2. Some erosion has occurred on the southern slope of the cap, adjacent to the Bethel A.M.E. property. The slope was inspected and Photographs #16 through #18 illustrate the condition of the surface cover on this slope. There is one area of erosion, located at the toe of slope, approximately 110 feet west of Hathaway Boulevard (Photograph #16). The southeastern corner of the cap suffered some minor damage from a piece of construction equipment (Photograph #17).

16) Area of erosion and sparse grass growth.

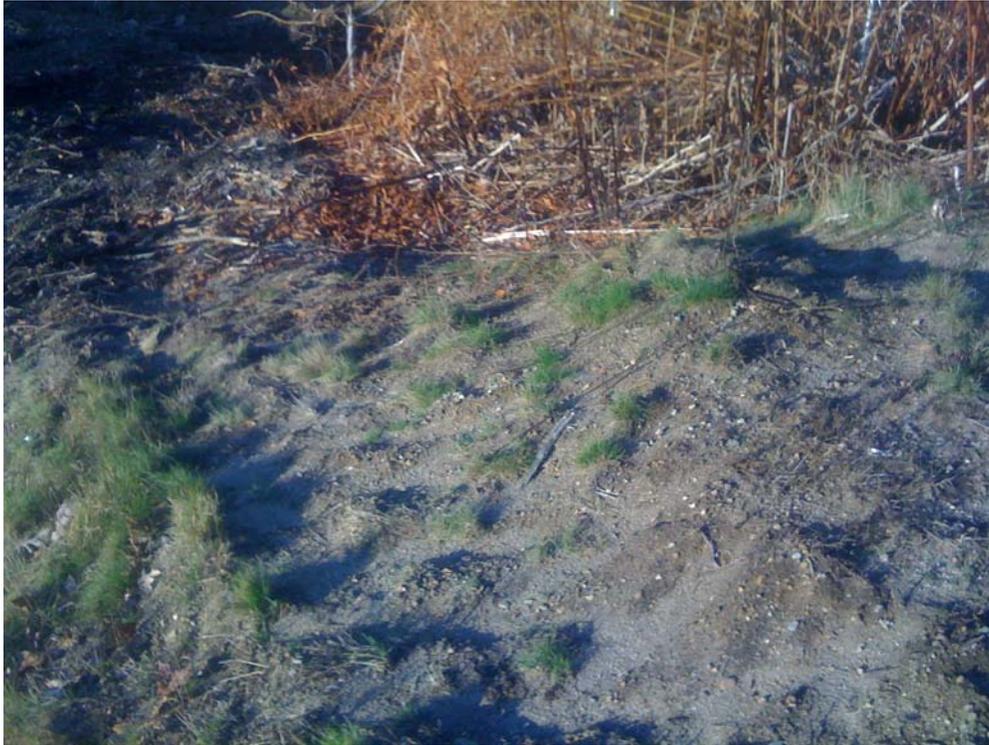
17) Southeastern corner with tracks evident.

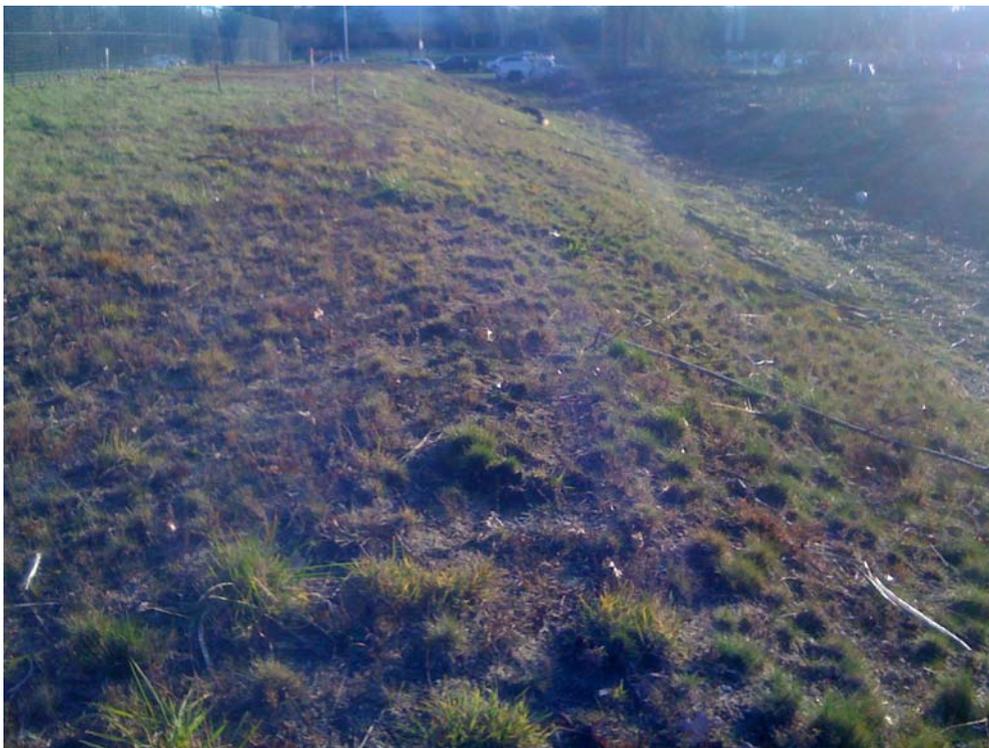
18) Southern slope facing west.

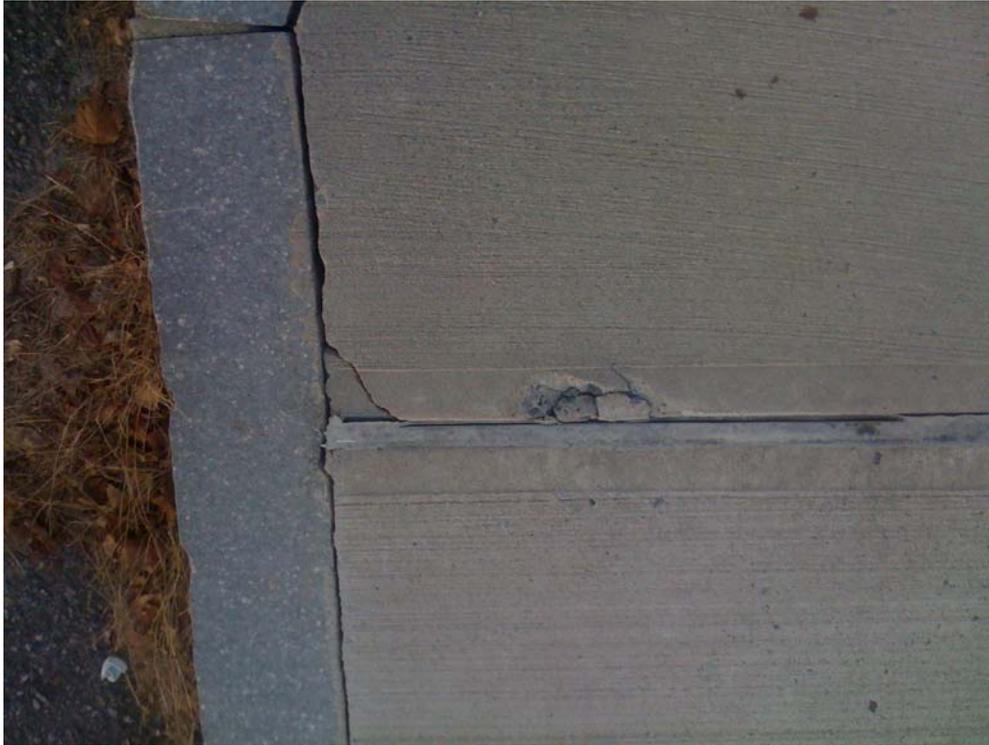
Some very minor cracking of the concrete sidewalks were observed but exposure to underlying soils is not a concern. The cracks will be monitored during future inspections. See Photographs #19 and #20.

19) Minor concrete sidewalk crack.

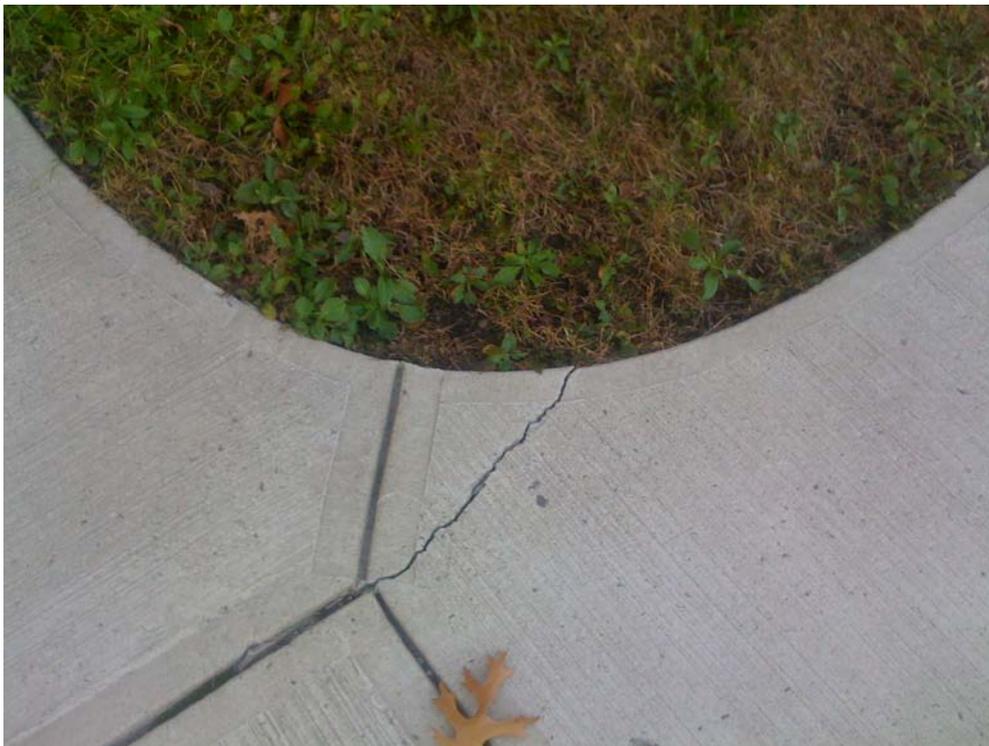
20) Minor concrete sidewalk crack.
